Technical Memorandum

Re. Forensic Desktop Study Report: California LTPP Test Section 06_7452

ATTACHMENT A. PAVEMENT CORES FROM SECTION 06_7452 OBTAINED IN FEBRUARY 2020.

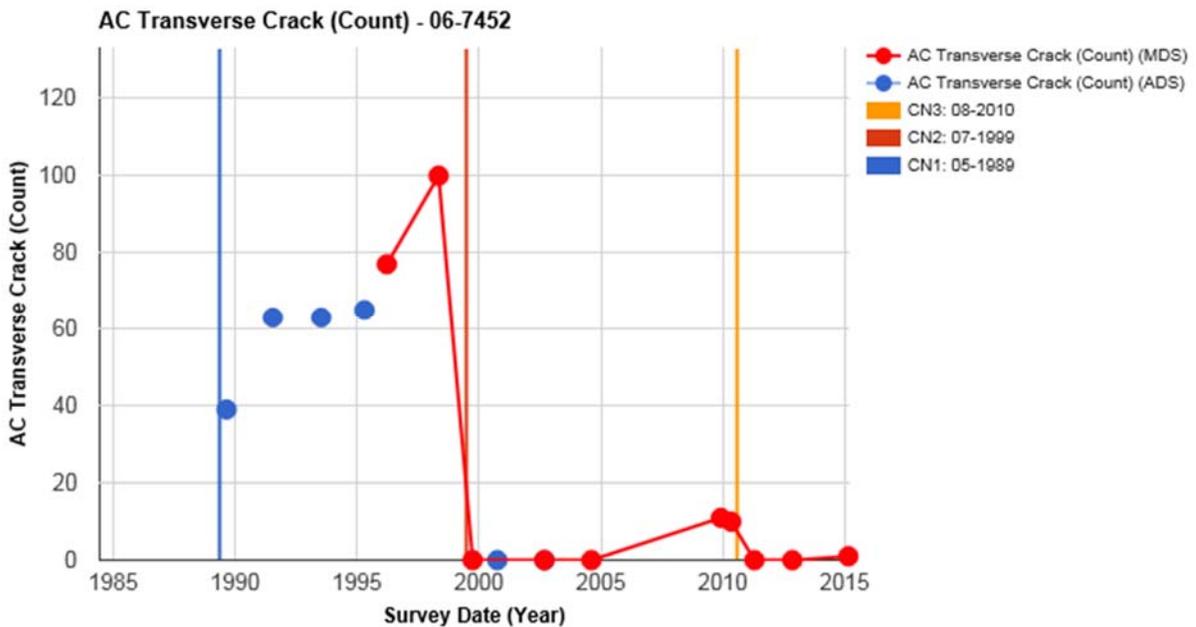
Figure 5. Time history of the number of transverse cracks.

Figures 5 and 6 show the time history of the number and length of transverse cracks. As shown in these two figures, the number of transverse cracks increases from 39 in 1989 to 100 in 1998, while the length of that cracking increases from 195 ft to 610 ft over the same time period. This would support the earlier theory that the backcalculated layer moduli for the lean concrete appears reasonable if the layer has developed a network of transverse cracks, which appears to be the case. It also supports the theory that the 1989 modulus value is high because the extent of transverses cracking had not yet fully developed, which again is supported by the transverse cracking data.

Figures 5 and 6 also show that the amount of transverse cracking remained very low after the application of the 1999 AC overlay; i.e., the transverse cracking did not reflect through either the 1999 or 2010 AC overlays. This raises an important issue that, if possible, needs to be investigated: why did transverse cracking reflect from the lean concrete base through the original AC surface layer, but not the overlays? One option, for example, would be to core at locations where transverse cracks were observed at the end of the CN = 1 period, but where transverse (reflection) cracks were not observed after placement of the first AC overlay in 1999.

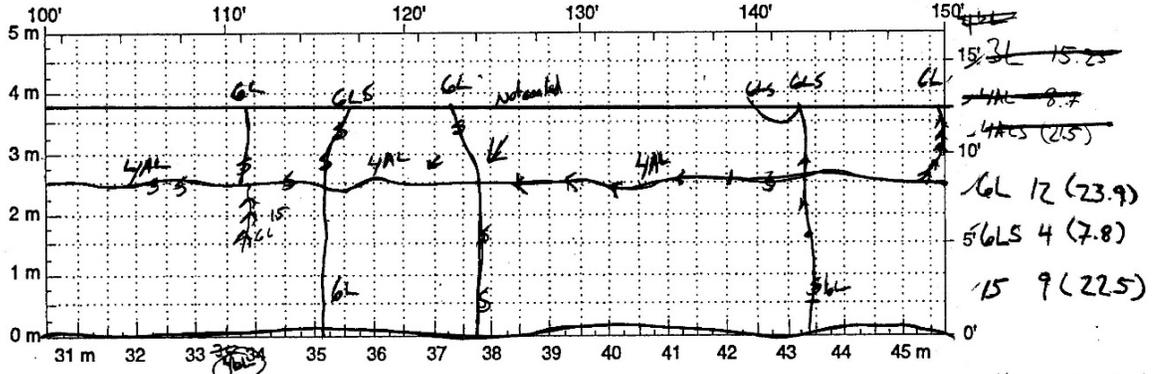
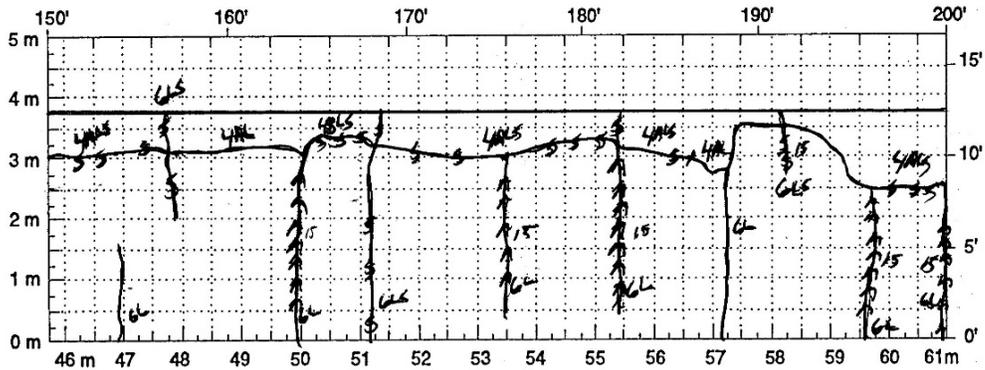
Figure 7. May 1998 Distress map from station 100 to 200 on test section 06_7452.

Figure 7 is the hand drawn distress map of the test section in 1998 prior to the application of the first overlay. This map illustrates the amount of transverse cracking on the test section. There is also a significant amount of non-wheel path longitudinal crack near the left edge of the test lane; this distress type is addressed later in the memorandum.

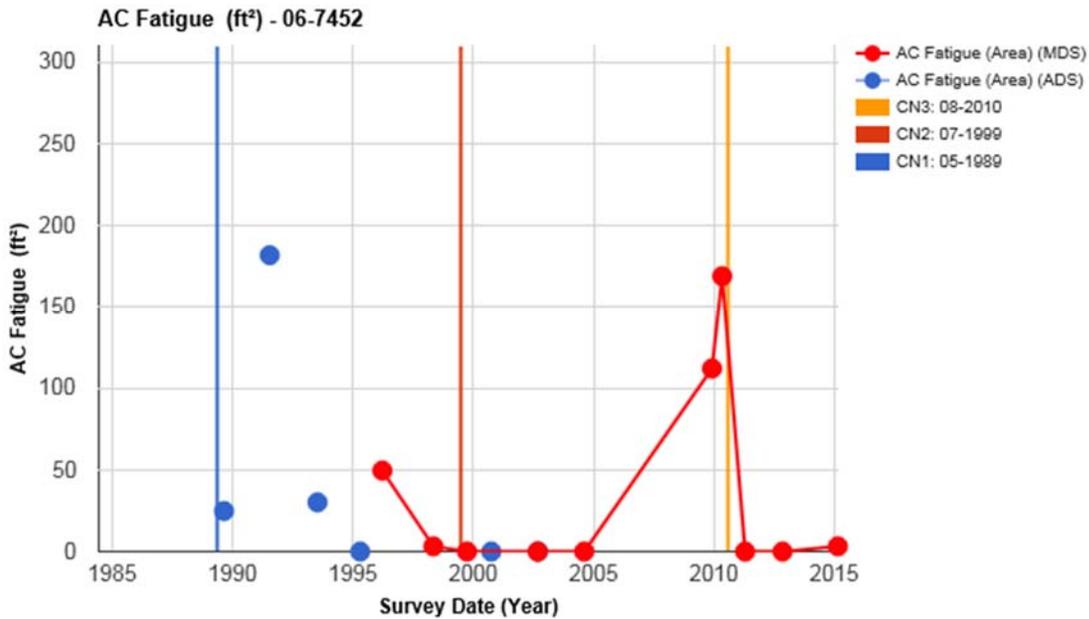
Figure 8. Time history of area of alligator cracking.

Figure 8 shows the time history plot of alligator cracking data. While the plot is labeled fatigue cracking, in the LTPP distress rating system, this is alligator cracking that is not limited to the wheel path. For the CN = 1 period, alligator cracking increased from 25 ft² in 1989 to 182 ft² in 1991, then decreased to 30 ft² in 1993 and to zero in 1995, then increased to 50 ft² in 1996 and back to zero in 1998. When this trend is compared with the trend in wheelpath (WP) longitudinal cracking shown in Figure 9 it is apparent that during this time period the rating of these distress types were changing within the LTPP program. During the same time period, the WP longitudinal cracking decreased from 149 ft in 1989 to 35 ft in 1991, then increased to 198 ft in 1993, then decreased to 175 ft in 1995, then increased to 235 ft in 1996 and 431 ft in 1998 – almost a reverse image to the alligator cracking trend.

Figure 8 also shows that alligator cracking after application of the 1999 AC overlay was non-existent, but it re-appeared and increased between 2005 and 2010, prior to application of the 2010 AC overlay. In 2015, alligator appears to be re-appearing, albeit only a small quantity was observed.

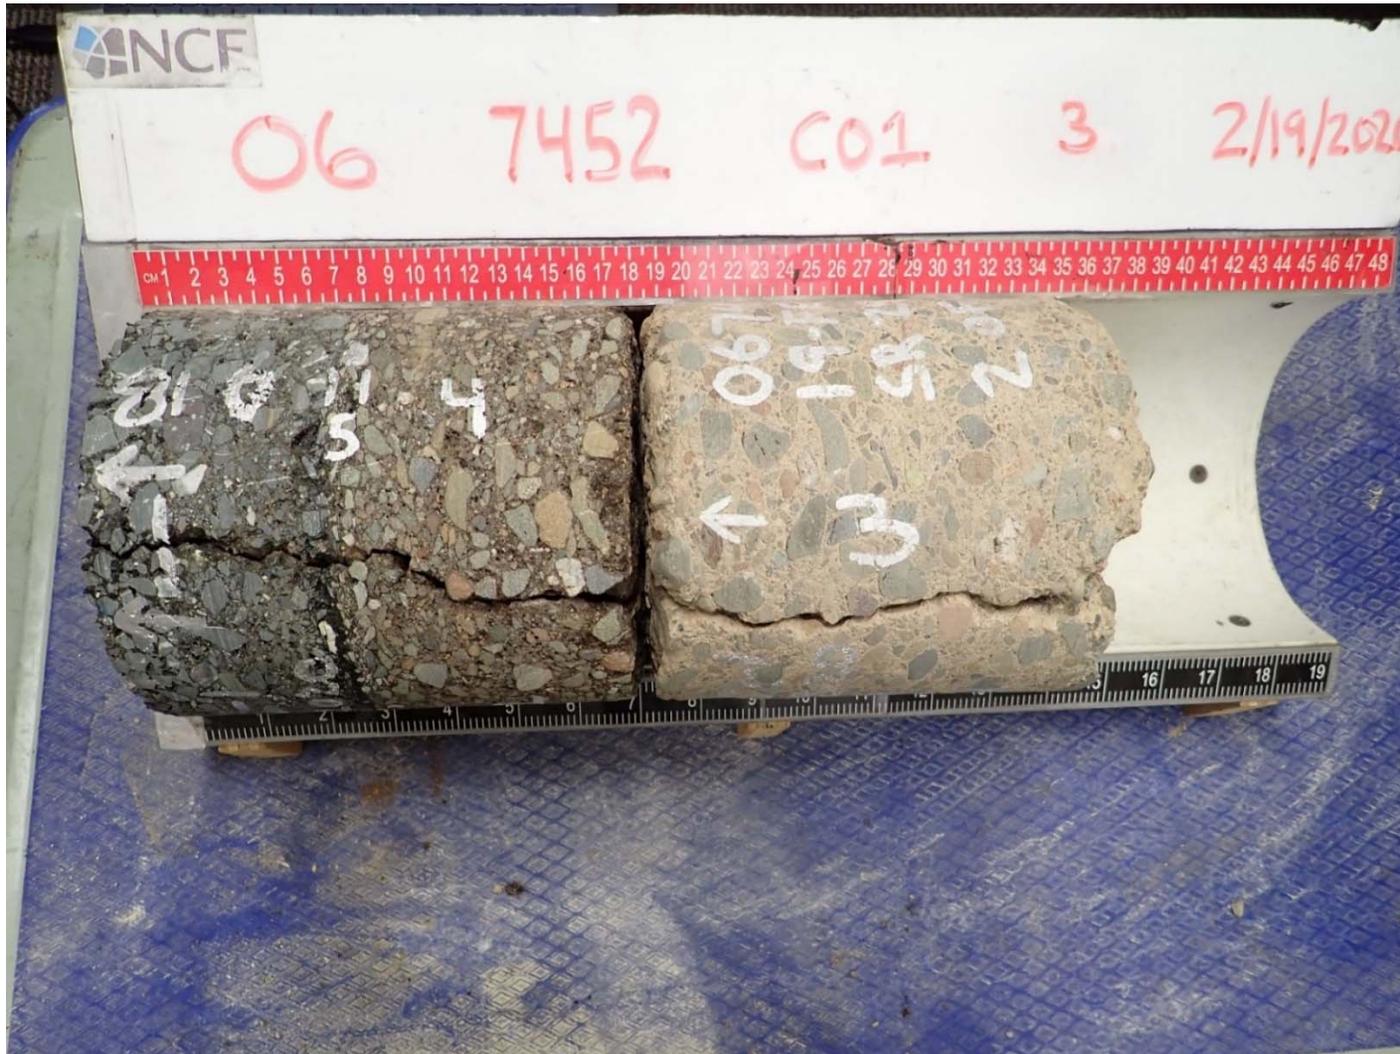
Core C01

Core Number	Core Location	Core Observations
C01	Outer Wheelpath on Transverse Crack with Pumping	Full-depth crack that likely started in LCB and reflected into AC; AC and LCB were not well-bonded.
C02	Midlane	LCB material is deteriorated and portions of the core were loose material that was not recovered; AC layers L4 and L5 showed moisture damage.
C03	Outer Wheelpath	Core shows material is in good condition with no cracks or deterioration.
C04	Midlane	Core shows material is in good condition, portion of LCB was not well-compacted; AC and LCB were not well-bonded.
C05	Outer Wheelpath on Small Transverse Crack	Core shows material is in good condition with no cracks or deterioration.
C06	Outer Wheelpath on Transverse Crack	Top-down crack in AC layers L8 through L6; AC and LCB were not well-bonded.
C07	Midlane on Small Transverse Crack	Core shows material is in good condition, portion of LCB was not well-compacted; AC and LCB were not well-bonded.

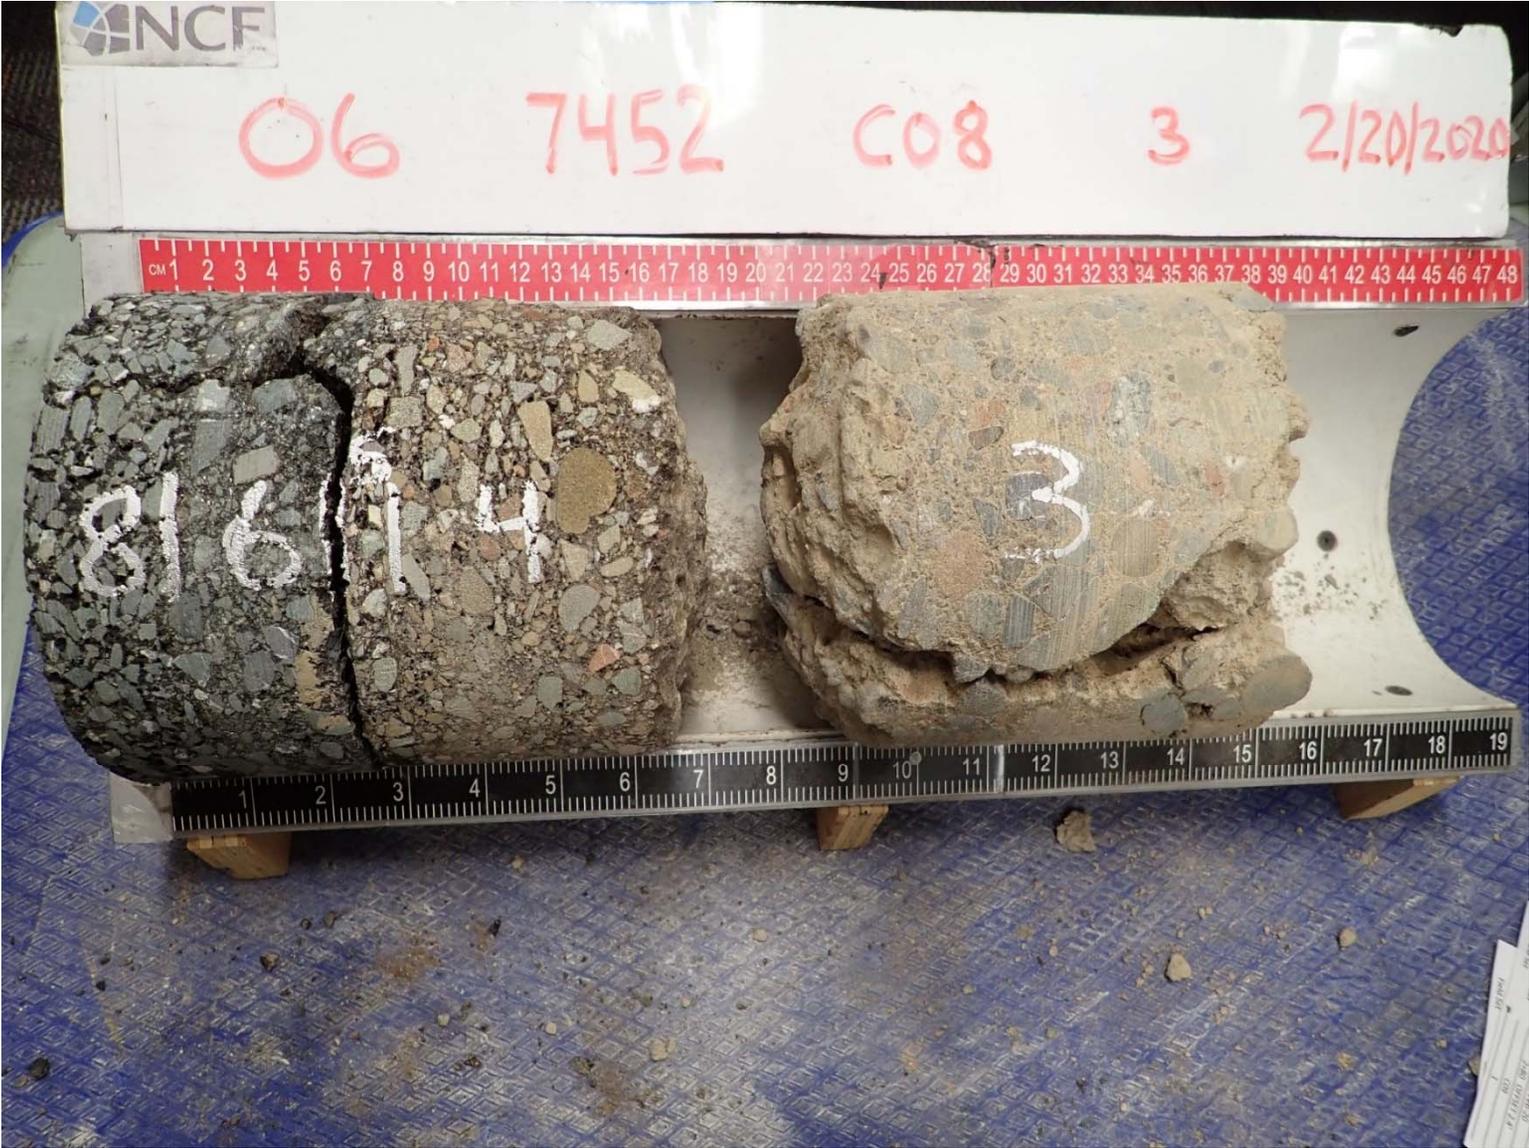
Core C08

C08	0.8 feet from Outside Shoulder on Transverse Crack with Pumping	Top-down crack in AC layers L8 through L6; bottom-up crack in LCB did not reflect due to top of LCB layer being severely deteriorated.
C09	Outer Wheelpath at Intersection of Fatigue and Transverse Cracking	Core shows extreme deterioration of all layers; both top-down cracking in AC layers L8 and L6, and bottom-up cracks in LCB that have reflected into AC layers L4 through L6.
