## Technical Memorandum

**Re.** Forensic Desktop Study Report: Texas LTPP Test Section 48\_1096

LTPP test section 48\_1096 is located on U.S. 90, westbound, in Medina County, Texas. U.S. 90 is a rural principal arterial with two lanes in the direction of traffic. It is classified as being in a Wet, No-Freeze climate zone with an average annual precipitation ranging between 14 inches (2011) and 52 inches (2007). The test section has an annual average air freezing index ranging between 0 deg-F deg-days (multiple years) and 47 deg-F deg-days (1989) during the performance period in question. The coordinates (in degrees) of the test section are 29.3559, -98.83502. Photograph 1 shows the test section at Station 0+00 looking westbound in 2017, while Map 1 shows the geographical location of the test section relative to San Antonio, Texas.

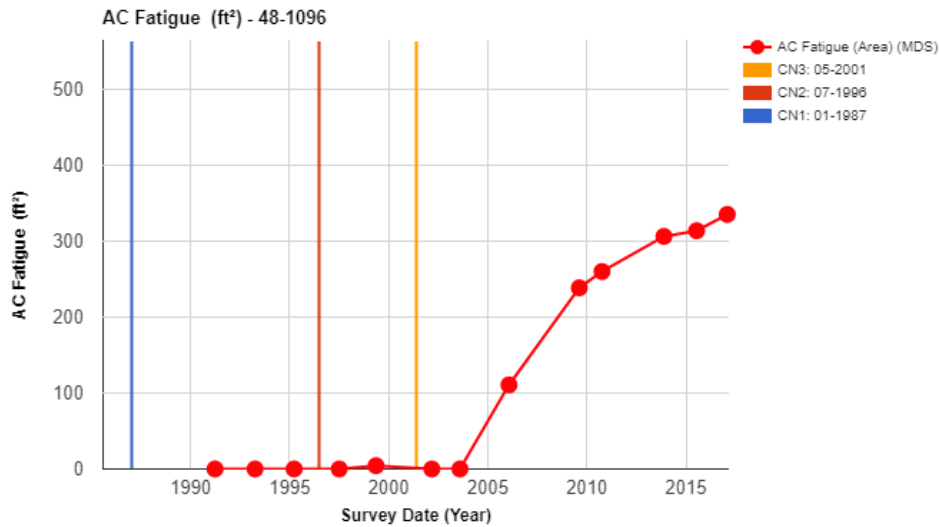
Figure 11 shows the total area of fatigue related cracking observed on the section. As the fatigue cracking observed on the section is limited to the wheel paths, it is hypothesized that it is the result of bottom-up cracking. Prior to the AC overlay in 2001, bottom-up cracking is not observed until 1999 when 4 ft<sup>2</sup> was reported on the section. Following the overlay in 2001, the area of the test section where fatigue cracking was observed increased over time. Fatigue cracking was first observed on the section in 2006, 5 years after the AC overlay, when 111 ft<sup>2</sup> of fatigue cracking was observed. Once the cracking had initiated, it propagated at an average rate of 20 ft<sup>2</sup>/year between 2006 and 2017. By 2017, 336 ft<sup>2</sup> of fatigue cracking was observed.

**Figure 11. Time history of the area of bottom-up cracking.**

The increase observed in bottom-up cracking following the AC overlay may be the result of increased precipitation and traffic in the early to mid-2000s. As water infiltrates the pavement layers, the base and subgrade tend to weaken (especially when reaching saturation conditions) causing the increase in fatigue cracking observed. Similarly, the increase in traffic loadings over time may have also contributed to the fatigue cracking of the AC surface layer. Finally, the increase in cracking observed between 2006 and 2017 may be the result of aging (and more appropriately oxidizing) of the AC surface layer, leading to a more brittle material prone to fatigue cracking.

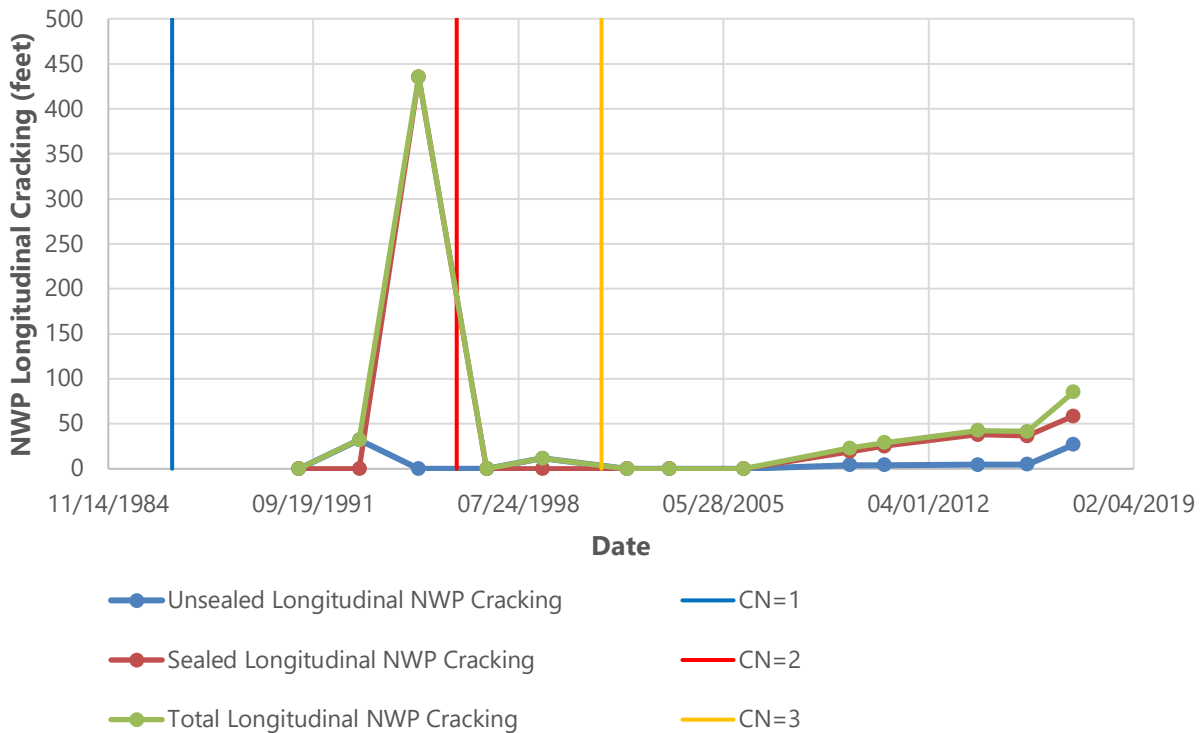
Data on longitudinal cracking, inside and outside the wheel path, was collected between 1991 and 2017 as shown in Figures 12 and 13. In 1993, 32 total feet of non-wheel path (NWP) longitudinal cracking was reported, 12 years after the construction of the test section. By 1995, the NWP longitudinal cracking increased to 435 feet, at a rate of 202 feet/year between 1993 and 1995. Following the chip seal in 1996 (CN=2), the NWP longitudinal cracking observed on the section dropped to zero. NWP longitudinal cracking was not observed again until 1999, three years after the application of the aggregate seal coat when 12 feet of NWP longitudinal cracking was observed. After the application of the AC overlay in 2001, NWP longitudinal cracking was not reported again until 2009, 8 years after CN=3, when 23 feet of NWP longitudinal cracking was observed. Once cracking was initiated, it propagated at a rate of 8 feet/year between 2009 and 2017. NWP longitudinal cracking was predominantly observed near the lane edge.

**Figure 12. Time history of the length of NWP longitudinal cracks.**

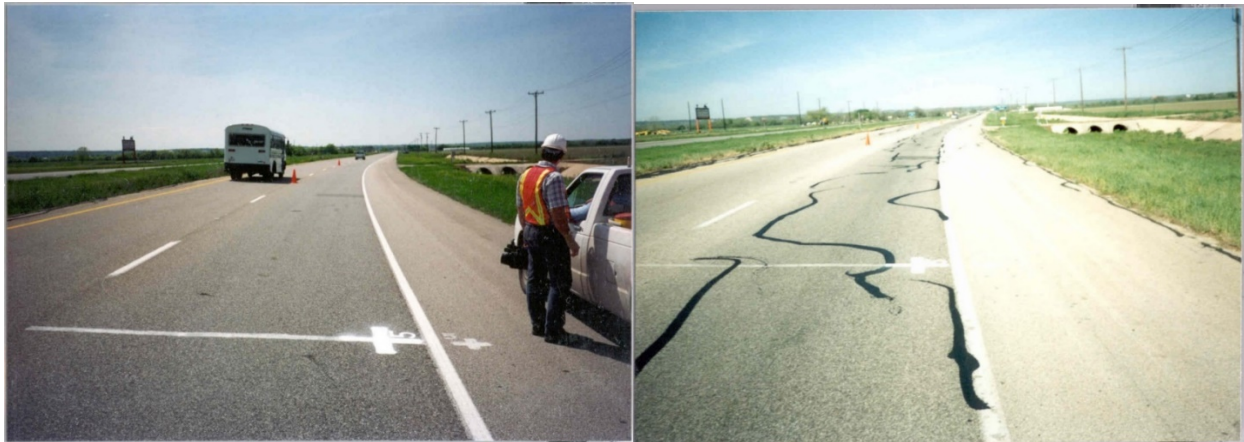
The spike in NWP longitudinal cracking observed in 1995 appears to be related to the crack sealing applied to the section between 1993 and 1995. As depicted in Figure 14, while there are very few visible cracks on the pavement section in 1993, the section is heavily crack sealed by 1995. This indicates that between these two distress surveys, the test section received aggressive crack sealing that is not indicated in the LTPP pavement history. Based on the limited cracking observed in 1993, it is assumed the crack

sealing applied during this time included areas of pavement that did not have cracking. Therefore, the spike in cracking during this period is related to an increase in sealed "cracks" rather than a spike in cracking as depicted in Figure 12.

**Figure 14. Test section at Station 5+00 looking westbound in 1993 (left) and 1995 (right) depicting an increase in crack sealing during this period.**

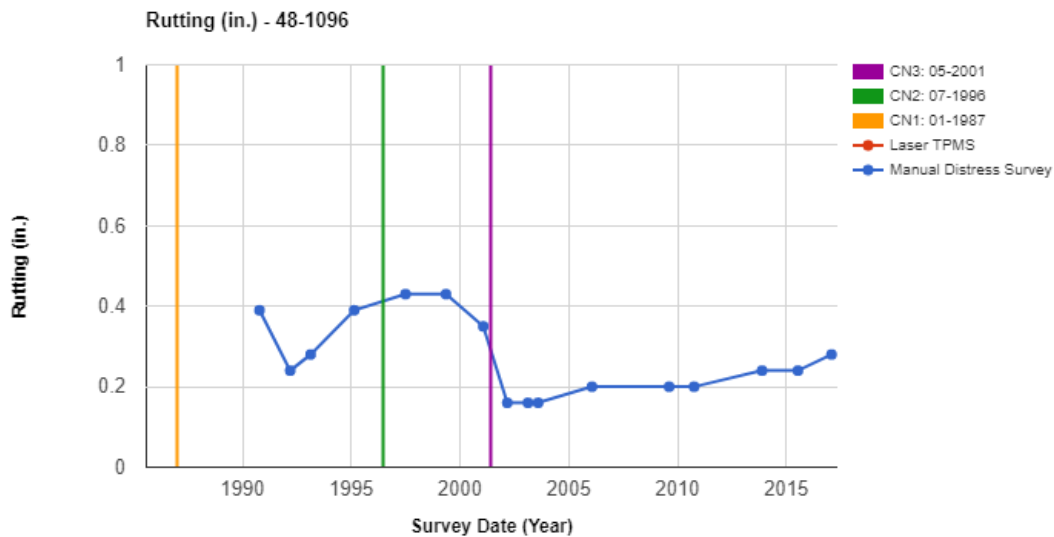
The rutting observed over time on the test section is shown in Figure 18. Prior to the overlay in 2001, the rut depths observed fluctuated, with an average reported rut depth of 0.36 inches. Following the overlay in 2001, the rutting observed on the section decreased to 0.16 inches in 2002. The rutting increased slightly between 2002 and 2017 reaching a rut depth of 0.28 inches in 2017.

**Figure 18. Time history plot of average rut depth computations.**

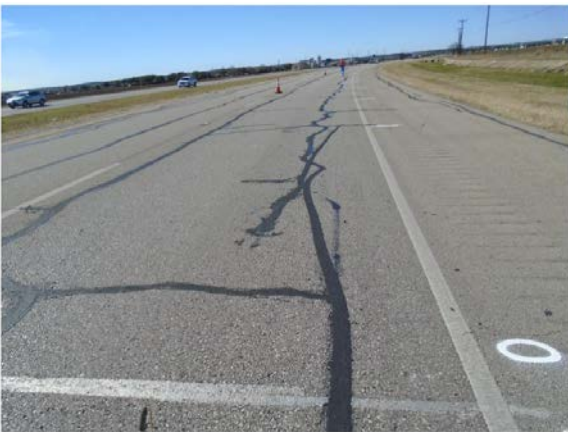
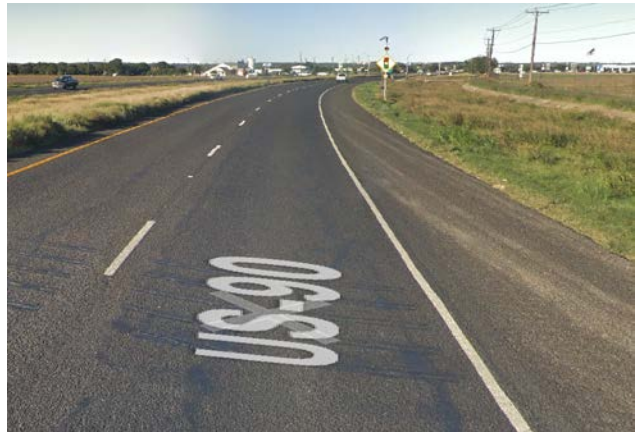
The LTPP Data Collection Contractor (DCC) noted upon arriving to the test section that a surface seal coat had been applied to the test section, which was not reported to the DCC. An image of the site in 2017 and Google Streetview imagery from 2018 are shown in Figure 21. According to the LTPP Directive GO-67, the application of the seal coat meant the section would have to be removed from study. While the data collected will not be entered into the LTPP database, the DCC continued with the scheduled performance monitoring in support of this investigation. Follow-up discussion with TxDOT revealed a seal coat was applied to the section in 2017. TxDOT also shared that crack-sealing occurred on test section 48\_1096 in 2013, 2014, 2017, and 2021. This helps explain the increase in the amount of sealed cracking observed during the manual distress surveys conducted after 2012.

**Figure 21. Picture of section before (left, 2017) and after (right, 2018) seal coat application.**

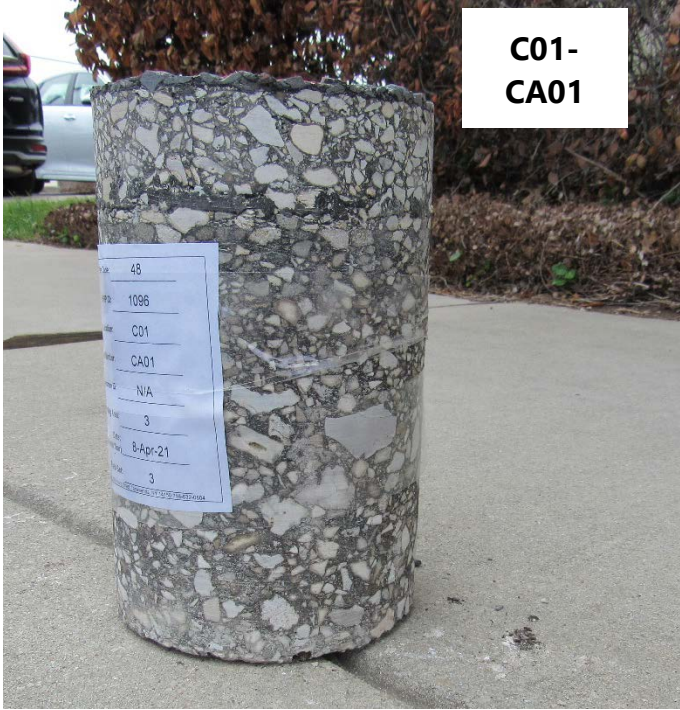
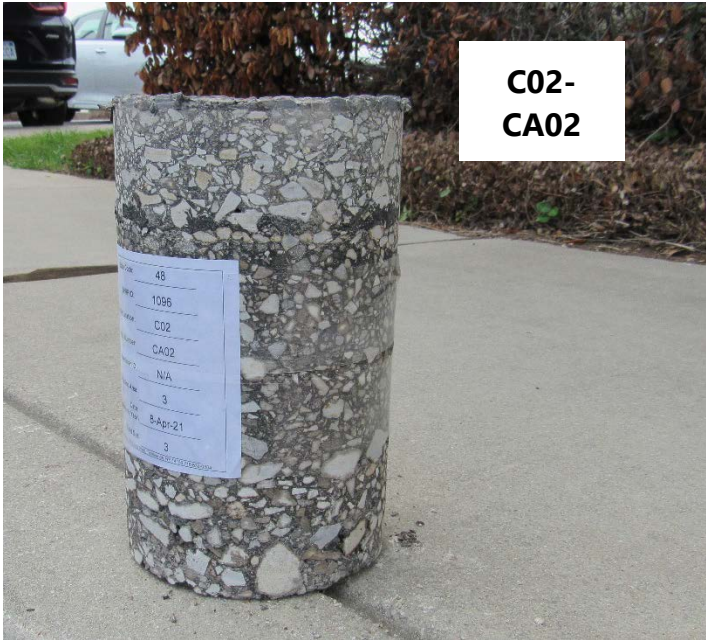
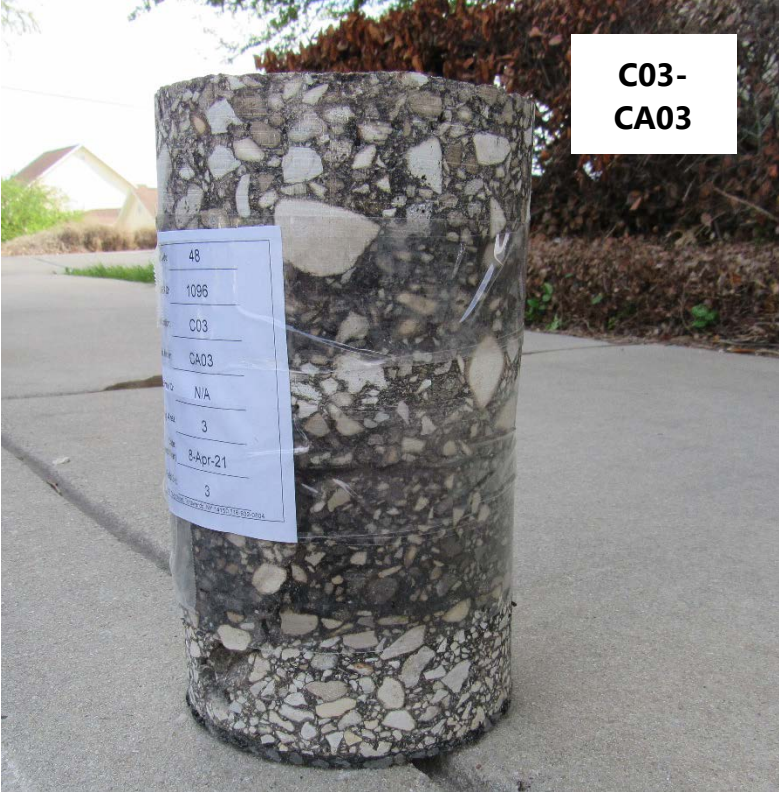
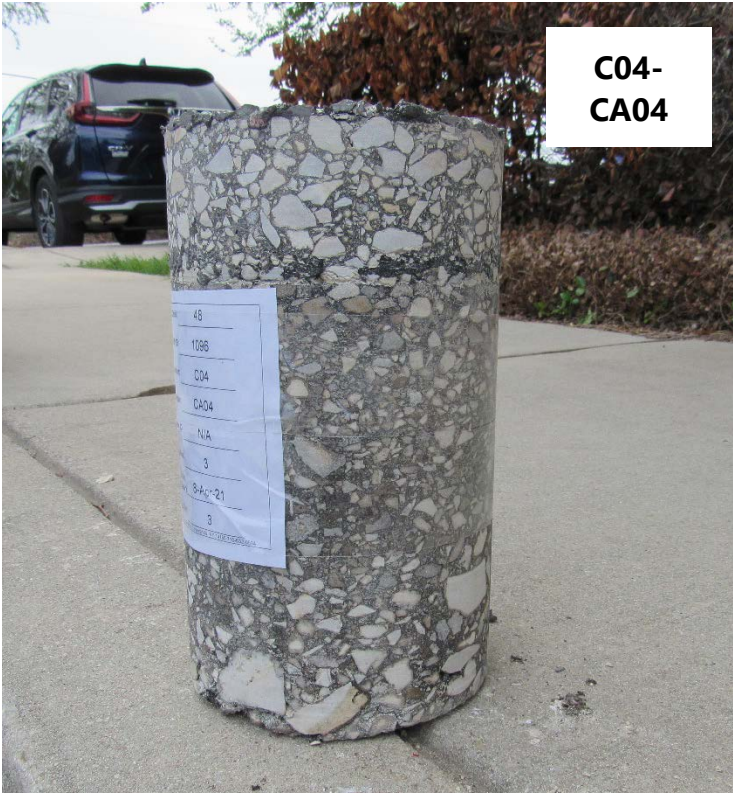
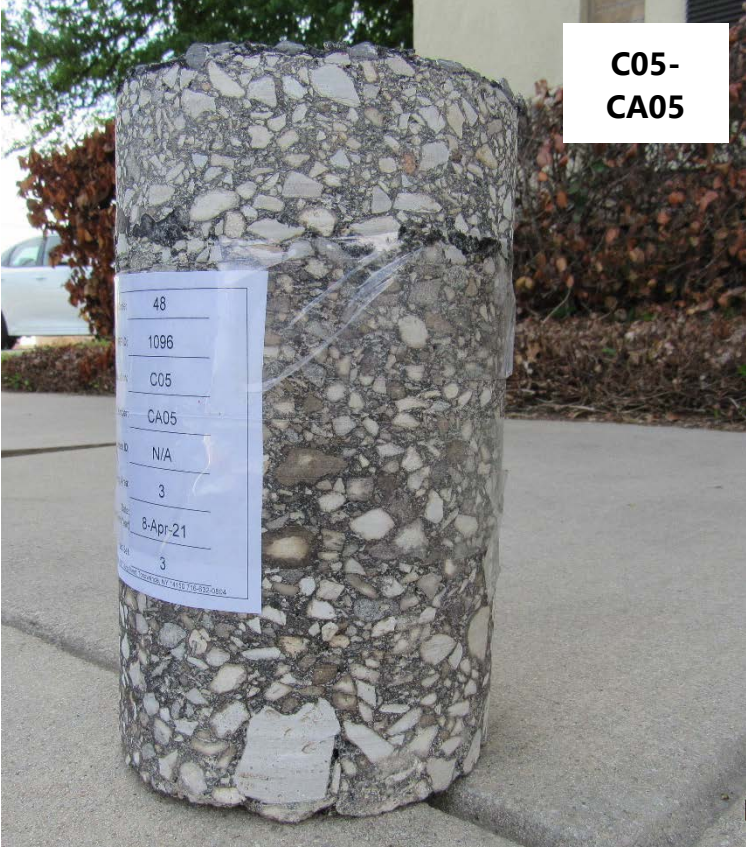
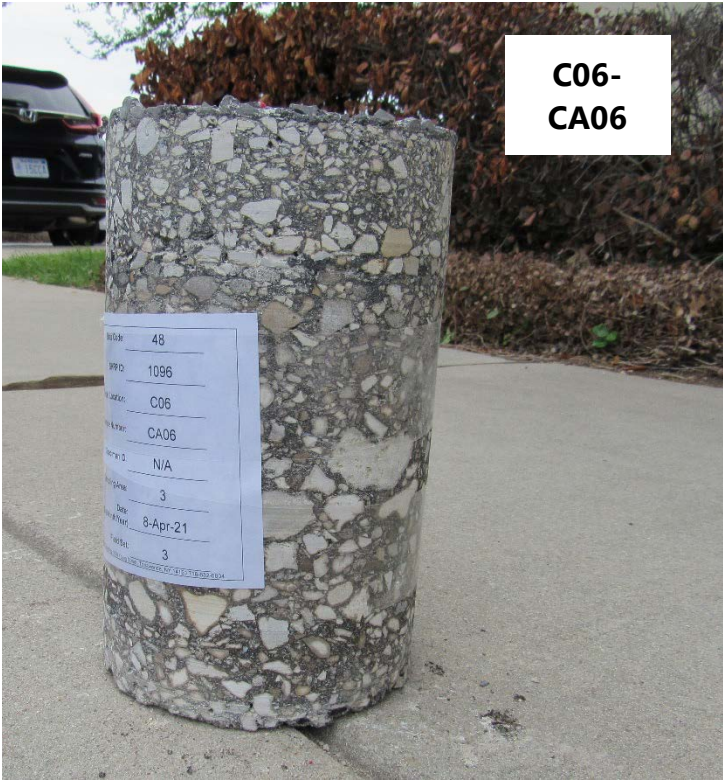
## **Appendix A. Core Photos**

Core photos are shown in Appendix A. The cores are all in good condition with no signs of material degradation such as cracking or stripping. The bond between the different lifts of AC appears to be strong for all cores.
