Technical Memorandum

Re. Forensic Desktop Study Report: LTPP Test Section 531005, Field Evaluation Update

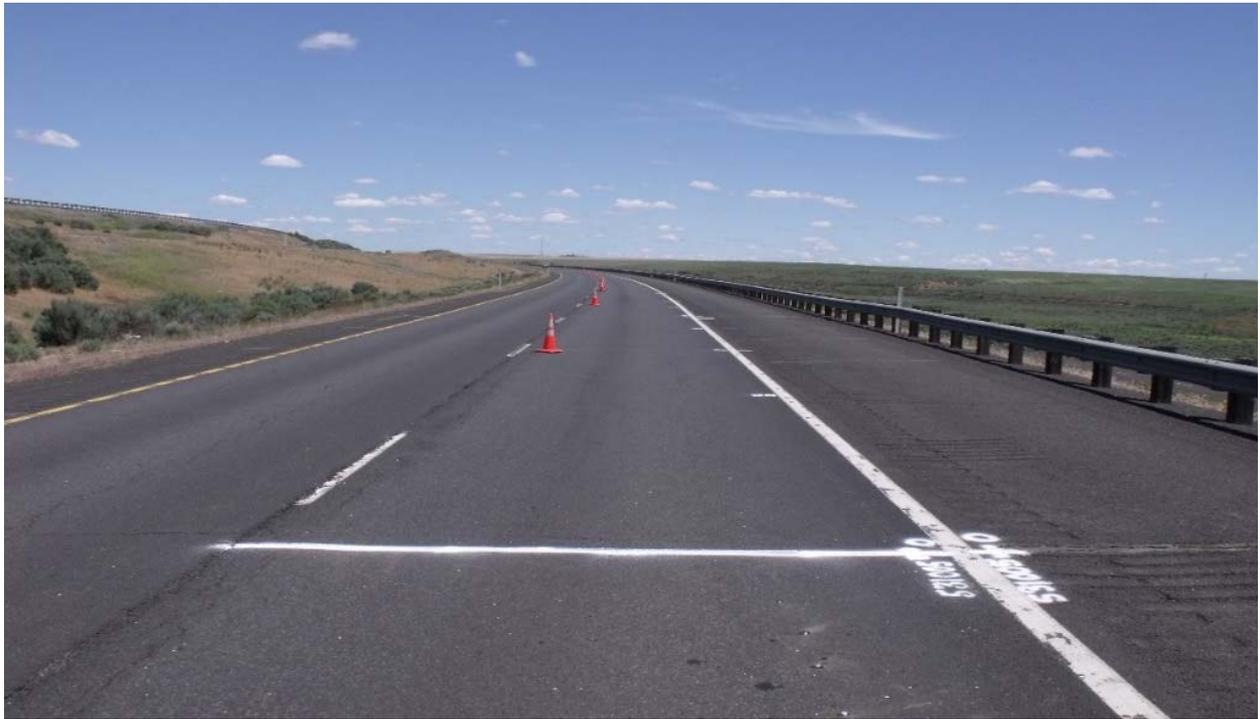
Photograph 1. Picture of test section 531005 in 2013 (from start of section looking west).

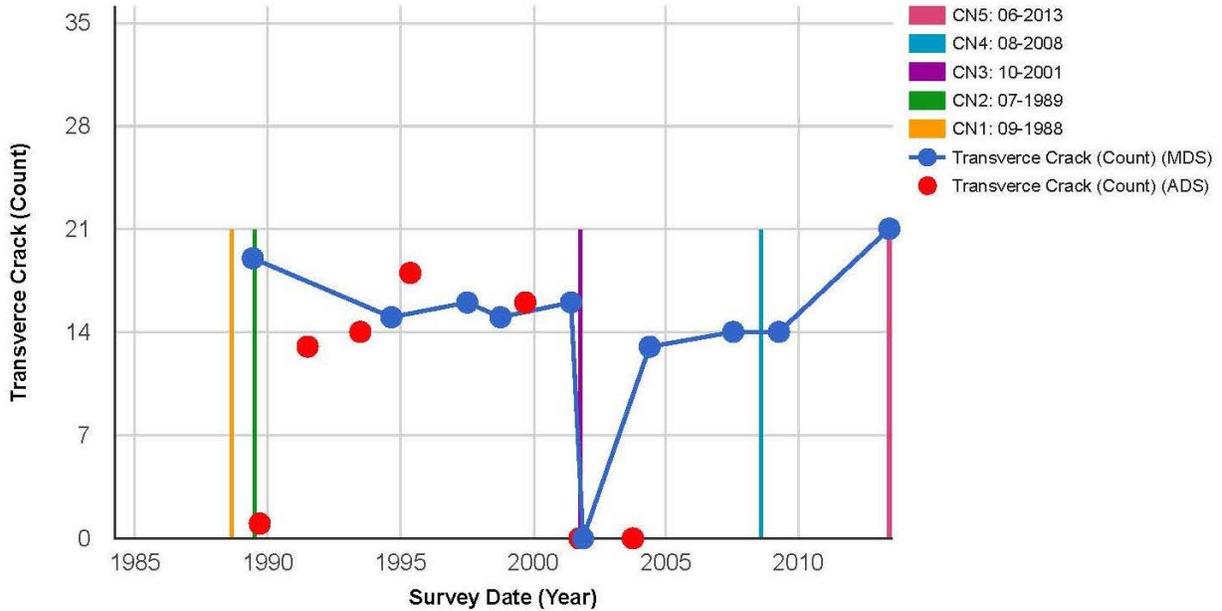
One of the more significant distresses on this test section appears to have been transverse cracking. Figure 4 shows the time history of the number of transverse cracks on the test section. In this figure, the construction events are shown with vertical lines. The distress data shown are from manual distress surveys. Note that a manual distress survey was not performed immediately after the July 1989 overlay. Photographic based automated distress survey (ADS) information shows that by September 1989, one transverse crack had reappeared, by July 1991 13 transverse

Figure 4. Time history of the number of transverse cracks.

Based on the location of the test section and the spacing between transverse cracks, it appears that these transverse cracks are related to low temperature cracking. After each overlay, it is postulated that it takes time for the transverse cracks in the previous pavement structure to reflect through the overlay layer. In Figure 4, the symbols connected with lines are from manual distress surveys (MDS), while the symbols not connected with lines are from automated distress surveys. Thus, after application of the overlays the number of transverse cracks visible on the pavement surface drop to zero, then they progressively reappear over time. During the most recent distress survey performed on this test section in 2013, 3 more transverse cracks had formed than were present in the original pavement structure in 1988, just prior to the 1989 overlay.

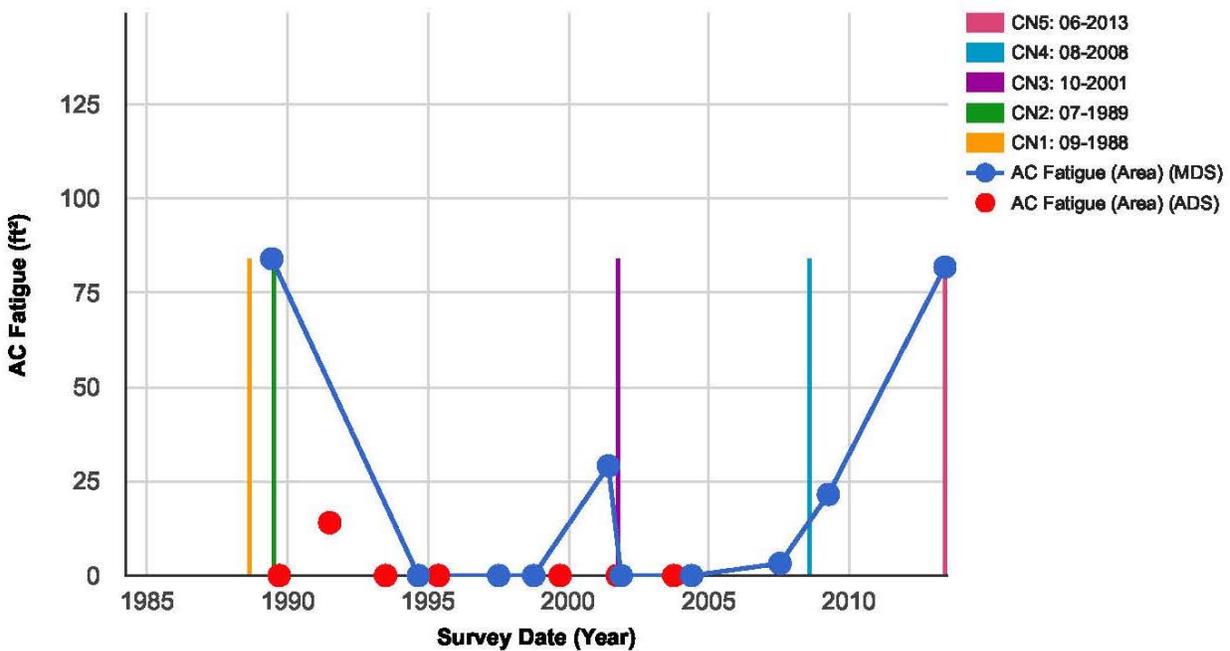
Figure 5 shows the time history plot of alligator cracking data on LTPP test section 531005. While the plot is labeled fatigue cracking, in the LTPP distress rating system, this is alligator cracking that is not limited to the wheel path. The amounts of alligator cracking on this test section are relatively low.

Figure 5. Time history of area of alligator cracking.

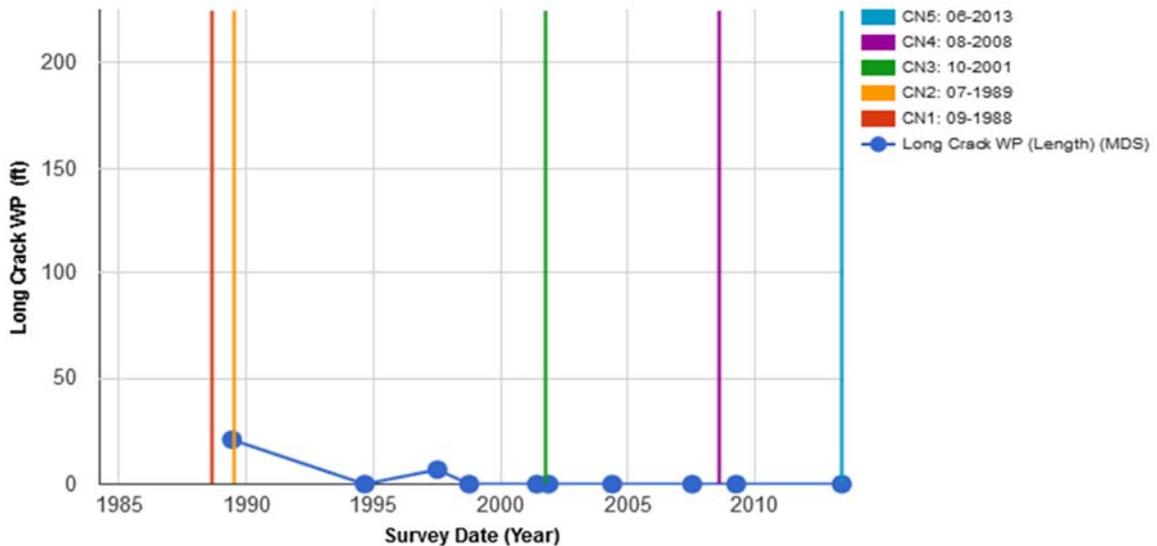
Figure 6 shows the time history plot of longitudinal cracking in the wheel path which can be considered as an indicator of fatigue cracking on a pavement. Except for the one minor rating of 6.9 feet in 1997, there essentially does not appear to be any wheel path cracking related to a fatigue mechanism on this test section.

Figure 6. Time history of longitudinal cracking in the wheel path.

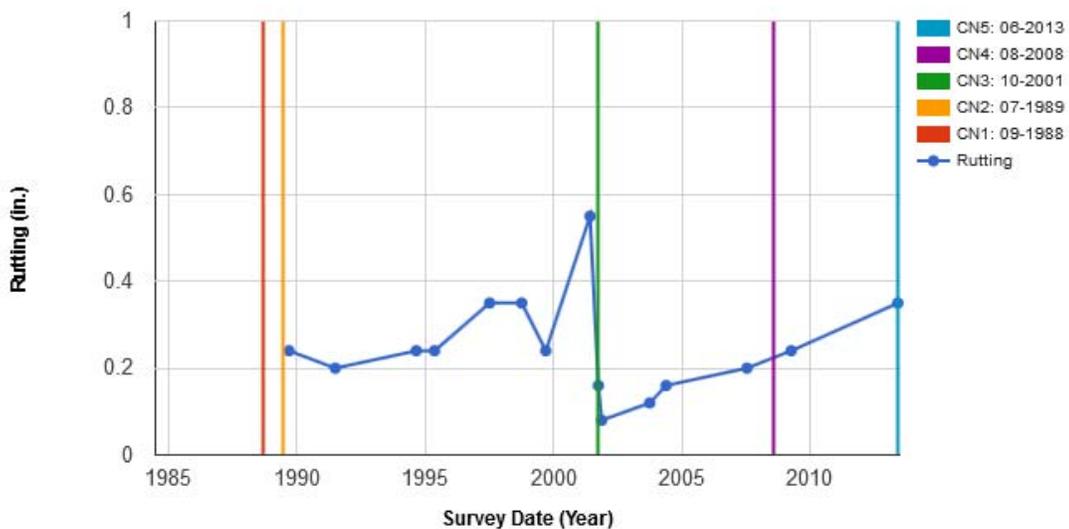
The time history plot of rutting on the test section is shown in Figure 7. LTPP does not appear to have transverse profile measurements prior to the 1989 overlay. However, the rut depth during the first overlay started at about 6 mm and progressed to 14 mm prior to the October 2001 mill and fill overlay. The noise in this graph is probably due to the way LTPP performs transverse

profile measures using a Dipstick. The starting point of the measurement at the outside lane edge can affect the computed rut depths. A maximum average rut depth of 0.4 inches is currently considered as being greater than the maximum limit for design purposes on Interstates according to the 2015 version of the AASHTO Mechanistic-Empirical Pavement Design Guide and may have been the trigger for the mill and fill overlay performed in 2001. It is not clear if the rutting is due to plastic deformation in the pavement layers or ablative wear on the surface potentially due to use of winter traction control devices, such as studded tires or chains.

Figure 7. Time history plot of average rut depth computations.

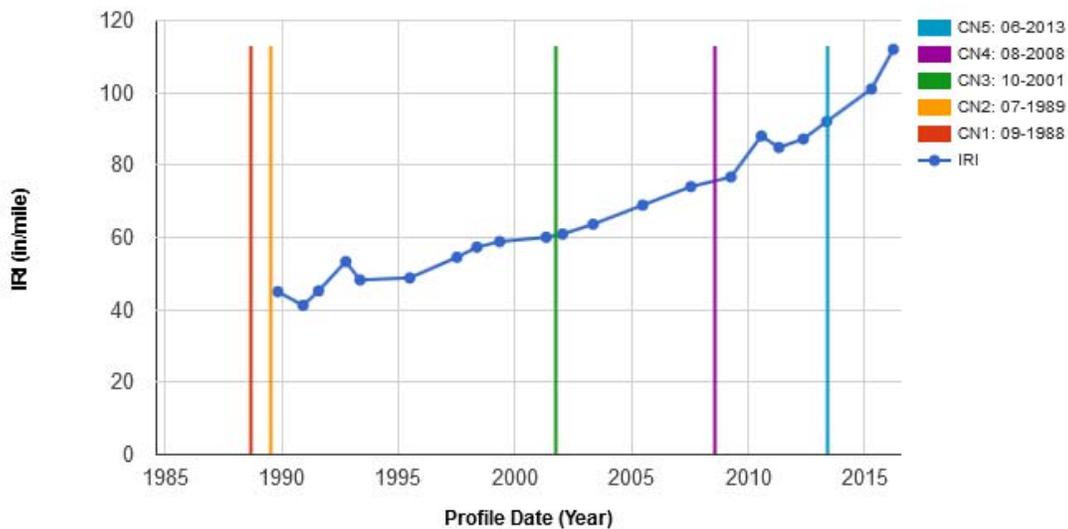
The time history of roughness measurements is shown in Figure 8. An interesting feature of this graph is that the IRI before and after the mill and fill overlay October 2001 is nearly identical. From 1989 through 2013, the rate of increase in IRI has been relatively linear, even after the mill and fill overlay performed in 2001. However, since 2013, the rate of increase in IRI appears to have been accelerated. Since 2015, the IRI has exceeded FHWA's "Good" category for interstates of 95 inches/mile but has not yet reached the unacceptable limit of 170 inches/mile. It is possible that the section IRI values are being affected by the winter traction control devices, which do not wear the pavement out smoothly.

Figure 8. Time history plot of pavement roughness.

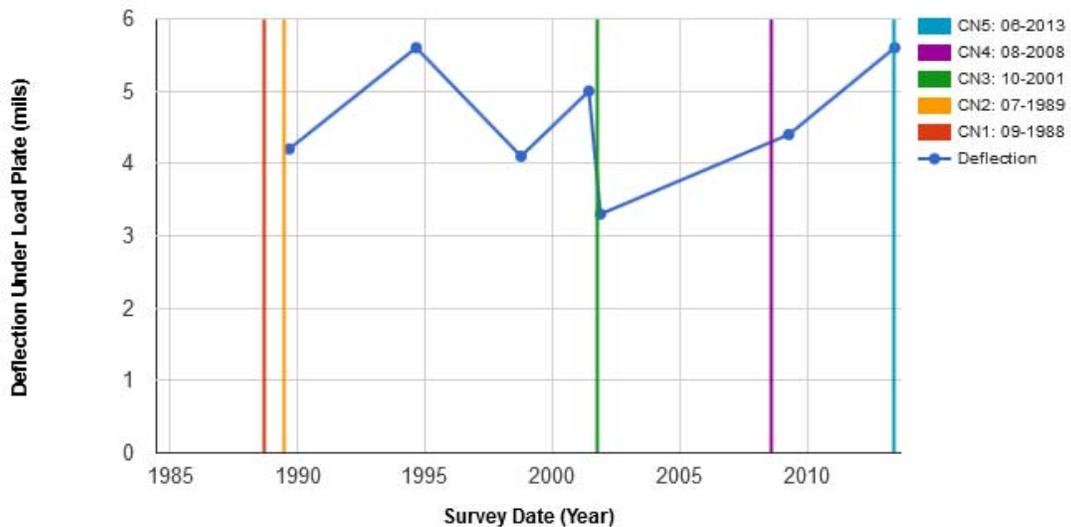
Figure 9 shows the time history average FWD deflection plot under the nominal 9,000 lb. load from the sensor position in the load plate on LTPP test section 531005. The deflection of the sensor located in the load plate is a general indication of the total "strength" or response of all layers in the pavement structure to a vertical applied load. This deflection can be influenced by pavement temperature at the time of testing, precipitation, and changes in pavement structure. In Figure 9, the short term decreases in deflection magnitude at the center sensor, resulting from what was an essentially a 2-inch mill and fill overlay construction event is interesting. One potential contributing factor to this minor decrease in deflection is that the deflection measurements prior to overlay were performed in June, while the measurements after overlay were performed in November when the pavement is generally colder. Overall the central sensor deflection time history magnitudes are judged to be relatively consistent with respect to natural variations in FWD measurements and very low indicating a "strong" pavement structure.

Figure 9. Time history of average deflection for the sensor located in the load plate normalized to 9,000 lb. drop load.

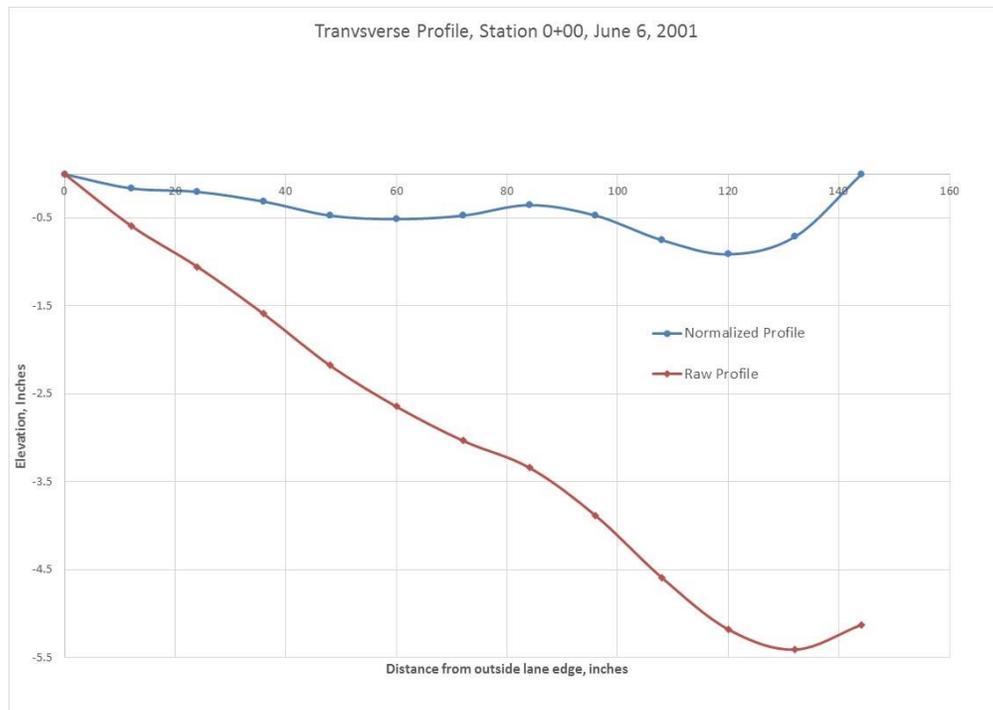
The maximum average rut depth was recorded in the June 2001 distress survey just prior to the mill and fill construction activity performed in October 2001. Figure 10 shows the comparisons between normalized transverse profile elevation plot for station 0+00 in June 2001 and raw transverse profile measurement. A normalized transverse profile elevation plot, is one where the start and end points of the transverse profile are assigned a zero elevation, and the elevations of the pavement profile measurements between these points are assigned a relative elevation interpolated to the straight line between the end points. This portion of the test section has a negative cross slope, meaning that the outside edge of the lane is higher in elevation than the inside lane edge. This is reasonable since the test section is located on a beginning of a horizontal curve to the left in the direction of traffic and a negative pavement cross slope is the norm in this situation. Note that the deepest rut is in the inside wheel path.

The more significant issue is that the normalized rut depth at station 0+00 is a little over an inch, based on the lane-width wire line method. This is enough to hold perhaps .25 inches of water looking at the raw transverse profile plot.

Figure 10. Normalized and raw transverse pavement profile at station 0+00 performed on June 6, 2001 prior to the mill and fill construction event.

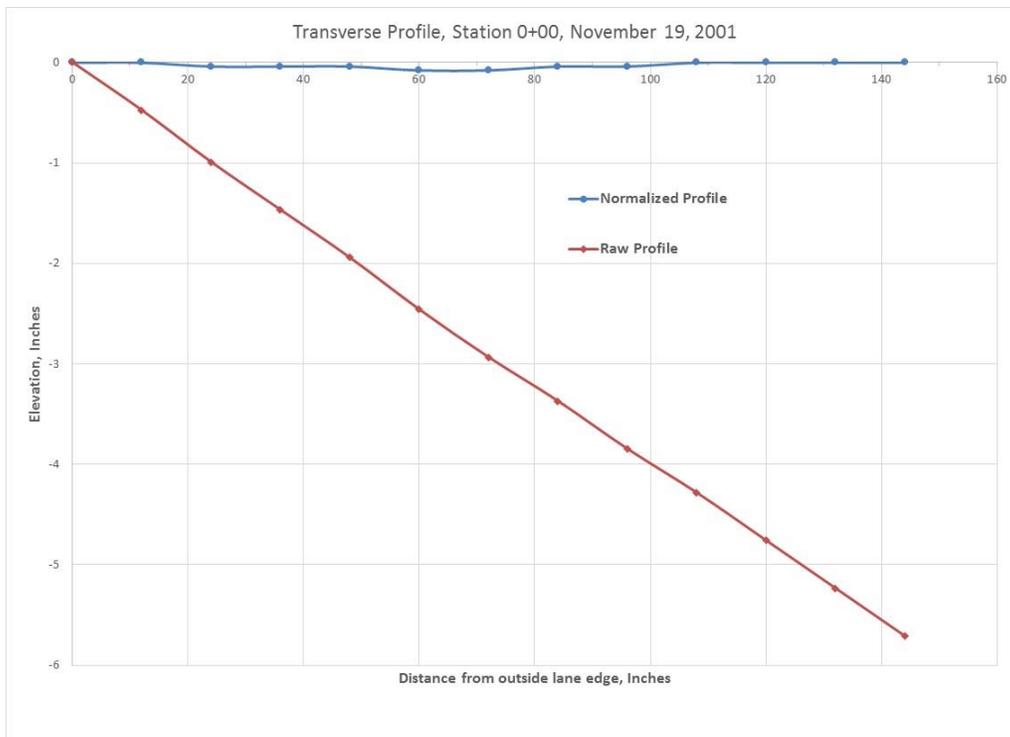
Figure 11 shows the same transverse profile elevation information performed in November 2001 after placement of the nominal 2-inch mill and fill overlay in October 2001. As seen in the figure, the transverse profile is relatively flat and the rutting in the inside lane has been removed. This shows a very successful application of a mill and fill overlay treatment.

Figure 11. Normalized and raw transverse profile at stat 0+00 measured November 19, 2001, after the mill and fill overlay placed in October 2001.

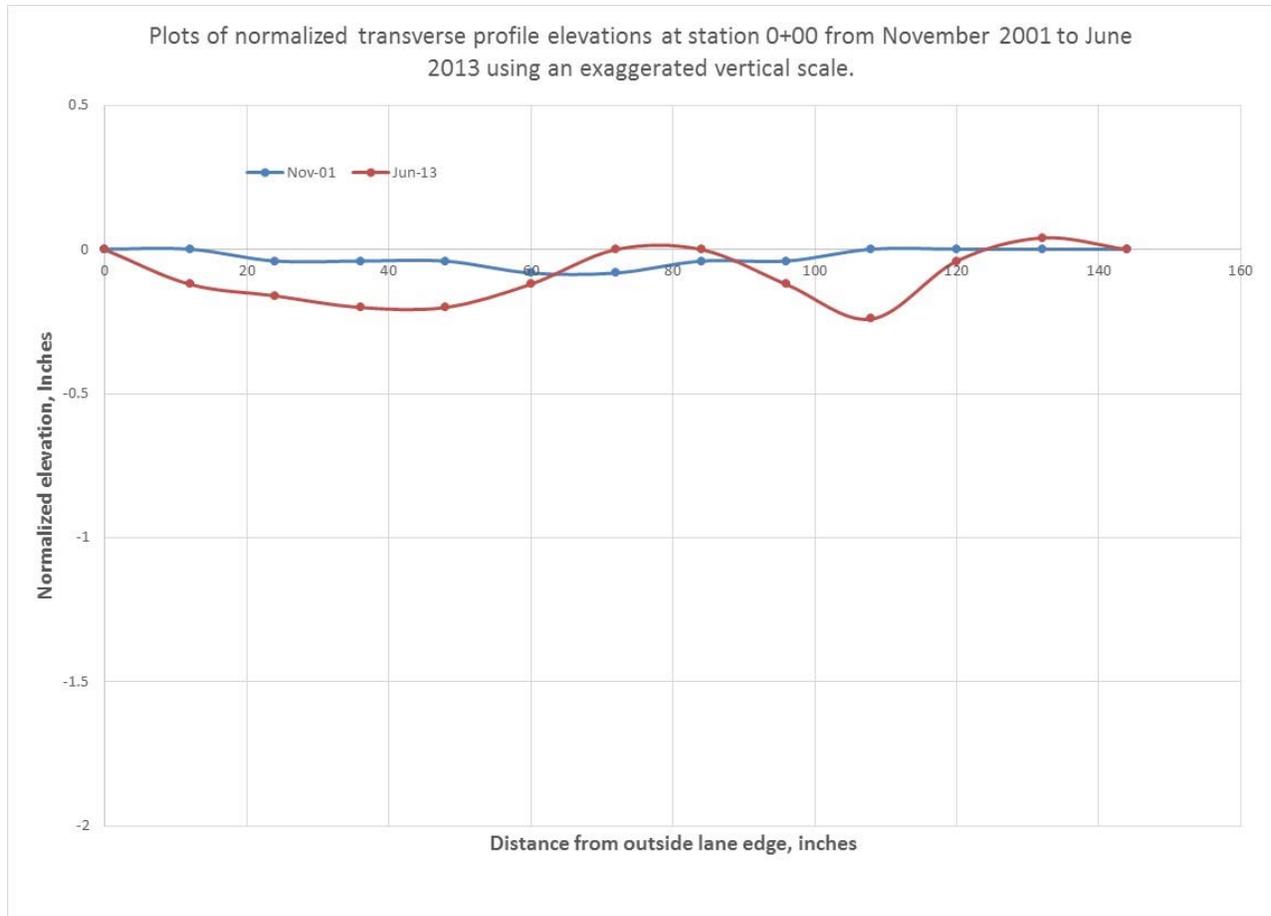
Figure 12 shows an exaggerated vertical scale image of the normalized transverse profile plot in 2001 just after the mill and fill overlay event and the last transverse profile measurement at station 0+00 performed in 2013. Station 0+00 was selected for this plot since it had the deepest rut depth prior to the 2001 overlay. These measurements are more than 12 years apart. More significantly, the deformation patterns in the pavement surface now appear to be significantly different than those shown in Figure 10 where the most significant rut depths were those in the inside lane. This evidence suggests that the rutting phenomena is contained within the upper layers of the pavement structure, i.e. the overlay surface layers.

Figure 12. Exaggerated vertical scale of the normalized transverse profile at station 0+00 after the mill and fill overlay placed in October 2001.

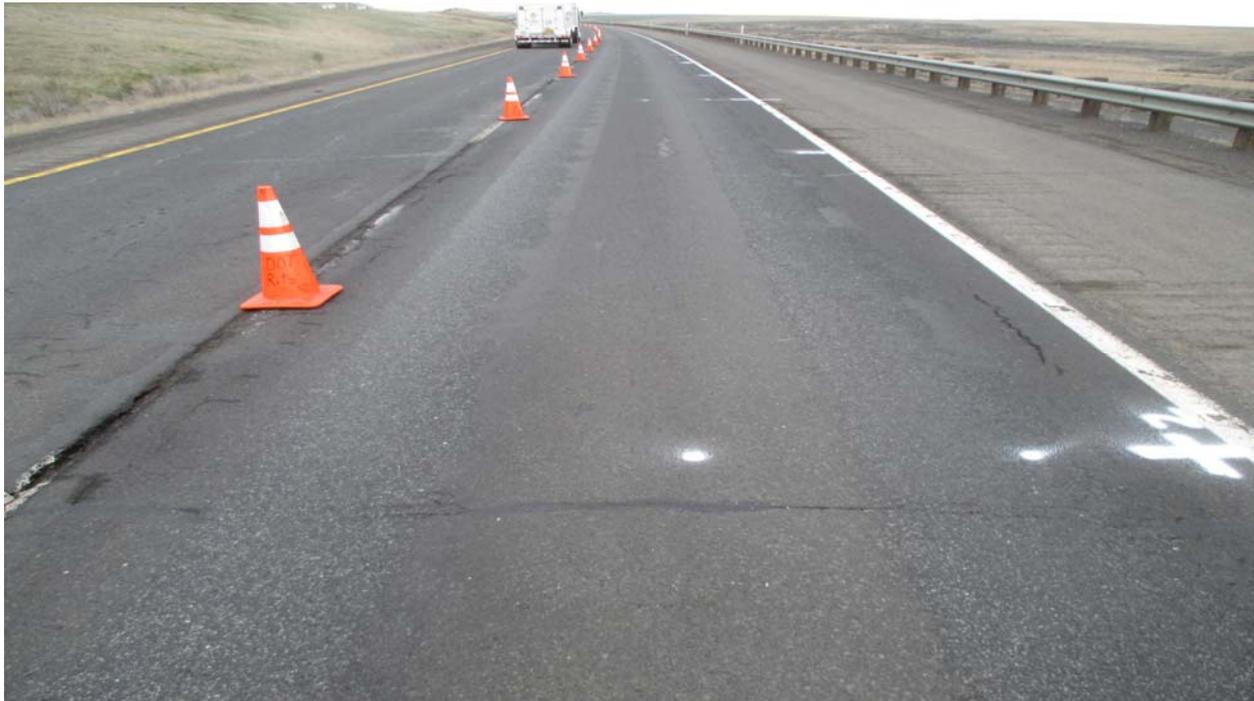
At station 200, five 6-inch diameter cores were obtained. Figure 12 shows the condition of the pavement at station 200 prior to coring. Patches can be seen in the wheel paths, which appear to be skin patches using something that approximates a slurry seal type of material. It was subsequently discovered based on discussions with WSDOT staff that they performed wheel path chip seals on this section in 2016.

Figure 12. Image of station 200 prior to coring in 2019. The white dot paint marks are locations for FWD measurements.

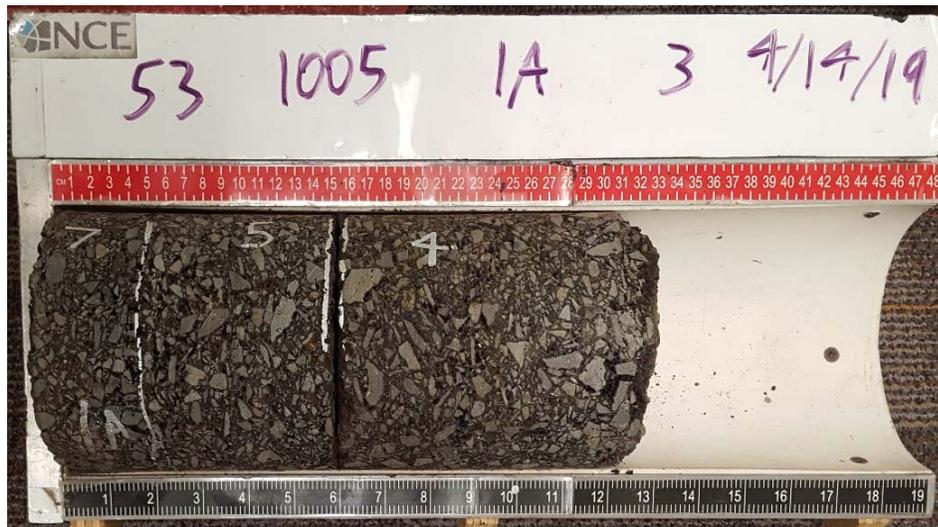
In Figure 13, there is an obvious separation between layers 4 and 5. This is the core at the upper most edge of the test section, nearest the right edge longitudinal joint.

Figure 13. Image of core 1A obtained at station 200 at an offset of 0.8 feet from the outside lane edge.

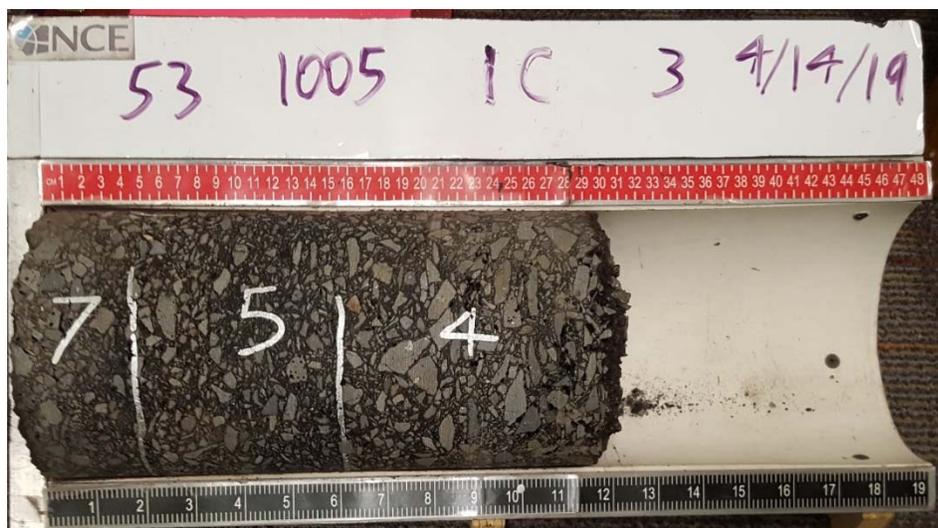
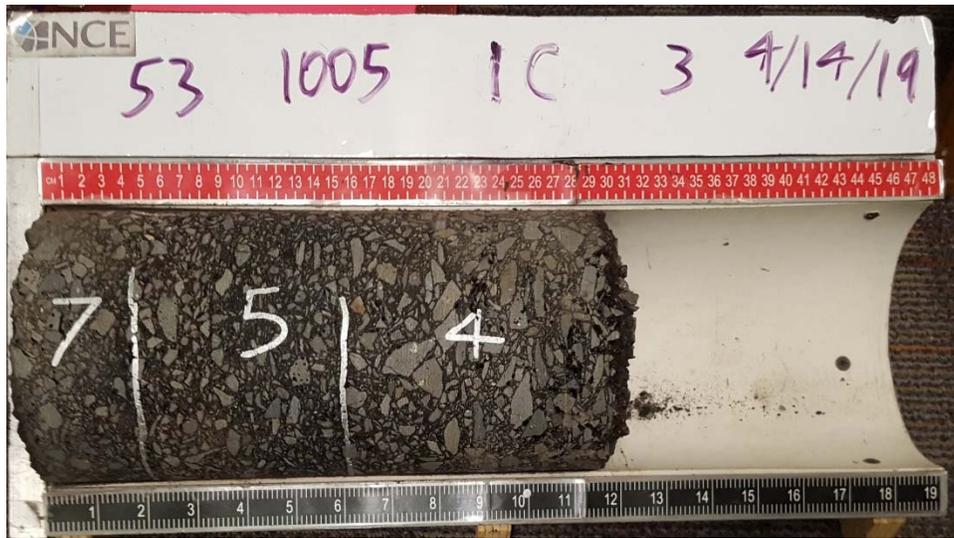
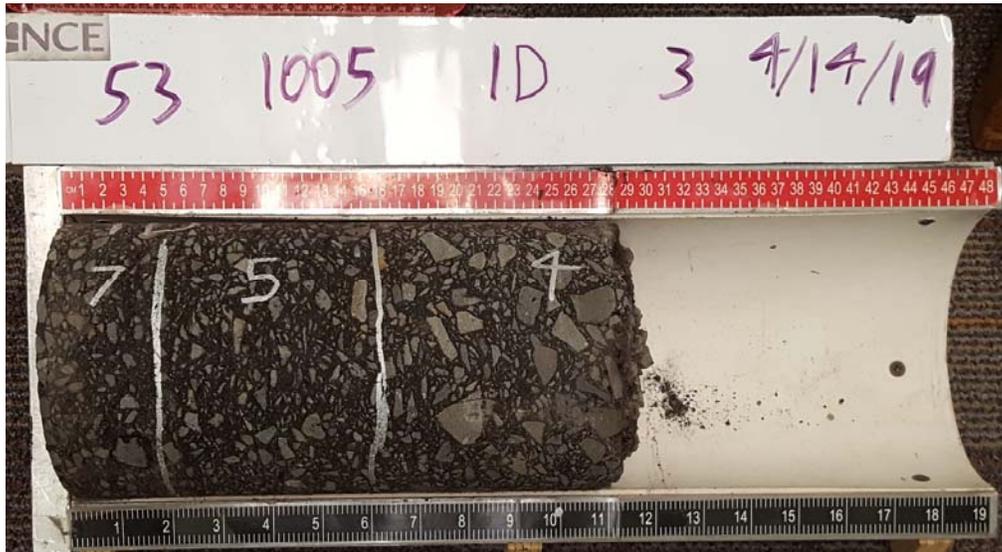
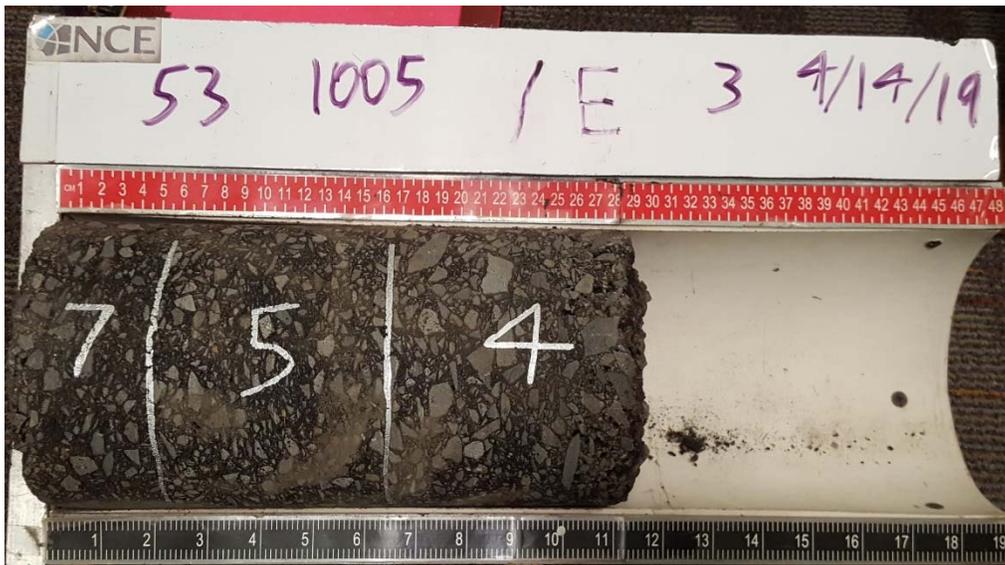
Figures 13 through 17 are images of the cores from station 200 obtained on April 3, 2019. The images were taken in a standard LTPP core box with scales at each side, and markings on the core to show individual layers within each core. The layer numbers as well as the change in layer strata are painted on each core. In general, the aggregate partials in all the layers look to contain many fractured faces, indicative of a crushed stone. The size of the aggregate in layer 4 looks to be larger than that in layer 5, while in turn appears to be larger than that in layer 7. The use of crushed stone in these pavement layers supports the general theory that the aggregate interlock provided by the angular interface from the crushed stone faces enhances the resistance to plastic deformation in the AC layers.

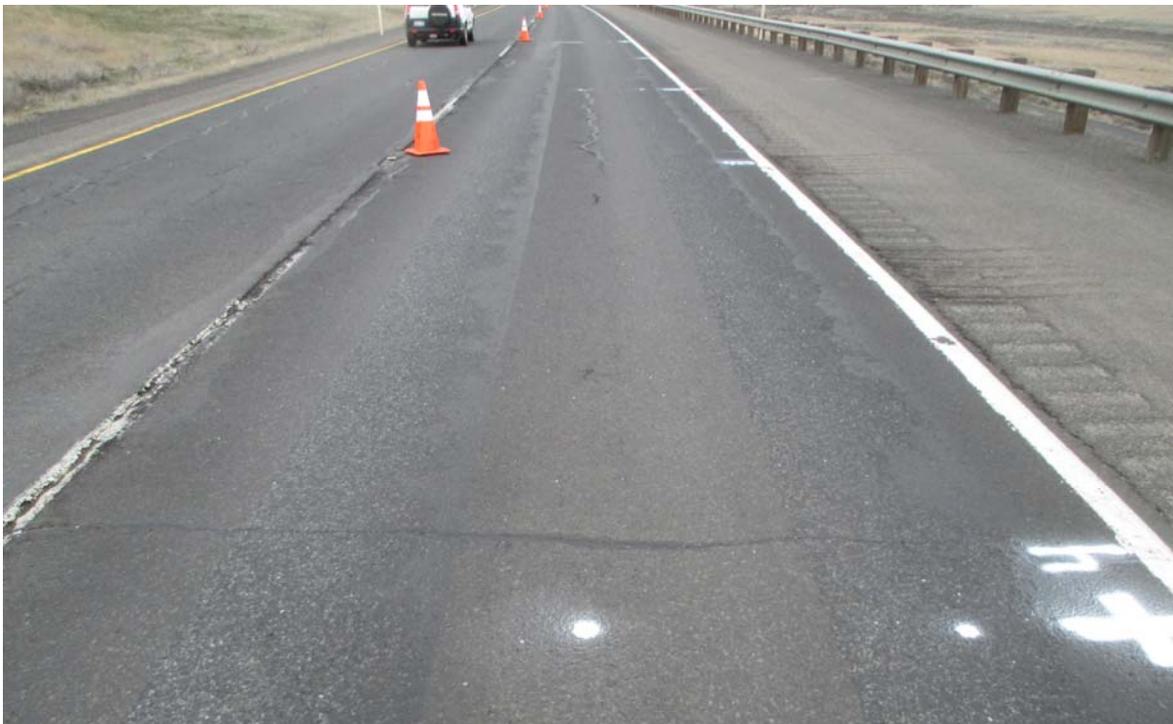
Figure 18 shows the condition of the pavement at station 4+00 where the other set of five cores was taken. The patches in the wheelpaths are visible in the picture. Table 6 contains the results of core examinations from the five cores extracted at this location. Figures 19 through 23 show images of the cores obtained from this station.

Figure 18. Condition of the pavement at station 400 prior to coring. The white dots are FWD test locations.

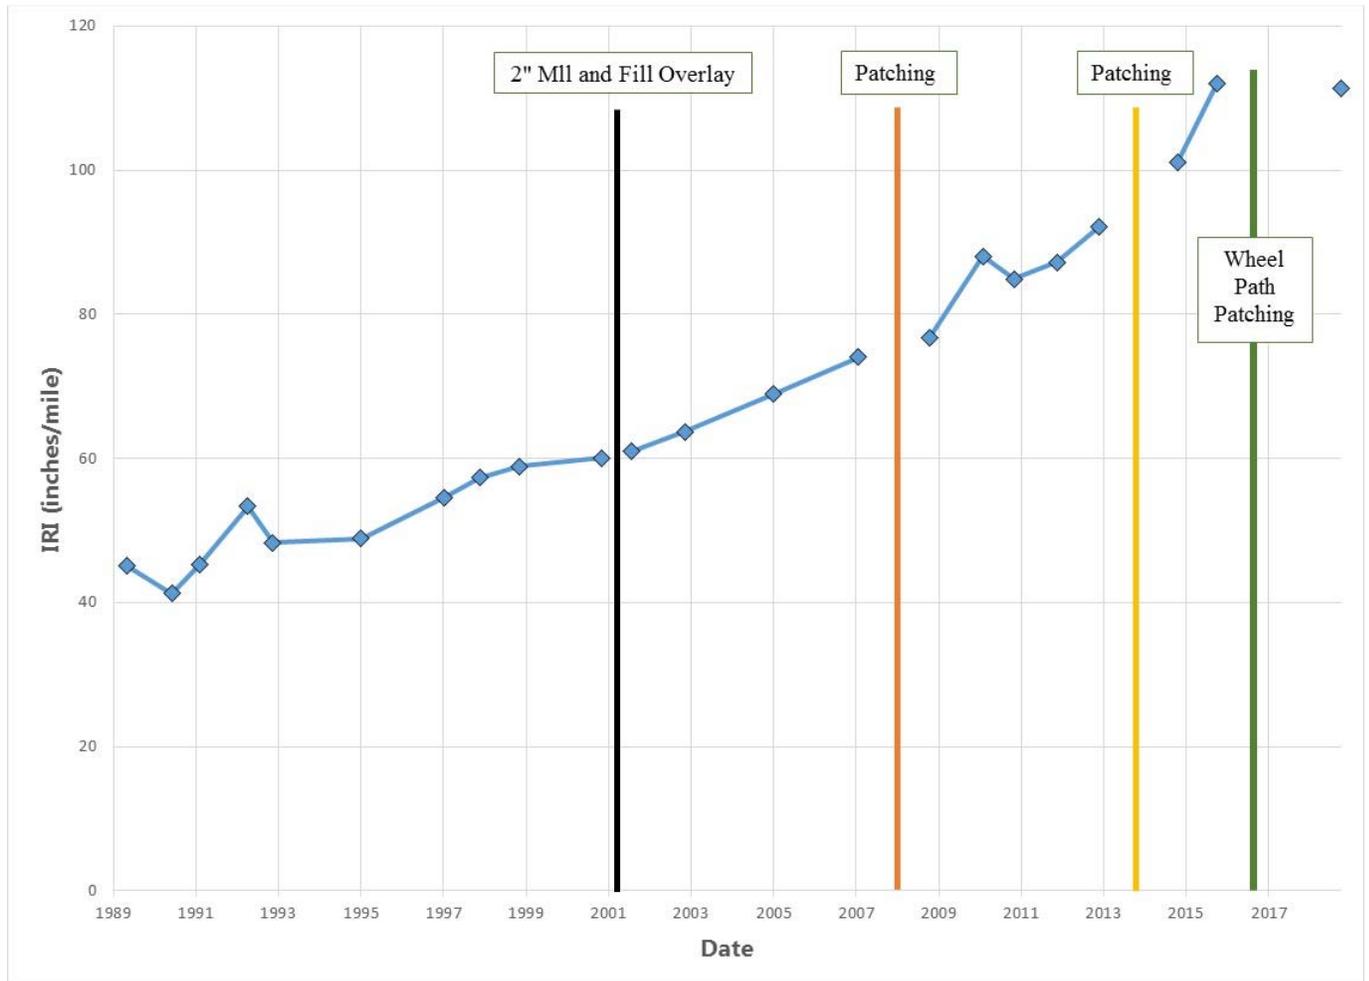
Figure 24 is the updated time history plot of pavement roughness, which includes breaks for rehabilitation and matinenance events. This is a plot of the combined mean IRI from both wheel

paths. The new measurement in 2019 appears to show the effect of the skin patch placed in the wheel path circa 2016 on improving pavement smoothness.

Figure 24. Updated pavement roughness time-history adding the April 2019 LTPP measurement. The wheel path skin patches appear to arrest the further increase in roughness, within the time frame of these measurements.

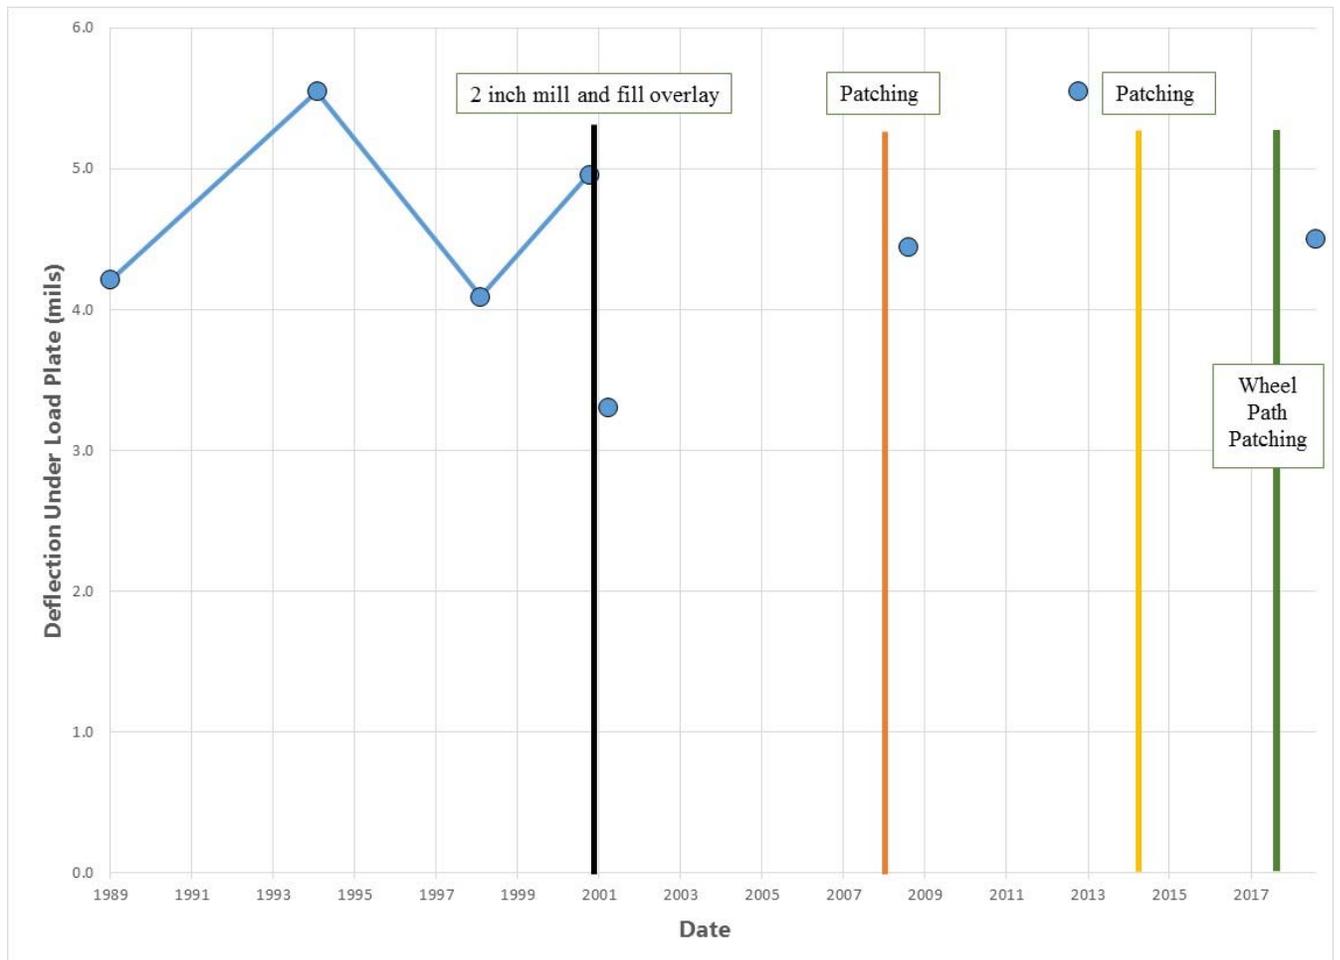
Figure 25 shows the updated FWD wheelpath average 9,000 lb level drop height measurements on section 53_1005. These are the average deflection measurements from the center of the load plate. As shown, the average deflection in 2019 is lower than the one in 2013, but it is still within the range of deflection variations on this test section over 20 years. Moreover, as with previous deflection measurements, the 2019 deflections confirm that this is a very stiff pavement structure, i.e. "strong" pavement structure.

Figure 25. Average FWD wheelpath deflection at the 9,000-lb drop level over time.

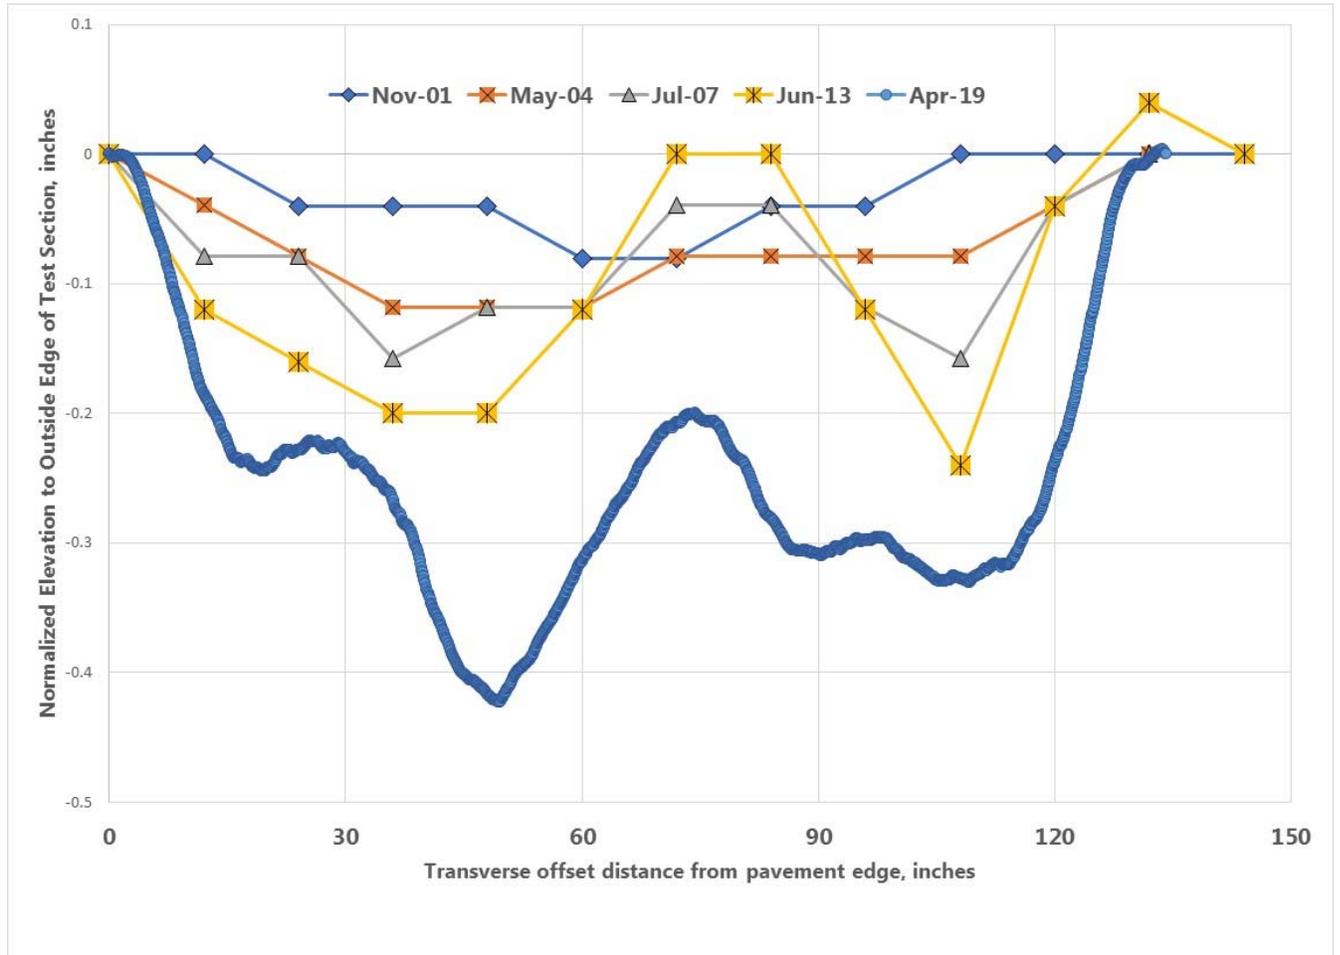
Figure 26 is a plot of the normalized transverse profile elevations at or within 1 foot of station 0+00 on section 53_1005. The plot shows the normalized transverse elevations starting in 2001 just after placement of the 2-inch mill and fill overlay and includes measurements through April 2009. Just after overlay placement in 2001, the maximum displacement in the surface profile, was less than 0.1 inches from a straight line through the lane's edges. The transverse profile distortions in 2001 look like differences in compaction due to movement of the compaction rollers over the AC mixture. The distortions in the elevation of transverse profile are relatively flat across the pavement profile. The level of displacement from a straight line is within the range of the thickness of a penny (.06 inches). The 2004 transverse profile measurements at this location

show a deepening of the transverse profile by about another 0.05 inches in the wheel paths. By June 2013, the depressions in the wheel paths are more pronounced. The measurement in 2019 using the new laser transverse measurement technology, shows a significant increase in the deformation of the pavement surface, even after application of a skin patch in the wheelpaths in 2016.

Fig 26. Comparison of historic normalized transverse profile plots at station 0+00 on section 53_1005.

The endpoint of the normalized transverse profile measurements should be noted. The June 2013 measurement went 13 feet wide, whereas most of the other measurements were only 12 feet wide. If the June 2013 measurement had been normalized to the 12-foot measurement width, this would have had the effect of moving down the normalized transverse profile elevations at most by 0.04 inches. This type of adjustment is in the range of a small stone sitting on the pavement surface.

While Figure 26 is at only one location in the test section, the application of the wheel path chip seals should have reduced the apparent rut depths by at least 0.2 inches based on the April 3, 2019 core thickness measurements.

- The best evidence available for the cause of rutting on this test sections comes from the transverse profile measurements. In Figure 26, the differences in the transverse profile of the surface of this pavement appear to be due to gradual eroding of the pavement surface. While the depths of the elevation in the wheel path have decreased, the depths in mid-path portion of the pavement structure have also decreased. This is the type of behavior that would be expected from test sections that are snow covered for portions of a year and traffic wandering when drivers cannot see the edges of the lane and use of traction control devices is the greatest. This is one of the more significant truck routes in Washington. The measurements reveal more rapid degradation in the wheel paths, which is consistent with the above theory.

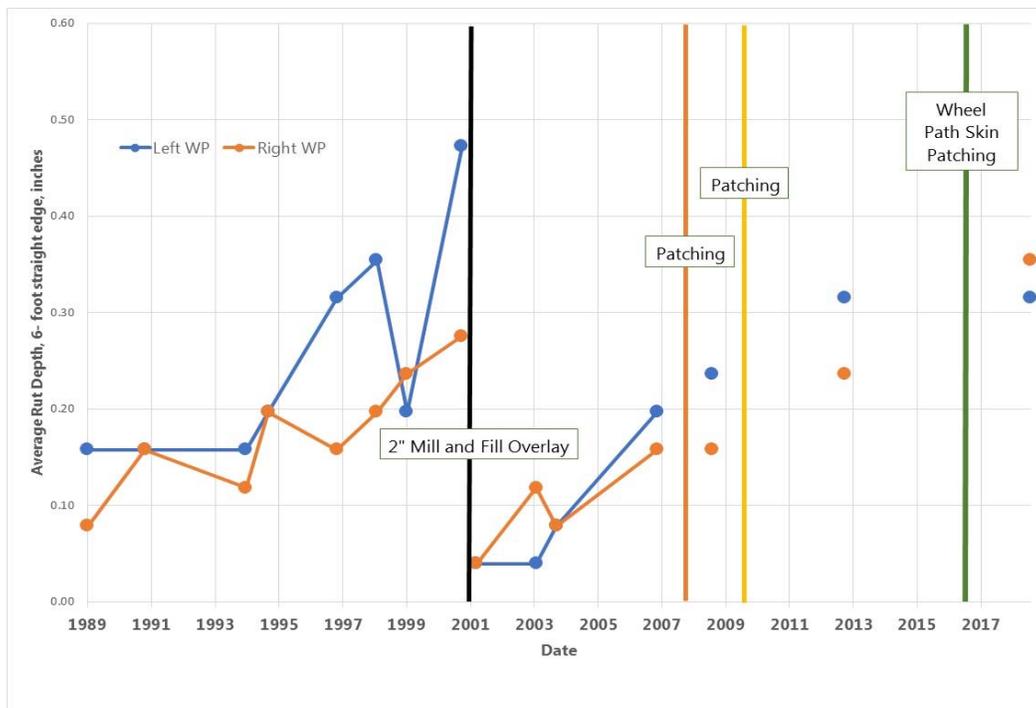
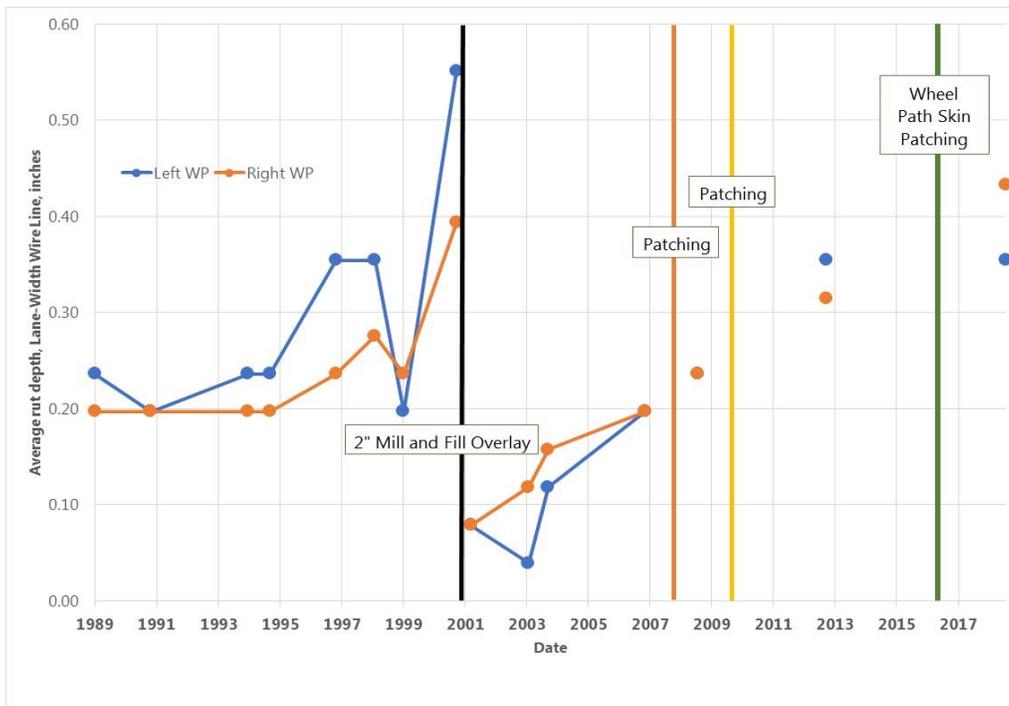
Figures 27 and 28 shows the time history of the average rut depths, in the left and right wheel paths over the entire pavement section for the 6-foot straight edge and wire line methods, respectively. Breaks in the plot are shown for the application of overly and maintenance treatments.

The time history average rut depth shows the influence of the rehabilitation and maintenance treatments. The biggest change is the 2001 2-inch mill and fill overlay. The calculated ruts depths just after construction appeared to be more related to rolling patterns since the transverse profile is relatively flat with plateaus that match typical compaction roller widths. From 2001 there is a gradual increase in rut depths and the patching events 2008 and 2013 did not appear to slow down the rutting rate. It is surprising that the wheel path skin patches placed in 2016 kept the rutting in the left wheel path the same, but rutting in the right wheel path increased by a 0.1 inch when comparing the 2013 and 2019 measurements.
