Report No. UT-002

**NON-DESTRUCTIVE AND
DESTRUCTIVE INVESTIGATION
OF AGED-IN-THE FIELD CARBON
FRP-WRAPPED COLUMNS**

New York State Department of
Transportation &
Utah Department of Transportation

October 2009

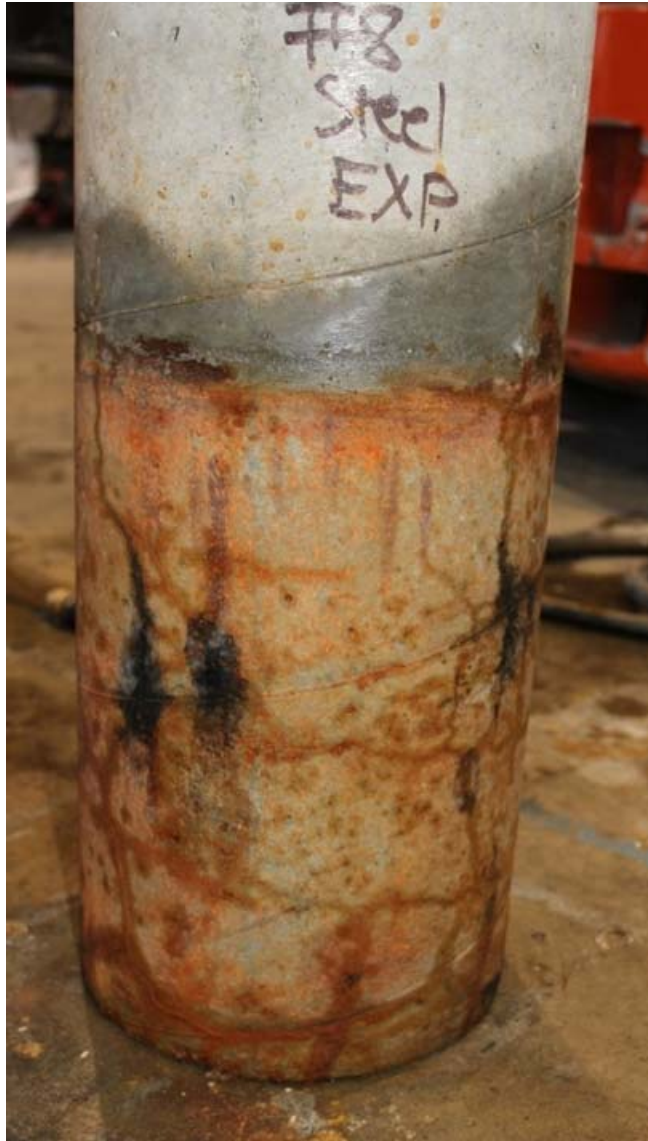
The two specimens were observed on a weekly basis and pictures were taken. One of the two initial test specimens was removed from the corrosion environment on October 23, 2009, and is shown in Figure 2; it is clear that corrosion, discoloration and cracking are limited to the portion of the small-scale column below the water line. This specimen will be tested in compression and the amount of rebar corrosion will be determined. The second test specimen will stay in the corrosion environment for as long as needed based on the state of corrosion of the first test specimen and the strength degradation observed. Therefore, the amount of time needed for the other small specimens to remain in the corrosion environment will be determined by using these two test specimens.

Figure 2. Corrosion deterioration of first small-scale steel reinforced column.

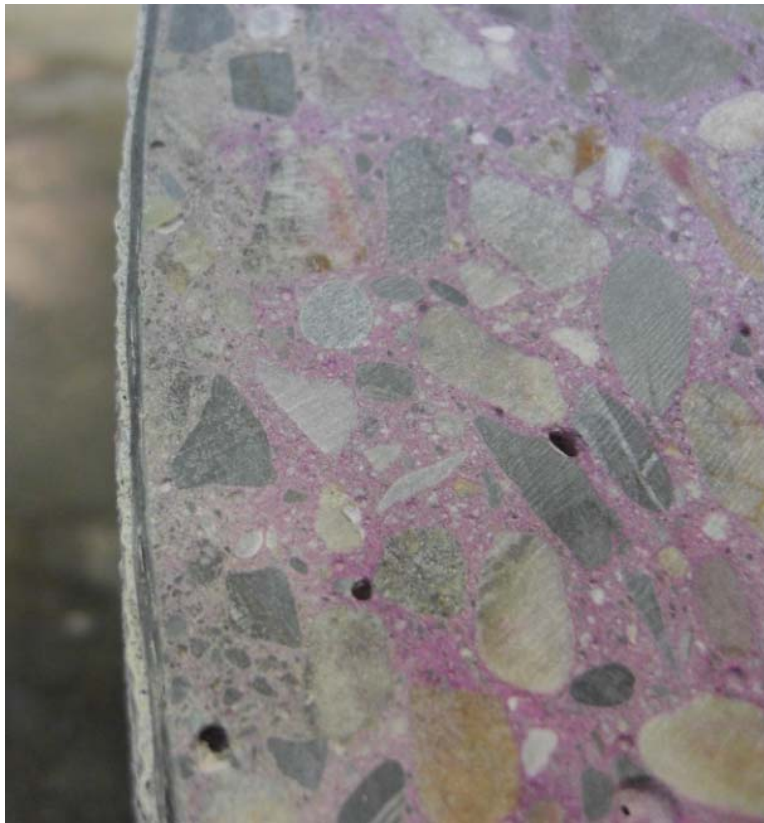
Penetration of carbonation into the concrete can be one of the causes of corrosion. The depth of penetration of the carbonation was found by using a Gilson HM-261 Carbonation Detection Kit on the saw-cut ends of the two full-scale columns. This kit contains a phenolphthalein solution that is sprayed over a freshly cut or fractured surface. The solution causes the concrete that has not been exposed to carbonation to turn into a pink color and the carbonated concrete appears normal. This solution was applied to the four cut surfaces of the two full-scale columns after they were cleaned. Minimal carbonation penetration was observed. Carbonation does not appear to have reached the column steel reinforcement in significant amounts, as shown in Figure 5. On average only the outer $\frac{3}{4}$ in. layer was observed to have high carbonation content. However, this finding may not be accurate at locations where the concrete had fallen off and was replaced in the rehabilitation process, as shown in Figure 6.

Figure 5. Concrete carbonation at perimeter of cut-off column section.

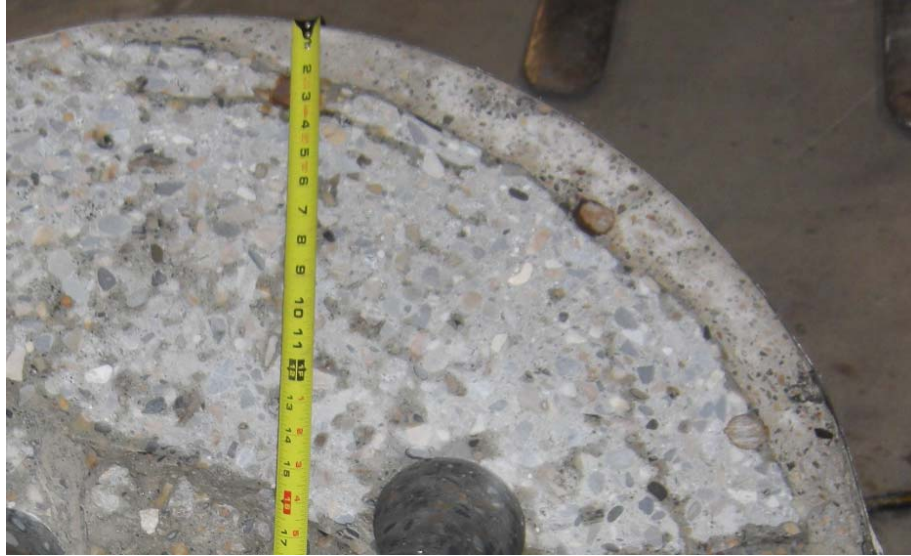
Figure 6. Replaced concrete around the perimeter of column section.

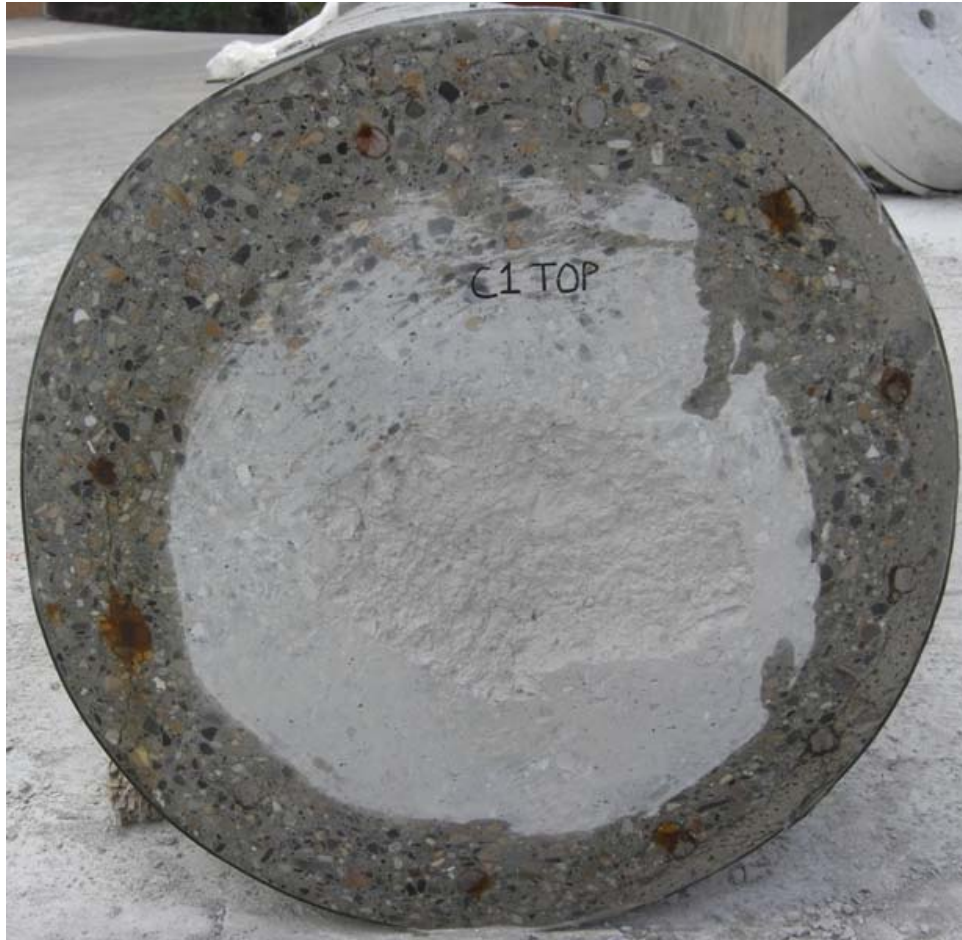
Corrosion in the vertical steel reinforcing bars of the full-scale columns was evident as shown in Figure 7. In general, bars with a smaller cover, resulting from construction tolerances, had higher levels of corrosion as shown in Figure 8(a), compared to bars with a larger cover, as shown in Figure 8(b). However, there are other factors to be considered, such as the flow of the salt water de-icing solution from the deck joints to the cap beam and then to the columns. To investigate this topic further, the corrosion patterns and concrete cover of all bars at the top and bottom of both columns has been recorded, as shown in Figure 9. The notations for bar number and amount of concrete cover are given in Figure 9 and Table 1.

The observed corrosion patterns indicate that the top of the columns had a higher frequency of corrosion and a more significant section loss, compared to the bottom of the columns. This is due to the presence of the salt water solution which is sprayed for de-icing; the decks had open expansion joints until the time of rehabilitation of the columns in 2000, when the deck joints were closed. A number of #9 vertical steel bars and #4 steel hoops bars from the cut-off portions of the two columns have been set aside; these bars will be examined for area section loss due to corrosion along with the steel bars inside the columns after the axial load tests of the columns have been performed.

Figure 7. Corrosion of vertical steel reinforcing bars at the top of full-scale column C1.

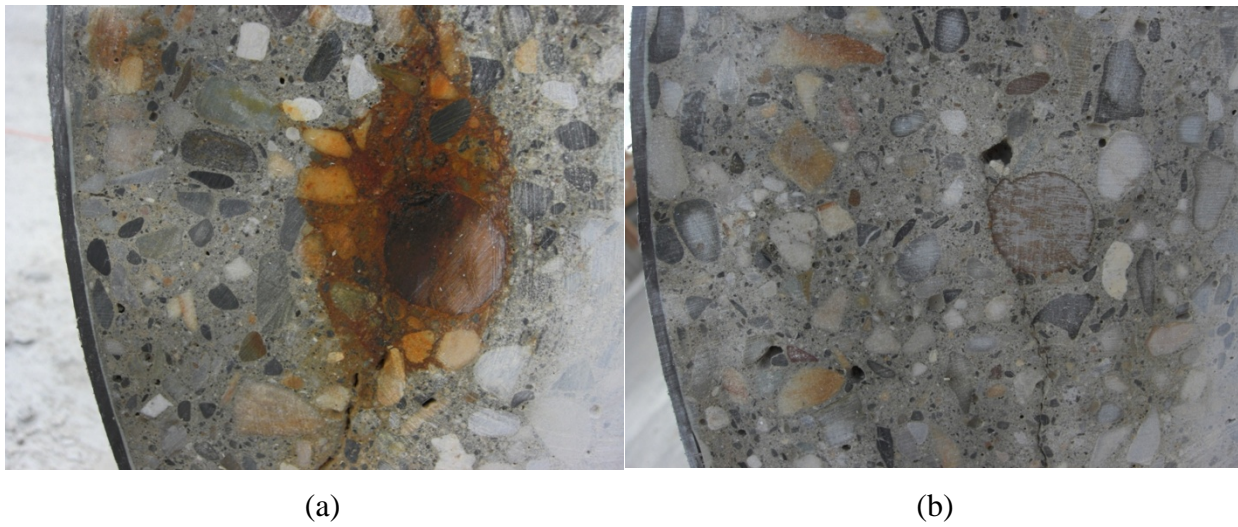
(a) (b)
Figure 8. Influence of column concrete cover on corrosion.

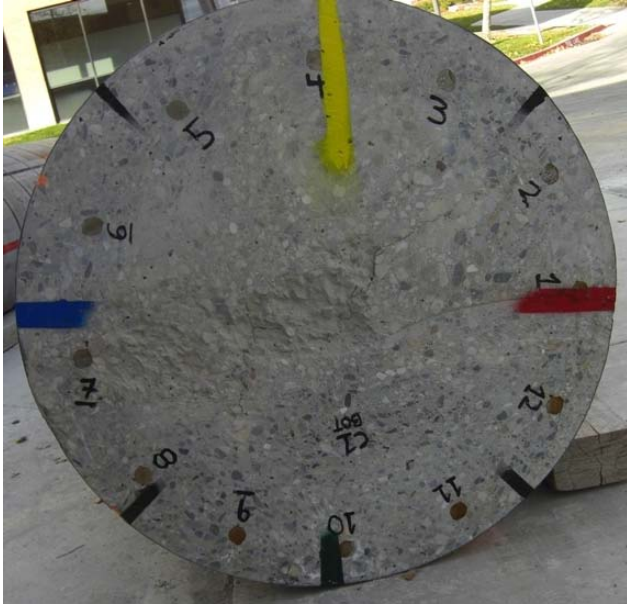
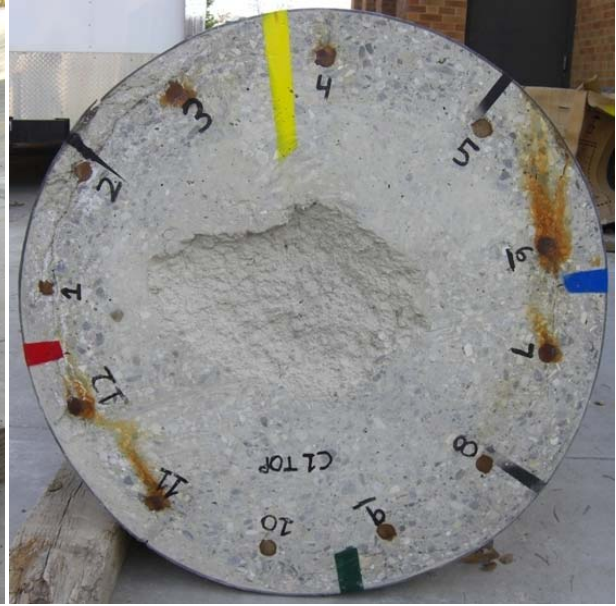
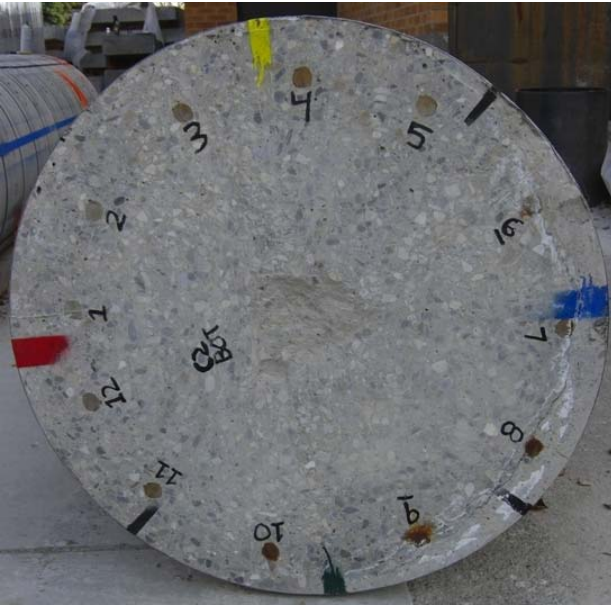
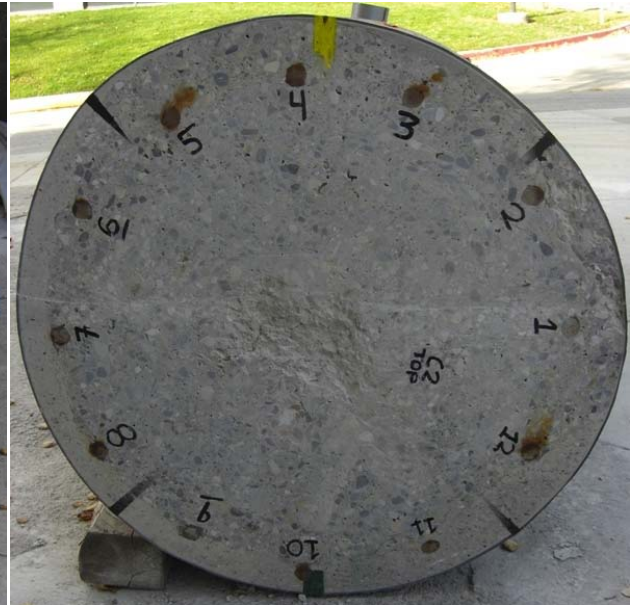
Figure 9. Column concrete cover: (a) C1 bottom, (b) C1 top, (c) C2 bottom, (d) C2 top.

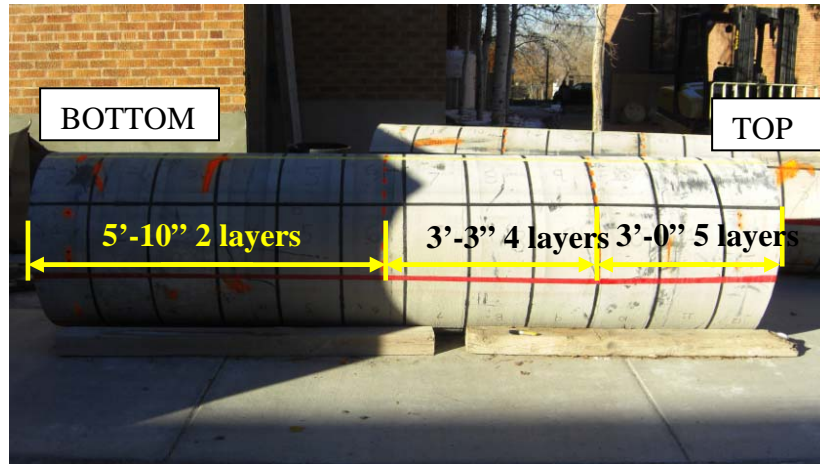
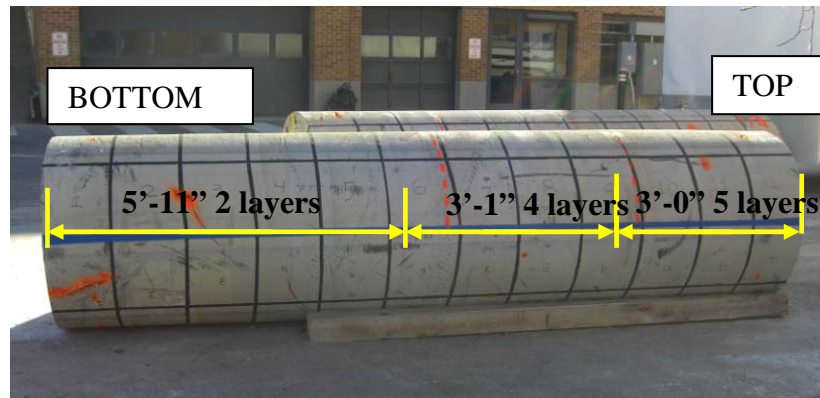
Once the two columns were saw-cut the column surfaces wrapped with CFRP composite were inspected. No voids between the CFRP composite and the concrete surface were detected by the method of tapping the surface with a quarter. By comparing pictures taken of the Pier #3 WB before demolition and the design drawings, the location of the column sections obtained were determined. It was found that the top of each specimen corresponded to the top of each column in the as-built pier. By measuring the CFRP thickness, the number of layers for each region was determined as shown in Figure 10 for both columns 1 and 2. It should be noted that one layer of CFRP composite is 0.04 in. thick.

Figure 10. Mapping the CFRP number of layers and location with respect to the column orientation.

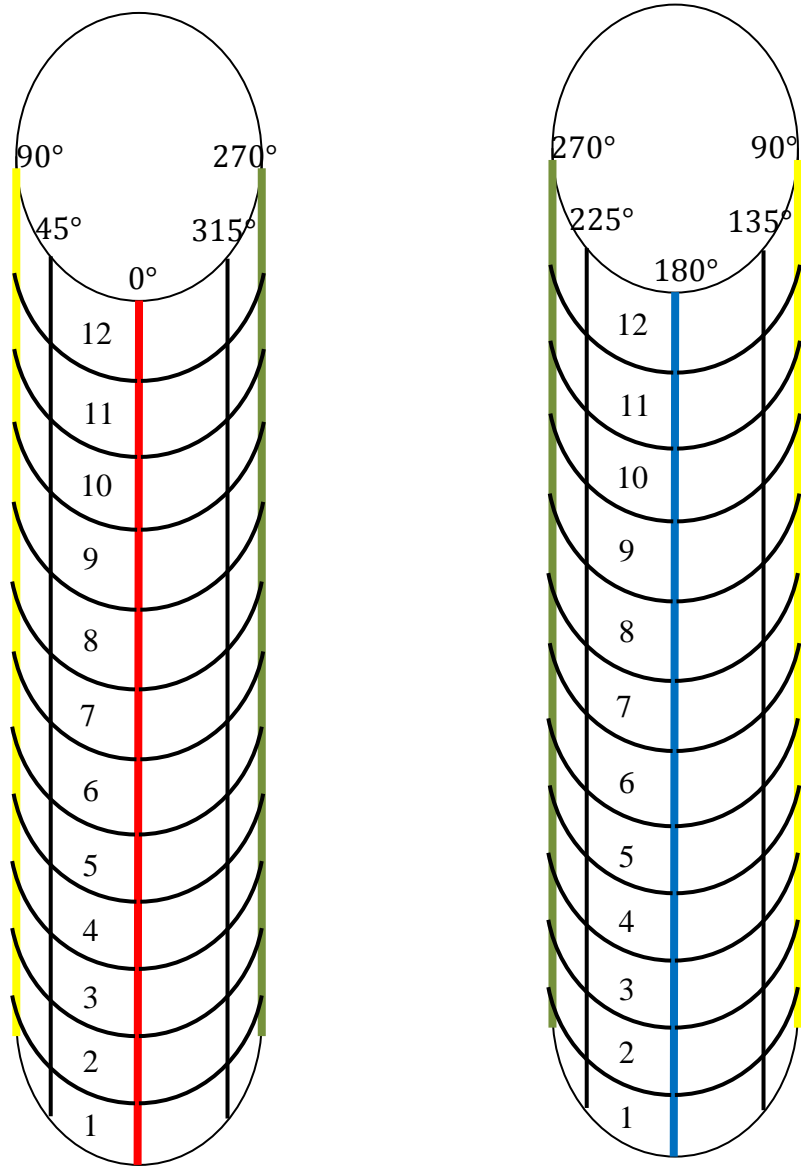
Figure 11. Diagram of typical column grid.

The damage levels on the carbon fiber polymer composite (CFRP) was determined using visual observations on two different dates. An ad-hoc terminology was used and is documented with extensive descriptions in Figure 11 and Table 2. This was done to identify weak locations of the CFRP wrap prior to testing, which will be helpful in interpreting the test results.
