Investigation of Deterioration of Joints in Concrete Pavements

National Concrete Pavement
Technology Center

Final Report
August 2012

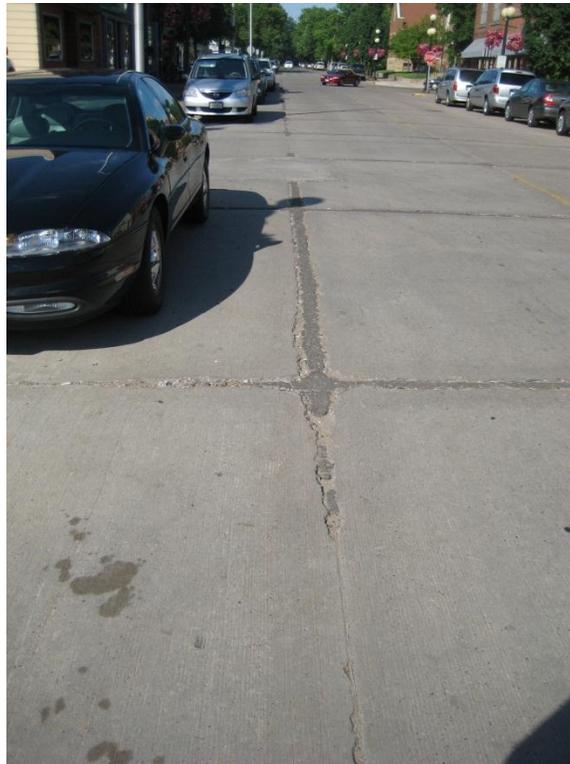
Figure 1. Grand Avenue

The intersection of First Avenue and Grand Avenue is in a local commercial area. It is a lightly-trafficked T junction. Distress was easily observed in the joints (Figures 1 and 2) on Grand Avenue, but not as apparent on First Avenue.

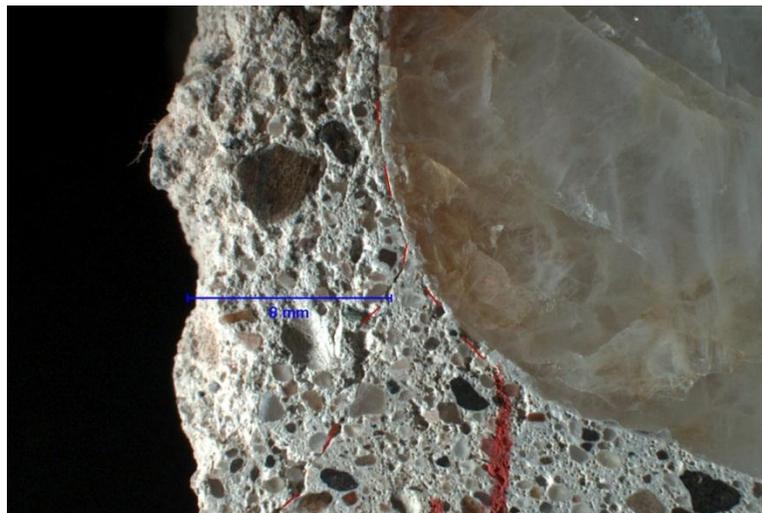
It is noted in one of the images, FG1 shows cracking propagating around the coarse aggregate (Figure 3).

Figure 3. Cracks concentrated adjacent to the coarse aggregate in FG1

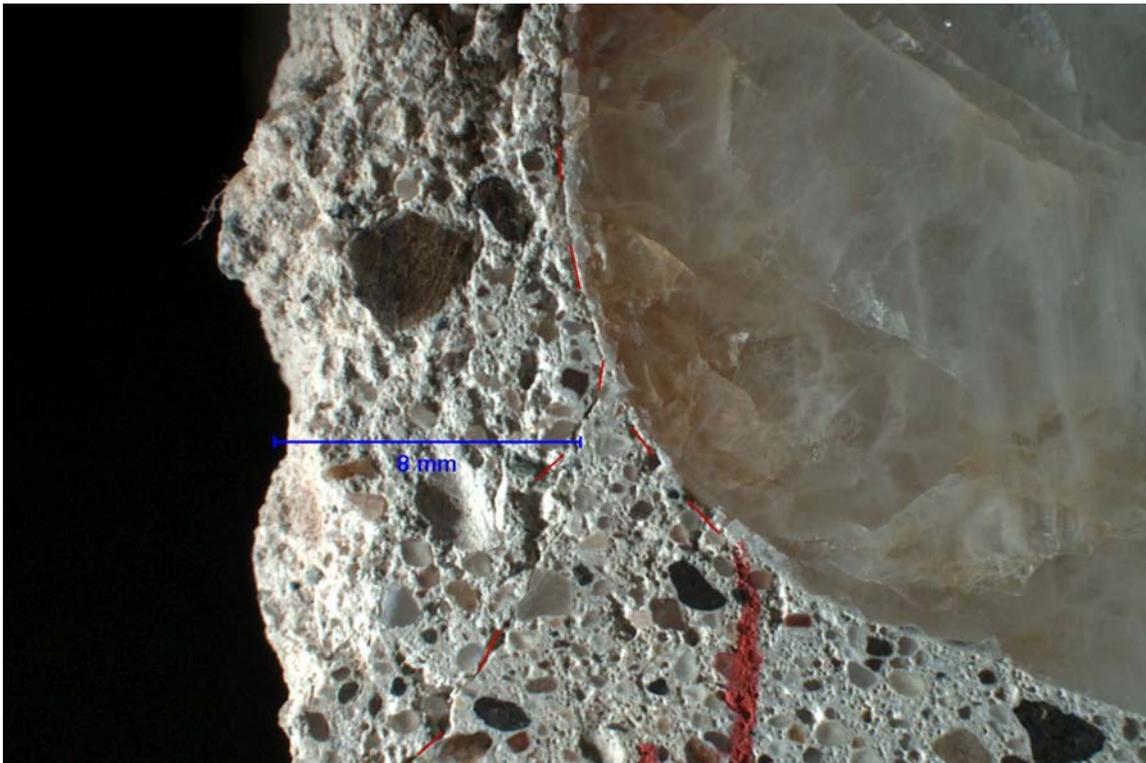
PHOTO: 12

SAMPLE ID: FG1 DESCRIPTION: Highly distressed paste directly adjacent to the joint crack at approx. 160mm depth in the core. The paste is lighter colored, softer, and filled with concentrated fine microcracking.
MAG: 5x

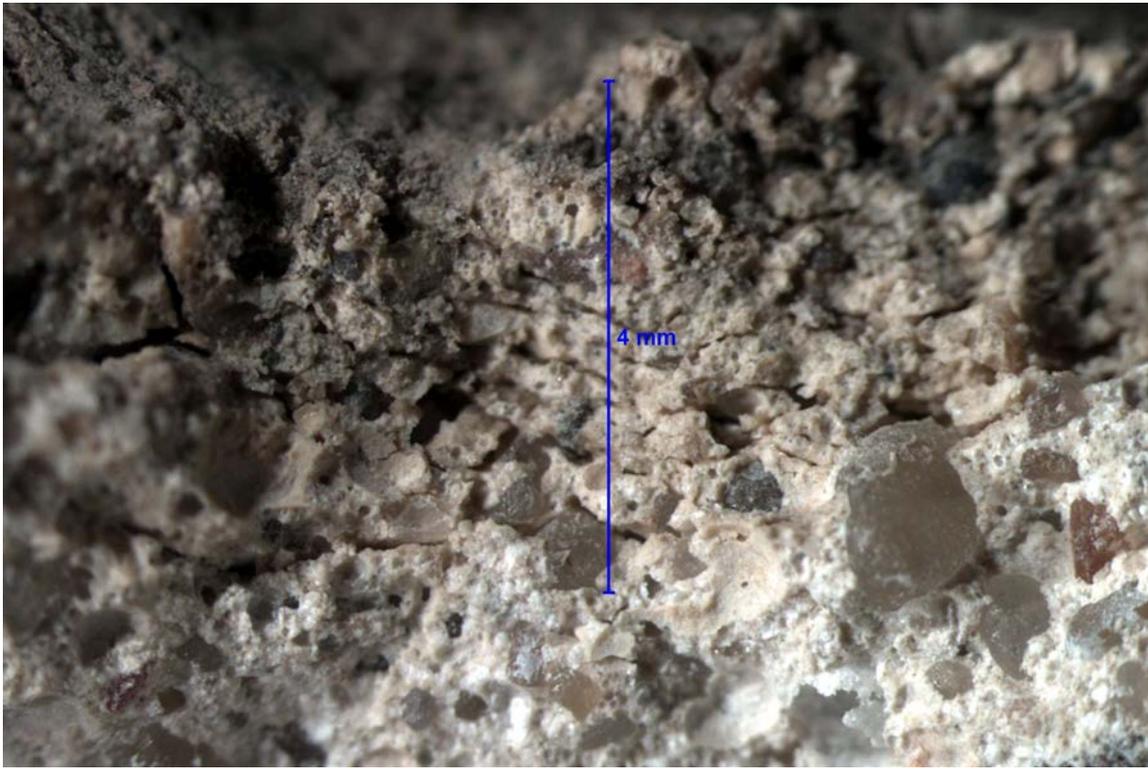
PHOTO: 13

SAMPLE ID: FG1 DESCRIPTION: Highly concentrated anastomosing microcracking in carbonated paste directly adjacent to distressed joint plane (top of image); in freshly fractured cross sectional surface of core.
MAG: 15x

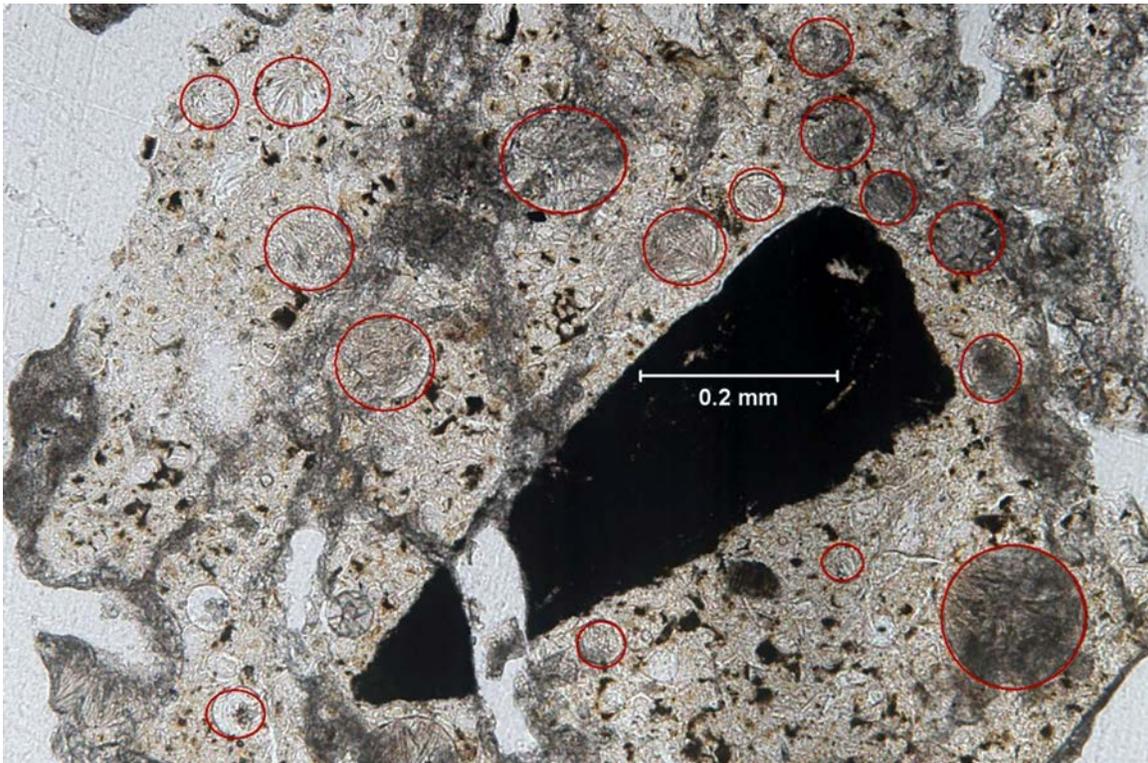
PHOTO: 14

SAMPLE ID: FG1 DESCRIPTION: Secondary ettringite and calcite fills fine air voidspaces (outlined in red) in thin section of the altered and highly distressed paste directly adjacent to the joint crack at below approx. 75mm depth in the core.
MAG: 100x

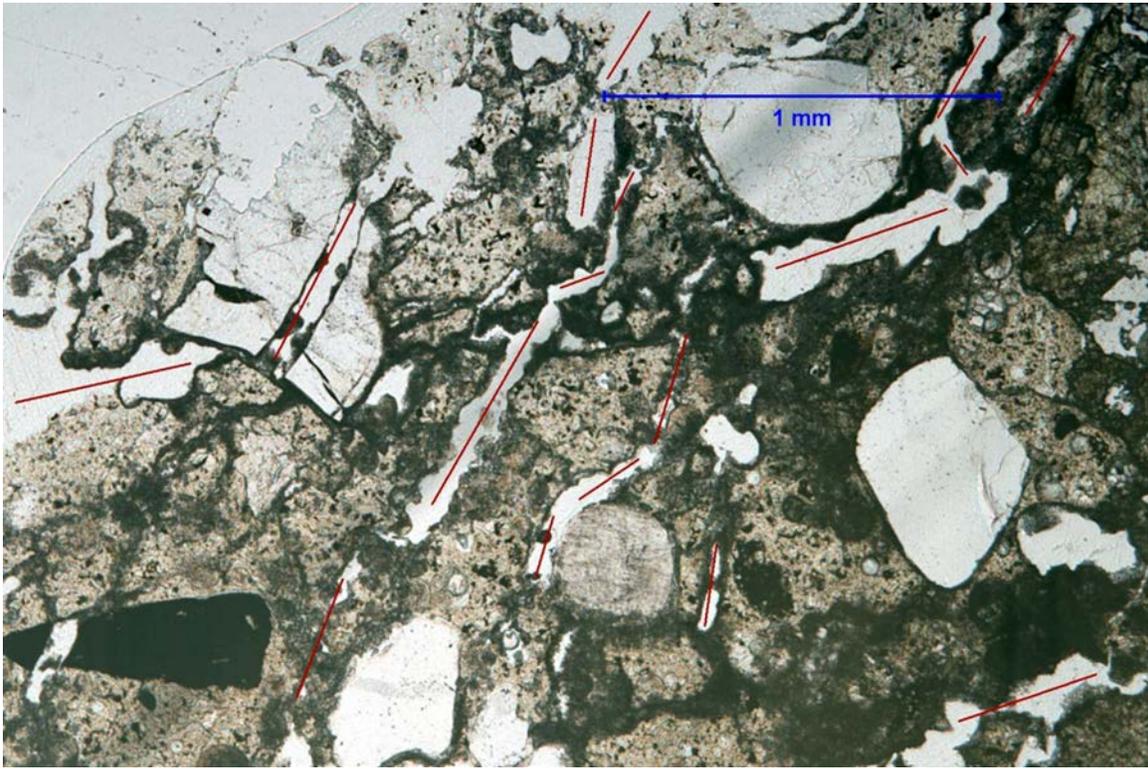
PHOTO: 15

SAMPLE ID: FG1 DESCRIPTION: Highly concentrated anastomosing microcracking (mapped in red dashed line) in carbonated paste directly adjacent to the distressed joint plane (top of image); in thin section concrete under plane polarized light.
MAG: 40x

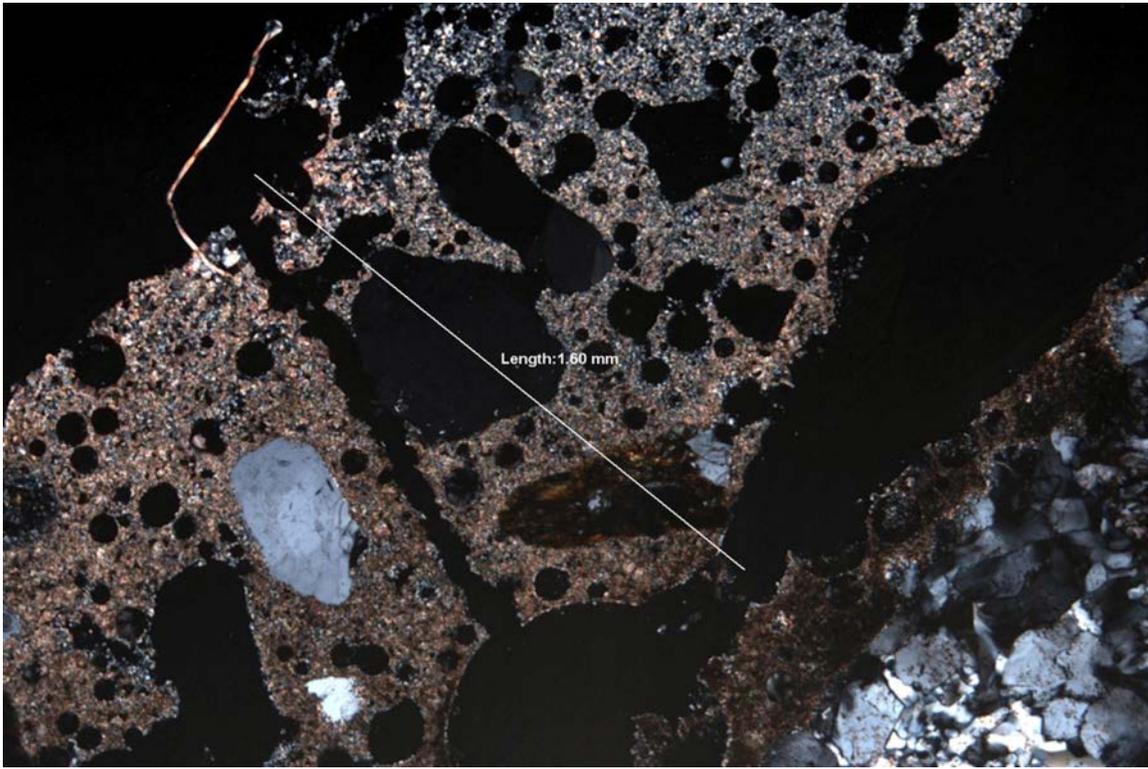
PHOTO: 23

SAMPLE ID: FG2 DESCRIPTION: Brightly colored, carbonated paste directly adjacent to the distressed joint plane (upper left); in thin section under cross polarized light.
MAG: 40x

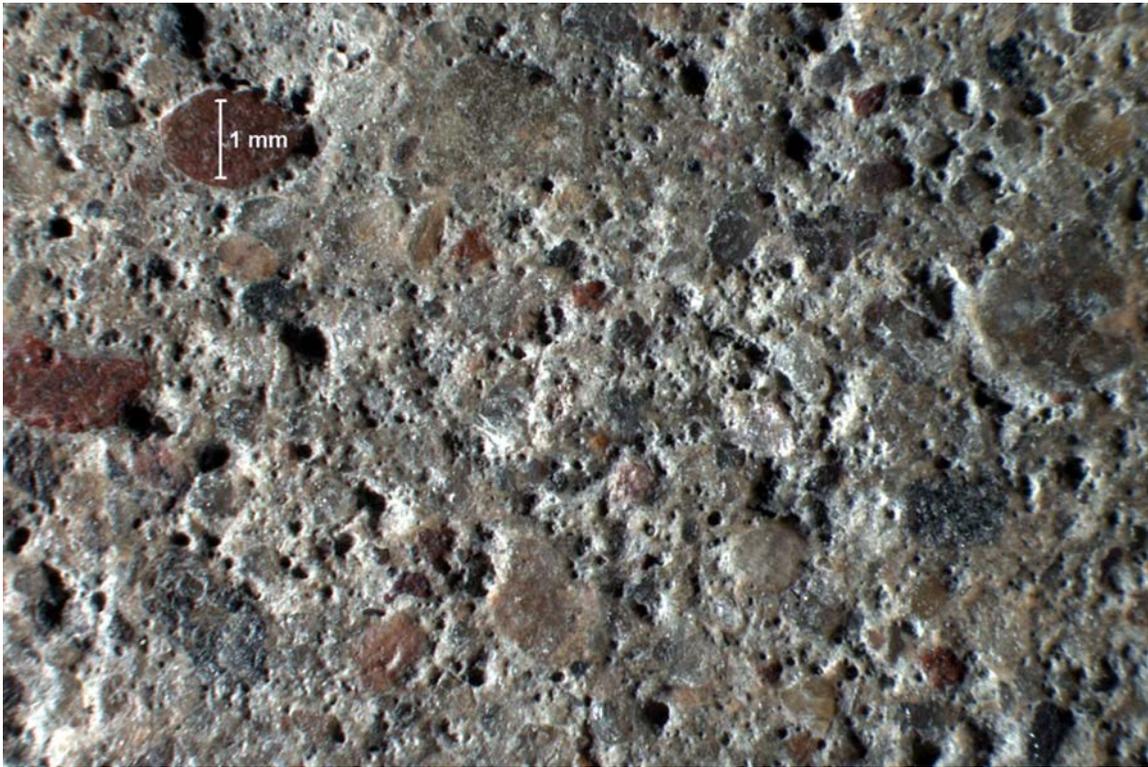
PHOTO: 27

SAMPLE ID: FG3 DESCRIPTION: Traffic-worn top surface of the concrete under magnification

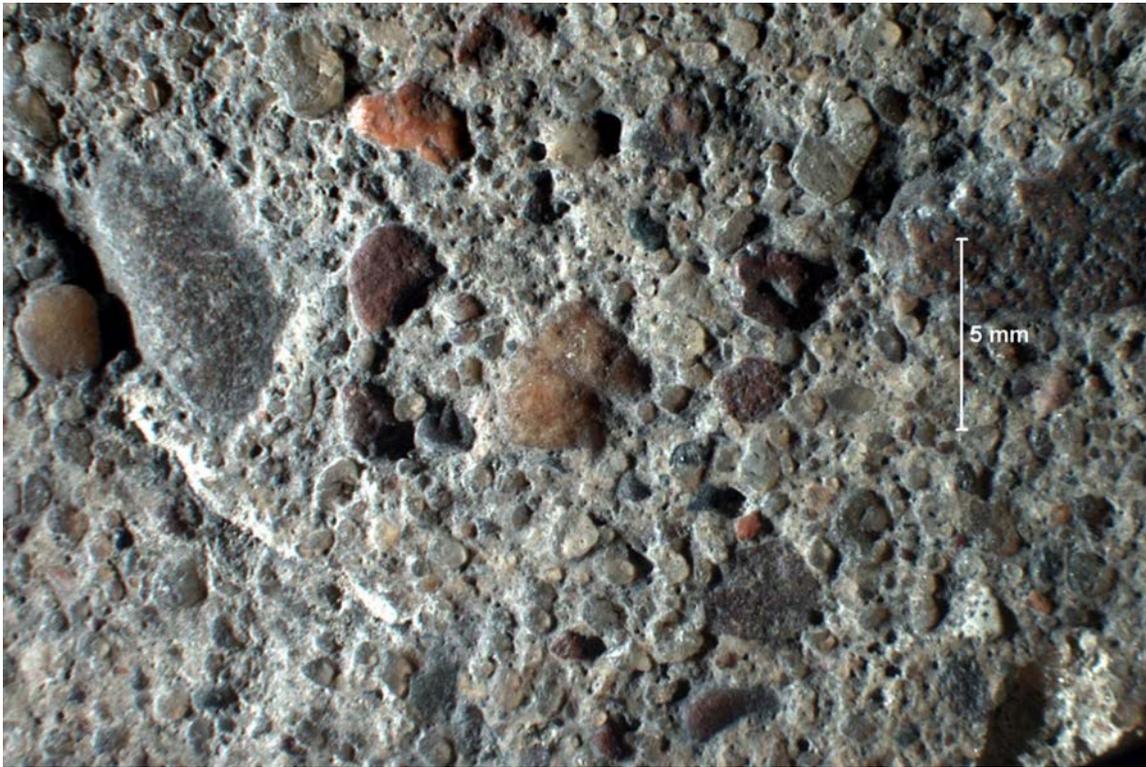
PHOTO: 31

SAMPLE ID: FG4 DESCRIPTION: Traffic-worn and mortar eroded top surface of the core under magnification.

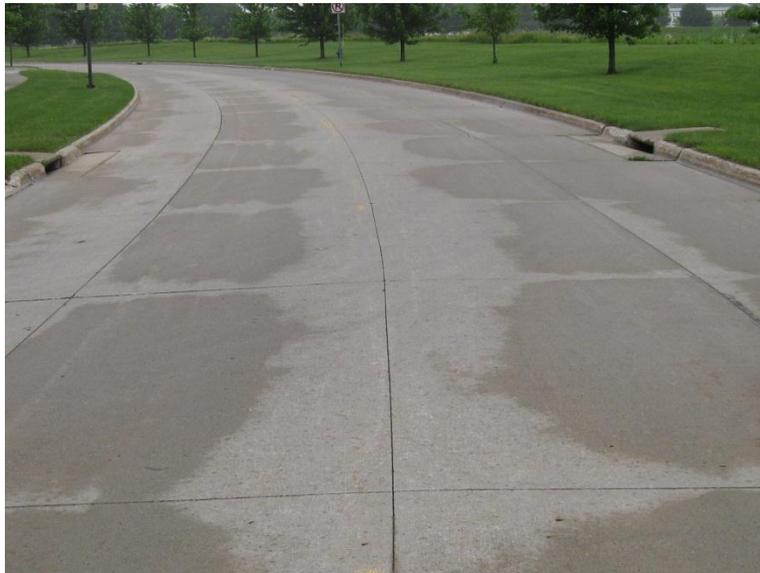
Figure 1. Evidence of joints that are draining well

This drainable base is evidenced by the dry joints and wet surface observed after a rainstorm in the summer of 2011 (Figure 1). At the time, it was noted that the drains were running with water.

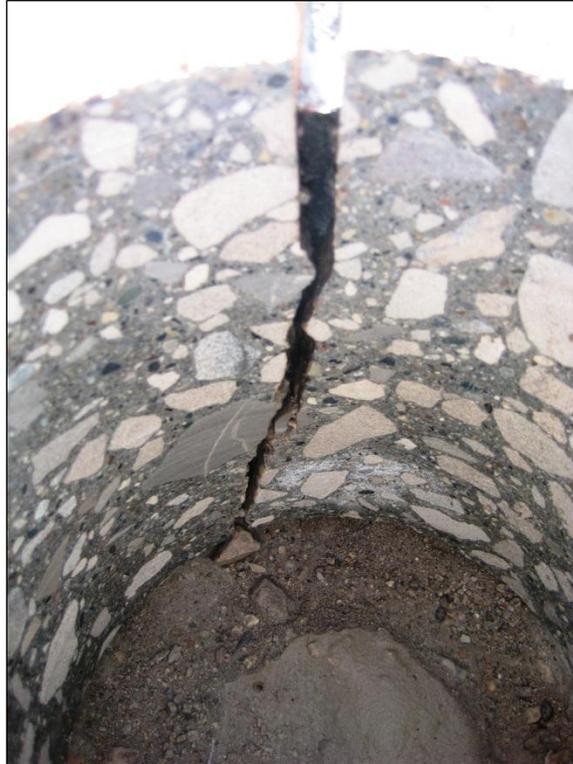
Figure 3. Faulting and loss of aggregate interlock

It is also noted that there is faulting starting to occur in the left-most joint, particularly at the northeast end of the road (Figure 3).

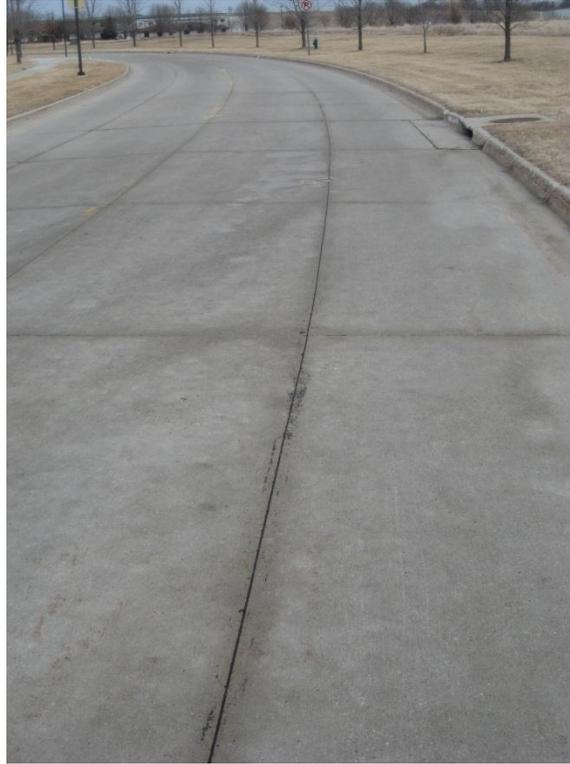
Figure 4. Wet joints and dry pavement

During the winter of 2011/2012 shortly after a light snow event, it was noted that contrary to the pattern observed in Figure 1, the joints appeared to be wet while the rest of the pavement had started to dry out. This is attributed to salts collecting in the joints and slowing the rate of drying (Figure 4).

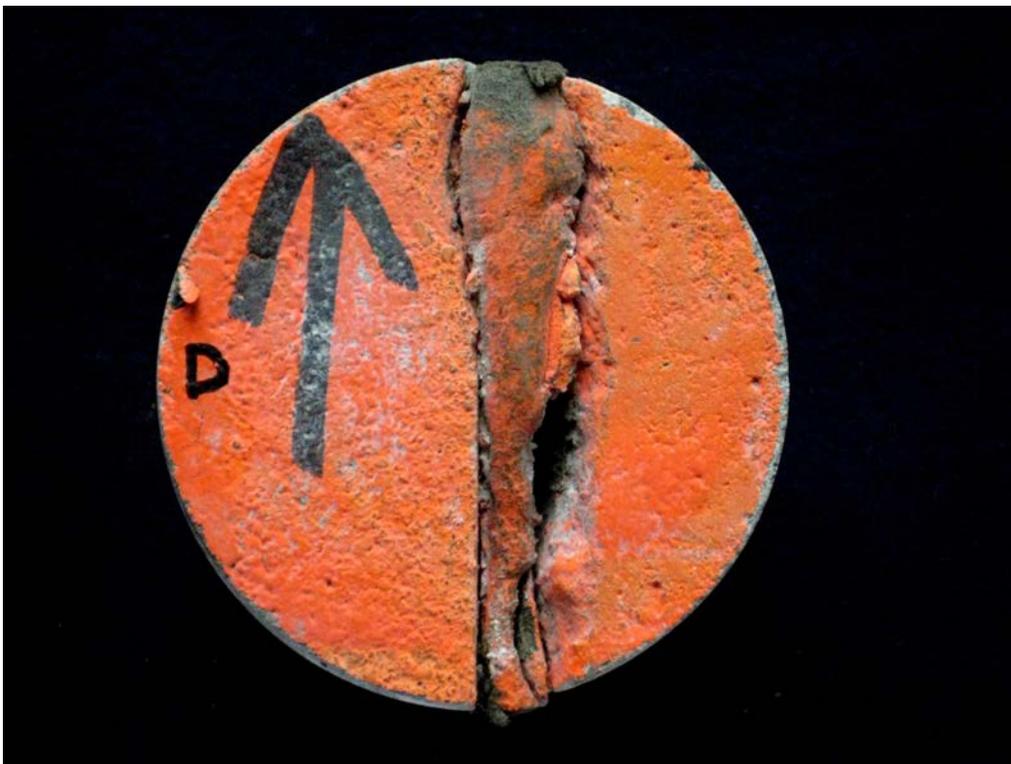
PHOTO: 2

SAMPLE ID: D DESCRIPTION: Top surface of the core as received; covered by orange marking paint. Note core was taken through sawcut control joint; which subsequently "sliver spalled" and was filled with hot-pour joint sealant (now de-bonded).

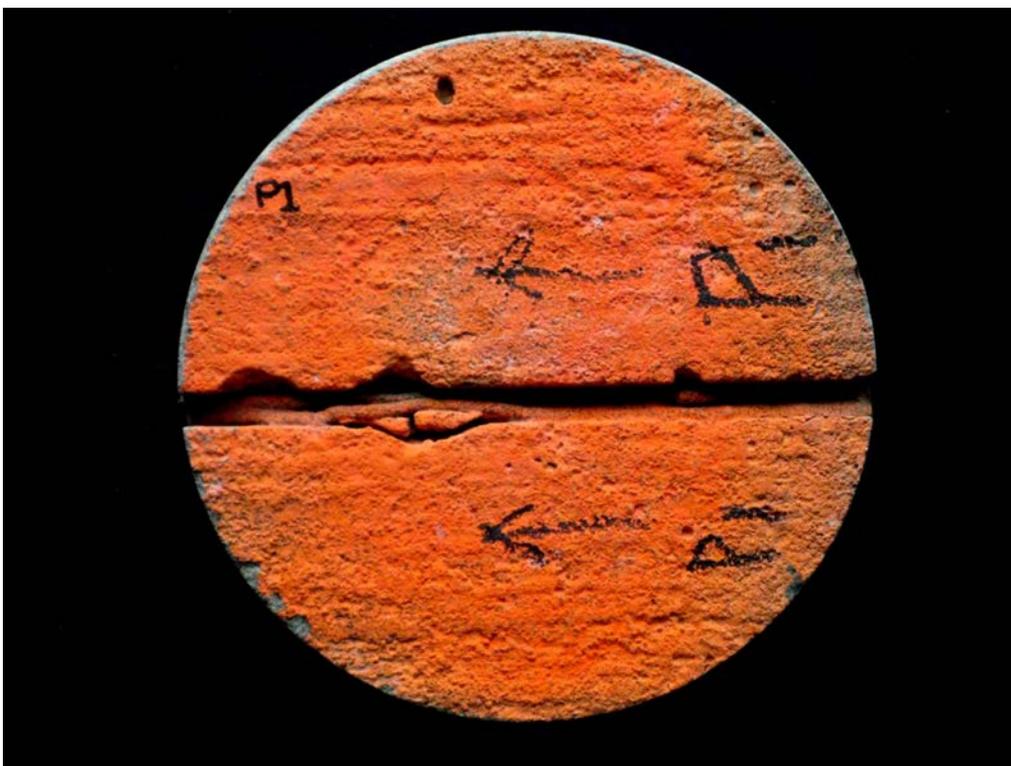
PHOTO: 4

SAMPLE ID: P1 DESCRIPTION: Top surface of the core as received; covered by orange marking paint. Note core was taken through a sawcut control joint; which exhibits intermittent "sliver spalling". The joint was filled with hot-pour joint sealant.

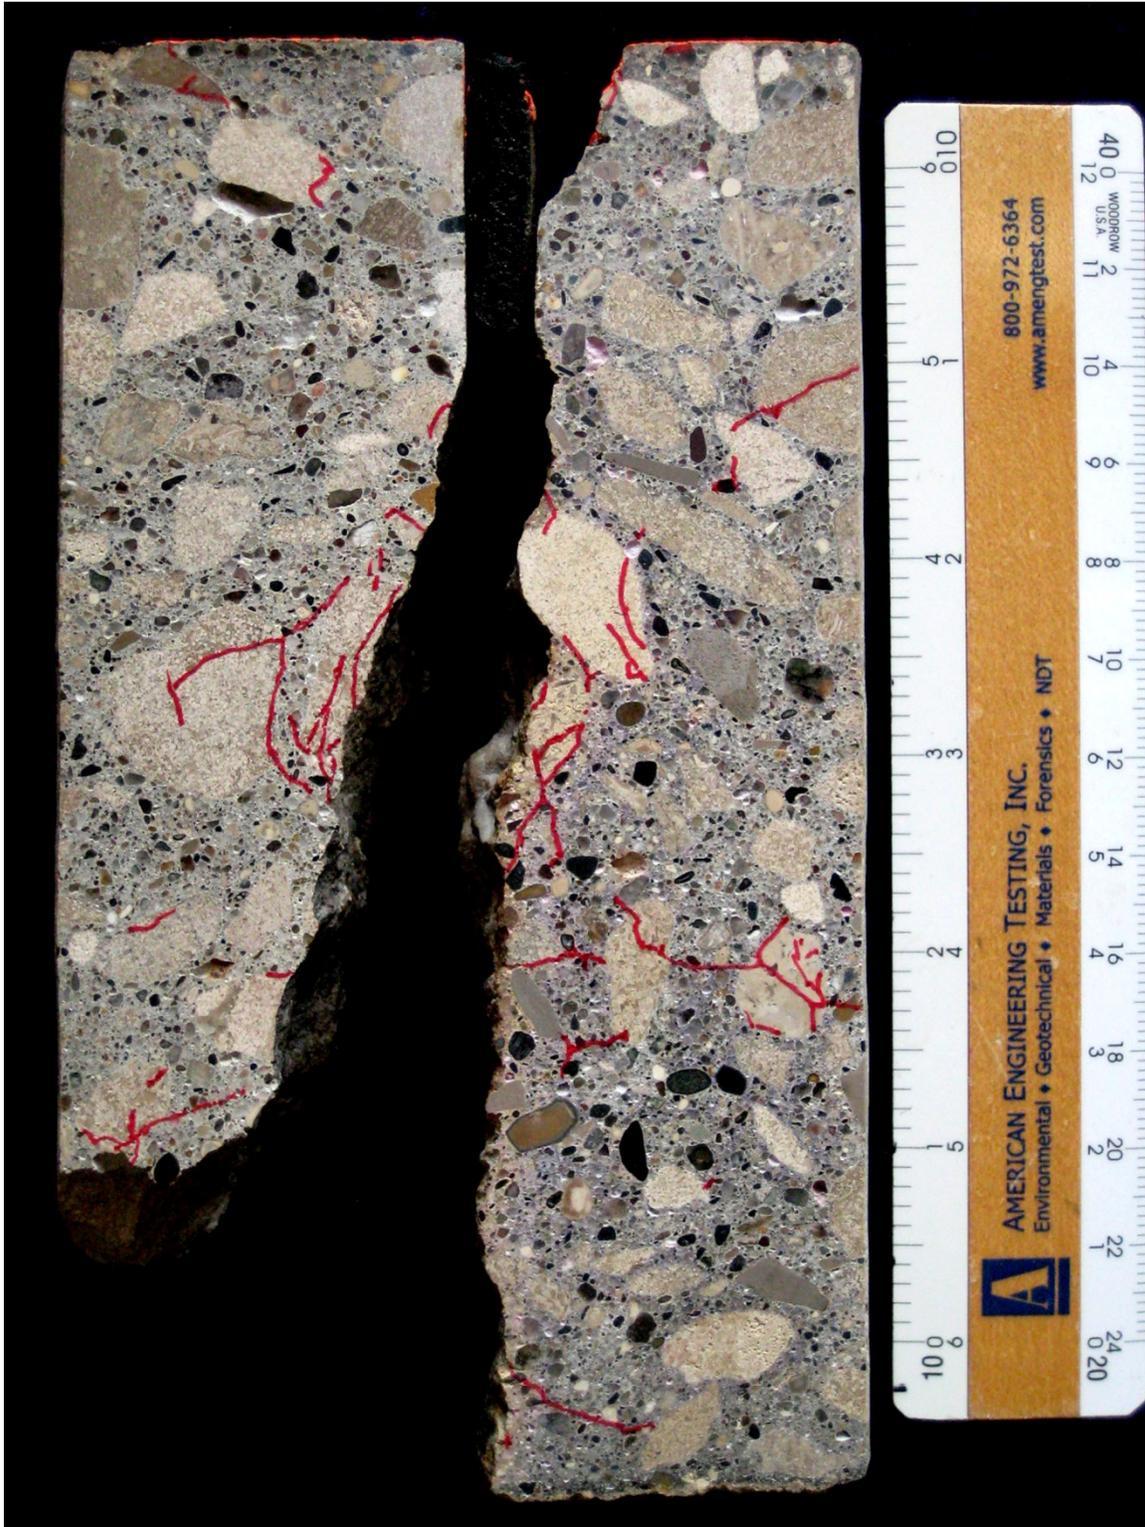
PHOTO: 7

SAMPLE ID: D **DESCRIPTION:** Sawcut and lapped cross section of core taken through joint. Microcracking is mapped in red ink. Note mass lost along the joint crack and cracking within coarse aggregate particles.

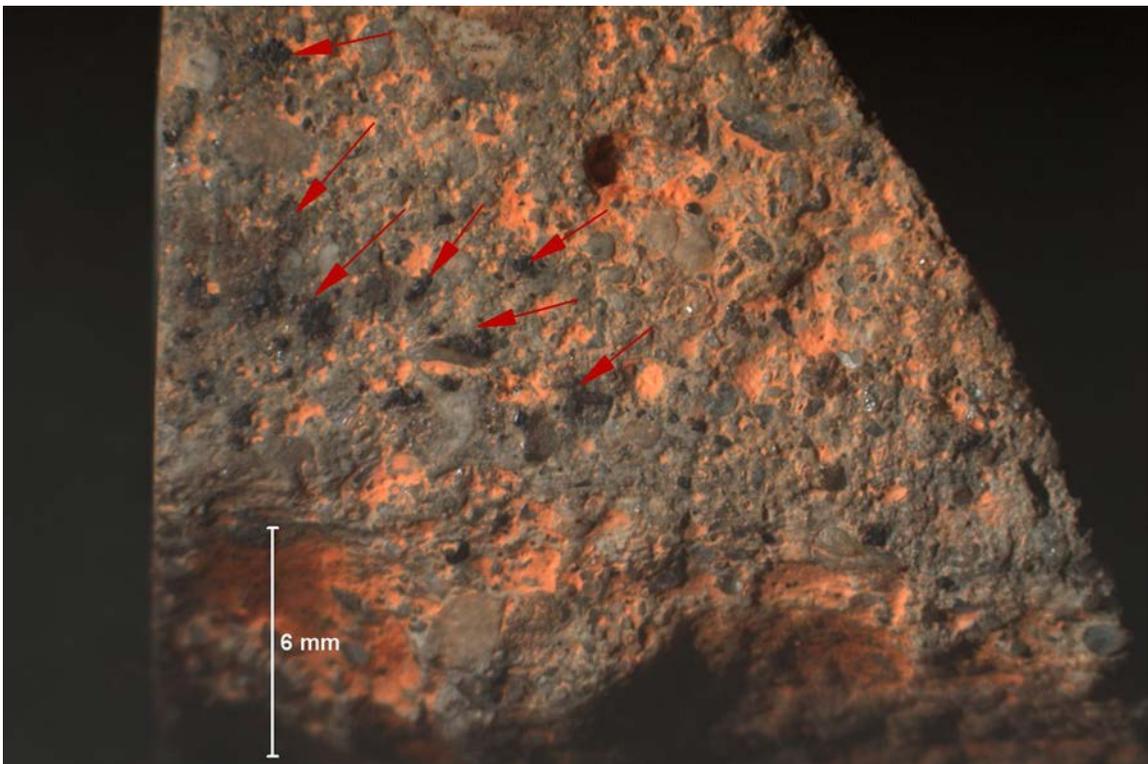
PHOTO: 10

SAMPLE ID: D DESCRIPTION: Sawcut portion of the top surface and joint (bottom of image) exhibiting sliver spalling. Arrows mark corroded metal adhered to exposed aggregates on the top surface.

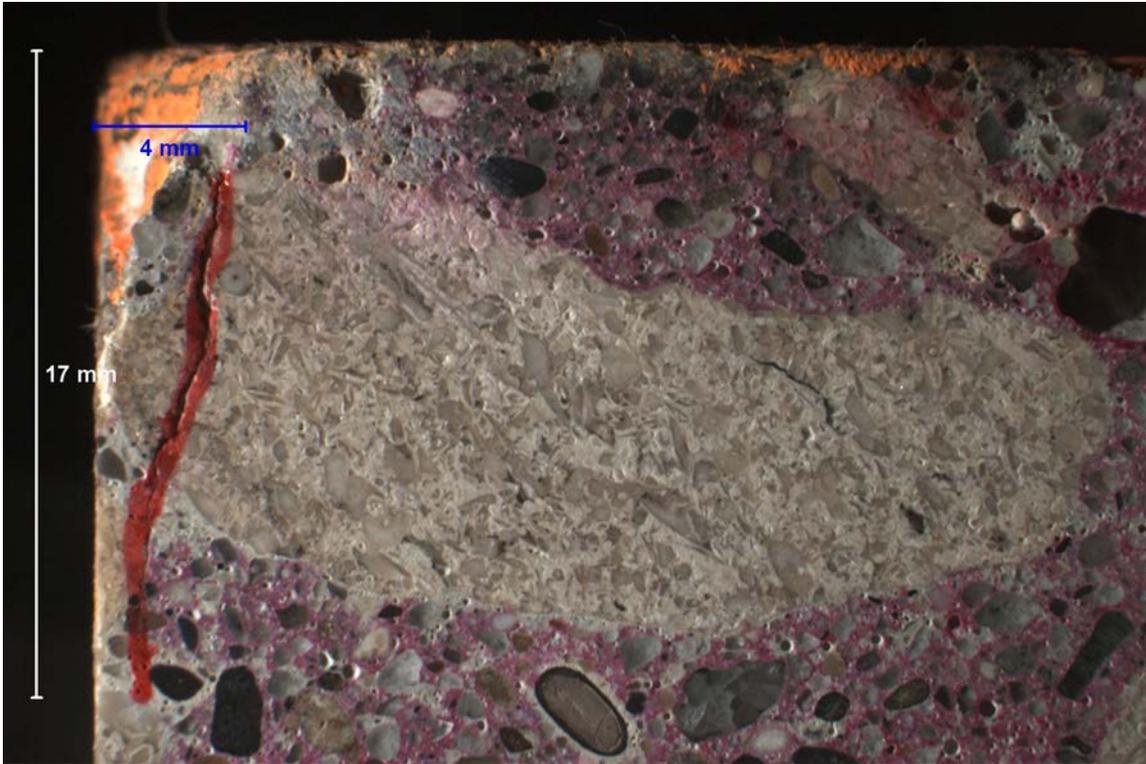
PHOTO: 11

SAMPLE ID: D DESCRIPTION: Incipient sliver spalling in sawcut and lapped cross section of concrete at joint (left).

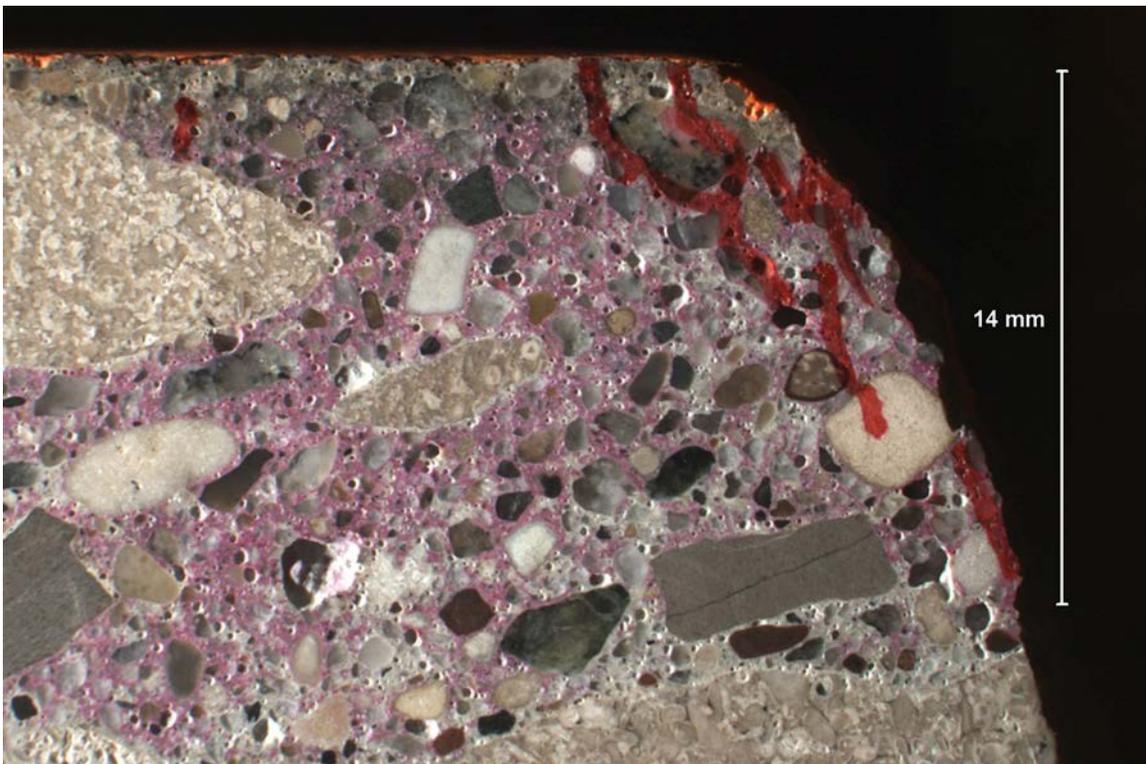
PHOTO: 12

SAMPLE ID: D DESCRIPTION: Another sawcut and lapped section of core exhibiting sliver spalling and incipient spalling mapped in red ink.

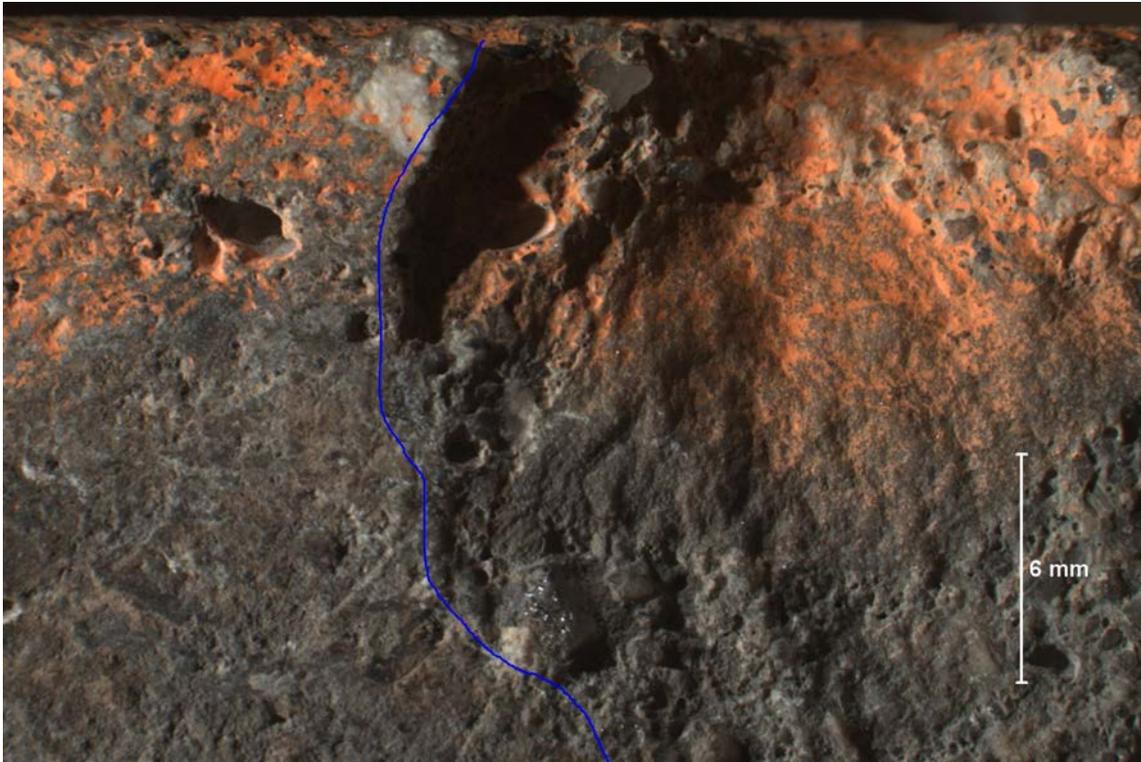
PHOTO: 21

SAMPLE ID: P1 DESCRIPTION: Thin, semi-circular sliver spall (outlined in blue) viewed from within the joint.

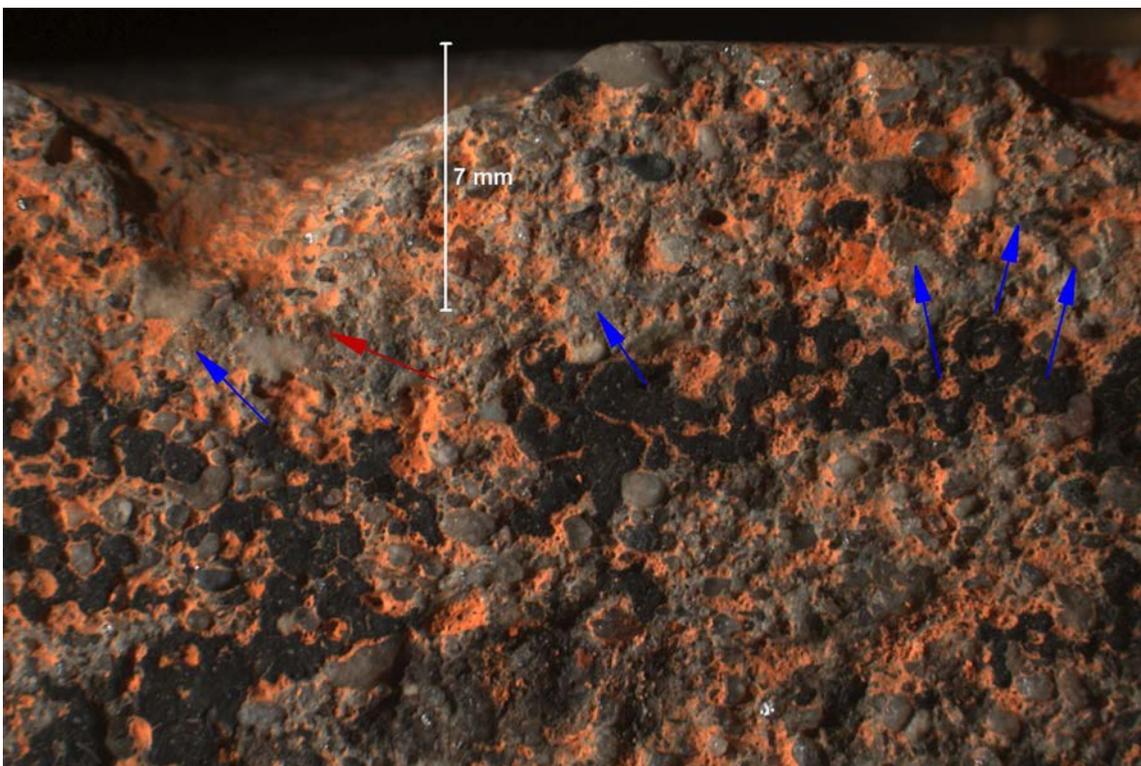
PHOTO: 22

SAMPLE ID: P1 DESCRIPTION: View of the mortar eroded top surface and joint (top of image) exhibiting 7mm wide sliver spalling. Arrows mark corroded metal adhered to exposed aggregates on the top surface.

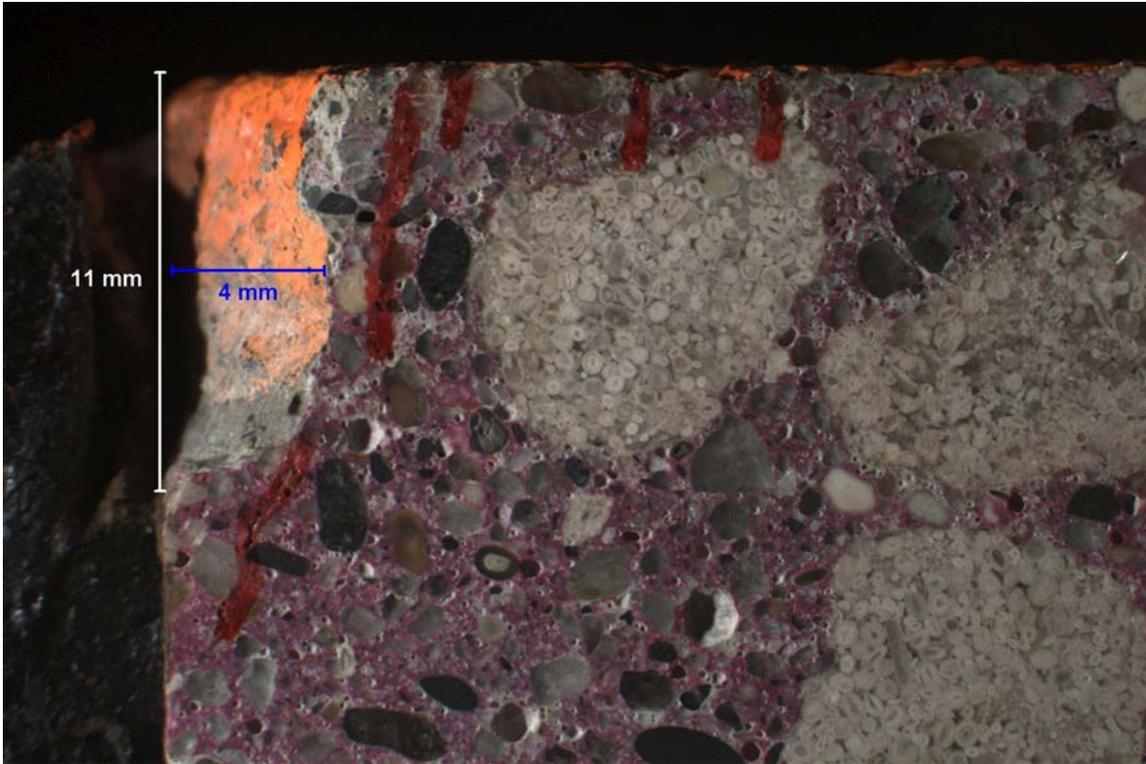
PHOTO: 23

SAMPLE ID: P1 DESCRIPTION: Corner or "sliver" spall viewed in sawcut and lapped cross section of core at the sawcut and sealed joint (left).
MAG: 5x

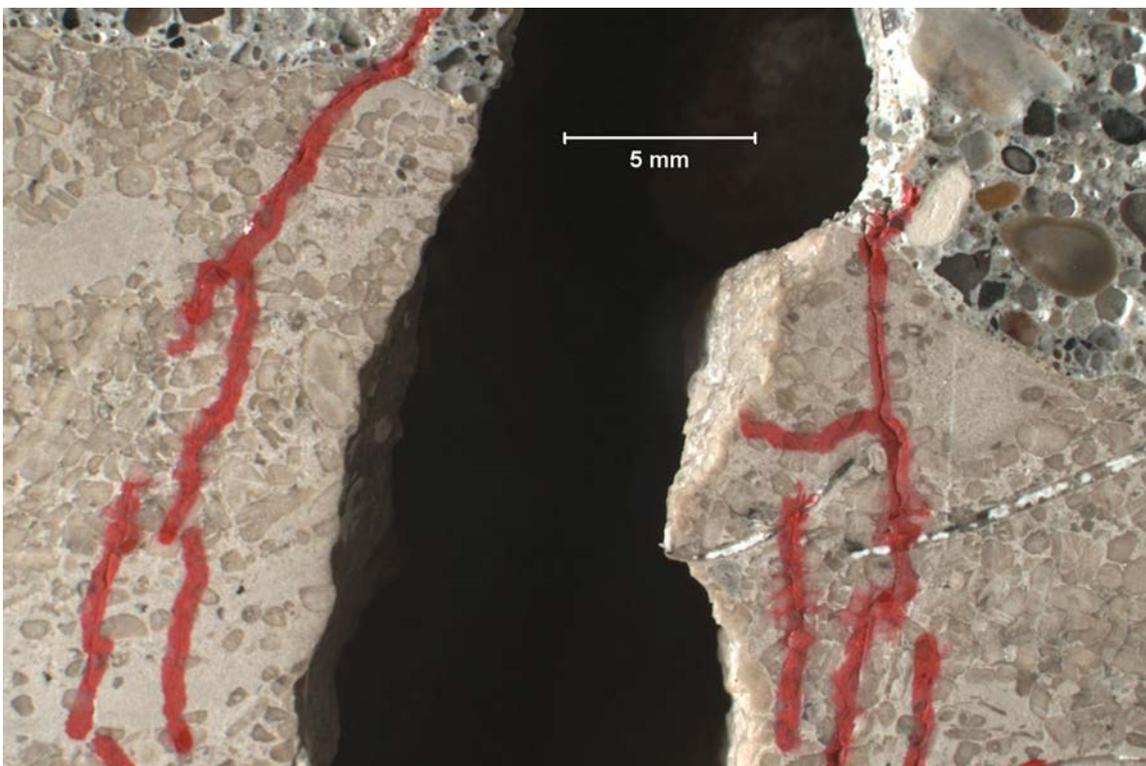
PHOTO: 24

SAMPLE ID: P1 DESCRIPTION: Concentrated microcracking within a coarse aggregate particle bisected by the joint crack and located at below 95mm depth in the core.
MAG: 5x

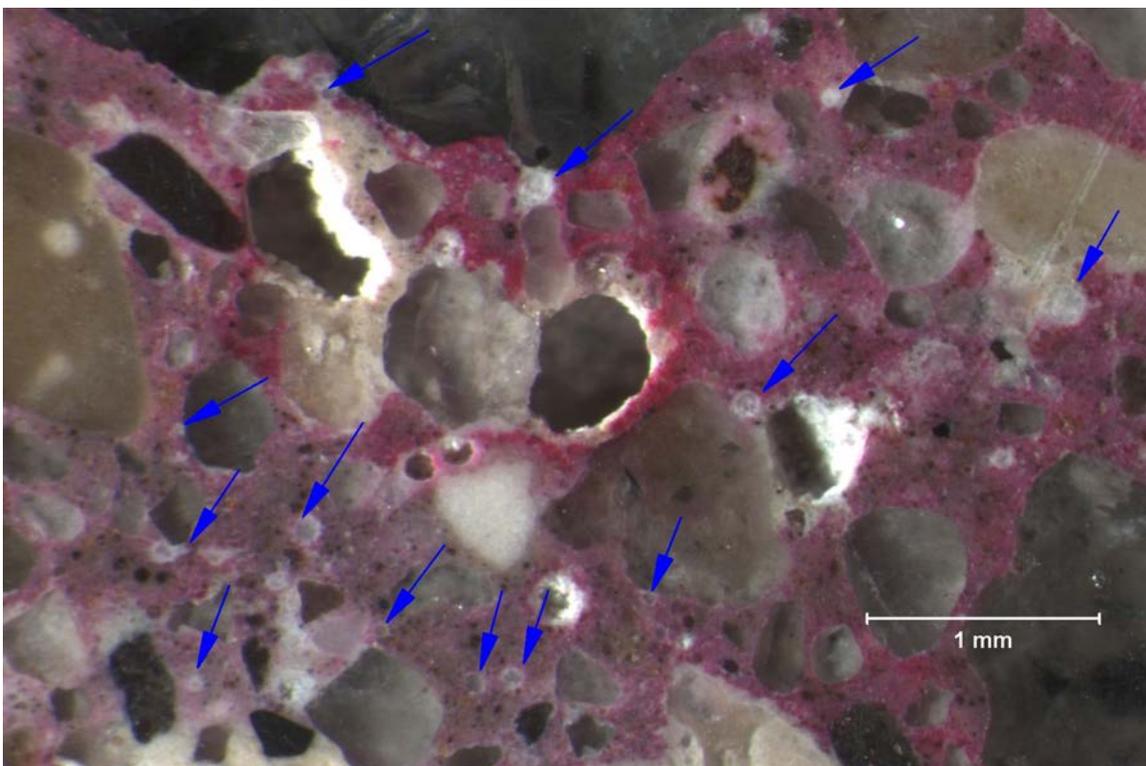
PHOTO: 26

SAMPLE ID: P1 DESCRIPTION: White to clear ettringite-filled voids in phenolphthalein-stained paste within 20mm of the joint.

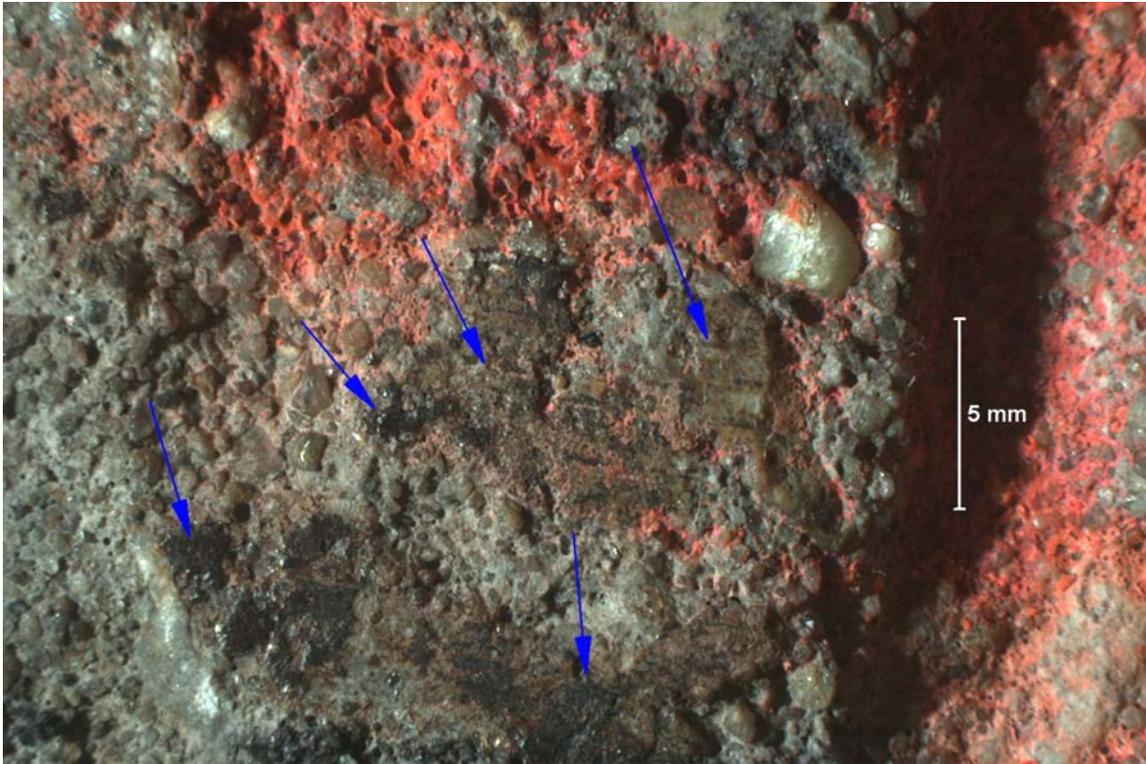
PHOTO: 6

SAMPLE ID: #1 DESCRIPTION: Mortar eroded top surface of the core sample with corroded metal adhered to topographic highs in the surface.
MAG: 5x

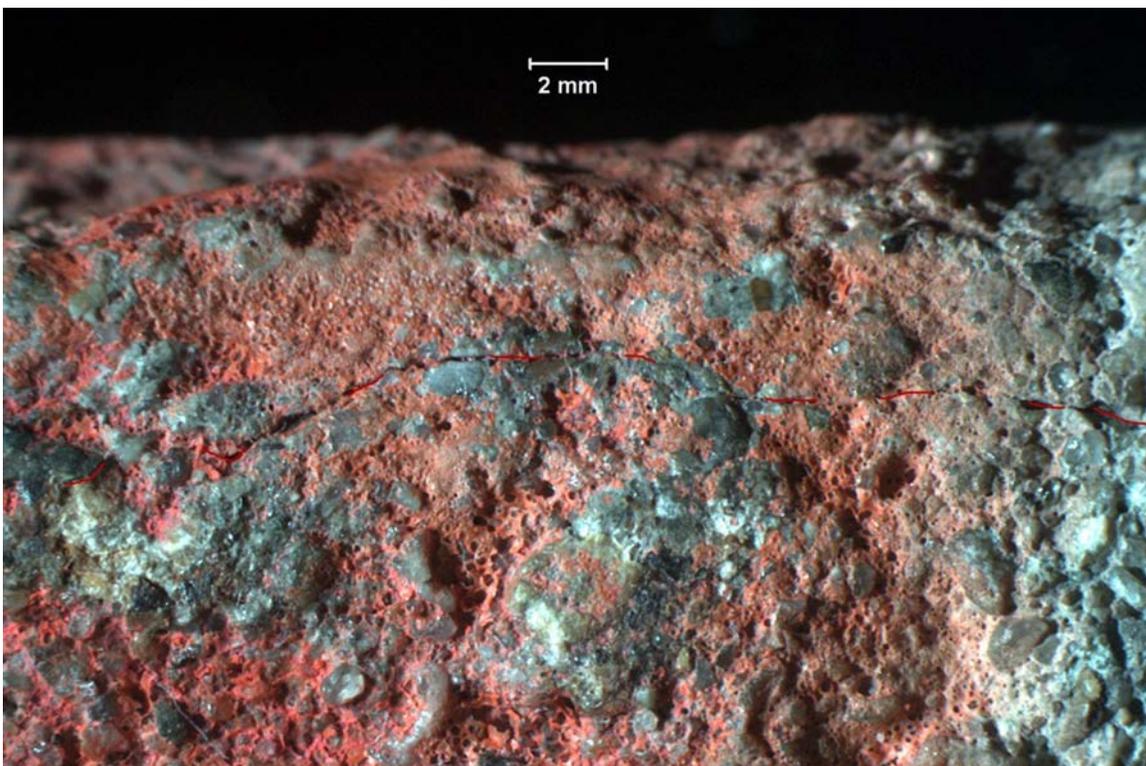
PHOTO: 7

SAMPLE ID: #1 DESCRIPTION: Incipient spalling in the top surface of the core sample(mapped in red dashed line), directly adjacent to the joint.
MAG: 5x

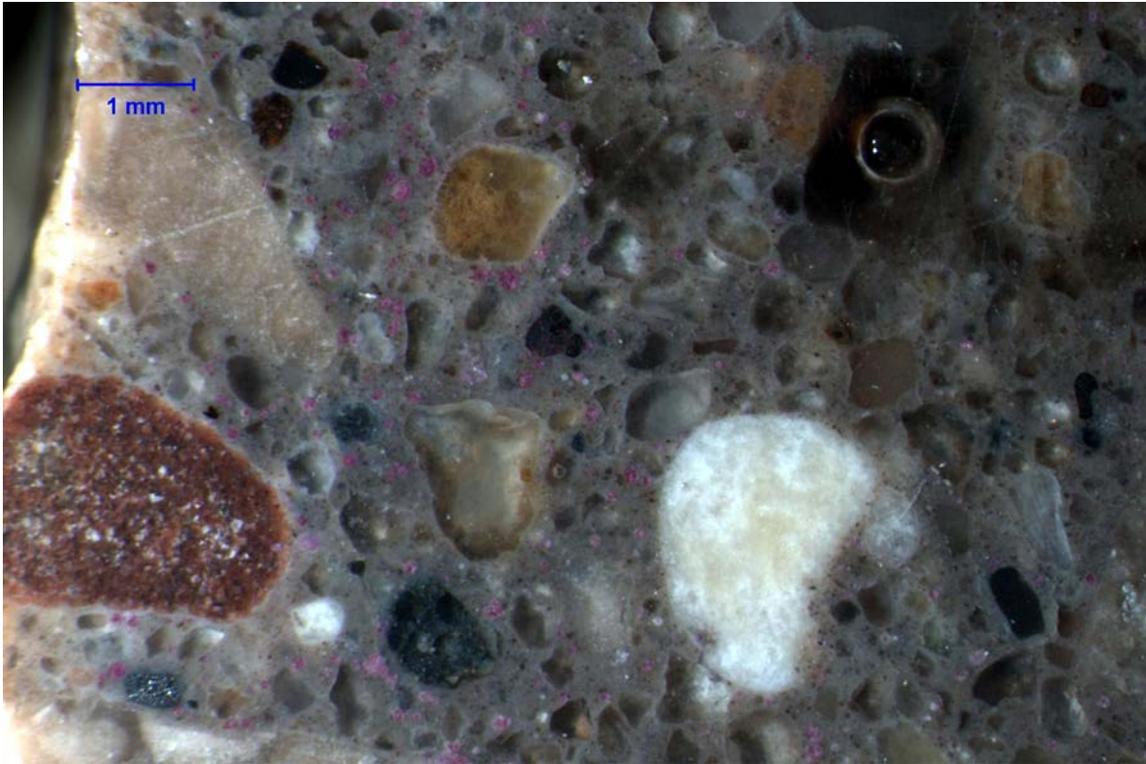
PHOTO: 12

SAMPLE ID: #1 DESCRIPTION: Much of the air voids proximate to the distressed joint plane are filled with secondary ettringite which has been stained a magenta coloration.
MAG: 15x
