Investigation of Deterioration of Joints in Concrete Pavements

National Concrete Pavement
Technology Center

Final Report
August 2012

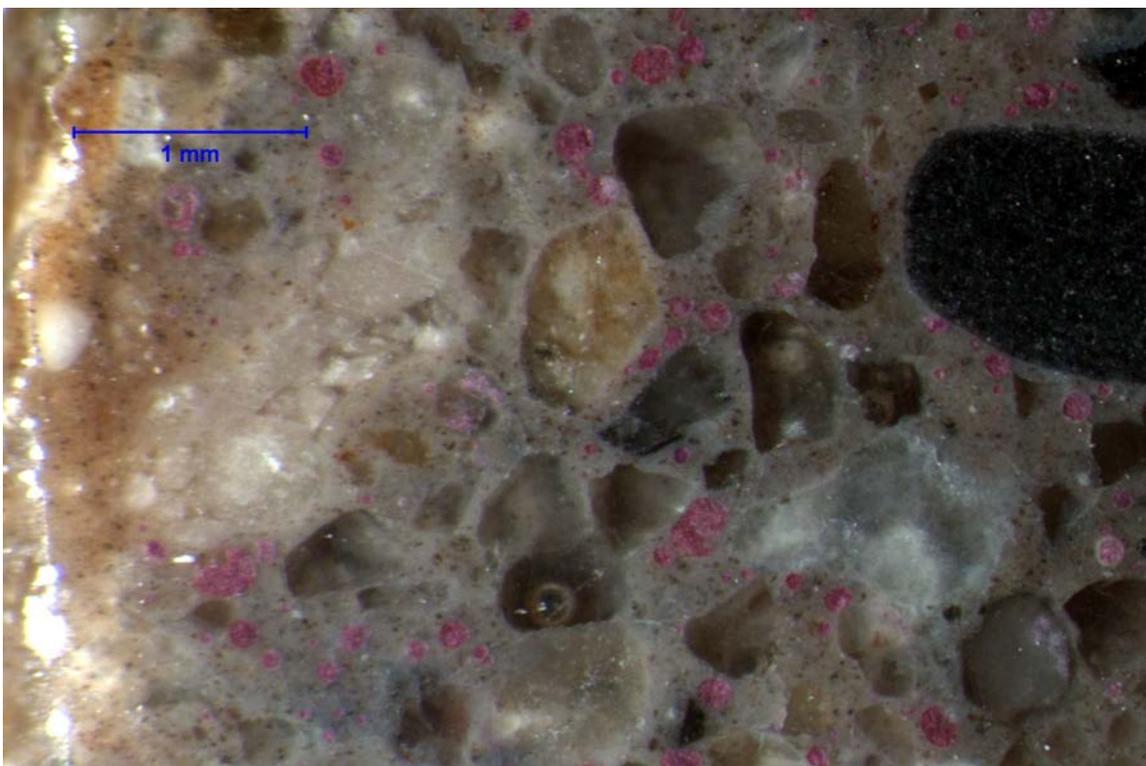
PHOTO: 13

SAMPLE ID: #1 DESCRIPTION: Much of the air voids proximate to the distressed joint plane are filled with secondary ettringite which has been stained a magenta coloration.
MAG: 30x

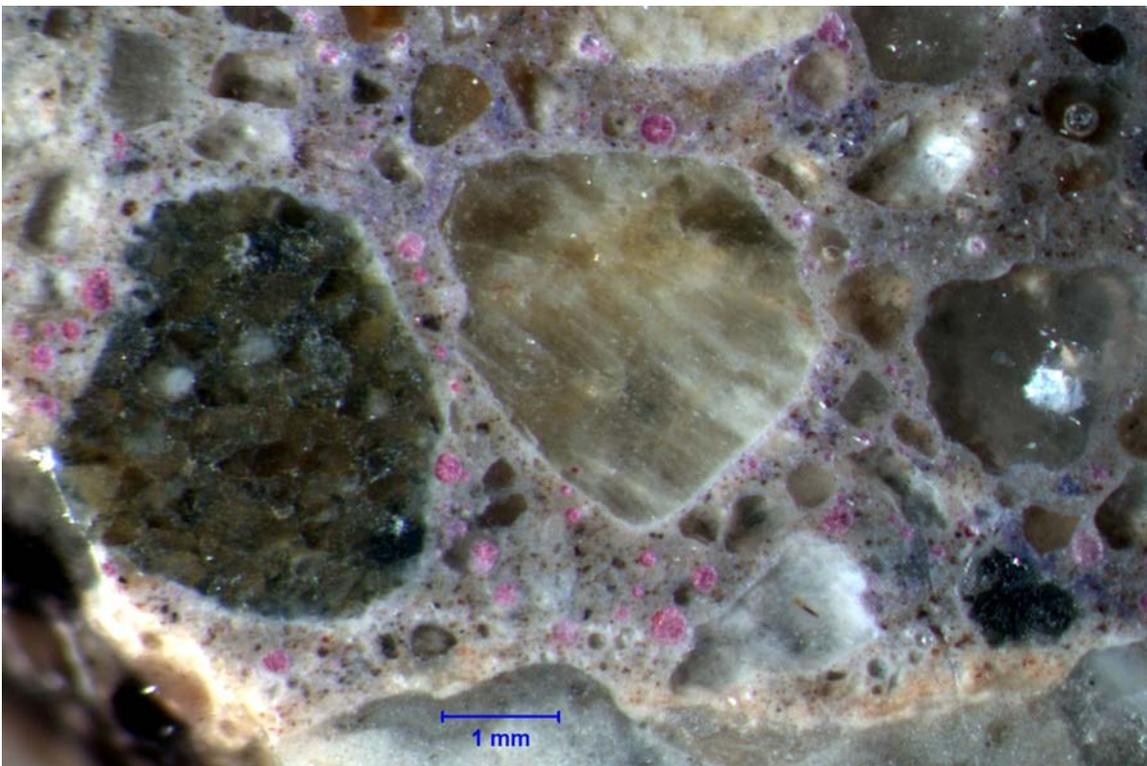
PHOTO: 23

SAMPLE ID: #2 DESCRIPTION: Much of the air voids proximate to the joint are filled with secondary ettringite; stained a magenta coloration.
MAG: 30x

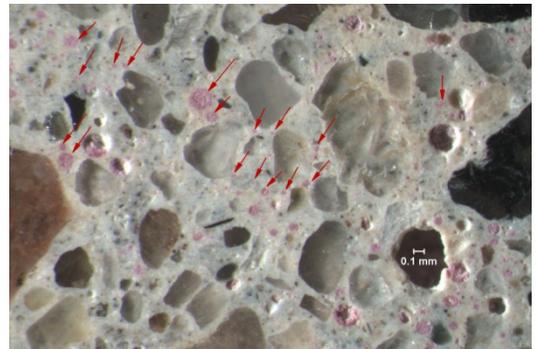
Magnification: 30x
 Description: Filled air void system 120mm from the top surface and 8mm from the joint crack.

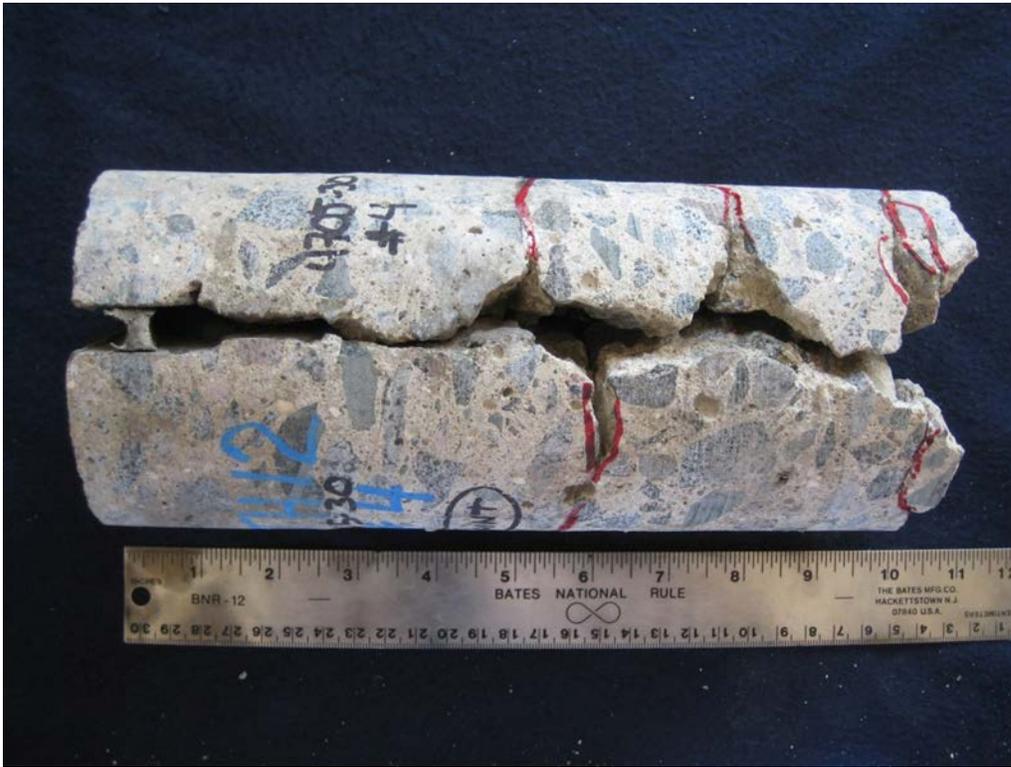
PHOTO: 1

SAMPLE ID: 4, 4705-30 DESCRIPTION: Core sample taken directly through a pavement joint, as received. Top surface is left. Existing fractures are mapped in red ink.

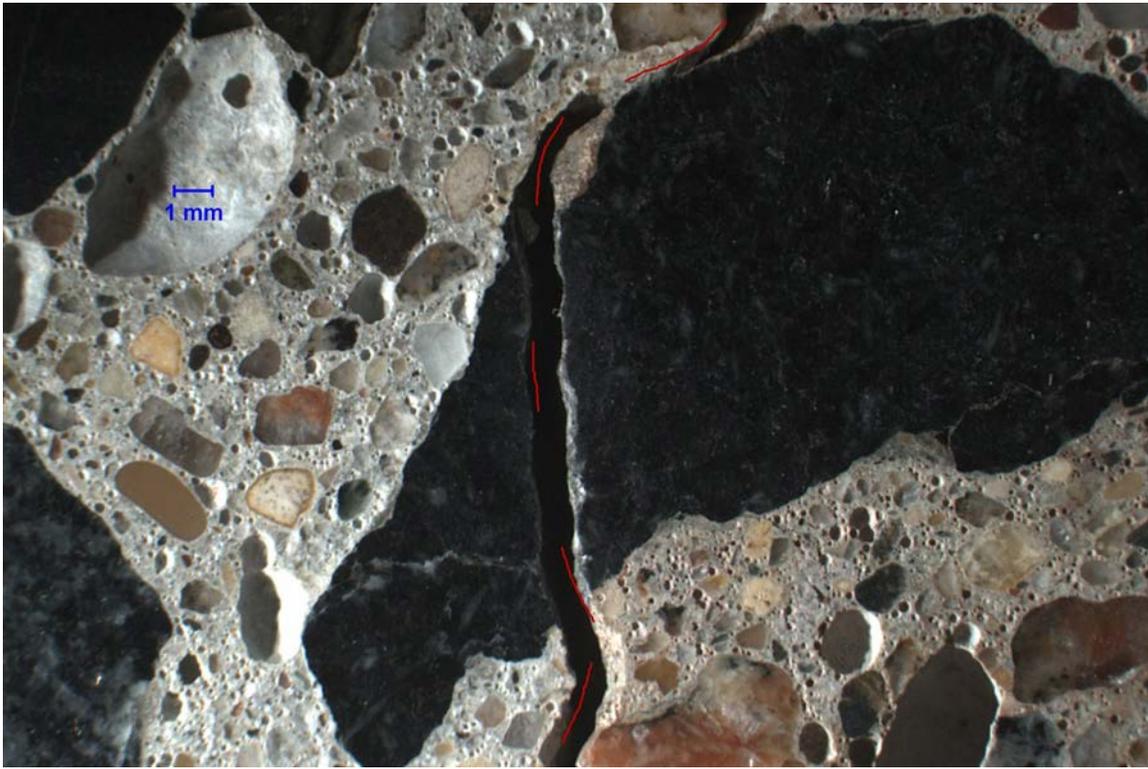
PHOTO: 23

SAMPLE ID: 7012, 7380-199 DESCRIPTION: Cracked coarse aggregate at 165mm depth in the joint crack.

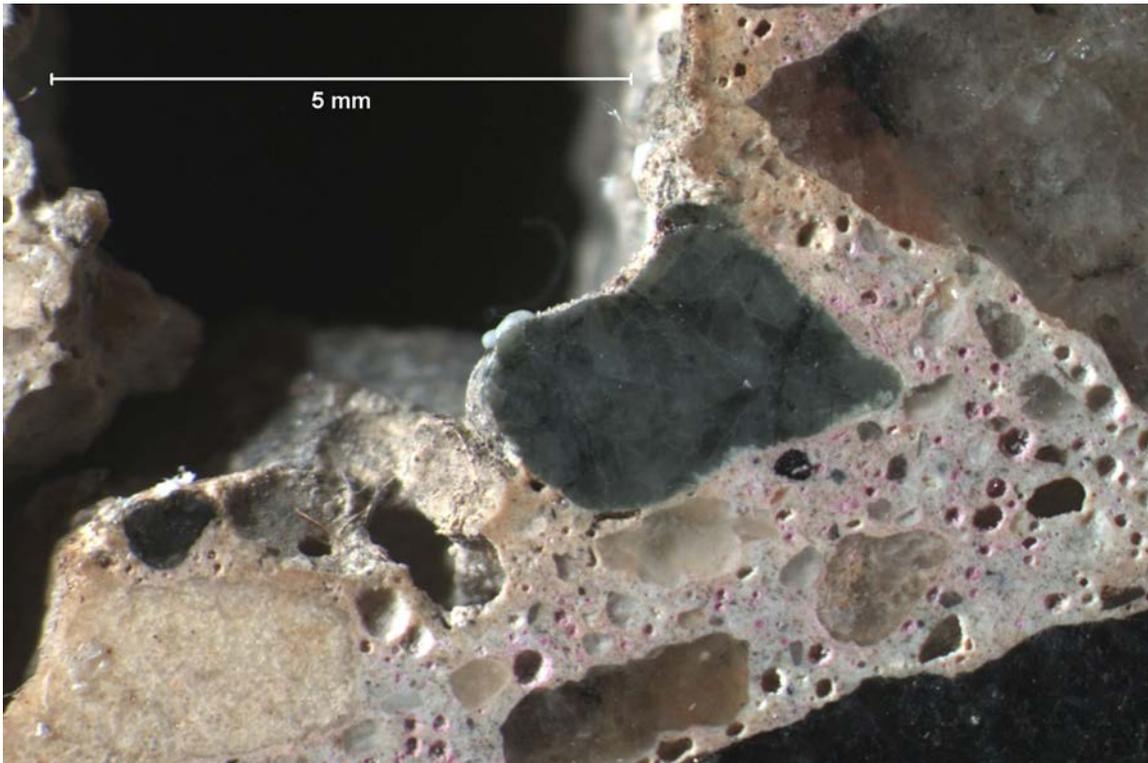
PHOTO: 24

SAMPLE ID: 7012, 7380-199 DESCRIPTION: A concentration of magenta-stained, ettringite-filled voidspaces at the base of the sawcut control joint.

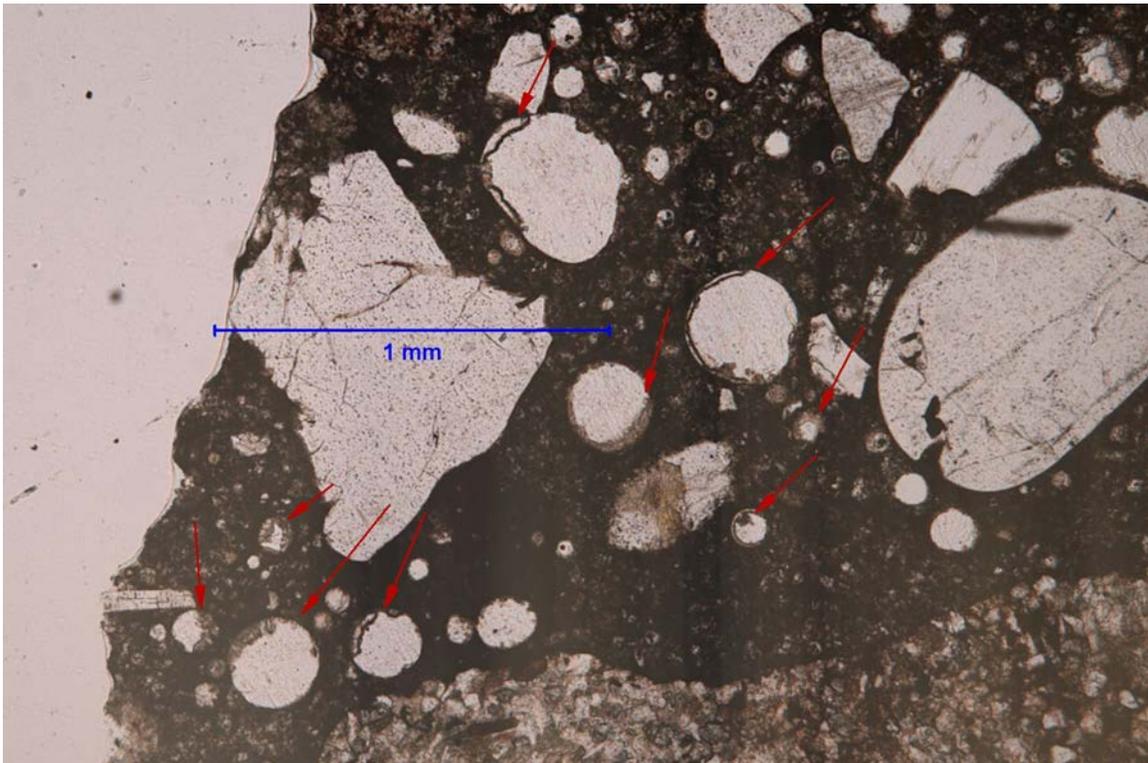
PHOTO: 26

SAMPLE ID: 7012, 7380-199 DESCRIPTION: Occurrences of ettringite on the linings of voidspaces at 140mm depth and directly adjacent to the joint crack (L).
MAG: 40x

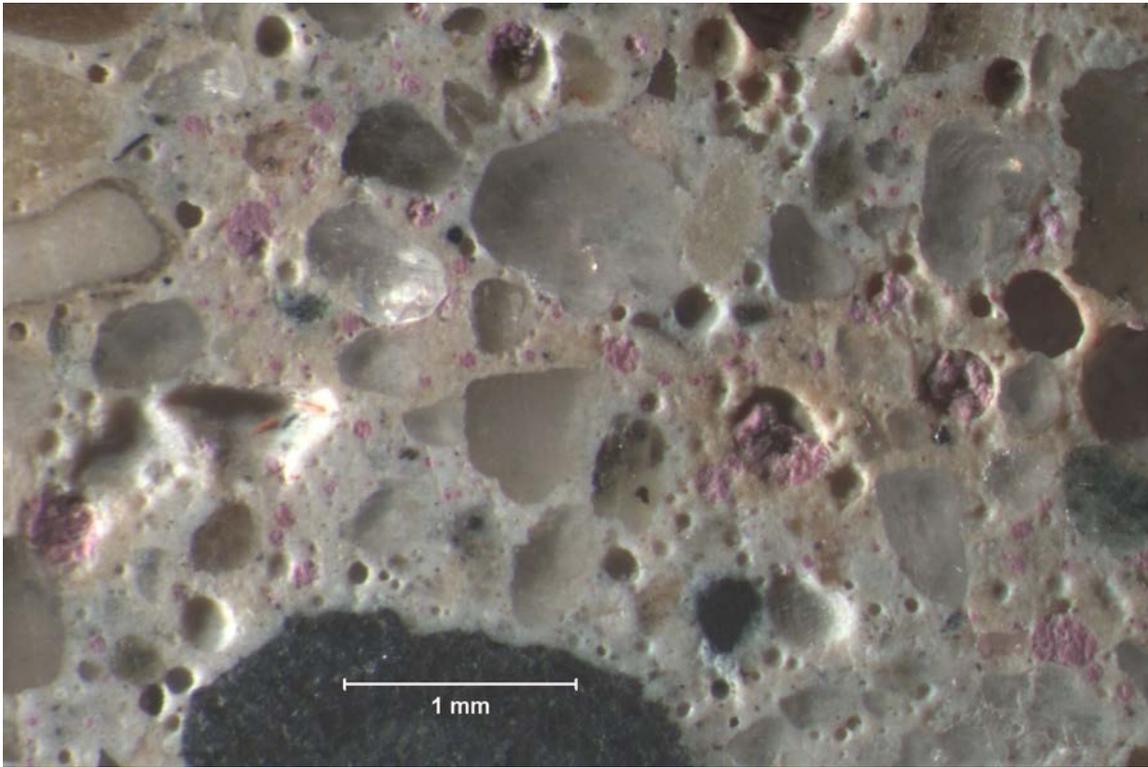
PHOTO: 31

SAMPLE ID: 4, 4705-30 DESCRIPTION: Magenta-stained ettringite fills many fine air voidspace in the paste at 20mm from the distressed joint plane at 155mm depth in the core.
MAG: 30x

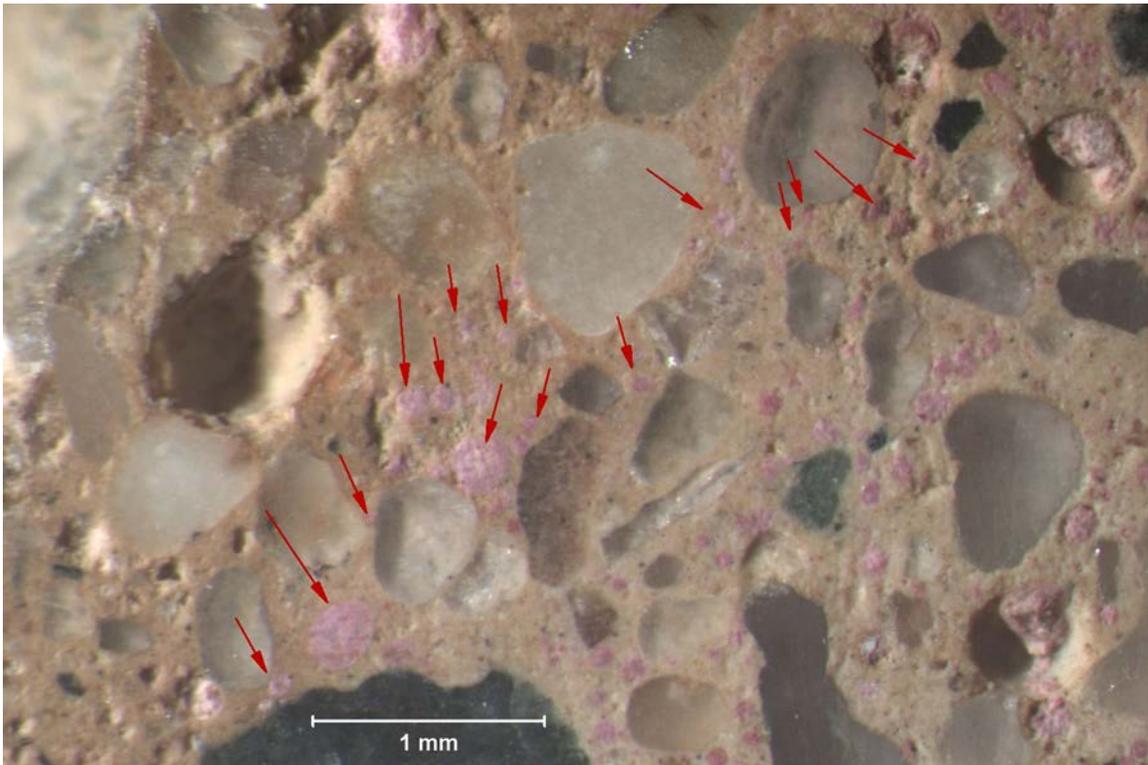
PHOTO: 32

SAMPLE ID: 4, 4705-30 DESCRIPTION: Magenta-stained ettringite fills most fine air voidspace in the paste directly adjacent to the distressed joint plane at 140mm depth in the core.
MAG: 30x

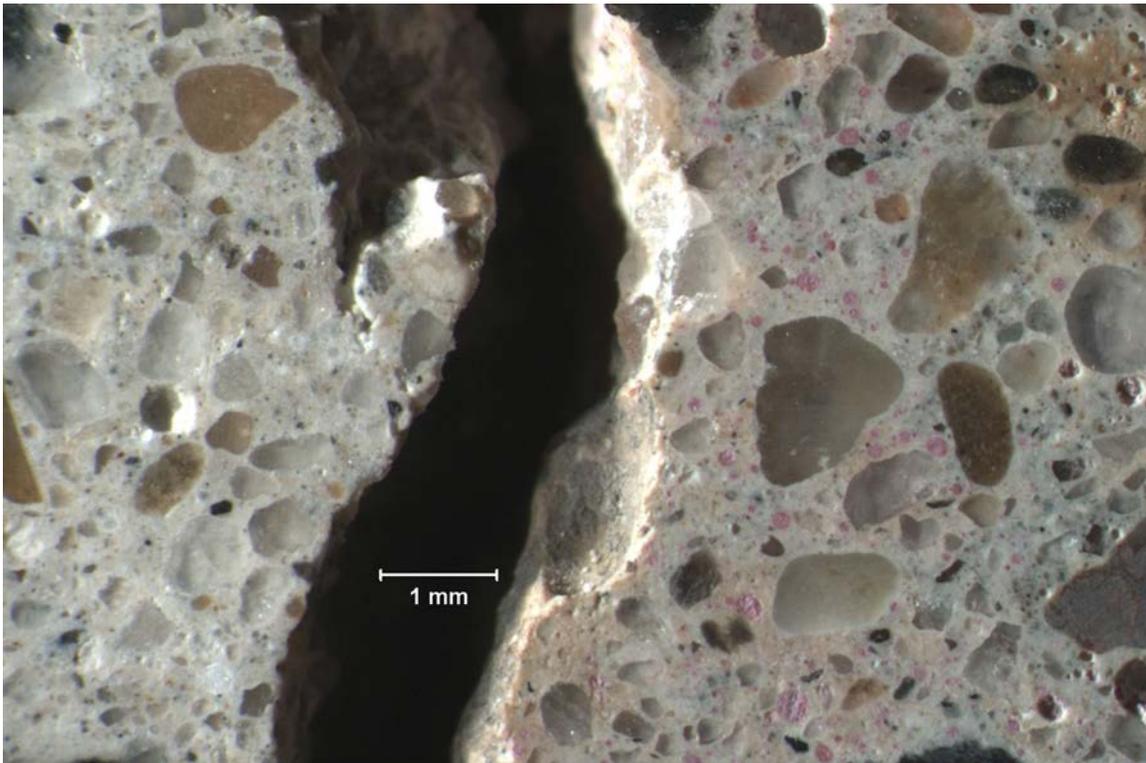
PHOTO: 34

SAMPLE ID: 7, 4705-30 DESCRIPTION: Magenta-stained ettringite (right side) and unstained ettringite (left) fills most fine air void-spaces in the paste directly adjacent to the mildly distressed joint plane at 130+mm depth in the core.
MAG: 15x

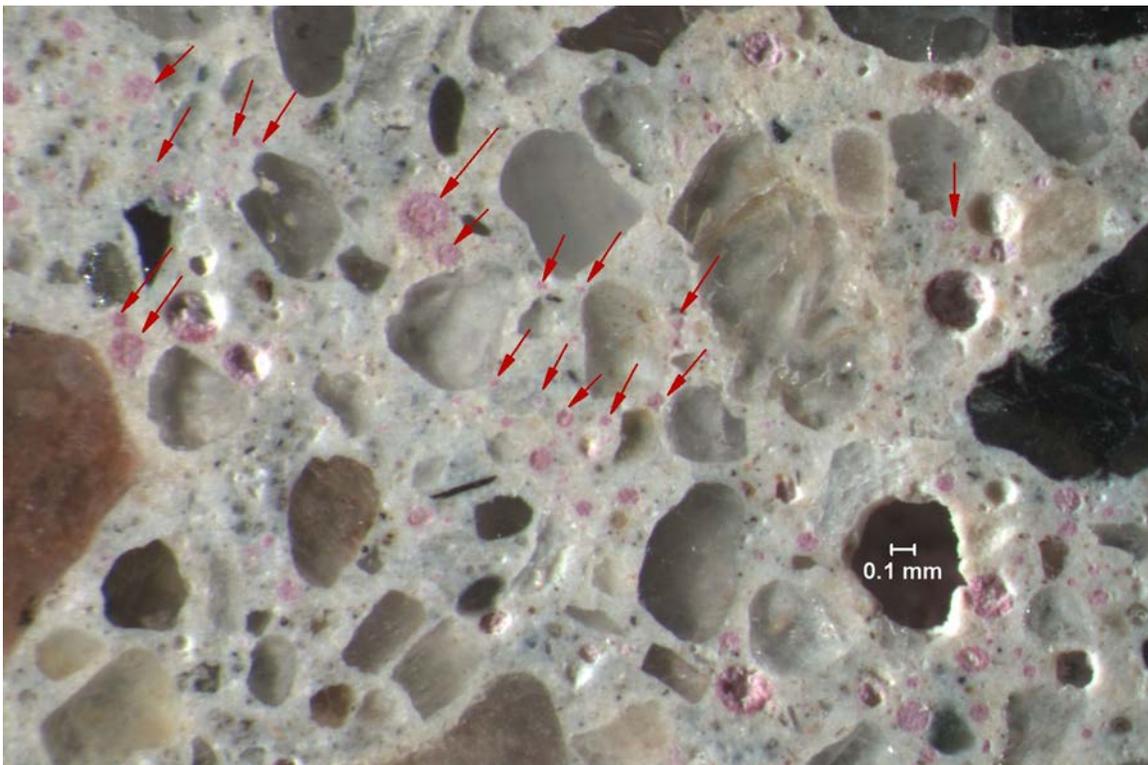
PHOTO: 36

SAMPLE ID: 7, 4705-30 DESCRIPTION: Magenta-stained ettringite fills most fine air voidspaces in the paste at 120mm depth in the core and within 8mm of the mildly distressed joint plane.
MAG: 30x

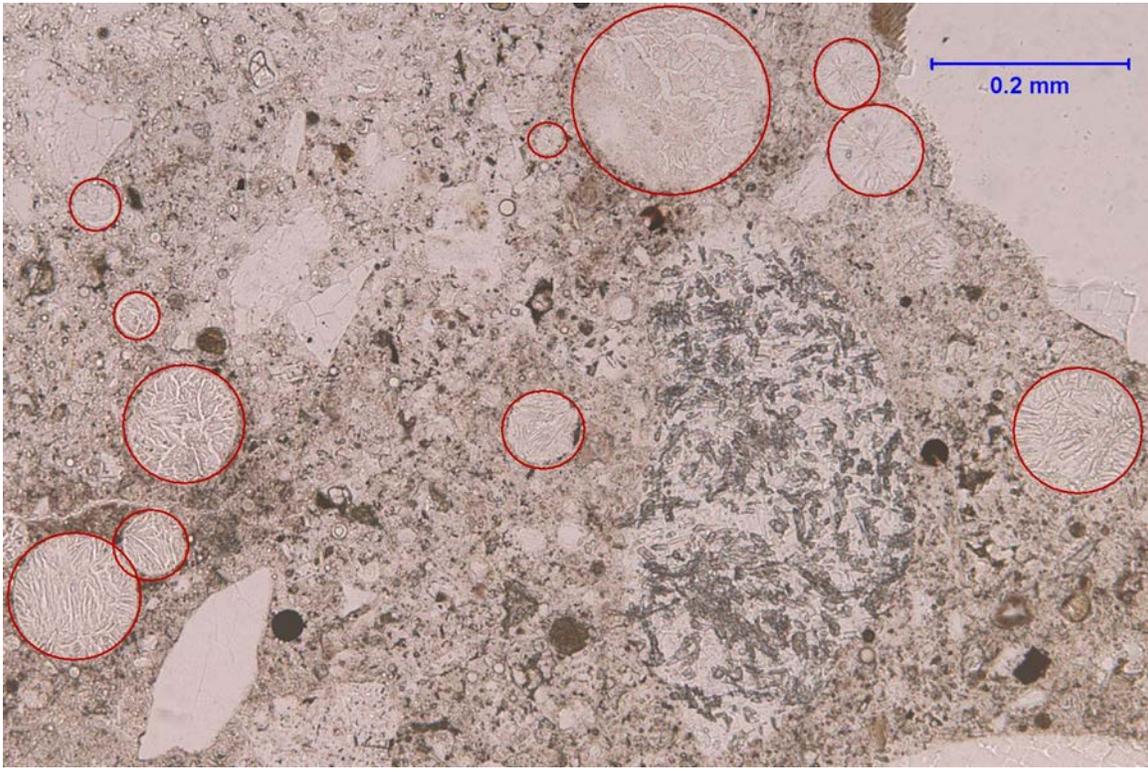
PHOTO: 37

SAMPLE ID: 7, 4705-30 DESCRIPTION: Ettringite-filled voidspaces (outlined in red) in the paste proximate to the joint plane in thin section under plane polarized light.
MAG: 100x

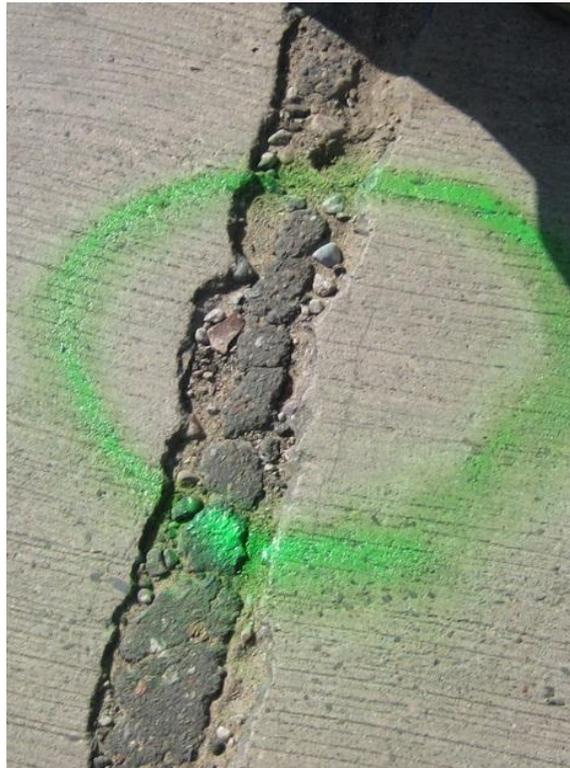
Figure 1. Crack formed about 1 in. from the free surface

It is not uncommon to observe a crack about 1 in. from the joint face (Figure 1).

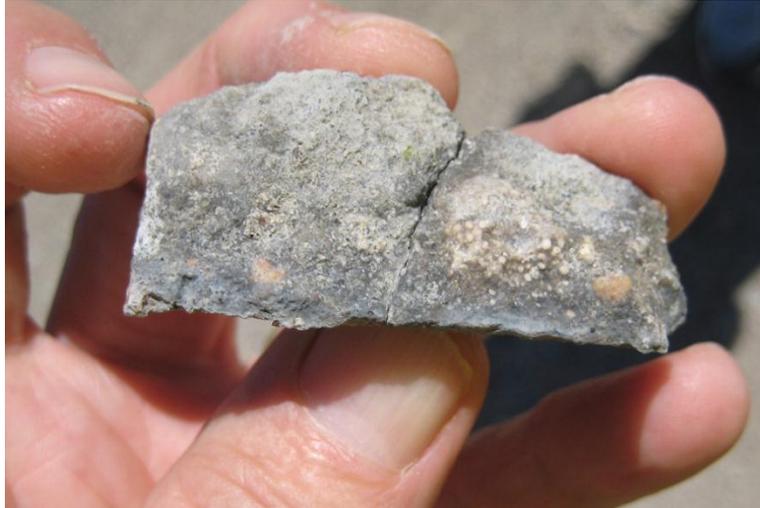
Figure 2. Sample removed piece showing that material between the free surface and the new crack is reasonably sound with coarse aggregate particles free of paste

In some cases, the concrete in between is in good condition (Figure 2).
