Guidelines for Thermographic Inspection of Concrete Bridges

**Development of Hand-held Thermographic Inspection
Technologies**

**Revised Guidelines for Thermographic
Inspection of Concrete Bridges**

RI06-038

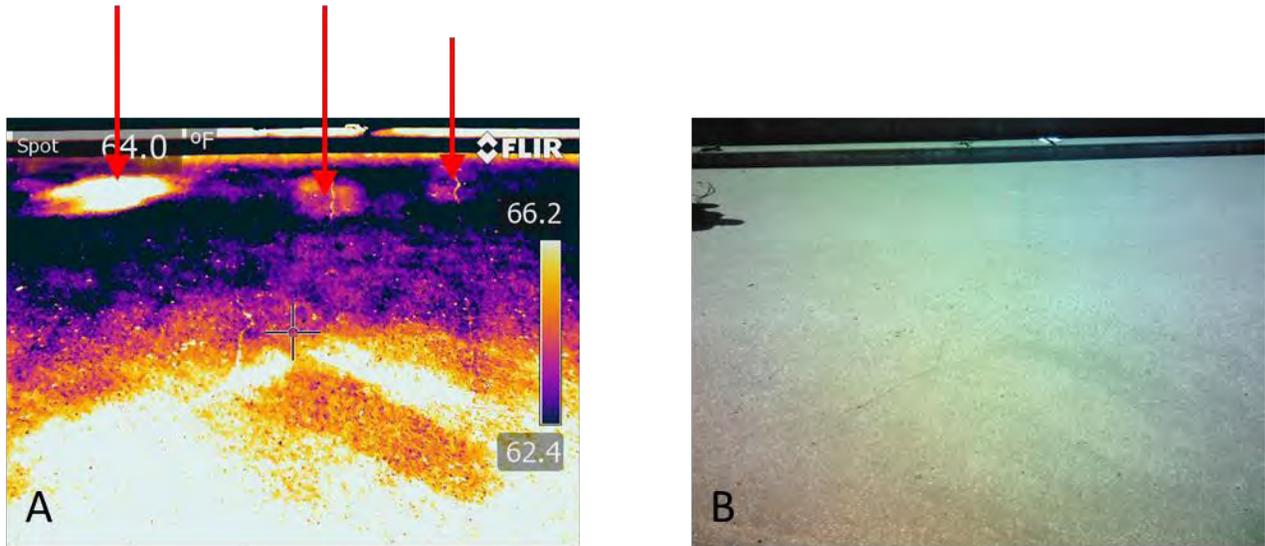
Figure 3: Infrared (A) and Digital (B) images of a group of delaminations in Kansas City

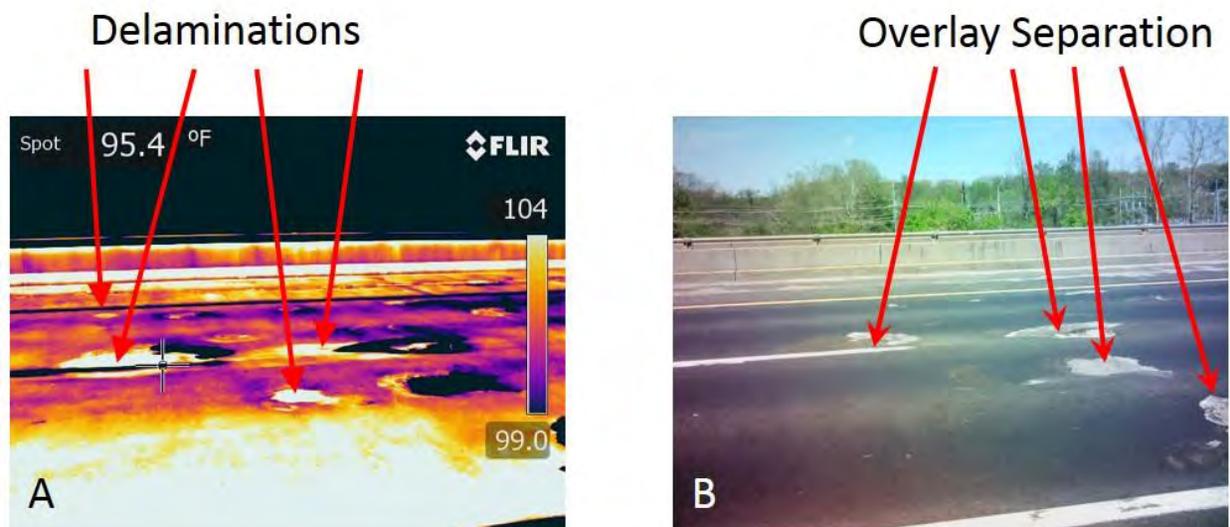
Figure 5: Infrared (A) and Digital (B) images of Providence Rd. Bridge (northbound) over Hinkson Creek

It is often the case that delaminations form near the edges of patches and separations in overlays. The reason for this occurrence is due to the fact that not all of the original damage was repaired. Cracks left unrepaired near the edge of a patch will continue to propagate and lead to more delamination.

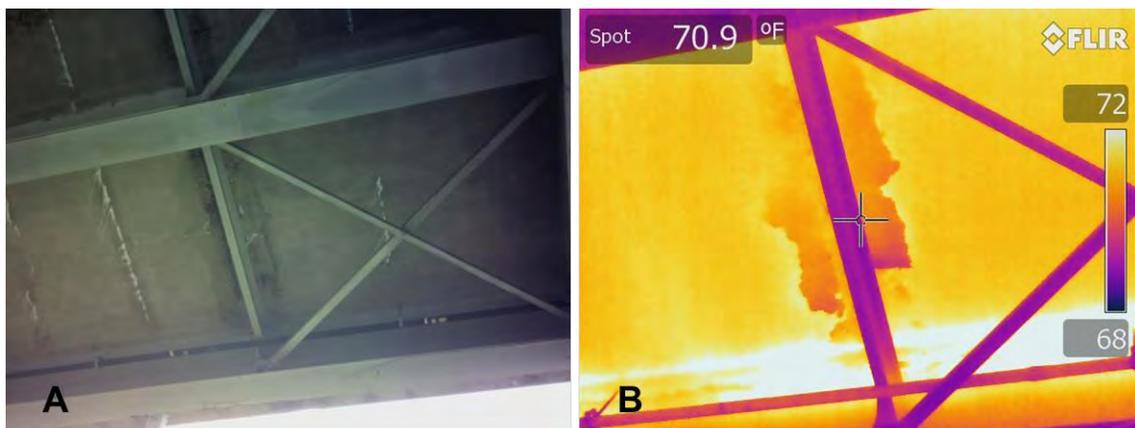
The inspections for the next two days of the verification trip focused on the soffit area of the bridge. This was due to poor weather conditions for deck inspection. The weather was cloudy with a light rain. In addition to the rain, the temperature range for these two days was smaller than recommended for a successful IR inspection. Figure 9 shows images of a defect in the soffit area around a cross brace detected using IR. The purpose of the figure is to demonstrate imaging from a distance under less than ideal weather conditions. Image A shows a digital picture of the soffit while image B shows a delamination detected using IR that had not been visible during ground inspection. The soffit of the bridge in this area is approximately 50 feet off the ground, which would require specialized equipment to have hands-on access to test for damage if IR had not been used.

Figure 9: Delamination with some spalling by a cross brace in the soffit

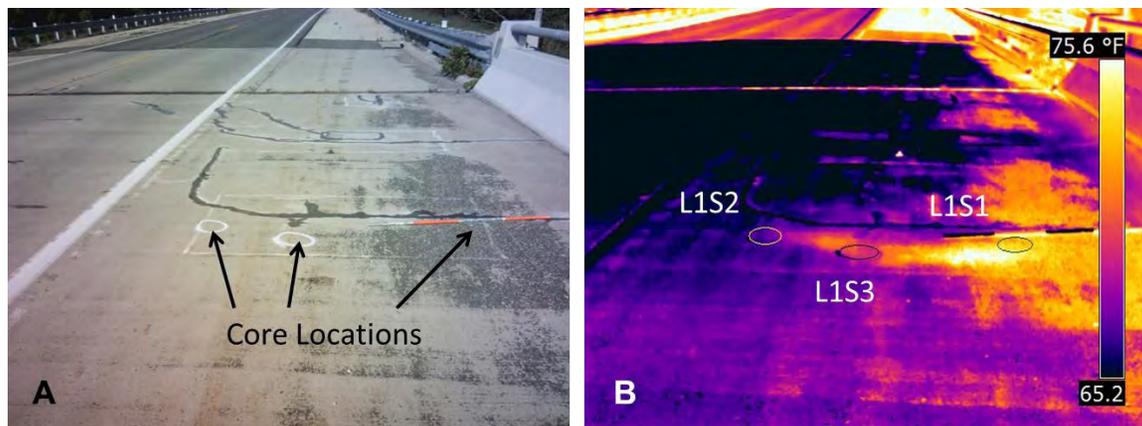
The third sample was taken from an area that had a distinct difference in thermal contrast from the first sample and less distinct thermal contrast than the second sample. This shows up as mostly yellow with some pink in image B below.

Figure 10: Cores at Location 1

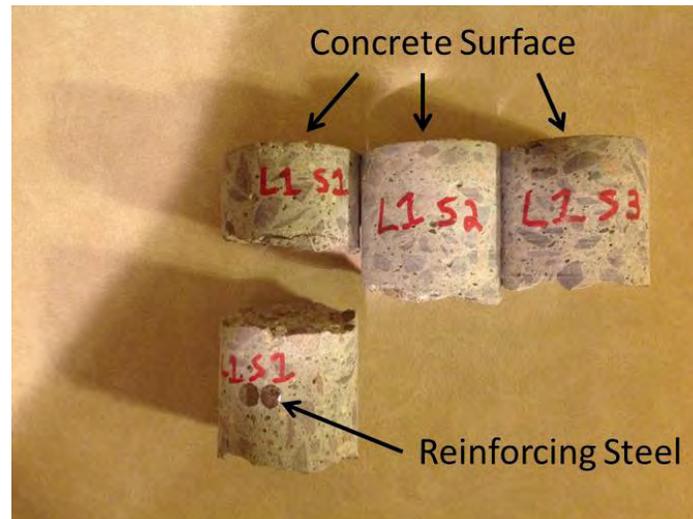
Figure 11: The cores taken from the delamination at L1

Figure 11 shows all three samples taken from location 1 and the depth of the reinforcing steel. The reinforcing steel was at a depth of approximately 3 ½" from the surface. None of the samples showed any signs of an overlay and all of the samples taken of the delamination at location 1 were well above steel. The causes of this delamination are not yet known and are still being investigated (Nelson).

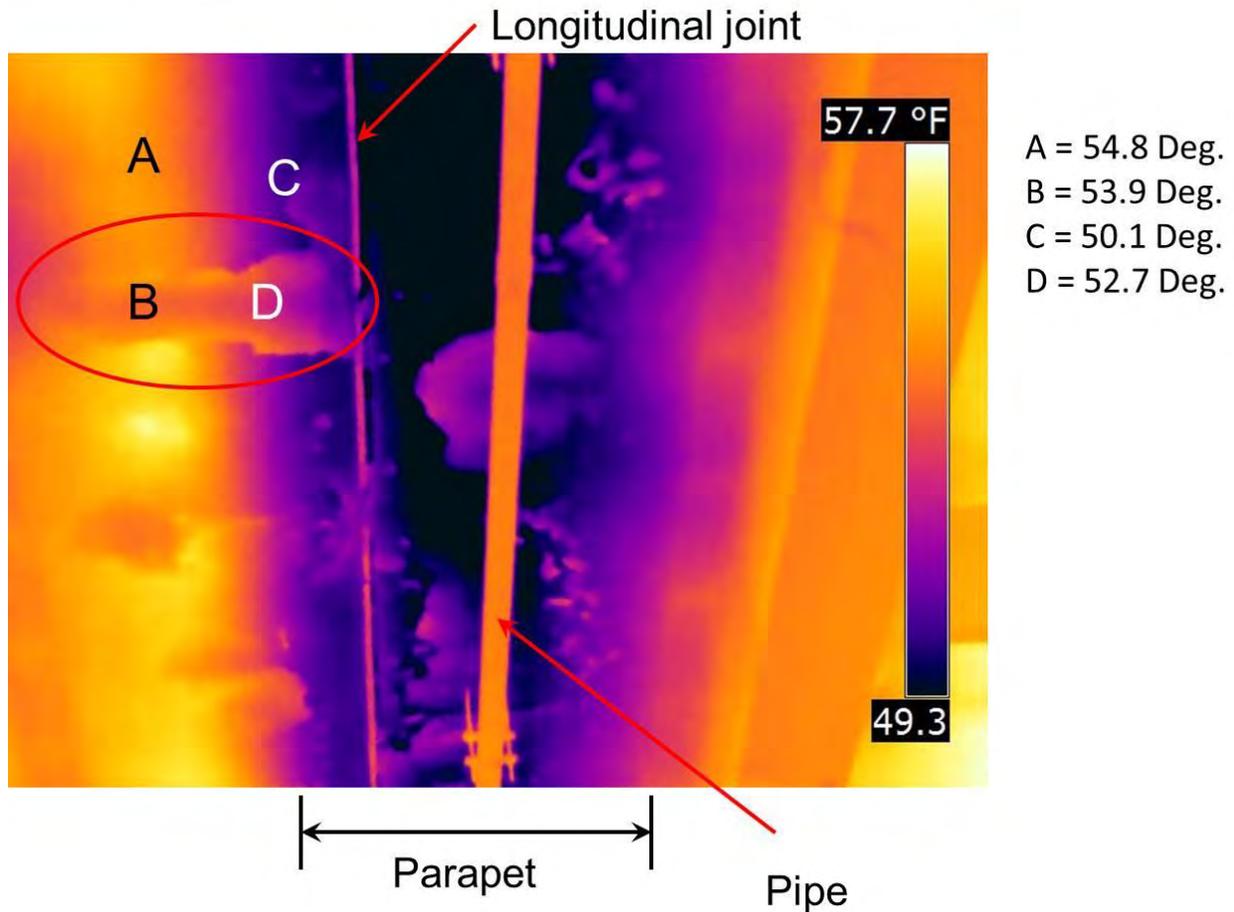
thermal mass. In deck areas adjacent to the parapet, the heating from the sun has conducted through the deck. In the figure, a delamination in the soffit area of the deck is encircled. Four temperature measurements were made in this area and are labeled A, B, C and D. These data indicated that the nominal temperature of the deck at point A was 54.8°F, while the delaminated area labeled B was 53.9°F, indicated that the delaminated area is cooler than the intact deck area, due to the conduction effect. Conversely, the delaminated area marked C displays a temperature of 50.1°F, while the delaminated area marked D 52.7°F, warmer than the surrounding concrete. This figure illustrate the conduction effect very well, because the same delamination appears both cooler than its surrounding where the conduction effect is warming the deck, and warmer than its surrounding where the parapet on the deck above is creating a shadowing effect that eliminates the conduction effect.

Figure 12: Thermal image of a deck soffit showing the conduction effect on the appearance of concrete delamination at the soffit

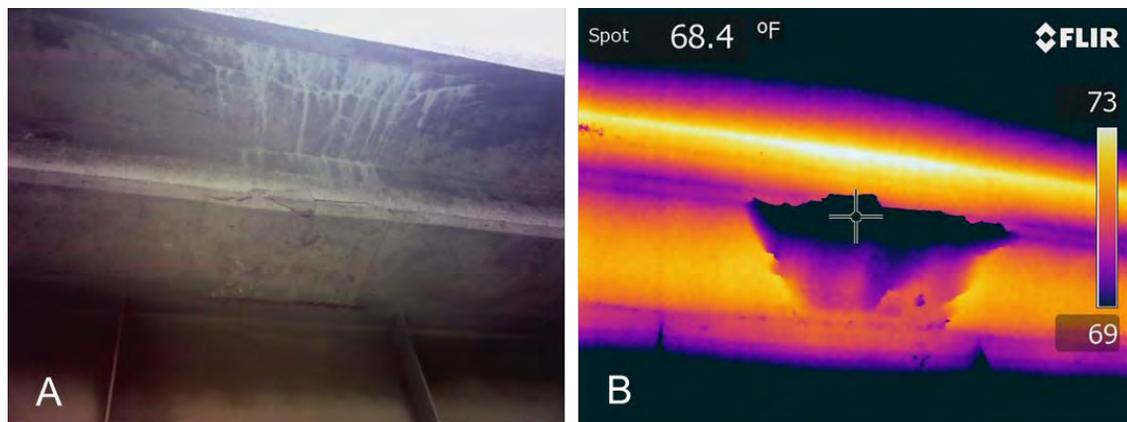
It was recommended to let the sun heat the bridge and try IR testing at different times throughout the day since the deck had not yet been exposed to the sun for a very long period of time. During the wait time, a chain drag was used to mark out the defects on the deck of the bridge; also, at that time, the soffit of the bridge was inspected. Several spalls and delaminations were visible in the soffit area of the bridge. Figure 13 shows a delamination along the edge of the bridge that was detected with the IR camera which was not clearly visible as shown in image A. The IR image, image B, shows parts of the defect being over 4°F cooler than the surrounding solid concrete.

Figure 13: Images of a delamination along the edge of the bridge

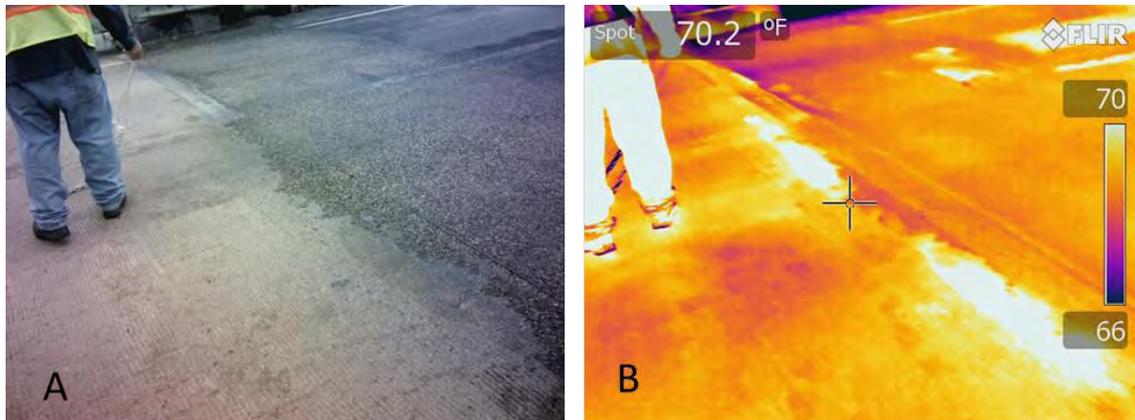
IR testing failed to show satisfactory results from the first day of testing so the bridge was revisited a second day. The second day of testing had similar results. The only visible defects in the deck by IR assessment were the defects at the ends of the bridge that appeared to have not been previously repaired and, therefore, had no epoxy. Figure 14 shows the delaminations along the edge of the bridge deck. Image A shows the digital image of the deck while image B shows the IR image. The delaminations appear as white in image B along the edge of the bridge deck.

Figure 14: Delaminations along the edge of the deck

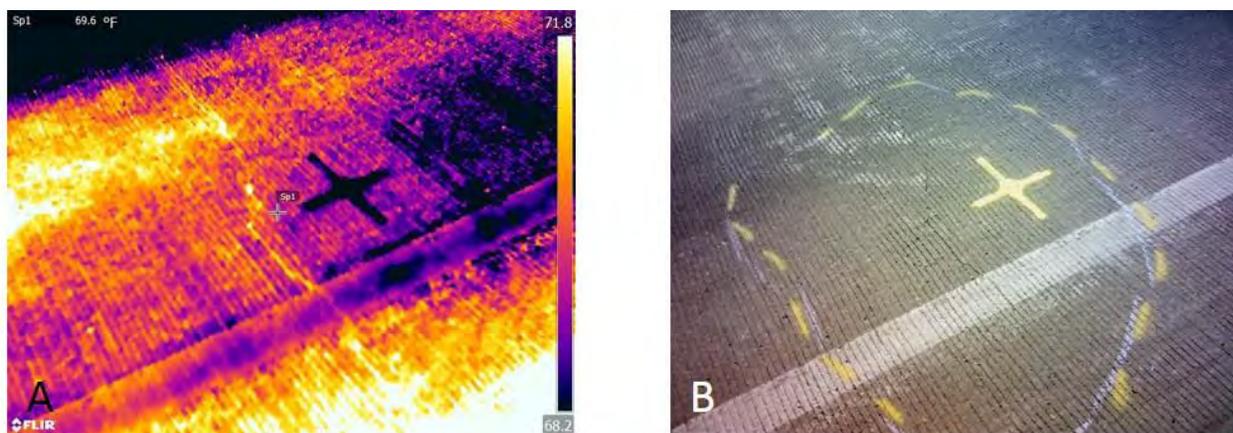
Delaminations that had been previously injected with epoxy were also imaged during the testing. Figure 15 shows an area including an epoxy-injected delamination. As shown in this figure, thermal contrast was not observed where the delamination had been repaired by epoxy injection.

Figure 15: Thermal image showing an area of deck repaired by epoxy injection

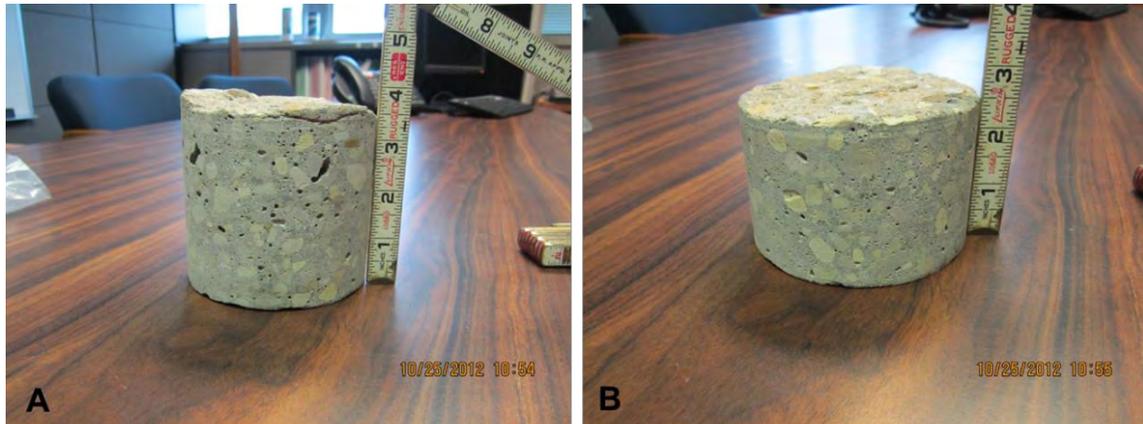
Figure 16: Cores from the delaminations in the deck

The delamination with four inches of cover may have been too deep for IR cameras to detect without almost perfect weather conditions for IR testing. Since the second core had only a two and a half inch cover, it should have been detectable. Since none of the epoxy-filled delaminations were detectable and there was varying cover above the delaminations, a computer model was used to determine if delaminations filled with epoxy, water, or ice are still as detectable as delaminations that have air gaps.

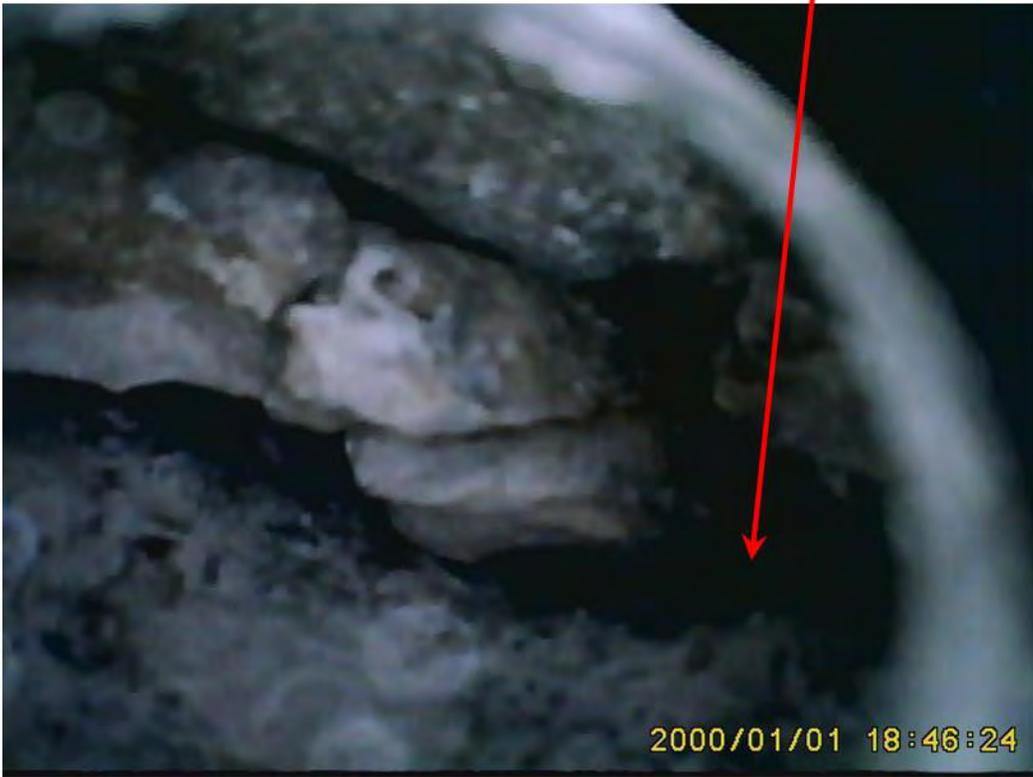
Figure 22: Borescope Image from location 6

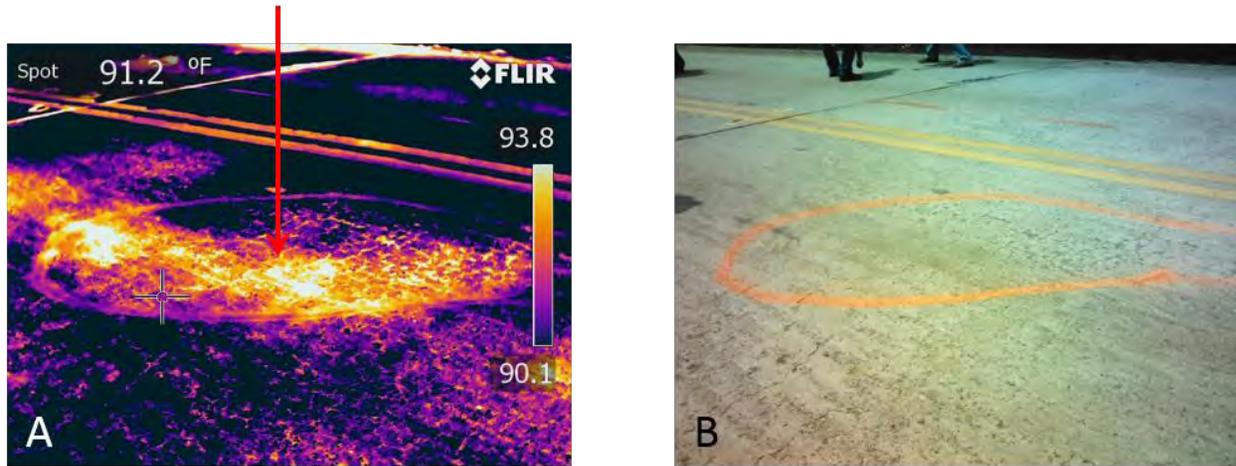
Figure 29: IR (A) and digital (B) images of a deck delamination over a railroad on Dames Ferry Rd.

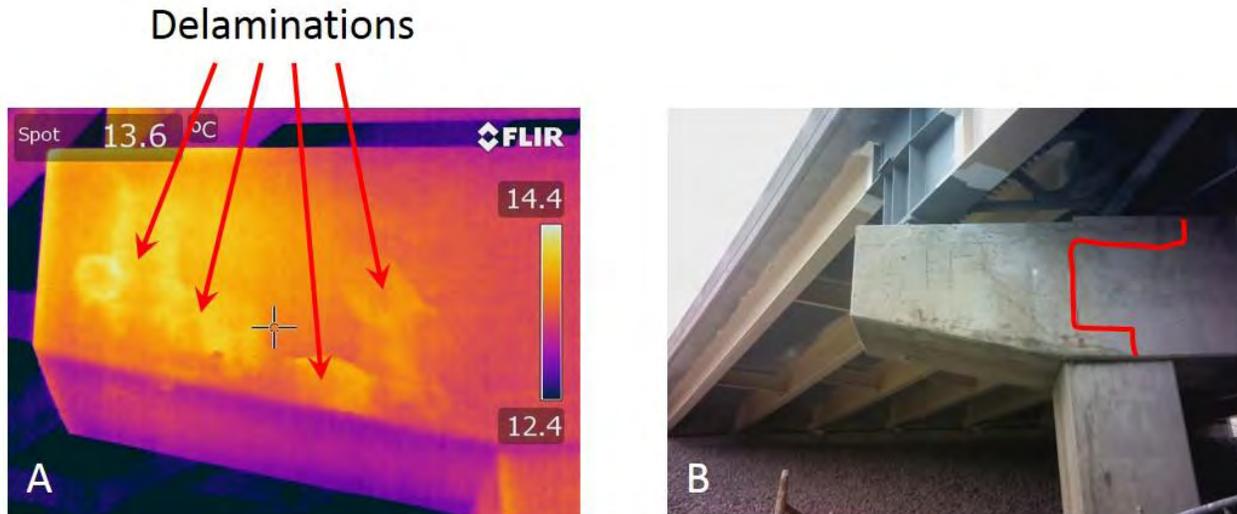
Scattered showers throughout the day interfered with the deck inspection; therefore, the substructure was inspected instead. Although weather conditions were less than ideal, a delamination could still be seen in one of the pier caps. A thermal and digital image of the delamination can be seen in Figure 31 below.

Figure 31: Thermal image (A) and digital image (B) of a pier cap delamination

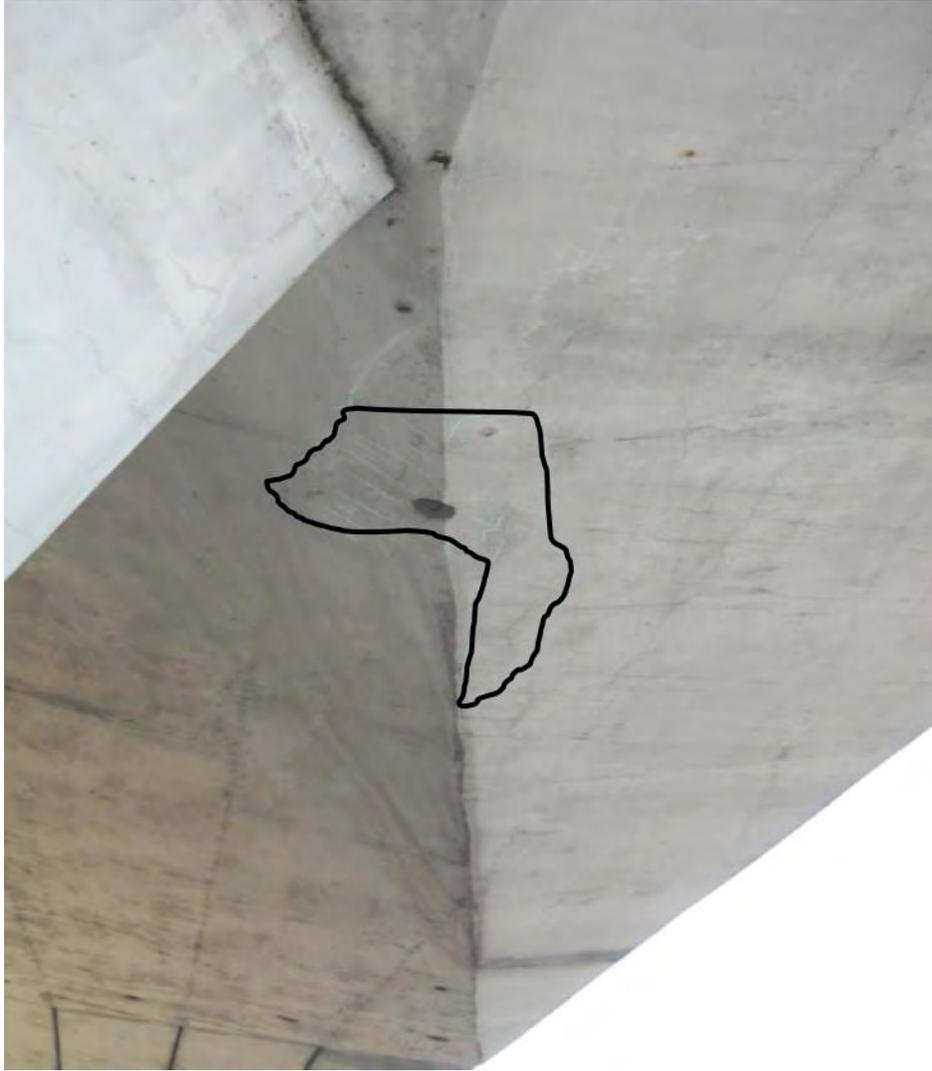
Figure 36: Hammer sounding results of a drain delamination from the WJE report

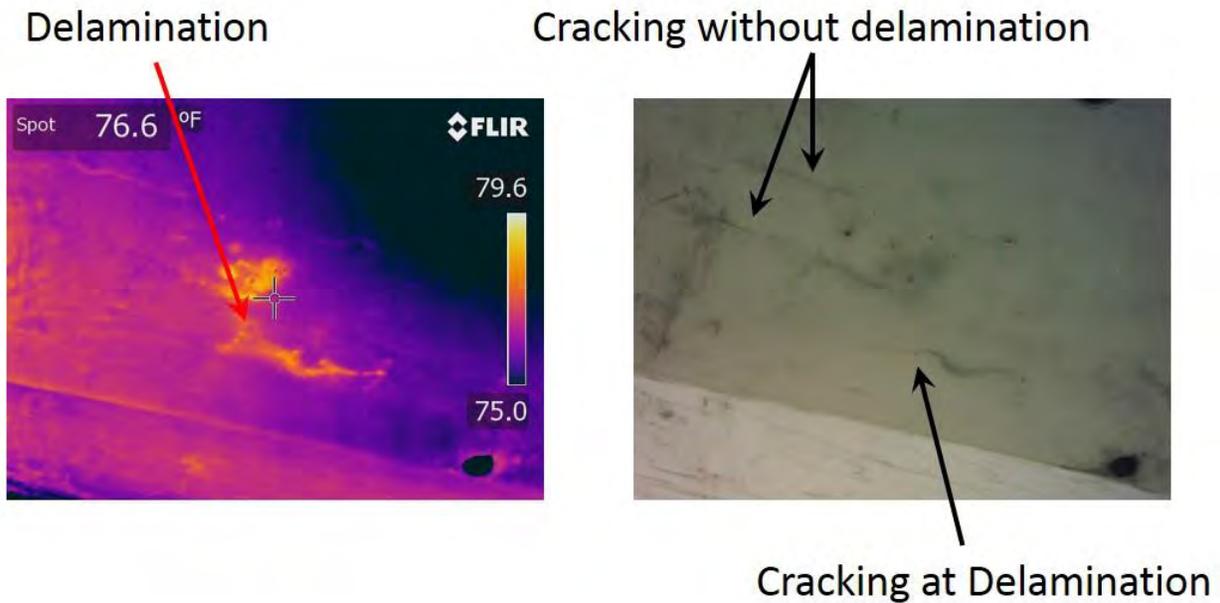
Figure 38: IR (A) and digital (B) image of a possible parge coat delamination

Figure 38 illustrates a possible delamination in the parge coating. There are other cracks similar to the area in question that show no evidence of thermal contrast. The fact that there is no thermal contrast in other areas leads us to believe that this is a delamination, not in the concrete, but in the parge coating.

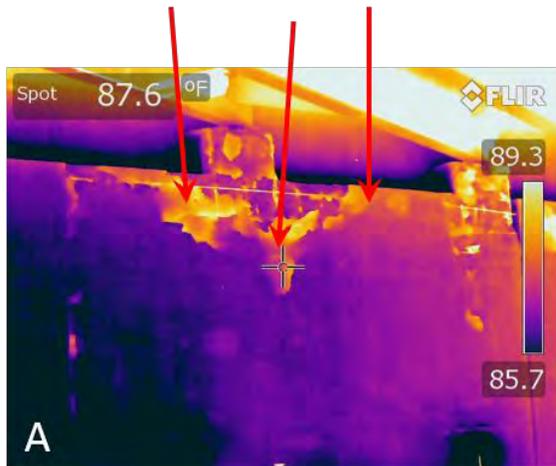
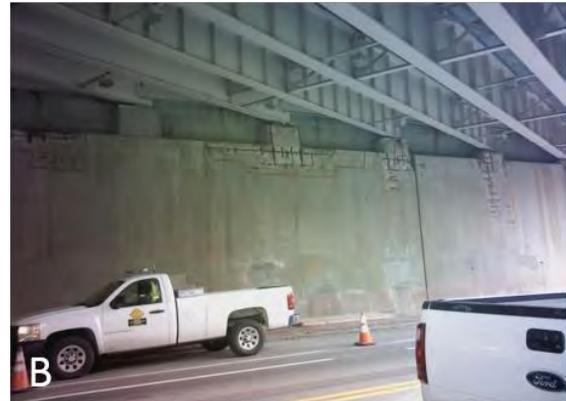
Figure 39: Thermal (A) and Digital (B) images of a delaminated abutment wall under I-265

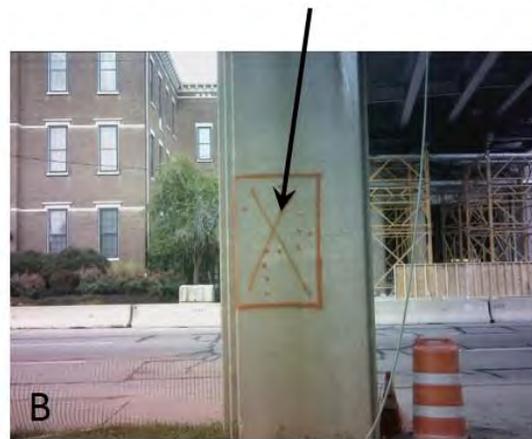
Figure 40: IR (A) and digital (B) images of hammer sounding results on a pier in Kentucky

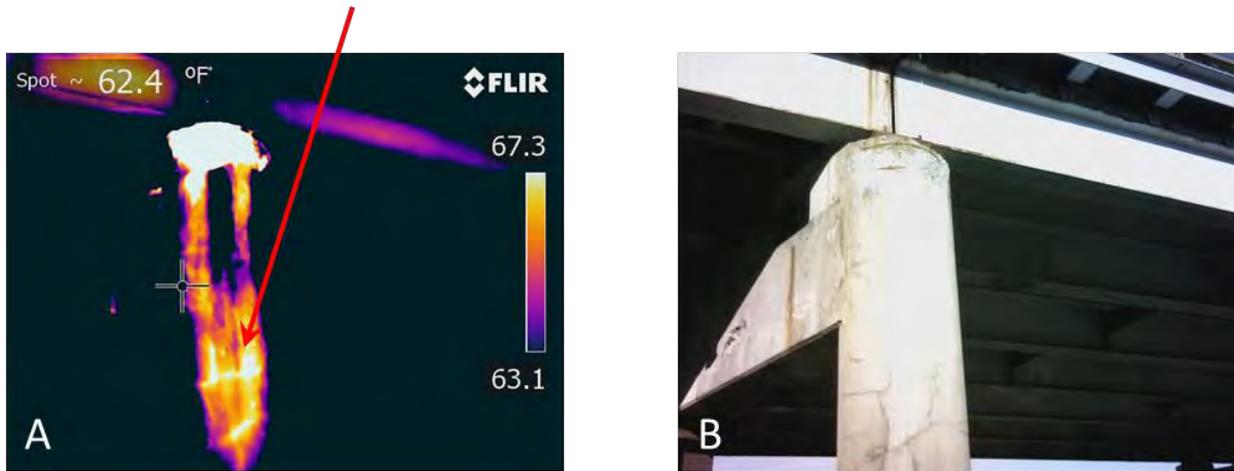
Figure 43: IR (A) and digital (B) images of a delaminated column on Pier 1 of South Bridge

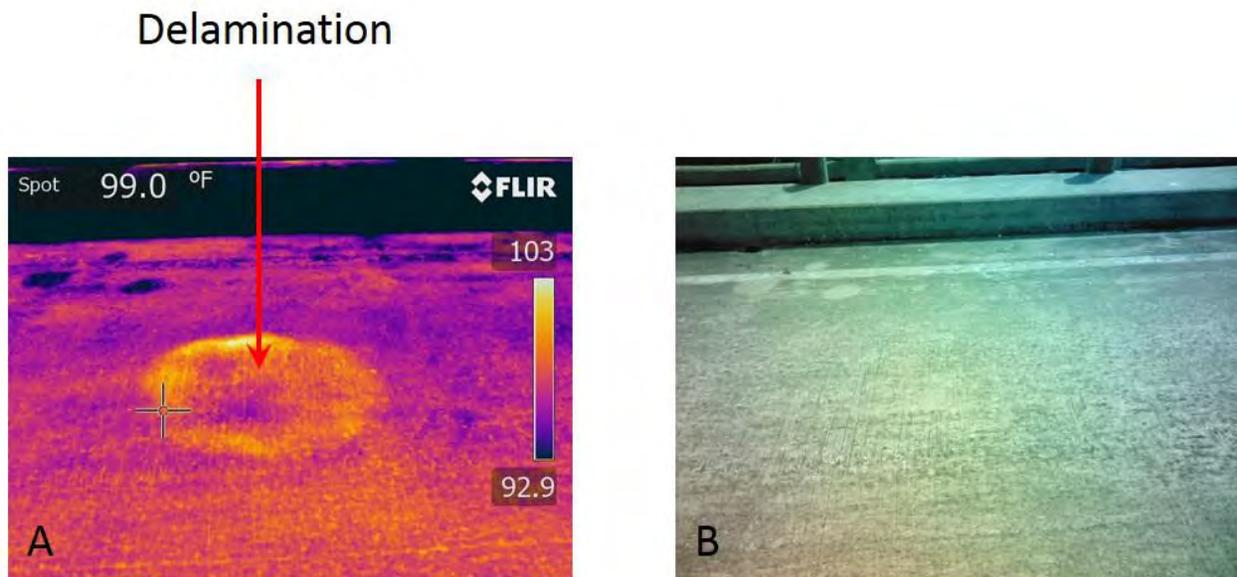
Figure 45: Infrared (A) and digital (B) images of a deck delamination in Florida

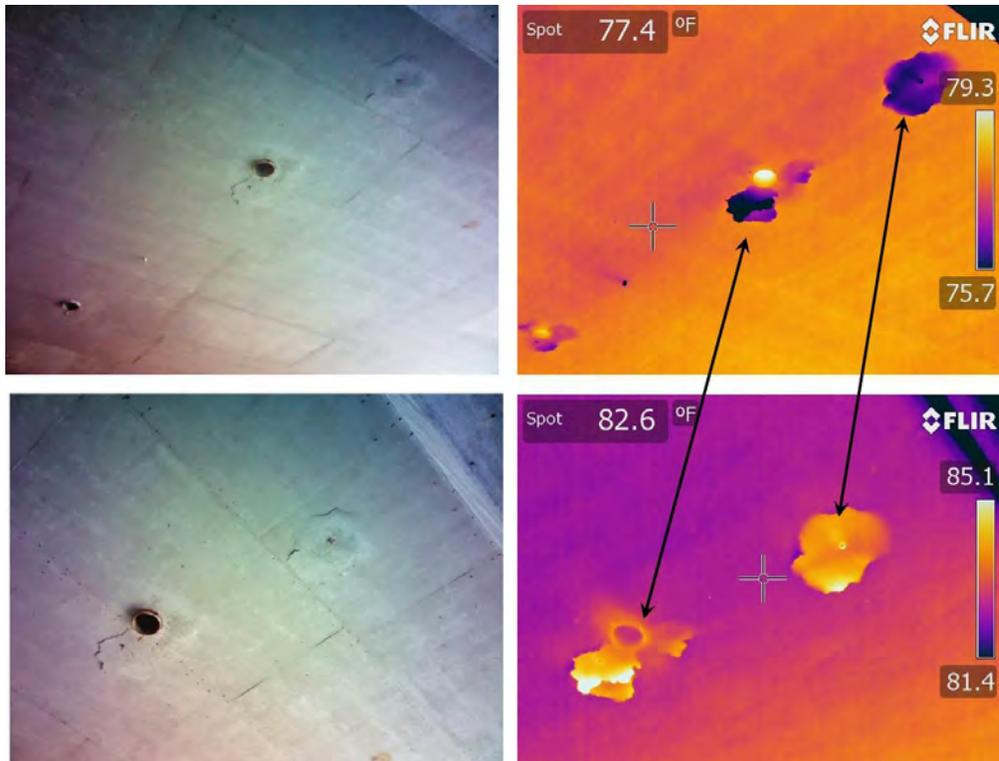
Figure 49: Thermal images of delaminations in the soffit of a wide slab bridge, showing morning (top) and afternoon (bottom) results

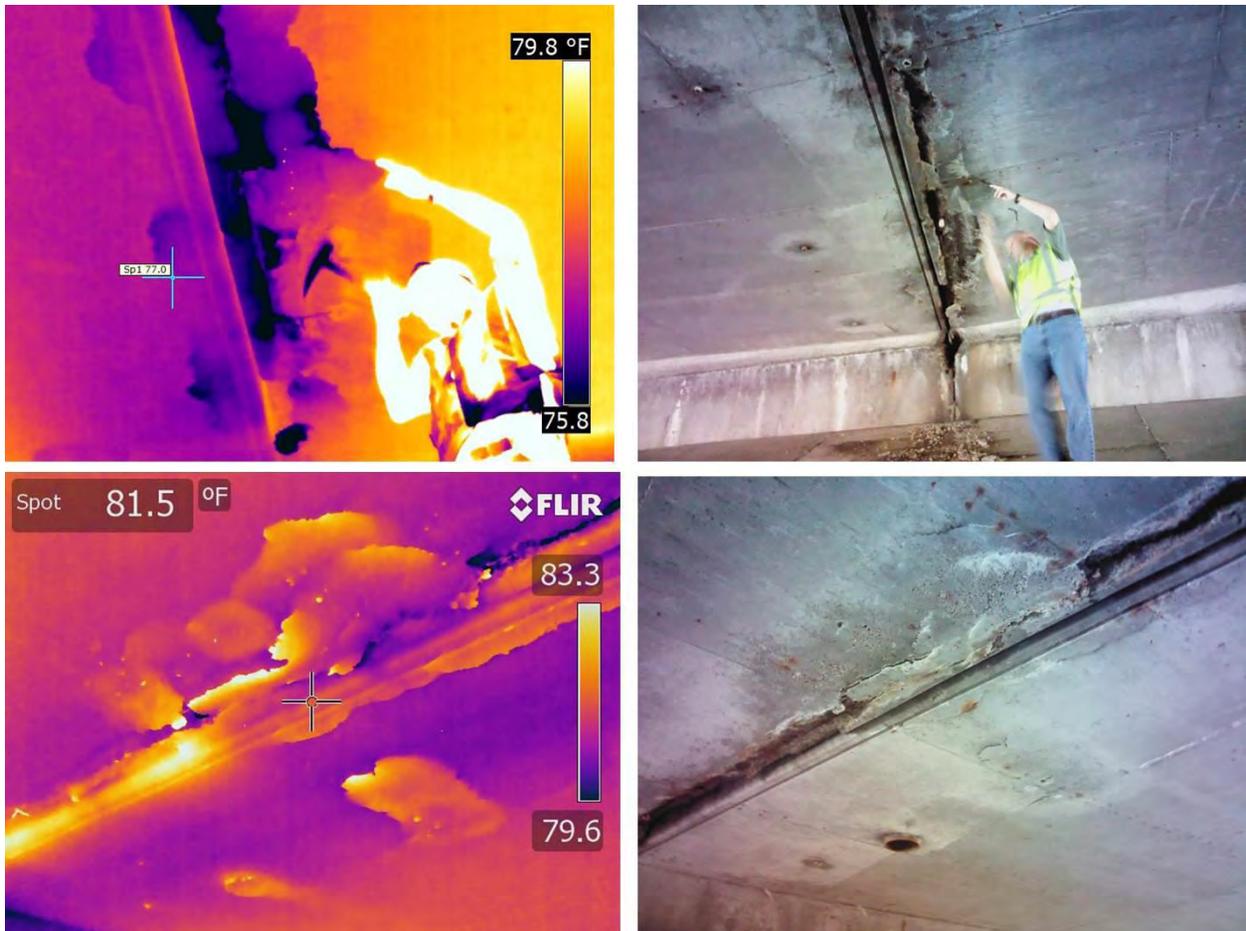
Figure 50: Thermal images showing damage along a longitudinal joint in a 159 ft. wide slab bridge
