Investigation of the Long Term Effects of Magnesium Chloride and Other Concentrated Salt Solutions on Pavement and Structural Portland Cement Concrete

Project Number: SD2002-01

Quarterly Report

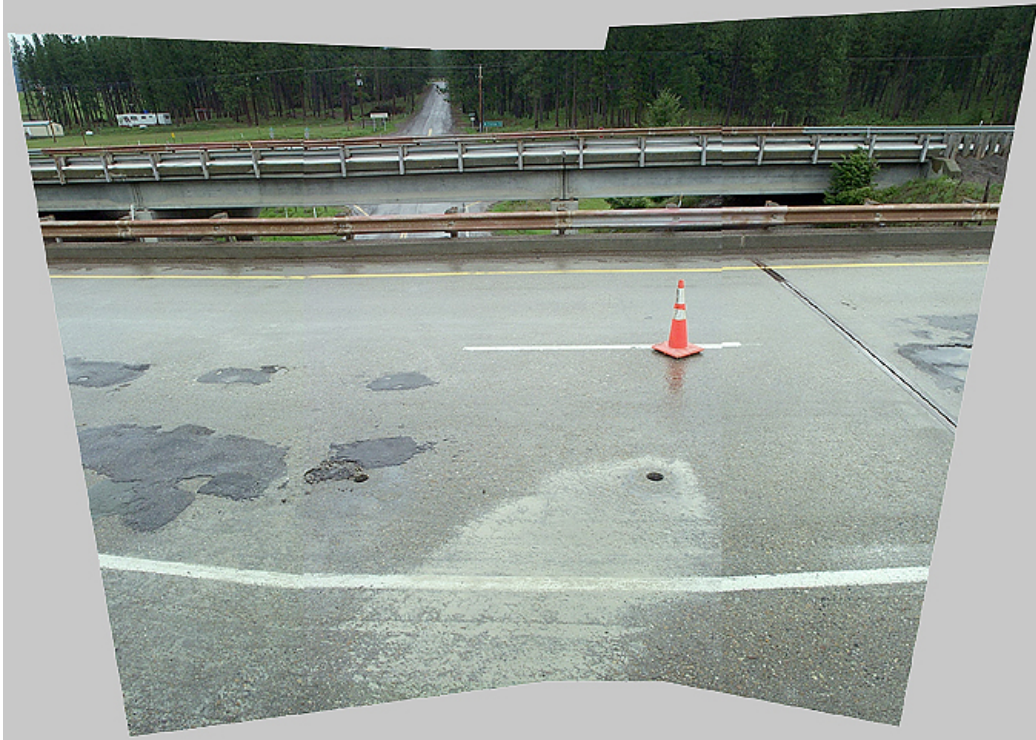
Figure 1 shows the first site, the eastbound bridge deck of the Tarkio interchange. Both core holes are visible in Figure 1, along with several areas covered with cold-patch material. The core taken adjacent to the deterioration (core T-1) did not penetrate the entire bridge deck. The core taken away from the deterioration (core T-2) did penetrate the deck, as is shown in Figure 2, a photo taken from beneath the bridge deck. Although core T-1 did not penetrate the deck, water seeping through cracks from the coring operation is visible in Figure 2. Also visible in Figure 2 are areas of white efflorescence situated directly below the deteriorated portions from the surface of the bridge deck. Figures 3 and 4 show core T-1, with a large crack plane oriented parallel to the pavement surface at a depth of approximately 4 cm. Figure 5 shows core T-2. No reinforcing steel was encountered in cores T-1 or T-2.

Figure 1: EB I-90 Tarkio interchange bridge deck after coring.

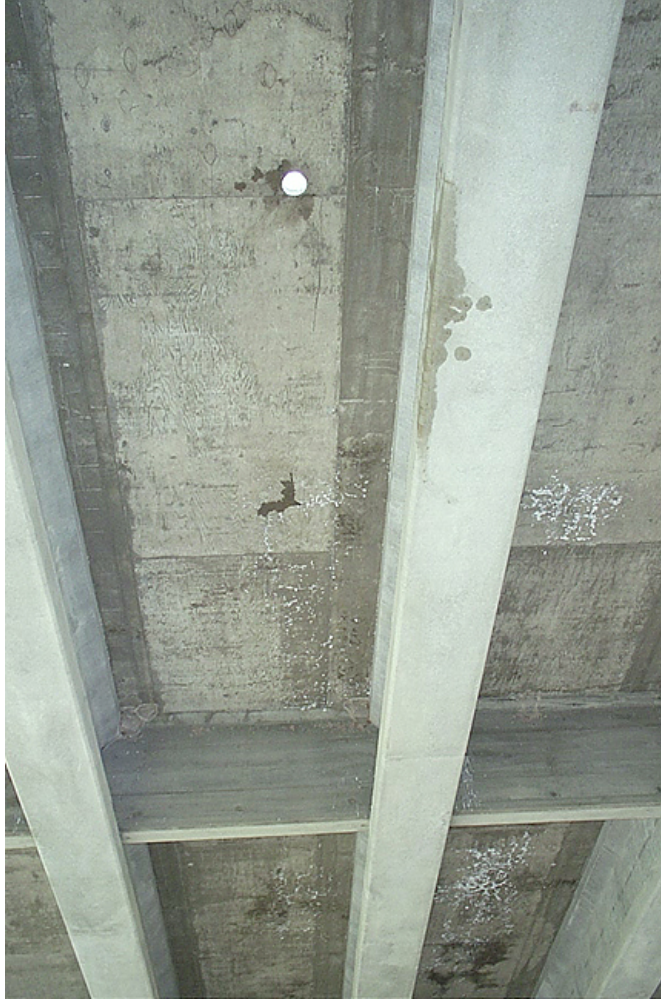
Figure 2: Beneath EB I-90 Tarkio interchange after coring.

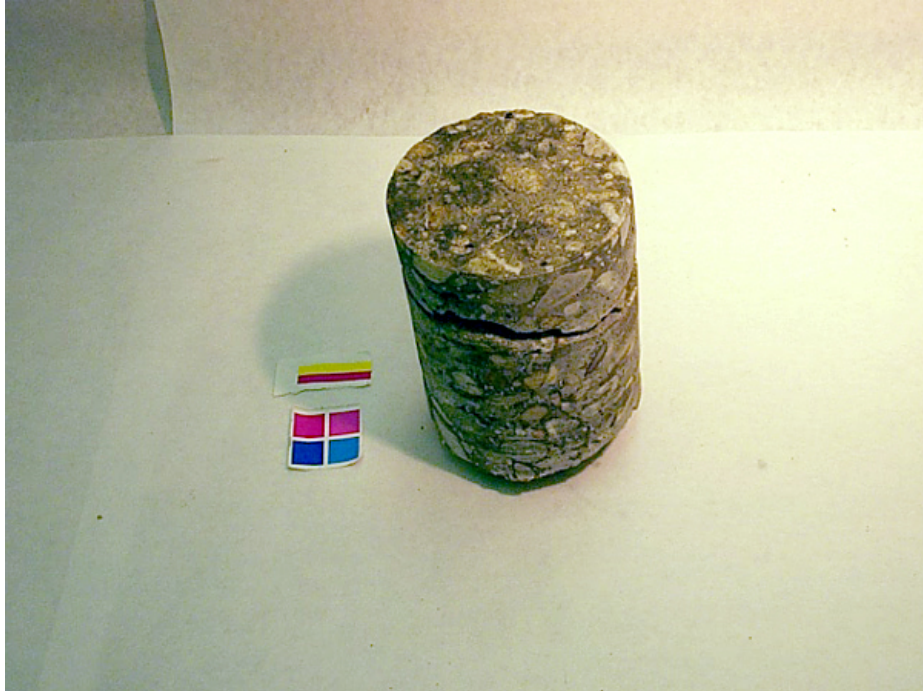
Figure 3: Core T-1, taken adjacent to deteriorated area.

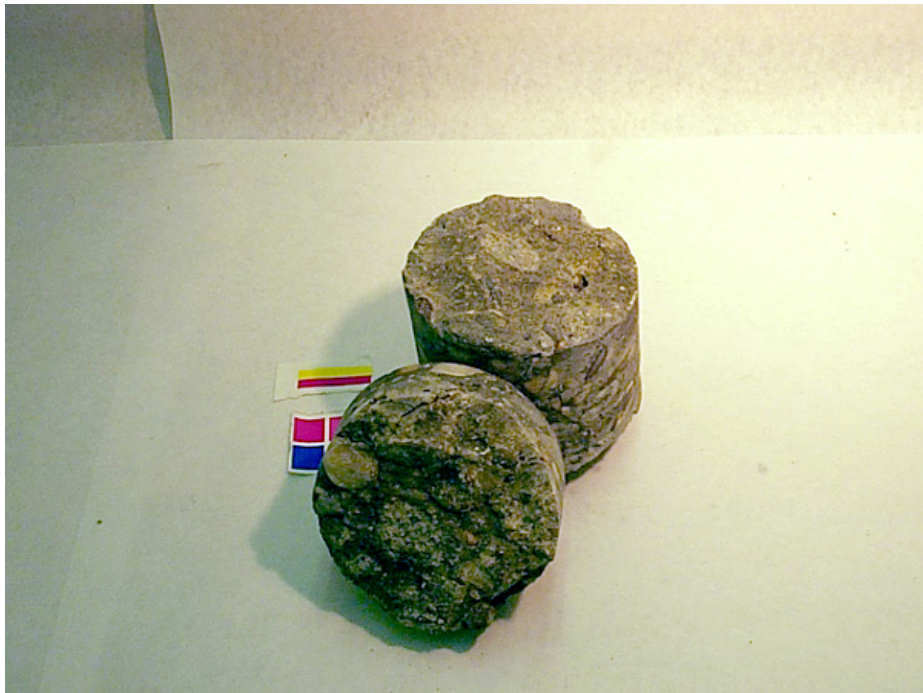
The deterioration at both sites is characterized by a crack plane oriented parallel to the pavement surface at a depth between 3 and 4 cm. In the case of the Sloway bridge deck, the depth of this crack plane coincides with the position of the reinforcing steel. Rust was observed associated with the reinforcing steel encountered at these depths. No reinforcing steel was encountered in cores from the Tarkio bridge deck. The thin sections prepared from the Tarkio bridge deck showed magnesium enrichment at the pavement surface similar to the magnesium enrichment observed in the constant cold temperature MgCl₂ brine mortar cylinder experiment. Magnesium enrichment was not evident in thin sections prepared from the Sloway bridge deck. Both bridge decks exhibited calcium hydroxide depletion of the cement paste in the immediate vicinity of the large crack at depth. Calcium hydroxide depletion was also pronounced in the cracked portions of the mortar cylinders from the constant cold MgCl₂ brine experiment. However, unlike the brine experiment, no calcium oxychloride phases were observed in any of the cracks from the bridge decks. The pronounced chlorine concentration above the large crack at 3 cm depth as shown in the elemental maps from the polished thin section prepared from the Sloway bridge deck shows that chloride rich fluids were present in the crack.

Figure 4: Core T-1, separated to illustrate crack plane.

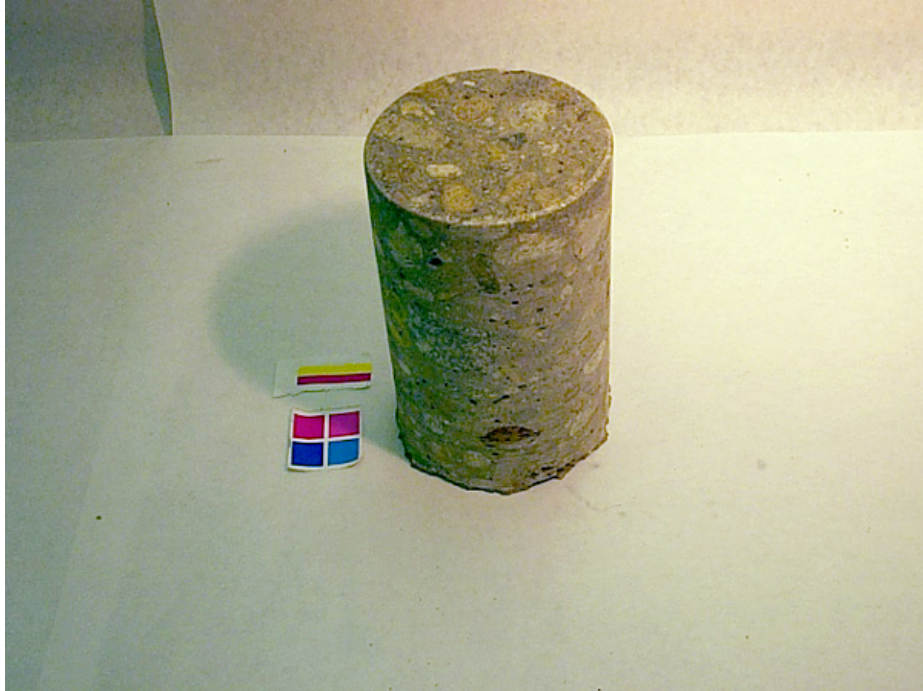
Figure 5: Core T-2, taken away from deteriorated area.

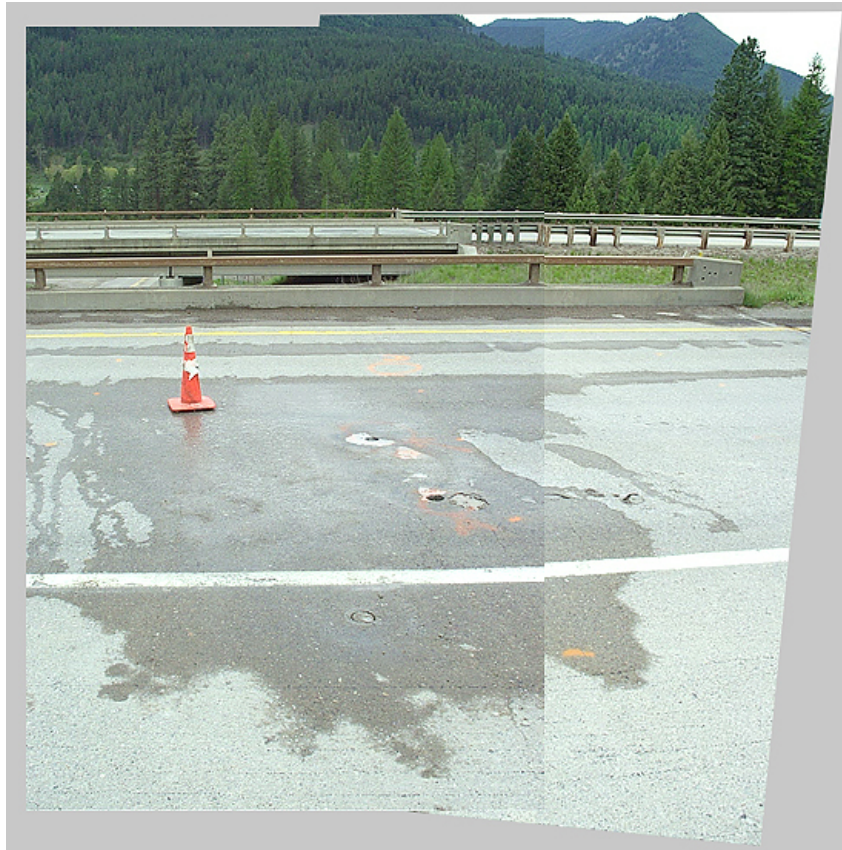
Figure 6 shows the second site, the westbound bridge deck of the Sloway interchange, after coring. Spalling of the pavement surface can be seen in Figure 6. Both cores penetrated the entire bridge deck. Also shown in the foreground of Figure 6 are markings

Figure 6: WB I-90 Sloway interchange bridge deck after coring.

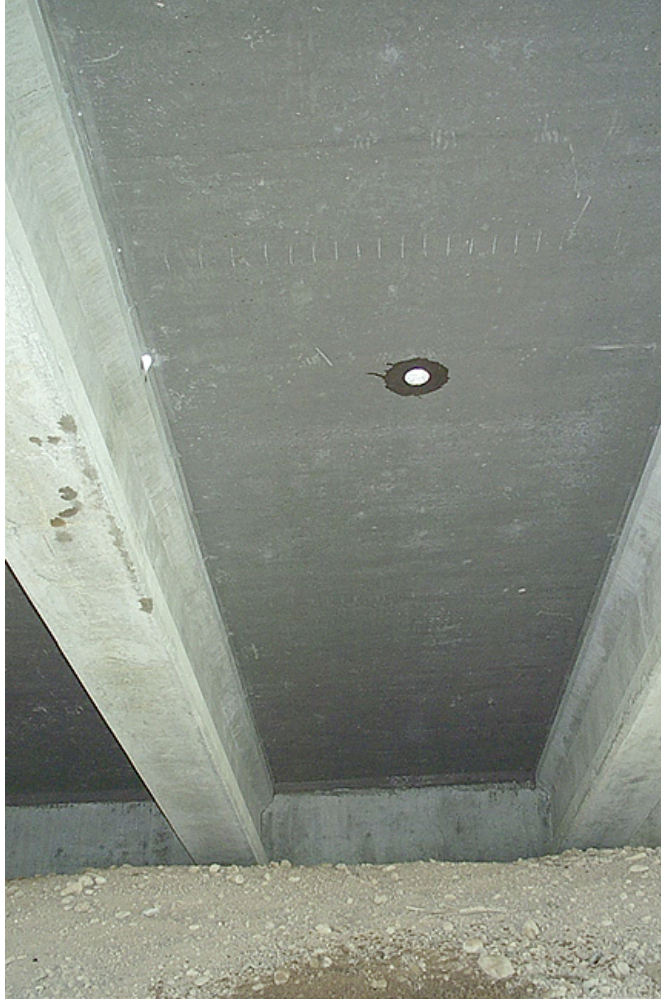
from a third aborted core attempt. Figure 7 shows a photo taken from beneath the bridge deck. The hole from the core taken adjacent to the deterioration, (core S-1) is clearly shown in the middle of Figure 7. The hole from the core taken away from the deterioration, (core S-2) is partly obscured by the pre-stressed beam, as seen in Figure 7. Figures 8 and 9 show core S-1, with a large rust-stained crack plane oriented parallel to the pavement surface at a depth of approximately 3 cm, just above the reinforcing steel. Figure 10 shows core S-2. Reinforcing steel was encountered in both cores S-1 and S-2.

Figure 7: Beneath WB I-90 Slowway interchange after coring.

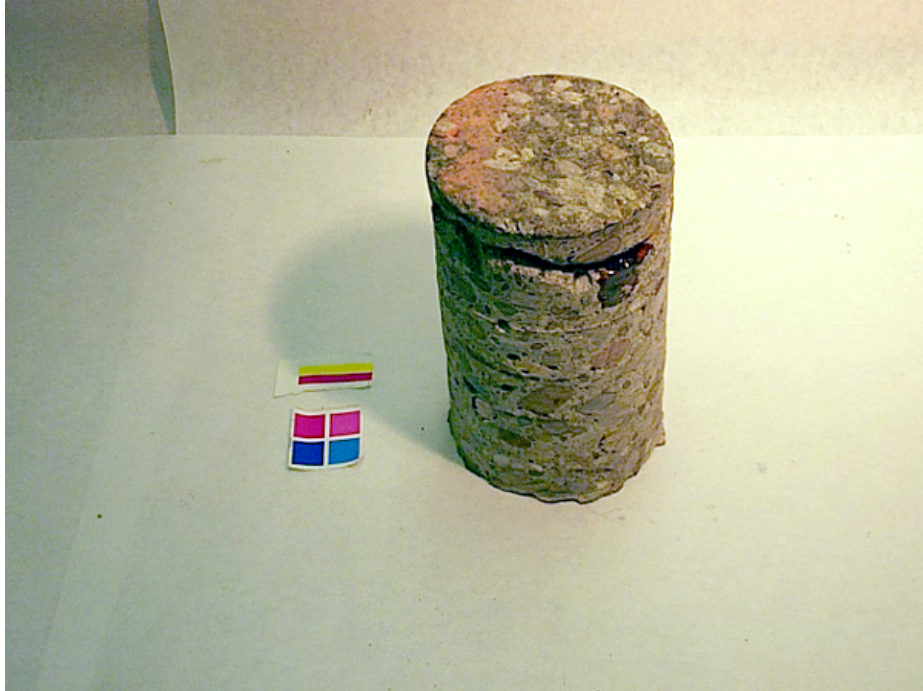
Figure 8: Core S-1, taken adjacent to deteriorated area.

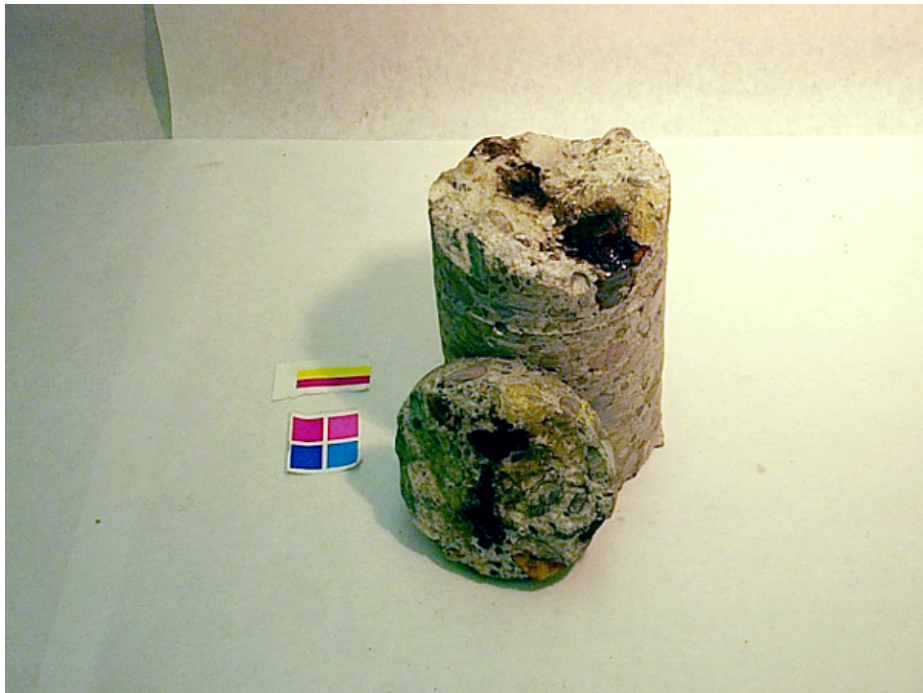
Figure 9: Core S-1, separated to illustrate crack plane.

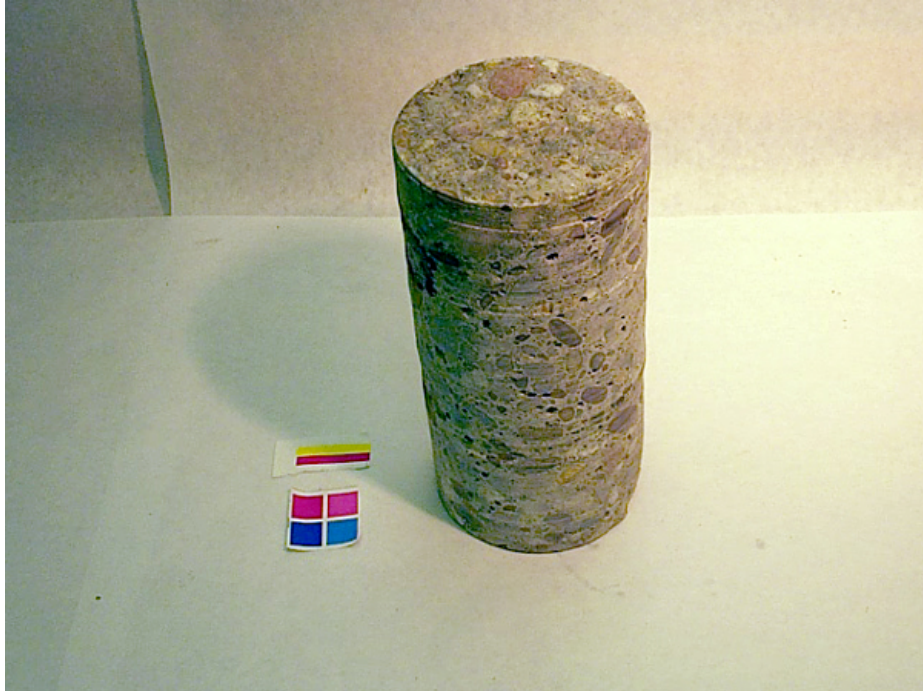
Figure 10: Core S-2, taken away from deteriorated area.

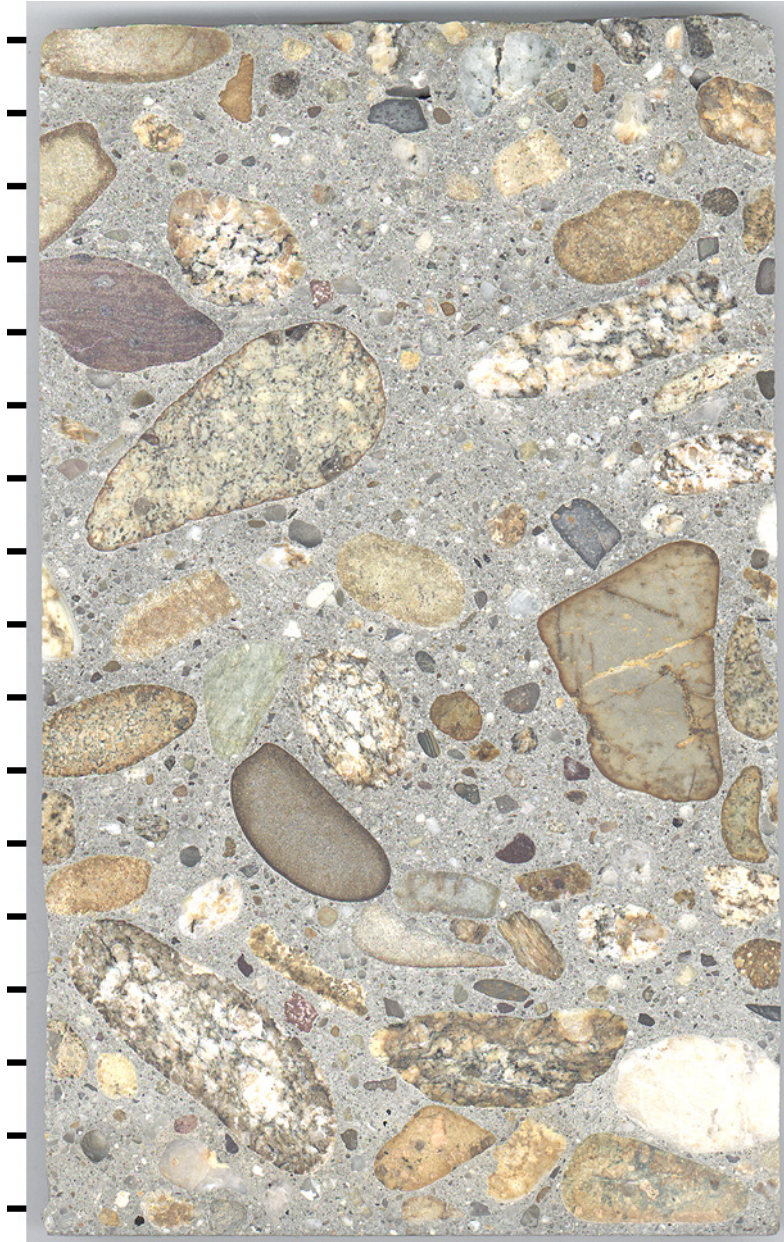
Figure 11: Polished slab from core T-2, tic marks every cm.

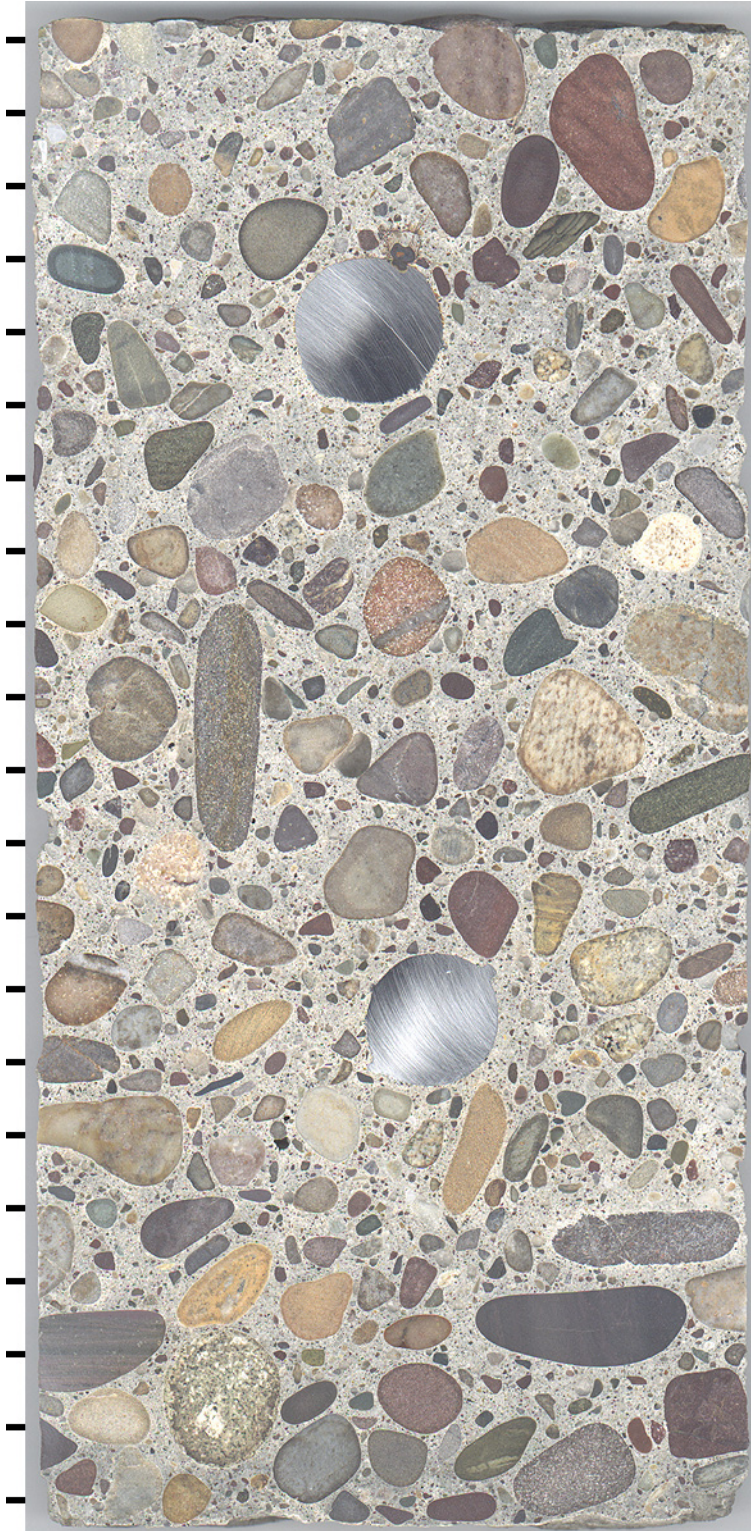
Figures 11 and 12 show scanned images of cores T-2 and S-2. The reinforcing steel of core S-2 is clearly visible in Figure 12. Figure 13 shows a close-up stereo microscope image of rust and cracks from the upper tier of steel reinforcement. Air-void analyses and chemical staining have not yet been performed on the polished slabs from cores T-2 and S-2.

Figure 12: Polished slab from core S-2, tic marks every cm.

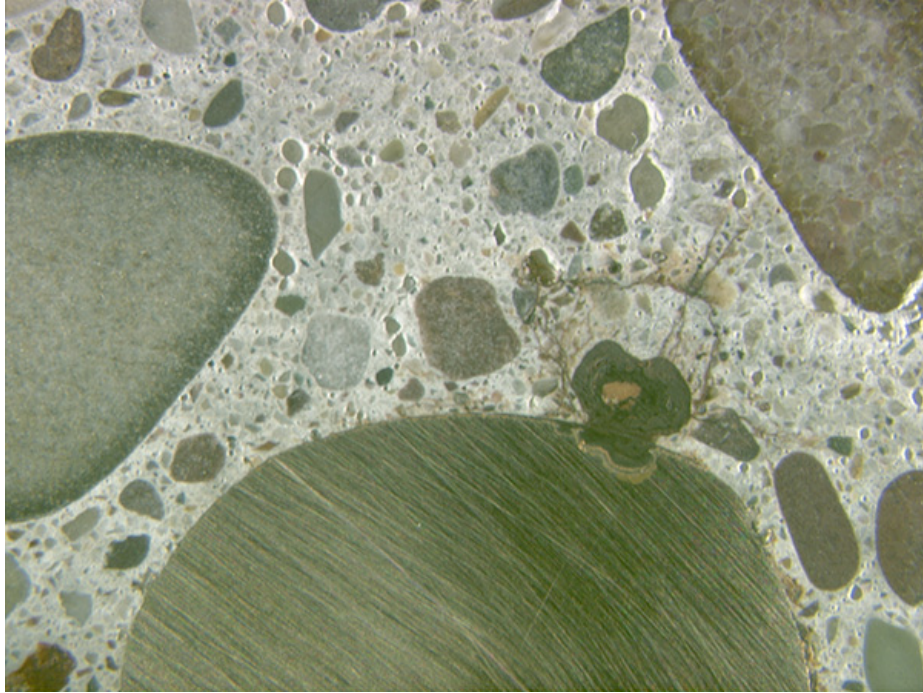
Figure 13: Stereo microscope image of rust along top of reinforcing steel as exposed on polished slab from core S-2.

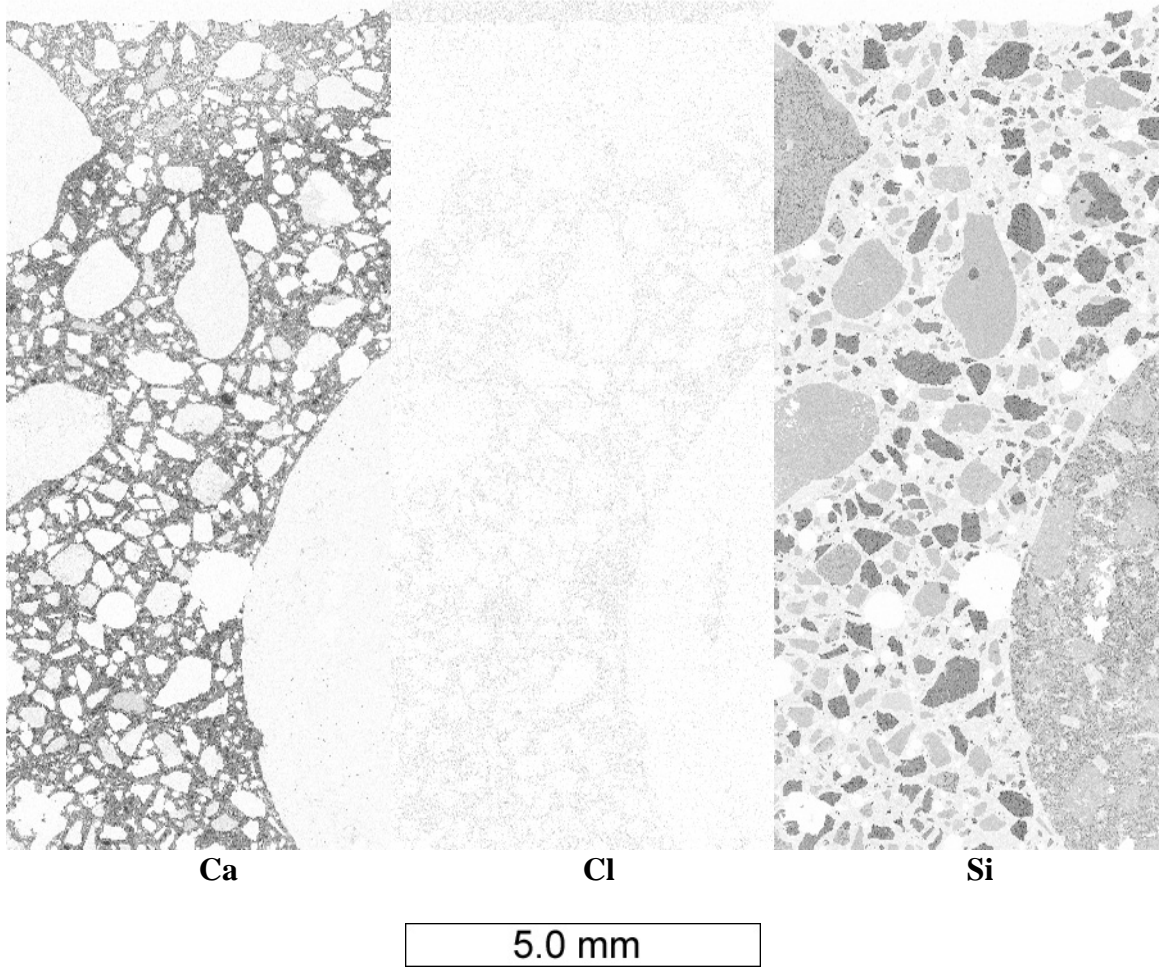
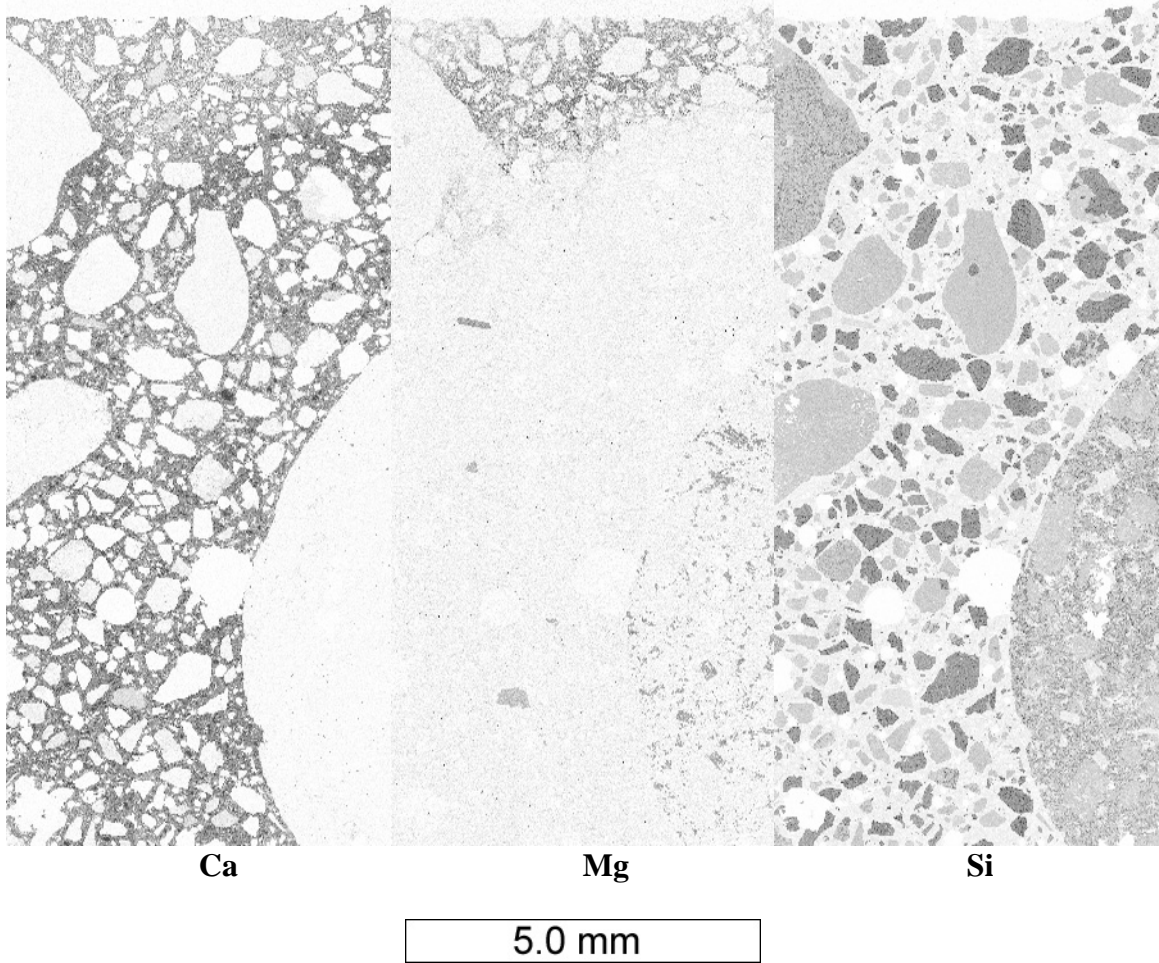
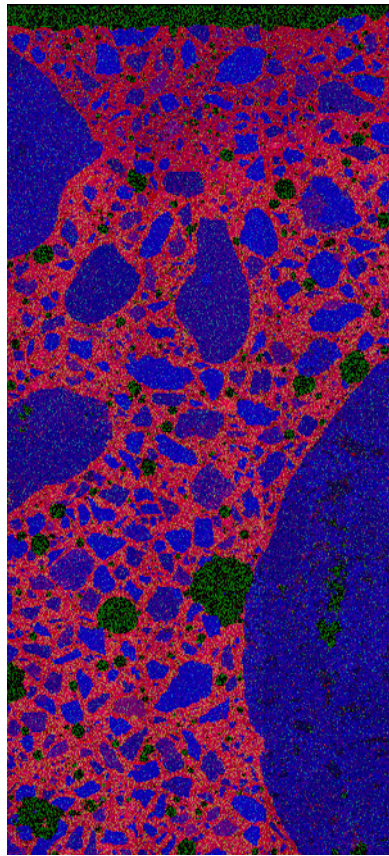
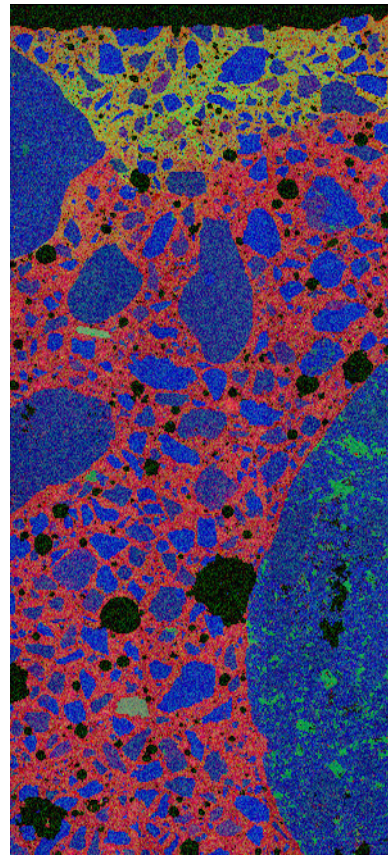
Figures 14 through 19 show elemental maps made from polished thin sections from core T-1. Figures 14, 15, and 16 represent a cross-section at the pavement surface. Figures 17, 18, and 19 represent a cross-section through the large crack at 4 cm depth. The magnesium maps of Figures 15 and 16 show pronounced magnesium enrichment of the hardened cement paste at the pavement surface. Magnesium enrichment is not evident at the crack at depth, as shown in Figures 18 and 19. The chlorine maps shown in Figures 14 and 16, and in Figures 17 and 19, do not show much chlorine enrichment. It should be noted, however, that the fluorescent dyed epoxy used to stabilize the samples also contains chlorine which can mask the residual chlorine that may be present from the deicer.

Figure 14: Characteristic $K\alpha$ x-ray maps showing concentrations for calcium, chlorine, and silicon from polished thin section prepared from core T-1 showing cross section through pavement surface. Darker regions correspond to higher x-ray counts.

Figure 14: Characteristic $K\alpha$ x-ray maps showing concentrations for calcium, magnesium, and silicon from polished thin section prepared from core T-1 showing cross section through pavement surface. Darker regions correspond to higher x-ray counts.

Figure 16: RGB composite image of characteristic $K\alpha$ x-ray maps from polished thin section prepared from core T-1 showing cross section through pavement surface. Brighter regions correspond to higher x-ray counts.

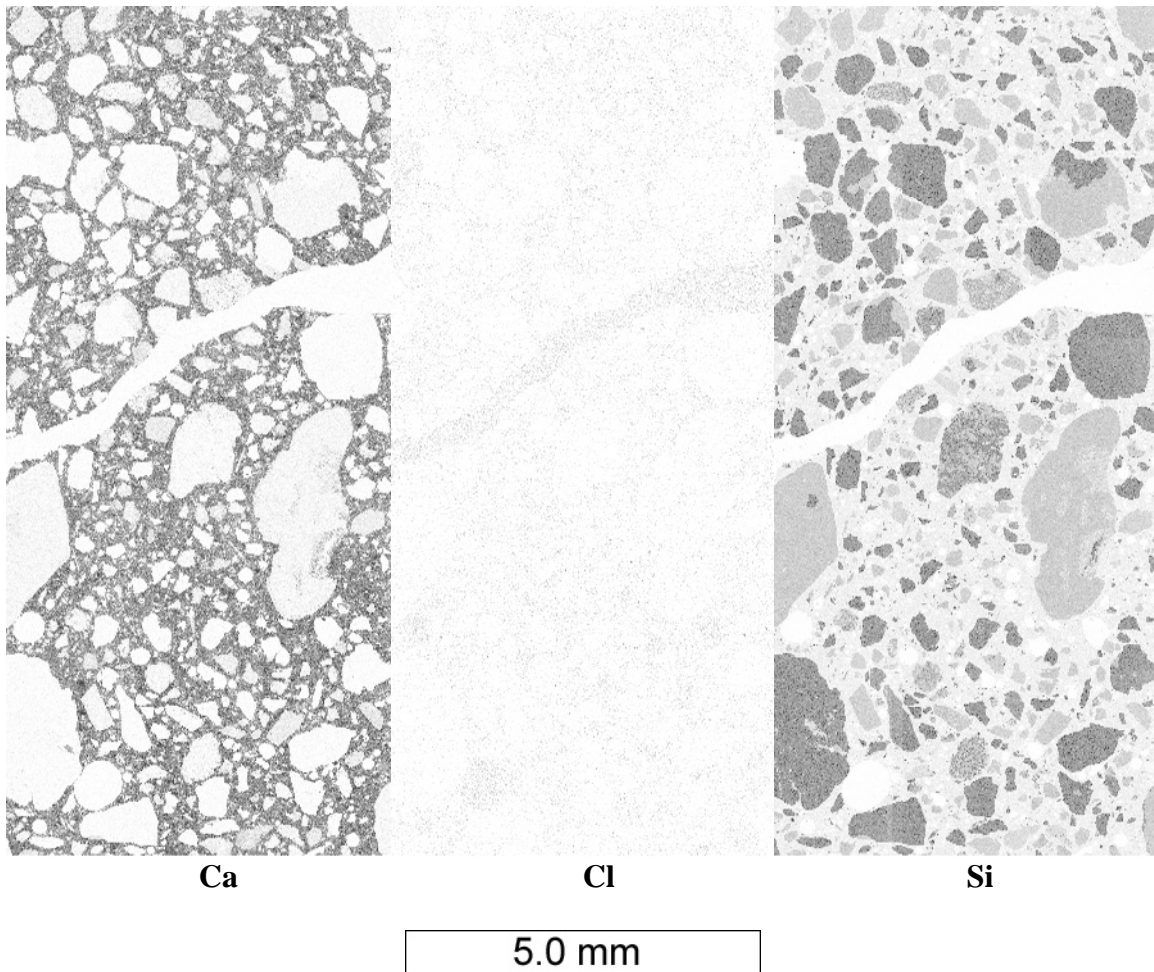
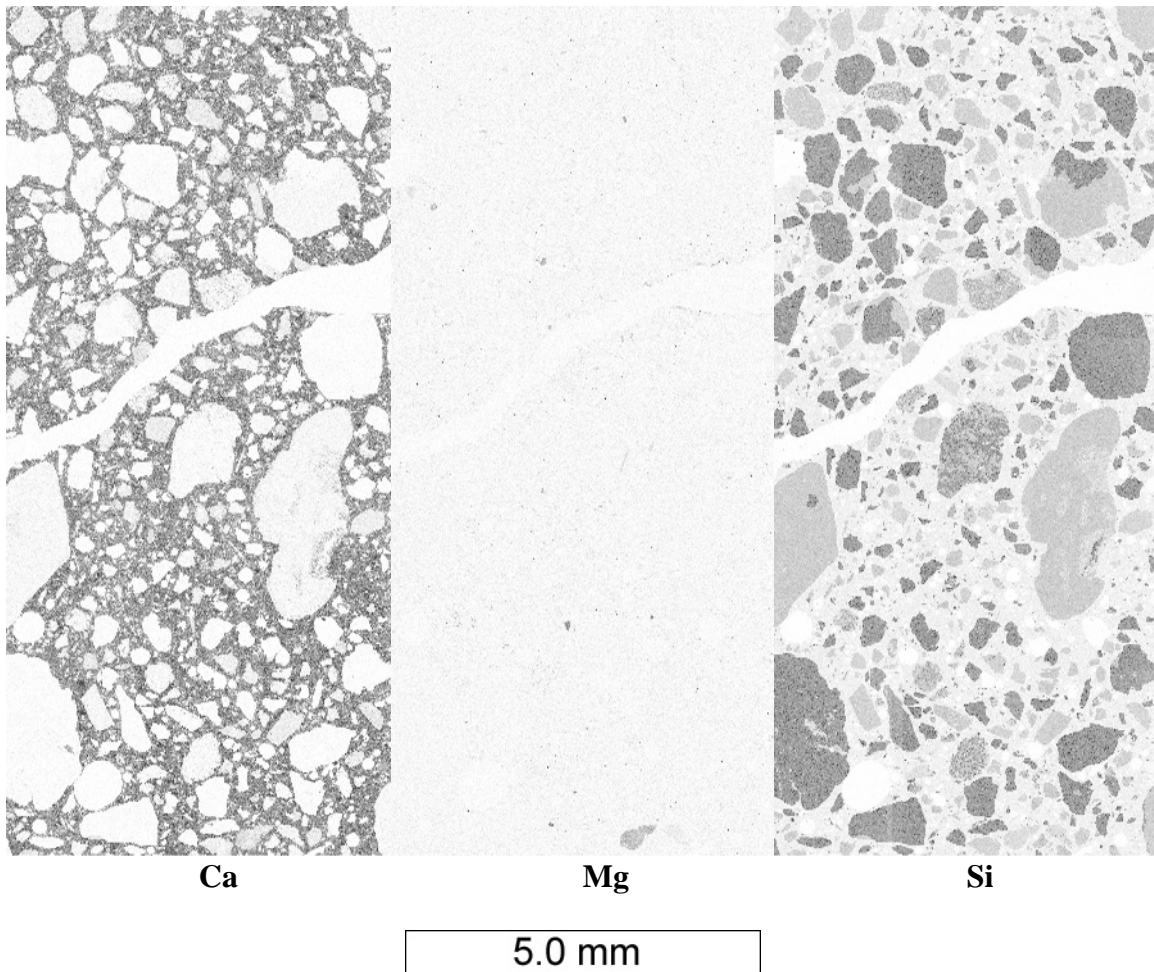
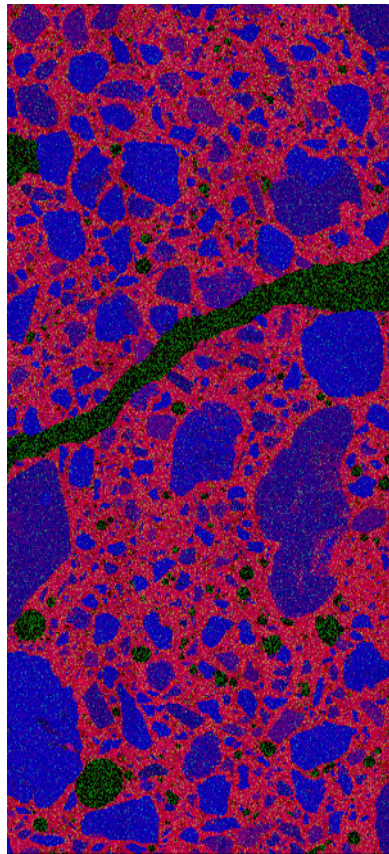
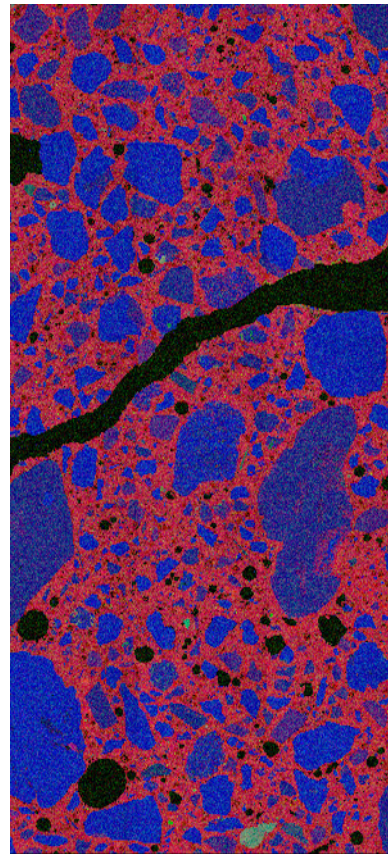
The thin sections prepared to represent a cross-section of the large crack at depth for both cores T-1 and S-1 exhibited pronounced depletion of calcium hydroxide in the hardened cement paste in a region of about 1 mm on either side of the crack. Petrographic work on these samples will continue to further investigate the alteration of the hardened cement paste within the vicinity of the large crack.

Figure 17: Characteristic $K\alpha$ x-ray maps showing concentrations for calcium, chlorine, and silicon from polished thin section prepared from core T-1 showing cross section through large crack at 4 cm depth. Darker regions correspond to higher x-ray counts.

Figure 18: Characteristic $K\alpha$ x-ray maps showing concentrations for calcium, magnesium, and silicon from polished thin section prepared from core T-1 showing cross section through large crack at 4 cm depth. Darker regions correspond to higher x-ray counts.

Figure 19: RGB composite image of characteristic $K\alpha$ x-ray maps from polished thin section prepared from core T-1 showing cross section through large crack at 4 cm depth. Brighter regions correspond to higher x-ray counts.

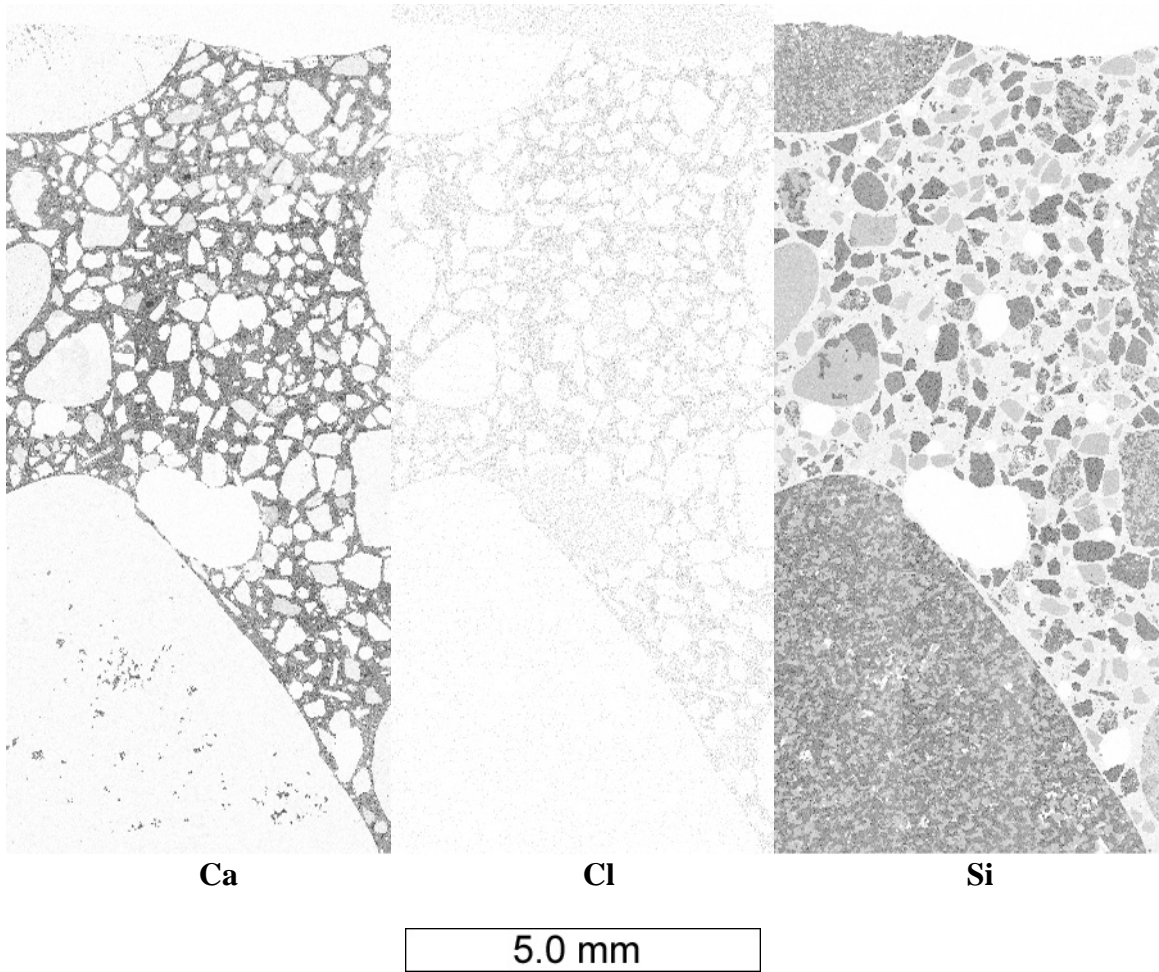
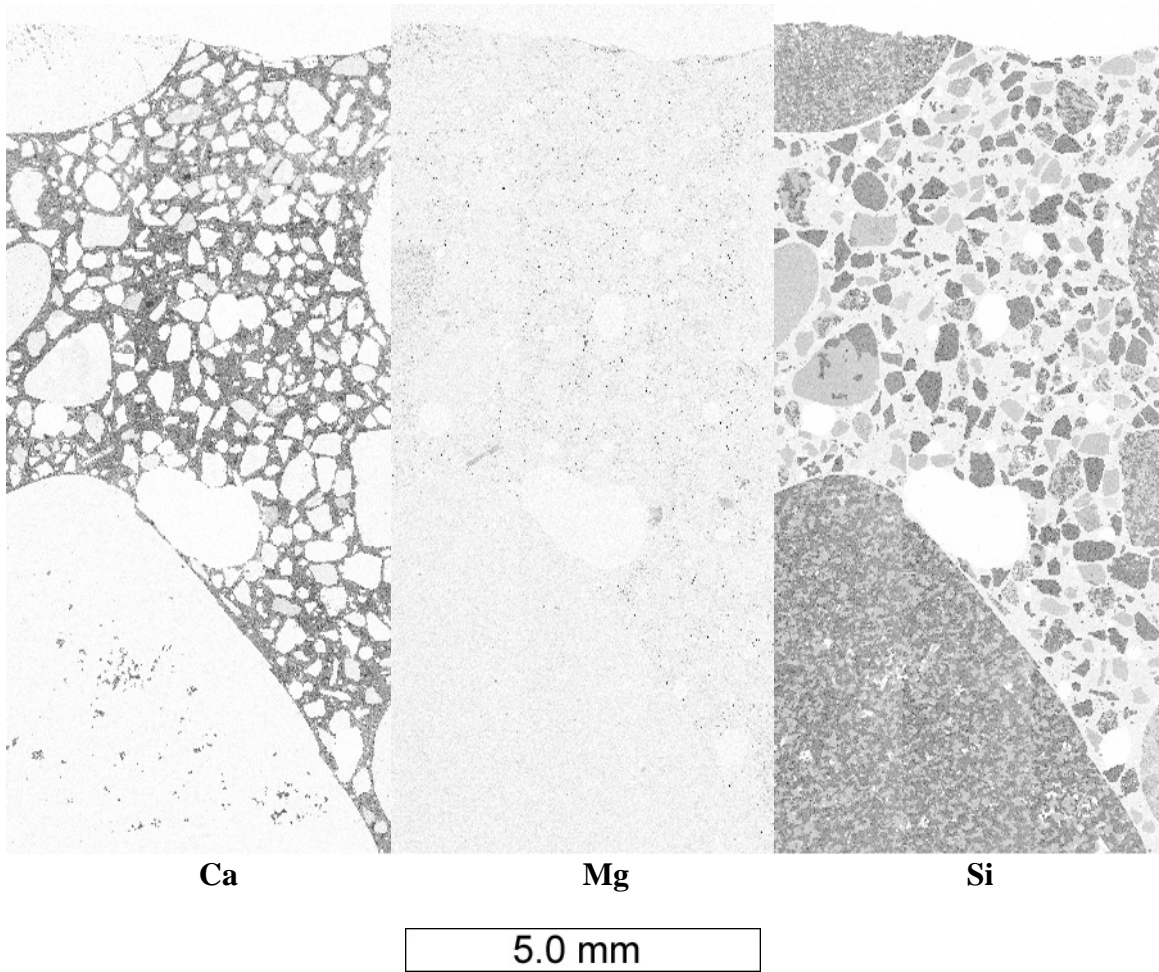
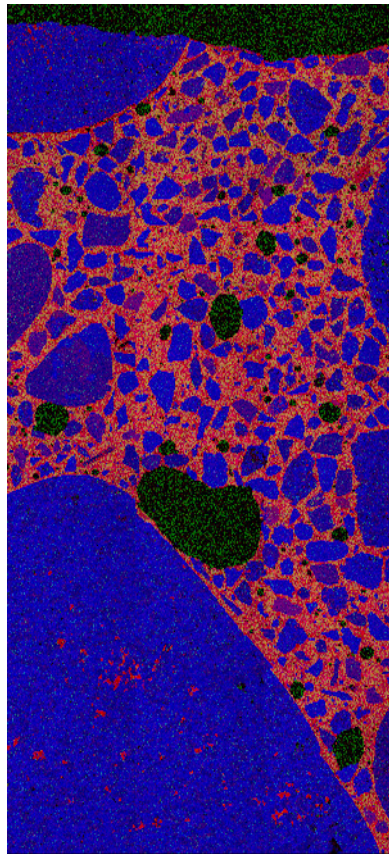
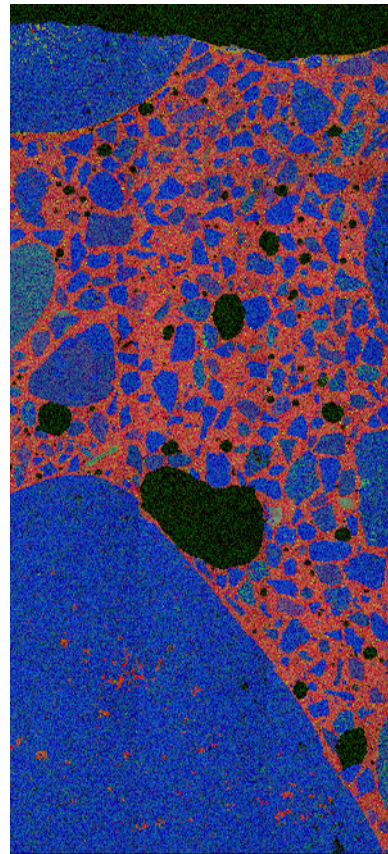
Figures 20 through 25 show elemental maps made from polished thin sections from core S-1. Figures 20, 21, and 22 represent a cross-section at the pavement surface. Figures 23, 24, and 25 represent a cross section through the large crack at 3 cm depth. Unlike the thin section prepared from core T-1, the thin section prepared to represent the cross-section at the pavement surface in core S-1 does not show pronounced magnesium enrichment, as shown in Figures 21 and 22. Magnesium enrichment is also not evident at the crack at depth, as shown in Figures 24 and 25. However, there is a chlorine enriched zone just above the crack at depth, as shown in Figures 23 and 25.

Figure 20: Characteristic $K\alpha$ x-ray maps showing concentrations for calcium, chlorine, and silicon from polished thin section prepared from core S-1 showing cross section through pavement surface. Darker regions correspond to higher x-ray counts.

Figure 21: Characteristic $K\alpha$ x-ray maps showing concentrations for calcium, magnesium, and silicon from polished thin section prepared from core S-1 showing cross section through pavement surface. Darker regions correspond to higher x-ray counts.

Figure 22: RGB composite image of characteristic K α x-ray maps from polished thin section prepared from core S-1 showing cross section through pavement surface. Brighter regions correspond to higher x-ray counts.
