Investigation of the Long Term Effects of Magnesium Chloride and Other Concentrated Salt Solutions on Pavement and Structural Portland Cement Concrete

Project Number: SD2002-01

Quarterly Report

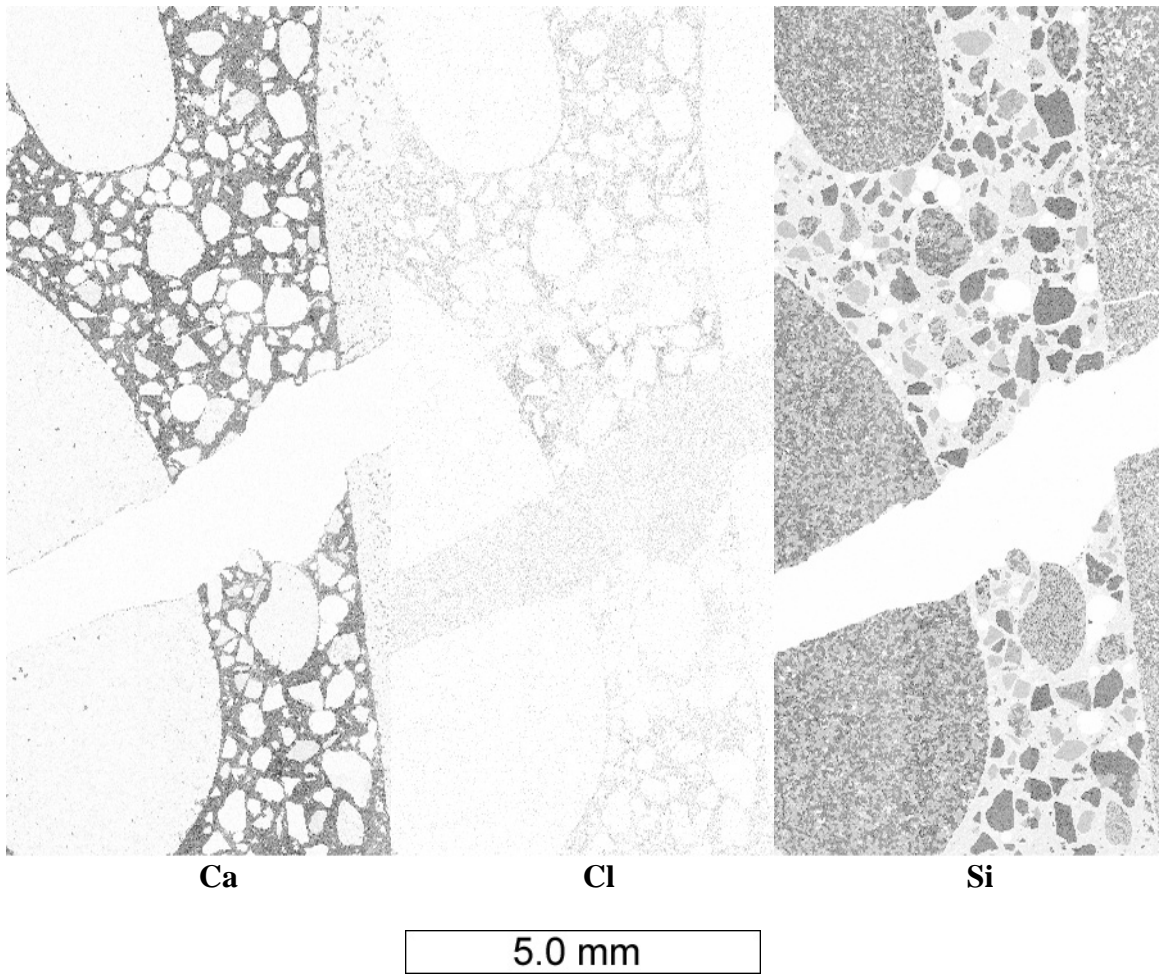
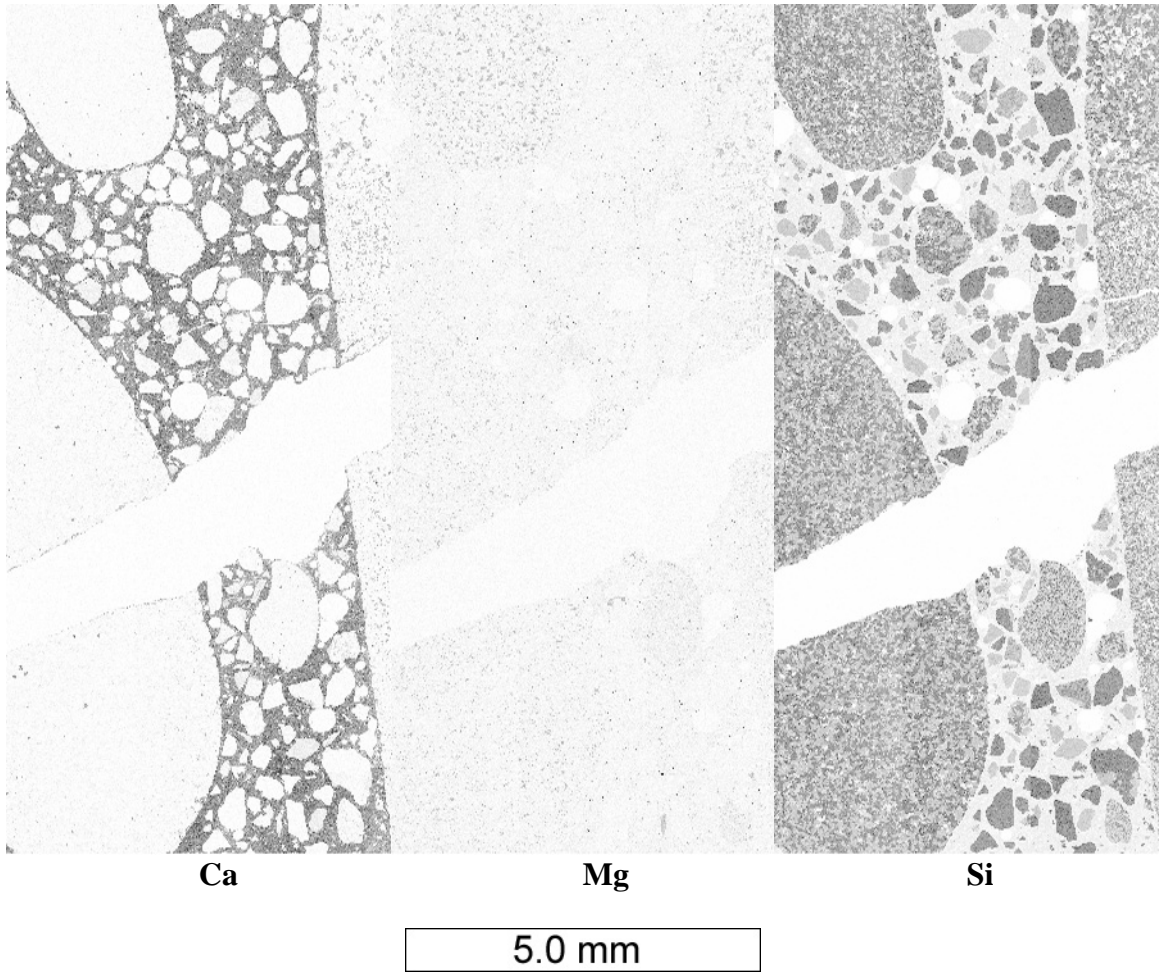
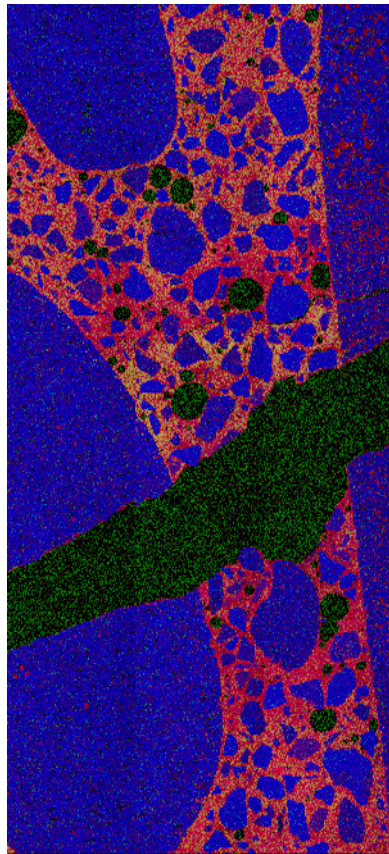
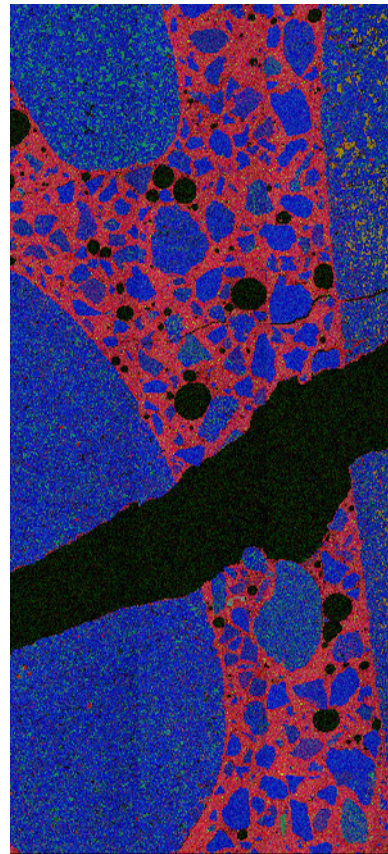
Figures 20 through 25 show elemental maps made from polished thin sections from core S-1. Figures 20, 21, and 22 represent a cross-section at the pavement surface. Figures 23, 24, and 25 represent a cross section through the large crack at 3 cm depth. Unlike the thin section prepared from core T-1, the thin section prepared to represent the cross-section at the pavement surface in core S-1 does not show pronounced magnesium enrichment, as shown in Figures 21 and 22. Magnesium enrichment is also not evident at the crack at depth, as shown in Figures 24 and 25. However, there is a chlorine enriched zone just above the crack at depth, as shown in Figures 23 and 25.

The thin sections prepared to represent a cross-section of the large crack at depth for both cores T-1 and S-1 exhibited pronounced depletion of calcium hydroxide in the hardened cement paste in a region of about 1 mm on either side of the crack. Petrographic work on these samples will continue to further investigate the alteration of the hardened cement paste within the vicinity of the large crack.

Figure 23: Characteristic $K\alpha$ x-ray maps showing concentrations for calcium, chlorine, and silicon from polished thin section prepared from core S-1 showing cross section through large crack at 4 cm depth. Darker regions correspond to higher x-ray counts.

Figure 24: Characteristic $K\alpha$ x-ray maps showing concentrations for calcium, magnesium, and silicon from polished thin section prepared from core S-1 showing cross section through large crack at 4 cm depth. Darker regions correspond to higher x-ray counts.

Figure 25: RGB composite image of characteristic $K\alpha$ x-ray maps from polished thin section prepared from core S-1 showing cross section through large crack at 4 cm depth. Brighter regions correspond to higher x-ray counts.

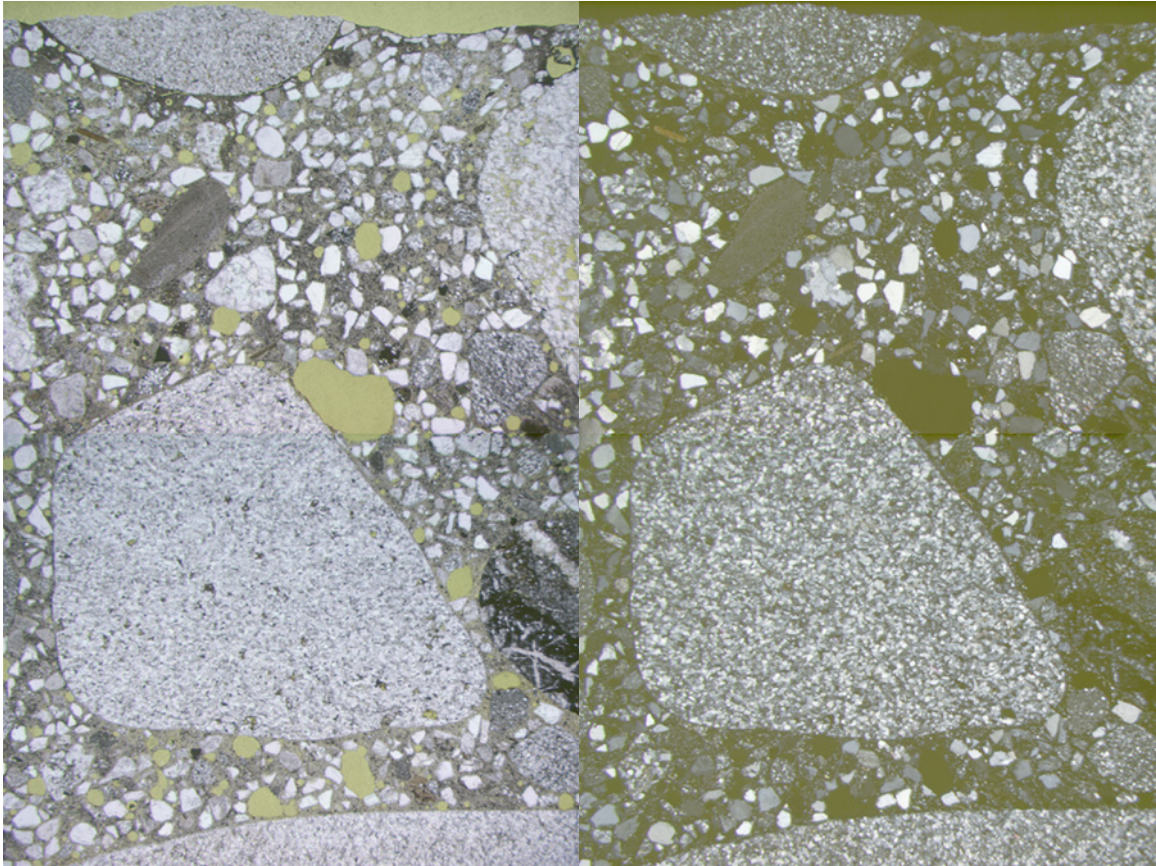
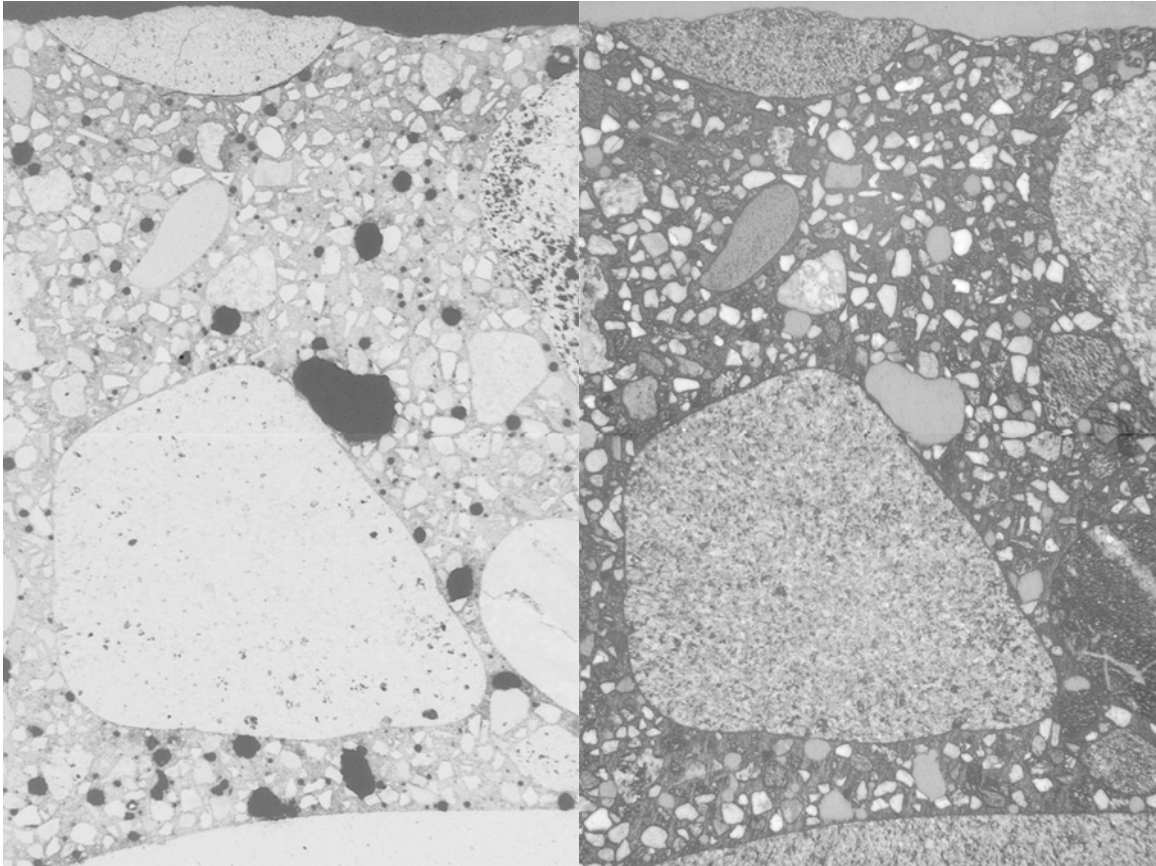
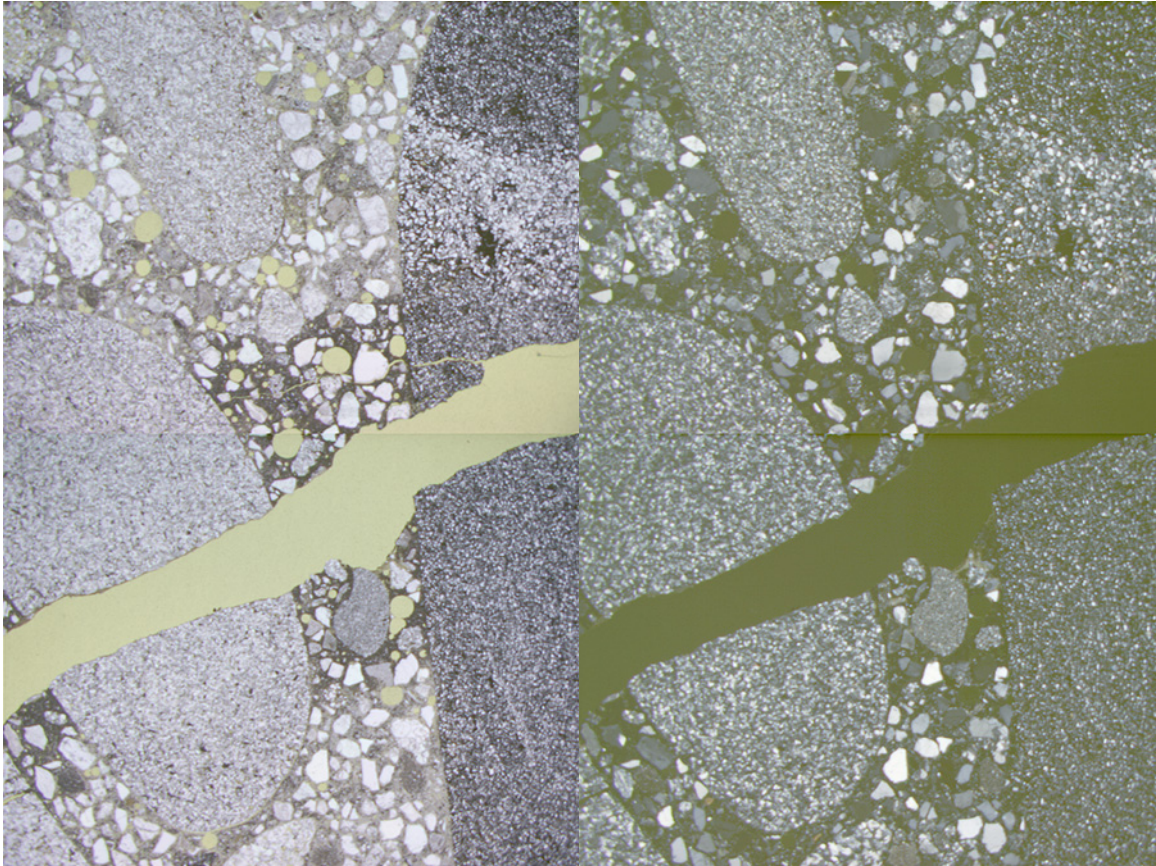
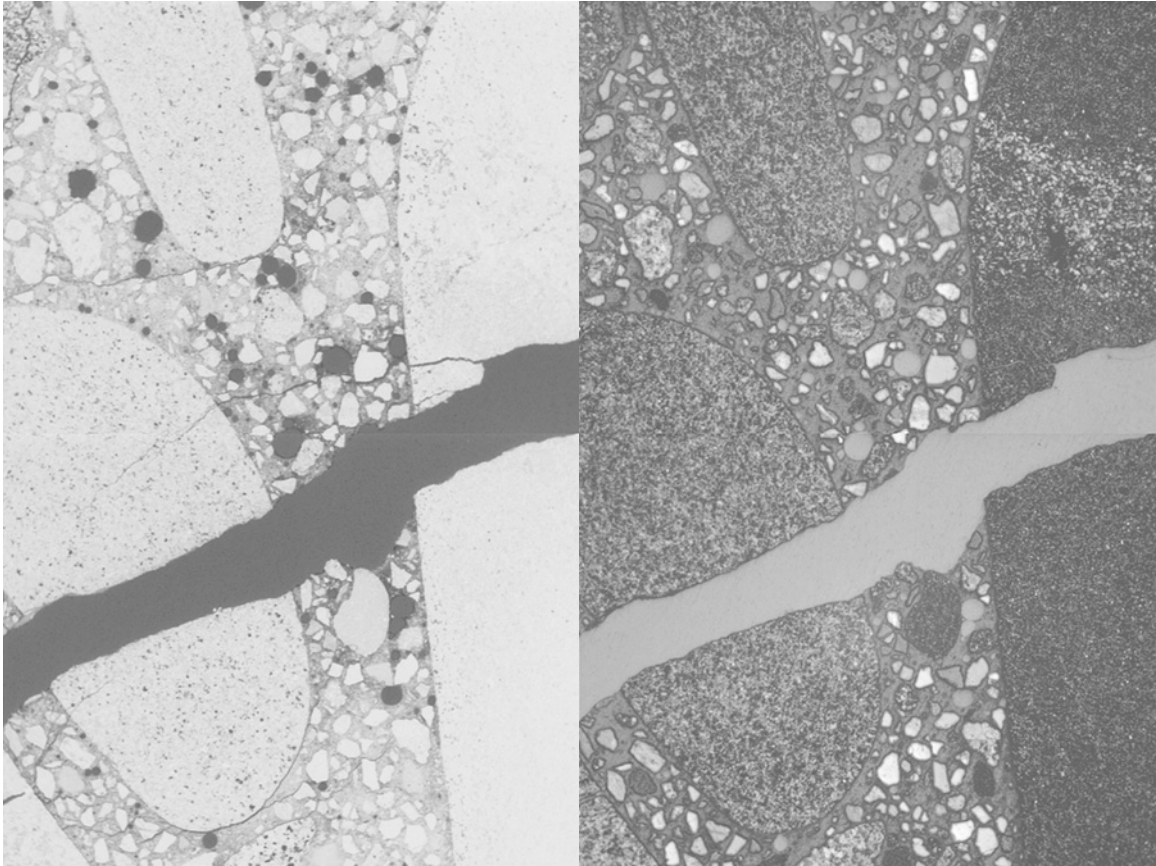
Figures 26a, 26b, 27a, and 27b show petrographic microscope images of the regions mapped on thin sections prepared from core S-1.

Figure 26a: Plane polarized, (left) and cross polarized, (right) images from polished thin section prepared from core S-1 showing cross section through pavement surface.

Figure 26a: Epifluorescent, (left) and reflected light, (right) images from polished thin section prepared from core S-1 showing cross section through pavement surface. The epifluorescent image is inverted, so that porous regions appear darker, and denser regions appear lighter.

Figure 26a: Plane polarized, (left) and cross polarized, (right) images from polished thin section prepared from core S-1 showing cross section through large crack at 4 cm depth.

Figure 26a: Epifluorescent, (left) and reflected light, (right) images from polished thin section prepared from core S-1 showing cross section through large crack at 4 cm depth. The epifluorescent image is inverted, so that porous regions appear darker, and denser regions appear lighter.

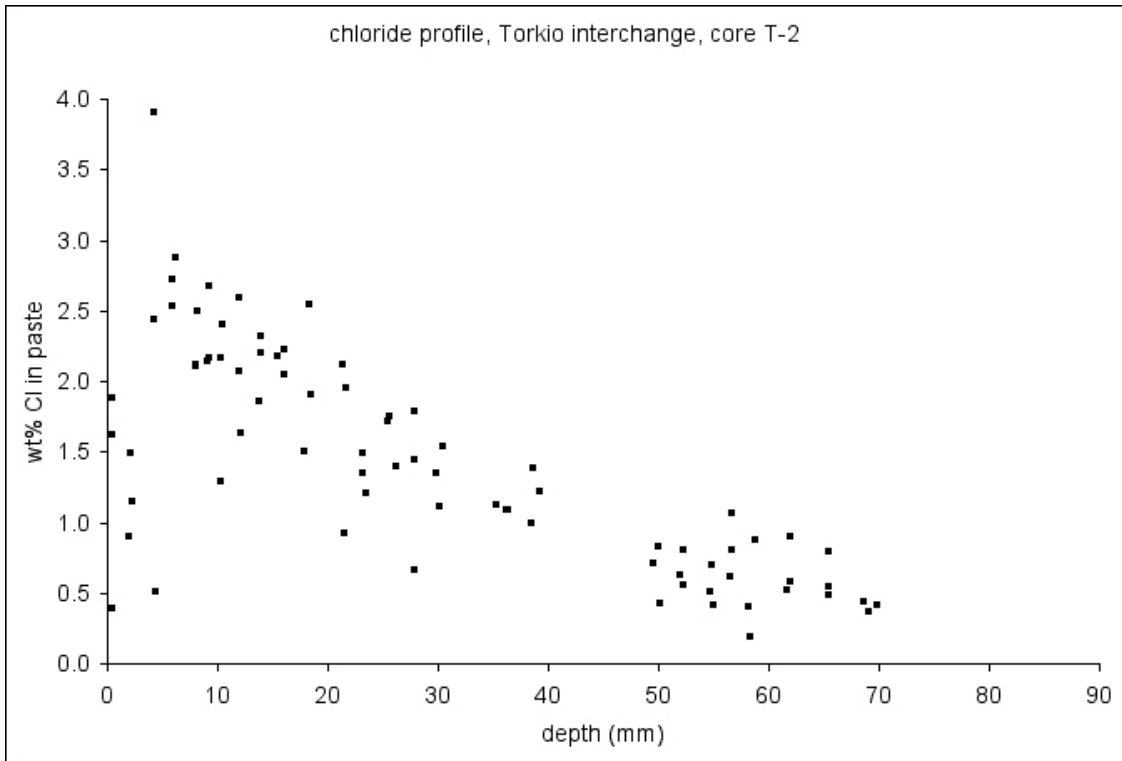
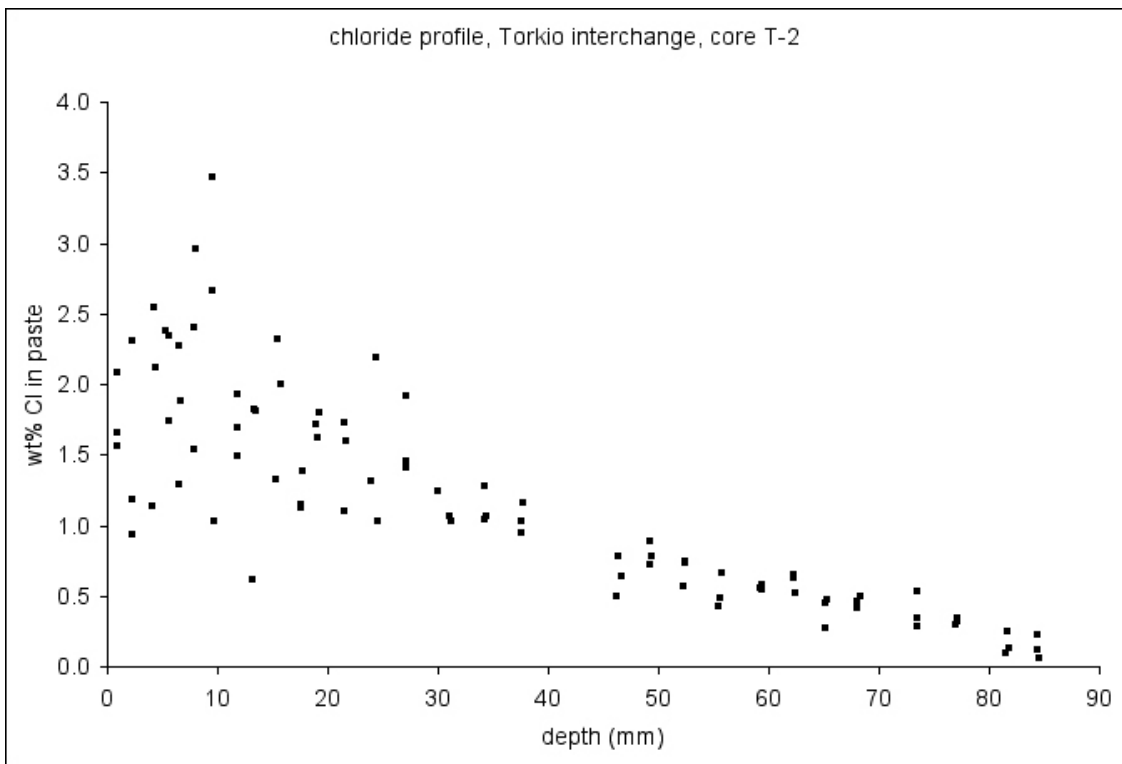
An x-ray microscope was used to collect characteristic Cl K α x-rays from points at varying depths in the cement paste from billets prepared from cores T-2 and S-2. Figures 28 and 29 show profiles obtained from core T-2, whereas Figures 30 and 31 show profiles obtained from core S-2. As shown in Figures 28 and 29, chloride concentrations drop to negligible levels at a depth between 70 and 90 mm for the samples prepared from core S-2. As shown in Figures 30 and 31, chloride concentrations are still in the range of 0.25 to 0.50 percent at depths of 70 to 90 mm for the samples prepared from core T-2. Additional points at depths greater than 90 mm have yet to be collected from samples prepared from core T-2.

Figure 28: First chloride profile from core T-2

Figure 29: Second chloride profile from core T-2.

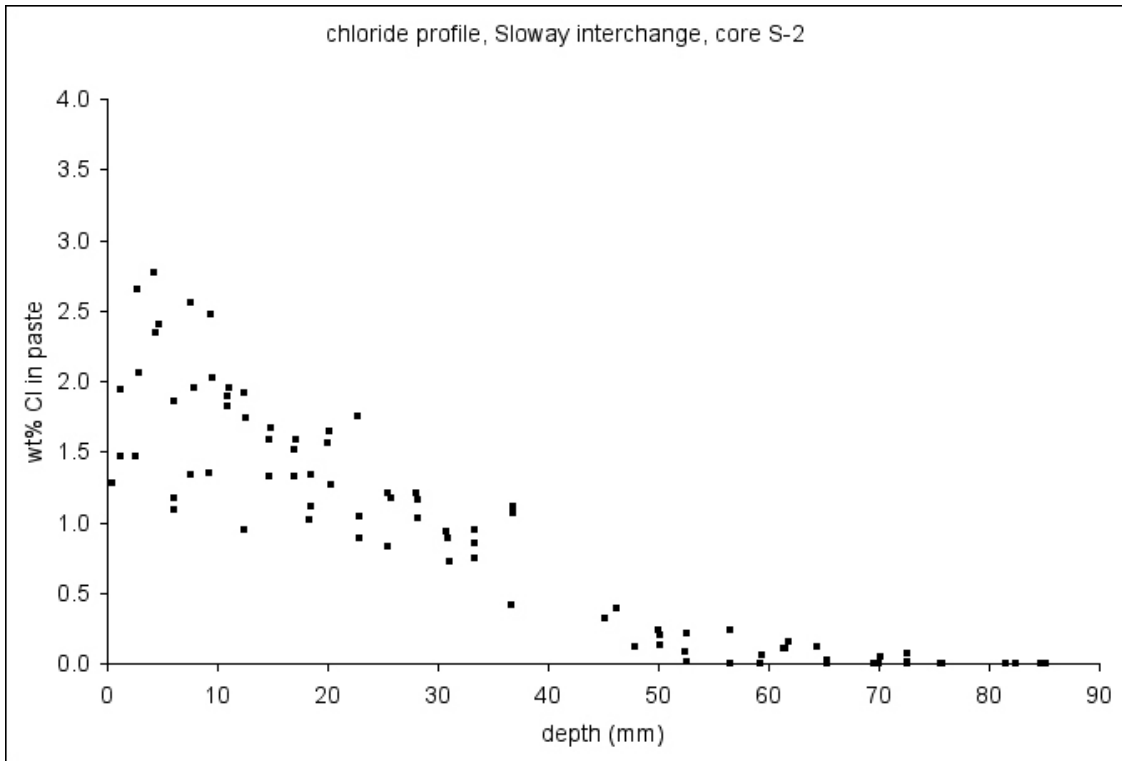
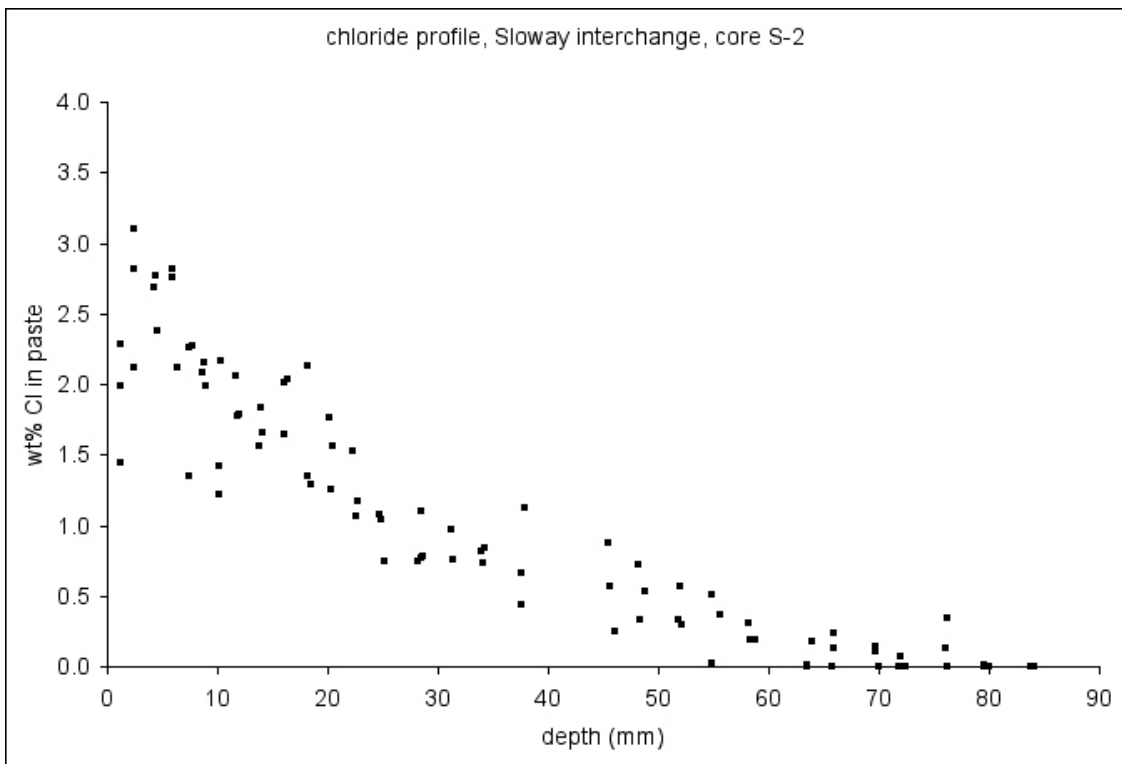
Figure 30: First chloride profile from core S-2.

Figure 29: Second chloride profile from core S-2.

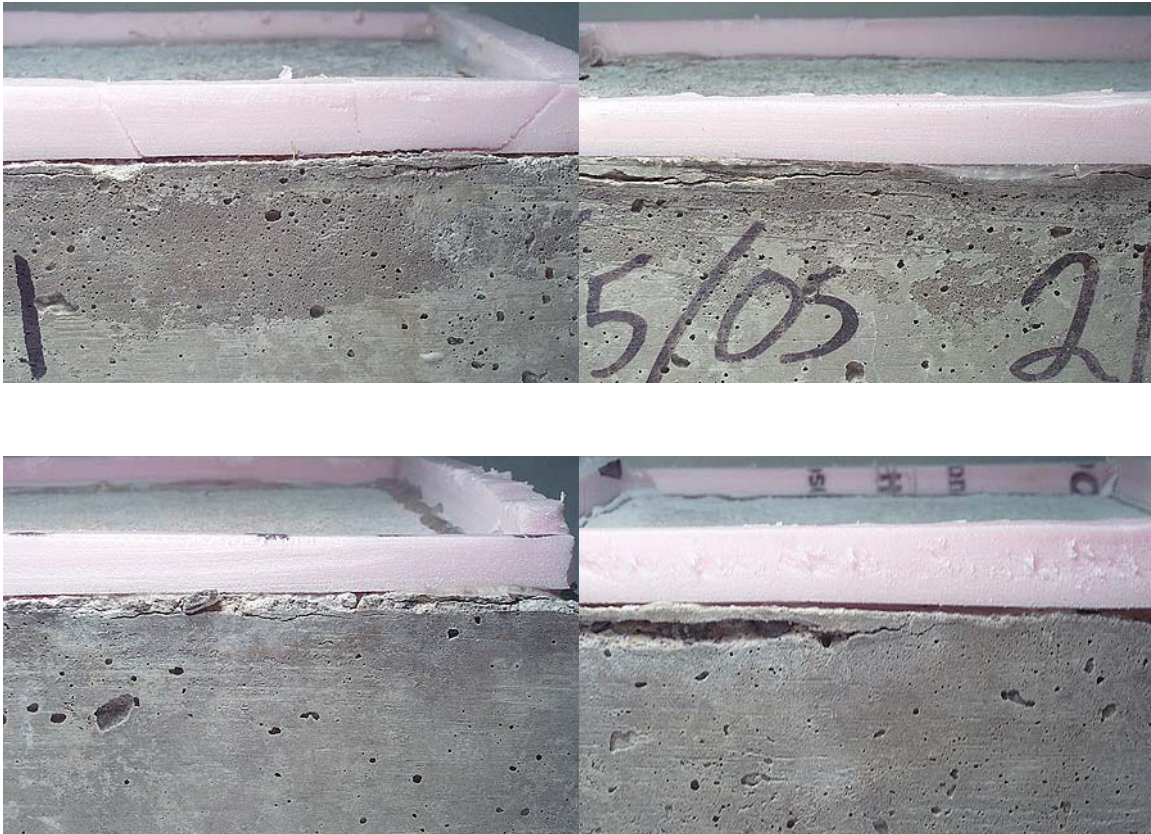
Work on Phase II of the laboratory experiments has continued. However, based upon preliminary results, it has been determined that the current approach being used in Phase II may not lead to useful data for determining the effects of the various deicers on concrete. Current Phase II testing includes performing the scaling test defined by ASTM C 672. This test deviates from the standard ASTM C 672 test by using solution strengths equal to those used in Phase I for all deicing chemicals tested. The high concentration solutions being used result in solutions that don't freeze. Hence, minimum scaling has been observed with the worse being observed for the control samples ponded with lime water. The ASTM C 672 testing was halted at 56 days and samples have been selected for petrographic examination and chloride profiling. Selected samples are presented in Figure 30 above. Besides modest scaling, sub-parallel cracking was observed on the perimeter of the CaCl_2 specimens. This deterioration will be examined petrographically.

Figure 31: Cracks parallel to ponding surface along sides of prisms just below the pink edge dams typical of prisms exposed to CaCl_2 solution, and not observed on prisms exposed to other solutions.
