**CRACK SURVEYS OF LOW-CRACKING
HIGH-PERFORMANCE CONCRETE
BRIDGE DECKS IN KANSAS
2009-2010**

**CONSTRUCTION OF CRACK-FREE BRIDGE DECKS
TRANSPORTATION POOLED-FUND STUDY
PROJECT NO. TPF-5(174)**

**Structural Engineering and Engineering Materials
SL Report 11-3**

**THE UNIVERSITY OF KANSAS CENTER FOR RESEARCH, INC.
LAWRENCE, KANSAS
October 2011**

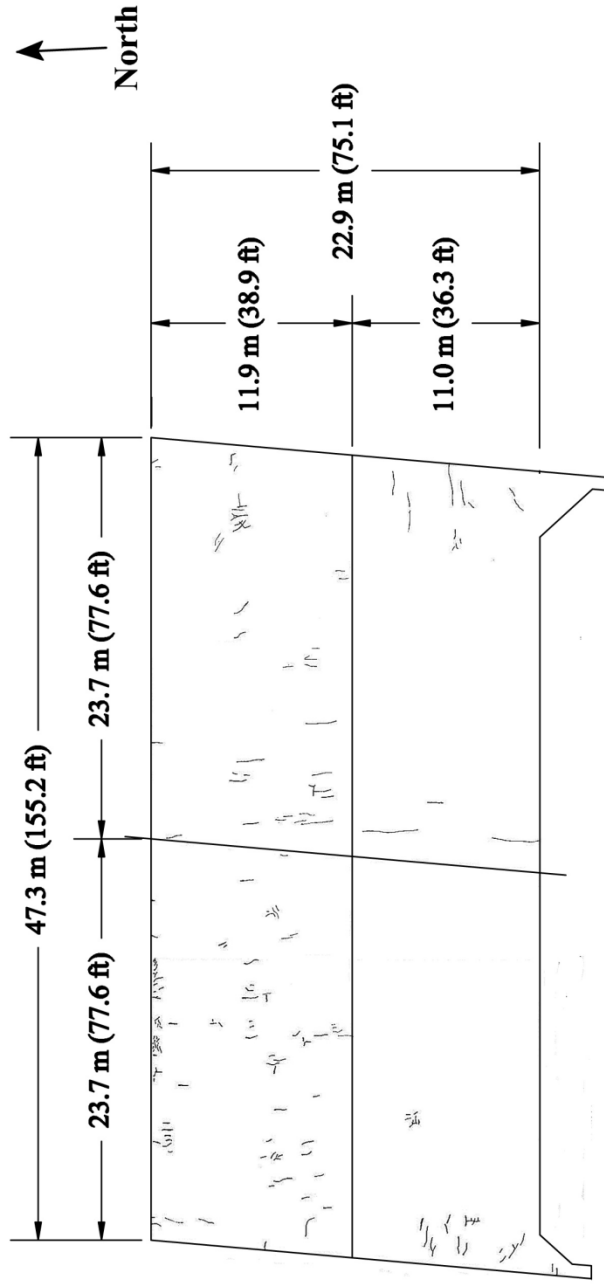
Figure 2: LC-HPC-1 (Survey 4)

LC-HPC-1 was cast in two placements separated by 19 days. Survey 4 at 43.5 and 44.1 months and Survey 5 at 55.0 and 55.6 months are included in this report. For Survey 4 (43.5 and 44.1 months), the total deck crack density was 0.093 m/m^2 , as shown in Figure 2. Approximately twice as much cracking was observed on the second placement (north) as on the first placement (0.125 m/m^2 vs. 0.060 m/m^2). This observation differs from the previous crack survey at approximately 32 months, where the first placement displayed more cracking than the second placement (0.044 m/m^2 vs. 0.024 m/m^2) (Gruman et al. 2009). During Survey 4, significant map cracking was observed throughout the second placement. A few long cracks were found near and parallel to the pier at midspan, the negative moment region of the bridge. The majority of cracks found at 44 months were longitudinal near the abutments, parallel with the length of the bridge; this cracking was most likely due to the restraint provided by the abutments. At ages of 55.0 and 55.6 months (Survey 5), the total deck crack density was significantly lower, at 0.027 m/m^2 . The cracks that were not marked in the 55 month survey were the smaller cracks in Survey 4 and could have been overlooked by the surveyors.

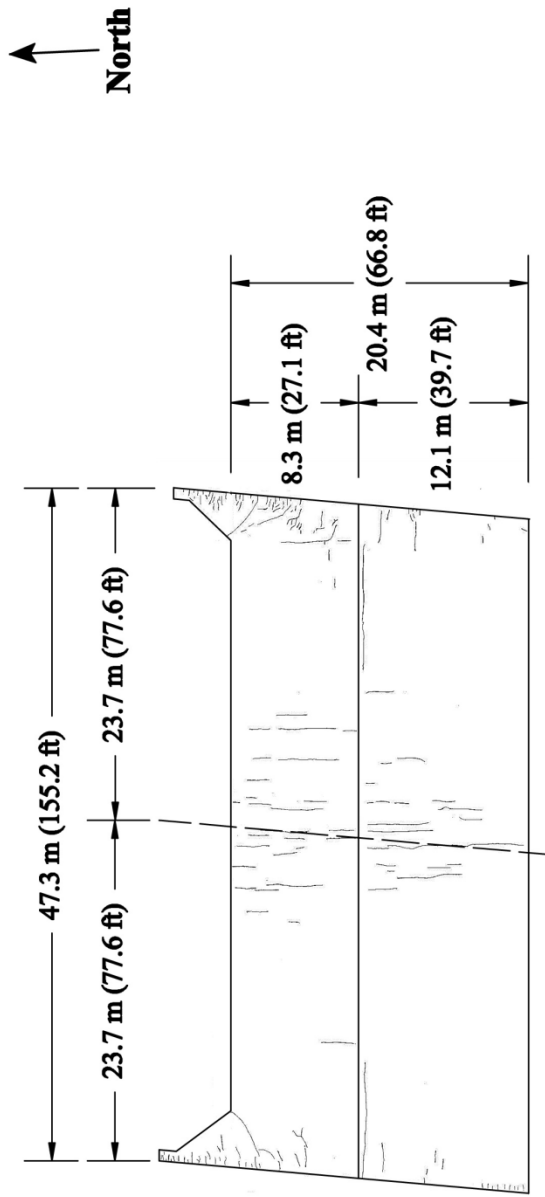
Control-1/2 was also cast in two placements. Survey 4 at 43.6 and 44.2 months and Survey 5 at 55.2 and 55.8 months are included in this report. After 44.2 months (Placement 1) and 43.6 months (Placement 2), this deck exhibited an overall crack density of 0.184 m/m^2 , as shown in Figure 4, nearly double the value from the previous year, of 0.099 m/m^2 , when the two placements were, respectively 32.2 and 31.6 months old (Gruman et al. 2009).

Placement 1 exhibited over twice the crack density of Placement 2 (0.261 m/m^2 vs. 0.133 m/m^2). A majority of the cracks were small, longitudinal cracks near the abutments on Placement 1. As with LC-HPC-1, this cracking is likely due to restraint provided by the abutments. Long cracks were found near and parallel to the pier, similar to LC-HPC-1. At ages of 55.8 and 55.2 months (Figure 5), the total deck crack density of 0.115 m/m^2 is, like that of Survey 5 for LC-HPC 1, lower than the value obtained in Survey 4. The unmarked cracks in the most recent survey were small and could have been overlooked by the surveyors.

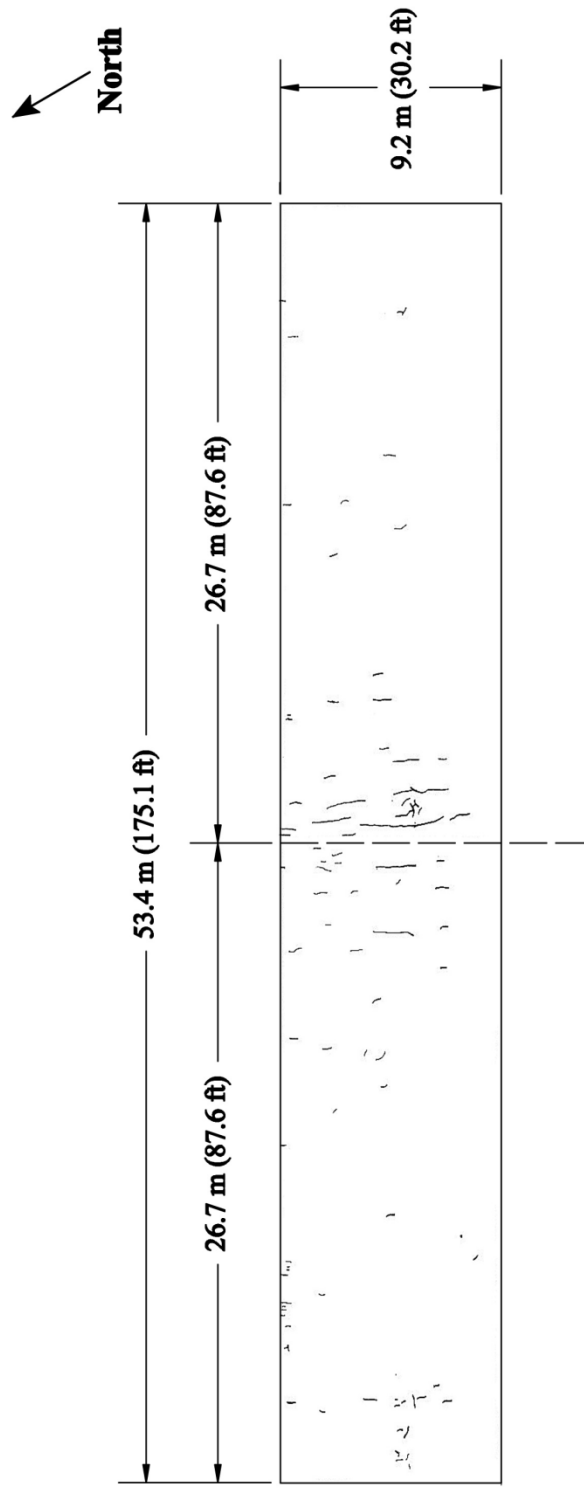
Figure 6: LC-HPC-2 (Survey 3)

Surveys 3 and 4 of LC-HPC-2, at 32.5 and 44.5 months, are included in this report. Surveys 3 and 4 produced crack densities of 0.085 m/m^2 after 32.5 months and 0.059 m/m^2 after 44.5 months, as shown in Figures 6 and 7, respectively. These crack density values are over twice as high as the previous value, 0.028 m/m^2 , at 21.2 months, reported by Gruman et al. (2009). The majority of the cracks are parallel to the pier in the negative moment region. The crack density after 43.6 and 44.2 months for Control-1/2 is more than three times the crack density of LC-HPC-2 at 44.5 months (0.184 m/m^2 vs. 0.059 m/m^2).

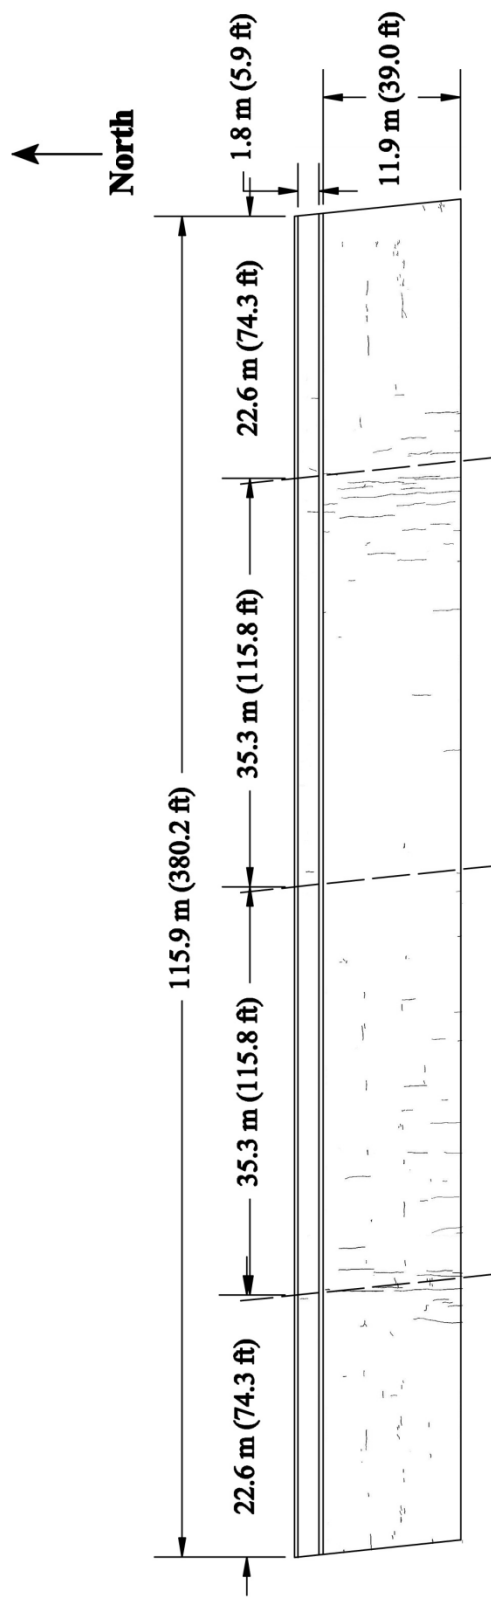
Figure 8: LC-HPC-3 (Survey 2)

Surveys 2 and 3 of LC-HPC-3, at 19.2 and 31.5 months, are included in this report. The crack density of LC-HPC-3 at 19.2 months was 0.110 m/m^2 , as shown in Figure 8. At 31.5 months, the crack density remained constant at 0.108 m/m^2 , shown in Figure 9. These values represent significant increases from the crack density at 6.5 months, 0.028 m/m^2 (Gruman et al. 2009). The majority of the cracks at both 19.2 months and 31.5 months occur near and parallel to the first and third piers, as shown in Figures 8 and 9. No significant cracking has occurred near the second (middle) pier.

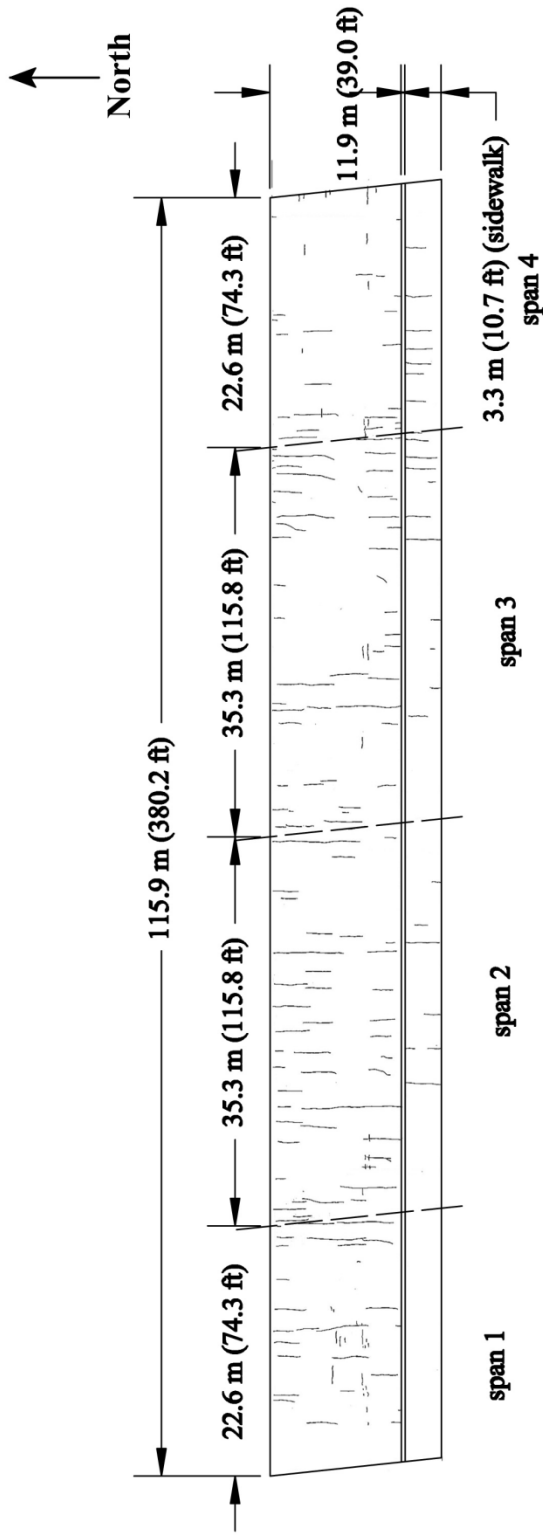
Figure 10: Control-3 (Survey 2)

Surveys 2 and 3 of Control-3, at 22.6 and 35.4 months, are included in this report. The crack density of Control-3 at 22.6 months was 0.216 m/m^2 , as shown in Figure 10, nearly double the crack density of LC-HPC-3 at 19.2 months and significantly greater than the value of 0.037 m/m^2 at 10.4 months (Gruman et al. 2009). The crack density at 35.4 months for Control-3 has increased again to 0.232 m/m^2 , as shown in Figure 11, more than double the crack density of LC-HPC-3 at 31.5 months. The cracks in Control-3 are primarily transverse and spread across the full length of the bridge. They appear to be directly above the top reinforcing steel. This transverse cracking is most likely due to settlement and shrinkage at the reinforcing steel. This is unlike the cracking observations from LC-HPC-3, where the majority of cracks have occurred near to the piers.

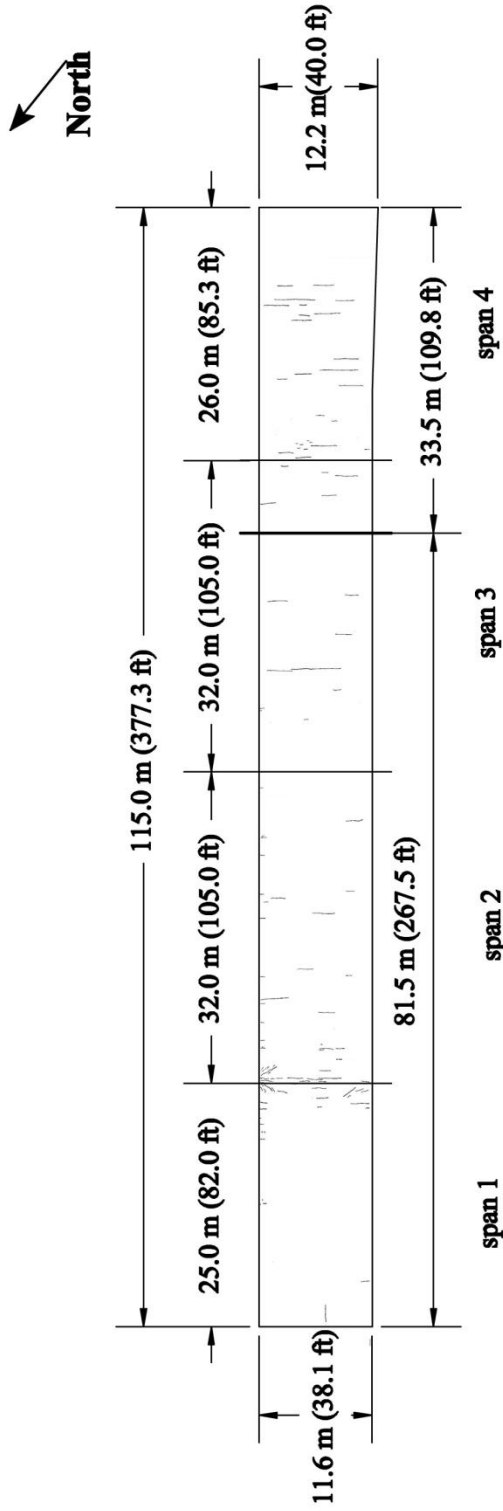
Figure 12: LC-HPC-4 (Survey 2)

LC-HPC-4 was cast in two placements, separated by a cold joint. Survey 2 at 21.2 and 21.3 months and Survey 3 at 32.7 and 32.8 months are included in this report. At ages of 21.3 months for Placement 1 and 21.2 months for Placement 2, the overall crack density was 0.090 m/m^2 , as shown in Figure 12; Placement 1 had a higher crack density than Placement 2 (0.113 m/m^2 vs. 0.079 m/m^2). The crack density at ages of 9.4 and 9.5 months for Placements 1 and 2, respectively, was considerably lower, at 0.008 m/m^2 (Gruman et al. 2009). At ages of 32.8 months for Placement 1 and 32.7 months for Placement 2, the overall crack density increased to 0.146 m/m^2 , as shown in Figure 13, with the crack density of Placement 1 again significantly higher than that of Placement 2 (0.261 m/m^2 vs. 0.094 m/m^2). Notably more cracking occurred in Placement 1 than Placement 2 between 21 months and 32 months. In Placement 1, small, transverse cracks developed near the easternmost pier. Transverse cracks developed near

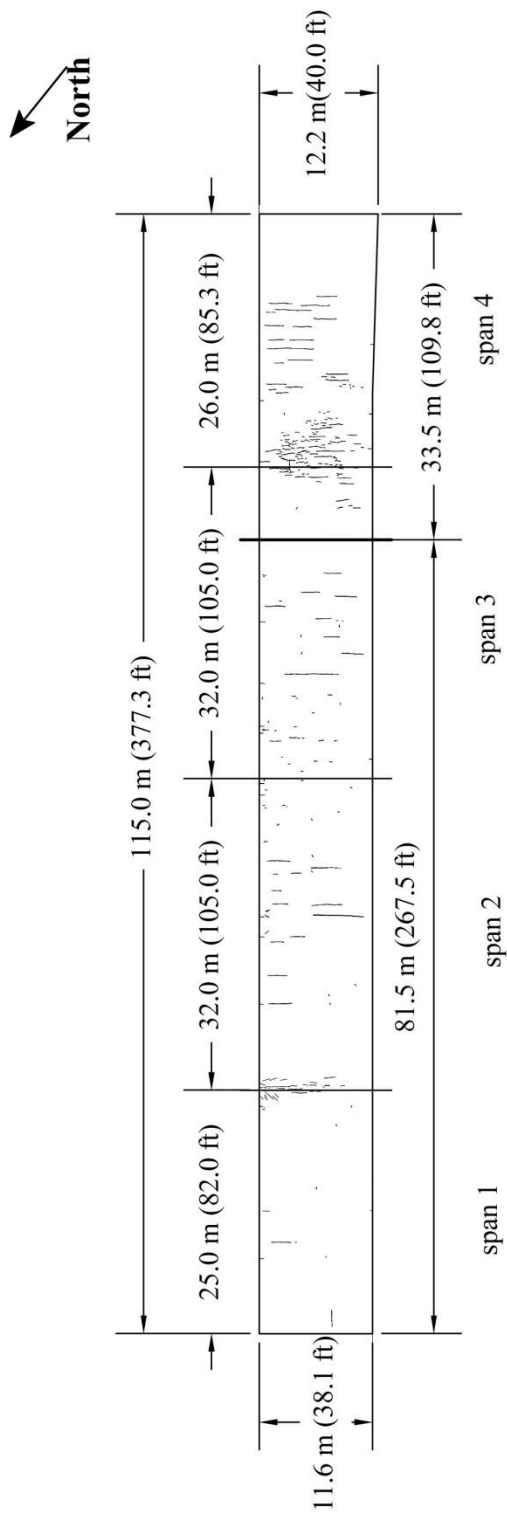
midspan in Placement 1. In Placement 2, a number of small cracks developed near the westernmost pier, with several longer transverse cracks developing randomly throughout the rest of Placement 2.

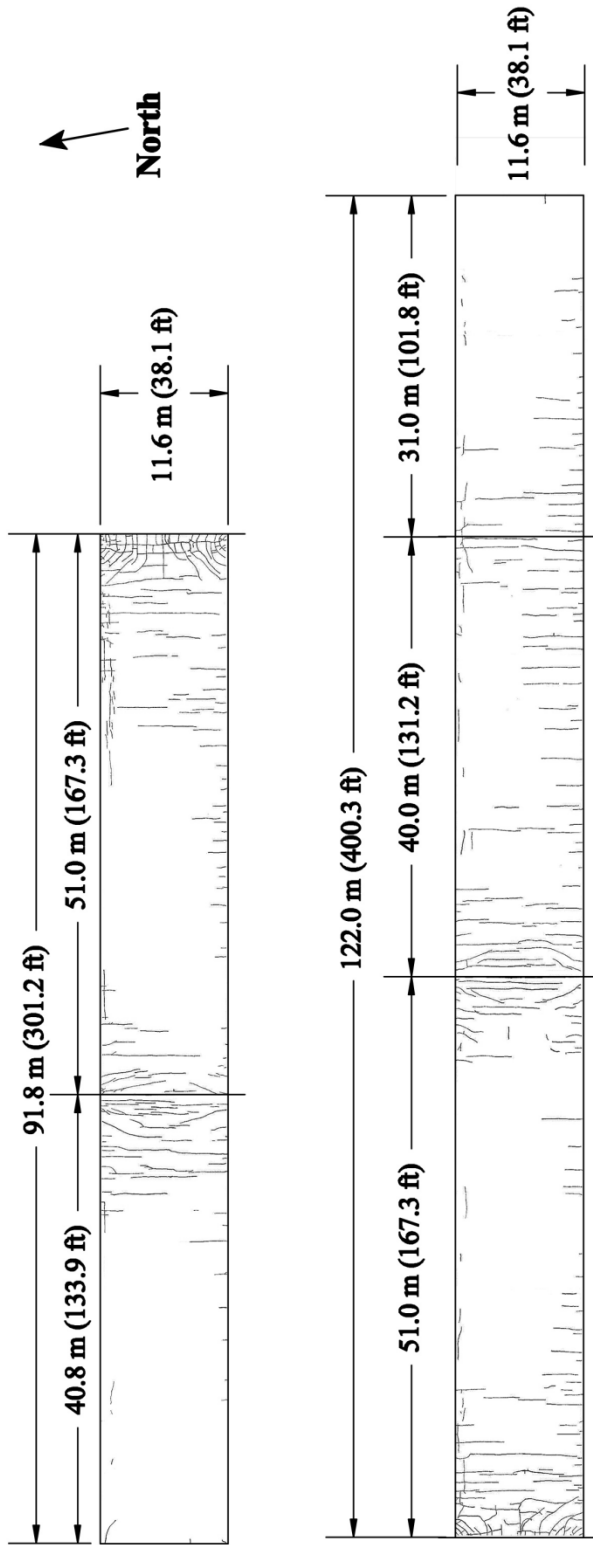
Surveys 2 and 3 of Control-4, at 19.7 and 31.6 months, are included in this report. The crack density for Control-4 at 19.7 months was high, at 0.366 m/m^2 , as shown in Figure 14, a value that was much higher than the value of 0.050 m/m^2 at 6.8 months (Gruman et al. 2009). The crack density at 31.6 months increased to 0.473 m/m^2 , as shown in Figure 15, which is over three times the crack density at 32.7 and 32.8 months for LC-HPC-4. For Control-4, significant cracking occurred near and parallel to each pier. In addition, significant cracking has occurred at both abutments, propagating concentrically from each corner of the deck. Most cracks are oriented transversely to the bridge, directly above the reinforcing steel. A number of cracks are also oriented longitudinally along the edges of the deck.

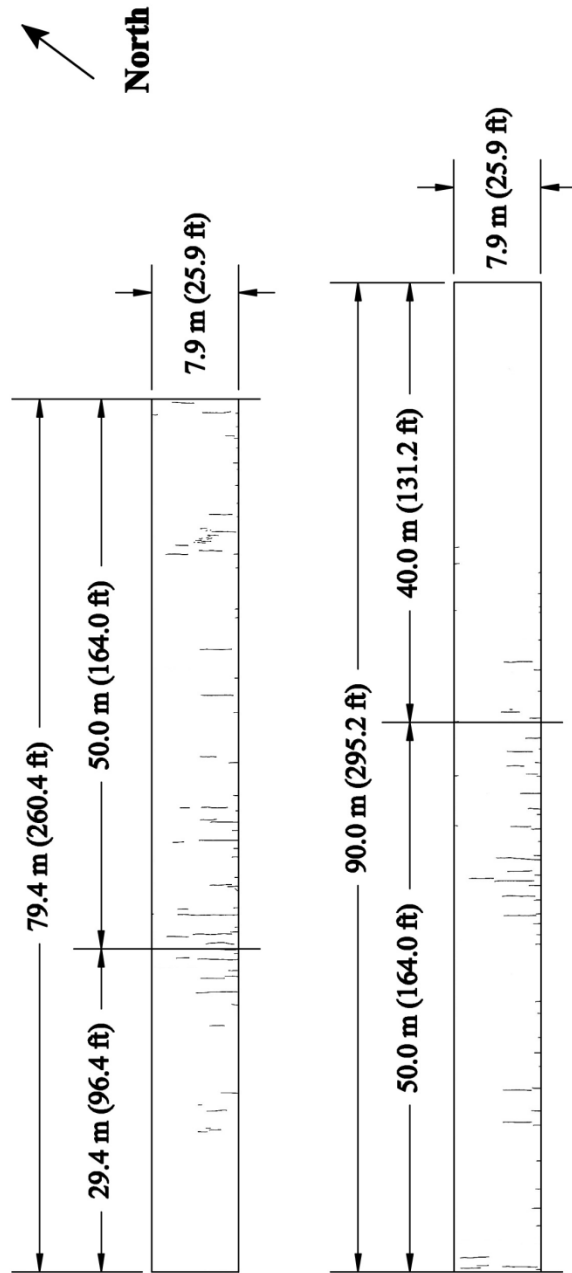
Surveys 2 and 3 of LC-HPC-5, at 19.4 and 31.1 months, are included in this report. The crack density for LC-HPC-5 at 19.4 months was higher than most other LC-HPC decks at 0.123 m/m^2 (Figure 16). The previous survey had yielded a crack density of 0.059 m/m^2 at 8.0 months (Gruman et al. 2009). The crack density at 31.1 months increased slightly to 0.128 m/m^2 . Nearly all cracks propagated transversely from the south side of the bridge, as shown in Figure 17. This is most likely due to the superelevation of the bridge deck, as the south side of the deck was constructed at a higher elevation than the north side. In addition, the south side of the deck likely dried out during curing because the curing water flowed to the north side, which

had a lower elevation. Settlement could have also played a role in the increased cracking of the south side of the deck due to concrete settling towards the lower side of the deck.

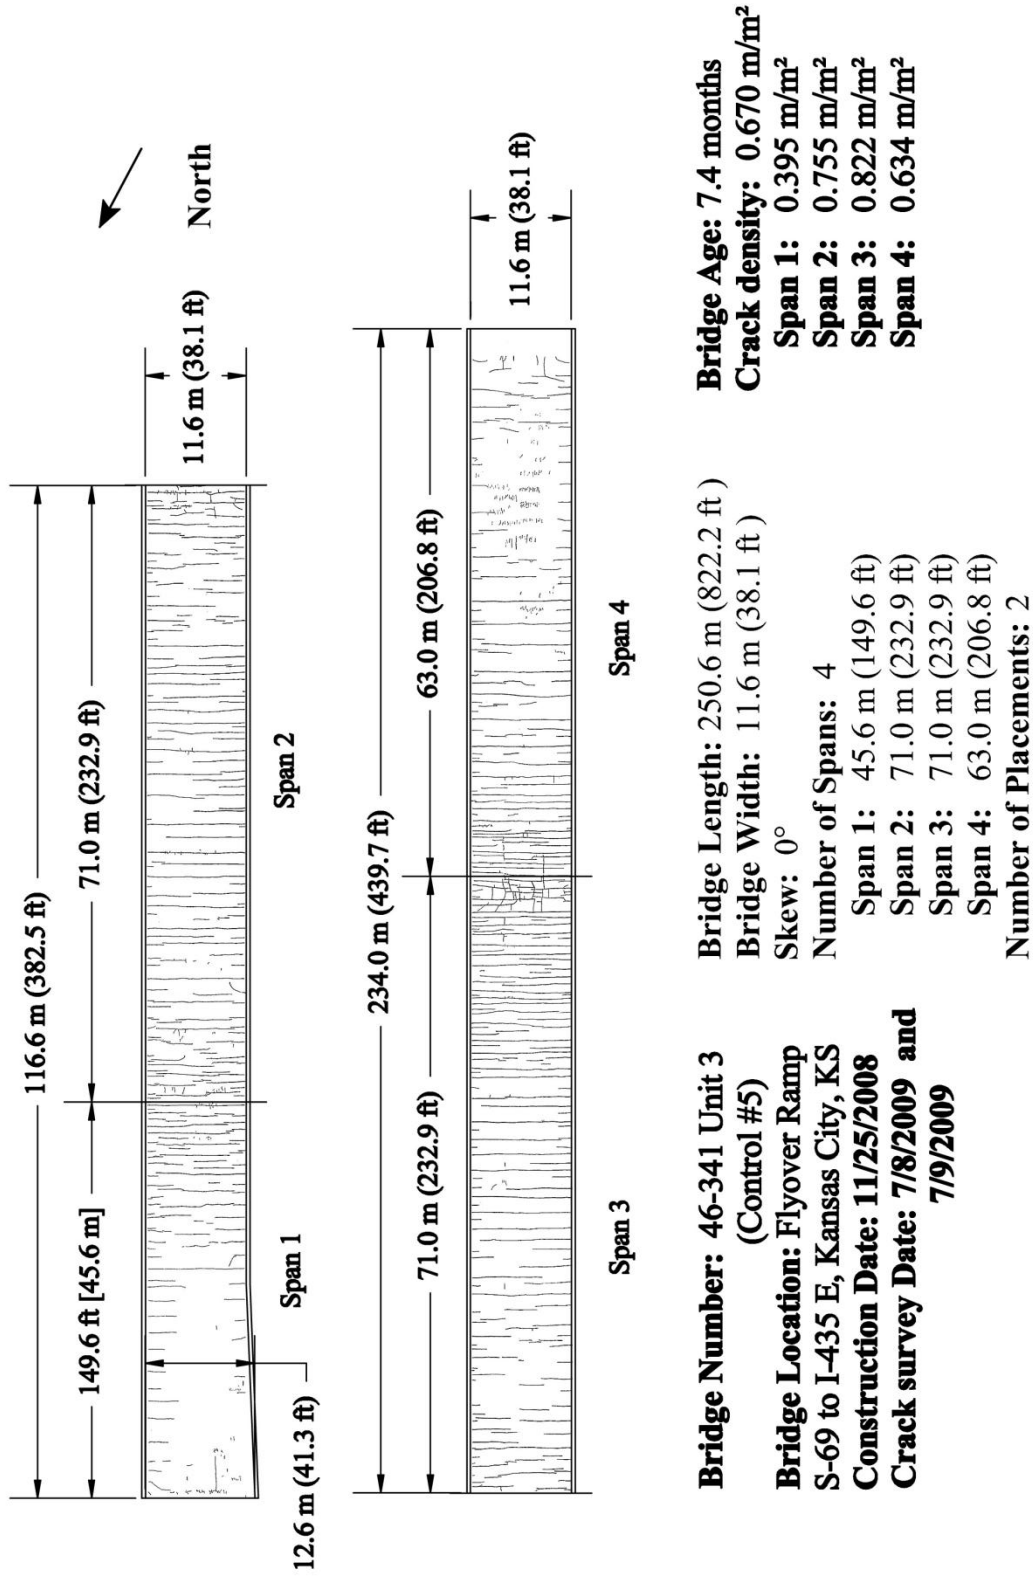
Figure 18: Control-5 (Survey 1)

Surveys 1 and 2 of Control-5, at 7.4 and 18.9 months, are included in this report. Control-5 has one of the highest crack densities of all surveyed bridge decks. At 7.4 months, the crack density for Control-5 was 0.670 m/m^2 , as shown in Figure 18. After 18.9 months, the crack density was 0.857 m/m^2 , as shown in Figure 19. This crack density at 18.9 months is nearly seven times the crack density of LC-HPC-5 at 19.4 months. Cracks have formed parallel and directly above the reinforcing steel, every one to three feet, along the entire width of the deck for the majority of the bridge length, increasing in number near each pier. Fewer cracks have formed near the midspan of Span 1 and small, longitudinal cracks have developed at each abutment.

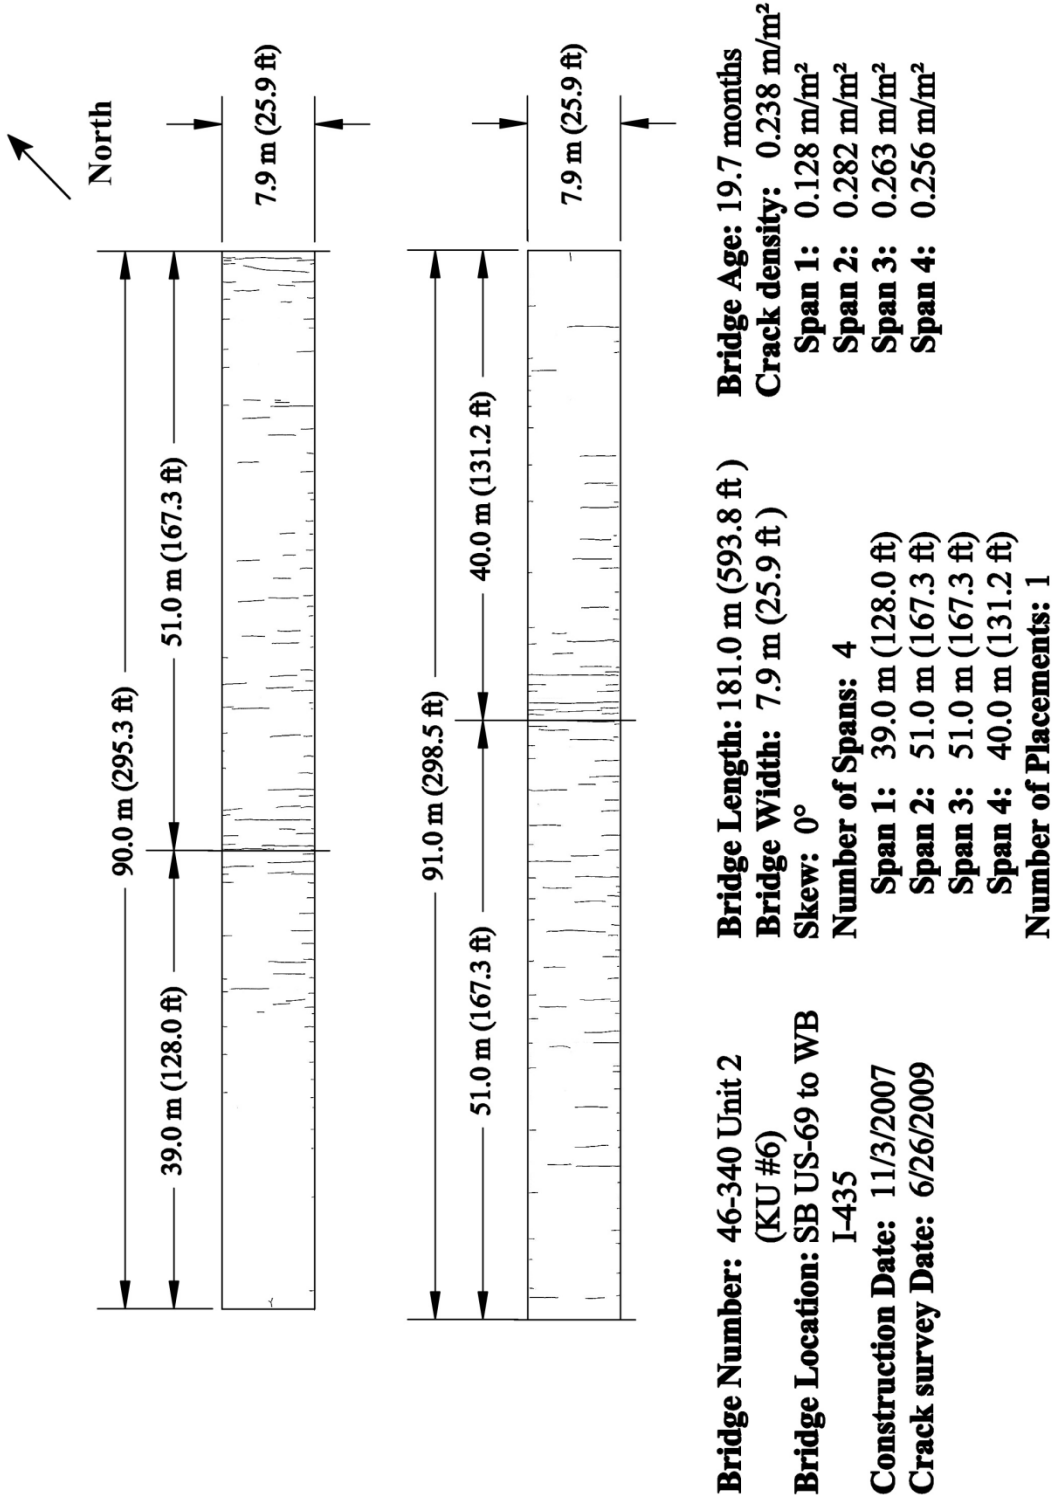
Figure 20: LC-HPC-6 (Survey 2)

Surveys 2 and 3 of LC-HPC-6, at 19.7 and 31.4 months, are included in this report. The crack density for LC-HPC-6 at 19.7 months was 0.238 m/m^2 , as shown in Figure 20. This is a high crack density for a LC-HPC deck, nearly twice as high as LC-HPC-5, at 19.4 months of age. The previous crack survey at 6.5 months yielded a crack density of 0.063 m/m^2 (Gruman et al. 2009). The crack density at 31.4 months has remained nearly constant, at 0.231 m/m^2 (Figure 21). As with LC-HPC-5, the majority of the cracks have propagated transversely above the reinforcing steel from the southeastern edge of the deck where the deck is superelevated.

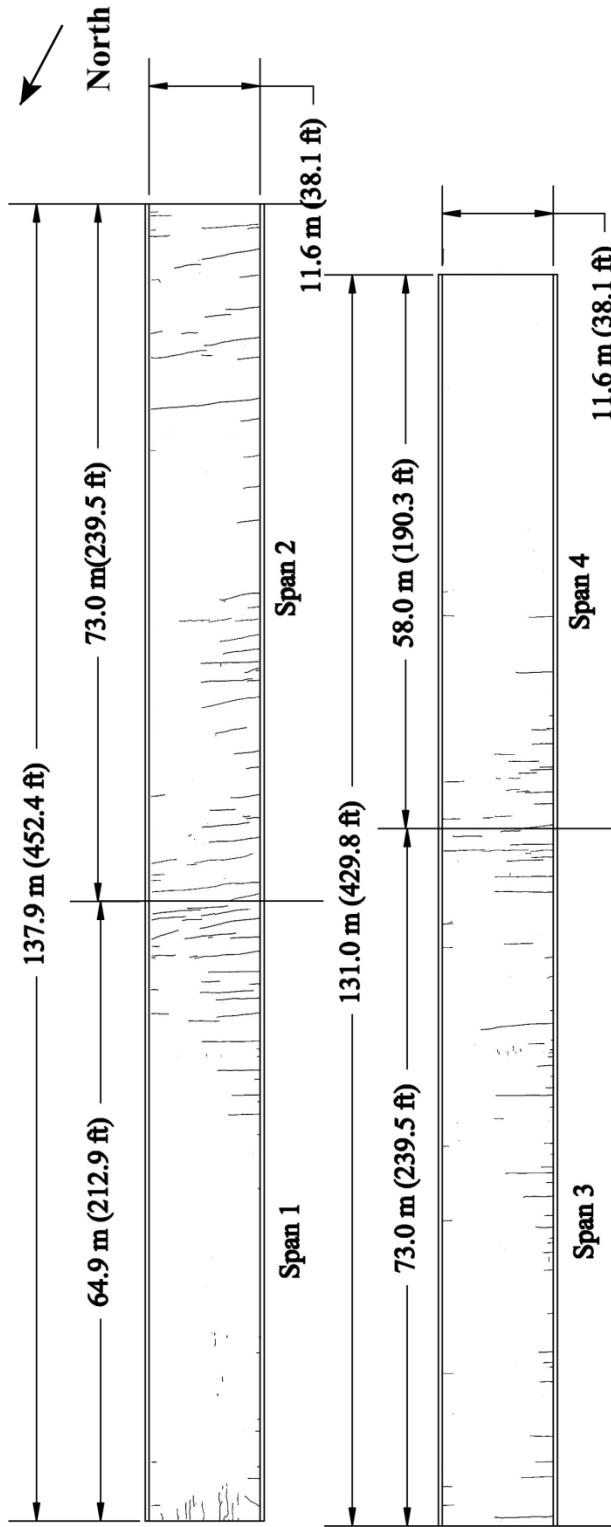
Surveys 1 and 2 of Control-6, at 8.6 and 20.0 months, are included in this report. At 8.6 months, the crack density for Control-6 was 0.142 m/m^2 , as shown in Figure 22. The crack

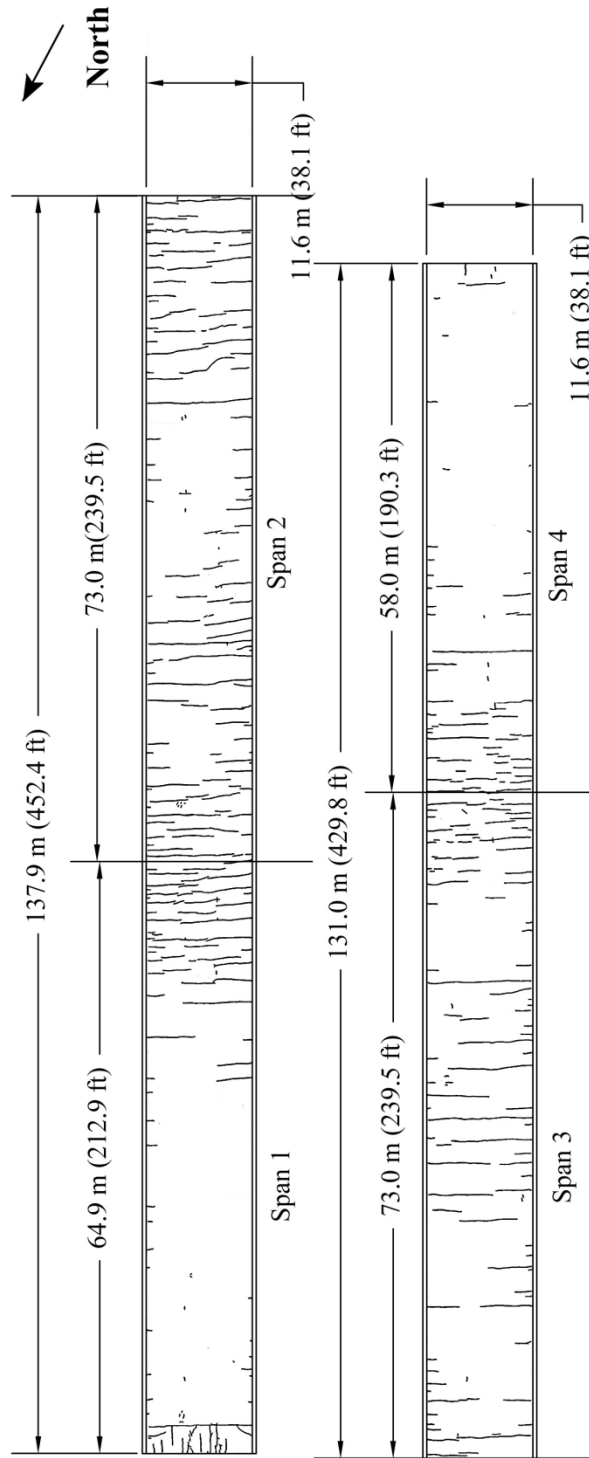
density at 20.0 months was 0.282 m/m^2 (Figure 23). This crack density at 20.0 months is higher than the crack density of LC-HPC-6 at 19.7 months. The majority of the cracks have propagated transversely from the western edge of the bridge deck, most likely due to the superelevation. By the time of the survey at 20.0 months, many of the cracks had propagated from the western edge across the entire deck width directly above and parallel to the reinforcing steel. A significant amount of cracking has developed near and parallel to each pier. Longitudinal cracks are evident at the northern abutment.

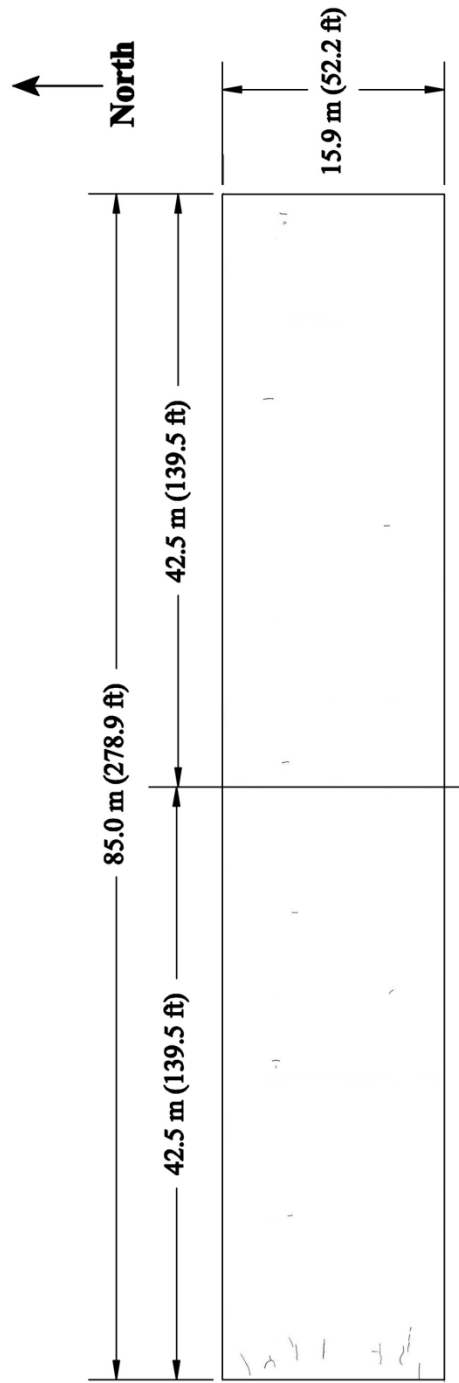
Surveys 3 and 4 of LC-HPC-7, at 34.8 and 46.8 months, are included in this report. The bridge deck with the lowest crack density of all those surveyed is LC-HPC-7. At 34.8 months, the crack density was 0.012 m/m^2 , as shown in Figure 24. Small longitudinal cracks were found at the west end near the abutment. In the previous survey at 24.2 months, the crack density was higher at 0.019 m/m^2 (Gruman et al. 2009). The survey at 46.8 months yielded a crack density of 0.005 m/m^2 (Figure 25). The differences in these three crack densities are not significant enough to state that the bridge deck has decreased cracking with time. The cracks that were not marked in the most recent surveys were small and could have been overlooked by the surveyors. The surveys at 34.8 months and 46.8 months were both completed on May 18 of their respective years, while the survey at 24.2 months was completed on July 1. The higher temperatures in July could have expanded the steel girders and widened the deck cracks. This point will be evaluated further as the study continues.

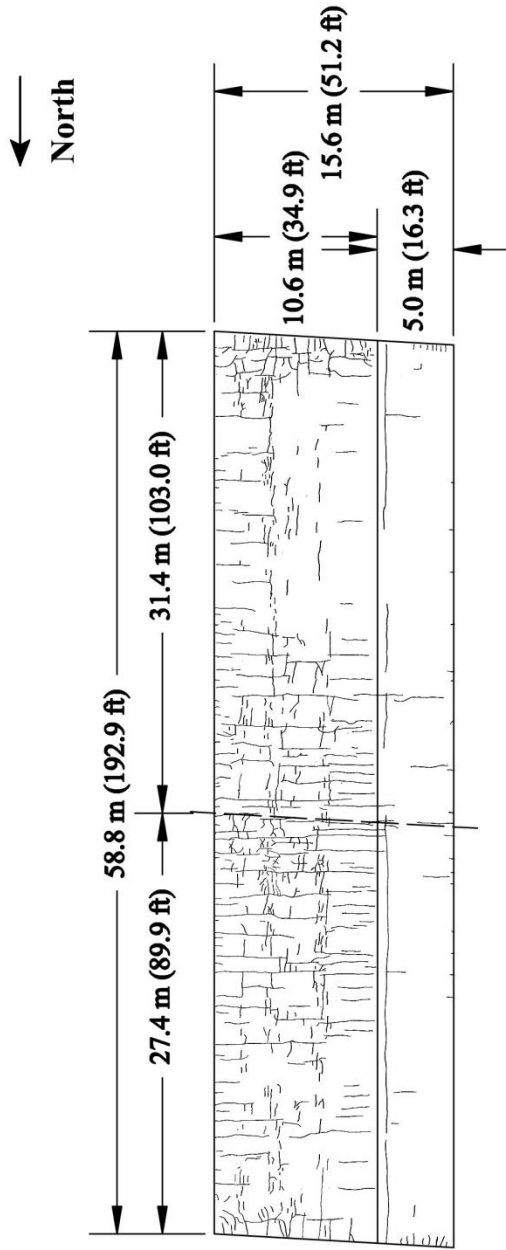
first (east) placement had a crack density of 1.003 m/m^2 at 38.2 months, as shown in Figure 26. Transverse cracks were found throughout the placement, but were somewhat more extensive near the pier. Smaller longitudinal cracks developed at both abutments. The second (west) placement had a crack density of 0.277 m/m^2 at 32.6 months. One long, continuous crack extends nearly the entire length of the deck near and parallel to the joint between the two placements. The overall crack density for this survey is 0.772 m/m^2 . The previous crack survey yielded crack densities of 0.476 m/m^2 for Placement 1 at 27.1 months and 0.069 m/m^2 for Placement 2 at 21.5 months (Gruman et al. 2009). The crack density of Placement 1 more than doubled between 27.1 months and 38.2 months, and the crack density of Placement 2 was four times greater at 32.6 months than at 21.5 months. At 51.1 and 45.5 months for Placements 1 and 2, respectively, the crack densities for each placement are 1.037 m/m^2 and 0.359 m/m^2 , respectively, as shown in Figure 27.

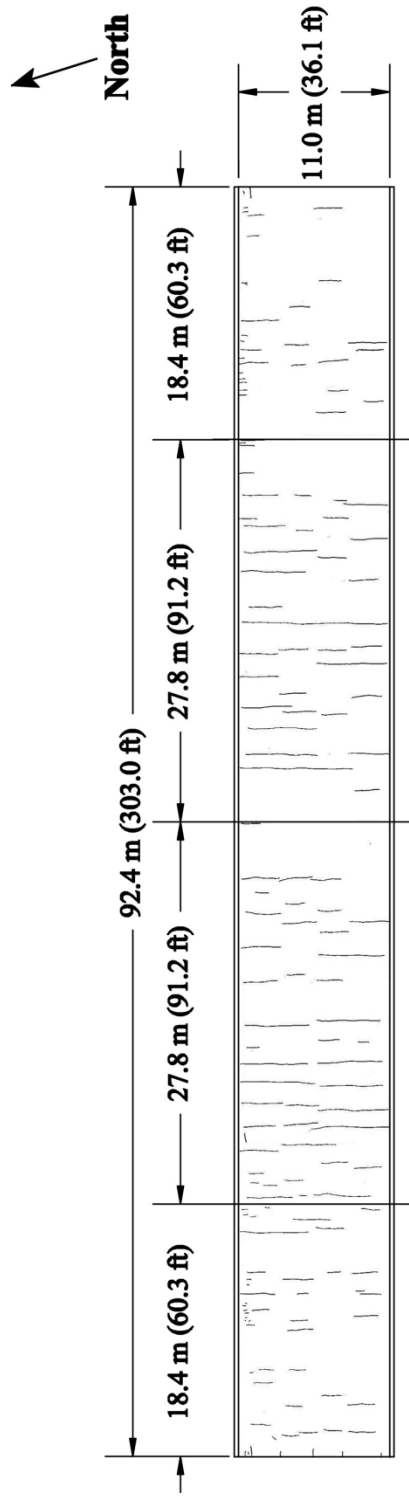
Surveys 1 and 2 of LC-HPC-8, at 20.9 and 31.8 months, are included in this report. LC-HPC-8 is one of two LC-HPC bridges with precast, prestressed concrete girders. The crack density for LC-HPC-8 at 20.9 months was 0.298 m/m^2 , as shown in Figure 28, increasing to 0.348 m/m^2 at 31.8 months, as shown in Figure 29. The majority of the cracks consist of long, transverse cracks that nearly extend across the entire width of the deck parallel with the top reinforcement, likely due to shrinkage and settlement. The cracks are evenly spaced along the entire length of the deck. No increase in cracking is observed near the piers. A small decrease in cracking is observed near the center pier, perhaps due to a combination of increased girder shrinkage and camber. A few small longitudinal cracks are observed propagating from each abutment.
