**Investigation of the Long Term Effects of Magnesium Chloride and  
Other Concentrated Salt Solutions on  
Pavement and Structural Portland Cement Concrete**

Project Number: SD2002-01

**Quarterly Report**

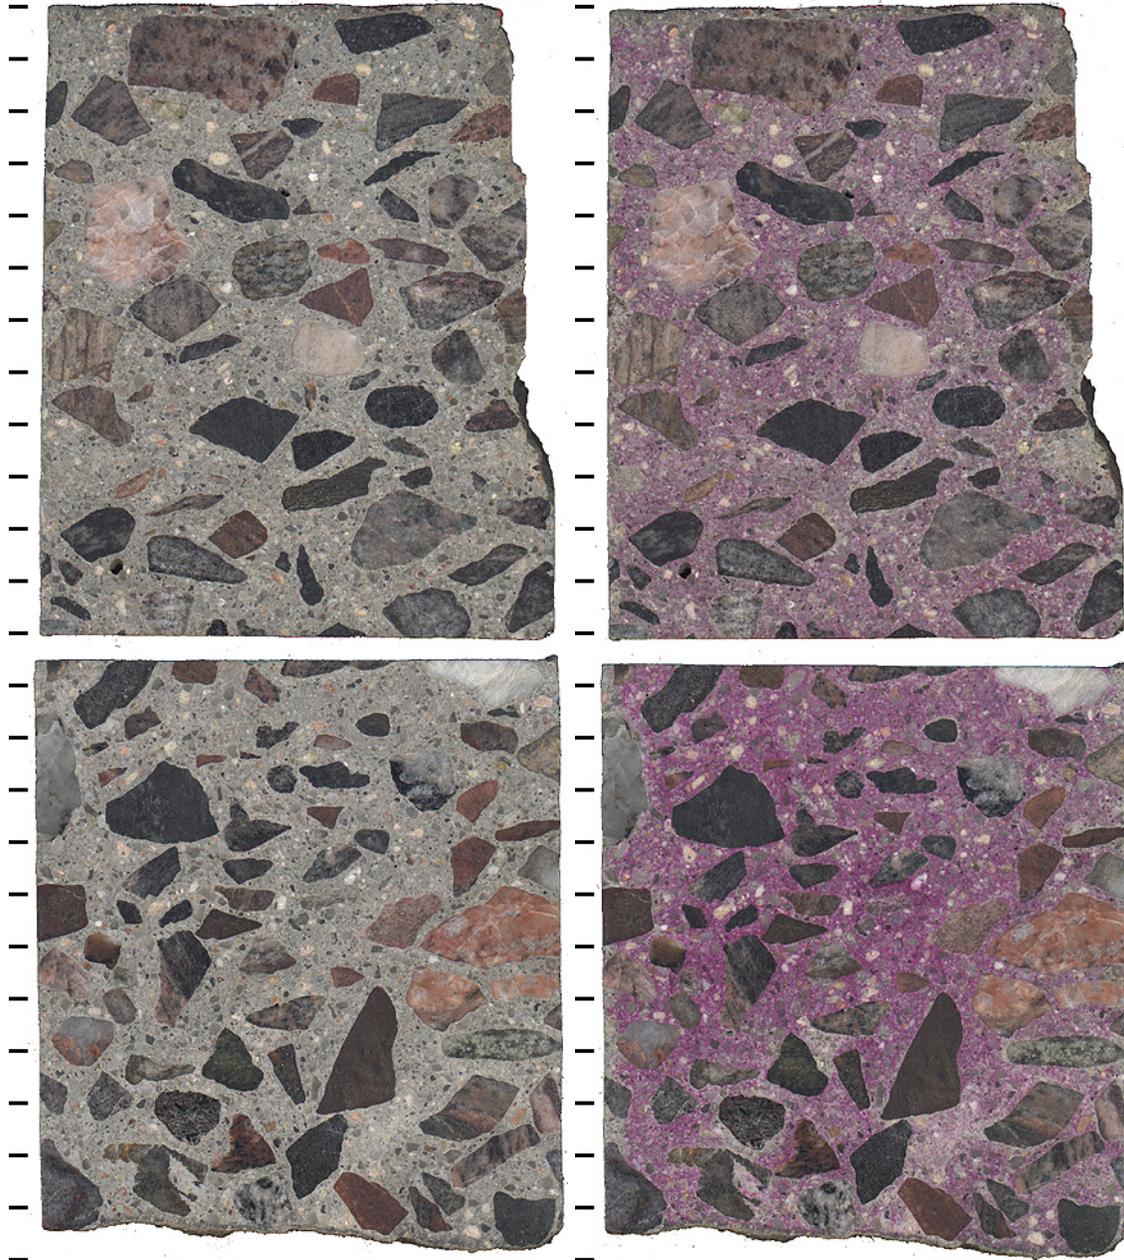
Figure CO-5: Polished slabs to show complete cross-section through core CO-1 both before (left) and after application of phenolphthalein stain (right) tic marks every cm.

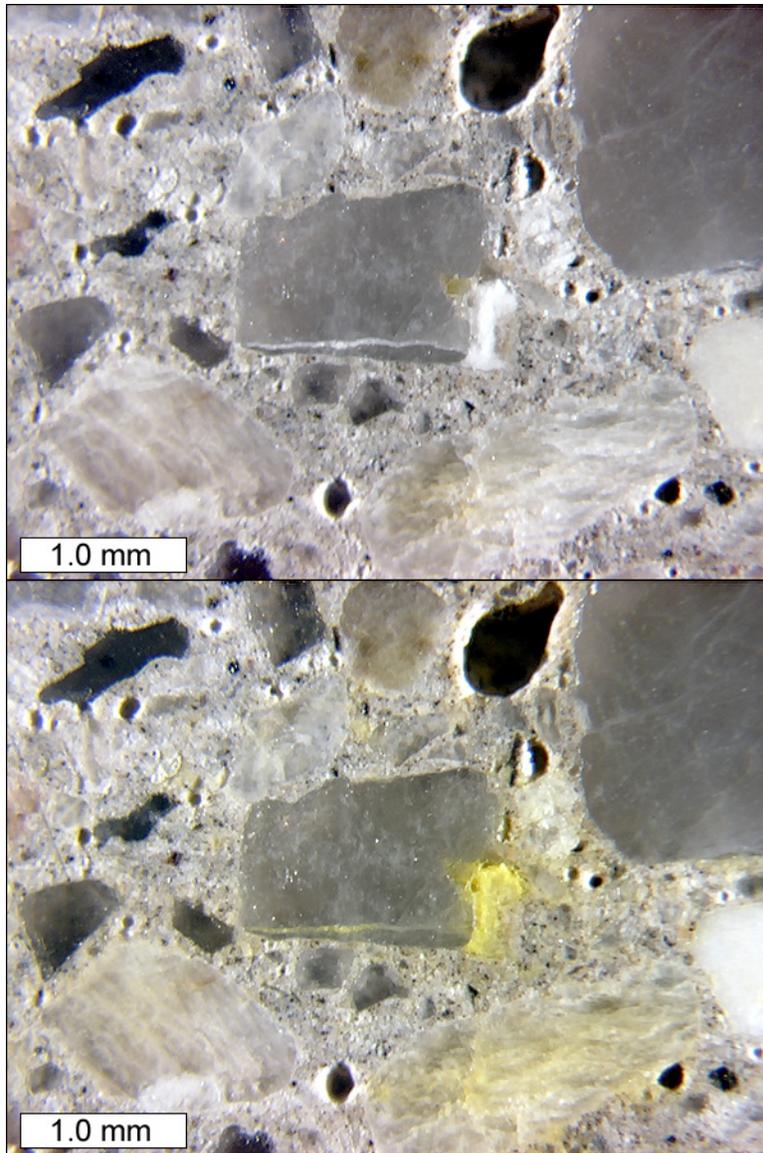
Figure CO-10: Stereo microscope images to show reactive aggregate particle both before (top) and after (bottom) treatment with sodium cobaltinitrite stain (sample CO-5).

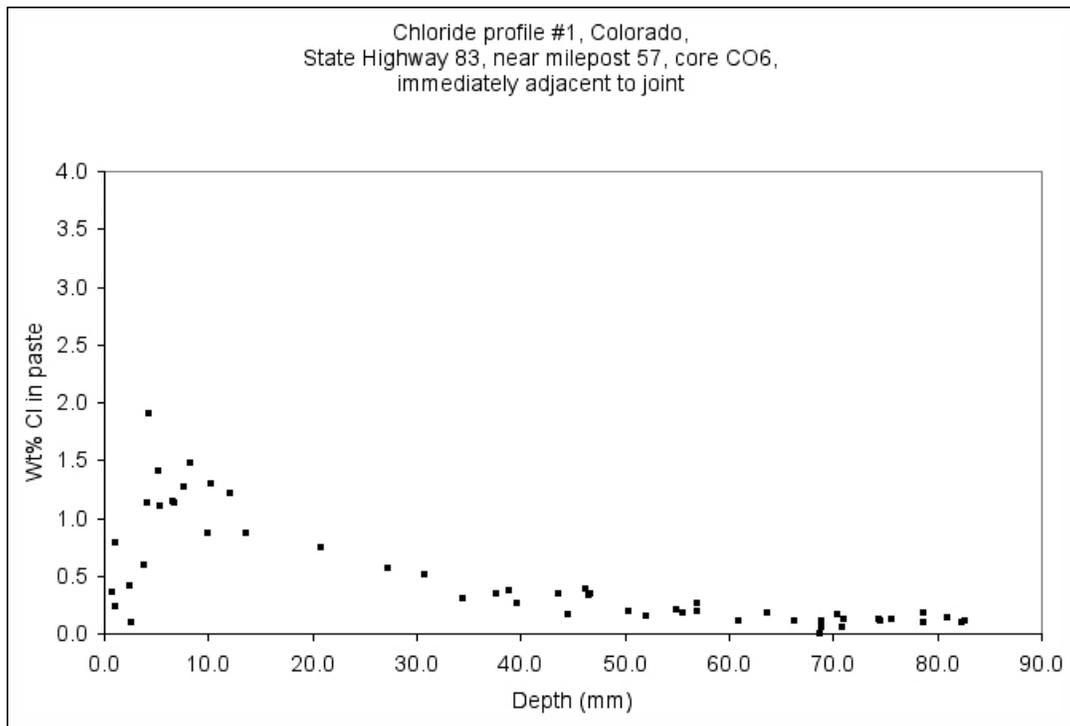
Figure CO-13: Chloride profile through cement paste, from billet prepared from core CO-6.

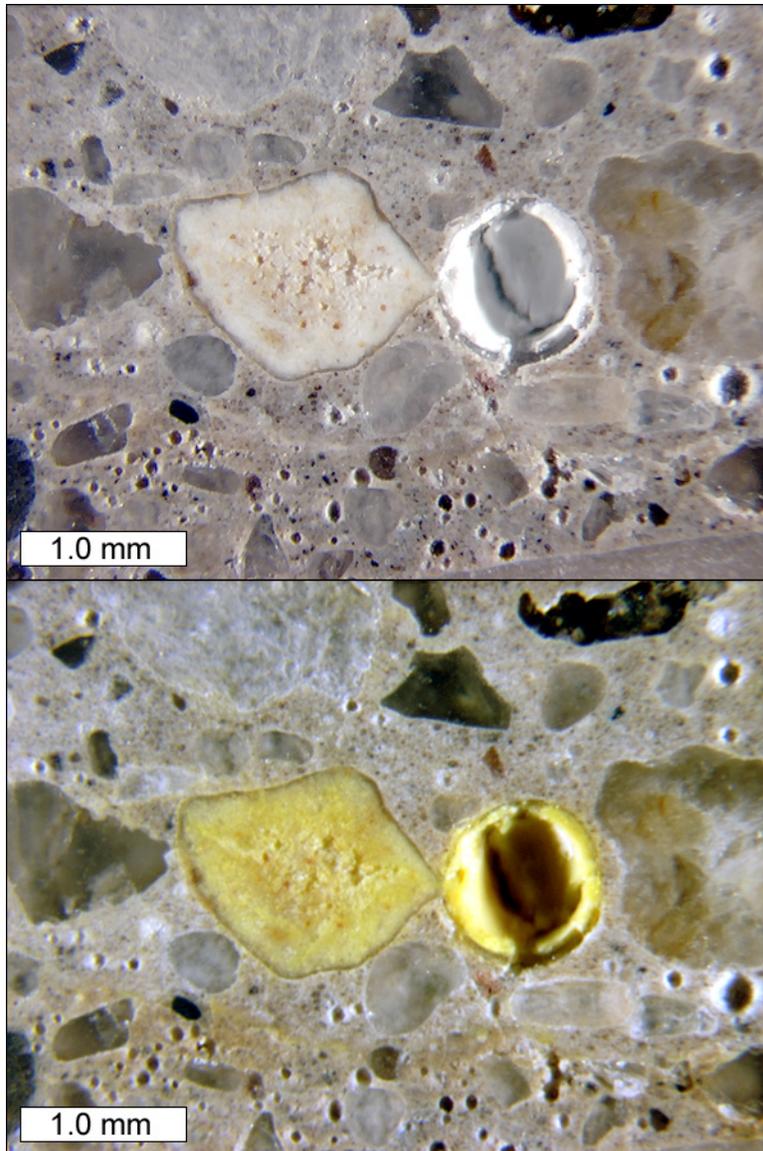
Figure IA-8: Stereo microscope images to show reactive aggregate particle both before (top) and after (bottom) treatment with sodium cobaltinitrite stain (sample IA-7). Image also illustrates the contrast in texture between the concrete overlay (top  $\frac{3}{4}$  of image) and the original concrete below (bottom  $\frac{1}{4}$  of image).

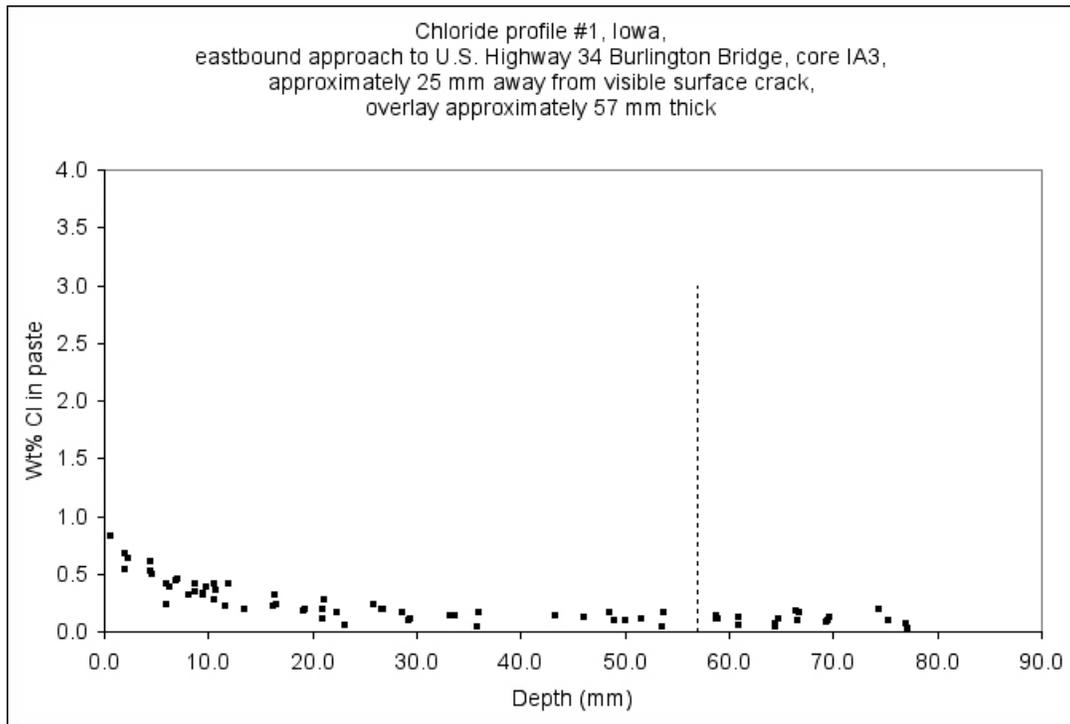
Figure IA-13: Chloride profile through cement paste about 25 mm away from visible surface crack, from billet prepared from core IA-3, dashed line marks the transition point between concrete overlay and the original concrete below the overlay.

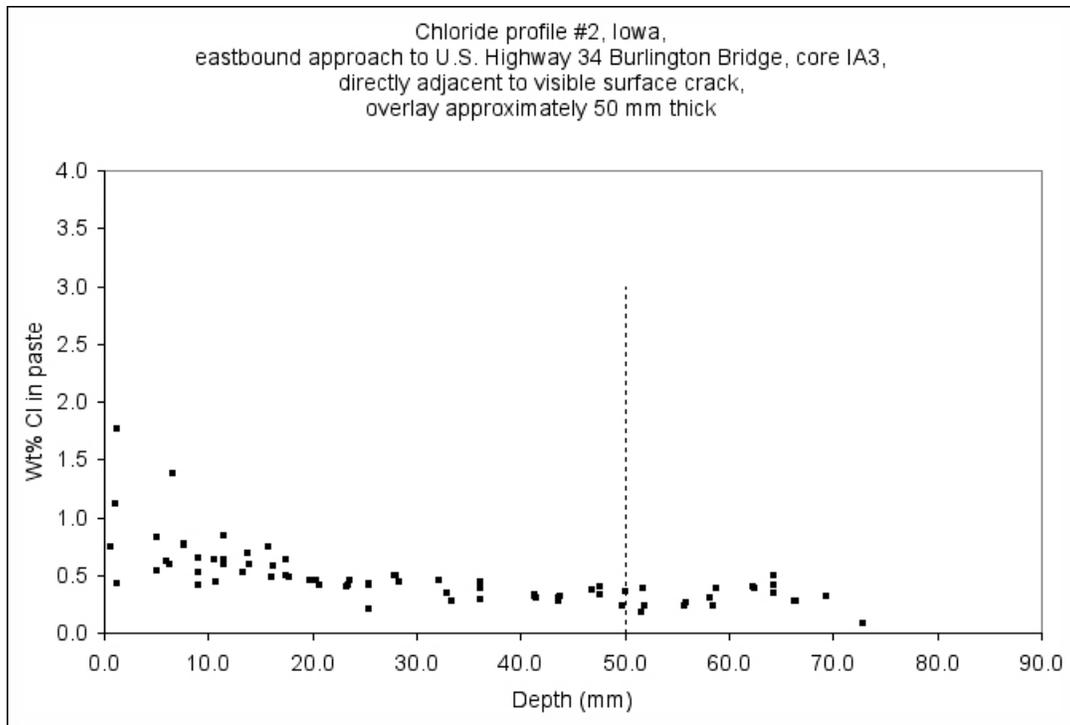
Figure IA-14: Chloride profile through cement paste, directly adjacent to visible surface crack, from billet prepared from core IA-3, dashed line marks the transition point between concrete overlay and the original concrete below the overlay.

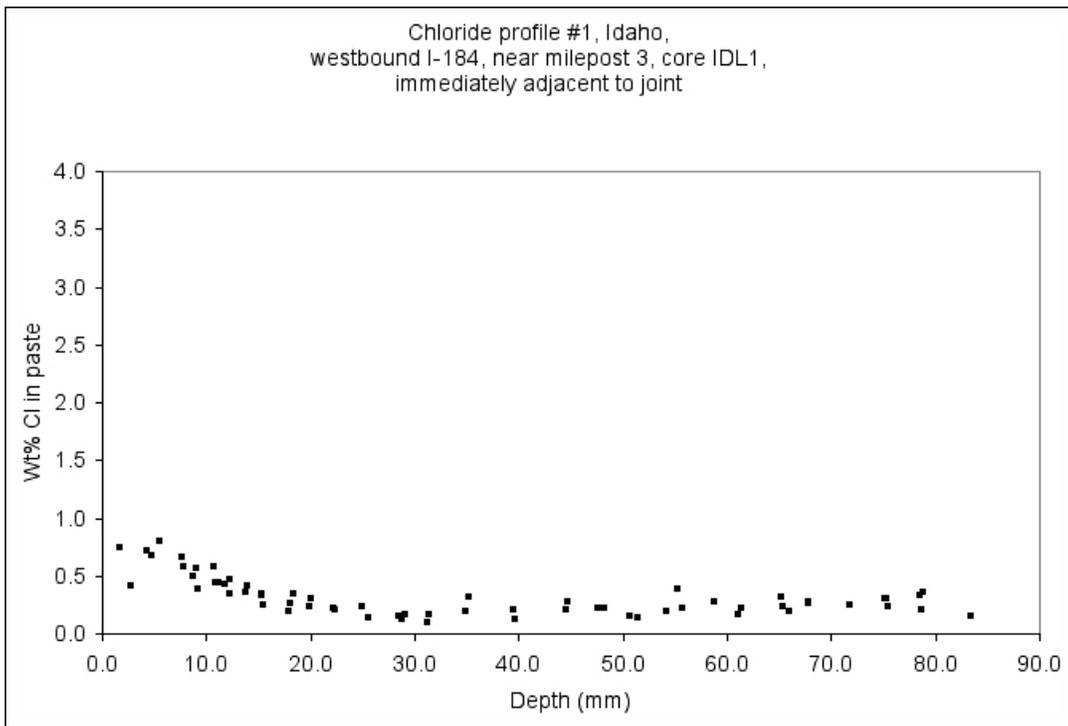
This pavement was constructed in 1992. It is reported to have been exposed to  $MgCl_2$  for anti-icing, and NaCl for deicing. Figure ID-1 shows the locations of the cores, which came from both the far left and far right lanes. Figures ID-2 through ID-5 show photographs of the cores. Cores were slabbed and polished from both lanes, both at the joint, and away from the joint. Figures ID-6 through ID-13 show the slabs as polished, after staining with phenolphthalein, and after treatment to enhance air voids and cracks. The phenolphthalein stain showed normal carbonation depths. The black and white treatment did not reveal any macro-cracking in either of the cores, except for one crack at depth in core IDR-7, as shown in Figure ID-11. Table ID-1 summarizes the air void parameters, which varied considerably, from a low spacing factor value of 0.118 mm for core IDR-3, to a high spacing factor value of 0.267 mm for core IDL-6. Figure ID-14 shows an example stereomicroscope image of the more borderline air void structure from core IDR-7, (spacing factor 0.238 mm). A w/c ratio estimation was performed on a thin section prepared from the top of core IDL-1. Figures ID-15 and ID-16 show the images used to make the measurements. The results of the w/c estimation are summarized in Table ID-2, with an average w/c value of 0.46 as compared to the 28-day moist cured mortar sample standards. Figures ID-17 through ID-20 show chloride profiles from cores IDL-1 (at joint) and IDL-5 (mid-panel). The profiles from core IDL-1 show increased Cl penetration as compared to the profiles from core IDL-5.

Figure ID-17: Chloride profile through cement paste immediately adjacent to joint, from billet prepared from core IDL-1.

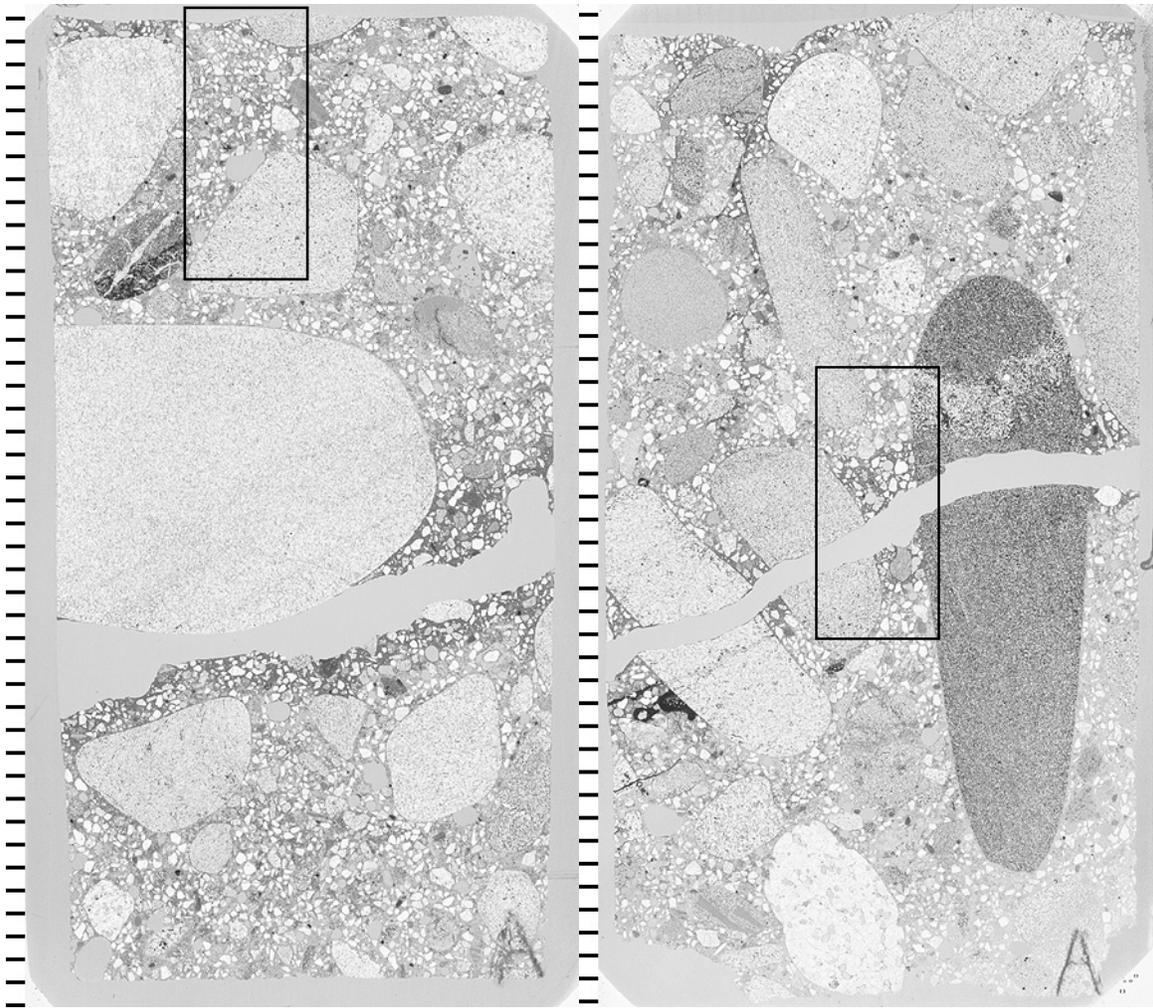
Figure S-12: Transmitted light scanned images of thin sections to show locations of elemental maps. The top of each thin section represents the wear surface of the pavement, the large cracks, sub-parallel to the surface, are at a depth of about 25 mm, (tic marks every mm).

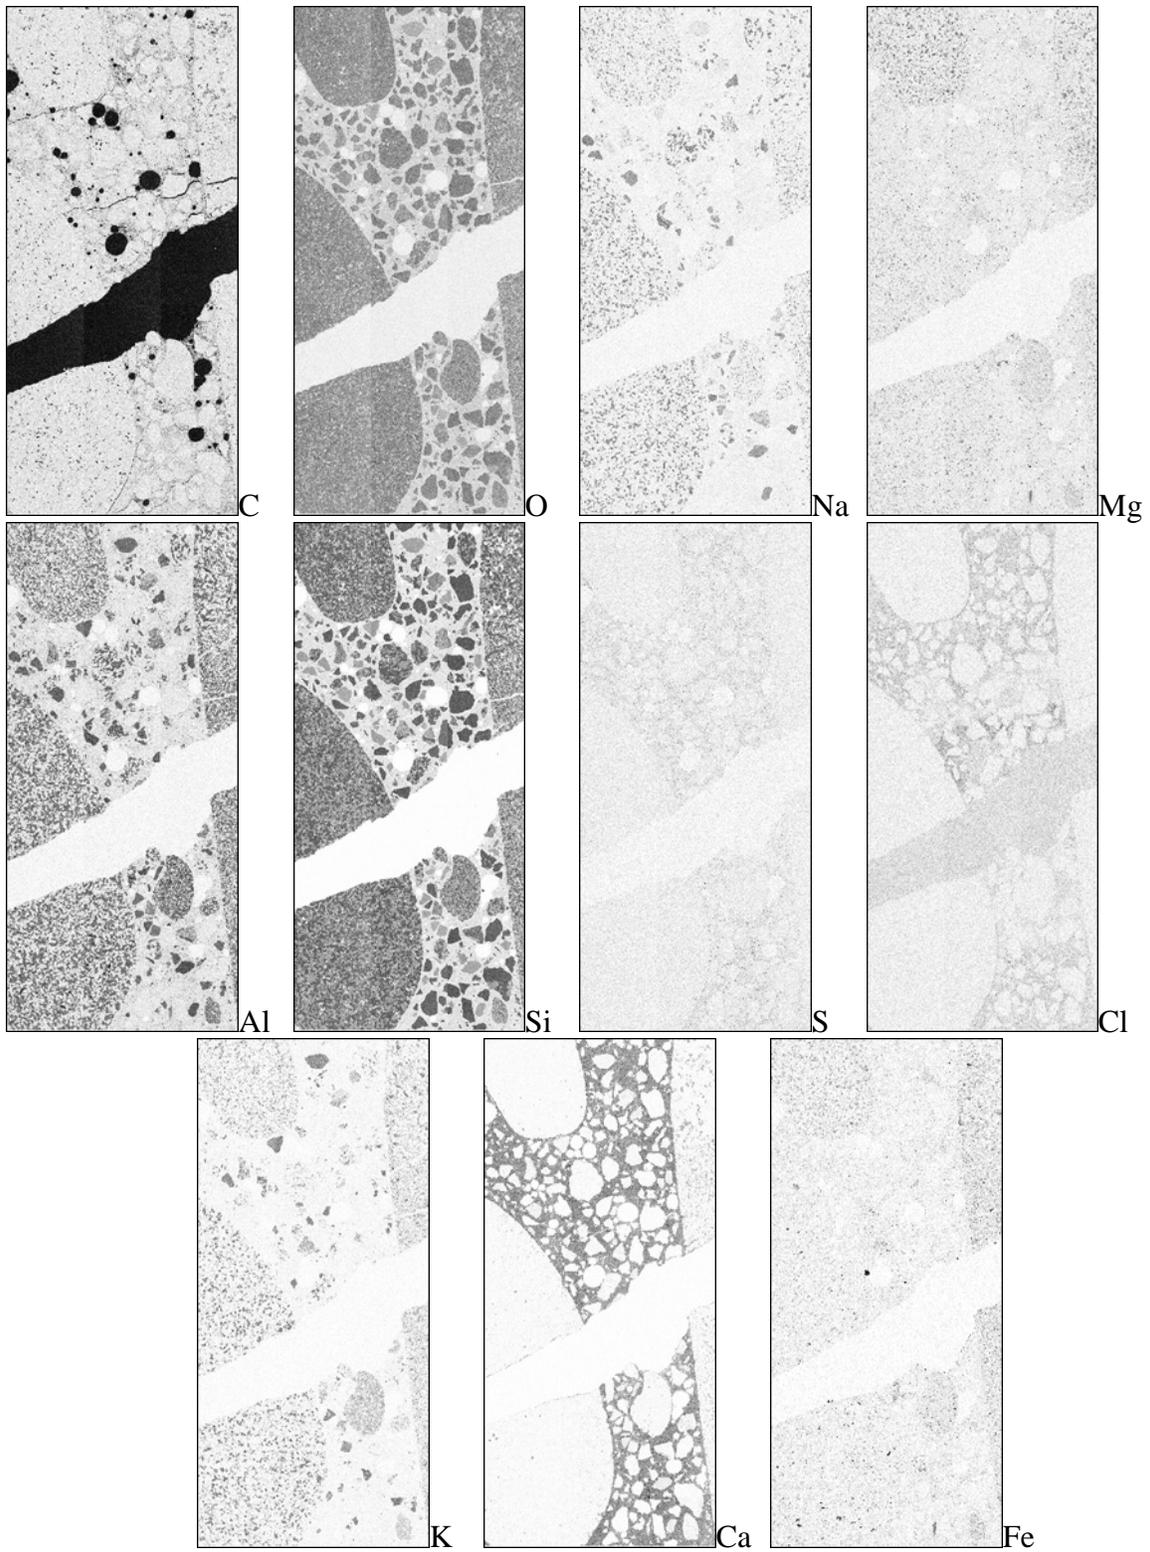
This bridge deck was in maintenance area 1114, and exposed to  $MgCl_2$  brine, and a combination of NaCl and sand. Figure S-1 shows the locations of the cores, and Figure S-2 shows the condition of the bridge deck, with some spalling. Figure S-3 shows the underside of the bridge deck. Figure S-4 shows photographs of the cores. Core S-1 exhibited a crack plane at a depth of about 30 mm coinciding with reinforcement steel. The entire core was vacuum impregnated with epoxy and used only for thin section preparation. Core S-2 was intact, and cut into slabs and polished. Figures S-5 and S-6 show the slab as polished, after staining with phenolphthalein, and after treatment to enhance air voids and cracks. The phenolphthalein stain showed normal carbonation. The black and white treatment did not reveal any macro-cracking, with the exception of a small crack perpendicular to the pavement surface. Table S-1 summarizes the air void parameters. The slab showed adequate entrained air, with a spacing factor of 0.173 mm. Figure S-7 shows an example stereomicroscope image of the air void structure. A w/c ratio estimation was performed on a thin section prepared from the top of core S-2. Figures S-8 and S-9 show the images used to make the measurements. The results of the w/c estimation are summarized in Table S-2, with an average w/c value of 0.33 as compared to the 28-day moist cured mortar sample standards. Figures S-10 and S-11 show chloride profiles from cores S-2. Figure S-12 shows the locations on the thin sections prepared from core S-1 that were used for elemental mapping. Regions were mapped to represent the pavement surface and the crack at depth. Figures S-13 and S-14 show the elemental maps from the two regions. Chloride profiles were not recorded from core S-1 because it had been epoxy impregnated; the epoxy contains chlorine. The most interesting feature of the elemental maps is the Cl map from Figure S-14 that shows chlorine enrichment along the top surface of the crack at depth.

Figure S-14: Elemental maps from crack at depth, darker regions indicate higher concentrations.
