Technical Memorandum

Re: Forensic Desktop Study Report: Arkansas LTPP SPS-8 Test Sections

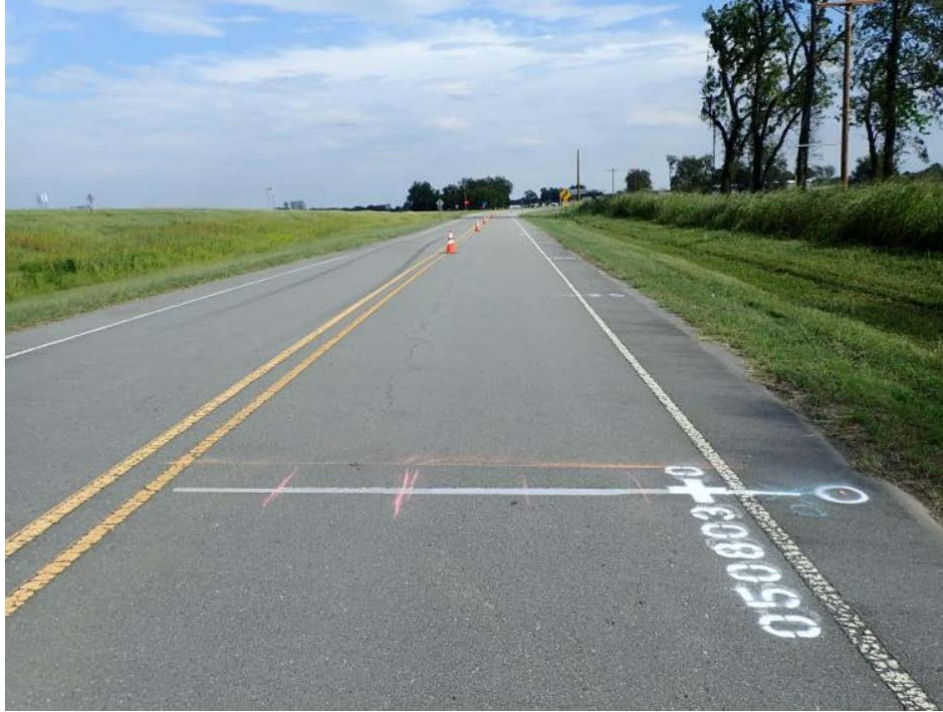
Photograph 1. LTPP Section 05_0803 at Station 0+00 looking southbound in 2019.

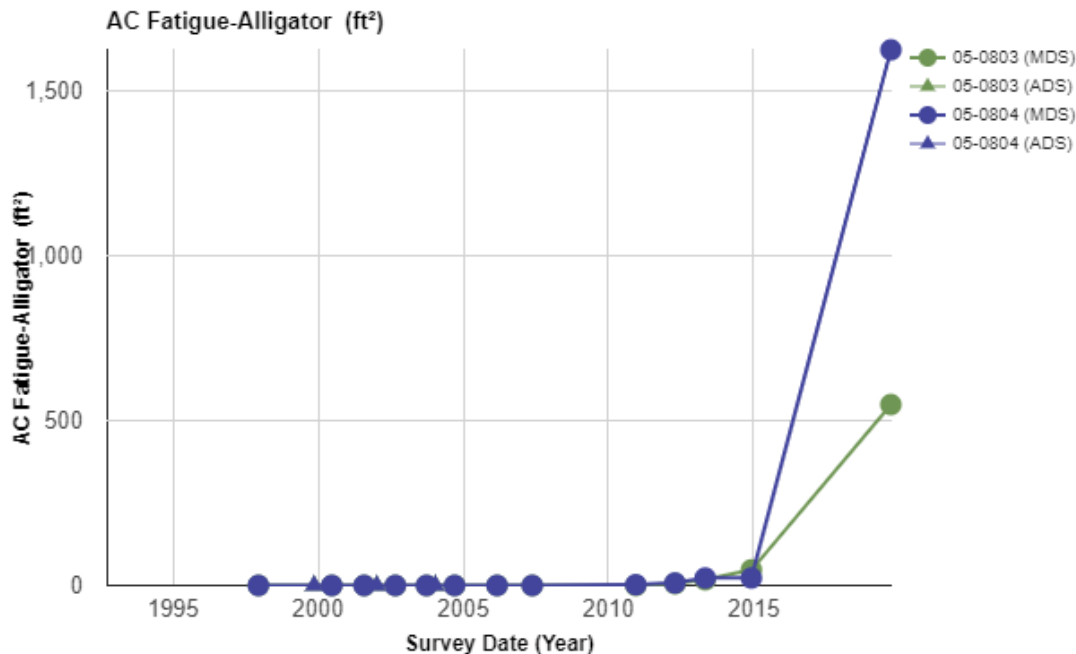
Figure 9 shows the total reported area of fatigue/alligator cracking between 1997 and 2019 for the two AC test sections. The distress values reported includes both fatigue cracking (inside the wheel path) and alligator cracking (outside the wheel path). Fatigue/alligator cracking was first reported during the manual distress survey in December 2010 for test section 05_0804 and April 2012 for test section 05_0803, 13 and 15 years after the construction of the test sections, respectively. Minimal fatigue/alligator cracking (less than 50 ft²) was reported on both test sections between 2010 and 2014. However, during the manual distress survey conducted in September 2019, both test sections reported a spike in fatigue/alligator cracking. In 2019, test section 05_0803 reported 549 ft² of fatigue/alligator cracking while test section 05_0804 reported 1,625 ft² of fatigue/alligator cracking.

Figure 9. Time history of the length of fatigue cracking.

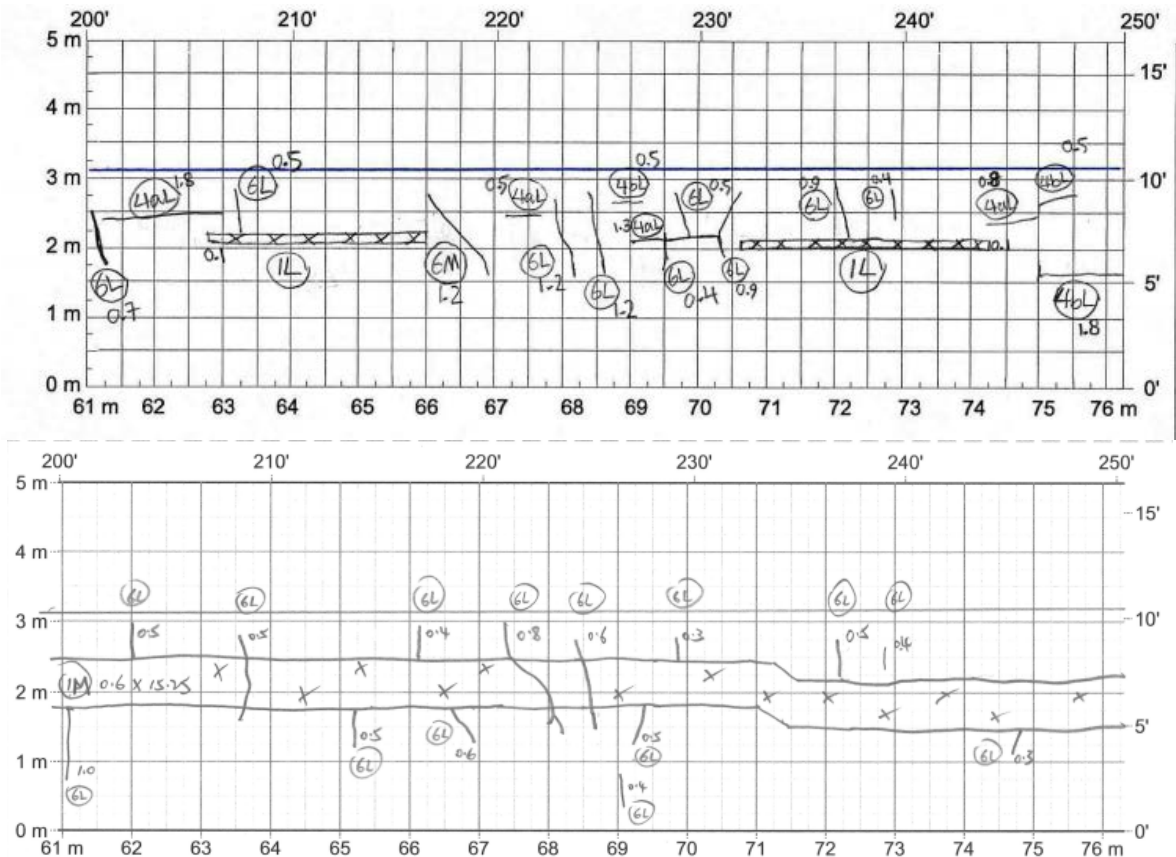
While no freeze climates typically exhibit more fatigue cracking due to the use of softer AC mixes², the amount of fatigue cracking exhibited at the test sections still increased at an abnormal level for a low-traffic roadway. As discussed later in the memorandum, some of the increase in fatigue/alligator cracking observed on the AC test sections may be explained by the way in which distresses were captured in the manual distress surveys in 2014 and 2019. As depicted in Figure 10, most of the additional fatigue cracking observed in 2019 is located in areas where wheel path longitudinal cracking and transverse cracking already existed. Therefore, in 2019, these cracking types were classified as fatigue/alligator cracking, which lead to an increase in fatigue/alligator cracking and a decrease in other cracking types.

Figure 10. Fatigue cracking propagation on test section 05_0803 in 2014 (top) and 2019 (bottom).

The sharp increase in fatigue/alligator cracking also coincides with high amounts of precipitation (80 inches) reported in 2019. As stated previously, this area of Arkansas experienced historic levels of flooding, which is likely one cause of this increase in fatigue/alligator cracking. As water infiltrates the pavement, unbound granular layers tend to weaken (especially when reaching saturation conditions), which can contribute to the observed cracking. Another potential reason for the observed increase in fatigue cracking over time is that the AC pavement surface layer is undergoing age hardening (or oxidation), hardening leads to a more brittle asphalt surface layer. Oxidation is influenced by the asphalt binder used, film thickness, aggregate gradation, in situ moisture content, and AC-mix percentage of air voids. To better

understand whether oxidation played a role in increased levels of fatigue/alligator cracking, it is suggested that each of the factors mentioned be assessed using information collected on the sections at the time of construction as well as through lab tests of the existing pavement material. Finally, the fatigue/alligator cracking observed may also be material or construction related. Both AC test sections were notably constructed as two AC layers, which may have resulted in debonding between the two layers and therefore, an effective reduction in the structural capacity of the test sections.

- Additional FWD testing to determine if deflections remained consistent over time or if the structural capacity of the pavements has begun to deteriorate. However, this activity is not considered critical.
- Perform coring, just outside the test sections, in order to address the following that could help explain one or more of the issues raised in this memorandum:
 - Provide asphalt concrete layer material for use in laboratory testing. This will be used to better understand whether the AC test sections experienced any debonding or aging/oxidation.
- Continued monitoring of these test sections is recommended.

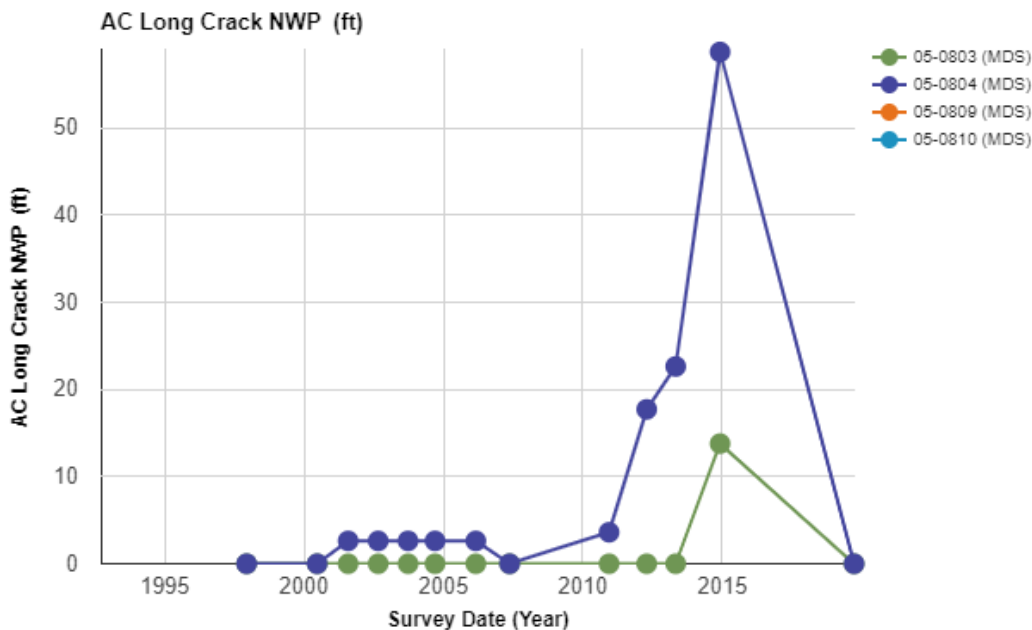
Non-wheel path (NWP) longitudinal cracking, depicted in Figure 11, was first reported during the distress survey in August 2001 for test section 05_0804 when 3 ft of cracking was reported. The reported NWP longitudinal cracking remained minimal on the test section between 2001 and 2010 and began to increase between 2010 and 2014. By December 2014, test section 05_0804 reported 59 ft of NWP longitudinal cracking while test section 05_0803 reported 14 ft of cracking (the only time NWP longitudinal cracking was reported on this test section). However, no NWP longitudinal cracking was reported during the next distress survey in September 2019. The majority of NWP longitudinal cracking observed prior to 2019, while minimal, was of low severity and was reported midlane, just outside the wheel path for both test sections. Therefore, the drop in NWP longitudinal cracking in 2019 is related to the cracking being incorporated into the higher amounts of fatigue/alligator cracking reported in 2019.

Figure 11. Time history of the length of NWP longitudinal cracks.

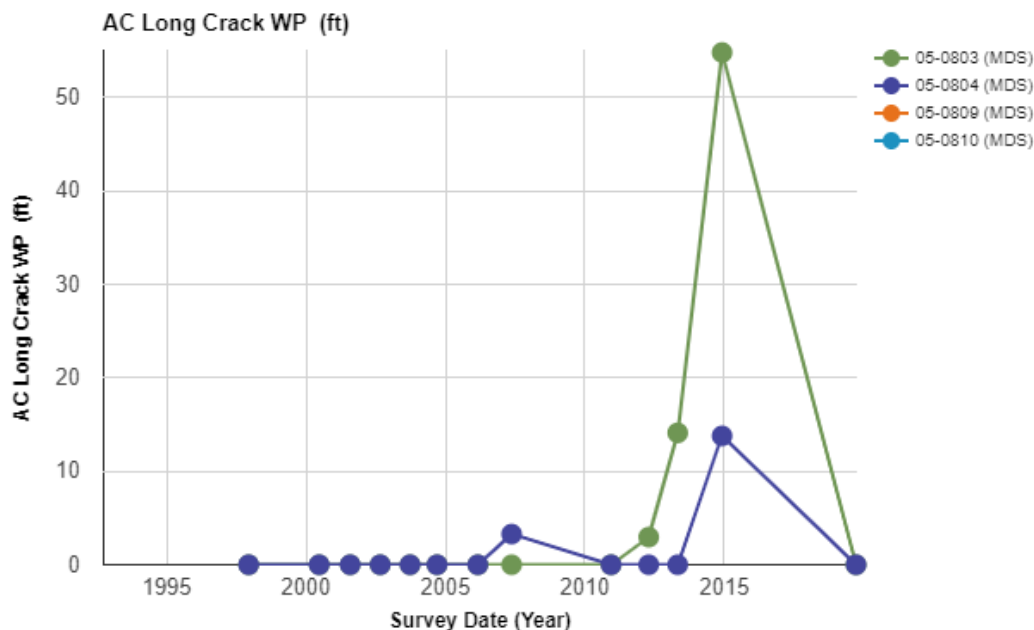
In May 2007, 10 years after the construction of the test sections, 3 ft of WP longitudinal cracking was reported on test section 05_0804. WP longitudinal cracking was first reported on test section 05_0803 in April 2012 when 3 ft of cracking was observed but continued to increase between April 2012 and December 2014. Both test sections reported a spike in WP longitudinal cracking in December 2014, when 55 ft and 14 ft of WP longitudinal cracking were reported on test sections 05_0803 and 05_0804, respectively. However, no WP longitudinal cracking was reported during the next distress survey in September 2019, due to the WP longitudinal cracking being incorporated into the higher amounts of fatigue/alligator cracking reported in 2019.

Figure 12. Time history of the length of WP longitudinal cracks.

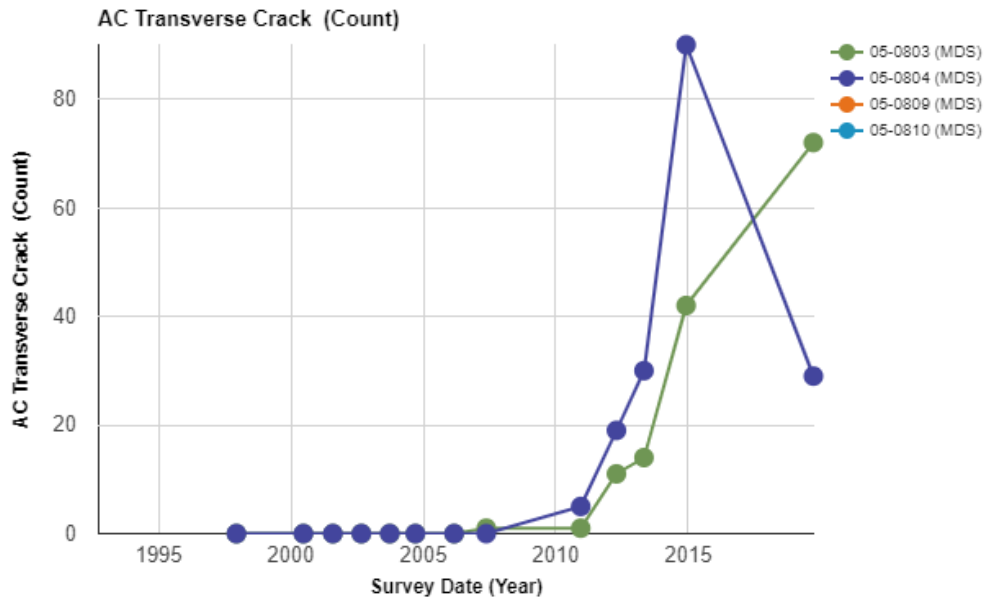
Data on transverse cracking was collected between 1997 and 2019, as shown in Figure 13 and Figure 14. Test section 05_0803 first reported transverse cracking during the manual distress survey in May 2007, 10 years after the construction of the test sections, when 2 feet of transverse cracking (1 crack) was observed. Transverse cracking was first reported on test section 05_0804 in December 2010, when 9 ft (5 cracks) was reported on the test section. Both test sections reported an increase in transverse cracking between December 2010 and December 2014, at which point 190 ft (90 cracks) and 88 ft (42 cracks) of transverse cracking was reported on test sections 05_0804 and 05_0803, respectively. The reported length of each transverse crack was relatively short, typically ranging from 1 to 2 ft. In September 2019, during the most recent pavement distress survey, the amount of transverse cracking reported increased for test section 05_0803 to 159 ft (72 cracks) and decreased for test section 05_0804 to 50 ft (29 cracks). The decrease in transverse cracking observed on test section 05_0804 is the result of some of the previously reported transverse cracking from 2014 being captured as fatigue/alligator cracking in 2019. The increase (rather than decrease) in transverse cracking on test section 05_0803 may be partially explained by the fact that there is substantially more fatigue/alligator on test section 05_0804 than test section 05_0803. While the reported transverse cracking on both sections remained minimal, it is hypothesized that its initiation and propagation is binder related or due to aging/oxidation of the AC surface layer.

Figure 13. Time history of the number of transverse cracks.

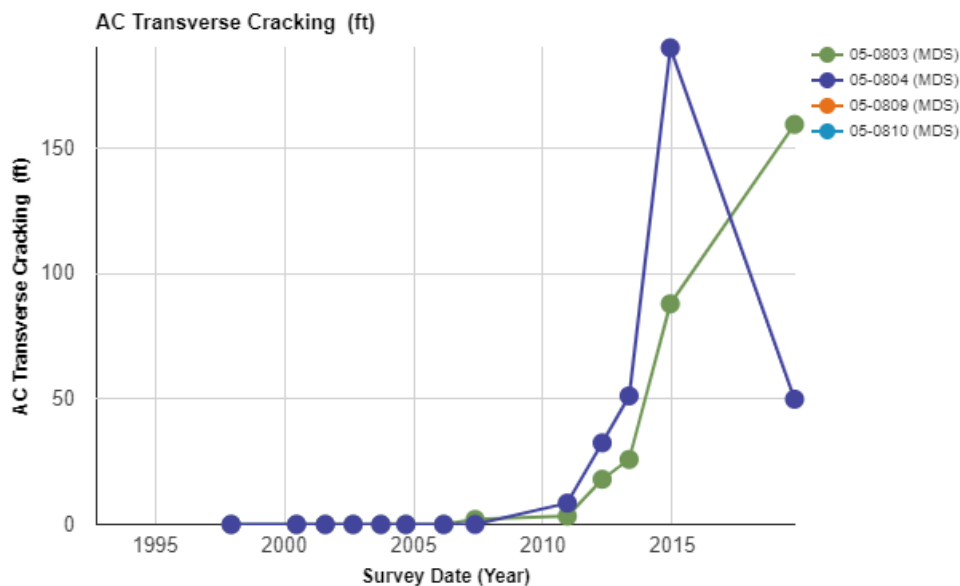
Figure 14. Time history of the length of transverse cracking.

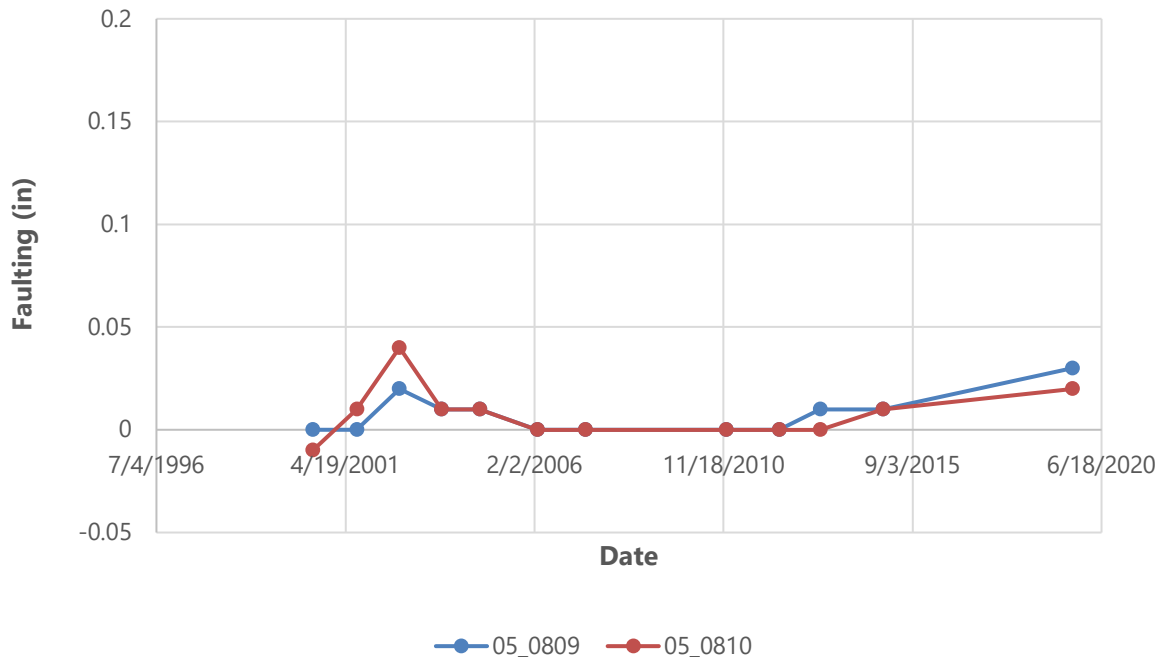
The average faulting observed over time on the JPCP test sections is shown in Figure 16. The faulting on both test sections was minimal and fluctuated over time. For test section 05_0810, faulting ranged from -0.01 in (2000) to 0.04 in (2002). Test section 05_0809 reported faulting between 0 in and 0.03 in (2019). The average faulting for the JPCP test sections is classified as "Good" based on FHWA performance definitions.

Figure 16. Time history plot of average faulting.
