Technical Memorandum

Re: Forensic Desktop Study Report: Arizona SPS-2 Test Sections 0214, 0215, 0217 and 0262

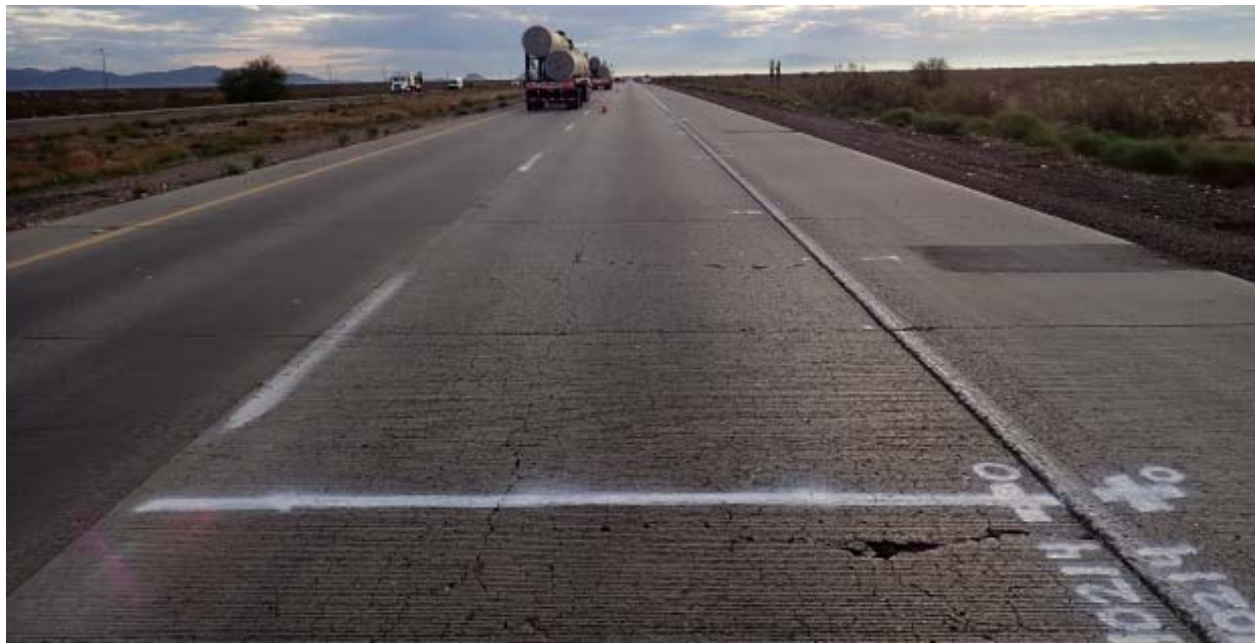
Figure 3. Test section 040214.

- Section 040214 had minimal distress development across all categories; as of 2016, ride quality remained in the FHWA "fair" category at 119 inches/mile, cracking and faulting were minimal, rutting was less than 0.15 inches, deflection was around 7 mils, and LTE was around 62%. However, significant map cracking developed in this section and photos indicate these map cracks have become wider at the surface (with spalling) and some appear to have developed into full-depth cracks. This section was characterized by an 8-inch PCC, 900-psi flexural strength mixture, unbound granular base, and a 12-foot lane.

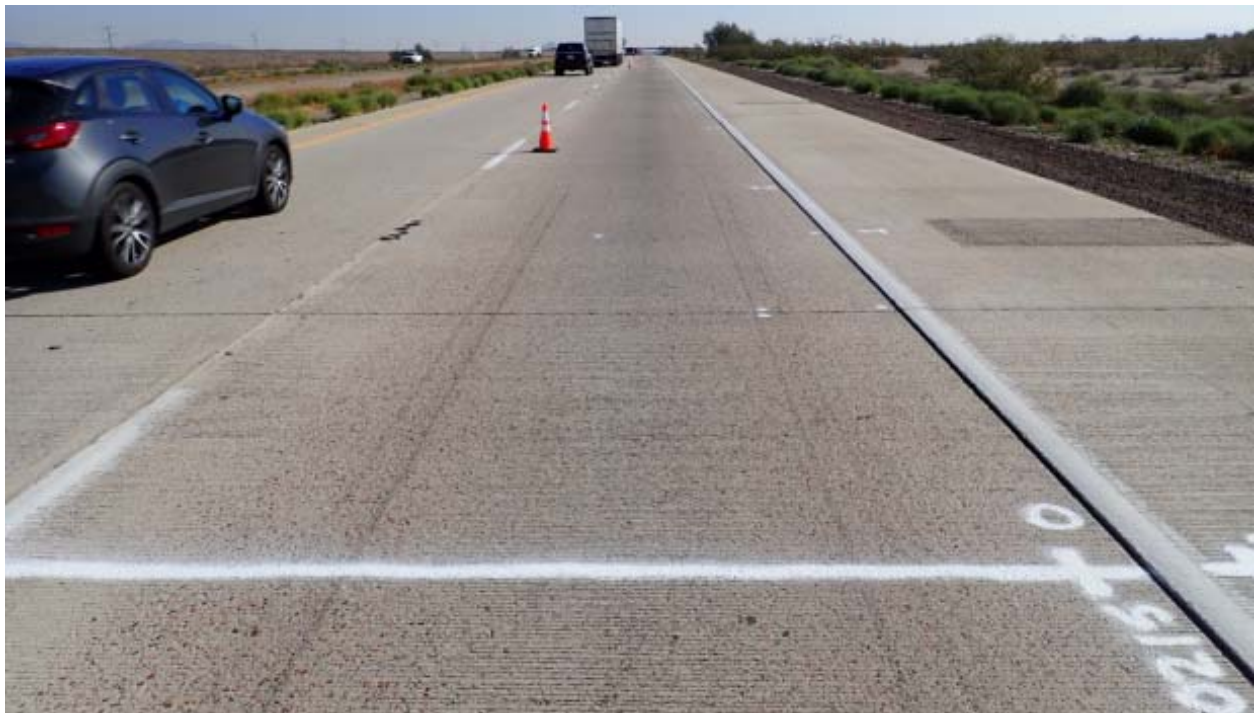
Figure 4. Test section 040215.

- Section 040215 had minimal distress development across all categories; as of 2016, ride quality remained in the FHWA “fair” category at 114 inches/mile, cracking and faulting were minimal, rutting was 0.2 inches, deflection was very low, and LTE was 73%. Significant map cracking was not documented by raters. This section was characterized by an 11-inch PCC, 550-psi flexural strength mixture, unbound granular base, and a 12-foot lane.

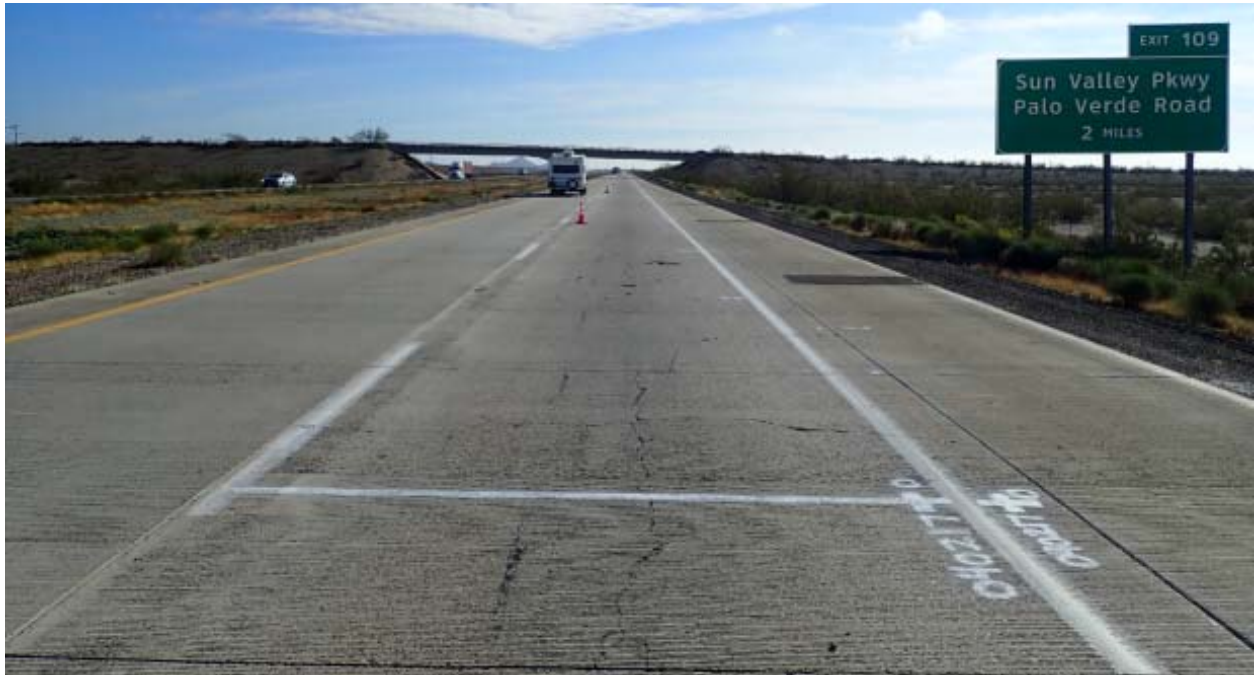
Figure 5. Test section 040217

- Section 040217 had moderate distress development across most categories except this section was the only one that remained in the FHWA “good” category for roughness with IRI at 74 inches/mile (2016). Longitudinal cracking was 699 linear feet and transverse cracking was 269 linear feet (most of the four sections). Faulting was minimal, rutting was less than 0.2 inches, deflection was very low, and LTE was 53%. Significant map cracking was noted. This section was characterized by an 8-inch PCC, 550-psi flexural strength mixture, lean concrete base, and a 14-foot lane.

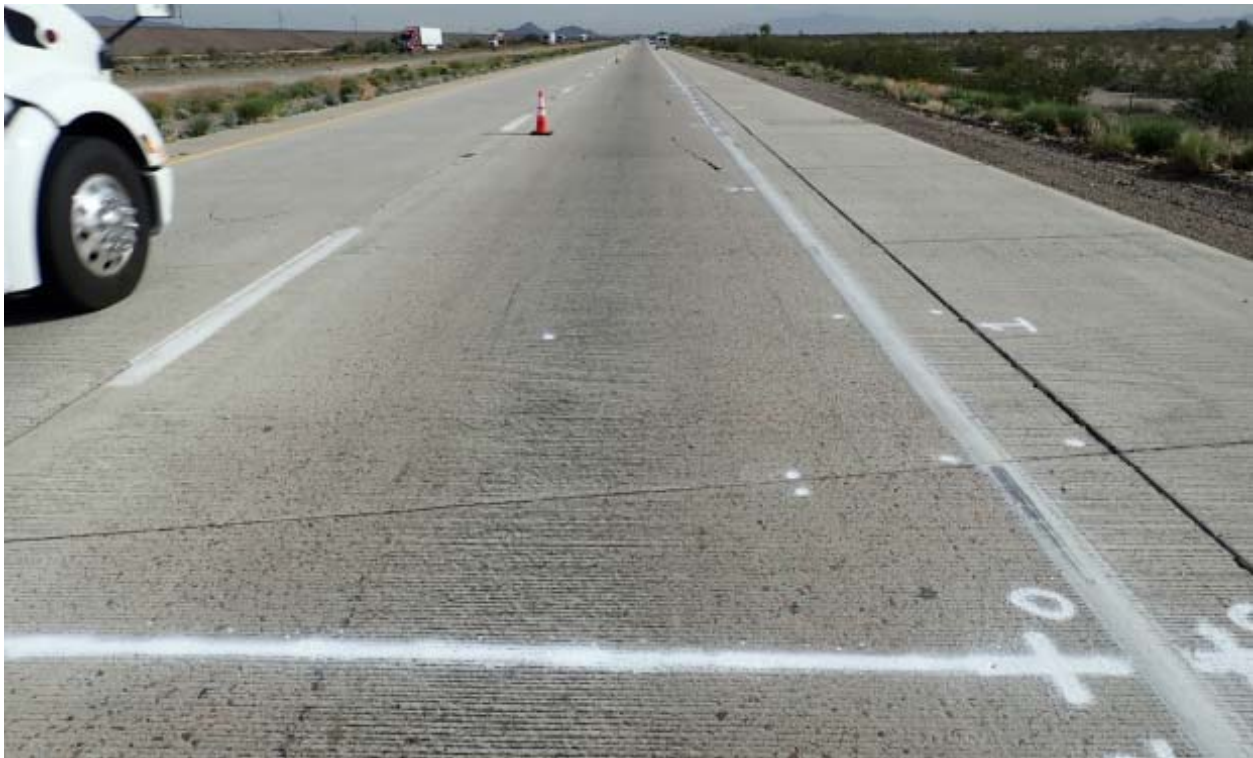
Figure 6. Test section 040262

- Section 040262 exhibited the most distress development in all categories except for transverse cracking. As of 2016, IRI was 245 inches/mile (FHWA “poor” category), deflection was 5 mils, LTE was 22%, longitudinal cracking was 144 feet, joint spalling was the highest of the four sections (5 affected joints), rutting was nearly 0.3 inches (FHWA “fair” category), and average faulting was over 0.2 inches. Significant map cracking was noted. This section was characterized by an 8-inch, undoweled PCC, unbound granular base, low flexural strength, and a 14-foot lane.

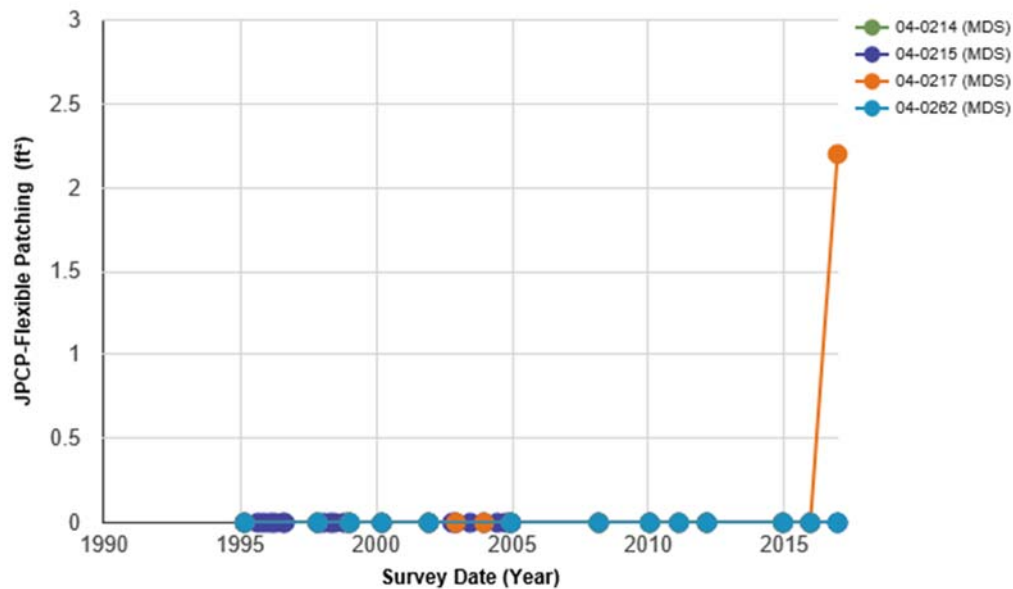
Figure 7. Time history of flexible patching.

Figure 7 displays the recorded quantities of patching. Only Section 040217 (CN3, February 2016) had patching recorded that met the LTPP minimum size (0.1m^2). The quantity of patching (2.2ft^2) was small considering the overall area of the test section.

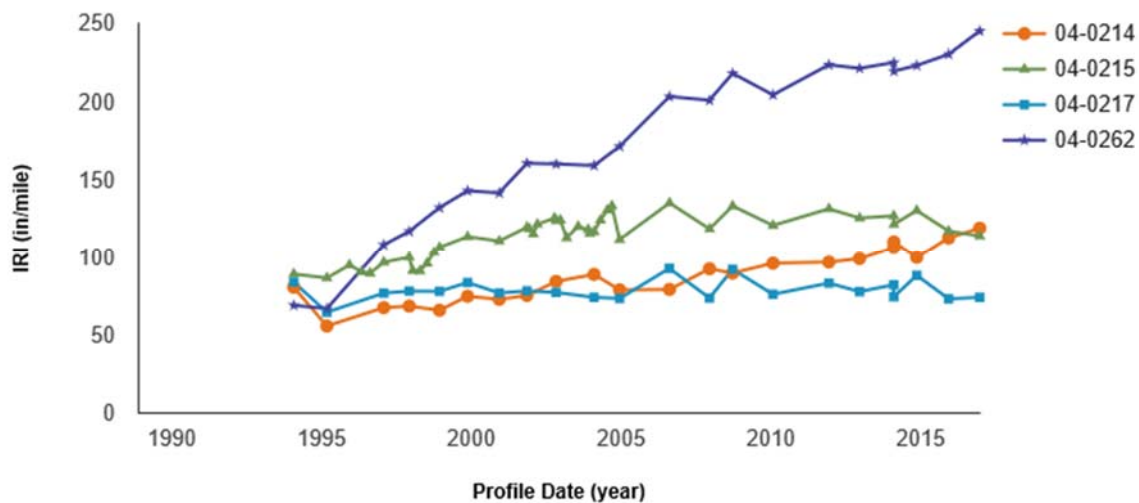
Figure 10. Time history plot of pavement roughness for 040214, 040215, 040217 and 040262.

The time history of roughness measurements for the four test sections in the study are shown in Figure 10. In Figures 12 through 15, IRI is broken up by section with the vertical lines indicating construction events, which are detailed under the Pavement Structure and Construction History section of this report. According to the FHWA performance standard, IRI is considered in the “Good” category if the IRI is less than 95 inches/mile. If the IRI is between 95 and 170 inches/mile it is considered “Fair”, and an IRI greater than 170 inches/mile is considered “Poor”. As of 2016 the only section with an IRI in the “Good” category is 040217. Sections 040214 and 040215 are in the “Fair” category, and 040262 is considered “Poor”.

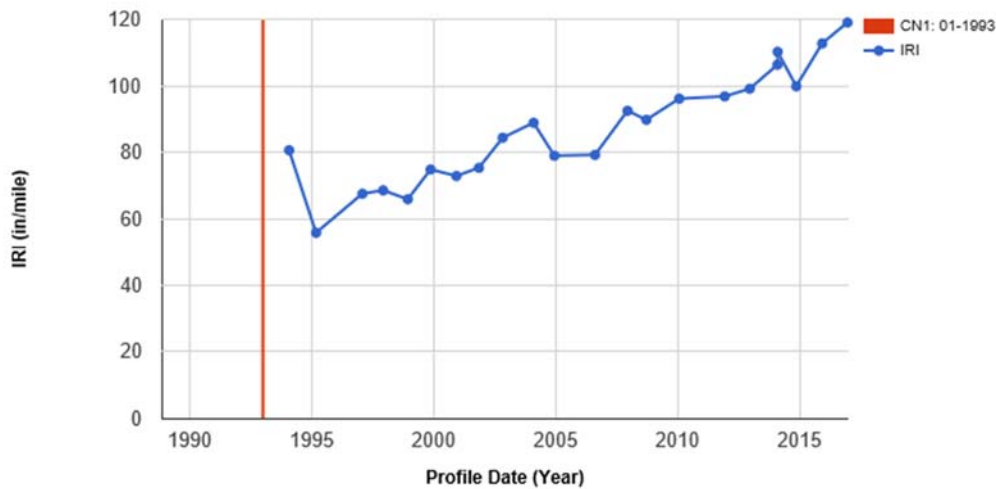
Figure 11. Section 040214 IRI and Construction Time History Plot.

Figure 11 shows that section 040214 stayed within the "Good" category according to FHWA's performance standard, until January 2010 when it reached 96 inches/mile. From there the IRI has gradually increased to 119 inches/mile in December 2016. The unexpected drop in post-construction IRI was likely related to data collection during different seasons and time-of-day as these can affect profile measurements used to calculate IRI. Ambient temperature impacts the temperature gradient within a slab and causes a warp or curl effect. The initial survey in January 1994 was collected from 6:00pm to 8:00pm while the next survey was collected in March 1995 at 11:20 am.

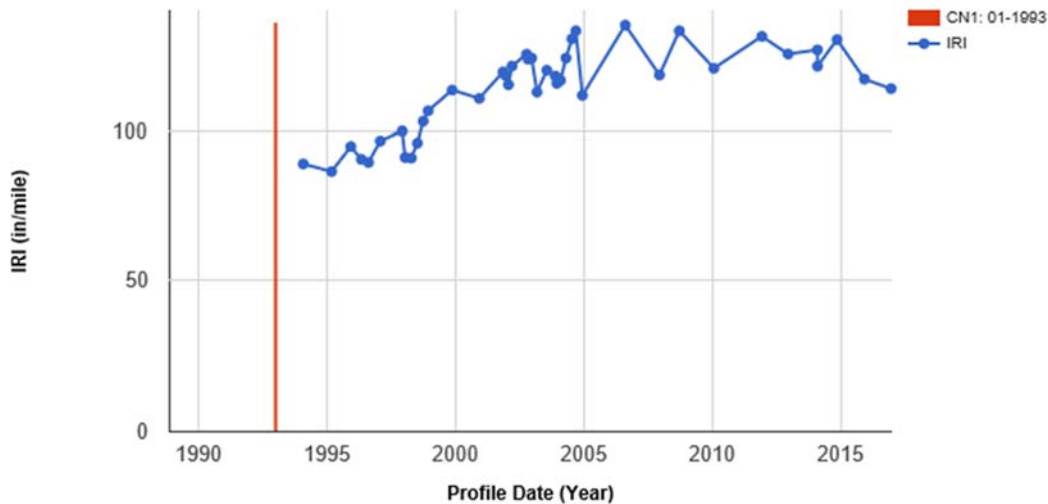
Figure 12. Section 040215 IRI and Construction Time History Plot.

Section 040215 IRI, shown in Figure 12, fluctuated within the "Good" category from January 1994 to July 1998, going a little bit above the 95 inches/mile "Good" category range in 1997 maxing at 100 inches/mile. In September 1998, IRI entered the "Fair" category and has fluctuated within this category. The IRI in December 2016 was 114 inches/mile.

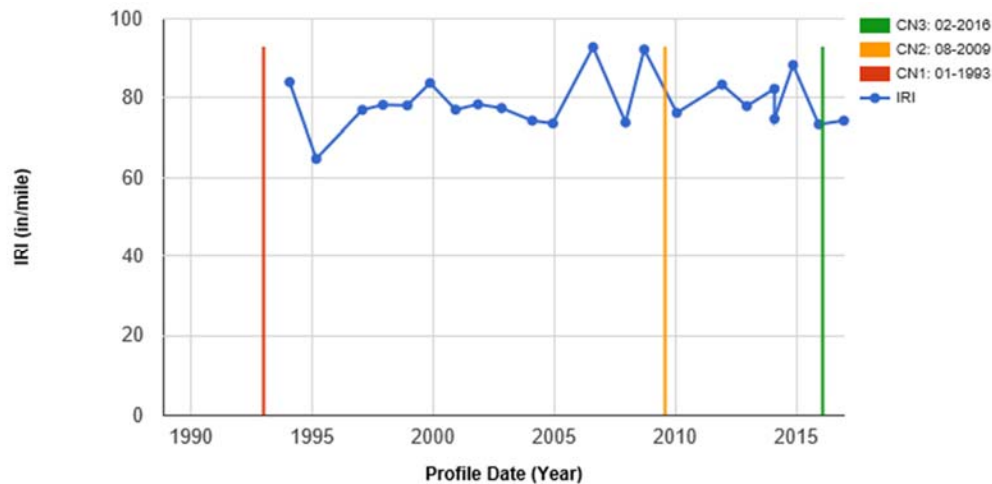
Figure 13. Section 040217 IRI and Construction Time History Plot.

Section 040217 shown in Figure 13 is the only section in this study that has continuously stayed within the “Good” category since it was accepted into the program. From 1994 to 2004 the IRI has been somewhat linear except for in 1995 where it dropped down 19 inches/mile to 65 inches/mile. This highest IRI value of 93 inches/mile was recorded in August 2006. In 2010 CN2 occurred and the IRI value decreased to 76 inches/mile. After CN2 the value fluctuated from 76 up to 88 inches/mile. After CN3 it stayed relatively the same and in 2016 IRI was 74 inches/mile.

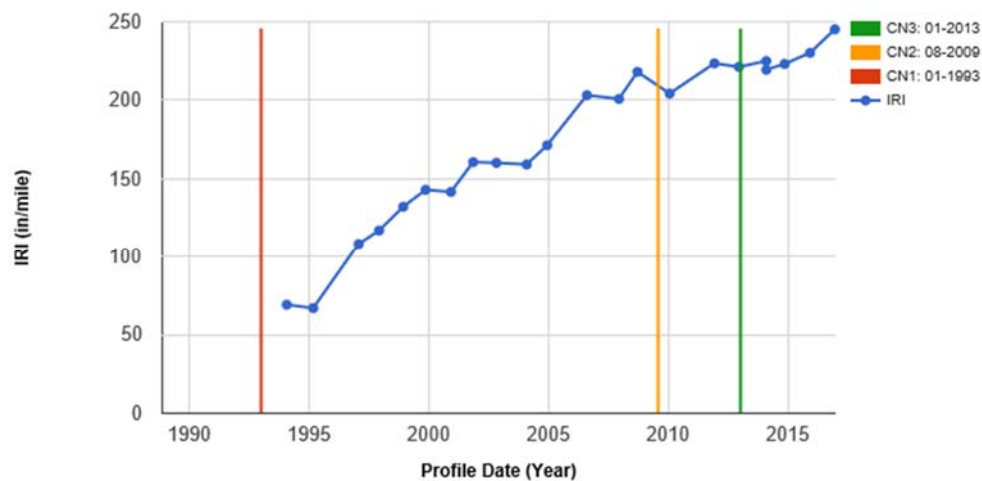
Figure 14. Section 040262 IRI and Construction Time History Plot.

Section 040262, shown in Figure 14, is the only section that has reached the unacceptable IRI limit according to FHWA's standard. In 1994, the roughness was at 69 inches/mile with a steady increase until the patching event occurred in August of 2009. IRI was considered “Good” for only the first two years after construction, 1994 and 1995. In 2004 the section transitioned from “Fair” to “Poor” category with an IRI of 171 inches/mile. After the August 2009 patching event (CN2) IRI dropped 14 inches/mile from 218 to 204 inches/mile and continued to increase thereafter. More patching occurred (CN3) in January 2013, but IRI after the CN event was nearly identical.

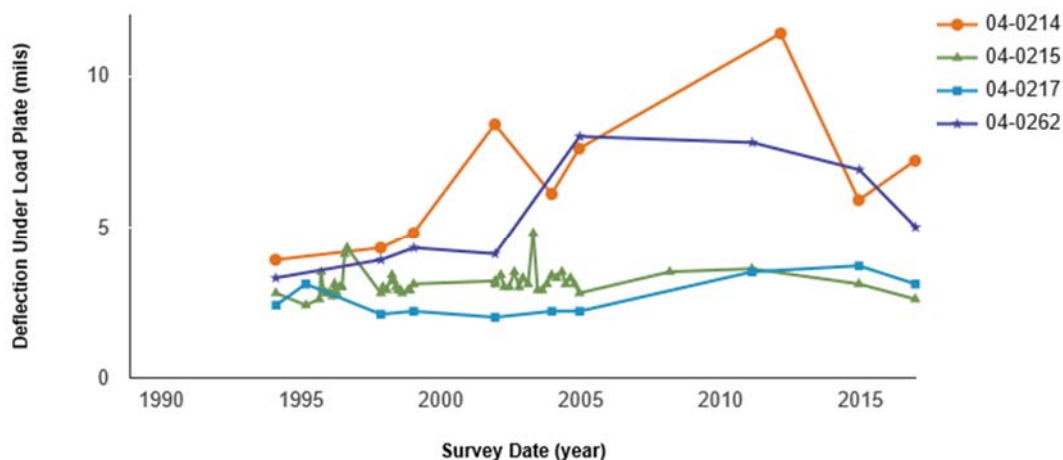
Figure 15. Time history plot of average deflection for the sensor located in the load plate normalized to 9,000 lb. drop load for 040214, 040215, 040217 and 040262.

The time history of average deflection under the load plate, normalized to a 9,000 lb. drop load, for the four test sections in the study are shown in Figure 15. The patching CN events do not affect slab deflection and therefore are not included in this discussion. FHWA does not have performance categories for deflection. Deflections for Sections 040215 and 040217 were very low (generally less than 4 mils) and remained constant throughout the 20+ year monitoring period. This was likely due to the presence of a thicker pavement slab (11 inches) in Section 040215 and the presence of a treated base (with an 8-inch slab) in Section 040217. Sections 040214 had steadily increasing deflection values with a sudden increase around 2012. This data point cannot be explained with available data. Section 040262 exhibited a trend of increased deflection until 2005 when values remained constant or dropped slightly. An explanation for this trend was that both sections were constructed with an 8-inch PCC slab over approximately 6-inches of unbound granular base and the pavement structures had less overall stiffness (compared to Sections 040215 and 040217).

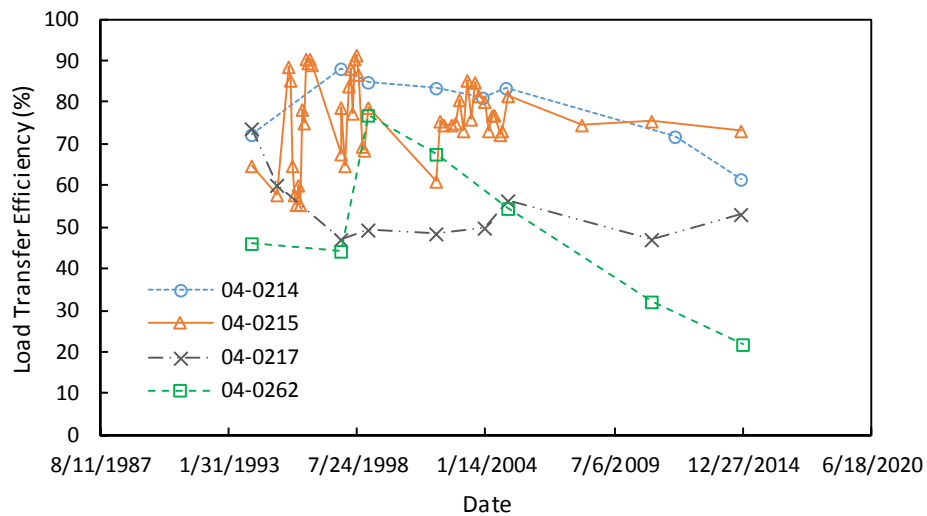
Figure 16. Load transfer efficiency summary.

Figure 16 provides a comparison of the load transfer efficiency (LTE) for the four sections. The time history of LTE confirms that dowels are an important aspect for load transfer. The undoweled section (040262) exhibited poor load transfer (as of 2014) compared to sections 040214 and 040215, which maintained good LTE throughout the monitoring period. It is not immediately clear why LTE started at 46% in 1994 and then increased to 77% in 1999. The continual decrease from 1997 is related to the lack of dowel bars. Immediately following construction, LTE was good for Section 040217, decreased rapidly until 1997, and then remained constant at round 50% for the remainder of the study period. Longitudinal and transverse cracking occurred early on in this section and increased throughout the 20+ year monitoring period and this was the only section constructed on treated base material. The exact cause of the sudden drop in LTE could not be determined from these data.

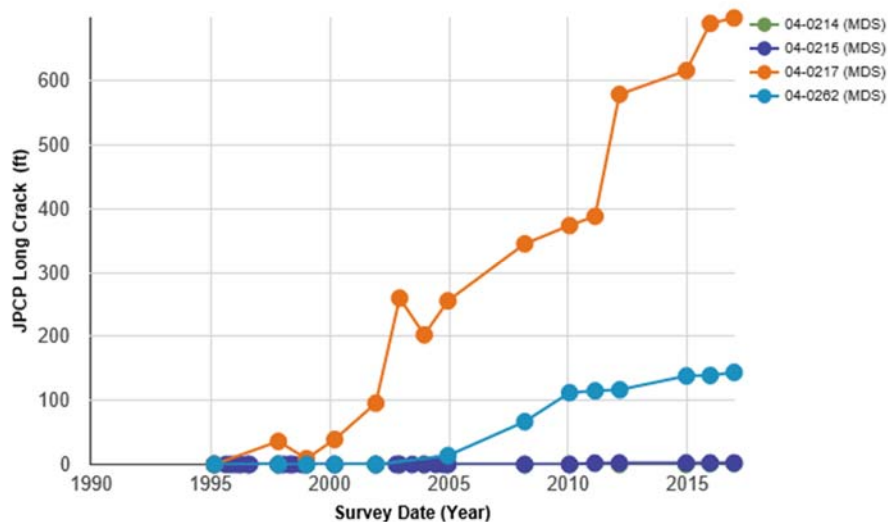
Figure 17. Time history of longitudinal cracking length.

Figure 17 shows the time history for longitudinal cracking length for the four Arizona SPS-2 sections of interest. Section 040217 has the largest amount of longitudinal cracking at 699 ft, 040262 has 144ft of longitudinal cracking and 040214 and 040215 have a very small amount of longitudinal cracking, at less than 3ft of longitudinal cracking. Sections 040214, 040217 and 040262 all exhibit a large amount of map cracking. This observation was logical for 040214 given a higher amount of total cementitious content to achieve a 900-psi design strength. However, sections 040217 and 040262 used a 550-psi design strength and the extent of map cracking was more significant than observed on other 550-psi sections in this experiment. The development of map cracking could have been an artifact of poor curing during construction or the onset of alkali-silica reactivity.

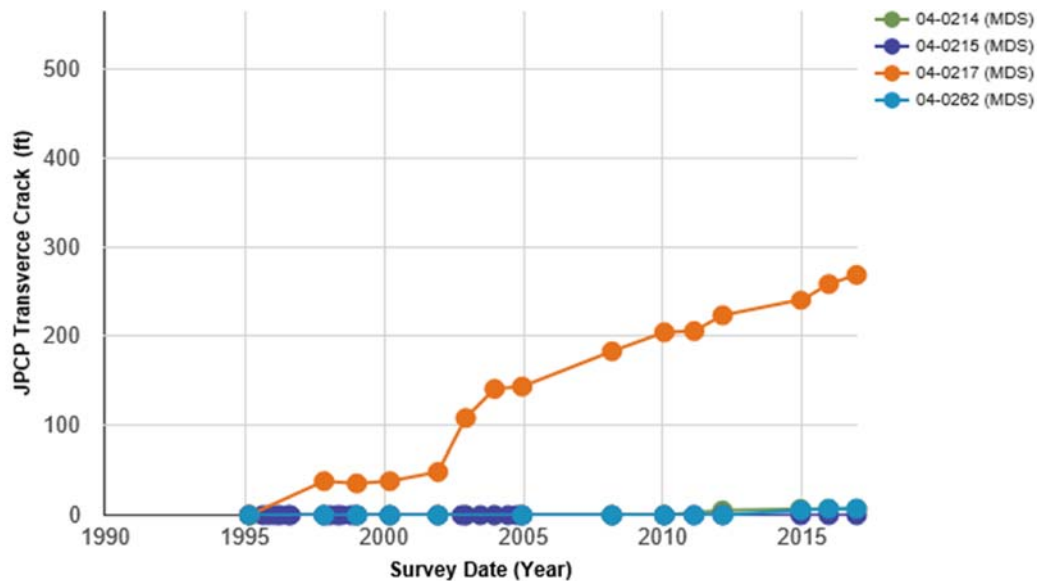
Figure18. Time history of transverse cracking length.

Similarly, Figure 18 shows that 040217 has the most transverse cracking, whereas the other sections had little to no transverse cracks. Section 040217 has 25 cracked slabs (transverse crack greater than or equal to 1.9ft) out of 34 slabs which translates to 73% of slabs cracked. Sections 040214 and 040262 have one cracked slab with less than 3% slabs cracked and 040215 has no cracked slabs. According to the FHWA performance standard, 040214, 040215 and 040262 are considered "Good" and 040217 has greater than 15% cracking, putting it in the "Poor" category.

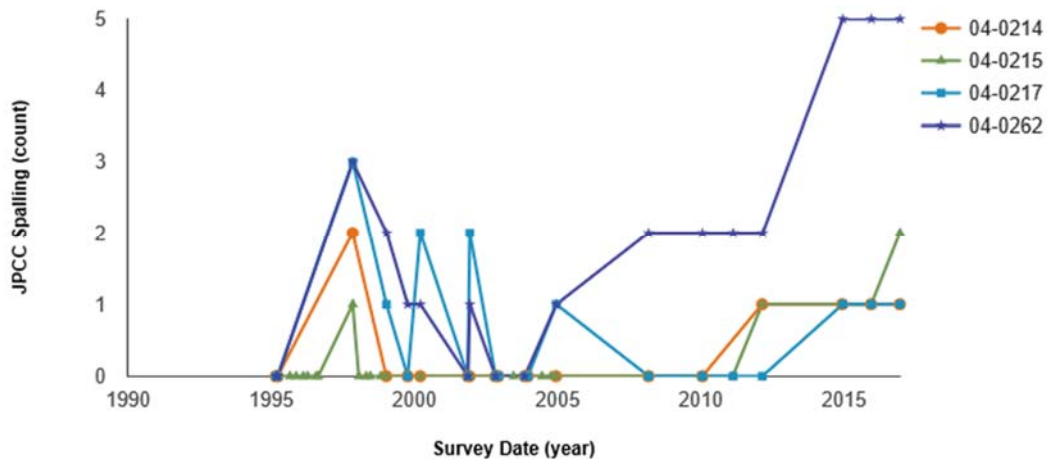
Figure 19. Time history of total number of JPCC spalling at transverse joints.

Figure 19 shows the time histories for spalling at transverse joints, indicating the number of affected joints. Based on the LTPP Distress Identification Manual (DIM), a transverse joint is considered affected if spalling is present for 10% or more of the length of the joint. Minor spalling at transverse joints is present on all sections with 040262 having the most spalling with five affected transverse joints. This undoweled section exhibited poor load transfer and resulting joint movement was a likely factor in the steady increase in spalled joints. Sections 040214 and 020215 did not exhibit spalling until approximately 18 years after construction. At that point, only one to two joints were affected. Section 040217 had a CN in 2009 that included partial-depth patching at the joints. This explains the drop in affected joints around that time period. The spike in spalled joints in 1997 was likely rater variability as these data points for 040214 and 020215 do not follow the trends for those sections.

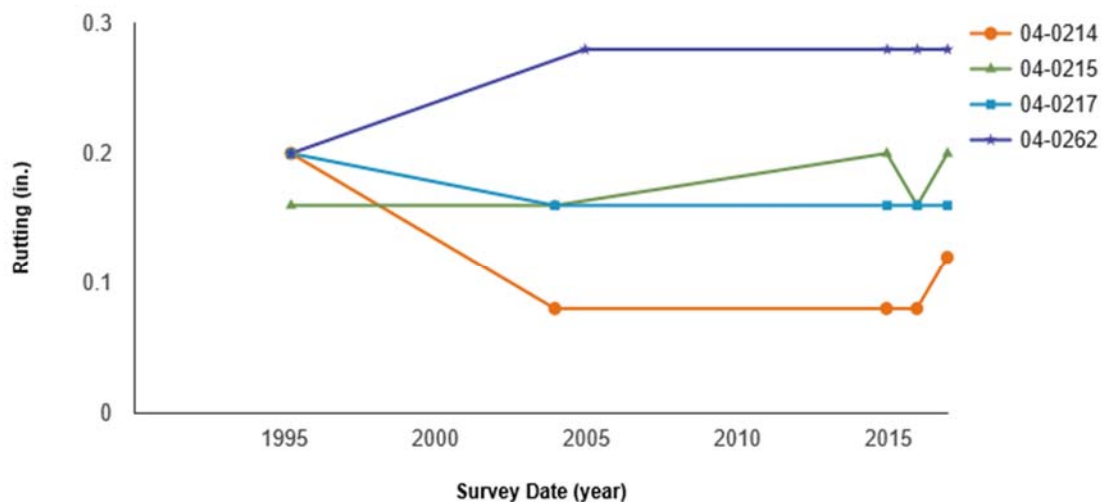
Figure 20. Time history plot of average rut depth computations.

Although typically collected on asphalt pavements, a Dipstick[®] was occasionally used to measure transverse profile on the four concrete SPS-2 sections in this study. For concrete pavements, wheel path ruts develop as a result of surface wear (paste and aggregate) and the distress is classified as rutting in LTPP. Figure 20 shows the rutting time history from Dipstick[®] data. Rut depths measured in March 1995, two years after construction began, ranged from 0.16 to 0.2 inches. This initial rutting is a result of the "weaker" tining ridges wearing away and once coarse

aggregate is exposed, the rate of wear decreases. Sections 04-0215 and 04-0217 did not exhibit a change in rutting over the 20-year monitoring period. Data show a decrease in Section 04-0214 and 04-0217 rutting between 1995 and 2003. This trend could be due to rater variability or changes in the elevation of the starting point to collect transverse profile data (i.e., if the tining between the wheel path and fog line wore away at a faster rate than the wheel path itself [between 1995 and 2003], the Dipstick starting elevation would have been lower on subsequent measurements and would have underestimated rut depths compared to the original datum point (with tining present at fog line).

According to the rutting FHWA performance standard on asphalt pavement, less than 0.2 inches is considered "Good", rutting between 0.2 and 0.4 inches is considered "Fair" and rutting greater than 0.4 inches is considered "Poor". Section 040262 was the only section considered to be "Fair" with rutting between 0.2 inches and 0.3 inches in every survey, and in 2014 section 040215 moved into the "Fair" category.

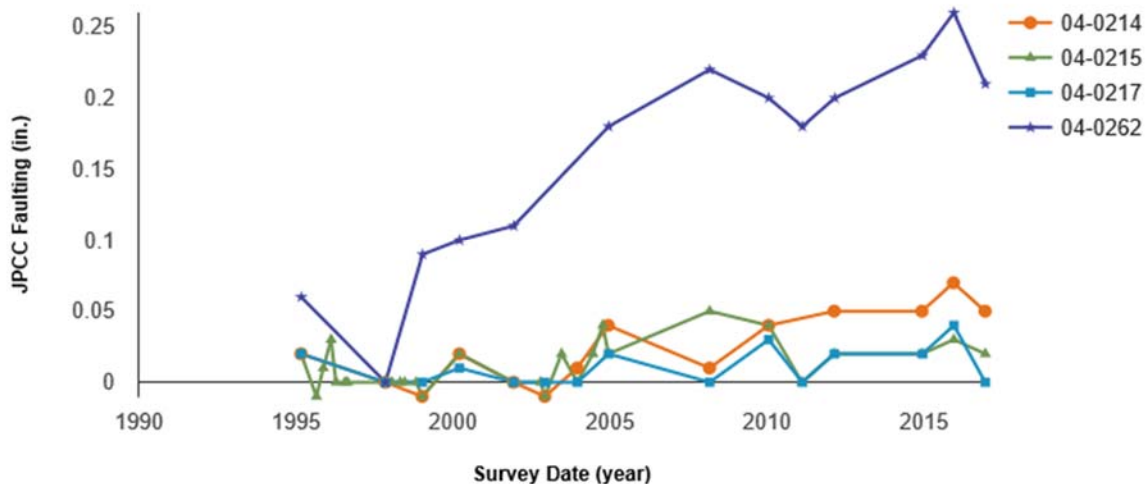
Figure 21. Time history plot of faulting.

Figure 21 shows the faulting time histories on the four Arizona SPS-2 sections. Most of the faulting values are positive fault heights, which occur when the leave side of the joint has a higher elevation than the approach. According to Figure 25, section 040262 had the most faulting present while the other sections have minimal to no faulting. The FHWA performance standard for faulting is as follows; faulting less than 0.1 inches is "Good", faulting between 0.1 and 0.15 inches is "Fair", and faulting greater than 0.15 inches is considered "Poor". According to the faulting performance standards 040262 has been in the "Poor" category since 2001. The three other sections remained below 0.1 inches, putting them all into the "Good" category. The steady increase in faulting is thought to be due to Section 040262 being undoweled; the other three sections were constructed with dowel bars.
