Technical Memorandum

Re. Forensic Desktop Study Report: Florida SPS-5 Project

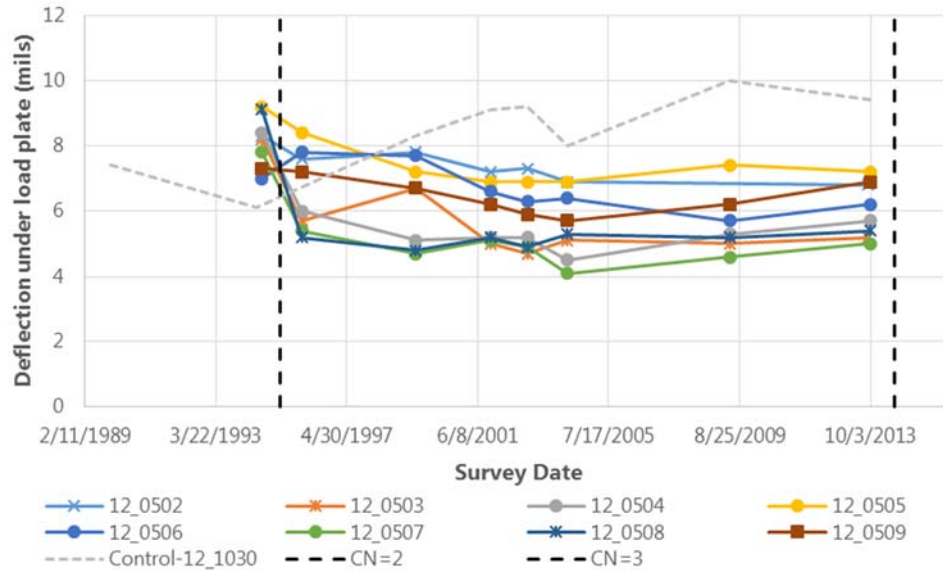
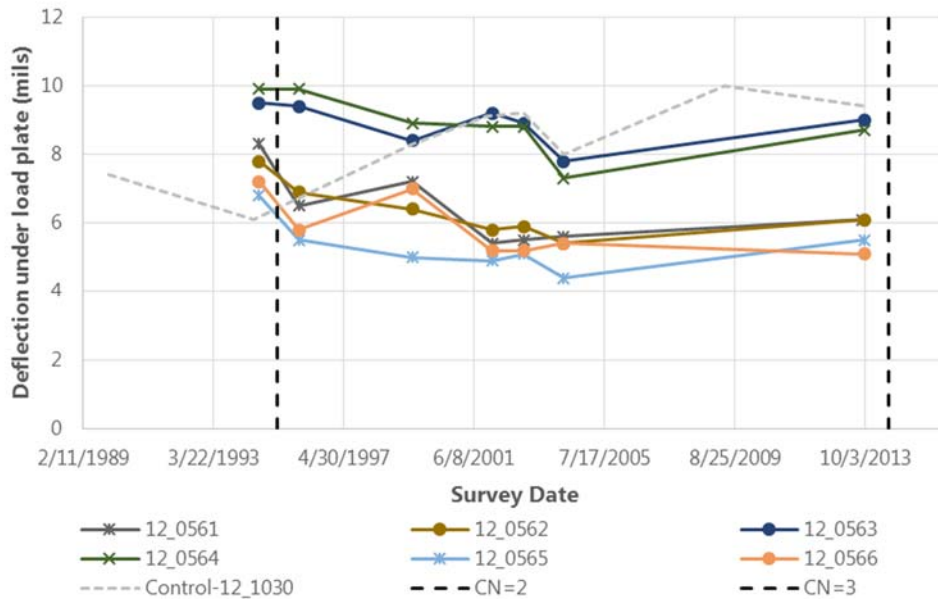
Figure 1. Average deflection for the sensor located in the load plate normalized to 9,000 lb. drop load over time.

As shown in Figure 1, the measured deflections ranged between 6.8 mils (section 12_0565) and 9.9 mils (section 12_0564) in 1994 prior to the application of the overlays. After the application of the first AC overlay in 1995, the deflections for all sections appear to have decreased, including the control test section, which did not receive an overlay. Between 1995 and 2004, the deflections observed on all sections remains relatively consistent, with slight variations in the deflections reported. The variations are consistent with the variability of temperatures during testing dates. By 2009, the deflections observed on most sections increased with values ranging from 4.6 mils to 10 mils in 2009. The deflections observed on the test sections in October 2013, prior to the second overlay ranged between 5.0 mils (section 12_0507) and 9.0 mils (section 12_0563). The control section 12_1030, which did not receive an overlay, appears to have higher deflections than the other site test sections, with an average deflection of 10 mils in 2009.

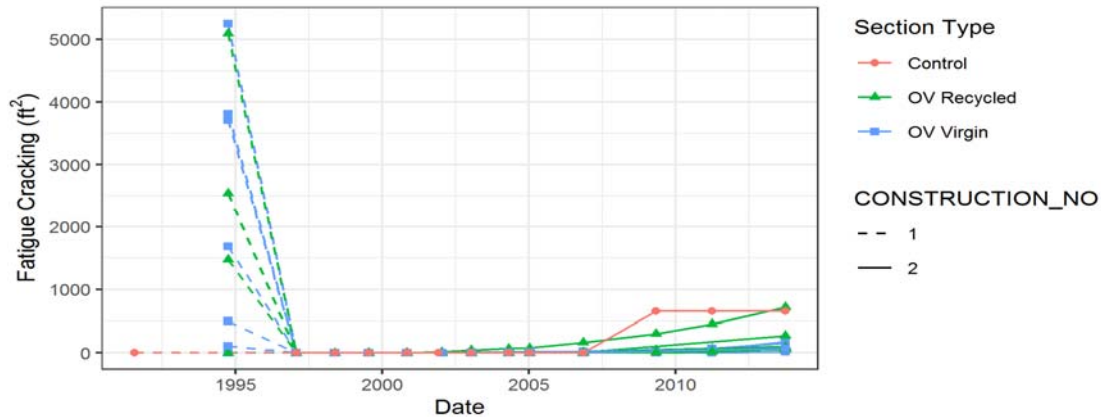
Figure 4. Fatigue cracking measurements before and during SPS-5 experiment.

Figure 4 shows that nine of the test sections had fatigue cracking before application of the 1995 AC overlay, with some test sections reporting values greater than 2,000 ft². This was considered relevant to the study and therefore this factor was taken into consideration as those test sections with higher amounts of alligator-fatigue cracking prior to the overlay were considered more prone to the earlier appearance of cracks on the surface after application of the overlay. It is interesting that the control test section, unlike the other test sections at the site, did not exhibit any fatigue-alligator cracking until 2009. It did however

experience significant block cracking, which can be a mixture of different types of cracks and confound distress analysis based on separate distress data.

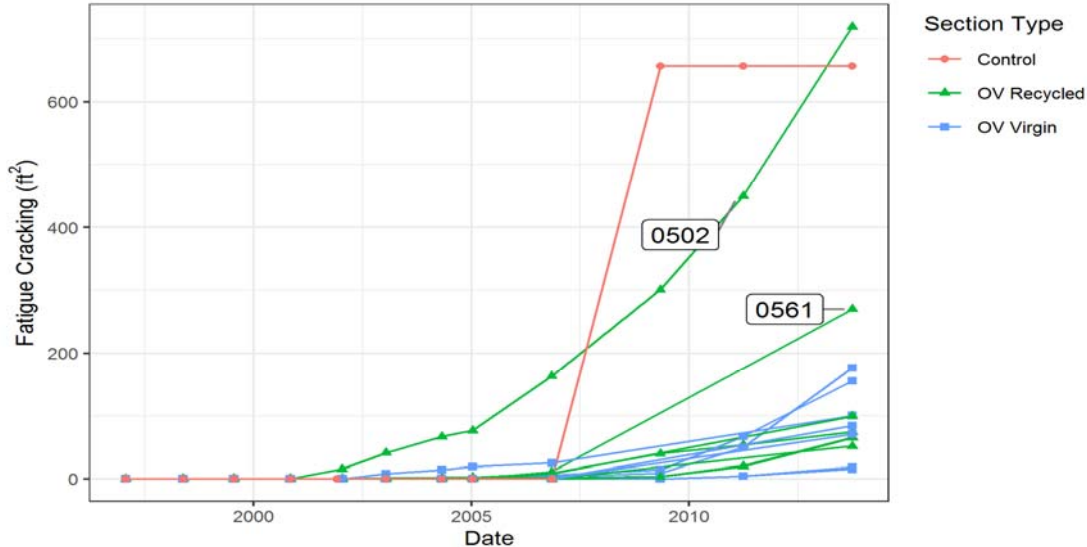
Figure 5. Fatigue cracking measurements during SPS-5 experiment.

Figure 5 shows that the test sections after placement of the 1995 AC overlay vary in terms of the number of years for FCRK initiation. Two sections (SHRPs 0502 and 0561) appear to deteriorate at a faster rate, while the performance curve for the control section shows a sudden increase in FCRK after 2007 while all other test sections show a smooth progression of FCRK over time. This cracking increase on the control test section might have been the progression of block cracking to smaller alligator cracks. It is also worth noting that except for the three referenced test sections, the FCRK values are relatively low for the remaining test sections.

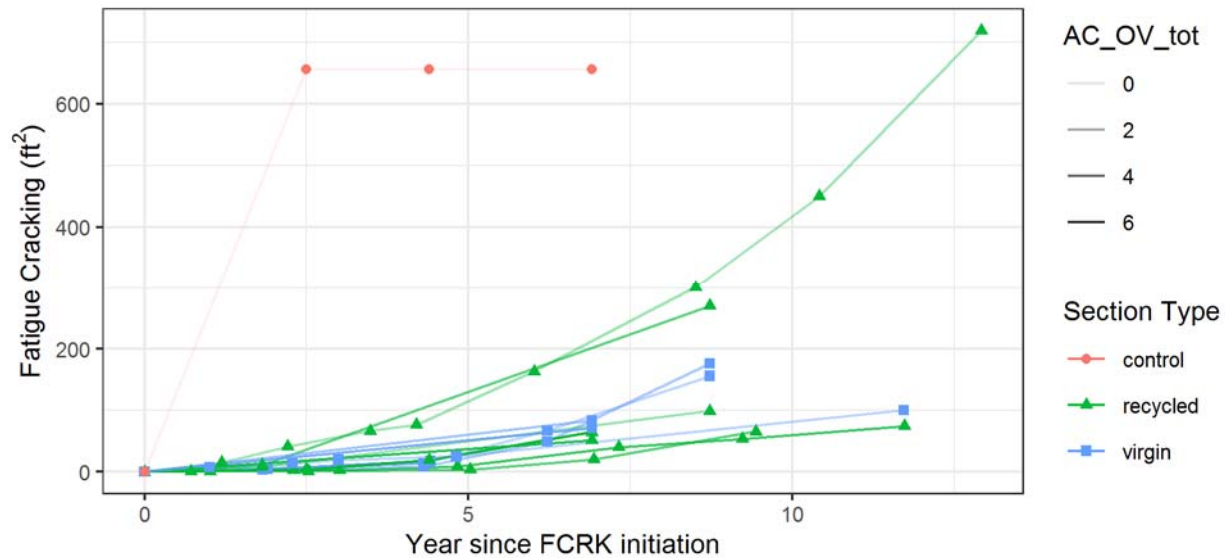
Figure 6. Fatigue/alligator cracking measurements in analysis dataset after crack initiation.

The p-values reported in Table 8 indicate that $Mill_{tot}$, AC_{rem} , and CRK_{ini} were the variables with a statistically significant effect on the deterioration rate. The effects of AC_{rem} and CRK_{ini} were positive; the higher the total thickness of pre-existing AC layers after milling and the greater the number of years until

fatigue cracking shows, the faster the fatigue growth rate. On the other hand, the greater the milling depth ($Mill_{tot}$), the slower the fatigue cracking growth rate.

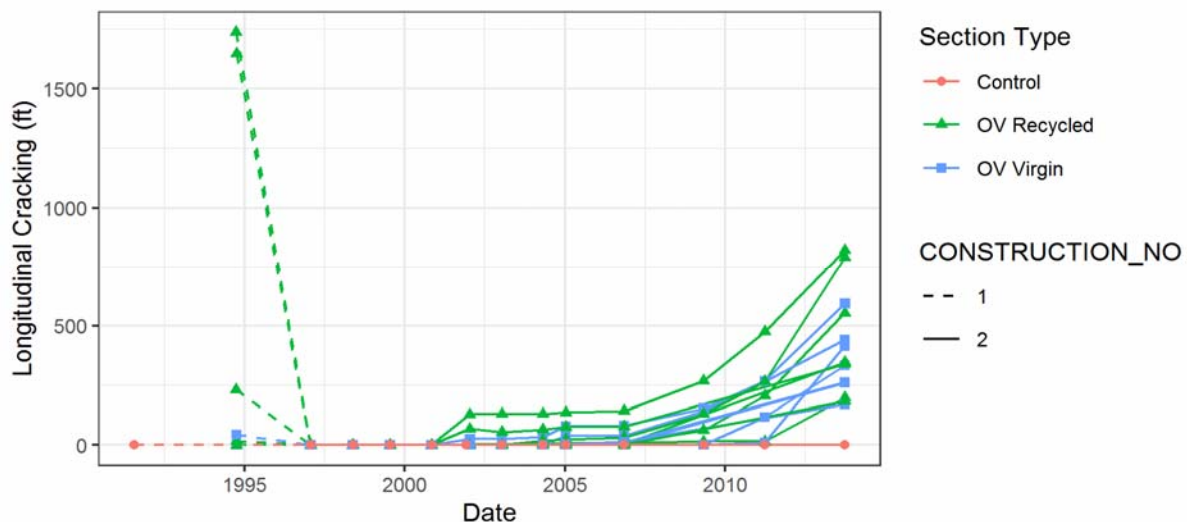
Figure 7. Longitudinal cracking measurements before and during SPS-5 experiment.

Figure 7 shows that five of the test sections presented longitudinal cracking before they were overlaid, while Figure 8 shows that there was no longitudinal cracking for at least six years (1995 to 2001) following the application of the AC overlay. Moreover, the test sections vary regarding the deterioration rate and the number of years until LCRK initiation.

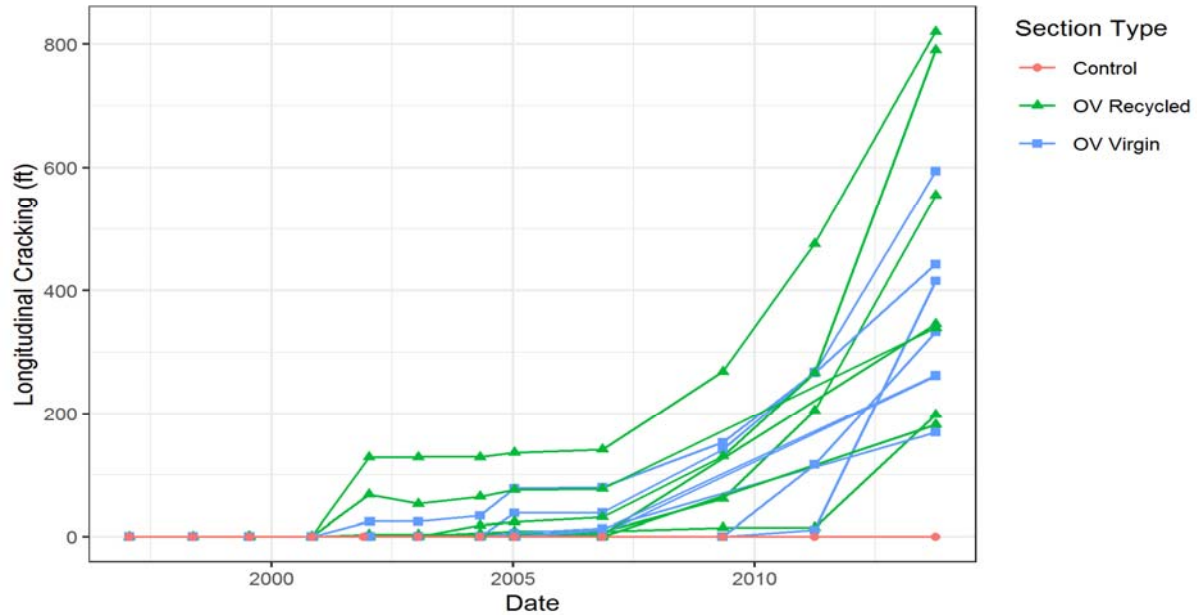
Figure 8. Longitudinal cracking measurements during SPS-5 experiment.

However, while none of the treatment factors played a significant role in the initiation of longitudinal cracking, the increase in precipitation that occurred in 1999, may have played a role. Additional analysis of the effect average annual precipitation had on the initiation and propagation of cracking is recommended.

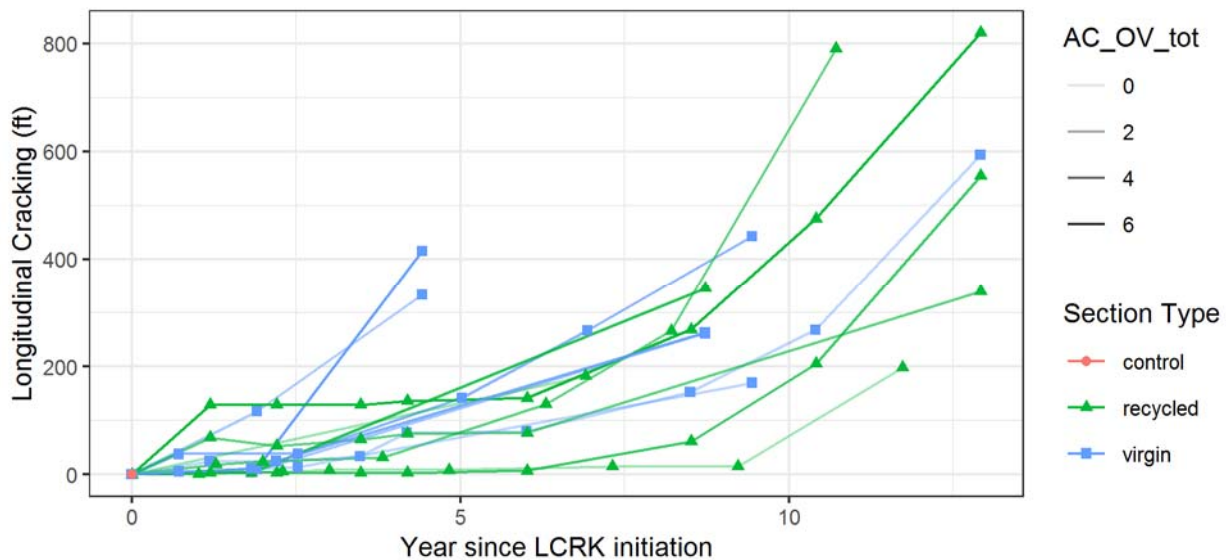
Figure 9. Longitudinal cracking measurements in analysis dataset after crack initiation.

Figure 9 shows the longitudinal cracking performance curves after cracking initiation. Different candidate propagation models were estimated to assess the effect of the different overlay treatment factors on the deterioration rate after crack initiation. These models were specified as exponential and included only overlaid test section data (i.e., no control test section data). After trying the different models, it was found that none of the available variables had a statistically significant effect on the deterioration rate over time of longitudinal cracking, which is likely due to the high variability in the results versus the primary experimental factors. In other words, there were no clear trends, statically or otherwise.

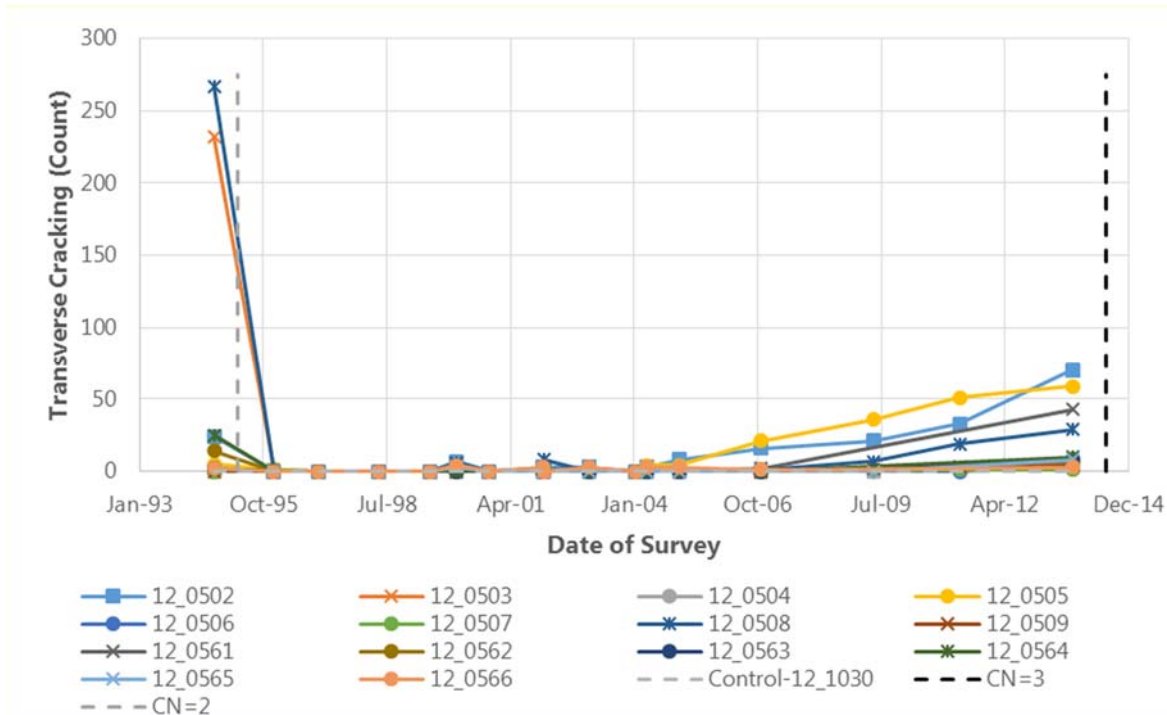
Figure 10. Time history of the number of transverse cracks.

Figure 10 summarizes the number of transverse cracks that were observed prior to and after the application of the 1995 AC overlay. Immediately following the application of the AC overlay in 1995, no significant amount of transverse cracking was observed on the test sections. As shown in the figure, transverse cracking was relatively stable between 1995 until 2005. By 2005 or 10 years after the application of the AC overlay, the amount of transverse cracking observed slowly increased for most of the test sections. By 2013, the amount of transverse cracking observed on the test sections varied from 0 (section 12_1030) to 70 (section 12_0502).

The cause of the transverse cracking initiation and propagation remains unclear. The type and thickness of the asphalt overlay selected did not seem to play a clear role. Because transverse cracking is typically a result of environmental factors, further assessment of the climatic factors at the sites need to be investigated.

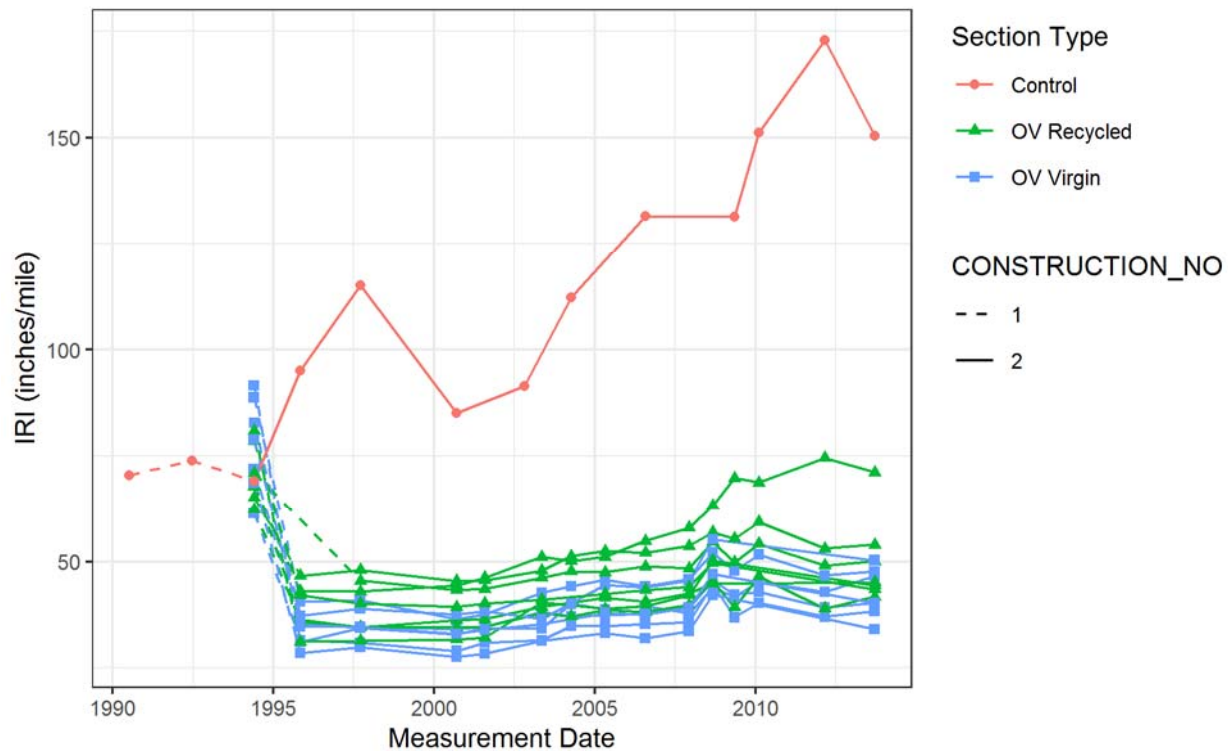
Figure 11. IRI measurements in analysis dataset.

Going back to Figure 11, this figure also suggests that the control test section deteriorated faster than the overlaid test sections, and that there is also a slight difference in deterioration rate between overlays using

virgin AC versus RAP mixtures. These variations in the deterioration rate may be a consequence of applying the overlays, having higher initial IRI, higher total AC thickness, or a combination of these and other factors. The analysis in the next section aims to address the effect of these factors.

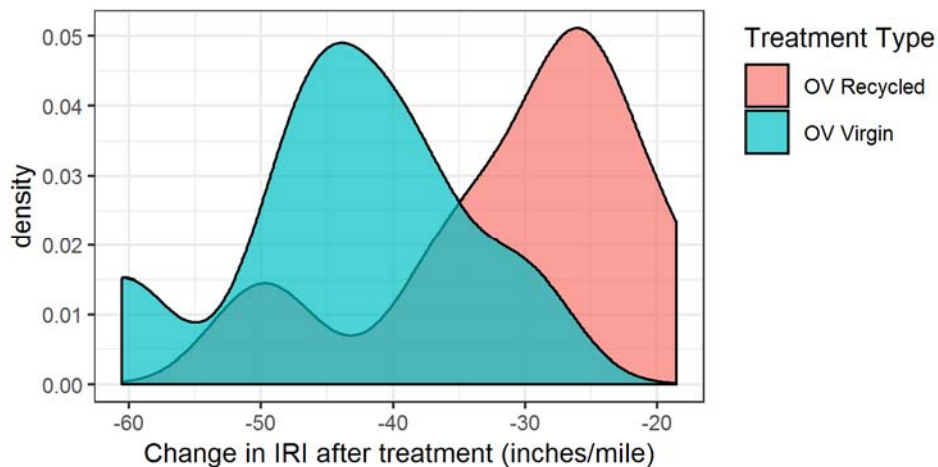
Figure 12. Distribution of drop in IRI before and after 1995 AC overlay.

The figure suggests that the test sections that the virgin AC mixtures resulted in higher reductions in IRI. Based on the p-value from a t-test between these two groups, the difference in the mean change in IRI values was statistically significant (with a 10% confidence level).

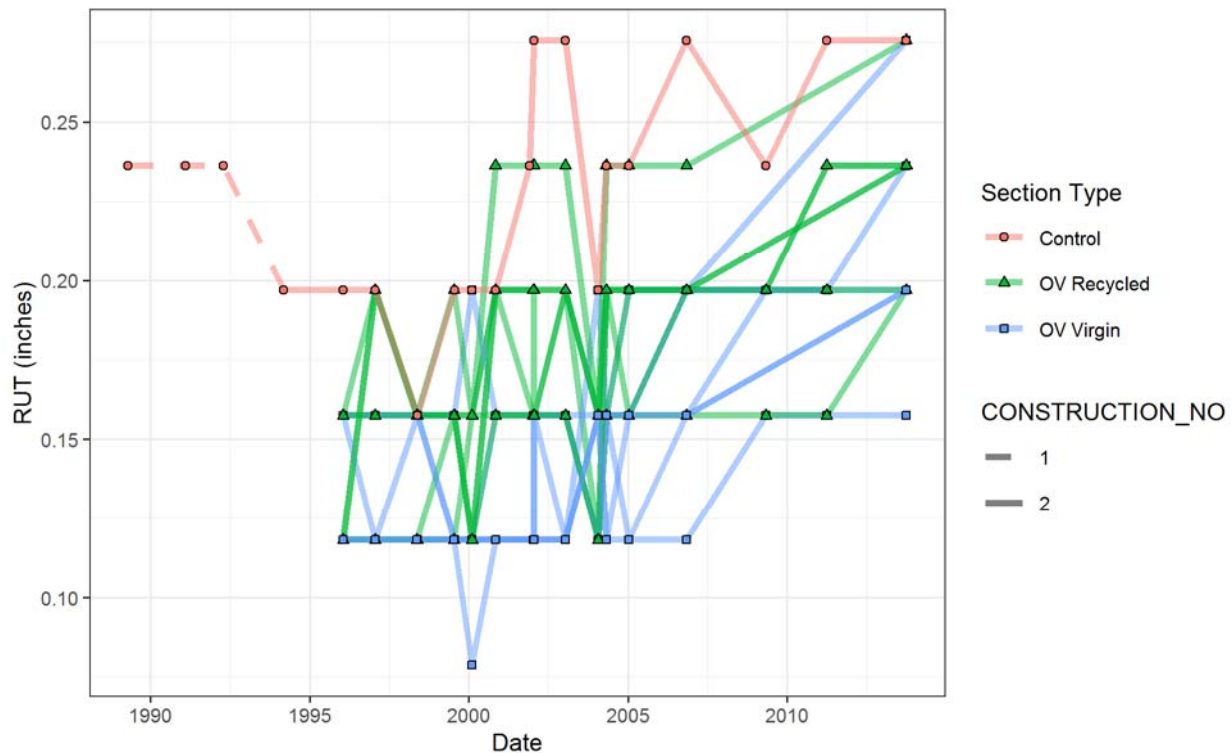
Figure 13. Rutting measurements in analysis dataset.

Figure 13 shows that none of the test sections reported significant rutting. Both the rutting values and the increase in rutting over the analysis period were not high. The performance curves in the figure show a drop in RUT value after application of the AC overlay; however, this drop does not appear to vary significantly. Both groups of test sections (virgin and recycled mixes) had an initial RUT value lower than the one for the control test section by 0.06 inches on average. Given the observed low magnitude and variability of rutting, no further analysis was performed on this condition metric.
