## Technical Memorandum

**Re:** Forensic Desktop Study Report: Georgia LTPP Test Section 13\_7028

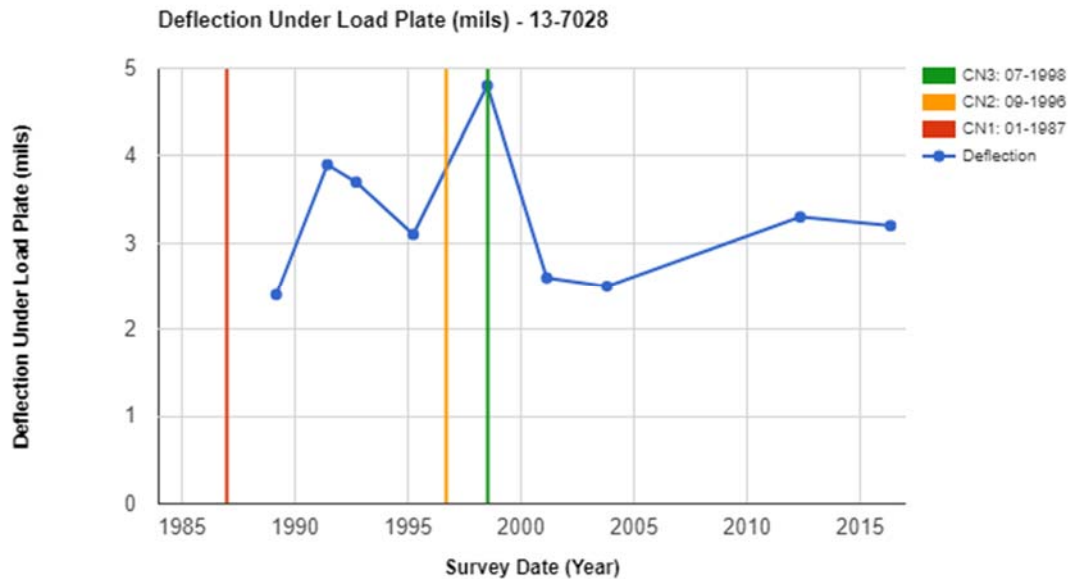
**Figure 2. Time history of average deflection for the sensor located in the load plate normalized to 9,000 lb. drop load.**

Figure 2 shows the average Falling Weight Deflectometer (FWD) deflection under the nominal 9,000-pound load plate over time. The deflection of the sensor located in the center of the load plate is a general indication of the total “strength” or response of all layers in the pavement structure to a vertically applied load. This deflection can be influenced by pavement temperature at the time of testing, precipitation, and moisture. As depicted in Figure 2, the deflections observed on the site fluctuate over time. The reported deflections over the load plate are greatest in June 1991 (3.9 mils) and July 1998 (4.8 mils; this was also the last set of deflection measurements before 1998 mill and overlay, so there could be some impact related to the deterioration of the existing AC layer), which correspond to high temperature collection dates as depicted in Table 3. However, overall, the deflections reported are low, ranging between 2 and 5 mils.

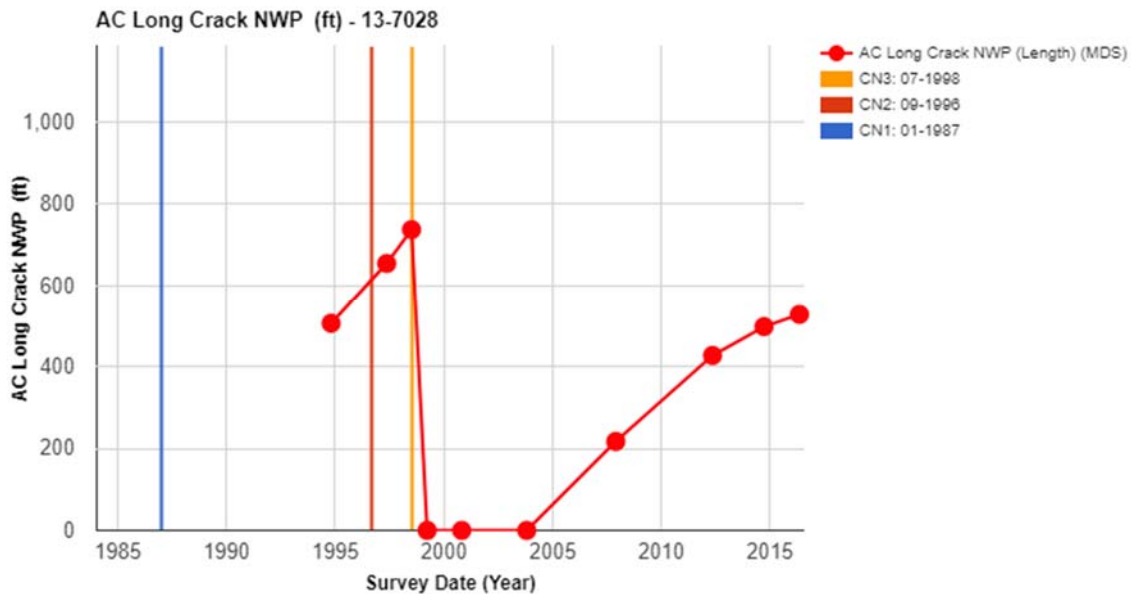
**Figure 7. Time history of the length of NWP longitudinal cracking.**

Data on longitudinal cracking, inside and outside the wheel paths of the test section, was collected between 1994 and 2016 as shown in Figures 7 and 8. Non-wheel path longitudinal cracking (NWP) was reported the first year a manual distress survey (MDS) was conducted. In 1994, 506 feet of NWP was reported, 8 years after CN=1. The NWP longitudinal cracking continued to increase at a rate of 58 feet/year over the next four years or at rate of 61 feet/year between 1986 and 1998 (assuming there was

no NWP longitudinal cracking on the test section after it received an AC overlay in 1986). Following the overlay event in July of 1998, the NWP longitudinal cracking observed on the section dropped to zero. NWP longitudinal cracking was not reported again until 2007 (9 years after the AC overlay) when 217 feet of NWP longitudinal cracking was observed. Once cracking was initiated, it propagated at a rate of 34 feet/year between 2007 and 2016, approximately half the rate of propagation reported prior to the AC overlay in 1998. A comparison of the distress maps before and after the overlay in 1998 shows the NWP longitudinal cracking appears in similar locations along the section (at the edge and along the longitudinal joint of the test section) as depicted in Figure 9. This indicates the NWP longitudinal cracking observed after the application of the overlay in 1998 is likely a reflection of the NWP longitudinal cracking observed before the overlay.

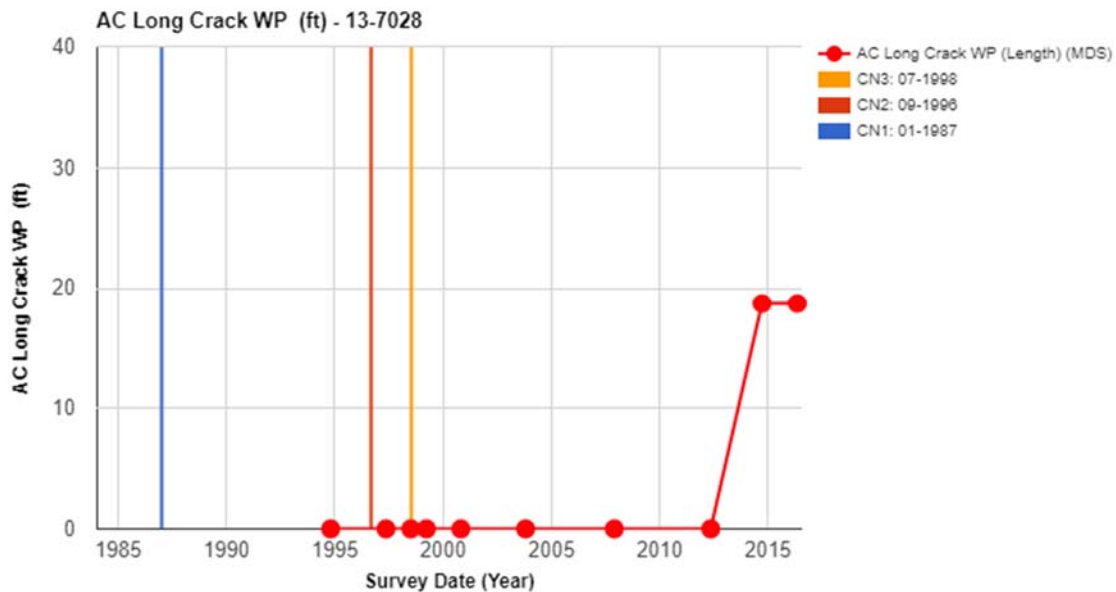
**Figure 8. Time history of the length of WP longitudinal cracking.**

Longitudinal cracking in the wheel path does not appear on the pavement section until 2014, 16 years after the application of the AC overlay, when 19 feet of low severity, sealed longitudinal cracking in the wheel path was observed. As indicated on the 2014 manual distress survey and as shown in Figure 9, the "longitudinal cracking" on the WP is a result of a rim gouge rather a typical distress mechanism, which is technically correct given LTPP rating procedures. Therefore, no increase in WP longitudinal cracking is reported in 2016.

4. **Exploring and clarifying the reason for the small quantity (19 feet) of wheel-path (WP) longitudinal cracking observed in the 2014 and 2016 distress surveys.** Longitudinal cracking on the wheel path does not appear on the pavement section until 2014, 16 years after the application of the AC overlay, when 19 feet of low severity, sealed longitudinal cracking in the wheel path is observed. As indicated on the 2014 manual distress survey, the "longitudinal cracking" on the WP is a result of a rim gouge rather a typical distress mechanism. Therefore, no increase in WP longitudinal cracking is reported in 2016.

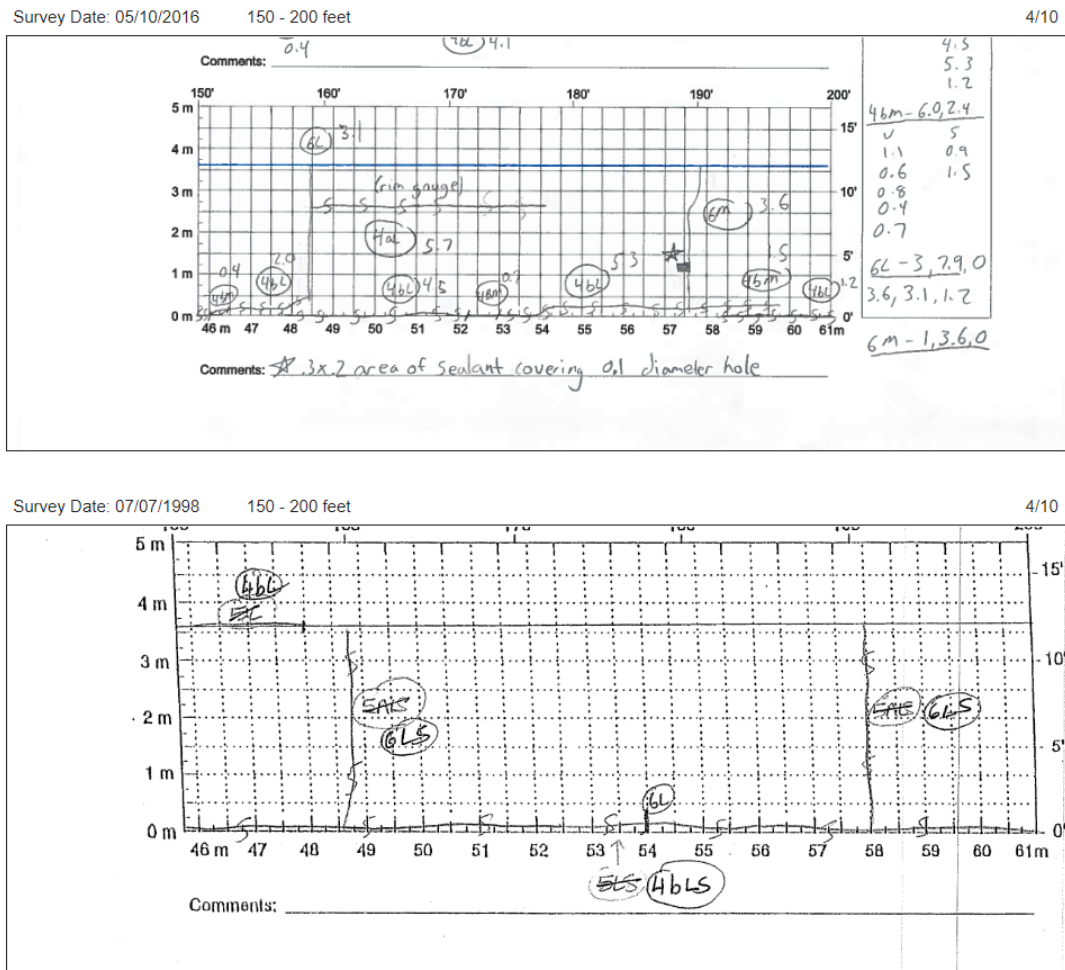
**Figure 9. Distress survey map between sta 01+50 and 02+00 in 2016 (top) and 1998 (bottom).**

This indicates that the transverse cracking observed after the application of the overlay in 1998 is likely a reflection of the transverse cracking observed before the overlay. As depicted in Figure 9, the transverse cracks appear approximately every 30 feet, which likely corresponds to the contraction joint spacing of the PCC layer.

2. **Confirming the transverse and NWP longitudinal cracking is reflection cracking.** A comparison of the distress maps before and after the AC overlay in 1998 shows that the transverse and NWP longitudinal cracking appears in similar locations along the test section (approximately every 30 feet and at the edge and along the longitudinal joint of the test section, respectively).

Based on the information gathered and analyzed in the above sections, only close-out monitoring (not including FWD testing) and coring is recommended at this time. The coring will be used to confirm that the test section thicknesses (including the PCC layer) match those reported when the test section was incorporated into the LTPP program and that the transverse and NWP longitudinal cracking reported is being reflected from the PCC joints.

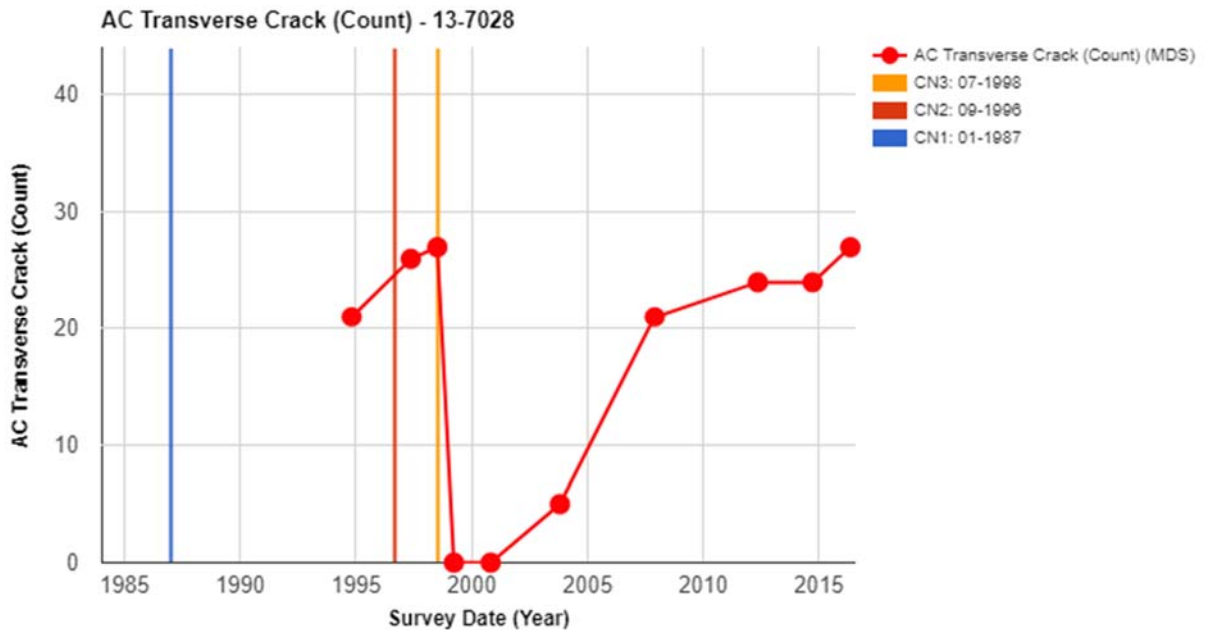
Figure 10. Time history of the number of transverse cracks.

Data on transverse cracking was collected between 1994 and 2016 as shown in Figures 10 and 11. Transverse cracking was reported the first year the manual distress survey (MDS) was conducted. In 1994, 210 feet (21 cracks) of transverse cracking was reported, 8 years after the construction of the test section. The transverse cracking continued to increase at a rate of 4.5 feet/year from 1994 to 1998 (or at a rate of 19 feet/year between 1986 and 1998 assuming there was no transverse cracking on the test section after it received an AC overlay in 1986). Following the overlay in July of 1998, the transverse cracking observed on the section dropped to zero. Transverse cracking was not reported again until 2003 when 15 feet (5 cracks) of transverse cracking was observed, 5 years after the AC overlay. Once cracking was initiated, it propagated at a rate of 15 feet/year between 2003 and 2016, which is slightly less than the rate of propagation reported prior to the AC overlay in 1998. A comparison of the distress maps before and after the overlay event in 1998 shows that the transverse cracking appears in similar locations along the section.

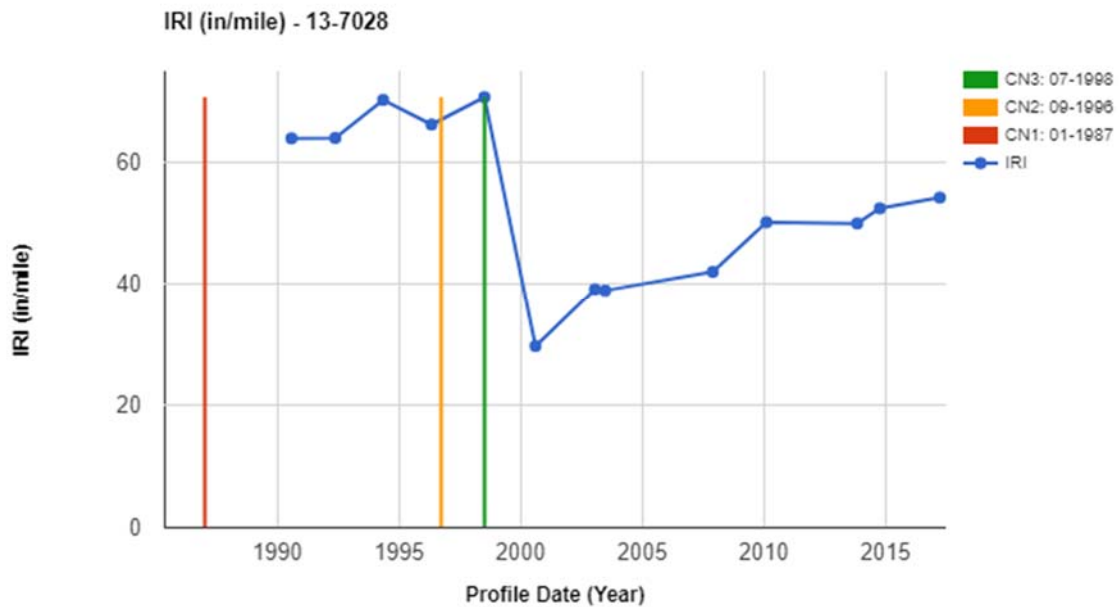
**Figure 12. Time history plot of pavement roughness.**

The average IRI measurements for the section over time are shown in Figure 12. Prior to the AC overlay in 1998, the IRI reported on the test section slightly increases from 64 in/mile in 1990 to 71 in/mile in 1998, at a rate of 0.9 in/mile/year, which is extremely low and indicative of how smooth the pavement has been throughout its life. Following the AC overlay in 1998, the IRI on the section drops to 30 in/mile in 2000. The IRI reported increases to 54 in/mile in 2017, increasing at a rate of 1.4 in/mile over the next 17 years. The pavement's IRI performance is classified as "Good" based on FHWA performance definitions.

Despite the amount of cracking observed on the section before and after the overlay in 1998, the IRI reported on the section remains relatively low. This is likely due to the type of cracking reported on the test section. Prior to the overlay, all cracking observed on the section is low severity. Following the overlay, the cracking observed on the section is low and medium severity cracking with most of the cracking observed being low severity. Additionally, the cracking most affecting the IRI of the test section is predominantly transverse cracking, which has reflected to the surface from the transverse joints of the PCC layer. Furthermore, it is hypothesized that the underlying PCC layer has contributed significantly to the smoothness of the pavement over time.

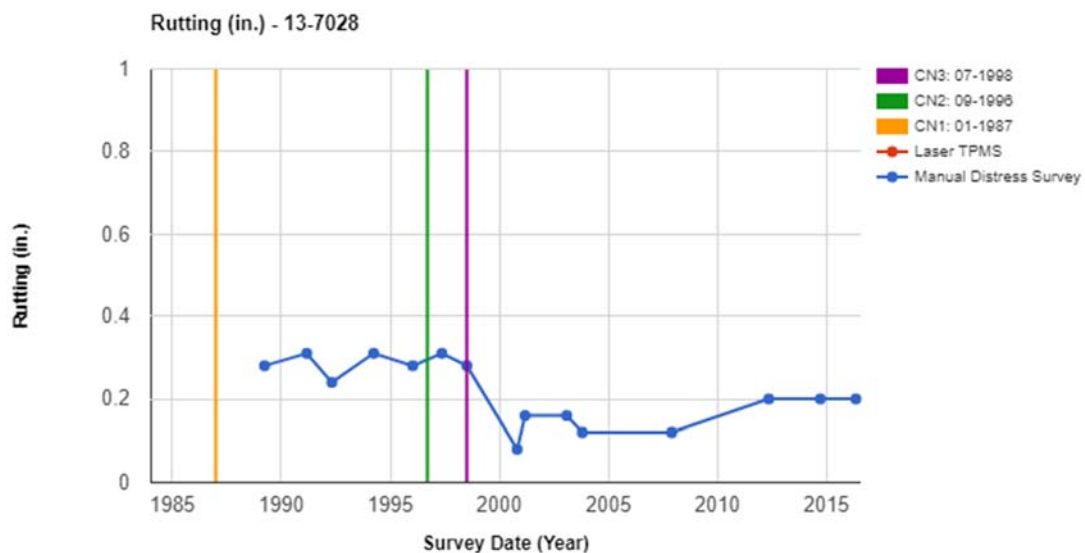
**Figure 13. Time history plot of average rut depth computations.**

The rutting observed over time on the test section is shown in Figure 13. Prior to the 1998 overlay, the rut depths observed on the overlay are consistent, with the average reported rut depth being 0.29 inches. Following the overlay in 1998, the rutting observed on the section decreases to 0.08 inches in 2000. The rutting observed increases slightly between 2000 and 2016 when a rut depth of 0.2 inches is reported on the test section. The lower levels of rutting after the 1998 AC overlay can be attributed to the stiffness of the AC layer applied in 1998 overlay.
