Technical Memorandum

Re: Forensic Desktop Study Report: Maryland LTPP Test Section 24_1634

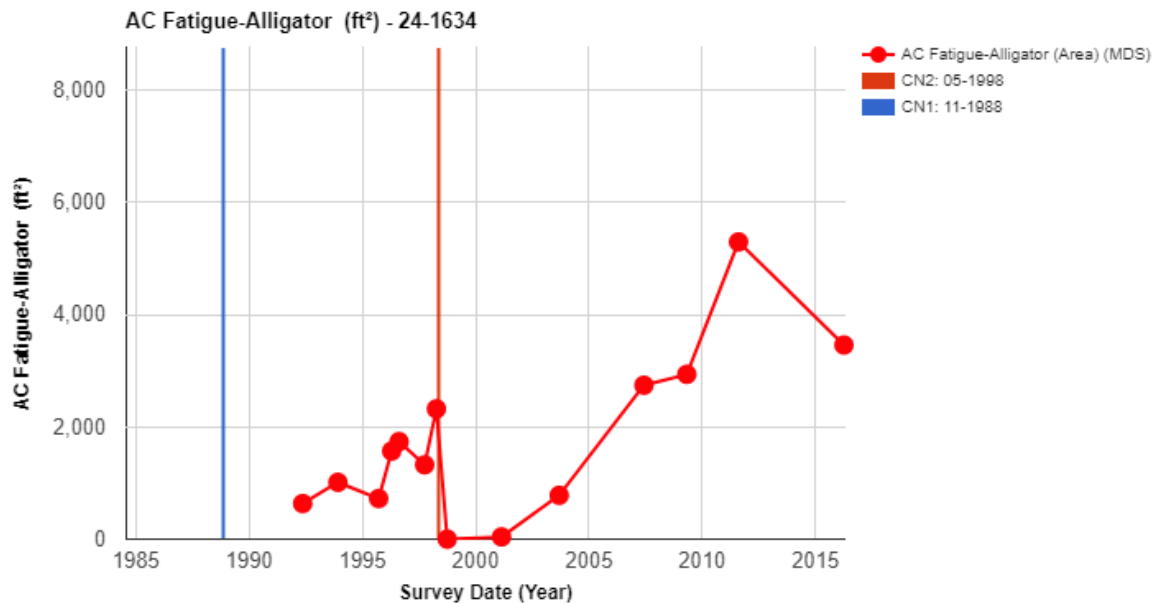
Figure 14. Time history of the length of fatigue cracking.

Figure 16 shows the total area in which fatigue/alligator cracking was observed for the section between 1992 and 2016. While the graph obtained from InfoPave™ is labelled fatigue cracking, which implies a mechanism, the distress values reported includes both fatigue cracking (inside the wheelpath) and alligator cracking (outside the wheelpath).

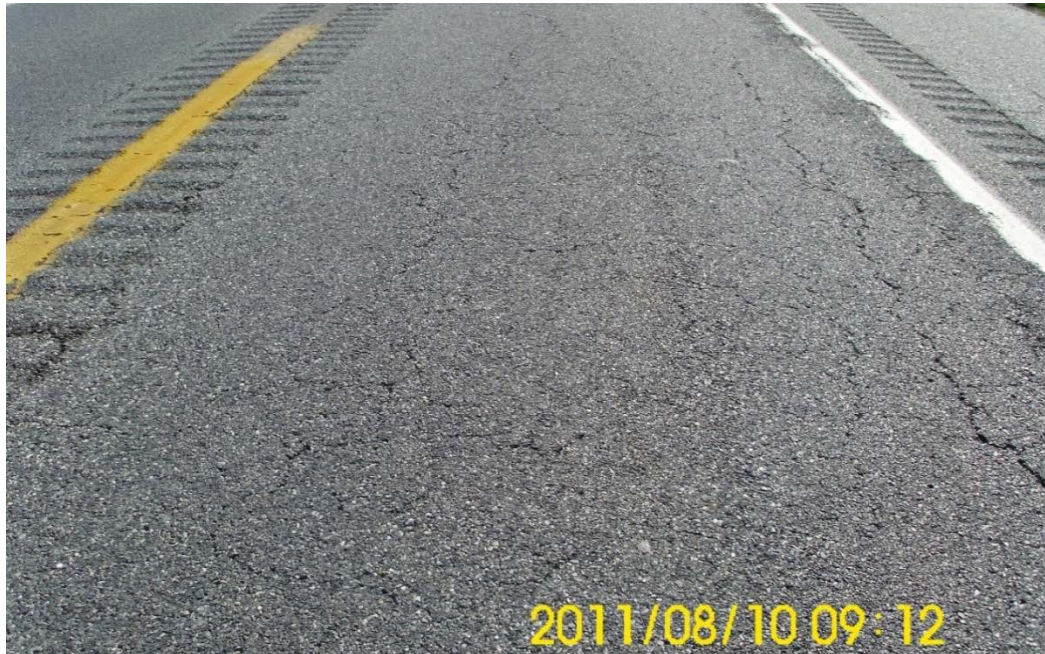
Figure 15. Fatigue cracking on the section in 2011.

Fatigue/alligator cracking was first reported during the manual distress survey in 1992, when 634 ft² was observed. The fatigue/alligator cracking observed increased between 1992 and 1998, reaching 2,321 ft² prior to the overlay, propagating at a rate of 281 ft²/year. After the overlay in May 1998, no fatigue cracking was observed until 2001 when 40 ft² of fatigue/alligator cracking was reported. Once observed, the cracking propagated at a rate of 525 ft²/year between 2001 and 2011, or nearly double the rate of propagation prior to the overlay. The fatigue/alligator cracking observed in 2016 decreased to 3,457 ft², likely due to differences in rater opinions between the 2011 and 2016 surveys. The rater in 2011 considered the full area of the last 200 feet of the pavement section to be fatigue cracking, whereas the rater in 2016 did not. The fatigue cracking observed in 2016, shown in Figure 17, was predominantly located inside the wheel paths between 2 and 5 feet and 7 and 10 feet from the right edge of the lane.

The increase in fatigue/alligator cracking following the overlay in 1998 may be related to pavement aging and overall structural degradation. The overlay event in 1998 did not appear to rejuvenate the original pavement structure and therefore, provided only near-term improvement. The original structure was constructed in 1976 and therefore, may have been experiencing increased cracking due to long-term environmental exposure and traffic loadings. This hypothesis is further supported by the high amounts of material degradation (raveling) reported throughout the section during the last two pavement distress surveys. Another potential reason for the increase in the fatigue/alligator cracking following the overlay in 1998 is the slightly increased levels of precipitation following the overlay. As water infiltrates the pavement layers, the base and subgrade tend to weaken (especially when reaching saturation conditions) possibly causing the increase in fatigue cracking observed.

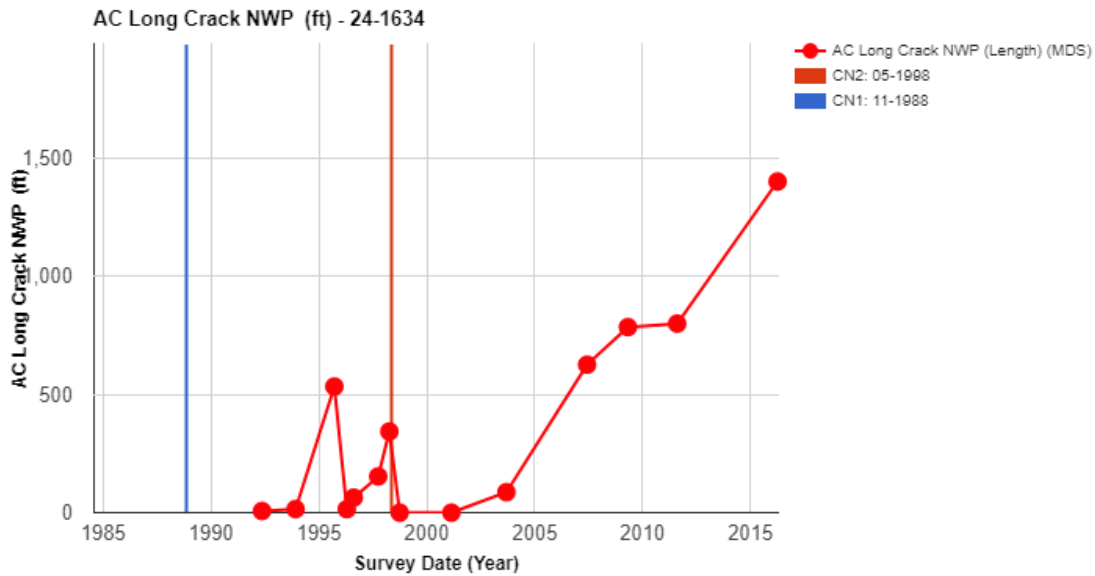
Figure 16. Time history of the length of NWP longitudinal cracks.

Non-wheel path (NWP) longitudinal cracking, depicted in Figure 18, was first reported during the manual distress survey in 1992, when 7 ft of cracking was observed. The NWP longitudinal cracking observed fluctuated between 1992 and 1998, with a spike in NWP longitudinal cracking in September 1995. The spike seemed to be related to the misidentification of fatigue cracking (outside the wheel path) as NWP longitudinal cracking. After the overlay in May 1998, no NWP longitudinal cracking was observed again until 2003 when 87 ft of NWP longitudinal cracking was observed. Once observed, the cracking

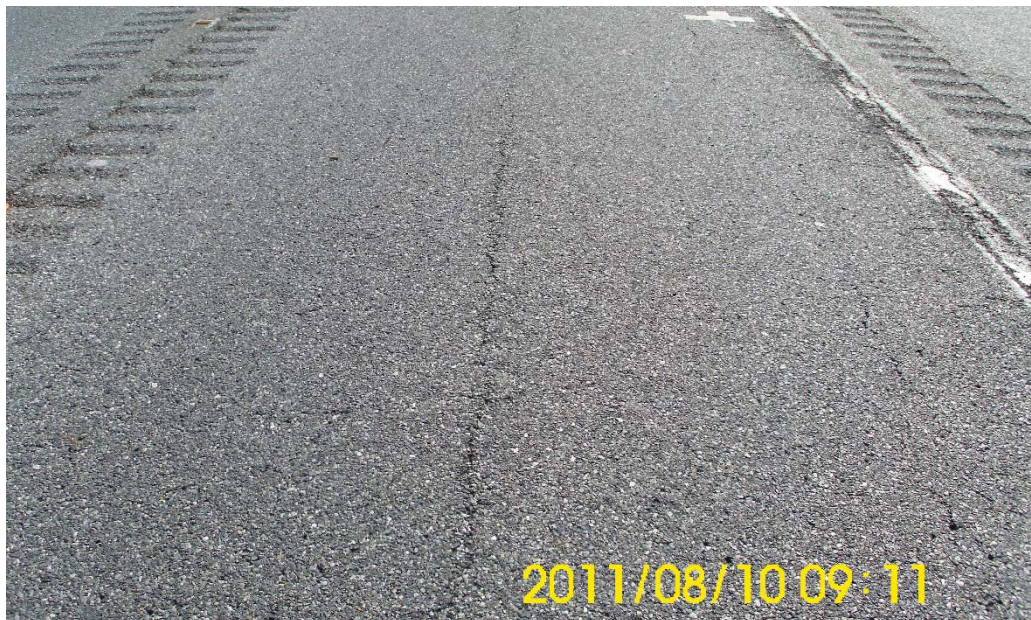
Figure 17. NWP longitudinal cracking on the pavement section in 2011.

propagated at a rate of 101 ft/year between 2003 and 2016, reaching 1,403 ft in 2016. The NWP longitudinal cracking observed in 2016 was located in the center (between the wheelpaths) and at the edges of the lane as depicted in Figure 19. Moreover, the cracking observed following the overlay propagated more rapidly than prior to the overlay. It is hypothesized that the increase in NWP longitudinal cracking following the overlay is related to the increased levels of precipitation and aging/structural deterioration of the pavement section.

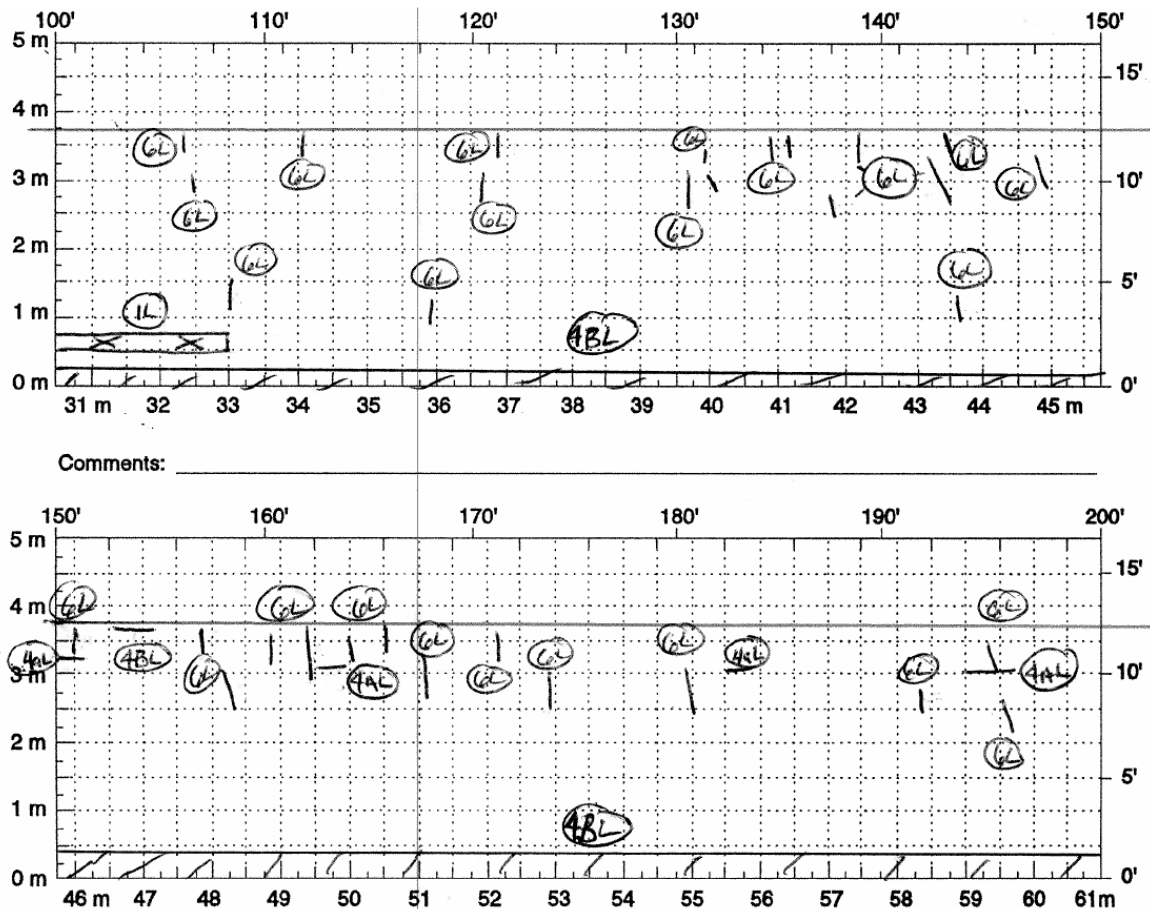
Figure 20. Transverse cracking reported on the pavement section in September 1995.

Data on transverse cracking was collected between 1992 and 2016 as shown in Figure 20 and Figure 21. Unlike the fatigue/alligator cracking and NWP longitudinal cracking observed on the section, most of the transverse cracking observed occurred prior to the overlay in 1998. Transverse cracking was first reported during the manual distress survey in 1992, when 54 ft of cracking (27 cracks) was observed. The transverse cracking fluctuated between 1992 and 1997, reaching 225 ft (140 cracks) in 1997. However, the length of transverse cracks observed abruptly fell to 5 ft (1 crack) in April 1998, just prior to the AC overlay. The transverse cracking observed prior to this event consisted of short (1.5 ft), low severity cracks every 2 to 5 feet as shown in Figure 22. Given the typical length and severity, these cracks may have been difficult for raters to see and therefore, accurately report. After the overlay in May 1998, no transverse cracking was observed again until 2003 when 2 ft of transverse cracking (1 crack) was reported. Once observed, transverse cracking spiked in 2009 when 60 ft of cracking (40 cracks) was reported, and subsequently decreased reaching 10 ft (5 cracks) in 2016. This spike appeared to be the result of fatigue/alligator cracking being misidentified or reported as transverse cracking in 2009.

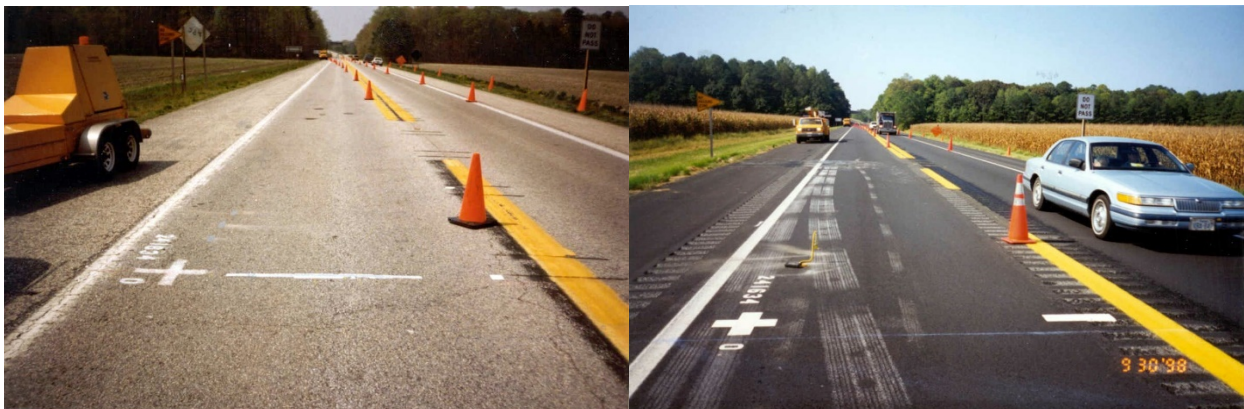
Figure 21. Rumble strips prior to (left) and following (right) the 1998 overlay.

In addition to the findings presented above, it is important to note the presence of rumble strips along the centerline of the pavement section both prior to and following the overlay, which likely contributed to the transverse cracking reported throughout time. Prior to the overlay, a set of saw and seal lines, depicted in Figure 23, which are seen in the site images in 1993, were placed approximately every five feet. Following the overlay, conventional rumble strips were placed along the centerline throughout the length of the section. While per the LTPP Distress Identification Manual, these saw and seal areas should be counted as cracks, they are not reported as such in the distress surveys. Instead, transverse cracks that appear to be related to, but not including, these saw and seal lines are reported prior to the overlay.

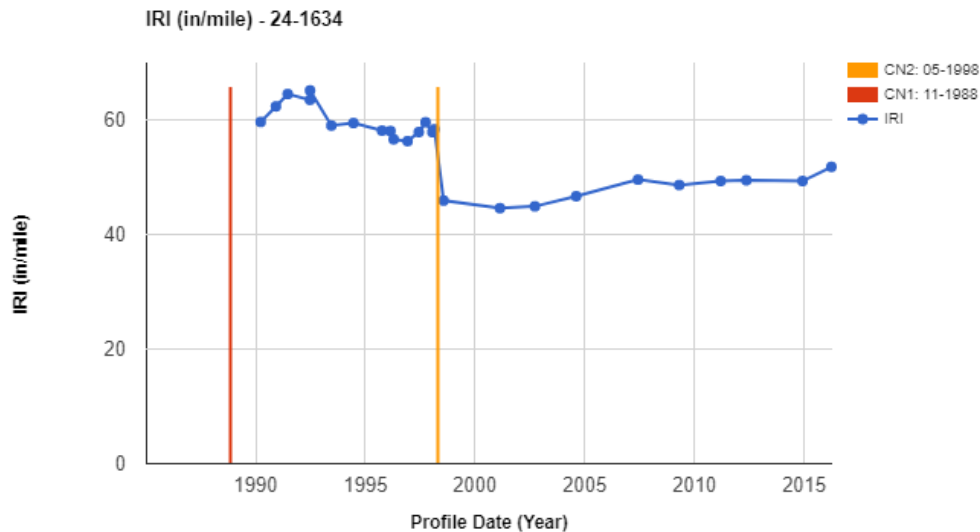
Figure 22. Time history plot of pavement roughness.

The average IRI measurements for the section over time are shown in Figure 24. The IRI on the section prior to the overlay averaged 60 in/mi, which means the performance of the pavement could be classified as “Good” based on FHWA performance definitions. Following the overlay of the pavement in 1998, the IRI dropped to 46 in/mi in July 1998. The IRI following the overlay remained low, with an average IRI of 48 in/mi between 1998 and 2016.

The low levels of IRI reported throughout the pavement’s history do not align with amount of cracking observed on the section, particularly following the overlay when high amounts of fatigue/alligator cracking are observed. As depicted in the figure above, while IRI is relatively low throughout the section’s history, higher IRI values are reported prior to the overlay and lower values are reported after the overlay. This observation points out why Departments of Transportation should not solely rely on IRI in assessing pavement performance. As the severity level of the cracking is predominantly low, the impacts on IRI are correspondingly low—higher severity cracking would likely result in increases in IRI, but probably not in a linear relationship.

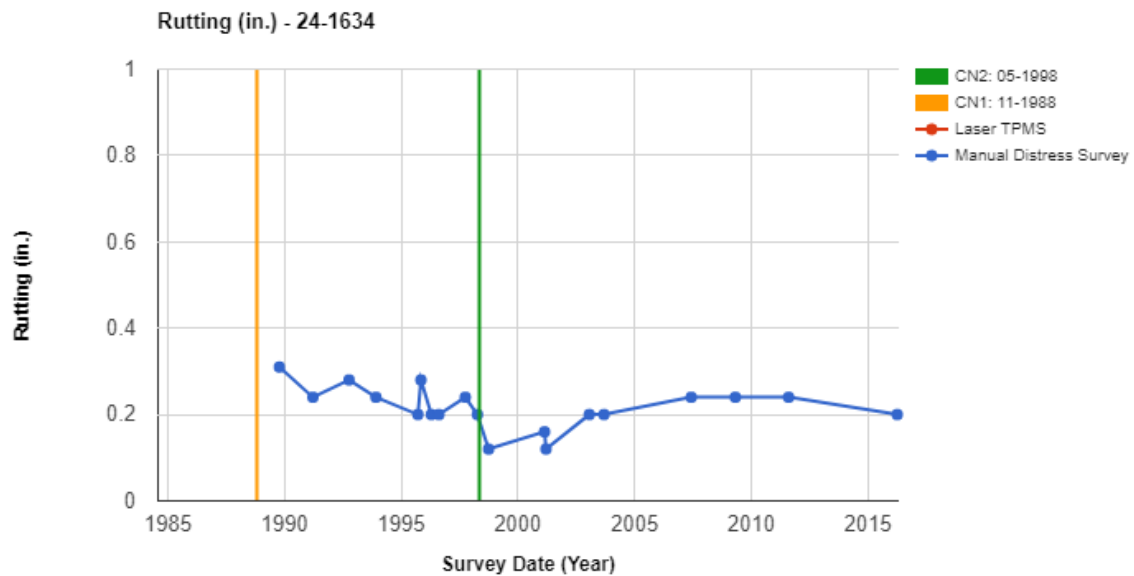
Figure 23. Time history plot of average rut depth.

The average rut depths observed for the section over time are shown in Figure 25. The rutting on the section prior to the overlay ranged between 0.2 and 0.3 in, but oddly enough decreasing over time from 0.3 to 0.2 ins. Following the overlay in 1998, the average rut depth dropped to slightly over 0.1 in. However, the average rut depth then began to increase following the overlay, with values increasing to between 0.2 and 0.3 in between 1998 and 2016.
