Technical Memorandum

Re. Forensic Desktop Study Report: Montana LTPP Test Sections 30_8129

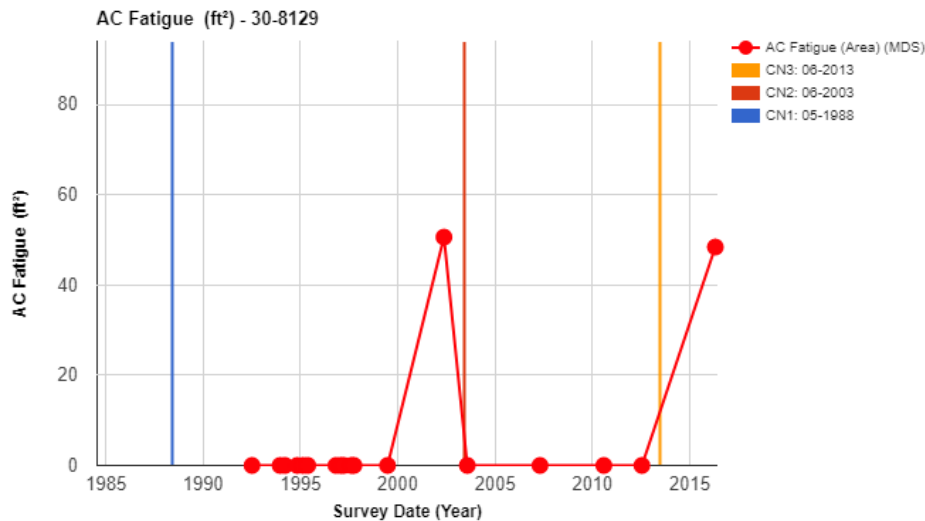
Figure 14 shows the total area in which fatigue/alligator cracking was observed for the section between 1992 and 2016. While the graph obtained from InfoPave is labeled fatigue cracking, in LTPP low severity wheel path cracking with an area component overlaps with alligator pattern cracks, which are not constrained to the wheel paths. The name fatigue cracking implies a mechanism, whereas the LTPP distress surveyors were reporting only observations of cracking on the surface of the pavement test sections following LTPP guidelines.

Figure 14. Time history of the area of fatigue/alligator cracks.

No fatigue/alligator cracking was observed on the section between 1992 and 2002. In May 2002, 14 years following CN=1, a total of 50.6 ft² of fatigue/alligator cracking was observed. Fatigue/alligator cracking observed in 2002 was predominantly low severity and within the wheel path. Following the AC overlay in 2003 (CN=2), fatigue/alligator cracking is not observed again for nearly 13 years. It is not until 2016 that 48.6 ft² of fatigue/alligator cracking was observed. Fatigue/alligator cracking observed in 2016 was also predominantly low severity and within the wheel path. However, the location (station numbers) in which fatigue/alligator cracking was observed in 2016 differed from the locations observed in 2002. The increase in fatigue/alligator cracking in 2002 and 2016 parallels the sudden increase in wheel path longitudinal cracking in those same years.

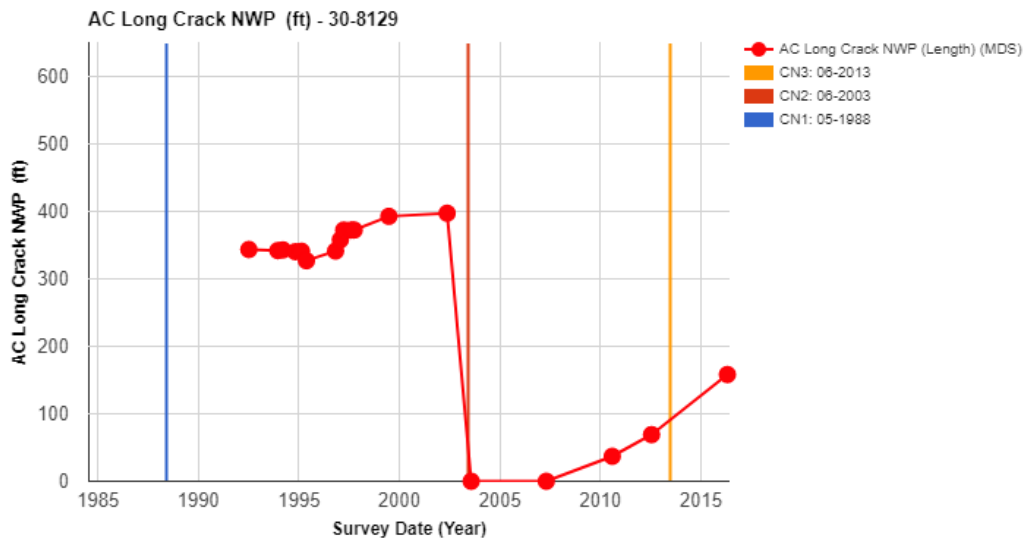
Longitudinal cracking, inside and outside the wheel paths of the test section, are defined by LTPP as cracks predominately parallel to the pavement center line and have no detectable area extent. Figure 15 depicts the longitudinal cracking observed in non-wheel path (NWP) portions of the section. The NWP longitudinal cracking observed increased from 344.1 ft in 1992 to 397.9 ft in 2002 or by 5.4 ft/year during the ten-year period or approximately 28.4 ft/year since the initial construction event (CN=1). The longitudinal cracking observed prior to the overlay predominantly occurred at the longitudinal centerline joint of the roadway. Following the AC overlay in 2003, no NWP longitudinal cracking is observed on the section until August 2010, 7 years after the overlay, when 37.1 ft of cracking was observed. By 2016, 13 years after the AC overlay, the NWP longitudinal cracking observed is 158.42 ft. The rate at which longitudinal cracking increases, once initiated, following the overlay is 20.2 ft/year, nearly quadruple the rate of increase observed prior to the overlay. The location of the longitudinal cracking following the overlay is predominantly in-between the two-wheel paths and on the longitudinal joint of the lane, which appears to be reflection cracking.

Figure 15. Time history of the length of NWP longitudinal cracks.

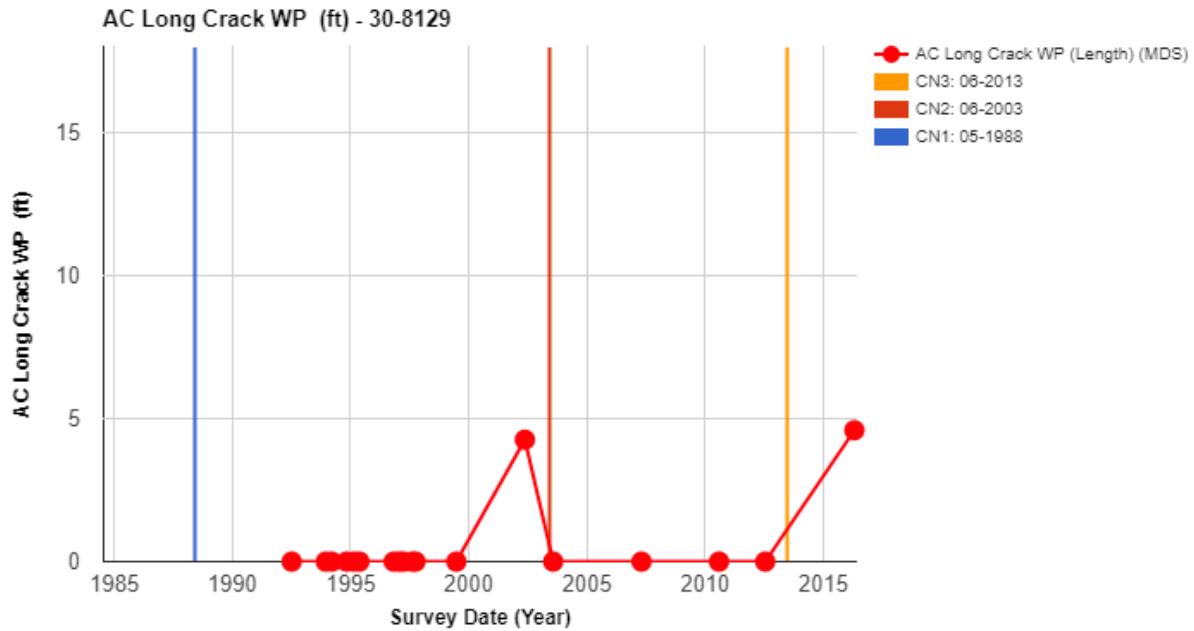
Figure 16. Time history of the length of WP longitudinal cracks.

The longitudinal cracking observed in the wheel path (WP), shown in Figure 16, between the date of the first manual LTPP distress survey (1992) and the date of the last survey before the second construction event remained consistent. Until May 2002, 14 years after CN=1, when 4.3 ft of WP longitudinal cracking was observed, no WP longitudinal cracking was observed on the section. Following the application of the overlay in 2003, no WP longitudinal cracking was observed on the test section until 2016, 13 years after the overlay, when 4.6 ft was observed. The location of the longitudinal cracking observed in the wheel path for the test section differed between 2002 and 2016. The increase in WP longitudinal cracking in 2002 and 2016 parallels the increase in fatigue/alligator cracking in those same years. Despite WP longitudinal cracking being observed in 2002 and 2016, these reported values may be attributed to the inconsistent interpretation of low severity longitudinal cracking within the wheel path and fatigue cracking – fatigue cracking is associated with “random cracking and meandering,” which is difficult to objectively determine in some cases.

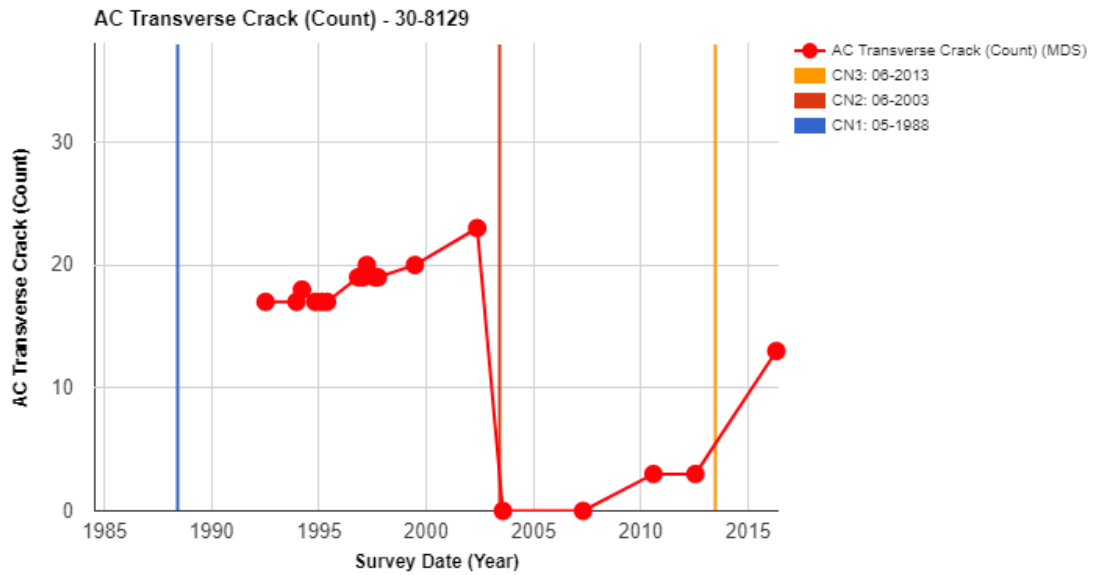
Transverse cracking was reported between 1992 and 2016 as shown in Figures 17 and 18. The pavement section reported 195.5 ft on approximately 17 transverse cracks in 1992. By 2002, prior to the AC overlay, 217.1 ft of transverse cracking or approximately 23 cracks were observed on the section. During the 10-year period in which transverse cracking was reported, the cracking increased at a rate of 2.2 ft/year. Following the application of the AC overlay in 2003, transverse cracking does not re-emerge until 2010, 7 years after the overlay, when 36.4 ft (3 cracks) of transverse cracking was observed. By 2016, the year of the last distress survey, 57.4 ft (13 cracks) was observed. The rate at which transverse cracking propagated, once initiated, following the overlay, was 3.5 ft/year. The location of the transverse cracks reported following the overlay are likely reflected transverse cracks observed prior to the overlay. As depicted in Figure 19, the location of the cracks in 2016 and 2002 are similar, indicating the reflection of transverse cracking after the overlay.

Figure 17. Time history of the number of transverse cracks (count).

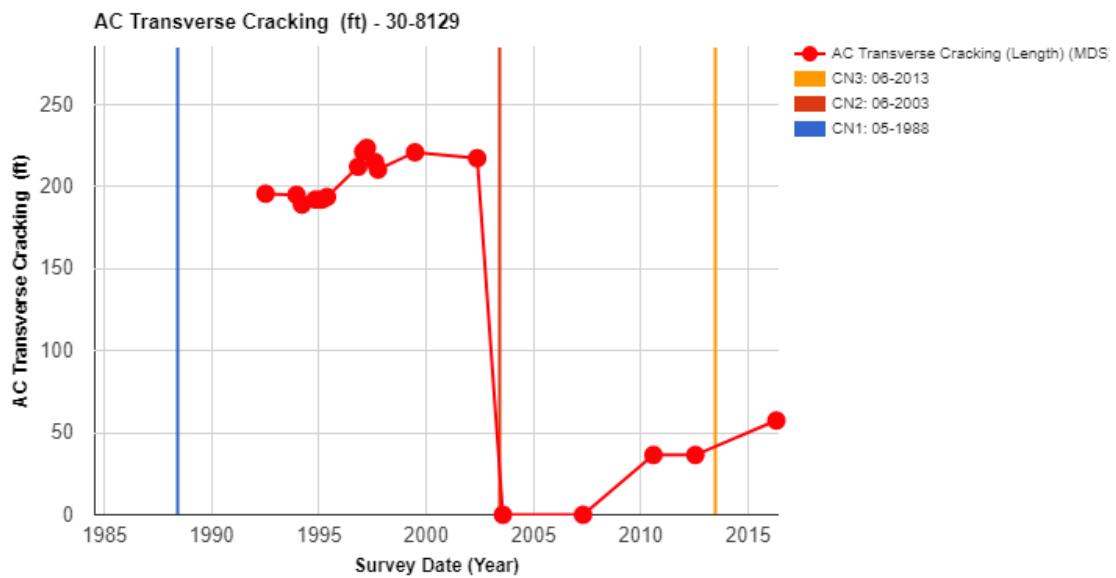
Figure 18. Time history of the length of transverse cracking (length).

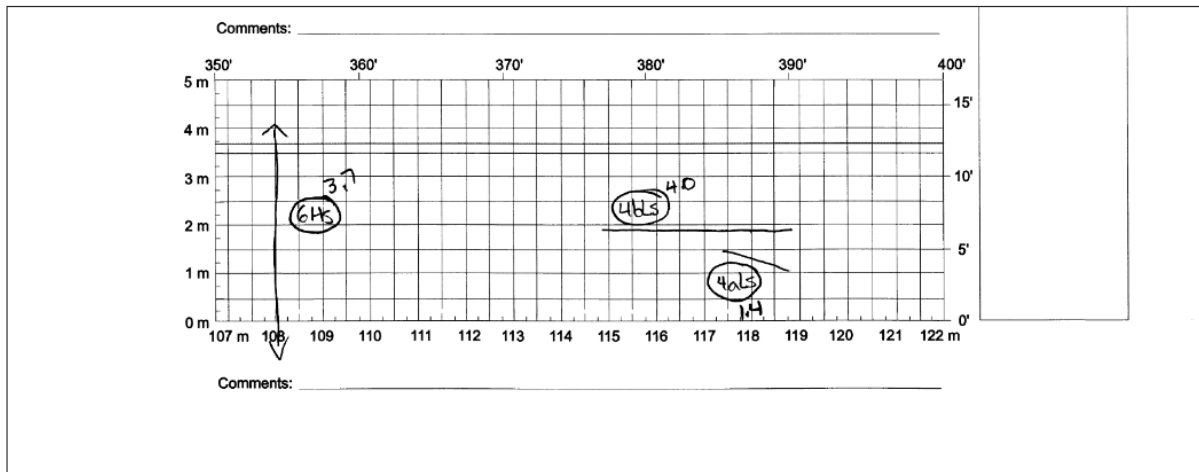
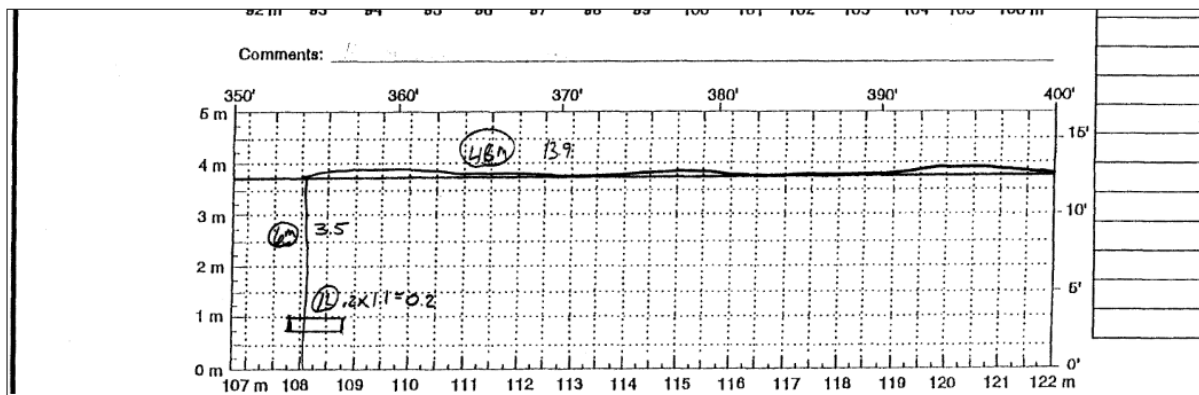
Figure 19. Distress surveys from 2016 (top) and 2002 (bottom) showing transverse cracking in similar locations on the test section between 350 feet and 400 feet from the start station.

The mechanism most often linked to transverse cracking in AC pavements is temperature changes in the AC layer. As discussed previously, the measured pavement temperature (Figure 1) notably varied due to seasonal changes. These variations in temperature likely played a role in the transverse cracking observed on this section. The length of the transverse cracks observed throughout the test section supports this claim. Most of the transverse cracking recorded on the test section was the full width of the lane, indicating low temperature cracking.

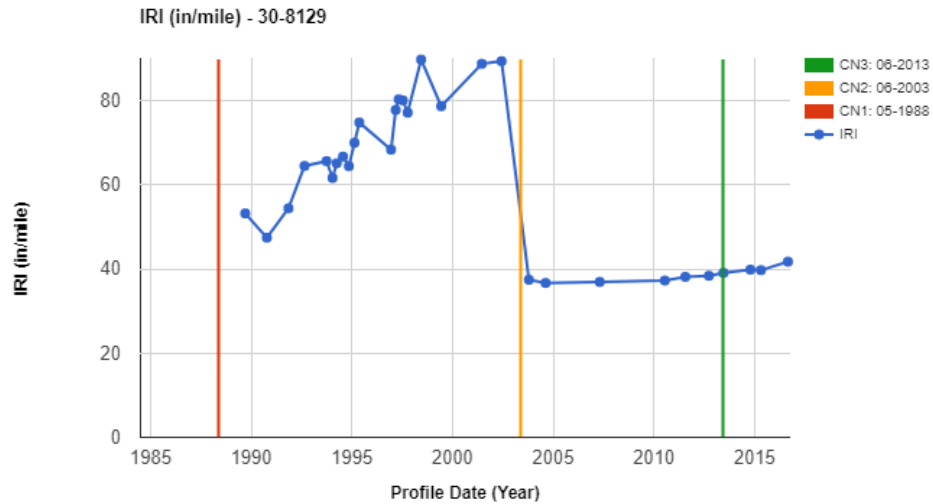
The IRI of the pavement test section, which was calculated from the measured roughness, between 1989 and 2016 is shown in Figure 20. Between 1989 and 2002, the roughness of the test section increased from 53.22 in/mi to 89.4 in/mi, both considered within the Good condition range based on FHWA definitions. While the increase in roughness was gradual prior to the overlay in 2003, the IRI reported on the test section varied slightly based on the time of year which the IRI was reported. In most cases, the roughness of the pavement dropped in colder months (December and January) and increased in warmer months (May, June, July).

Figure 20. Time history plot of pavement roughness.

Following the application of the AC overlay, reported IRI was more consistent. In October 2003, the roughness reported on the section dropped to 37.5 ft/mi. By 2016, the reported roughness was 41.8 in/mi. Therefore, the increase in IRI value following the AC overlay was 0.3 in/mi/year following the overlay.

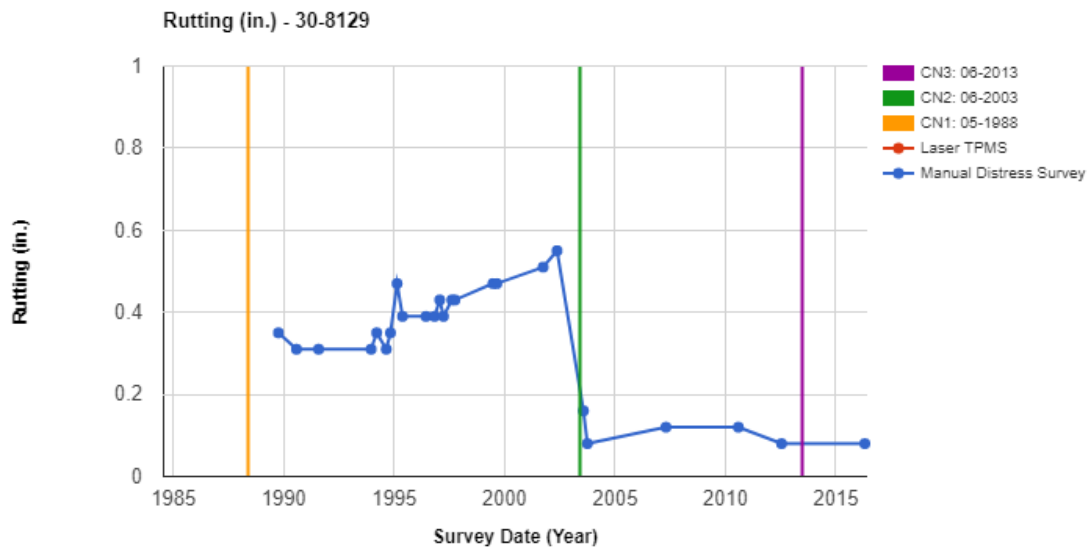
The rutting observed for the section over time is shown in Figure 21. Between 1988, when the section was accepted, into the study and 2003, when the section received an AC overlay, the rutting steadily increased from 0.35 inches in 1989 to 0.55 in 2002. On average, rut depth increased 0.02 inches/year over a 13-year period. The rutting observed between 1989 and 2002 is aligned with the steady increase in truck traffic during this period. Following the overlay, the rutting observed reduced to 0.08 inches in October 2003. While the average rut depth reported slightly increased in 2007 and 2010, the rut depth reported in 2016 is also 0.08 inches.

Figure 21. Time history plot of average rut depth computations.

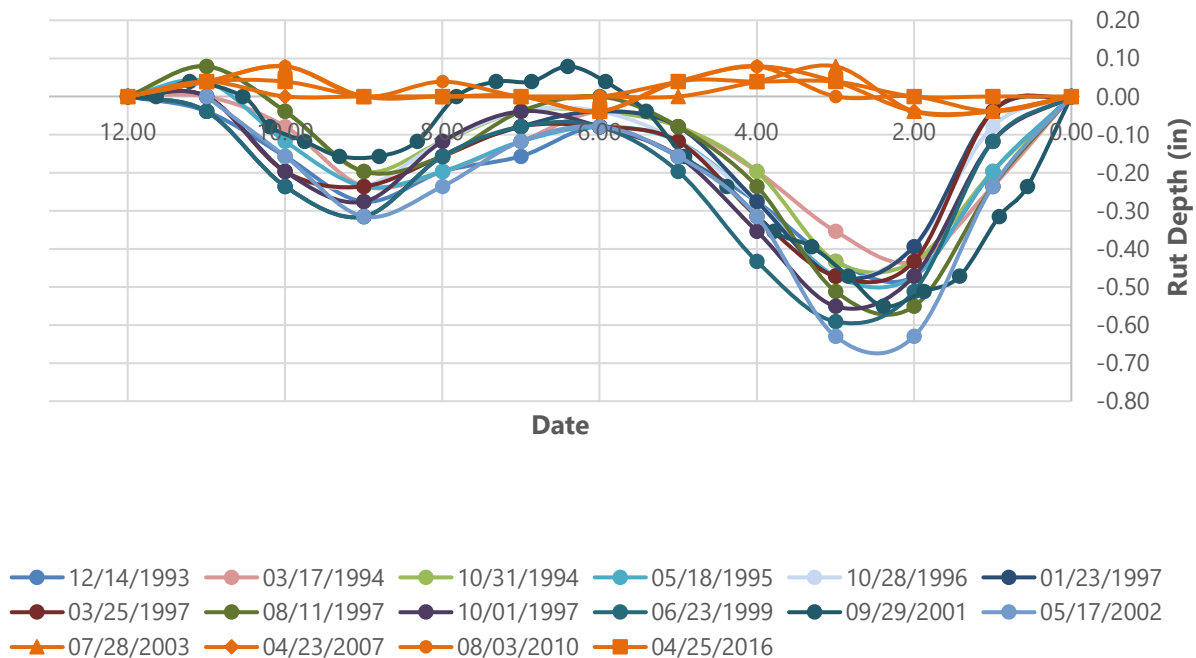
In addition to the average rut depth observed over time, the change in the transverse profile of the test section at station 300 was also investigated. Figure 22 depicts the changes in the profile over time with orange lines representing rutting profiles of the roadway following the overlay in 2003. From the figure, the transverse profiles observed prior to the AC overlay in 2003 show deeper depressions along the wheel path over time. This aligns with the increased average rutting observed over time in Figure 21. Following the overlay in 2003, the normalized elevation is more consistent and closer to level (0 inches).

Figure 22. Plot of transverse profile of station 299.79 of transverse profile over time.

Based on the analysis conducted for each of the transverse profiles in Figure 22, the lowest layer contributing to rutting was calculated for each date of collection. Except for September 2001 (where the surface layer was the lowest layer contributing to rutting), the lowest layer contributing to rutting prior to overlay in 2003 was the base layer. Following the overlay in 2003, the lowest layer contributing to rutting was found to be the surface layer. Based on both the findings of the analysis and the transverse profiles, rutting appears to be due to permanent deformation rather than ablative wear of the pavement surface due to vehicle traction devices, i.e. chains and studded tires.
