Technical Memorandum

Date: June 1, 2021

Re: Forensic Desktop Study Report: Washington State LTPP SPS-8 Test Sections

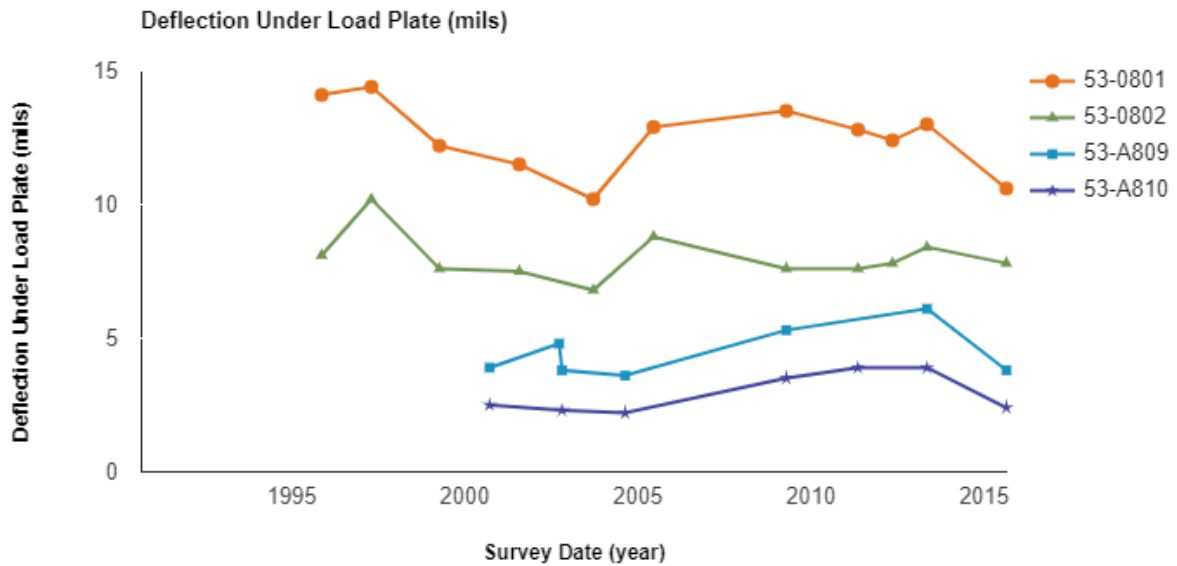
Figure 1. FWD deflections under the load plate over time.

Figure 1 shows the average FWD deflections under the nominal 9,000-pound load plate. The deflection of the sensor located in the center of the load plate is a general indication of the total "strength" or response of all layers in the pavement structure to a vertically applied load. As shown in Figure 1, the deflections reported for the JPCP test sections were lower than those reported for the AC test sections, as expected. Test section 53_A810, the thicker JPCP test section, reported the lowest deflection values, which ranged from 2.4 to 3.9 mils. The other JPCP test section, test section 53_A809, reported the second lowest deflection values, which ranged from 3.6 to 6.1 mils. Of the two AC test sections, the test section with the thicker pavement structure, 53_0802, reported the third lowest deflections over time, ranging from 6.8 to 10.2 mils, while test section 53_0801 reported the highest deflections, ranging from 10.2 to 14.4 mils. For all four test sections, the reported deflections were relatively constant over time, indicating structurally sound pavement structures.

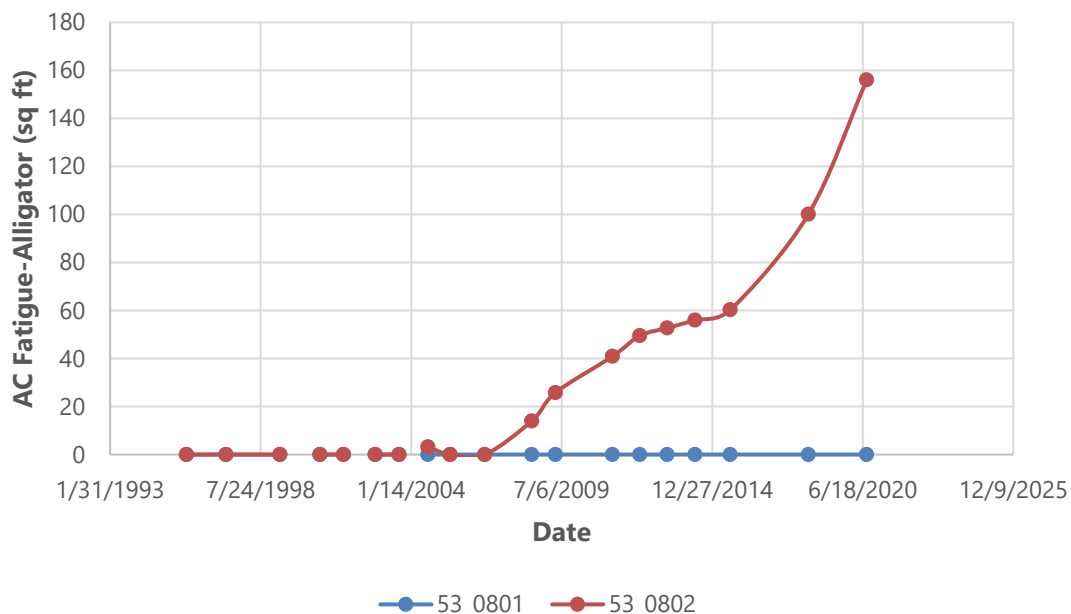
Figure 9. Time history of the length of fatigue cracking.

Figure 9 shows the total reported area of fatigue/alligator cracking between 1995 and 2020 for the two AC test sections. Fatigue/alligator cracking was only reported on test section 53_0802, despite it being the thicker of the two AC test sections. It was first reported during the manual distress survey in 2004 when 3.20 ft² of fatigue/alligator cracking was observed. However, fatigue cracking was not observed again until 2008 due to the chip seal applied on the test section in 2005. Between 2008 and 2020, the fatigue/alligator cracking observed continued to increase from 14 ft² to 156 ft² at an average rate of 11.8 ft²/year. The observed cracking was predominantly located in the wheel path.

As fatigue/alligator cracking indicates that a pavement is either structurally inadequate or has reached the end of its service life, the fatigue/alligator cracking observed on the thicker pavement structure is counterintuitive, especially in light of the limited amount of traffic at the site. One potential reason for the

differences in the fatigue/alligator cracking observed on the test sections is the difference in construction of the two test sections. It was noted in the construction report that the AC surface of test section 53_0802 was constructed in multiple lifts. However, between the first and second lift, the contractor did not allow time for the first lift to cool before the second lift was applied. Instead, an emulsified tack coat was added. It is therefore hypothesized that the lack of bonding between these two lifts may have resulted in fatigue/alligator cracking observed on test section 53_0802. An interview with Washington State DOT staff familiar with the test sections revealed that fatigue/alligator cracking is typical within this area. The State DOT has previously tried to mitigate the problem by chip sealing the roadway every 4-5 years but has since shifted to placing fog seals and chip sealing every 12-14 years instead.

The cause(s) of fatigue/alligator cracking observed on the test section was also considered in terms of overall SPS-8 experiment. A study by Glover et al.³ focused on identifying and quantifying the effects of environmental and design factors on the performance of pavements in the absence of heavy loads by comparing the performance of SPS-8 test sections to heavily trafficked test sections from other LTPP experiments. Specifically, the study considered the impact of factors such as freeze versus non-freeze climates, freeze-thaw cycles, frost depth, AC temperature, annual precipitation, in situ moisture content, subgrade type, clay content, and others on the development of different distress types including fatigue cracking. The analysis found that for low-traffic test sections, most of the assessed factors had little impact on the development and progression of fatigue/alligator cracking. However, the study did find that while base and subgrade in situ moisture content was 3 percent or less for low traffic test sections, the higher the in-situ moisture content, the increased impact on the development of fatigue cracking after 15 years. The study also found that for both low traffic and high traffic test sections in non-freeze climates and test sections with higher in situ temperatures, typically had increased amounts of fatigue/alligator cracking. While this helps describe why fatigue/alligator cracking may have developed on this test section, it fails to explain why fatigue/alligator cracking was only observed on the thicker AC test section.

1. **The cause(s) of the fatigue cracking observed on test section 53_0802.** The fatigue/alligator cracking observed on the thicker pavement structure is counterintuitive. One potential reason for the differences in the fatigue/alligator cracking observed on the test sections is the difference in construction of the two test sections. It was noted in the construction report that the AC surface of test section 53_0802 was constructed in multiple lifts. However, between the first and second lift, the contractor did not allow time for the first lift to cool before the second lift was applied. Instead, an emulsified tack coat was added. It is therefore hypothesized that the lack of bonding between these two lifts may have resulted in fatigue/alligator cracking observed on test section 53_0802.

- Continued performance monitoring of test sections while each is active.
- Perform FWD testing on a two-year interval to measure the change in structural capacity.
- Coring outside of test sections 53_0801 and 53_0802 to examine whether observed cracking is top down or bottom up.

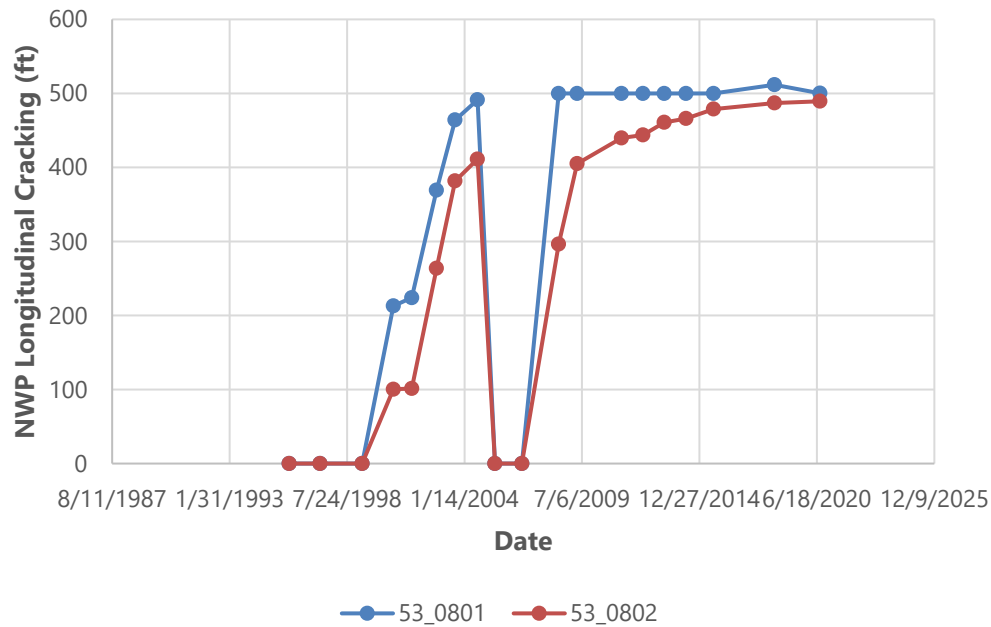
Figure 10. Time history of the length of NWP longitudinal cracks.

Non-wheel path (NWP) longitudinal cracking, depicted in Figure 10, was first reported during the manual distress survey in 2000 for both AC test sections. Between 2000 and 2004, length of cracking observed on the test section increased at a rate of 69.5 feet/year and 77.7 feet/year for test section 53_0801 and 53_0802, respectively. However, following the chip seal applied on the test sections in 2005, NWP longitudinal cracking was not observed again until 2008, at which point the reported amounts of NWP longitudinal cracking was similar to the levels observed prior to the chip seal; 297 feet of NWP cracking was reported on test section 53_0802 while 500 feet of cracking was reported on test section 53_0801. Between 2008 and 2020, the amount of NWP cracking reported on test section 53_0801 remained consistent while the cracking observed on test section 53_0802 increased levels similar to test section 53_0801. By 2020, test section 53_0801 reported 500 feet of NWP longitudinal cracking while test section 53_0802 reported 489 feet of NWP longitudinal cracking. The observed NWP longitudinal cracking reported on both test sections was located on the centerline of the roadway. Therefore, the reported cracking is likely construction-related as the cracking appears to be located on a roadway joint.

Wheel path (WP) longitudinal cracking was minimal on the AC test sections; less than 5 feet of WP longitudinal cracking was reported on the test sections over time.

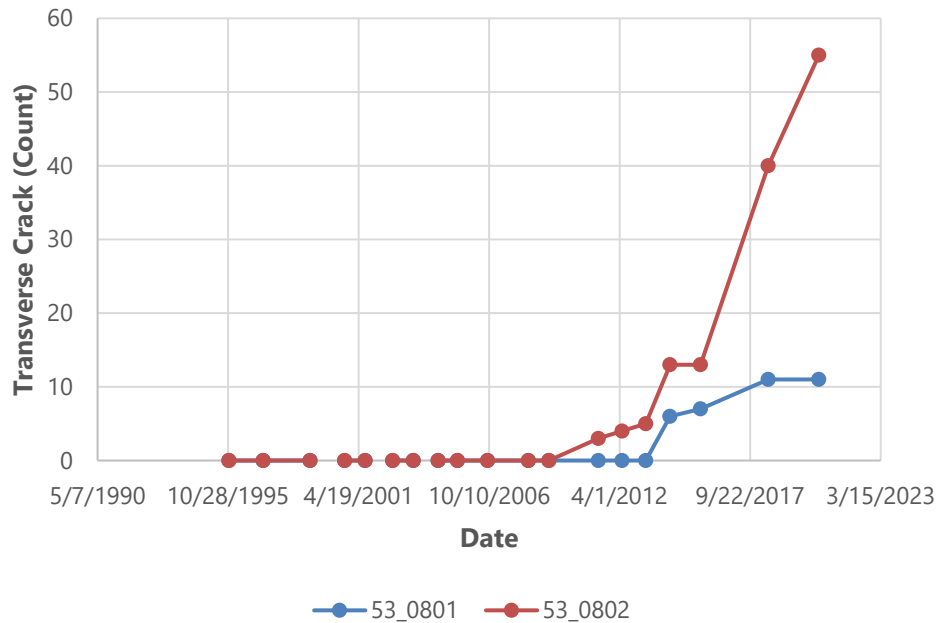
Figure 11. Time history of the number of transverse cracks.

Data on transverse cracking was collected between 1995 and 2020, as shown in Figure 11 and Figure 12. Test section 53_0802 first reported transverse cracking during the manual distress survey in 2011, 16 years after the construction of the test sections, when 5 feet of transverse cracking (3 cracks) were observed. Between 2011 and 2020, the reported transverse cracking increased at a rate of 19 feet/year, reaching 176 feet of cracking (55 cracks) in 2020. Transverse cracking was first reported on test section 53_0801 in 2014, when 48 feet (6 cracks) was reported on the test section. Test section 53_0801 reported an increase in transverse cracking between 2014 and 2020, at which point 110 feet (11 cracks) of transverse cracking was observed. For test section 53_0801, the observed transverse cracking was a mix of both full width (length of the lane) and partial width cracks while for test 53_0802, the reported cracking was predominantly partial width cracks, some in which crack sealing was applied but failed. While the reported transverse cracking on both sections remained minimal, it is hypothesized that it was thermal induced cracking or related to freeze-thaw cycles. Washington State DOT staff familiar with the test sections noted that transverse cracking was typical on this roadway and that the cracking would likely develop to full width over time. The State DOT also mentioned that they had spent a lot of effort on crack sealing to help mitigate this issue.

The transverse cracking observed on the test sections was also considered in terms of overall SPS-8 experiment. Glover et al.⁴ found that for low traffic, thin AC test sections (such as test section 53_0801) transverse cracking was more prevalent in freeze climates, on test sections with high amounts of freeze-thaw cycles, on sections with high frost depths, on test sections with low in situ AC temperatures, and on sections that were in dry climates. For thick, low-traffic AC test sections (such as test section 53_0802), the study showed transverse cracking was more prevalent in no-freeze climates, on test sections with high

2. **The difference(s) in the number of transverse cracks reported on the AC test sections (53_0801 and 53_0802).** Test section 53_0801 reported 110 feet (11 cracks) of transverse cracking in 2020 while test section 53_0802 reported 176 feet of cracking (55 cracks) in 2020. For test section 53_0801, the observed transverse cracking was a mix of both full width (length of the lane) and partial width cracks while for test section 53_0802, the reported cracking was predominantly partial width cracks, some in which crack sealing was applied but failed. While the reported transverse cracking on both sections remained minimal, it is hypothesized that it was thermal induced cracking or related to freeze-thaw cycles.

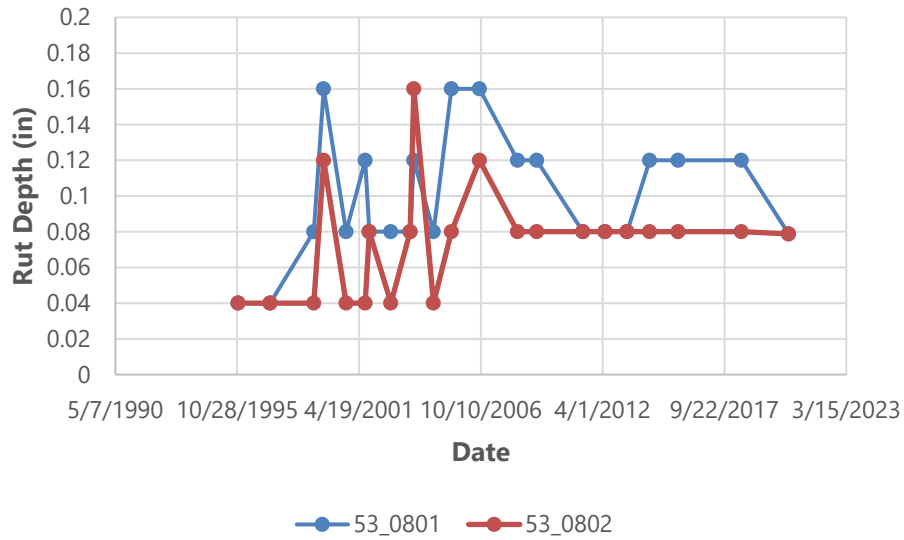
Figure 13. Time history plot of average rut depth.

The average rut depths observed on the AC test sections between 1995 and 2020 are shown in Figure 15. Both test sections reported relatively low rut depths over time, ranging between 0.04- and 0.16-inch. Each AC test section reported variability in rut depths reported over time, but this variability was within error.⁵

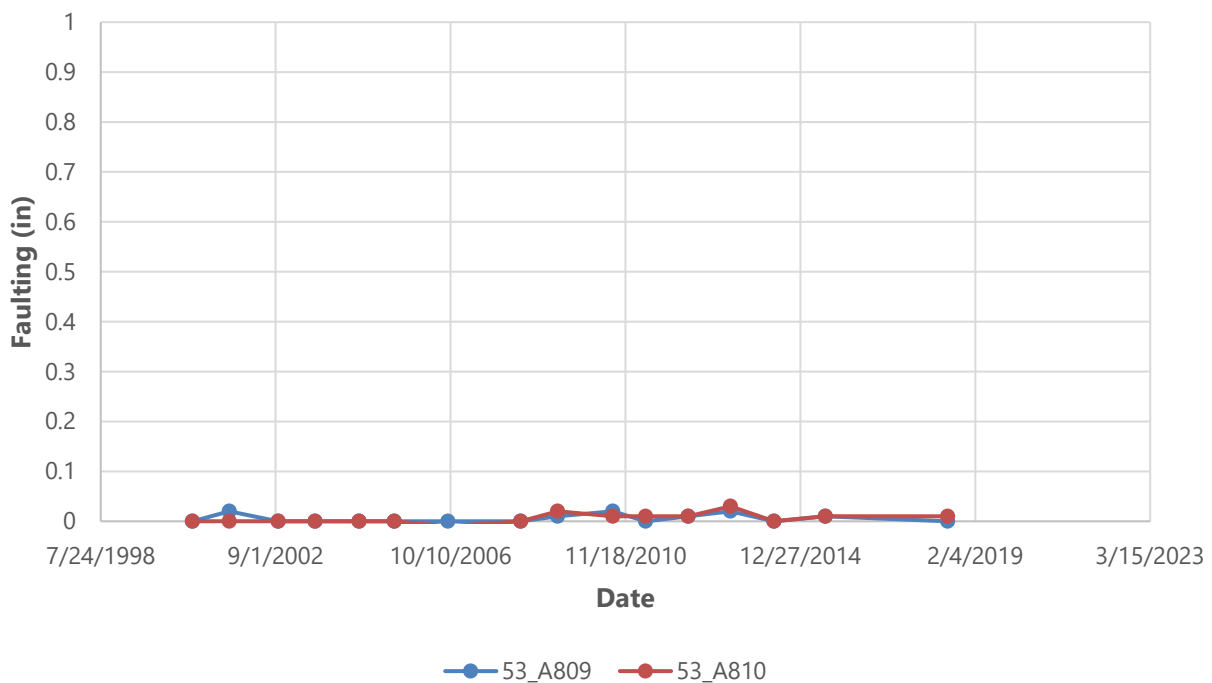
Figure 14. Time history plot of average faulting.

The average faulting observed over time on the JPCP test sections is shown in Figure 16. The faulting on both test sections was minimal. Test section 53_A809 reported faulting between 0 in and 0.02 in (2013). For test section 53_A810, faulting ranged from -0.01 in (2006) to 0.03 in (2013). The average faulting for the JPCP test sections is classified as "Good" based on FHWA performance definitions.

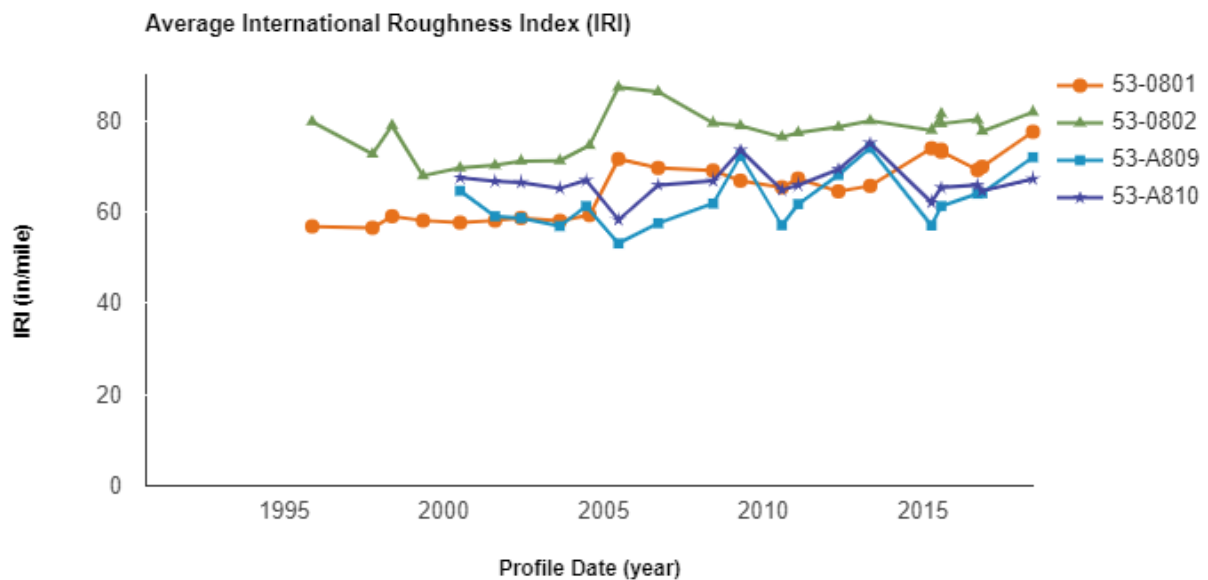
Figure 15. Time history plot of pavement roughness.

The average IRI measurements for all four test sections over time are shown in Figure 14. While test section 53_0802 reported slightly higher IRI values for every collection date, likely due to the fatigue/alligator cracking reported on this section, the test sections generally performed similarly. The reported IRI on the test sections slightly increased or stayed the same between the first date of IRI data collection (1995 for test sections 53_0801 and 53_0802 and 2000 for test sections 53_A809 and 53_A810) and 2018: from 57 to 78 inches/mile for test section 53_0801, from 80 to 82 inches/mile for test section 53_0802, from 65 to 72 inches/mile for test section 53_A809, and it remained close to 67 inches/mile for test section 53_A810. For both AC test sections, the chip seal applied in 2005 resulted in a slight increase in IRI as shown in the figure below. However, the average IRI of all four test sections is classified as “Good” based on FHWA performance definitions. It is notable that while the JPCP test sections did not report any cracking and only minimum faulting, the smoothness of the two test sections was comparable to the AC test sections. This might be the result curl and warp on the JPCP test sections. Overall, the IRI reported on all test sections was consistent over the history of the test sections.

3. **The differences in the reported IRI of the AC and JPCP test sections over time.** All four test sections performed similarly in terms of IRI. It was notable that while JPCP test did not report any cracking and only minimal faulting that the smoothness of the PCC sections was comparable to the AC test sections. This might be the result curl and warp on the JPCP test sections.
