## Technical Memorandum

**Re:** Forensic Desktop Study Report: Indiana LTPP Test Section 18\_1037

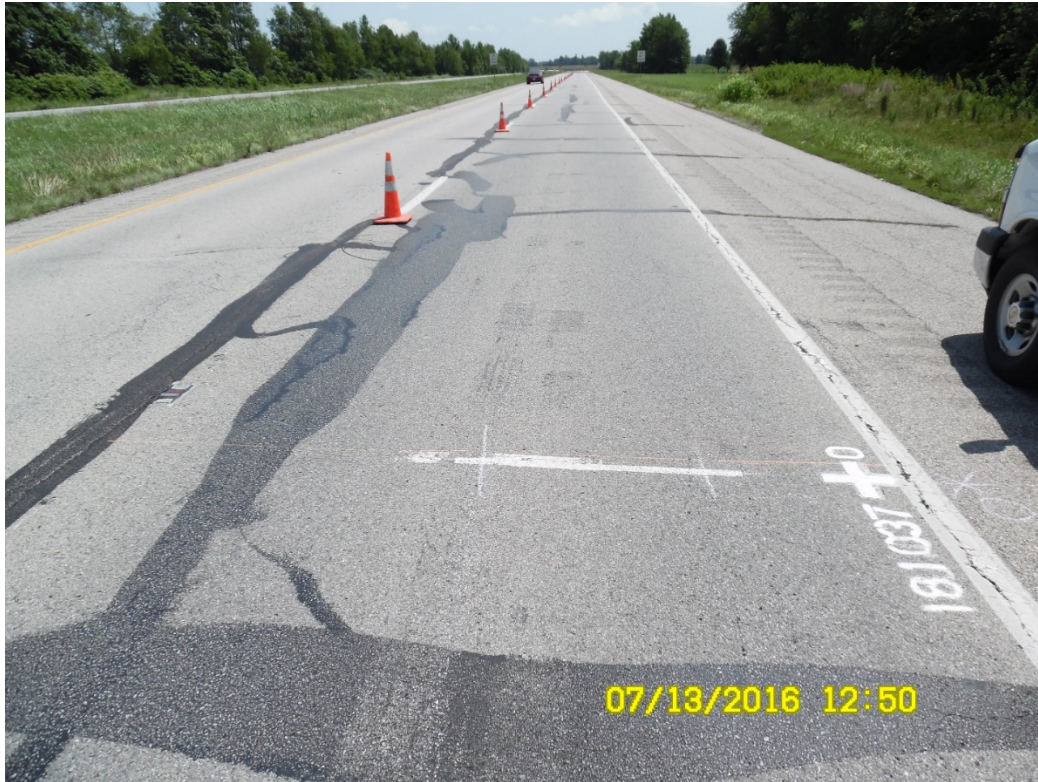
**Photograph 1. LTPP Section 18\_1037 at Station 0+00 looking eastbound in 2016.**

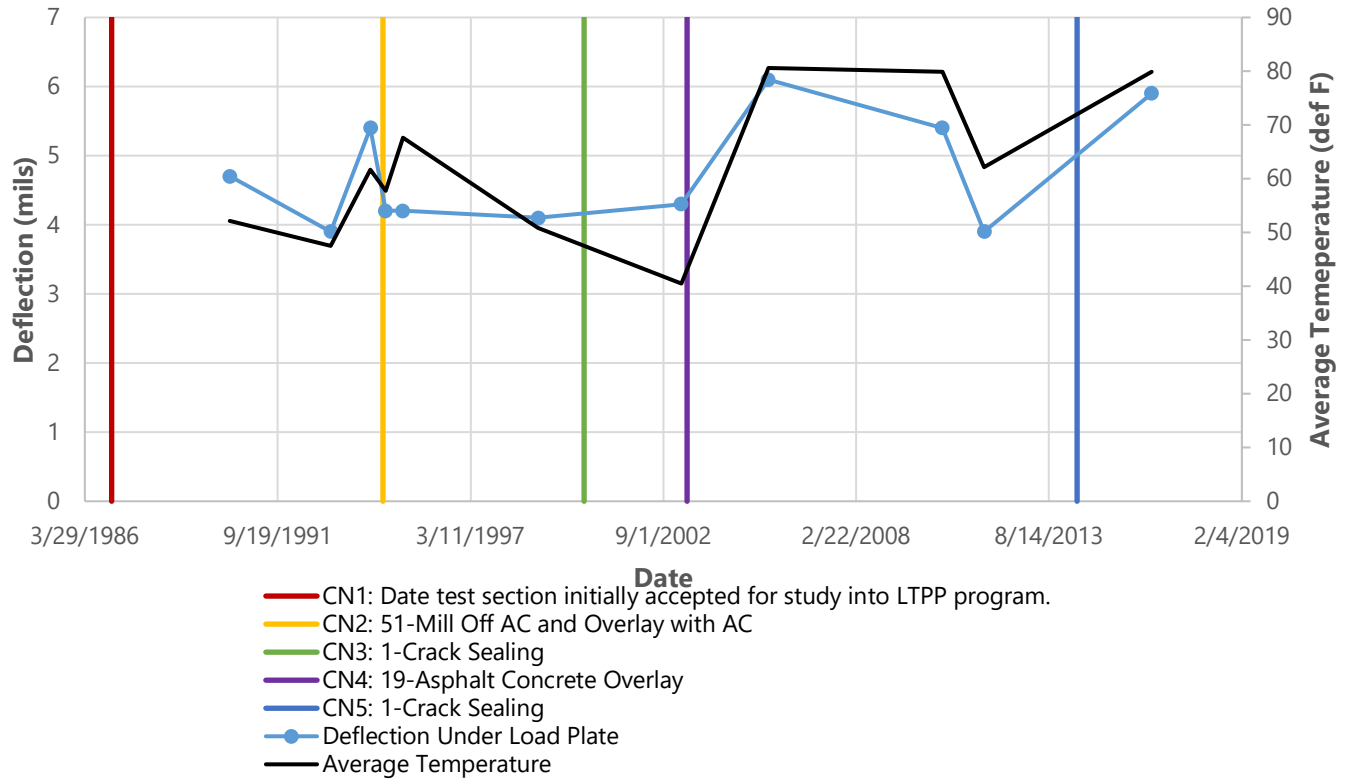
Figure 1 shows the average FWD deflections under the nominal 9,000-pound load plate during the entire period the test section was in study. The deflection of the sensor located in the center of the load plate is a general indication of the total “strength” or response of all layers in the pavement structure to a vertically applied load. As shown in Figure 1, the deflections reported were relatively low, ranging from 3.9 mils (1993) to 6.1 mils (2005), likely because of the overall thickness of AC layer of the pavement. The deflections observed appear to fluctuate based on the temperature at the time of collection. As the temperature increased, the deflections reported also increased, with the highest deflections observed in July and August. This relationship, which is further confirmed in Figure 2, helps explain the increase in the deflections observed following the overlay events. However, this observation still fails to explain why the reported deflections in 1994 and 1995 remained the same despite an increase in temperature between the two test dates.

**Figure 1. FWD deflections under the load plate and average daily temperature (using Modern-Era Retrospective analysis for Research and Applications, or MERRA data) over time.**

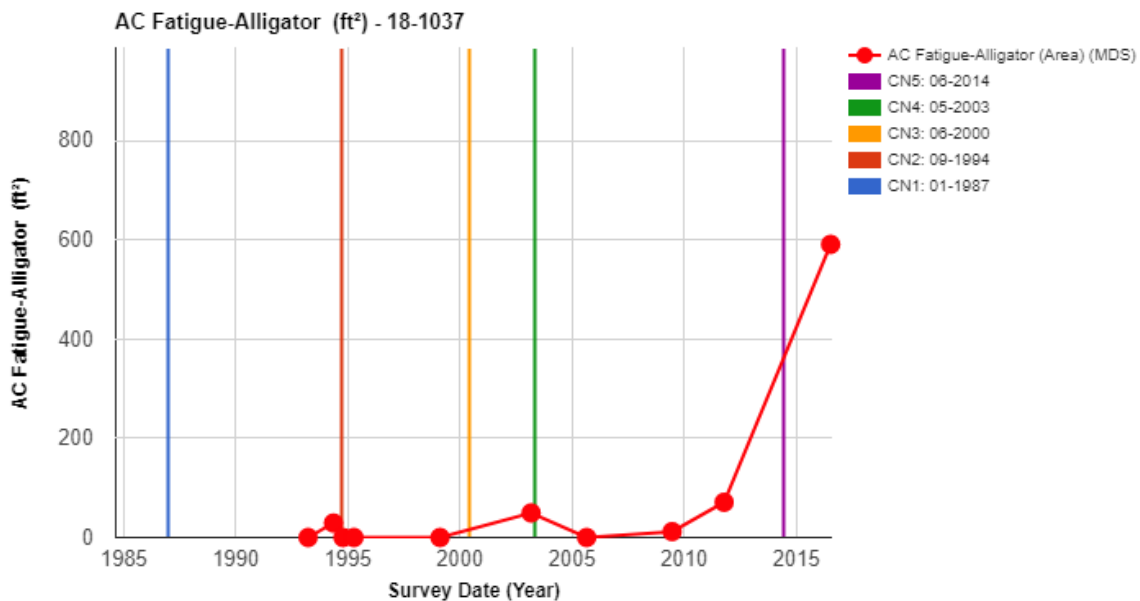
Figure 11 shows the total reported area of fatigue/alligator cracking between 1993 and 2016. While the graph obtained from InfoPave™ is labelled fatigue cracking, which implies a mechanism, the distress values reported includes both fatigue cracking (inside the wheelpath) and alligator cracking (outside the wheelpath).

**Figure 11. Time history of the length of fatigue cracking.**

Fatigue/alligator cracking was first reported during the manual distress survey in May 1994, when 29.1 ft<sup>2</sup> was observed. After the mill and overlay event in September 1994, no fatigue/alligator cracking was reported again until the March 2003 distress survey, when 49.5 ft<sup>2</sup> of fatigue/alligator cracking was reported. Following the overlay event in May 2003, no fatigue cracking was reported again until the June 2009 distress survey when 11.8 ft<sup>2</sup> of fatigue/alligator cracking was observed. Once initiated, the fatigue/alligator cracking propagated at a rate of 82.7 ft<sup>2</sup> between 2009 and 2016, reaching 590.9 ft<sup>2</sup> in 2016.

As depicted in the figure, fatigue cracking was not significant on the test section until after 2010. It is hypothesized that delay in the appearance of significant fatigue cracking is related to the combination of the AC thickness of the test section and the application of AC overlays just as fatigue cracking appeared to propagate. The increase in the fatigue/alligator cracking between 2010 and 2016, may also be related to the increased levels of precipitation during this period, particularly in 2011 when 75 inches of precipitation was recorded in the area. As water infiltrates the pavement, unbound granular layers (subgrade only for test section in question) tend to weaken (especially when reaching saturation conditions), which can contribute to the observed fatigue cracking. It would have been interesting to see if the cracking was top-down or bottom-up (or some combination), but this will not be possible since the test section has been milled and overlaid.

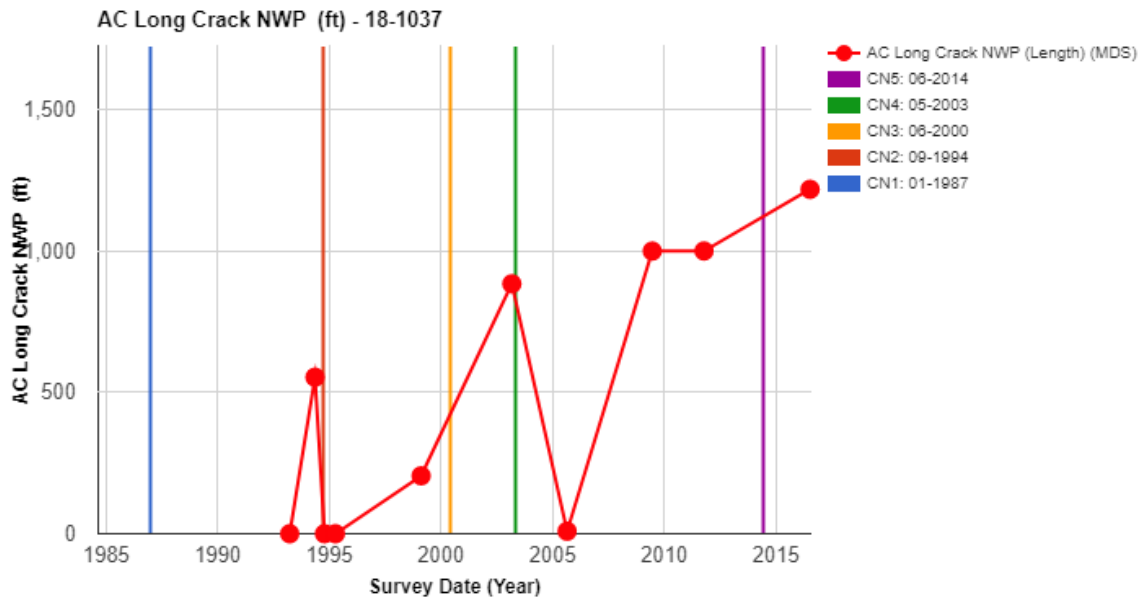
Non-wheel path (NWP) longitudinal cracking, depicted in Figure 12, was first reported during the manual distress survey in May 1994, when 554 feet of cracking was observed. After the mill and overlay event in September 1994, NWP longitudinal cracking was again reported during the distress survey conducted in February 1999, when 205 feet of NWP longitudinal cracking was observed. The NWP longitudinal cracking continued to increase between 1999 and March 2003, prior to the second overlay event in May 2003, at a rate of 170 feet/year between 1999 and 2003. Following the overlay event in May 2003, NWP longitudinal cracking was observed again during the June 2009 distress survey when 1,000 feet of NWP longitudinal cracking was observed. Once initiated, the NWP longitudinal cracking propagated at a rate of 31 feet/year between 2009 and 2016, reaching 1,219 feet in 2016.

Between the first and second overlay events (in 1994 and 2003, respectively) and after the second overlay event, NWP longitudinal cracking was predominantly located on the edge and centerline of the lane, indicating NWP longitudinal cracking observed prior to the second overlay event was reflected to the overlay surface. Given the location of the cracking, it is hypothesized that the propagation of the NWP longitudinal cracking is construction-related as it appears the cracking may be located along construction joints.

Figure 12. Time history of the length of NWP longitudinal cracks.

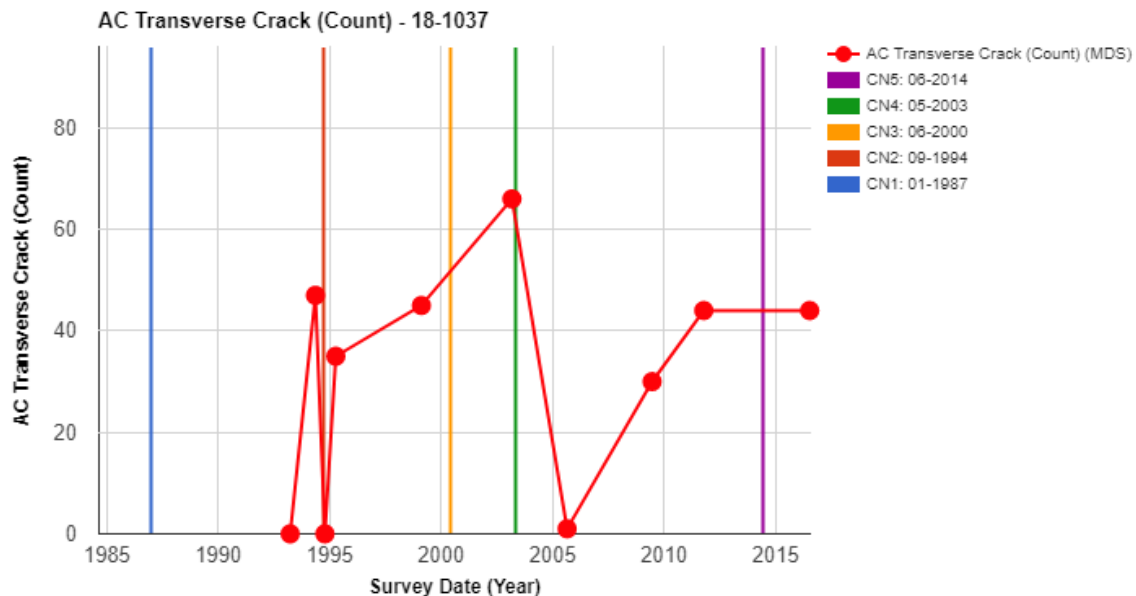
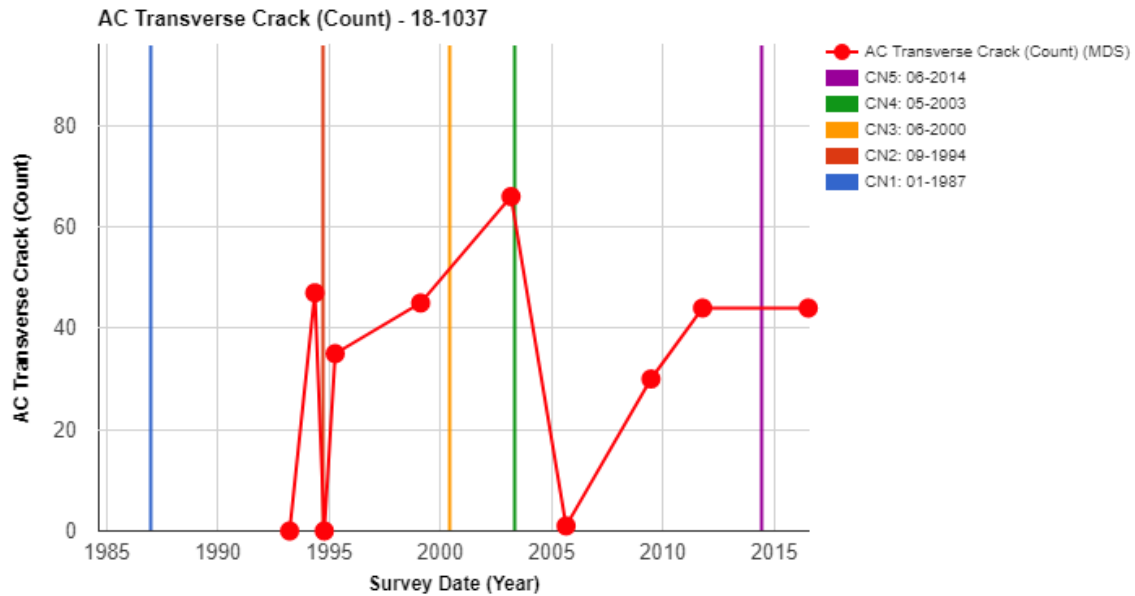
Data on transverse cracking was collected between 1993 and 2016 as shown in Figure 13 and Figure 14. Transverse cracking was first reported during the manual distress survey in May 1994, when 301 feet of transverse cracking (47 cracks) was observed. Shortly after the mill and overlay event in September 1994, transverse cracking was observed again during the April 1995 distress survey when 115 feet (35 cracks) of transverse cracking was reported. The transverse cracking continued to increase between 1995 and March 2003, at a rate of 28 feet/year between 1995 and 2003. Following the overlay event in May 2003, transverse cracking was reported again during the June 2009 distress survey when 175 feet (30 cracks) of transverse cracking was observed. Unlike after the mill and overlay event, there was more time before transverse cracking appeared after the second overlay event and fewer cracks once cracking was initiated. Once initiated, the transverse cracking propagated at a rate of 26 feet/year between 2009 and 2016, reaching 354 feet (44 cracks) in 2016. The increase in the transverse cracking length and count between

2011 and 2016 was slowed as some cracks were sealed during 2014. The rate of propagation between the first and second overlay events (in 1994 and 2003) and after the second overlay event was similar. In both cases, transverse cracking was located in similar locations, indicating transverse cracking observed prior to the second overlay event was reflected to the overlay surface. It is hypothesized that the propagation of the transverse cracking is primarily related to the freeze-thaw periods (evidenced by the high freezing indices) of the pavement section over time.

Figure 13. Time history of the number of transverse cracks.

**Figure 14. Time history of the length of transverse cracking.**

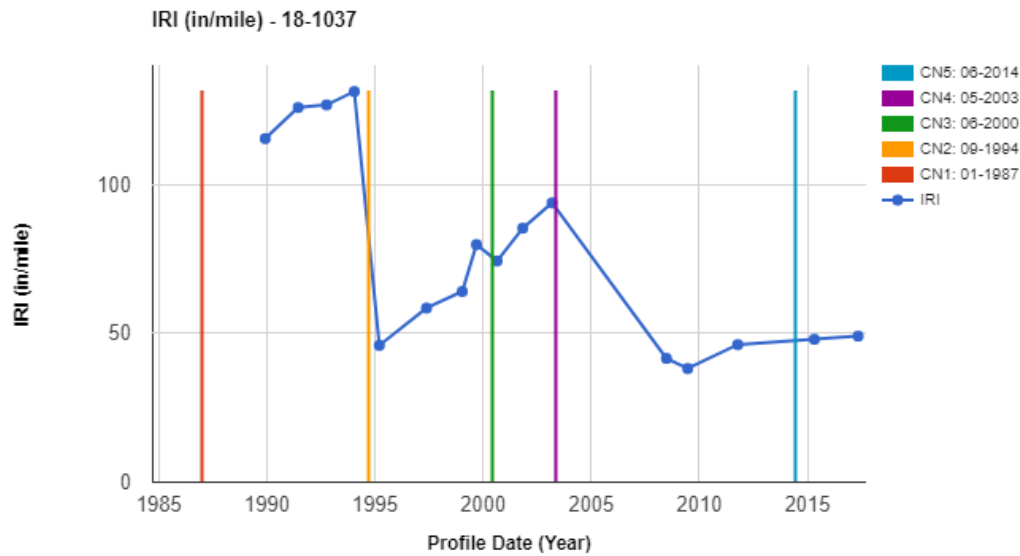
The average IRI measurements for the section over time are shown in Figure 15. During the first performance period of the test section, from its incorporation into the LTPP program to the mill and overlay event in 1994, the IRI on the test section slightly increased over time. The IRI on the section prior to the mill and overlay event in 1994 averaged 125 in/mi, which means the performance of the pavement is classified as “Fair” based on FHWA performance definitions. During the second performance period, between the 1994 mill and overlay and the 2003 overlay event, the IRI of the test section dropped to 46 in/mile in 1995 before increasing again at a steady rate of 6 in/mi. The average IRI during this performance period is classified as “Good” based on FHWA performance definitions. Finally, during the third performance period, following the 2003 overlay event, the IRI again dropped to 42 in/mile before increasing at a rate of 1 in/mi between 2008 and 2017. The average IRI during this performance period is classified as “Good” based on FHWA performance definitions. It is important to note that after the 2003 overlay event IRI is not reported on the section again until 2008 and increases at a rate that is noticeably slower than the rate of IRI increase during both the first and second performance periods. It is hypothesized that there may have been an additional unreported M&R event between the 2003 overlay and the next time IRI is reported on the section. Further investigation of the reason for this gap between IRI collection dates is recommended.

The IRI reported during the three performance periods does not correlate with the observed cracking over time. Specifically, the predominant cracking types that purportedly affect the overall IRI of the test section—fatigue/alligator and transverse cracking—are present in higher quantities between the two overlay events in 1994 and 2003 (for transverse cracking only) and following the 2003 overlay event (for transverse and fatigue/alligator cracking) despite the lower average IRI reported during these periods. Prior to the 1994 mill and overlay event, when less fatigue/alligator and transverse cracking is present, IRI is at its highest. This may be related to the severity of the cracking observed on the section—predominantly low and medium—which plays less of a role in the roughness of the test section. Additionally, since the initial IRI of test section (at the time of its incorporation in the LTPP program in 1987) is unknown, it is also possible the initial roughness or IRI of the test section was not as smooth as the IRI reported after CN=2 and CN=4.

**Figure 15. Time history plot of pavement roughness.**

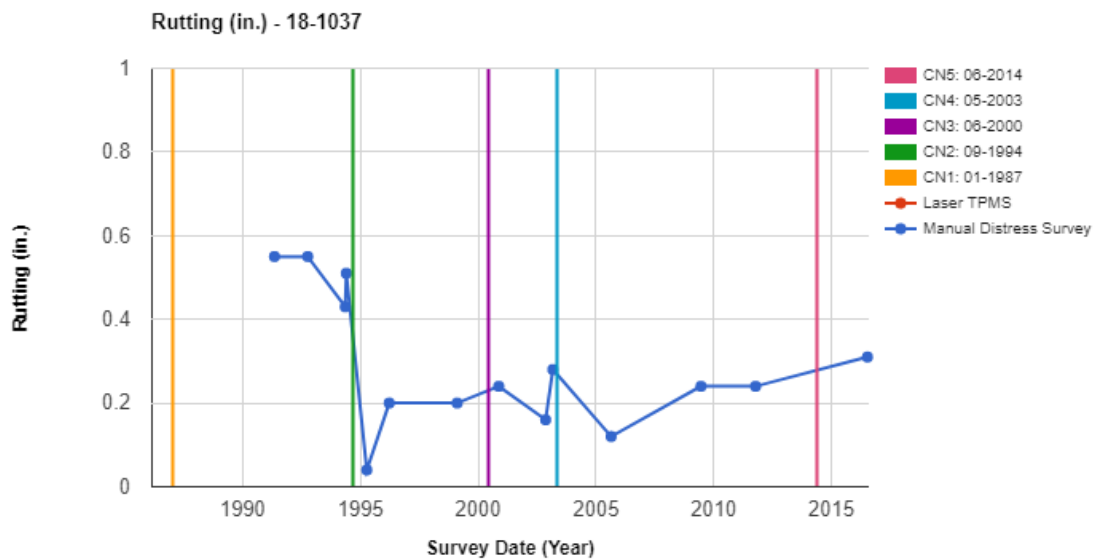
The average rut depths observed for the section over time are shown in Figure 16. The rutting on the section prior to the first overlay in 1994 averaged 0.51 in. Following the mill and overlay in 1994, the average rut depth dropped to 0.04 in. However, the average rut depth began to increase following the overlay, at a rate of 0.03 in/year between 1995 and 2003. Following the second overlay event in 2003, the average rut depth again decreased this time to 0.12 in in 2005. The average rut depth slightly increased between 2005 and 2016 to 0.31 in. It is hypothesized that the rutting observed prior to 1994 occurred within the top 0.7-inch AC layer (which was effectively removed during the mill and overlay event in 1994, leading to lower rutting values following the overlay).

**Figure 16. Time history plot of average rut depth.**
