Technical Memorandum

Re. Forensic Desktop Study Report: Oklahoma LTPP Test Sections 40_AA**

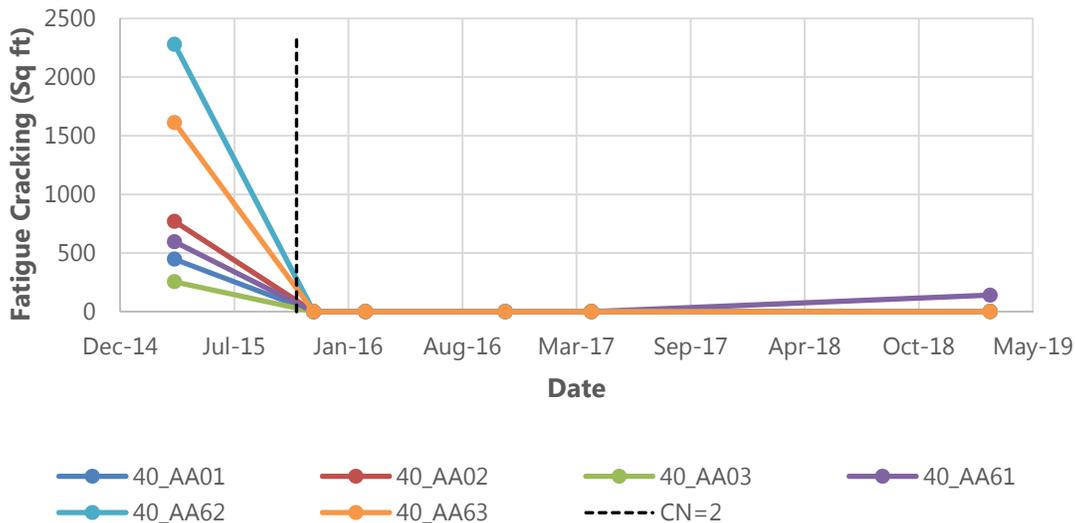
Figure 7 summarizes the total area in which fatigue/alligator cracking was observed prior to and after the application of the AC overlay in November 2015. As shown in the figure, fatigue cracking prior to the overlay varied by section. Section 40_AA62 exhibited the most cracking, 2,279.8 square feet or approximately 38% of the test section's area, and section 40_AA03 exhibited the least amount of fatigue/alligator cracking, 255.1 square feet or approximately 4% of the test section prior to the overlay.

Figure 7. Time history of the area of fatigue/alligator cracks.

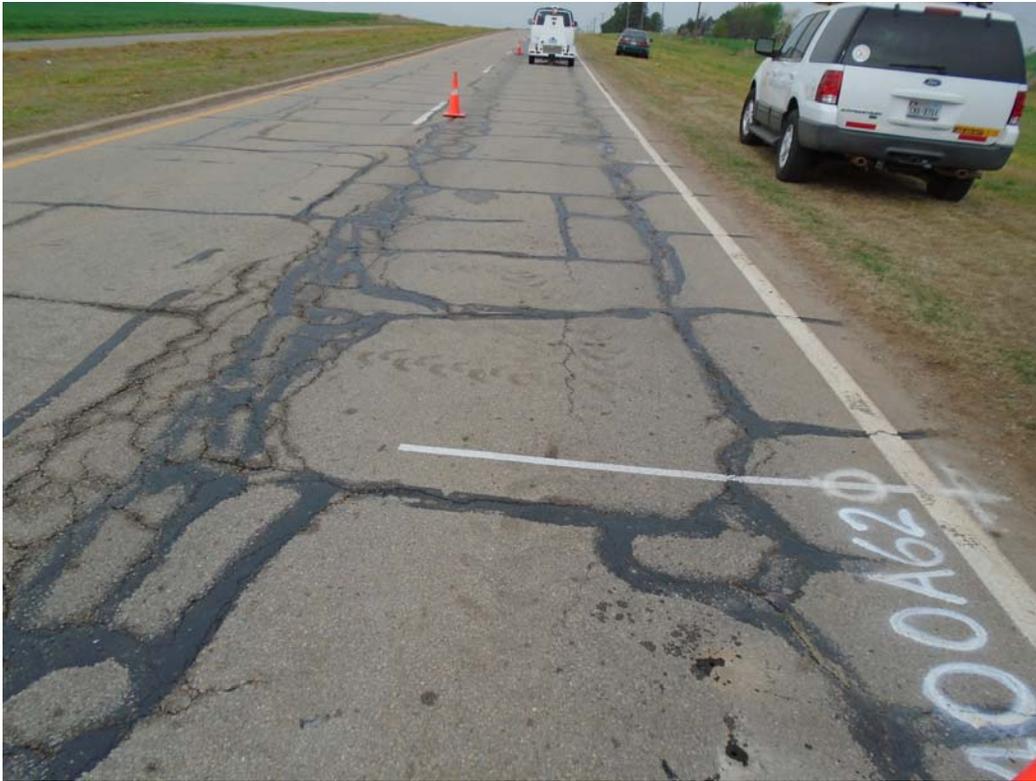
Figure 8 shows the fatigue/alligator cracking on test section 40_AA62 prior to placement of the overlay. Note that the severe cracking on the inside portion of the lane appears to be outside the wheel path. In Figure 9 shows an after overlay image of this test section where it is easier to actual wheel path locations. The longitudinal crack down the outside portion of the lane was also rated as fatigue/alligator cracking. It is interesting that the most severe cracks are at the outside wheel path edges where shear stresses tend to be the greatest. The transverse cracks seen in this figure were rated as block cracking, however some of these cracks could also have been rated as transverse cracks.

Figure 8. Image of section 40_AA62 in April 2015 at station 0+00 prior to overlay showing severe level of cracking. This test section was rated as having block cracking and no transverse cracking.

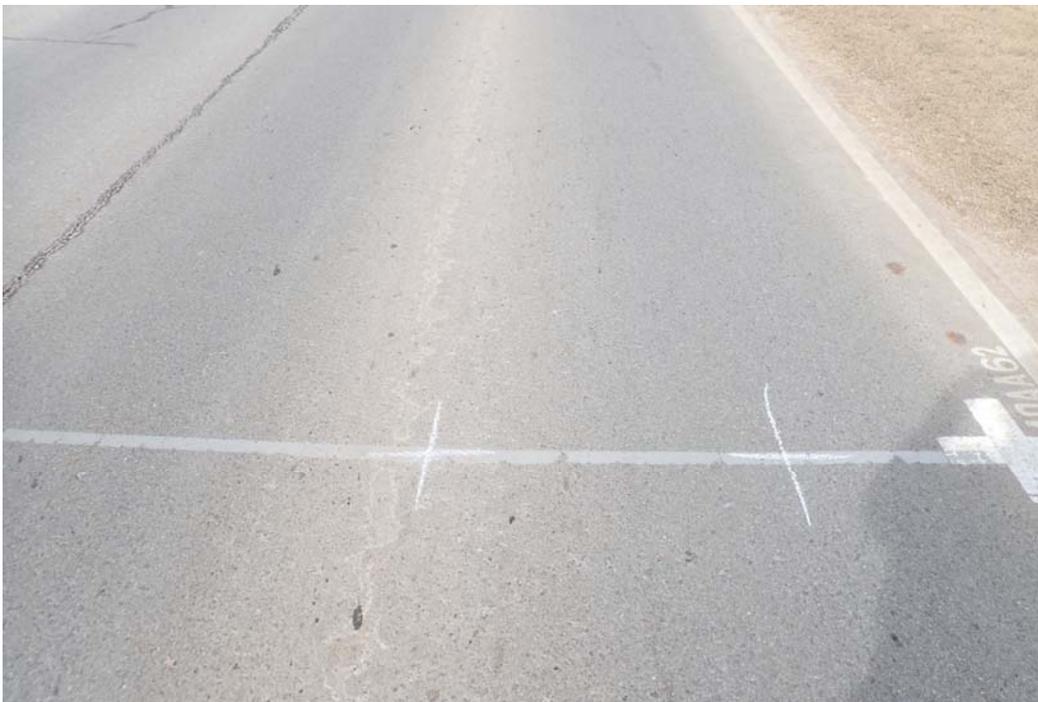
While the fatigue/alligator cracking reported prior to the overlay varied greatly between sections (potentially due to variations in total AC thickness), no fatigue cracking was observed on any of the test sections between 2015 and March 2017 following the AC overlay. By March 2019, there were three sections where fatigue cracking was observed: section 40AA01 with 1.1 ft², section 40_AA02 with 1.1 ft², and section 40_AA61 with 139.9 ft². These sections represent the HMA overlay and two WMA overlays of varying thicknesses. They do not represent the sections with highest amounts of fatigue cracking observed prior to the overlay. Figure 10 is an image of section 40_AA62 from March 2019 at the same location as Figure 8. While this test section had the greatest amount of cracking prior to the overlay, in 2019 it the longitudinal crack between lanes had reappeared and a minor amount of longitudinal on the outside edge of the lane had started to appear on the pavement surface. The chalk marks indicate where the data collection contractor thought the middle of the right wheelpath and lane center were located.

Figure 9. Image of test section 40_AA62 in March 2019 at station 0+00 approximately 3.5 years after mill and overlay. The longitudinal chalk lines show lane center and middle of right wheel path, where the line of FWD measurements will be performed along the test section.

Moreover, because cracking is now starting to reappear on the surface of some test sections which previously had some severe cracking patterns, it is important to continue to monitor this cracking in order to enable better quantification or modeling of crack initiation and crack propagation.

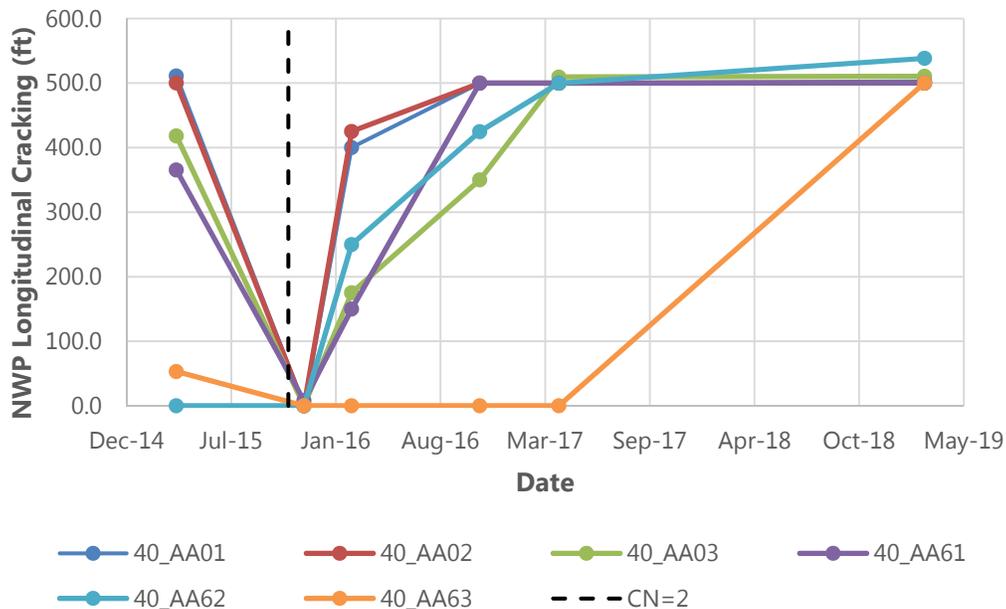
Figure 10 depicts the NWP longitudinal cracking observed from 2015 to 2019. Looking at this distress feature alone can lead to faulty conclusions. While sections 62 and 63 had very low rated NWP longitudinal cracking prior to overlay, judging by Figure 8, section 62 had many other types of cracking that were longitudinal in nature, not located in the wheel path, but appear to have been rated in other distress categories. Looking at figure 9, there is a very straight NWP longitudinal crack between the lanes, when such a crack did not exit prior to the overlay as shown in figure 8.

Figure 10. Time history of the length of NWP longitudinal cracks. Most of the NWP longitudinal after the overlay placed in CN=2 are associated with the between lane longitudinal joint created during the construction process.

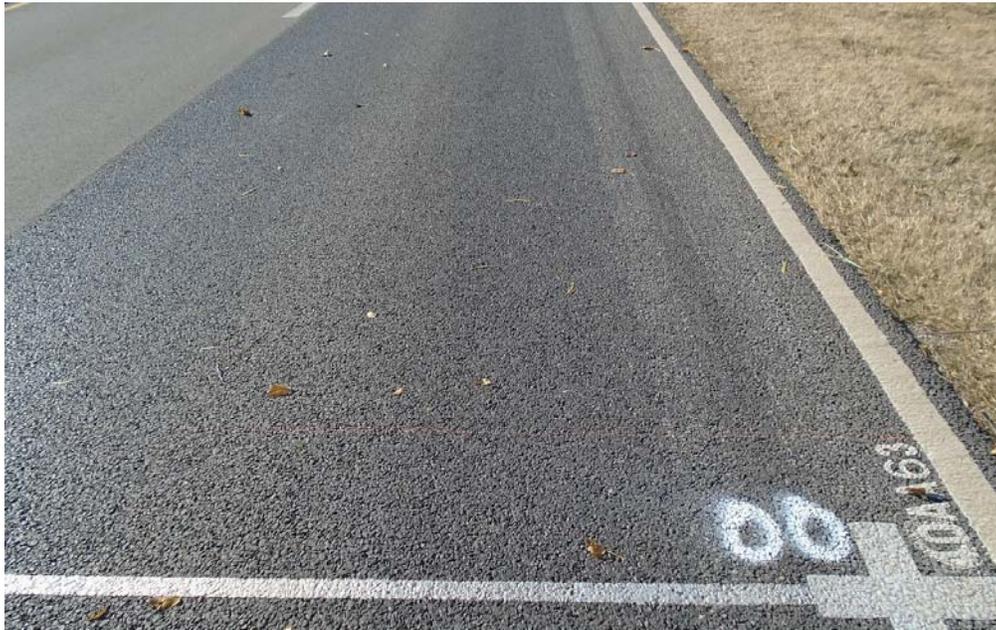
Figure 11 is an image of section 63 in 2016 at station 0+00. The two interesting features from this image is that the left (passing) lane has an obvious different type of surface material than the experimental test section in the right lane. The longitudinal construction joint between the right and left lane was not rated

as an NWP longitudinal crack. (Note the open graded texture of this Stone Matrix Mixture is what allows the ability to put more asphalt into the mix.) .

Figure 11. Image of section 40_AA63 in 2016 showing the new as-placed SMA mixture in the right lane. Note the tight center-lane longitudinal joint and different surface type uses in the left lane.

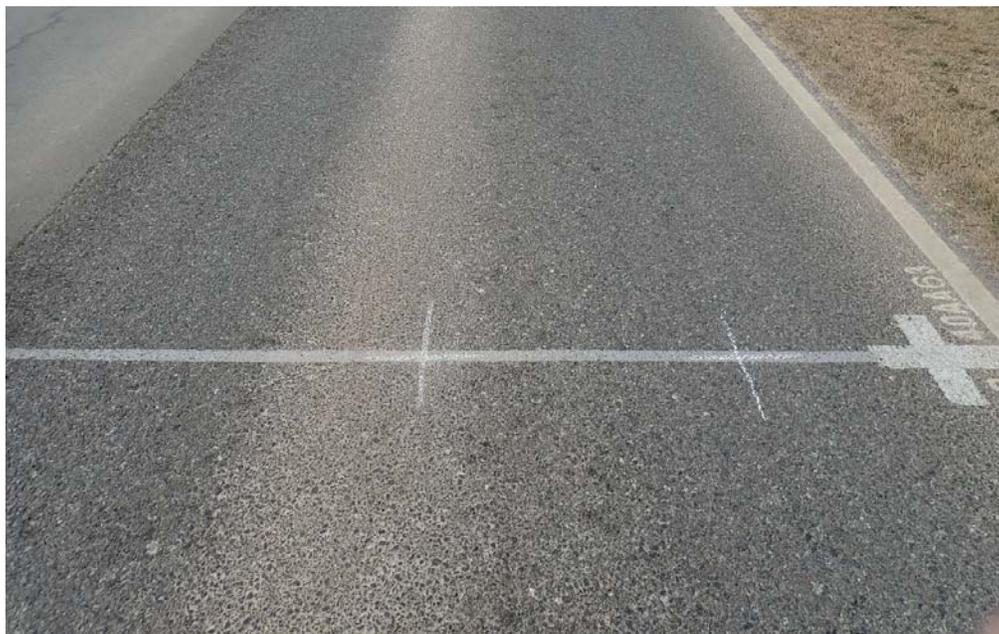
Figure 12 is an image of the same portion of the test section in 2019, where the between lane longitudinal construction joint is now rated as a full test section length NWP longitudinal crack. From this visual evidence it appears that the NWP longitudinal cracking variability shown in figure 10 appears to be related to how the between lane longitudinal joint is rated in the distress surveys.

Figure 12. Image of section 40_AA63 in 2019, when the between lane longitudinal joint is now rated as a full test section length NWP longitudinal crack.

The overall observation from this analysis is that the rise in NWP longitudinal cracking shown in figure 10 is more likely due to degradation of the between lane longitudinal joint created during overlay placement, than a reflection cracking mechanism.

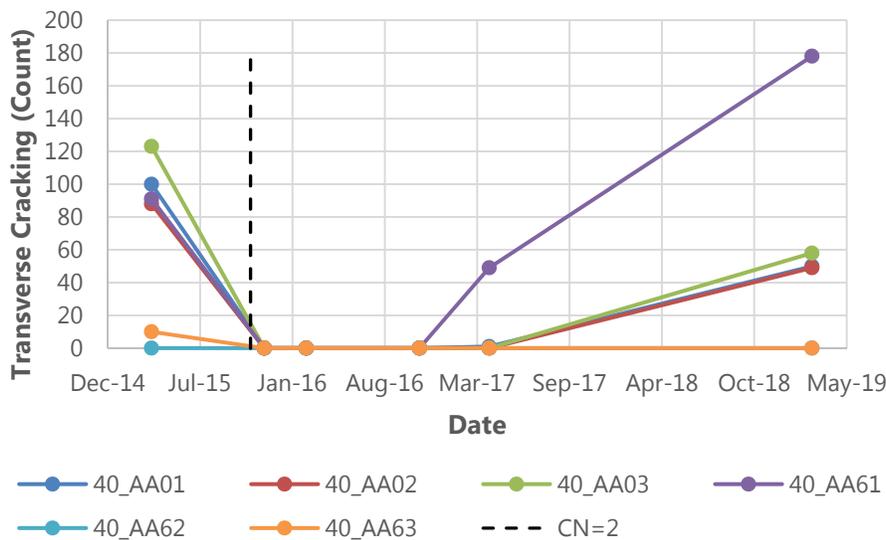
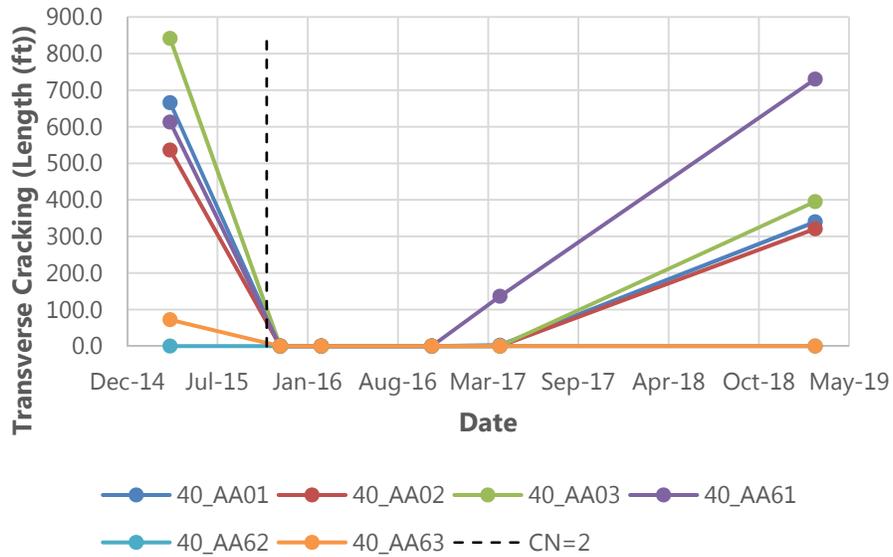
Figures 13 and 14 show the total number and total length of transverse cracks observed on the six test sections prior to and following the application of the AC overlay in 2015. As shown in the figures, transverse cracking varied by section prior to the overlay with section 40_AA03 exhibiting the most cracking, 123 total transverse cracks or 841.6 ft of cracking, and section 40_AA62 exhibiting the least cracking, with 0 transverse cracks in 2015.

While the transverse cracking reported prior to the AC overlay varied from section to section, no transverse cracking was observed on any of the sections until April 2017 when one transverse crack, 2.3 ft in length, was observed on section 40_AA01, and 49 transverse cracks, 136.1 feet in total length, were observed on section 40_AA61. By March of 2019, transverse cracking was also observed on sections 40_AA02 and 40_AA03. The transverse cracking observed in 2019 ranged between 320.9 ft (49 total cracks) on test section 40_AA02 and 730.4 ft (178 total cracks) on section 40_AA61.

It appears that transverse cracking observed following the application of the overlay is related to the amount of transverse cracking observed prior to the overlay. As shown in Figures 13 and 14, the only sections where transverse cracking was not observed following the AC overlay are the sections that had little to no transverse cracking prior to the overlay (sections 40_AA62 and 40_AA63). As shown in the image in Figure 8 of test section 40_AA61, the pre-overlay cracking was rated as block cracking. As can be seen in Figure 8, many of the "blocks" had significant transverse cracks although they were not rated as transverse cracks. Figure 15 is a pre-overlay image of test section 40_AA62 showing very similar cracking patterns to those on test section 40_AA62. For sections that did have transverse cracking following the AC overlay, transverse cracking reappeared between 17 and 40 months following the overlay event. There is some indication that the transverse cracking observed following the overlay is a reflection of transverse cracking observed prior to the overlay.

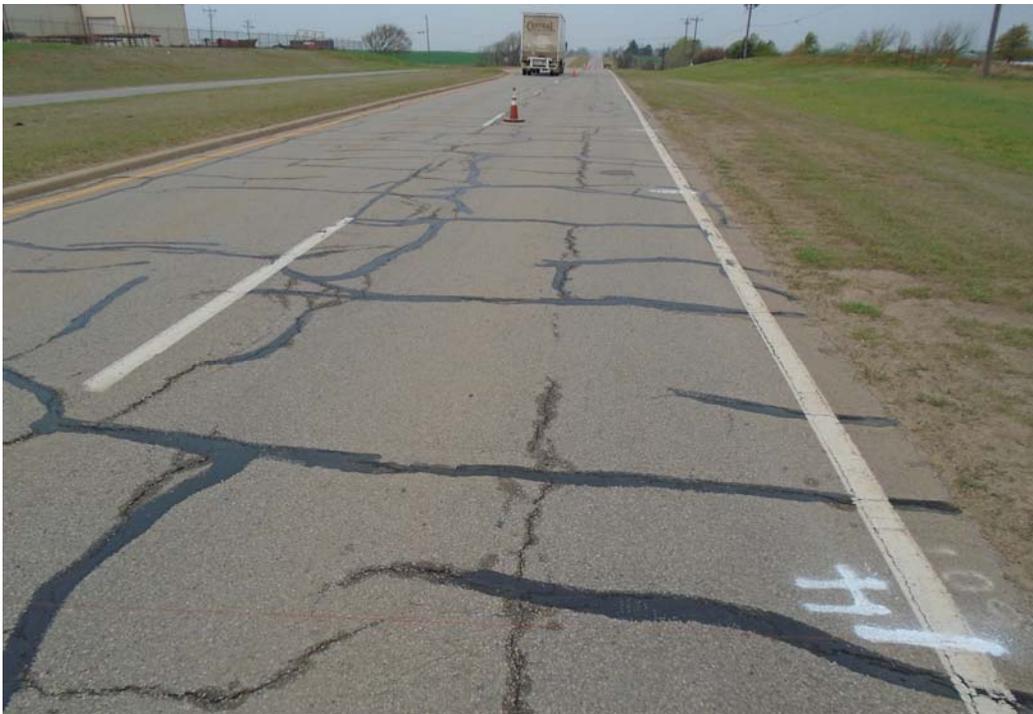
Figure 15. Preoverlay image of section 40_AA61. This section has a similar cracking pattern to section 40_AA62, shown in figure 8 that were rated as block cracking. The transverse cracks on this test section were rated as transverse cracks.

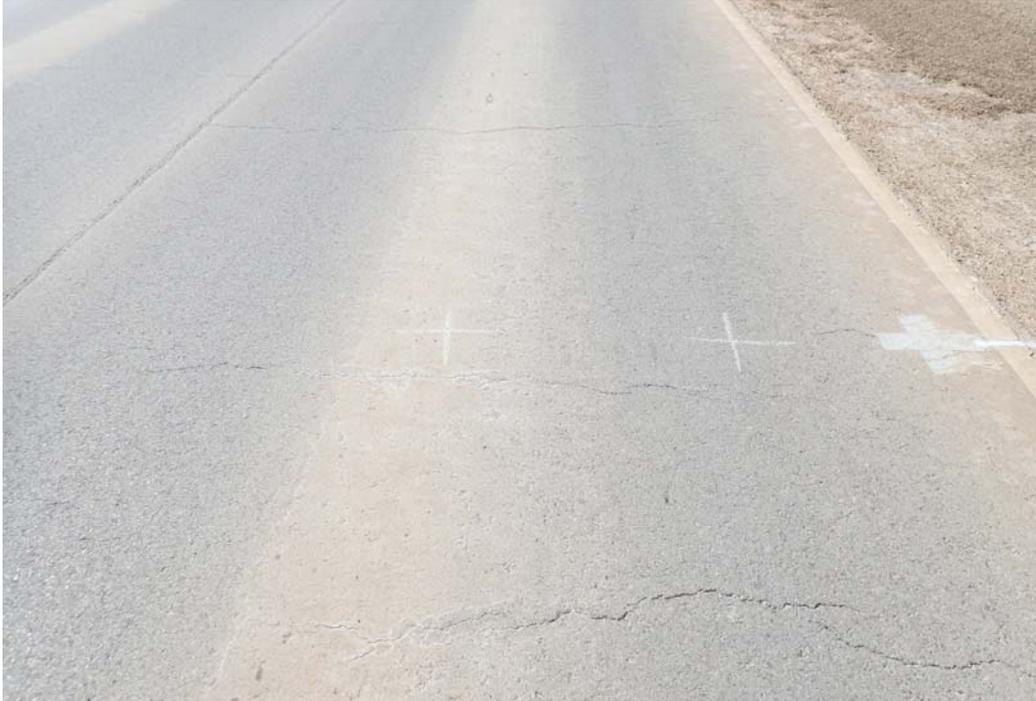
Figure 16. Image of Section 40_AA62 in March 2019. This is an image of the same portion of test section as shown in figure 15. The location and pattern of the cracks support the reflection cracking hypothesis. This test section had the highest amount of post-overlay transverse cracking in 2019.

Because pavement distresses have only been monitored over a three-year period after application of the AC overlay, it is important to continue to monitor transverse cracking on the test sections. By doing so, the initiation of cracking and the effect of the extent of cracking prior to application of the overlay on the propagation of cracking following the overlay can be better studied.
