Technical Memorandum

Re. Forensic Desktop Study Report: Kansas SPS-2 test sections 0201, 0203, 0206, 0212

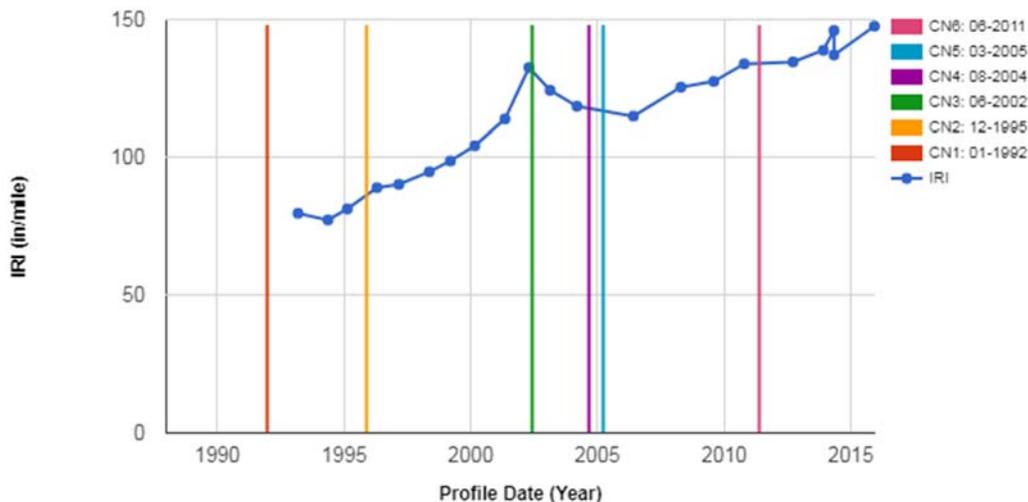
Figure 7. Section 20_0201 IRI and construction time history plot.

The IRI and construction time history for test section 20_0201 is shown in figure 7. The vertical lines are construction events, as follows:

- CN1 – test section accepted into LTPP program, January 1992
- CN2 – partial depth patching at joints, replaced one PCC slab, December 1995
- CN3 – replaced 2 PCC slabs, June 2002
- CN4 – replaced 4 PCC slabs some previously replaced, August 2004
- CN5 – joint Sealing, March 2005
- CN6 – full depth transverse joint repair, full depth patching other than joint, June 2011

The IRI shows a relatively steep increase in IRI, until the slab replacement performed in 2002. There is a drop in IRI after the slab replacements, and then the IRI starts increasing again. The apparent “spikes” in the May 2014 measurements is a bit of a mystery. The distress survey performed at this time indicates diamond grinding that was not captured in a construction event. However, the more probable explanation is that profile measurements on May 5, 2014 were performed following standard LTPP protocol and a set of LTPP diurnal profile measurements on May 6, 2014 were performed at times when the temperature gradient in the top and bottom of the PCC slab was the greatest positive, neutral, and greatest negative.

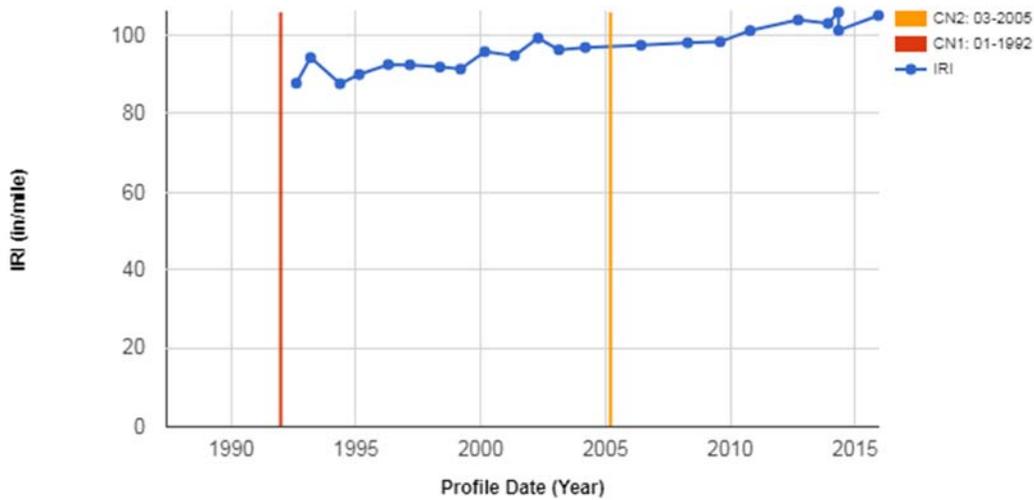
Figure 8. Section 20_0203 IRI and construction time history plot.

Figure 8 shows the IRI and construction time history plot for section 20_0203. The only maintenance event performed on this test section was joint sealing in March 2005. The IRI for this section has remained relatively stable with only a slight increase over time.

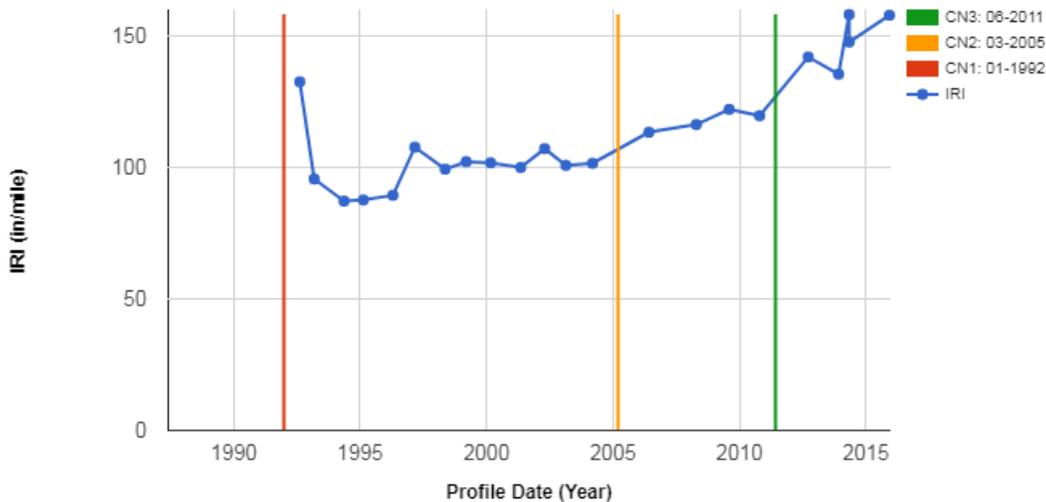
Figure 9. Section 20_0206 IRI time history plot.

Figure 9 shows the IRI and construction time history for section 20_0206. The following construction events have occurred on this test section:

- CN1- test section accepted into LTPP program, January 1992
- CN2- joint sealing, March 2005
- CN3 – replaced one PCC slab, June 2011

The initial IRI values measured in August 1992 appear high as compared to future measurements. There are no noted problems in the profile operator comments for the August 1992 IRI measurements. In the 1992 measurements, the roughness of the left wheelpath was considerably higher than the right wheelpath. The 1992 profile measurements were performed from approximately 1 pm to 3 pm on 8/14/1992. Profile operator notes in the March 1993 profile measurement indicated the IRI values had dropped since the 1992 measurements; however, no equipment related issues were reported. These measurements were performed on 3/10/1993 from 11 am to 12:30 pm. The apparent “spikes” in the May 2014 measurements is due to a standard profile measurement set measurement on May 5, 2014 and a set

of diurnal measurements performed on May 6, 2014 at times when the temperature gradient in the top and bottom of the PCC slab was the greatest positive, neutral, and greatest negative.

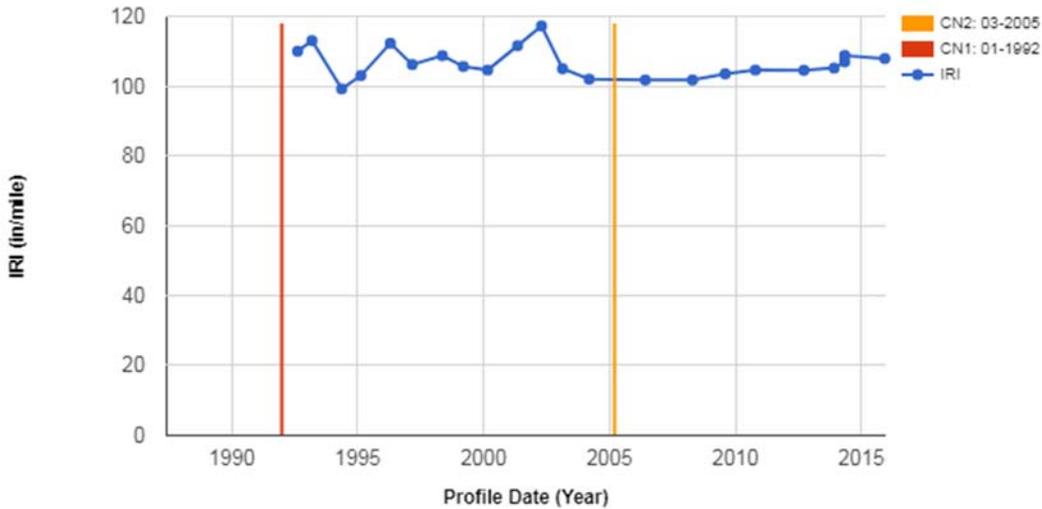
Figure 10. Section 20_0212 IRI and construction time history plot.

Figure 10 shows the IRI construction time history for section 20_0212. Joint sealing in March 2015 is the only maintenance event that has occurred on this test section. It is unknown why the average IRI prior to 2004 shows variability, and after 2004 becomes very stable. There is one operator comment in the measurements performed in 2002 indicating that profile spikes are pavement related. Other than having a significant cross tining pavement texture, the only other notable issue with the test section are random white paint spatters on the pavement surface in 2002. The diurnal profile measurements performed in 2015 did not show very much diurnal variability on this test section.

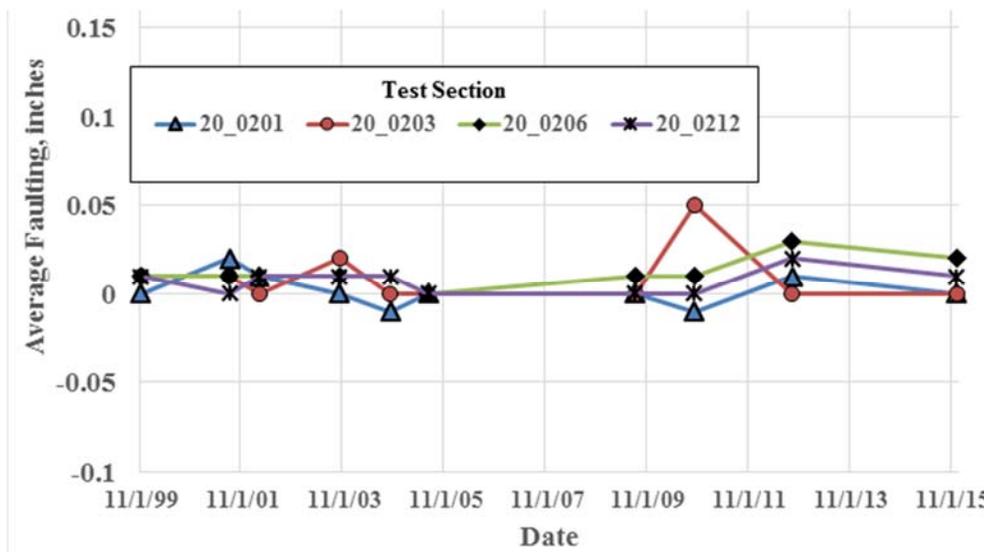
Figure 11. Average faulting time history for selected Kansas SPS-2 test sections.

Figure 11 shows the average faulting time histories on the selected Kansas SPS-2 test sections. Note that a positive fault height occurs when the leave side of the joint has a higher elevation than the approach. As can be seen in figure 11, the amount of faulting observed on these test sections is very minor.

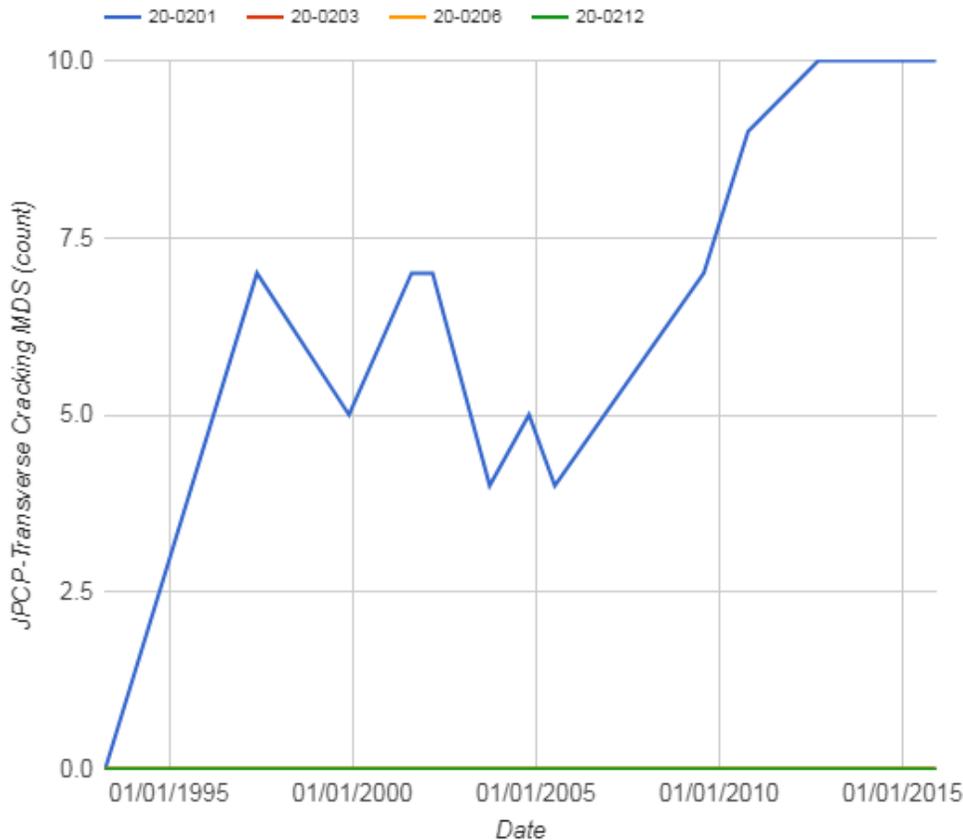
Figure 12. Transverse cracking history on the selected SPS-2 test sections, by number of transverse cracks.

Figure 12 shows the time history progression of transverse cracking on the four selected test sections for this study from the Kansas SPS-2 project site. Test section 20_0201 was the only test section of the selected group to experience transverse cracking. Variations in the number of transverse cracks may be due to full depth slab replacements on the slabs at the end of the test section which exhibited the most significant distress, and growth of transverse cracks on other slabs. In the SPS-2 experiment design, this test section was designed to be the weakest PCC test section structure (without consideration of applied pavement loads).

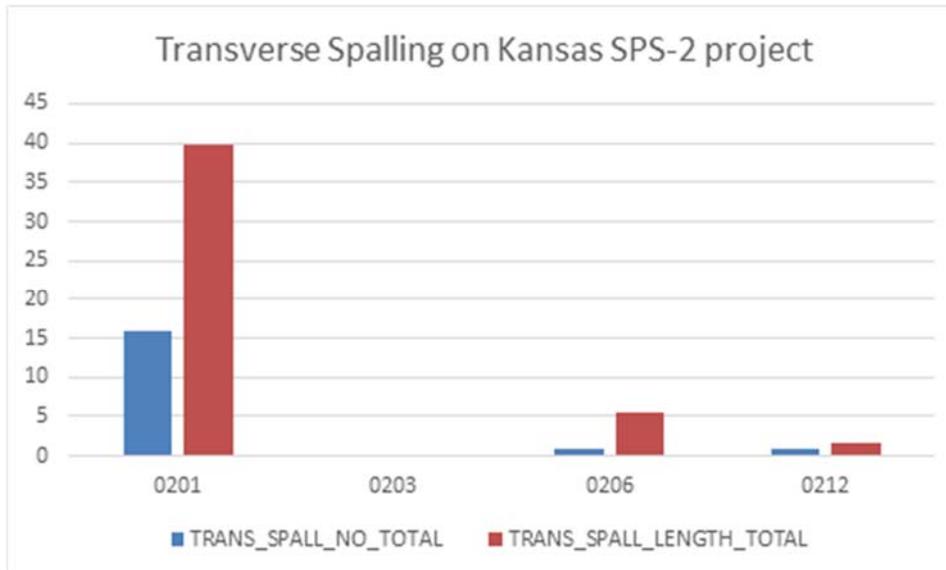
Figure 13. Plot of transverse joint and crack spalling by number and length.

Figure 13 shows the number and length of spalling at transverse cracks and joints from the last distress survey performed in 2015 on the test section under study. Only test section 20_0201 has significant spalling. From the distress surveys it is clear that many patches have been placed at joints to correct spalling defects.

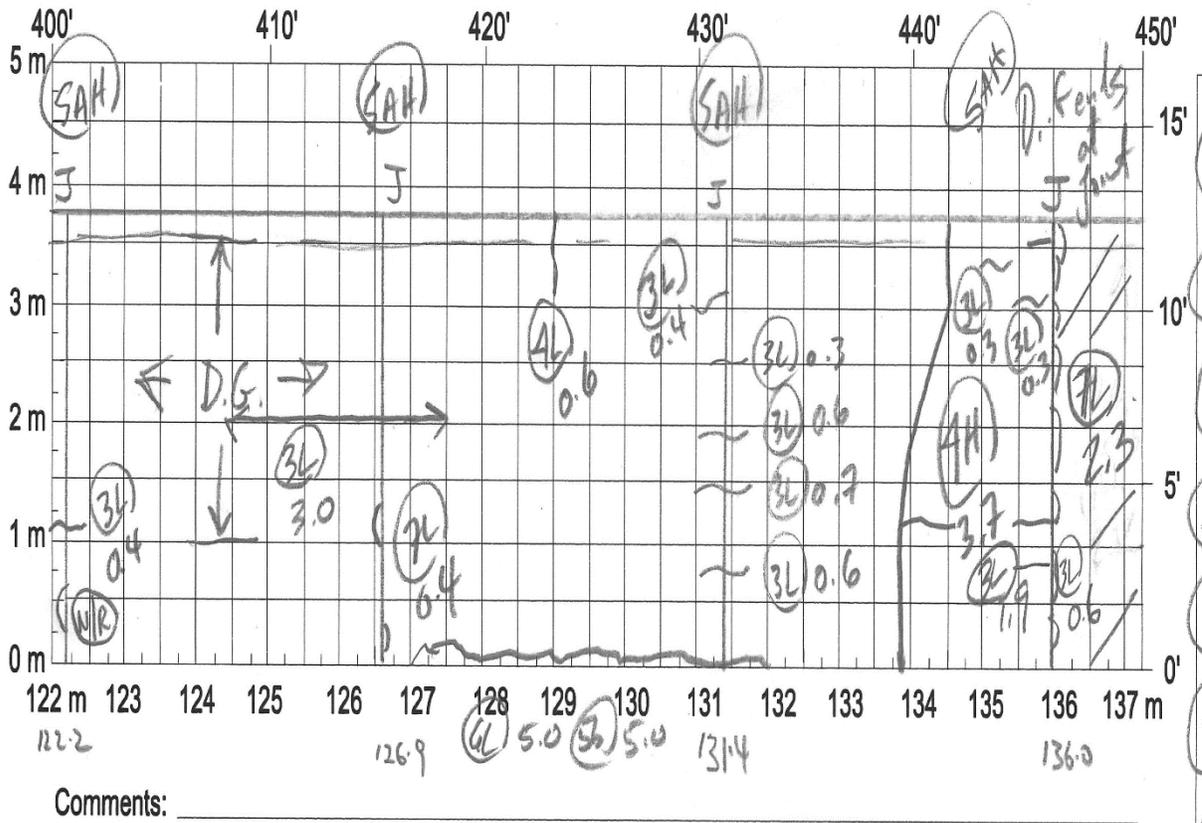
Figure 14 is the image of the manual distress map on section 20_0201 from the December 2015 distress survey for test stations between 400–450 feet (122–137 m)¹. The joint located at around 432 feet (131.4 m) shows 5 short longitudinal cracks centered on the joint location. These are labelled as 3L cracks. A more thorough review of this image also shows transverse cracking approximate to the joint located at the joint located at ~ 460 feet (136 m). The downstream portion of this joint is a complete slab replacement type of patch.

joints showed between 1 to 5 short longitudinal cracks at the joint, which appears to be associated with dowel bar locations.

Figure 14. Distress map from December 2015 distress survey that appears to illustrate longitudinal cracking at dowel bar locations.

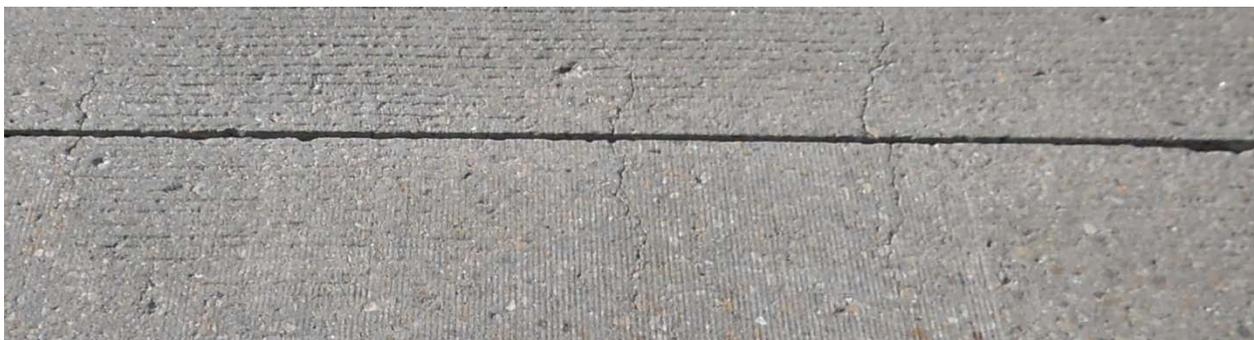
Figure 15 is a close-up picture of the short longitudinal cracks at the joint located approximate to station 432 ft (131.1 m). This picture appears to reinforce the observation that these cracks are above dowel bar locations. From review of the manual distress map test section 20_0201 from December 2015, 16 of the 33

Figure 15. Close-up image of joint located at station 32 ft (131.1 m) on test section 20_0201 in December 2015, showing short longitudinal cracks that approximate the location of dowel bars.

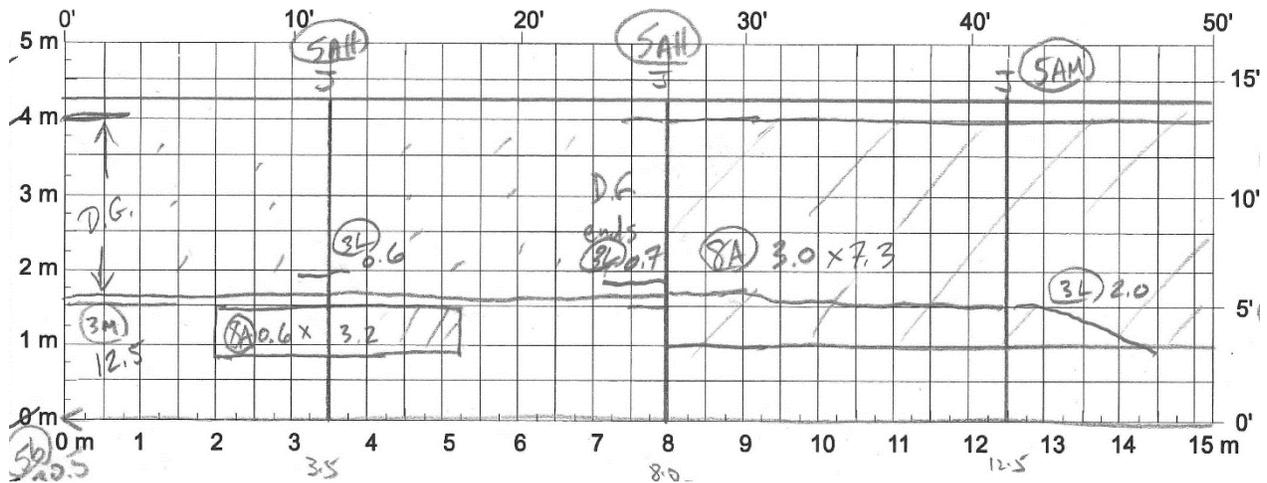
Figure 16. Manual distress survey map from December 2015, of the start of test section 20_0206.

The distress survey from section 20_0206, showed two joints with potential longitudinal cracks located over dowel bars. Figure 16 is the relevant portion of the manual distress survey map for section 20_0206 in December 2015. The transverse joints at approximate stations 11 feet (3.5 m) and 26 feet (8 m), were the only two joints with this issue. Another feature of this distress map is distress 8A, which is map cracking on

the pavement surface. There is also a significant longitudinal crack with an offset of about 5 feet (1.5 m) from the lane edge. This is a 14-foot-wide pavement slab.

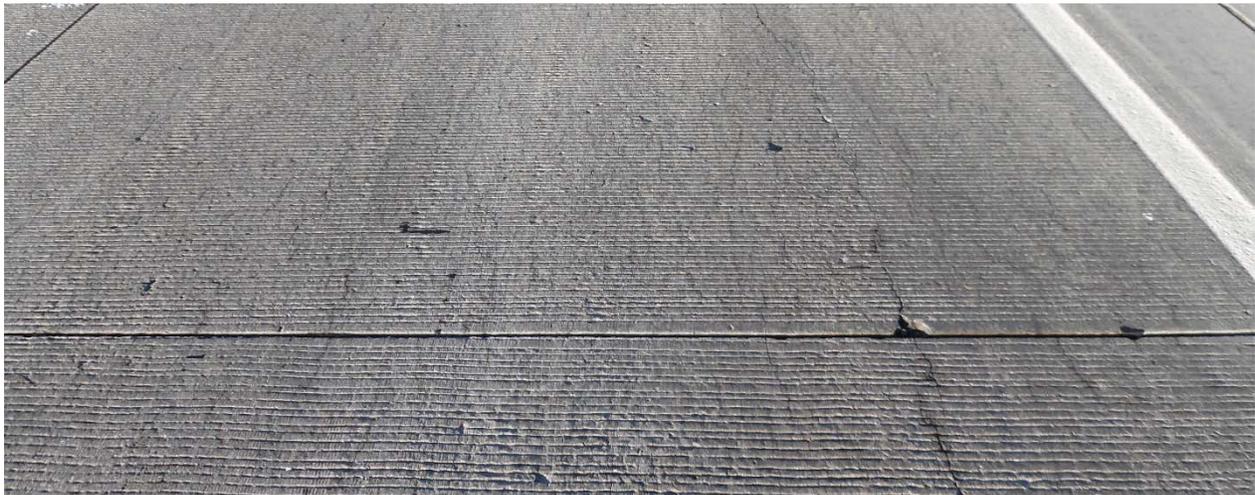
Figure 17 shows a close-up picture of the joint located at 26 feet (8 m). There appears to be more short longitudinal cracks at this joint than noted in the manual distress survey. Also the map cracking noted in the distress survey could be influencing the rating of longitudinal cracks at the joint in this distress survey.

Figure 17. December 2015 image of joint on test section 20_0206 at stations 26 feet (8 m). Image shows potential masking of short longitudinal cracking over dowel bars rated as map cracking.

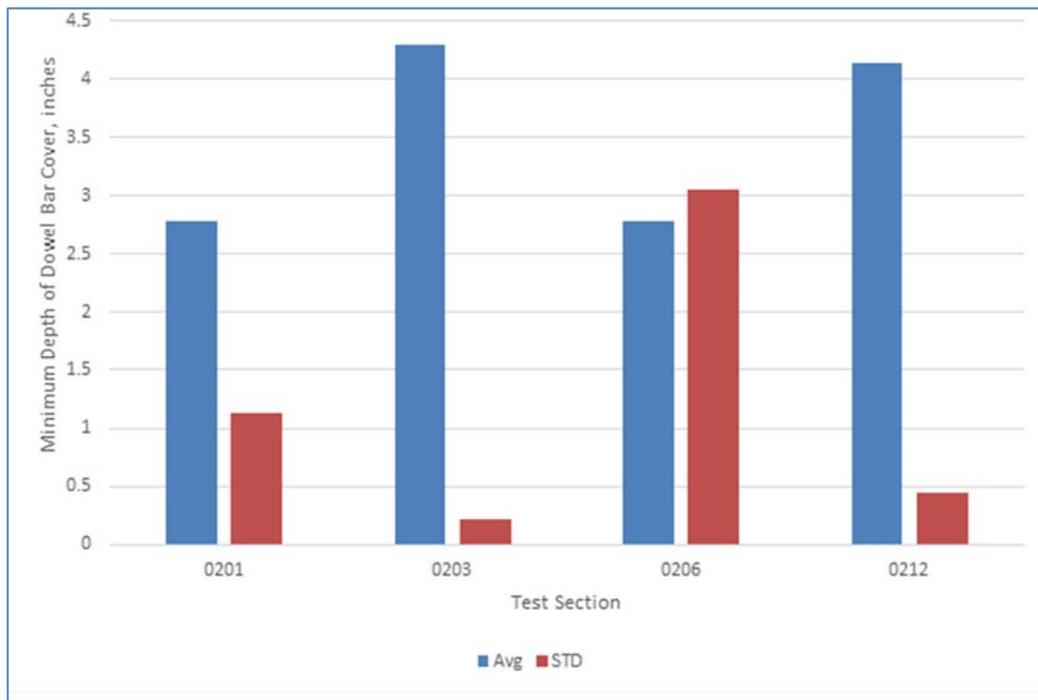
Figure 18. Depth of coverage dowel bar statistics for the selected test sections on the Kansas SPS-2 project site.

Attachment A contains the joint score and computed effective dowel diameter from measurements at each joint from MIT measurements, while Figure 18 illustrates average and minimum depth of PCC coverage over the dowel bars on the Kansas SPS-2 test sections included in this study. Sections 20_0201 and 20_0206, have the lowest depth of cover. They are also the thinnest test sections on the project site. While the design construction thickness was specified as 8 inch, these test sections have an average thickness of the PCC layer of 7.7 inches.

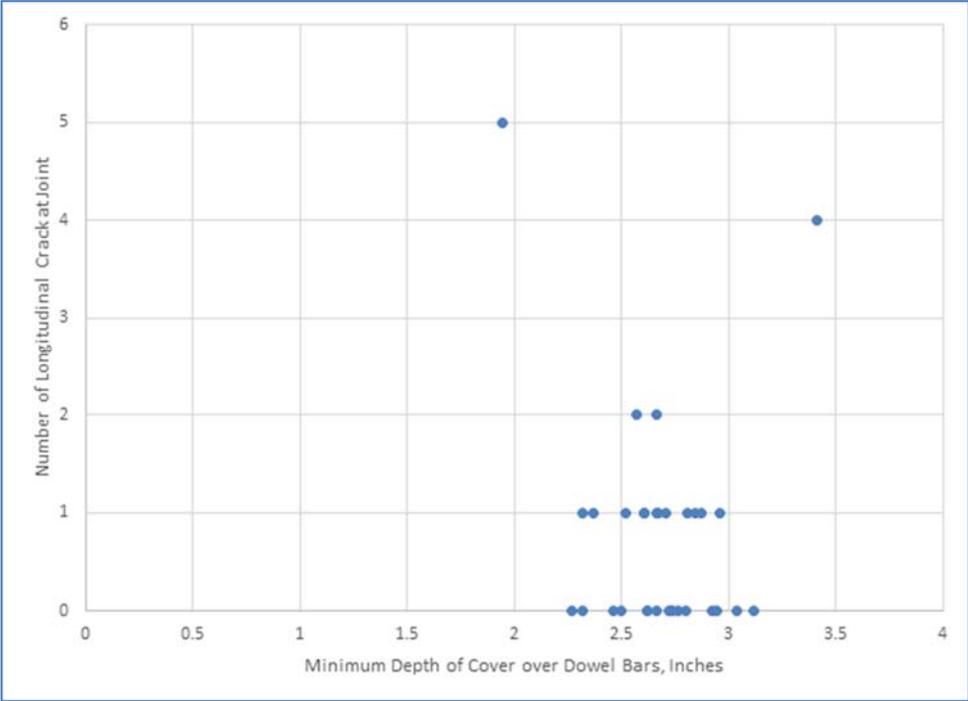
One of the postulates from the SPS-2 Tech day was that cracking at the joints appeared to be located above dowel bar locations. Figure 19 shows the relationship between the number of short longitudinal cracks at each joint location on test section 20_0201 and the average dowel bar coverage depth statistic for each joint. Joint 29 had the most longitudinal cracks at the joint and the shallowest depth of dowel bar embedment. The outlier in this plot is for joint 30, which has 4 longitudinal cracks located at the transverse joint. The minimal coverage MIT measurements reported in the baseline at this joint range between 18.3, which is thicker than the PCC pavement, and -2.4 inches which is above the pavement surface; thus, the depth of coverage MIT measurements at joint 30 on this test section are not reliable.

Figure 19. Minimum depth of dowel bar coverage from MIT measurements versus number of longitudinal cracks at each joint location on section 20_0201. It is noted that the computation of minimum depth of cover for the data point with 4 longitudinal cracks has indicated MIT measurement discrepancies.

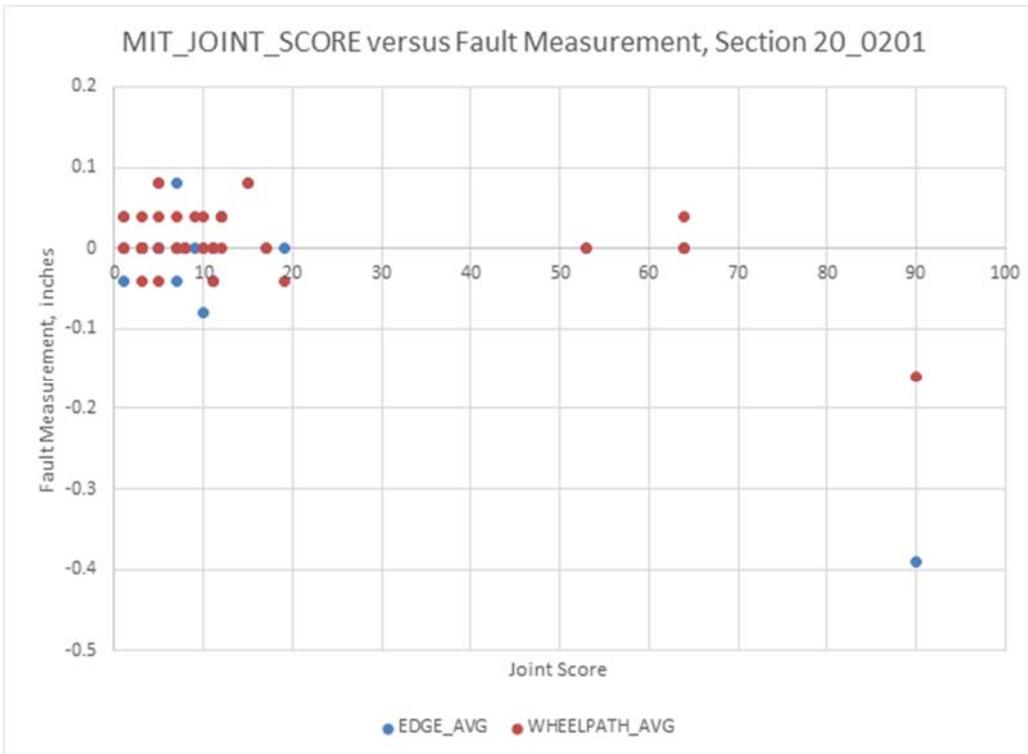
Figure 20. Fault measurements versus joint scores from MIT measurements on test section 20_0201.

Figure 20 shows the fault height at each joint on test section 20_0201 as a function of joint score. There appears to be no relationship between fault height and joint score on this test section. It should be noted that a negative fault height measurement means the leave side of the joint has a higher elevation than the approach. The largest negative fault height on this test section is located where a new full depth slab was replaced and created an upward “bump” in the longitudinal profile.

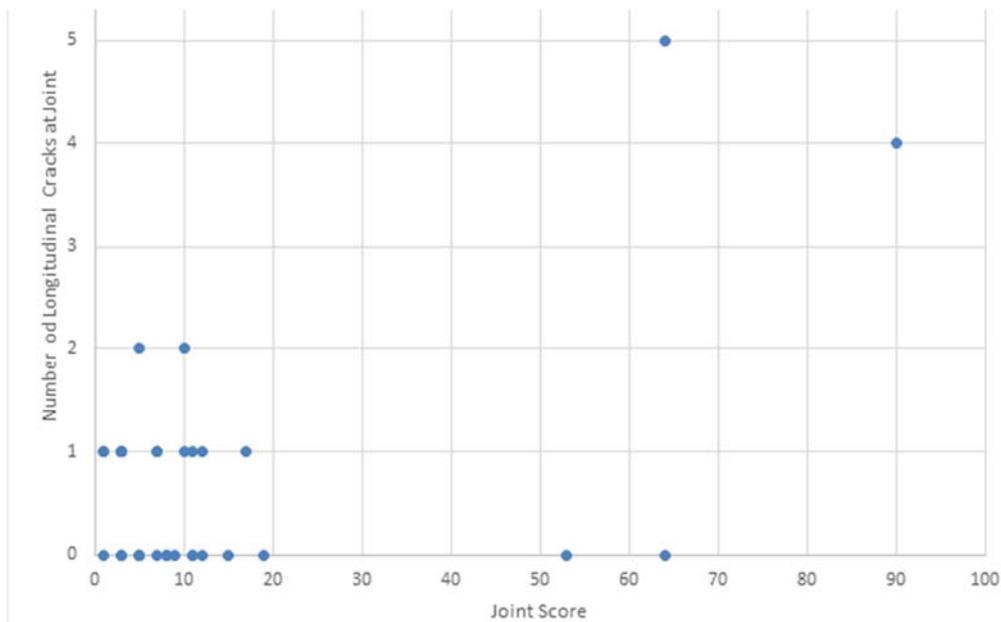
Figure 21. Number of longitudinal joints at transverse joints versus joint score from MIT measurements for test section 20_0201.

Figure 21 illustrates the relationship between the MIT derived joint score and the number of longitudinal cracks at transverse joints interpreted from the LTPP manual distress survey maps. While there is a causal trend for the joints with the highest dowel score to also contain the most longitudinal cracks at dowel bar locations, there are also joints with high joint scores that have no indication of longitudinal cracks over the dowel bars.

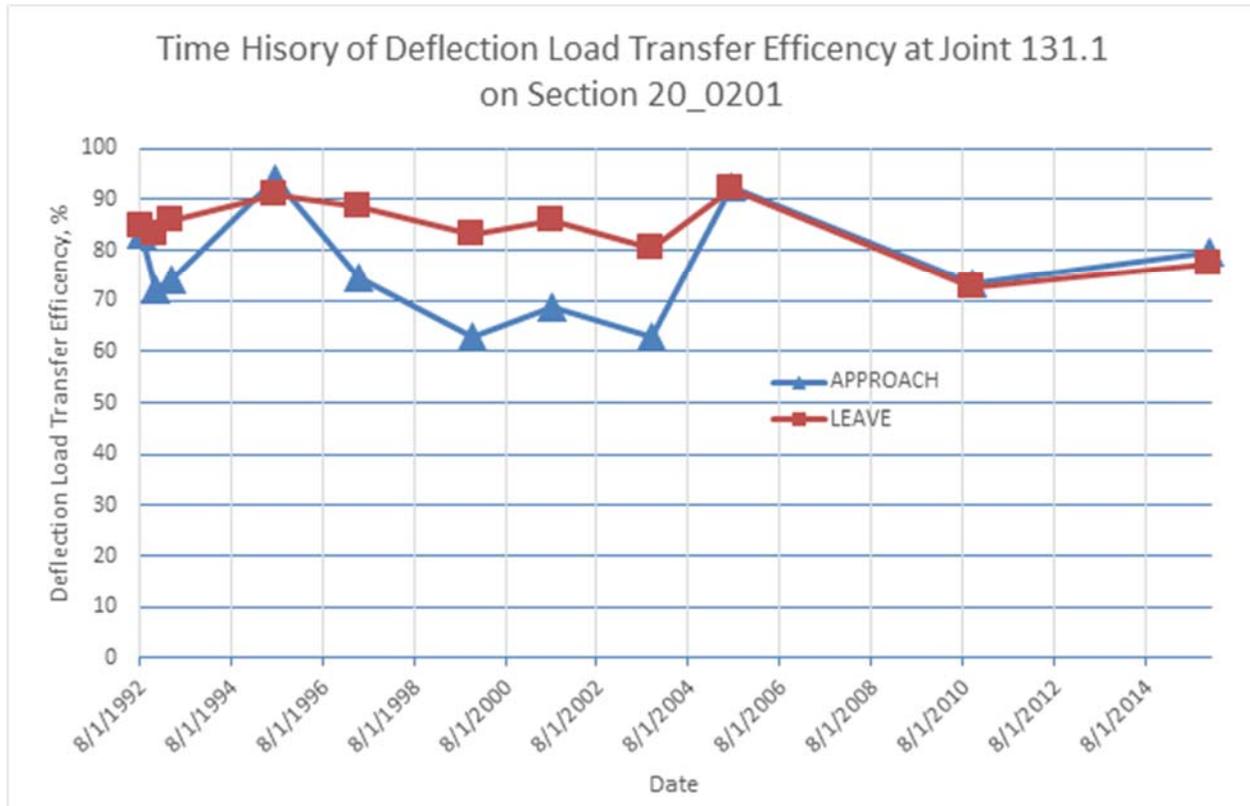
Figure 23. Time history of average deflection load transfer efficiency at joint 131.1 on section 20_0201 from drop height 4.

suggests that the cracks that appear to be located over the dowel bars are not having a significant impact on the dowel bar function related to load transfer across the joint.

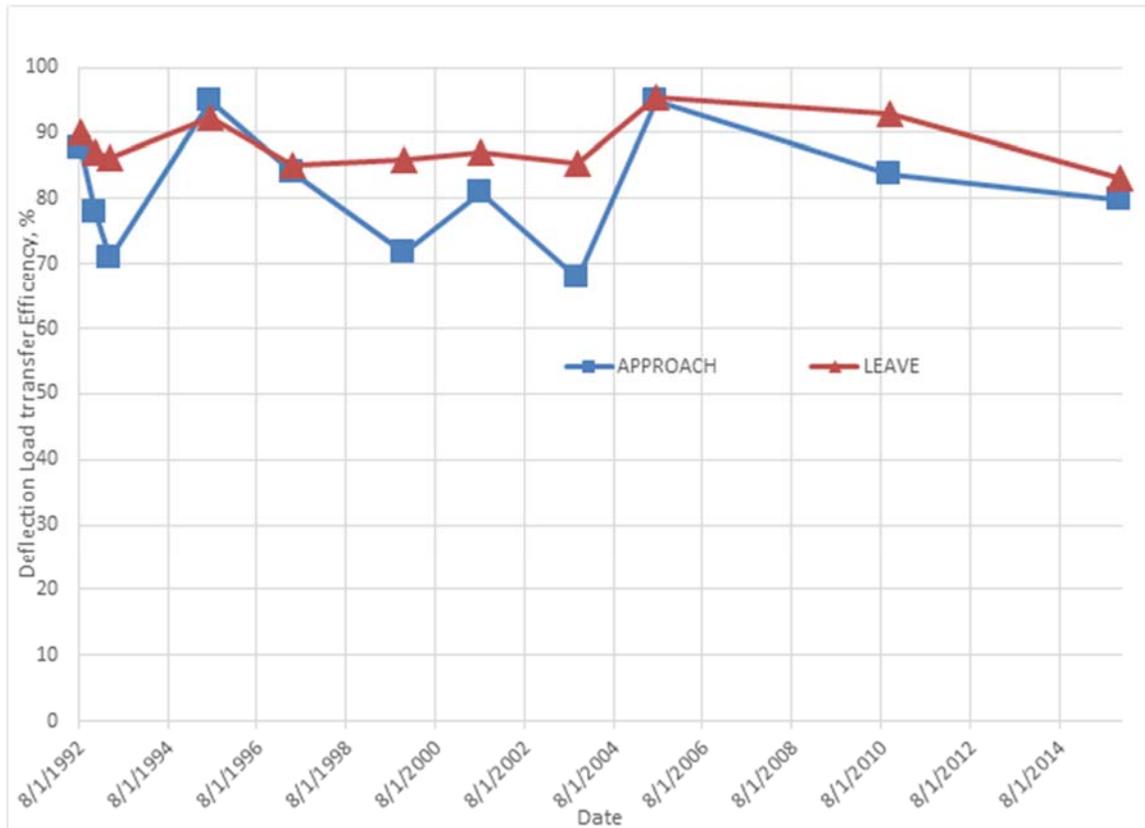
Figure 24. Time history plot of average deflection load transfer efficiency at joint 3.1 on test section 20_0201 from drop height 4.

Figure 24 shows the time history LTE measurements from the joint on test section 20_0201 at station 3.1. This joint had one minor longitudinal crack associated with a dowel bar. LTPP LTE measurements are performed in the wheel path which is not near the longitudinal crack associated with dowel bar cracks. While this time history plot shows a general decrease in LTE over time, the decrease in LTE is not very significant from those for the joint at station 131.1.
