Technical Memorandum

Re: Forensic Desktop Study Report: Maine LTPP Test Section 23_1028

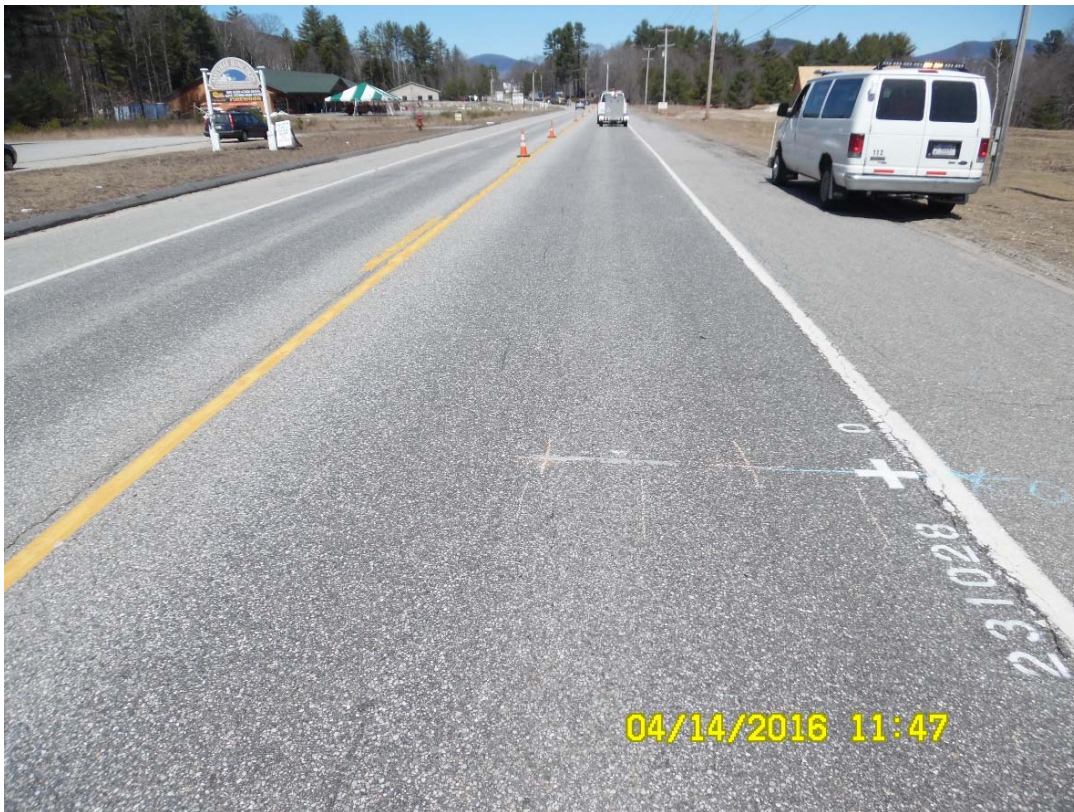
Photograph 1. LTPP Section 23_1028 at Station 0+00 looking eastbound in 2016.

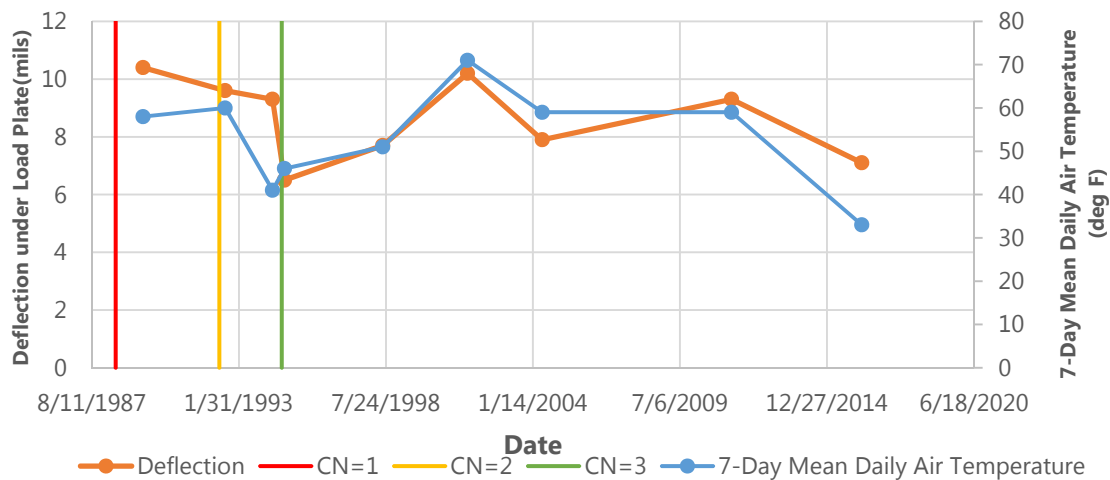
Figure 1. Time history of average deflection for the sensor located in the load plate normalized to 9,000 lb. drop load.

Figure 1 shows the average Falling Weight Deflectometer (FWD) deflection under the nominal 9,000-pound load plate over time. The deflection of the sensor located in the center of the load plate is a general indication of the total “strength” or response of all layers in the pavement structure to a vertically applied load. This deflection can be influenced by pavement temperature and moisture at the time of testing, and by other factors. As depicted in Figure 1, the deflections observed on the site fluctuate over time. Prior to the overlay in 1994, the reported deflections over the load plate decreased modestly from 10.4 mils in July 1989 to 9.3 mils in May 1994. Following (and as a direct result of) the overlay in September 1994, the deflection reported drops to 6.3 mils. However, after 1994 the deflections fluctuate between 7.1 mils (2016) and 10.2 mils (2001). As depicted in Figure 1, some of the highest and lowest deflections values reported on the section, especially in 2001 and 2016, appear to be related to the temperatures leading up to the testing day – the highest temperature of 71°F and lowest temperature of 33°F, respectively—as shown in Figure 1.

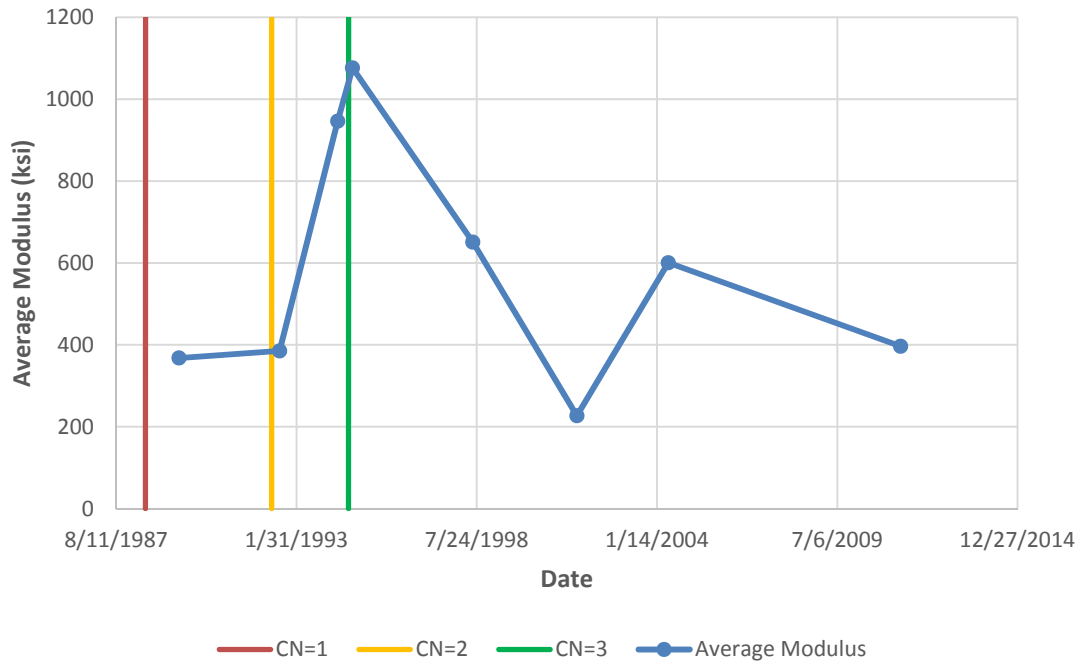
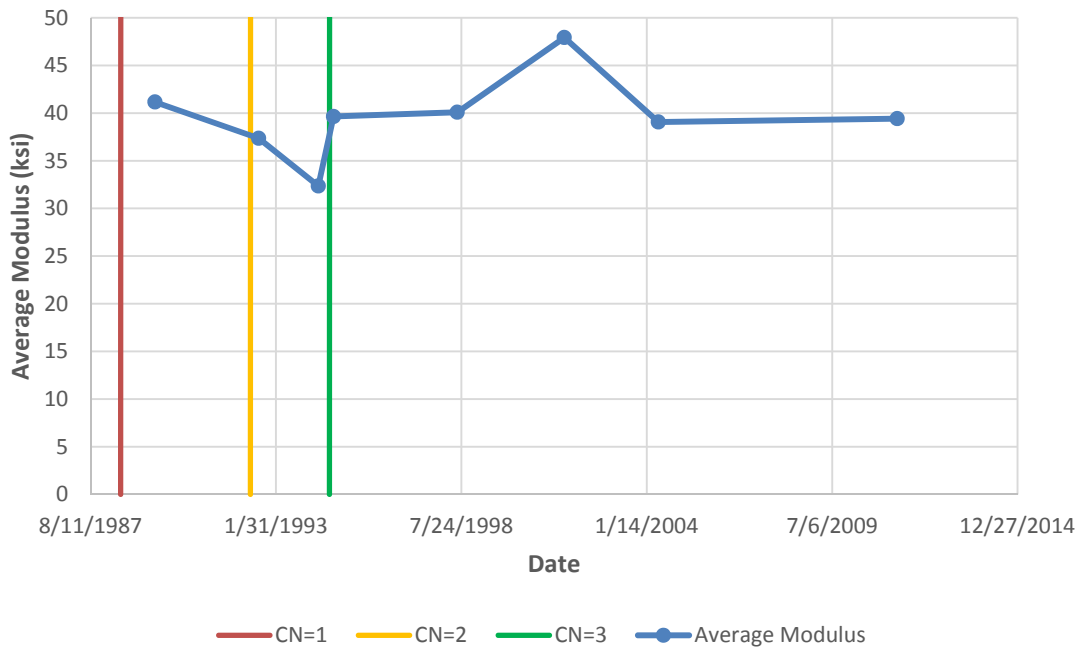
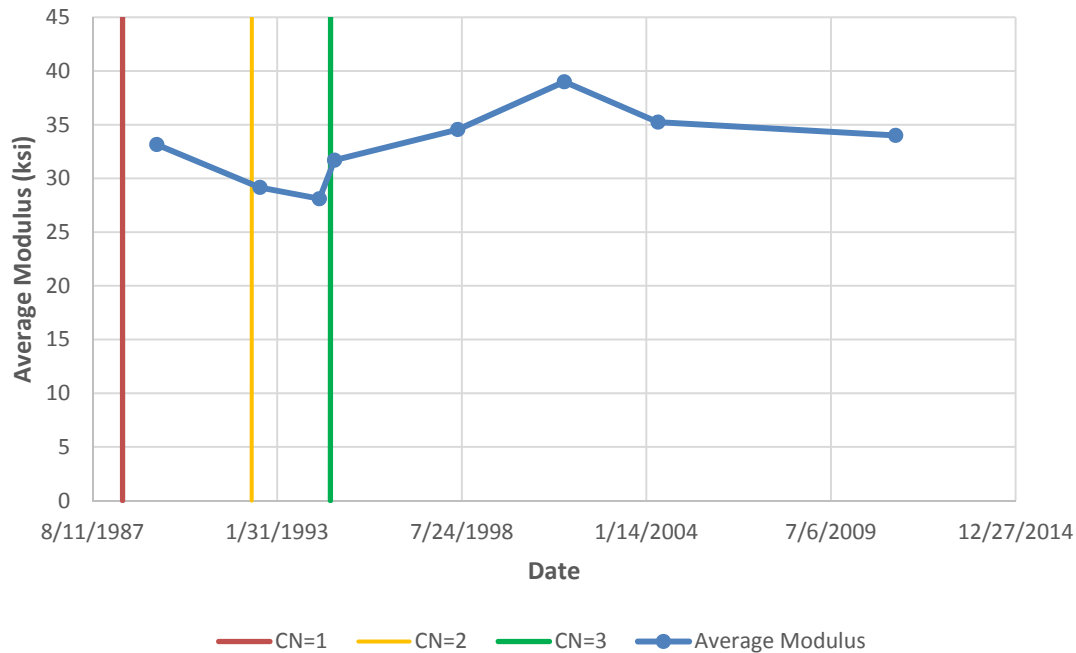
The AC moduli appear to be quite reasonable, varying between 200 and 1,100 ksi. The value of 200 ksi was determined when the temperature was 71°F, while values close to 1,100 ksi were determined when the temperature was in the low-to-mid 40s (°F). Perhaps the only surprising value is 400 ksi when the temperature was 33°F. Similarly, the backcalculated granular base layer moduli (includes 18.1 inches of granular material and 5.9 inches of top of subgrade) appear quite reasonable, ranging between 32 and 48 ksi over the 22-year period of 1989 to 2011. This is also the case for the remainder of the subgrade layer, with values ranging between 28 and 39 ksi over the same 22-year period.

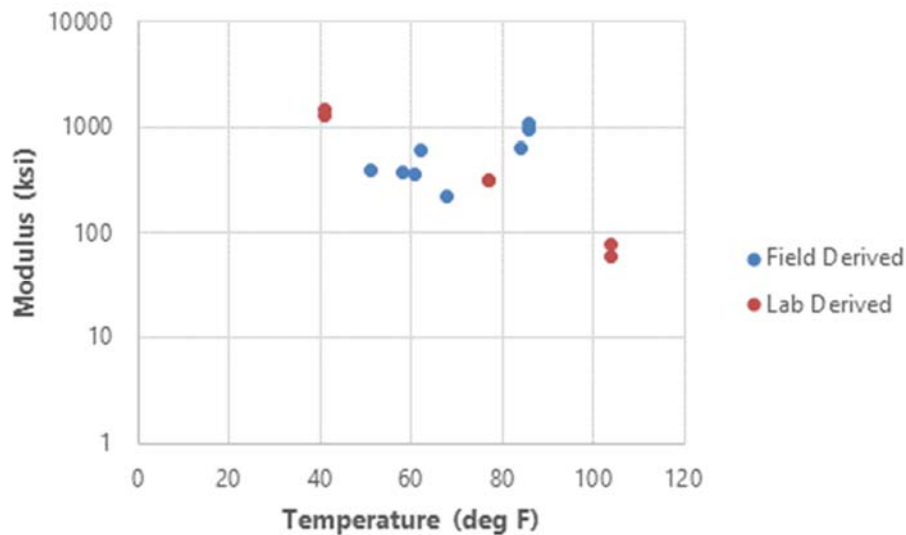
Figure 5. Field- and lab-derived AC resilient modulus values.

As shown in Figure 5, the AC modulus-temperature trend defined by the two datasets appears to be reasonable. The exception is the field-derived values above 80°F, which appear unusually high.

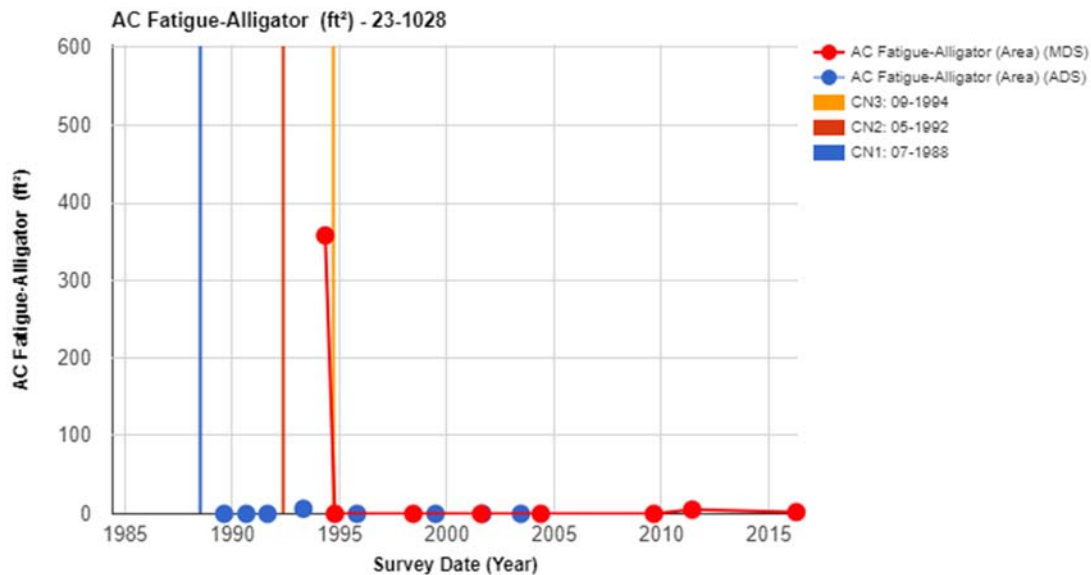
Figure 10. Time history of the area of bottom-up cracking.

Figure 10 shows the total area of fatigue-related cracking observed on the section. Prior to the AC overlay in 1994, fatigue cracking was not observed until 1993 when 7 ft² was reported on the section. A spike in fatigue cracking was reported in May 1994 when 358 ft² of fatigue cracking is observed.

As shown in Figure 10, the fatigue cracking reported in 1994 corresponds to the first manual distress survey conducted on the section; all surveys prior to this date were automated distress surveys. As automated distress surveys relied on images to assess distresses along test sections, some cracking,

especially low severity cracking like the fatigue cracking observed on this section, was not adequately captured and therefore, underreported. The fatigue cracking that was observed in the 1994 manual distress survey was mostly near the centerline of the section. Following the overlay in 1994, the area of roadway where fatigue cracking had been observed is no longer notable. Fatigue cracking is first observed in 2011, 17 years after the overlay, when 5 ft² was reported on the section. Minimal fatigue cracking is observed in the subsequent distress survey in 2016.

It is hypothesized that the cause of the fatigue cracking prior to the overlay in 1994 is likely a result of the high levels of moisture and the freeze-thaw cycles experienced at this test section. Because this area is in a wet, freeze climate with thaw in the spring, the fatigue cracking may be related to weakened base and subgrade layers. However, the reason why fatigue cracking is occurring near the centerline is not clear. Is it because the base and subgrade layers are weaker near the centerline? Is it because the layers in the pavement structure are thinner near the centerline? Is winter traffic more damaging and are the wheel paths being shifted towards the centerline because of snow cover? This fatigue cracking location issue will need to be addressed as part of follow-up investigations.

- iii. Investigation into whether or not layer thicknesses decrease towards the centerline, which is where fatigue cracking was observed.
 - b. Confirm that NWP longitudinal cracking at the test section is reflection cracking.

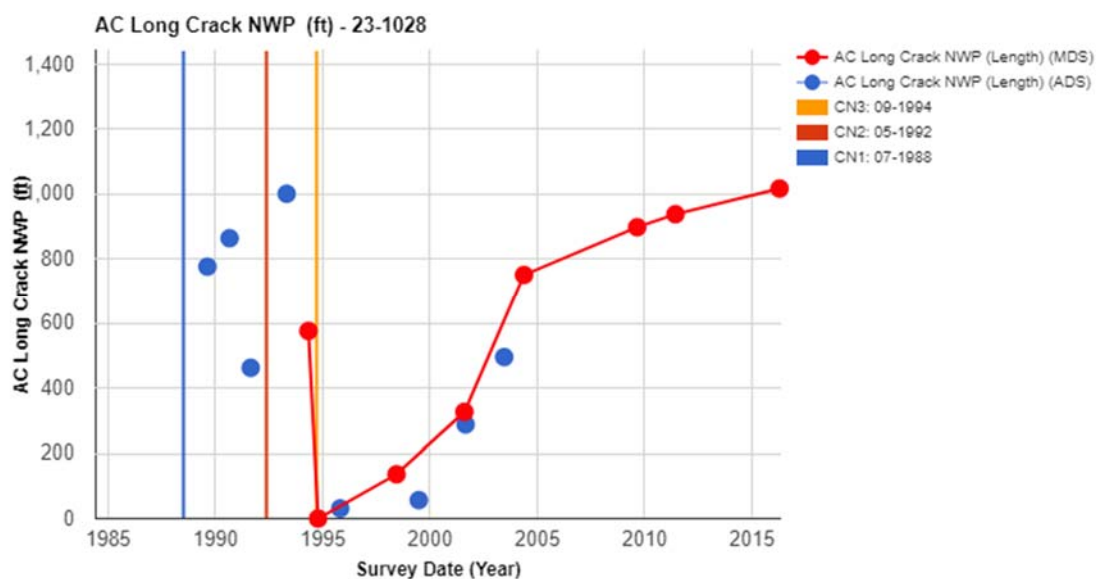
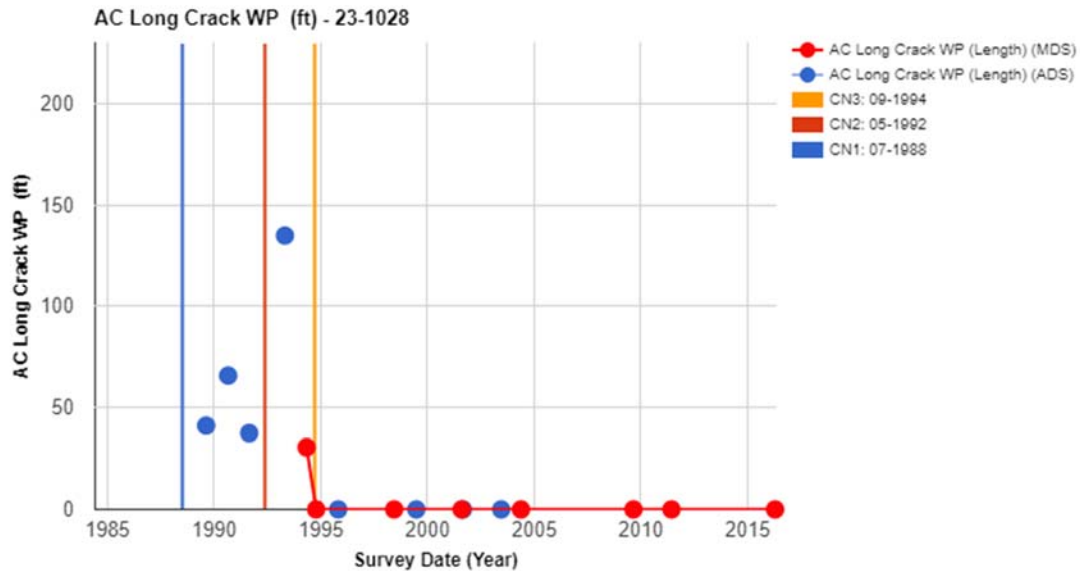
Data on longitudinal cracking, inside and outside the wheel path, were collected between 1989 and 2016 as shown in Figures 11 and 12. In May 1994, the date of the first manual distress survey for this section, 575 feet of non-wheel path (NWP) longitudinal cracking was reported. Prior to the overlay in 1994, the NWP longitudinal cracking observed fluctuated. This is likely due to the source of the data reported. As discussed previously, the first manual distress survey was conducted on this site in 1994. Prior to 1994, automated distress surveys were used to report the longitudinal cracking observed on this site. The NWP longitudinal cracking observed prior to the overlay was mostly located at the edges of the lane and in between the wheel paths. Following the overlay, the NWP longitudinal cracking observed on the section dropped to zero in 1994. However, NWP longitudinal cracking was observed again in 1998, four years after the overlay, when 136 feet of NWP longitudinal cracking was observed. Once cracking was initiated, it propagated at a rate of 49 feet/year between 1998 and 2016. The NWP longitudinal cracking observed following the overlay is predominantly located at the edges of the lane.

It is hypothesized that some (not all) of the NWP longitudinal cracking observed on this section is likely related to the fatigue cracking observed near the centerline of the test section; i.e., it is probable that it is low severity fatigue cracking and not NWP longitudinal cracking. This is further confirmed by the state of the test section's shoulder over time which shows similar fatigue-related distresses as well as pumping. The remaining NWP longitudinal cracking observed at the test section, as depicted in Figure 13, appears to be reflection cracking of the NWP longitudinal cracking observed prior to the overlay. While the amount of cracking observed following the overlay has surpassed the amount of NWP longitudinal cracking observed in 1994, the level of severity of the cracking following the overlay is mostly low while prior to the overlay the severity ranged from low to high.

Minimal longitudinal cracking inside the wheel path (WP) is observed on this section. In 1994, 9.30 feet of longitudinal cracking inside the wheel path (WP) appeared along the section during the first reported manual distress survey. Prior to the overlay in 1994, the observed WP longitudinal cracking fluctuates. This is likely due to the source of the data reported. As discussed previously, the first manual distress survey was conducted on this site in 1994. Prior to 1994, automated distress surveys were used to report the longitudinal cracking observed on this site. After the application of the AC overlay in 1994, WP longitudinal cracking was not reported again.

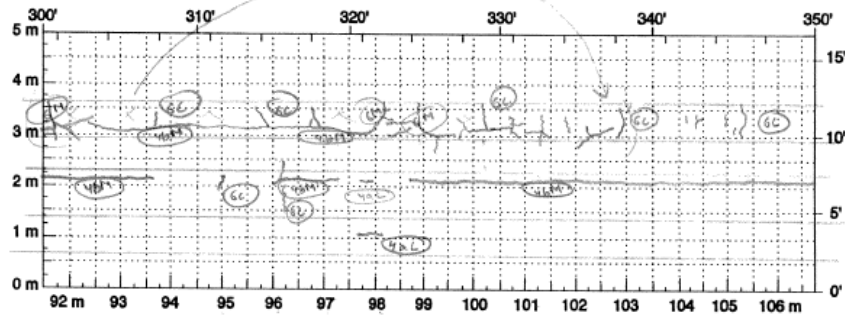
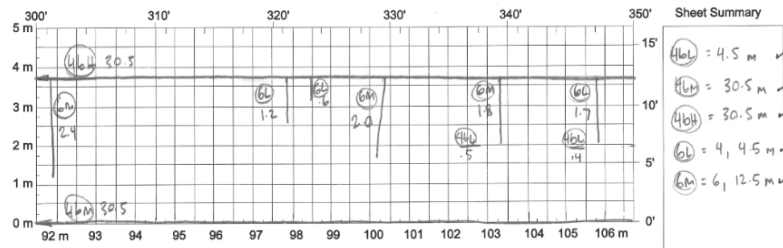
Figure 13. NWP longitudinal cracking on the test section between Station 3 and Station 3.5 in 1994 prior to the overlay (top) and 2016 (bottom)

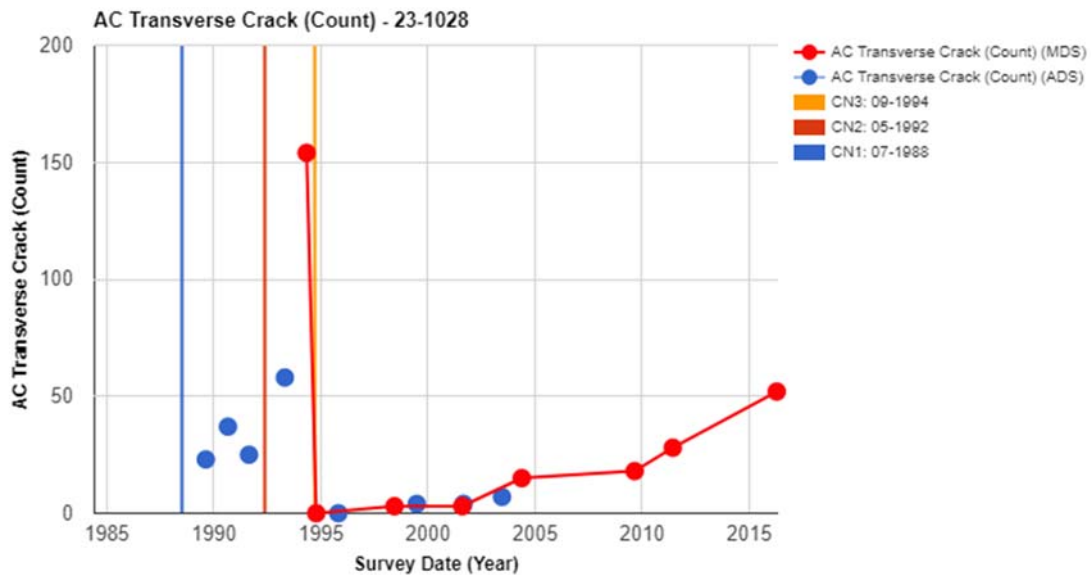
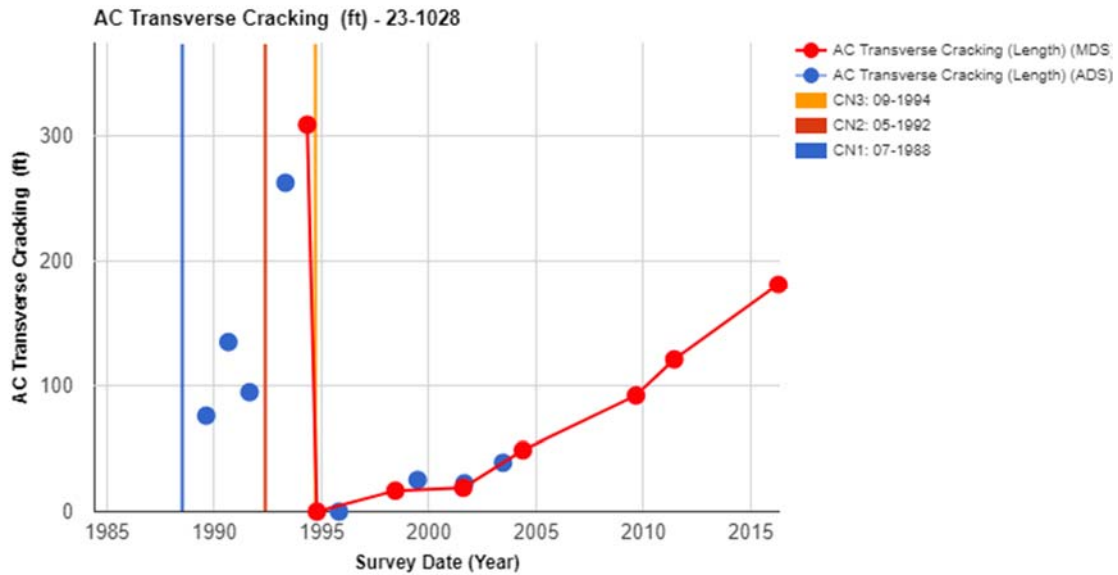
Data on transverse cracking was collected between 1989 and 2016 as shown in Figures 14 and 15. Transverse cracking appeared along the section during the first reported automated distress survey in 1989, when 76 feet (23 cracks) of cracking was reported. The transverse cracking observed increases prior to the 1994 overlay reaching 309 feet (154 cracks) in 1994. Following the overlay, the transverse cracking observed on the section dropped to zero. However, transverse cracking was observed again in 1998, four years after the overlay, when 17 feet (3 cracks) were observed. Once cracking initiated, it propagated at a rate of 9 feet/year between 1998 and 2016.

The transverse cracking observed on this section was mostly short cracks near the edges of the lane rather than full width transverse cracks. This appears to indicate that the observed transverse cracking is not likely low temperature cracking.

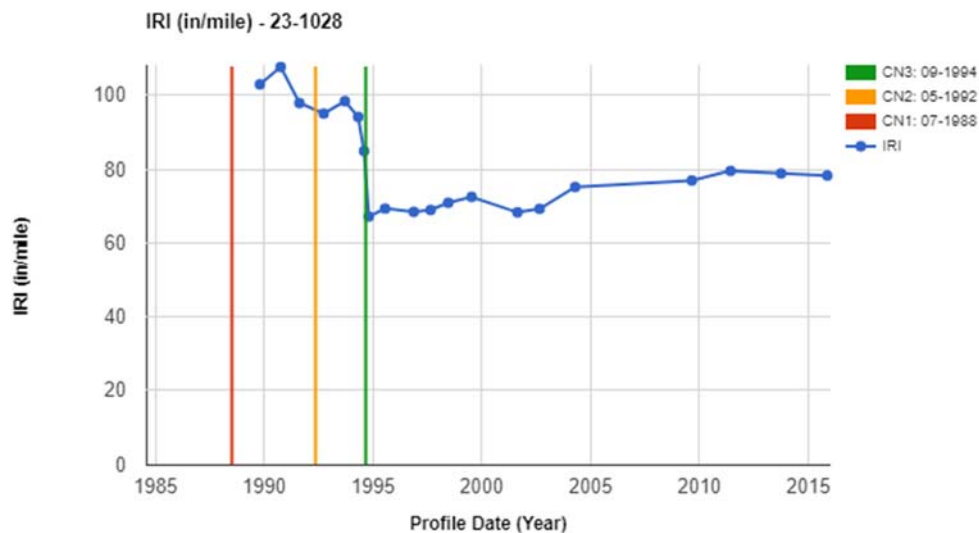
Figure 16. Time history plot of pavement roughness.

Prior to the AC overlay in 1994, the IRI reported on the test section fluctuated modestly with values ranging from 108 in/mi in 1990 to 94 in/mi in 1994. The reported IRI appears to decrease overall prior to the overlay with the pavement's IRI performance starting at "Fair" and ending at "Good" based on FHWA performance definitions. This downward trend in IRI prior to the overlay may be related to the variability in the measurements used to calculate the average IRI of the test section over time. As shown in Table 4, while subtle, the standard deviations of the average IRI values recorded per run per test date prior to the overlay were on average greater than after the overlay. This indicates a higher variability in the IRI values reported prior to the overlay, which could explain the downward trend in IRI observed. Following the AC overlay in 1994, the IRI on the section dropped to 67 in/mile in 1994. The IRI reported increases to 78 in/mile by 2015, increasing at a rate of just 0.5 in/mile over 21 years. The pavement's IRI performance is classified as "Good" during this period based on FHWA performance definitions.

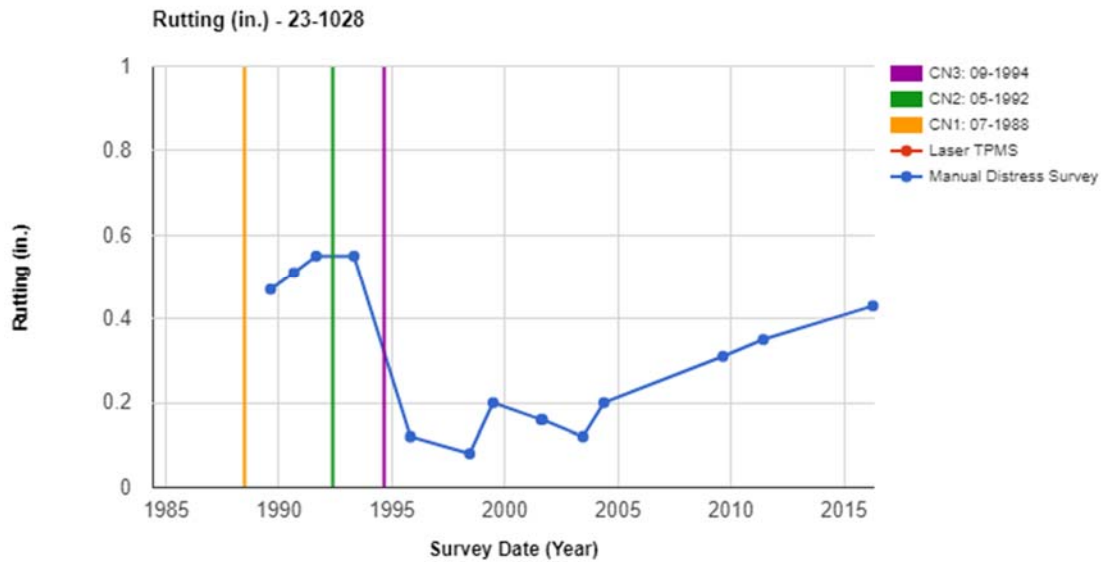
Figure 17. Time history plot of average rut depth computations.

The rutting observed over time on the test section is shown in Figure 17. Prior to the overlay in 1994, the rut depths observed increased from 0.47 inches in 1989 to 0.55 inches in 1993. These large rutting values were likely the driver for the application of the overlay in 1994, but this needs to be confirmed by the LTPP program as such information could not be found in the LTPP database. Following the overlay in 1994, the rutting observed on the section decreased to 0.12 inches in 1995. The rutting increased between 1995 and 2016 reaching a rut depth of 0.43 inches in 2016.

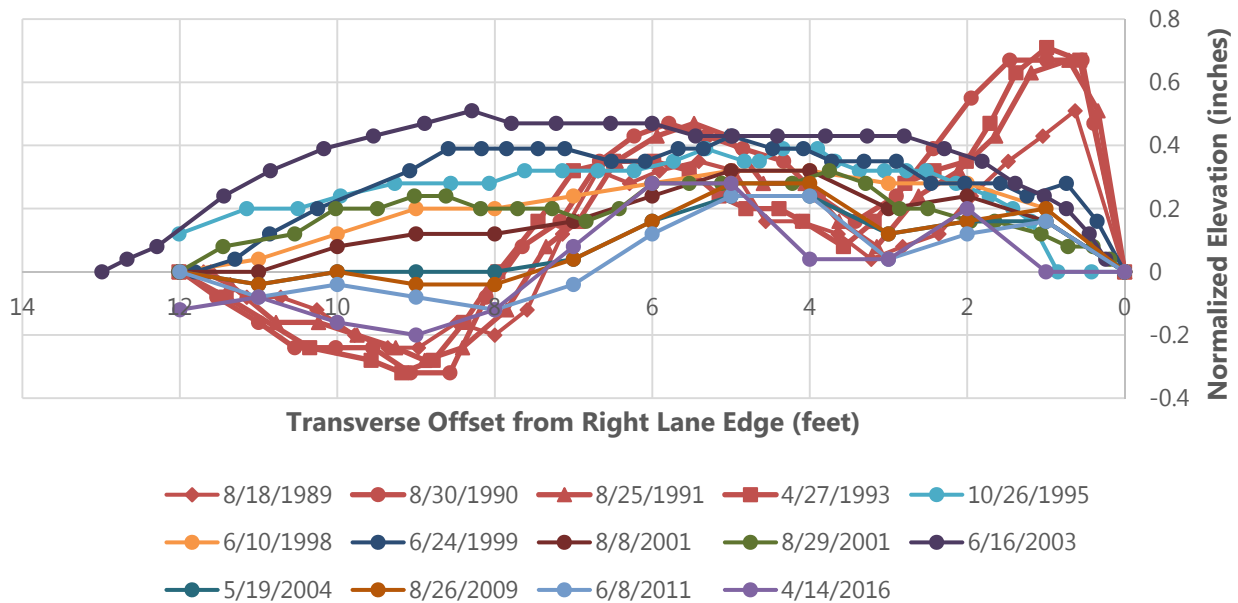
Figure 18. Plot of transverse profiles at Station 1.5 over time.

In addition to the average rut depth observed over time, the change in the transverse profile of the test section at one location (station 150) was also investigated. Figure 18 depicts the changes in the profile over time with red lines representing rutting profiles of the roadway prior to the overlay in 1994. From the figure, the transverse profiles observed prior to the AC overlay in 1994 showed deeper depressions along the wheel path over time whereas the rutting following the overlay was less pronounced in the wheel-path

and is instead concave down. It should also be noted that the transverse profiles prior to the overlay, while normalized, show the edge of the lane (offset equal to 0) is more than 0.4 inches below the next point of the transverse profile (to the left of the edge). This seems to indicate that the values calculated on the lane edge, which showed material degradation, may be abnormally lower than the rest of the surface. The use of the deteriorated edge as the first point of the transverse profile may have also impacted the overall rut depths reported on this section.

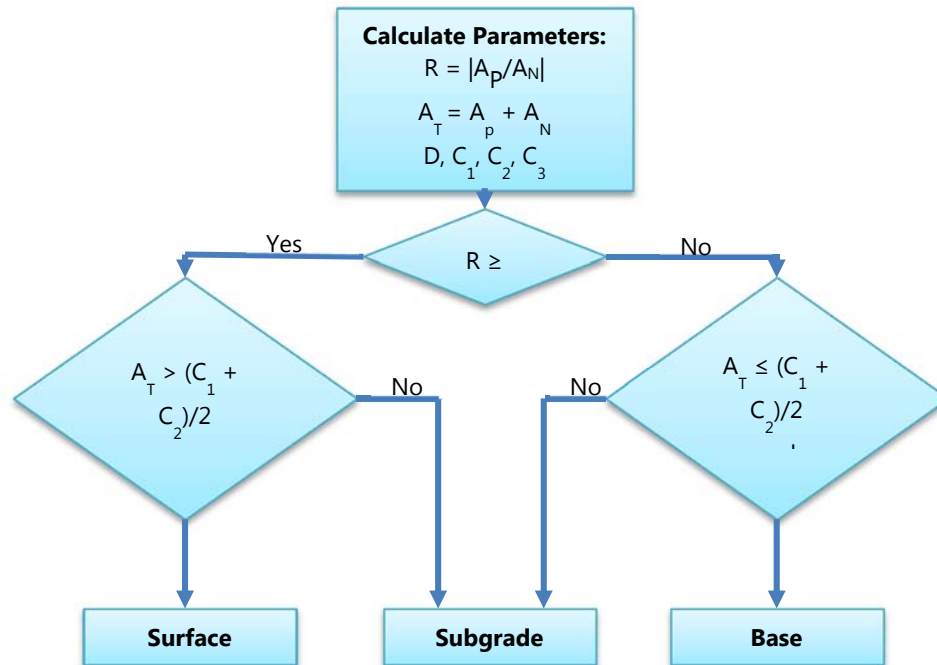
Figure 20. Failure layer determination using methodology by White et al. (2002)

Based on the analysis conducted for each of the transverse profiles (total of 9-11 profiles spaced at 50 ft), the layer contributing the most to rutting was determined for each data collection date at multiple locations along the section. It was determined that the AC surface was the lowest layer contributing to rutting for every transverse profile assessed except one in 1989. Based on both the findings of the analysis and the transverse profiles, the rutting observed is likely related to permanent deformations in the AC layer. This may be the result of a softer asphalt binder being used in Maine coupled with hot temperatures during the summer and traffic loadings.
