## Technical Memorandum

**Re:** Forensic Desktop Study Report: South Carolina LTPP Test Section 45\_1024

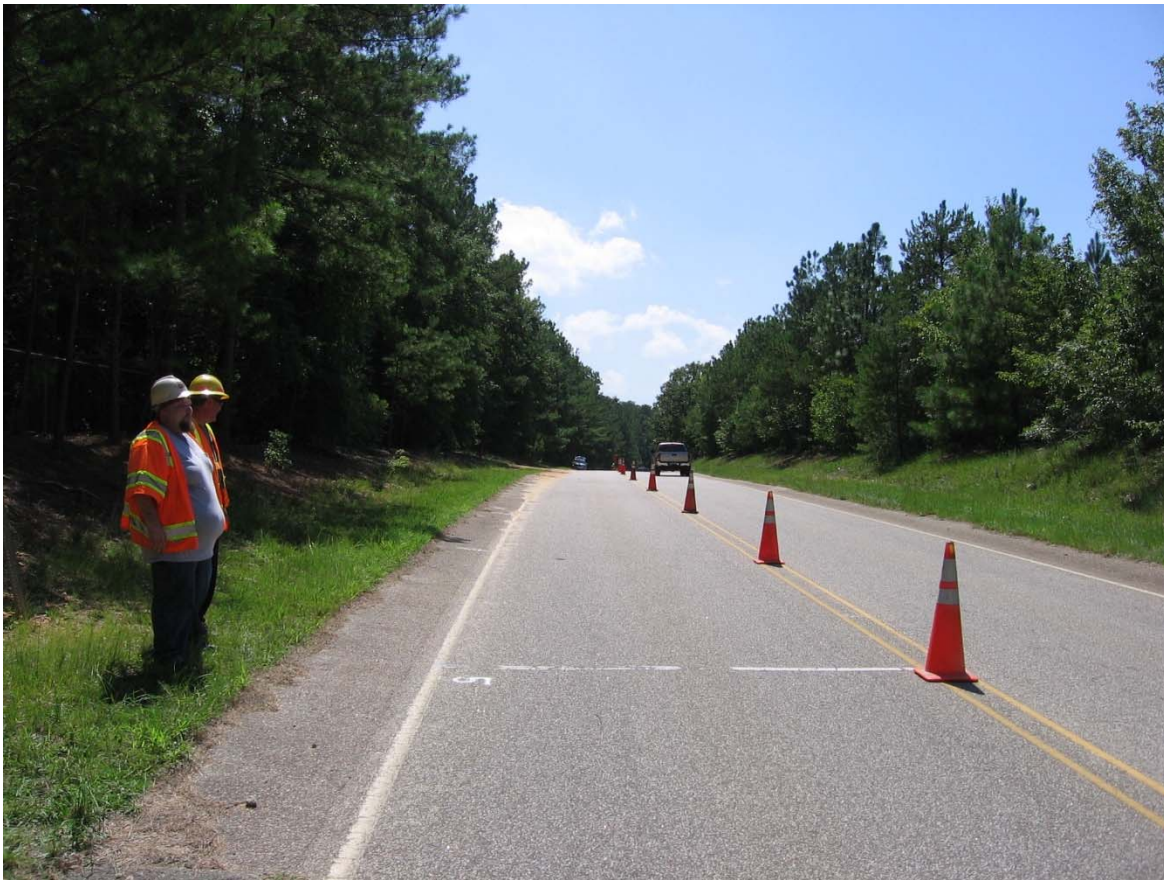
**Photograph 1. LTPP Section 45\_1024 at Station 5+00 looking westbound in 2014.**

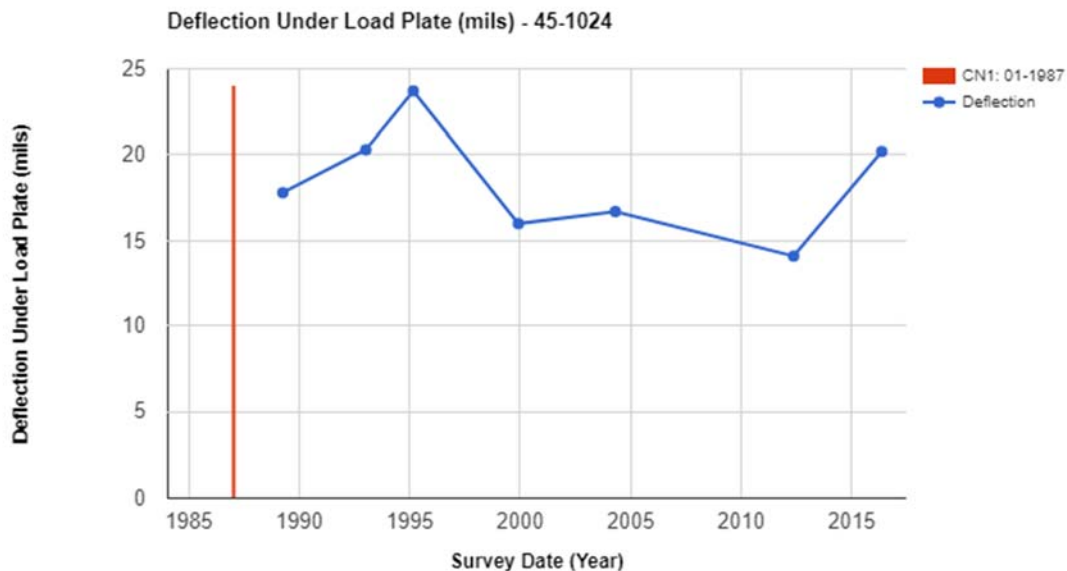
**Figure 1. Average deflections over time.**

Figure 1 shows the average Falling Weight Deflectometer (FWD) deflection under the nominal 9,000-pound load plate over time. The deflection of the sensor located in the center of the load plate is a general indication of the total “strength” or response of all layers in the pavement structure to a vertically applied load. This deflection can be influenced by pavement temperature at the time of testing, precipitation, and moisture. As depicted in Figure 1, the deflections observed on the site have remained relatively constant, with values ranging between 14.1 mils (2012) to 23.7 mils (1995).

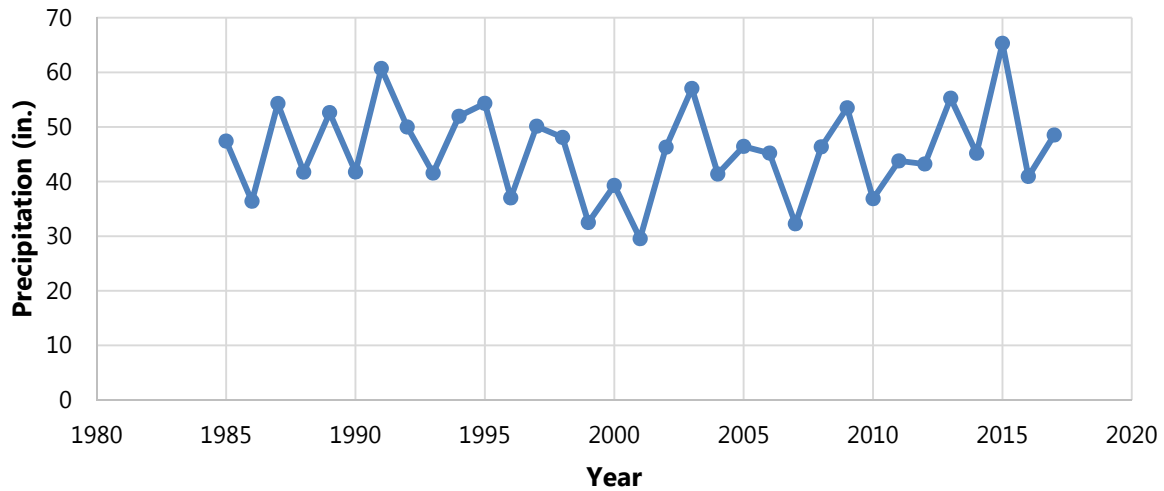
**Figure 2. Average annual precipitation over time.**

The time history for average annual precipitation (from the virtual weather station (VWS) for the site) since 1985 is shown in Figure 2. In 2015, the amount of precipitation appears to be a local high (65 inches), while the low (30 inches) was recorded in 2001. The mean precipitation recorded at the site was 46 inches for the period shown in Figure 2. While some variation in precipitation is expected, the amount of precipitation reported in 2015 is notable. The increase in precipitation in 2015 on the test site is likely related to flooding event that occurred in South Carolina in early October of 2015. The severe flooding, which was

caused in part by Hurricane Joaquin, resulted in more than 20 inches of rainfall in nearby Columbia, SC<sup>2</sup>. As discussed in the sections to follow, the high amount of precipitation observed in 2015 is likely the cause of the increased cracking and the sand deposits observed on the test section in 2016.

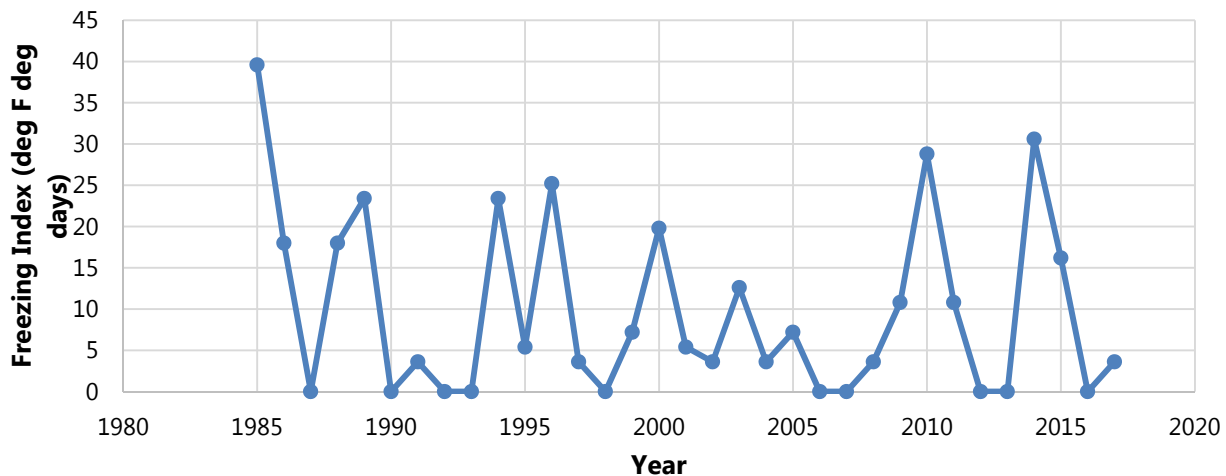
**Figure 3. Average annual air temperature freezing index over time.**

Figure 3 shows the time history of the average annual freezing index (from the VWS) for the test site. The freezing index is the summation of the difference between freezing temperature and the average air temperature when it is less than freezing over a year's time. This index is an indicator of the harshness of the winter season relative to issues such as ground frost and low temperature cracking in pavements. As depicted in Figure 3, the freezing index values ranged from 0 (multiple years) to 40 (in 1985)—which is well below the 150 deg F deg days used to classify a freeze region—indicating it is not a likely factor affecting the performance of the test section.

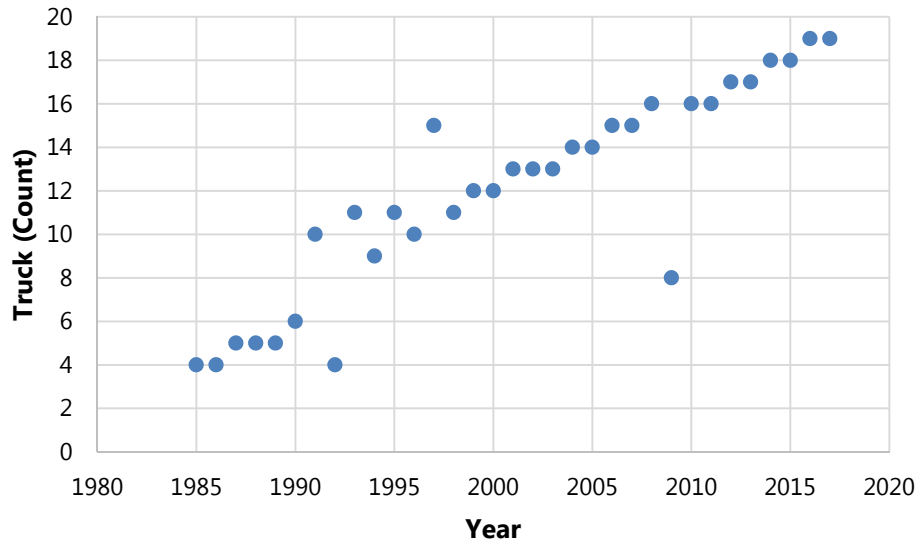
**Figure 4. Average annual daily truck traffic history.**

Figure 4 shows the average annual daily truck traffic data in the LTPP test lane by year. In 1985, when the section was constructed, the average daily truck traffic reported was 4. By 2017, the average daily truck traffic increased to 19. The number of 18-kip ESALS increased from 1 in 1985 to 3 in 2008. While a slight increase in the traffic and loading is observed over time, the total amount of traffic and loading is still extremely low (close to 0) and therefore, the performance of the pavement may be similar to the performance of a pavement in the absence of traffic loading.

The slight increase in truck traffic and ESALs reported, while minimal, may be the result of the change in land use along this roadway over time. Between 1994 and 2002, the corporate office for Southeastern Freight Lines was constructed just north of the test site. The construction of the office may have contributed to an increase in both traffic due to construction as well as deliveries. The increase in the number of ESALs may be related to the increased loads from FWD testing on the roadway. Regardless, the amount of truck traffic and ESALs observed on this roadway remains relatively low and therefore, likely plays a limited role in the performance of the pavement over time.

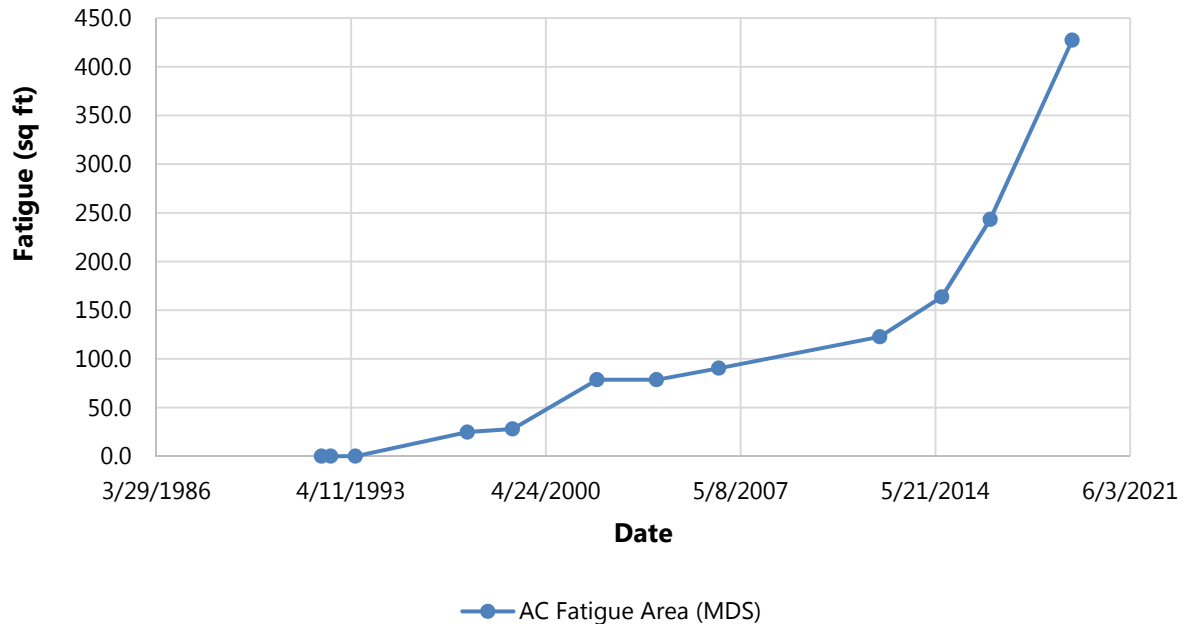
**Figure 5. Time history of the area of fatigue cracks.**

Figure 5 shows the total area of fatigue related cracking observed on the sections. As the cracking observed on the section is limited to the wheel paths, it is hypothesized that it is the result of bottom-up cracking. For the test section, the area of roadway where fatigue cracking was observed increased over

time. Fatigue cracking was first observed on the section in June 1997, almost 12 years after the initial construction of the site, when 25 ft<sup>2</sup> of fatigue cracking was observed. Once the cracking had initiated, it propagated at an average rate of 18 ft<sup>2</sup>/year over the next 22 years. By 2019, 427 ft<sup>2</sup> of fatigue cracking was observed.

While an increase in fatigue cracking as the pavement ages is expected, a notable (80 ft<sup>2</sup>) increase is observed between 2014 and 2016, or prior to and following the 2015 flood event. As discussed previously, the increase in fatigue cracking in 2016 and subsequent years is likely a result in the increased average annual precipitation observed in 2015. As water infiltrates the pavement layers, the base and subgrade tend to weaken (especially when reaching saturation conditions) causing the increase in fatigue cracking observed. This is further exacerbated as both the base and AC layers are thin.

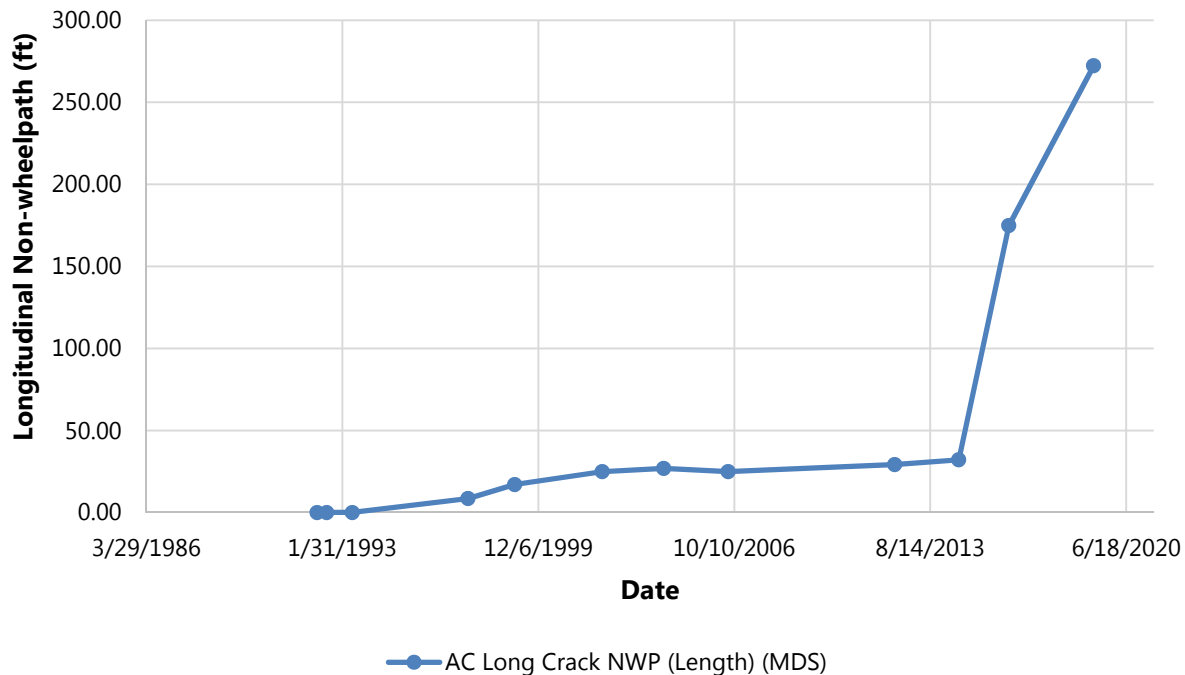
**Figure 6. Time history of the length of NWP longitudinal cracks.**

Figure 6 shows the total length of non-wheel path (NWP) longitudinal cracking observed on the section. The length of NWP longitudinal cracking was observed to increase over time. NWP longitudinal cracking was first observed on the section in June 1997, almost 12 years after initial construction, when 9 ft of NWP longitudinal cracking was observed. Once the cracking had initiated, it propagated at a rate of 2 ft/year, over the next 22 years. By 2019, 272ft of NWP longitudinal cracking was observed. The NWP longitudinal cracking was predominantly found along the centerline and edge of the lane. Similar to the fatigue cracking observed on the section, there was a notable increase in the amount of NWP longitudinal cracking observed between 2014 and 2016, before and after the 2015 flood event, which is likely a result of the increased average annual precipitation observed in 2015.

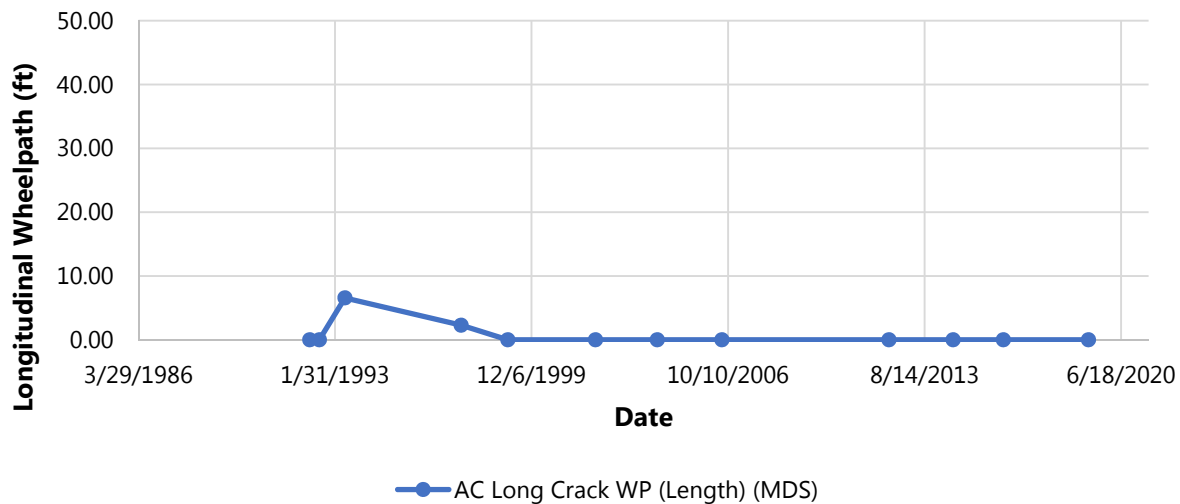
**Figure 7. Time history of the length of WP longitudinal cracks.**

Figure 7 shows the total length of wheel path (WP) longitudinal cracking observed on the section. For the pavement section, little to no WP longitudinal cracking was observed over time. WP longitudinal cracking was first observed on the section in June 1993, 8 years after the construction of the pavement structure, when 7 ft of WP longitudinal cracking was observed. WP longitudinal cracking was also observed in June

1997. Both these reported values may be attributed to WP longitudinal cracking that evolved into fatigue cracking by 1999.

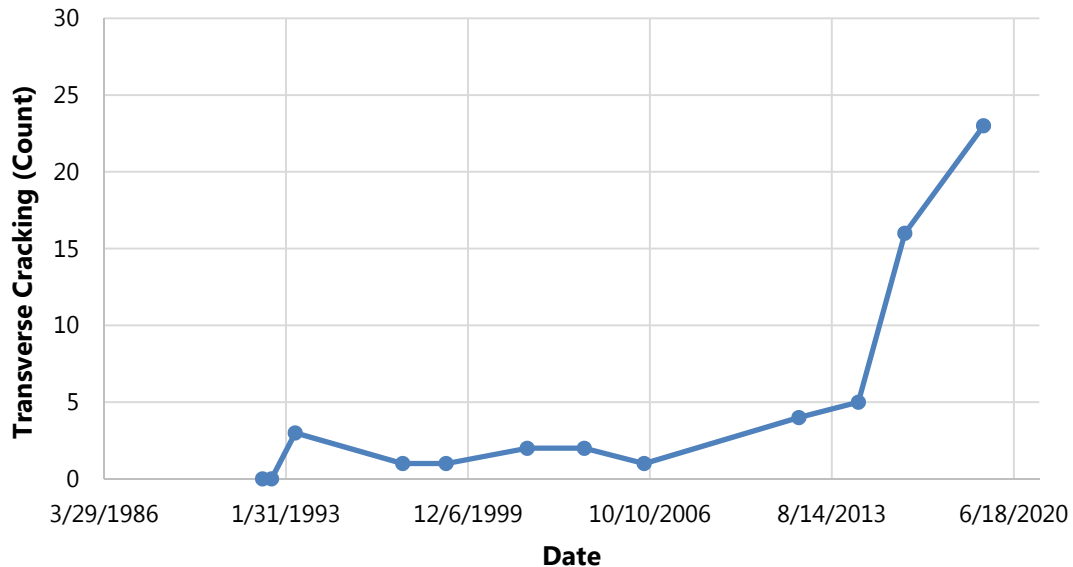
**Figure 8. Time history of the number of transverse cracks (count).**

Figures 8 and 9 show the total count and length of transverse cracking observed on the section. Transverse cracking was first observed on the section in June 1993, nearly 8 years after construction, when 5 ft (3 cracks) of transverse cracking was observed. Once the cracking had initiated, it propagated at a rate of 3 ft/year over the next 26 years. By 2019, 81 ft (23 cracks) of transverse cracking was observed. The transverse cracks observed were mostly low severity and located near patches, non-functioning AVC loops within the pavement structure, and at random intervals along the edge or centerline of the pavement; the

cracks observed were not the full width of the lane. In some cases, the transverse cracks observed continued into the westbound lane of the roadway.

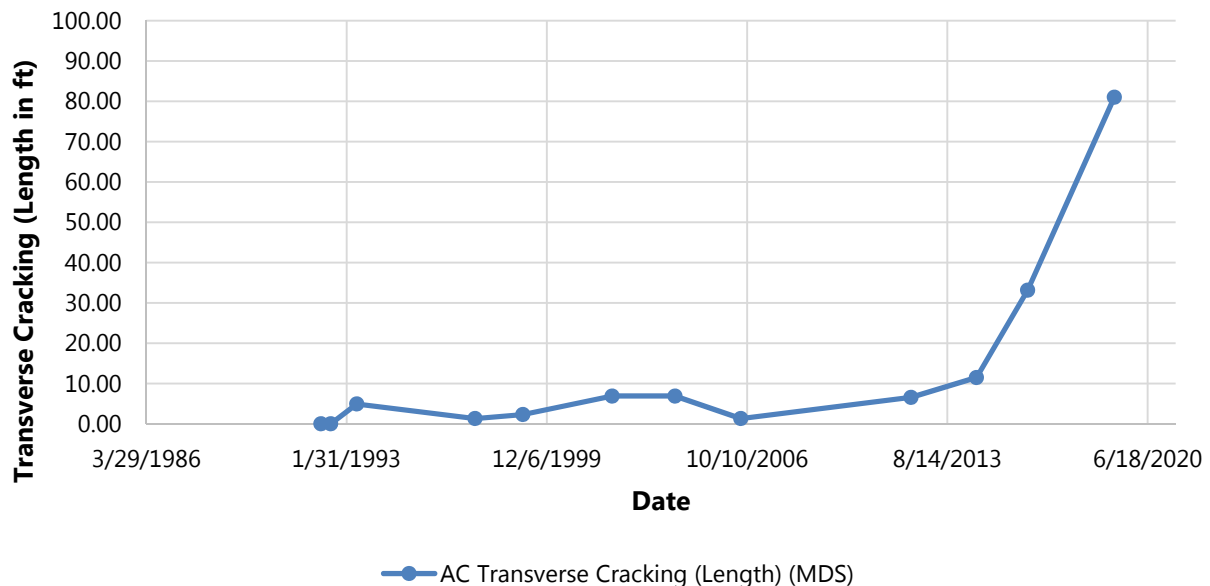
**Figure 9. Time history of the length of transverse cracking (length).**

As depicted in Figure 9, a notable increase in the transverse cracking observed on the test site occurs between 2015 and 2019. The increase in transverse cracking in 2016 is likely a result in the increased average annual precipitation observed in 2015 and material degradation due to pavement aging. Material degradation along the section is also evidenced by the 982 ft<sup>2</sup> of raveling that is first reported on the pavement section in 2019.

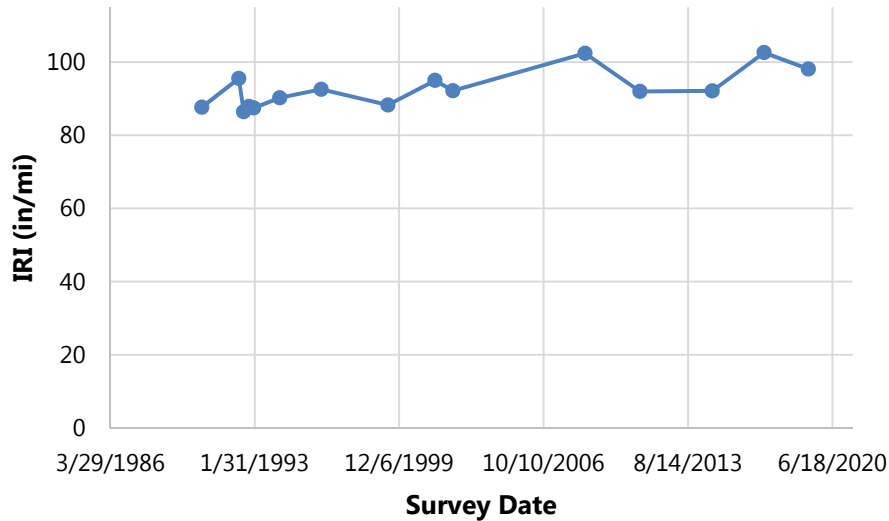
**Figure 10. Time history plot of pavement roughness.**

The average IRI measurements for the section over time is shown in Figure 10. The IRI of the test section slightly increased over time. The section's IRI increased from 88 in/mile in 1990 to 98 in/mile in 2019. There was a gradual increase in roughness over time, 0.34 in/mi/yr. The pavement's IRI performance is classified as "Fair" based on FHWA performance definitions.

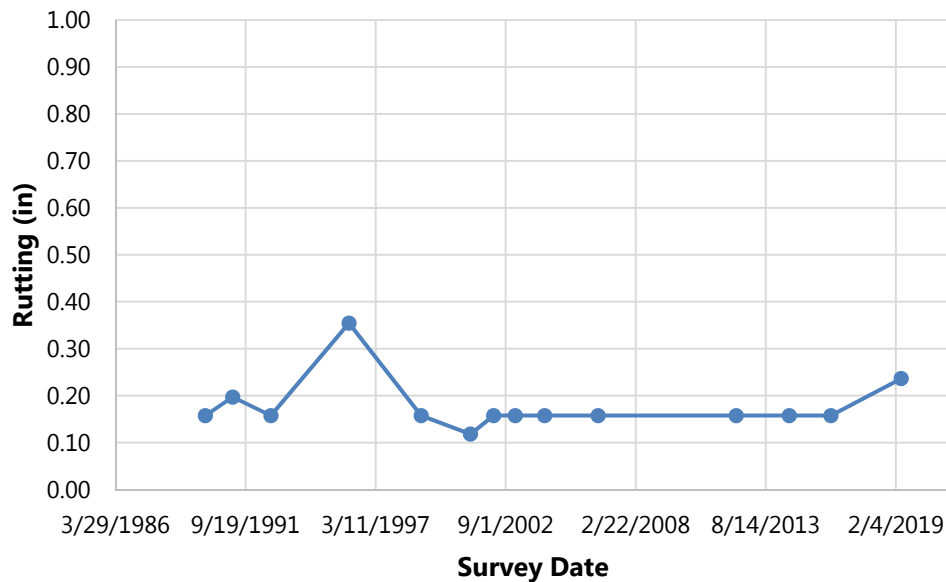
**Figure 11. Time history of average rut depth.**

The last distress observed was rutting, and the rutting trend over time is shown in Figure 11. The rut depths are considered steady over time with 0.16 inches of rutting observed in 1990 and 0.24 inches in 2016. There was consistent rut depth measurements between 2003 and 2016 (0.16 in). The median of the rutting measurements was 0.16 inches. The lack of rutting is likely related to the low traffic volumes observed on this site.
