## Technical Memorandum

**To:** Jeff Uhlmeyer  
**From:** Gonzalo Rada, Gary Elkins and Kevin Senn  
**cc:** Mustafa Mohamedali  
**Date:** September 6, 2019 (original)  
**Re.** Forensic Desktop Study Report: LTPP Test Section 395003

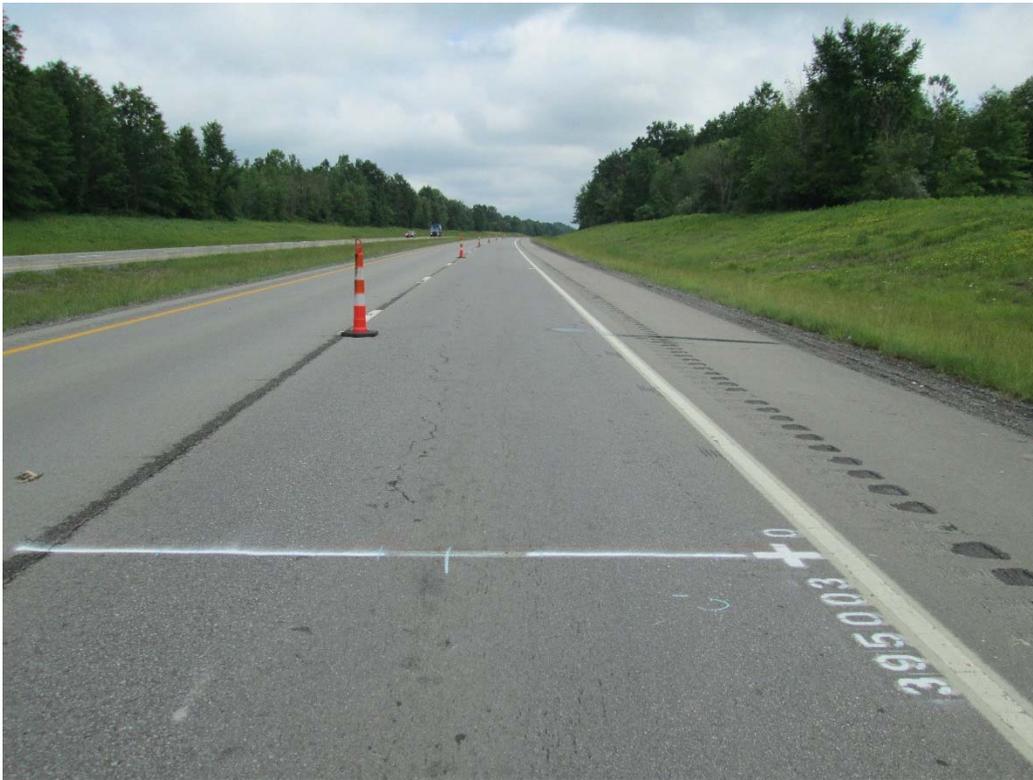
**Photograph 1. Picture of test section 395003 in 2014 (from start of section looking east).**

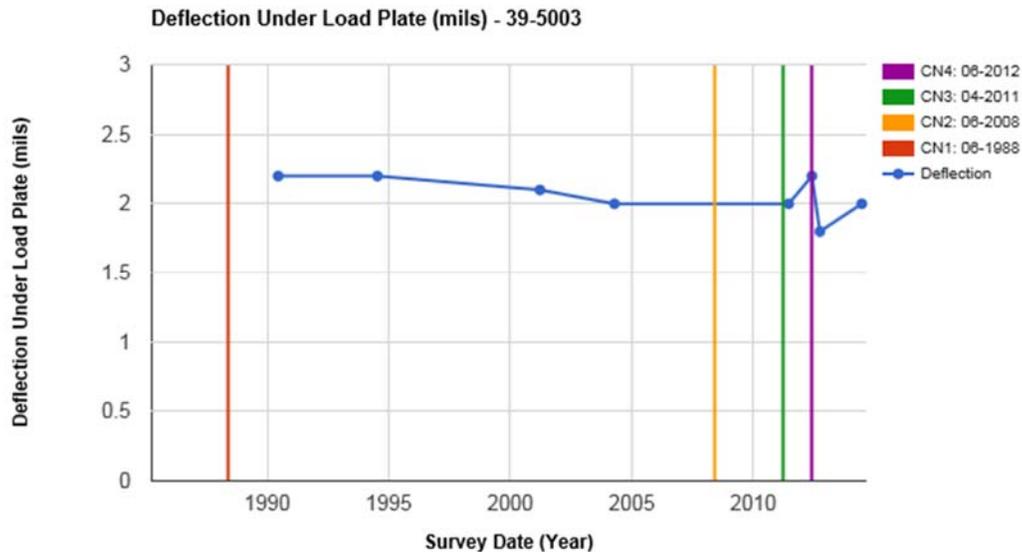
Figure 1 shows the time history average FWD deflection plot under the nominal 9,000 lb. load from the sensor position in the load plate. The deflection of the sensor located in the load plate is a general indication of the total "strength" or response of all layers in the pavement structure to a vertically applied

load. This deflection can be influenced by pavement temperature at the time of testing, precipitation, and changes in pavement structure. As shown, deflections are not only very small but they have remained low (below 2.2 mils) over the entire life of the pavement test section. The 2012 AC overlay does not appear to have had much of an impact on the deflections, as they have remained at about the same level prior to the overlay. Overall the central sensor deflection time history magnitudes are judged to be very low, indicating a very “strong” pavement structure.

**Figure 11. Time history of average deflection for the sensor located in the load plate normalized to 9,000 lb. drop load.**

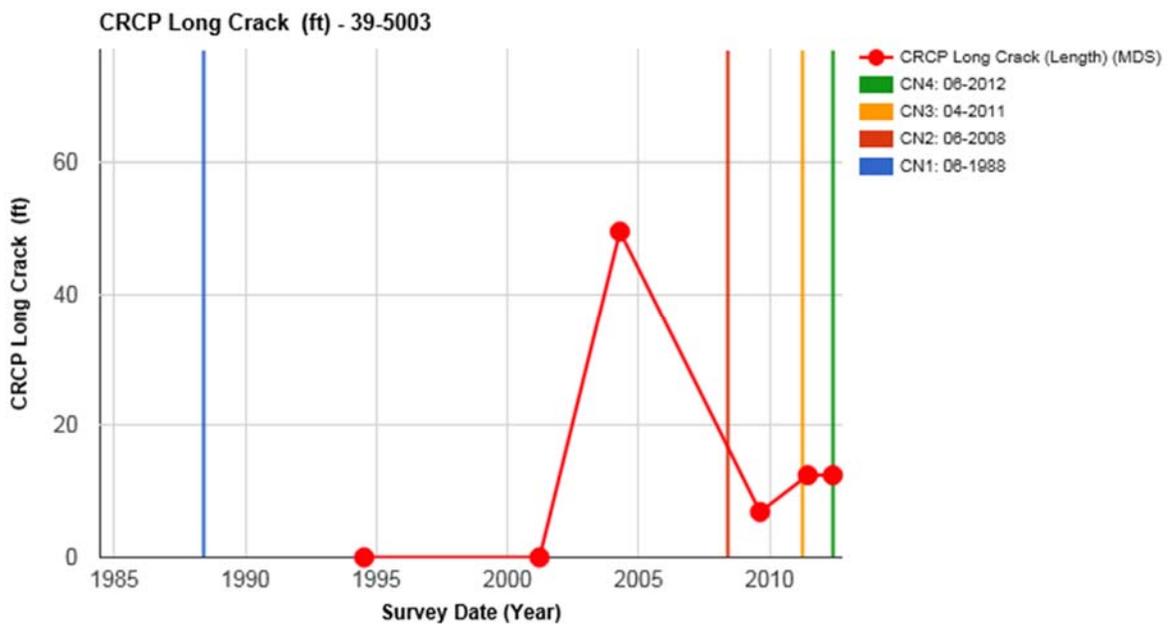
Figure 5 shows the time history plot of longitudinal cracking. As shown, there has been limited longitudinal cracking throughout the life of the CRCP pavement. Except for a spike in 2004 of close to 50 feet (not a significant amount), longitudinal cracking remained at or below 12.5 ft (almost non-existent) through 2012 when it was overlaid with a thin AC layer. Attempts were made to review the distress maps, images and videos from the 2004 survey to explain the spike, but they were not readily accessible via LTPP InfoPave™, and consequently this information will need to be pursued as part of the follow-up investigations. In the interim, it is hypothesized that the 2014 spike is an outlier related to the interpretation of lane edge cracking.

**Figure 5. Time history of longitudinal cracking (CRCP).**

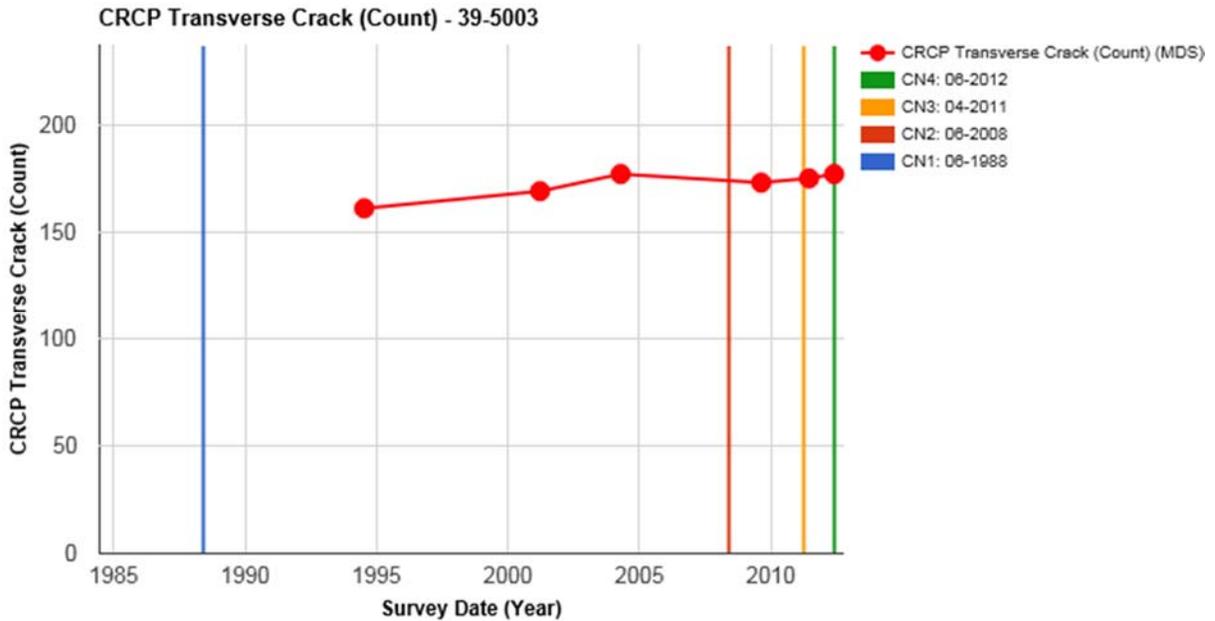
Figures 6 and 7 show the time history of the number and length of transverse cracks, respectively, on the pavement. In this figure, the construction events are shown with vertical lines – the focus of this investigation is the period of 1988 (CN = 1) to 2012 (CN = 2 and 3), which captures the performance of the CRCP pavement. As shown in these two figures, the number and length of transverse cracking remained at or close to zero from 1994 through 2001 (no manual surveys were performed prior to 1994, only photographic surveys), and then jumped to 160 to 180 cracks totaling 1,800 to 2,100 feet during the 1994 to 2012 period, which averages to about one transverse crack every three feet.

**Figure 6. Time history of the number of transverse cracks (CRCP).**

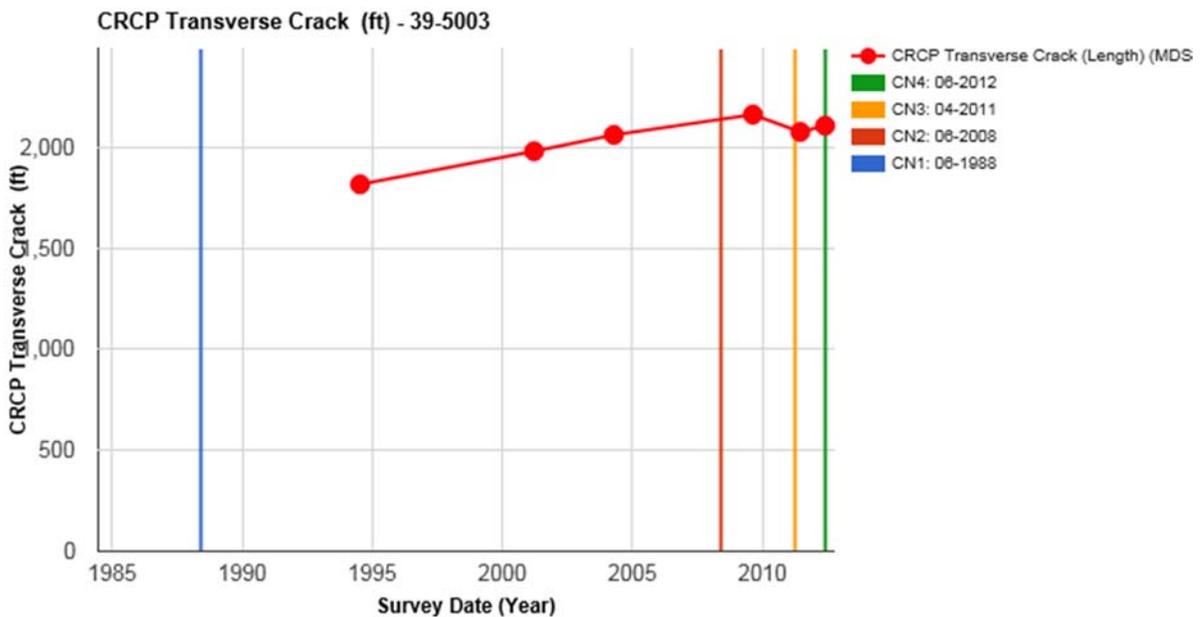
**Figure 7. Time history of length of transverse cracks (CRCP).**

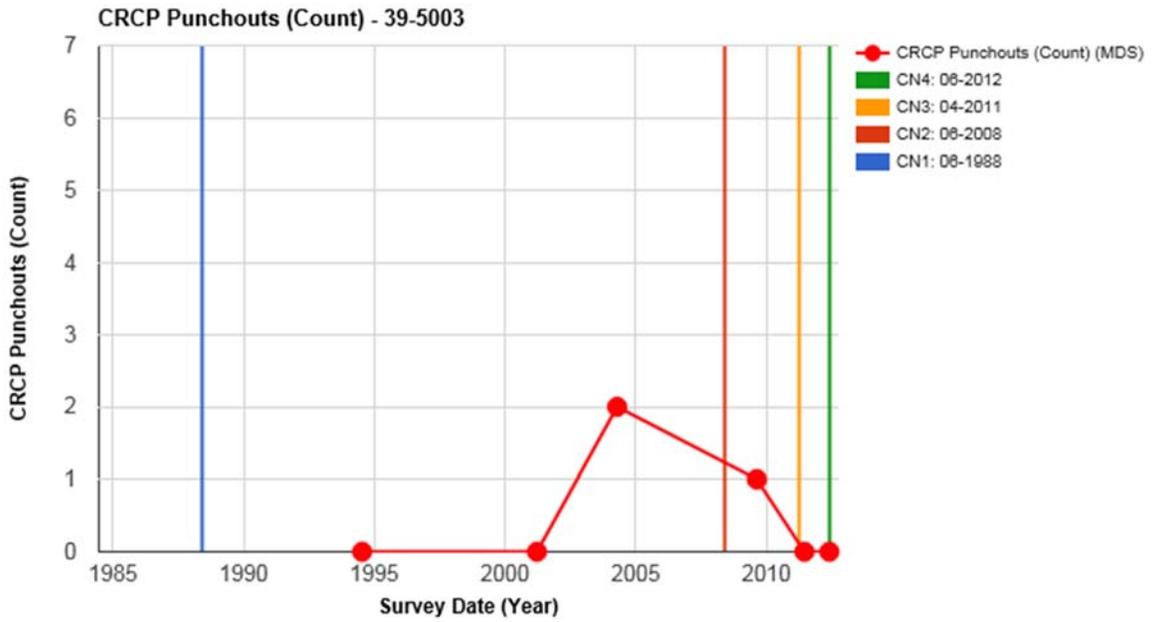
Figure 8 shows the number of punchouts during the 1994 to 2012 period; no manual surveys were performed prior to 1994, only photographic surveys. As shown, there were no punchouts until 2004, when two of them were identified. Both of the punchouts appear to have been fixed by means of flexible patches in 2008 (CN = 2), but another punchout was identified in 2009 and this one appears to have been fixed in 2011 (CN = 3), which reduced the number of punchouts to zero. No further punchouts were identified after this time. As shown in Figures 9 and 10, the number flexible patches increased from zero in

Figure 8. Time history of the number of punchouts (CRCP).

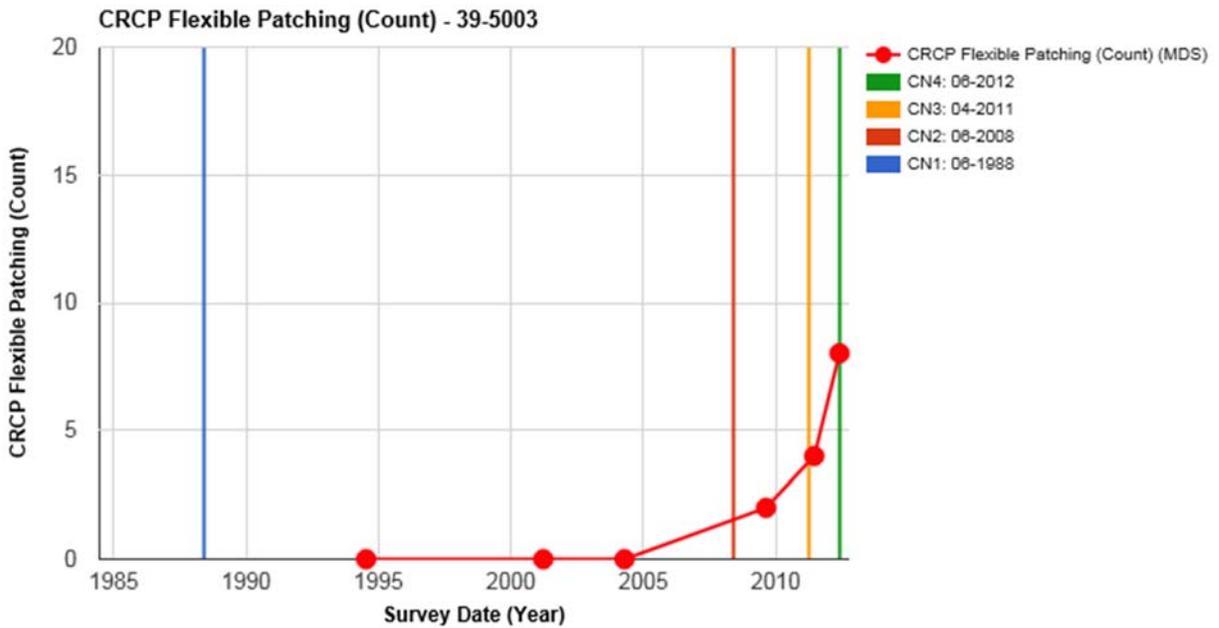
2004 to eight in 2012, while the area of the patches increased from zero to 14 ft<sup>2</sup> during the same time period.

Figure 9. Time history of the number of flexible patches (CRCP).

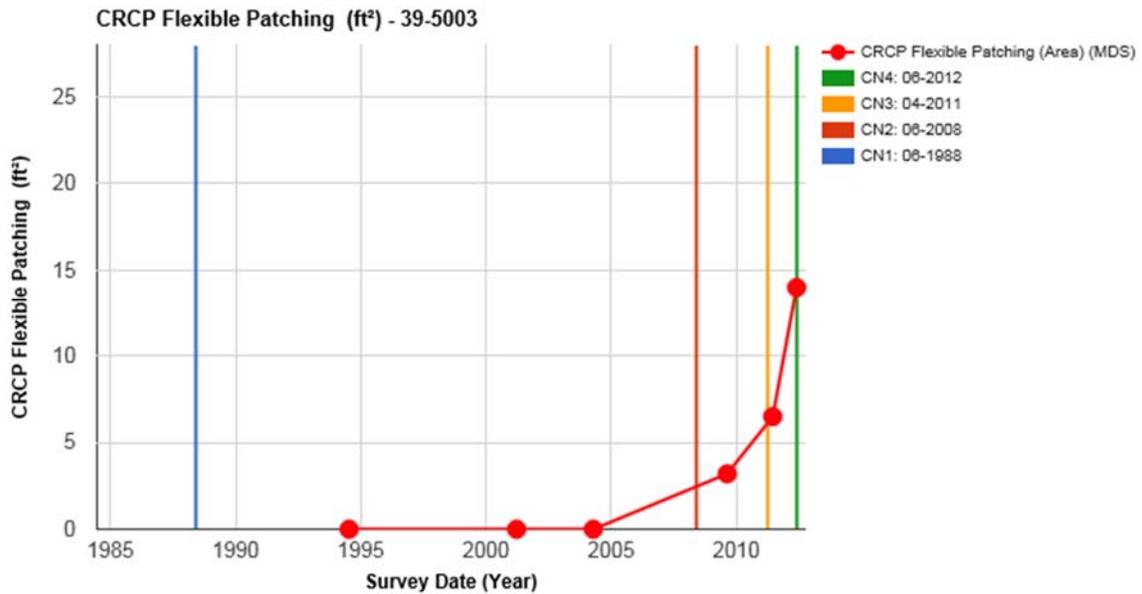
**Figure 10. Time history of the area of flexible patches (CRCP).**

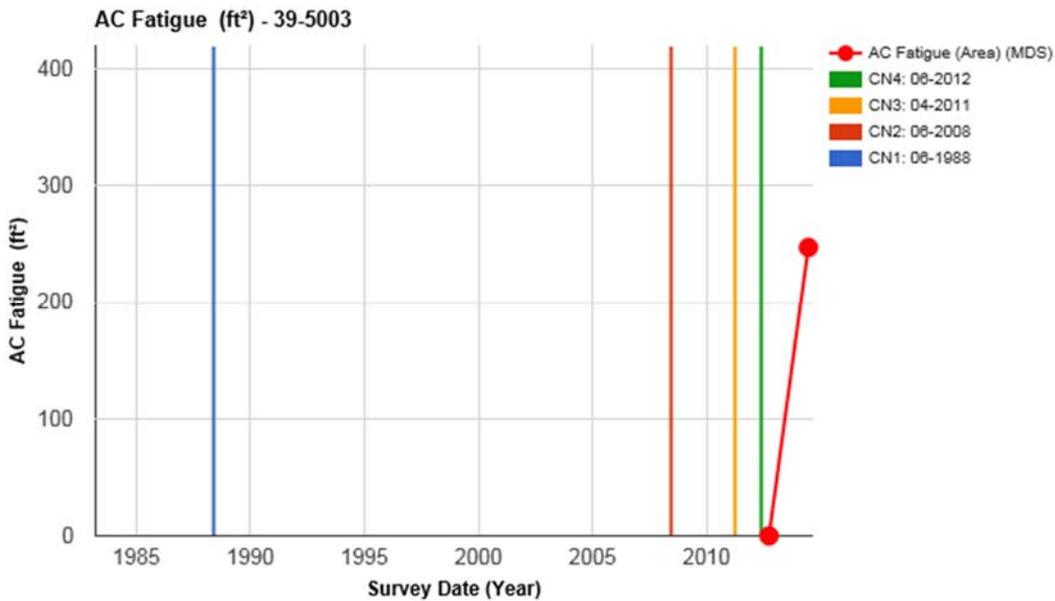
Figure 11 shows the time history plot of alligator cracking data on LTPP test section 395003. While the plot is labeled fatigue cracking, in the LTPP distress rating system, this is alligator cracking that is not limited to the wheel path. As shown, the amount of alligator cracking on this test section is high (248 ft<sup>2</sup>) within two years after the AC overlay. Moreover, the presence of cracking that appears to look like alligator cracking is somewhat surprising given the underlying CRCP pavement; see Photograph 1 earlier in this technical memorandum. As such, further information, including a follow-up surface distress survey, is required to more clearly explain this cracking.

**Figure 11. Time history of area of alligator cracking.**

- The observance of alligator cracking on the AC overlay appears odd given the presence of the relatively strong structure of the underlying CRCP pavement structure.

- It could be hypothesized that this alligator cracking is the result of separation between the AC overlay and CRCP layer, but the deflections values do not support this hypothesis – i.e., the referenced layers appear to be acting monolithically given the low deflections. It is also possible that the issue may be materials related, but no laboratory test data is available in the LTPP database for the overlay layer.

- Theoretical study to assess effects of bonding versus no bonding of AC overlay and CRC layer on deflections, and in turn to determine if lack of bonding may be a contributor to the presence of alligator cracking on the AC overlay.

- Perform limited coring to confirm (1) bonding conditions between the AC overlay and the CRCP layer and (2) whether transverse cracks observed on the AC overlay are reflection cracks.

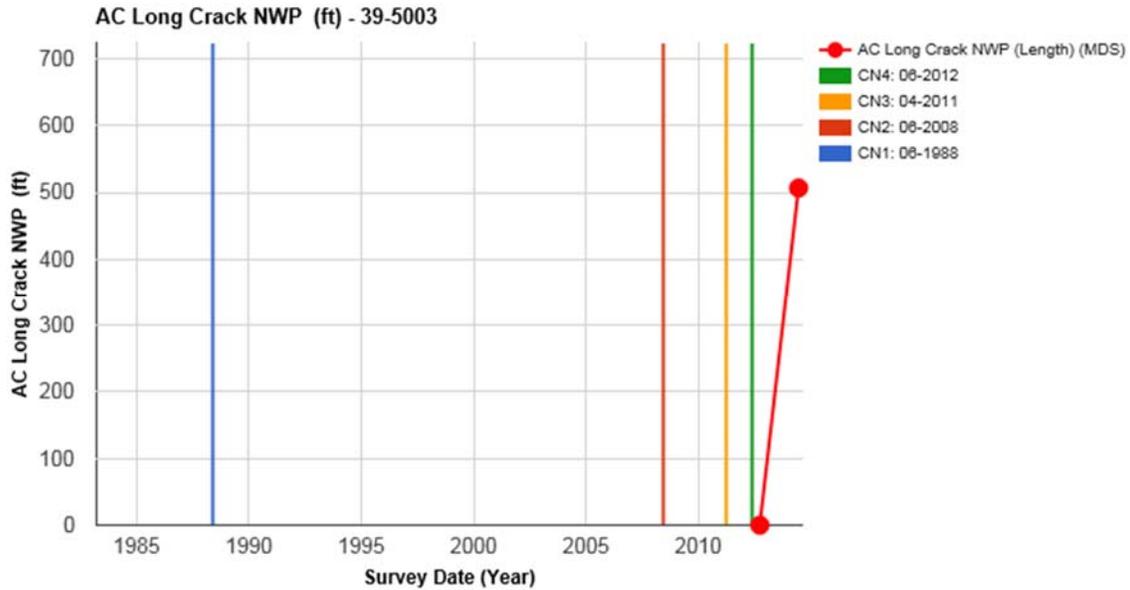
Figure 12 shows the time history plots of longitudinal cracking not in the wheel path (NWP). Like alligator cracking, the length of longitudinal cracking NWP is high (507 ft) within two years of application of the AC overlay.

**Figure 12. Time history of longitudinal cracking in the wheel path.**

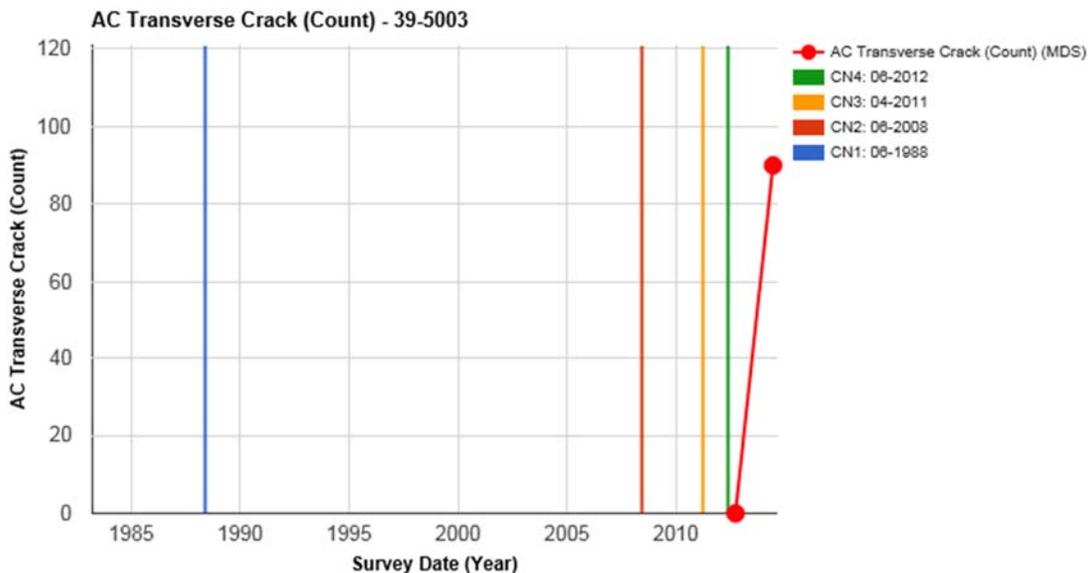
Figures 13 and 14 show the time history of the number and length of transverse cracks, respectively, on the overlaid pavement. As shown in these two figures, the number and length of transverse cracking is high – 90 and 490 feet, respectively. The number of cracks is approximately half the number of transverse cracks on the CRCP pavement prior to the AC overlay, which appears to imply that half of the transverse cracks are not acting as slabs. Moreover, the fact that the transverse cracks on the AC overlay have developed within two years of placement of the overlay appears to indicate that they are reflection cracks.

**Figure 13. Time history of the number of transverse cracks for CN = 4.**

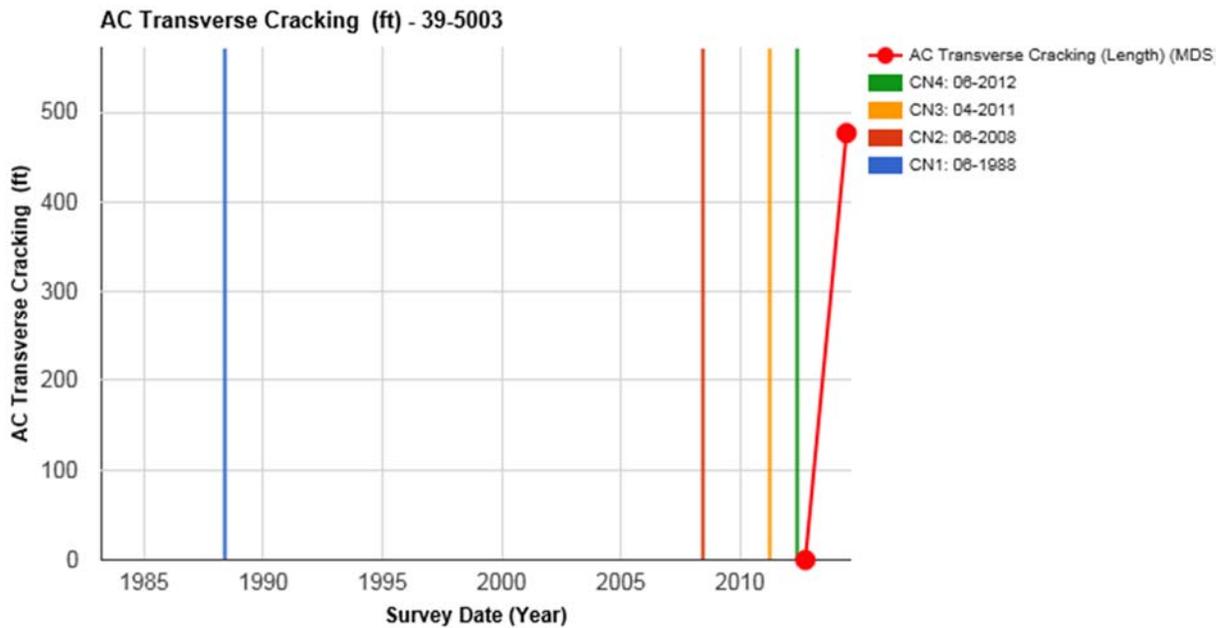
**Figure 14. Time history of the length of transverse cracks for CN = 4.**

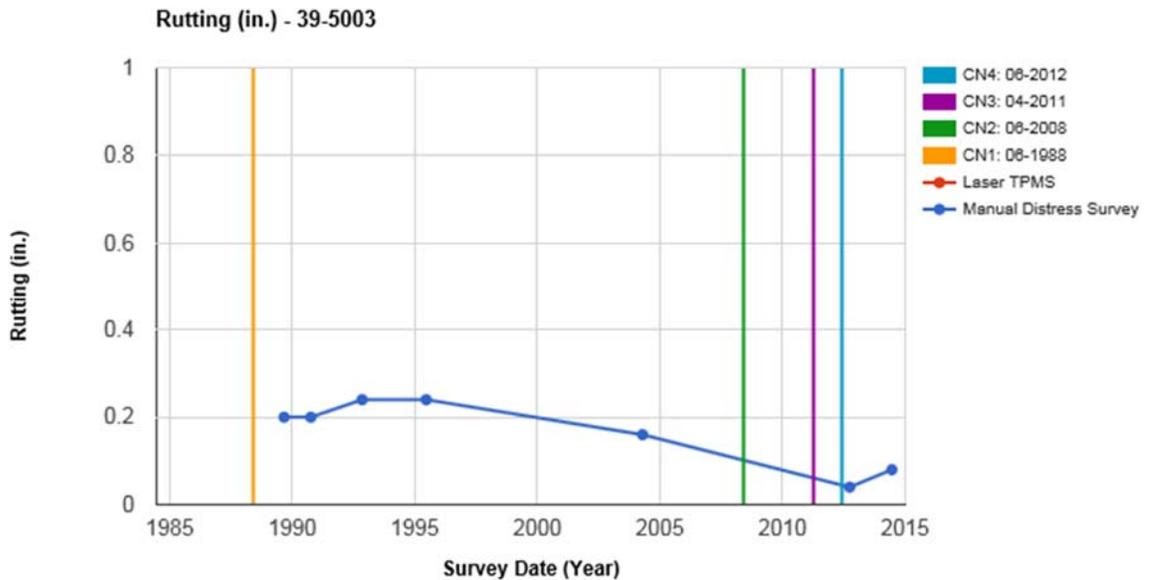
The time history plot of rutting on the test section is shown in Figure 15. As shown, rutting of the pavement test sections has remained low (~0.2 inches) throughout the life of the pavement, and under 0.1 inches since the application of the 3.4 inch AC overlay in 2012.

**Figure 15. Time history plot of average rut depth computations.**

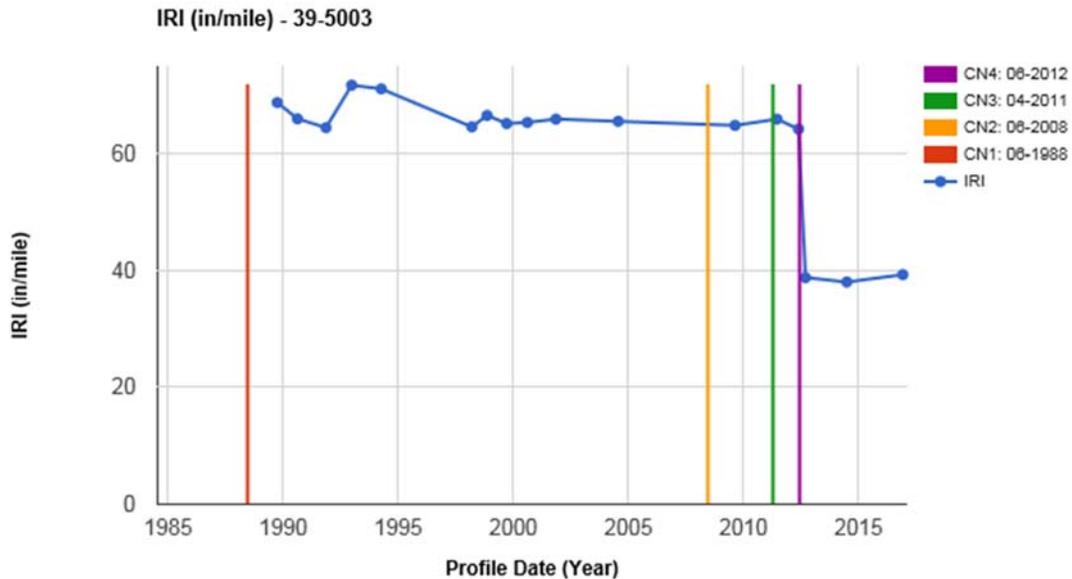
Similarly, the time history of roughness measurements is shown in Figure 16. As shown, the IRI remained close to 70 inches/mile throughout the life of the CRCP pavement. After placement of the AC overlay in

2012, the IRI of the pavement test section dropped to around 39 inches/mile, an extremely smooth value, and it has remained at that level through 2016, which is when the last survey was performed.

**Figure 16. Time history plot of pavement roughness.**
