Technical Memorandum

To: Kim Schofield
From: Lauren Gardner, Gonzalo Rada, and Kevin Senn
cc: Mustafa Mohamedali
Date: June 18, 2021
Re. Forensic Desktop Study Report: Oklahoma LTPP Test Section 40_4157

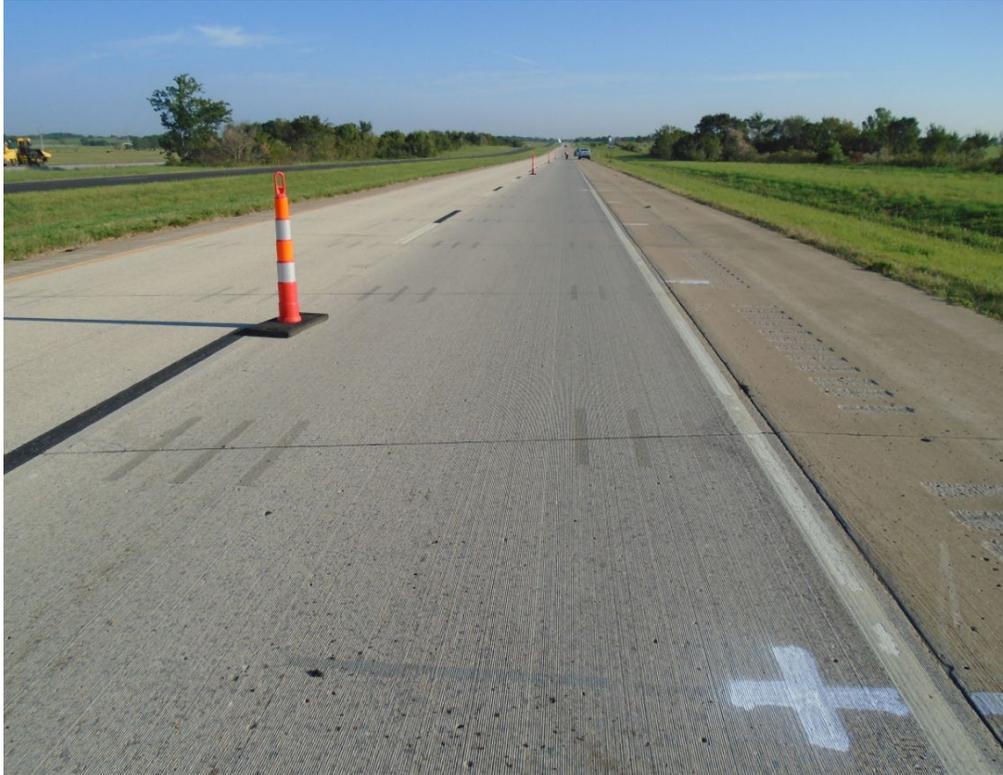
Photograph 1. LTPP Section 40_4157 at Station 0+00 looking northbound in 2015.

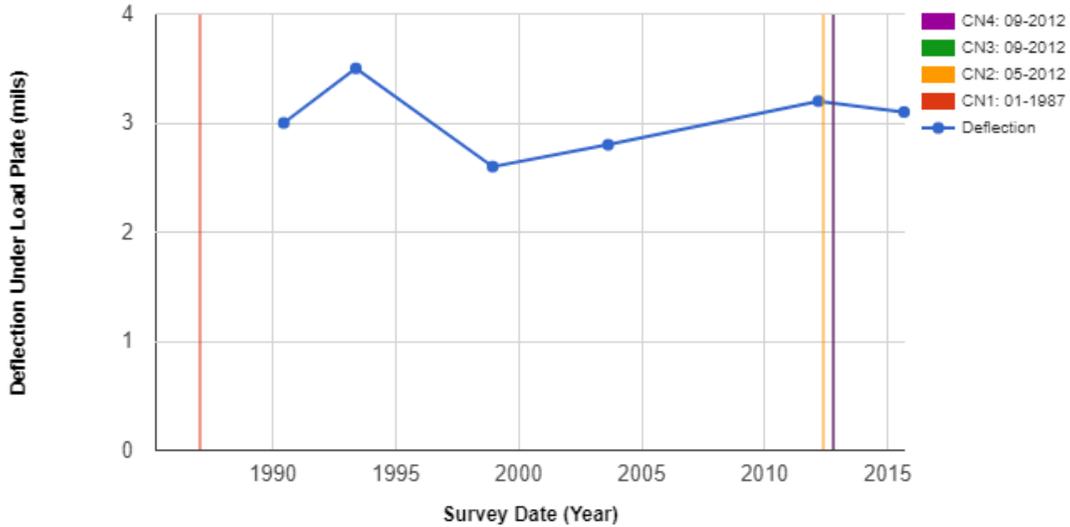
Figure 1. FWD deflections under the load plate over time.

Figure 1 shows the average FWD deflections under the nominal 9,000-pound load plate. The deflection of the sensor located in the center of the load plate is a general indication of the total "strength" or response of all layers in the pavement structure to a vertically applied load. As shown in Figure 1, the deflections reported ranged from 2.6 mils (December 1998) to 3.5 mils (May 1993) over the analysis period. The fluctuations in deflections were minimal over time and the overall deflections reported were low, which is consistent with a concrete pavement.

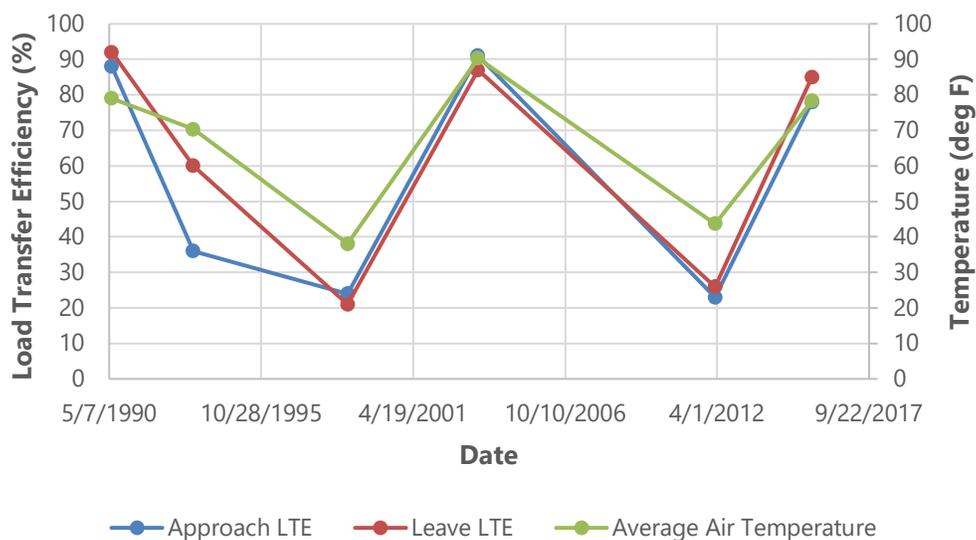
Figure 5. Load Transfer Efficiency over time.

Prior to the dowel bar retrofit that occurred in 2012, the test section generally reported poor load transfer efficiencies. Table 3 shows the average LTE over time on both the approach and leave slabs. During the warmer months of the year, it is hypothesized that expansion of the slabs occurred, and the resulting locked joints provided sufficient load transfer of the joints. In colder months, the load transfer was quite poor, which typically results in faulting, pumping, and—if left untreated—corner breaks. The relationship between average daily air temperature (MERRA) and LTE is quite apparent in Figure 5; as the temperature increased, the load transfer efficiency increased. The only measurement after the dowel bar retrofit, in September 2015, showed a substantially improved load transfer, although this also aligned similarly with the temperature/LTE trend prior to the construction event.

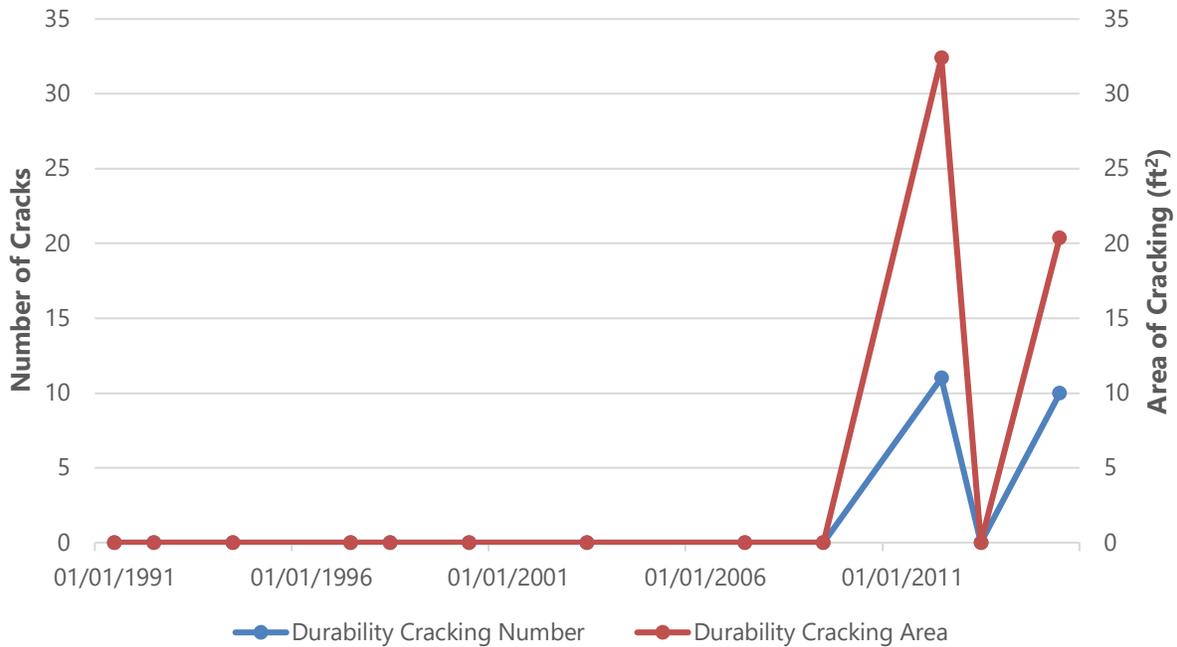
Figure 10. Durability cracking on the test section over time.

Figure 10 shows the total reported number and area of D cracking between 1991 and 2015. The D cracking did not manifest until after the 2009 manual distress survey. By 2012, 32.4 ft² of D cracking (11 cracks) was reported on the test section. Following the construction events in 2012, D cracking returned to zero, but was observed again in 2015 when 20.4 ft² (10 cracks) was reported. D cracking is typically associated with freeze and thaw damage to the aggregates within the PCC layer, and therefore it is not unexpected the cracking would resume following the construction events, given the pavement materials were unchanged following the milling and dowel bar retrofit.

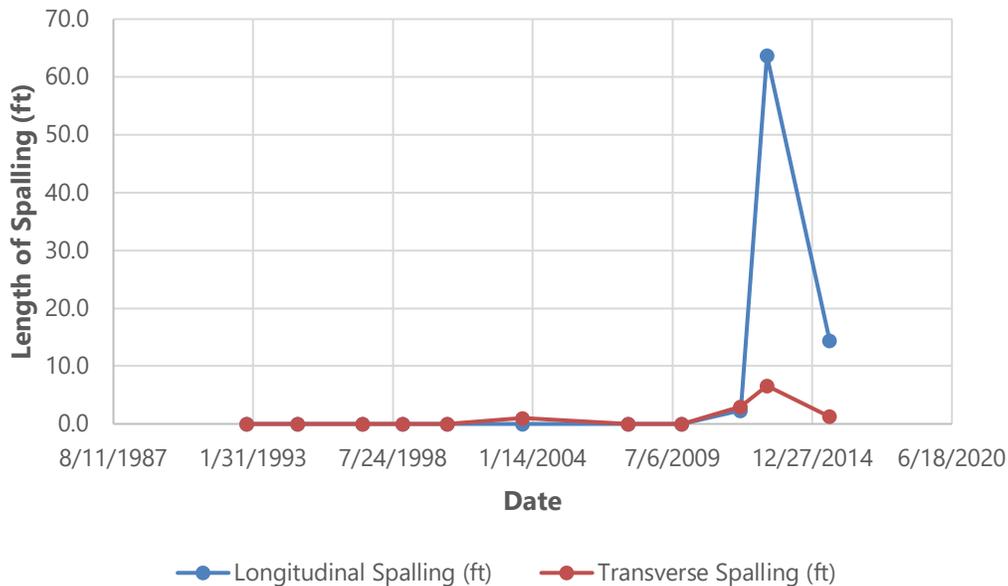
Figure 11. Length of spalling over time.

Figure 11 shows the total length of spalling for both longitudinal and transverse joints. For longitudinal joints, all spalling is counted, while for transverse joints, only joints that are at least 10% spalled are counted as having spalling. With the exception of one transverse joint rated as having spalled in 2001 (which is likely due to rater variability), 2009 was the first instance of spalling being rated, and this occurred to a low degree both longitudinally and transversely. By 2007, over 60 feet of longitudinal spalling was present, with four transverse joints possessing sufficient spalling as to be rated (only 6.6 feet of transverse spalls in total). Spall repairs were not a part of the construction work in 2012, but the amount of spalling still reduced substantially for both longitudinal and transverse joints following CN=3. This is assumed to be related to the 0.2 inches of milling that was performed. Low severity spalling was removed or became more difficult to perceive following the milling. The reduction in longitudinal spalling between 2013 and 2015 is attributed to rater variability.

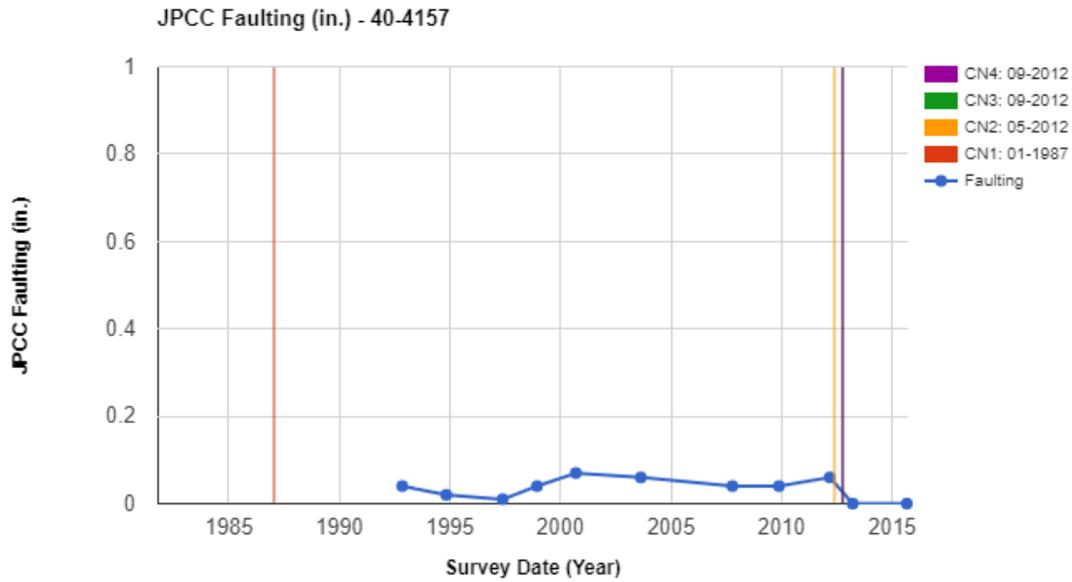
Figure 12. Faulting on test section over time.

Figure 12 shows the average amount of faulting present during each monitoring event. Per FHWA's Performance Measures, faulting less than 0.1 inches is categorized as "Good", 0.1-0.15 inches as "Fair" and faulting greater than 0.15 inches as "Poor." Faulting measurements on the test section were consistently less than 0.1 inches but were higher before the construction activities in 2012 than after. Following this work, the faulting on the section was essentially zero, which is to be expected with the combination of dowel bar retrofits and surface grinding.

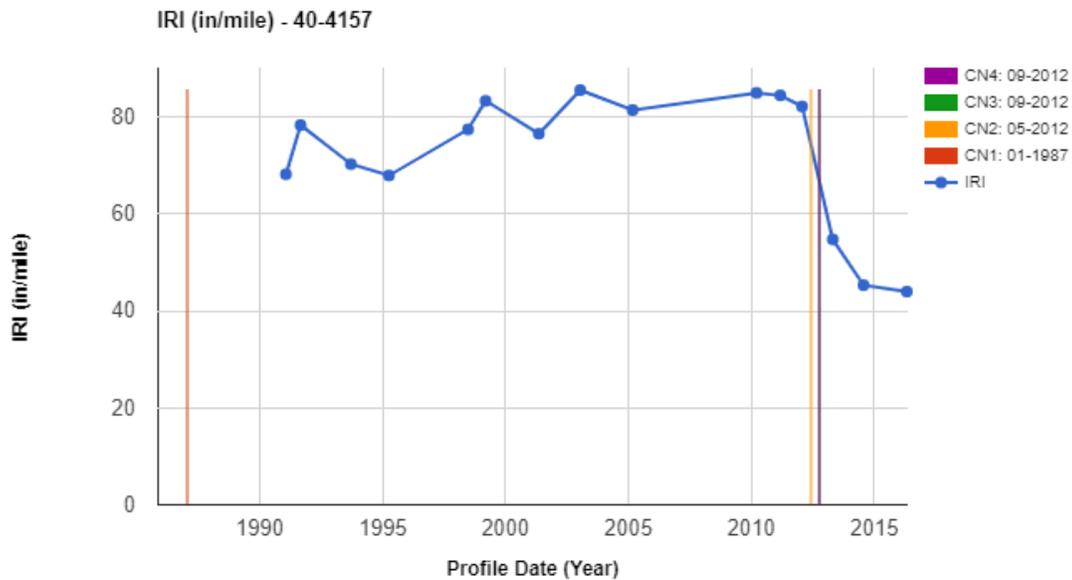
Figure 13. Time history plot of pavement roughness.

The average IRI measurements for the section over time are shown in Figure 13. Again, based on FHWA's performance measures, IRI values below 95 inches/mile are categorized as "Good", between 95-170 in/mi as "Fair", and greater than 170 inches/mile as "Poor." While the roughness measurements were consistently in the "Good" range prior to the 2012 construction activities, following the dowel bar retrofit and surface grinding, the IRI dropped substantially (from around 80 in/mi to below 45 in/mi). Given the

faulting present, as described above, approximately half of the measured roughness during CN=1 is likely attributed to faulting.
