## Technical Memorandum

**Re.** Forensic Desktop Study Report: Idaho LTPP Test Section 16\_1020

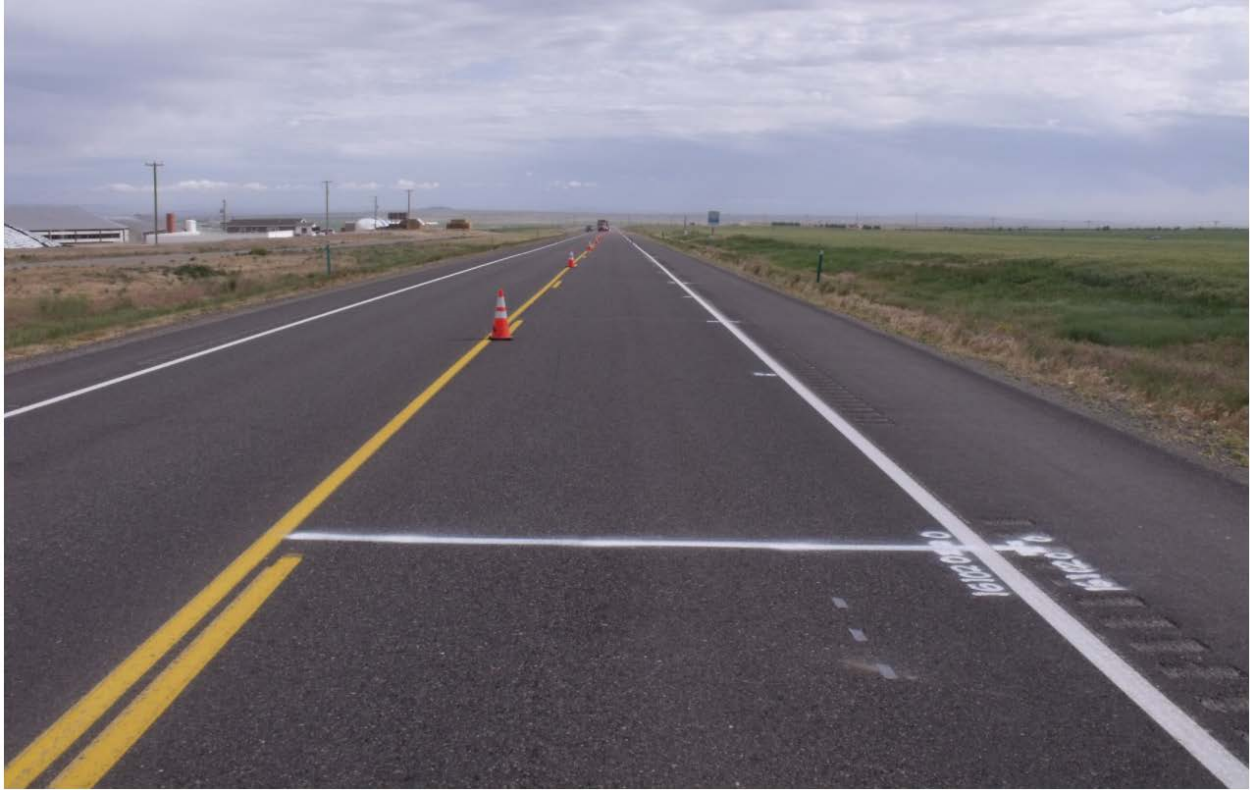
**Photograph 1. LTPP Section 16\_1020 at Station 0+00 looking northbound in 2013.**

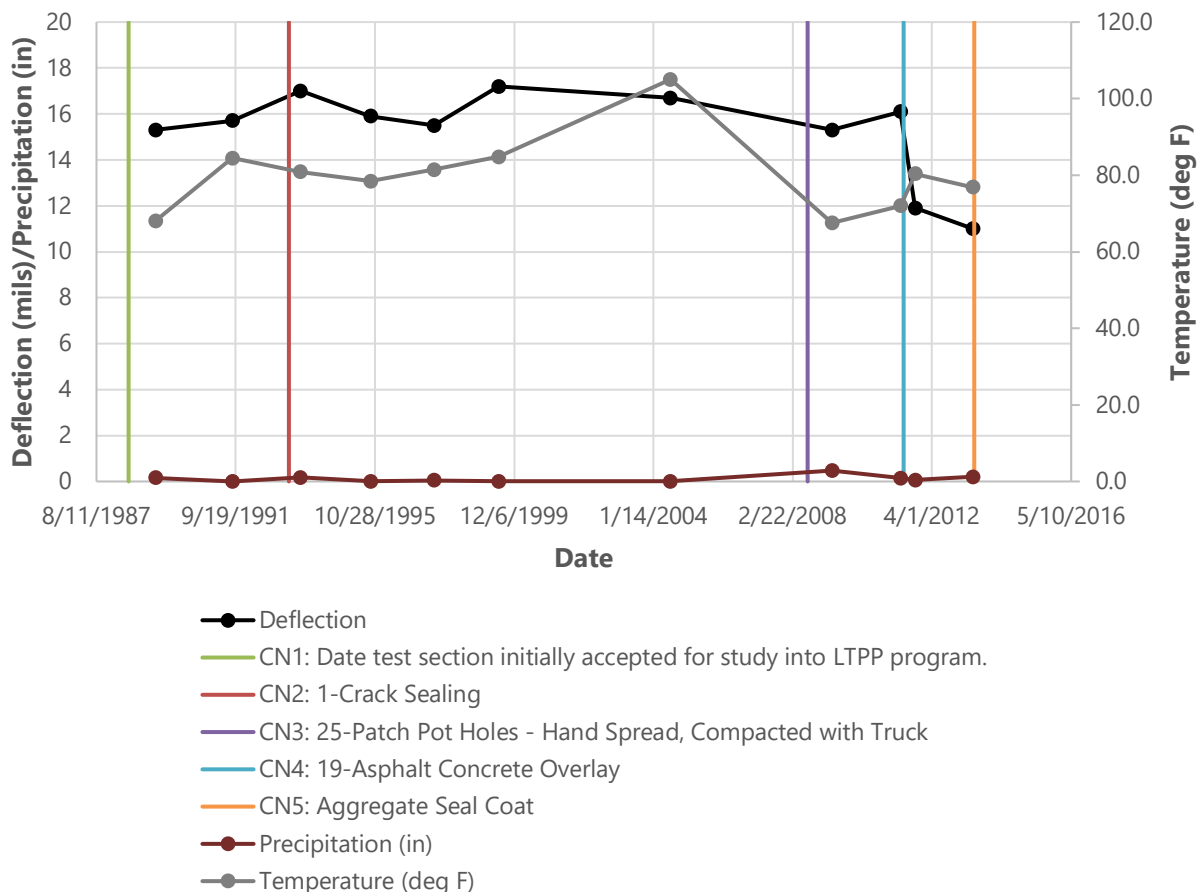
**Figure 1. FWD deflections under the load plate over time with pavement temperature and the 7-day precipitation at test section.**

Figure 1 shows the average FWD deflections under the nominal 9,000-pound load plate. The deflection of the sensor located in the center of the load plate is a general indication of the total “strength” or response of all layers in the pavement structure to a vertically applied load. As shown in Figure 1, the deflections reported increased from 15.3 mils (May 1989) to 16.1 mils (April 2011) prior to the overlay and from 11.9 mils (October 2011) to 11 mils (July 2013) following the overlay. The drop in deflection reported following the 2011 overlay is aligned with expectations; as the AC thickness increased, the deflections subsequently decreased. As shown in the figure, the fluctuations in the deflections reported prior to and following the overlay event appear to be affected by the pavement temperature at the time of testing. Generally, as the pavement temperature at the time of testing increased, the deflections reported increased. Notable exceptions to this trend included the deflections reported in August 1993, July 1997, and July 2004. However, despite the changes in temperature, the deflections remained fairly consistent overall. There was no clear relationship between the reported deflections and the 7-day cumulative precipitation at the test section, which is not surprising as little to no precipitation was reported on the test section prior to each FWD test date.

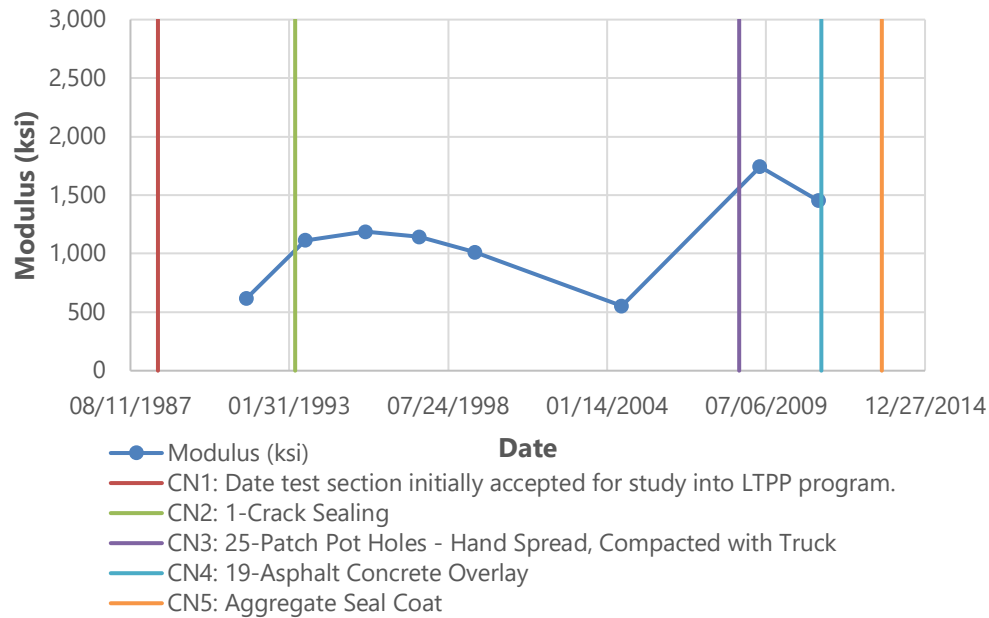
**Figure 2. Average backcalculated modulus for AC (Layer 1).**

The backcalculated moduli reported for the AC layer (Layer 1) varied over time. Between 1991 and 2004, the reported modulus of the test section ranged from 553 ksi to 1,186 ksi. However, in 2009, the reported modulus value for Layer 1 spiked. The increase in modulus reported in 2009 was not explained by a change in the pavement structure. Instead, this deviation in the reported moduli values may be related to the compensating layer moduli effect; i.e., during backcalculation the modulus value for one layer went up so the value of another layer had to go down. In this case, in 2009, the reported modulus value for the base layer decreased while the modulus of the AC layer increased. Overall, the moduli values reported for the AC layer appear reasonable.

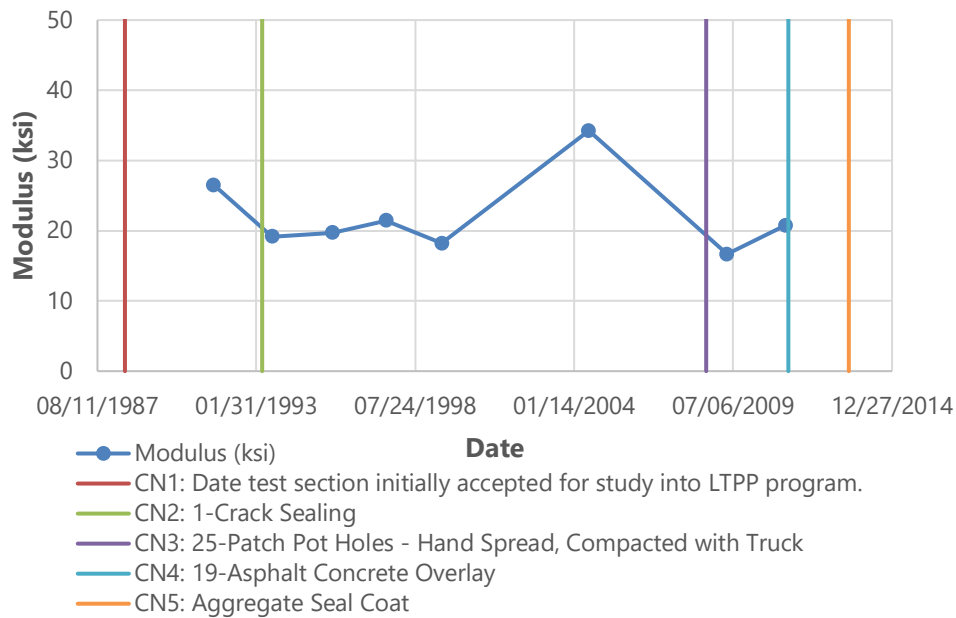
**Figure 3. Average backcalculated modulus for base layer (Layer 2).**

The reported backcalculated moduli values for the base layer (Layer 2) followed a similar trend to the AC layer. Between 1991 and 1999, the reported modulus was consistent, ranging from 18 ksi to 26 ksi. However, by 2004, the test section reported a peak in the average modulus of 34 ksi before decreasing and leveling out again. The range of values reported for Layers 3 and 4 greatly fluctuated over time with values from 13 to 58 ksi and 20 to 38 ksi, respectively. However, an outlier of 85 ksi in 1995 was removed from the plot and analysis of Layer 3. Layer 5, the remaining subgrade layer, was the most consistent over time, with modulus values ranging from 23 to 33 ksi. Overall, the moduli values of Layers 2 through 5 appear to have been affected by the way in which the backcalculation layers were created. While the pavement structure did have five layers at the time of construction, the use of five layers in the backcalculations appeared to underestimate the base modulus and overestimate the subbase modulus.

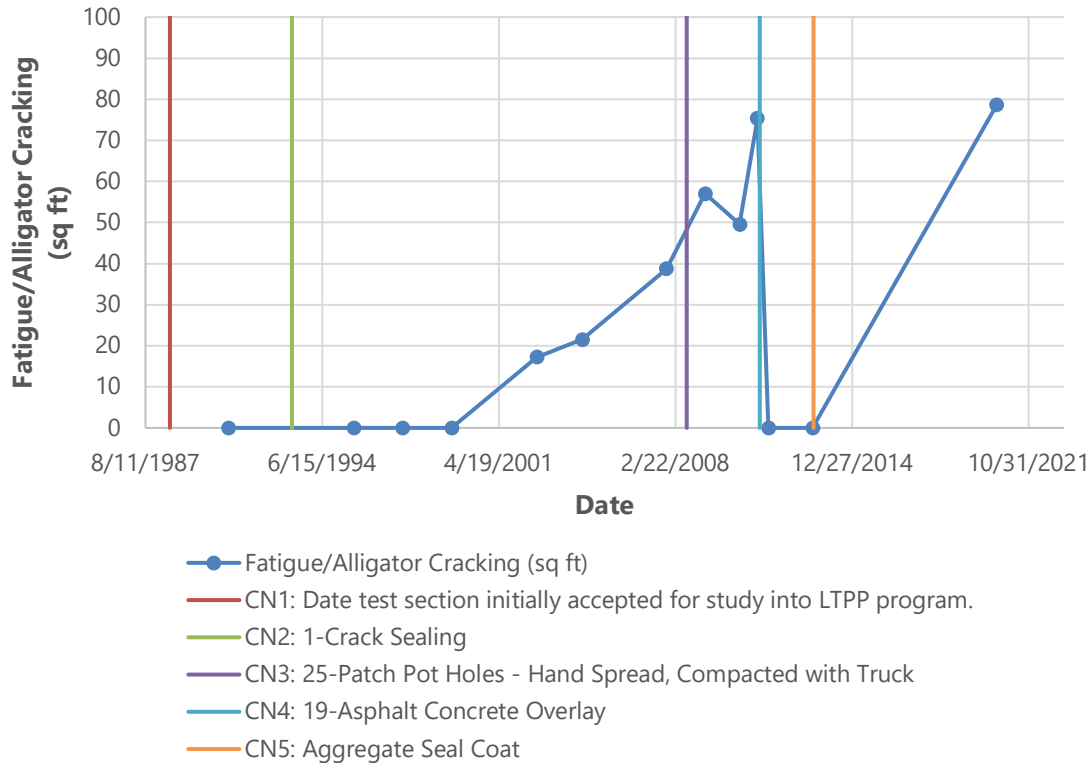
**Figure 11. Time history of the length of fatigue cracking.**

Figure 11 shows the total reported area of fatigue/alligator cracking between 1990 and 2020. Fatigue/alligator cracking was first reported during the manual distress survey in October 2002, 16 years after the construction of the roadway, when 17.2 ft<sup>2</sup> was observed. Between 2002 and 2011, fatigue/alligator cracking increased at a rate of 6.4 ft<sup>2</sup>/year, reaching 75 ft<sup>2</sup> of fatigue/alligator cracking by 2011. Following the overlay event in 2011, fatigue/alligator cracking was not reported again until the manual distress survey conducted in 2020, 9 years after the overlay, when 79 ft<sup>2</sup> of fatigue/alligator cracking was observed on the section or slightly more than pre-overlay conditions. Both prior to and following the overlay, the reported fatigue/alligator cracking was predominantly in the wheelpath. Despite the age of the test section, only small quantities and predominantly low severity fatigue cracking was reported on the section. It is hypothesized that the delay in the development of fatigue cracking is related to the minimal precipitation and traffic loading at the section in the early years of the test section's life. The development of the fatigue cracking may also have been related to issues with tack coats between the AC layers. Following the overlay, the reported fatigue/alligator cracking is likely a result of the increase in truck traffic along the test section.

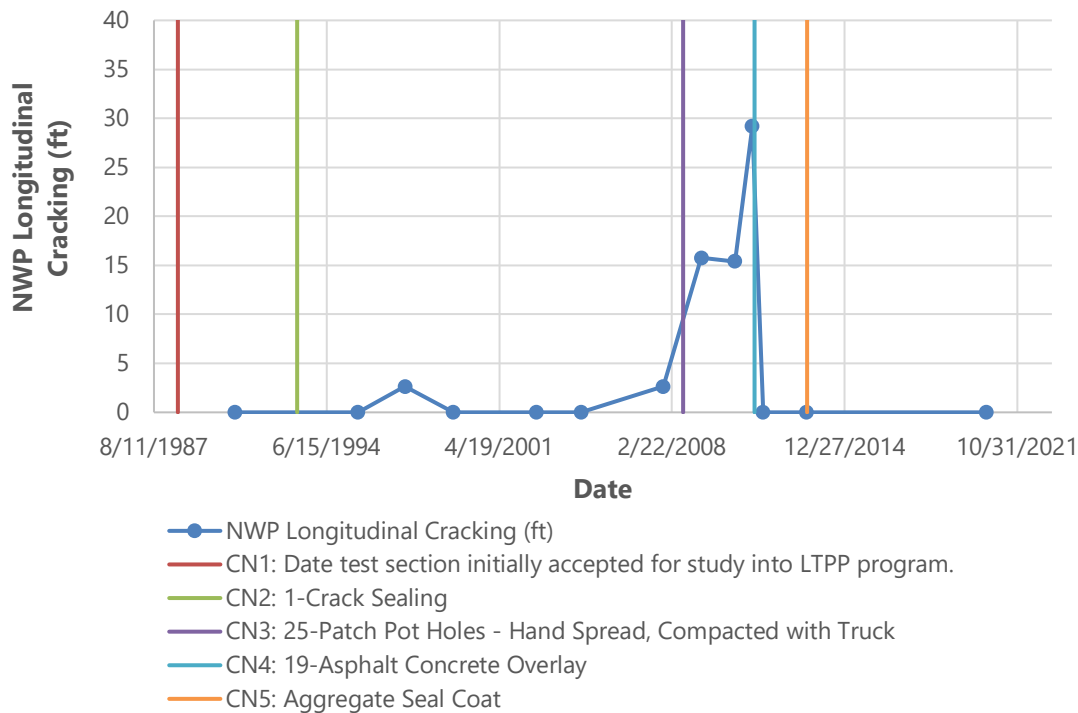
**Figure 12. Time history of the length of NWP longitudinal cracks.**

Minimal non-wheel path (NWP) longitudinal cracking, depicted in Figure 12, was reported during the first manual distress survey in July 1997, 11 years after the construction of the roadway, when 2.6 ft of low severity cracking was observed. However, between 1999 and 2004, NWP longitudinal cracking was not reported on the test section. Instead, this location of cracking was rated as fatigue cracking. In 2007, 2.6 ft of low severity cracking was reported again (although in a different location), and the NWP longitudinal cracking continued to increase between 2007 and 2011. By April 2011, 29 ft of NWP longitudinal cracking was reported on the test section. Following the overlay event in late 2011, NWP longitudinal cracking was not reported again. All NWP longitudinal cracking in 2011 was observed on the right edge of the test section lane in multiple locations along the test section. There was no wheel path (WP) longitudinal cracking observed on the test section throughout the analysis period.

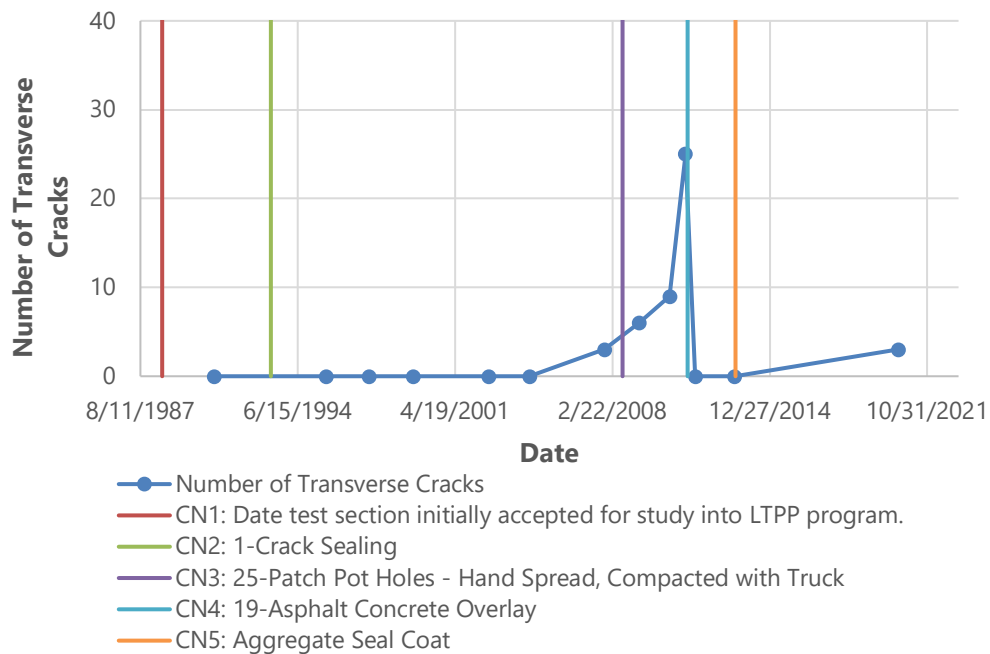
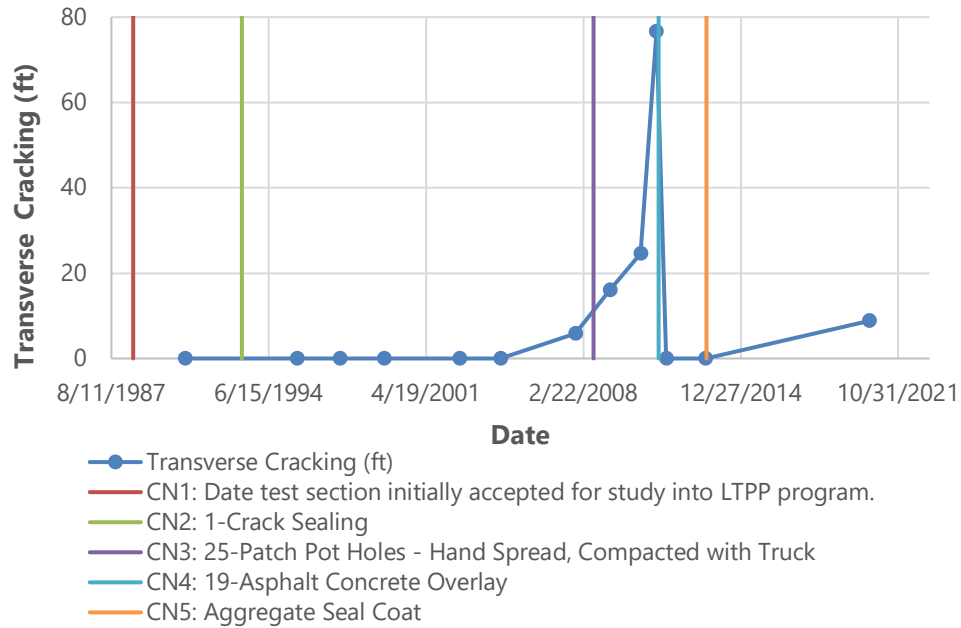
Data on transverse cracking was collected between 1990 and 2020, as shown in Figure 13 and Figure 14. Transverse cracking was first reported during the manual distress survey in October 2007, 21 years after the construction of the roadway, when 6 ft of transverse cracking (3 cracks) was observed. The transverse cracking continued to increase between 2007 and April 2011, at a rate of 17.8 feet/year, reaching 77 feet (25 cracks) by 2011. The reported transverse cracking was predominantly of low severity. Following the overlay event in 2011, transverse cracking was not observed again until the August 2020 manual distress survey, nine years after the construction event, when 9 feet (3 cracks) of transverse cracking was reported. The transverse cracking reported on the test section, while minimal, was predominantly partial width cracking rather than the full width of the lane. It is hypothesized the transverse cracking observed was related to thermal expansion or the rumble strips in the shoulder of the section. However, during an interview, ITD noted rumble strips were not a typical cause of transverse cracking and were likely a non-

factor in the observed performance. Regardless, given the age of the pavement, the test section performed well in terms of transverse cracking.

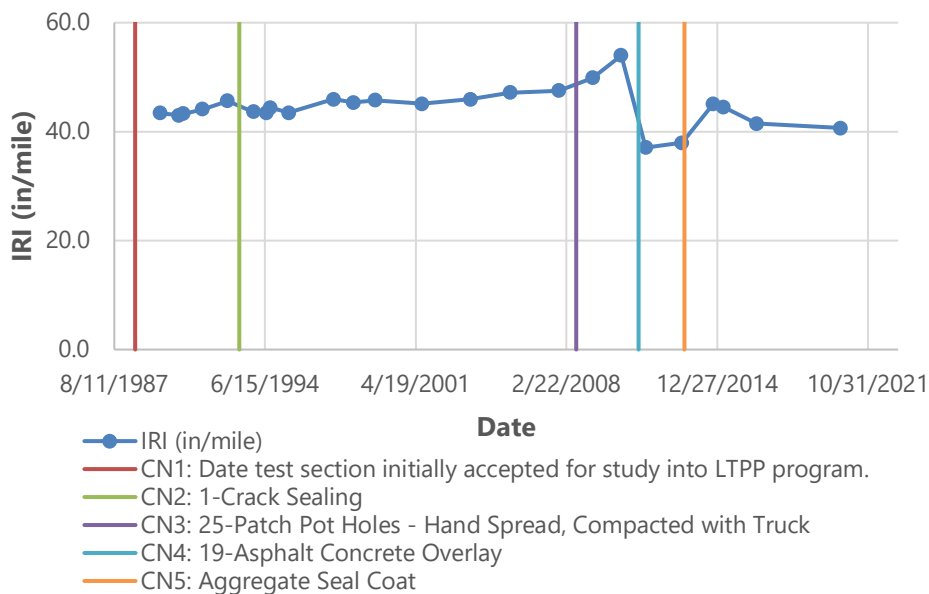
**Figure 15. Time history plot of pavement roughness.**

The average IRI measurements for the test section over time are shown in Figure 15. During the first performance period of the test section, from its incorporation into the LTPP program to the overlay event in 2011, the IRI on the test section slightly increased over time from 43.4 in/mile in 1989 to 54 in/mile in 2010. Throughout this period, the performance of the pavement was classified as "Good" based on FHWA performance definitions. During the second performance period, after the 2011 overlay event, the IRI of the test section dropped to 37 in/mile in October 2011. With the application of an aggregate seal coat in 2013, the IRI again increased to 45.1 in/mile in 2014 before slightly decreasing to an average IRI of 40.7 in/mile in 2020. Again, the average IRI during this performance period was classified as "Good" based on FHWA performance definitions.

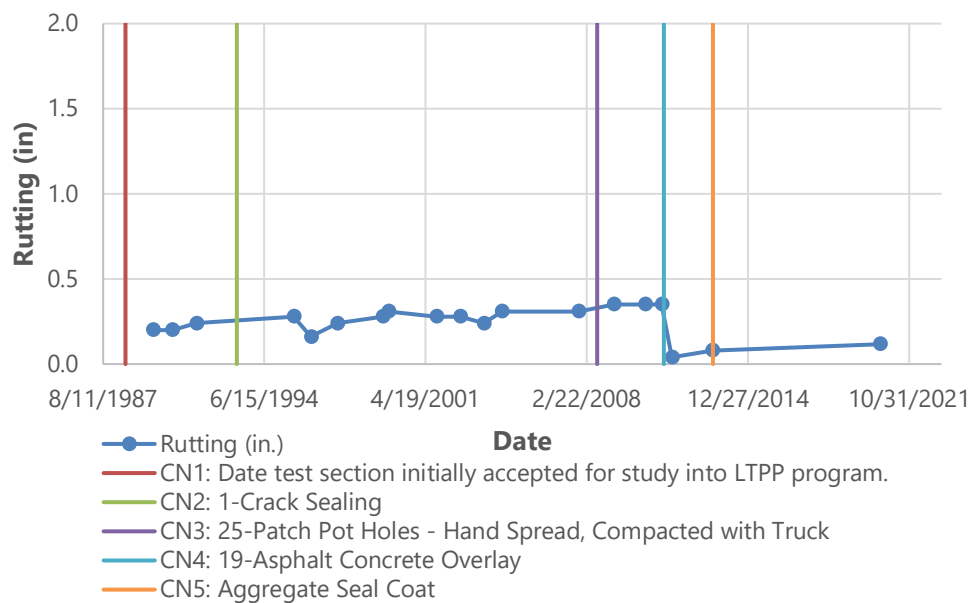
**Figure 16. Time history plot of average rut depth.**

The average rut depths observed for the test section between 1989 and 2020 are shown in Figure 16. The rutting on the section prior to 2011 increased from 0.2 in 1989 to 0.35 in 2011. Following the overlay in 2011, the average rut depth dropped to 0.04 in. The average rut depth began to slightly increase following the overlay, at a rate of less than 0.01 in/year between 2011 and 2020.

Due to the amount of rutting observed on the test section prior to the overlay, the change in the transverse profile of the test section was investigated. Using the transverse profiles of the test section at multiple locations, an analysis of the predominant layer in which plastic deformation occurs was assessed using the method developed in NCHRP 01-34a.<sup>2</sup> The NCHRP method, which was derived using finite element analyses of rutting mechanisms in the HMA surface, base, and subgrade, is focused on the transverse profile characteristics indicative of permanent deformation such as densification, shear failure, or shear flow.

1. Coring to enable the following activities:
  - a. Confirm that layer thicknesses match those reported when the test section was incorporated into the LTPP program.
  - b. Determine if any of the cracking observed following the overlay event were reflected from the original AC surface.
  - c. Identify the rutting failure layer via visual inspection.
2. Analysis of 2020 TSD data, collected at the direction of ITD, including:
  - a. Computation of layer moduli.
  - b. Computation of  $SN_{eff}$ .
