Technical Memorandum

To: Jeff Uhlmeier
From: Lauren Gardner, Gonzalo Rada, and Kevin Senn
cc: Mustafa Mohamedali
Date: December 11, 2020
Re. Forensic Desktop Study Report: Minnesota LTPP Test Section 27_6251

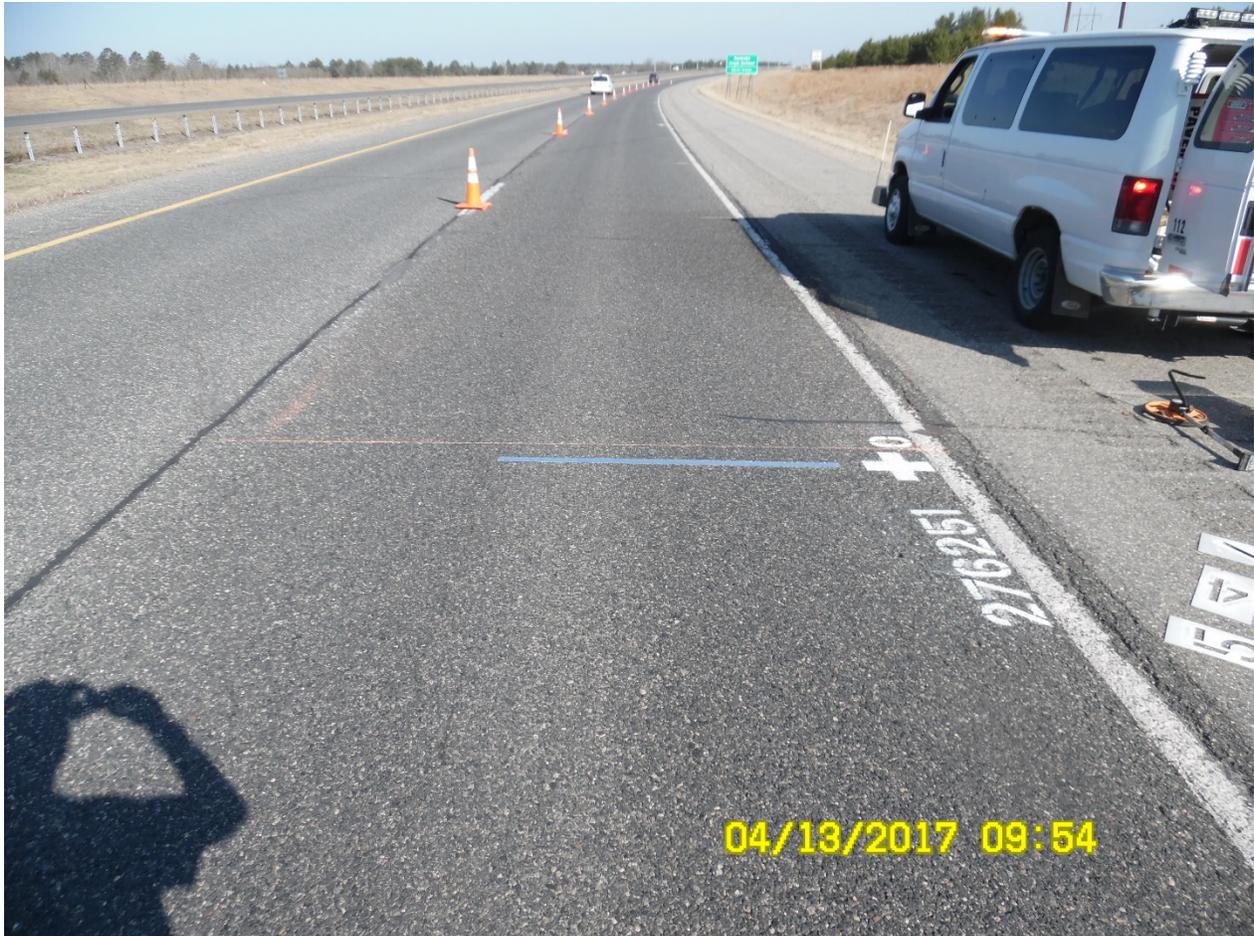
Photograph 1. LTPP Section 27_6251 at Station 0+00 looking westbound in 2017.

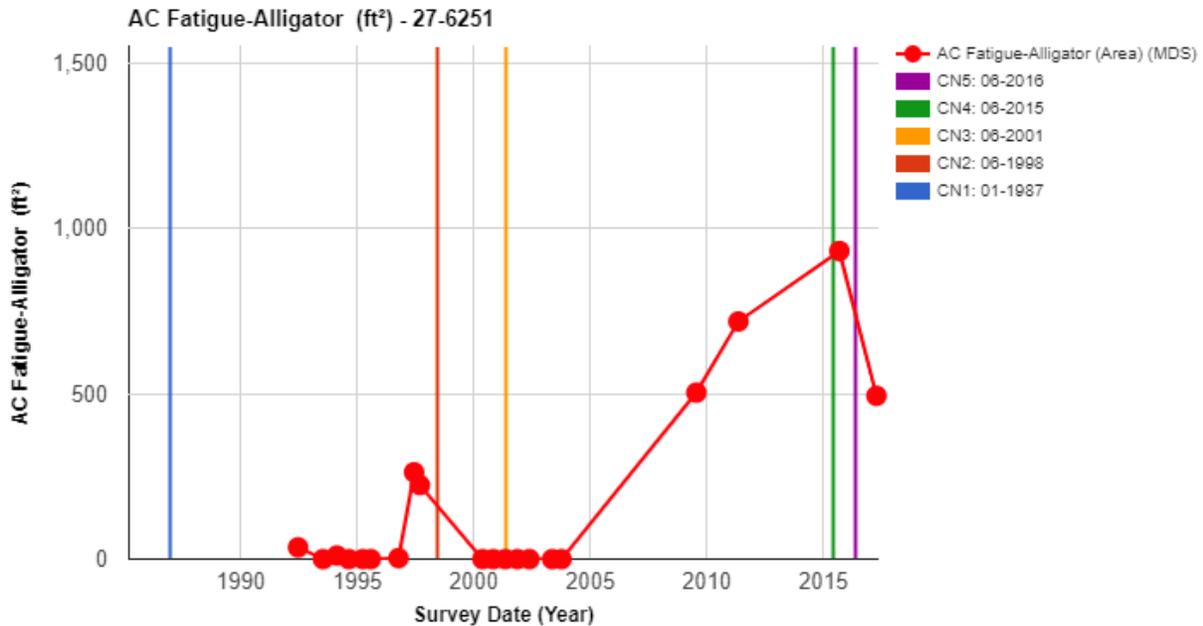
Figure 16 shows the total area in which fatigue/alligator cracking was observed for the section between 1992 and 2016. While the graph obtained from InfoPave™ is labelled fatigue cracking, which implies a mechanism, the distress values reported includes both fatigue cracking (inside the wheel path) and alligator cracking (outside the wheel path).

Figure 16. Time history of the length of fatigue cracking.

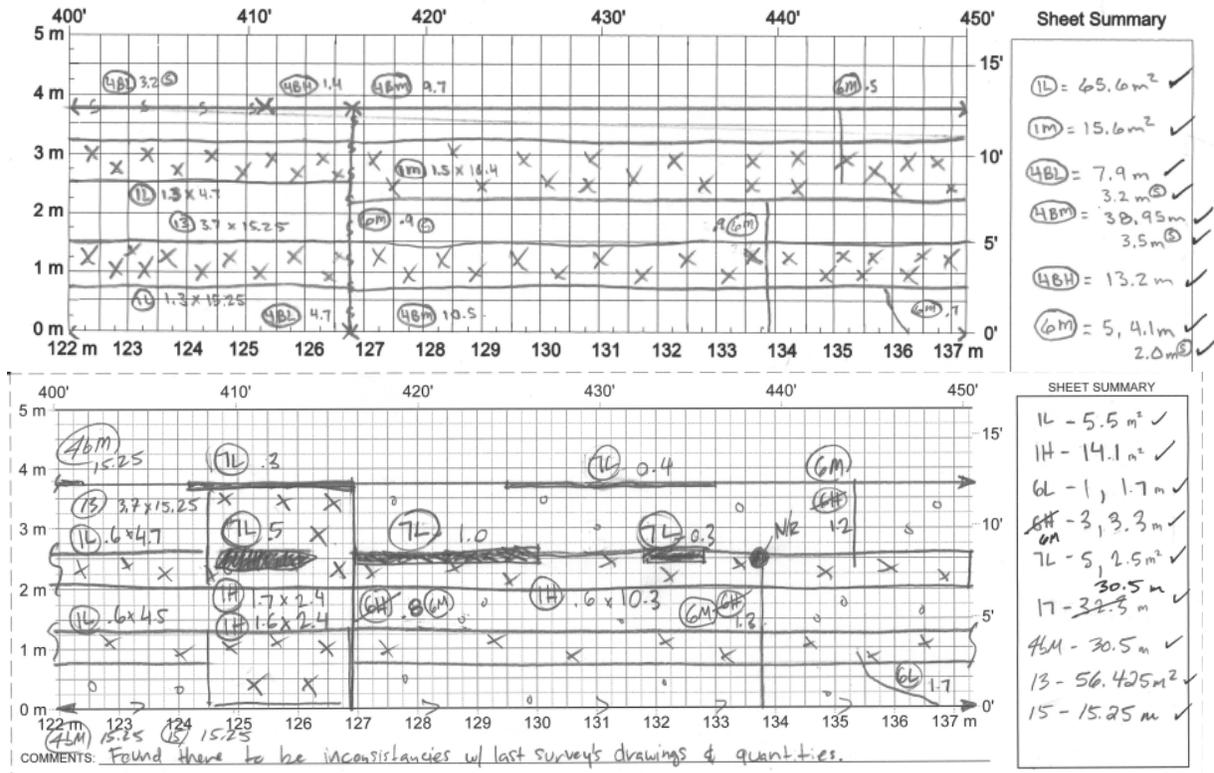
Fatigue/alligator cracking was first reported during the manual distress survey in 1992, when 36 ft² was observed. The fatigue/alligator cracking observed decreased between 1992 and 1993, before increasing again in 1997 when 224 ft² was reported. Following the mill and overlay in June 1998, no fatigue/alligator cracking was observed until the 2009 distress survey, 11 years after CN=2, when 504 ft² of fatigue/alligator cracking was reported. Once observed, the cracking propagated at a rate of 71 ft²/year between 2009 and 2015, reaching 932 ft² in 2015. However, in April 2017, following the skin patching event in June 2016 (CN=5), the fatigue/alligator cracking observed decreased to 494 ft². The drop in fatigue/alligator cracking in 2016 is likely due to a combination of the differences in rater opinions between the 2015 and 2017 surveys and the effects of the skin patching that occurred in 2016 (CN=5). As shown in Figure 17, while fatigue/alligator cracking is mostly reported in the same locations in 2015 and 2017, the rater in 2015 reported larger areas of low severity fatigue/alligator cracking (3.3-foot width in the wheel path compared to a 2-foot width reported in 2017) while the 2017 rater reported smaller areas of medium and high severity fatigue/alligator cracking. This figure also shows, under the comments section for the 2017 survey, that the rater found inconsistencies with the 2015 survey's drawings and quantities. In addition to the differences in the width of fatigue cracking reported between the two years, additional fatigue/alligator cracking (~13.5 ft²) was reported between stations 3+00 and 3+50 in 2015, but not in 2017. This is likely due to the difficulty in rating low severity fatigue/alligator cracking. Finally, the patching that took place in 2016, reported as 7L in Figure 17, also seems to have played a role in the overall cracking reported in 2017.

Figure 17. Fatigue cracking on the section in 2015 (top) and 2017 (bottom).

The increase in fatigue/alligator cracking following CN=3 seems to be related to pavement aging and overall structural degradation. The original structure was constructed in 1981 and therefore, may have been experiencing increased cracking due to long-term environmental exposure (high levels of precipitation and freeze-thaw) and traffic loadings. This hypothesis is further supported by the high amounts of material degradation (raveling and pumping) reported throughout the section during the last three pavement distress surveys. Another factor that could have contributed to the increase in fatigue/alligator cracking after CN=3 is the increased precipitation observed during the performance period following the mill and overlay in 1998. As noted earlier, prior to the mill and overlay event in 1998, the average yearly precipitation was approximately 29.5 inches. Following the mill and overlay event, the average yearly precipitation was slightly higher; approximately 31.8 inches. As water infiltrates the pavement, unbound granular layers tend to weaken (especially when reaching saturation conditions), which can contribute to the observed fatigue/alligator cracking.

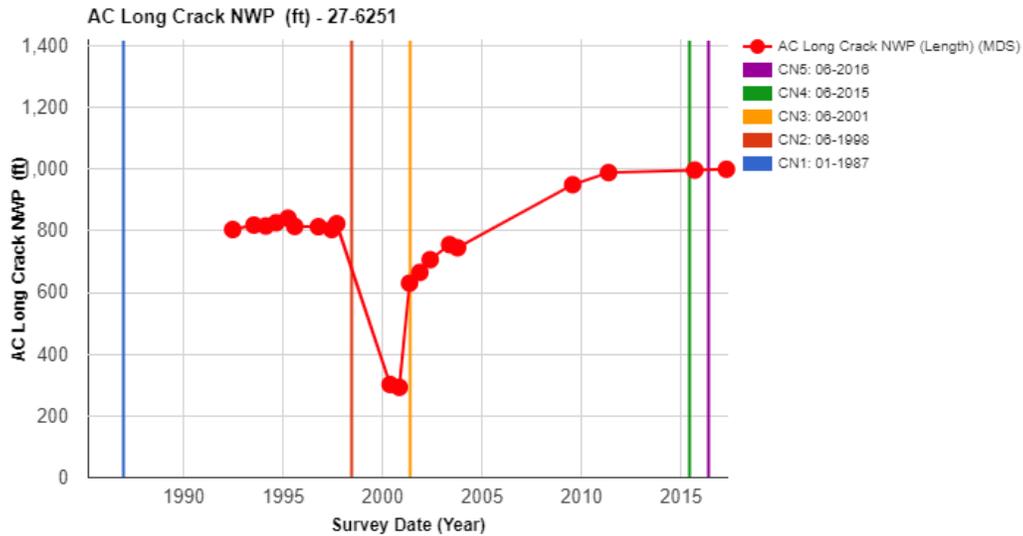
Non-wheel path (NWP) longitudinal cracking, depicted in Figure 18, was reported during the first manual distress survey in 1992, when 804 ft of cracking was observed. The NWP longitudinal cracking observed slightly increased between 1992 and 1997 at a rate of 3.8 feet/year. After the mill and overlay in June 1998, the NWP longitudinal cracking observed during the next distress survey in May 2000 decreased to 302 feet. However, the NWP longitudinal cracking again increased at a rate of 41 feet/year between 2000 and 2017, with a reported 1,000 feet of cracking by April 2017. Upon further inspection of the location and severity of the non-wheel path longitudinal cracking on the test section, it was found that the cracking reported in the LTPP AC distress summary table (MON_DIS_AC_REV) did not align with the distresses reported in manual distress surveys prior to 1998 mill and overlay. The values reported in InfoPave™ were

approximately double that of the distresses reported in the manual distress surveys. The discrepancy between the LTPP database and the manual distress surveys is recommended for further investigation.

The NWP longitudinal cracking reported prior to the mill and overlay was predominantly located on the edge of the lane and between the wheel paths. After the overlay, the cracking was predominantly observed on the edge and centerline of the lane. Given the cracking location, it is hypothesized that the propagation of the NWP longitudinal cracking is construction related (rather than reflection cracking) as it appears the cracking may be located along construction joints.

Figure 18. Time history of the length of NWP longitudinal cracks.

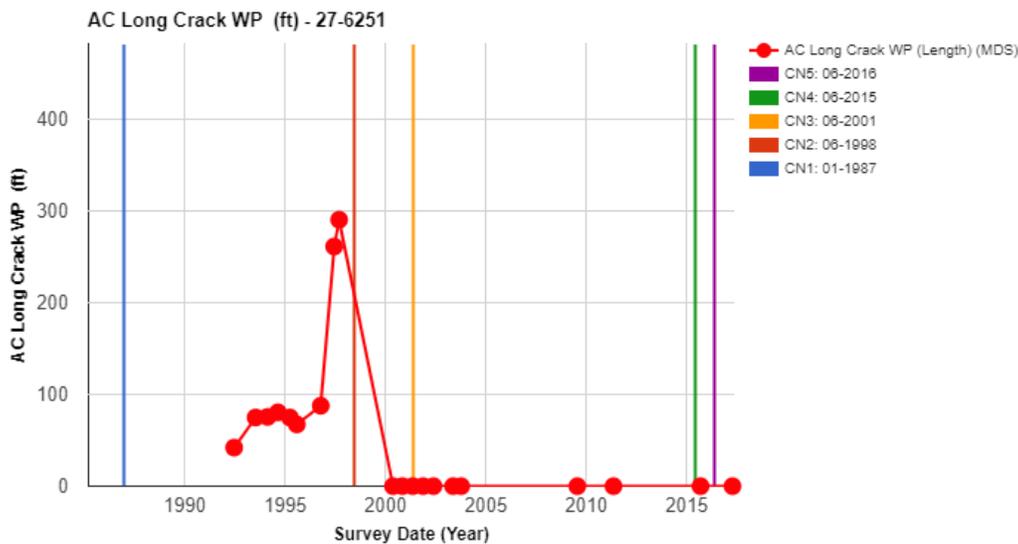
Wheel path (WP) longitudinal cracking, depicted in Figure 19, was reported during the first manual distress survey in 1992, when 42 ft of cracking was observed. The WP longitudinal cracking observed increased between 1992 and 1997 at a rate of 50 feet/year, reaching 290 feet in 1997. After the mill and overlay in June 1998, no WP longitudinal cracking was observed. This is likely because wheel path cracking after the mill and overlay was rated as fatigue/alligator cracking.

Figure 19. Time history of the length of WP longitudinal cracks.

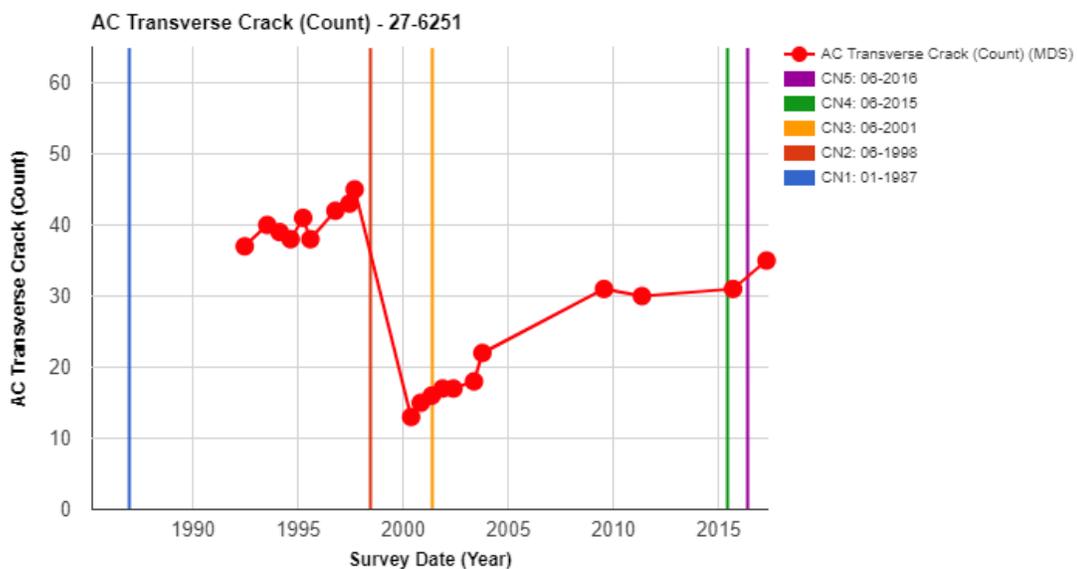
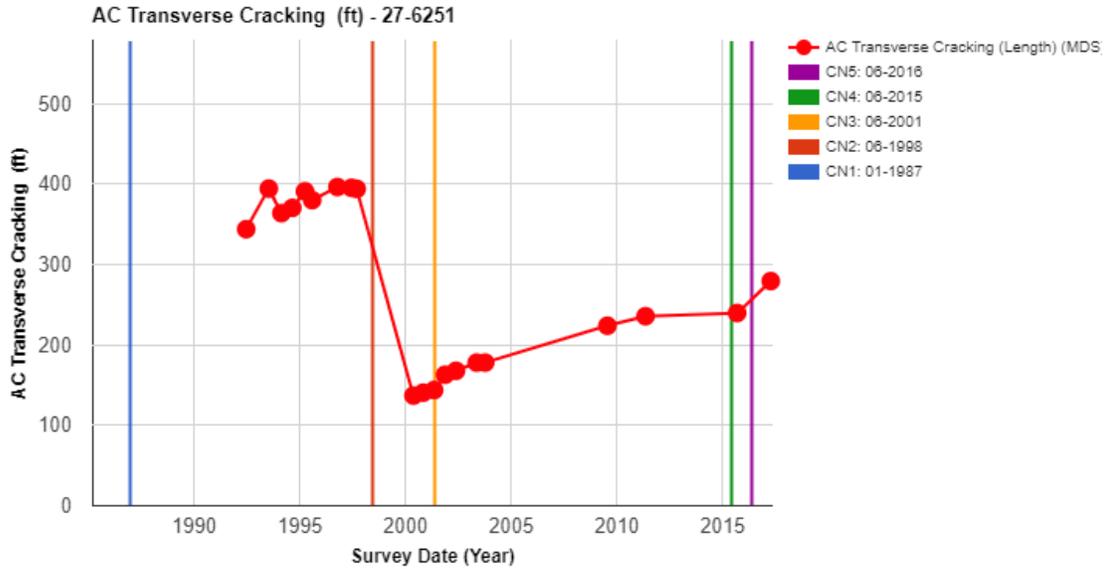
Data on transverse cracking was collected between 1992 and 2017 as shown in Figure 20 and Figure 21. Transverse cracking was first reported during the manual distress survey in 1992, when 344 ft of cracking (37 cracks) was observed. The transverse cracking fluctuated between 1992 and 1997, reaching 394 ft (45 cracks) in 1997. Following the mill and overlay in 1998, the reported transverse cracking dropped to 137 feet (13 cracks) during the next manual distress survey in May 2000. Between 2000 and 2017, the reported cracking increased at a rate of 8.4 feet/year, reaching 280 feet (35 cracks) by 2017.

Both prior to and following the mill and overlay event in 1998, transverse cracking was located in similar locations, indicating transverse cracking observed prior to the overlay event was reflected to the overlay surface. It is hypothesized that the propagation of the transverse cracking is primarily related to the freeze-thaw periods (evidenced by the high freezing indices) of the pavement section over time. This explanation would also justify the greater length of transverse cracking prior to the mill and overlay event as the average annual freezing index, and therefore, the assumed harshness of the freeze-thaw, during this performance period was slightly higher than after the mill and overlay. Another explanation is that the relative stiffness of the original AC layer was greater than relative stiffness of the overlay layer (as evidenced by the backcalculated moduli). With the original AC layer being stiffer, the freeze-thaw period would cause more transverse cracking prior to the mill and overlay.

Figure 20. Time history of the number of transverse cracks.

Figure 21. Time history of the length of transverse cracking.

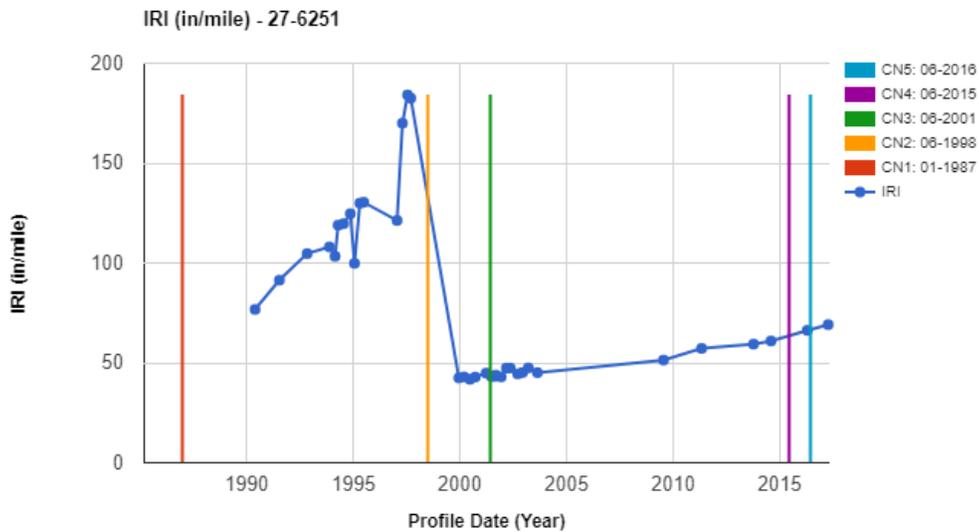
The average IRI measurements for the section over time are shown in Figure 22. During the first performance period of the test section, from its incorporation into the LTPP program to the mill and overlay event in 1998, the IRI on the test section increased over time. The IRI on the section, prior to the mill and overlay event in 1998, was 182 in/mi, which means the performance of the pavement was classified as "Poor" based on FHWA performance definitions. After CN=2, the IRI of the test section dropped to 42 in/mile in 1999 before increasing again at a modest but steady rate of 1.5 in/mi/year between December 1999 and April 2017. The average IRI during this performance period is classified as "Good" based on FHWA performance definitions.

Figure 22. Time history plot of pavement roughness.

The IRI reported after the mill and overlay in 1998 does not correlate with the observed cracking during this period. Specifically, one of the predominant cracking types that purportedly affects the overall IRI of the test section—fatigue/alligator cracking—is present in higher quantities following the overlay despite the lower average IRI reported during this period. This may be related to the severity of the cracking observed on the section—predominantly low and medium prior to the 2017 manual distress survey—which plays less of a role in the roughness of the test section. Additionally, the lower amounts of transverse cracking reported after the mill and overlay, which is another cracking type that purportedly affects the overall IRI of the test section, may have played a role in the IRI observed. The transverse cracking following the mill and overlay was also predominantly low and medium severity, compared to the predominantly high severity transverse cracking reported prior to the mill and overlay.

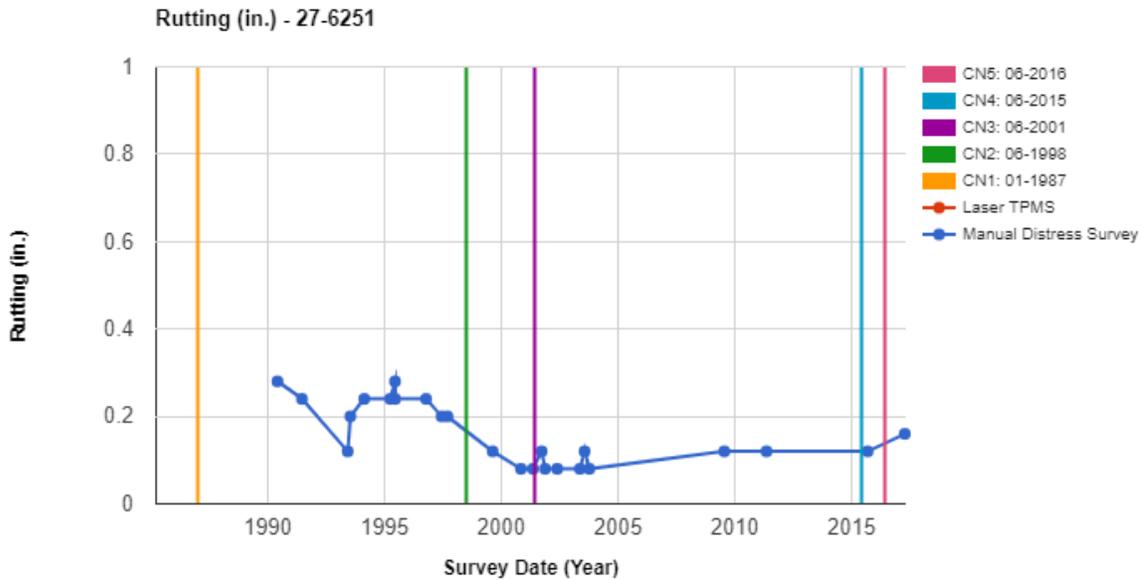
The average rut depths observed for the section over time are shown in Figure 23. The rutting on the section prior to the mill and overlay ranged between 0.1 and 0.3 in, but oddly enough decreased from 0.3 in (1990) to 0.1 in (1993) before increasing again to 0.2 in by 1997. Following the mill and overlay in 1998, the average rut depth dropped to slightly over 0.1 in. At that point, the average rut depth then began to increase between 2000 and 2017, with values increasing from 0.1 to 0.2 in between 2000 and 2017.

Figure 23. Time history plot of average rut depth.
