Technical Memorandum

Re. Forensic Desktop Study Report: Colorado SPS-2 Test Sections 0216, 0218, 0223 and 0224

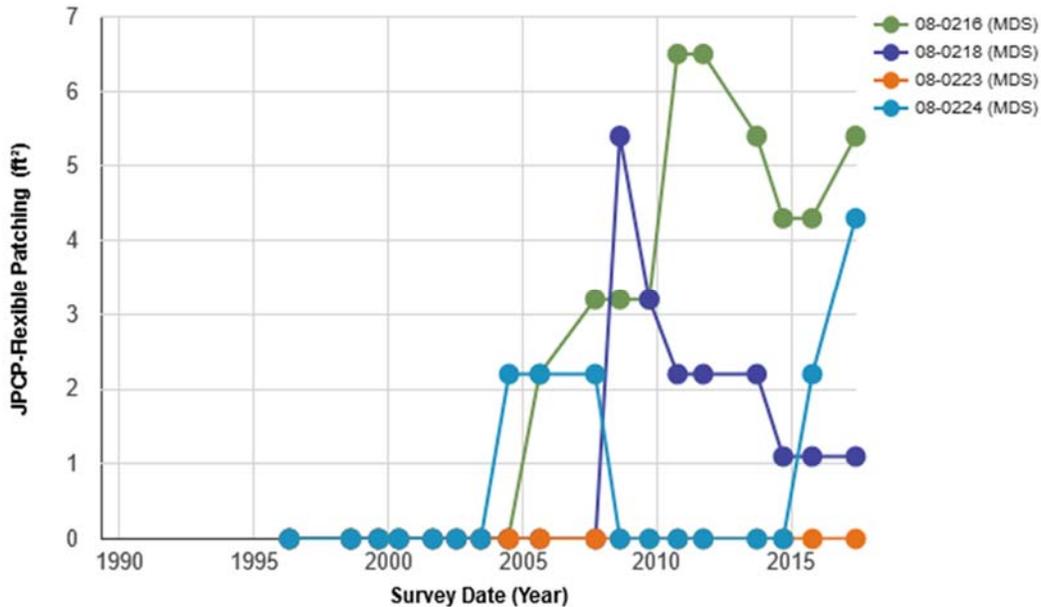
Figure 7. Time history of flexible patching.

Figure 7 displays the recorded quantities of flexible patching for the four sections in this study. In Figure 7 section 080224 has one 2.2ft² flexible patch not displayed in September 2014. Section 080218 is the only section in this study that has received rigid patching. In June 2015 a 2.2ft² rigid patch at the centerline and transverse joint was added to section 080218.

Note: There was a patch in 2014 that was not recorded on the MDS. The patch has been added to the manual distress survey (MDS) and the LTPP pavement performance database (PPDB), but since graph is a reflection of what is currently in LTPP InfoPave, the patch is not displayed in the figure.

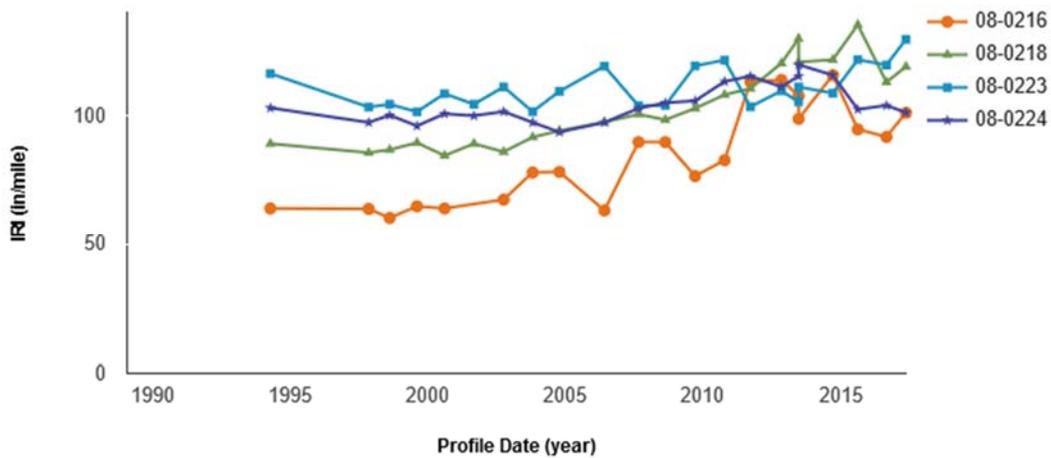
Figure 11. Time history plot of pavement roughness for 080216, 080218, 080223 and 080224.

The time history of roughness measurements for the four test sections in the study are shown in Figure 11. According to the FHWA performance standard, IRI is considered in the “Good” category if the IRI is less than 95 inches/mile. If the IRI is between 95 and 170 inches/mile it is considered “Fair”, and an IRI greater than 170 inches/mile is considered “Poor”. As shown in Figure 11, as of 2017 all four sections had an IRI value in the “Fair” category with IRI values ranging between 101 and 130. The average IRI values in 2013, for regular data collection and diurnal data collection, put all four sections in the “Fair” category with IRI values ranging between 99 inches/mile and 130 inches/mile.

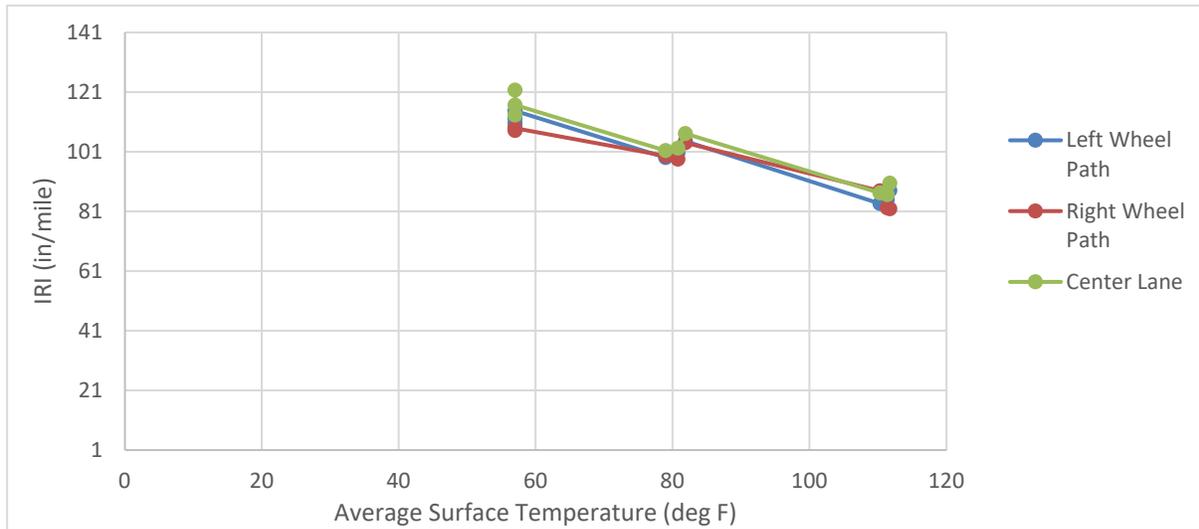
Figure 12. Section 080216 IRI versus temperature, June 23, 2013.

In Figures 12 through 15 the diurnal longitudinal profile measurements, collected on June 23, 2013, display the changes in IRI over the time of a single day for each section. The diurnal data were collected at three separate times of the day; early morning, mid-morning and the afternoon. Figures 12 through 15 shows data for three runs during each time of the day for the left wheel path, right wheel path and the center lane. Section 080216, shown in Figure 12, had a decrease in IRI as average surface temperatures increased throughout the day. IRI values during the early morning and mid-morning fluctuated within the “Fair” category ranging between 99 inches/mile and 122 inches/mile, but as the temperatures increased the IRI values in the afternoon were at their lowest, and fluctuated within the “Good” category with IRI values ranging between 82 and 91 inches/mile.

This behavior of decreasing IRI versus increasing temperature could be due to built-in upward curling of the concrete slabs at the time of paving. This can occur when the temperature of top of the PCC is lower than the temperature at the bottom of the slab due to high base layer temperature. During the use-phase of these slabs, when the temperature increases, the slabs will begin to flatten out, resulting in lower IRI values. This phenomenon was first discovered in a 1998 report¹.

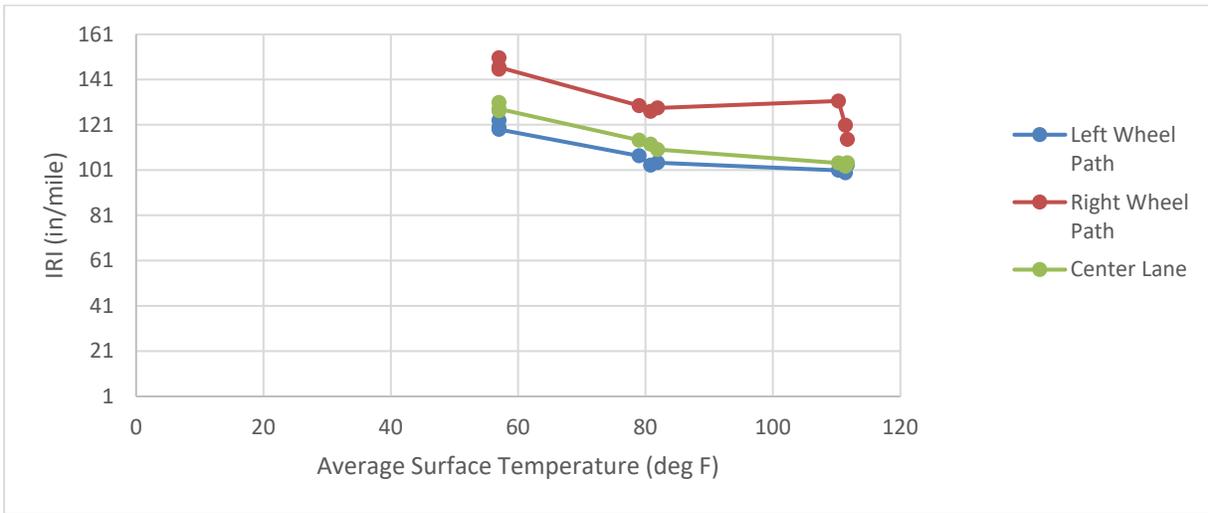
Figure 13. Section 080218 IRI versus temperature, June 23, 2013.

For section 080218, shown in Figure 13, IRI values slightly decreased as average surface temperatures increased, but unlike 080216 it never moved into the “Good” category and fluctuated within the “Fair” category, with IRI values ranging from 100 inches/mile to 151 inches/mile. During the afternoon, the lowest IRI value for 080218 was 100 inches/mile in the left wheel path, which is close to the “Good” category, but still puts it in the “Fair” category.

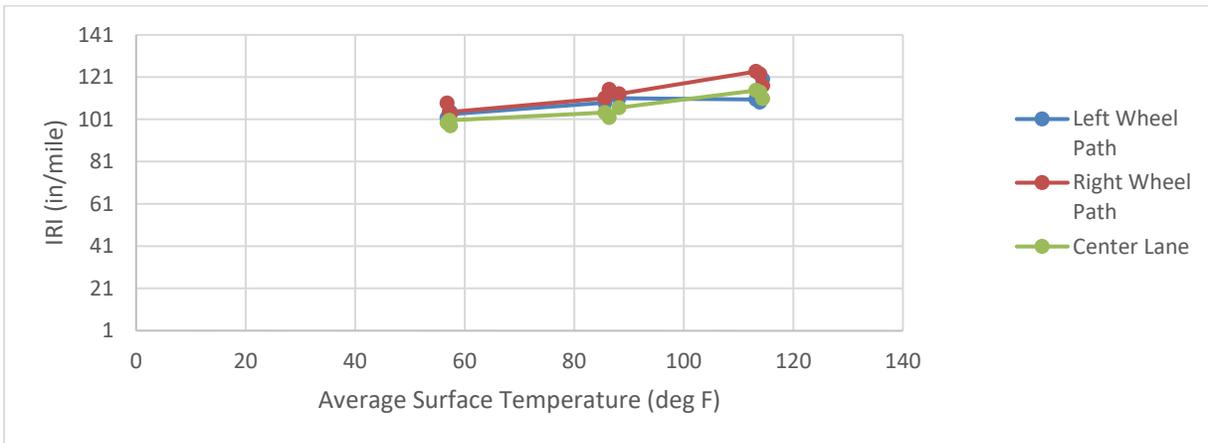
Figure 14. Section 080223 IRI versus temperature, June 23, 2013.

Unlike 080218, test section 080223, shown in Figure 14, experienced the opposite IRI value change, where the IRI values increased as temperatures increased throughout the day. The IRI values fluctuated within the "Fair" category, ranging between 98 inches/mile and 124 inches/mile. The lowest IRI values that were closest to the "Good" category were during the morning run when average surface temperatures were at their lowest.

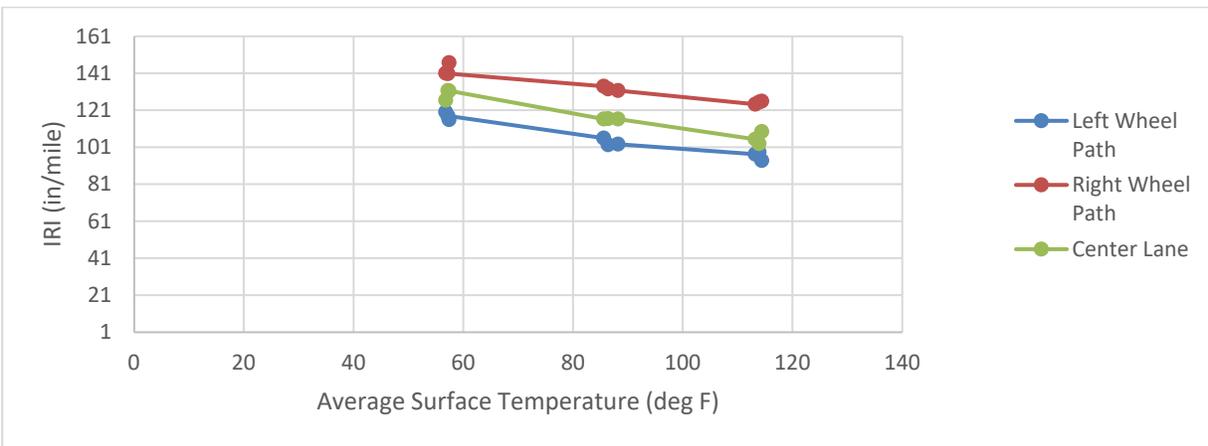
Figure 15. Section 080224 IRI versus temperature, June 23, 2013.

Section 080224, shown in Figure 15, had higher IRI values in the beginning of the day and as temperatures began to increase the IRI values began to slightly decrease. The lowest IRI values for 080224 were in the afternoon. The IRI values fell within the "Fair" category throughout the entire day except in the left wheel path where one of the runs produced an IRI value at 94 inches/mile, which is considered "Good". However, the other two runs had IRI values that would put it on the low end of the "Fair" category.

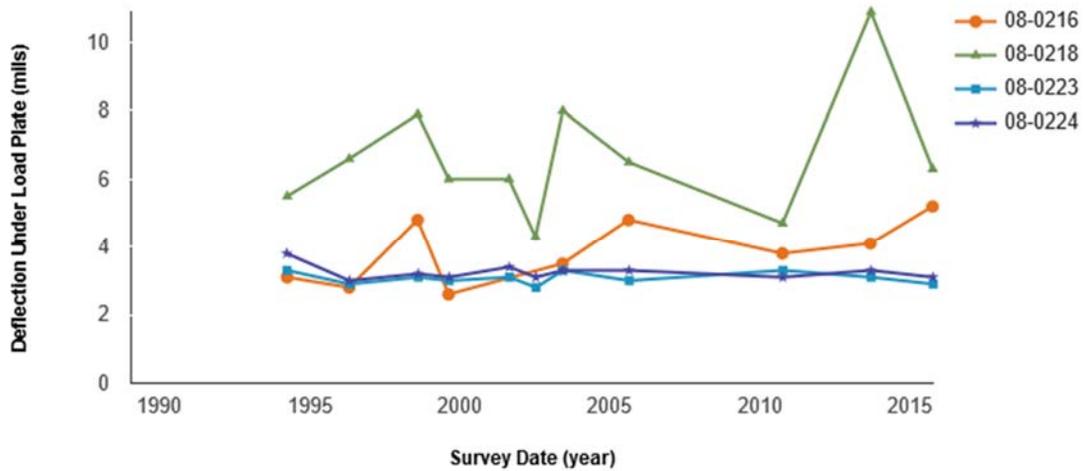
Figure 16. Time history plot of average deflection for the sensor located in the load plate normalized to 9,000 lb. drop load for 080216, 080218, 080223 and 080224.

The time history of average deflection under the load plate, normalized to a 9,000 lb. drop load, for the four test sections in the study are shown in Figure 16. The patching CN events do not affect slab deflection and therefore are not included in this discussion. FHWA does not have performance categories for deflection. Deflections for Sections 080223 and 080224 were very low (less than 4 mils) and remained constant throughout the 20+ year monitoring period to date. This was likely due to the presence of a thicker pavement slab (almost 12-inches) and the presence of a treated base (with an almost 5-inch thickness) and a granular base (3 inches for 080223 and almost 5-inches for 080224). Section 080216 had low deflections, fluctuating between 3 and 5 mils, and at the end of the monitoring period in 2015, deflection values were 2 mils higher than 080223 and 080224. Section 080218 had the highest deflections out of the four sections in this study. Deflection values for 080218 started off with steadily increasing deflection values, until 1999 and 2001 where it dropped to 6 mils. From 2002 to 2015 deflection values fluctuated between 4 and 8 mils, except in 2013 when there was a significant increase to 11 mils, which then dropped to 6 mils during the 2015 deflection testing. An explanation for the high deflections for 080218, is that the PCC layer thickness is 4-inches thinner than the PCC layer in the other three sections, leaving it with a PCC layer pavement structure that has less overall stiffness compared to 080216, 080223 and 080224. However, 0218 is also the only section that has a lean concrete base (LCB). Further investigation, including whether the deflection data is consistent with a bond between the slab and LCB, would require more sophisticated analysis on the deflection data, such as backcalculation. Section 080216 had the second highest deflections which is not surprising as, opposed to 0223 and 0224, 0216 only has a DGAB below the PCC surface.

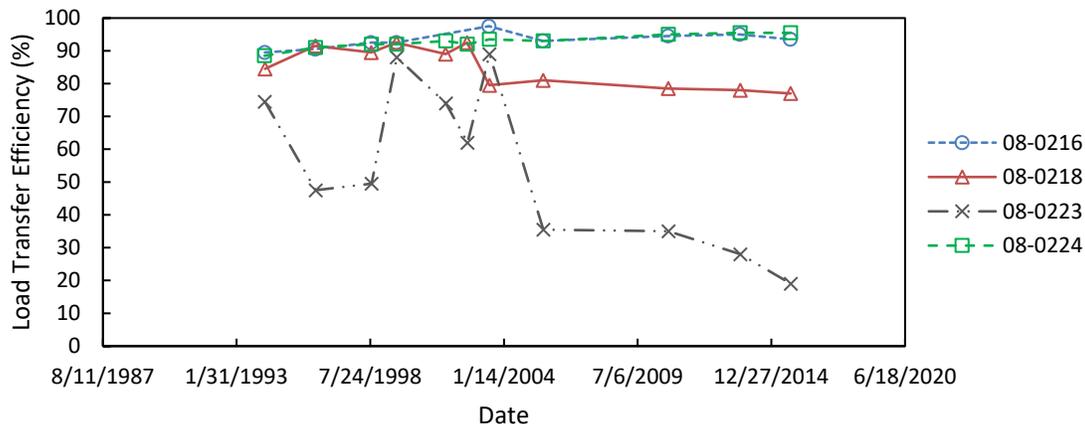
Figure 17. Load transfer efficiency summary.

Figure 17 provides a comparison of the load transfer efficiency (LTE) for the four sections in this study. Sections 080216 and 080224 maintained a good LTE throughout the monitoring period, staying between 89% and 98%. Section 080218 maintained a good LTE starting at 85% in 1994 and increasing to 93% in 2002. In 2003 the LTE for 080218 dropped to 80%, increased slightly in 2005 and gradually decreased until the end of the monitoring period. The LTE for 080223 started at 75% in 1994, dropped to 48% in 1996 and fluctuated between 50% and 89%, until 2005 when it dropped down to 36%. From 2005 on the LTE decreased gradually until the last deflection survey was conducted in 2015 where the LTE dropped to 19%. Values of LTE this low indicate that the dowels are not providing load transfer. The reason cannot be inferred from the data examined in this study. Section 0223 and 0216 both have the same nominal slab thickness and granular base. The differences are that 0223 had a narrower slab and the low strength mix. The narrower slab has two fewer dowels, and the lower strength mix possibly is less capable of resisting loads at the interface with the dowel, leading to local crushing of the concrete and “play” or “socketing” in the dowels. 0223 is the only low-strength mix section in this study, further investigation would require review of the data from the other low-strength sections. Interestingly, 0218, the other 12 foot wide slab in this study also shows lower LTE than the two 14 foot wide slabs, indicating that a combination of effects may be operative.

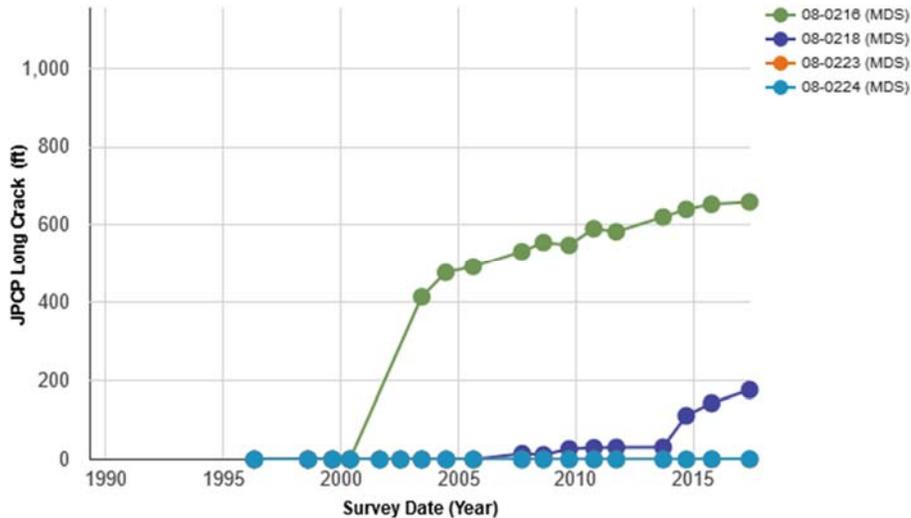
Figure 18. Time history of longitudinal cracking length.

Figure 18 shows the time history for longitudinal cracking lengths for the four Colorado SPS-2 sections in the study. Section 080216 has the largest amount of longitudinal cracking at 659ft, 080218 has 177ft of cracking, 080224 has about 1ft of longitudinal cracking and 080223 has no longitudinal cracking present.

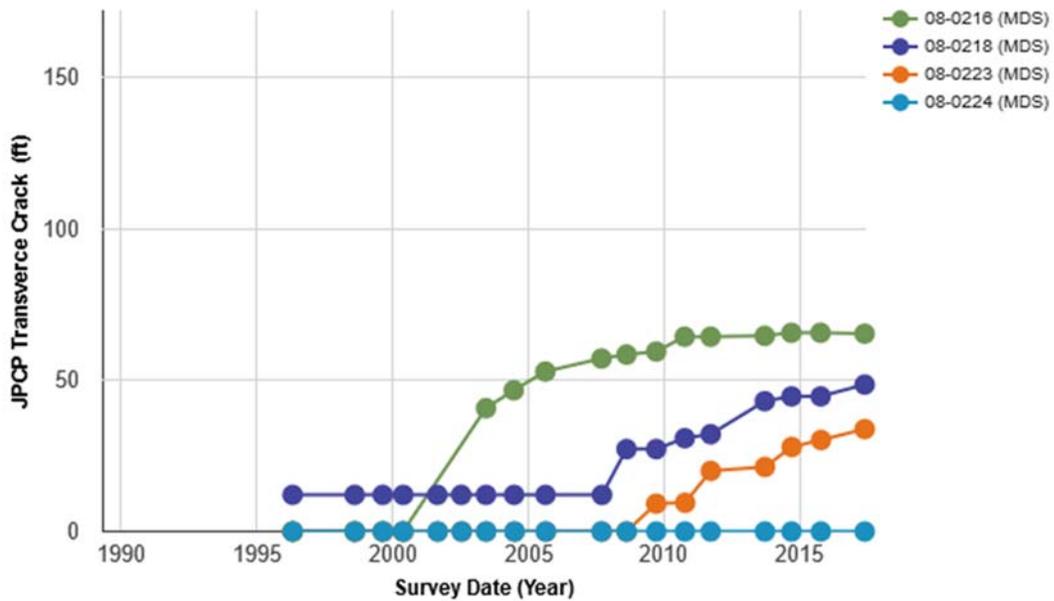
Figure 19. Time history of transverse cracking length.

In Figure 19, transverse cracking lengths are displayed for the four sections. For section 080216, not only does it have the most longitudinal cracking, but it also has the most transverse cracking at 65ft. Section 080216 has 6 cracked slabs (slab with a transverse crack greater than or equal to 1.9ft) out of 33, which converts to 18% of slabs cracked. This section also exhibits map cracking primarily in the outer wheel path. Section 080218 also has 6 cracked slabs out of 33, which is 18% of slabs cracked. 080218 was the only section that exhibited corner breaks, durability cracking and it had the most map cracking out of the four test sections (5,757ft²). Section 080223 has 5 cracked slabs out of 33 which is 15% of slabs cracked and although this section had no longitudinal cracking the section exhibits 3,971ft² of map cracking throughout the section, the most polished aggregate (6,070ft²) out of the four test sections in this study and the section with the most scaling present (651ft²). Section 080224 has no transverse cracking, a small amount of longitudinal cracking and had the least amount of surface deformations; only a limited scaling (13ft²), a small amount of map cracking (18ft²) and some polished aggregate (349ft²). According to the FHWA performance standard, 080224 is considered "Good" with less than 5% cracked slabs, 080223 is considered "Fair" with cracked slabs between 5%-15% and 080216 and 080218 have greater than 15% cracking putting them in the "Poor" category.

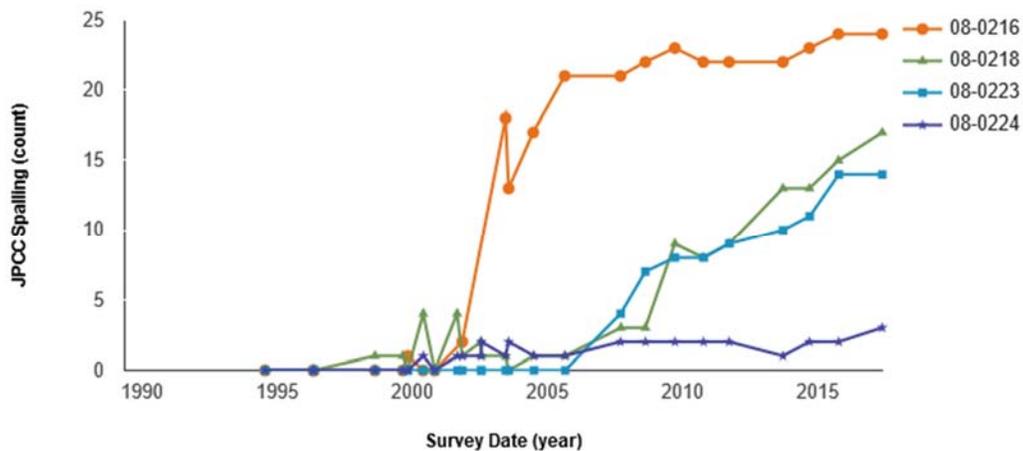
Figure 20. Time history of total number of JPCC spalling at transverse joints.

Figure 20 shows the time histories for spalling at transverse joints, indicating the number of affected joints. Based on the LTPP Distress Identification Manual (DIM), a transverse joint is considered affected if spalling is present for 10% or more of the length of the joint. Section 080224 displayed the least amount of spalling with three affected transverse joints. For sections 080218 and 080223, affected joints began to gradually increase after 2005. At the end of the monitoring period 080218 had 17 affected joints and 080223 had 14 affected joints. Of all four sections 080216 had the most dramatic increase from 2001 to 2003, jumping from two affected joints to 18 affected joints. The data point for section 080216 in July 2003 is from an Automated Distress Survey, which is analyzed from photos. For the purpose of this study, it is recommended that the July 2003 data point be ignored due to variability from data not being analyzed in the field. Beginning in 2004, the number of affected joints for 080216 steadily increased. At the end of the monitoring period, 080216 had twenty-four affected joints, the most affected joints of the four test sections in this study.

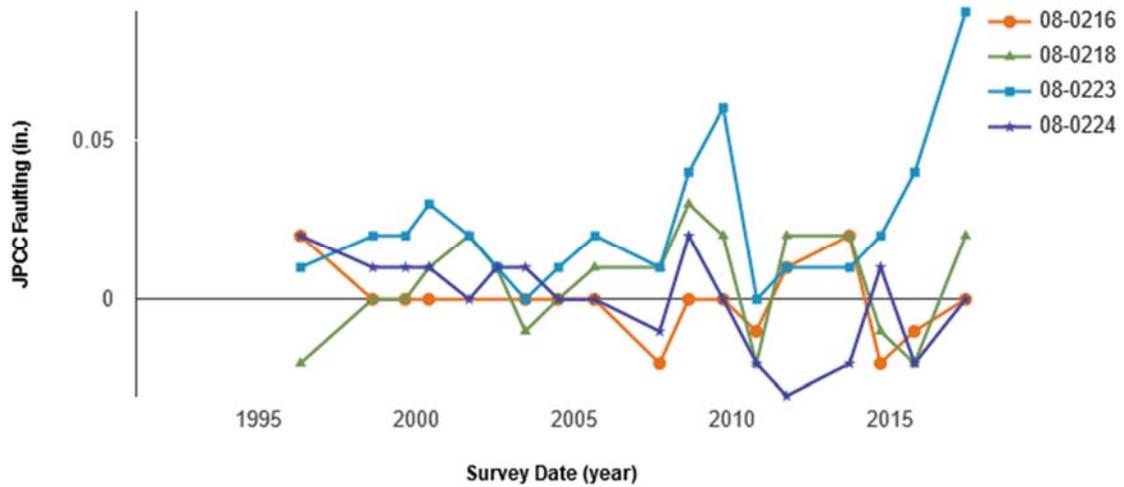
Figure 22. Time history plot of faulting.

Figure 22 shows the faulting time histories on the four Colorado SPS-2 sections. Faulting values at the end of the monitoring period for 080218 and 080223 are positive fault heights, which occur when the leave side of the joint has a higher elevation than the approach. Sections 080216 and 080224 ended with no faulting, but throughout it's monitoring life they fluctuated from positive and negative faulting values. As seen in Figure 22, faulting values for all four sections have fluctuated throughout the twenty plus years they have been monitored. Section 080223 is the only section that did not have negative faulting values and steadily increased after 2013. 080223 ended with the highest faulting values at .09 inches in 2017. Section 080223 is the only section with a design flexural strength of 550 psi unlike the three other sections that have a design flexural strength of 900 psi. Although the faulting values have fluctuated throughout the years and section 080223 ended with the highest faulting value of 0.09 inches, all sections have stayed in the "Good" category according to the FHWA performance standard. The FHWA performance standard for faulting is as follows; faulting less than 0.1 inches is "Good", faulting between 0.1 inches and 0.15 inches is "Fair" and faulting greater than 0.15 inches is considered "Poor".

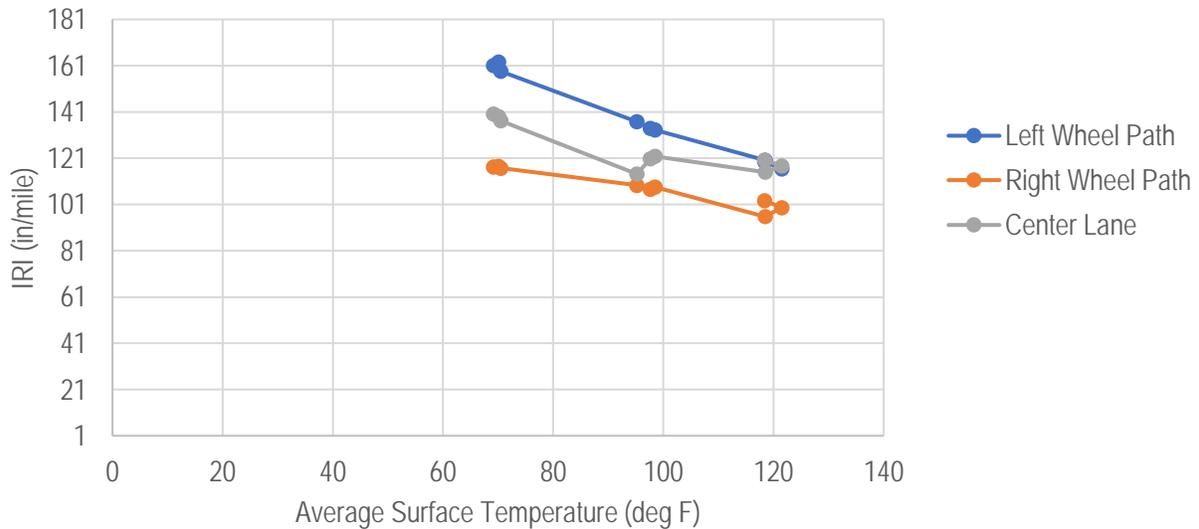
Figure 24. Section 080216 IRI versus temperature, July 13, 2019.

increased. with IRI values that start out in the "Fair" condition and remain that way throughout the day, with the exception of the Right Wheel Path in the afternoon approaching "Good" condition

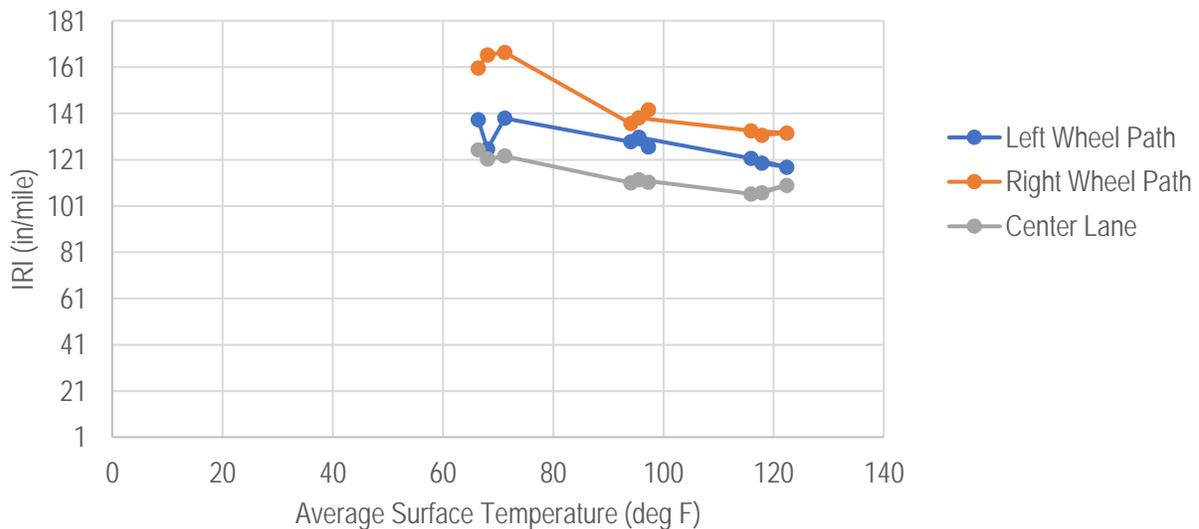
Figure 25. Section 080218 IRI versus temperature, July 13, 2019.

For section 080218, shown in Figure 25, IRI values slightly decreased as average surface temperatures increased, and fluctuated within the "Fair" category. During the afternoon, the lowest IRI value for 080218 was 106 inches/mile in the center of the lane, which is close to the "Good" category, but still puts it in the "Fair" category.

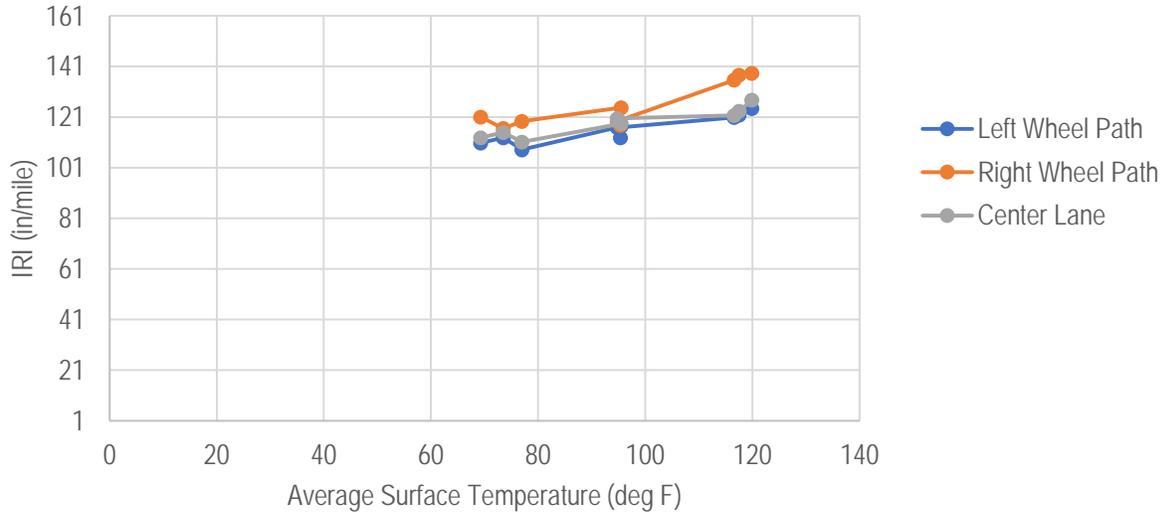
Figure 26. Section 080223 IRI versus temperature, July 13, 2019.

For section 080223, shown in Figure 26, IRI values actually increase as average surface temperatures increased, going from an average value of 114 inches/mile up to 128 inches/mile. There was a slight

increase for both the left wheel path and center lane IRI values, but the right wheel path values increases a bit more between the mid-morning and afternoon testing. During the early morning, the lowest IRI value for 080223 was 108 inches/mile in the left wheel path.

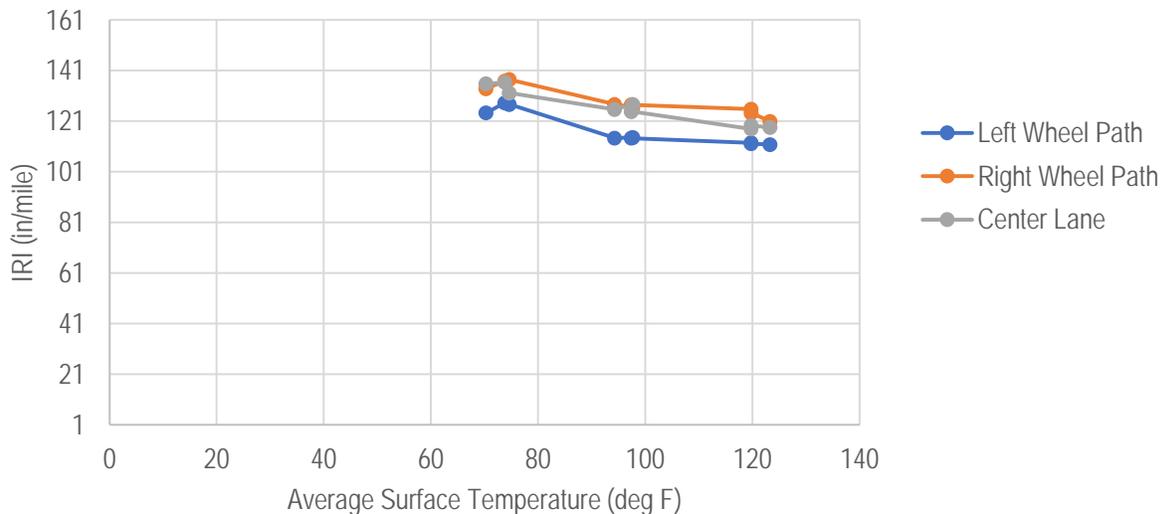
Figure 27. Section 080224 IRI versus temperature, July 13, 2019.

For section 080224 (Figure 27), the IRI values slightly decreased as average surface temperatures increased, decreasing from an average value of 132 inches/mile in the early morning to a value of 118 inches/mile in the afternoon. The IRI values decrease at a roughly steady rate for the center lane throughout the day. However, both wheel paths experience a larger decrease between the early morning and mid-morning testing and then a smaller decrease between the mid-morning and afternoon testing.

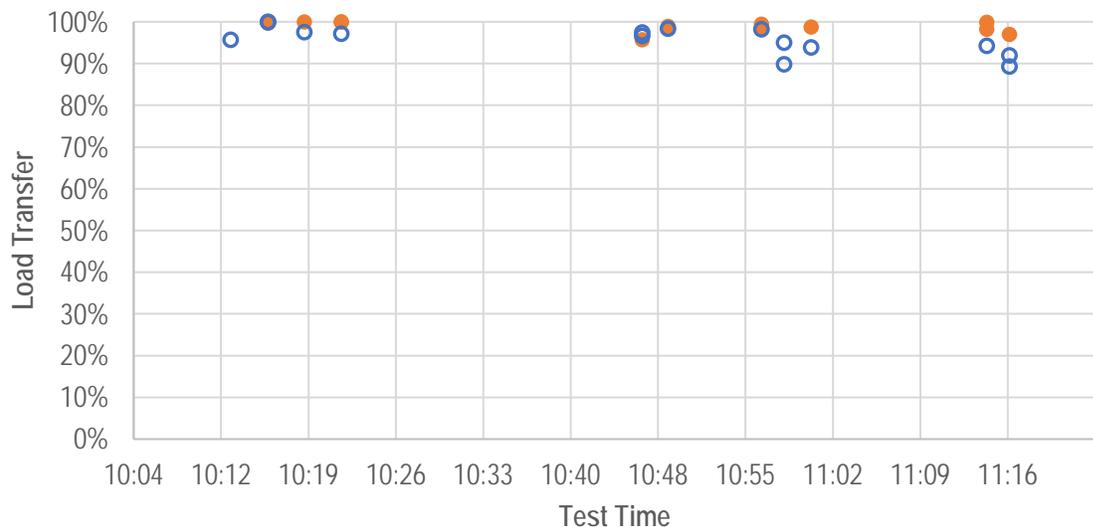
Figure 38. Time history plot of load transfer efficiency at approach (solid orange) and leave (blue) joints for 080224.

For section 080224, the load transfer values start out extremely high and slightly decrease throughout the day. This behavior can't be easily explained, but given nearly all of the load transfer values are greater than 90%, the small decrease is not expected to cause any change in the pavement's performance.

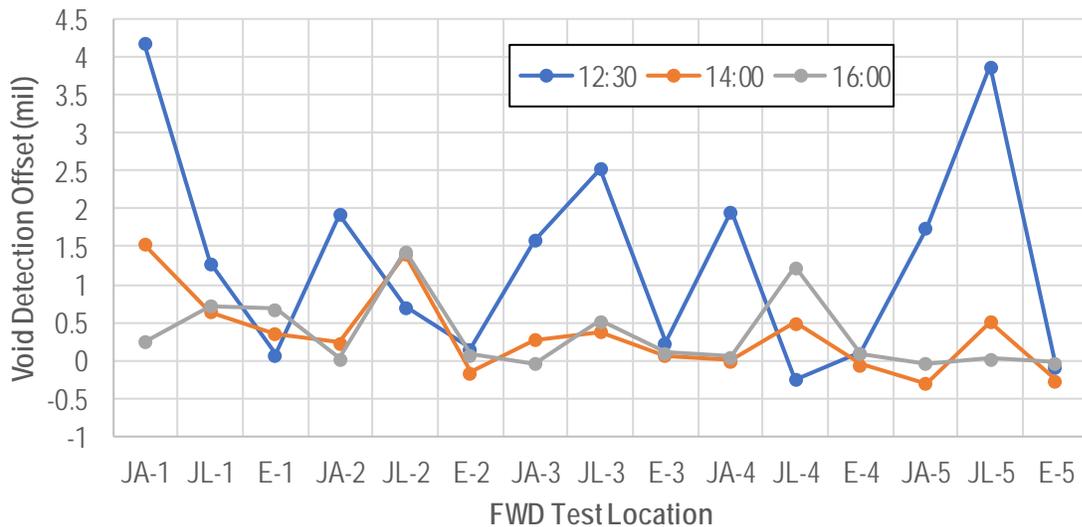
Figure 39. Void detection offset per test point for 080223.

The void detection offset values for 080223 show there are possible voids in the morning hours, but as the temperature increases, the slab will curl and the joints will come further into contact with the underlying base material. This would result in lower void offset values as the temperature increases, which is supported by the data in Figure 35. The data cannot explain if the voids formed first and the excessive movement deteriorated load transfer, or if poor load transfer allowed the slabs to move excessively and slowly wear the base material away.

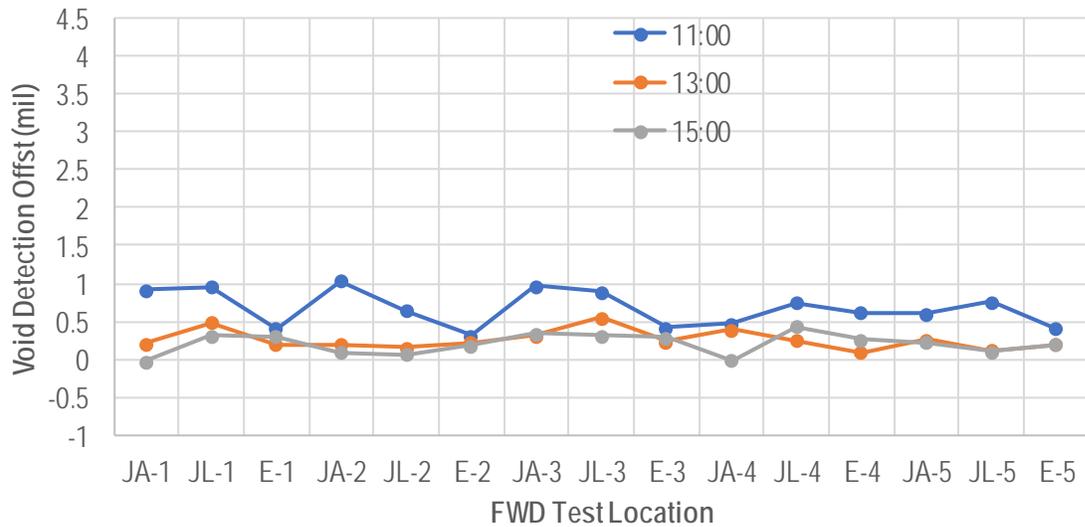
Figure 40. Void detection offset per test point for 080224.

For section 080224, the void offset values do not change throughout the day and do not show any potential voids at any of the 15 test locations. The data can't explain whether or not the high load transfer has meant less potential for voids to occur, or if the lack of voids underneath the joints has kept the load transfer from eroding on section 080224, but both show the section is performing very well.
