Technical Memorandum

Re. Forensic Desktop Study Report: New Mexico LTPP Test Sections 35_0801 and 35_0802

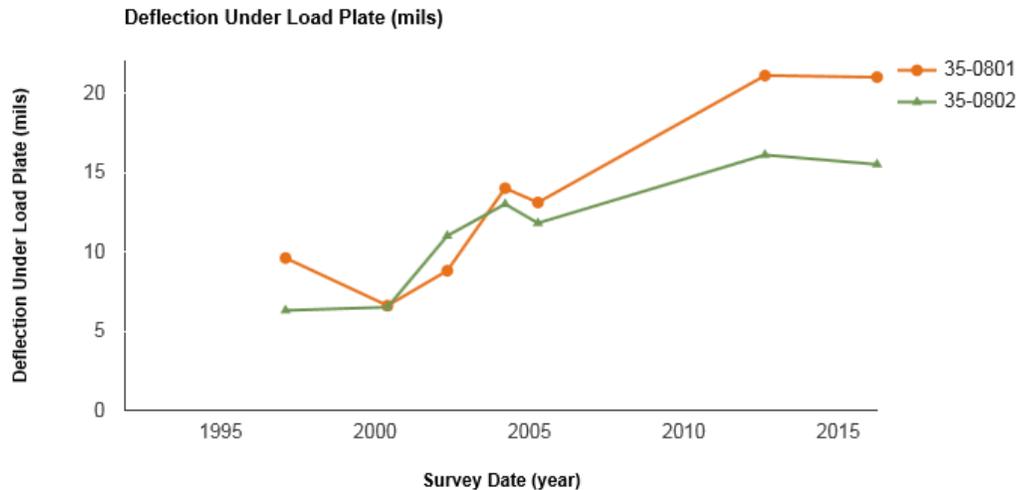
Figure 1. Average deflection for the sensor located in the load plate normalized to 9,000 lb. drop load over time.

Figure 1 shows the average Falling Weight Deflectometer (FWD) deflection under the nominal 9,000-pound load plate over time for each test section. The deflection of the sensor located in the center of the load plate is a general indication of the total “strength” or response of all layers in the pavement structure to a vertically applied load. This deflection can be influenced by pavement temperature at the time of testing, precipitation, and changes in pavement structure. As shown, the original pavement structure of the test sections had a maximum deflection of 9.6 mils (for section 35_0801) and 6.3 mils (for section 35_0802) in 1997, which increased over time to 21.1 mils (for section 35_0801) and 16.1 mils (for section 35_0802) by 2012 when deflection measurements reached a maximum for both sections. These deflections show the pavement structure is deteriorating with time under local climatic and traffic conditions. However, while an increase in deflection due to pavement deterioration is expected, the average deflections observed more than doubled between the time the pavement was constructed in 1995 and the last time an FWD test was conducted in 2016. The magnitude of deflection reported for each test section is reflective of each section’s pavement structure; section 35_0801, which is less thick than the second test section, has higher measured deflections throughout the study’s duration as the section has less structural support than section 35_0802. An exception to this observation occurred in 2002 when section 35_0802 reported higher deflections than section 35_0801; this may be a result of the conditions at the time of testing as temperature and environmental elements may have influenced the deflections recorded.

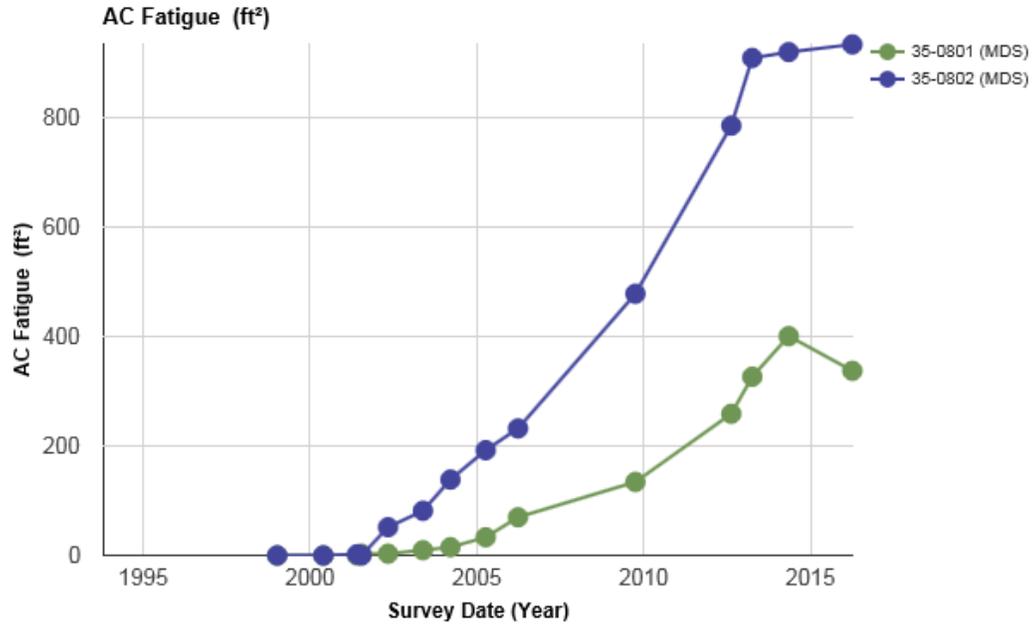
Figure 6. Total area of alligator cracking over time.

Figure 6 shows the total area of fatigue related cracking observed for sections 35_0801 and 35_0802 between 1996 and 2016. While the graph obtained from InfoPave is labeled fatigue cracking, it might be better thought of alligator cracking since the area is not constrained to the wheel paths. The name fatigue cracking implies a mechanism, where-as the LTPP distress surveyors were reporting only observations of cracking on the surface of the pavement test sections following LTPP guidelines. For both pavement sections, the area of roadway with fatigue/alligator cracking was observed to increase over time. For test section 35_0801, 338 ft² of fatigue/alligator cracking or nearly six percent of the total section area was observed in 2016, while for test section 35_0802, 935.40 ft² or nearly sixteen percent of the total section area was observed in the last year of collection. In both test sections, the increasing area of fatigue/alligator cracking that appears over time plateaued in 2014 when the observed distress increased at a reduced rate.

While no freeze climates typically exhibit more fatigue cracking due to the use of softer AC mixes², the amount of fatigue cracking exhibited at the test sections is still increasing at an abnormal level for a low-traffic roadway. One potential reason for the observed increase in fatigue cracking over time is that the AC pavement surface layer is undergoing age hardening (or oxidation); hardening leads to a more brittle asphalt surface layer and the development of raveling. Oxidation is influenced by the asphalt binder used,

Another possible reason for an increase in fatigue cracking on a low-traffic roadway is the development of stripping, which occurs when the aggregate and the binder in the AC layer begin debonding. Stripping is typically caused by water infiltration or inadequate surface or subsurface drainage and is common in hot, dry locations like the one where the test sections are located. Stripping is also associated with high levels of raveling, or progressive asphalt disintegration, which is confirmed by high levels of raveling reported at these sites. Additional lab tests to assess if stripping is occurring on these test sections is recommended to confirm this hypothesis.

As fatigue cracking indicates that a pavement is either structurally inadequate or has reached the end of its service life, the high percentage of what appears to be fatigue related cracking observed on the thicker pavement structure (section 35_0802) is counterintuitive, especially in light of the limited amount of traffic at the site. Because thicker layers of asphalt concrete and subgrade implicate increased strength to withstand loads and section 35_0802 is thicker than section 35_0801, further investigation of the high levels of what appears to be fatigue-related cracking observed on section 35_0802 is needed. One possible explanation is that section 35_0802 has worse drainage than Section 35_0801, which resulted in increased pavement stripping and subsequently increased cracking indices. This explanation can be supported by photographs of the sites. In the photographs from 2013 and 2014, both sections depict darker cracks and cracks where plants are growing out of them as shown in Photograph 3. Each of these observations may indicate increased moisture due to poor drainage resulting in pumping. Despite both sections exhibiting these conditions, section 35_0802 appears to have slightly more instances of cracking that appears to be wet and is the only section with reported pumping in the distress survey. An additional distress survey and analysis of drainage at the two sections is necessary to assess whether drainage issues caused additional fatigue cracking in section 35_0802.

film thickness, aggregate gradation, in situ moisture content, and AC-mix percentage of air voids. To better understand whether oxidation played a role in increased levels of fatigue cracking, it is suggested that each of the factors mentioned be assessed using information collected on the sections at the time of construction as well as through lab tests of the existing pavement material.

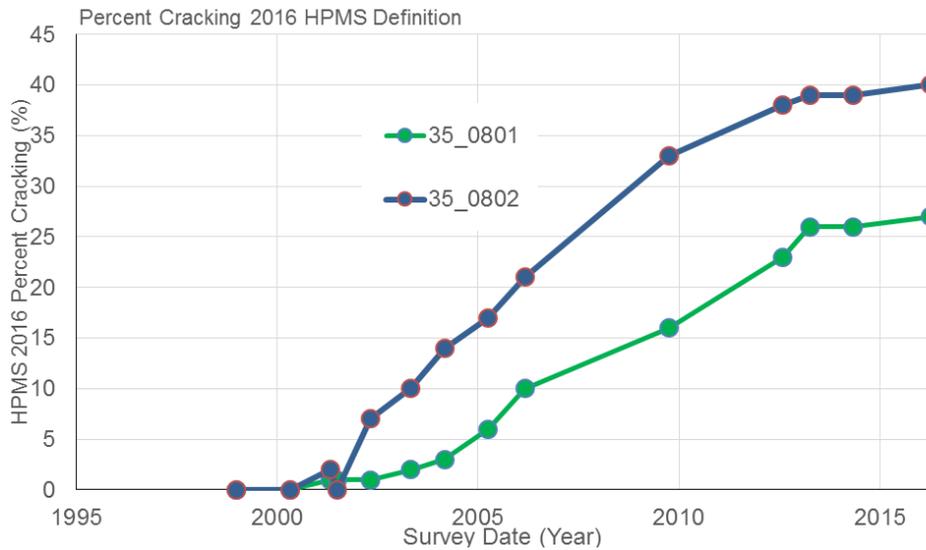
Figure 7. HPMS 2016 percent cracking definition using cracking limited to the wheel paths.

Figure 7 shows the time history trend for cracking in the wheelpaths using the 2016 Highway Performance Monitoring System (HPMS) percent cracking metric that all states now report to the Federal Highway Administration (FHWA). This is computed by the total length of cracking in the wheel paths, assumed to be 39 inches wide, by the total area of the test section. The maximum value for a 12-foot-wide lane is approximately 55%. Wheelpath cracking is one of the traditional methods used to assess fatigue response of an AC pavement. Figure 7 shows a similar time history trend to the fatigue/alligator cracking shown in Figure 6, with the thicker test section, 35_0802, exhibiting greater cracking. The plateau in the rate of percent cracking after 2013 is more consistent between the two test sections than that shown in Figure 6.

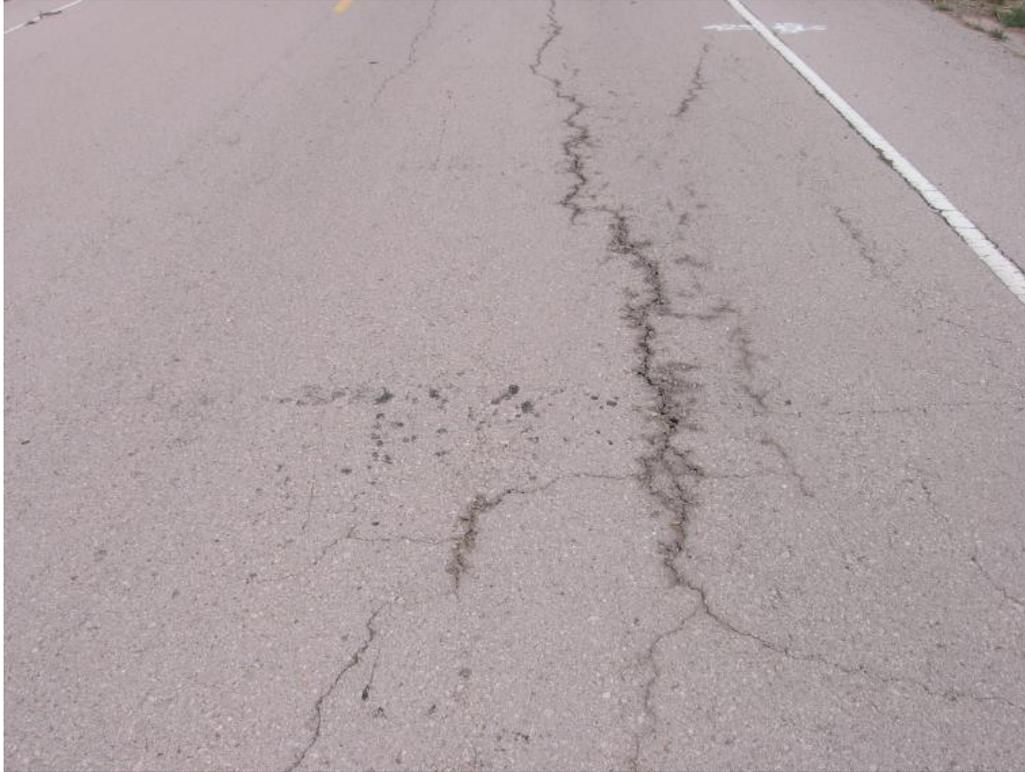
Photograph 3. Picture of what appears to be moisture at the surface of cracks on section 35_0802.

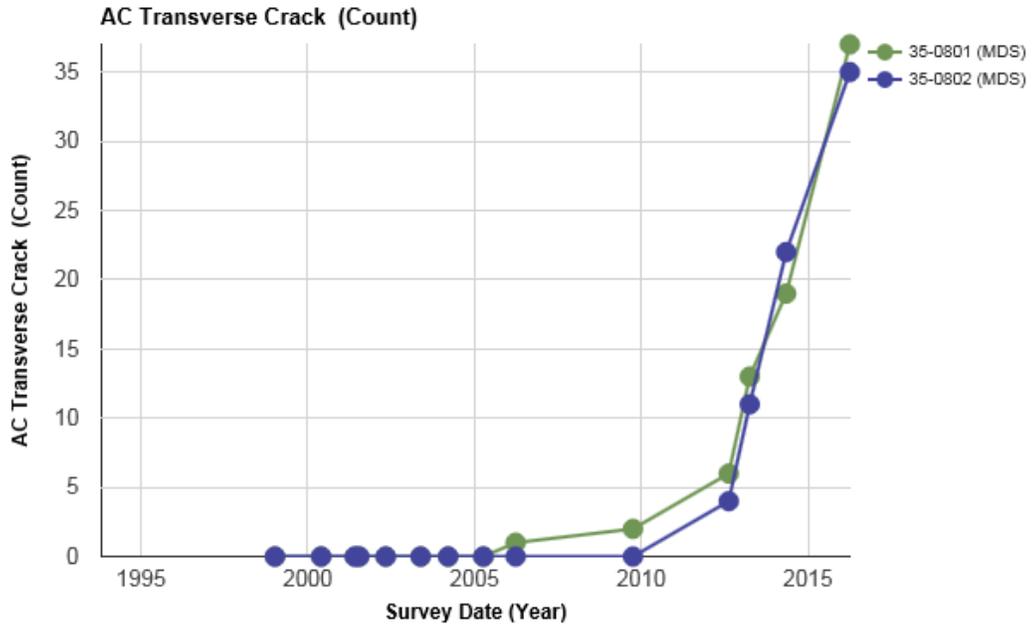
Figure 10. Total transverse cracking (count) observed over time.

Figures 10 and 11 depict the total transverse cracking reported for both sections of pavement throughout the analysis period; the transverse cracking observed increases over time in the test sections. For both sections, no transverse cracking was observed prior to 2006, but by 2006 and 2012 for section 35_0801 and section 35_0802 respectively, the transverse cracking observed began to increase rapidly. By 2016, 125.30 feet (37 total cracks) and 100.40 feet (35 total cracks) of transverse cracking are observed along test sections 35_0801 and 35_0802 respectively. The mechanism most often linked to transverse cracking in AC pavements is due to temperature changes in the AC layer. Unlike pavements in freeze zones that experience very low air temperatures, pavements in high-altitude no-freeze desert areas can experience higher diurnal changes in temperature between the maximum and minimum temperatures over a short duration than pavements in humid environments. These pavement test sections are at an altitude greater than 4,000 feet above sea level. This altitude also increases the solar radiation input energy into pavement structures. Another mechanism that is likely at play in the development of transverse cracking is the hardening of the AC layers, making them more brittle and more prone to thermal-induced cracking. The combination of age hardening with temperature-induced "fatigue" in the AC due to diurnal temperature-induced stresses is one potential reason for the development of transverse cracking on these test sections.

One way to assess AC hardening is to perform viscosity related tests on asphalts extracted from the test sections and compare the results to the results from initial construction.

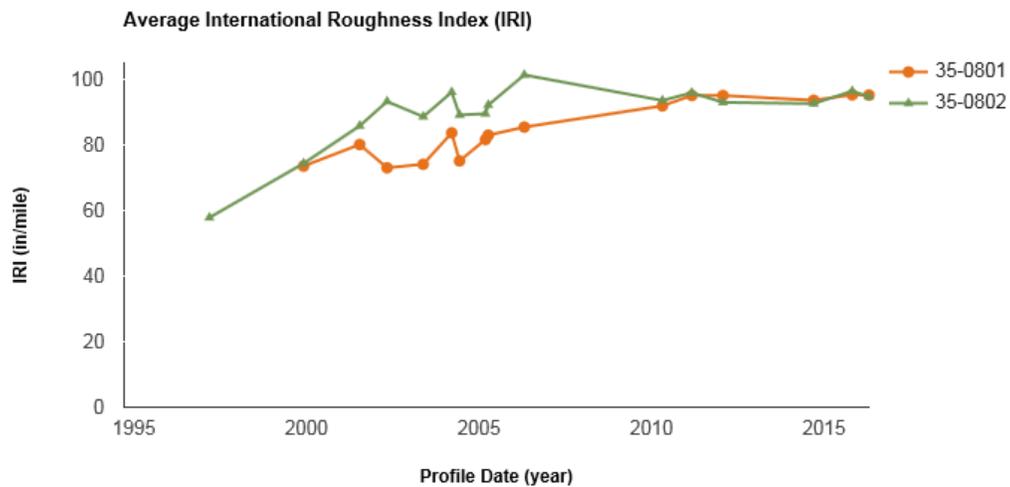
Figure 12. Average pavement roughness over time.

The average IRI measurements for each section over time are shown in Figure 12. The IRI of the test sections gradually increased over time. Section 35_0801's IRI increased from 73.56 in/mile in 1999 to 95.23 in/mile in 2016 while section 35_0802's IRI increased from 74.38 in/mile in 1999 to 94.72 in/mile in 2016. The gradual increase in roughness over time is reasonable as the amount of cracking observed on the pavement sections also increased over time. Despite the increase in cracking distresses observed, the pavement's IRI performance is classified as "Good" based on FHWA performance definitions. This type of pavement roughness history is also not consistent with heavy truck load related cracking. With truck load related cracking, there tends to be pot-hole formation as chunks of the pavement surface are dislodged. This observation tends to support the environmental aging hypothesis and age hardening of the AC materials in the pavement structure. It also suggests that low temperature cracking, as witnessed in low temperature environmental zones, is not happening since the transverse cracks are not building up surface "heaves" on each side of the transverse cracks, which will affect pavement roughness measurements.

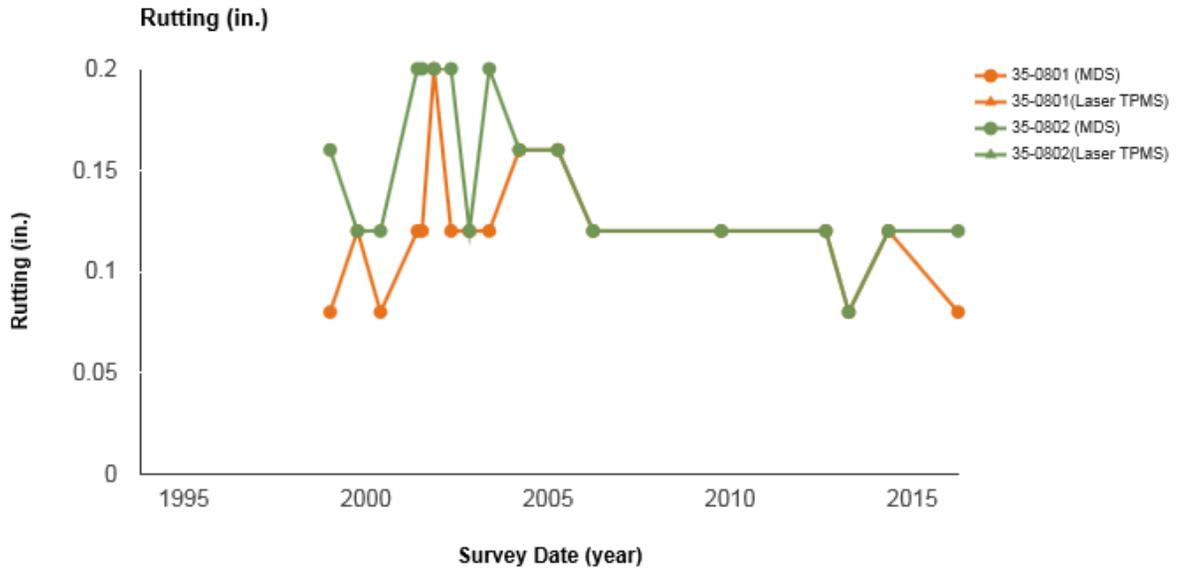
Figure 13. Rutting over time.

The last distress assessed for both sections was rutting and is shown in Figure 13. While there appears to be some variation in rut depths over time, these ruts are considered steady and not increasing over time because LTPP reports rut depths to a single millimeter precision. From this information rutting is not a critical factor for these test sections, which reinforces the very low/nonexistent traffic volumes applied to the test sections. For both sections, the mode of the rutting measurements was 0.12 inches, which can be due to raveling.

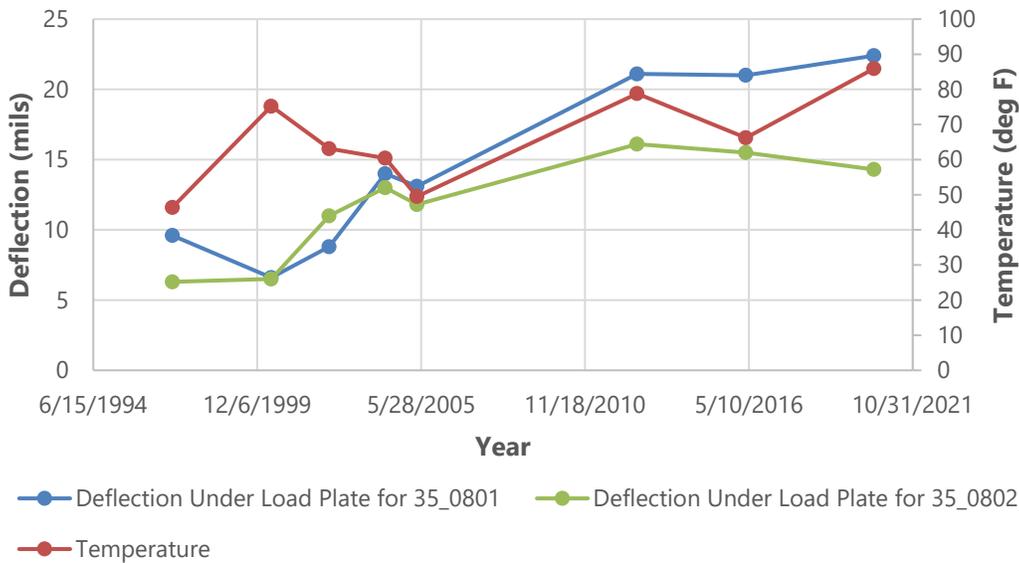
Figure 14. FWD deflections under the load plate and average daily temperature over time.

The additional FWD testing, conducted in July 2020, showed an increase in the deflection reported for test section 35_0801 and a decrease in the deflection reported for 35_0802 when compared to 2016 deflection data; however, the change in deflections between 2016 and 2020 was small (+1.4 mils for test section 35_0801 and -1.2 mils for test section 35_0802). As depicted in Figure 14, the average daily temperature reported on the day of FWD testing (using MERRA data) was also investigated to better describe the reported deflections on the test sections over time. The relationship between the average daily temperature and reported deflections is unclear between 2000 and 2004. Before 2000 and after 2004,

there is generally a positive relationship between the reported temperature and the reported deflections at the test sections: the higher the daily temperature, the higher the reported deflection. The relationship between temperature and deflection helps to explain the increase in deflection reported on both test sections over time. However, it is still expected that the aging of the pavements played some role in the increase in deflections. Aging, which would make the AC layer stiffer, can also lead to an increase in cracking, which reduces the effective modulus of the AC layer and leads to higher deflections. As evidenced later in this addendum, there is an increase in cracking (particularly transverse and fatigue/alligator cracking) reported on the sections throughout time which helps support this hypothesis.

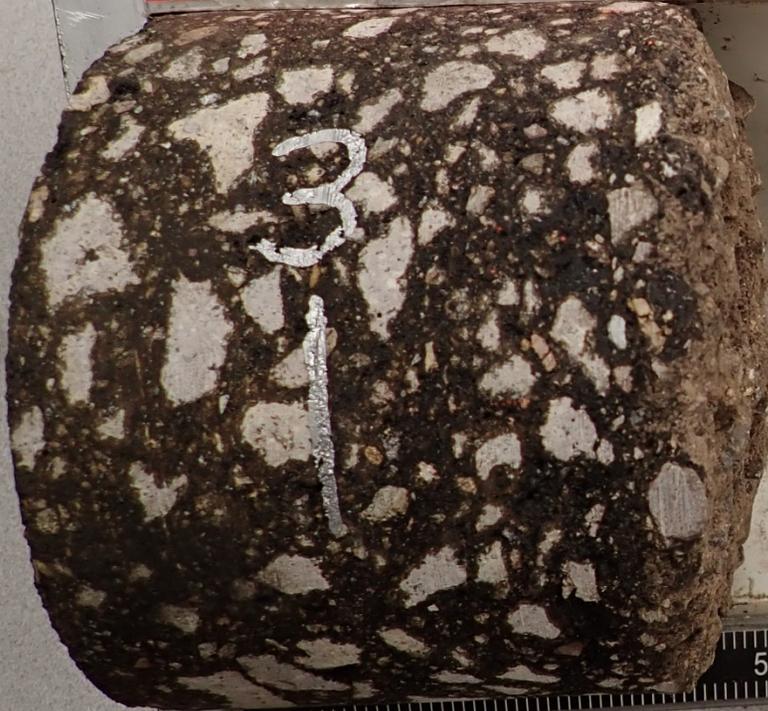
35 0801 C01 1 7/15/2020

The cores were also used to assess whether stripping was present in the AC layer. As depicted in Appendices A and B, there were no obvious signs of moisture damage or other kinds of material breakdown in the cores for either test section. This indicates that stripping likely was not the primary cause of the fatigue cracking observed on the test sections and that other potential causes of the fatigue/alligator cracking (such as age hardening/oxidation) should be considered.
