Technical Memorandum

Date: August 15, 2019 (original), June 30, 2020 (revised)

Re: Forensic Desktop Study Report: LTPP Test Section 48_1111

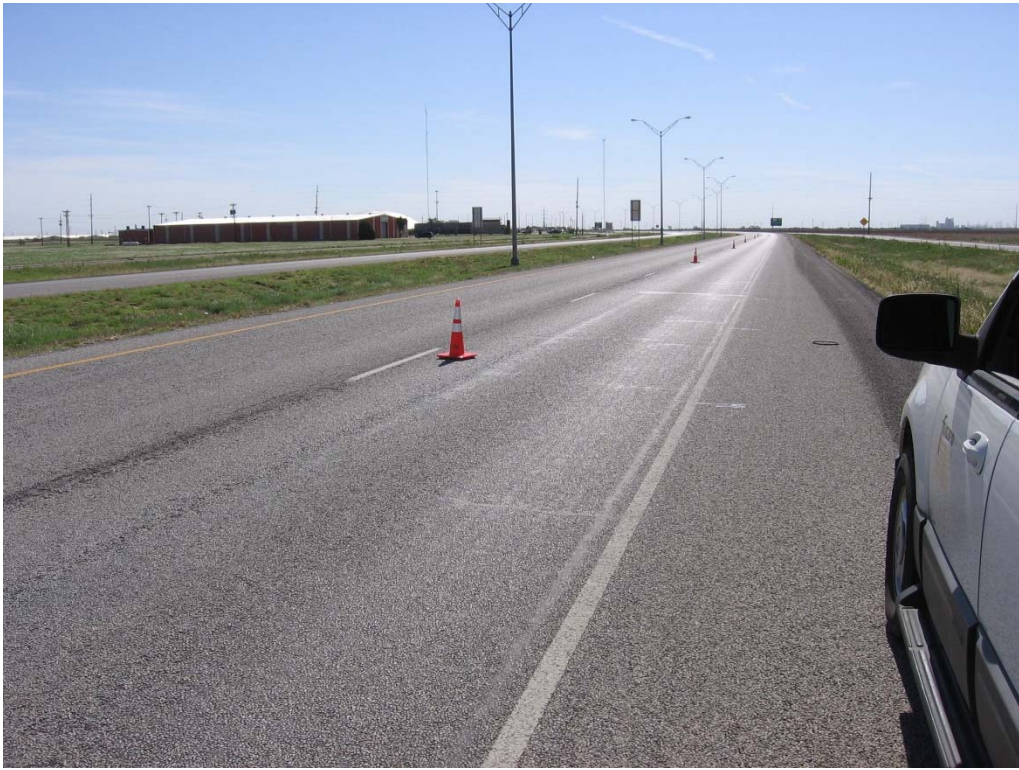
Photograph 1. Picture of test section 48_1111 in 2014 (from start of section looking west).

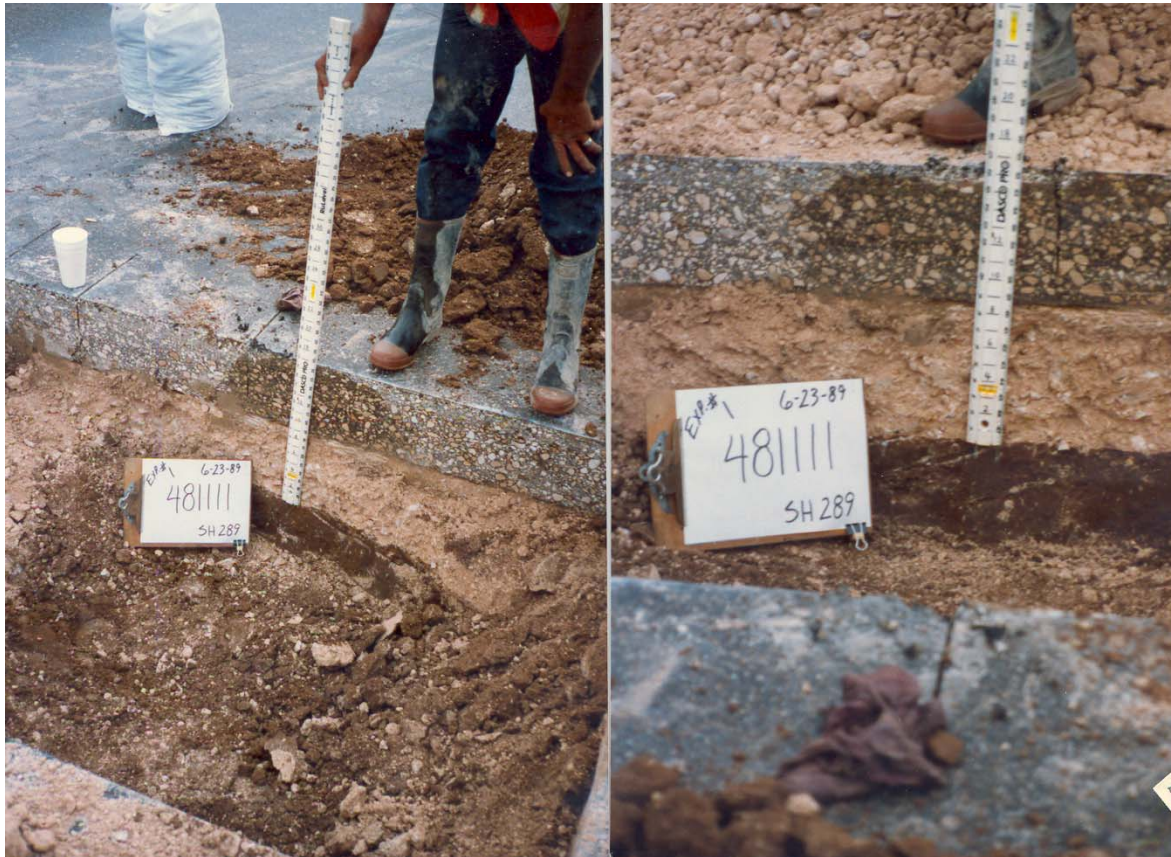
Further exploration of the available records on the Infopave™ website led to the discovery of a test pit being dug in Section 48_1111 on June 23, 1989. The test pit clearly shows approximately 9 inches of aggregate base which is placed on top of a dark, fine-grained soil. This photo is shown in Figure 13. This shows that there is most likely no subgrade stabilization beneath the aggregate base.

Figure 13. Test pit dug in section 48_1111.

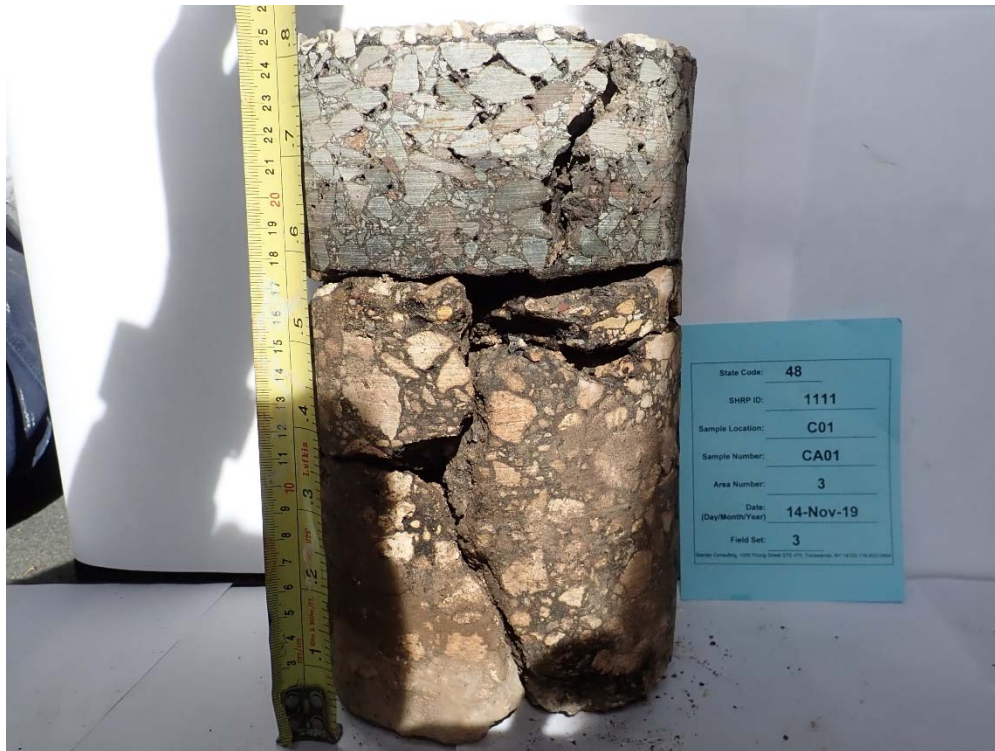
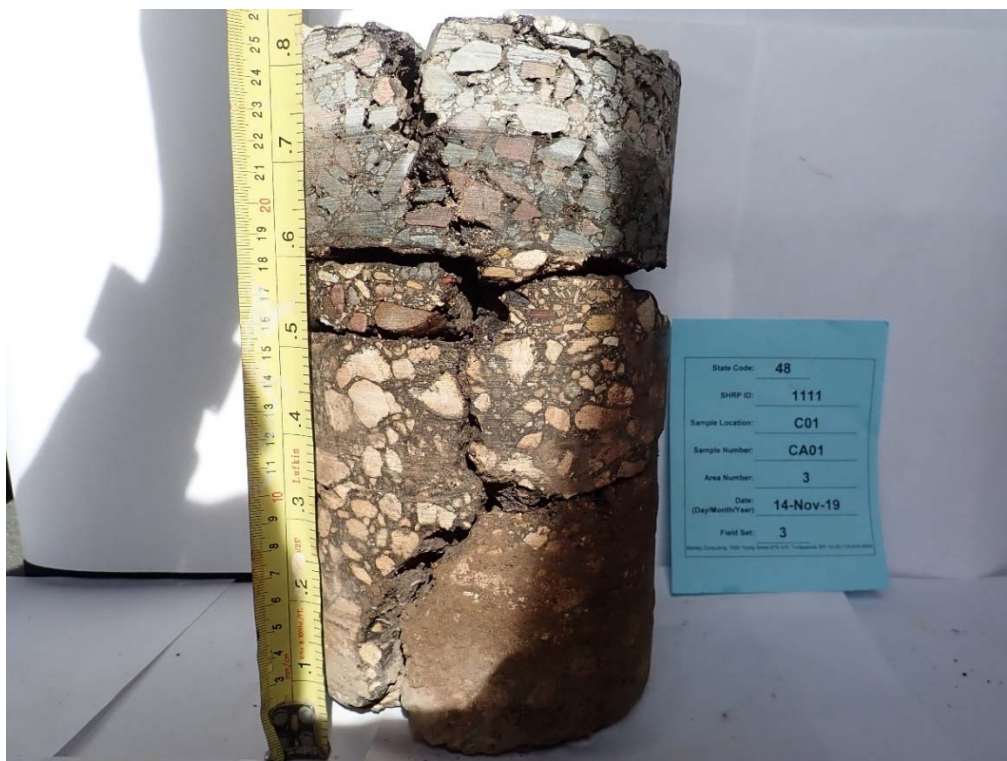
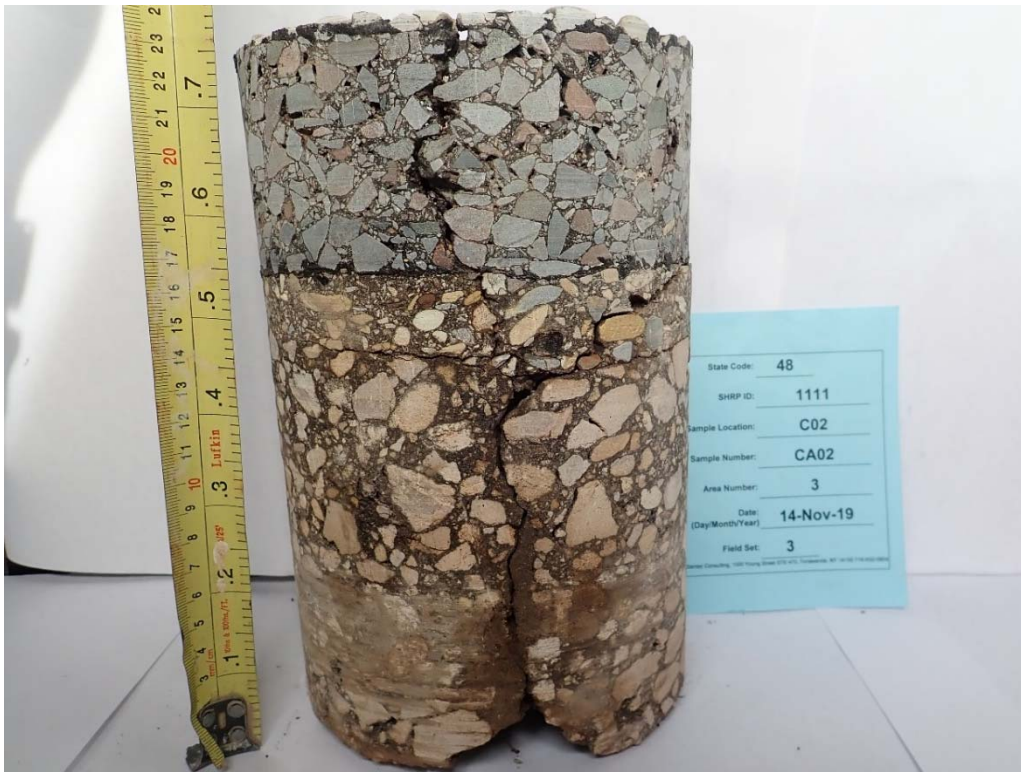
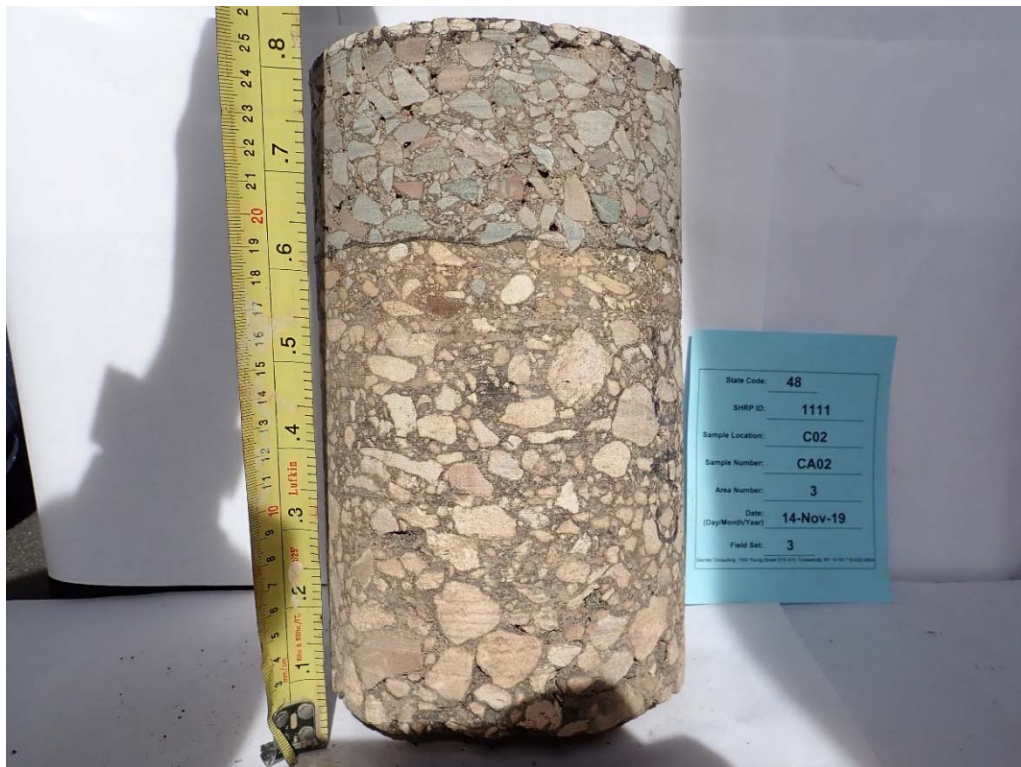
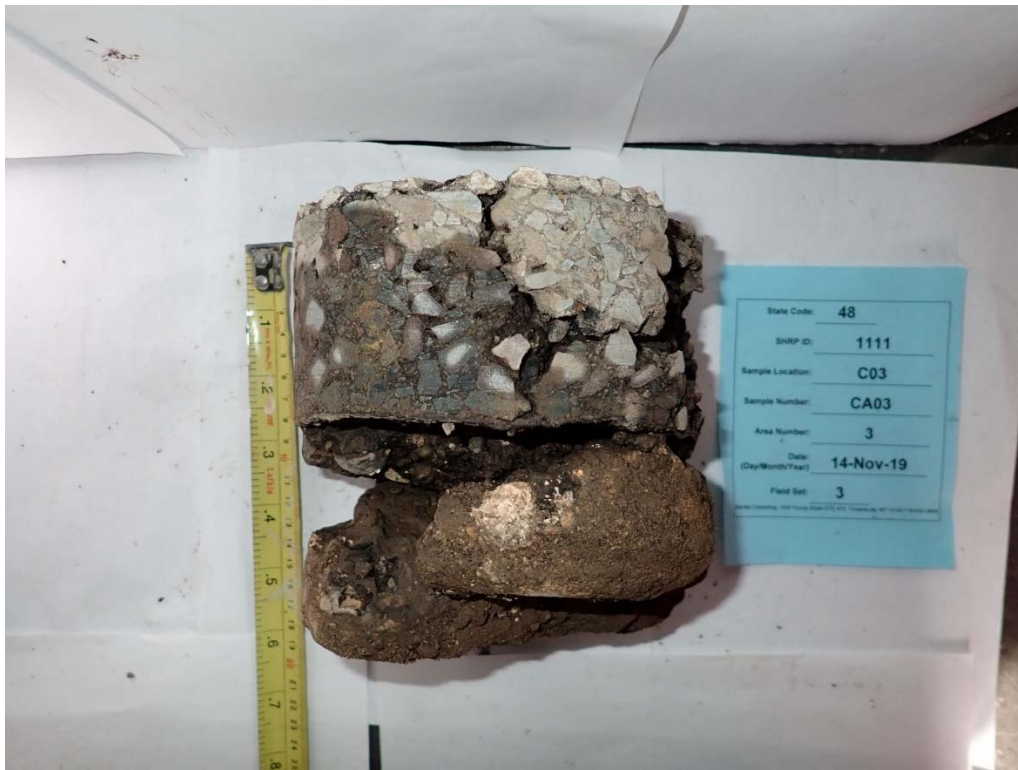
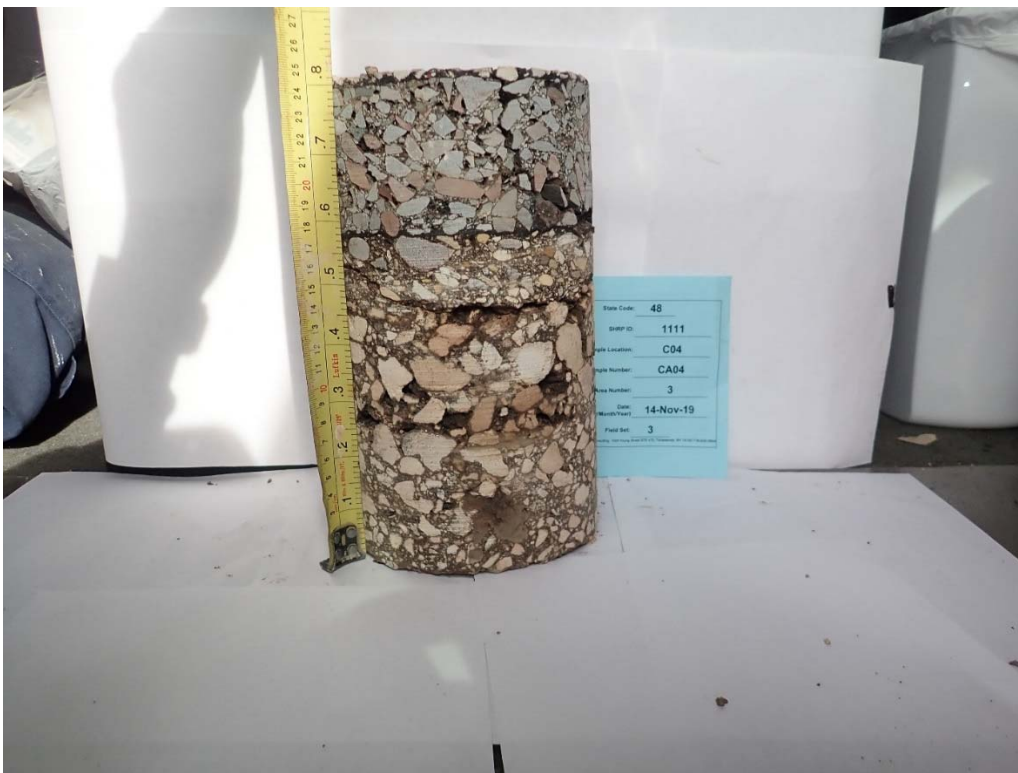
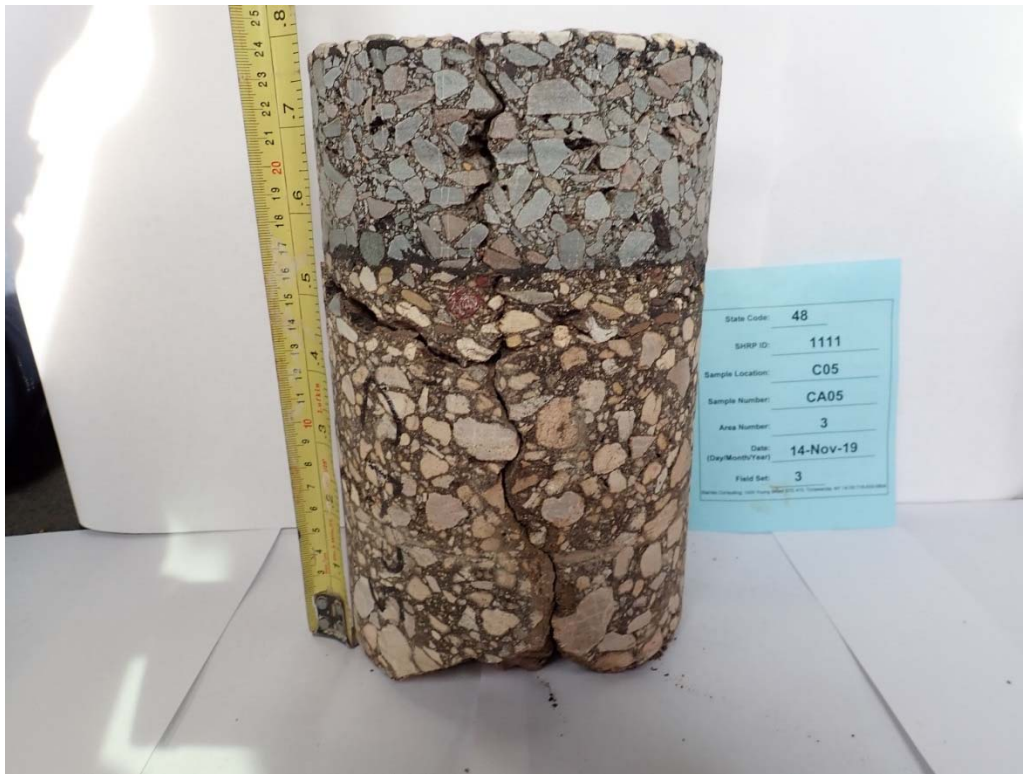
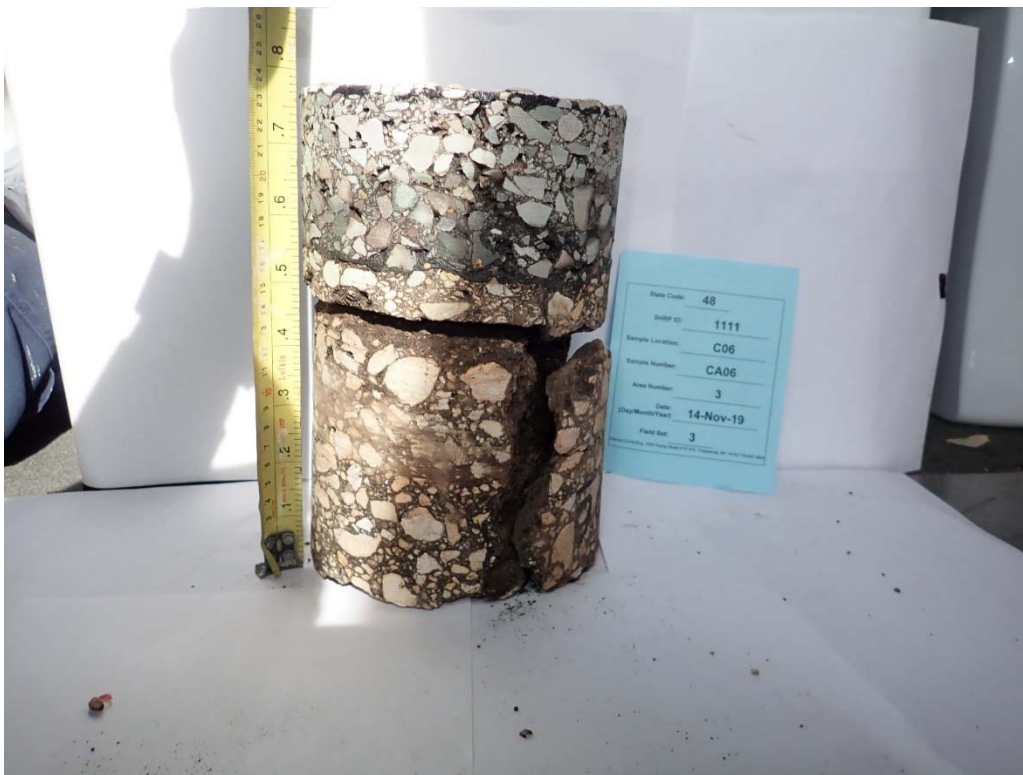
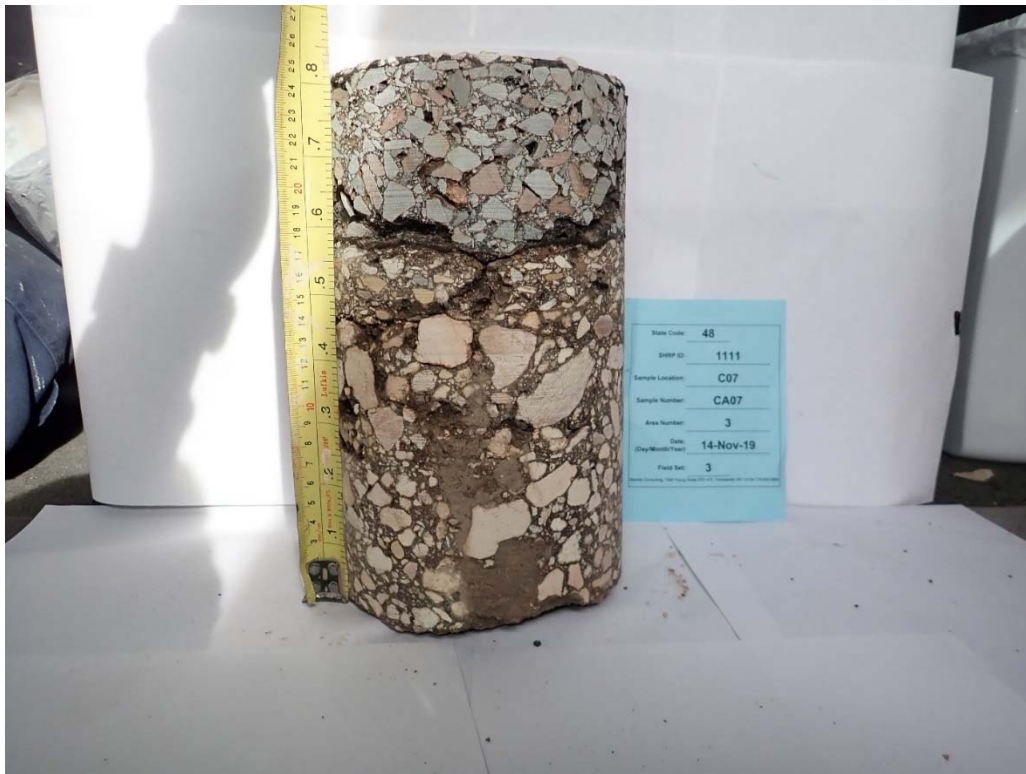
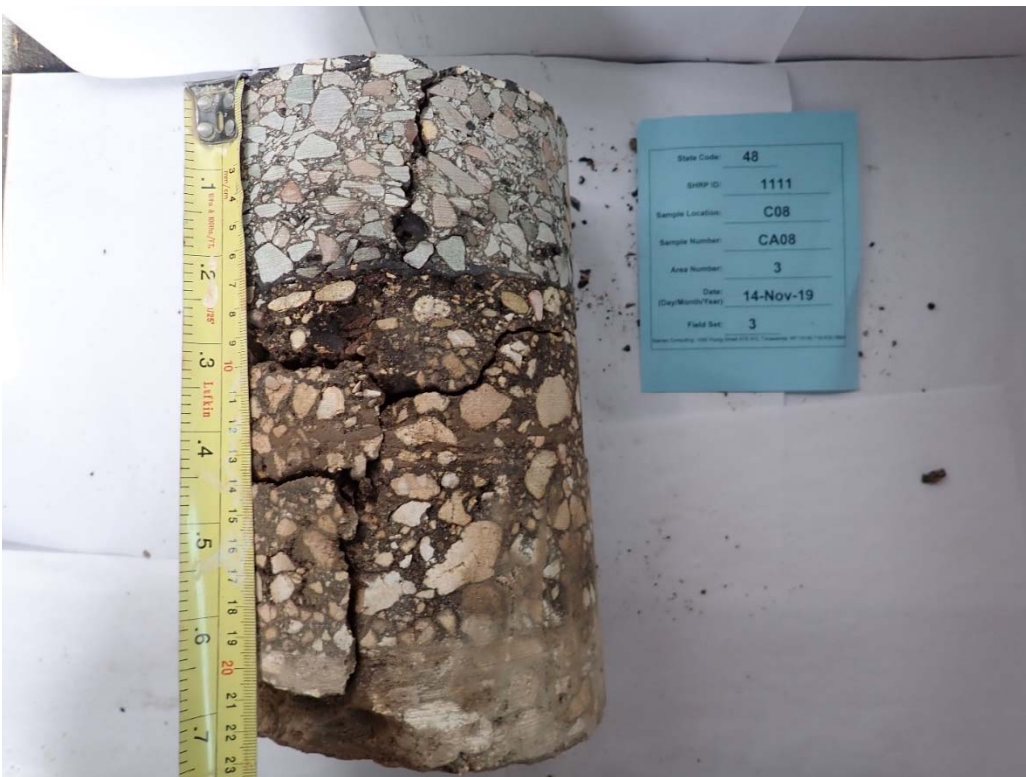
ATTACHMENT B. CORE PHOTOGRAPHS

Several of the cores were obtained on top of cracks to determine the depth of cracking and whether to crack was a top-down or bottom-up crack. The condition of the underlying AC (layers L4 and L3) was mostly in poor condition with several cores showing extensive cracking in these layers. Core CA06 was taken at a location where cracking existed before the overlay, and no surface cracking was observed. The observed cores are summarized in Table 8. Seven of the eight cores recovered from the section showed the surface cracks had reflected into the overlay and through the geosynthetic fabric placed underneath the overlay. In cores where the integrity of Layer 4 is best, reflective cracking is minimized. The geosynthetic fabric could have played a role in slowing down crack propagation into the AC overlay as well. Core photographs are shown in Attachment B.

Core Number	Station (ft)	Visual Condition and Cracking Notes	Crack Reflected through Fabric?
CA01	11.8	ENTIRE CORE SPLIT IN HALF. TOP LAYER BROKE OFF. Split Through.	Yes
CA02	42.3	ONLY CAPTURED PART OF THE KNOWN CRACK WITHIN THE LOWER LAYERS (REF 1999 MDS). Reflected through Top.	Yes
CA03	96.8	CORE BROKE OFF. SHORT. Split Through.	Yes
CA04	197.5	CRACK AT AN ANGLE. Reflected through Top.	Most Likely Yes
CA05	240.8	CRACK ALL THE WAY THROUGH. Split through.	Yes
CA06	277.6	BARELY CAUGHT CRACK UNDERNEITH. Bottom Up not Through.	No
CA07	332.0	CRACK ONLY SEEN ON TOP 2 LAYERS (5 & 6). Reflected through Top.	Yes
CA08	381.2	CRACK GOES THROUGH. Split Through.	Yes

- Visual observations showed that at least 6, possibly 7, of these 8 cores had cracks which had reflected from below the fabric into the AC overlay. Despite this, the amount of surface distress observed in 2019 does not indicate this is a widespread problem throughout the section.

- The degree of deterioration in Layer 4 appears to correlate strongly with reflective cracking.
- Traffic Data
 - The LTPP traffic data does not line up with TxDOT truck traffic counts. While the LTPP traffic data show estimated average daily truck traffic ranging from around 325 to 400 trucks per day since 2013, the TxDOT truck traffic counts stay consistently lower at around 300 trucks per day since 2013.
