Technical Memorandum

Re. Forensic Desktop Study Report: Utah LTPP Test Sections 49_7082, 49_7085, and 49_7086

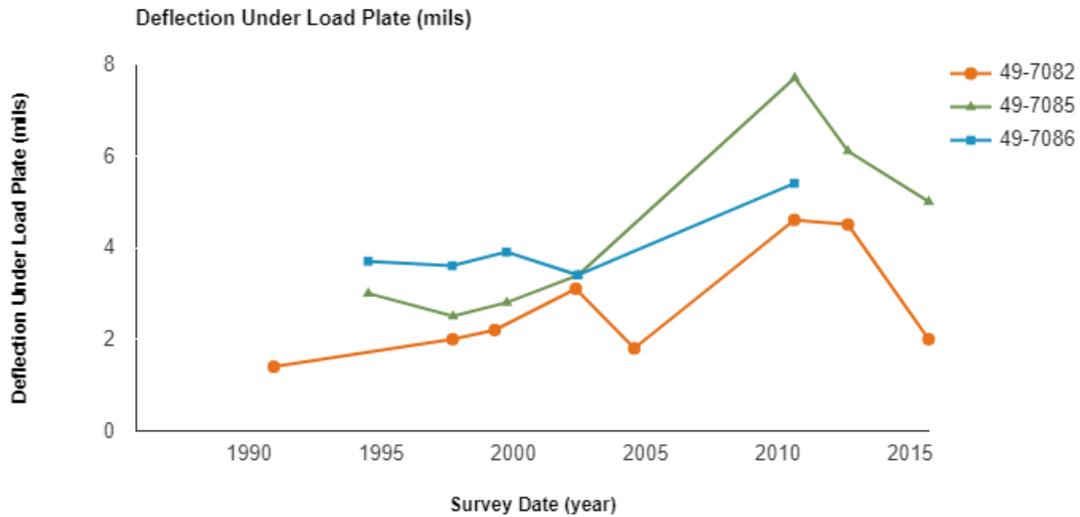
Figure 1. Time history of average deflection for the sensor located in the load plate normalized to 9,000 lb. drop load.

Figure 1 shows the average Falling Weight Deflectometer (FWD) deflection under the nominal 9,000-pound load plate over time for the three test sections. The deflection of the sensor located in the center of the load plate is a general indication of the total “strength” or response of all layers in the pavement structure to a vertically applied load. This deflection can be influenced by pavement temperature at the time of testing, precipitation, and moisture. As depicted in Figure 1, the deflections observed on the three sites are minimal. The deflections observed range from 1.4 to 7.7 mils. Overall, section 49-7082 showed the smallest deflections throughout the analysis period. Sections 49-7085 and 49-7086 reported similar deflections with 49-7085 reporting smaller deflections until 2002 and subsequently section 49-7086 reporting smaller deflections following 2002.

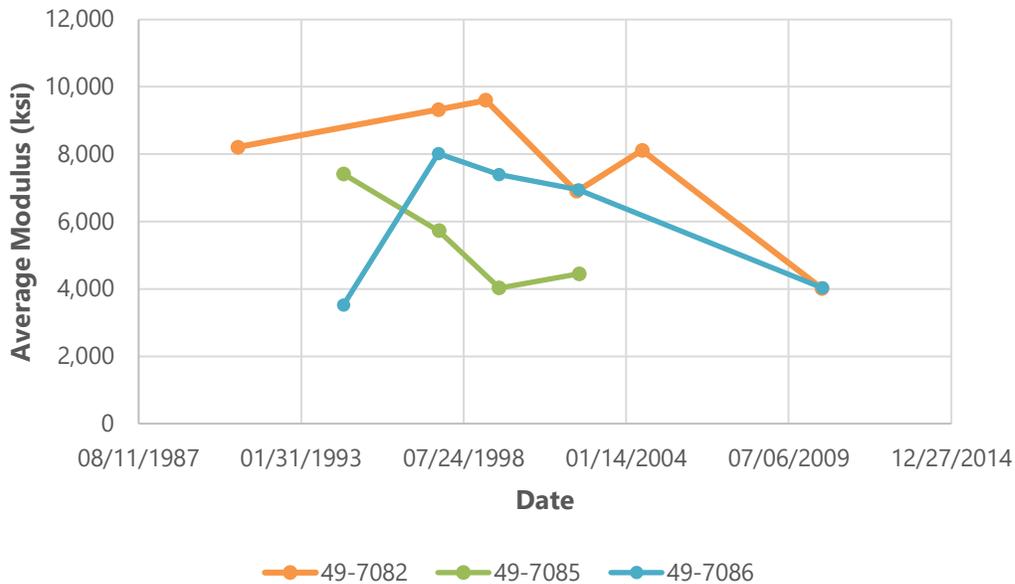
Figure 2. Average backcalculated modulus for portland cement concrete (Layer 1).

In general, the field-derived layer moduli appear reasonable for all four layers. Values for the PCC surface layer ranged between 3,500 and 8,000 ksi, which is a common range of PCC modulus values. The only exception was two points for test section 49_7082 with values in the 9,000 to 10,000 ksi range, which seem somewhat high and which may be the result of backcalculation analysis (e.g., compensating layer moduli, seed moduli values, etc.). Figure 2 also appears to indicate test sections 49_7082 has a slightly higher PCC modulus than test section 49_7086, which has a slightly higher PCC modulus than 49_7085.

The above conclusions about the reasonableness of the PCC backcalculated layer moduli is further confirmed by comparing the results to those derived from laboratory elastic modulus testing. Table 4 summarizes the laboratory test results for the PCC layer (lab results for the subgrade and base layers were limited). As shown, all laboratory test results fall within the range of 3,500 and 5,400 ksi, which is in line with the field-derived moduli (3,500 to 8,000 ksi).

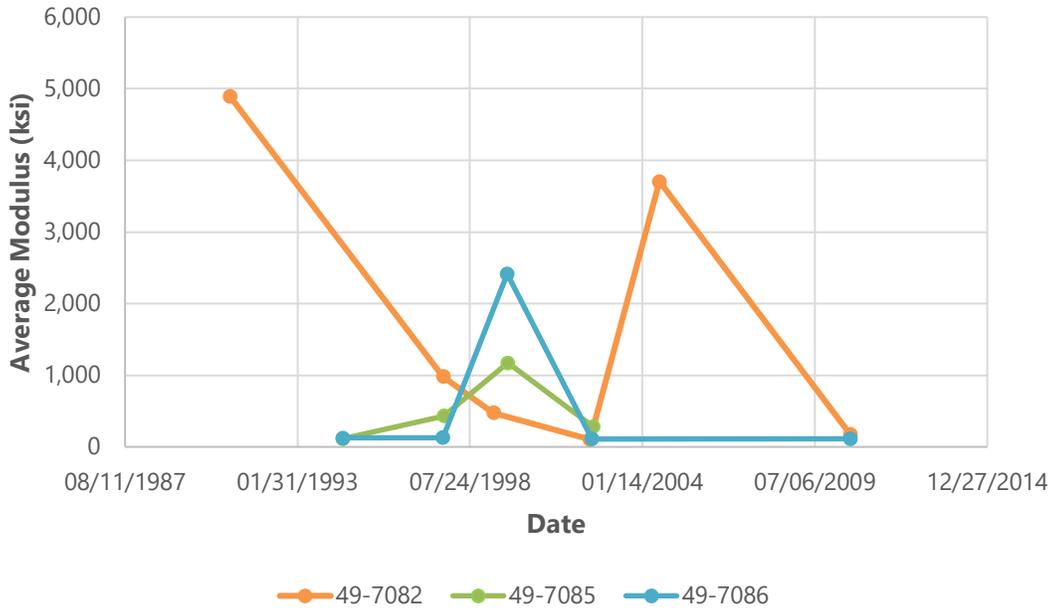
Figure 3. Average backcalculated modulus for lean concrete base (Layer 2).

The lean concrete base moduli ranged mostly between 100 and 1,100 ksi, which appears reasonable if the base layer has cracked, which would need to be confirmed. There are three points above 2,000 ksi, but as was the case with the PCC surface layer, it is suspected these higher values are related to the peculiarities of the backcalculation analysis. There is also no clear indication that the lean concrete base modulus is higher for one test section over the others.

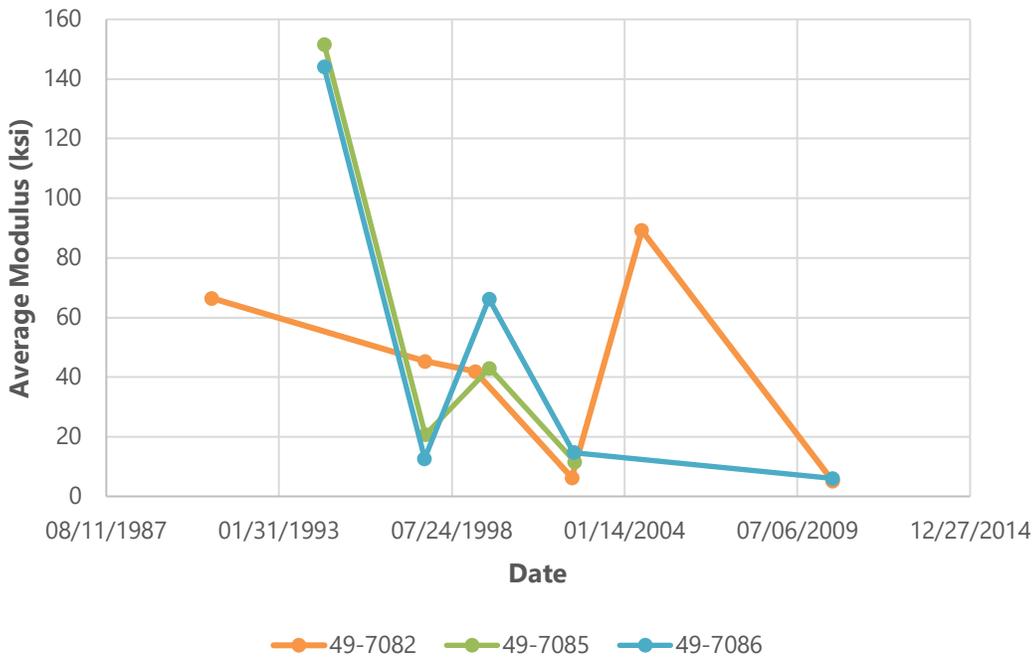
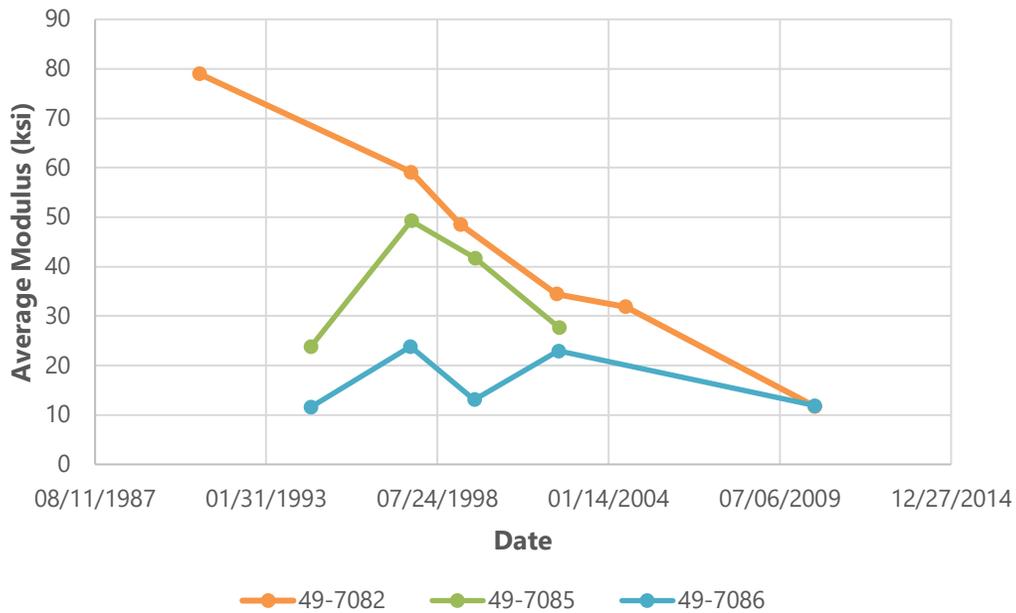
In terms of the granular subbase and subgrade backcalculated layer moduli, the values range mostly between 6 and 65 ksi, which is quite reasonable for unbound granular material. There are three granular subbase values that exceed 80 ksi and one subgrade value that exceeds 60 ksi, but these appear to be related software backcalculation issues or due to ambient effects such as freezing of moisture in one or both of the unbound layers.

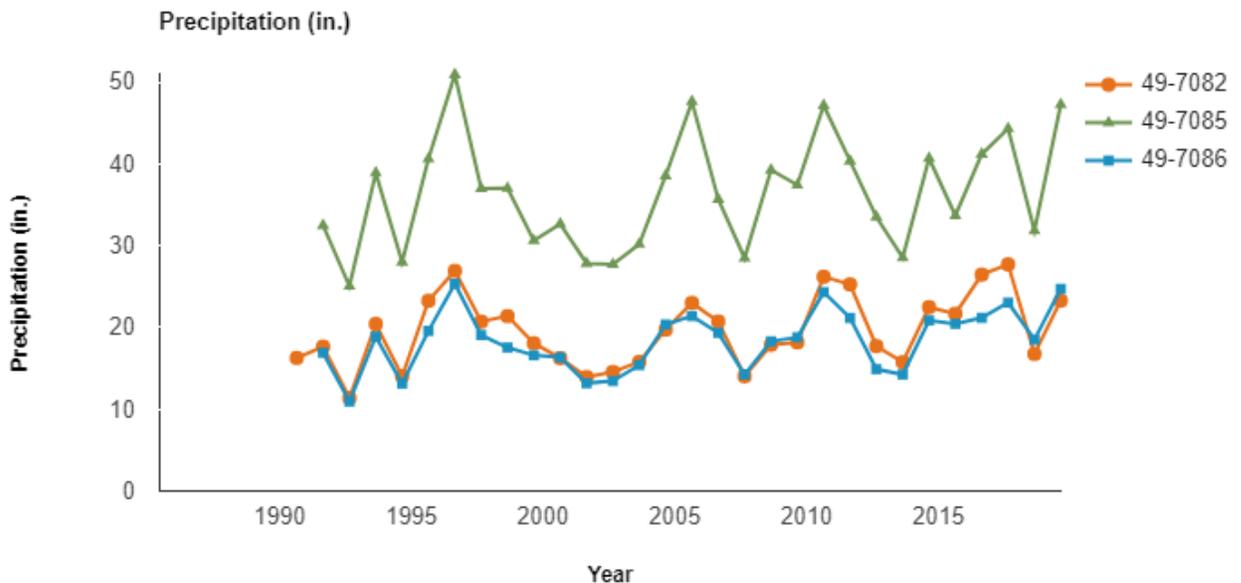
Figure 6. Average yearly precipitation over time.

The time history for average annual precipitation (from Modern-Era Retrospective analysis for Research and Applications or MERRA) since 1990 is shown in Figure 6. The mean precipitation recorded at sections 49_7082, 49_7085, and 49_7086 prior to 2019 was 19.6, 36.4, and 18.3 inches, respectively, for the period shown in Figure 6. For all three sites, the amount of precipitation reported spiked in 1996, 2010, 2017, and 2019. Section 49_7085 reported the highest amounts of precipitation overall, which is expected given its proximity to the mountainous Uinta-Wasatch-Cache National Forest. The precipitation observed on all three sites likely affected the performance of the test sections. This is especially the case of test section 49_7085, which has an average annual precipitation that is significantly higher than the other two test sections. Much or most of this precipitation is in the form of snow, and hence winter maintenance practices could play a factor in the performance of the test section. It is also worth noting the precipitation for test section 49_7085 falls outside the "Dry" definition (20 inches per year), so this will be brought to the attention of the LTPP program for correction.

As noted in the original memorandum and as depicted in Figure 6, while test section 49_7085 reports high levels of precipitation each year, the test section was classified as being a “Dry” region. Further information as to why the test section was classified as “Dry,” given the precipitation reported on the section, was pursued. In the current LTPP dataset, it appears climate classifications are based on the location of the section rather than the average annual precipitation or freezing index at the test site. However, starting with the 2021 LTPP data release, the climatic region for each LTPP test section will be assigned using the MERRA-2 dataset. In the updated web portal, the average annual freezing index and precipitation will be used to classify the climatic region of each test section. Through this update, the threshold between Wet and Dry regions will be an average annual precipitation of 508 millimeters (20 inches). Therefore, test section 49_7085 will be classified as being in a “Wet” region based on these conditions.

- b. Identify key properties of the base and subgrade layers via materials sampling and field and laboratory testing.
3. Clarification and exploration as to why section 49_7085 is labelled as a Dry climate site in the LTPP database even though the reported precipitation at this section indicates it is a Wet climate site.

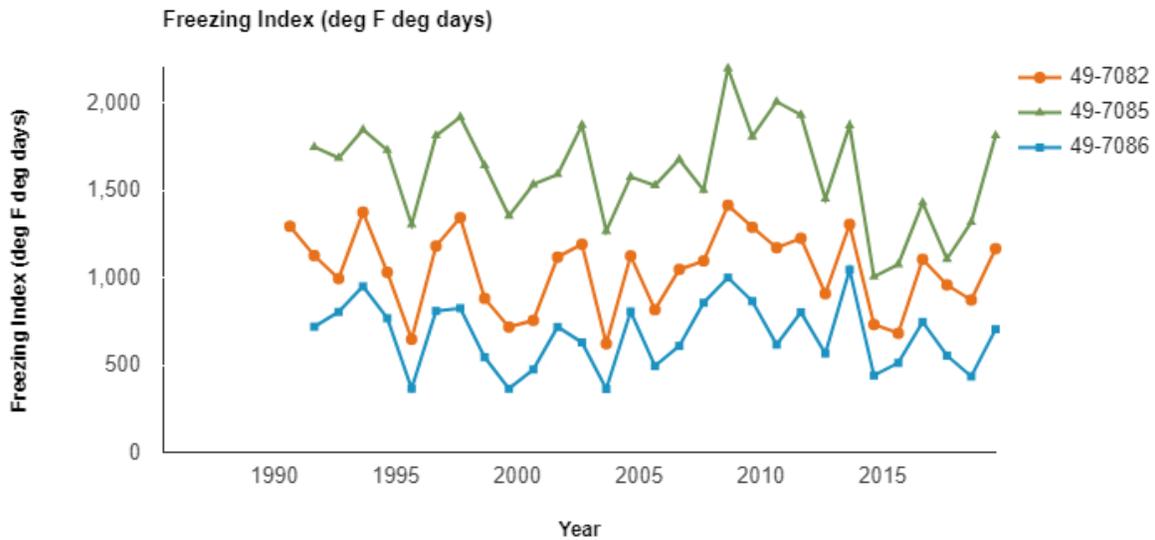
Figure 7. Average annual freezing index over time.

Figure 7 shows the time history of the average annual freezing index (from MERRA) for the test sites. The freezing index is the summation of the difference between freezing temperature and the average air temperature when it is less than freezing over a year's time. This index is an indicator of the harshness of

the winter season relative to issues such as ground frost and low temperature cracking in pavements. As depicted in Figure 7, the freezing index values ranged from 621 (2003) to 1,413 deg F deg days (2008) for section 49_7082, from 1,004 (2014) to 2,196 deg F deg days (2008) for section 49_7085, and from 362 (2003) to 1,044 deg F deg days (2013) for section 49_7086—all of which are well above the 150 deg F deg days used to classify a freeze region. This indicates the freezing index is likely a factor affecting the performance of all the test sections. Additionally, while all three sections follow similar trends on a year to year basis, section 49_7085 reports noticeably higher freezing indices, followed by section 49_7082 and then section 49_7086. When viewed in combination with the annual precipitation history presented earlier, it appears that climate plays a more significant role on the performance of test section 49_7085 as compared to the other two test sections.

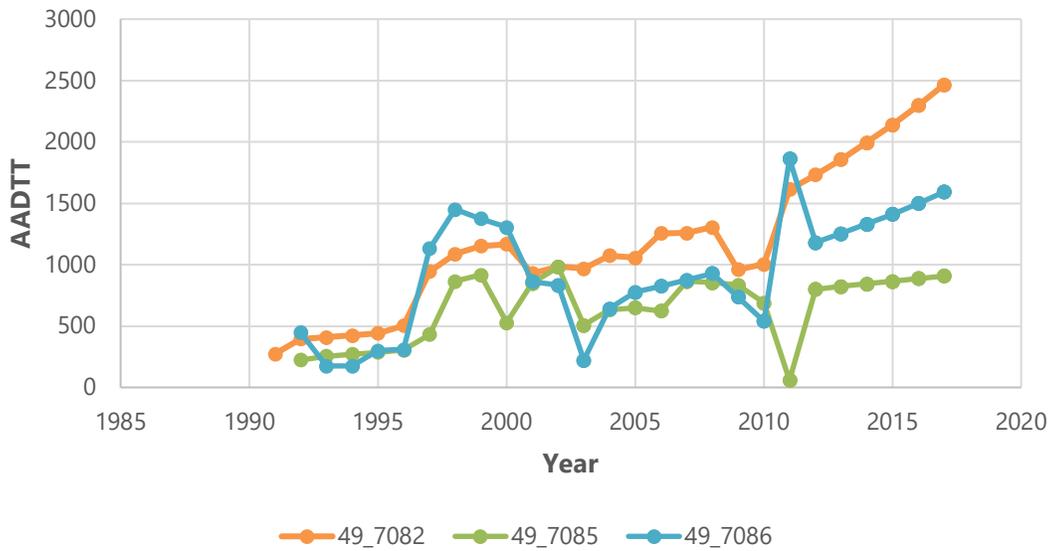
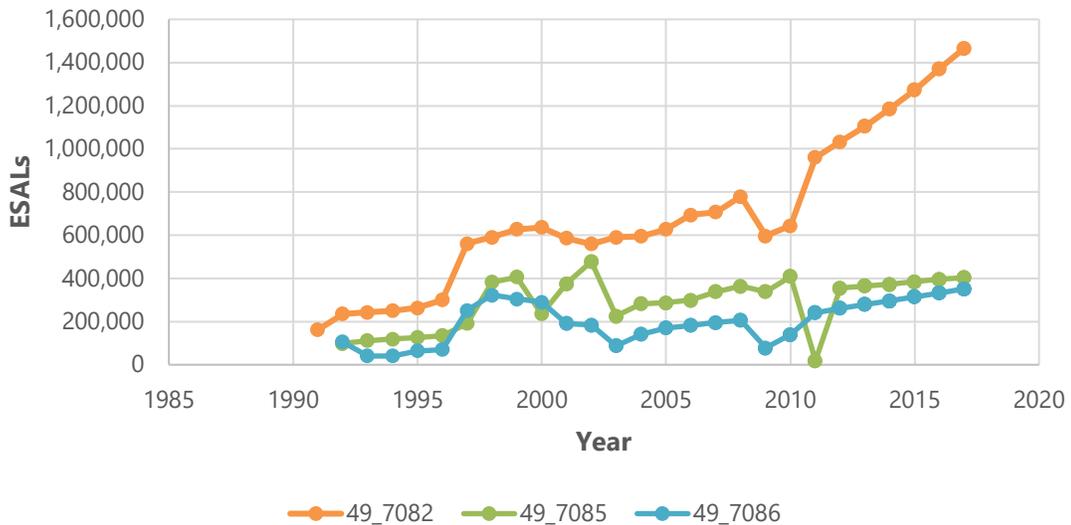
Figure 8 shows the annual average daily truck traffic (AADTT) data in the LTPP test lane by year. For section 49_7082, the annual truck traffic counts increase from 273 in 1991 to 2,465 in 2017, or approximately 84 additional trucks per day per year. For section 49_7085, the annual truck traffic counts increase from 223 in 1992 to 909 in 2017, or approximately 27 additional trucks per day per year. For section 49_7086, the annual truck traffic counts increase from 448 in 1992 to 1,592 in 2017, or approximately 46 additional

trucks per day per year. The average number of ESALS reported on these sections also increased over time as depicted in Figure 9. For section 49_7082, the number of ESALS increased from 162,241 in 1991 to 1,466,698 in 2017. For section 49_7085, the number of ESALS increased from 98,824 in 1992 to 403,070 in 2017. For section 49_7086, the number of ESALS increased from 105,000 in 1992 to 352,349 in 2017. The fluctuations in both the AADTT and ESALS reported for the test sections is likely a result of the source of the data for each. A combination of state provided AADTT values, monitored values, values calculated using monitored class data, a compound growth function, or a linear growth function was used to report traffic along these test sections.

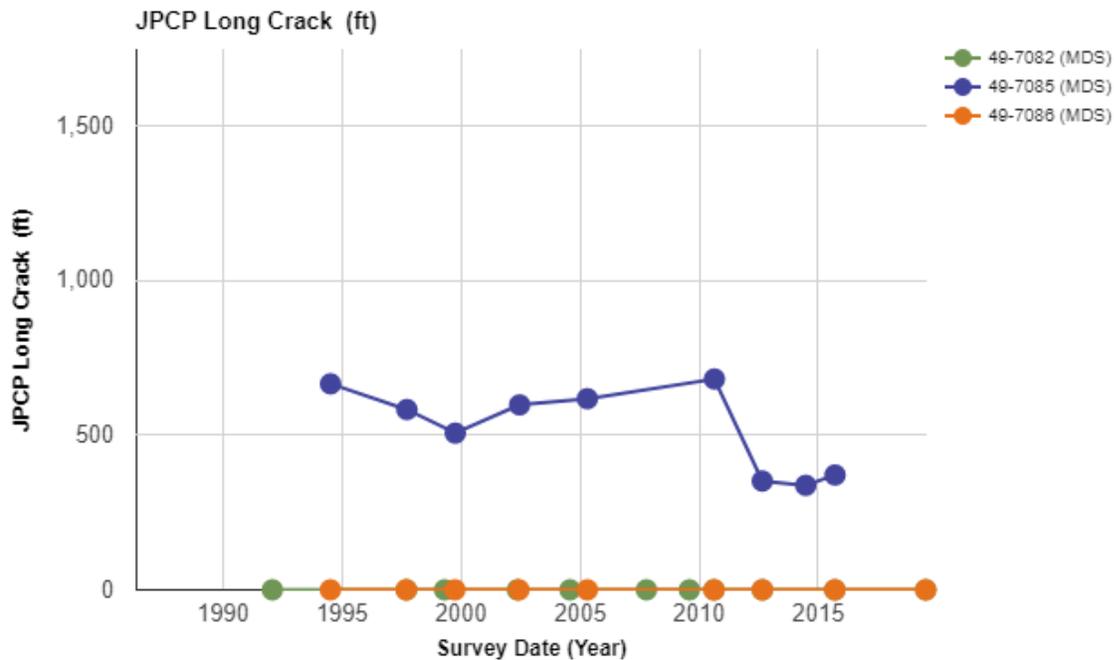
Figure 10. Time history of the length of NWP longitudinal cracks.

Data on longitudinal cracking was collected between 1992 and 2019 as shown in Figures 10. The only section where longitudinal cracking is reported is 49_7085 which first reports 666 feet of cracking in 1994, when the first manual distress survey was reported for the section. The longitudinal cracking on the section fluctuates throughout the pavement’s history, but ultimately decreases between 2010 and 2012. By 2015, 371 feet of longitudinal cracking is observed along the section. The decrease in cracking reported is likely a result of the construction event (CN=3) that took place on this section in 2012 during which some of the PCC slabs were replaced. It is also hypothesized that the initiation and propagation of cracking along this section is related to the significantly higher amounts of precipitation and freezing index reported when compared to the other two test sections.

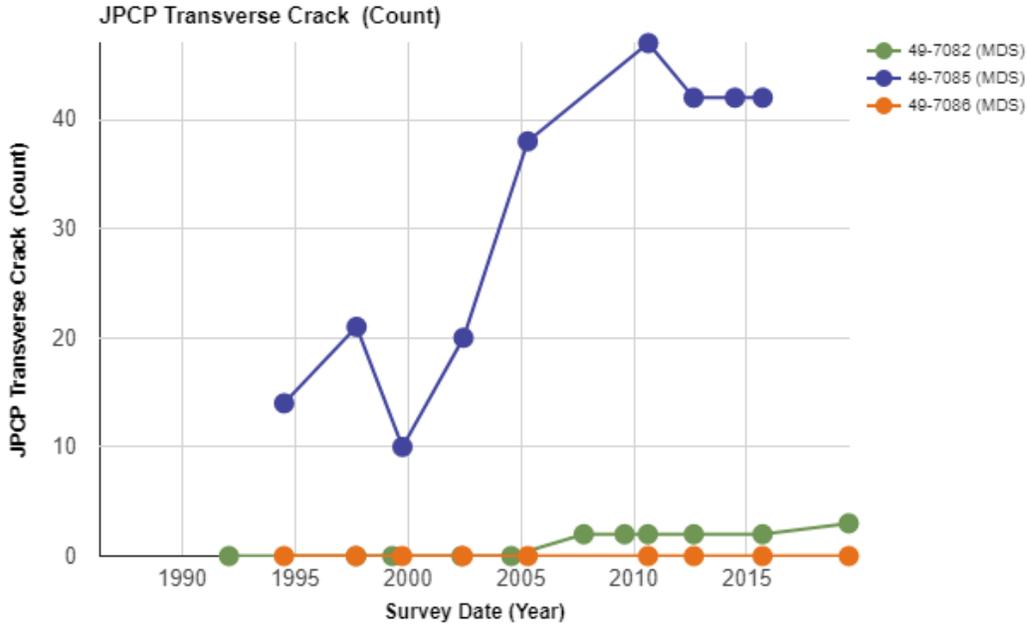
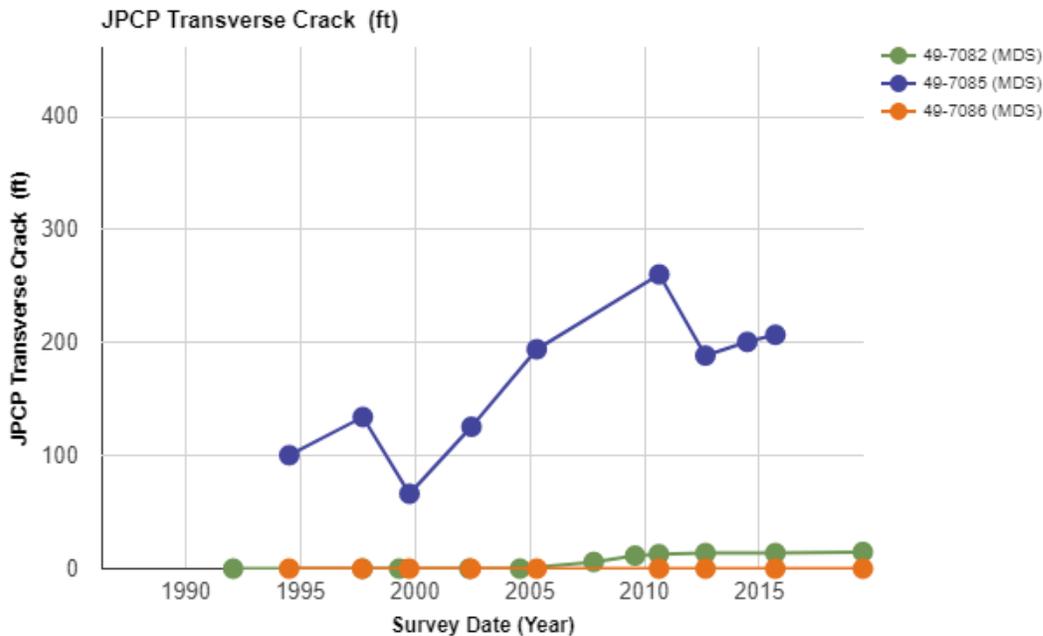
Data on transverse cracking was collected between 1992 and 2019 as shown in Figures 11 and 12. Similar to the reported longitudinal cracking, substantial amounts of transverse cracking were only reported on section 49_7085, likely due to significantly higher amounts of precipitation and higher freezing index reported on this section as compared to the other two test sections. Transverse cracking reported on section 49_7085 was first reported in 1994, when 100 feet (14 cracks) were observed. The amount of cracking reported increased until 1997 and then subsequently decreased in 1999. However, the amount of cracking observed increased again between 1999 and 2010. The transverse cracking reported increased from 66 feet (10 cracks) in 1999 to 260 feet of cracking (47 cracks) in 2010, propagating at a rate of 17.6 feet/year over this 11-year period. In 2012, following the replacement of some of the PCC slabs during CN=3, the transverse cracking observed on section 49_7085 decreased to 189 feet (42 cracks). During the

last distress survey taken at this section in 2015, 2017 feet (42 cracks) were observed. For section 49_7082, transverse cracking was not observed on the section until 2007, 17 years after CN=1, when 6 feet (2 cracks) were observed on the section. The amount of transverse cracking slightly increased and by 2019, 15 feet (3 cracks) were observed. Therefore, cracking propagated at a rate of less than 1 foot/year over the 12-year period. No transverse cracking was reported on section 49_7086. No transverse cracking was reported on section 49_7086.

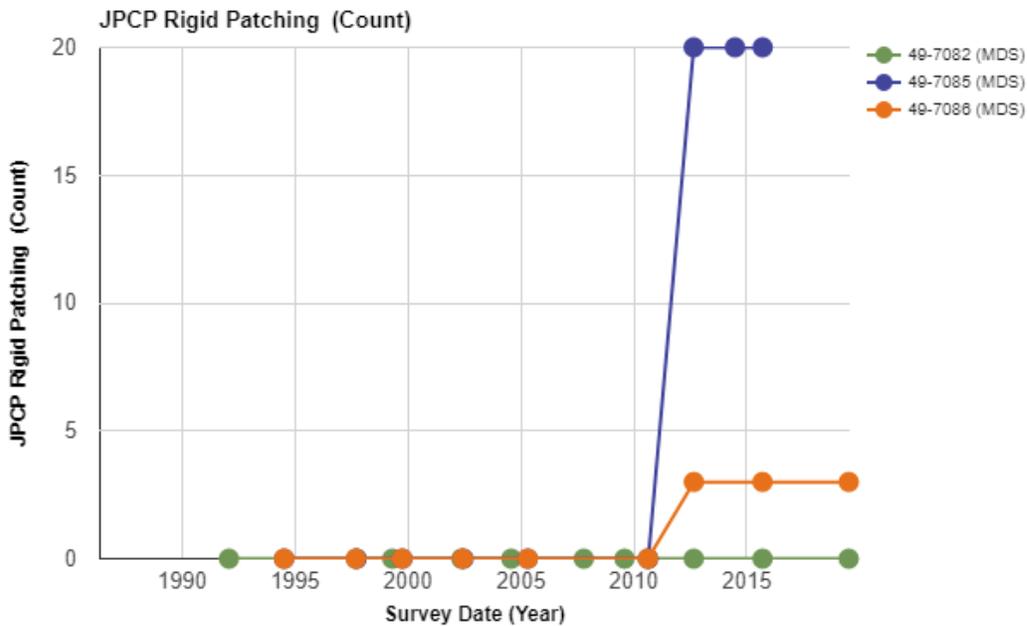
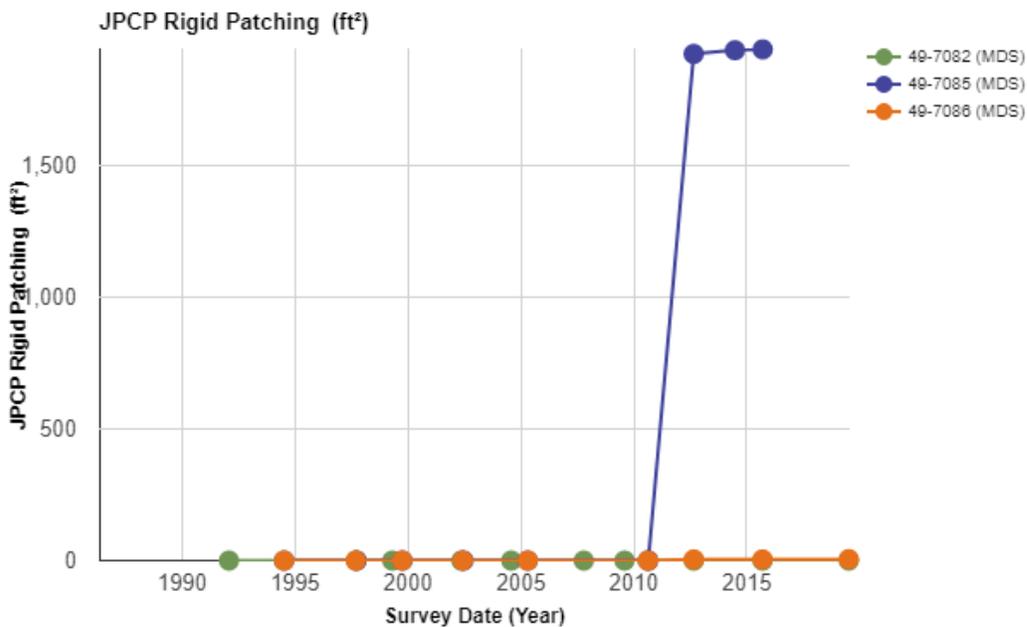
Data on rigid patching was collected between 1992 and 2019 as shown in Figures 13 and 14. The only section where substantial rigid patching was reported is 49_7085. Rigid patching was first observed on section 49_7085 in 2012 when 1927.10 ft² (20 patches) were recorded the section. The amount of patching slightly increased between 2012 and 2015, and by 2015, 1,944 ft² of rigid patching was observed. Minimal rigid patching was observed on section 49_7086 starting in 2012, when 4 ft² of patching (3 patches) was recorded. The amount of patching observed slightly increased between 2012 and 2015 when 5 ft² of patching was observed. No rigid patching was observed on section 49_7082.

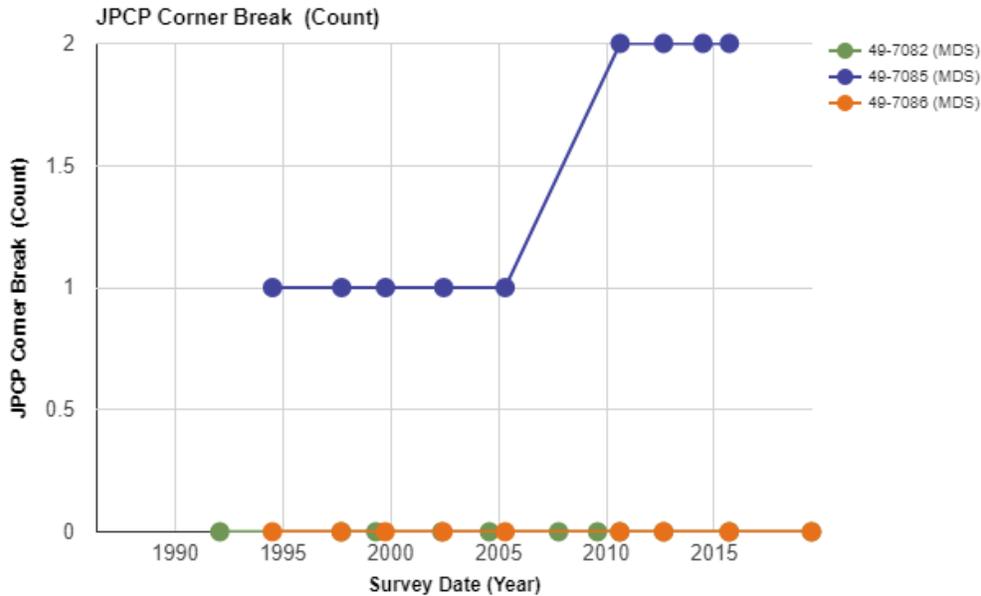
Figure 15. Time history of the number of corner breaks.

Data on corner breaks was collected between 1992 and 2019 as shown in Figure 15. The only section where substantial corner breaks were reported is 49_7085. A corner break was first observed on section 49_7085 in 1994 when one corner break was observed on the section. An additional corner break was observed in 2012, resulting in a total of two corner breaks on this section. No corner breaks were observed on sections 49_7082 or 49_7086.

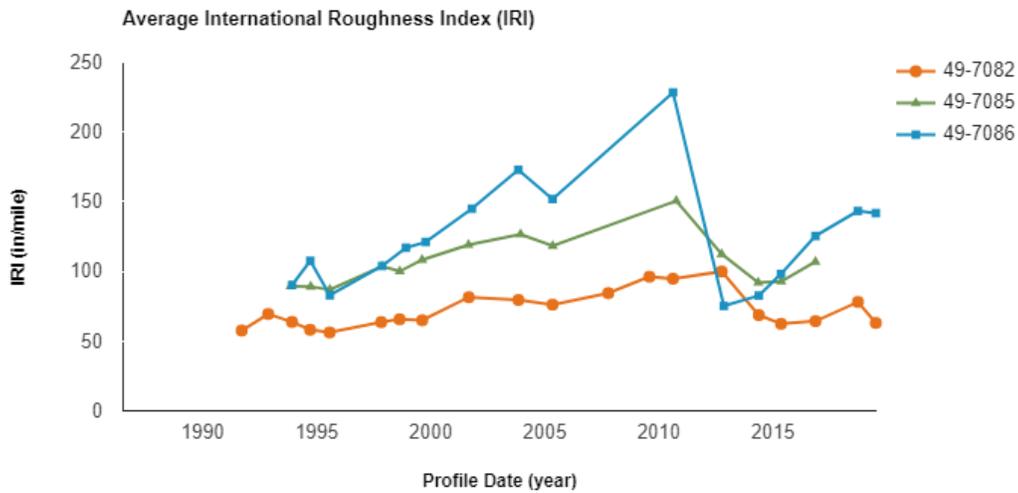
Figure 16. Time history plot of pavement roughness.

The average IRI measurements for the sections over time are shown in Figure 16. Section 49_7082 reported the lowest IRI of the three test sections between 1991 and 2019. The IRI on the section increased from 58 in/mi in 1991 to 100 in/mi in 2012, which means the performance of the pavement could be classified as “Good” to “Fair” based on FHWA performance definitions. In 2013, after the surface was diamond grinded, the IRI decreased and by 2014, the IRI on the section was 69 in/mi. The IRI on section 49_7082 remained relatively consistent between 2014 and 2019 when 63 in/mi of IRI was reported on the section.

Section 49_7085 had the next lowest amount of IRI reported throughout time. In 1993, IRI was reported to be 90 in/mi. IRI increased between 1993 and 2010 when IRI was reported as 151 in/mi. The pavement’s IRI performance during this time is classified as “Fair” based on FHWA performance definitions. Following the replacement of some of the concrete slabs and grinding of the surface in 2012, the section’s IRI decreased significantly to 112 in/mi. By 2016, the date of the last measurement for this section, the reported IRI had further decreased to 107 in/mi, but no construction or other event had been reported that would help explain this decrease. Section 49_7086 had the highest amount of IRI reported throughout time. In 1993, IRI was reported to be 90 in/mi. IRI increased between 1993 and 2010 when IRI was reported as 228 in/mi. The pavement’s IRI performance during this time is classified as “Fair” to “Poor” based on FHWA performance definitions. Following grinding of the surface in 2010, the section’s IRI decreased to 75 in/mi in 2012. By 2019, the date of the most recent measurement for this section, IRI was reported as 142 in/mi.

While the memorandum provides an accurate summary of the changes in IRI over time for each test section, the updated construction history of test section 49_7086 helps better explain the changes in IRI reported for that section. Under the previous assumptions that the test section was grinded during a fourth construction event (CN=4) in June 2013, it would have been expected that IRI following this event would decrease. However, as depicted in Figure 16, a significant decrease in the average IRI reported occurs after the third construction event in 2010, but not in 2013 after the “supposed” fourth construction event. As no construction event (and therefore, no surface grinding) took place in 2013, it is reasonable for the IRI reported on the test section continued to increase after CN=3.

4. Further pursue reason(s) for higher faulting and IRI at test section 49_7086, including review of climatic conditions at the time of construction as well as review of faulting and IRI surveys results relative to climatic conditions.

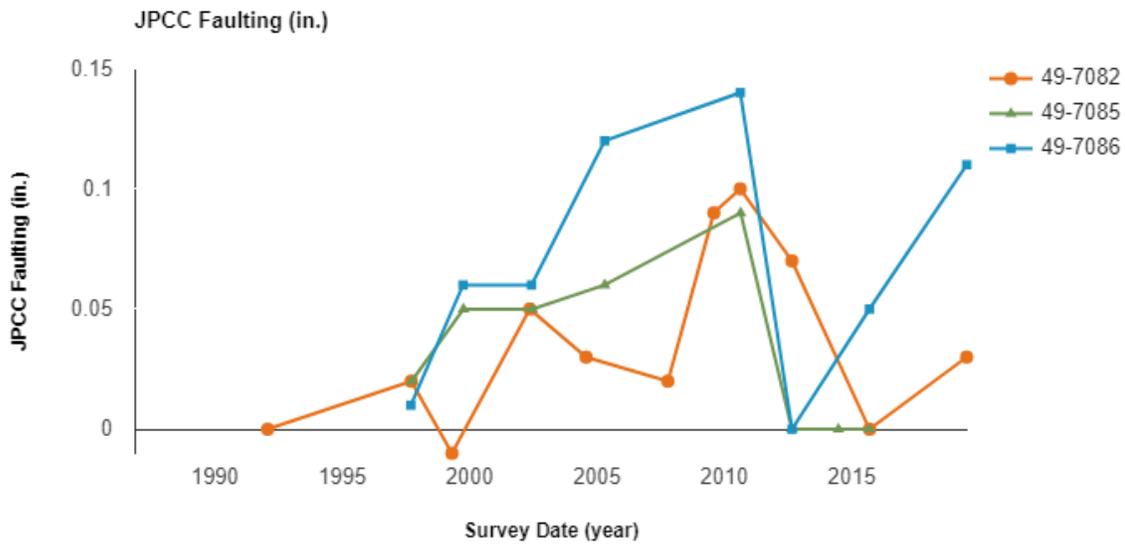
Figure 17. Time history plot of faulting.

The average faulting observed over time on the test sections is shown in Figure 17. Faulting on section 49_7082 fluctuated between the first time it was reported in 1992 and 2013. In 1990, faulting on the section was reported to be 0 in. By 2013, the reported faulting was 0.07 in. Following the preservation treatments in 2013 (diamond grinding and joint load transfer restoration) the faulting dropped to 0 in in 2015. By 2019, the faulting observed increases to 0.03 in. Faulting on test section 49_7085 increased between 1997, when faulting is first reported for this section, and 2010. In 1990, faulting on the section was reported to be 0.02 in. By 2010, the reported faulting was 0.09 in. Following CN=3, where the section received additional crack sealing and transverse joint sealing, the surface was diamond grinded, joint load transfer restored, and there was a replacement of some of the PCC slabs, the faulting observed on the site dropped to 0 in. The faulting on this section remained 0 in until the section went out of study. Faulting on section 49_7086 increased between the first time it was reported in 1997 and 2010. In 1997, faulting on the section was reported to be 0.01 in. By 2010, the reported faulting was 0.14 in. Following the preservation treatments in 2010 (surface grinding and partial depth patching) the faulting dropped to 0 in in 2012. However, the faulting observed increased immediately after and by 2019, the faulting reported was 0.11 in. Overall, section 49_7086 reported the highest average faulting and it is hypothesized this may be associated with the temperature regime.

As indicated earlier in the memorandum, test section 49_7086 had the largest amount of faulting and also the highest average annual air temperature at 48.4°F. Test section 49_7082 has the next highest amount of faulting and also the second highest average annual air temperature at 44.8°F, while test section 49_7085 had the lowest amount of faulting and also the lowest average annual air temperature at 39.5°F.

Like IRI, the findings on faulting reported in the original memorandum already provide an accurate summary of the history of faulting for the three test sections. The updated construction history of the test sections does, however, better explain the faulting observed over time. Specifically, for test section 49_7086, the continual increase in faulting between 2013 and 2019 is more aligned with the updated construction history of the test section. While previously, under the assumption that a fourth construction

event of joint sealing and grinding took place in June 2013, the increase in faulting in 2015 was counterintuitive; diamond grinding is a technique that helps mitigate faulting along joints. However, as no grinding occurred in 2013, the trend shown in Figure 17 seems more reasonable.

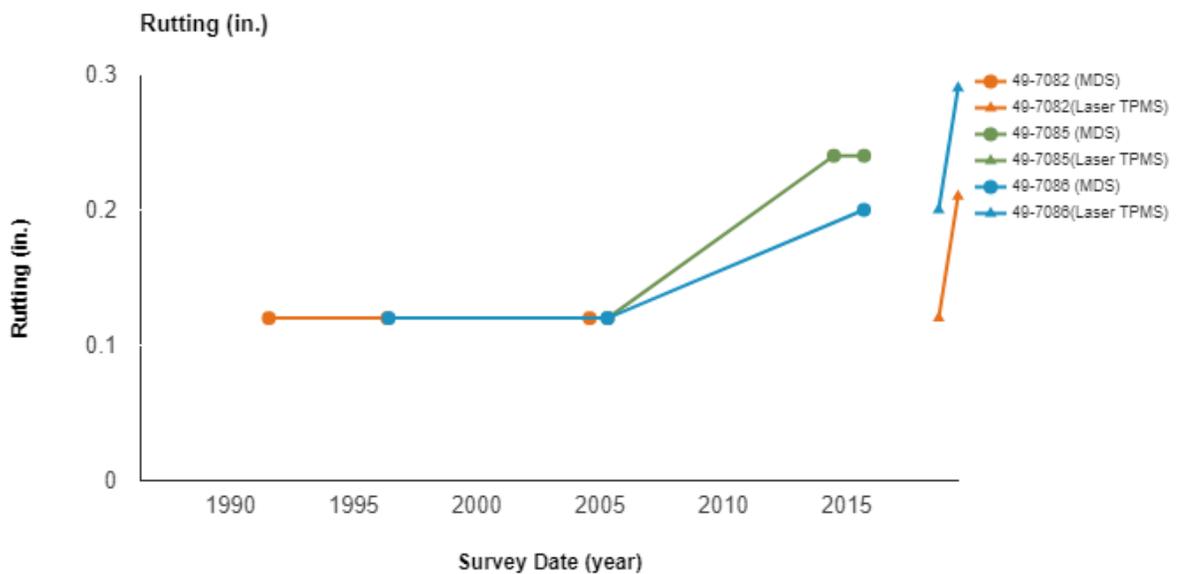
Figure 18. Time history plot of average wheelpath surface wear.

The wheelpath surface wear observed over time on the test sections is shown in Figure 18. Prior to 2005, all three sections reported wheelpath surface wear of 0.12 in. Following 2005, the wheelpath surface wear depths reported increased for 49_7085 and 49_7086. In 2015, section 49_7085 reported 0.24-inch rut depth and section 49_7086 reported 0.2 in rut depth. Wheelpath surface wear is likely related to winter traffic—chains and studded tires—and is therefore greater on section 49_7085, which reported higher amounts of precipitation and is more likely to have traffic using chains and studded tires.
