Pooled Fund Study TPF-5(332) LTPP Forensic Evaluations

WA-RD 905.1

June 2021

Final Report
Pooled Fund Study TPF-5(332)
LTPP Forensic Evaluations
WA-RD 905.1

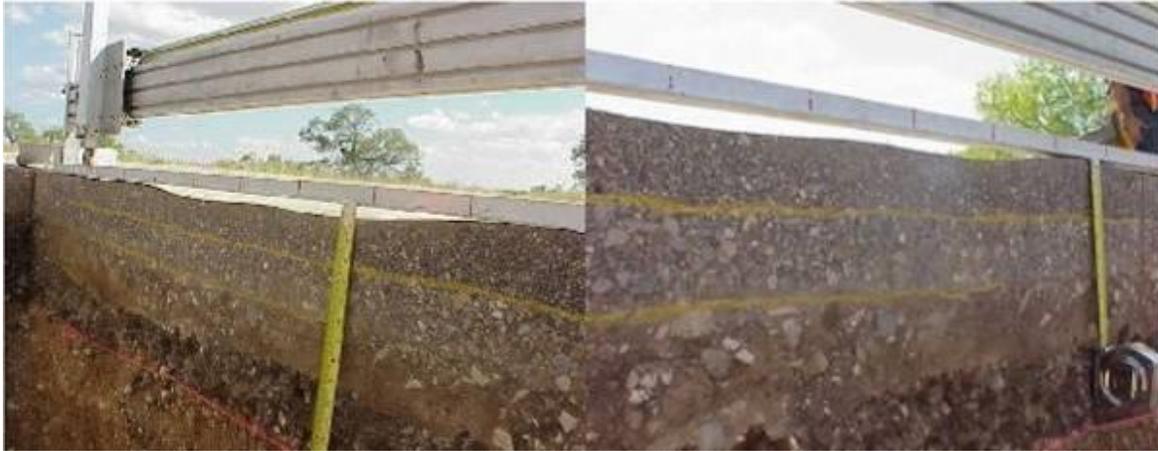
Figure 3. Photo. Texas SPS-1 trenches.

were performed in addition to typical LTPP monitoring. Based on the collected data, it was determined the rutting was due to AC mix problems, so the surface was milled and replaced.

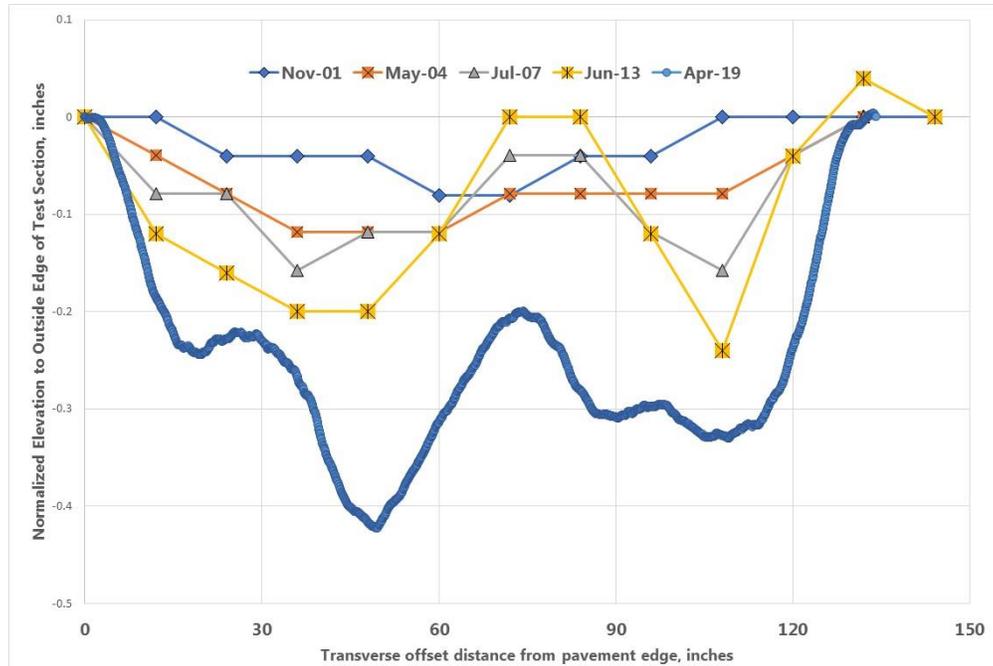
Figure 11. Chart. Historic normalized transverse profile plots at station 0+00.

While many questions surrounding the performance of the test section over time were answered by the desktop study, forensic field evaluations were recommended to be performed at the test site to better understand the observed rutting on the section as well as to confirm the structural capacity of the pavement. As such, follow-up field investigations were performed on April 1, 2019, during which five cores were taken across the width of the pavement at stations 200 and 400 in lieu of trenching, FWD testing was performed, a manual distress survey was performed, and transverse profiles and surface texture measurements were collected.

Overall, the desktop study and forensic field evaluations found that the pavement section, while located on a major interstate highway, performed well over its 45 years in service, with just two minor overlay construction events. The findings reinforced Washington State DOT's practice of performing "preservation" and "rehabilitation" construction treatments in advance of the time normal PMS threshold limits are reached. Deviations from this good performance (particularly due to rutting) appeared to be caused by ablative wear in the wheel paths. Sufficient information was available to adequately explain the observed performance of the pavement test section and therefore, no further activities were recommended.

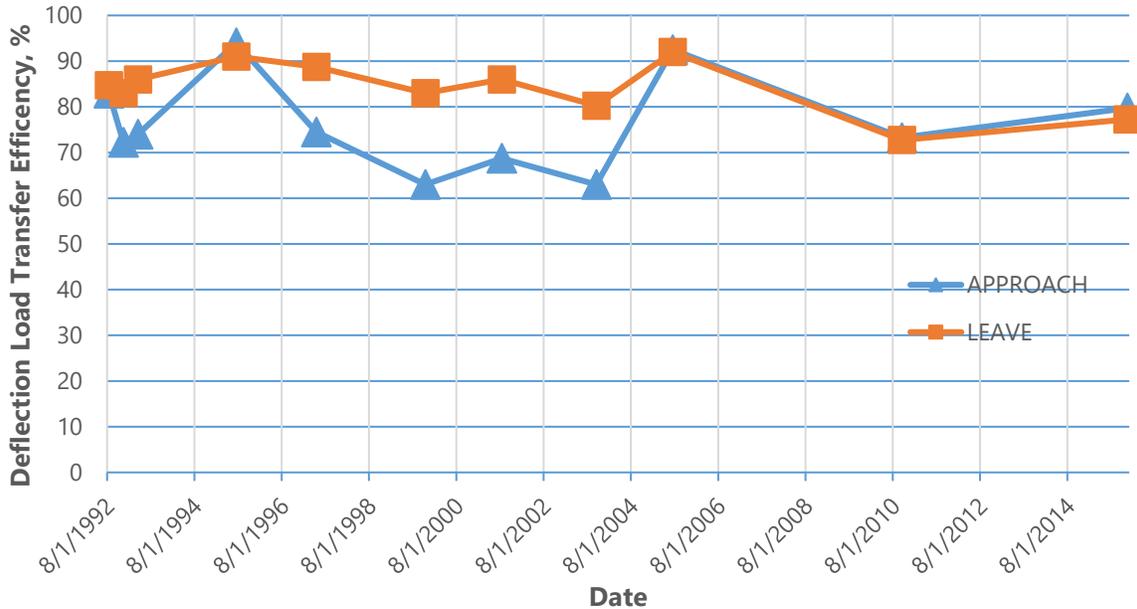
Figure 12. Chart. Time history of average deflection load transfer efficiency at joint 131.1 on section 20_0201 from drop height 4.

bars were positioned above the PCC pavement surface and below the depth of the PCC layer. The desktop study also found little relationship between the fault height and the number of longitudinal cracks at the transverse joint. The most effective rank ordering of observed longitudinal cracks at the transverse joints appeared to be the computed dowel bar diameter statistic. These findings suggest the current summary statistics derived from the MIT measurements do not satisfactorily explain the performance of doweled joints relative to surface distresses.

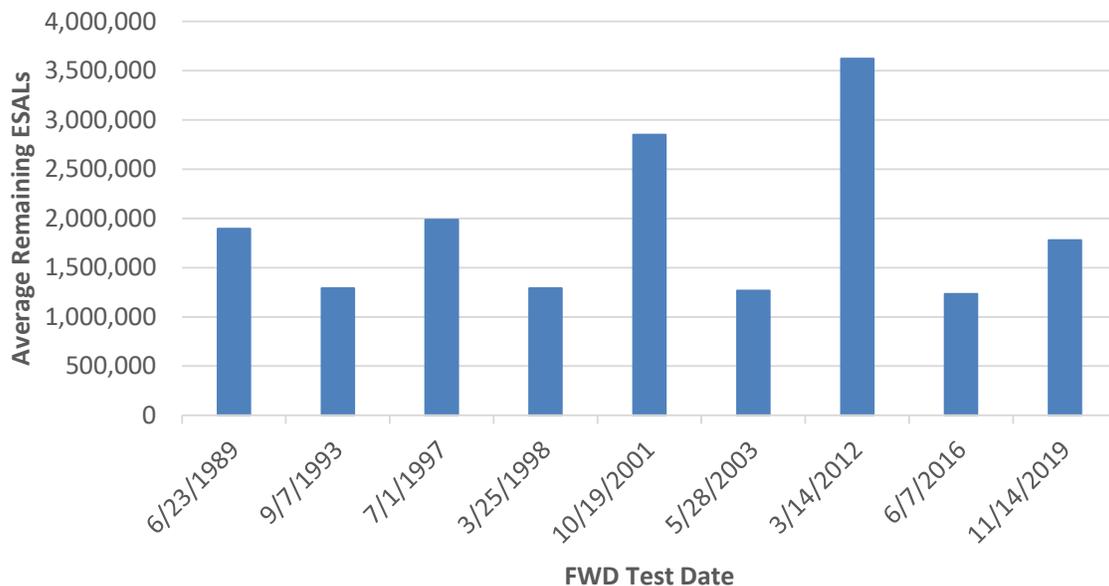
Figure 14. Chart. Average remaining ESALs values over life of test section 48_1111.

Additional data collected as a part of the follow-up investigation showed the test section continued to perform well in terms of longitudinal cracking, alligator cracking, and IRI despite the level of degradation found in the original AC layers through the cores. In addition to revealing AC degradation, the cores also showed the total thickness of the AC varied throughout the test section and that cracks below the surface of the geofabric appeared to have reflected to the overlay in six of the eight cores. The bonding between layers also varied from core to core. Through a comparison of the LTPP traffic data (estimated data) and the TxDOT truck traffic counts (measured data), it was found that while the LTPP traffic data showed an estimated average daily truck traffic ranging from around 325 to 400 trucks per day since 2013, the TxDOT truck traffic counts were consistently lower at around 300 trucks per day since 2013. Finally, the IRI of the test section in 2019 indicated the test section was still very smooth, and the IRI had only increased by 13 in/mi over the nearly 20 years since the overlay was placed.

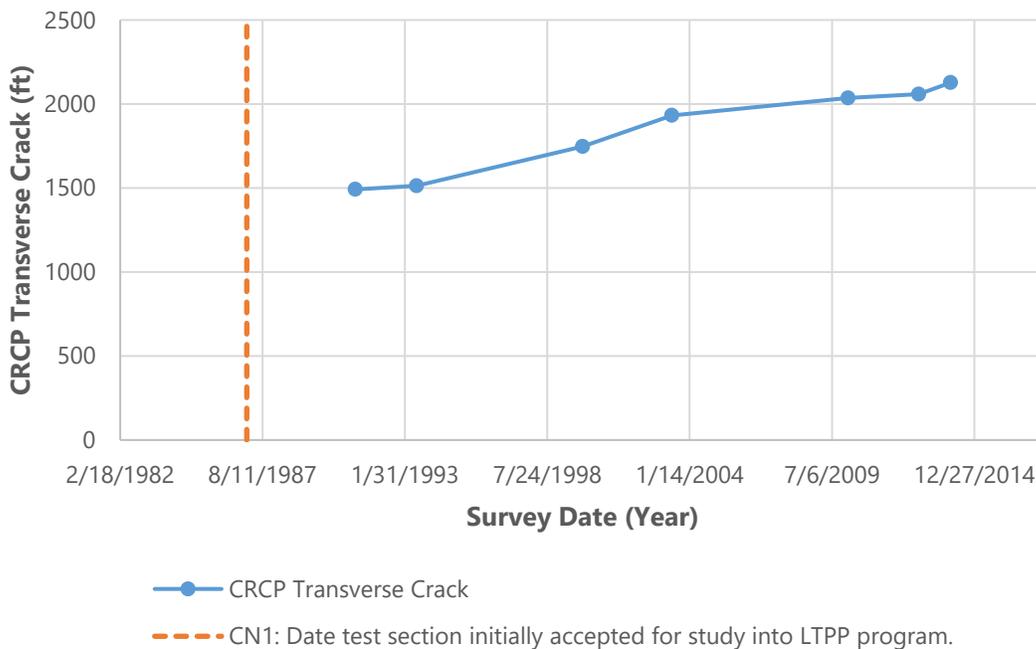
Figure 15. Chart. Time history of transverse cracking length on test section 28_5025.

Other distresses observed on the section included significant pumping. However, the time history of pavement pumping was inconsistent. Pumping peaked in 1999 and by 2014 it was nearly nonexistent. Pavement pumping on CRCP pavements is thought to be due to the eroding of the base structure under the outside edge of the pavement. This eroding leads to punchouts at the lane edge that requires maintenance events to repair. However, this test section had not reported punchouts or patches. In the pictures taken during the manual distress surveys, what was rated as pumping appeared to be water seeping to the pavement surface at the outside pavement edge and not the eroding of the unbound base layers.

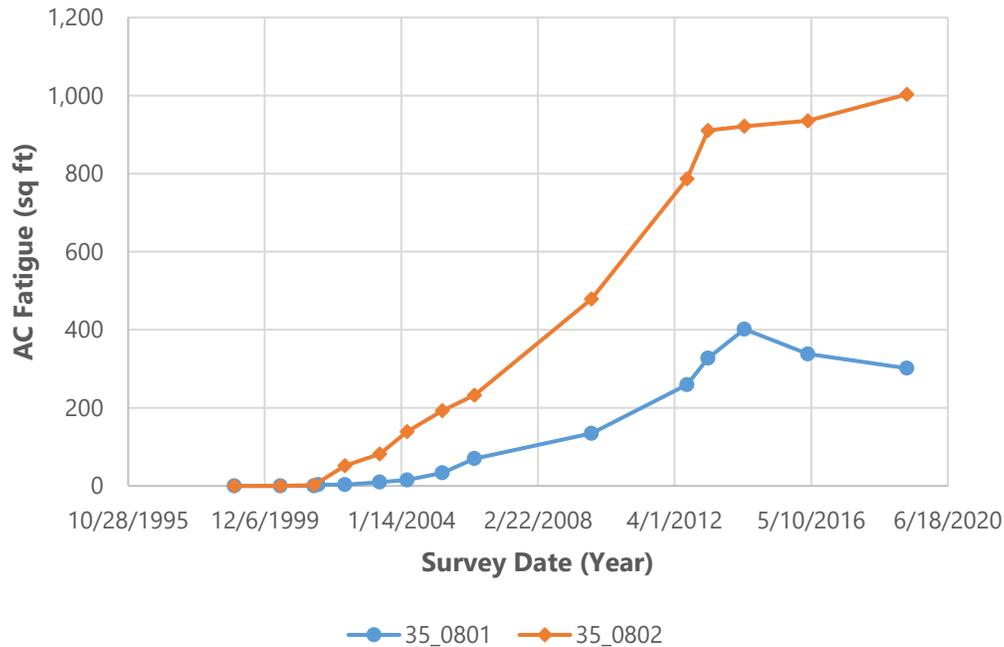
Figure 16. Chart. Total area of alligator cracking over time.

The activities conducted as a follow-up to the desktop study revealed the performance of the test sections was likely related to age hardening or oxidation as stripping; variation in test section thicknesses, and truck traffic were not found to play a clear role in the performance of these test sections. However, additional material testing on the collected cores was recommended to confirm this conclusion.

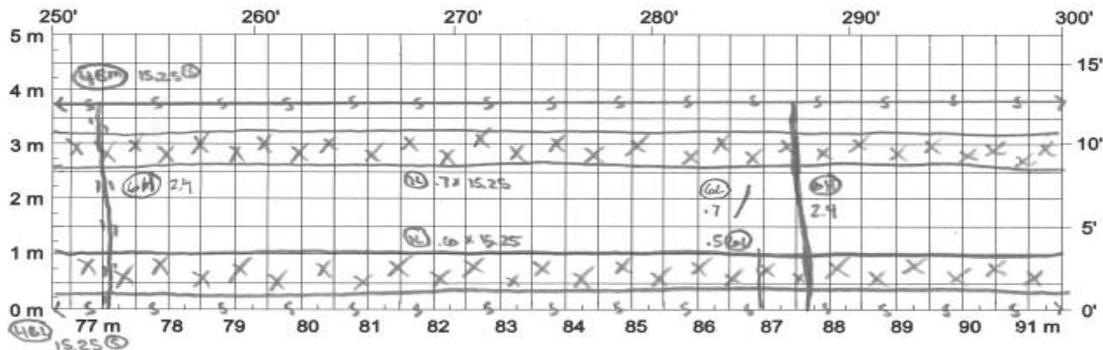
Figure 17. Map. 2015 distress survey of test section between 250 feet to 500 feet.

Through an interview with Iowa staff, it was found that for the most part, the performance of the pavement section over time was aligned with the expected performance of a relatively thick pavement segment. The Iowa DOT hypothesized the lack of milling prior to the 2002 overlay event and the AC mix used at the section played a role in the fatigue/alligator cracking observed on the test section, while the propagation of transverse cracking was likely exacerbated by the expansion of the lime-treated base. The Iowa DOT also noted the rutting on the test section was inconsistent with rutting typically observed on DOT roadways and hypothesized the rutting occurred in the AC surface layers. The performance of the test section in terms of IRI was thought to have been affected by the changing smoothness specifications, use of contractor incentives for smooth pavements, and improved equipment used by the DOT. In addition to these key findings, it was found that an additional construction event had occurred on the test section. This important information was shared with the LTPP Data Collection contractor.

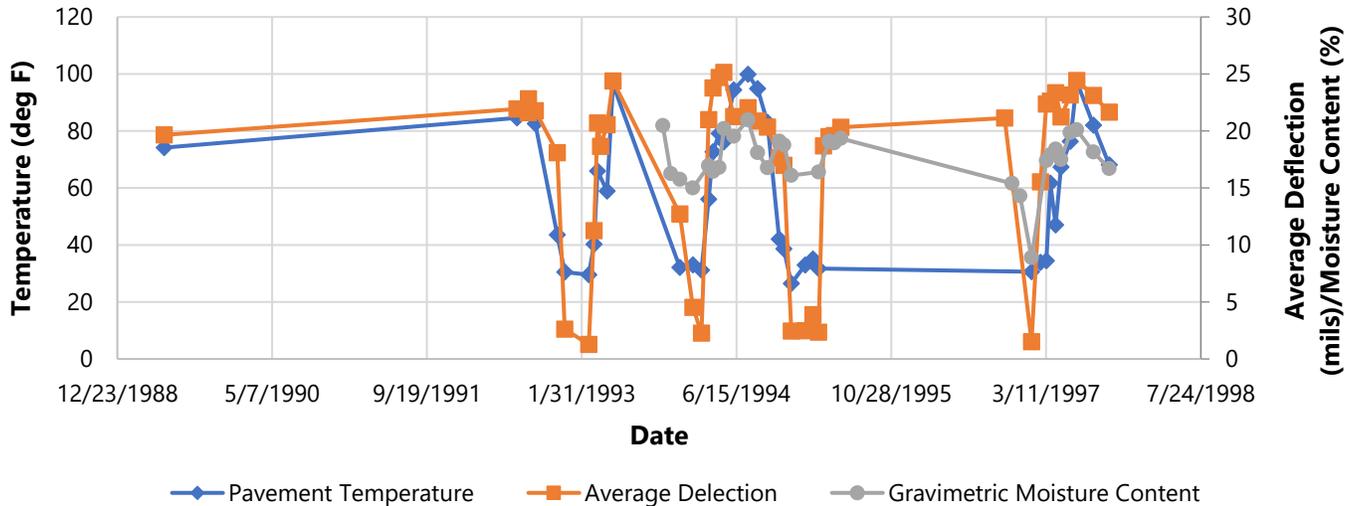
Figure 18. Chart. FWD deflections, average daily pavement temperature 1.85 inches below surface, and gravimetric moisture content 33 inches below surface.

Based on these findings, a regression analysis was performed to statistically relate variations in deflection to the changes in both the referenced variables and the test section age. Ultimately, the regression analysis yielded the following model to predict pavement deflection (mils) based on pavement temperature (°F), subgrade moisture content (%), and measurement position (0 under the center of load plate or 1 at 48 inches from the center of the load plate). The relationship between the predicted deflection values from the model and the actual deflected values showed a good correlation with a coefficient of determination (R^2) of 0.88. It was recommended this model, given in Figure 19, be further explored as a means of establishing load restrictions during the spring-thaw period.

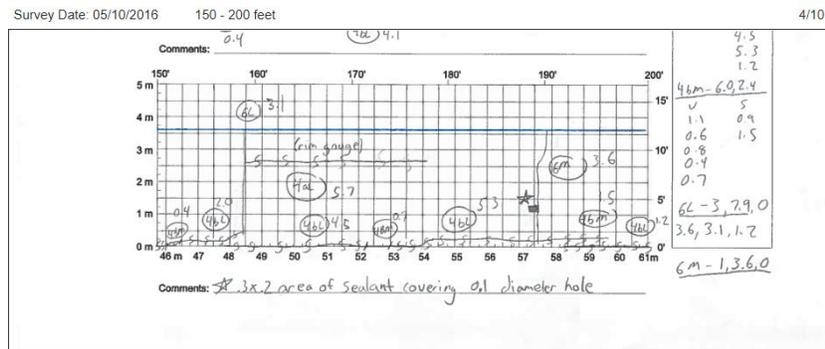
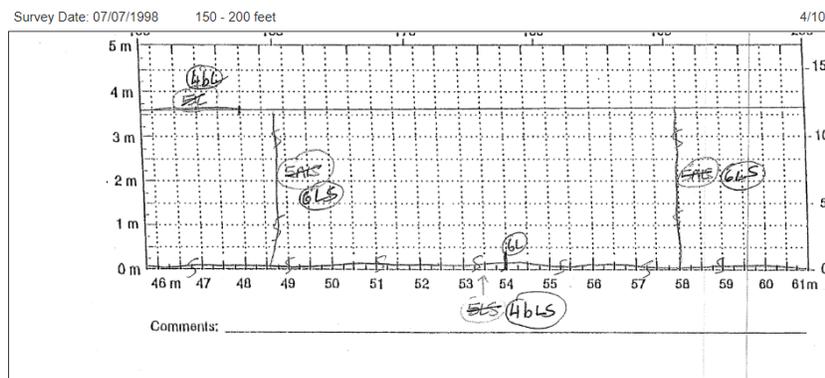
By evaluating data on InfoPave™, it was found that the PCC layer of the test section consisted of sawed transverse joints that were spaced 30 feet apart and were undoweled; no steel reinforcement was used. A lab test of a core taken in 1990 determined the compressive strength, modulus of elasticity, Poisson's ratio, and coefficient of thermal expansion of the PCC layer were 5,980 psi, 3,350,000 psi, 0.16, and 0 in/in/deg F, respectively. The presence of undoweled PCC pavement below the AC layers helped better explain the cause and location of transverse cracking on the test section. A comparison of the distress maps before and after the AC overlay in 1998 showed the transverse and NWP longitudinal cracking appeared in similar locations along the test section (approximately every 30 feet, or at the transverse joints of the PCC layer, and at the edge and along the longitudinal joint of the test section, respectively) as depicted in Figure 20 and Figure 21. This indicated the transverse cracking and NWP longitudinal cracking observed after the application of the overlay in 1998 was likely a reflection of the cracking observed before the overlay.

Figure 20. Map. 2016 distress survey map between sta 01+50 and 02+00.

Figure 21. Map. 1998 distress survey map between sta 01+50 and 02+00.

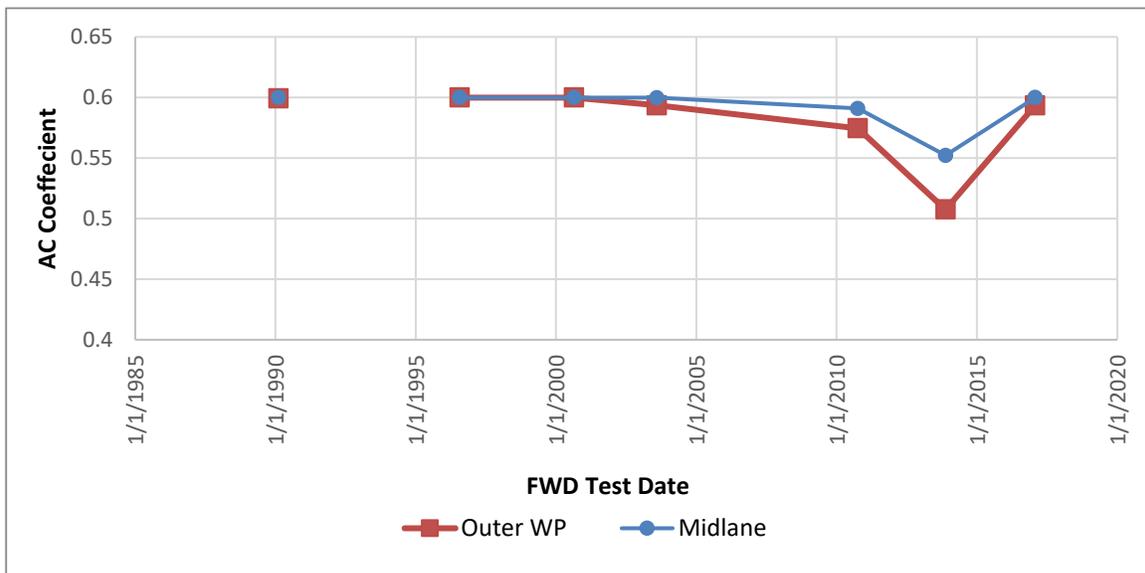
Figure 22. Chart. Average AC layer coefficient.

Coring was also conducted as a part of the follow-up investigation. The cores showed the relative uniformity of pavement layers when compared to the thicknesses reported in the LTPP database. Layer 5 did show two areas that were thicker than reported: (1) in the mid-lane at station 100 and (2) nearly the entire width across at station 400. The cores were all in good condition with no signs of material degradation such as cracking or stripping. The backcalculated AC moduli, which used temperature-adjusted and normalized FWD data, were used to calculate the AC layer coefficient and structural numbers. The results, depicted in Figure 22, showed the AC layer coefficient was high prior to the AC overlay in 2001, but began to drop in 2011 and reached lower values in 2013 before jumping up in 2017. The results show the decreasing layer coefficient was lagging behind the development of fatigue cracking. In terms of the structural number, the results showed the effective structural number remained relatively stable pre-overlay and then hovered around 6 after placement of the overlay. Placement of the overlay has only increased the structural capacity, which would mean the cracking observed on the pavement surface is likely not full-depth structural cracking, but instead top-down cracking caused by a combination of AC oxidation, poor bonding between the overlay and the original AC surface, and the stresses resulting from tire-pavement interactions such as vehicle braking and accelerating.

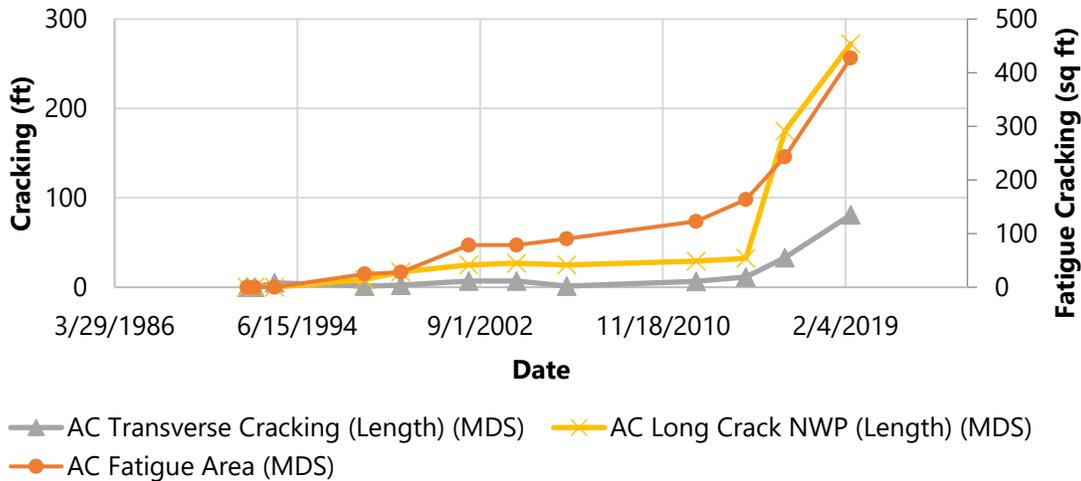
Figure 24. Chart. Time history of length of cracks.

24 provides a summary of the cracking reported on the pavement section over time with the increase starting in 2016. Despite the substantial increases in cracking along the section during this period, there was no notable increases in IRI or rutting in 2016.

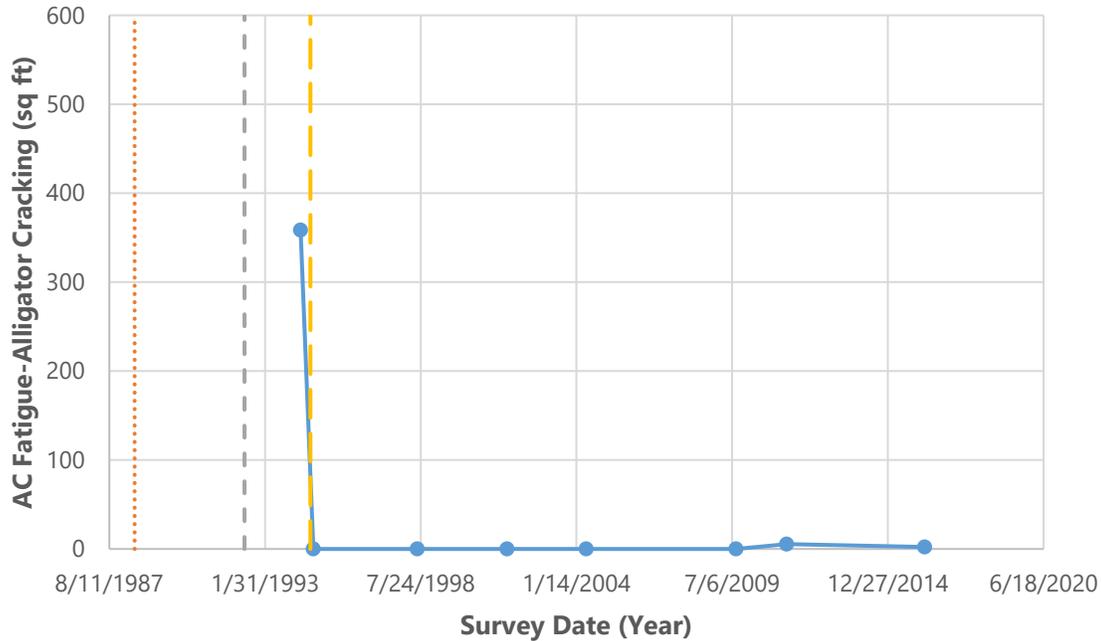
Figure 25. Time history of bottom-up cracking area on test section 23_1028.

longitudinal cracking observed prior to the overlay was reflected onto the new overlay surface. The transverse cracking observed on the section was mostly short cracks near the edges of the lane rather than full width transverse cracks, indicating the observed transverse cracking was not likely low temperature cracking.

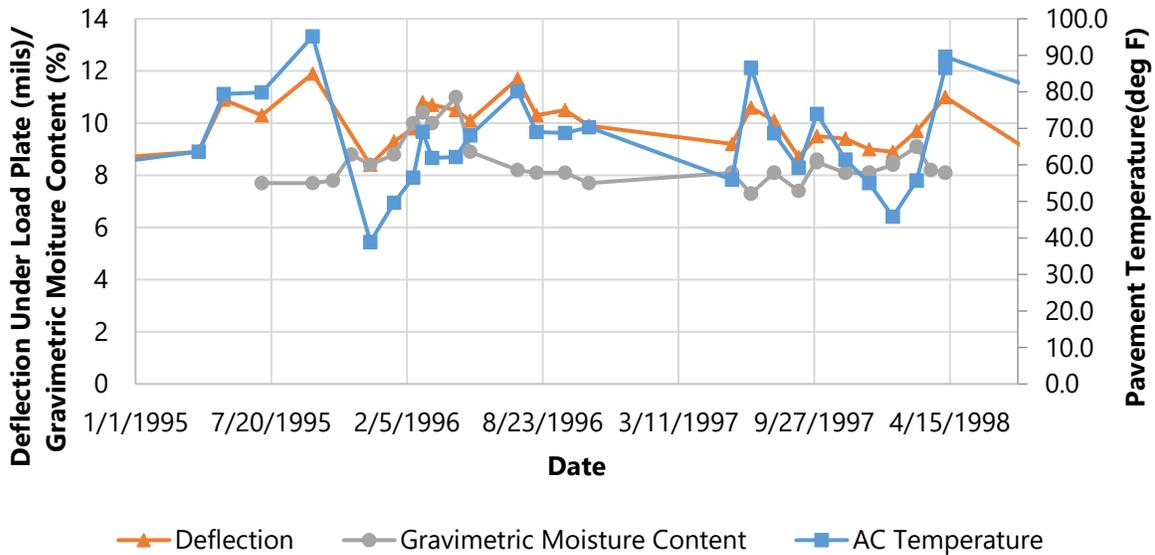
Figure 26. Comparison of FWD deflections, average pavement temperature 0.98 inches below surface, and gravimetric moisture content 26 inches below surface.

Utilizing data collected during the SMP analysis period, an assessment of the change in pavement deflection over time with regards to pavement temperature and subgrade moisture content was conducted. As depicted in Figure 26, increases and decreases in deflections under the center load plate typically corresponded to increases and decreases in the pavement temperature and subgrade moisture content. The change in deflection 48 inches from the load plate (Sensor 7) appeared to be related to the change in moisture content over time, but less so to the change in pavement temperature over time.

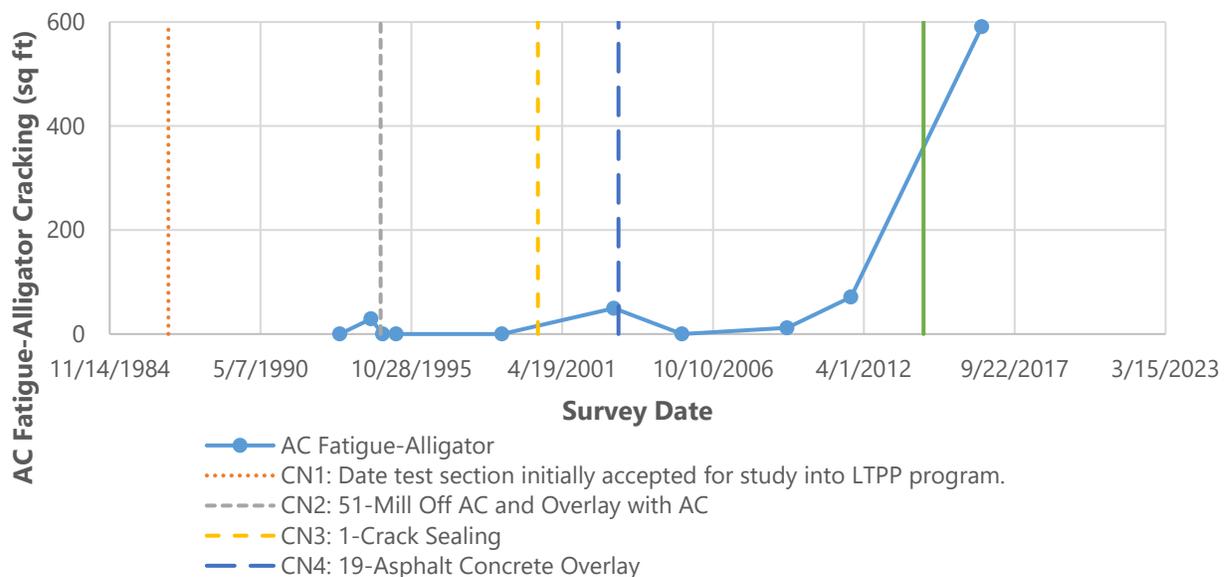
Figure 28. Chart. Time history of fatigue cracking on test section 18_1037.

Another objective of the desktop study was to assess the cause(s) of the increase in both fatigue/alligator cracking and NWP longitudinal cracking following the second AC overlay in 2003. As shown in Figure 28, while there was little-to-no fatigue/alligator cracking prior to the mill and overlay in 1994 and the overlay in 2003, starting in 2009, fatigue/alligator cracking propagated at a rate of 82.7 ft²/year. Similarly, for NWP longitudinal cracking, while cracking was reported prior to the overlay in 2003, the cracking reported after the overlay was greater in length. The increase in the cracking was likely related to a combination of aging/structural deterioration of the pavement section over time and the increased levels of precipitation during this period, particularly in 2011 when 75 inches of precipitation was recorded in the area.

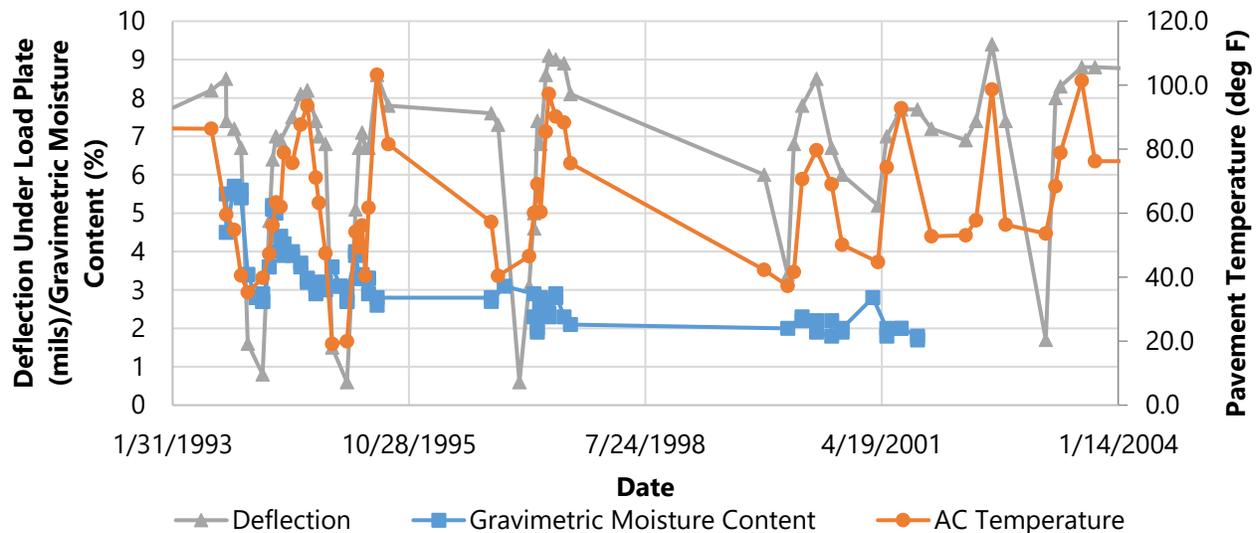
Figure 31. Chart. Comparison of FWD deflections, average pavement temperature 1-inch below surface, and gravimetric moisture content at 24 inches below surface.

From the data collected during the SMP analysis period, an assessment of the change in pavement deflection over time with regards to pavement temperature and subgrade moisture content was conducted. As depicted in Figure 31, the change in deflection under the load plate over time appeared to be directly related to the change in pavement temperature over time. For the most part, increases and decreases in deflections corresponded to increases and decreases in the pavement temperature. The relationship between the change in deflection measured at the farthest sensor from the load plate did not show a clear correlation to either temperature or moisture.

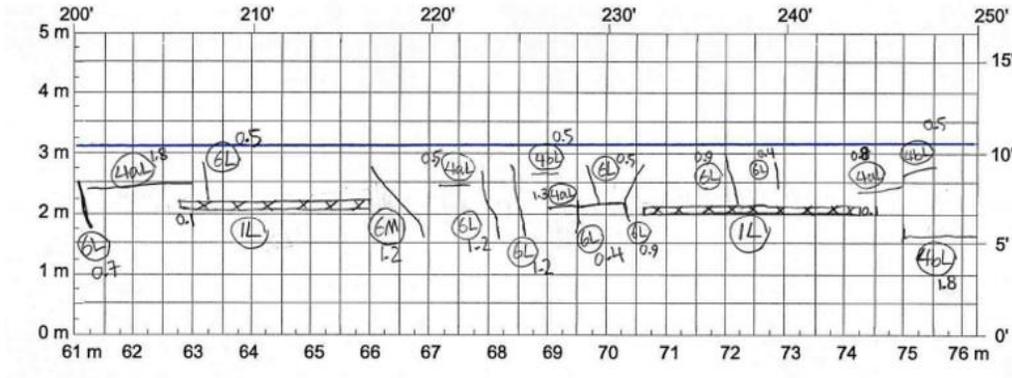
Figure 33. Map. Fatigue cracking propagation on test section 05_0803 in 2014.

The desktop study provided insight on the causes of the increase in fatigue, longitudinal, and transverse cracking observed on the AC test sections (05_0803 and 05_0804) over time. Between 2014 and 2019, the amount of fatigue cracking exhibited at the test sections increased at an abnormally high level for a low-traffic roadway. Some of the increase in fatigue/alligator cracking was related to other cracking types in the wheel path evolving into fatigue/alligator cracking starting in 2019; most of the additional fatigue cracking observed in 2019 was located in areas where wheel path longitudinal cracking and transverse cracking already existed, as depicted in Figure 33 and Figure 34. Hypothesized causes for the increase in fatigue/alligator cracking along the test sections included the high levels of precipitation due to a flooding event in 2019, aging/oxidation of the AC layers, and construction or material inconsistencies. The increase and subsequent drop in NWP and WP longitudinal cracking and transverse cracking on the AC test sections was related to the fatigue/alligator cracking observed on the test sections as discussed previously.

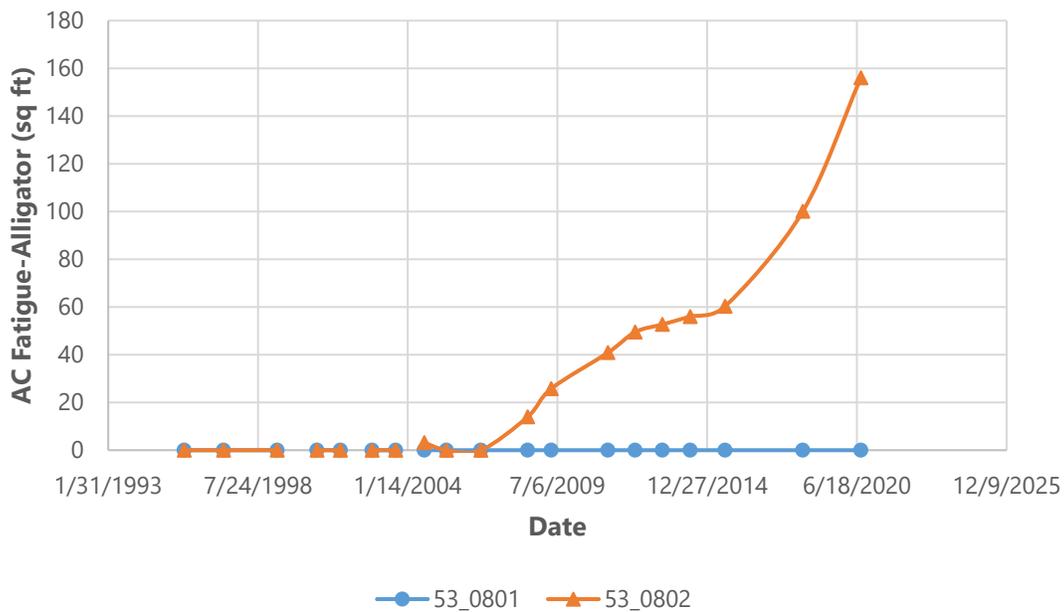
Figure 36. Chart. Time history of fatigue cracking on test sections 53_0801 and 53_0802.

One of the key areas of investigation was the fatigue/alligator cracking observed on test section 53_0802. Despite test section 53_0802 being the thicker of the two AC test sections, fatigue/alligator cracking was only reported on test section 53_0802. Between 2008 and 2020, the fatigue/alligator cracking observed increased from 14 ft² to 156 ft² at an average rate of 11.8 ft²/year, as observed in Figure 36. One potential reason for the differences in the fatigue/alligator cracking observed on the AC test sections was the difference in construction of the two test sections. It was noted in the construction report for the test sections that the AC surface of test section 53_0802 was constructed in multiple lifts. However, between the first and second lift, the contractor did not allow time for the first lift to cool before the second lift was applied. Instead, an emulsified tack coat was added. It is therefore suspected that a lack of bonding between these two lifts may have resulted in the fatigue/alligator cracking observed on test section 53_0802.

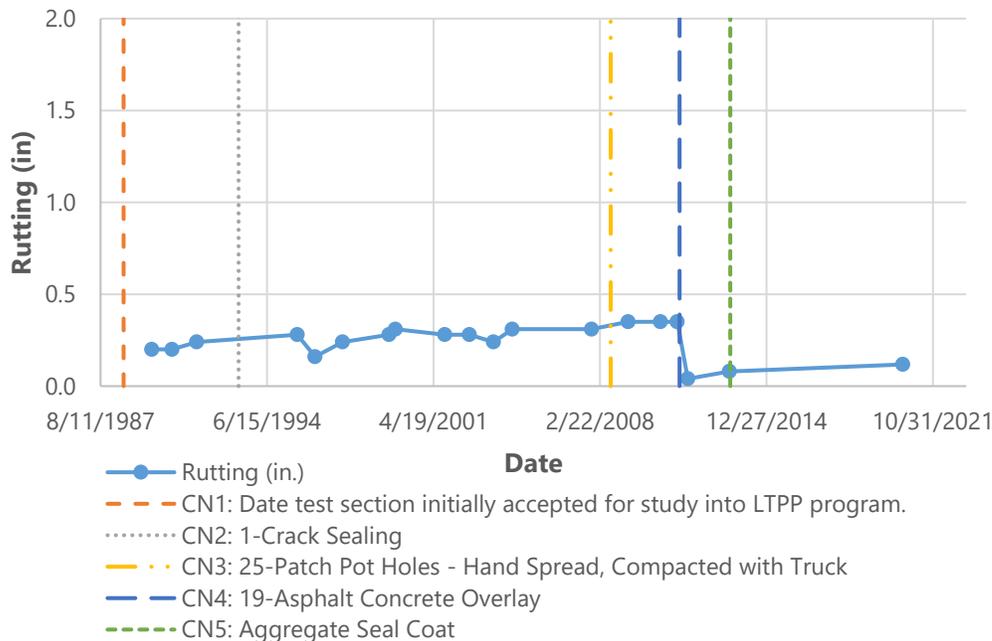
Figure 37. Chart. Time history of average rut depth on test section 16_1020.

Another key objective of the desktop study was to investigate was the key cause(s) of rutting observed on the test section. The rutting on the section prior to 2011 increased from 0.2 in in 1989 to 0.35 in in 2011. Following the overlay in 2011, the average rut depth dropped to 0.04 in. The average rut depth began to slightly increase following the overlay, at a rate of less than 0.01 in/year between 2011 and 2020, as depicted in Figure 37. Using the transverse profiles of the test section at multiple locations, an analysis of the predominant layer in which plastic deformation occurs was assessed using the method developed in NCHRP Project 01-34a. Based on the analysis conducted for each of the transverse profiles of the test section for the collection dates between September 1989 and June 2013, the predominant layer contributing to rutting was the surface layer. It was hypothesized that the rutting observed prior to 1990 may have been related to the AC thickness, annual pavement temperature, the binder used, and to a lesser extent, the increase in agricultural and constructed-related traffic along the roadway. Additionally, while there may have been some studded tires used on this road, studded tire and chain abrasion in the winter months were not considered by ITD as significantly impacting rut measurements.

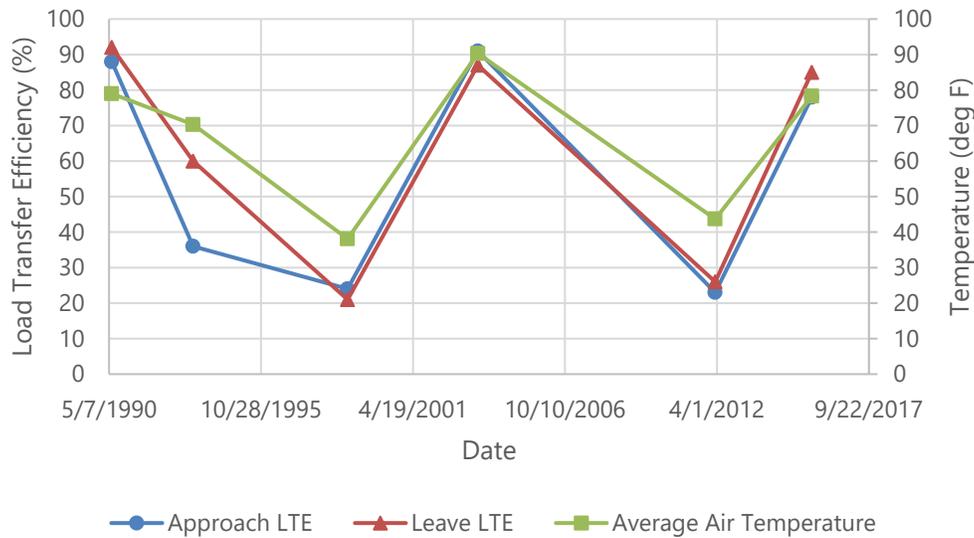
Figure 38. Load Transfer Efficiency on test section 40_4157 over time.

Through the desktop study, an analysis of the LTE prior to and following the 2012 construction events was conducted. As depicted in Figure 38, except for values reported in 1990 and 2003, the test section generally reported poor load transfer efficiency prior to 2012. However, after further investigation, the reported LTE values appeared to be strongly related to the daily air temperature (MERRA). During the warmer months of the year, it is likely that slabs expanded, and the resulting locked joints provided sufficient load transfer of the joints. In colder months, the load transfer was poor, which typically results in faulting, pumping, and—if left untreated—corner breaks. The only measurement after the dowel bar retrofit showed a substantially improved load transfer, although this also aligned with the temperature/LTE trend observed prior to the construction event.
