TPF-5(291) FINAL REPORT:

EVALUATING THE IMPACT OF NON-EXPERIMENTAL FACTORS ON PAVEMENT PERFORMANCE:

Task 3: Review of SPS-2 Early Failures

Prepared On Behalf Of:	Date	Project Number
State Pooled Fund Study TPF-5(291)	October 2021	56A0418-008 (TPF 5(291)) 219.03.10 (NCE)

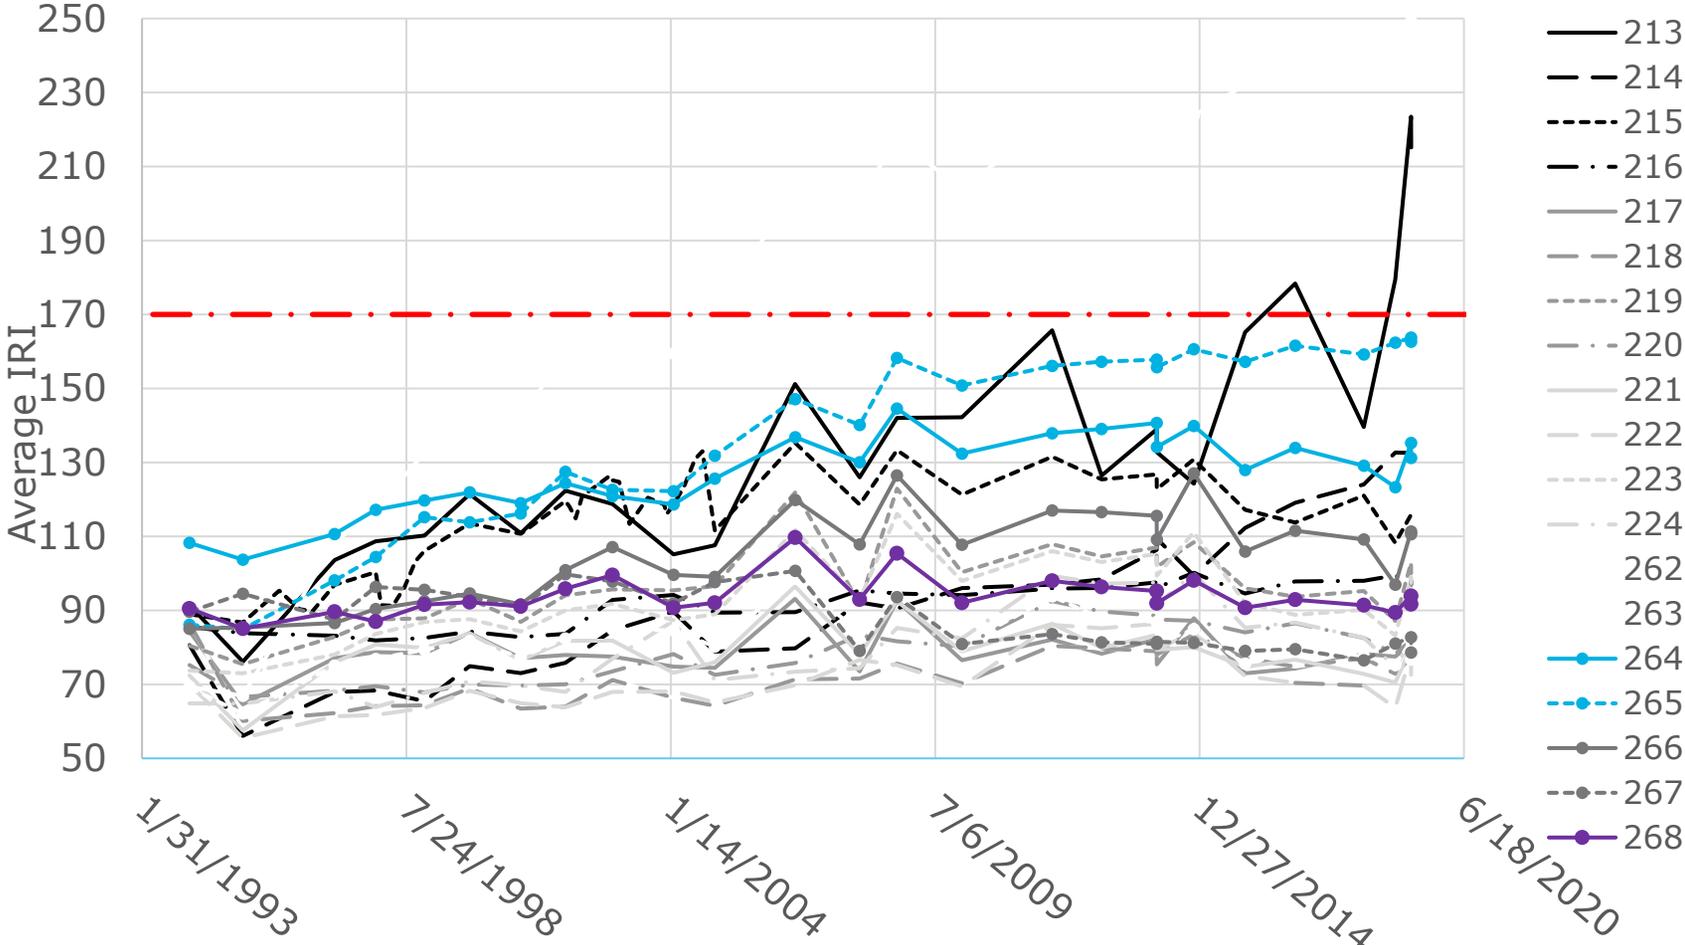
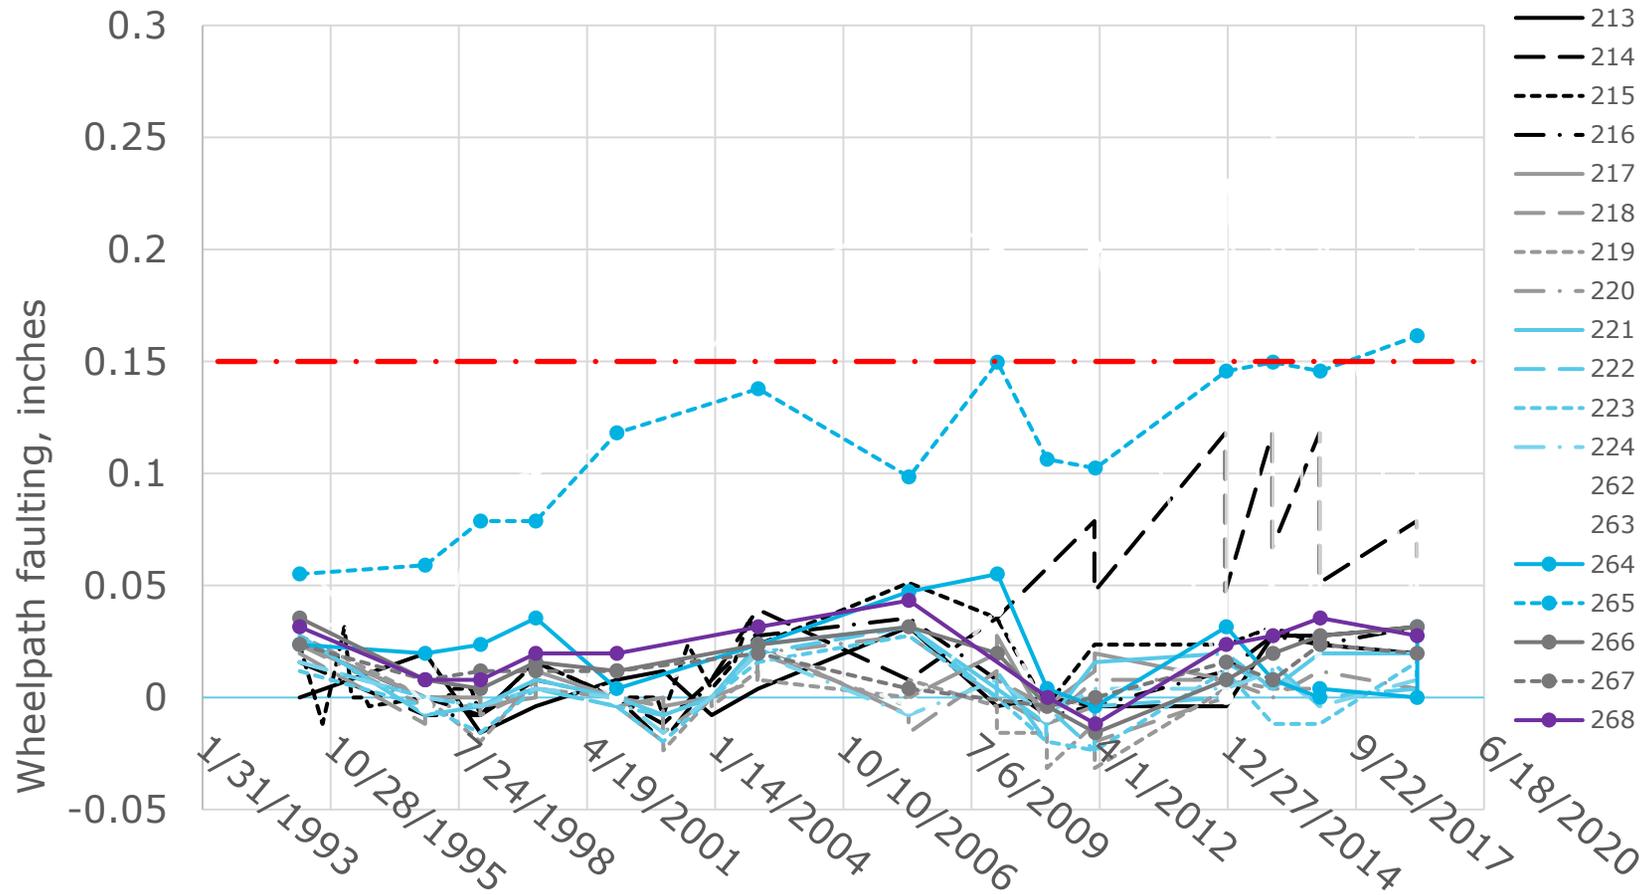
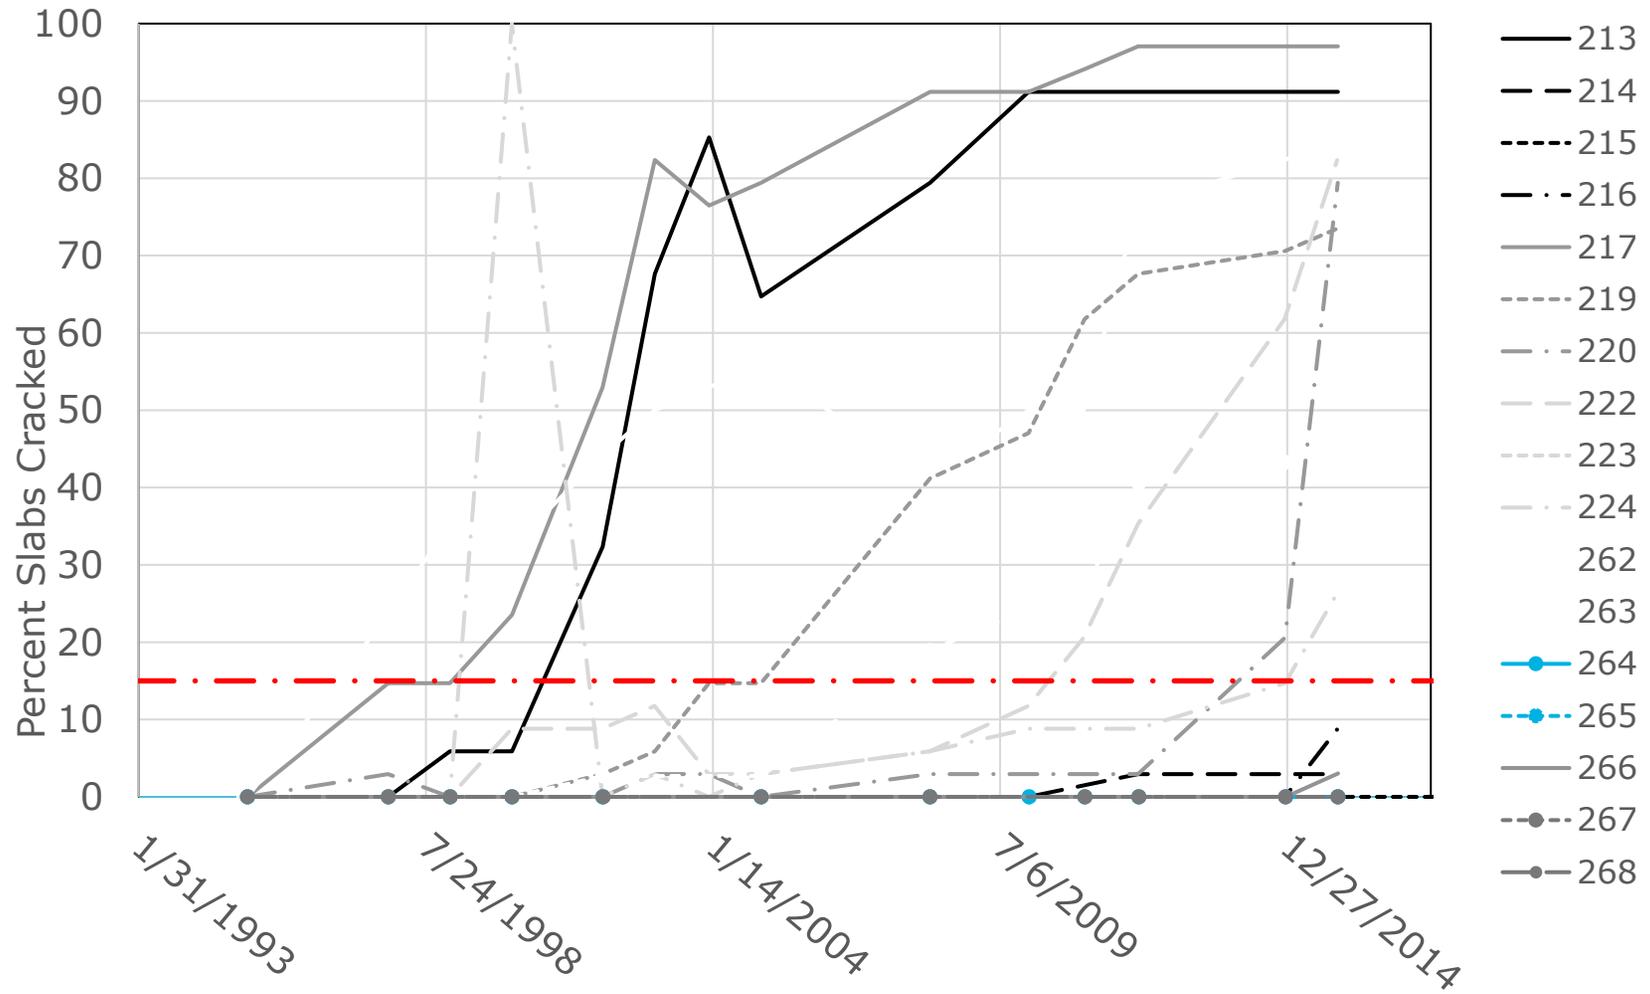
It can be seen from the plots that several test sections exhibited poor performance across the measured performance metrics. Specifically, test sections 040262 and 040213 exhibited poor levels of roughness with test section 040265 trending upward to poor roughness performance as well. Test sections 040262 and 040265 both exhibited poor performance with regards to wheel-path faulting. Slab cracking was the most common indicator exhibiting poor performance, test sections 040213, 040217, 040218, 040219, 040220, 040222 040224, and 040263 all exhibited poor performance regarding slab cracking. Summarized performance trends of the Arizona SPS-2 test sections are given in Table 3 below.

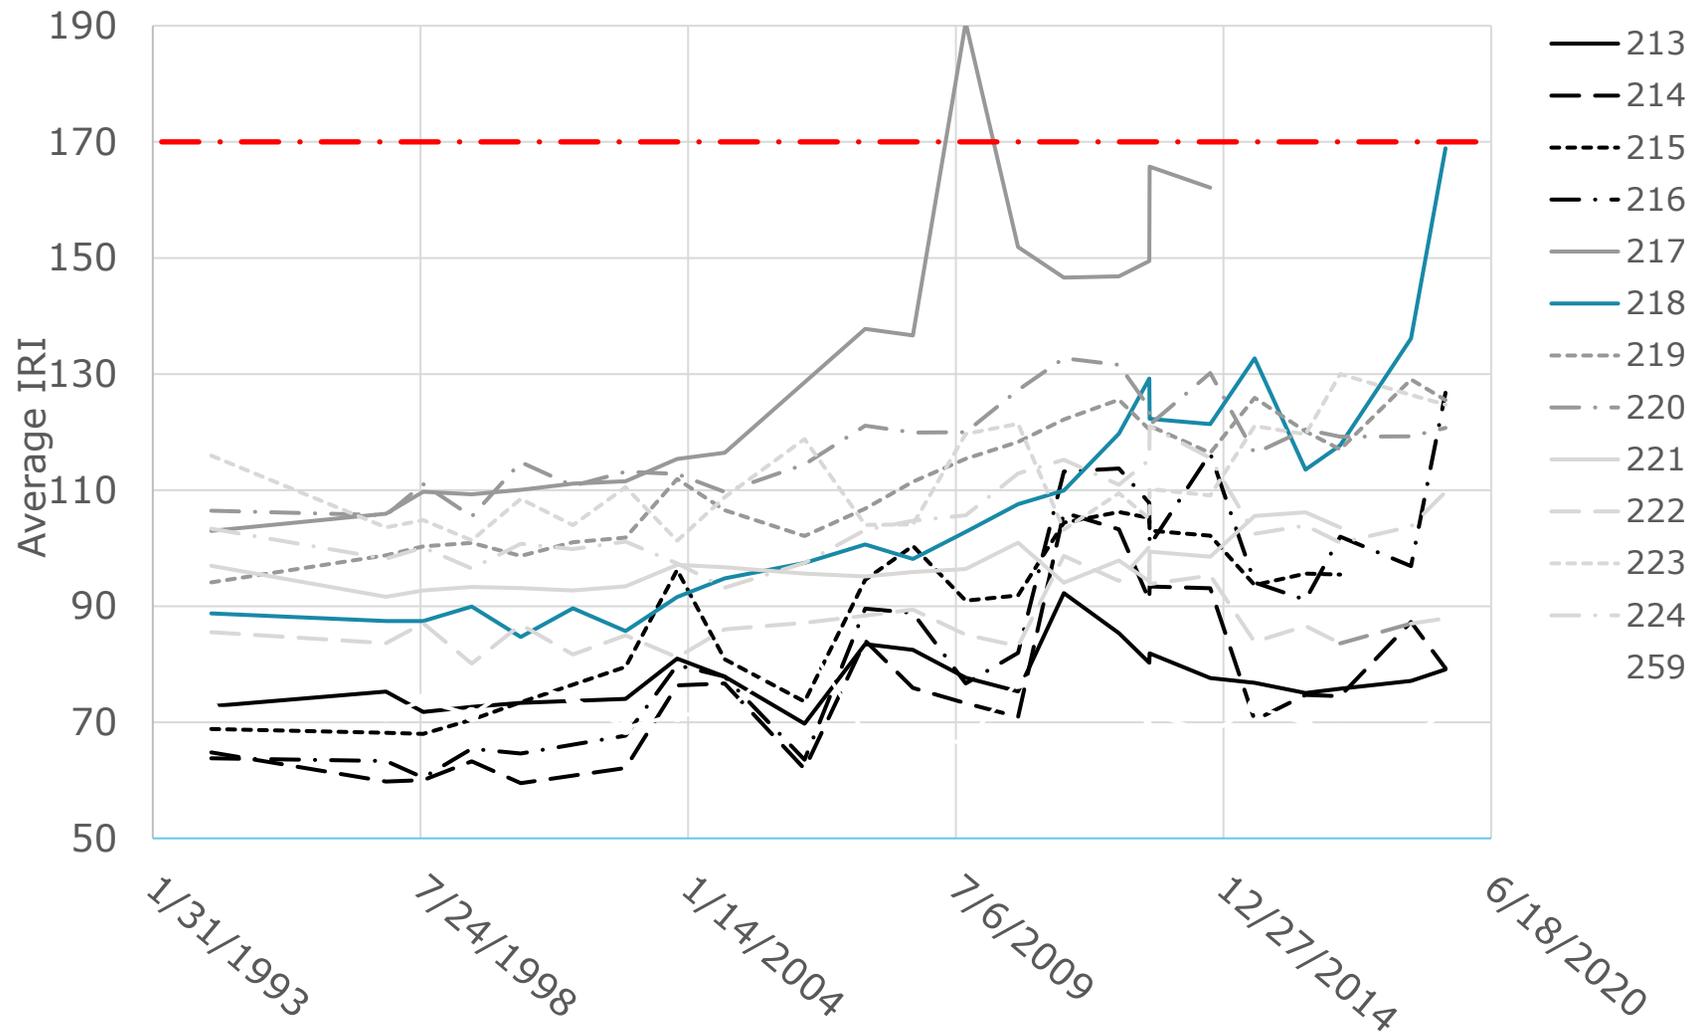
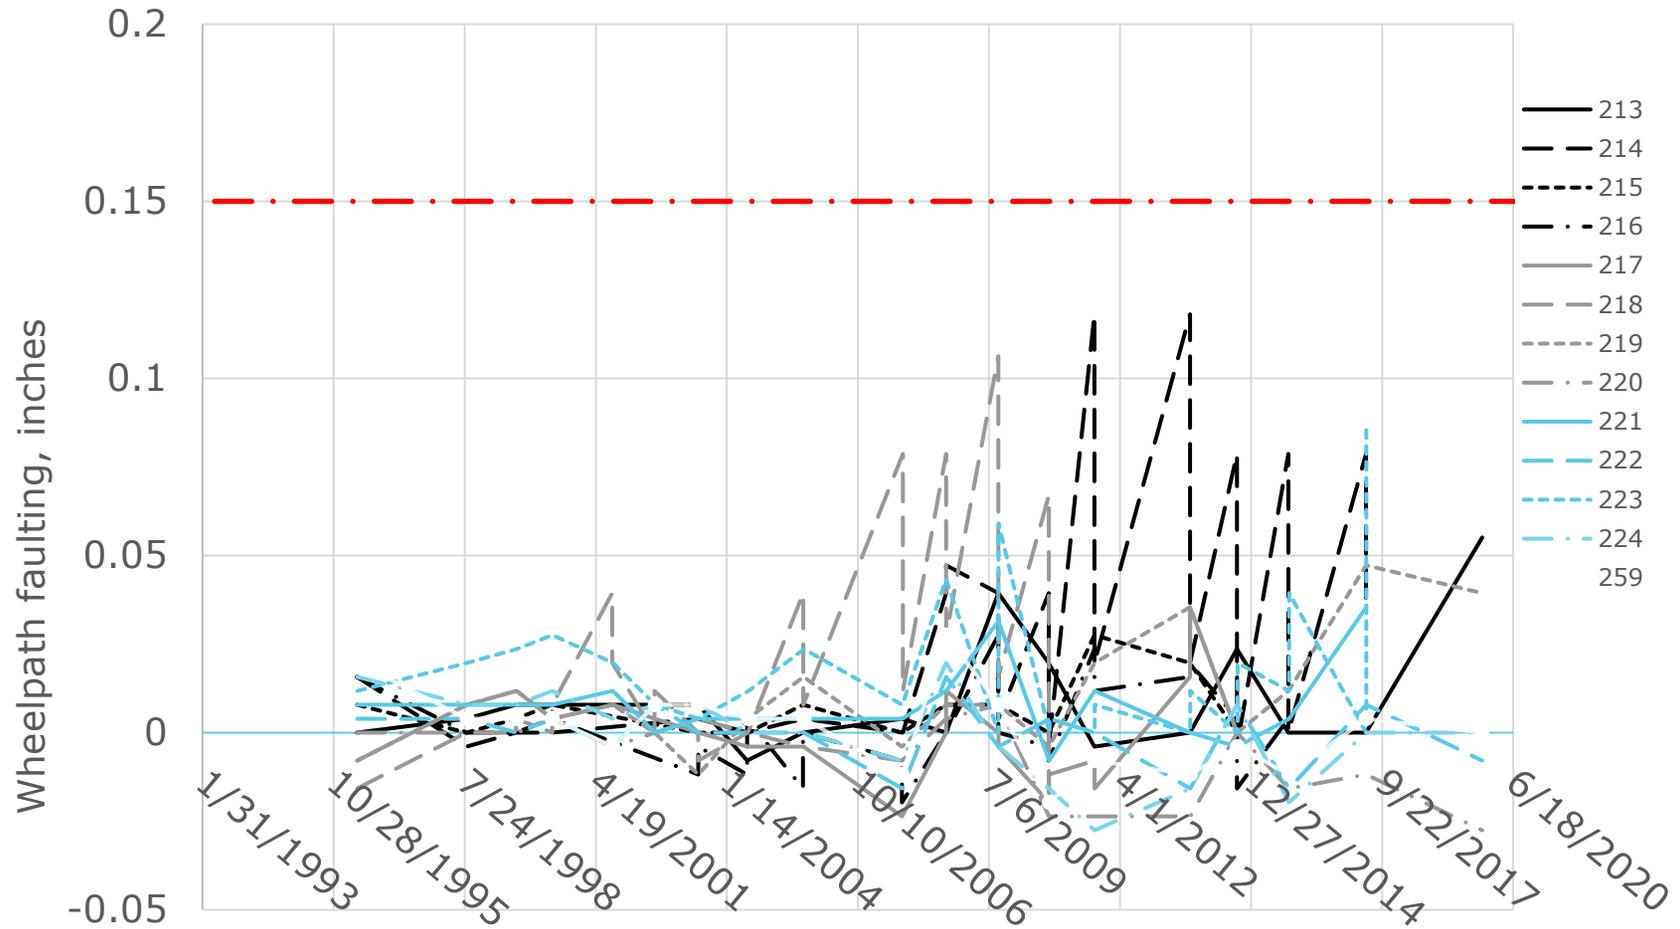
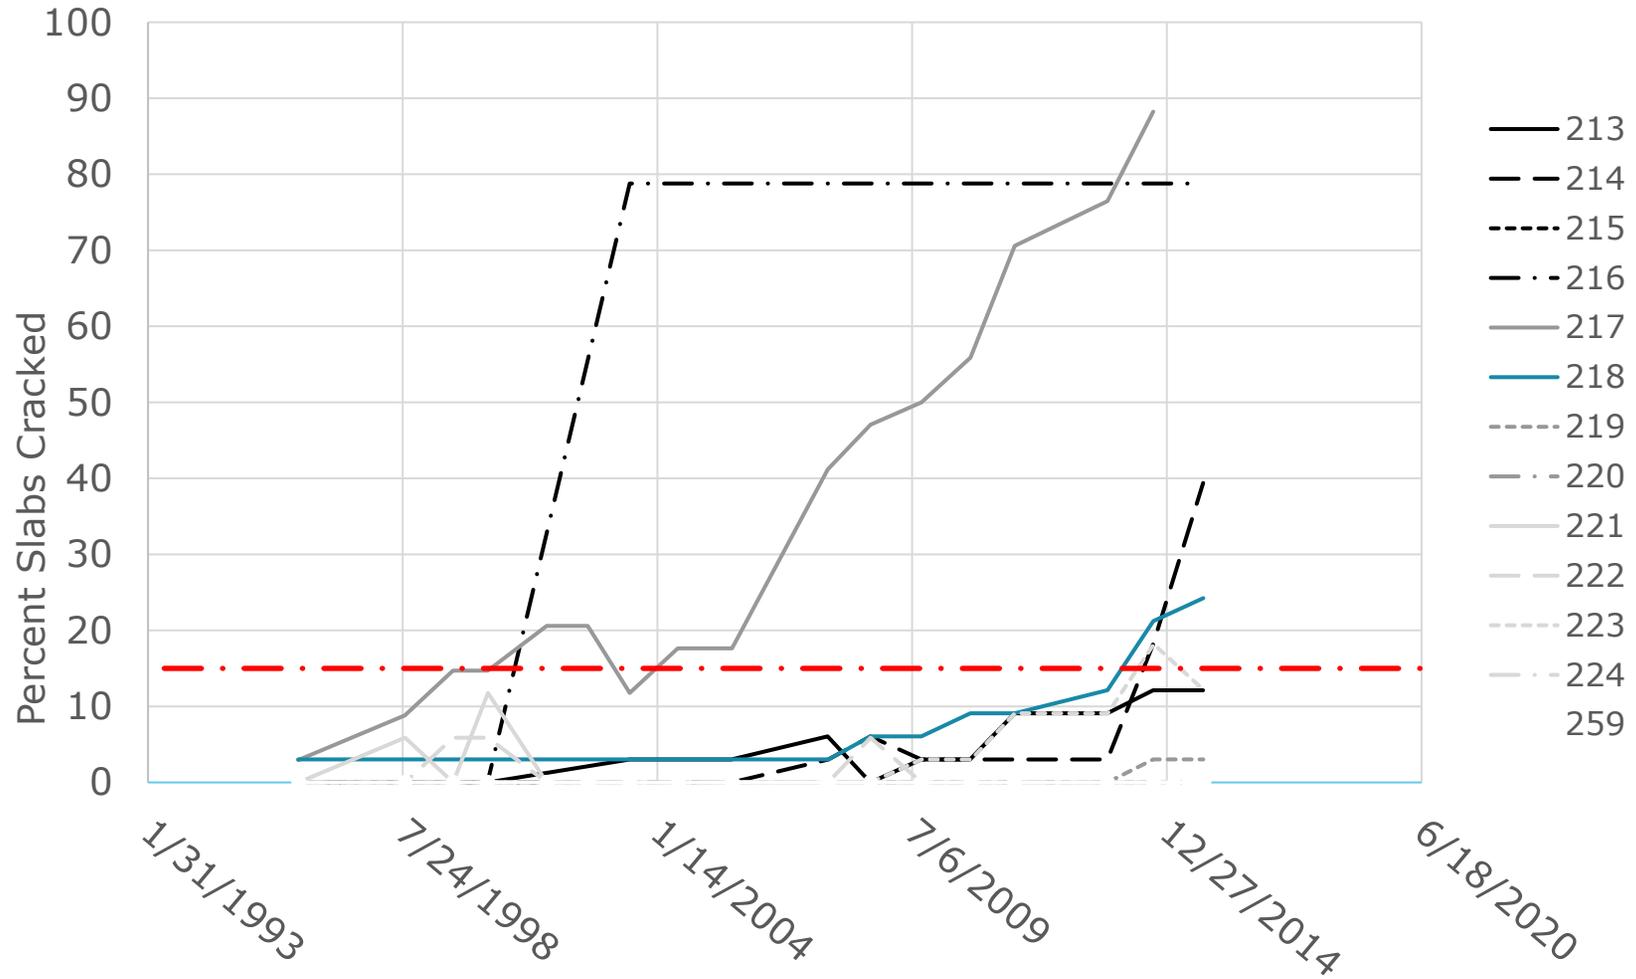
Only test sections 080217 and 080218 exhibited poor performance with respect to roughness while no test sections exhibited poor performance with respect to wheel-path faulting. However, test section 080214, 080216, 080217, 080218, and 080223 all exhibited poor performance with respect to slab cracking. A summary of the performance of the test sections are given in Table 12 below.

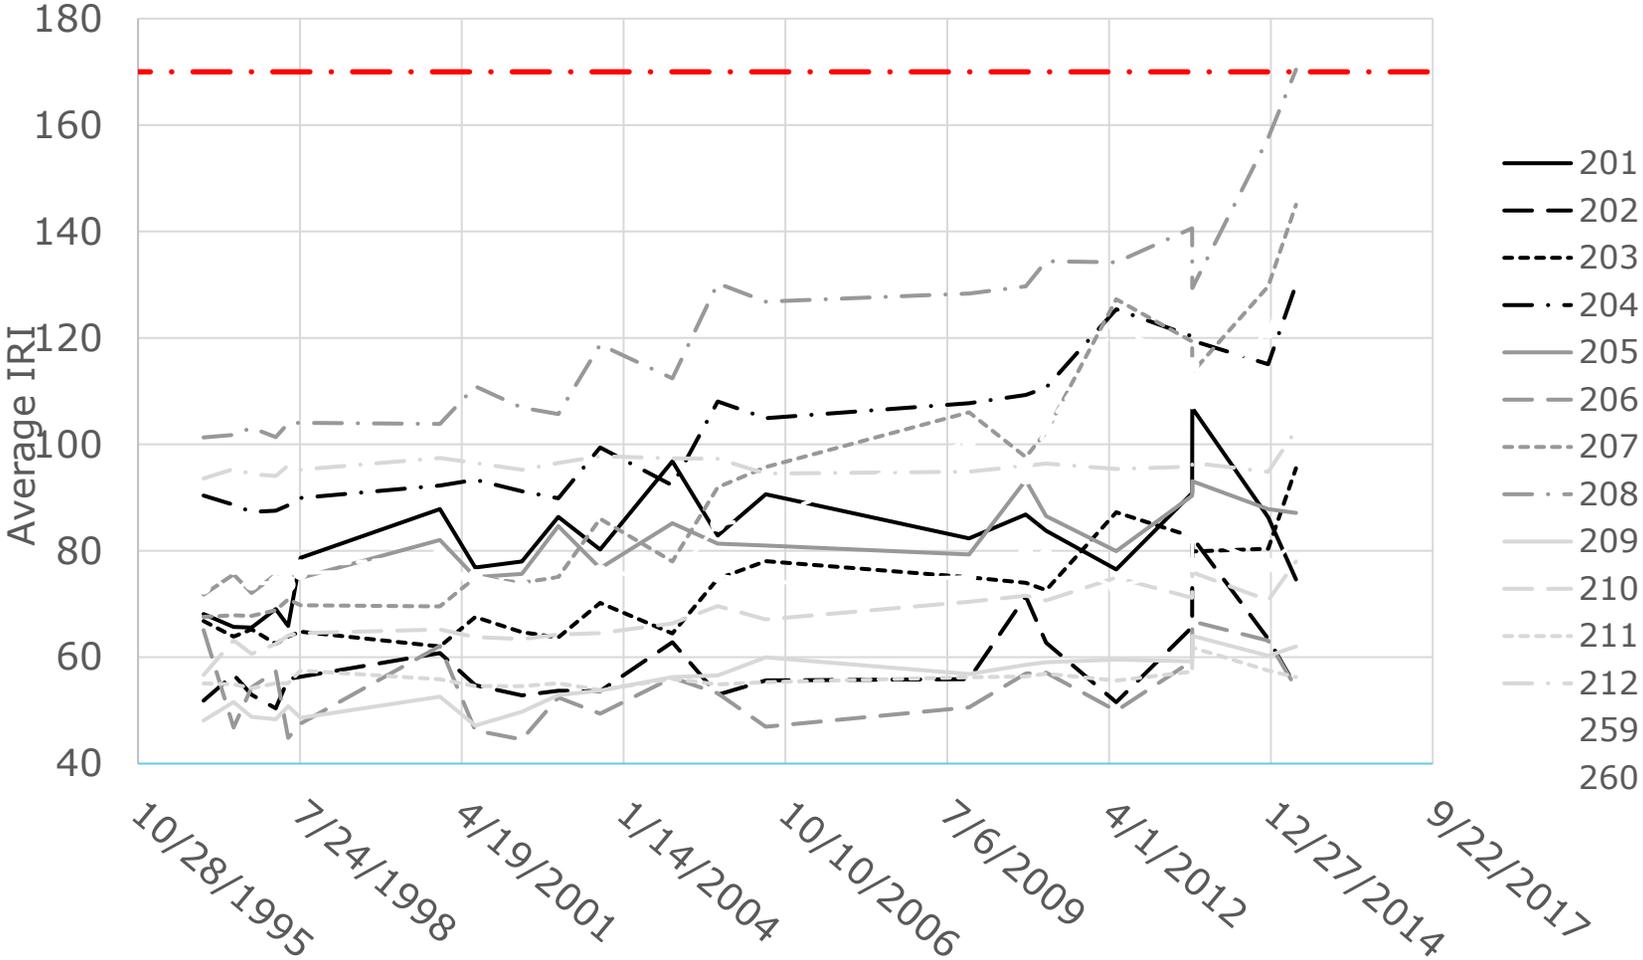
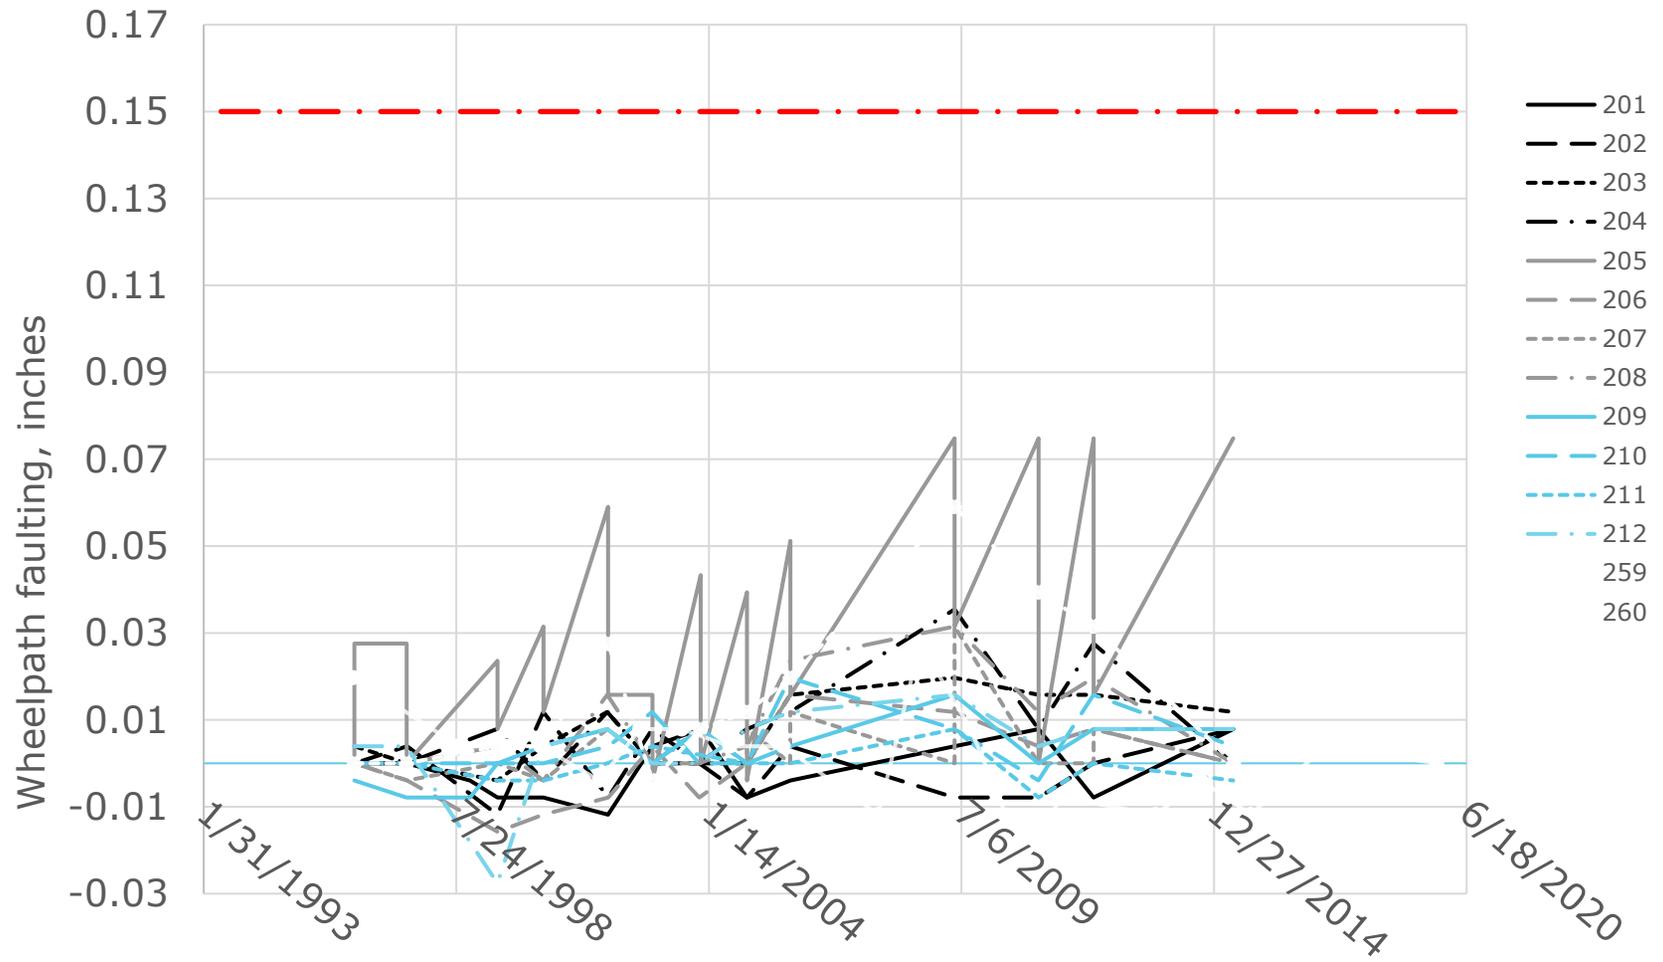
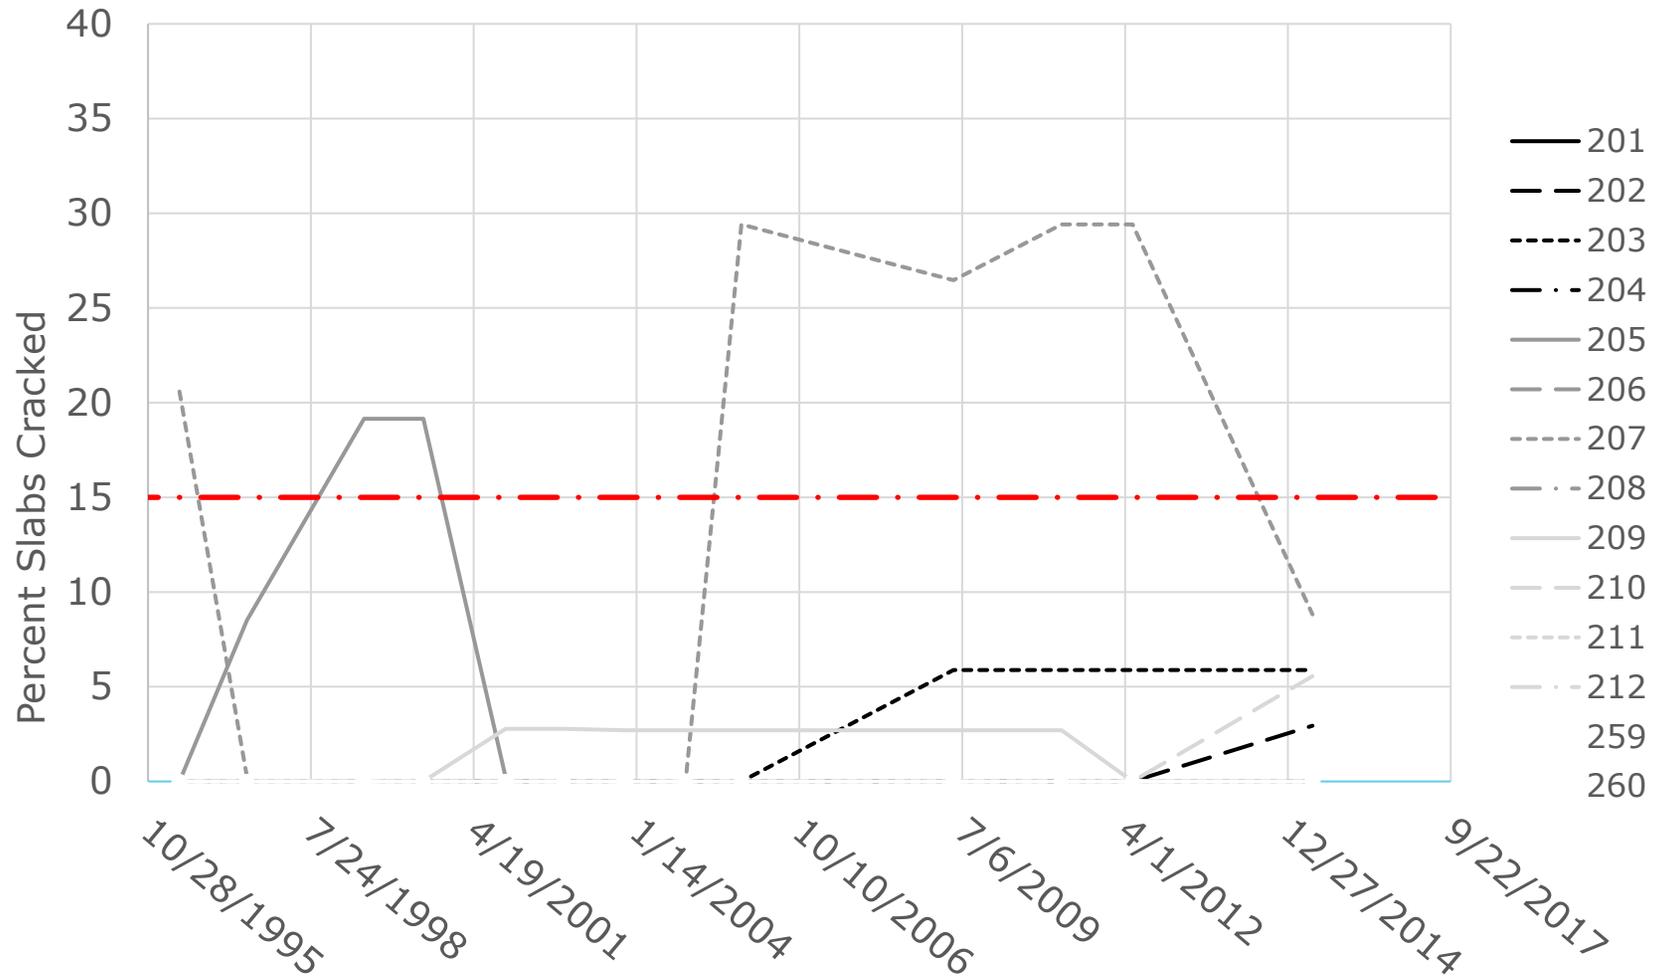
Only test section 100208 exhibited poor performance with respect to surface roughness while all test sections were well below the poor performance threshold in wheel-path faulting. Test sections 100205 and 100207 exhibited poor performance with respect to slab cracking. A summary of the noted performance trends for Delaware SPS-2 test sections is given in Table 17.

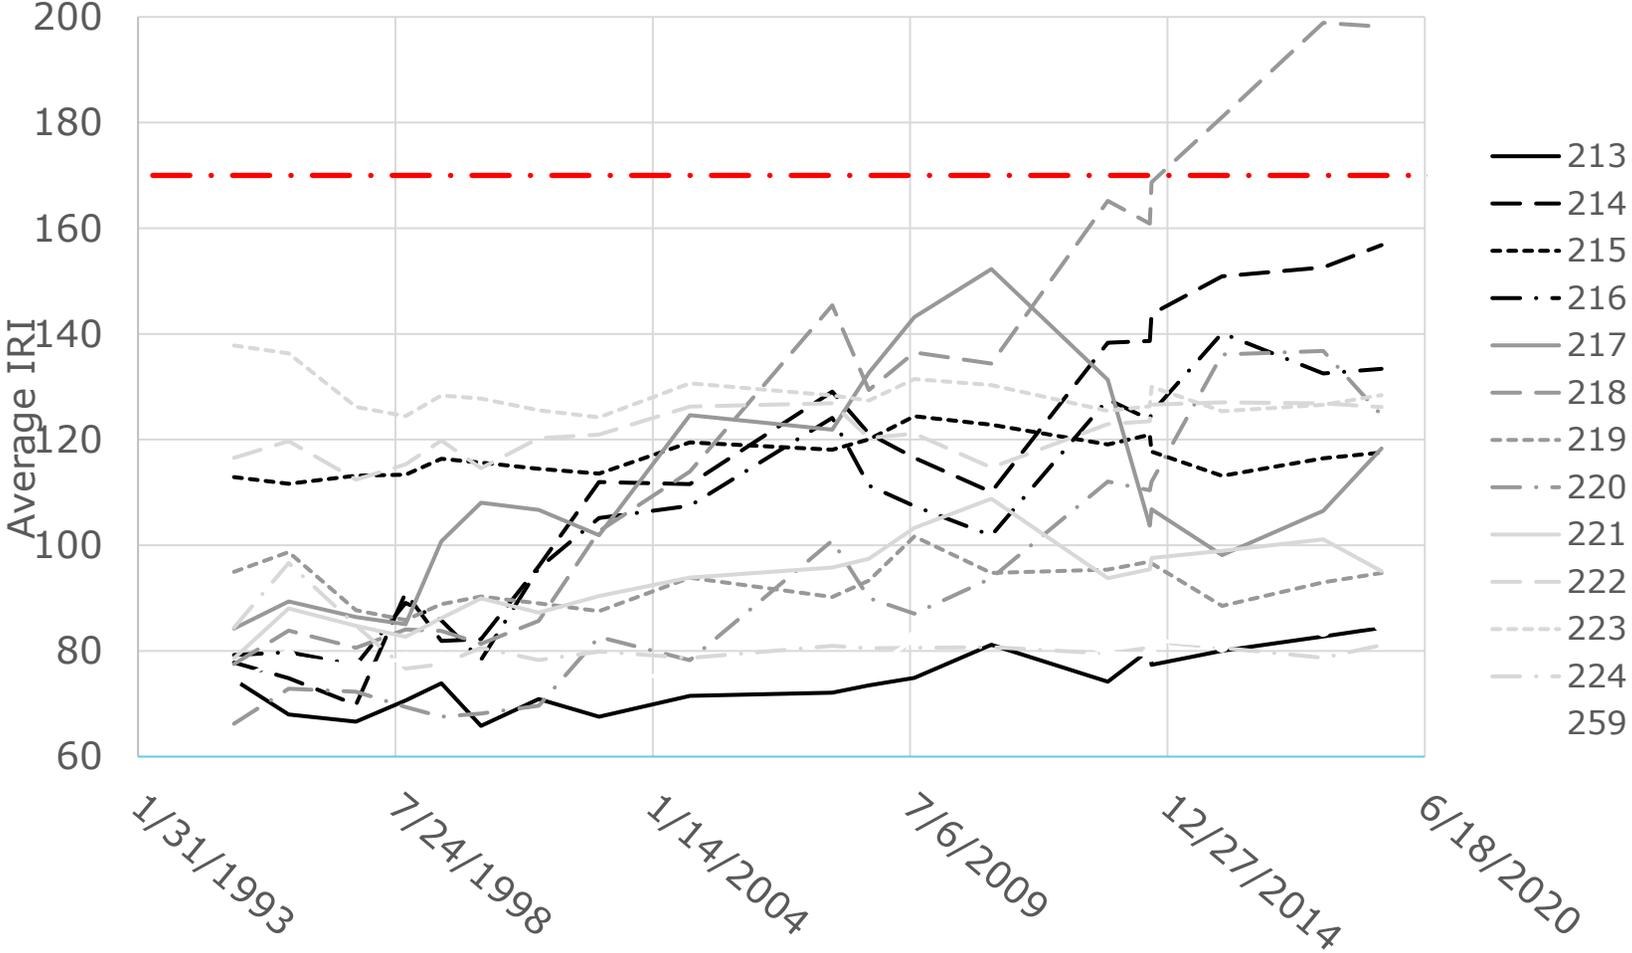
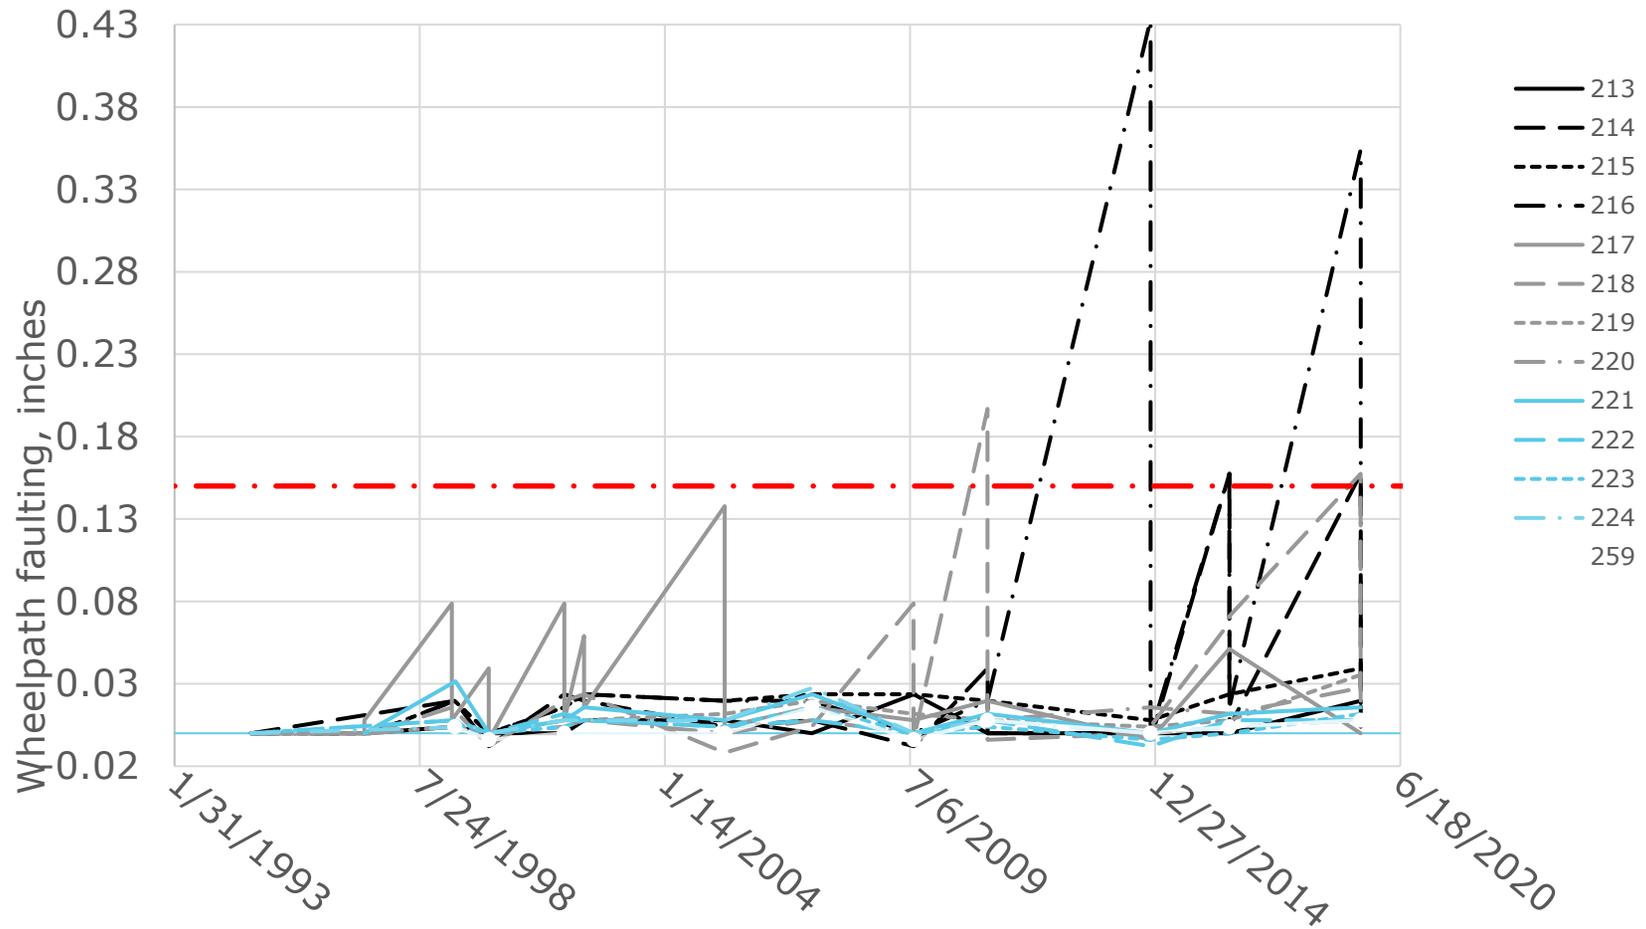
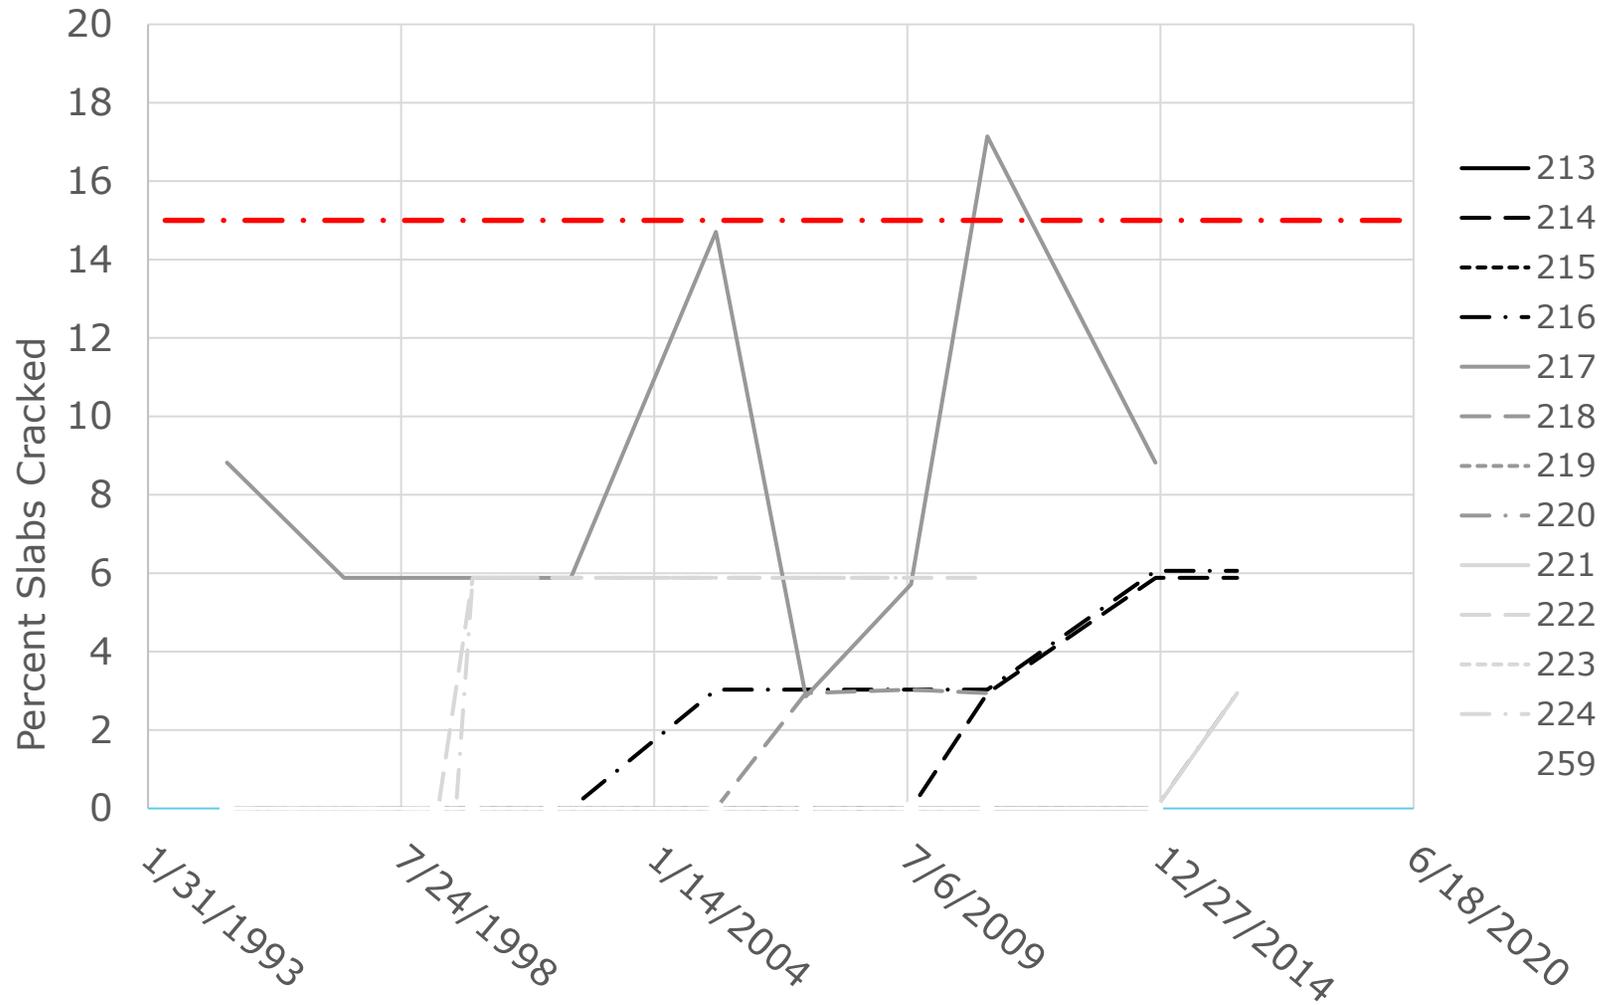
Many test sections exhibited fair performance across roughness with only test section 190218 exhibited poor performance with respect to roughness. Test sections 190216 and 190218 both exhibited poor performance with respect to wheel-path faulting and test section 190217, while exhibiting fair performance, was extremely close to the threshold for poor performance with respect to wheel-path faulting. Test section 190217 exhibited poor performance with respect to slab cracking. The performance trends of the Iowa SPS-2 test sections are summarized in Table 21 below.
