TPF-5(291) FINAL REPORT:

EVALUATING THE IMPACT OF NON-EXPERIMENTAL FACTORS ON PAVEMENT PERFORMANCE:

Task 3: Review of SPS-2 Early Failures

Prepared On Behalf Of:	Date	Project Number
State Pooled Fund Study TPF-5(291)	October 2021	56A0418-008 (TPF 5(291)) 219.03.10 (NCE)

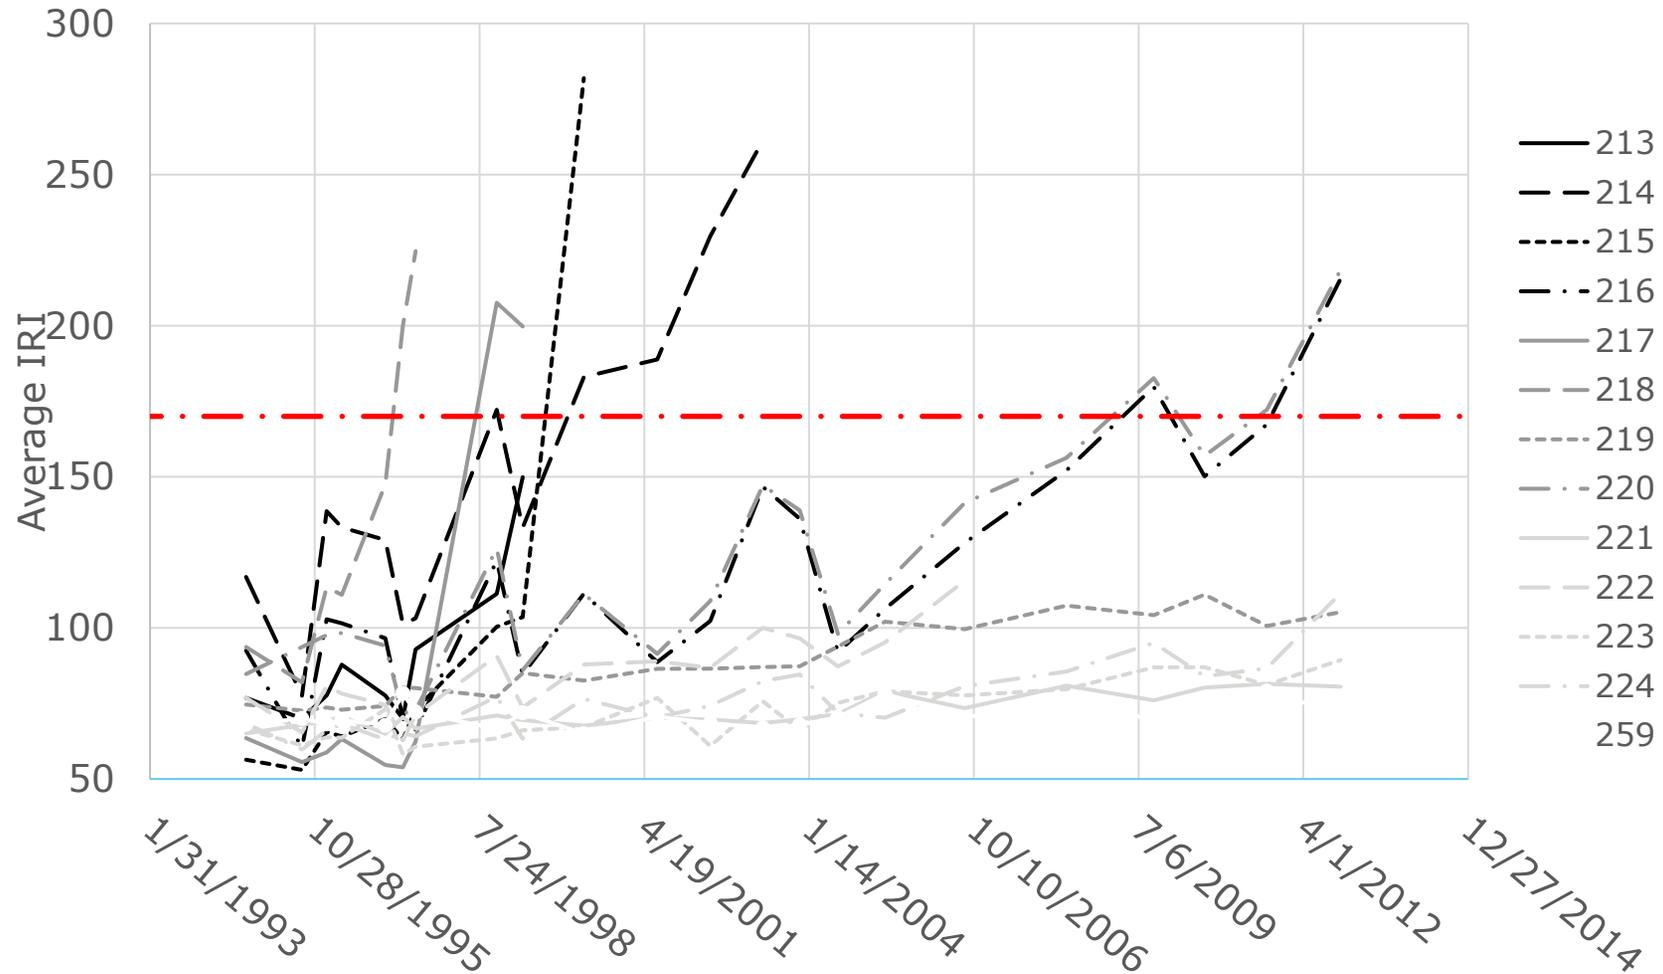
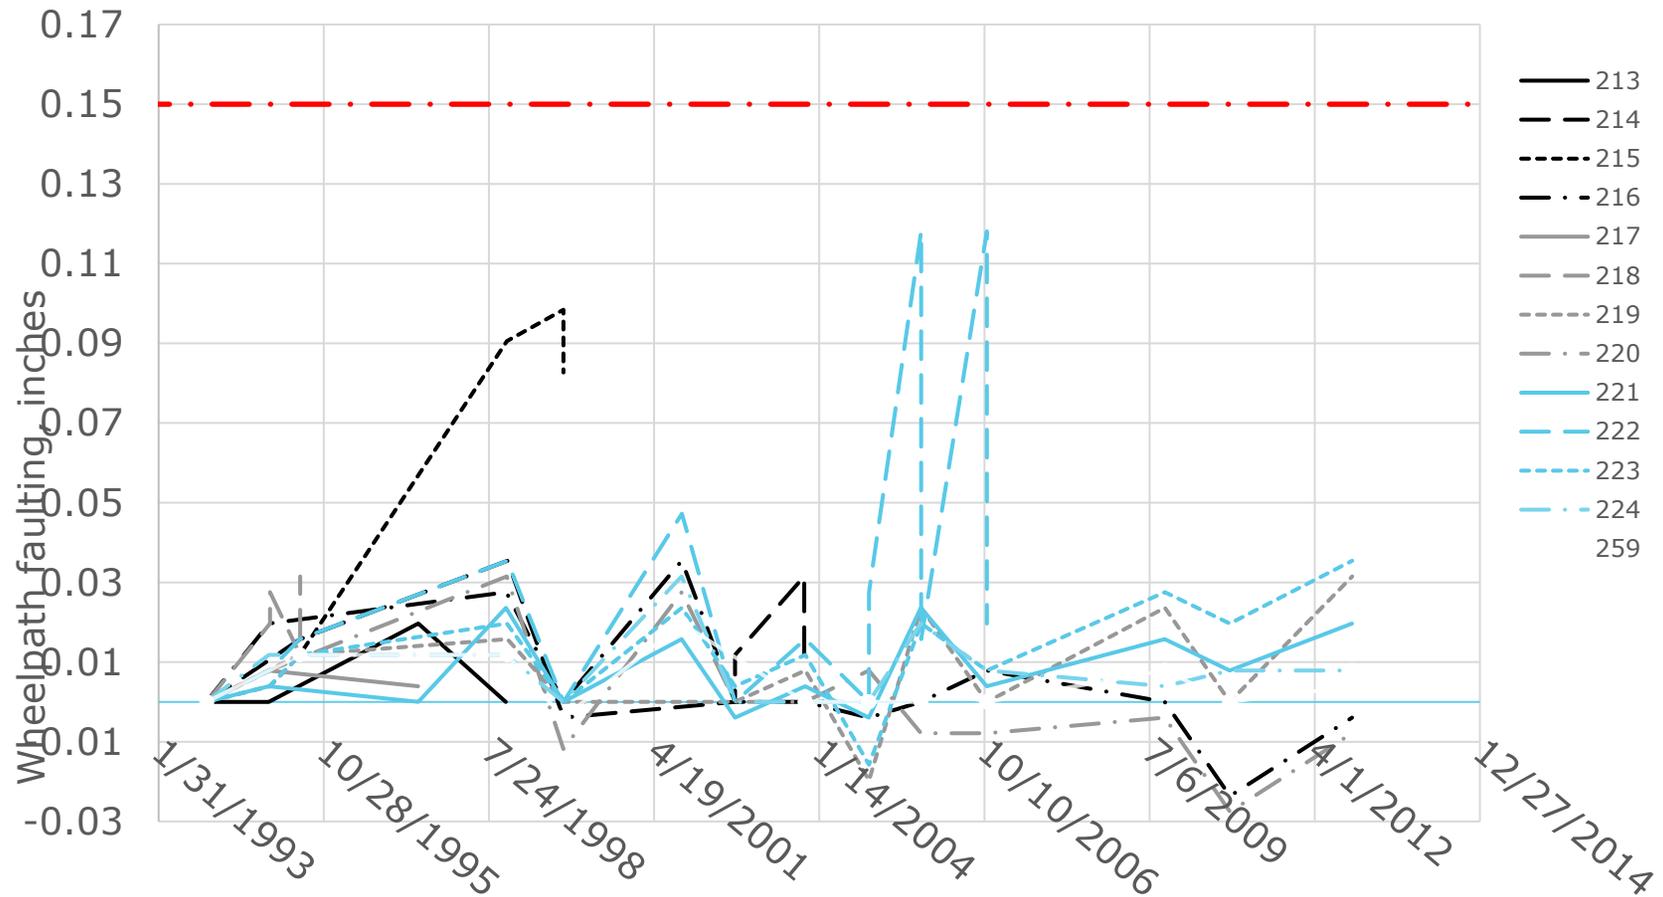
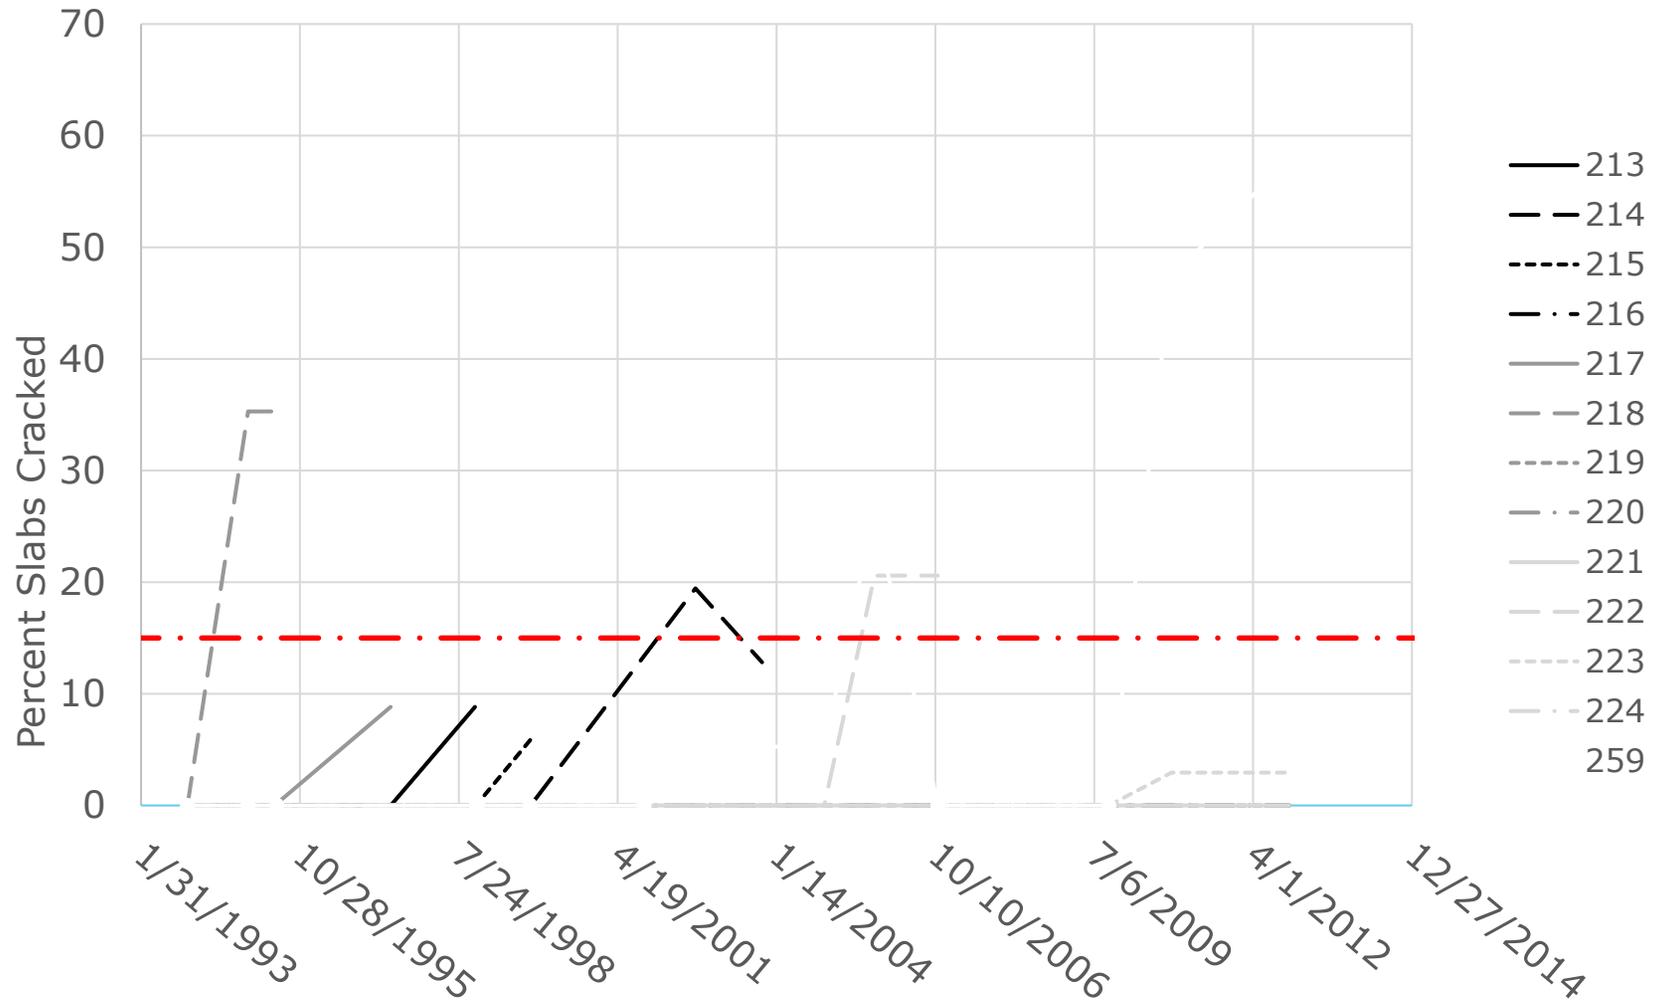
Test section 260214, 260215, 260216, 260217, 260218, and 260220 all exhibited poor performance with respect to roughness. It can also be seen that all test sections were well below the poor threshold for wheel-path faulting with test sections 260215 and 260222 exhibited the highest recorded level among the test sections. Test sections 260214, 260218, 260222 and 260259 exhibited poor performance with respect to slab cracking. Summarized performance trends of the Michigan SPS-2 test sections are given in Table 31 below.

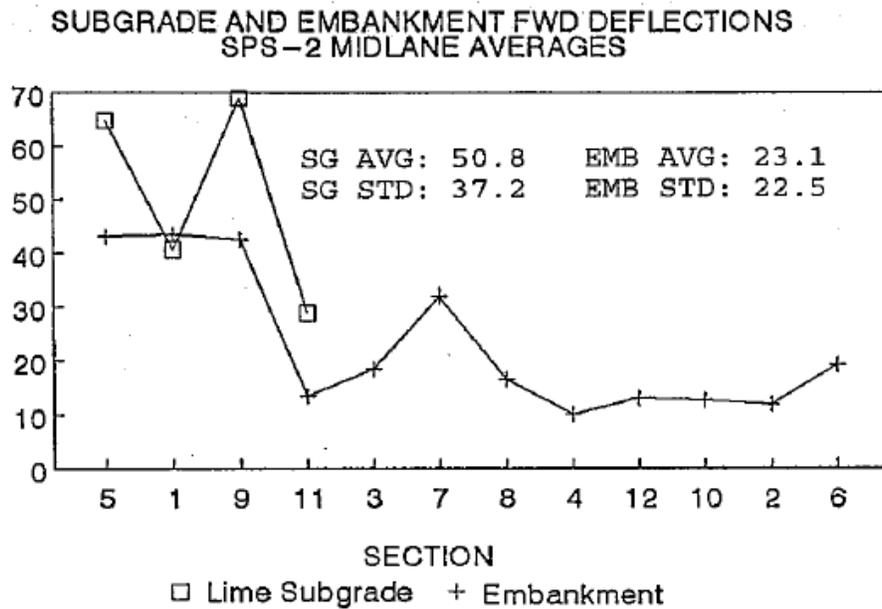
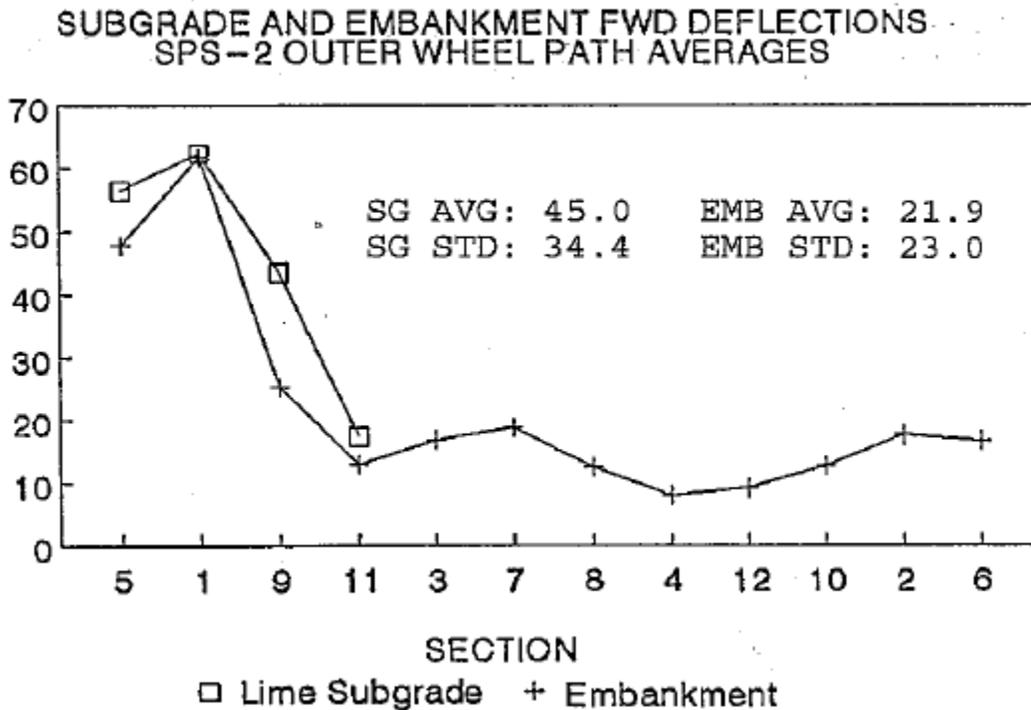
FWD testing was then conducted on the outer wheel-path and midlane for the stabilized subgrade and embankment prior to the placement of the pavement layers. The results from this FWD testing are reproduced in Figure 25 and Figure 26. These figures show that despite the stabilization, there were still substantial deflections detected in test sections 320205, 320201, and 320209.

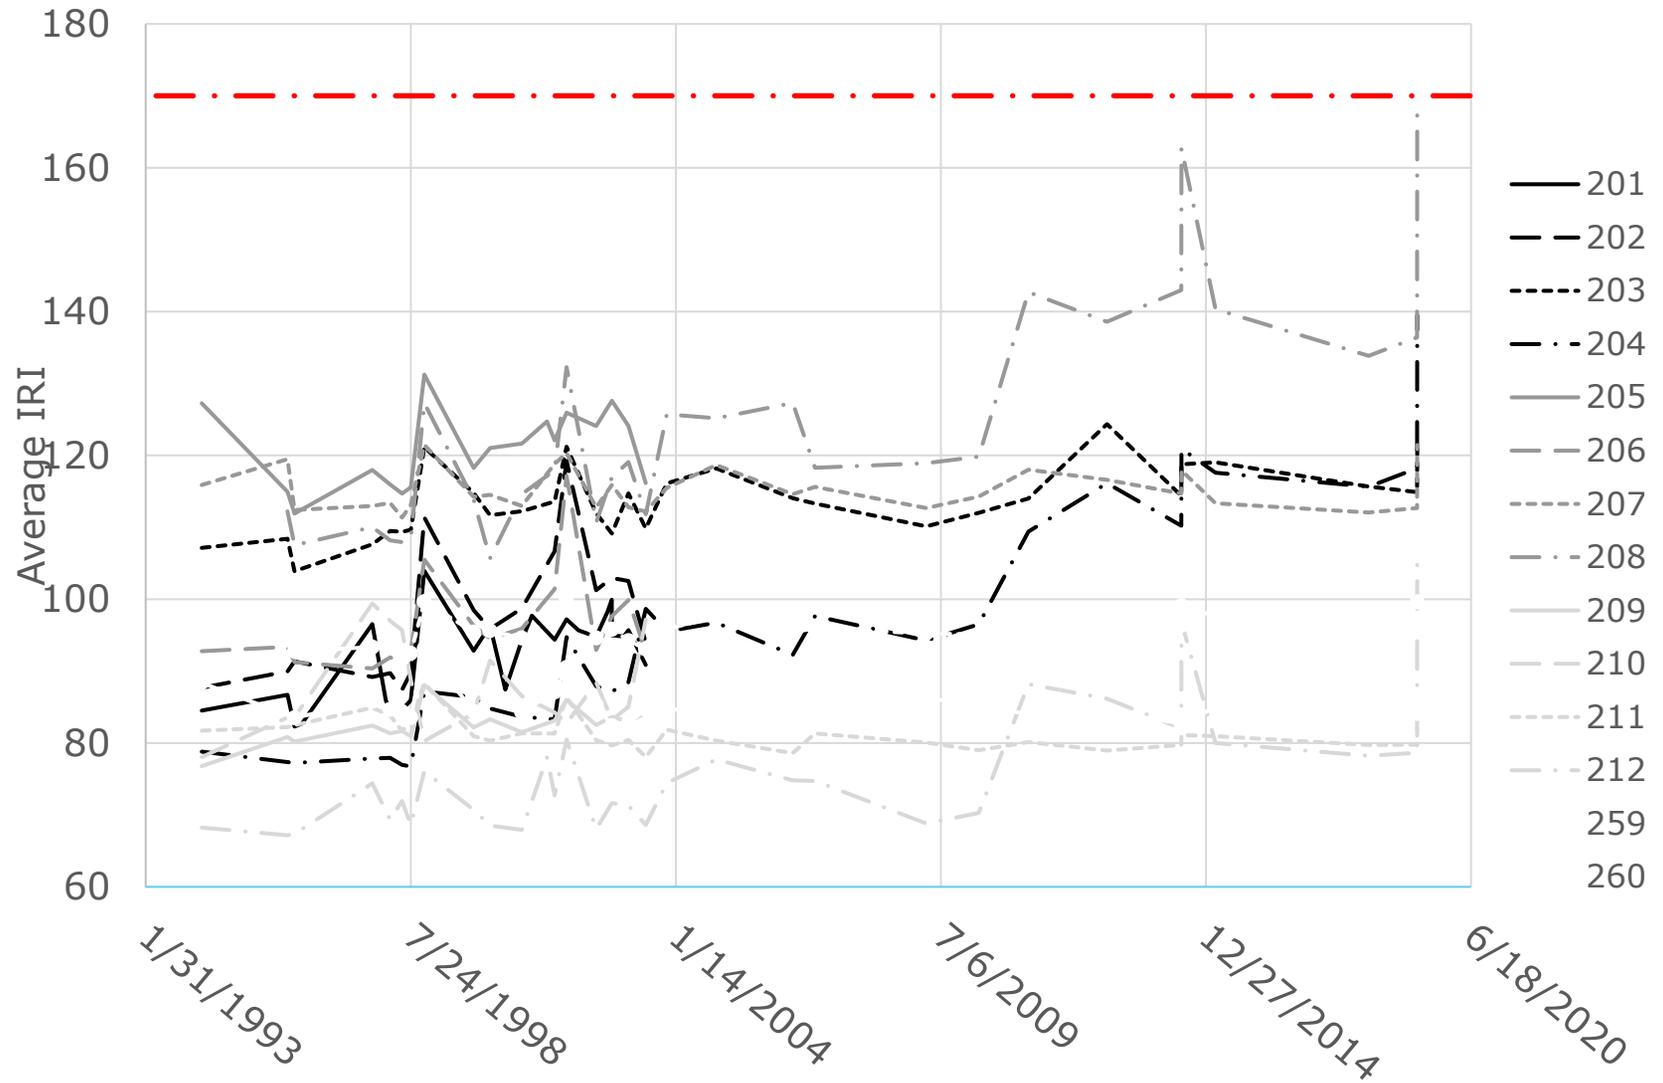
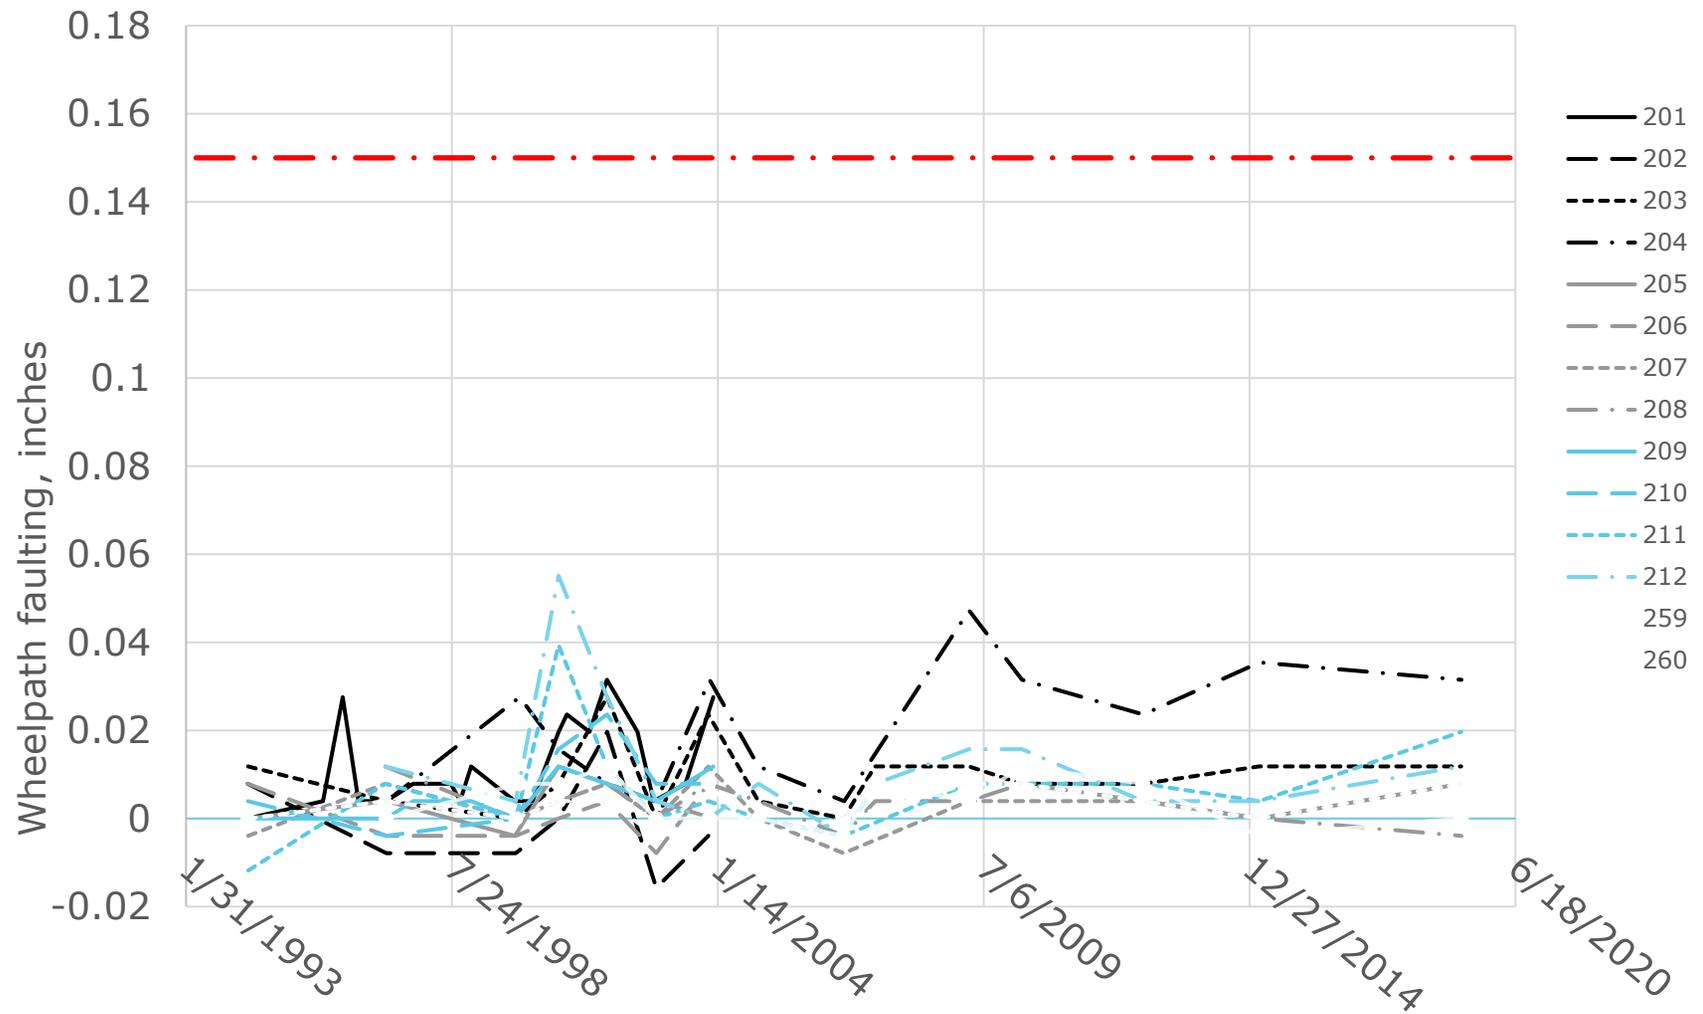
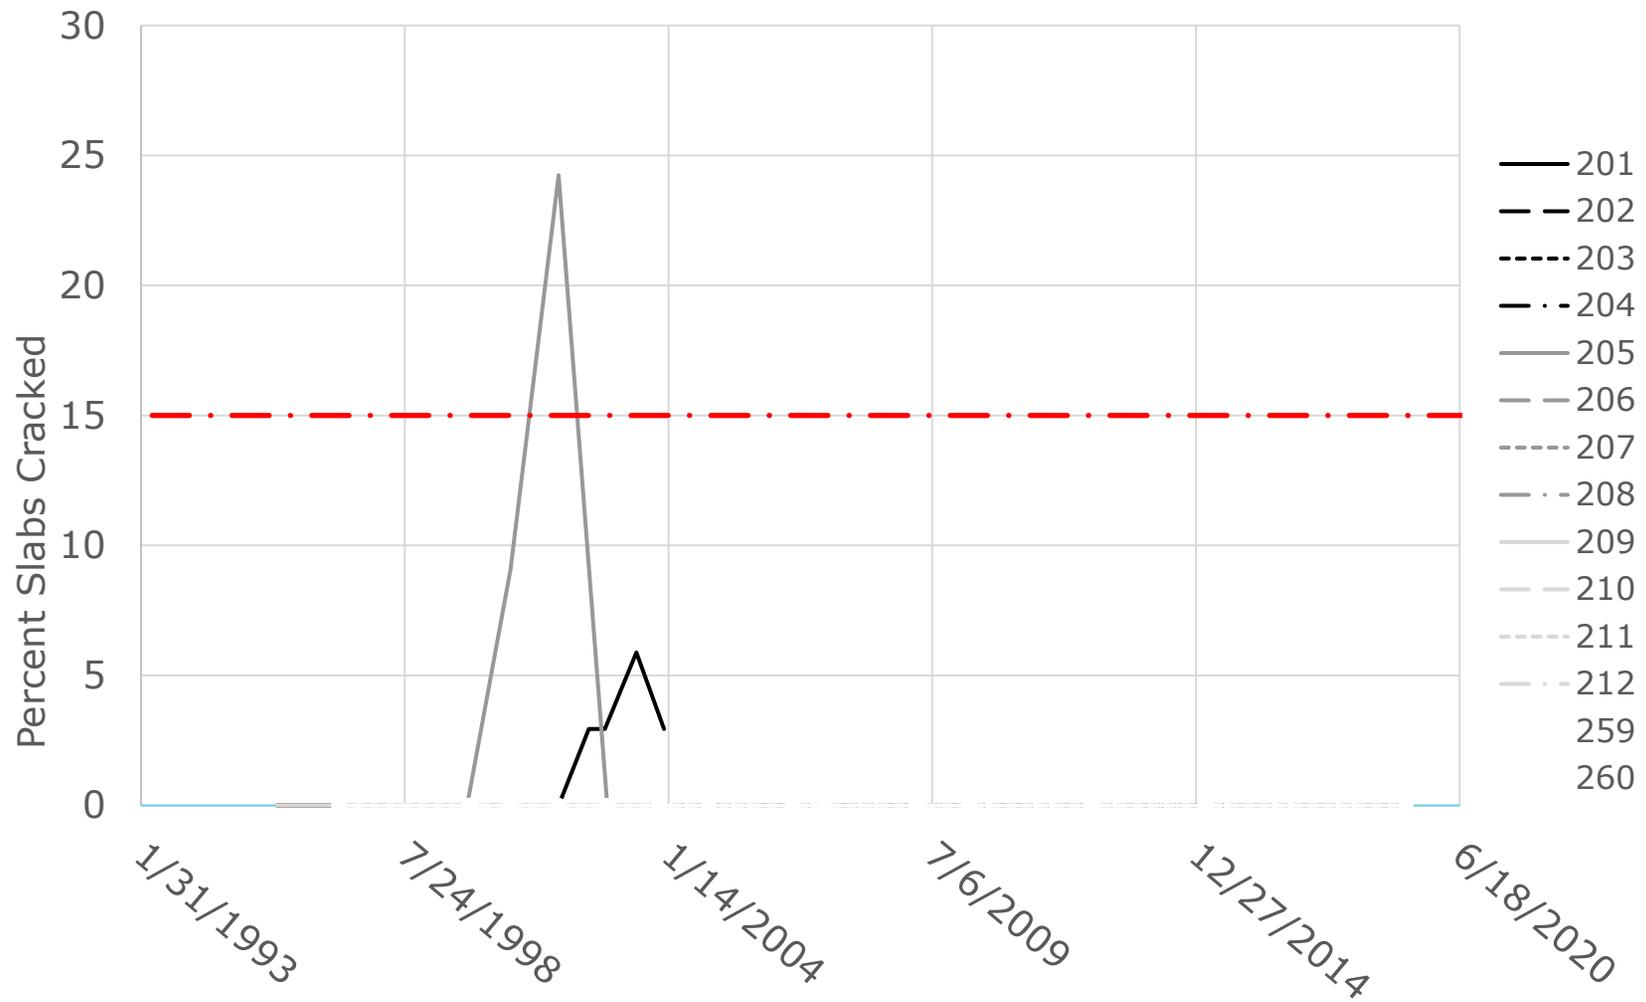
The test sections are generally performing well. Only test section 370208 exhibited poor performance with respect to surface roughness. No test sections exhibited poor performance with respect to wheel-path faulting, with all rated as having good performance. Only test section 370205 exhibited poor performance with respect to slab cracking, whereas all other test sections exhibited good ratings. A table of summarized performance trends of the test sections is given in Table 43.

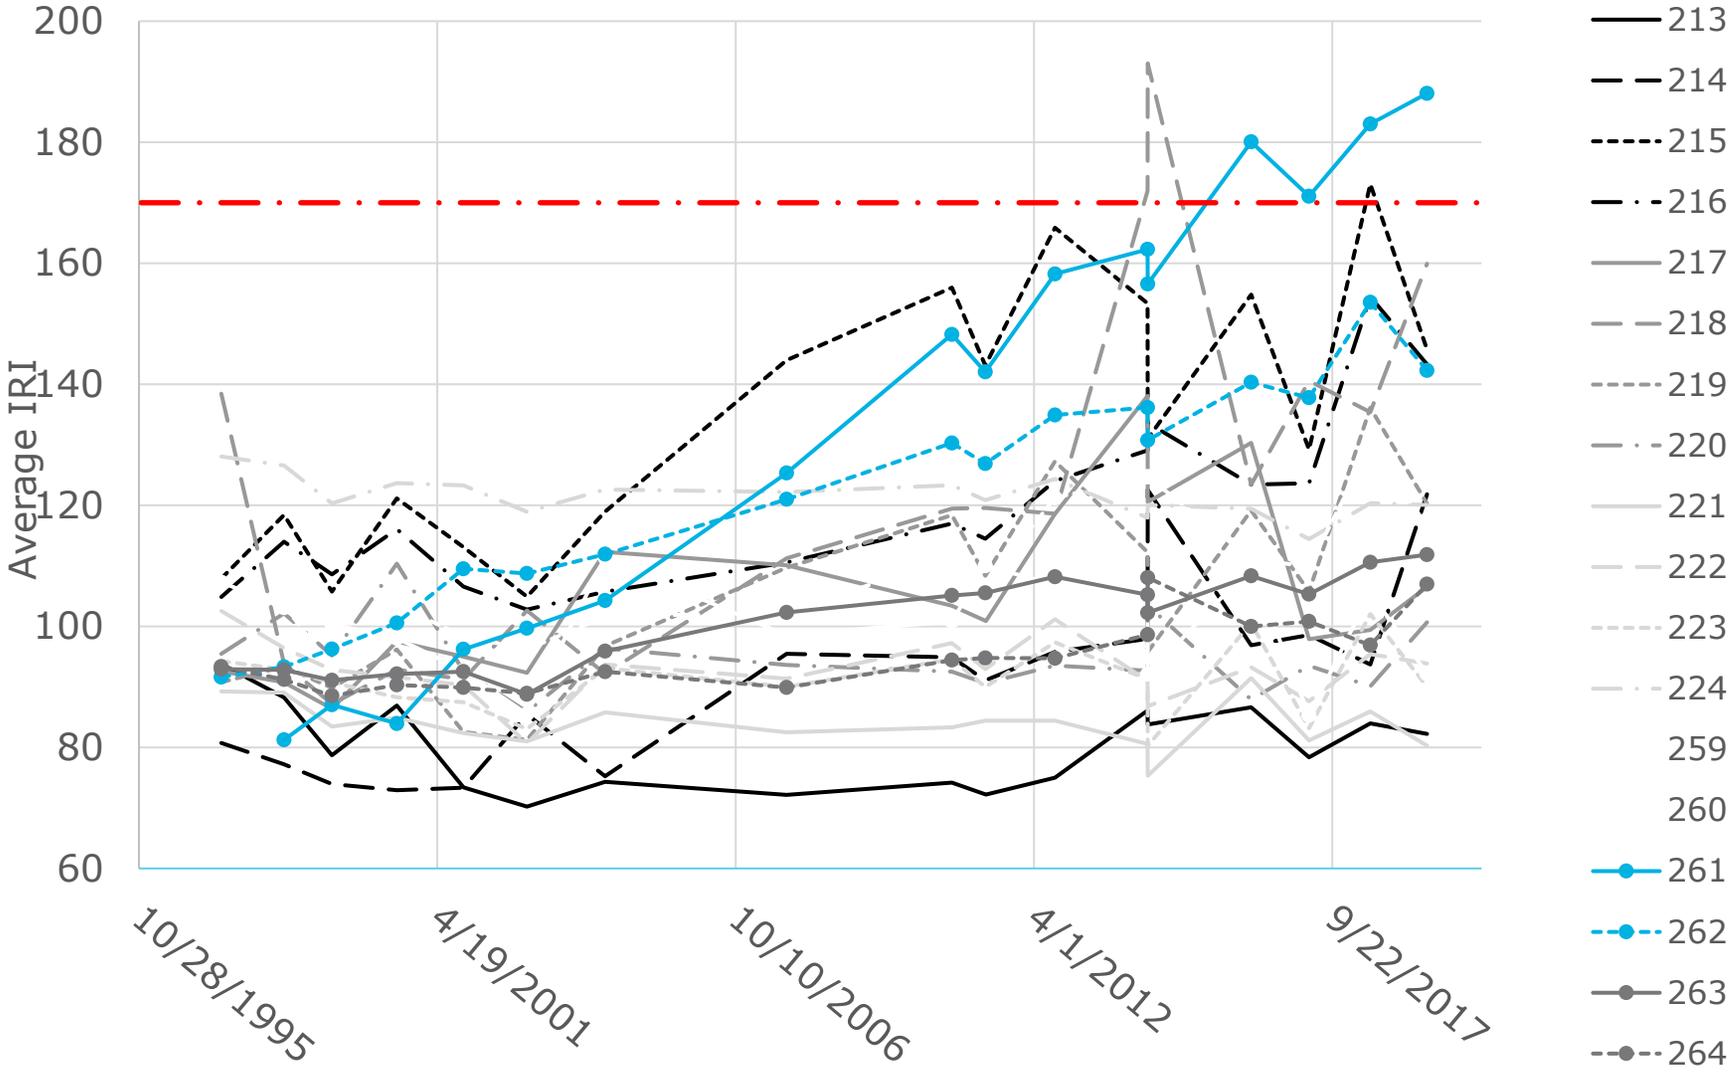
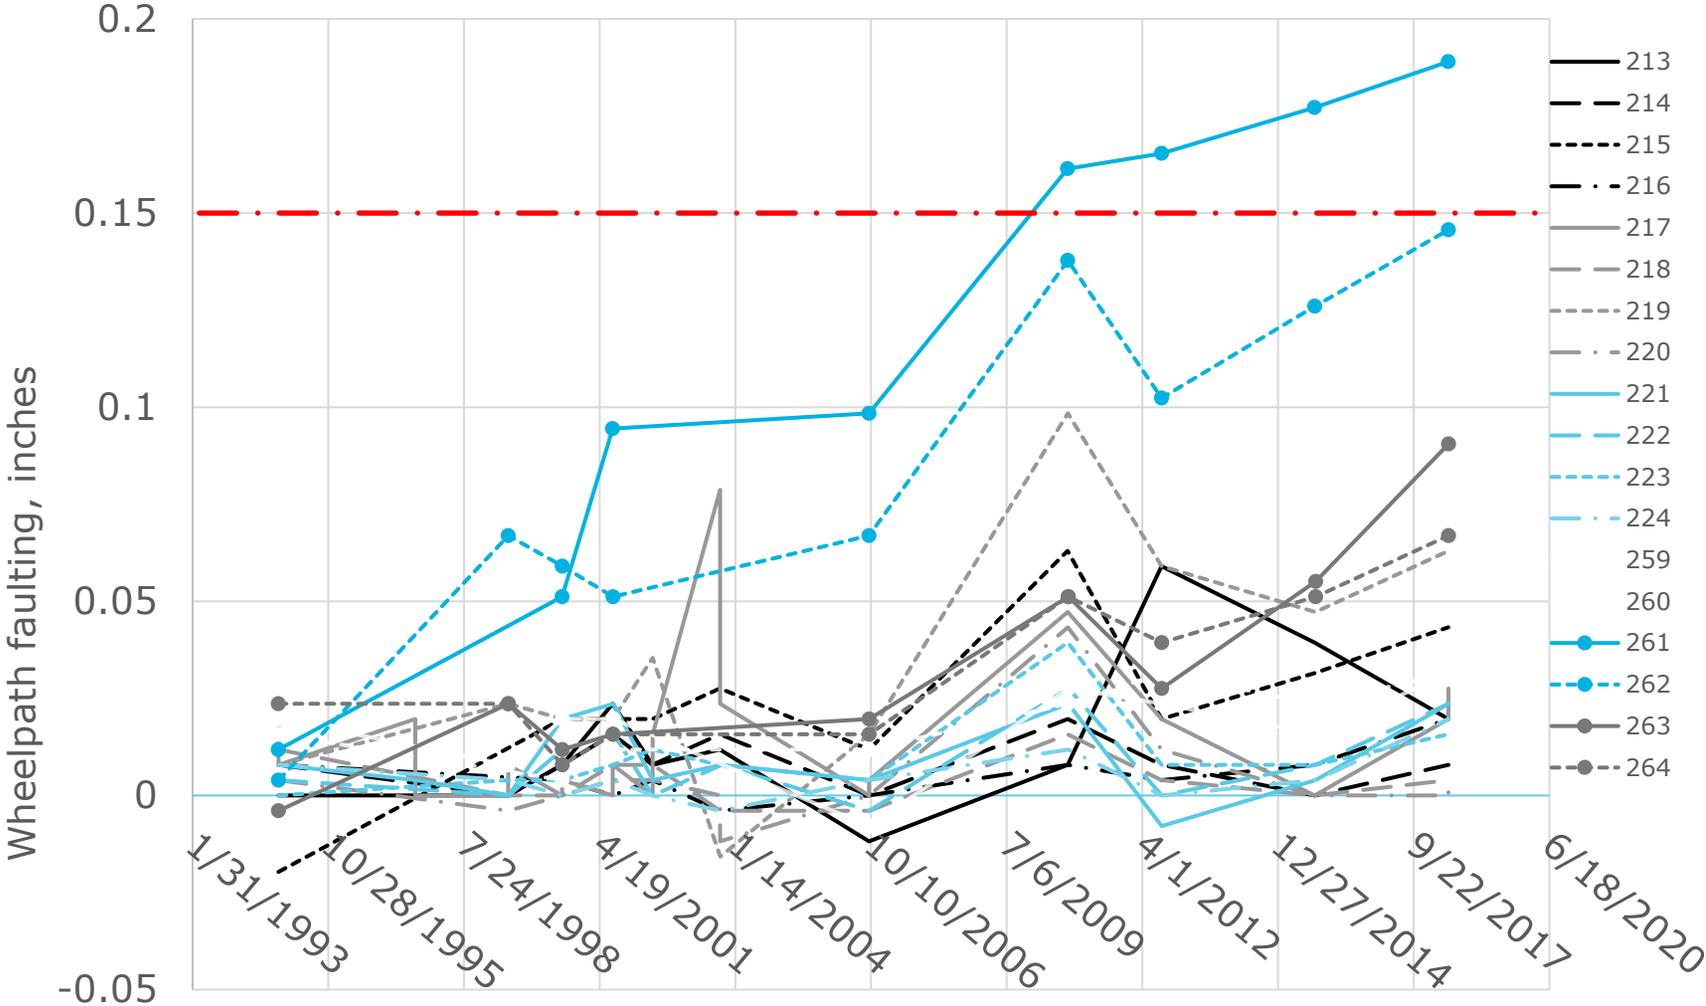
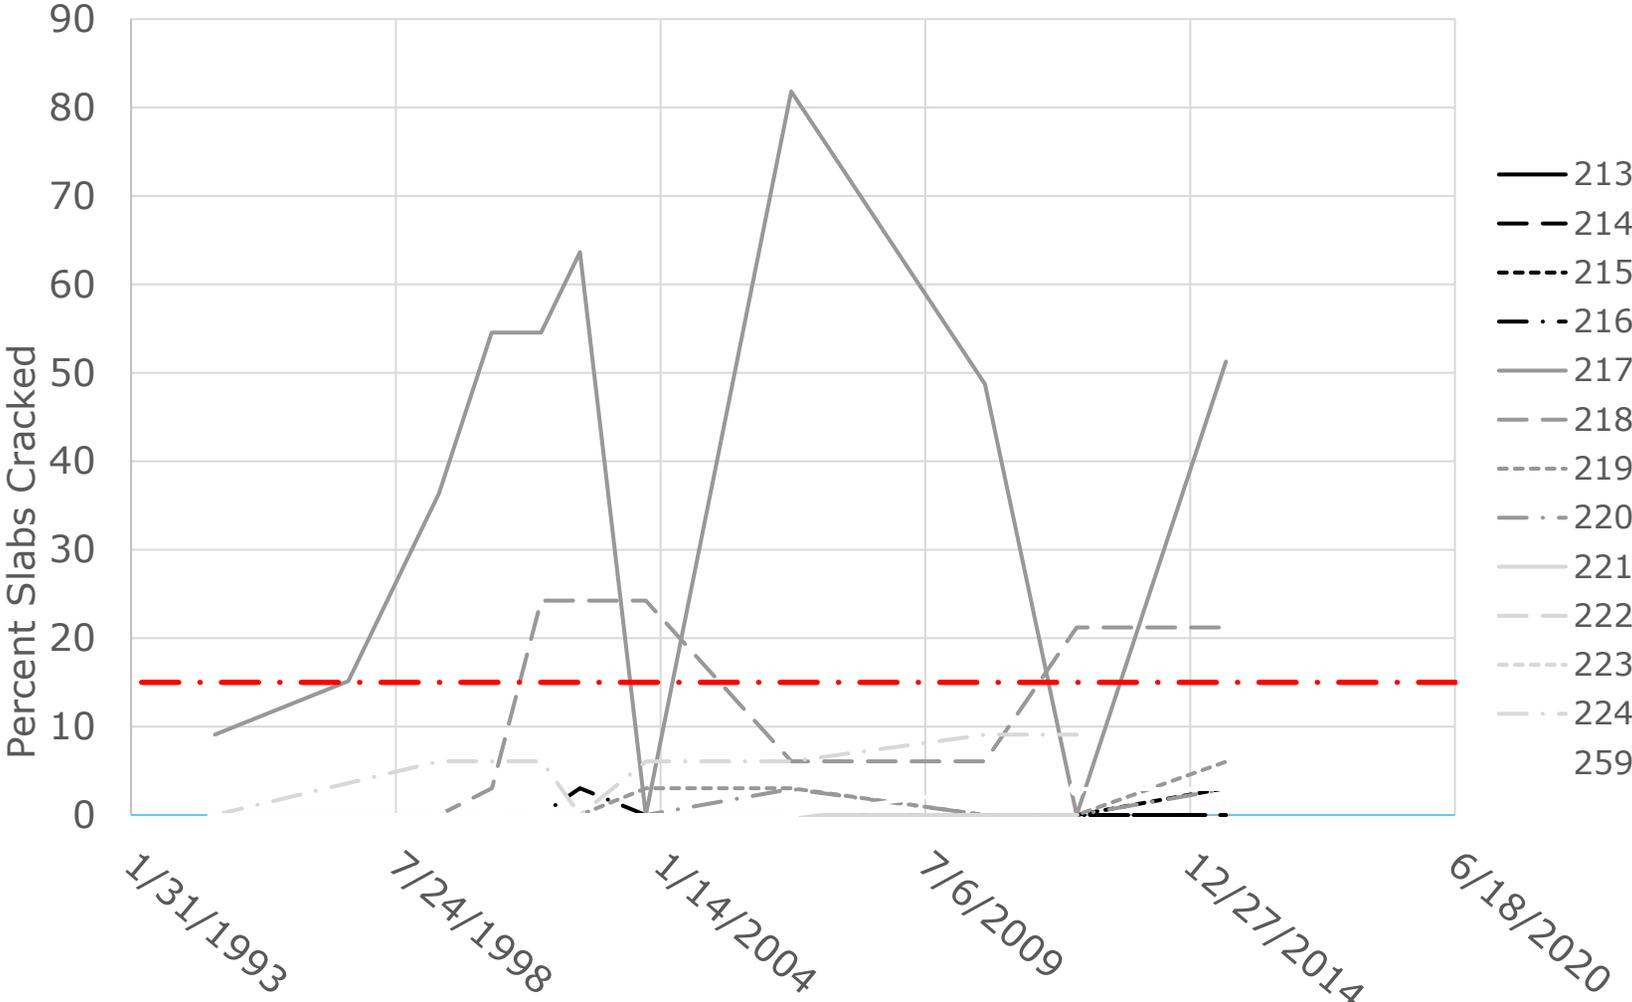
Most test sections experienced heightened surface roughness with three test sections, 380215, 380218, and 380261 exhibiting poor levels of performance with respect to surface roughness. Test section 380262 experienced poor performance with respect to wheel-path faulting and test section 380261 was very near to the threshold. Most other test sections experienced very low levels of wheel-path faulting. Test sections 380217 and 380218 were the only test sections that exhibited poor performance with respect to cracking while most other test sections exhibited good performance with respect to slab cracking. Test section 380217 exhibited by far the highest level of slab cracking of all test sections. A summarized table of test section performance is given in Table 36.

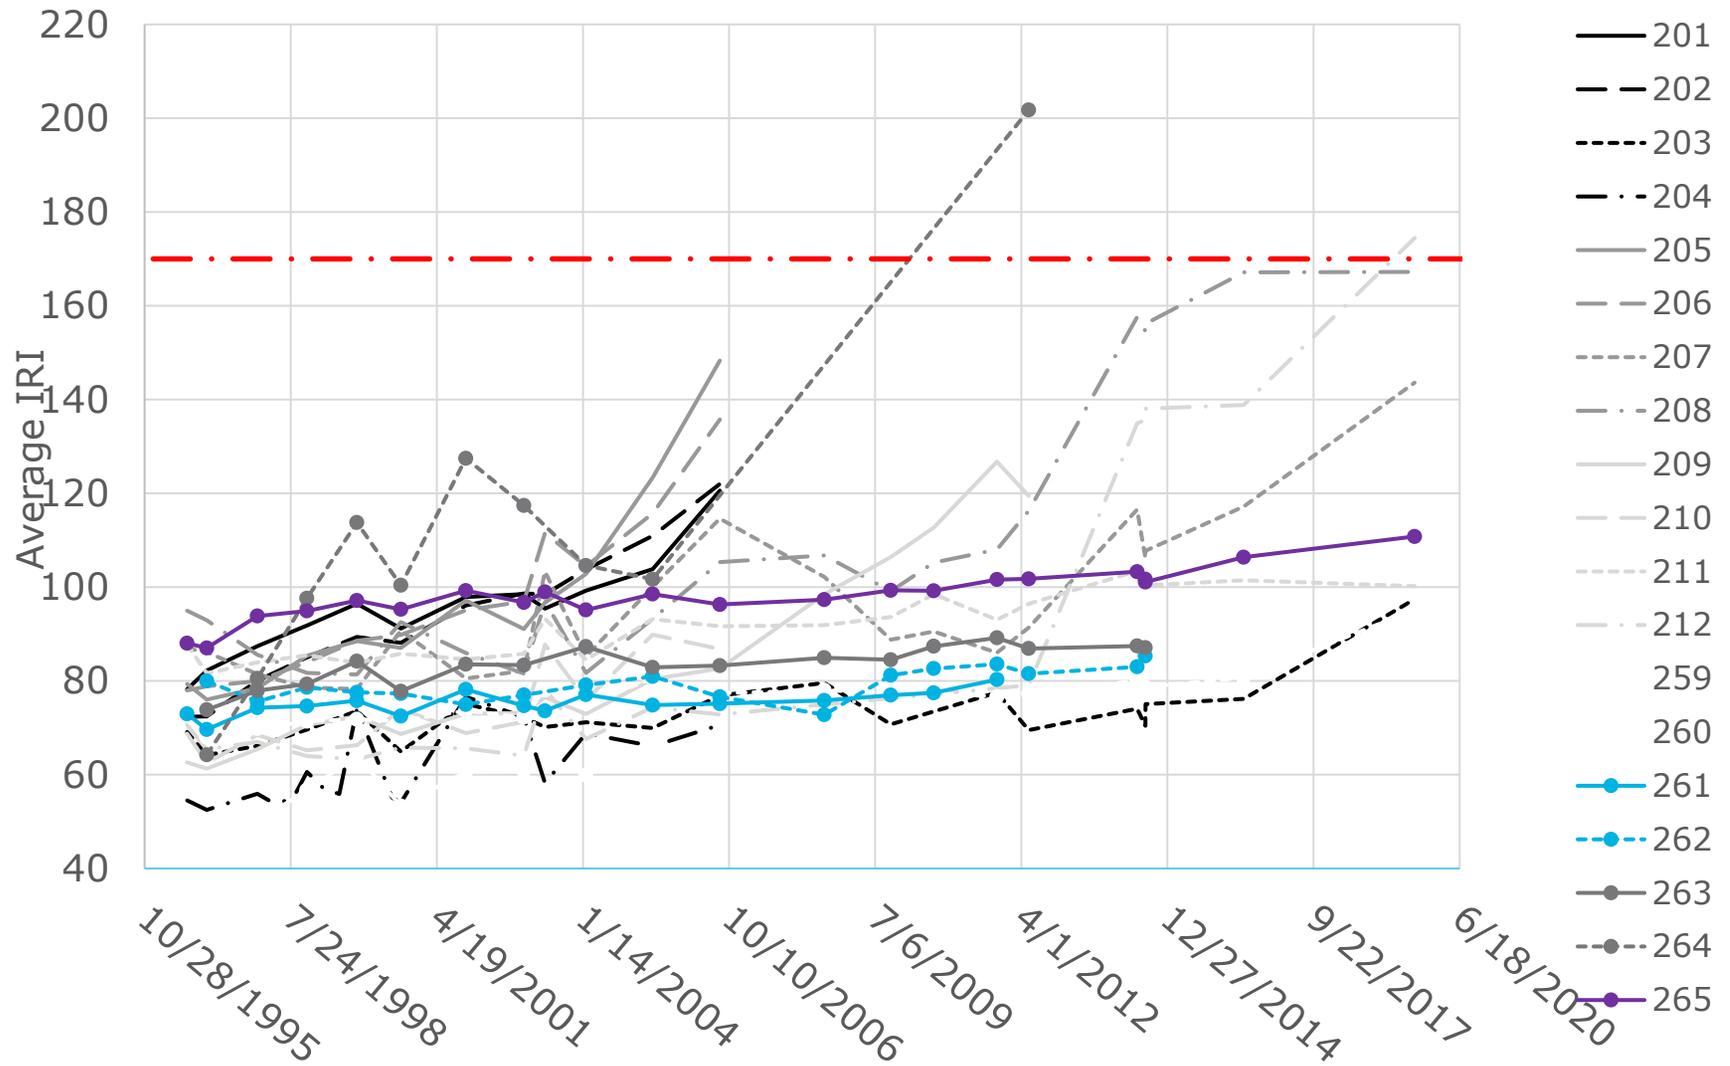
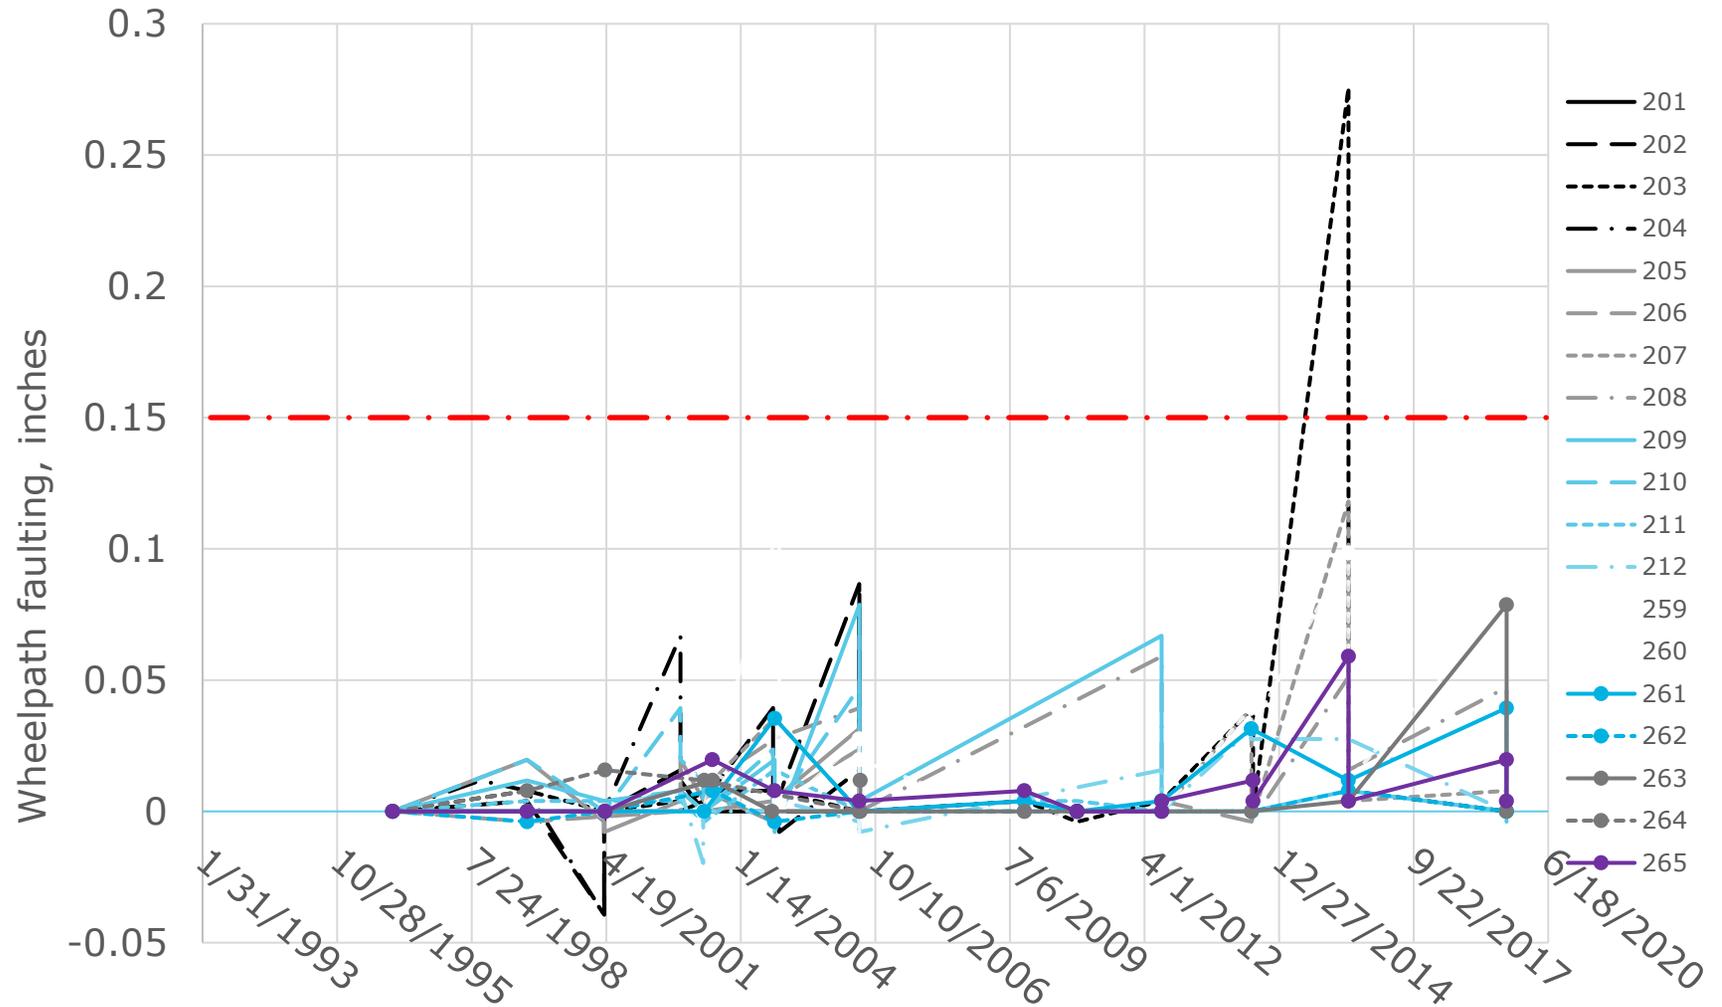
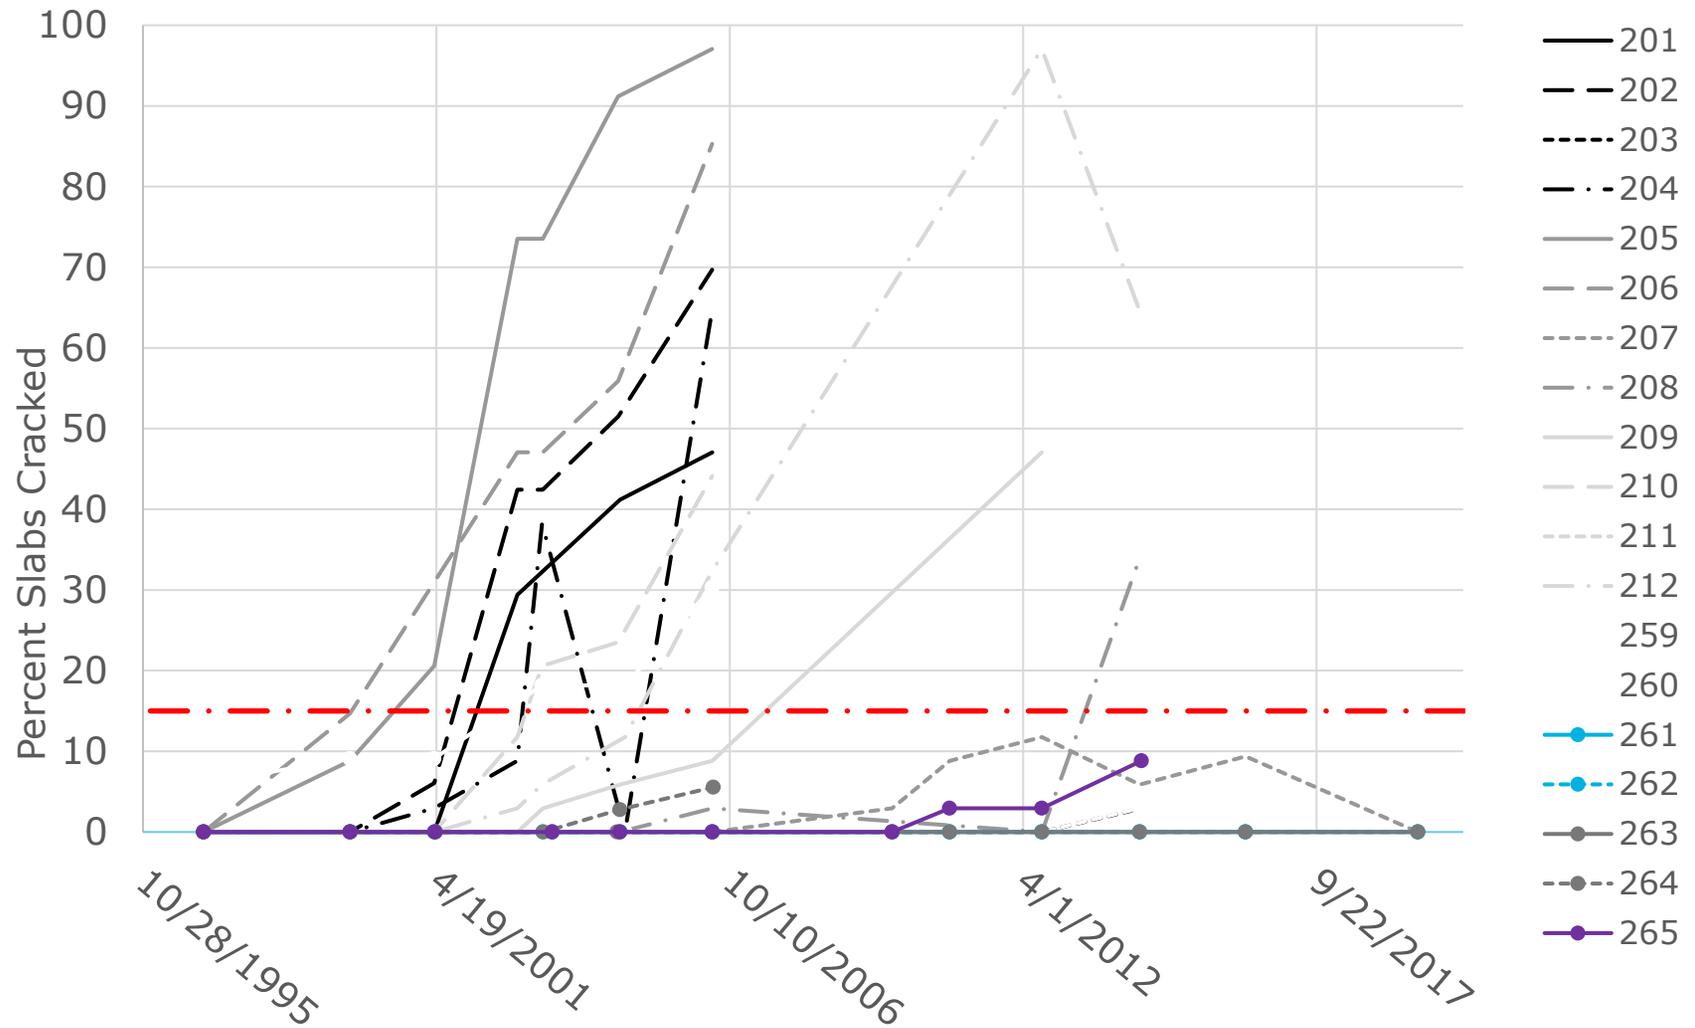
Test sections 390212 and 390264 exhibited poor levels of surface roughness while test section 390208 was just immediately below the threshold. Only test section 390203 exhibited poor performance with respect to wheel-path faulting. Most test sections exhibited poor performance with respect to slab cracking and most test sections exhibited excessive slab cracking within nine years of construction. Test sections 390201, 390202, 390204, 390205, 390206, 390208, 390209, 390210, 390212, and 390259 all exhibited poor performance with respect to slab cracking. A summarized overview of these performance trends is given in Table 53.
