TPF-5(291) FINAL REPORT:

EVALUATING THE IMPACT OF NON-EXPERIMENTAL FACTORS ON PAVEMENT PERFORMANCE:

Task 3: Review of SPS-2 Early Failures

Prepared On Behalf Of:	Date	Project Number
State Pooled Fund Study TPF-5(291)	October 2021	56A0418-008 (TPF 5(291)) 219.03.10 (NCE)

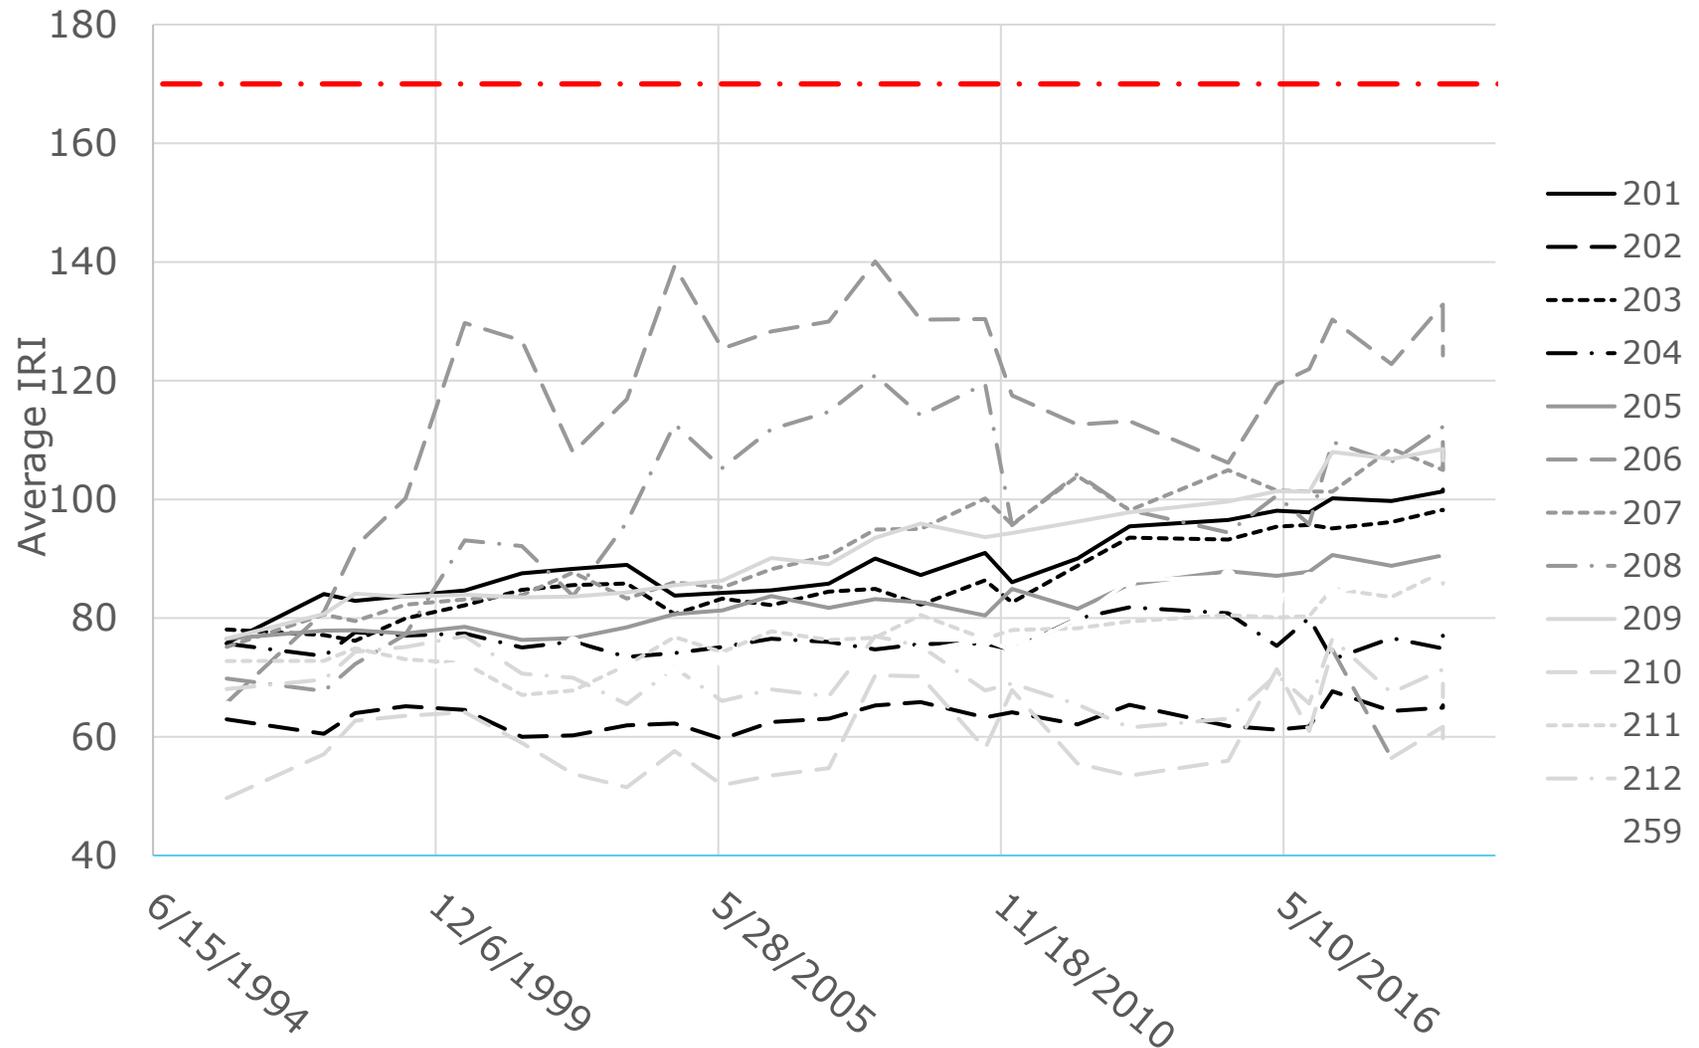
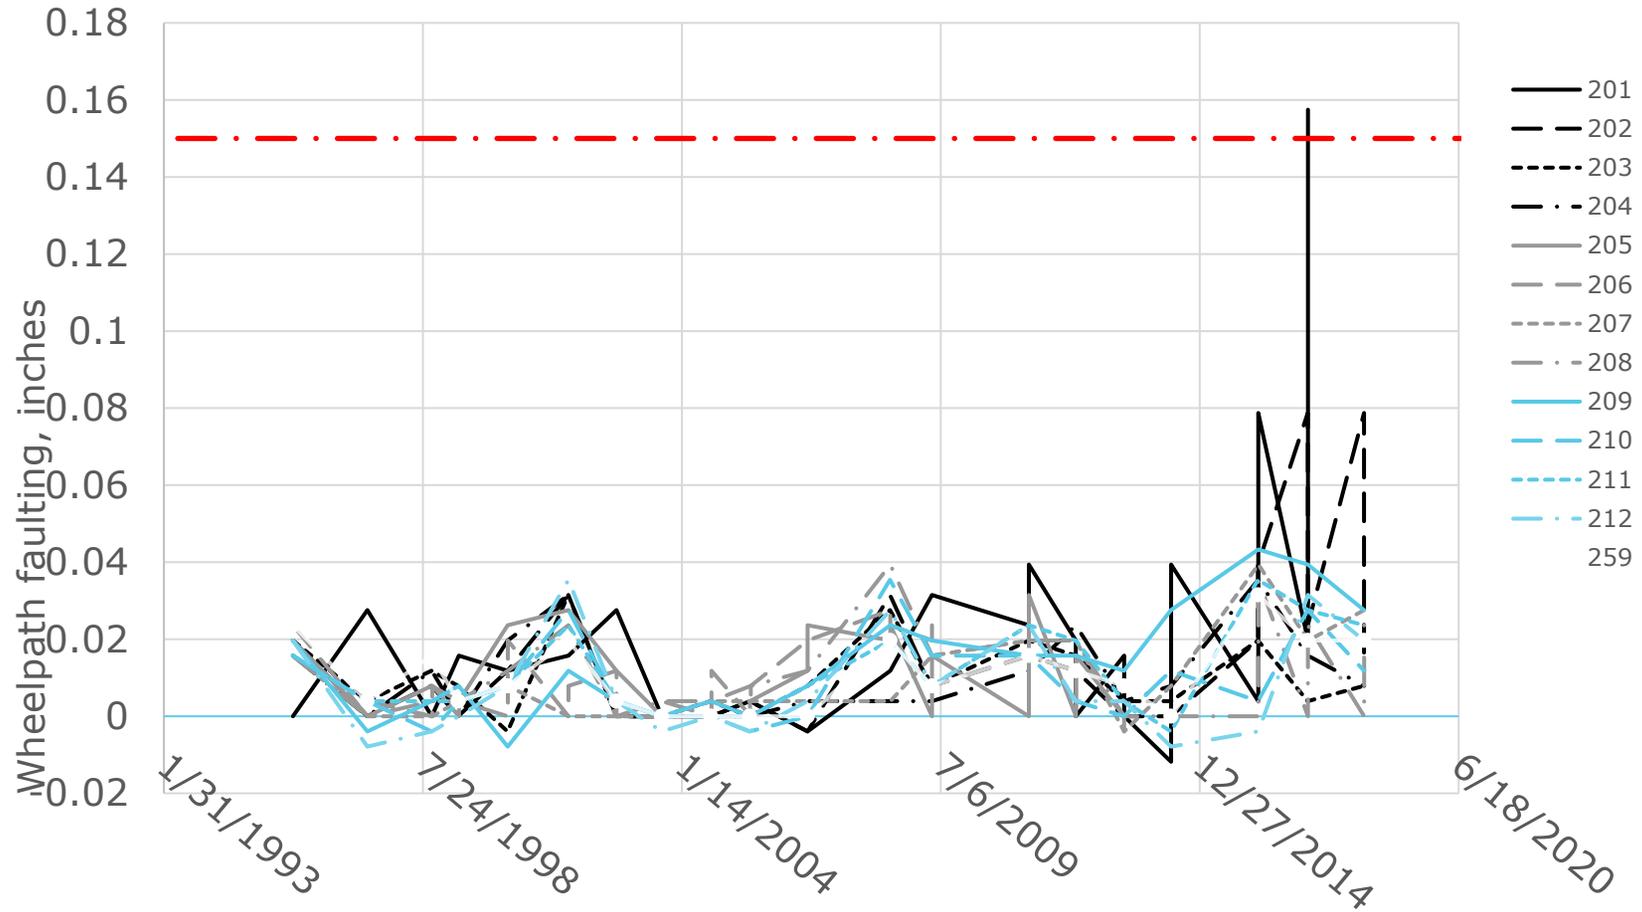
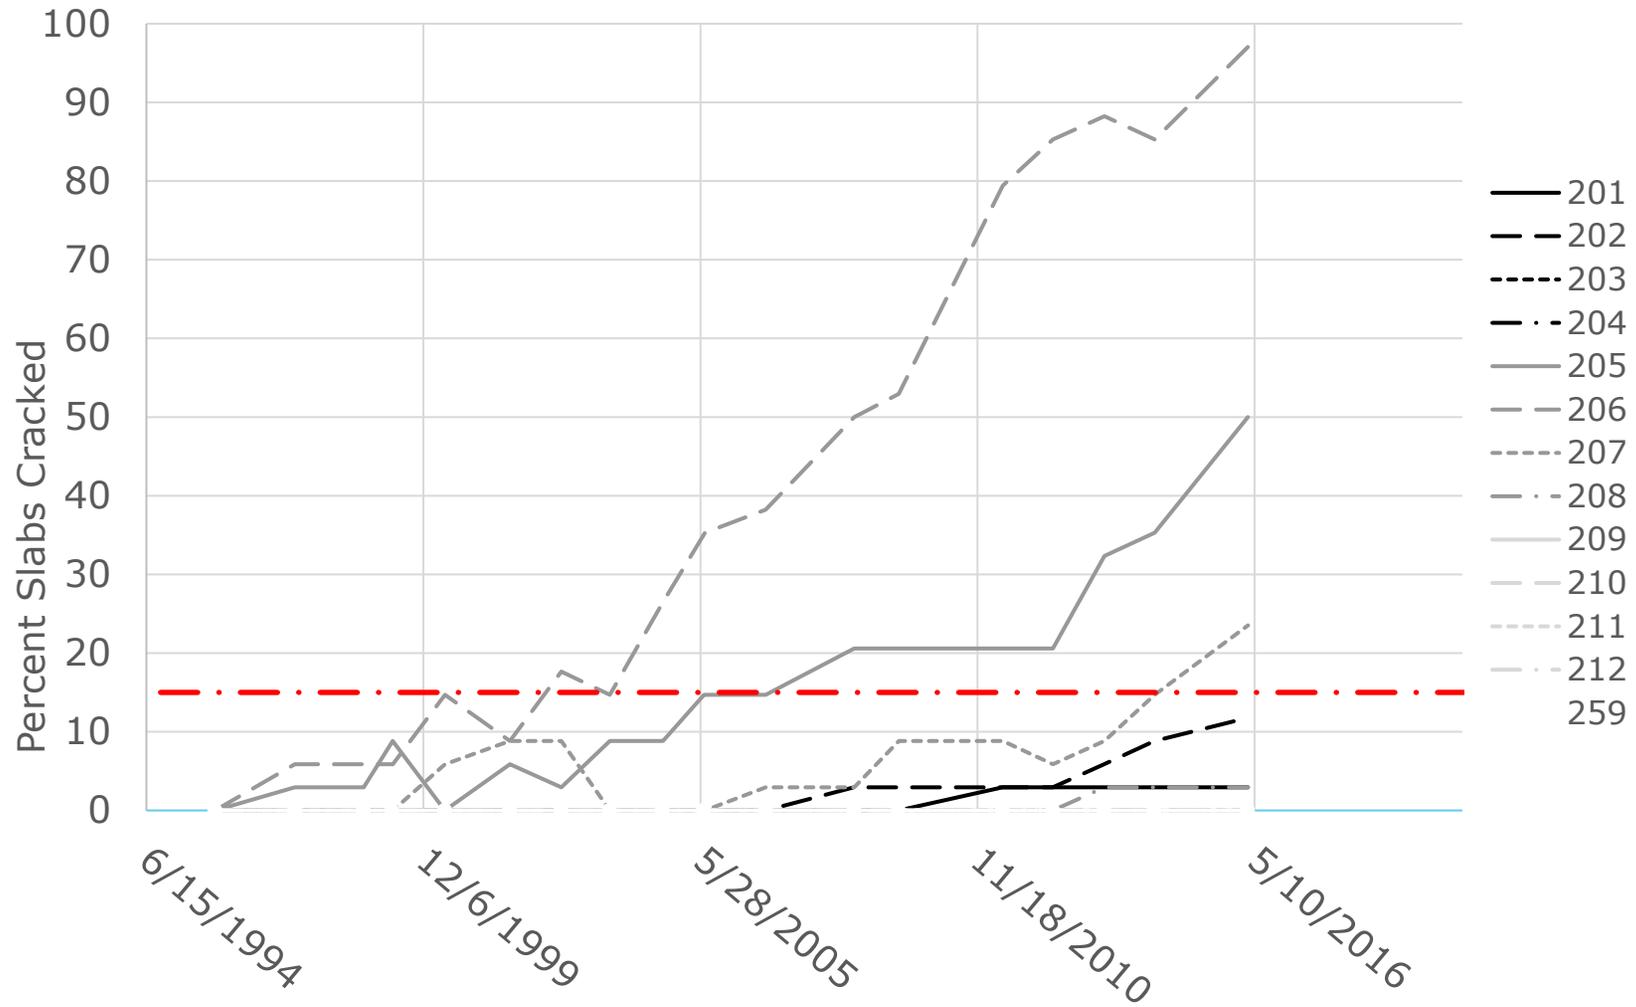
None of the Washington test sections exhibited poor performance with respect to surface roughness and only 1 test section (530201) experienced poor levels of wheel-path faulting while all other test sections had relatively low levels of wheel-path faulting. Test sections 530205, 530206, and 530207 all exhibited poor performance with respect to slab cracking with test section 530207 exhibiting poor slab cracking performance within 8 years of initial construction. Summarized performance trends of the Washington test sections are given in Table 57.

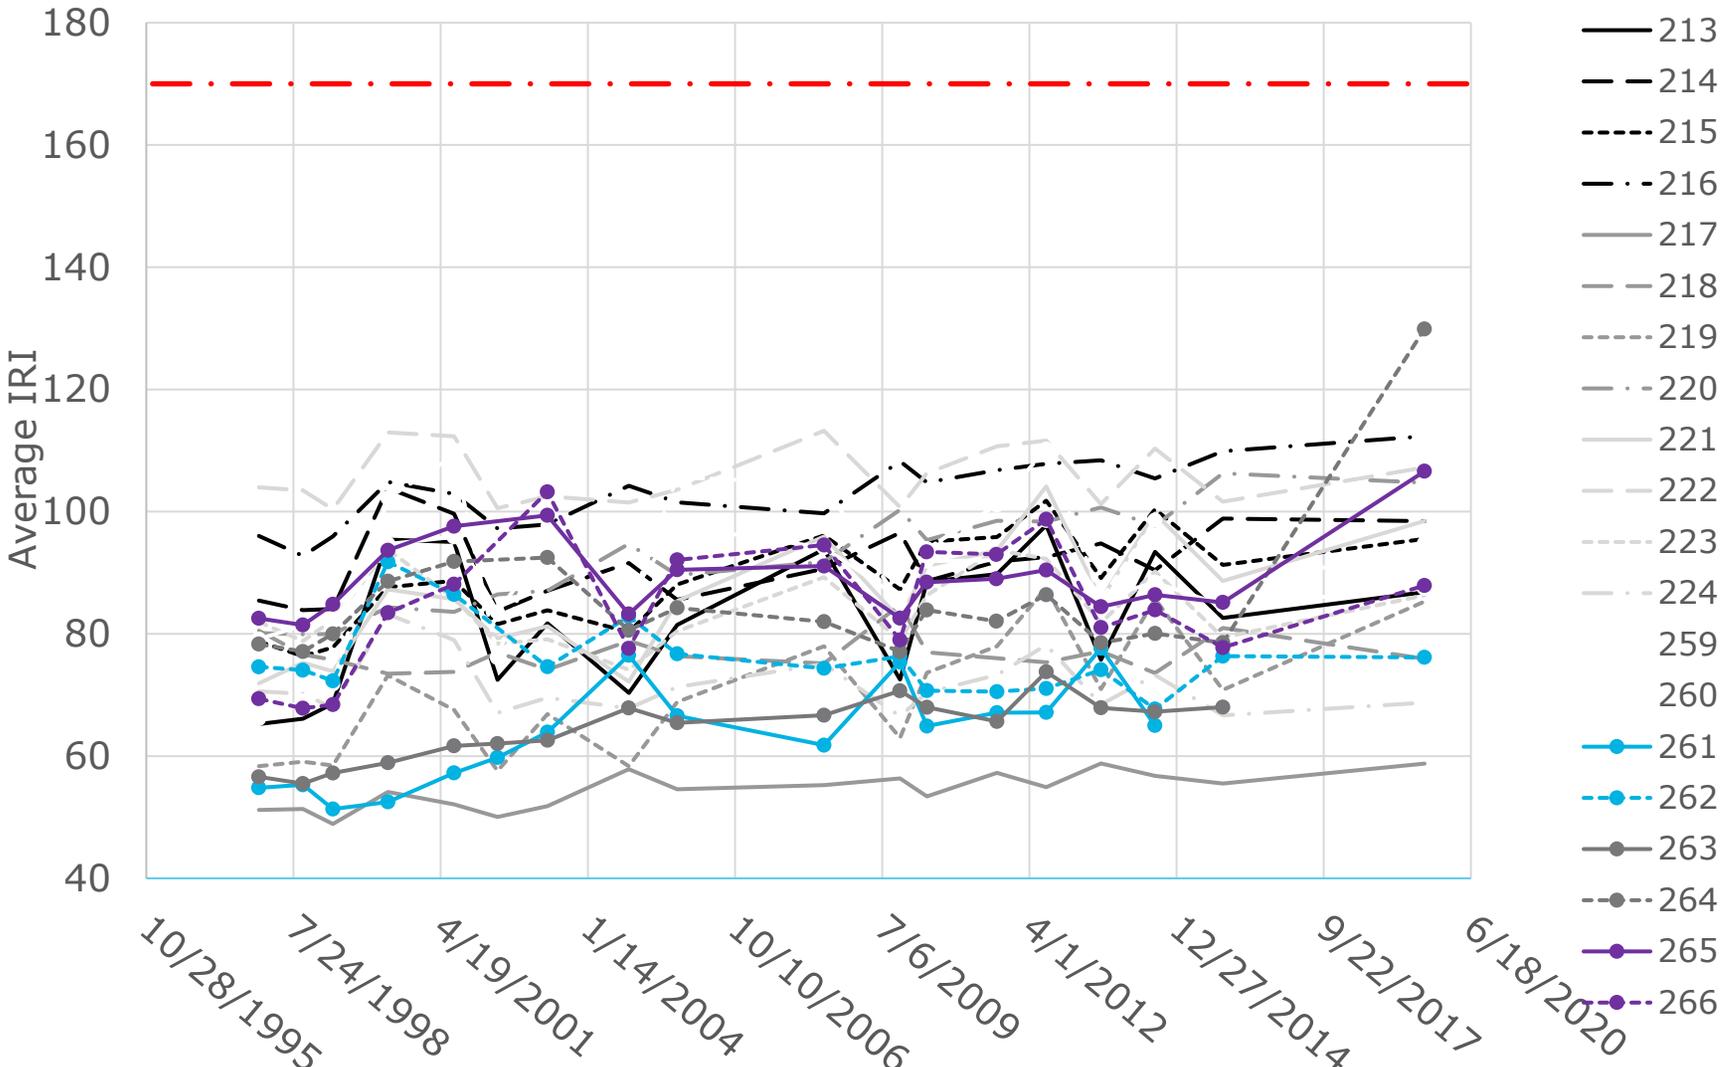
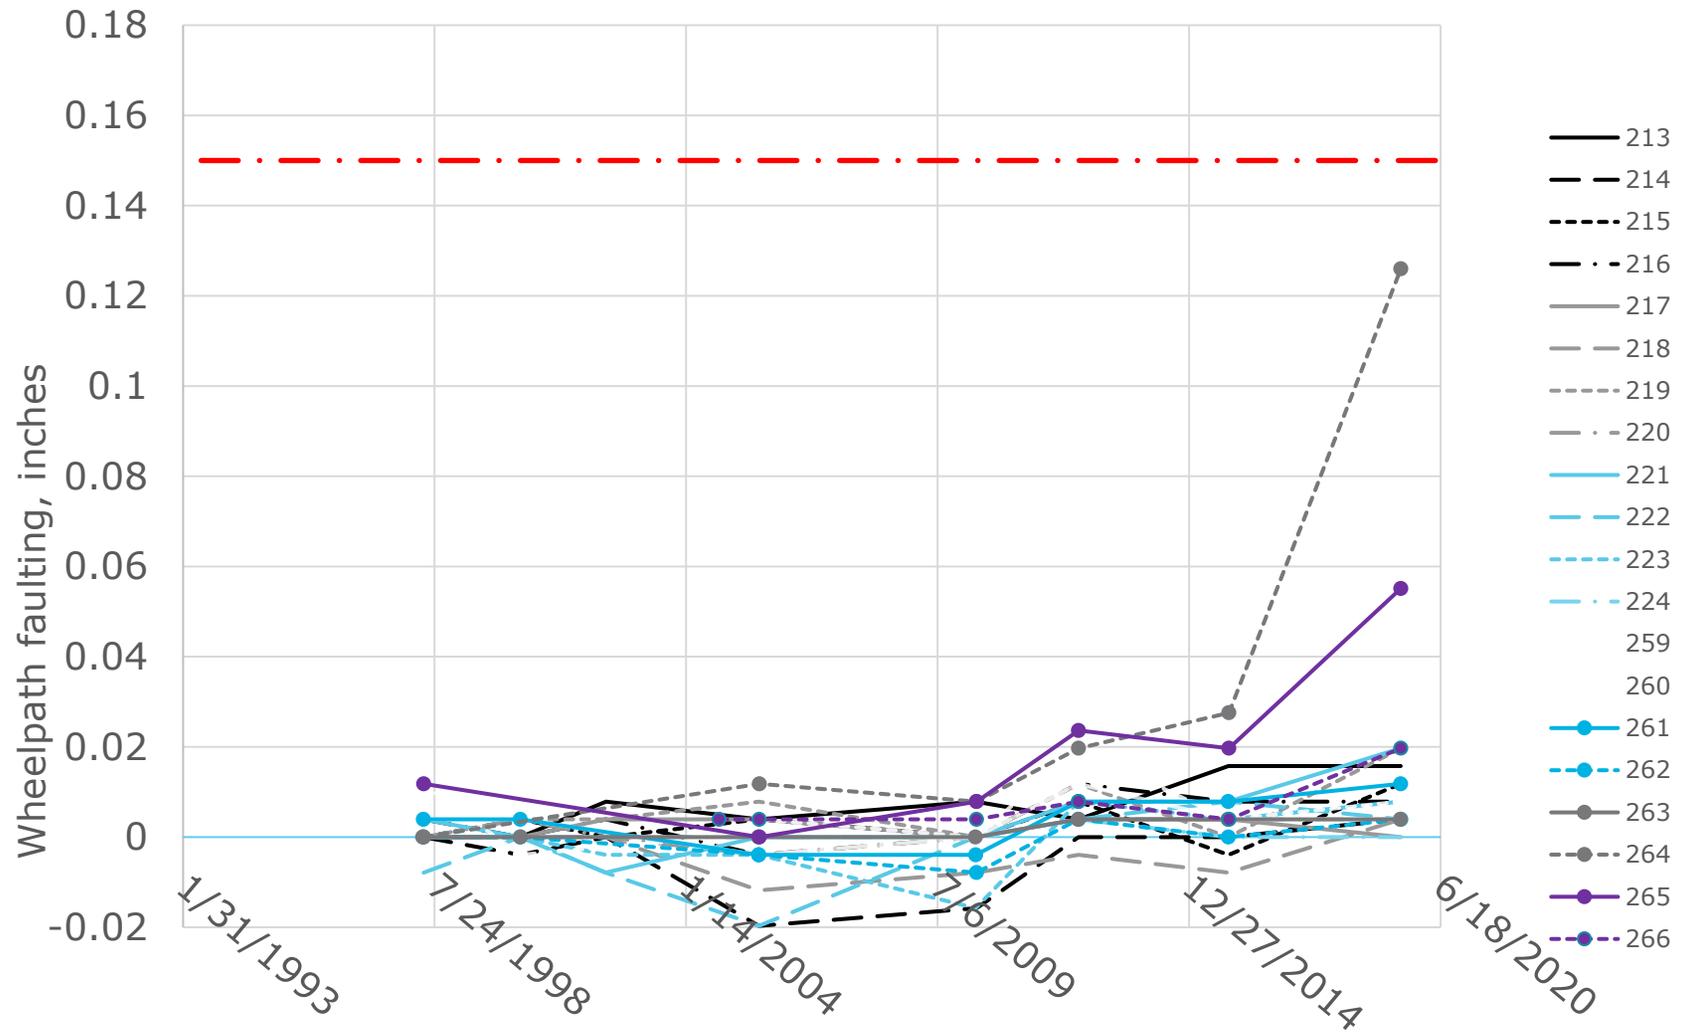
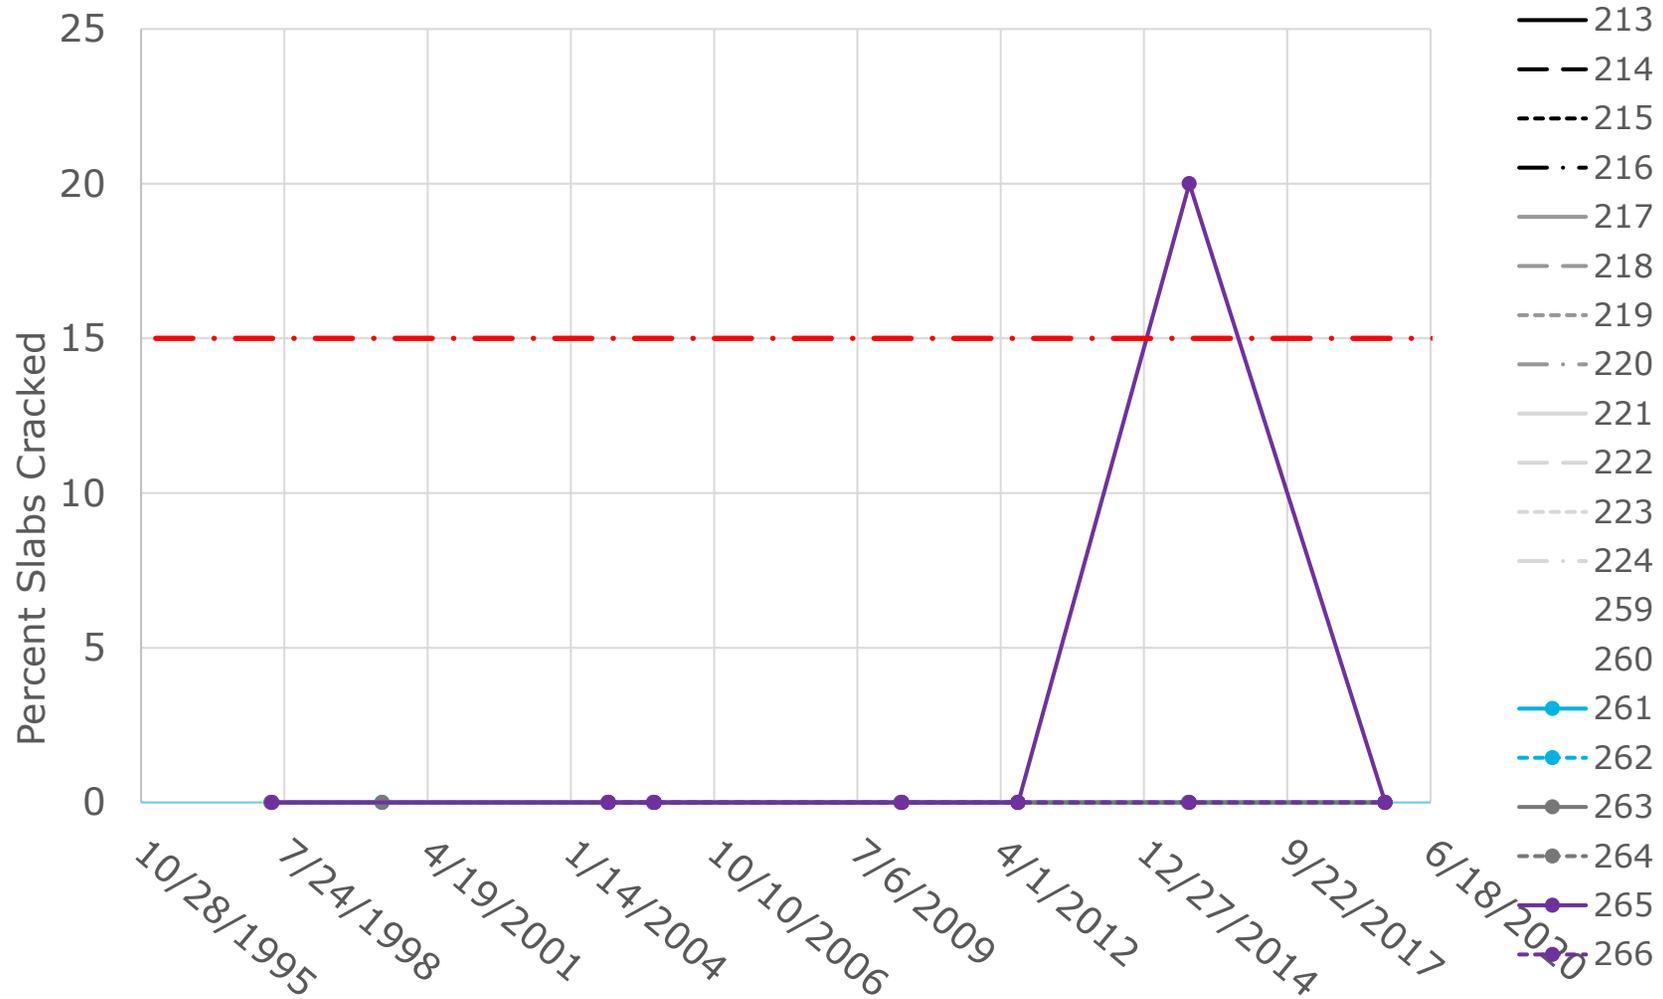
No test section exhibited poor performance with respect to surface roughness. Additionally, most test sections had very low measurements for wheel-path faulting except for test sections 550264 and 550265. While neither of these test sections exhibited poor performance with respect to wheel-path faulting, both were trending upward and experienced significantly more wheel-path faulting than other test sections. Test section 550265 exhibited poor performance with respect to slab cracking while other test sections exhibited no slab cracking. A table of summarized performance trends for Wisconsin test sections is given in Table 60 below.
