## TRANSPORTATION POOLED FUND PROGRAM QUARTERLY PROGRESS REPORT

<b>Transportation Pooled Fund Program Project #</b> TPF-5(189)	<b>Transportation Pooled Fund Program - Report Period:</b> <input type="checkbox"/> Quarter 1 (January 1 – March 31) <input checked="" type="checkbox"/> Quarter 2 (April 1 – June 30) <input type="checkbox"/> Quarter 3 (July 1 – September 30) <input type="checkbox"/> Quarter 4 (October 4 – December 31)	
<b>Project Title:</b> <i>"Enhancement of Welded Steel Bridge Girders Susceptible to Distortion-Induced Fatigue"</i>		
<b>Project Manager:</b> John Jones, KDOT	<b>Phone:</b> 785-368-7175	<b>E-mail:</b> <a href="mailto:jjones@ksdot.org">jjones@ksdot.org</a>
<b>Project Investigator:</b>	<b>Phone:</b>	<b>E-mail:</b>
Caroline Bennett Adolfo Matamoros Stan Rolfe Ron Barrett-Gonzalez	785-864-3235 785-864-3761 785-864-3767 785-864-2226	<a href="mailto:crb@ku.edu">crb@ku.edu</a> <a href="mailto:abm@ku.edu">abm@ku.edu</a> <a href="mailto:srolfe@ku.edu">srolfe@ku.edu</a> <a href="mailto:barretr@ku.edu">barretr@ku.edu</a>

## Project Description:

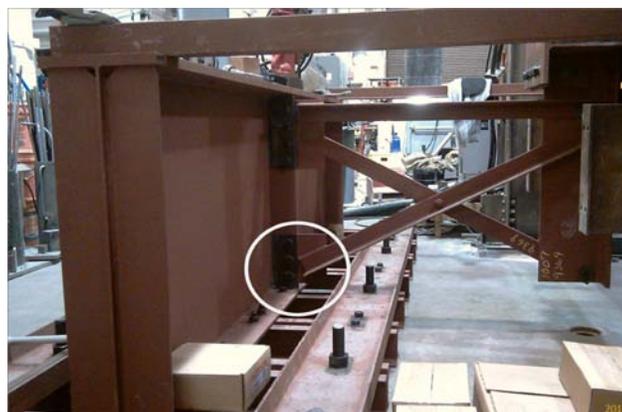
Two retrofits were applied to Specimen 2 this quarter: (1) crack-stop holes and (2) bolted steel angles, connecting the connection stiffener and girder web. The test procedure for Specimen 2 was conducted as follows. First, Specimen 2 was allowed to develop cracking under cyclic loads (load range of 4.5 kips, corresponding to an approximate stress range of 28.5 ksi in the web gap, as determined by strain gages). Cracking developed rapidly in the bottom web gap, circled in Fig. 5. (*The reader should be aware that in this test set-up, the web gaps are referenced herein according to the orientation of the test girder; in other words, "bottom web gap" in this report refers to the web gap in the bottom of the 9 ft test girder, which is representative of a top web gap in a bridge system.*)

**Fig 5. View of 9-ft girder test set-up; bottom web gap (representative of real top web gap) is circled.**

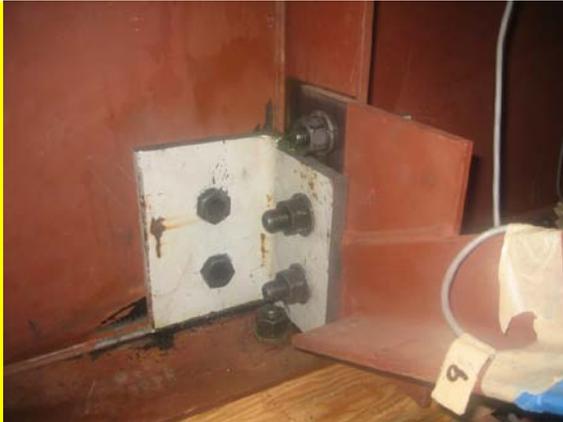
Two distinct crack patterns formed in the bottom web gap: a horizontal crack between the bottom flange and the web, and one running vertically along the welds connecting the connection stiffener to the girder web. These cracks were allowed to propagate until they reached lengths of 8 in. and 5 in., respectively. At this point, the bottom web gap was repaired with a double-angle retrofit. The double-angle retrofit designed consisted of two L6x6x3/4, each with one leg bolted to the connection stiffener and one leg bolted to the girder web in the bottom web gap region. Since the girder being studied is representative of an exterior girder, a stiff steel plate with dimensions PL 18"x18"x3/4" was bolted on the fascia side of the girder web to aid in load transfer. If this had been an interior girder, double angles could have also been applied on the opposite side of the web. Details of the completed angle retrofit are shown in Figs. 6, 7, and 8.

**Fig 6. View of angle retrofit in bottom web gap; connection is made between the web and connection stiffener**

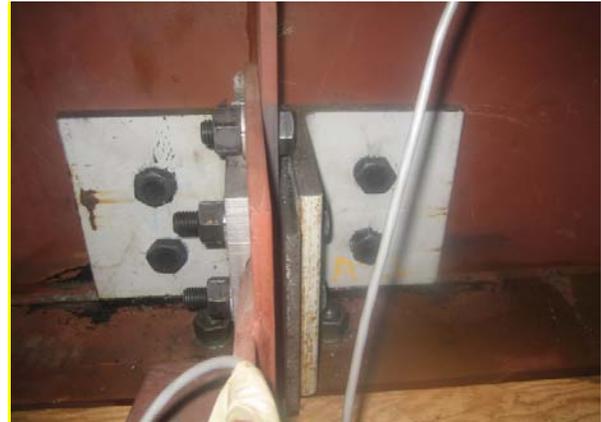
**Fig 7. Alternate view of angle retrofit in bottom web gap; connection is made between the web and connection stiffener**

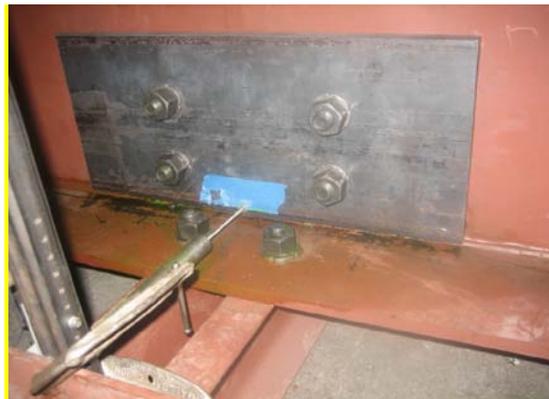
**Fig 8. Fascia view of angle retrofit in bottom web gap; steel back plate is applied on fascia side of girder to aid in load transfer around the web gap region.**

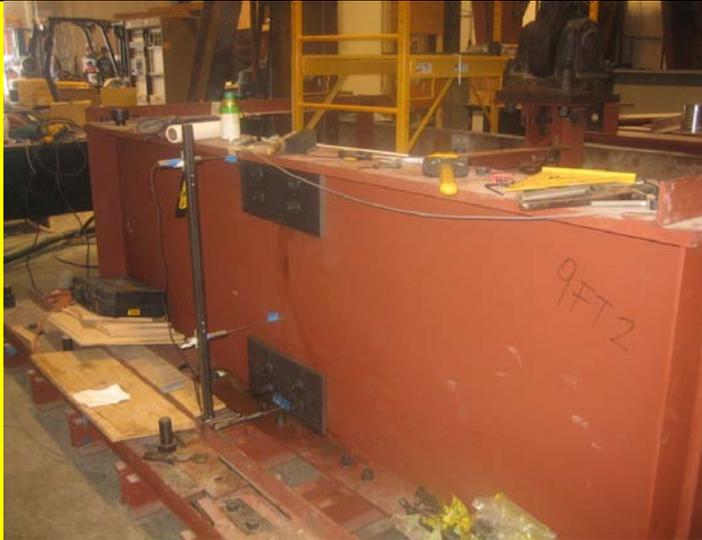
The girder was cycled with the bottom web gap retrofit for an additional 1.2 million cycles, which was considered run-out at the stress range being utilized. During this time, the top web gap developed a 2.5" crack while it was cycling in an unreinforced condition. Therefore, the top web gap was retrofitted with an identical double-angle repair as had been used in the bottom web gap (Figs. 9 and 10). The specimen was then subjected to another 1.2 million cycles, during which the bottom web gap cracks experienced no growth and the top web gap crack grew approximately 1 in. Reasons for crack growth in the top web gap are currently being investigated.

**Fig 9. Fascia view of girder after angle retrofit has been applied in both the top and bottom web gaps.**

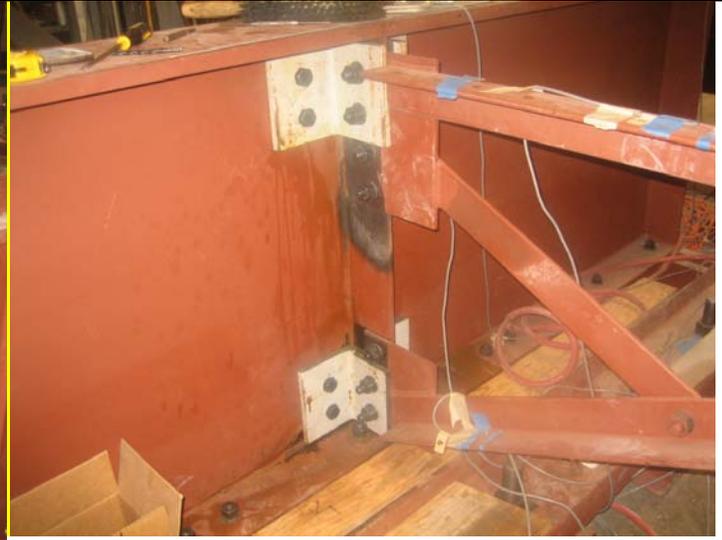
**Fig 10. Interior view of girder after angle retrofit has been applied to both the top and bottom web gap**

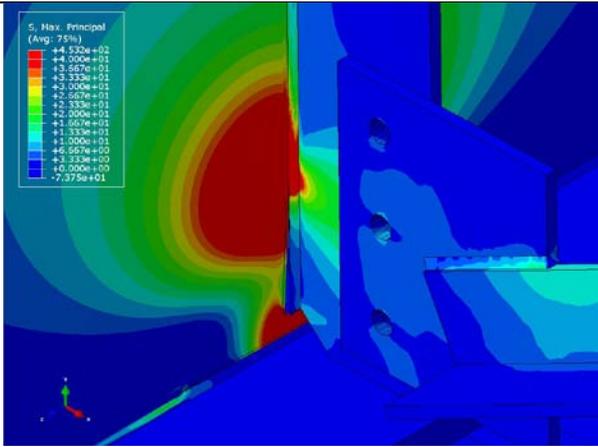
Results from detailed, 3D finite element analyses corroborated the experimental results. The base finite element model has been described in previous progress reports, and a cross-section view of the FEM is shown here in Fig. 11. The model was further refined to reflect the crack geometries seen in the physical test, using ABAQUS Extended Finite Element Modeling (XFEM) capabilities. A view of the model in the bottom web gap region both before and after the retrofit is applied can be seen in Figs. 12 and 13. It is clear that the hot spot stresses have been drastically reduced in the web gap region after the retrofit was introduced. Similar behavior was predicted by the FEA for the top web gap region, as shown in Figs. 14 and 15. The retrofit has been removed from the model views in Figs. 13 and 15 so that stresses in the girder are apparent.

Fig 12. FEA results (with cracks modeled) before any applied retrofits

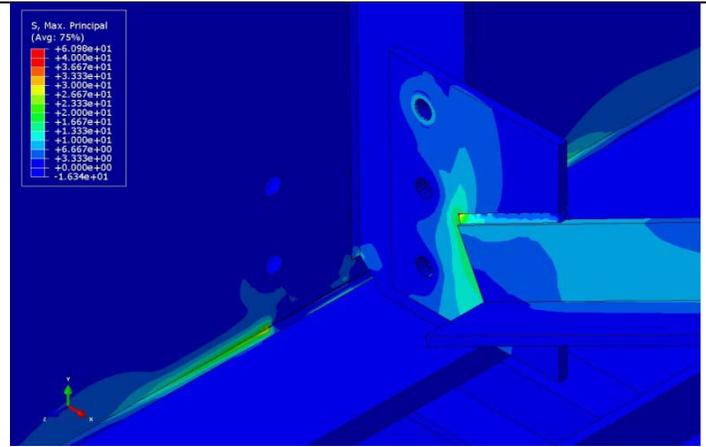
Fig 13. FEA results after steel angles (connecting connection stiffener and web) are included

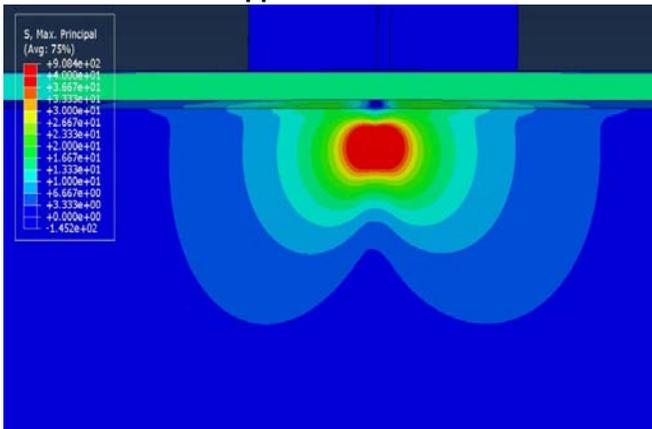
Fig 14. FEA results in top web gap (representative of real bottom web gap) before retrofit

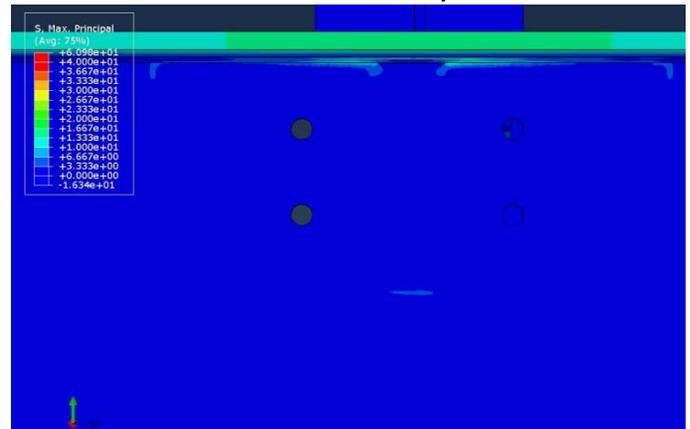
Fig 15. FEA results in top web gap (representative of real bottom web gap) after angle retrofit was installed

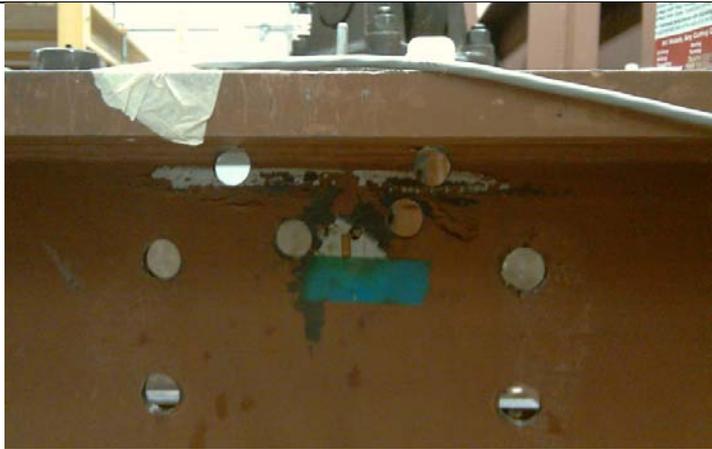
It should be noted that after the retrofitted specimen was subjected to a total of 2.4 million cycles in the reinforced configurations, the retrofits were removed and  $\frac{3}{4}$ " diameter crack stop holes were drilled at the tips of the various cracks in the top and bottom web gaps. This can be seen in Figs. 16 and 17. This diameter of crack-stop hole was chosen because of the tight geometry in this region, which would not accommodate significantly larger crack-stop holes. This is often a realistic field consideration when drilling crack stop holes in bridge web gaps, and often the holes cannot be drilled to proper diameter. Specimen 2 was then subjected to additional cycles to evaluate the effectiveness of undersized crack-stop holes. Within an additional 40,000 fatigue cycles at the same stress range as used throughout the testing, the bottom horizontal crack had "jumped" the crack-stop holes and grown an additional 0.5 in. on one side of the crack. Additionally, the vertical cracks in the bottom web gap also "jumped" the crack stop holes and grew an additional 2.5 in. A comparison in performance between the angle-retrofitted case and the crack-stop hole case shows the ineffectiveness of the crack-stop holes in this particular test, and the high degree of effectiveness of the angle retrofit.

**Fig 16. Specimen 2 with drilled crack-stop holes (four) in top web gap region**

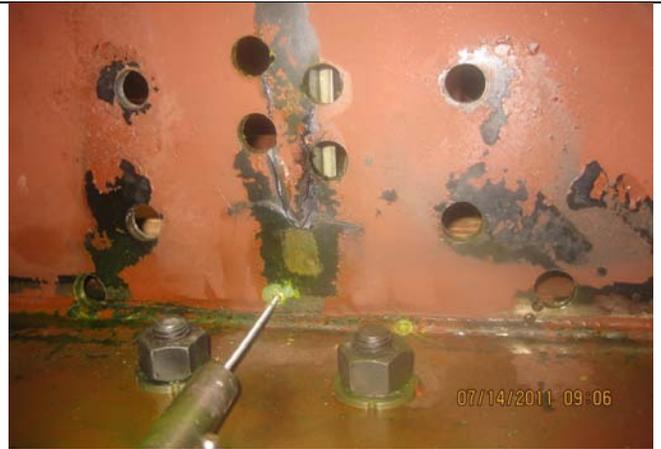
**Fig 17. Specimen 2 with drilled crack-stop holes (six) in bottom web gap region**
