# EVALUATION OF ALTERNATIVE DOWEL BAR MATERIALS AND COATINGS

## Final Report

Ohio Department of Transportation  
Office of Research and Development

November 2011

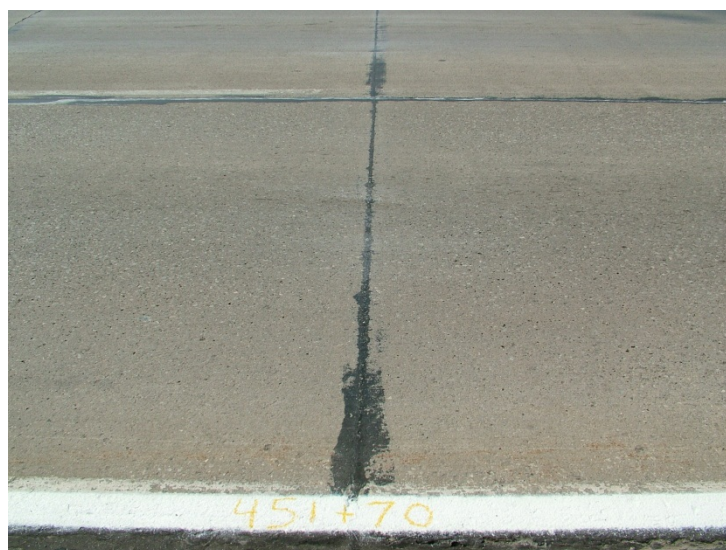
Figure 13. Photo of surface condition of pavement with plastic-coated dowels (State Route 81).

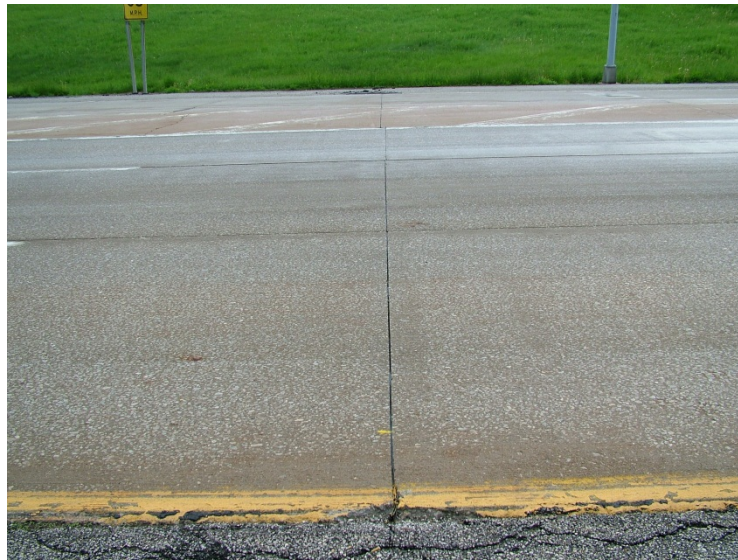
Figure 14. Photo of surface condition of pavement with plastic-coated dowels (State Route 59).

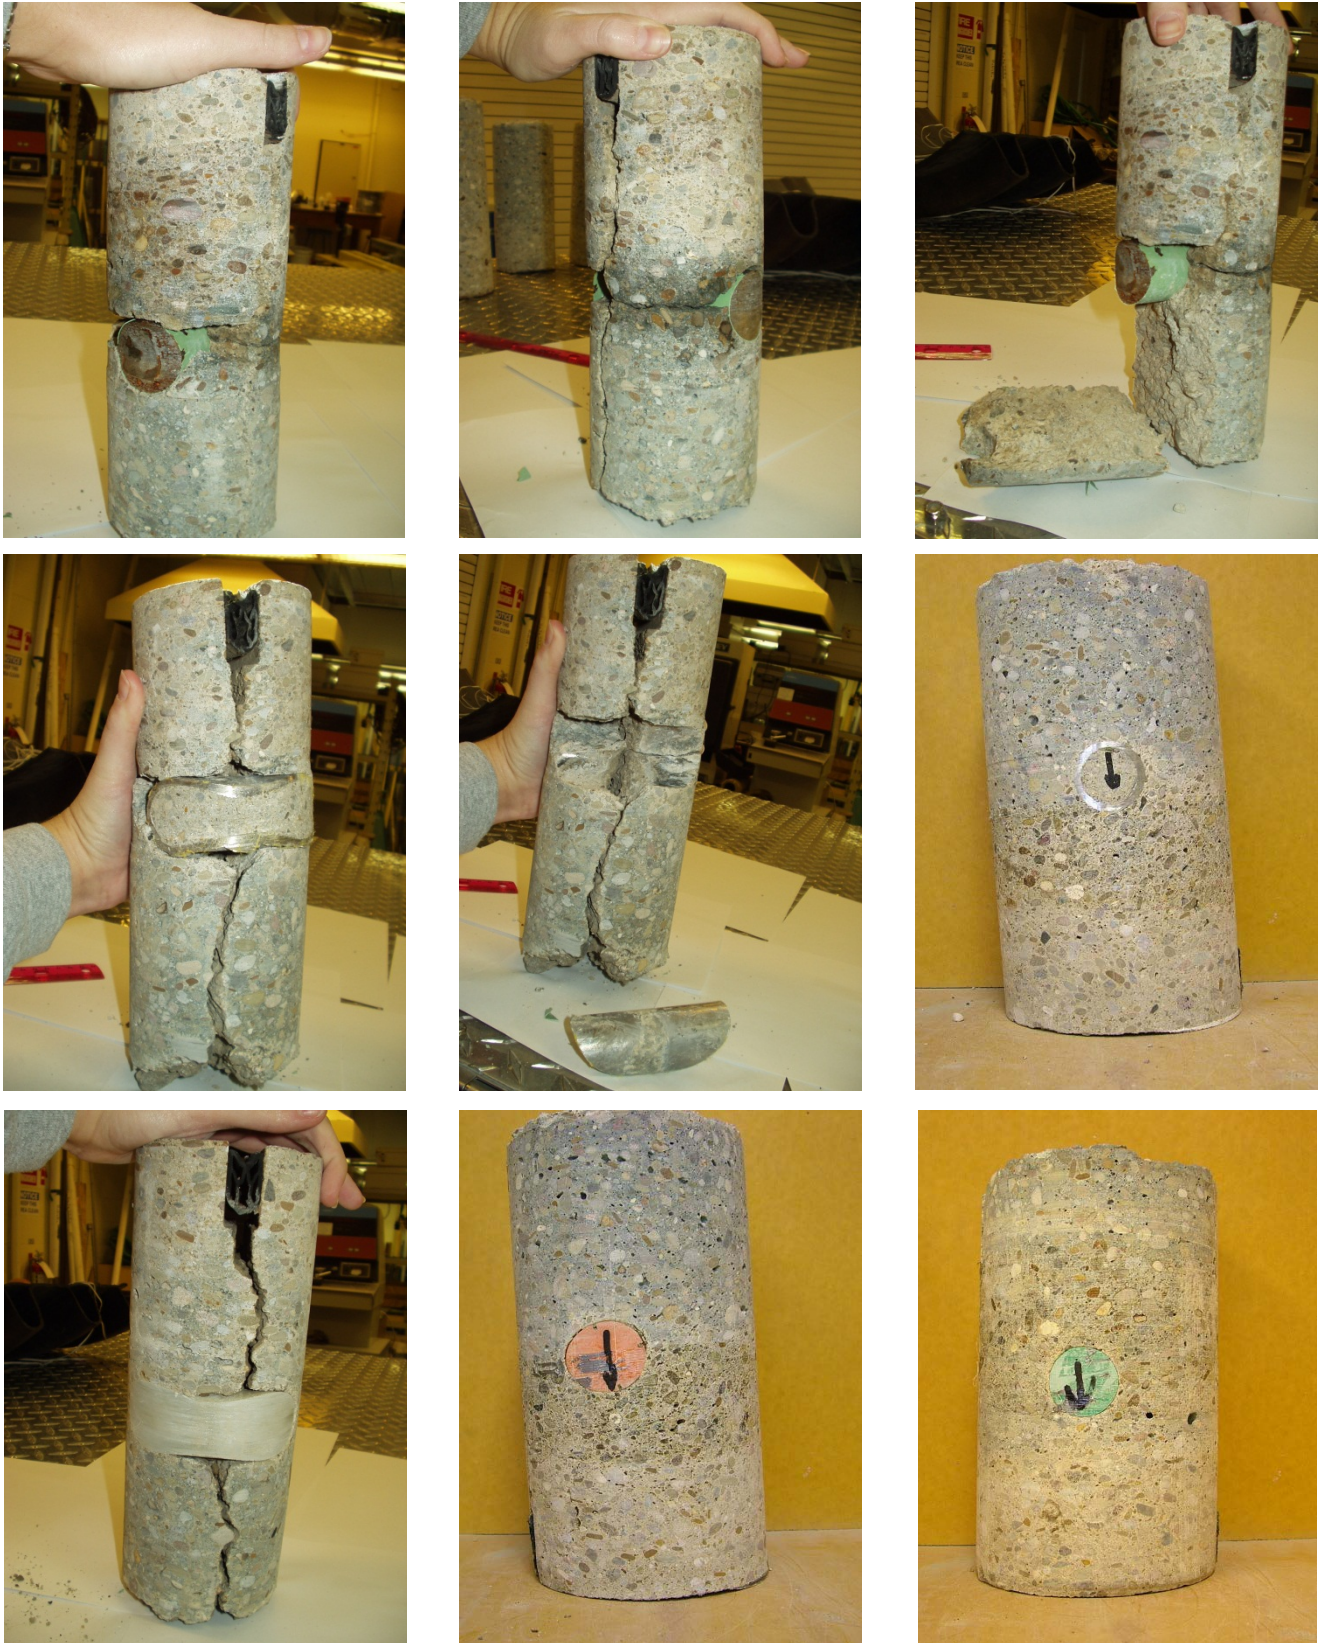
Figure C-1. Cores taken from OH 2 (ATH-50). Top: Epoxy-coated dowels; Middle: Stainless steel tubes filled with mortar; Bottom: FRP bars

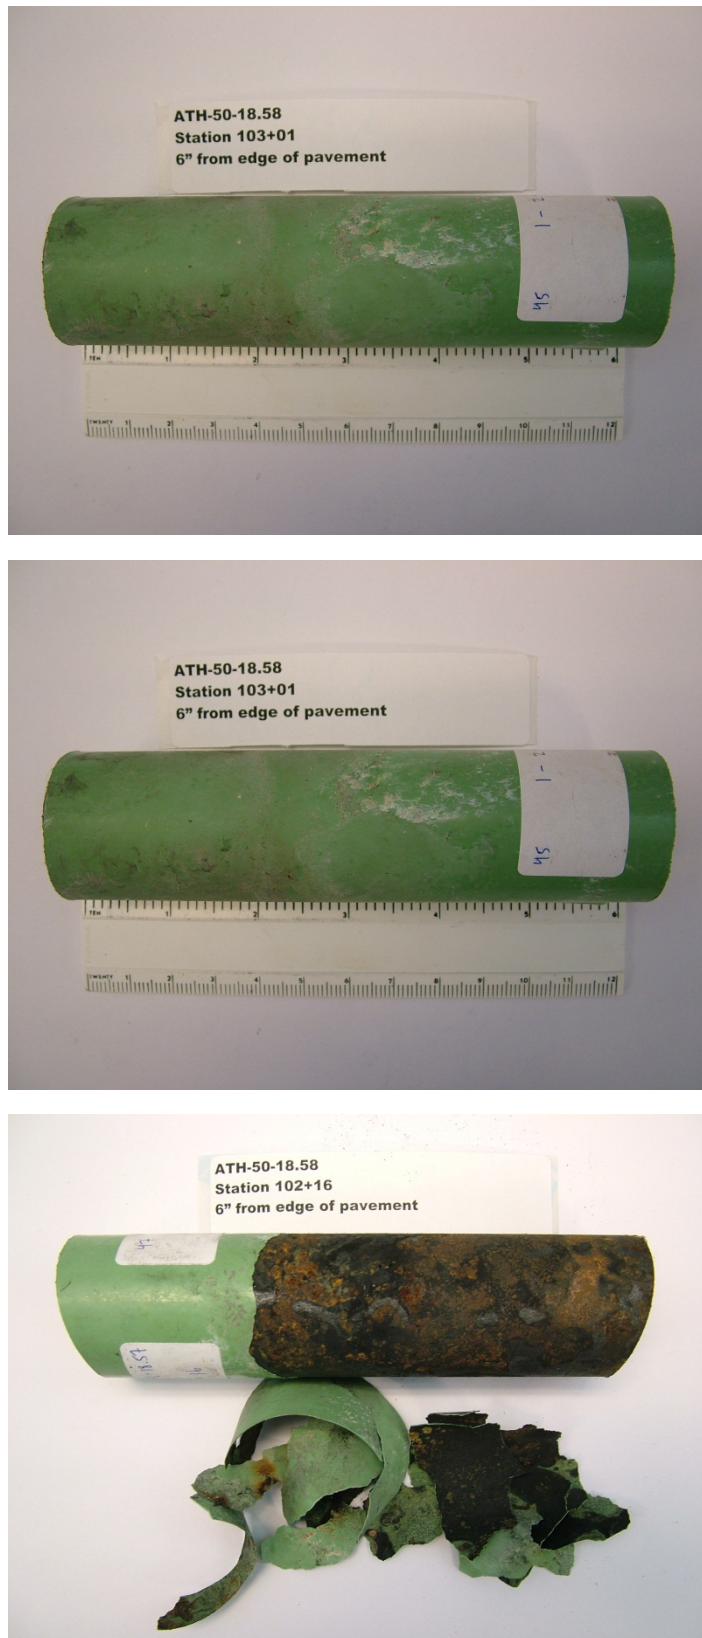
Figure C-2. Epoxy-coated dowels from OH 2 (ATH-50).

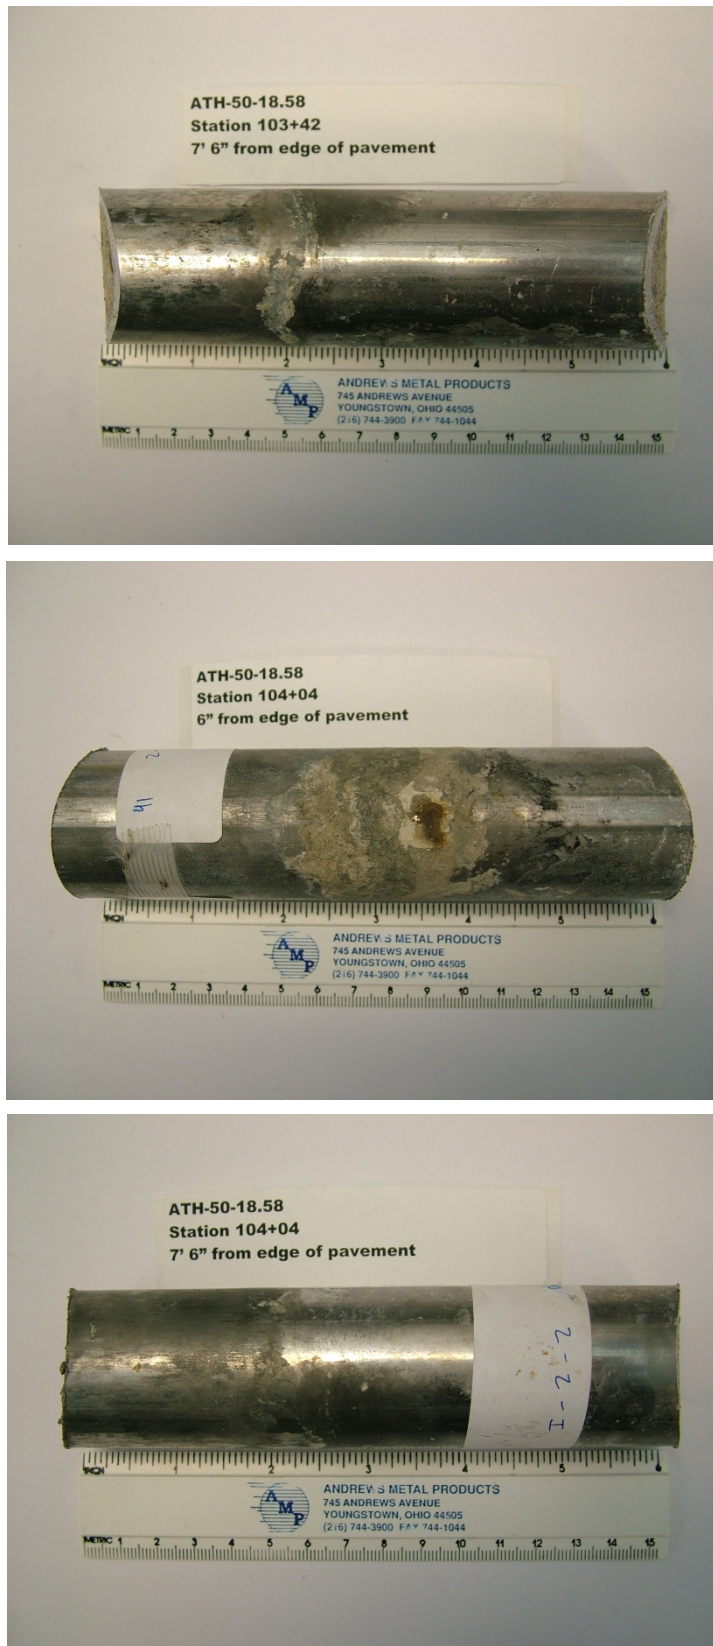
Figure C-3. Stainless steel tubes from OH 2 (ATH-50).

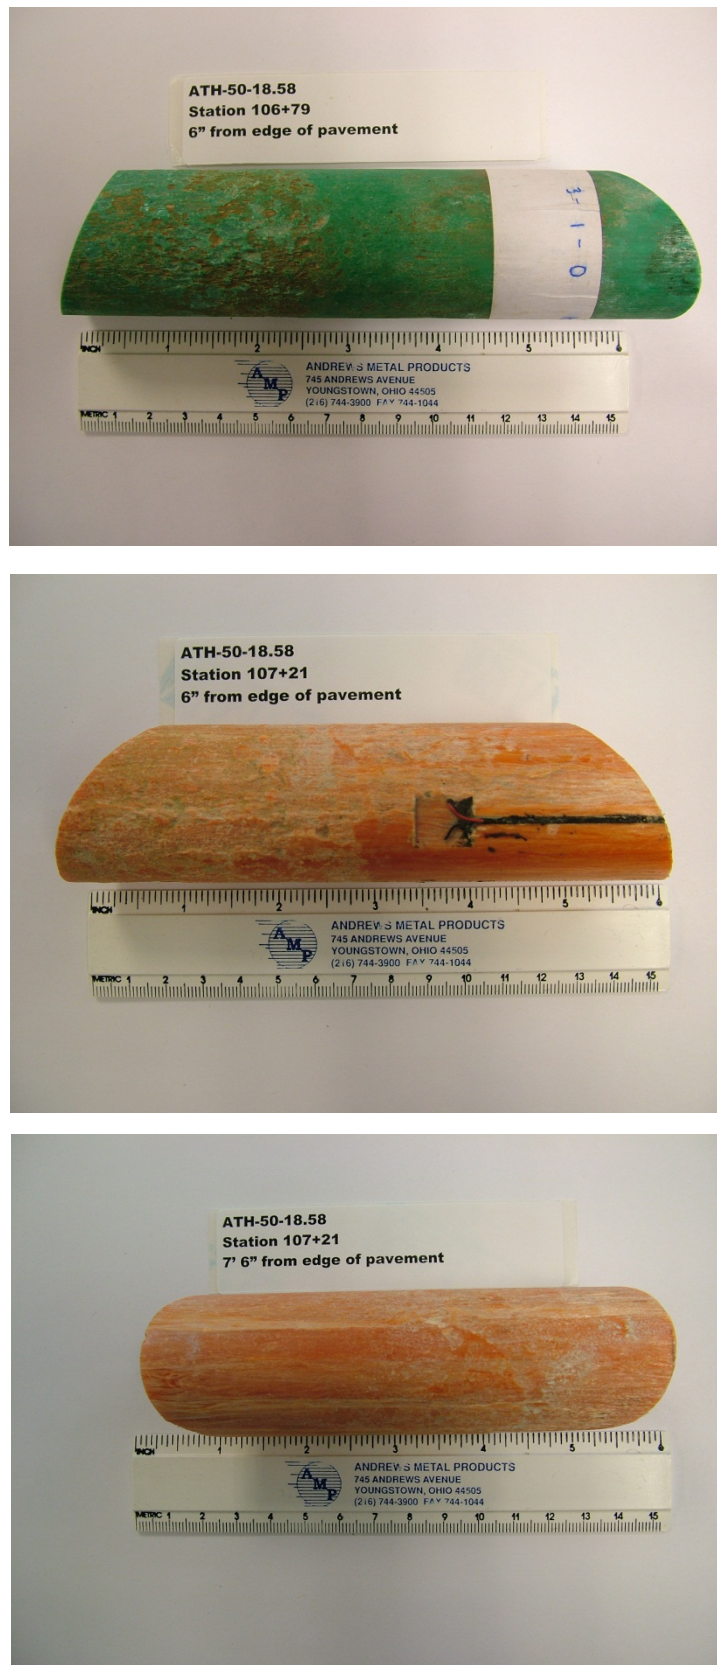
Figure C-4. FRP dowel bars from OH 2 (ATH-50).

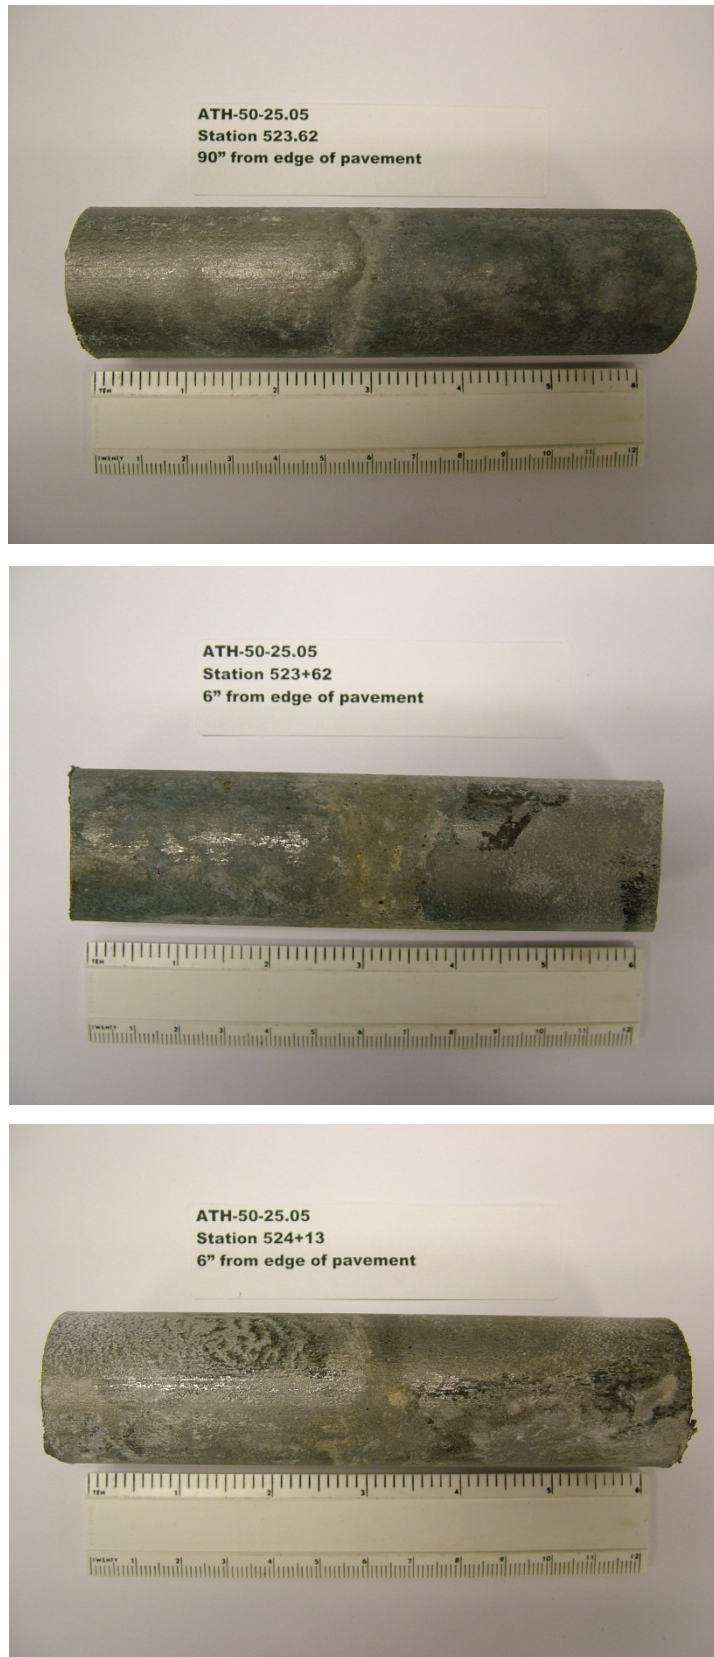
Figure C-5. Stainless steel clad dowel bars from OH 2 (ATH-50).

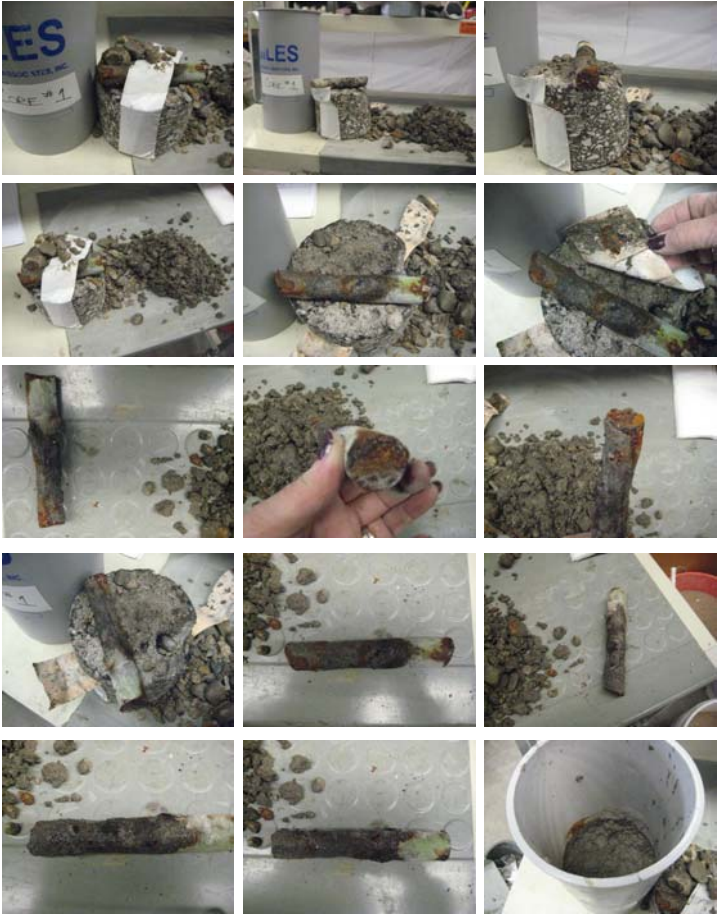
Core Intact, Y or N	No			
Type of Joint Sealant	NA			
Socketing around dowel	Unable to see			
Corrosion of dowel at concrete interface	Extensive			
Abrasion of the dowel surface at the crack face	Extensive			
Dowel Deterioration	Extensive			
Dowel Type	Epoxy Coated			
PCC Deterioration	Complete deterioration, only AC layer intact.			
PCC Stain				
Signs of Defect in Core-holes				
Date when core was taken	NA			
Dowel/Concrete Slab Interface				
Base Material Noted				
General Comments: All the pieces of the PCC were collected in a bag. The dowel bar is loose and the AC layer by itself.

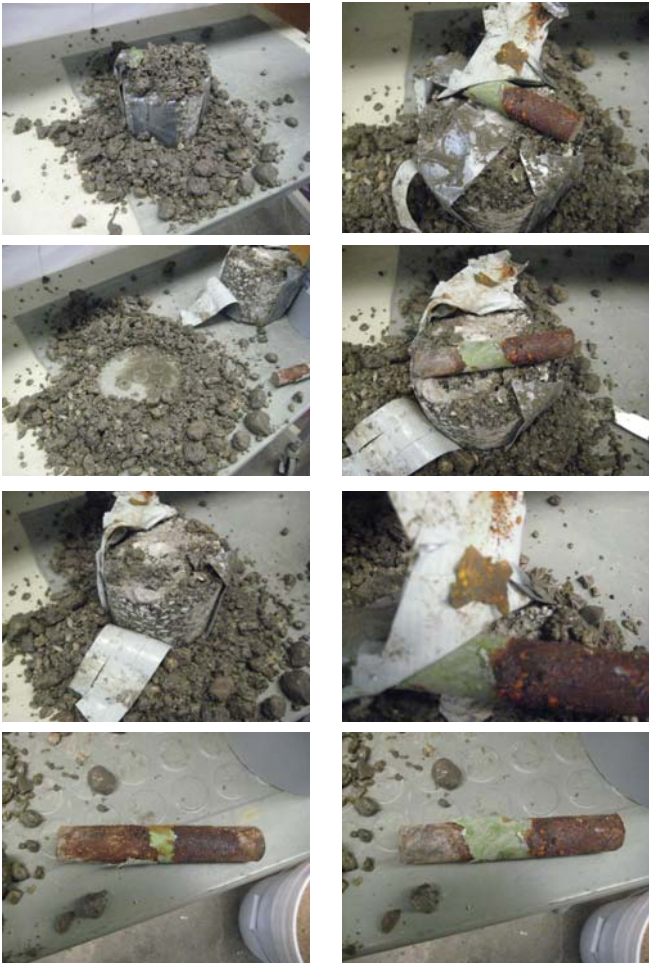
Core Intact, Y or N	No, PCC all desintegratedNA		
Type of Joint Sealant	NA		
Socketing around dowel	NA		
Corrosion of dowel at concrete interface	Extensive		
Abrasion of the dowel surface at the crack face	Extensive		
Dowel Deterioration	Extensive		
Dowel Type	Epoxy Coated		
PCC Deterioration	Extensive		
PCC Stain	NA		
Signs of Defect in Core-holes			
Date when core was taken			
Dowel/Concrete Slab Interface			
Base Material Noted			
General Comments: The aggregate is all in pieces.

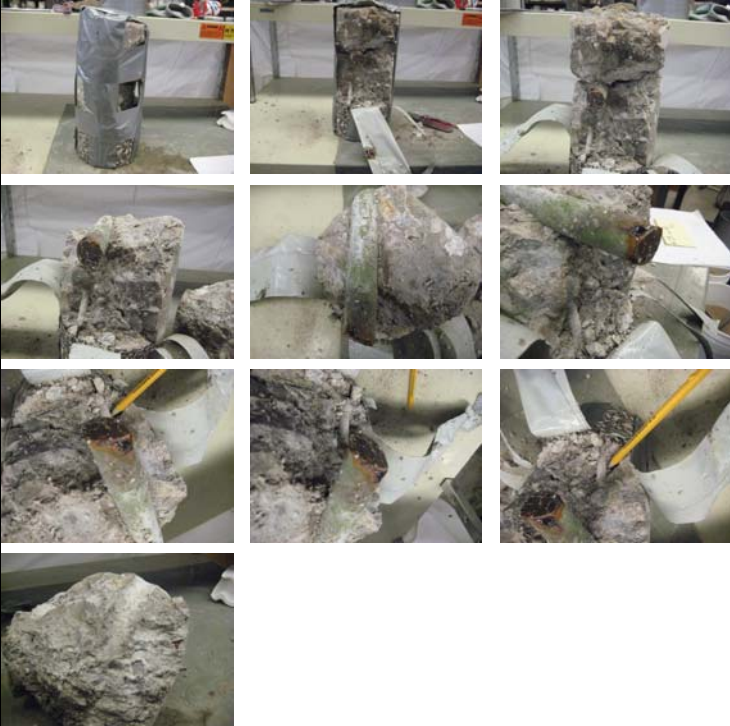
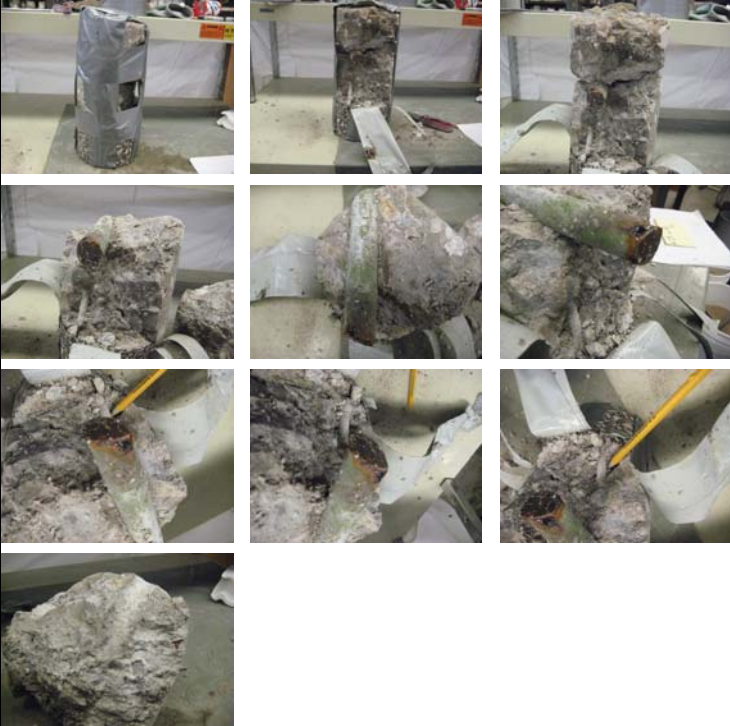
Core Intact, Y or N	No (2 pieces)			
Type of Joint Sealant	NA			
Socketing around dowel	Minor			
Corrosion of dowel at concrete interface	Moderate in one end			
Abrasion of the dowel surface at the crack face	Moderate			
Dowel Deterioration	Moderate			
Dowel Type	Epoxy Coated			
PCC Deterioration	Moderate			
PCC Stain	Small dark spots in one side			
Signs of Defect in Core-holes

Date when core was taken	NA			
Dowel/Concrete Slab Interface				
Base Material Noted				
General Comments: AC Overlay and dowel are attached to the PCC.

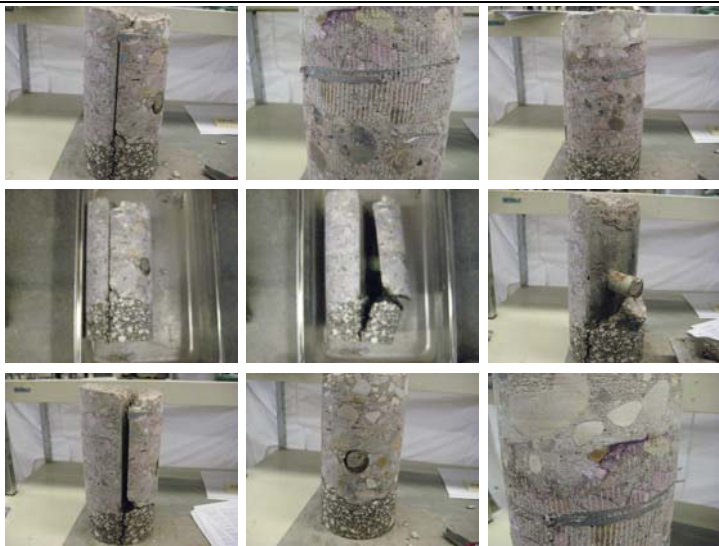
Core Intact, Y or N	Yes			
Type of Joint Sealant	NA			
Socketing around dowel	Yes			
Corrosion of dowel at concrete interface	Minor			
Abrasion of the dowel surface at the crack face	Minor, some orange color spots at ends face			
Dowel Deterioration	Minor			
Dowel Type	Epoxy Coated			
PCC Deterioration	No			
PCC Stain	Yes, dark and brown colors at dowel placement areas			
Signs of Defect in Core-holes

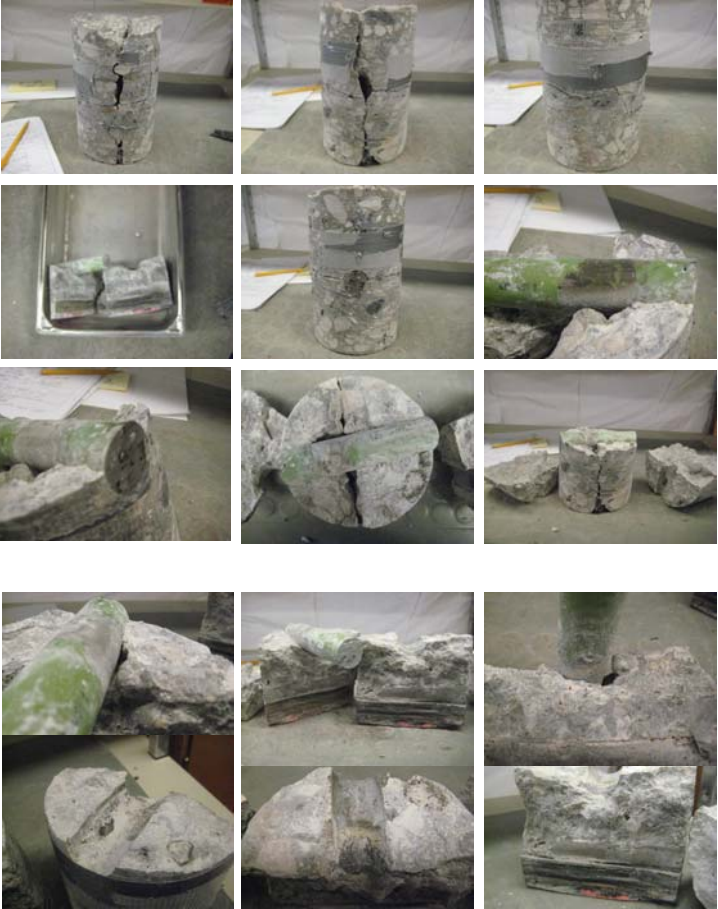
Core Intact, Y or N	No (3 pieces)	
Type of Joint Sealant	Neoprene	
Socketing around dowel	Yes, minor	
Corrosion of dowel at concrete interface	Minor	
Abrasion of the dowel surface at the crack face	Minor	
Dowel Deterioration	Minor	
Dowel Type	Epoxy Coated	
PCC Deterioration	No	
PCC Stain	Yes, starting to show some yellowish spots, there is one dark area	
Signs of Defect in Core-holes

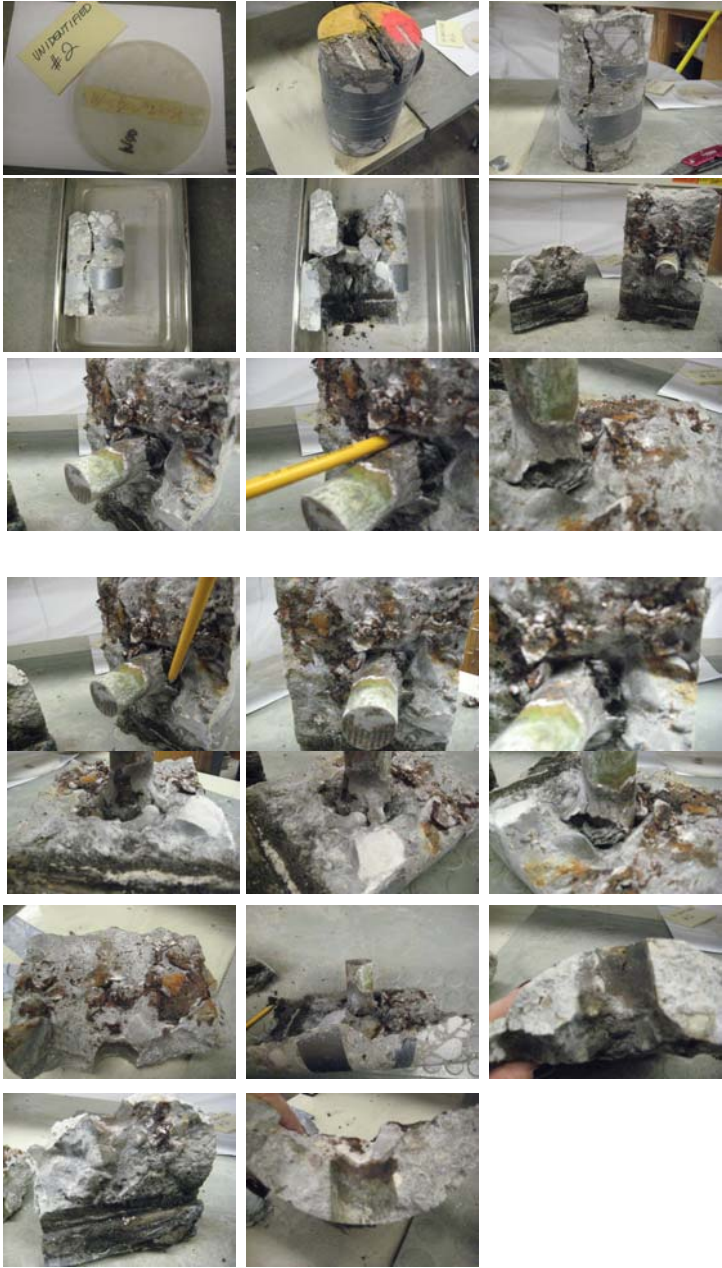
Core Intact, Y or N	Yes	
Type of Joint Sealant	Neoprene	
Socketing around dowel	Yes, some at the joint	
Corrosion of dowel at concrete interface	Extensive	
Abrasion of the dowel surface at the crack face	Extensive	
Dowel Deterioration	Extensive at joint	
Dowel Type	Epoxy Coated	
PCC Deterioration	No	
PCC Stain	Yes, at dowel and joint below dowel, see photos.	
<b>Signs of Defect in Core-holes</b>		
Date when core was taken	NA	
Dowel/Concrete Slab Interface		
Base Material Noted		
General Comments: The core was broken with the electrical hammer to be able to see the dowel. There are 4 big pieces of PCC.

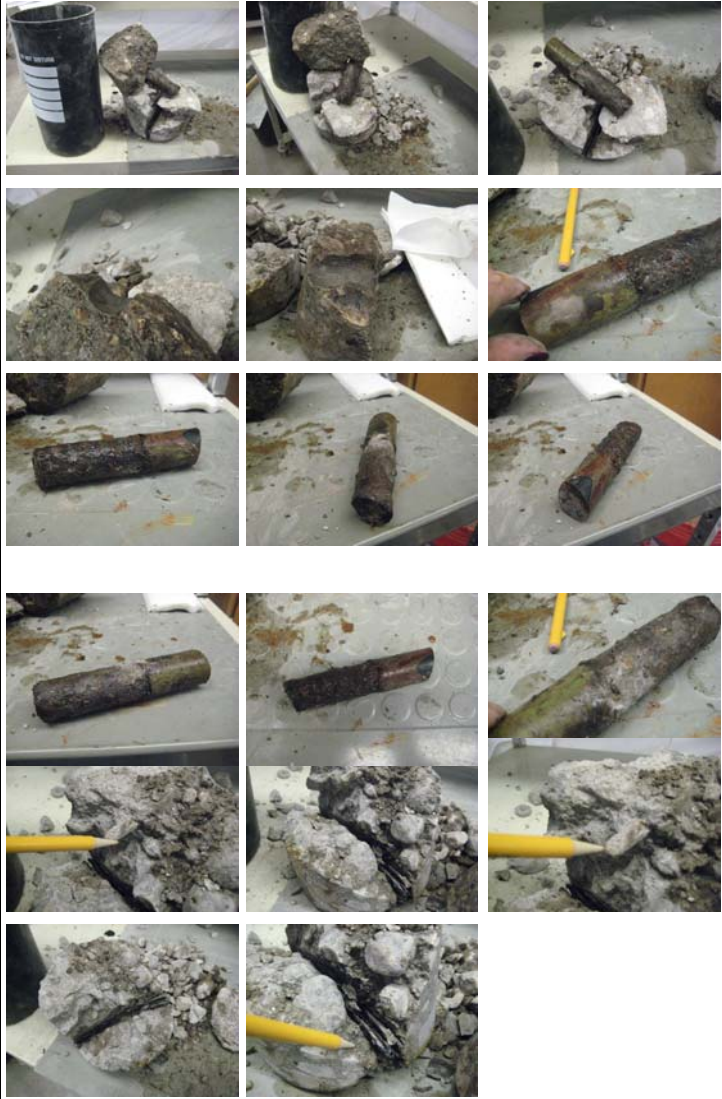
Core Intact, Y or N	No			
Type of Joint Sealant	Neoprene			
Socketing around dowel	Yes			
Corrosion of dowel at concrete interface	Extensive			
Abrasion of the dowel surface at the crack face	Extensive			
Dowel Deterioration	Extensive			
Dowel Type	Epoxy Coated			
PCC Deterioration	Yes			
PCC Stain	Yes, some dark areas			
<b>Signs of Defect in Core-holes</b>				
Date when core was taken	NA			
Dowel/Concrete Slab Interface				
Base Material Noted				
General Comments: There is a lot of loose aggregate. See photos.

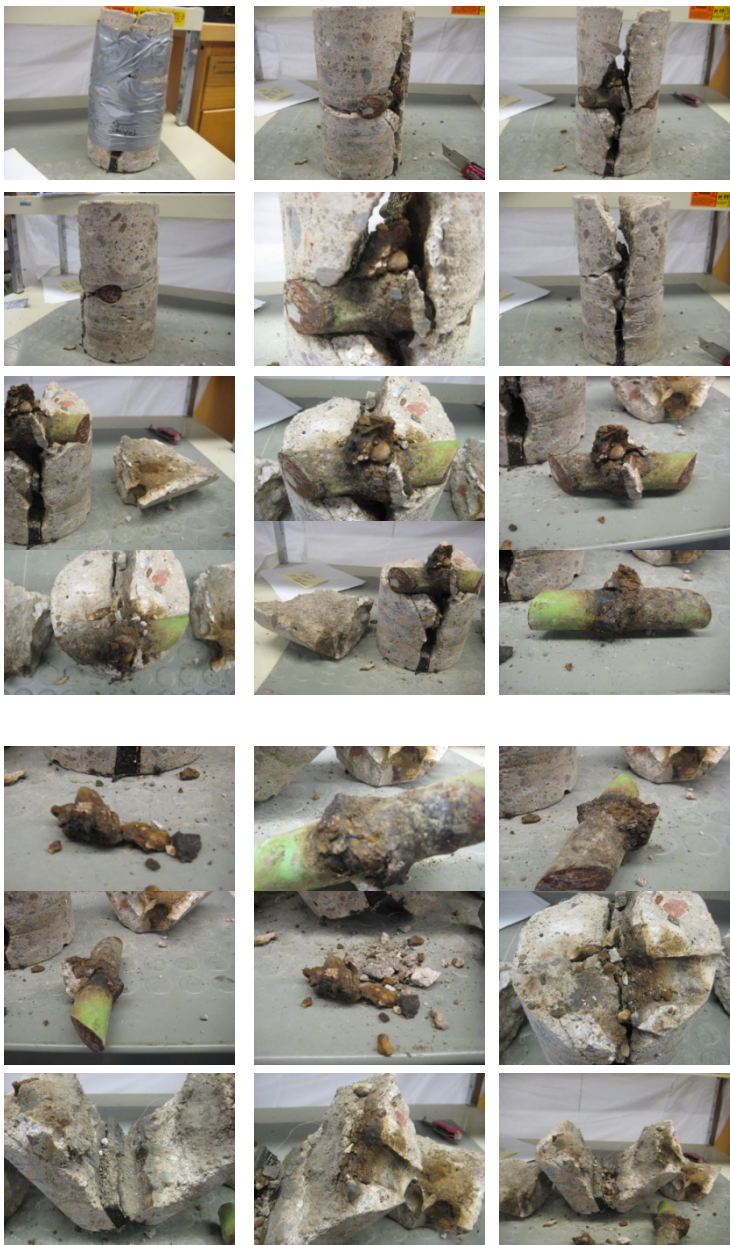
Core Intact, Y or N	No			
Type of Joint Sealant	Neoprene			
Socketing around dowel	Some slightly			
Corrosion of dowel at concrete interface	Extensive			
Abrasion of the dowel surface at the crack face	Extensive			
Dowel Deterioration	Extensive			
Dowel Type	Epoxy Coated			
PCC Deterioration	Moderate			
PCC Stain	Dark colors around the dowel			
Signs of Defect in Core-holes				
Date when core was taken	NA			
Dowel/Concrete Slab Interface				
Base Material Noted				
General Comments: There are 4 big pieces, one medium piece attached to corroded dowel. The rest of small pieces were collected in a bag.

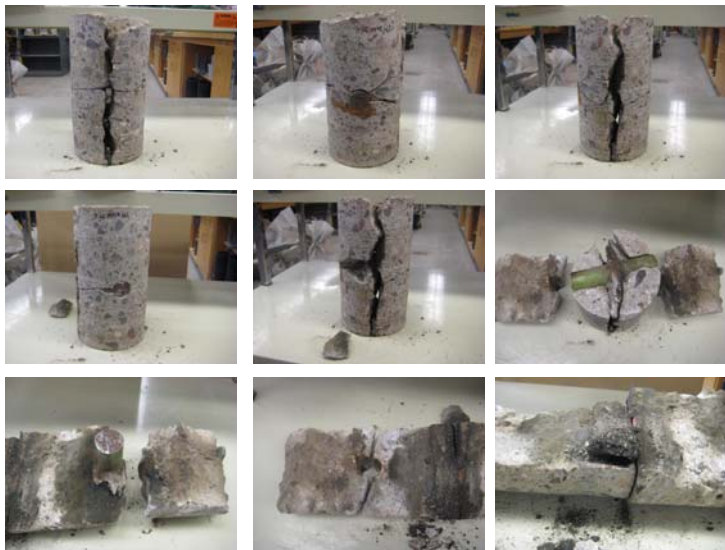
Core Intact, Y or N	No			
Type of Joint Sealant	Liquid Hot Poured AC			
Socketing around dowel	No			
Corrosion of dowel at concrete interface	Minor			
Abrasion of the dowel surface at the crack face	Minor			
Dowel Deterioration	Minor			
Dowel Type	Epoxy Coated			
PCC Deterioration	Yes			
PCC Stain	Yes, dark browns			
Signs of Defect in Core-holes				
Date when core was taken	10-19-2009			
Dowel/Concrete Slab Interface				
Base Material Noted				
General Comments: PCC dark at joint and dowel area. Corrosion of dowel mainly at joint, dark browns. PCC broken into 5 pieces.

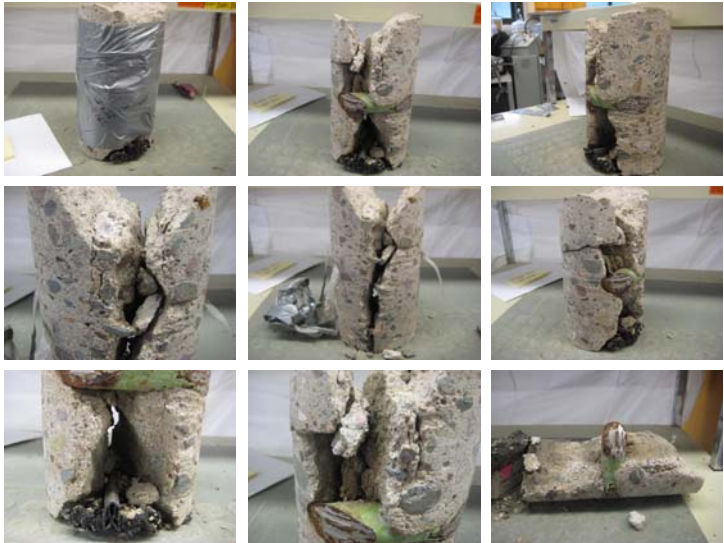
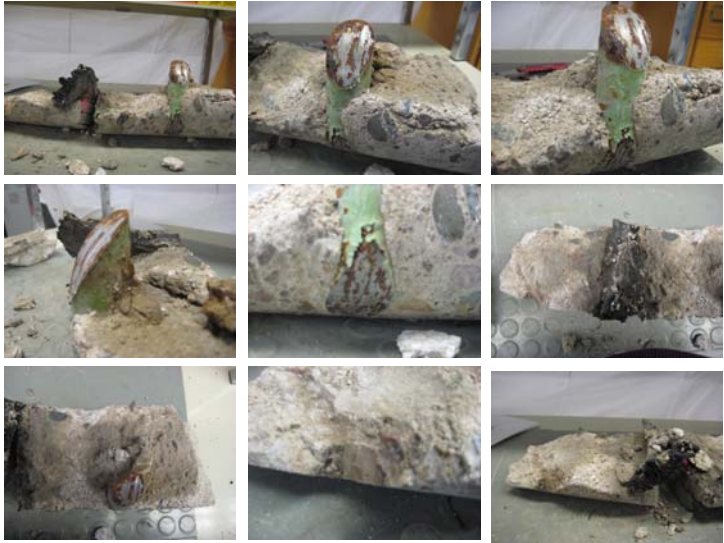
Core Intact, Y or N	No			
Type of Joint Sealant	Neoprene			
Socketing around dowel	Minor			
Corrosion of dowel at concrete interface	Moderate			
Abrasion of the dowel surface at the crack face	Moderate			
Dowel Deterioration	Moderate			
Dowel Type	Epoxy Coated			
PCC Deterioration	Moderate (core is crumbled)			
PCC Stain	No visible to the pieces available			
Signs of Defect in Core-holes

Date when core was taken	NA			
Dowel/Concrete Slab Interface				
Base Material Noted				
General Comments: There are 3 big pieces, a lot of little pieces and dowel is attached to the big piece.

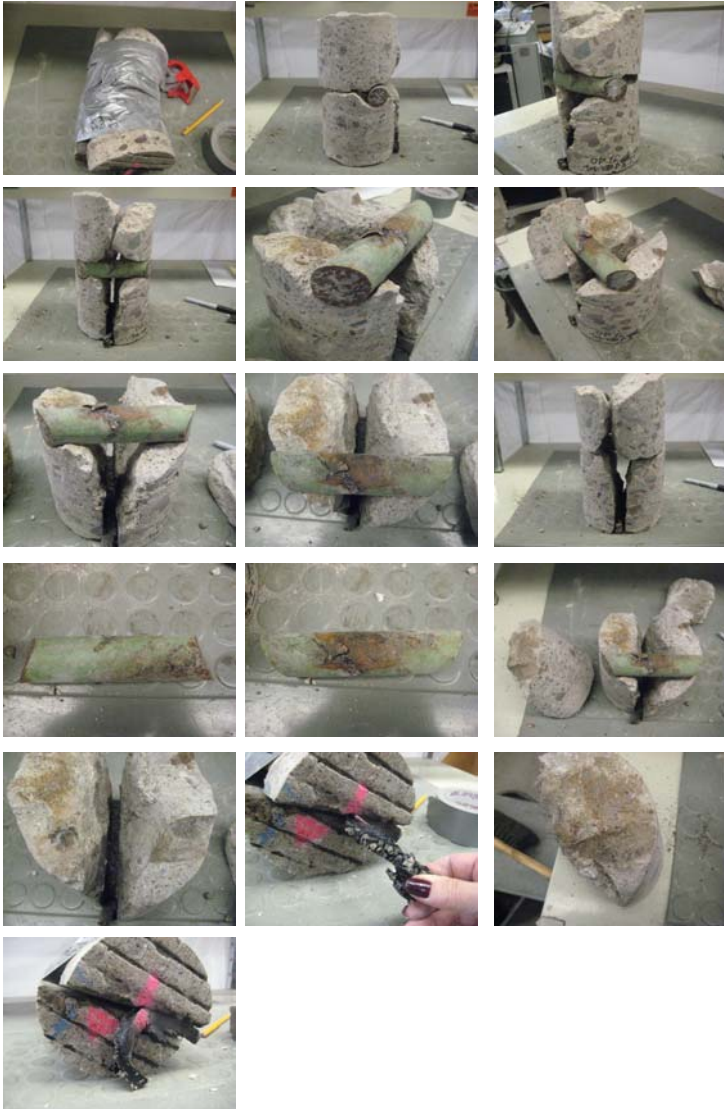
Core Intact, Y or N	No (4 pieces)			
Type of Joint Sealant	Liquid Hot Poured			
Socketing around dowel	Very little			
Corrosion of dowel at concrete interface	Moderate			
Abrasion of the dowel surface at the crack face	Moderate			
Dowel Deterioration	Moderate			
Dowel Type	Epoxy Coated			
PCC Deterioration	Minor			
PCC Stain	Some spots at dowel placing area			
Signs of Defect in Core-holes				
Date when core was taken	10-19-2009			
Dowel/Concrete Slab Interface				
Base Material Noted				
General Comments: There are 4 big pieces of PCC, dowel is loose and joint sealant still attached to PCC

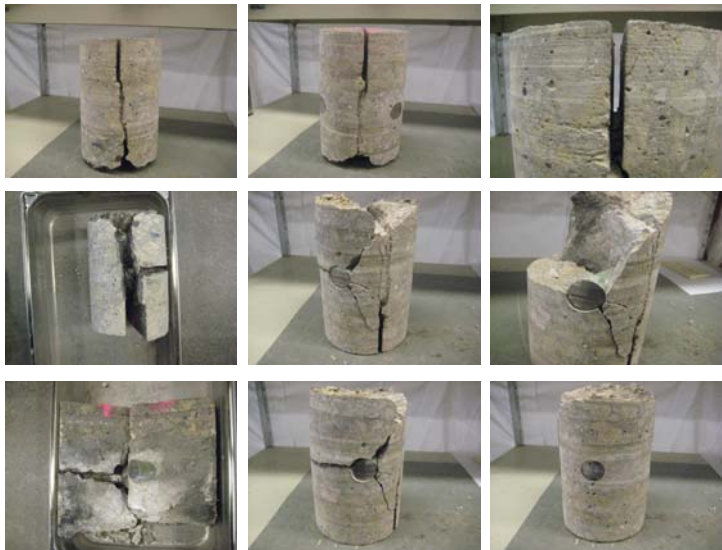
Core Intact, Y or N	Yes			
Type of Joint Sealant	NA			
Socketing around dowel	No			
Corrosion of dowel at concrete interface	No			
Abrasion of the dowel surface at the crack face	No			
Dowel Deterioration	One small spot, light brown			
Dowel Type	Epoxy Coated			
PCC Deterioration	Some after core was opened with electrical hammer.			
PCC Stain				
Signs of Defect in Core-holes

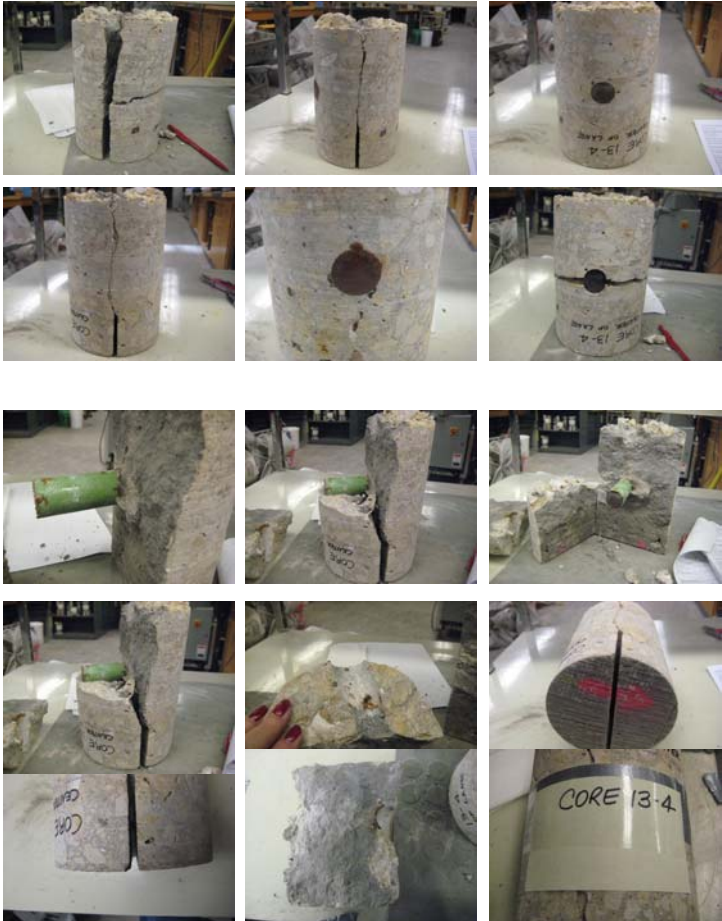
Core Intact, Y or N	Yes	
Type of Joint Sealant	NA	
Socketing around dowel	No	
Corrosion of dowel at concrete interface	Yes	
Abrasion of the dowel surface at the crack face	Minor	
Dowel Deterioration	Minor	
Dowel Type	Epoxy Coated	
PCC Deterioration	No	
PCC Stain	Yes, a few colors of orange and dark brown spots	
<b>Signs of Defect in Core-holes</b>		
Date when core was taken	6-17-2009	
Dowel/Concrete Slab Interface		
Base Material Noted		
<p>General Comments:</p> <p>The core was broken with the electrical hammer to be able to observe the inside. Now there are 3 big pieces and 1 medium</p>

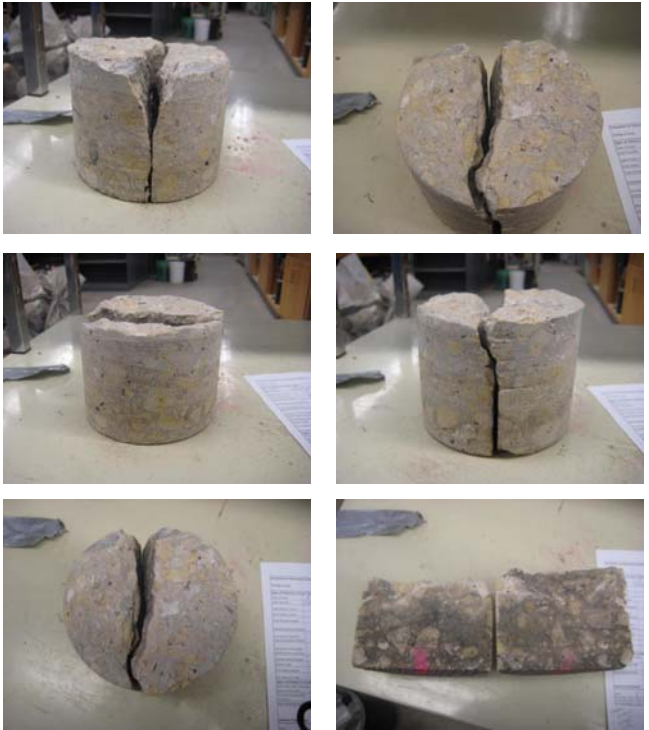
Core Intact, Y or N	No	
Type of Joint Sealant	NA	
Socketing around dowel	Dowel missing but apparently none	
Corrosion of dowel at concrete interface	NA	
Abrasion of the dowel surface at the crack face	NA	
Dowel Deterioration	NA	
Dowel Type	NA	
PCC Deterioration	Bottom portion is missing	
PCC Stain	Dark at joint due to pollution	
<b>Signs of Defect in Core-holes</b>		
Date when core was taken		
Dowel/Concrete Slab Interface		
Base Material Noted		
General Comments: Only 2 big pieces of PCC and no dowel to analyze.

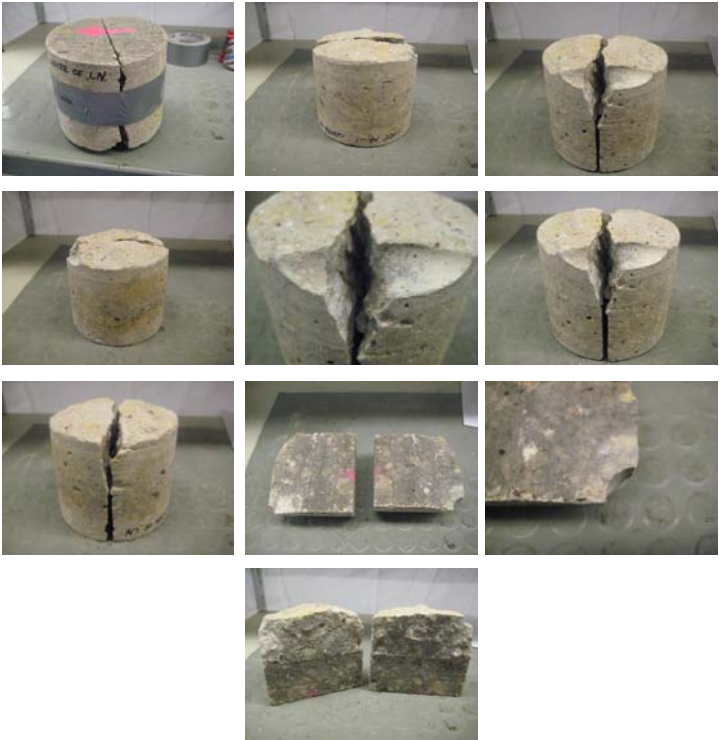
Core Intact, Y or N	No	
Type of Joint Sealant	NA	
Socketing around dowel	No	
Corrosion of dowel at concrete interface	No Dowel available	
Abrasion of the dowel surface at the crack face	No Dowel available	
Dowel Deterioration	NA	
Dowel Type	NA	
PCC Deterioration	None	
PCC Stain	None	
Signs of Defect in Core-holes		
Date when core was taken	6-17-2009	
Dowel/Concrete Slab Interface		
Base Material Noted		
General Comments: Only the top half of the core was available. No dowel included.

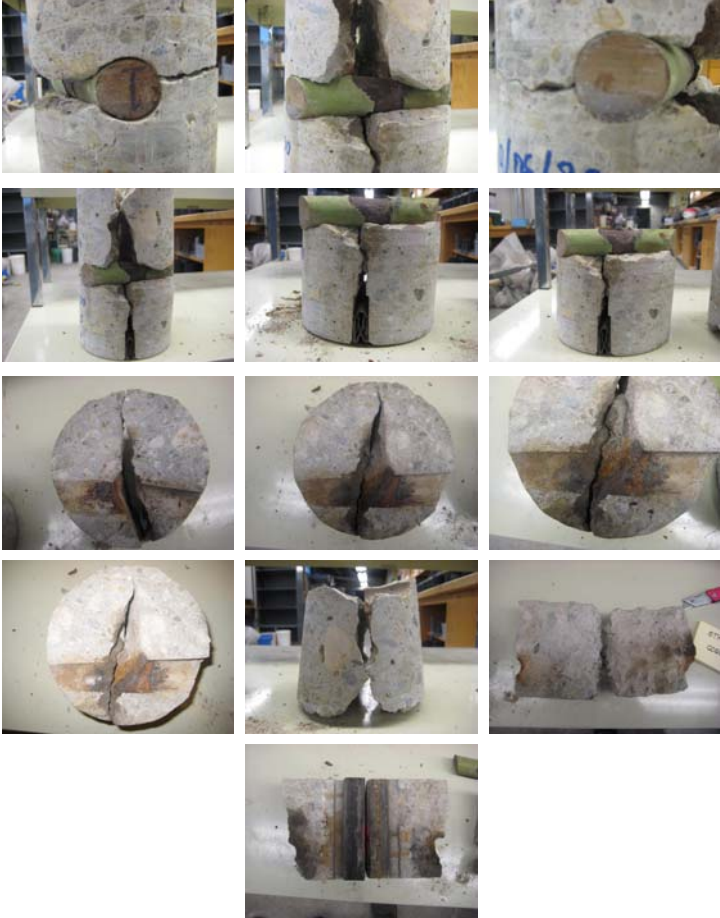
Core Intact, Y or N	No	
Type of Joint Sealant	Neoprene	
Socketing around dowel	None	
Corrosion of dowel at concrete interface	Moderate	
Abrasion of the dowel surface at the crack face	Moderate	
Dowel Deterioration	Significantly at joint	
Dowel Type	Epoxy Coated	
PCC Deterioration	Moderate at joints and minor at bottom	
PCC Stain	Yes, colors ranging from dark browns and oranges, dark colors mainly at joint.	
<b>Signs of Defect in Core-holes</b>		
Date when core was taken	6-30-09	
Dowel/Concrete Slab Interface	NA	
Base Material Noted	NA	
General Comments: PCC in 4 big pieces.

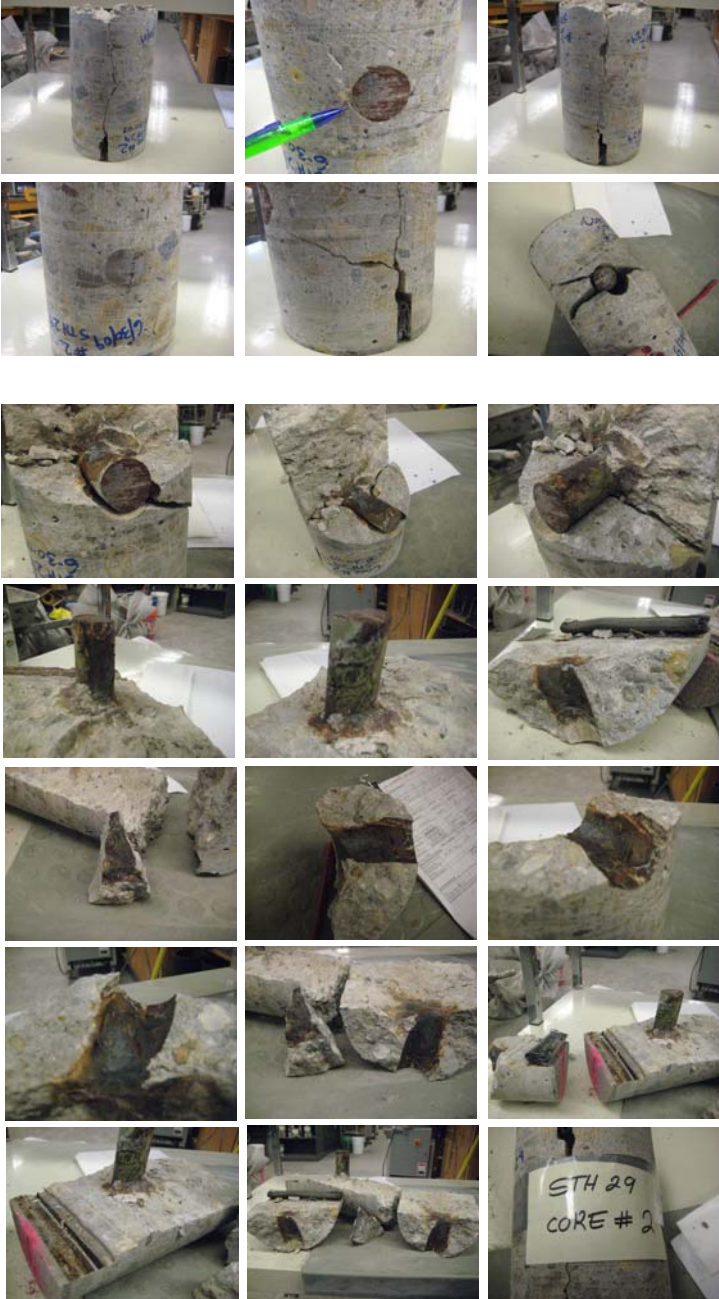
Core Intact, Y or N	Yes			
Type of Joint Sealant	Neoprene			
Socketing around dowel	No			
Corrosion of dowel at concrete interface	Moderate			
Abrasion of the dowel surface at the crack face	Moderate			
Dowel Deterioration	Moderate			
Dowel Type	Epoxy Coated			
PCC Deterioration	No			
PCC Stain	Yes, spots of colors yellow, dark browns and dark oranges			
Signs of Defect in Core-holes				
Date when core was taken	6-30-2009			
Dowel/Concrete Slab Interface				
Base Material Noted				
<p>General Comments:</p> <p>There are now a total of 4 pieces after core was opened with an electrical hammer. There are 3 big pieces and 1 medium.</p>

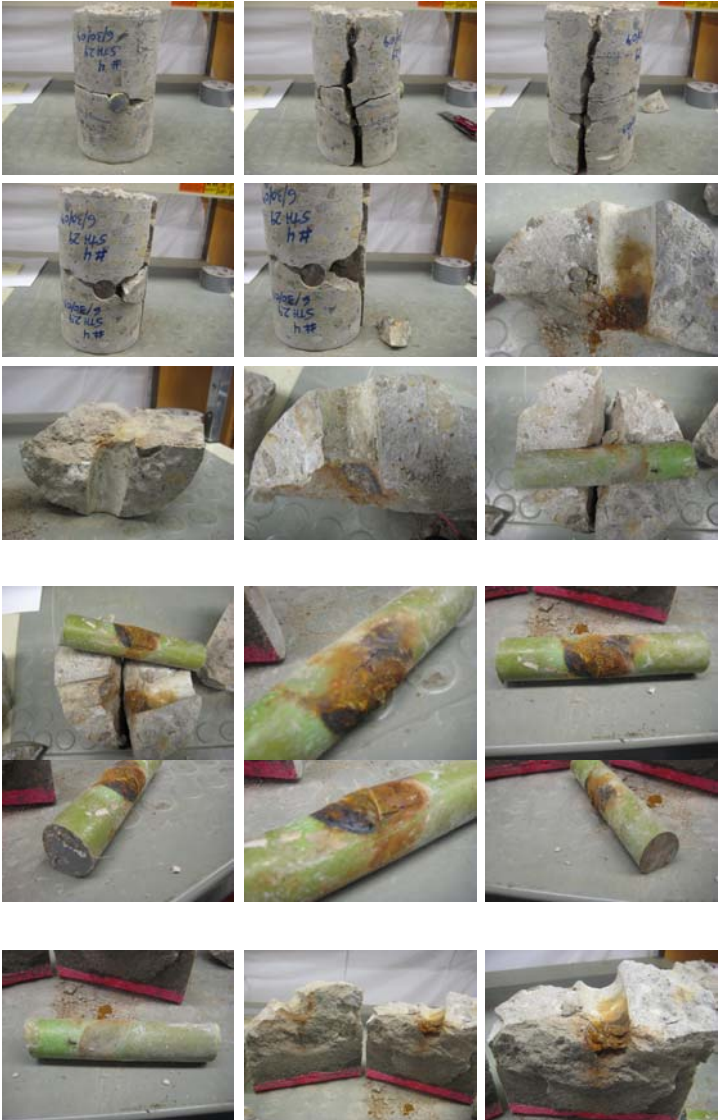
Core Intact, Y or N	No	
Type of Joint Sealant	NA	
Socketing around dowel	Minor	
Corrosion of dowel at concrete interface	Moderate	
Abrasion of the dowel surface at the crack face	Moderate	
Dowel Deterioration	Yes	
Dowel Type	Epoxy Coated	
PCC Deterioration	Minor	
PCC Stain	Yes, dark browns and oranges by corroded areas.	
Signs of Defect in Core-holes
