# EVALUATION OF ALTERNATIVE DOWEL BAR MATERIALS AND COATINGS

## Final Report

Ohio Department of Transportation  
Office of Research and Development

November 2011

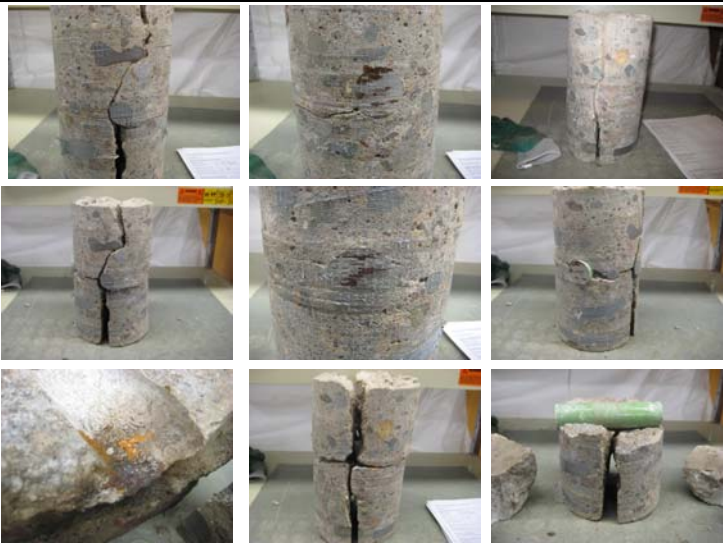
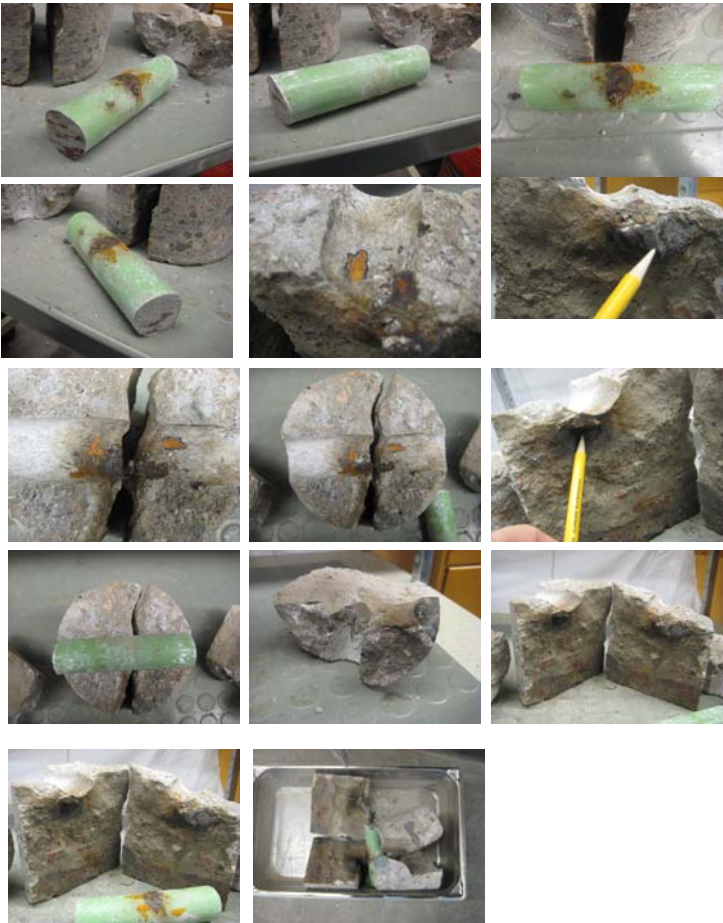
Core Intact, Y or N	Yes			
Type of Joint Sealant	NA			
Socketing around dowel	No			
Corrosion of dowel at concrete interface	Yes			
Abrasion of the dowel surface at the crack face	Minor			
Dowel Deterioration	Minor			
Dowel Type	Epoxy Coated			
PCC Deterioration	No			
PCC Stain	Yes (mainly at joint, dark brown spots)

Signs of Defect in Core-holes				
Date when core was taken	6-30-2009			
Dowel/Concrete Slab Interface				
Base Material Noted				
General Comments: The core was broken with an electrical hammer to be able to see the dowel. The core consist of 4 big pieces and the dowel is loose.

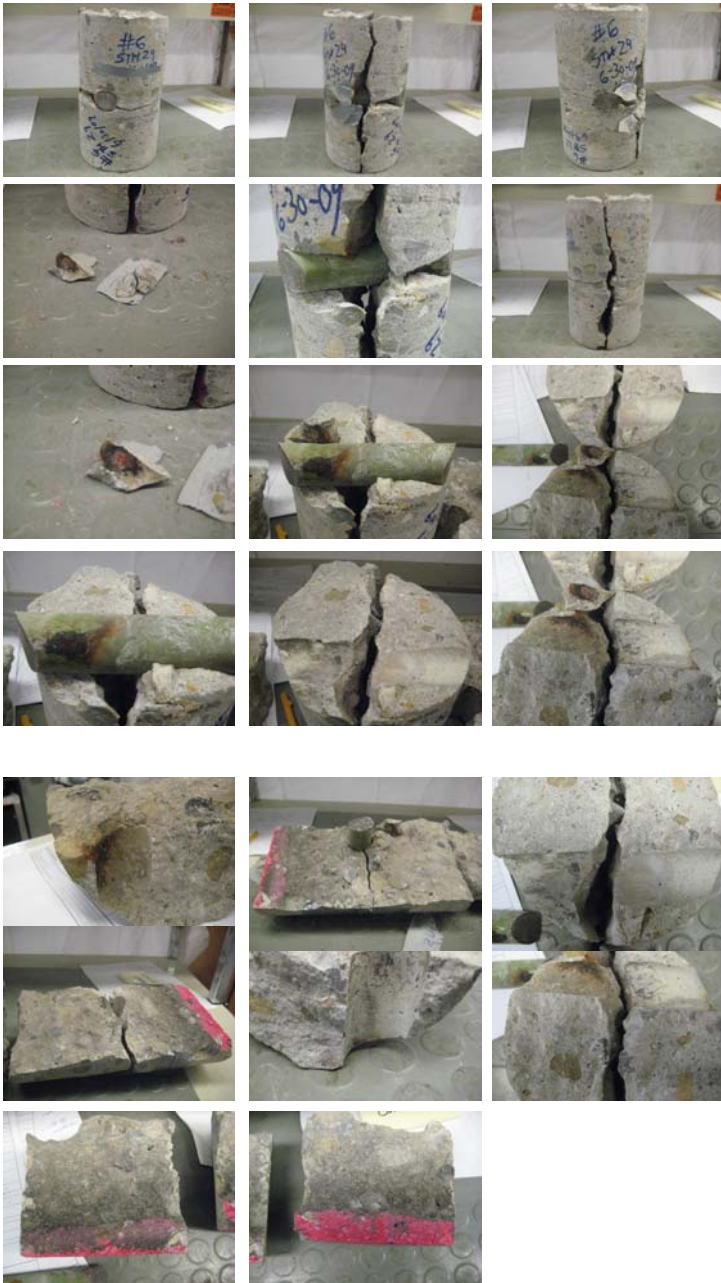
Core Intact, Y or N	No (4 pieces)			
Type of Joint Sealant	NA			
Socketing around dowel	No			
Corrosion of dowel at concrete interface	Minor			
Abrasion of the dowel surface at the crack face	Moderate			
Dowel Deterioration	Minor			
Dowel Type	Epoxy Coated			
PCC Deterioration	Minor			
PCC Stain	One spot very dark brown and orange			
Signs of Defect in Core-holes				
Date when core was taken	6-30-2009			
Dowel/Concrete Slab Interface	No			
Base Material Noted				
General Comments: There are 2 small pieces of PCC with stain and attached to the duck tape

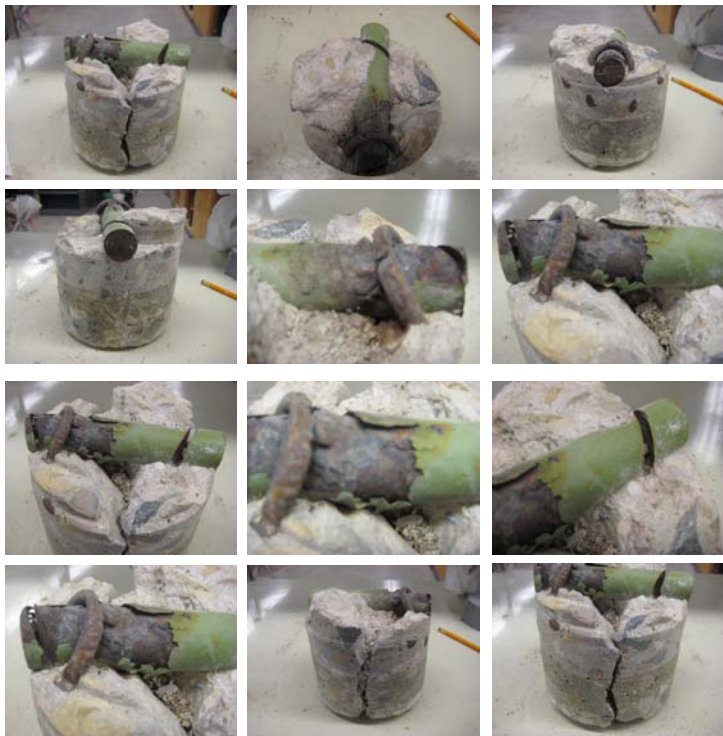
Core Intact, Y or N	Yes, only available top portion of core			
Type of Joint Sealant	NA			
Socketing around dowel	No			
Corrosion of dowel at concrete interface	Extensive			
Abrasion of the dowel surface at the crack face	Extensive			
Dowel Deterioration	Extensive			
Dowel Type	Epoxy Coated			
PCC Deterioration	Minor			
PCC Stain	Unable to observe			
Signs of Defect in Core-holes				
Date when core was taken	4-20-09			
Dowel/Concrete Slab Interface				
Base Material Noted				
General Comments: PCC need to be hammered drilled to separate sides to observe joint face.

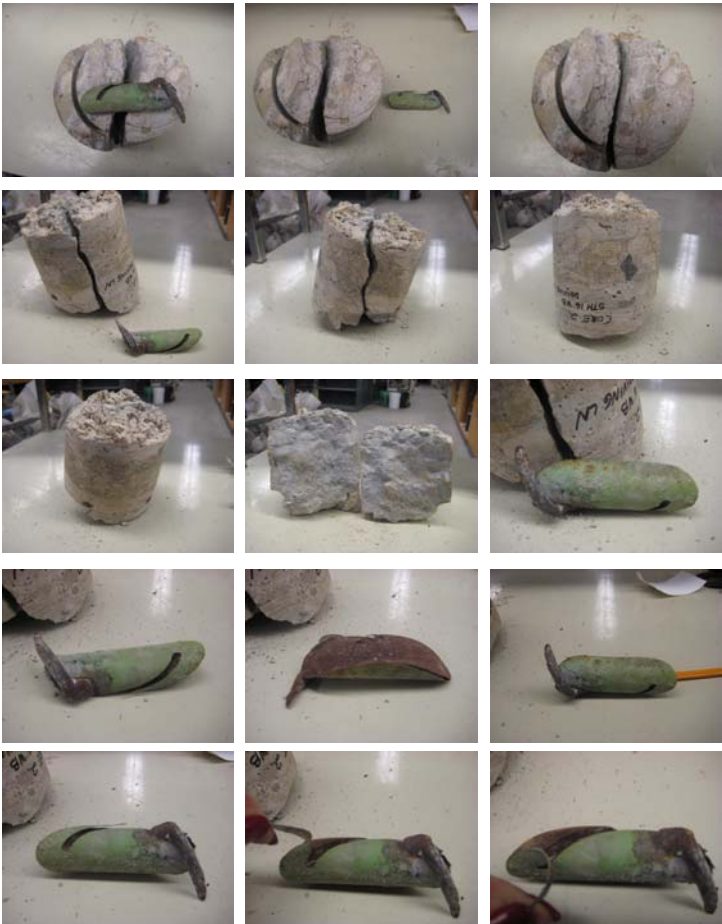
Core Intact, Y or N	No			
Type of Joint Sealant	NA			
Socketing around dowel	NA			
Corrosion of dowel at concrete interface	Moderate			
Abrasion of the dowel surface at the crack face	Moderate			
Dowel Deterioration	Moderate			
Dowel Type	Epoxy Coated			
PCC Deterioration	Minor			
PCC Stain	Unable to see			
Signs of Defect in Core-holes				
Date when core was taken	4-20-09			
Dowel/Concrete Slab Interface				
Base Material Noted				
General Comments: This core came in 3 pieces, 2PCC and the dowel. Unable to see any stain in PCC. The dowel was loose and moderately corroded.

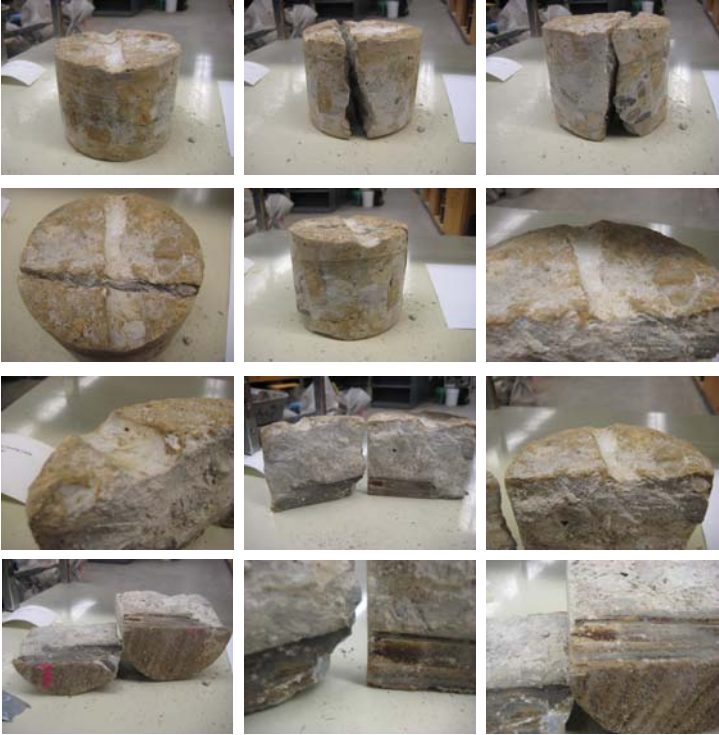
Core Intact, Y or N	No	
Type of Joint Sealant	NA	
Socketing around dowel	NA	
Corrosion of dowel at concrete interface	NA	
Abrasion of the dowel surface at the crack face	NA	
Dowel Deterioration	NA	
Dowel Type	Dowel Missing	
PCC Deterioration	Minor	
PCC Stain	Yes, a few spots light brown where dowelsits.	
<b>Signs of Defect in Core-holes</b>		
Date when core was taken	4-20-09	
Dowel/Concrete Slab Interface		
Base Material Noted		
General Comments: The core came with only 2 pieces of PCC (top portion) and dowel was missing. Regarding the joint seal, it was missing but looking at the core, it could have been neoprene. See last 2 photos of this page.

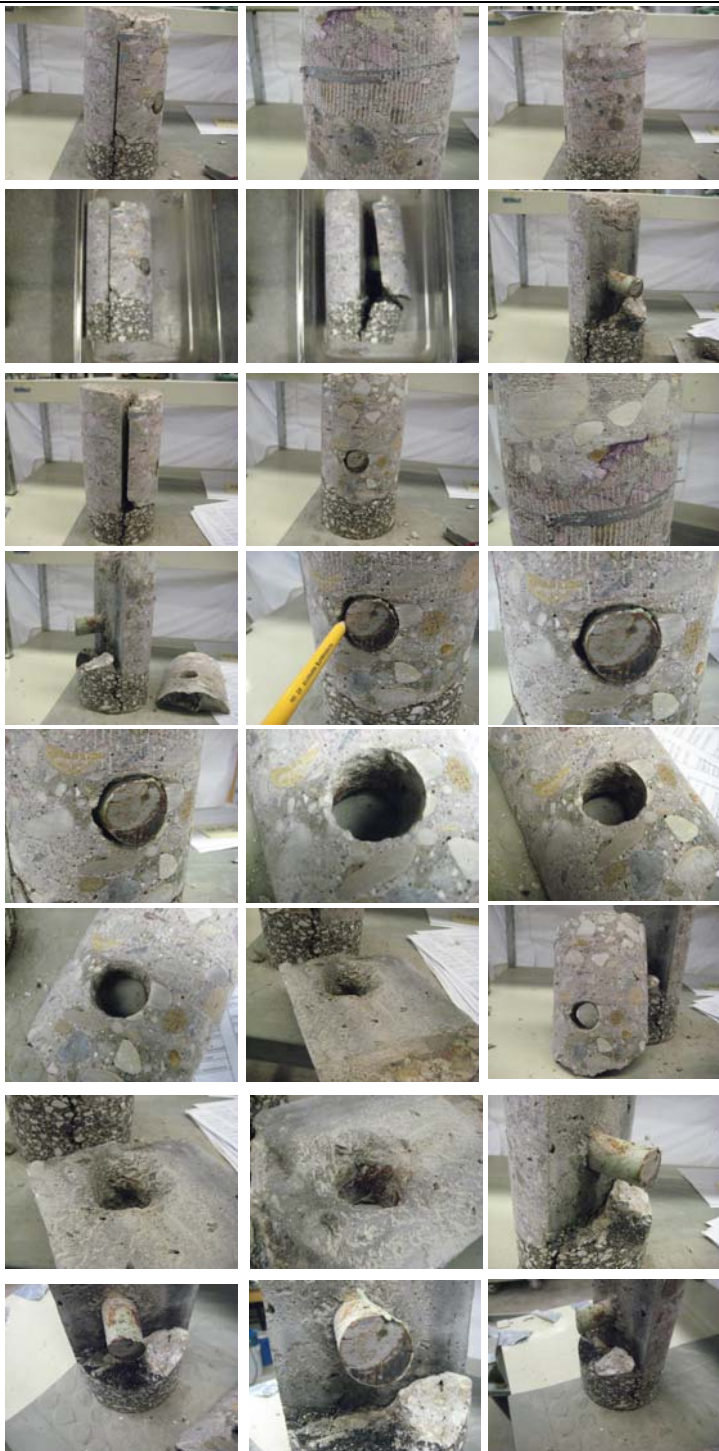
Core Intact, Y or N	Yes			
Type of Joint Sealant	NA			
Socketing around dowel	Yes			
Corrosion of dowel at concrete interface	Minor			
Abrasion of the dowel surface at the crack face	Minor, some orange color spots at ends face			
Dowel Deterioration	Minor			
Dowel Type	Epoxy Coated			
PCC Deterioration	No			
PCC Stain	Yes, dark and brown colors at dowel placement areas			
Signs of Defect in Core-holes				
Date when core was taken	NA			
Dowel/Concrete Slab Interface				
Base Material Noted				
General Comments: The AC Overlay layer is attached to PCC as well as the dowel.

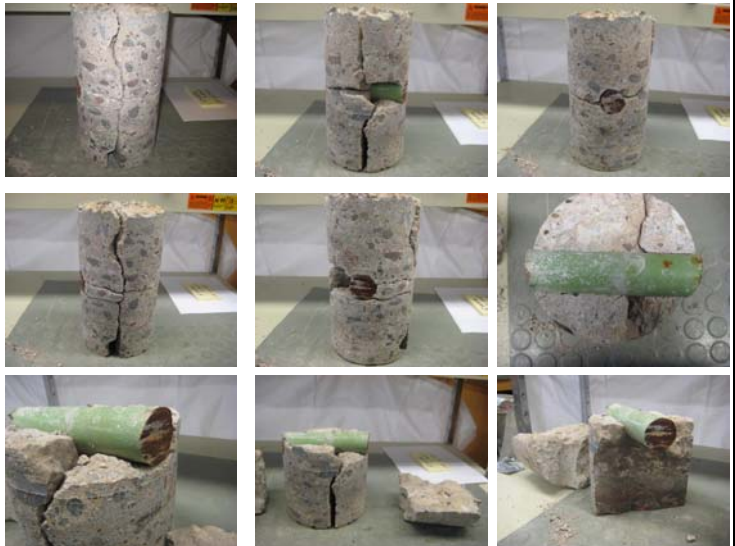
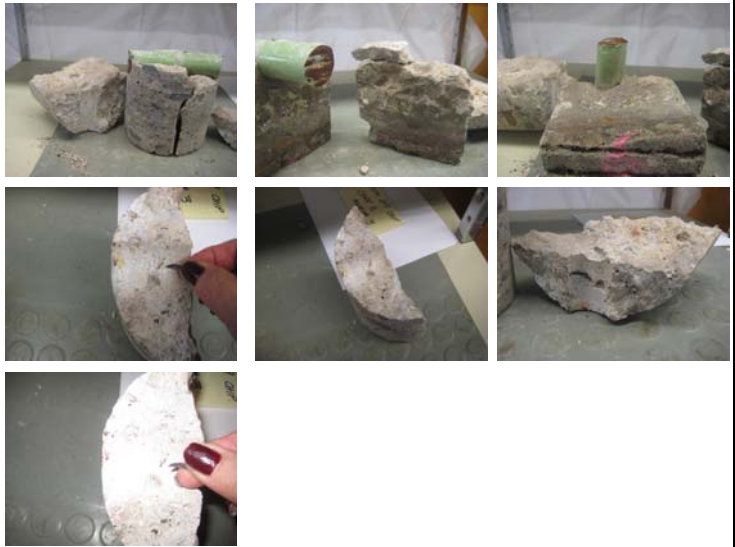
Core Intact, Y or N	No (4 Big pieces)			
Type of Joint Sealant	NA			
Socketing around dowel	No			
Corrosion of dowel at concrete interface	Small orange spot			
Abrasion of the dowel surface at the crack face	Only at cut edges			
Dowel Deterioration	No			
Dowel Type	Epoxy Coated			
PCC Deterioration	Yes, minor			
PCC Stain	No stains			
Signs of Defect in Core-holes

Date when core was taken	NA			
Dowel/Concrete Slab Interface				
Base Material Noted				
General Comments: The dowel is still attached to one of the PCC pieces.

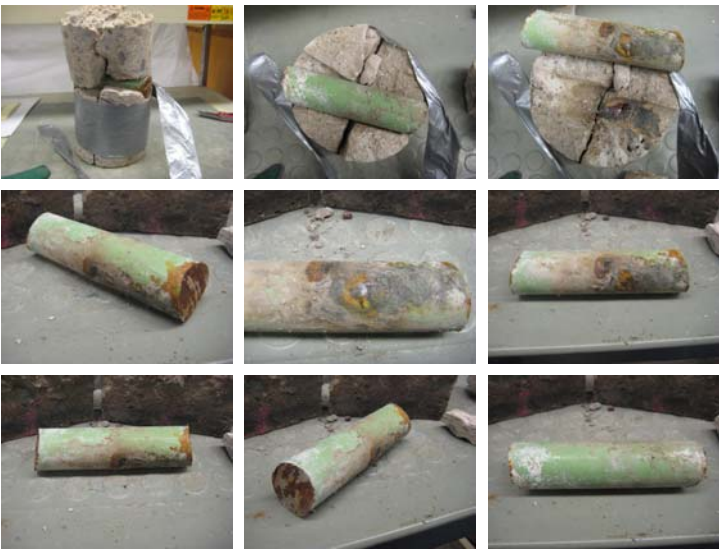
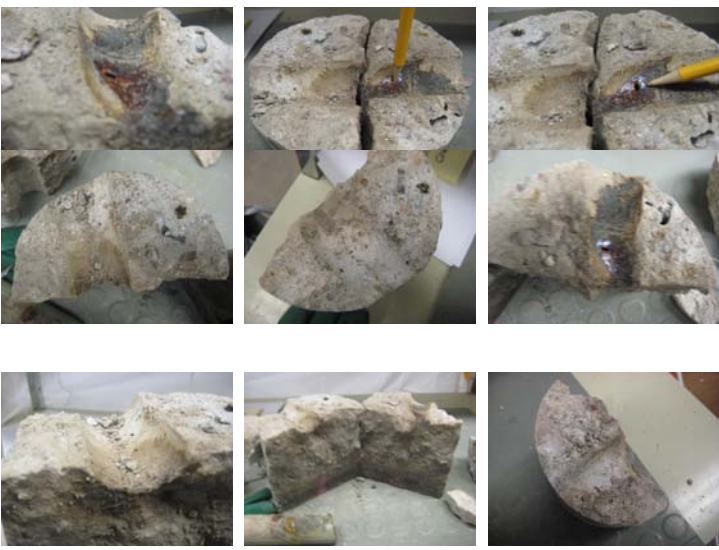
Core Intact, Y or N	No			
Type of Joint Sealant	NA			
Socketing around dowel	Minor			
Corrosion of dowel at concrete interface	Yes, minor			
Abrasion of the dowel surface at the crack face	Moderate			
Dowel Deterioration	Minor			
Dowel Type	Epoxy Coated			
PCC Deterioration	Yes, minor			
PCC Stain	Orange and dark brown spots in one area only			
Signs of Defect in Core-holes

Date when core was taken	10-20-2009			
Dowel/Concrete Slab Interface				
Base Material Noted				
General Comments: There are 4 big pieces, 1 medium and dowel is loose.

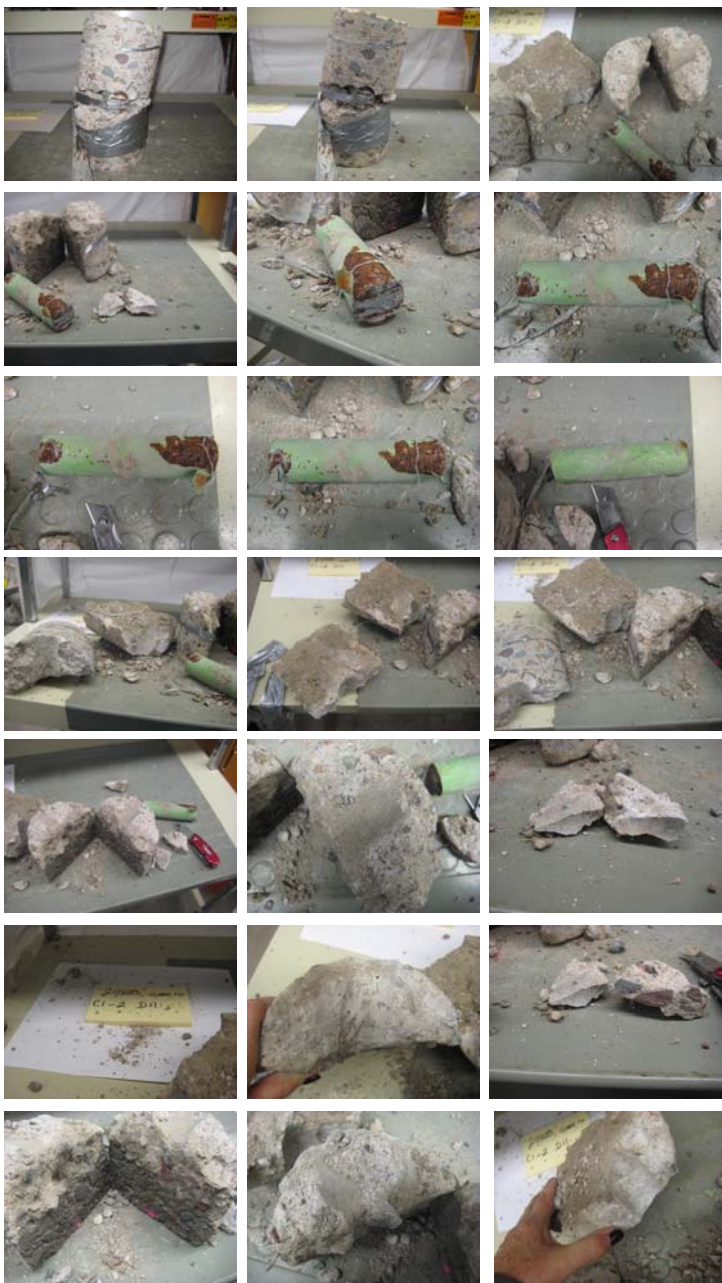
Core Intact, Y or N	No			
Type of Joint Sealant	NA			
Socketing around dowel	Minor			
Corrosion of dowel at concrete interface	Minor			
Abrasion of the dowel surface at the crack face	Extensive			
Dowel Deterioration	Yes			
Dowel Type	Epoxy Coated Steel			
PCC Deterioration	Yes, core crumbled			
PCC Stain	No			
Signs of Defect in Core-holes				
Date when core was taken	10/21/2009			
Dowel/Concrete Slab Interface				
Base Material Noted				
General Comments: The core is broken into 4 big pieces, 3 medium, dowel is loose and a lot of small pieces.

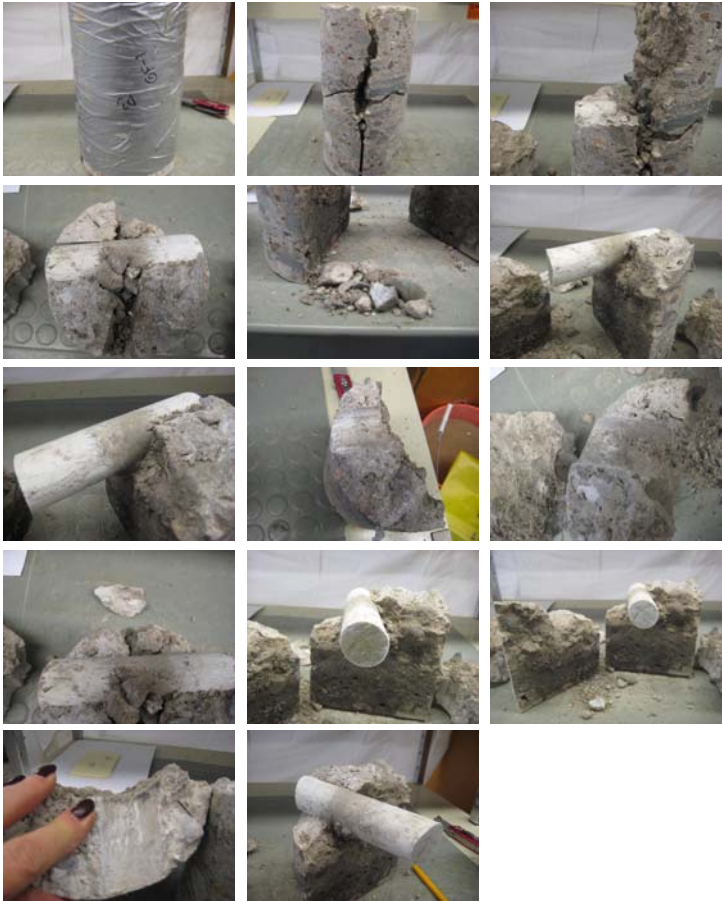
Core Intact, Y or N	No	
Type of Joint Sealant	NA	
Socketing around dowel	No	
Corrosion of dowel at concrete interface	Dark areas at joints	
Abrasion of the dowel surface at the crack face	No	
Dowel Deterioration	No	
Dowel Type	Glasforms FRP (Fiber Reinforced Polymer)	
PCC Deterioration	Moderate	
PCC Stain	Some dark areas at joint	
<b>Signs of Defect in Core-holes</b>

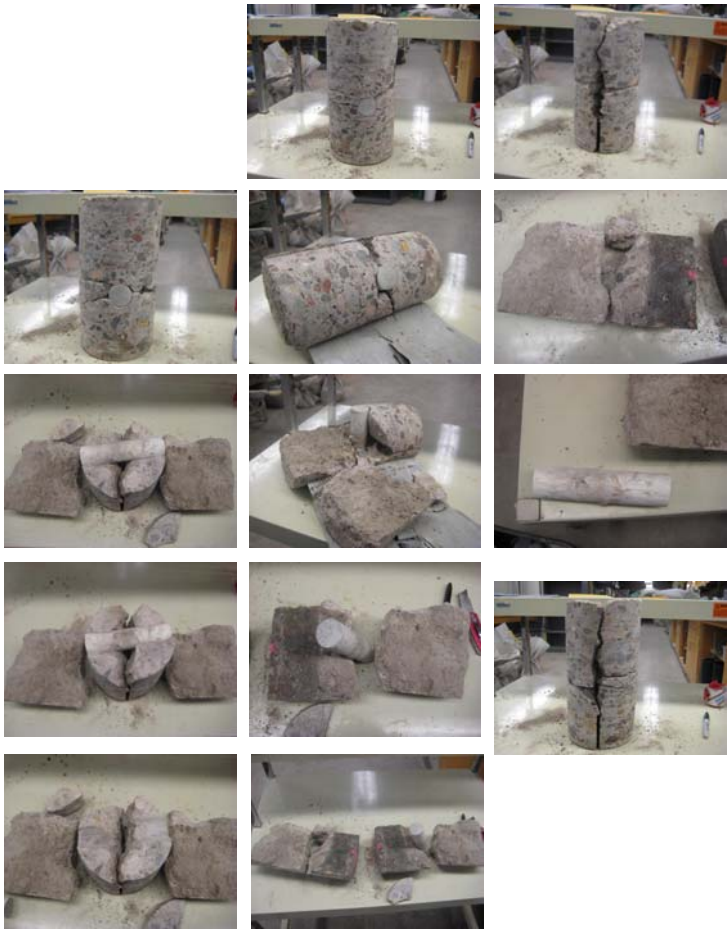
Core Intact, Y or N	No (6 pieces)	
Type of Joint Sealant	NA	
Socketing around dowel	None	
Corrosion of dowel at concrete interface	None	
Abrasion of the dowel surface at the crack face	None	
Dowel Deterioration	None	
Dowel Type	Glasforms FRP (Filled Reinforced Polymer)	
PCC Deterioration	Very minor due to the breaking of the core when extracted.	
PCC Stain	There are dark gray areas which believed to be from pollution due to lacking of joint seal.	
<b>Signs of Defect in Core-holes</b>

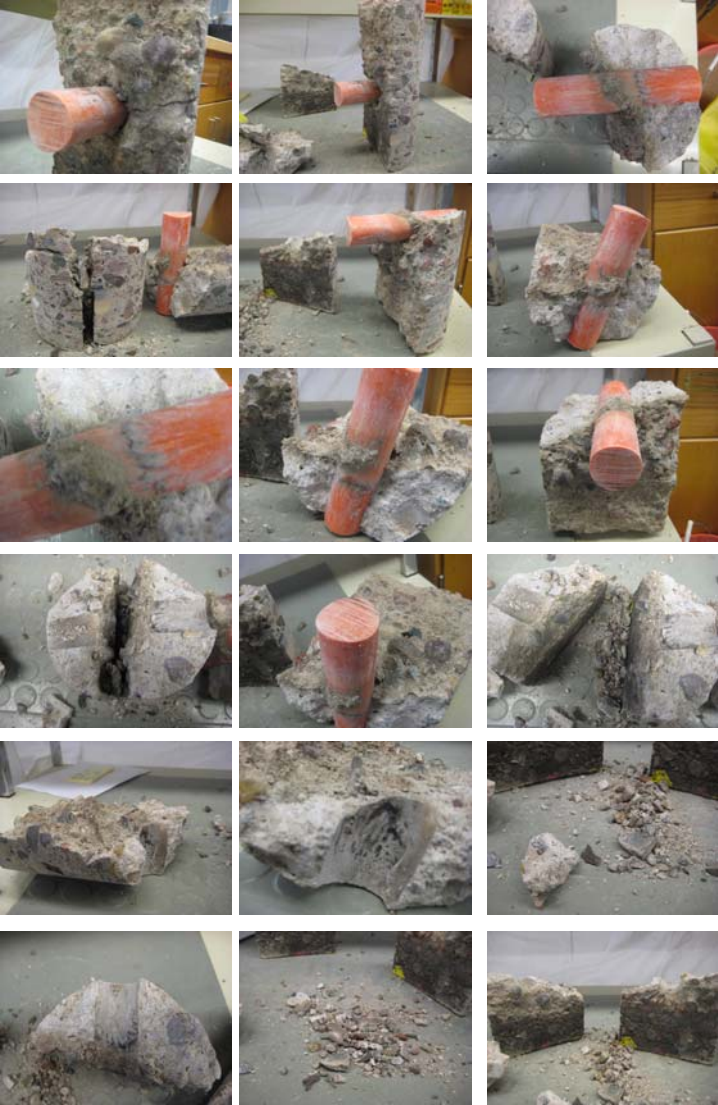
Core Intact, Y or N	No	
Type of Joint Sealant	NA	
Socketing around dowel	No	
Corrosion of dowel at concrete interface	Yes, some dark spots at joint	
Abrasion of the dowel surface at the crack face	No	
Dowel Deterioration	No	
Dowel Type	RJD FRP (Fiber Reinforced Polymer)	
PCC Deterioration	Yes, some crumbled	
PCC Stain	Yes, some dark spots at dowel placement	
<b>Signs of Defect in Core-holes</b>		
Date when core was taken	10/21/2009	
Dowel/Concrete Slab Interface		
Base Material Noted		
General Comments: There are 4 big pieces, one medium and a lot of small pieces. The dowel is still attached to ¼ of the PCC core.

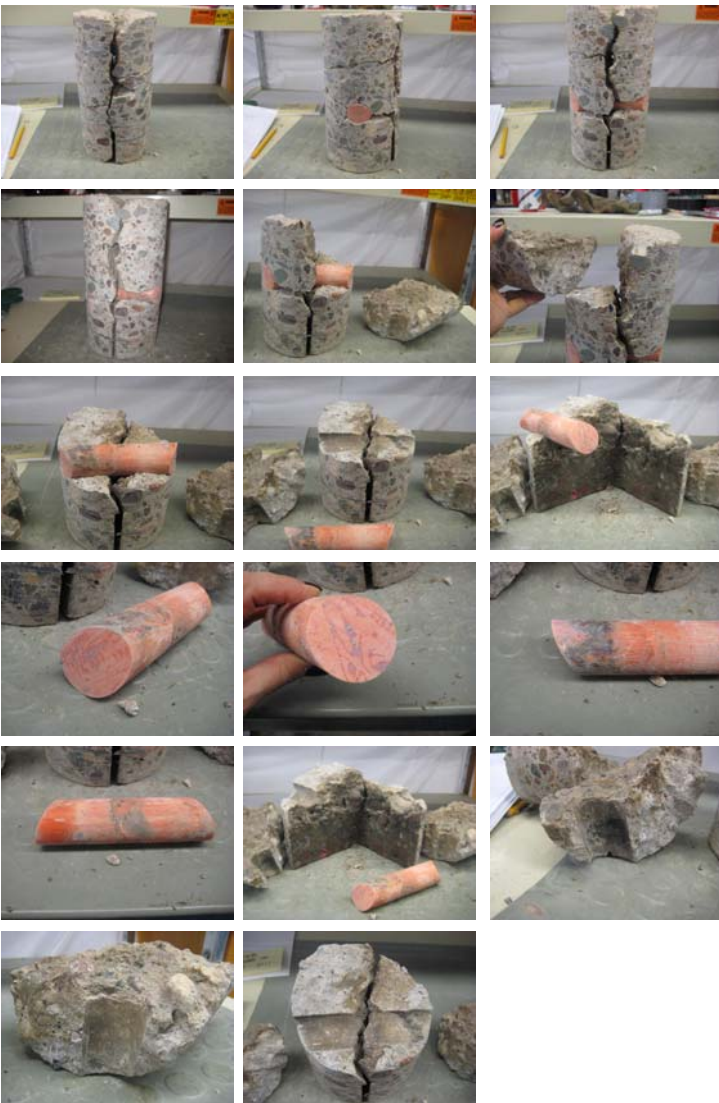
Core Intact, Y or N	No (5 pieces)			
Type of Joint Sealant	NA			
Socketing around dowel	No			
Corrosion of dowel at concrete interface	Minor in one side			
Abrasion of the dowel surface at the crack face	No			
Dowel Deterioration	Minor			
Dowel Type	RJD FRP (Fiber Reinforced Polymer)			
PCC Deterioration	Minor			
PCC Stain	Some dark brown areas			
Signs of Defect in Core-holes				
Date when core was taken	10/21/2009			
Dowel/Concrete Slab Interface				
Base Material Noted				
General Comments: The core is broken into 5 pieces and the dowel is loose.

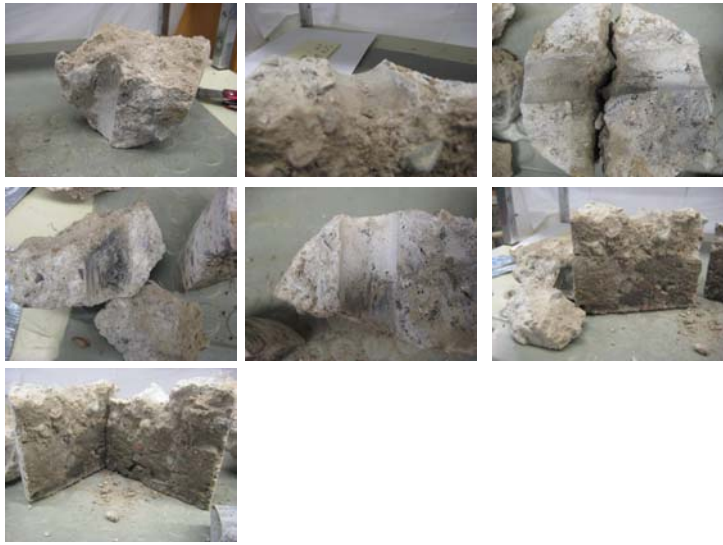
Date when core was taken	10/21/2009			
Dowel/Concrete Slab Interface				
Base Material Noted				
General Comments: There are 3 big pieces of PCC, 3 medium pieces and dowel is loose.

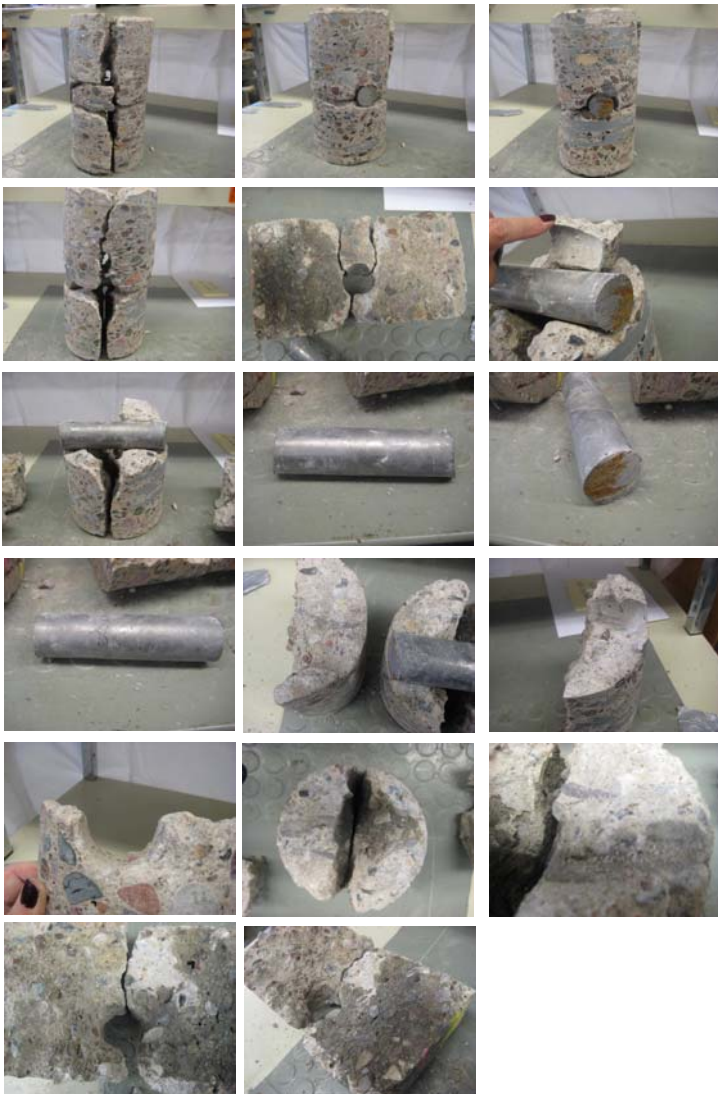
Core Intact, Y or N	No			
Type of Joint Sealant	NA			
Socketing around dowel	Yes, PCC crumbling at joint			
Corrosion of dowel at concrete interface	No			
Abrasion of the dowel surface at the crack face	No			
Dowel Deterioration	No			
Dowel Type	Solid Stainless Steel			
PCC Deterioration	Yes			
PCC Stain	Some darker areas at joint. Could be due to dirt and pollution			
Signs of Defect in Core-holes				
Date when core was taken	10/21/2009			
Dowel/Concrete Slab Interface				
Base Material Noted	No			
General Comments: There are 4 big pieces of PCC and one medium. Dowel is not attached to any of the pieces.
