**CRACK SURVEYS OF LOW-CRACKING HIGH-PERFORMANCE CONCRETE
BRIDGE DECKS IN KANSAS
2014-2015**

**By
Abdallah Alhmoody
David Darwin
Matt O'Reilly**

**Structural Engineering and Engineering Materials
SL Report 15-3**

**THE UNIVERSITY OF KANSAS CENTER FOR RESEARCH, INC.
LAWRENCE, KANSAS
September 2015**

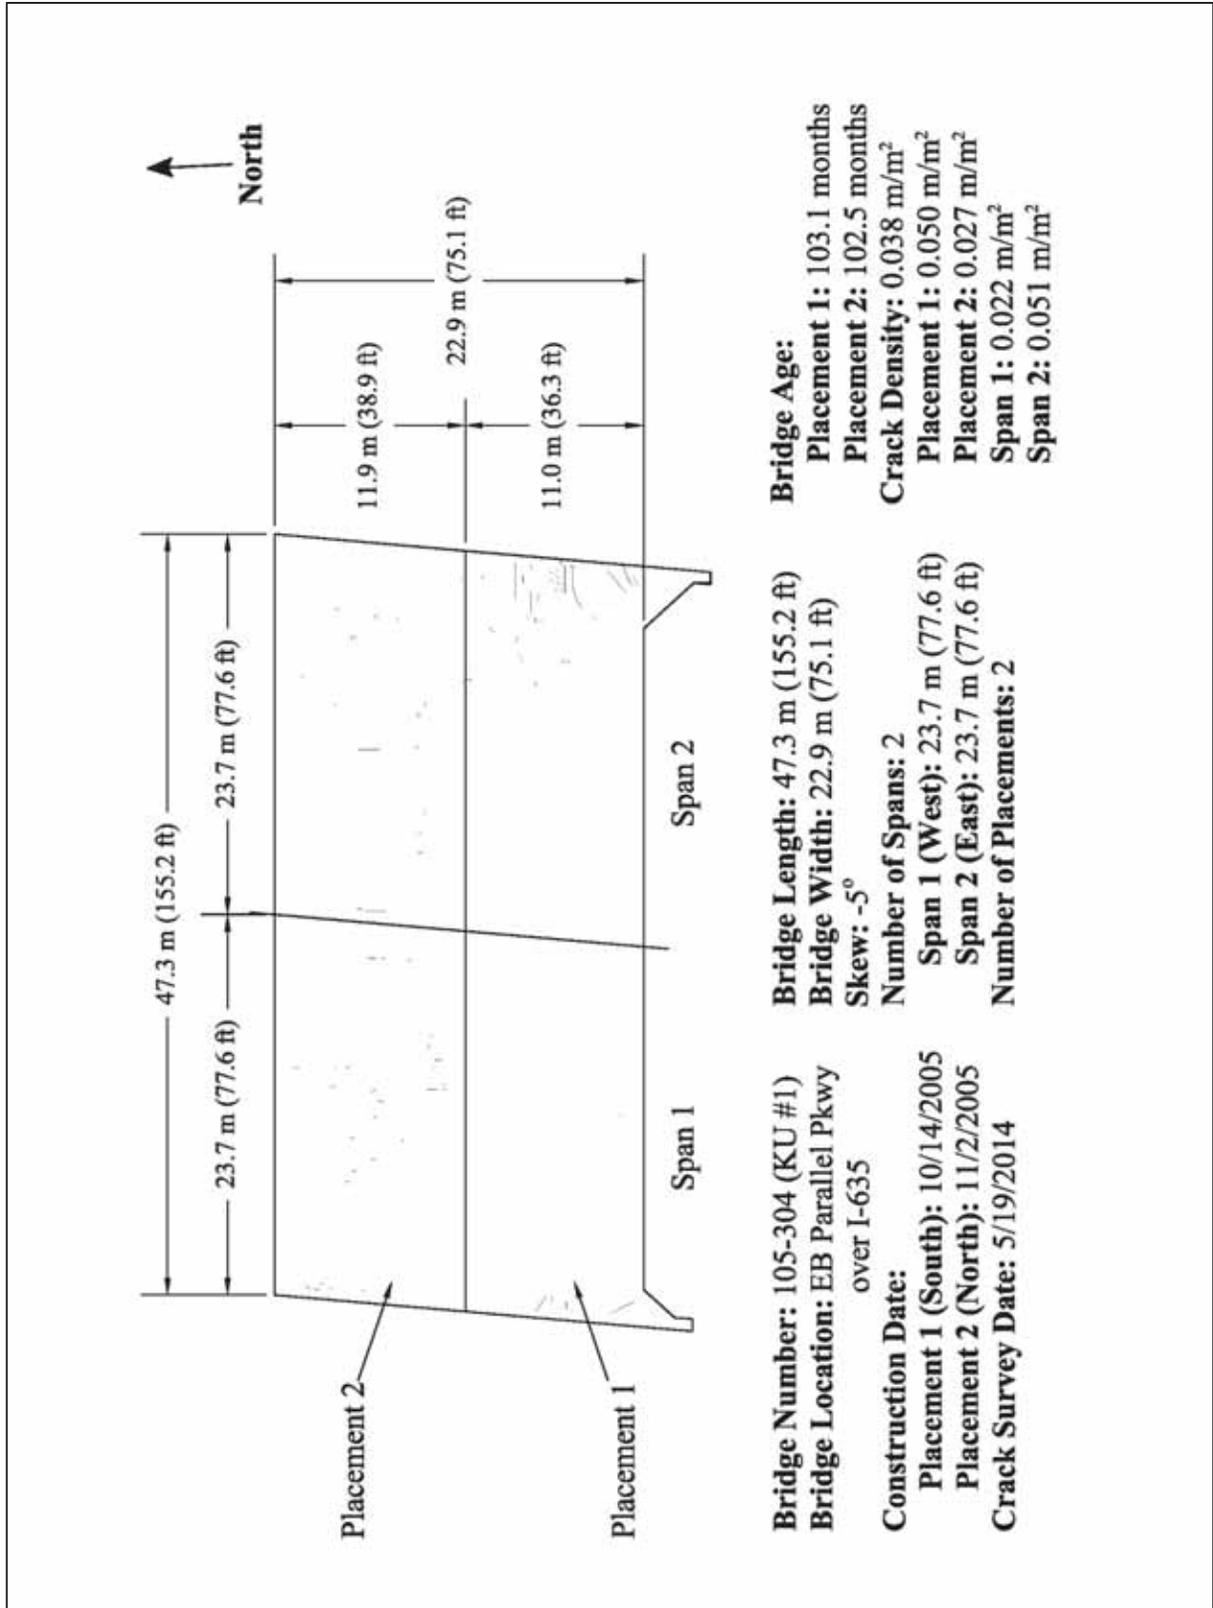
Figure 3: LC-HPC-1 (Survey 9)

The bridge deck of LC-HPC-1 was constructed in two placements; Placement 1 was placed on 10/14/2005 and Placement 2 was placed on 11/2/2005. This bridge has been surveyed ten times; the results of Surveys 9 and 10 of LC-HPC-1 are included in this report. Survey 9 was performed at a deck age of 103.1 months for Placement 1 and 102.5 months for Placement 2; the crack map from this survey is shown in Figure 3. Survey 10 was performed at a deck age of 115.1 months for Placement 1 and 114.5 months for Placement 2; the crack map from this survey is shown in Figure 4. Crack densities of 0.050 and 0.027 m/m² were observed in Survey 9 (Figure 3) for Placements 1 and 2, respectively. These values are similar to the crack densities from Survey 8, reported by Bohaty et al. (2013). Crack densities of 0.037 and 0.055 m/m² were observed in Survey 10 (Figure 4) for Placements 1 and 2, respectively. Survey 10 for Placement 1 showed that the bridge deck had a slightly lower crack density compared to Survey 9. The surveys showed that the deck has experienced some scaling, making it harder to identify cracks during the survey. As shown in Figures 3 and 4, most of the cracks that were marked for both placements are relatively small transverse cracks, parallel to the deck's top reinforcement, with longitudinal cracks near the abutments.

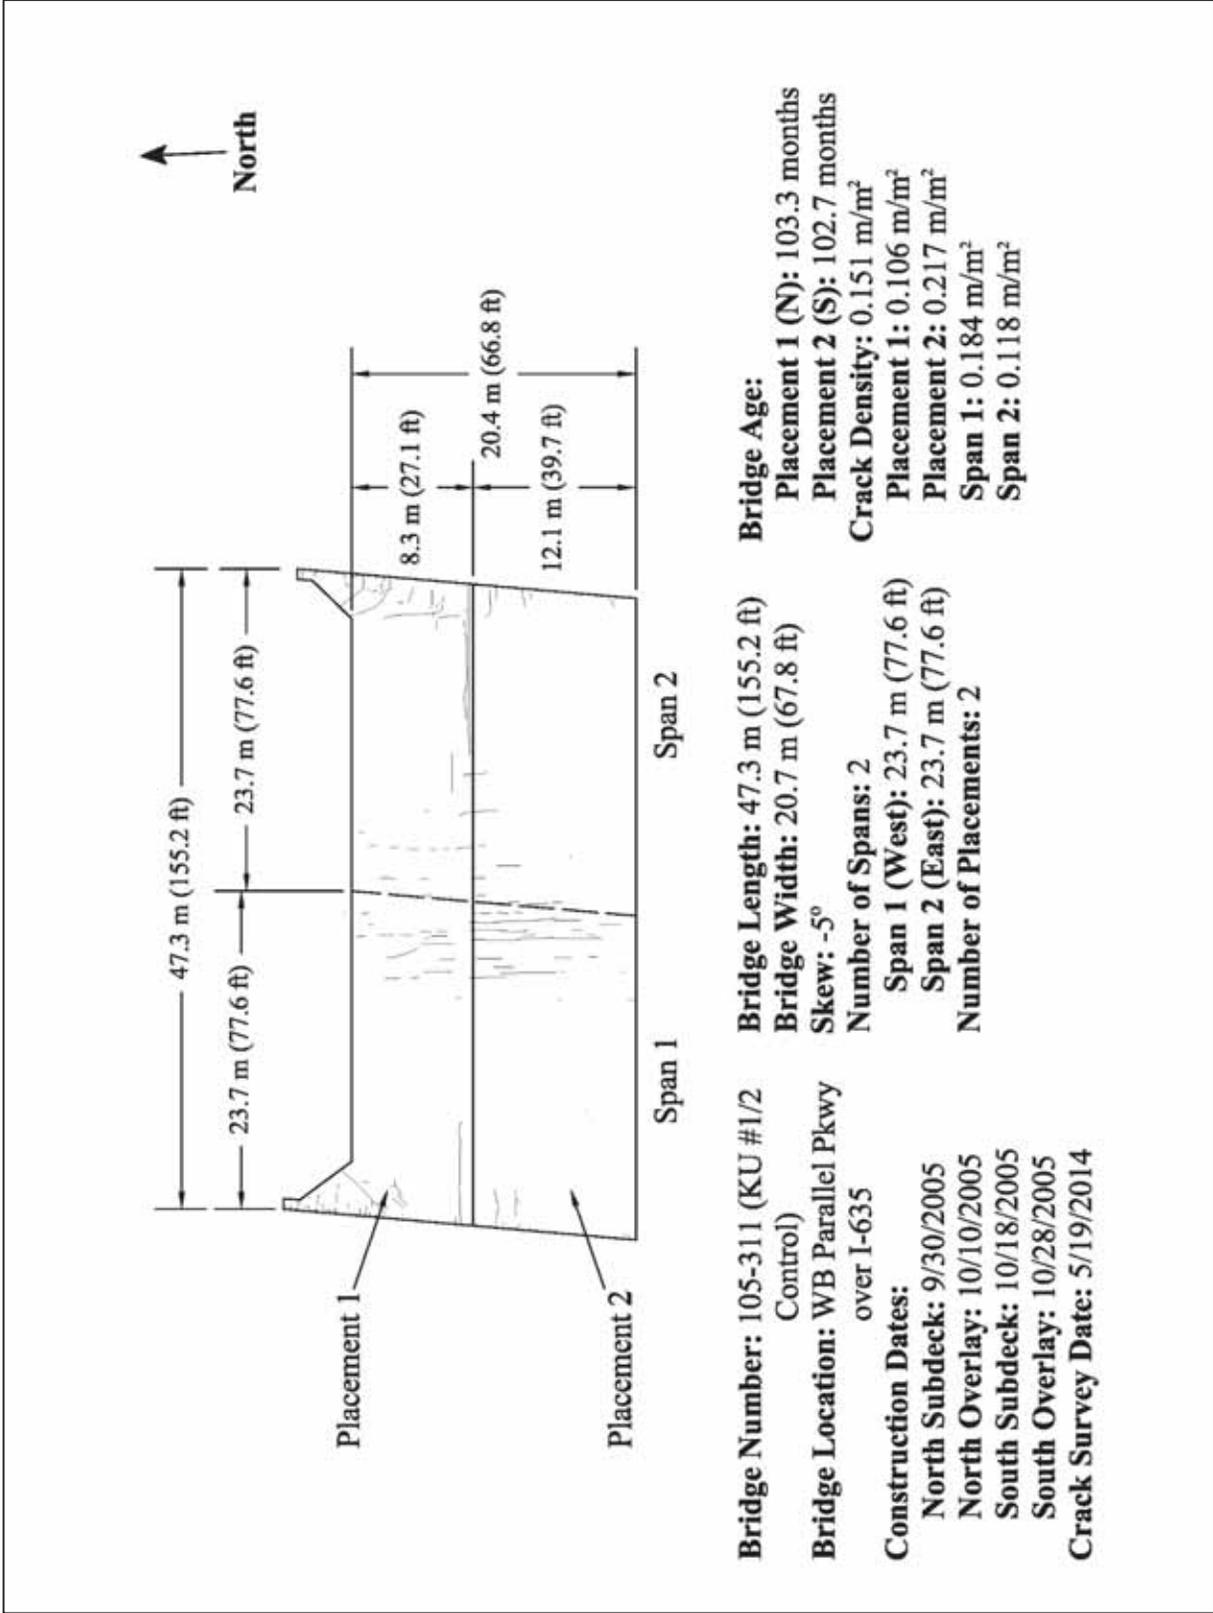
Figure 5: Control-1/2 (Survey 9)

Control-1/2 is paired with both LC-HPC-1 and LC-HPC-2, which have similar environmental conditions, age, and traffic volume. To date, Control-1/2 has been surveyed ten times. The deck was constructed in two placements; Placement 1 was constructed on 9/30/2005 and Placement 2 was constructed on 10/10/2005. The results of Surveys 9 and 10 of Control-1/2 are included in this report. Survey 9 was performed at a deck age of 103.3 months for Placement 1 and 102.7 months for Placement 2; the crack map from this survey is shown in Figure 5. Survey 10 was completed at a deck age of 115.6 months for Placement 1 and 115.3 months for Placement 2; the crack map from this survey is shown in Figure 6. Crack densities of 0.106 and 0.217 m/m² were observed in Survey 9 for Placements 1 and 2, respectively (Figure 5). Crack densities of 0.164 and 0.239 m/m² were observed in Survey 10 for Placements 1 and 2, respectively (Figure 6). These crack densities are greater than the densities from Survey 8 reported by Bohaty et al. (2013). Most of the cracking is transverse and took place above the pier. These cracks are parallel to the top reinforcement. Cracks have propagated longitudinally near the abutments. A limited amount of map cracking has occurred since Survey 9.

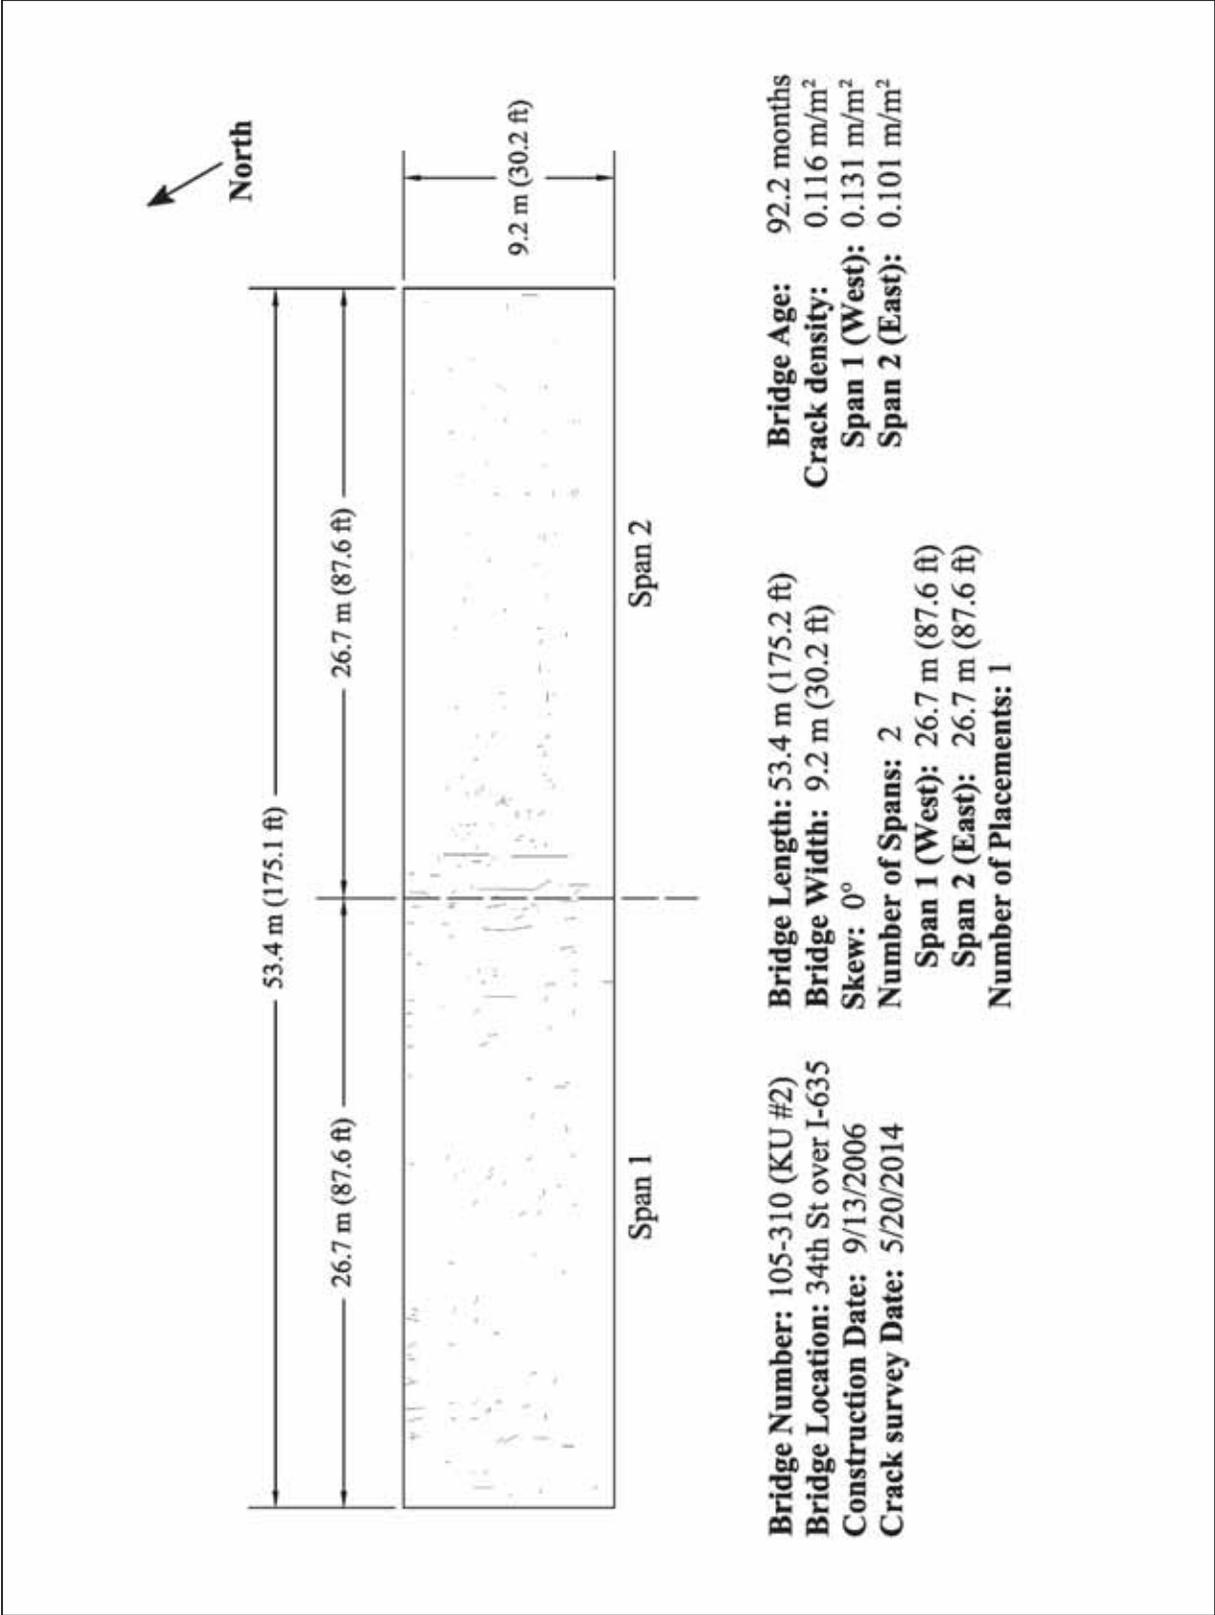
Figure 8: LC-HPC-2 (Survey 8)

Bridge deck LC-HPC-2 was constructed on 9/13/2006, and has been surveyed 9 times. Survey 8 was performed at a deck age of 92.2 months; the crack map from this survey is displayed in Figure 8. Survey 9 was completed at a deck age of 104.2 months; the crack map from this survey is shown in Figure 9. A crack density of 0.116 m/m^2 was observed in Survey 8 (Figure 8). This value is noticeably lower than observed in Survey 7, 0.141 m/m^2 , as reported by Bohaty et al. (2013) at an age of 80.3 months. A crack density of 0.220 m/m^2 was observed in Survey 9 (Figure 9), which is higher than all previously reported crack densities. As shown in Figure 10, LC-HPC-2 has a higher overall crack density than Placement 1 of Control-1/2 and a slightly lower crack density than Placement 2 of Control-1/2 at approximately the same age. Map cracking is the dominant type of crack that has been surveyed. Some transverse cracks appear in the middle of the bridge above the pier.

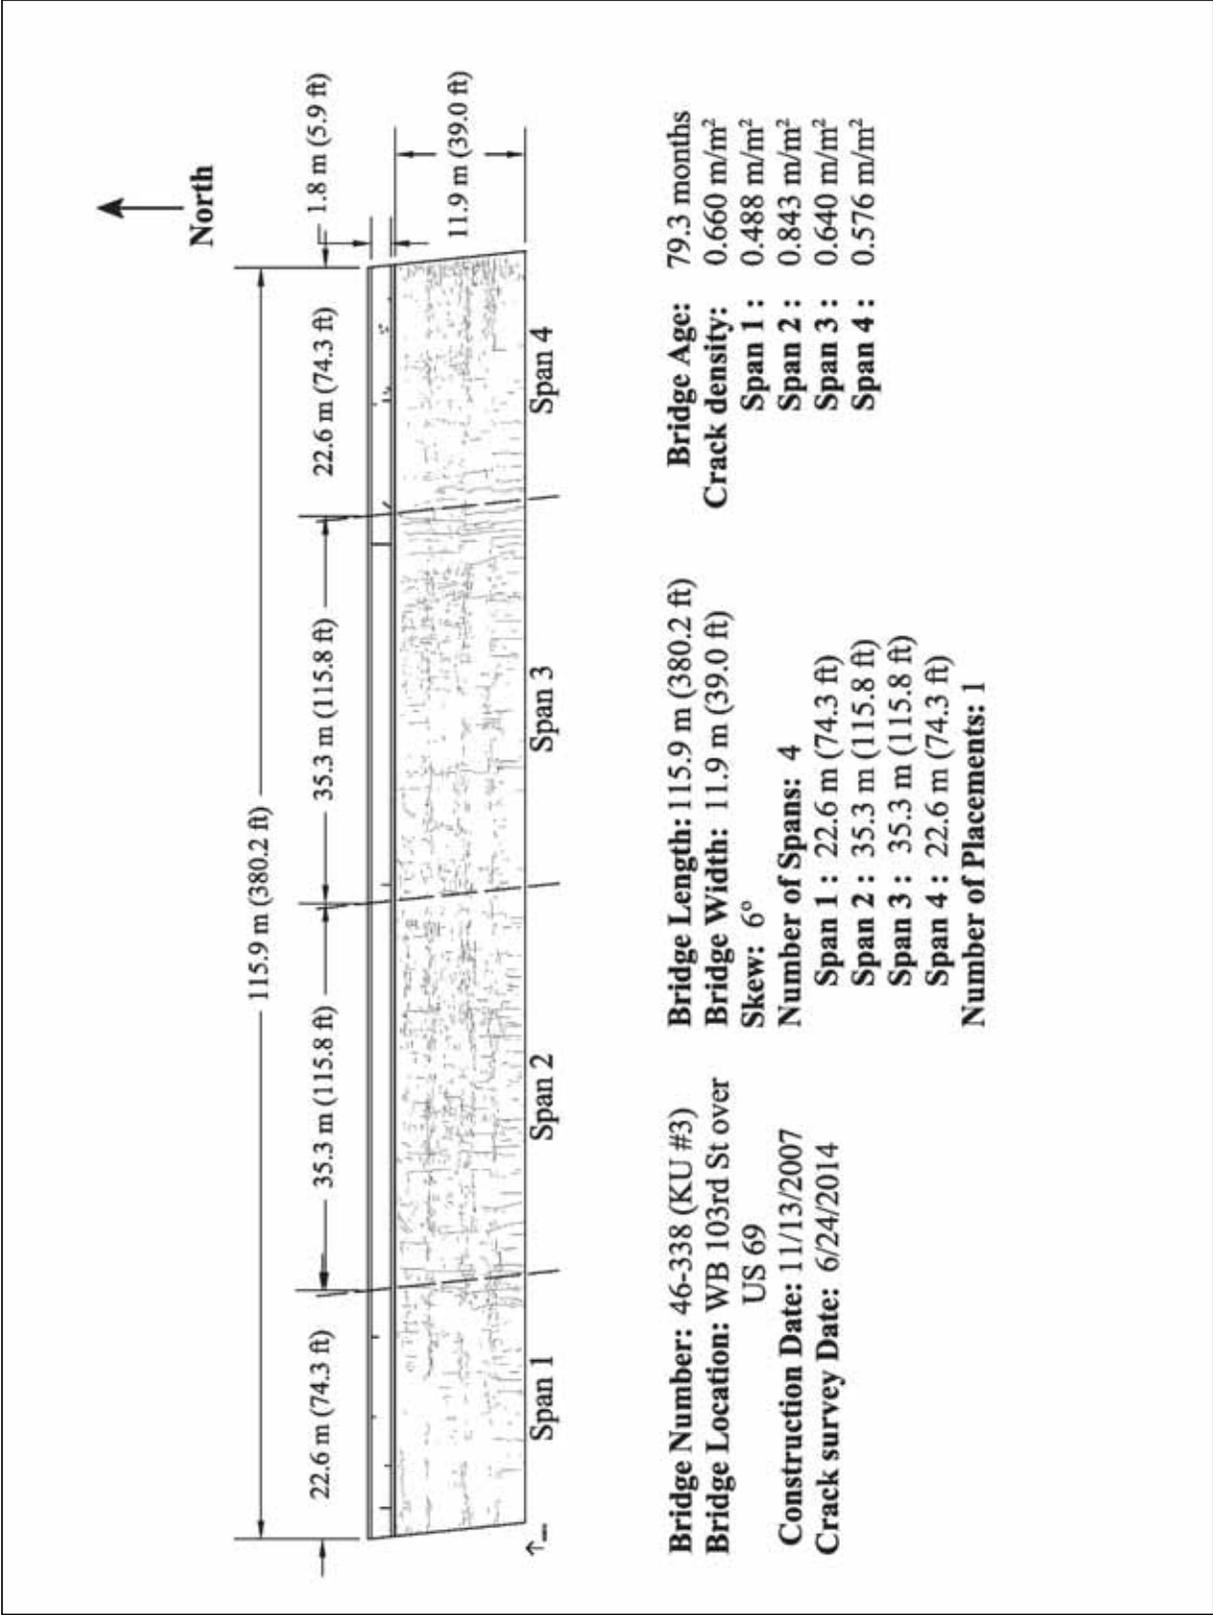
Figure 11: LC-HPC-3 (Survey 7)

Bridge deck LC-HPC-3 was constructed on 11/13/2007. To date, LC-HPC-3 has been surveyed eight times. The results from surveys 7 and 8 are included in this report. Survey 7 of LC-HPC-3 was completed at deck age of 83.2 months; the crack map is shown in Figure 11. Survey 8 of LC-HPC-3 was performed at a deck age of 91.5 months; the crack map is shown in Figure 12. A crack density of 0.663 m/m² was observed in Survey 7 (Figure 11), which is significantly higher than obtained in Survey 6 at 0.174 m/m² reported by Bohaty et al. (2013). A crack density of 0.487 m/m² was observed in Survey 8 (Figure 12). During Survey 7, the surveyors may have mistakenly misidentified the outlines of the aggregate as cracks. Survey 7 could be considered as an outlier. The vast majority of the cracks are relatively short in length. A few medium-length transverse cracks run parallel to the top layer of reinforcement, primarily over the two outer piers.

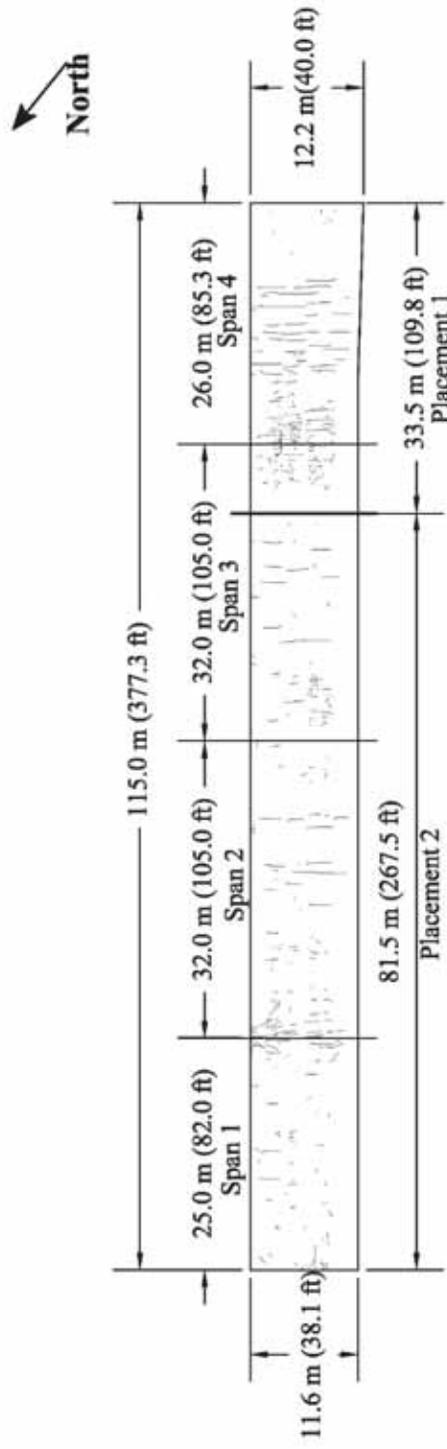
Figure 16: LC-HPC-4 (Survey 7)

Bridge deck LC-HPC-4 was constructed in two placements. Placement 1 was cast on 9/29/2007 and Placement 2 was cast on 10/2/2007. This deck has been surveyed eight times, and the results of Surveys 7 and 8 of LC-HPC-4 are discussed in this report. Survey 7 (Figure 16) was completed at a deck age of 80.4 and 80.3 months for Placements 1 and 2, respectively; the crack map appears in Figure 16. Survey 8 (Figure 17) was completed at a deck age of 93.3 and 93.2 months for Placements 1 and 2, respectively; the crack map appears in Figure 17. Crack densities of 0.371, 0.173, and 0.225 m/m² overall, and for Placements 1 and 2 were observed in Survey 7, respectively. In Survey 7, the crack density for Placement 1 was significantly higher than for Placement 2. Compared to Survey 6, reported by Bohaty et al. (2013), with respective crack densities of 0.147, 0.077, and 0.105 m/m². Crack densities of 0.305, 0.181, and 0.217 m/m² overall, and for Placements 1 and 2 were observed in Survey 8, respectively. These values are nearly the same to those recorded during Survey 7. Medium-length transverse cracks are present and distributed over the area of the deck. Near the deck's north western abutment, some cracks propagate longitudinally.

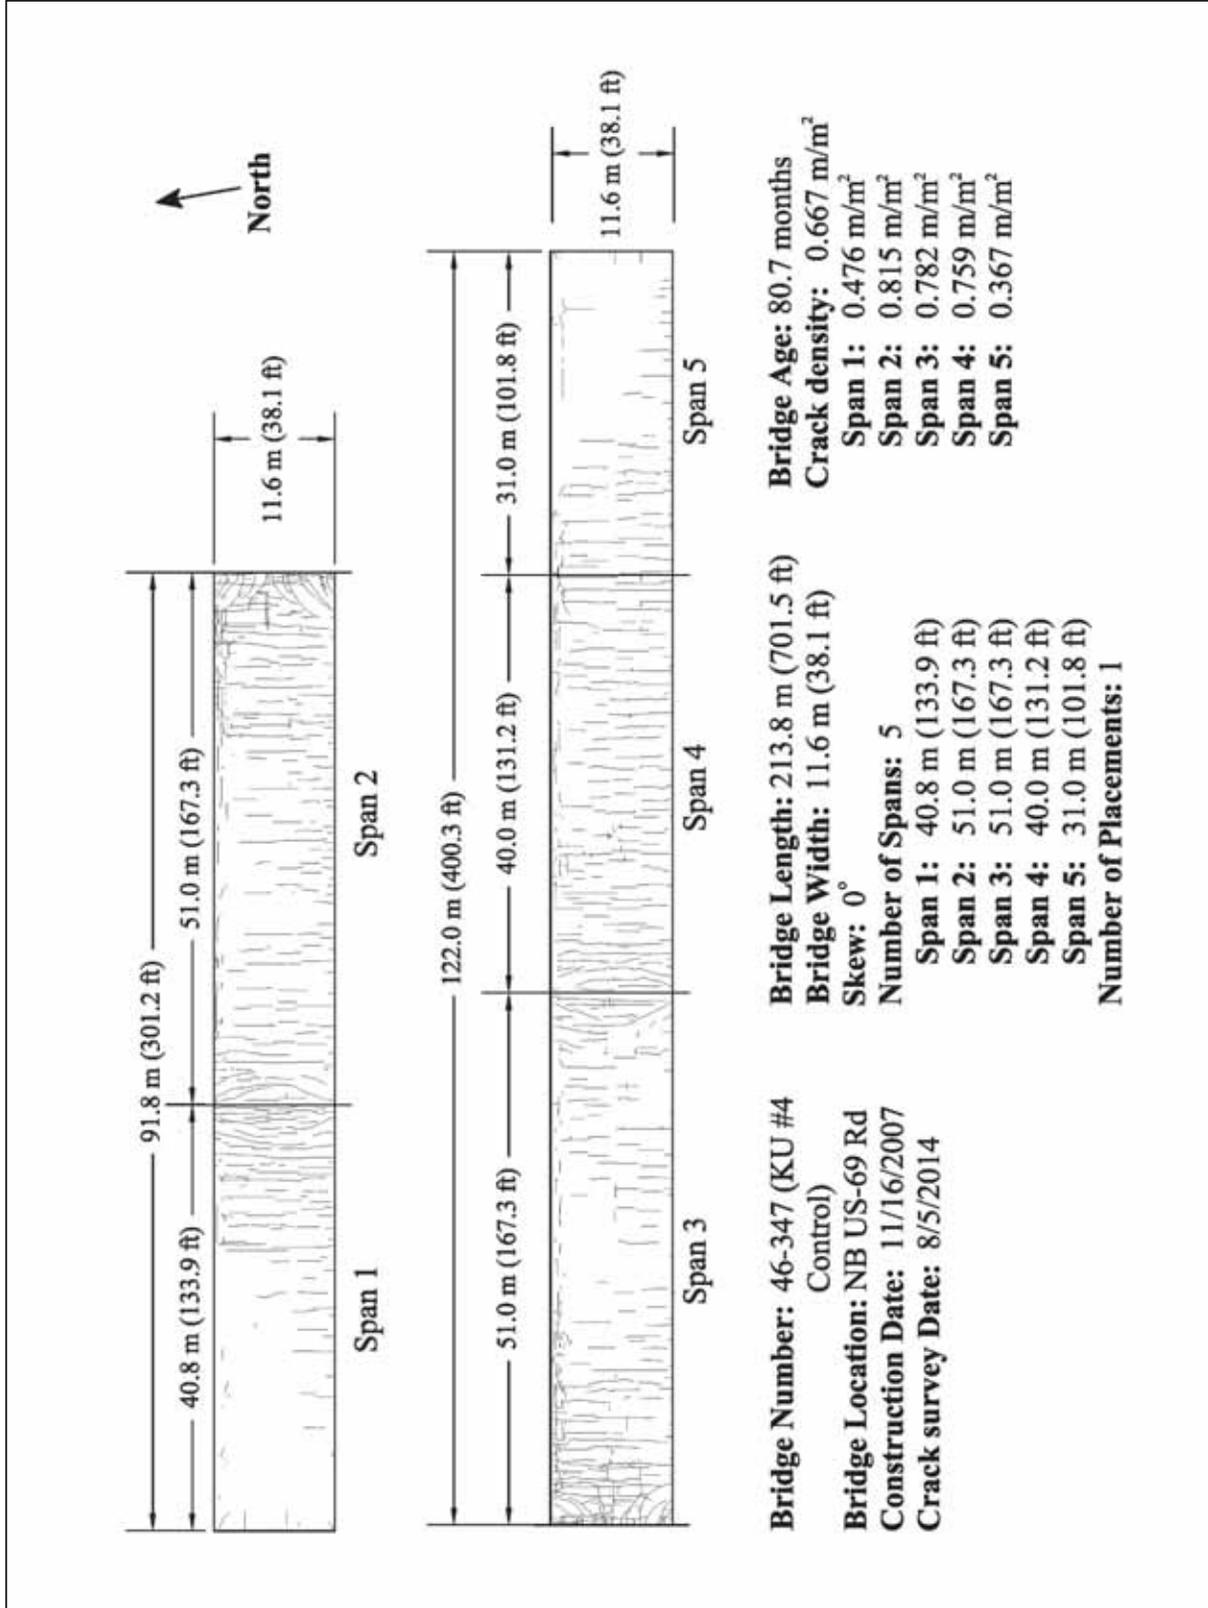
Figure 18: Control-4 (Survey 7)

Bridge deck Control-4 was constructed on 8/5/2014. This deck has been surveyed eight times. Surveys 7 and 8 are discussed in this report. Survey 7 was completed at a deck age of 80.7 months, and the crack map for this survey is shown in Figure 18. Survey 8 was completed at a deck age of 92.2 months, and the crack map for this survey is shown in Figure 19. A crack density of 0.667 m/m^2 was observed in Survey 7 (Figure 18), an increase from the value recorded in Survey 6 at 0.561 m/m^2 (Bohaty et al. 2013). A crack density of 0.755 m/m^2 was observed in Survey 8 (Figure 19). Cracking in Control-4 is significant in the outer portions of the end spans. The majority of the cracks are transverse and appear to run parallel to the top layer of reinforcement. Cracks propagate from both abutments. Longitudinal cracks are present near the northern side of the deck parallel to the parapet, and might be a result of the 3.2 ft (0.975-m) overhang at the exterior steel girder.

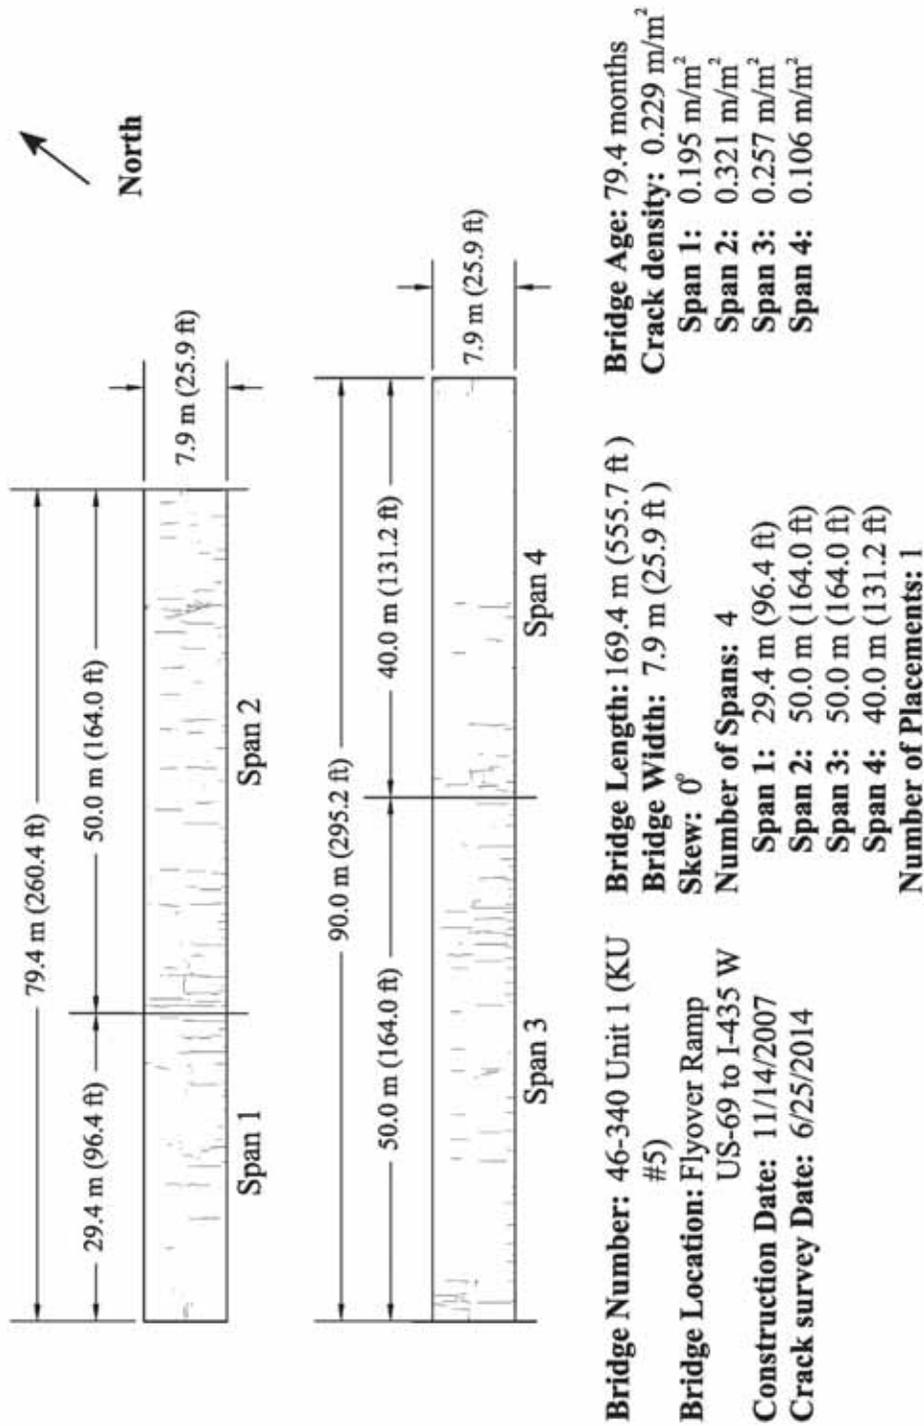
Figure 21: LC-HPC-5 (Survey 7)

Bridge deck LC-HPC-5 was placed on 11/14/2007. To date, LC-HPC-5 has been surveyed eight times. The results for Surveys 7 and 8 are included in this report. Survey 7 was completed at 79.4 months; the results are shown in Figure 21. Survey 8 was completed at 91.8 months; the results are shown in Figure 22. A crack density of 0.229 m/m² was observed in Survey 7 (Figure 21). This value indicates a nearly 70% increase in crack density compared to Survey 6 reported by Bohaty et al. (2013), which was 0.140 m/m². A crack density of 0.247 m/m² was observed in Survey 8 (Figure 22). The majority of the cracks marked are medium-length transverse cracks. Also, some cracks have propagated longitudinally from both bridge ends near the abutments. It can be noted that most of the cracking has occurred on the southern side of the bridge. This may be related to the bridge being superelevated and the soaker hoses being placed at the centerline of the bridge at the time of construction, resulting a lack of water for curing at the more elevated side of the deck.

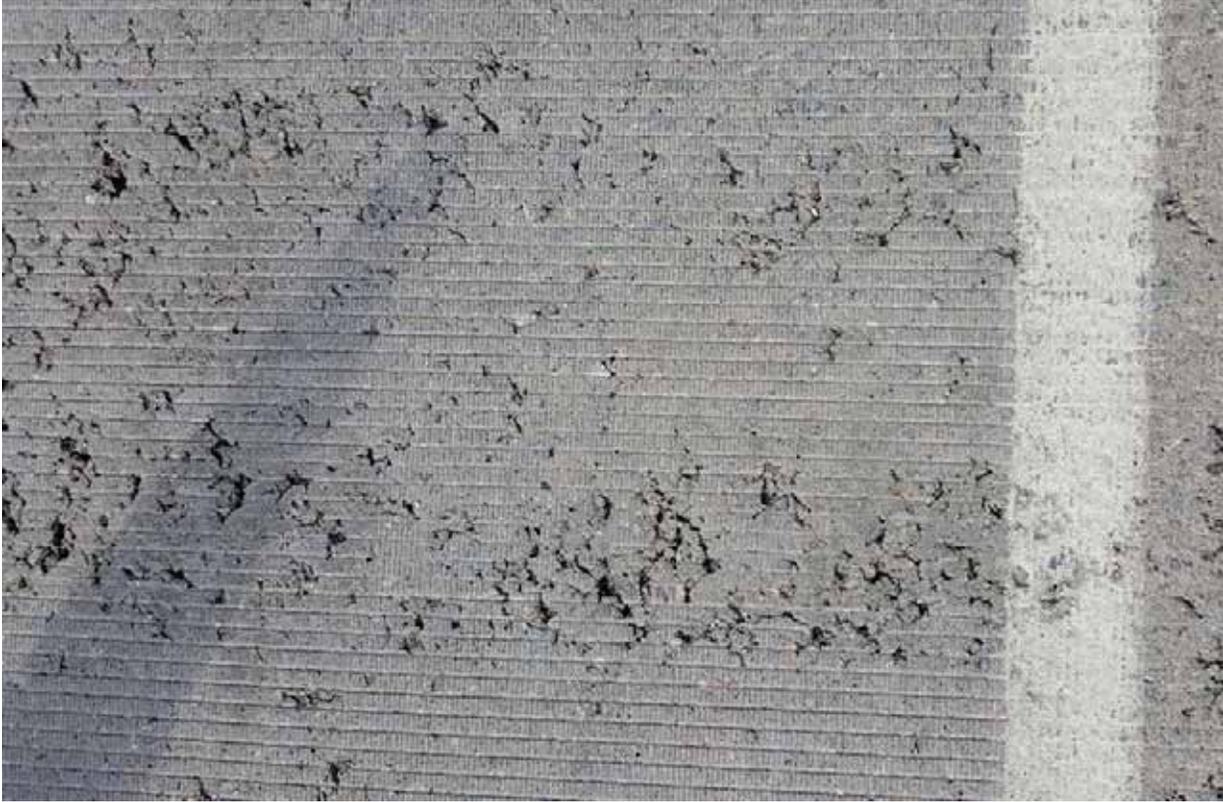
It was noted during the surveys that surface voids were present on the deck, likely due to incomplete finishing. These voids were noted in the construction report for LC-HPC-5 as being present immediately after bullfloating. Figure 23 shows a photo sample of the deck taken during Survey 8 illustrating these voids.

Figure 23: Surface Voids in LC-HPC-5 Bridge Deck

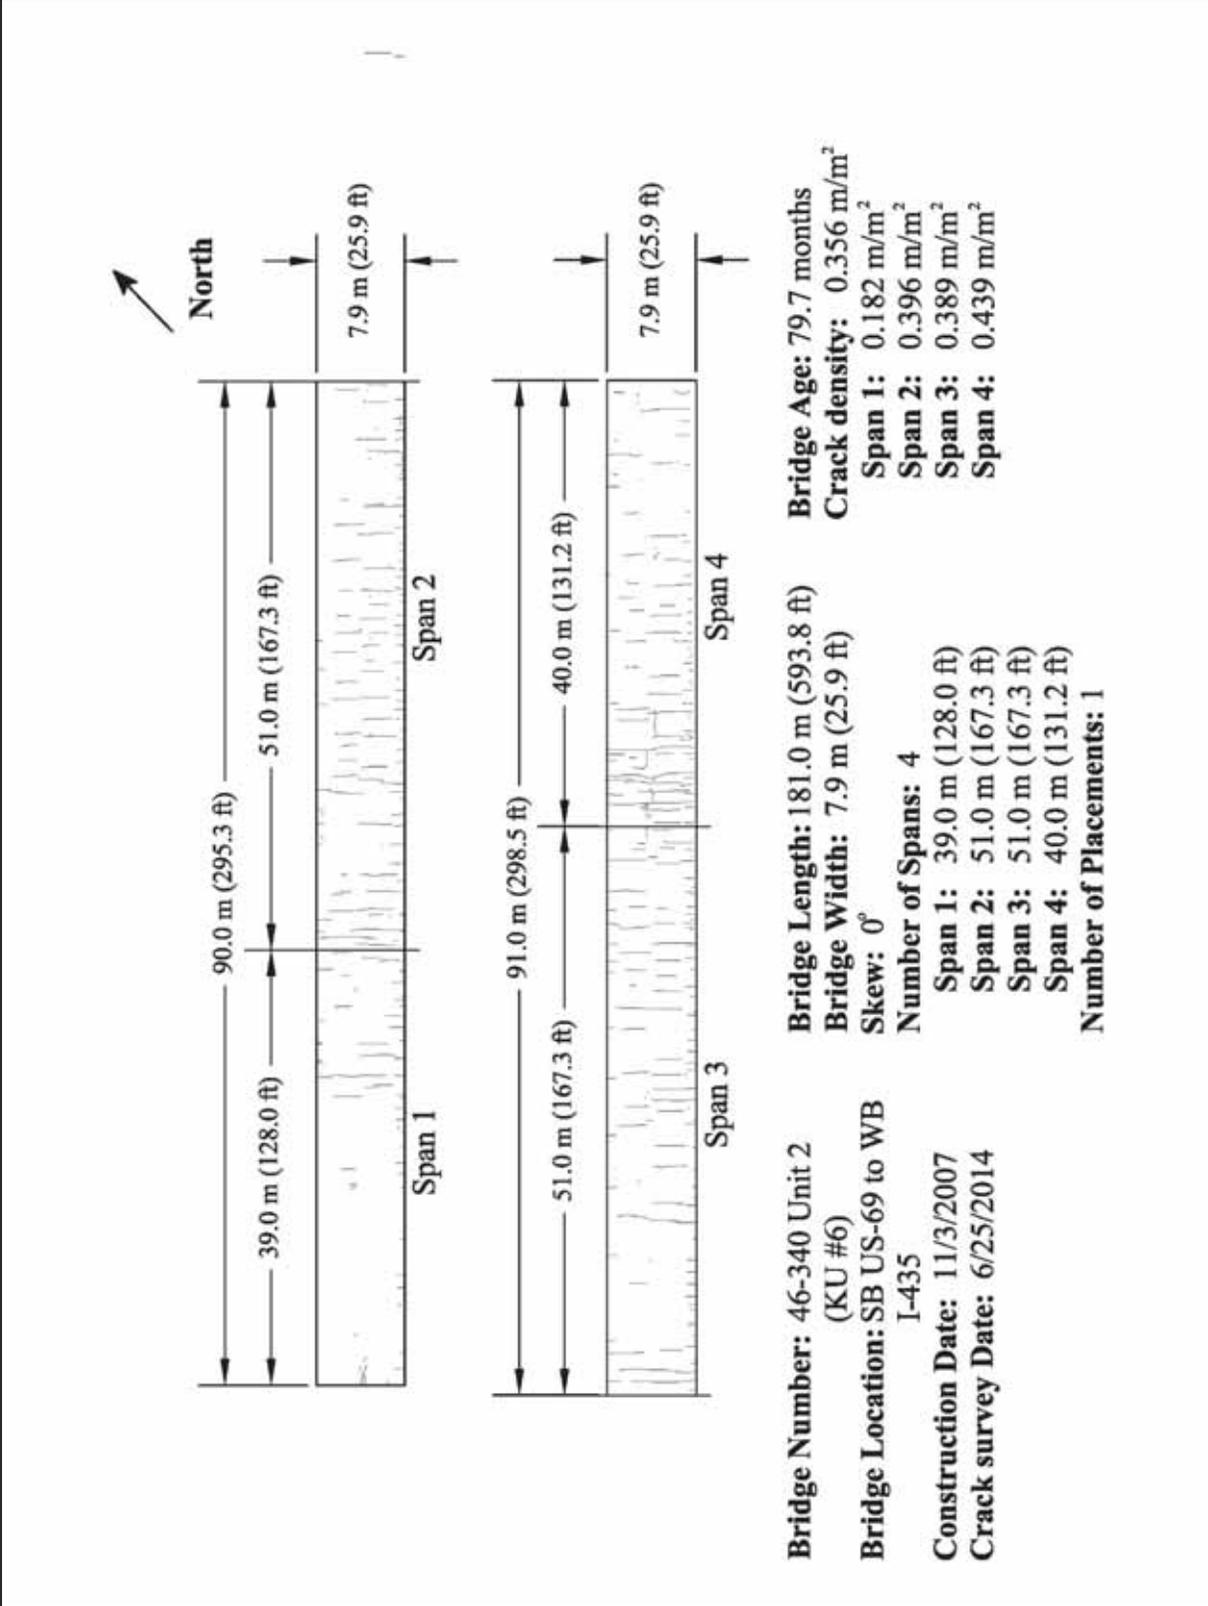
Figure 25: LC-HPC-6 (Survey 7)

Bridge deck LC-HPC-6 was constructed on 11/3/2007, and has been surveyed eight times. The results of Surveys 7 and 8 are included in this report. Survey 7 was performed at a deck age of 79.7 months; the crack map appears in Figure 25. Survey 8 was performed at a deck age of 92.2 months; the crack map appears in Figure 26. An overall crack density of 0.356 m/m^2 was observed in Survey 7 (Figure 25). This value represents an increase in crack density when compared to Survey 6, 0.303 m/m^2 , reported by Bohaty et al. (2013). An overall crack density of 0.386 m/m^2 was observed in Survey 8 (Figure 26). Similar to LC-HPC-5, surface voids were observed during construction and during the surveys. Most of the cracks are transverse.

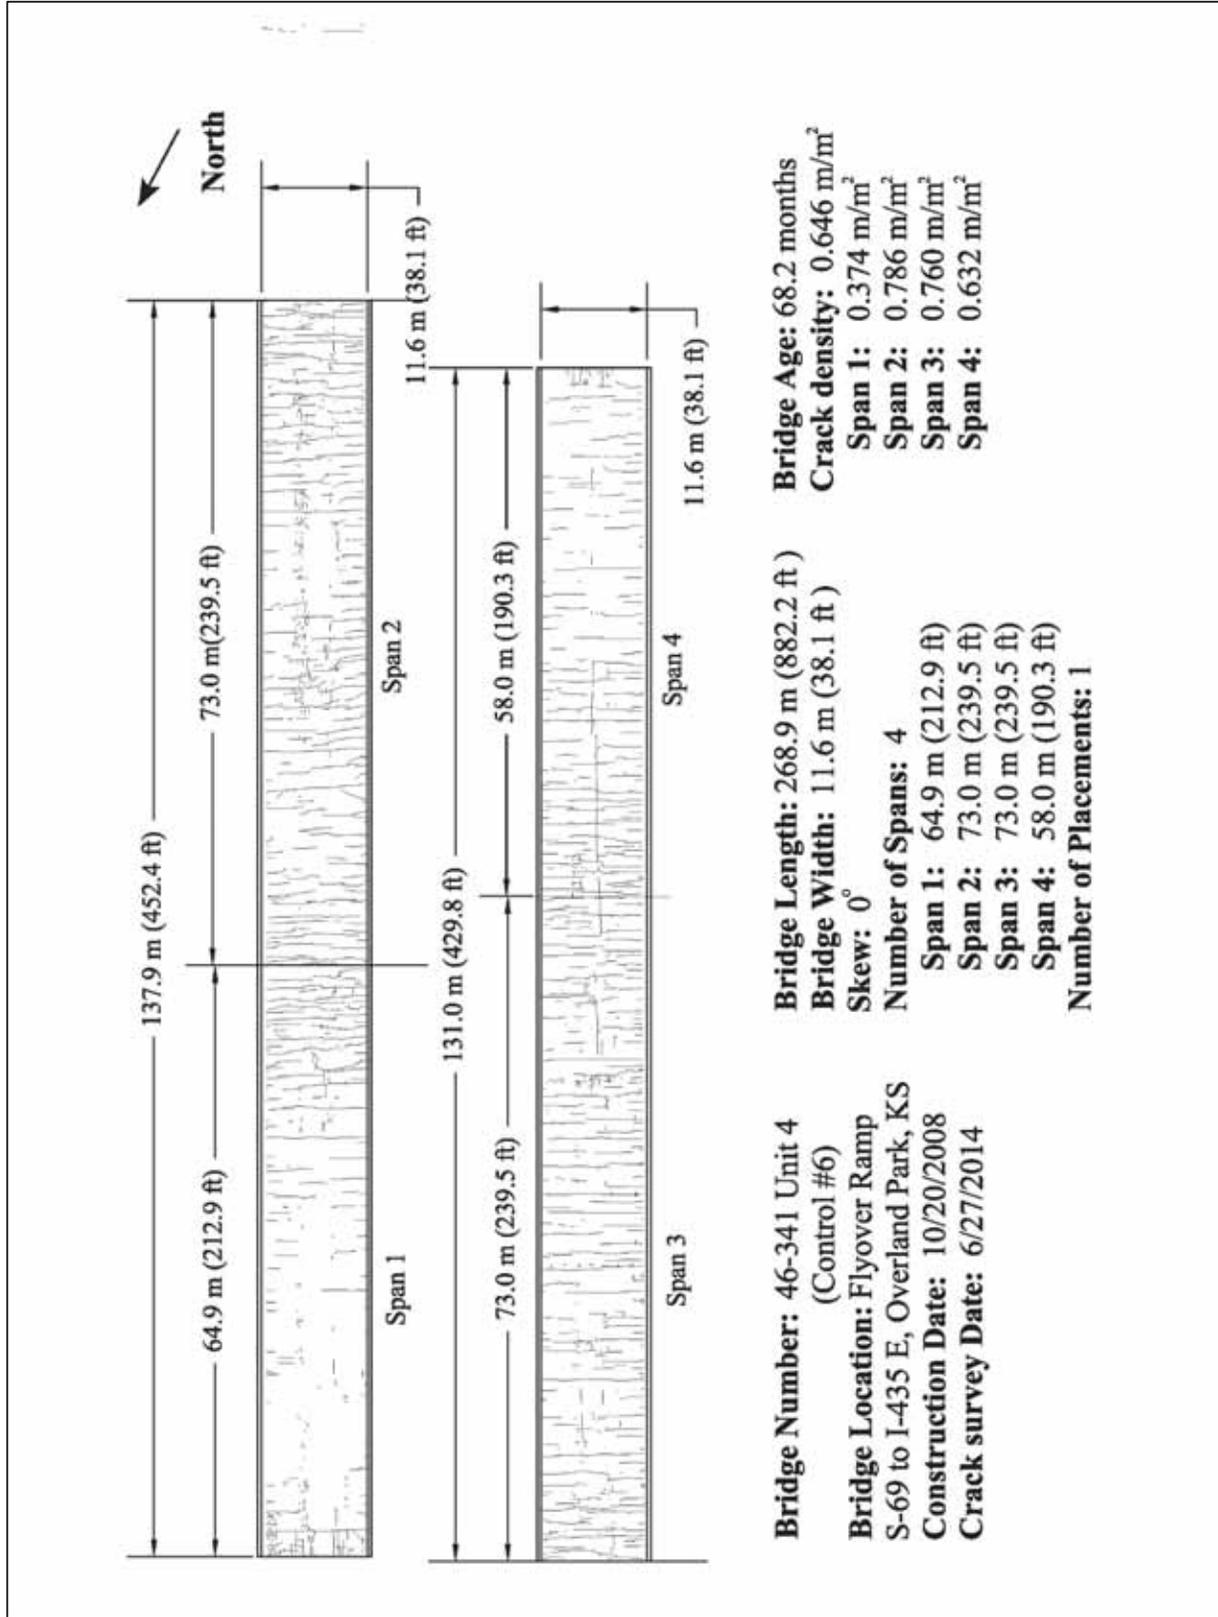
Figure 27: Control-6 (Survey 6)

Bridge deck Control-6 was placed on 10/20/2008 and has been surveyed seven times. The results for Surveys 6 and 7 are included in this report. Survey 6 was completed at 68.2 months; the crack map is shown in Figure 27. Survey 7 was completed at 81.9 months; the crack map is shown in Figure 28. A crack density of 0.646 m/m^2 was observed in Survey 6 (Figure 27), which is considerably higher than Survey 5 at 0.461 m/m^2 (Bohaty et al. 2013). A crack density of 0.628 m/m^2 was observed in Survey 7 (Figure 28), slightly lower than Survey 6. The majority of the cracks are transverse and run across the full width of the deck. The cracks are closer to each other over the piers than at other locations. Cracks propagate longitudinally adjacent the abutments. Some longitudinal cracks are present in the middle of the deck.

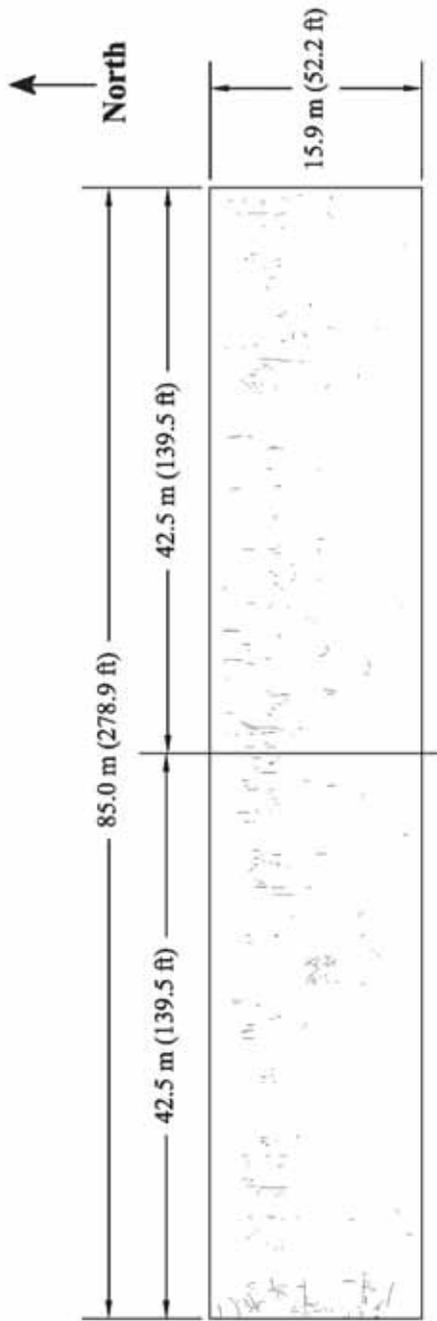
Figure 30: LC-HPC-7 (Survey 8)

Bridge deck LC-HPC-7 was constructed on 6/24/2006, and the deck has been surveyed nine times. The results of Surveys 8 and 9 of LC-HPC-7 are presented in this report. Survey 8 was completed at a deck age of 95.7 months; the crack map is shown in Figure 30. Survey 9 was completed at a deck age of 106.9 months; the crack map for this survey is shown in Figure 31. A crack density of 0.087 m/m² was observed in Survey 8 (Figure 30). This value is greater than the crack density reported by Bohaty et al. (2013) for Survey 7, 0.074 m/m². In Survey 9, however, a crack density of only 0.036 m/m² was observed (Figure 31). The measured crack density might have dropped due to dirt present on some portions of the bridge deck at the time of Survey 9. As shown in Figures 31 and 32, most of the cracks are relatively short and are distributed over the whole area of the bridge. There are some cracks near the west abutment that have propagated

perpendicular to the abutment of the bridge. This deck has consistently exhibited the lowest crack density in this study.

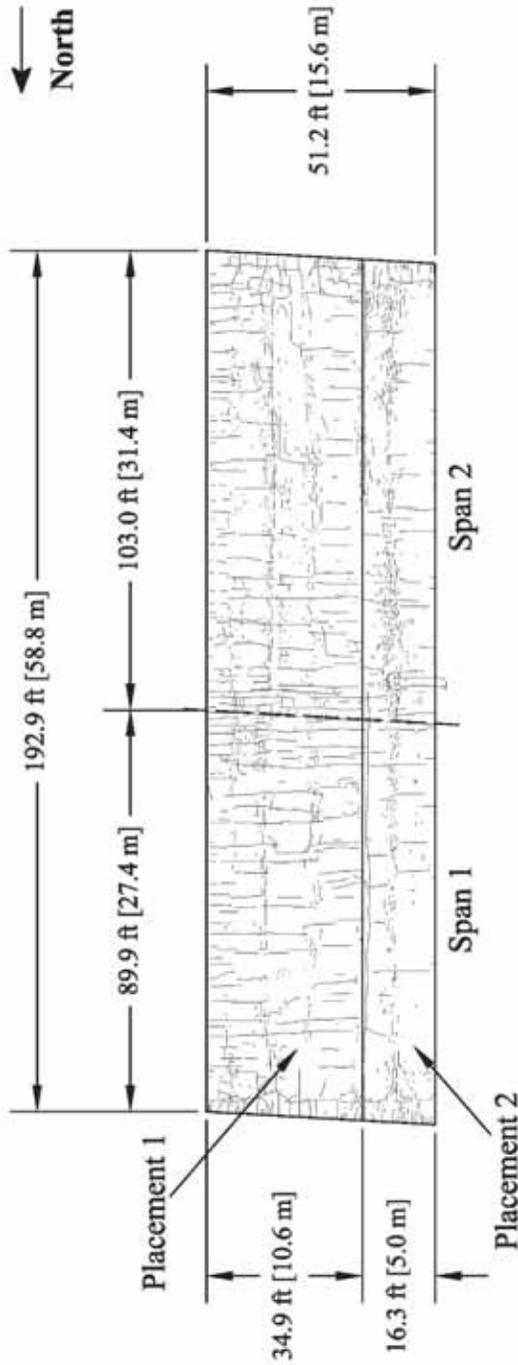
Figure 32: Control-7 (Survey 7)

Control-7 was constructed in two placements. Placement 1 was cast on 3/29/2006 and Placement 2 was cast on 9/15/2006. This deck has been surveyed seven times, and the crack survey results of Survey 7 are included in this report. Survey 7 was performed at a deck age of 98.5 months for Placement 1 and 93.0 months for Placement 2; the crack map for this survey is shown in Figure 32. In Survey 7, crack densities of 1.165 m/m² for Placement 1 and 1.15 m/m² for Placement 2 were observed. These values are higher than the crack densities last reported by Bohaty et al. (2013), 1.022 m/m² for Placement 1 and 0.638 m/m² for Placement 2. Due to high cracking of Control-7, Survey 7 is considered the last survey of this bridge deck. The majority of the cracks present in Placement 1 are transverse. Relatively long longitudinal cracks cross the transverse cracks. Above the pier, cracks are much closer to each other compared to other areas of the deck. Placement 2 has a longitudinal crack running next to the construction joint. In both placements, cracks propagate longitudinally near the abutments.
