**CRACK SURVEYS OF LOW-CRACKING HIGH-PERFORMANCE CONCRETE
BRIDGE DECKS IN KANSAS
2014-2015**

**By
Abdallah Alhmoody
David Darwin
Matt O'Reilly**

**Structural Engineering and Engineering Materials
SL Report 15-3**

**THE UNIVERSITY OF KANSAS CENTER FOR RESEARCH, INC.
LAWRENCE, KANSAS
September 2015**

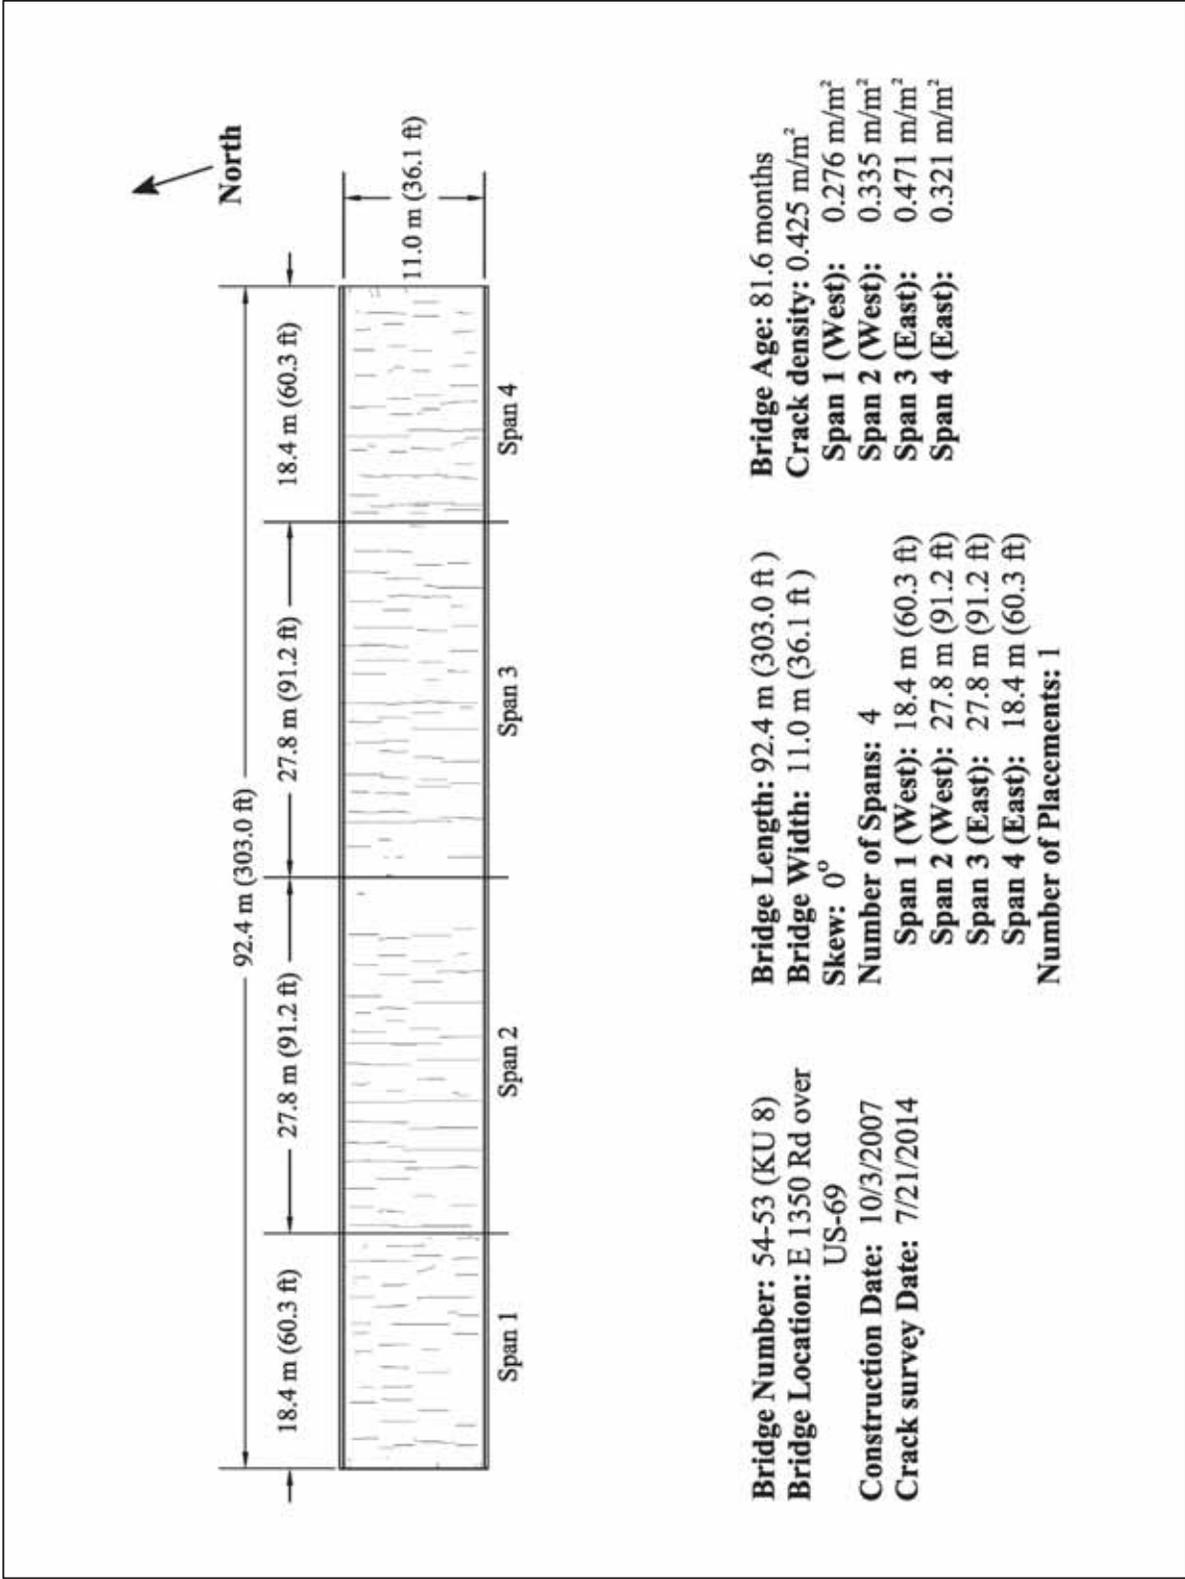
Figure 34: LC-HPC-8 (Survey 6)

Bridge deck LC-HPC-8 is supported by on precast-prestressed girders and was constructed on 10/3/2007. LC-HPC-8 has been surveyed seven times, and the results of Surveys 6 and 7 are presented in this report. Survey 6 was completed at a deck age of 81.6 months; the crack map appears in Figure 34. Survey 7 was performed at a deck age of 92.0 months; the crack map appears in Figure 35. A crack density of 0.425 m/m² was observed in Survey 6 (Figure 34). In Survey 7, a crack density of 0.462 m/m² was observed (Figure 35). Both values exceed the crack densities that were observed in previous surveys. Figures 34 and 35 show that almost all of the cracks are transverse. Additionally, cracks are minor above the center pier, suggesting that cracking may be a result from increased girder camber. Small longitudinal cracks are present near the abutments.

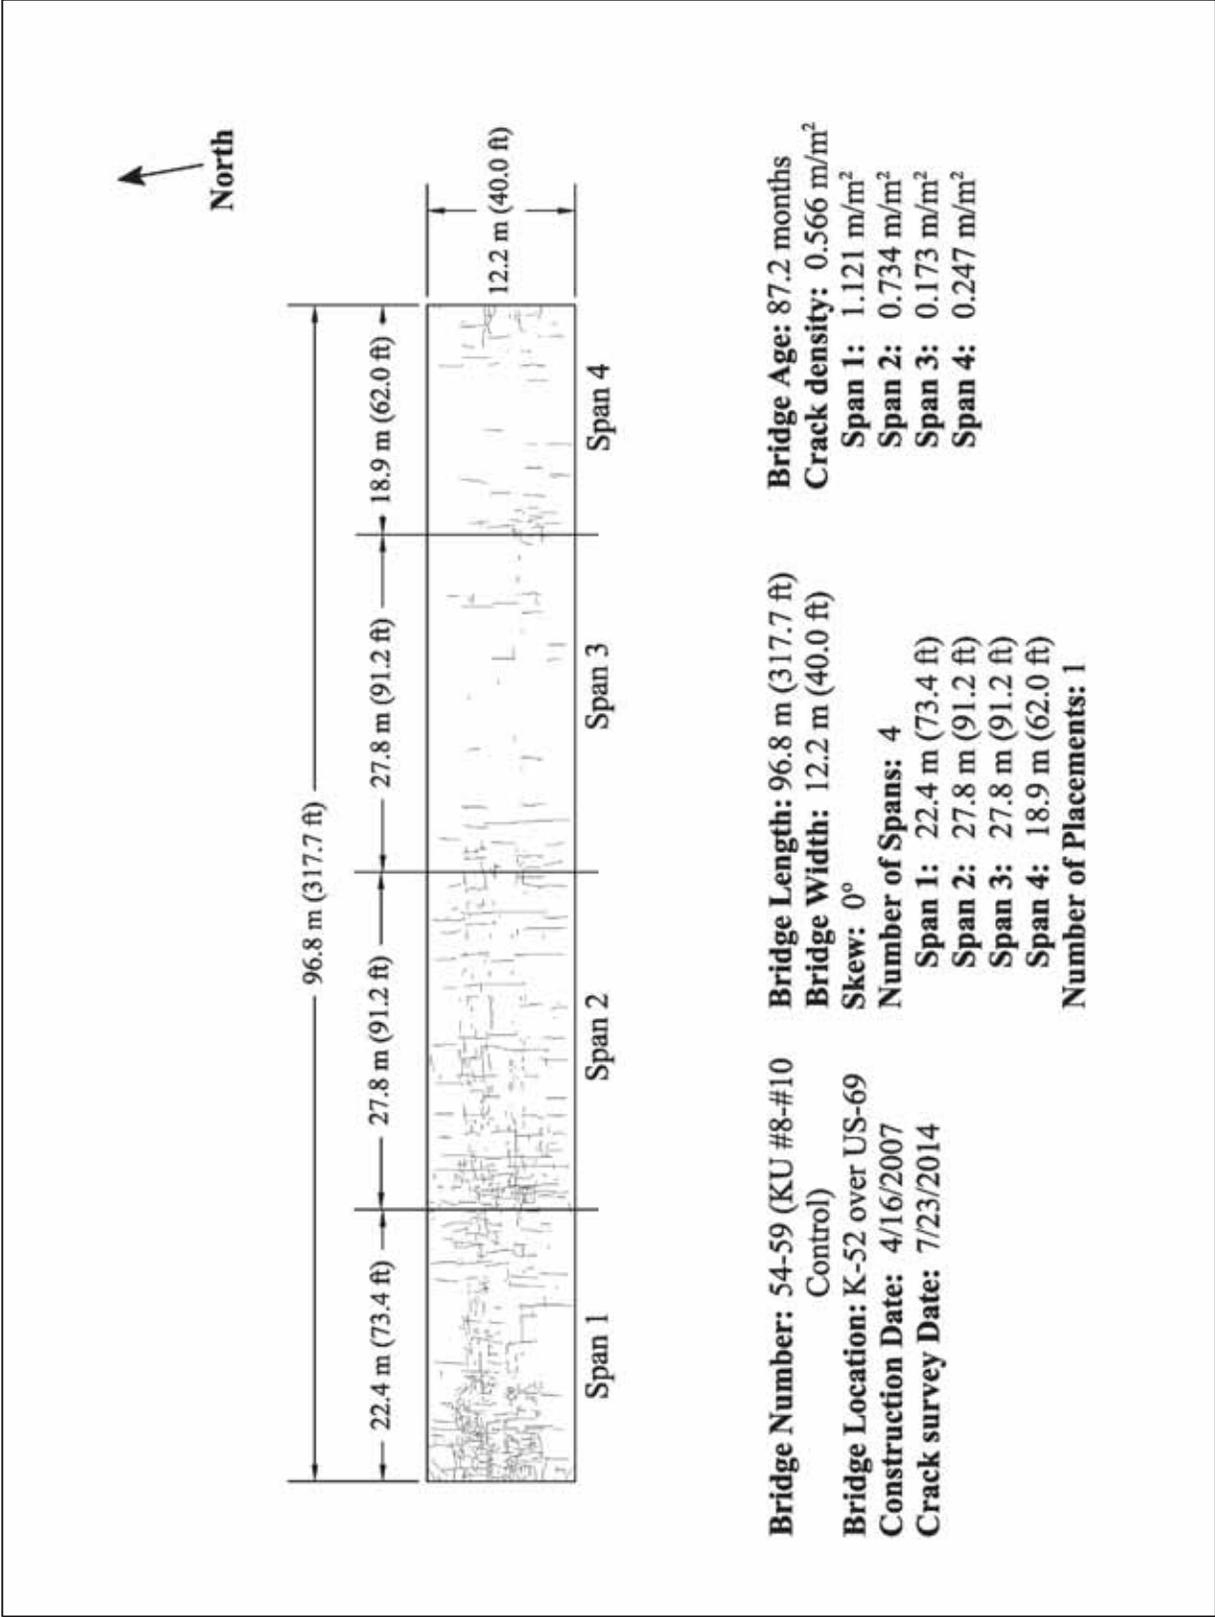
Figure 36: Control-8/10 (Survey 7)

Bridge deck Control-8/10 serves as the control for both LC-HPC-8 and LC-HPC-10. It is a monolithic deck supported by precast-prestressed girders. Control-8/10 was constructed on 4/16/2007 and has been surveyed eight times. This report includes the results for Surveys 7 and 8. Survey 7 was completed at a deck age of 87.2 months; the crack map is shown in Figure 36. Survey 8 was completed at a deck age of 98.1 months; the crack map is shown in Figure 37. A crack density of 0.566 m/m^2 was observed in Survey 7 (Figure 36). Survey 7 shows a similar crack density to that recorded Survey 6 by Bohaty et al. (2013), which was 0.581 m/m^2 . In Survey 8, a crack density of 0.680 m/m^2 was observed (Figure 37). Span 1 of the bridge has a higher crack density than the other spans, with a significant portion of these cracks due to map cracking. Also, there are moderately-sized transverse cracks distributed over the whole area of the bridge, but there are fewer in Spans 3 and 4 than in Spans 1 and 2.

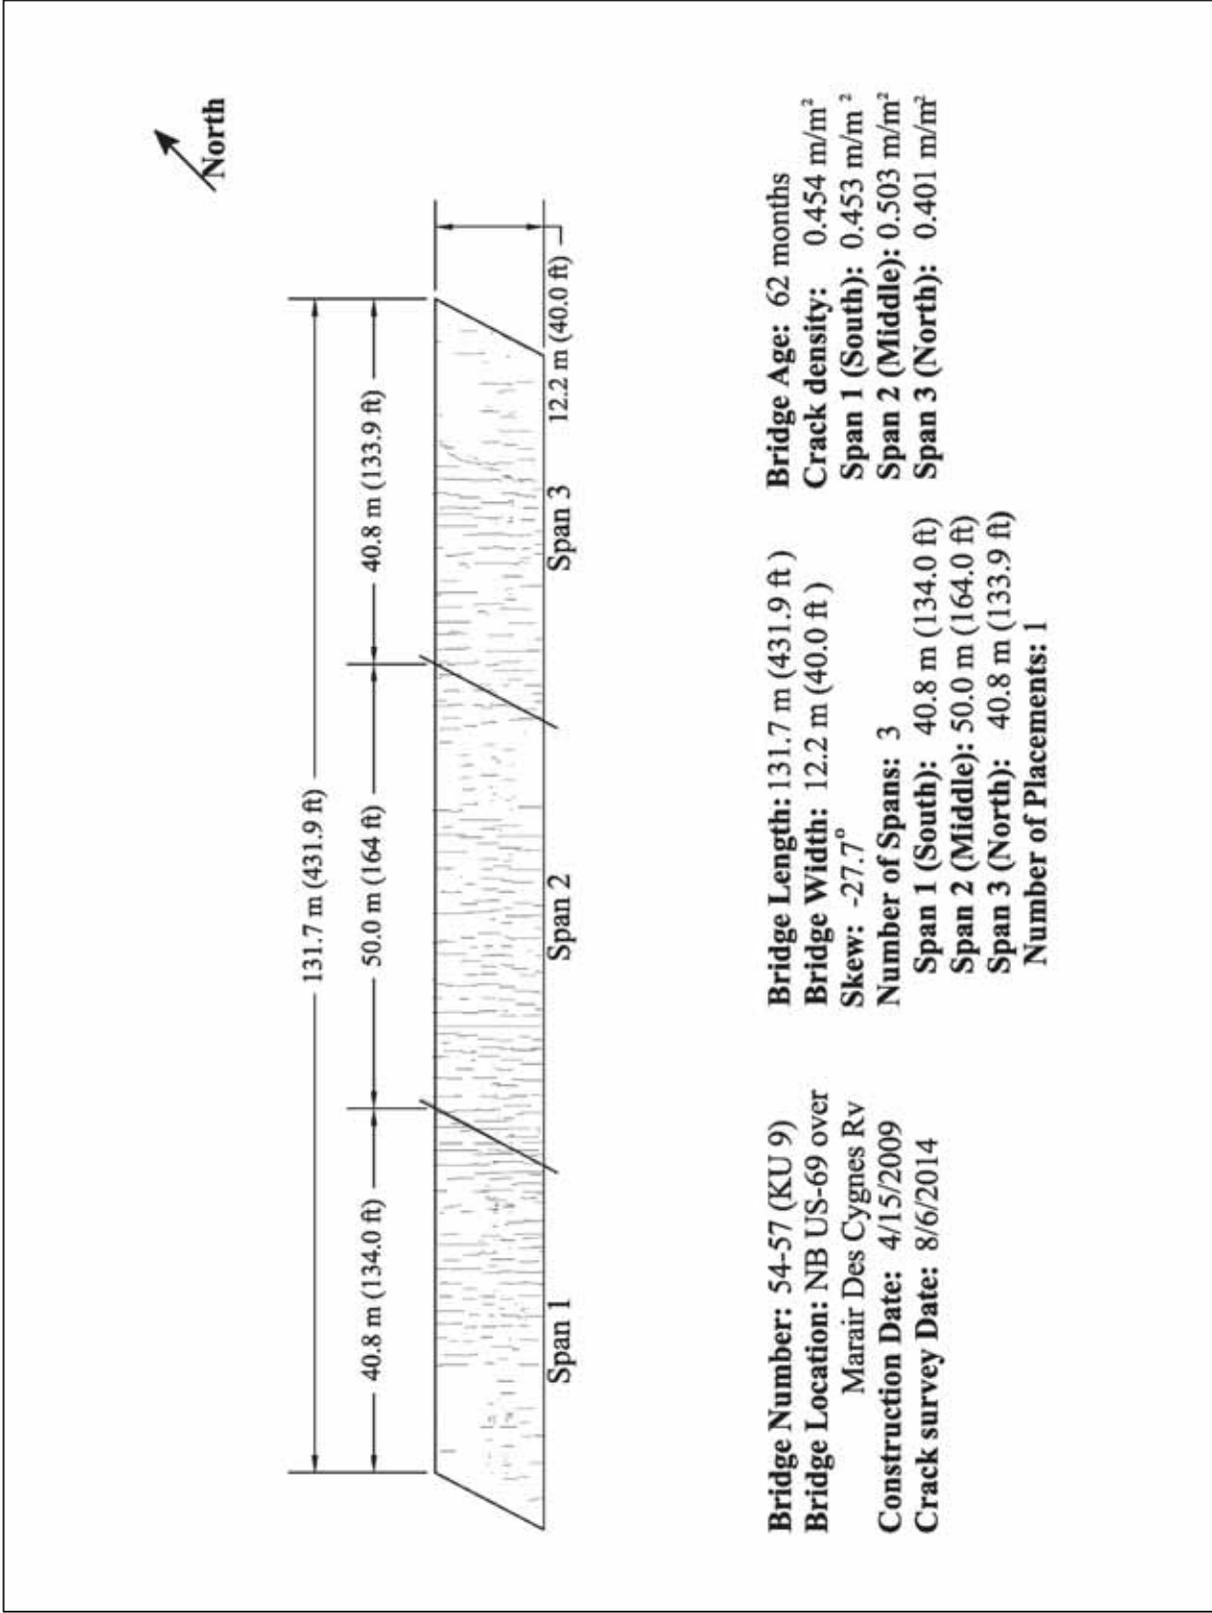
Figure 39: LC-HPC-9 (Survey 5)

Bridge deck LC-HPC-9 was constructed on 4/15/2009, and has been surveyed six times. This report includes the results of Surveys 5 and 6. Survey 5 was performed at a deck age of 62.0 months; the crack map is shown in Figure 39. Survey 6 was performed at a deck age of 73.6 months; the crack map is shown in Figure 40. In Survey 5, a crack density of 0.454 m/m² was observed (Figure 39). This value is significantly greater than that reported for Survey 4 by Bohaty et al. (2013), 0.299 m/m². A crack density of 0.430 m/m² was observed in Survey 6 (Figure 40), slightly lower than Survey 5. The cracks are uniformly distributed over much of the deck with the exception of the end spans, which exhibit a lower crack density.

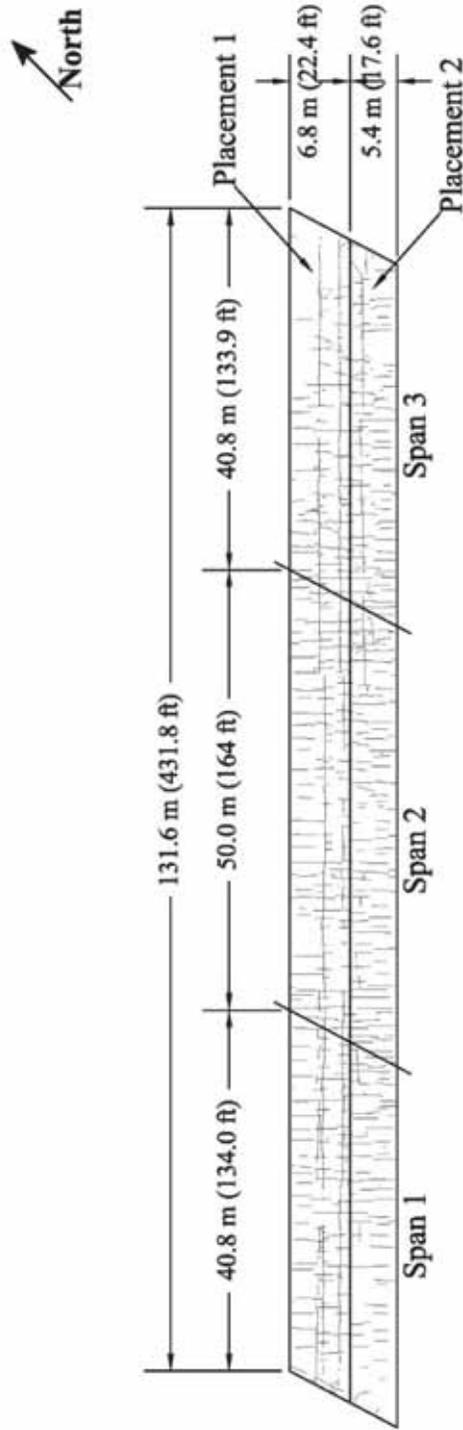
Figure 41: Control-9 (Survey 5)

Bridge deck Control-9 was constructed in two placements. Placement 1 was constructed on 5/21/2008 and Placement 2 was constructed on 5/29/2008. To date, Control-9 deck has been surveyed six times. The results of Surveys 5 and 6 are included in this report. Survey 5 was completed at deck 74.1 and 73.8 months; the crack map is shown in Figure 41. Survey 6 was performed at deck age of 84.4 and 84.1 months; the crack map is shown in Figure 42. In Survey 5, crack densities of 0.732 and 0.755 m/m² were observed for Placements 1 and 2, respectively. Both of these values are higher than Survey 4, which recorded crack densities of 0.561 and 0.635 m/m² for Placements 1 and 2, respectively (Bohaty et al. 2013). In Survey 6, crack densities of 0.722 and 0.845 m/m² were observed for Placements 1 and 2, respectively. For Survey 6, Placement 1 exhibited a slight decrease in crack density compared to Survey 5, while the crack density for Placement 2 increased compared to the previous survey. As shown in Figures 41 and 42, the majority of the cracks are transverse, parallel to the top layer of reinforcement. In Placement 1, there are two longitudinal cracks that run almost over the entire length of the deck. In Placement 2 some relatively short cracks run longitudinally. Some cracks are present near the abutments, where they have propagated longitudinally.

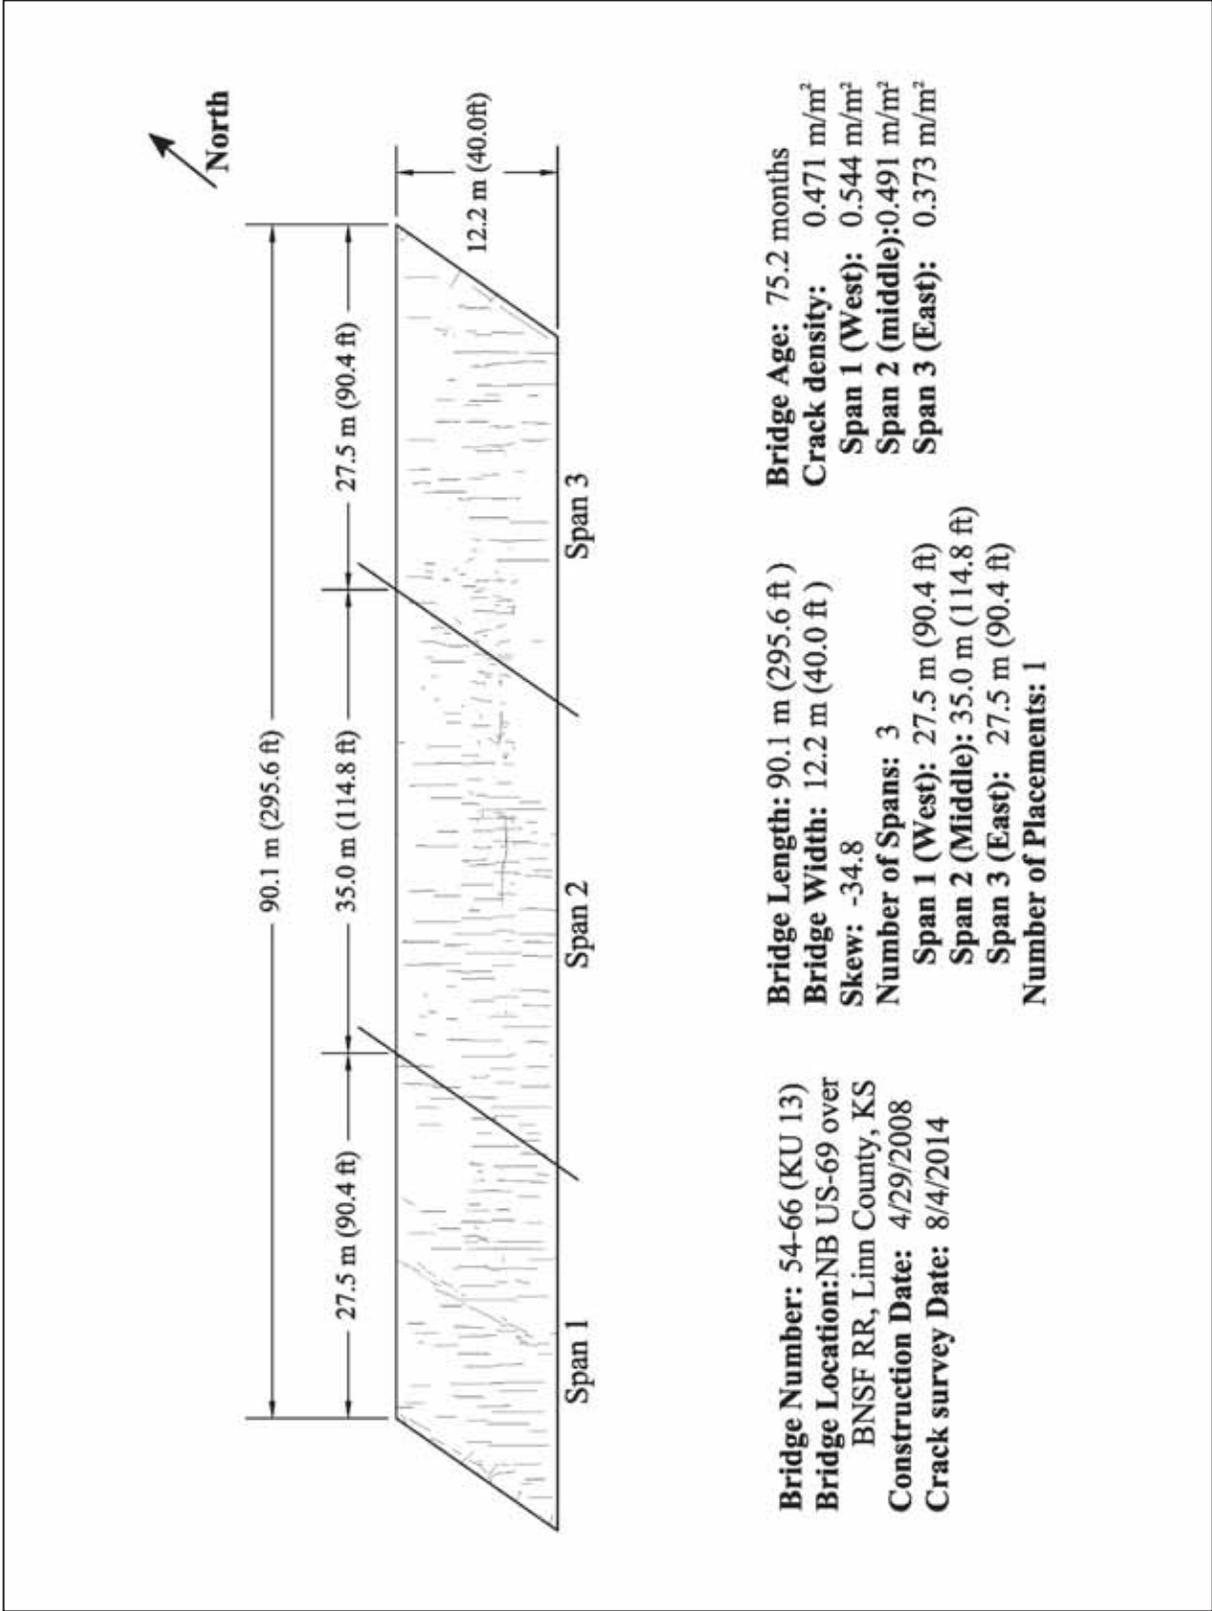
Figure 53: LC-HPC-13 (Survey 6)

Bridge deck LC-HPC-13 was constructed on 4/29/2008 and has been surveyed seven times. The results of Surveys 6 and 7 of LC-HPC-13 are included in this report. Survey 6 was completed at a deck age of 75.2 months; the crack map is shown in Figure 53. Survey 7 was completed at a deck age of 85.9 months; the crack map is shown in Figure 54. A crack density of 0.471 m/m² was observed in Survey 6 (Figure 53). This value is lower than recorded during Survey 5 at 0.576 m/m² (Bohaty et al. 2013). Based on surveys before and since, it appears that Survey 5 is an outlier. In Survey 7, a crack density of 0.486 m/m² was observed (Figure 54). Moderate sized cracks were marked during both surveys. Short cracks are present above the eastern pier.

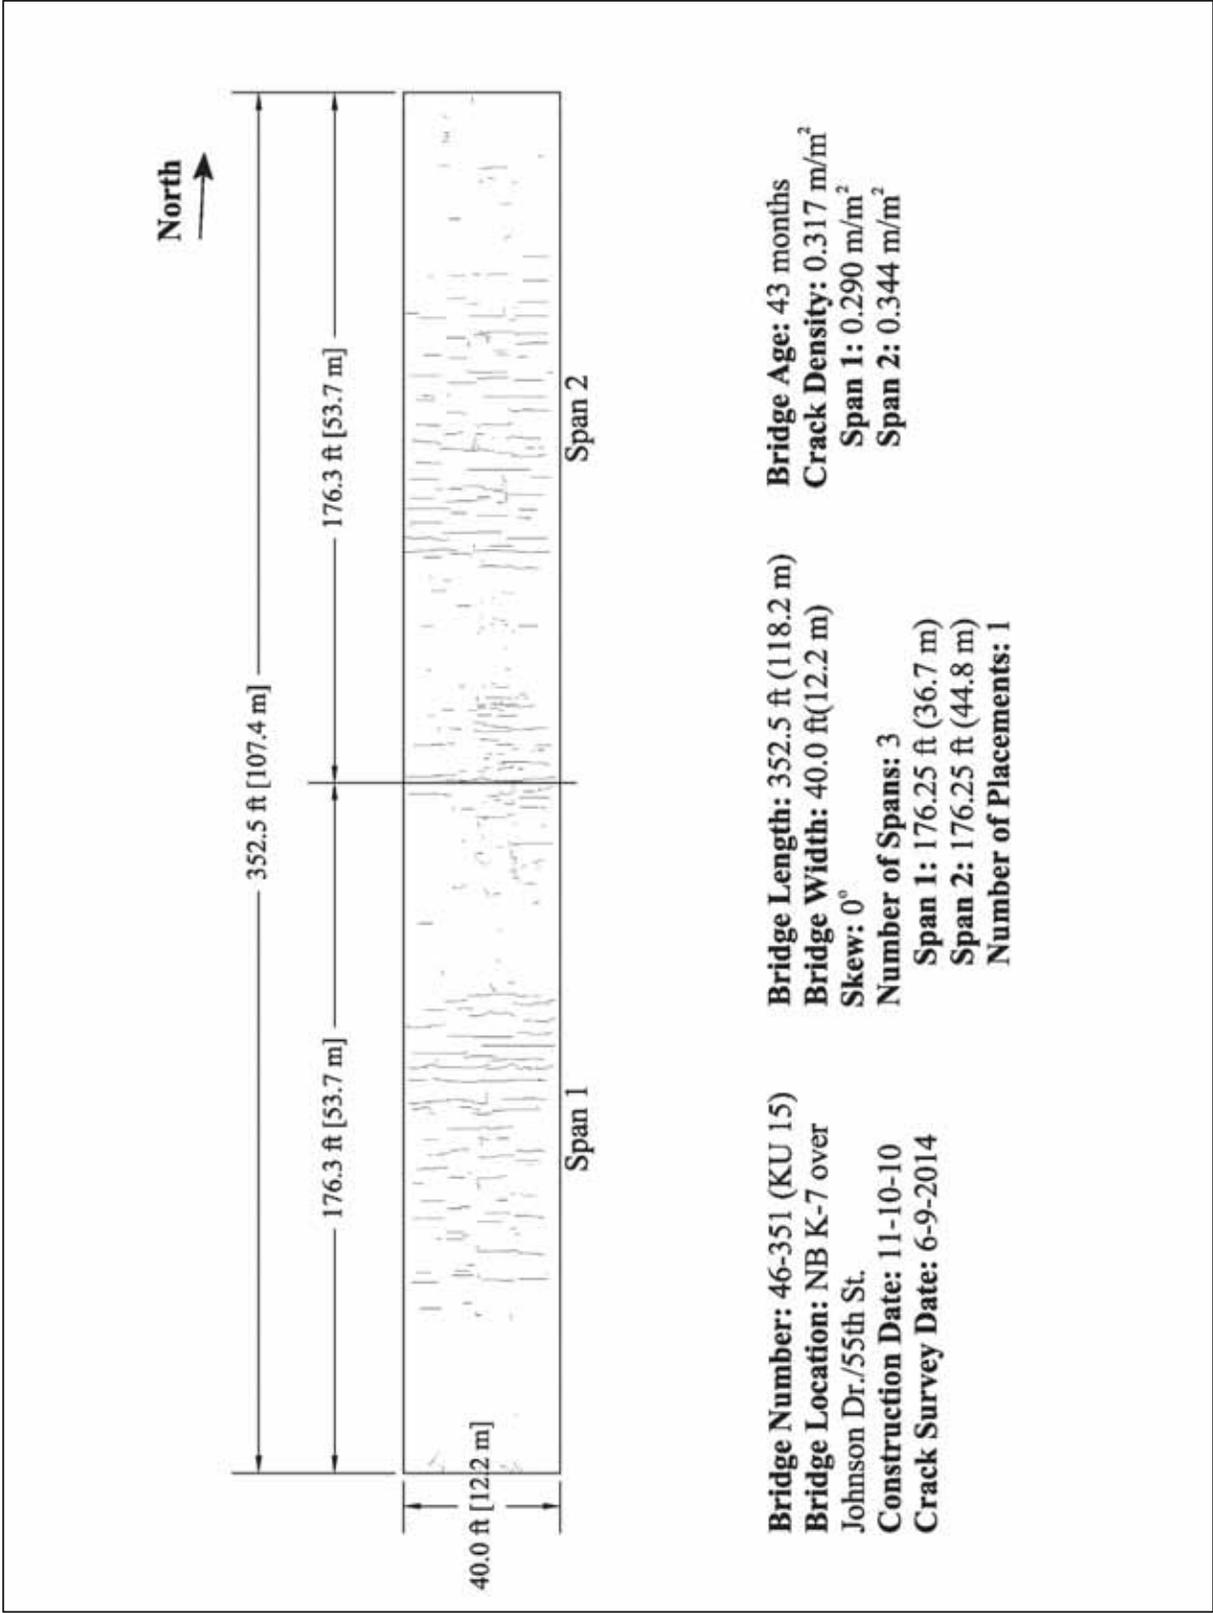
Figure 59: LC-HPC-15 (Survey 3)

Bridge deck LC-HPC-15 was constructed on 11/10/2010. This deck does not have a control deck for comparison. LC-HPC-15 has been surveyed four times and this report includes the results of Surveys 3 and 4. Survey 3 was performed at a deck age of 43.0 months; the crack map is shown in Figure 59. Survey 4 was performed at a deck age of 56.2 months; the crack map is shown in Figure 60. A crack density of 0.316 m/m^2 was observed in Survey 3 (Figure 58), a significant increase in crack density from Survey 2, 0.161 m/m^2 (Bohaty et al. 2013). In Survey 4, a crack density of 0.299 m/m^2 was observed (Figure 59), slightly lower than in Survey 3. As shown in Figures 59 and 60, the majority of the cracks in LC-HPC-15 are transverse, and appear to run parallel to the top reinforcement layer. A few short cracks appear near the abutments. Figure 61 displays the crack density versus deck age for LC-HPC-15.

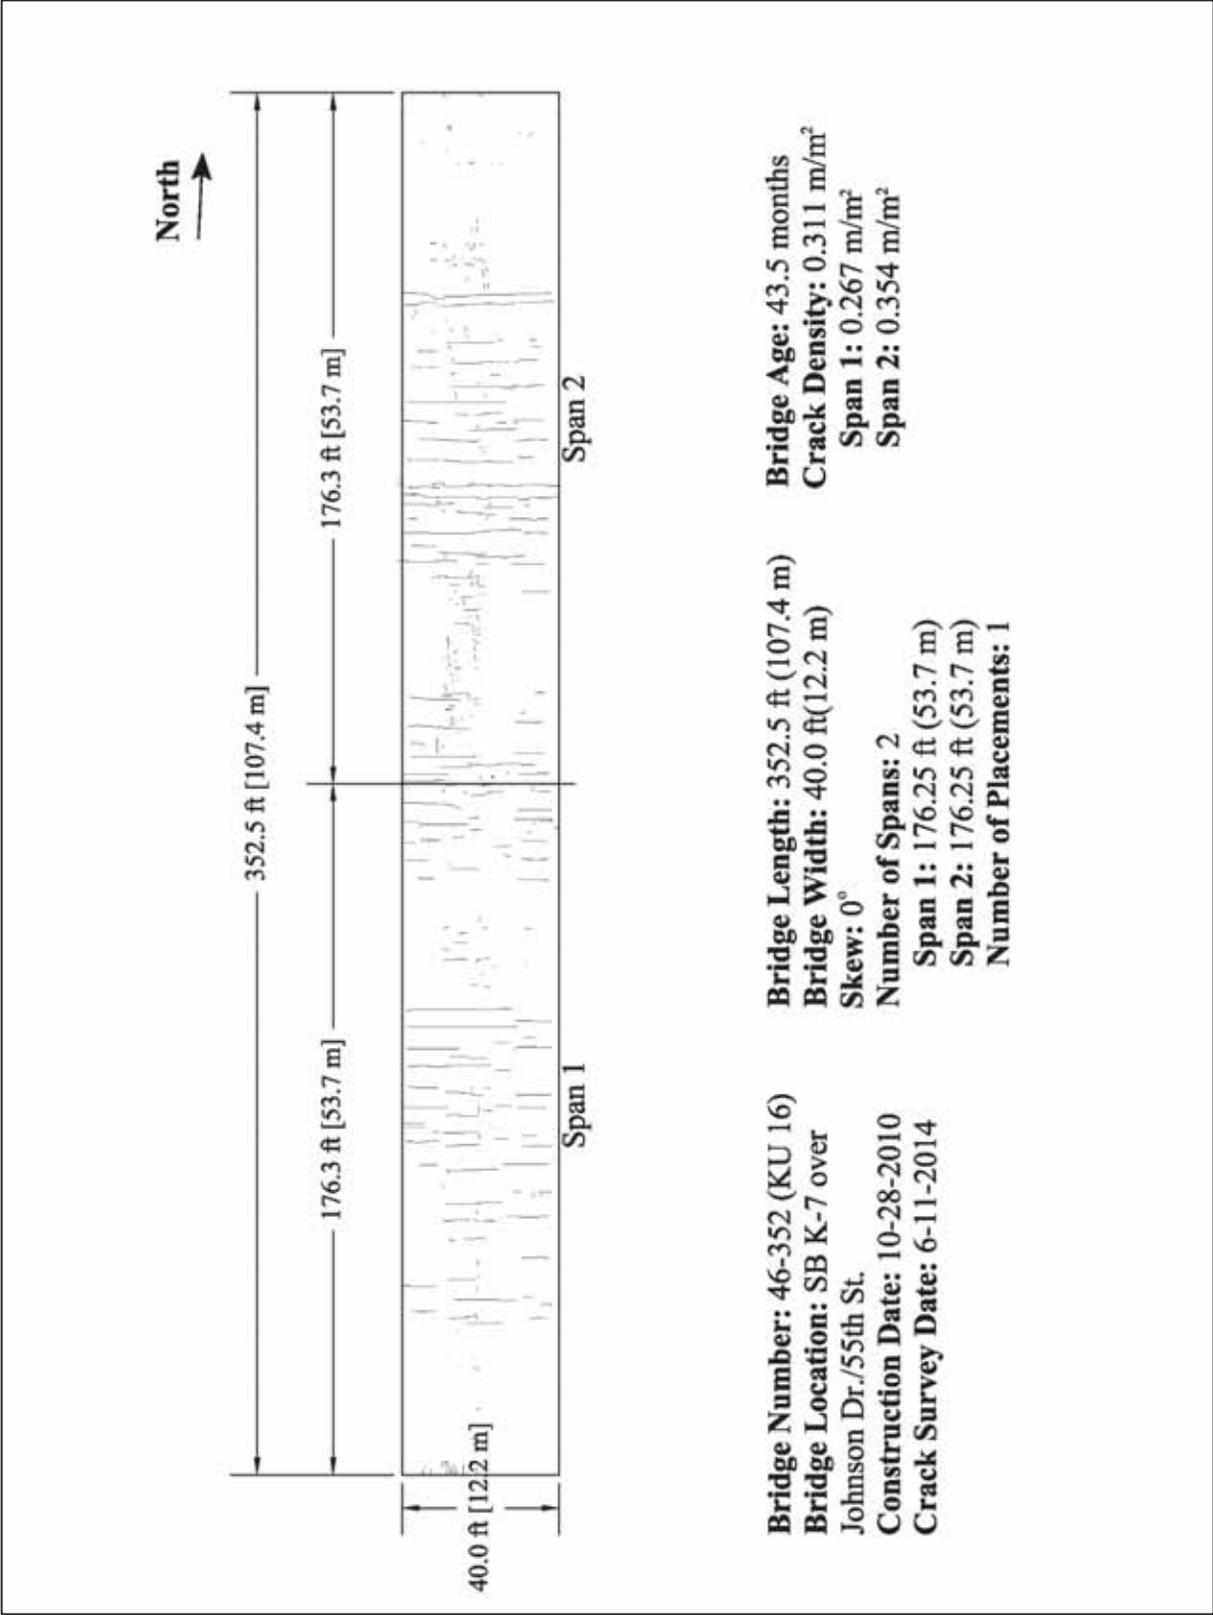
Figure 62: LC-HPC-16 (Survey 4)

Bridge deck LC-HPC-16 was constructed on 6/11/2014. This bridge does not have a control deck for comparison. This deck has been surveyed five times. The results of Surveys 4 and 5 of LC-HPC-16 are discussed in this report. Survey 4 was completed at a deck age of 43.5 months; the crack map is displayed in Figure 62. Survey 5 was completed at a deck age of 55.0 months; the crack map is displayed in Figure 63. A crack density of 0.311 m/m² was observed in Survey 4 (Figure 62) compared to a crack density of Survey 3, 0.211 m/m² (Bohaty et al. 2013). In Survey 5, a crack density of 0.397 m/m² was observed (Figure 63). Most of the cracks are transverse (Figures 62 and 63). Map cracking is also present on some portions of the deck. Near the abutments, some cracks have propagated longitudinally. Figure 64 shows the crack density as a function of age for LC-HPC-16.

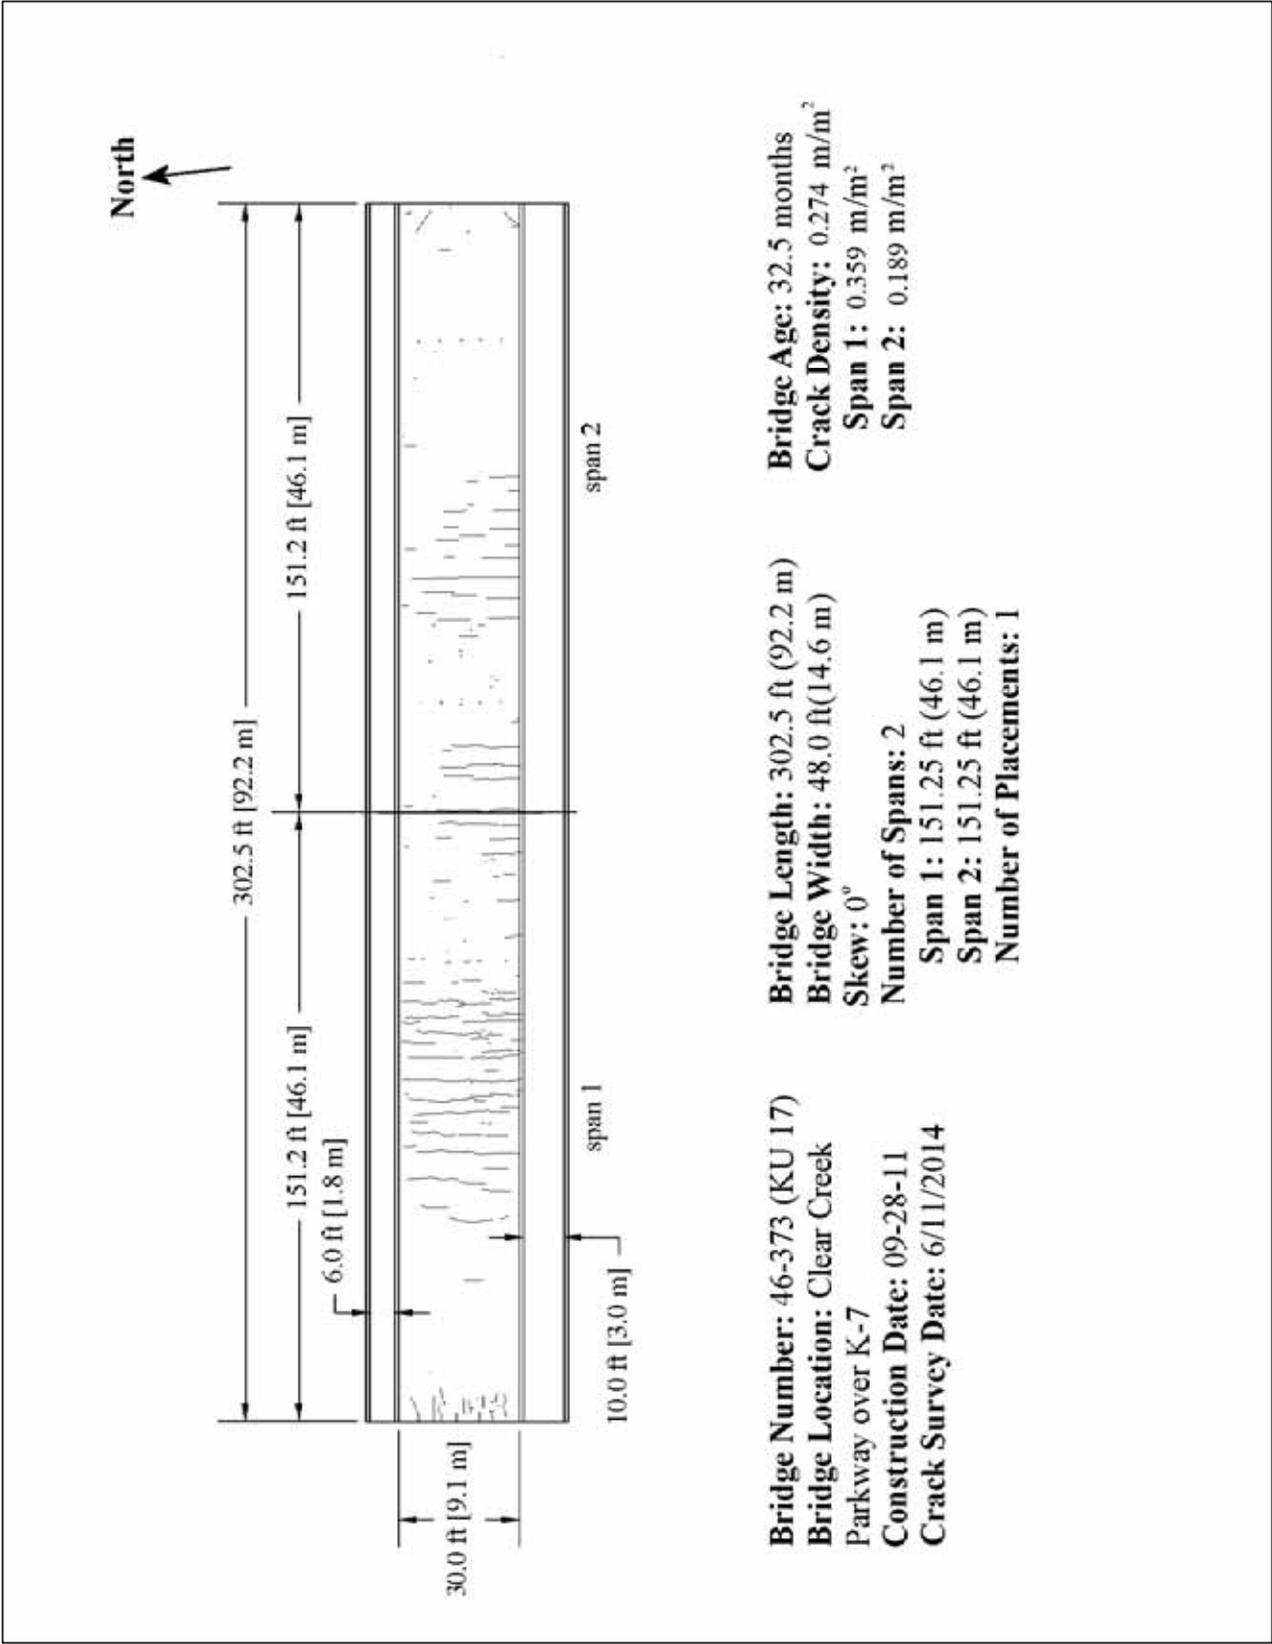
Figure 65: LC-HPC-17 (Survey 3)

Bridge deck LC-HPC-17 was placed on 9/28/2011. There is no control deck for this bridge. This deck has been surveyed four times, and the results of Surveys 3 and 4 are included in this report. Survey 3 was performed at a deck age of 32.5 months; the crack map is shown in Figure 65. Survey 4 was performed at a deck age of 45.5 months; the crack map is shown in Figure 66. In Survey 3, an overall crack density of 0.274 m/m² was observed (Figure 65), slightly higher than the value reported by Bohaty et al. (2013) for Survey 2, 0.240 m/m². An overall crack density of 0.308 m/m² was observed in Survey 4 (Figure 66). The surveys do not include the sidewalks. As shown in Figures 65 and 66, the majority of the cracks are transverse and located near the mid-span. There are, also, some transverse cracks above the pier. Survey 4 recorded some small areas of map cracking near the east abutment. Cracks also propagate longitudinally near the west abutment. Figure 67 shows the crack density for LC-HPC-17 over time.
