**CRACK SURVEYS OF LOW-CRACKING
HIGH-PERFORMANCE CONCRETE
BRIDGE DECKS IN KANSAS
2011-2013**

**By
Brent Bohaty
Elizabeth Riedel
David Darwin**

**A Report on Research Sponsored by
CONSTRUCTION OF CRACK-FREE BRIDGE DECKS
TRANSPORTATION POOLED-FUND PROGRAM
PROJECT NO. TPF-5(174)**

**Structural Engineering and Engineering Materials
SL Report 13-6**

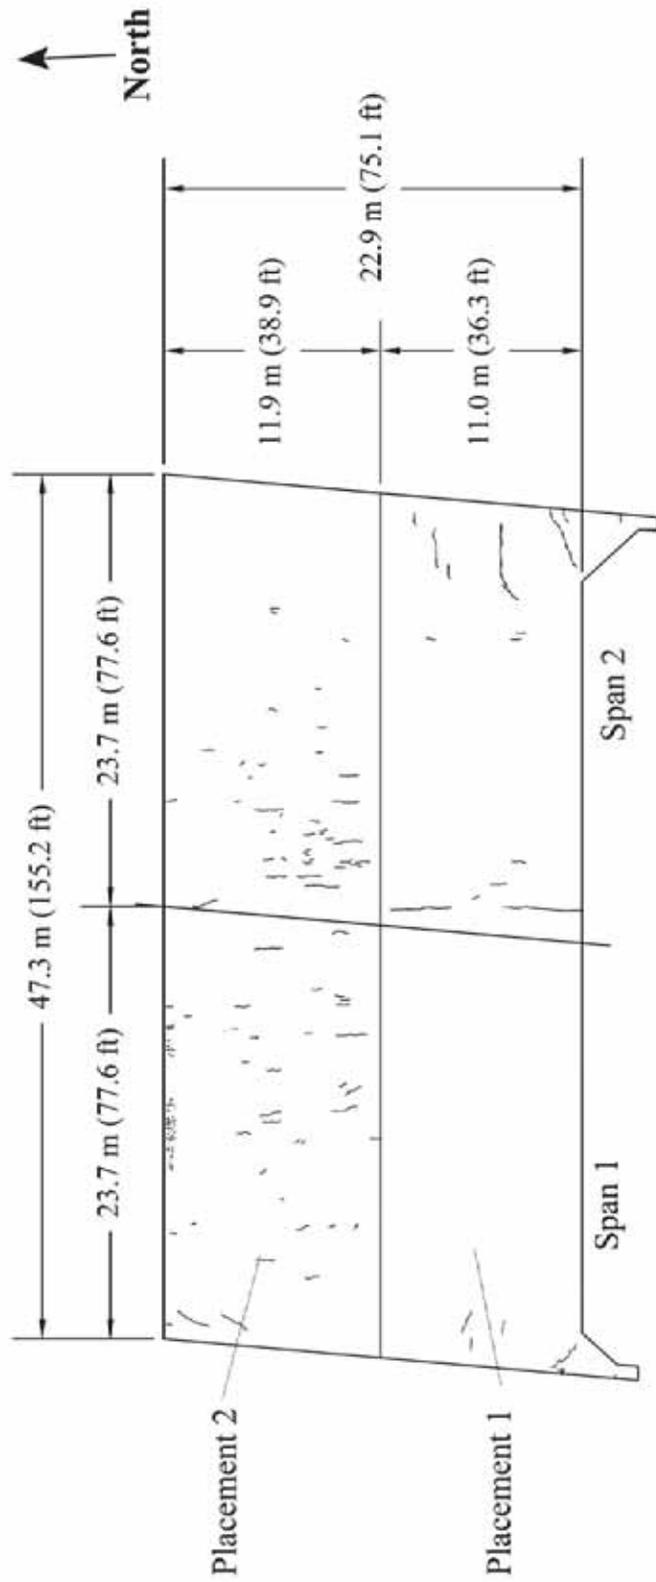
Figure 3: LC-HPC-1 (Survey 6)

LC-HPC-1 was cast in two separate placements, which were placed 19 days apart. The results of Survey 6 at 70.6 and 69.9 months, Survey 7 at 79.0 and 78.4 months, and Survey 8 at 91.3 and 90.6 months are included in this report. At 70.6 months, LC-HPC-1 had a crack density of 0.061 m/m² for Placement 1 and 0.103 m/m² for Placement 2. These values are both significantly larger than the densities from the previous survey (0.032 m/m² for Placement 1 and 0.023 m/m² for Placement 2) reported by Pendergrass et al. (2011). The crack densities at 79.0 and 78.4 months increased to 0.096 m/m² for Placement 1 and decreased to 0.081 m/m² for Placement 2. In Survey 8 at 91.3 and 90.6 months, the crack densities decreased markedly to 0.059 m/m² for Placement 1, and Placement 2 fell to 0.023 m/m². During Survey 8, it was noted

that many surfaces on the bridge had experienced scaling, which exposed the aggregate at the surface of the deck. It is believed that the outlines of these aggregates were mistaken as cracks in previous surveys. Figures 3, 4, and 5 show the crack maps for Surveys 6, 7, and 8. It is evident that many of the small cracks, which are likely misidentified as such, shown in Surveys 6 and 7, are not present in Survey 8. Cracking on LC-HPC-1 consists mainly of small cracks parallel to and directly above the top layer of deck reinforcement, except near the abutments, where cracks propagate longitudinally. Survey 6 has more distinct cracking near the midspan than is present in either of the two later surveys.

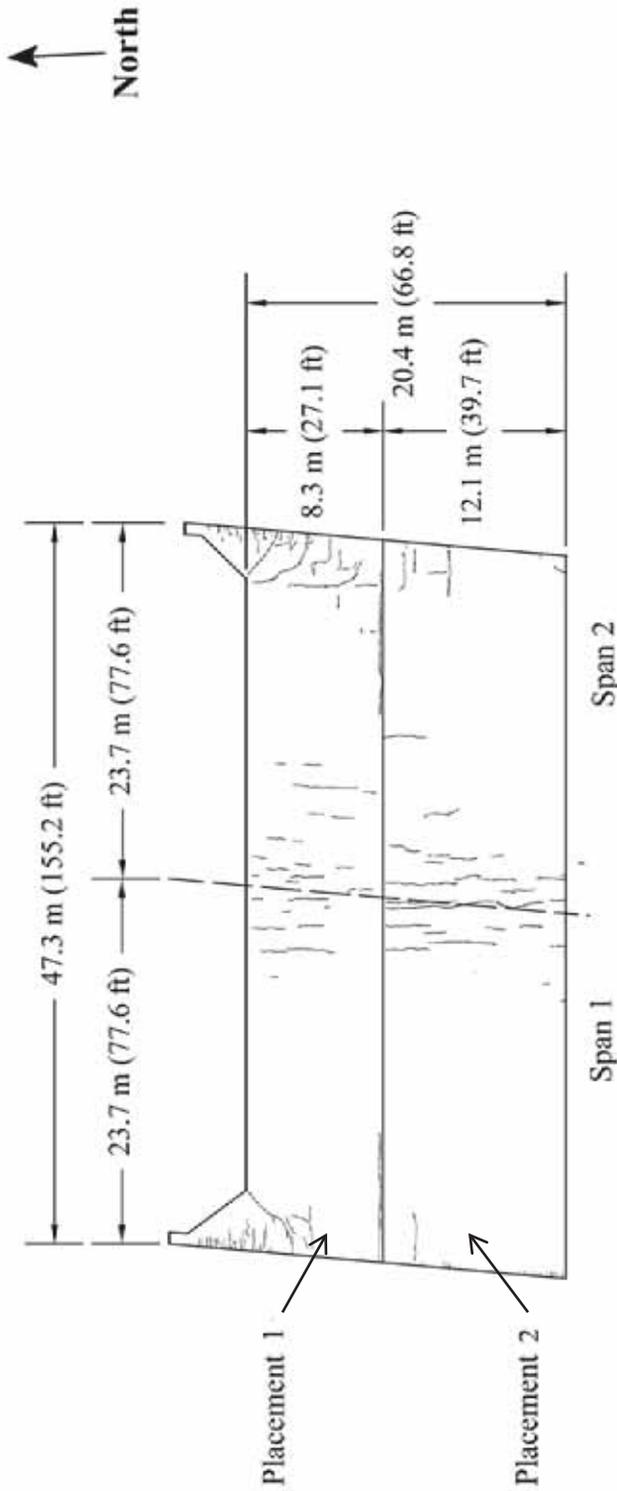
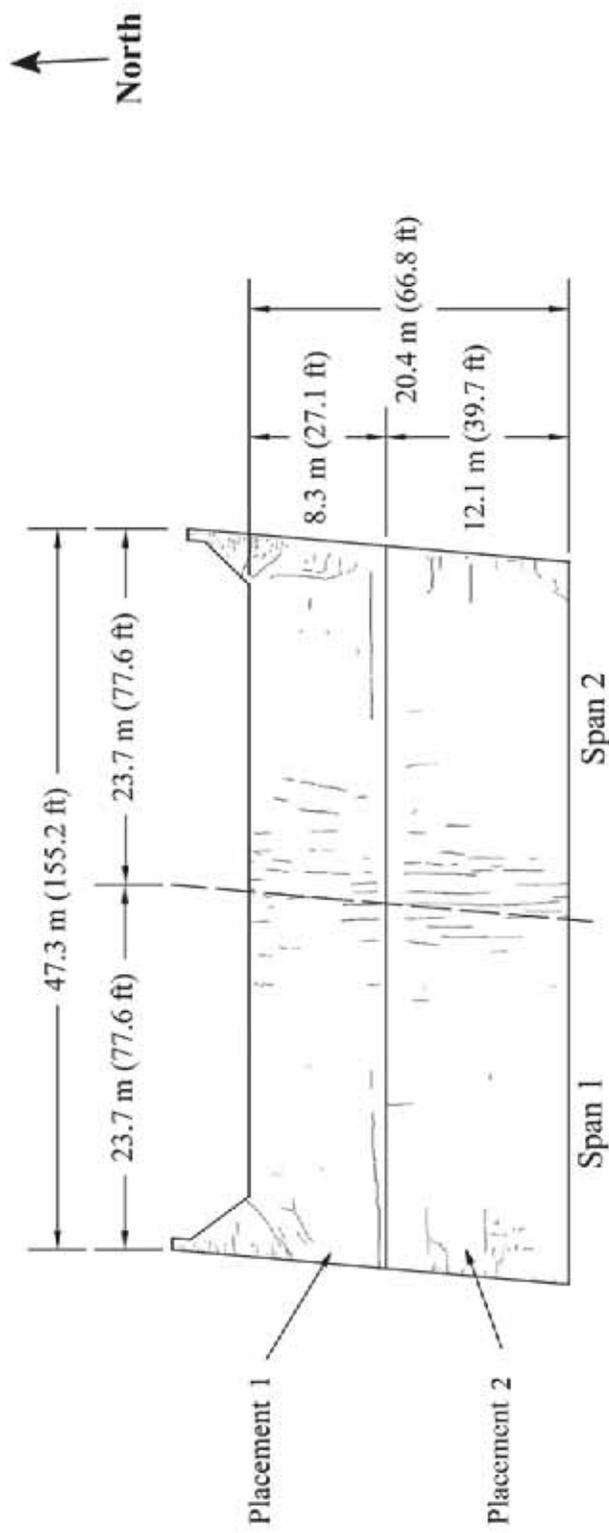
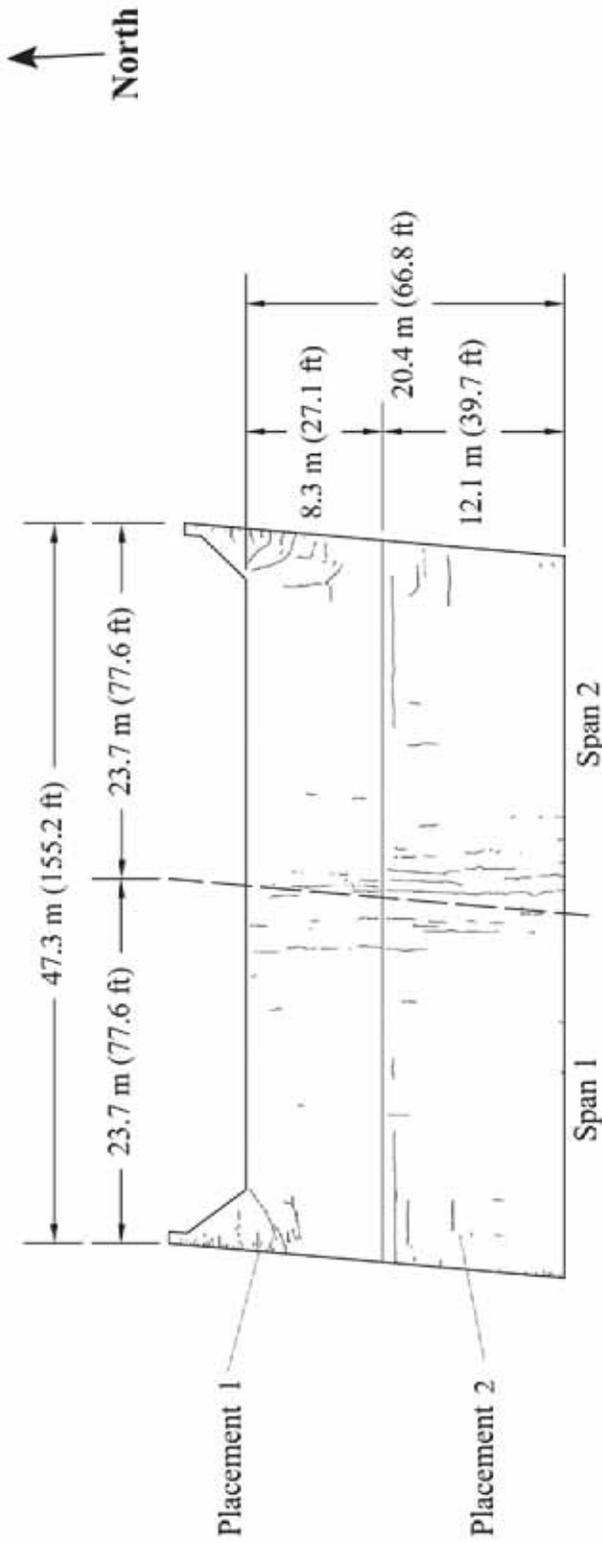
Control-1/2 is adjacent to LC-HPC-1 and serves as the control deck for both LC-HPC-1 and LC-HPC-2. Like LC-HPC-1, Control-1/2 was cast in two separate placements. The results of Survey 6 at 70.7 and 70.1 months, Survey 7 at 79.2 and 78.6 months, and Survey 8 at 91.4 and 90.8 months are included in this report. The crack densities for Placement 1 and 2 measured in Survey 6, shown in Figure 6, were 0.139 and 0.176 m/m², which are both higher than measured in Survey 5 (Pendergrass et al. 2011). In Survey 7, the crack density of Placement 1 increased to 0.240 m/m² at 79.2 months, while the crack density of Placement 2 decreased to 0.161 m/m² at 78.6 months (see Figure 7). Crack densities for both placements decreased in Survey 8, to 0.141 m/m² and 0.149 m/m², respectively. The crack map for Survey 8 is shown in Figure 8. Cracking on Control-1/2 is very prominent around the pier at midspan. Cracks in this area run directly parallel to and above the reinforcing bars. There is also significant cracking at the ends of the bridge. Particularly, there are two large cracks running longitudinally down the middle of the bridge originating at either abutment. There is also map cracking in the northeast and northwest

corners of the bridge. Figure 9 compares cracking on Control-1/2 to LC-HPC-1 over time. Crack densities on both placements of Control-1/2 have been consistently higher than densities on both placements of LC-HPC-1 over time.

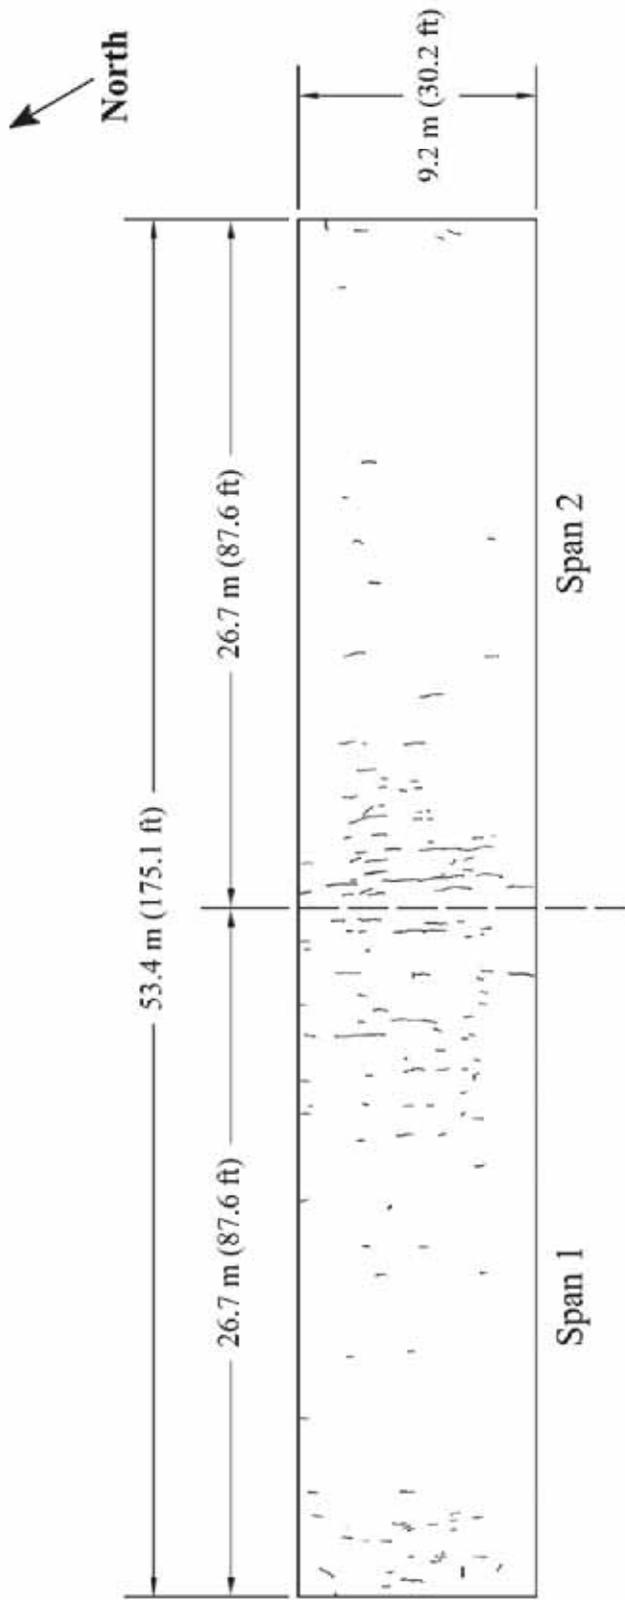
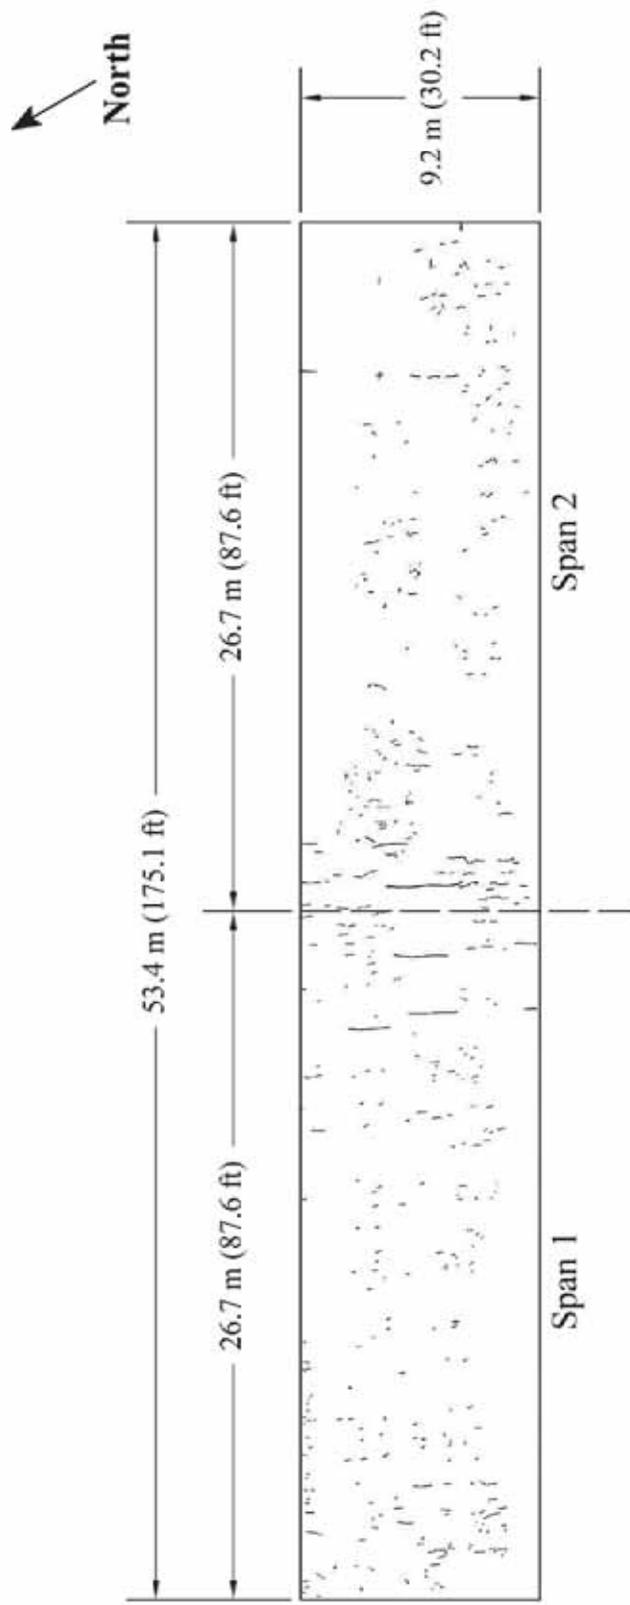
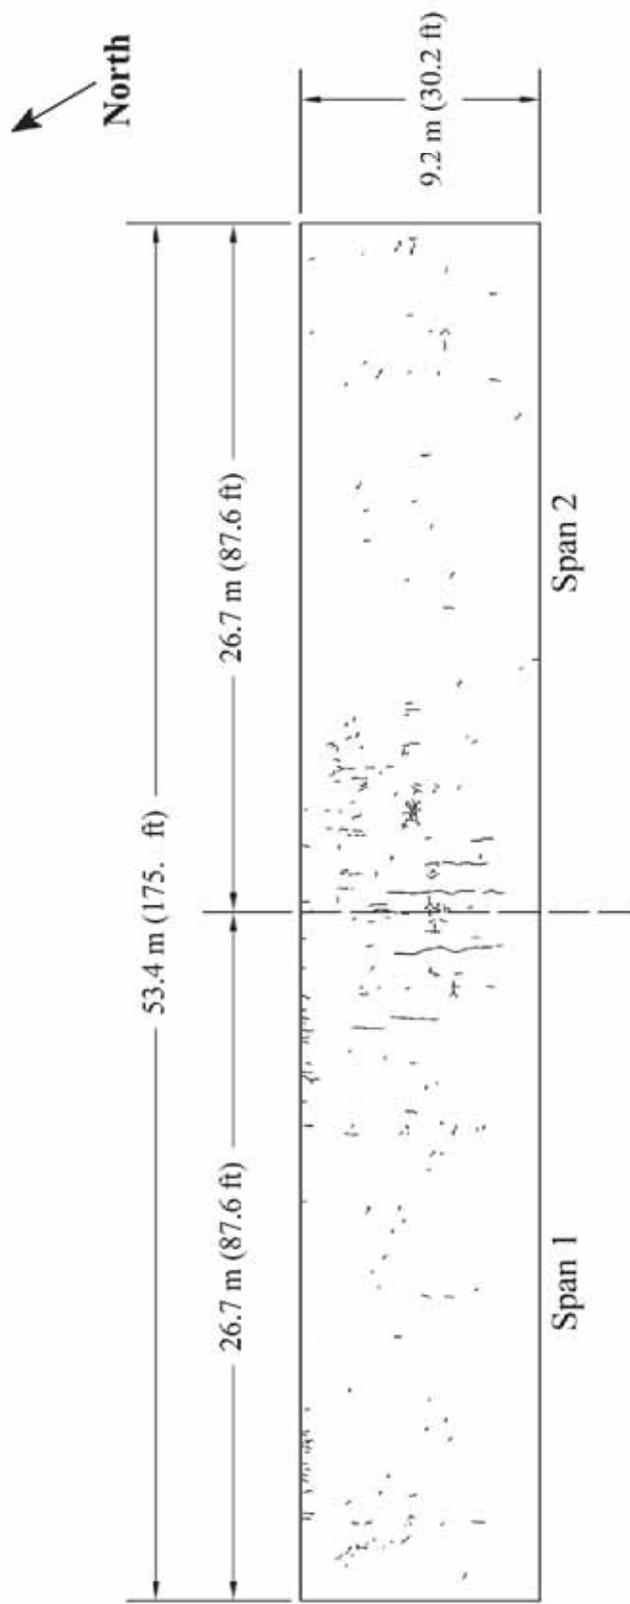
The results of Survey 5 at 59.3 months, Survey 6 at 68.1 months, and Survey 7 at 80.3 months are included in this report. Crack densities of 0.143 m/m² and 0.197 m/m² were measured at 59.3 months and 68.1 months, respectively. These densities are, respectively, more than two and three times the previous density of 0.059 m/m² at 44.5 months reported by Pendergrass et al. (2011). Crack maps for Surveys 5 and 6 are shown in Figures 10 and 11. At 80.3 months, LC-HPC-2 had a crack density of 0.141 m/m², more than 25% lower than the density at 68.1 months. Figure 12 shows the crack map for Survey 7. Cracking in all three of these surveys is

prominent in the negative moment region above the pier, with small cracks extending from the northern edge of the deck and distributed throughout the entire deck. The crack map for Survey 6 shows many small cracks throughout the deck that were not captured in any previous surveys, likely the result of mistaking aggregate boundaries for cracks. Figure 13 compares cracking on LC-HPC-2 to Control-1/2 over time. It is evident that cracking on LC-HPC-2 has increased over time, experiencing a sharp rise after 42 months, and has moved closer in value to the crack densities for Control-1/2 in recent years.

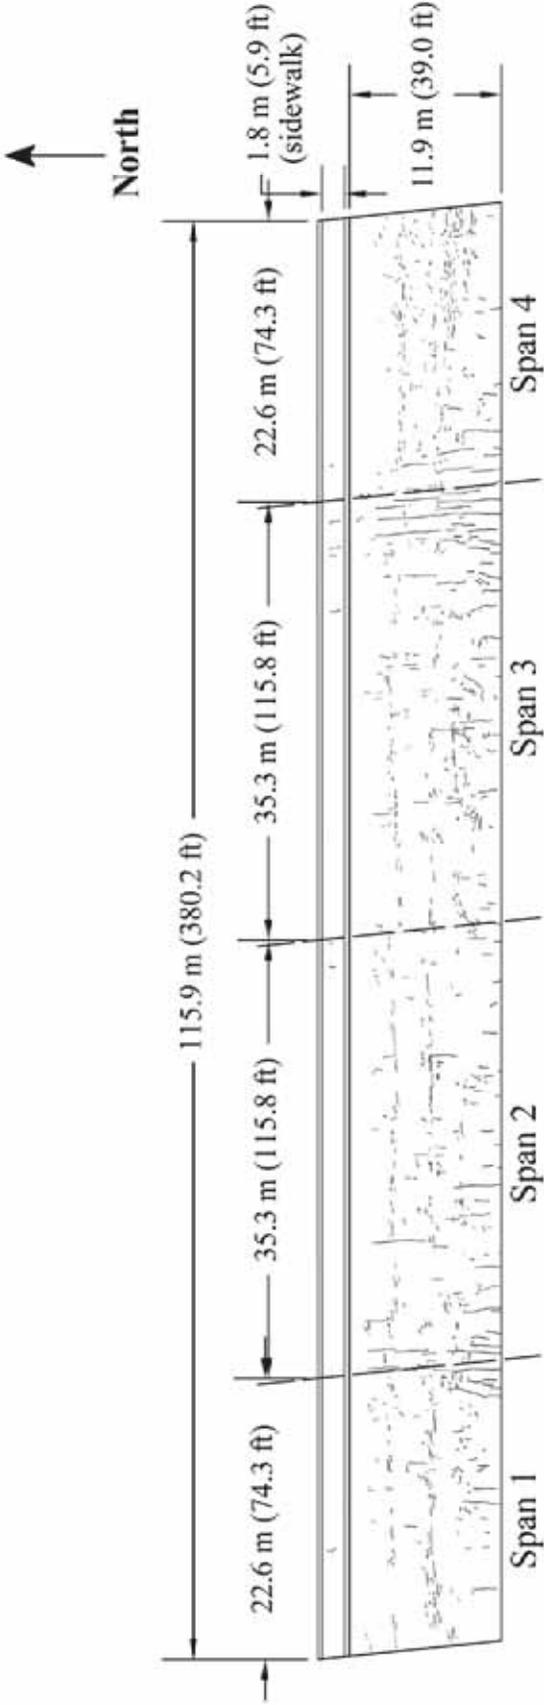
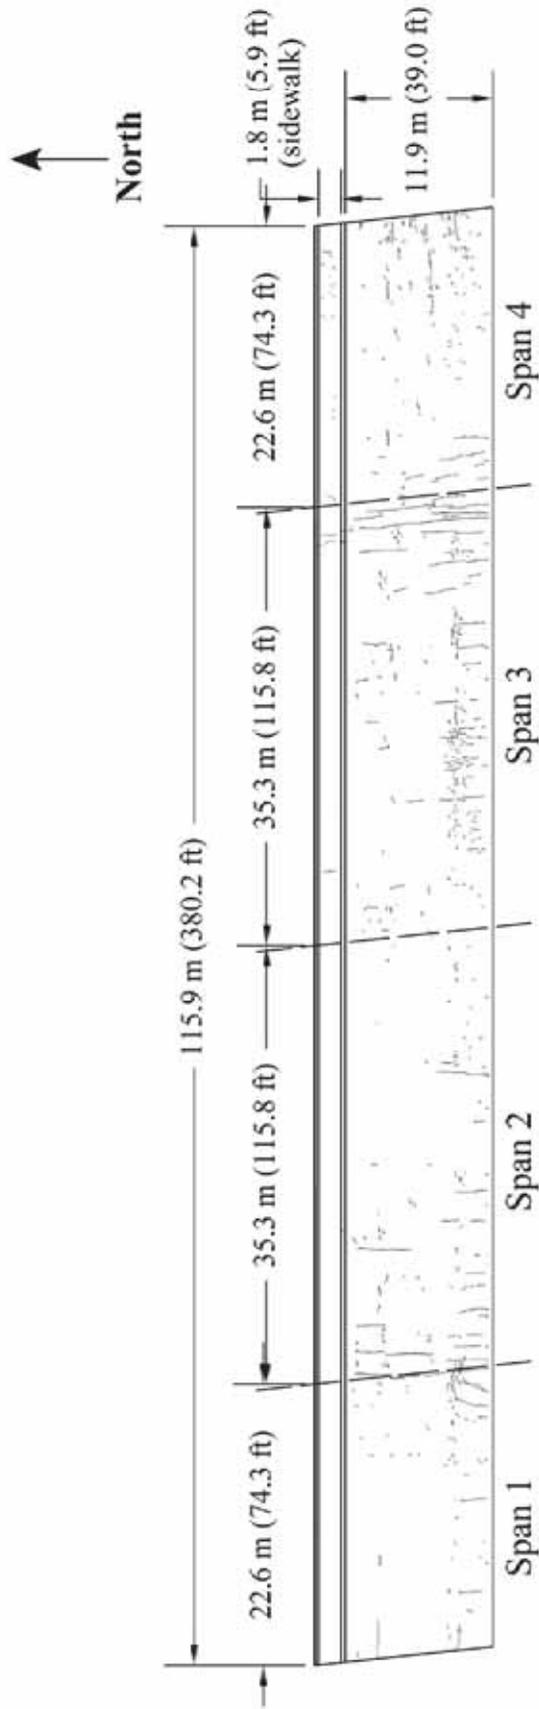
The results of Survey 4 at 42.6 months, Survey 5 at 54.0 months, and Survey 6 at 66.2 months for LC-HPC-3 are included in this report. Crack densities measured in Surveys 4, 5, and 6 were 0.315 m/m², 0.173 m/m², and 0.174 m/m², respectively. These densities represent an increase from Survey 3, which measured a crack density of 0.108 m/m², as presented by

Pendergrass et al. (2011). In relation to the crack densities calculated for LC-HPC-3 in previous years, the large increase in crack density corresponding to Survey 4 (0.315 m/m^2) appears to be an outlier. Crack maps for Surveys 4, 5, and 6 are shown in Figures 14, 15, and 16, respectively. Cracking is significant above the outside piers, but not at center span. Smaller cracks are within the spans and at the east end of the bridge. The larger cracks located above the piers appear to lie directly above and parallel to the reinforcement.

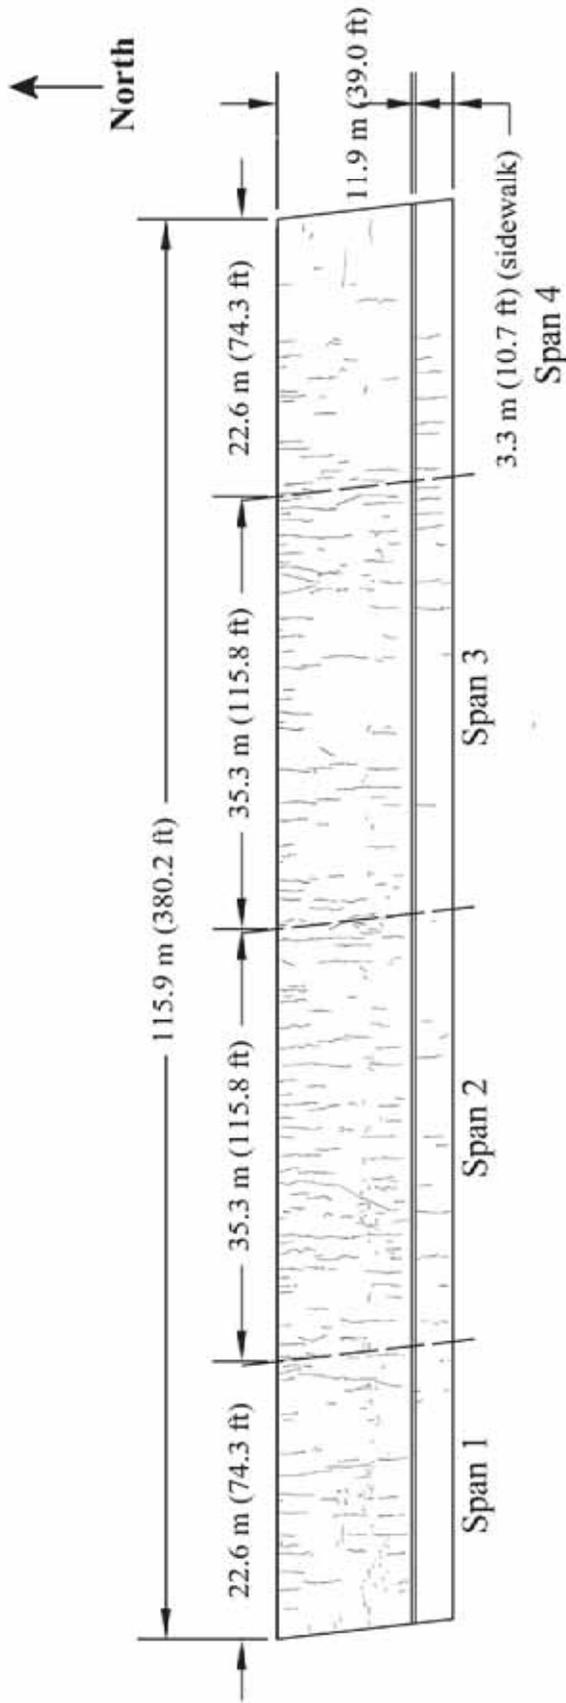
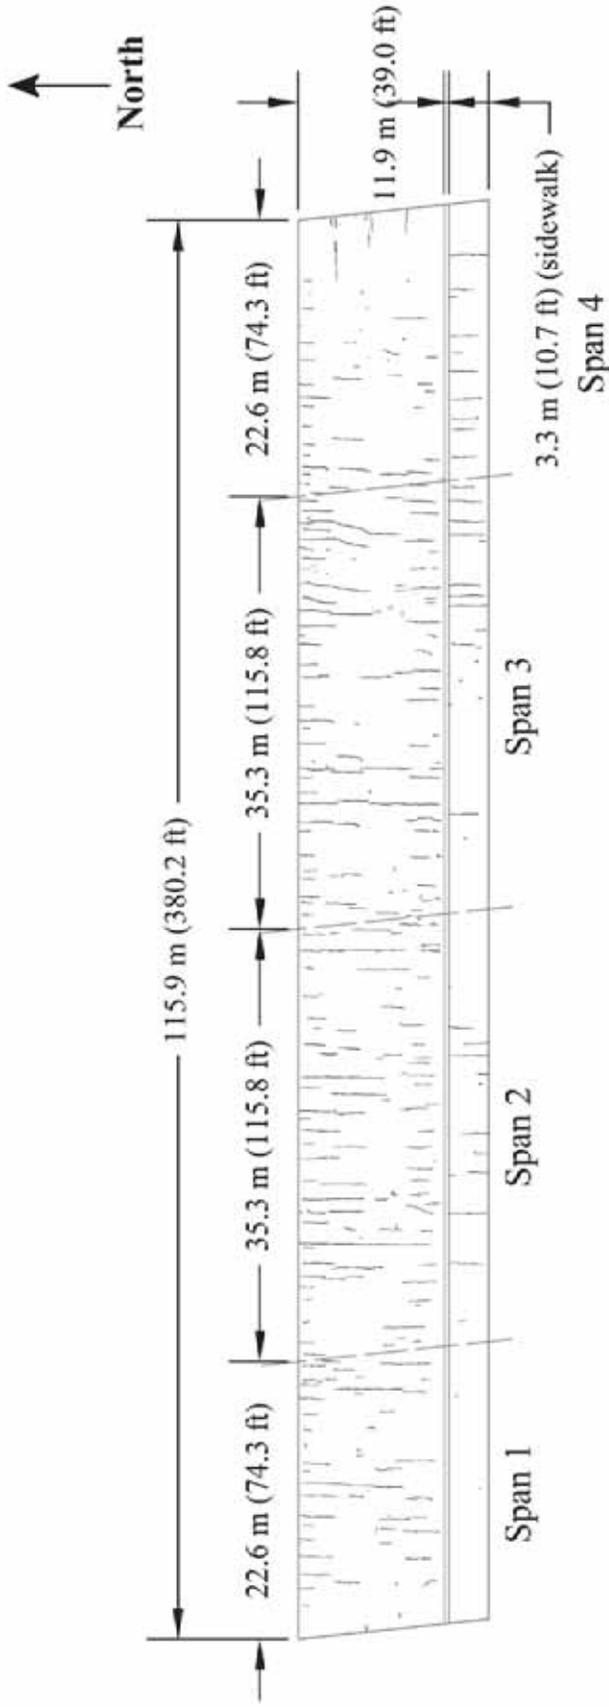
The results of Survey 4 at 46.6 months, Survey 5 at 57.9 months, and Survey 6 at 70.1 months are included in this report. Crack densities of 0.323 m/m^2 and 0.314 m/m^2 were observed in Surveys 4 and 5, respectively. These values represent a significant increase from crack densities of 0.216 m/m^2 and 0.232 m/m^2 corresponding, respectively, to Surveys 2 and 3 (Pendergrass et al. 2011). The crack density of Control-3 at 57.9 months, 0.314 m/m^2 , is nearly double the crack density of LC-HPC 3 at 54 months, 0.173 m/m^2 . At 70.1 months, a crack density of 0.288 m/m^2 was recorded in Survey 6, which is slightly lower than the densities measured in Surveys 4 and 5, but is still larger than the crack density of LC-HPC-3 at 66.2 months, 0.174 m/m^2 . Figures 17, 18, and 19 show the crack maps for Surveys 4, 5, and 6, respectively. Cracking on Control-3 is largely located parallel to the reinforcement and is relatively evenly distributed throughout the deck. Figure 20 compares cracking on Control-3 to LC-HPC-3 over time. Cracking on LC-HPC-3 has, for the most part, remained lower than cracking on Control-3 over the life of the decks, with the exception of the density of LC-HPC-3 at 42.6 months, which, as discussed earlier in this section, appears to be an outlier.

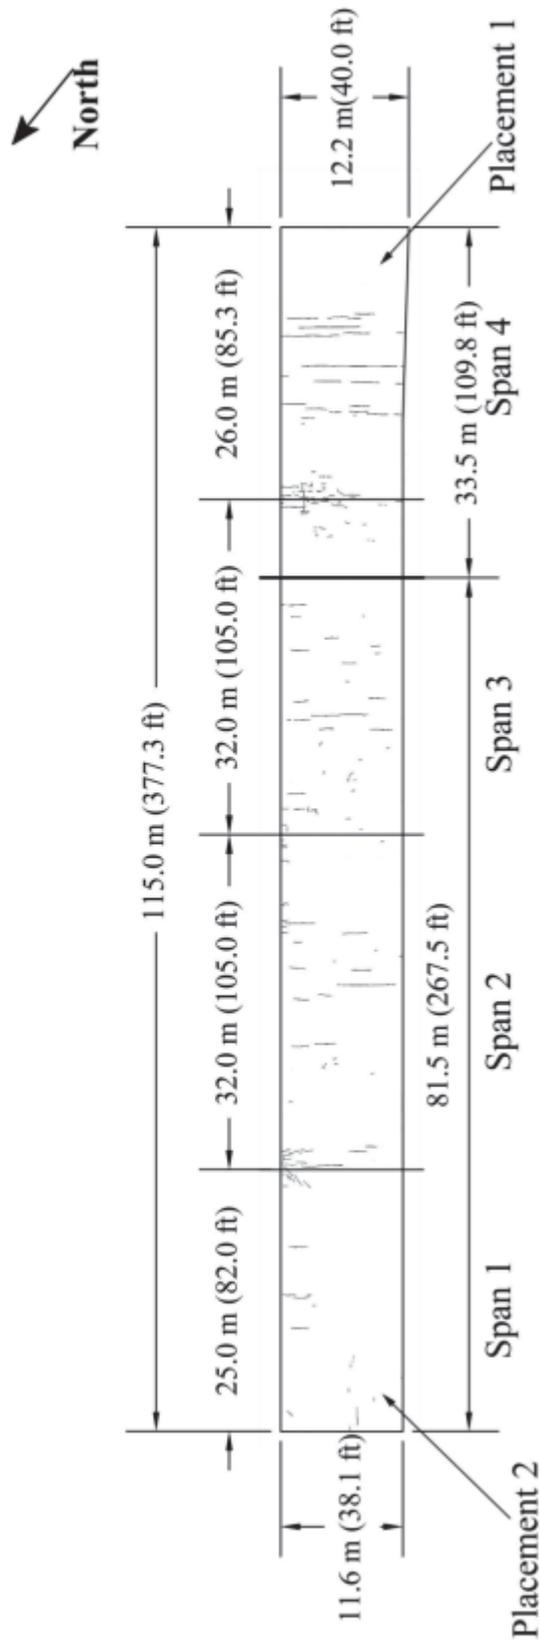
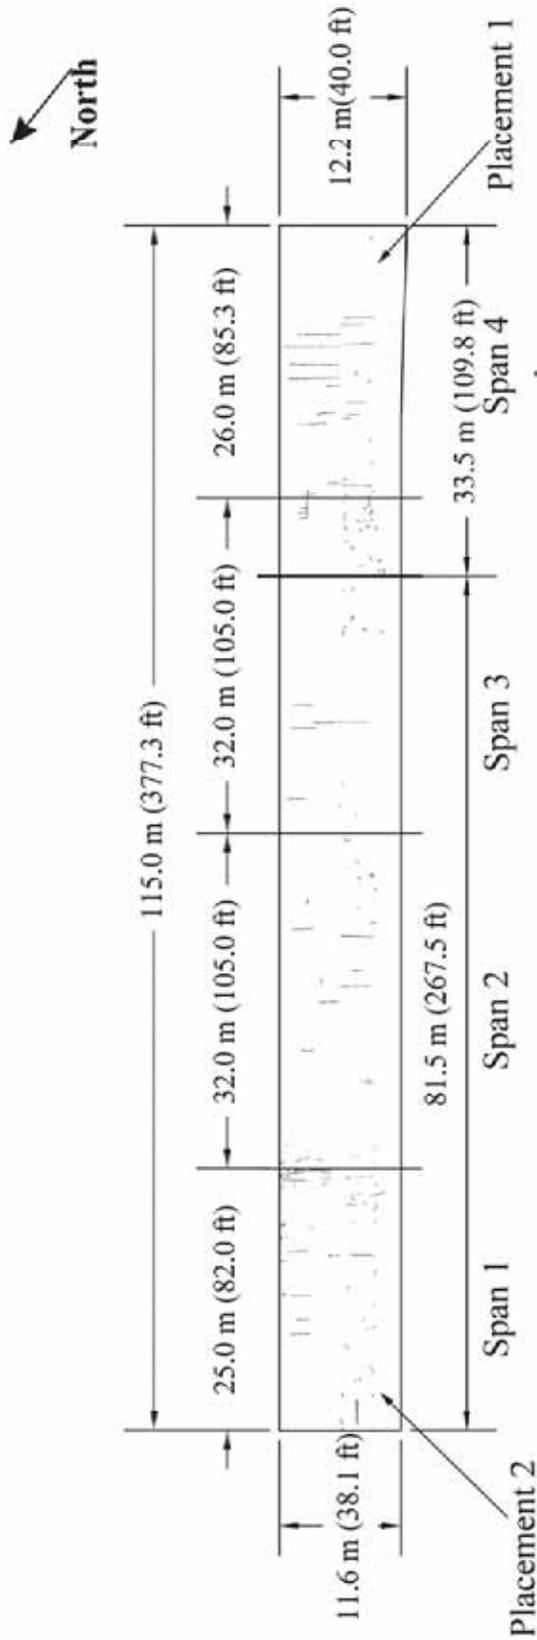
LC-HPC-4 was constructed in two placements three days apart. The results of Survey 4 at 45.0 and 44.9 months, Survey 5 at 56.0 and 55.9 months, and Survey 6 at 68.5 and 68.4 months are included in this report. Crack maps for Surveys 4, 5, and 6 are shown in Figures 21, 22, and 23. At ages of 45 months for Placement 1 and 44.9 months for Placement 2, the overall crack density was 0.107 m/m², with Placement 1 having a density twice that of Placement 2 (0.167 m/m² and 0.080 m/m²). This represents a decrease from the crack densities measured in Survey 3 at 32.8 months for Placement 1 and 32.7 months for Placement 2: 0.146 m/m² overall, 0.261 m/m² for Placement 1, and 0.094 m/m² for Placement 2 (Pendergrass et al. 2011). At ages of 56 months for Placement 1 and 55.9 months for Placement 2 (Survey 5), the overall crack density was 0.120 m/m², an increase from Survey 4, but still lower than the crack density measured in Survey 3. Furthermore, the crack density of Placement 1 is still twice as large as the density of

Placement 2 measured during Survey 5 (0.184 m/m² versus 0.092 m/m²). For Survey 6 at 68.5 months, the overall crack density was 0.097 m/m², a decrease from Survey 5. The crack density of Placement 1 decreased slightly to 0.179 m/m² and the crack density of Placement 2 at 68.4 months decreased about 35 percent to 0.060 m/m². Cracking of LC-HPC-4 Placement 1 occurs around the easternmost pier, along with transverse cracks located in the midspan. Cracking of Placement 2 is most prominent around the westernmost pier. Placement 2 also contains transverse cracks in the midspans.

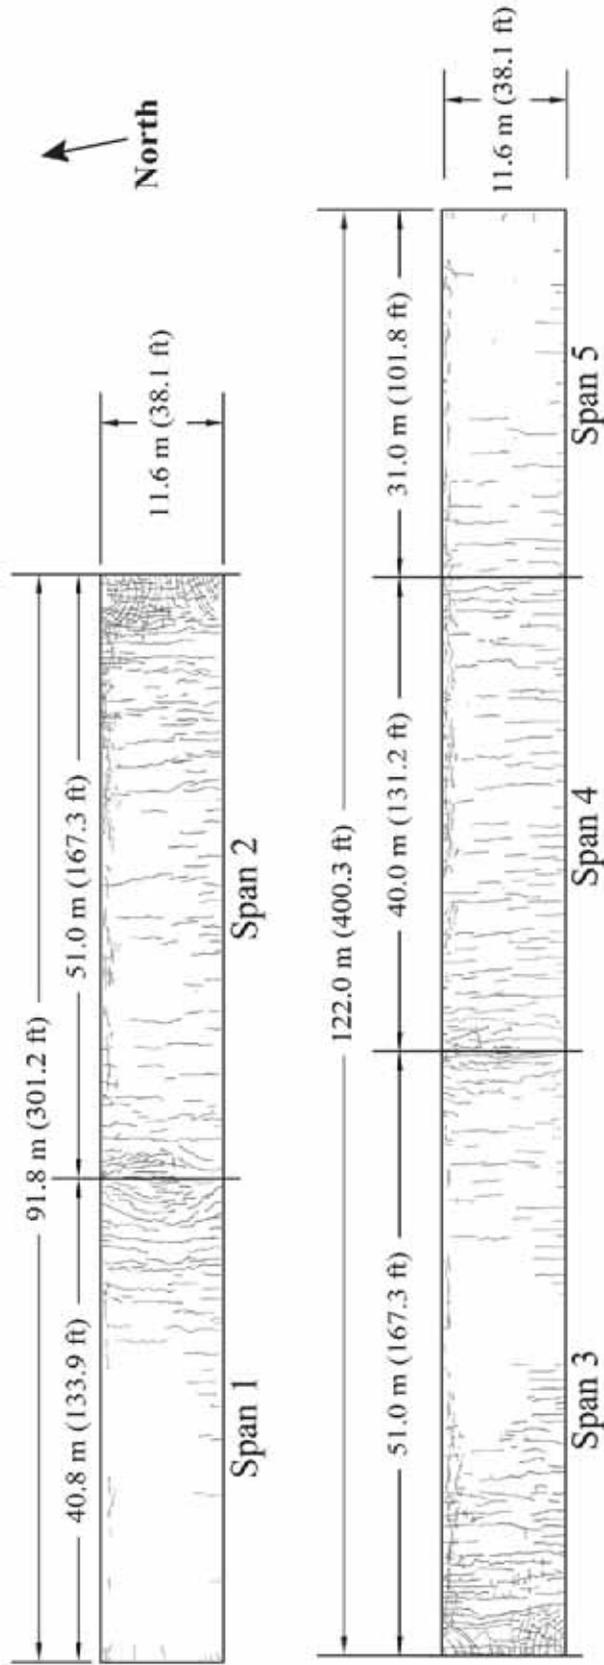
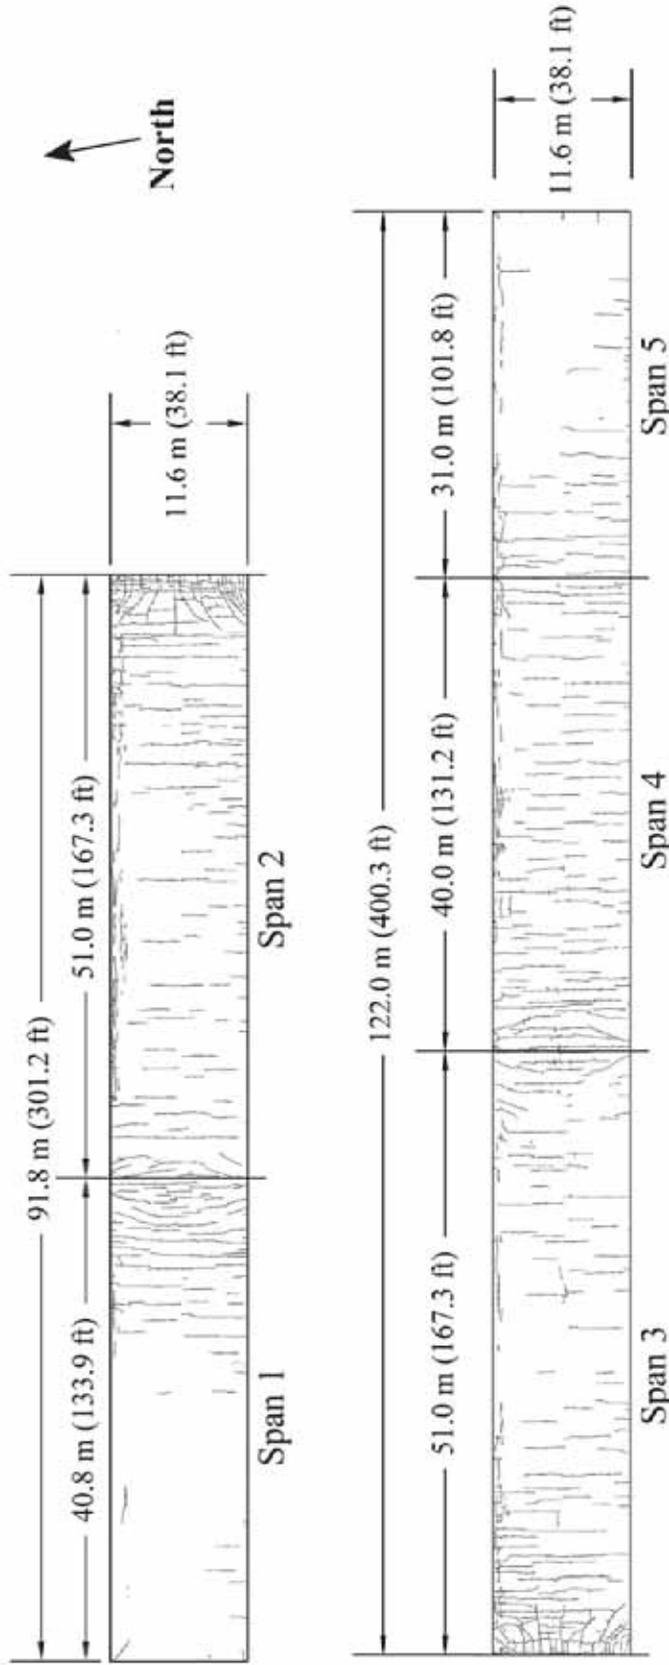
The results of Surveys 4, 5, and 6, at 42.7, 54.9, and 67.1 months, are included in this report. The crack densities of Control-4 measured in Surveys 4 and 5, shown in Figures 24 and 25, were 0.618 m/m² and 0.669 m/m², respectively. These densities represent a significant increase from the value measured in Survey 3 at 31.6 months of 0.473 m/m² (Pendergrass et al. 2011). These densities are also much larger than the crack densities of LC-HPC-4 at 45.0 and 56.0 months. The crack density at 67.1 months was 0.561 m/m² (see Figure 26), a decrease from the crack densities measured in Surveys 4 and 5. However, this density is still much greater than the overall crack density of LC-HPC-4 at 68.5 months of 0.105 m/m². Control-4 has significant transverse cracking near the piers of the bridge. Above the second pier from the west, there is longitudinal and transverse cracking. There is also significant longitudinal cracking along the northern edge of the deck, which is likely due to a small portion of the bridge deck that is cantilevered out over the exterior girder. Figure 27 compares crack densities on Control-4 to crack densities on LC-HPC-4 over time. Clearly, cracking on Control-4 has been significantly greater than on either placement of LC-HPC-4 over time. While LC-HPC-4 seems to have had relatively stable cracking over its life, Control-4 has had a general trend of increased cracking.

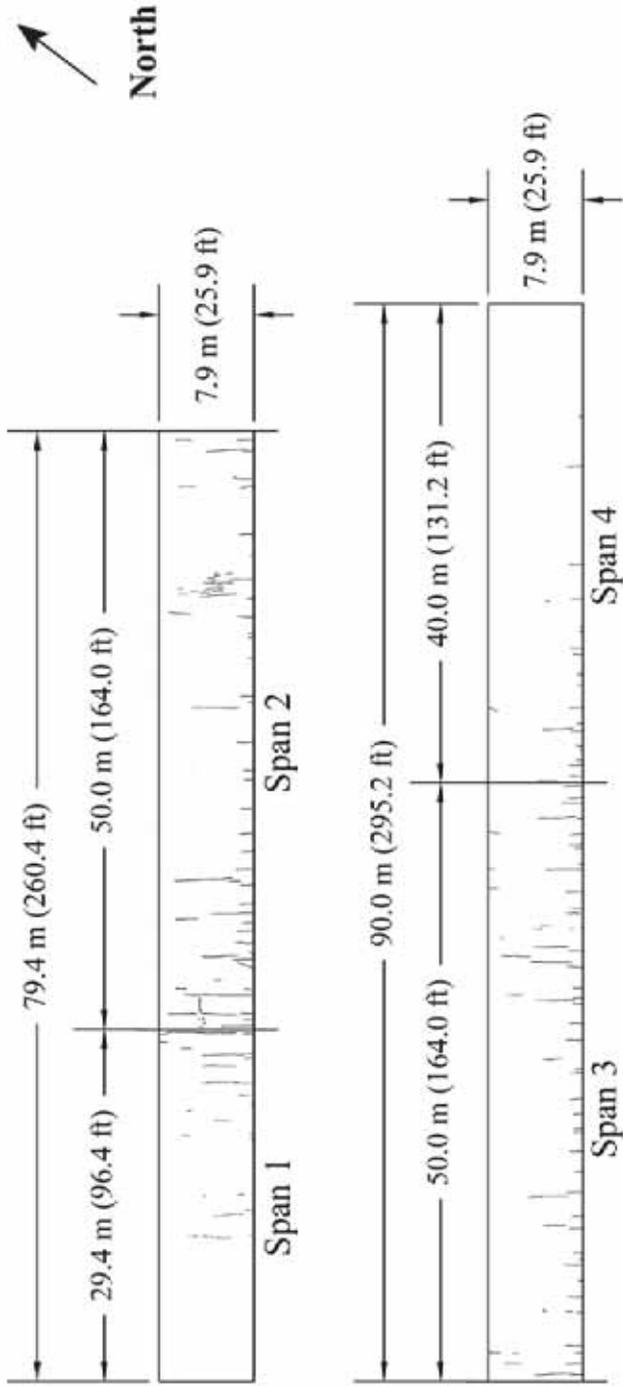
The results of Surveys 4, 5, and 6 of LC-HPC-5, at 43.0, 54.2, and 67.0 months, are included in this report. The crack density of LC-HPC-5 at 43.0 months was 0.190 m/m², shown in Figure 28, represents an increase from the Survey 3 result at 31.1 months, 0.128 m/m² (Pendergrass et al. 2011). The crack densities from Surveys 5 and 6 show decreases from Survey 4. The crack density for LC-HPC-5 at 54.2 months was 0.158 m/m², as shown in Figure 29. The crack density for LC-HPC-5 at 67.0 months was 0.131 m/m², as shown in Figure 30. Due to the small amount of cracking in the deck, overlooking just a few cracks can make an impact in the crack density, and is likely the cause of this decrease. Most of the cracks are transverse, propagating from the south side of the deck. The south side is superelevated, which

may have caused plastic concrete to flow away from it, leaving the hardened concrete more susceptible to cracking. Furthermore, the soaker hoses were placed at the center of the deck, thus not providing curing water to the more elevated side of the deck. The effects of the superelevation can be seen in the crack maps, which show that the cracks occur only near the southern edge of the deck.

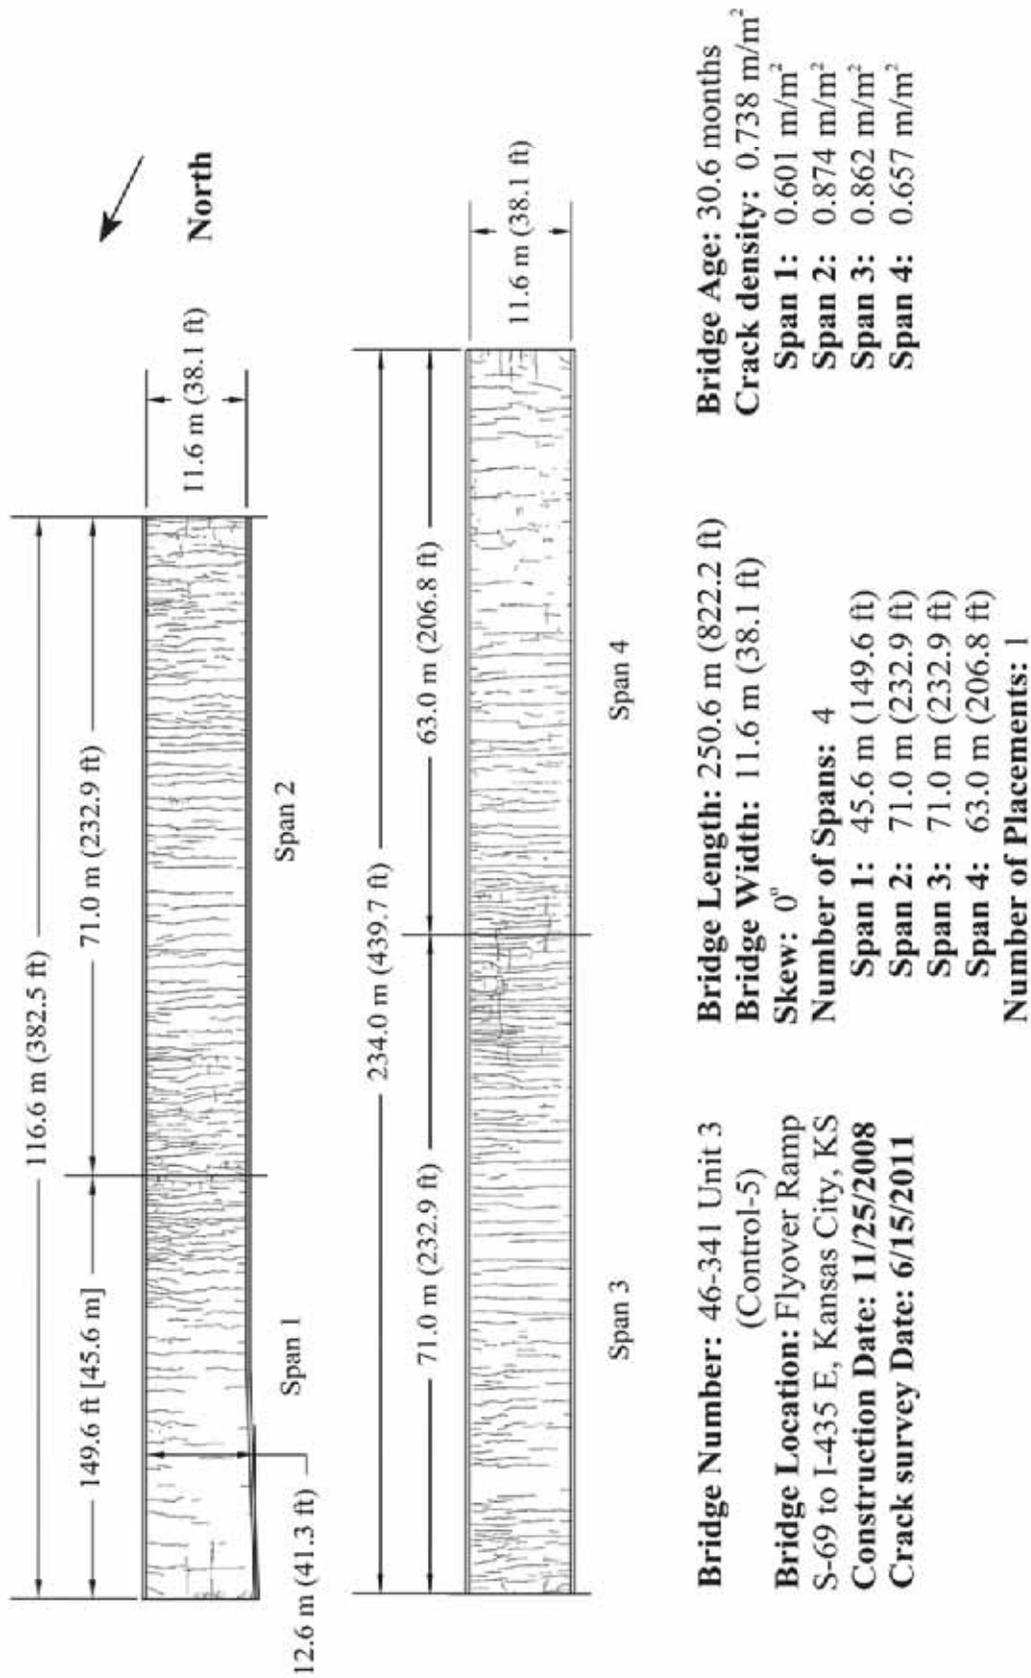
Figure 31: Control-5 (Survey 3)

The results of Survey 3 for Control-5 at 30.6 months are included in this report. Because of the high crack density, an overlay was applied to the bridge in 2012, after which crack surveys ceased being conducted. As shown in Figure 31, the crack density of Control-5 at 30.6 months was 0.738 m/m^2 , a decrease from the crack density at 18.9 months of 0.857 m/m^2 (Pendergrass et al. 2011). Control-5 has an extremely high crack density with long transverse cracks every few feet for the length of the bridge. The crack density increases near the piers and some longitudinal cracks are present near the piers and propagate from the abutments. Figure 32 compares crack densities on Control-5 to crack densities on LC-HPC-5 over time. Even with only three survey data points for Control-5, it is clear that LC-HPC-5 has performed much better than Control-5. Overall, crack densities appear to be more than four times larger on Control-5 than on LC-HPC-5.

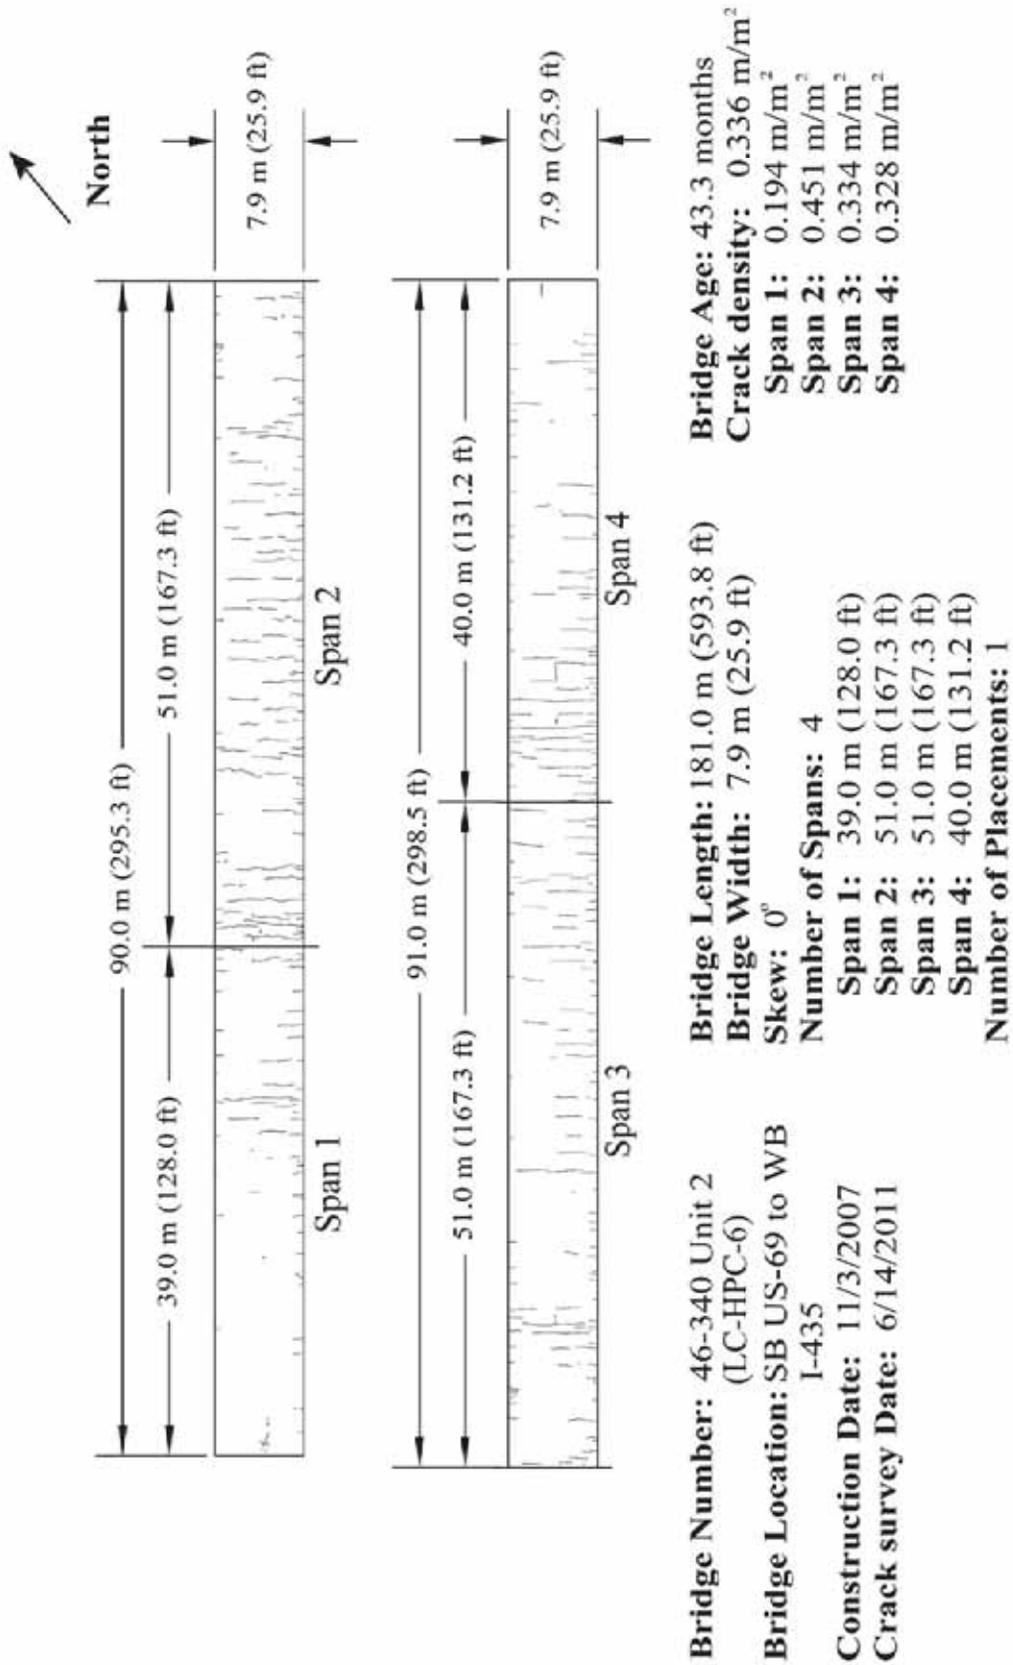
Figure 33: LC-HPC-6 (Survey 4)

The results of Surveys 4, 5, and 6 of LC-HPC-6, at 43.3, 54.6, and 67.3 months, are included in this report. The crack density of LC-HPC-6 at 43.3 months was 0.336 m/m², as shown in Figure 33. This is an increase from the crack density at 31.4 months of 0.231 m/m² (Pendergrass et al. 2011). The crack density at 54.6 months was 0.362 m/m², as shown in Figure 34. The crack density at 67.3 months was 0.303 m/m², as shown in Figure 35. Like LC-HPC-5, the cracking is mainly transverse, propagating from the superelevated southern edge. Similar to LC-HPC-5, the superelevation caused concrete and water to flow away from the southern edge of the deck. Most of the cracks are above the piers and spread throughout the second span.
