**CRACK SURVEYS OF LOW-CRACKING
HIGH-PERFORMANCE CONCRETE
BRIDGE DECKS IN KANSAS
2011-2013**

**By
Brent Bohaty
Elizabeth Riedel
David Darwin**

**A Report on Research Sponsored by
CONSTRUCTION OF CRACK-FREE BRIDGE DECKS
TRANSPORTATION POOLED-FUND PROGRAM
PROJECT NO. TPF-5(174)**

**Structural Engineering and Engineering Materials
SL Report 13-6**

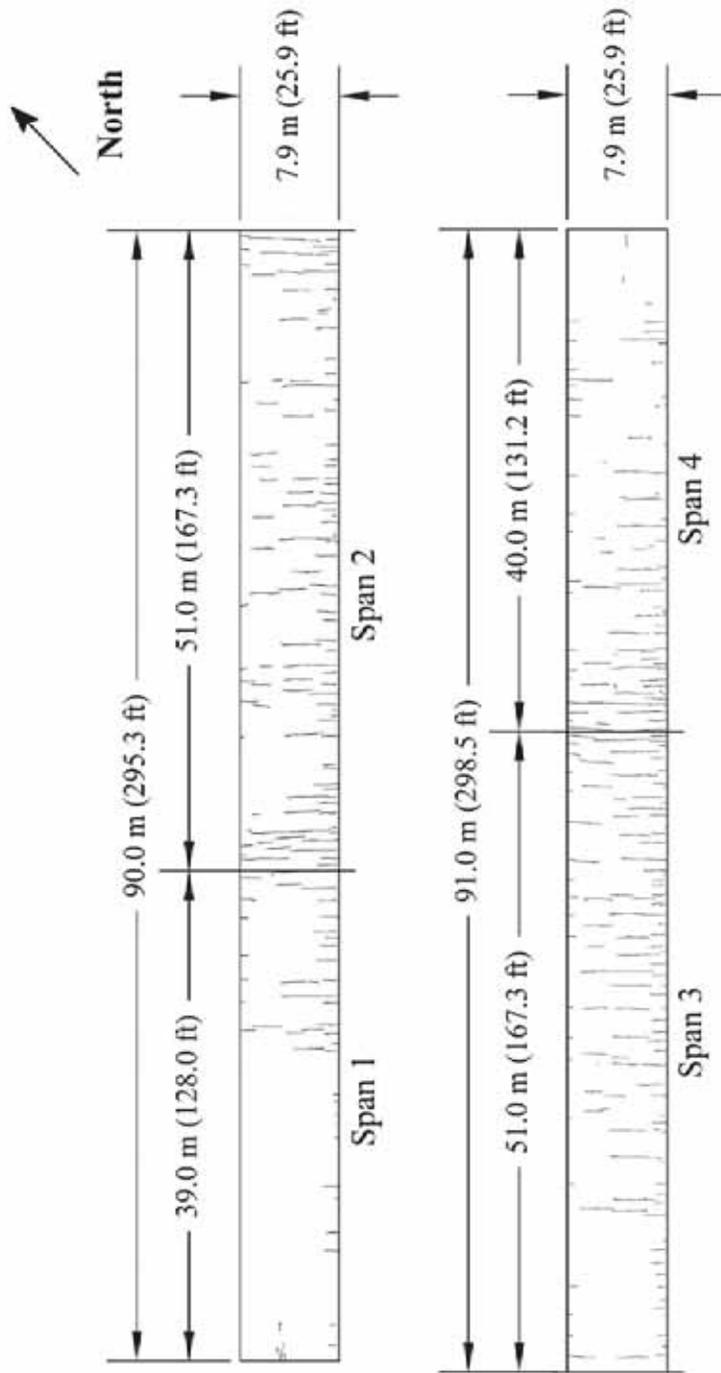
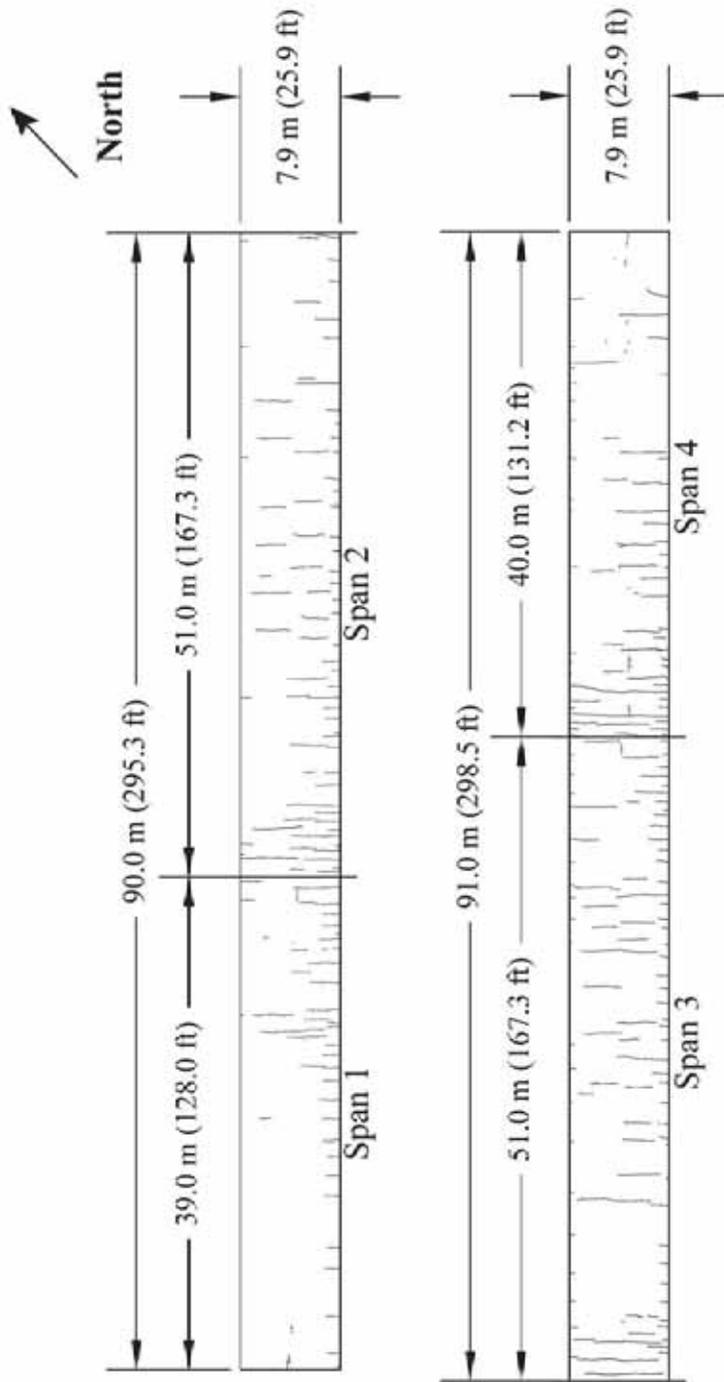
The results of Surveys 4, 5, and 6 of LC-HPC-6, at 43.3, 54.6, and 67.3 months, are included in this report. The crack density of LC-HPC-6 at 43.3 months was 0.336 m/m², as shown in Figure 33. This is an increase from the crack density at 31.4 months of 0.231 m/m² (Pendergrass et al. 2011). The crack density at 54.6 months was 0.362 m/m², as shown in Figure 34. The crack density at 67.3 months was 0.303 m/m², as shown in Figure 35. Like LC-HPC-5, the cracking is mainly transverse, propagating from the superelevated southern edge. Similar to LC-HPC-5, the superelevation caused concrete and water to flow away from the southern edge of the deck. Most of the cracks are above the piers and spread throughout the second span.

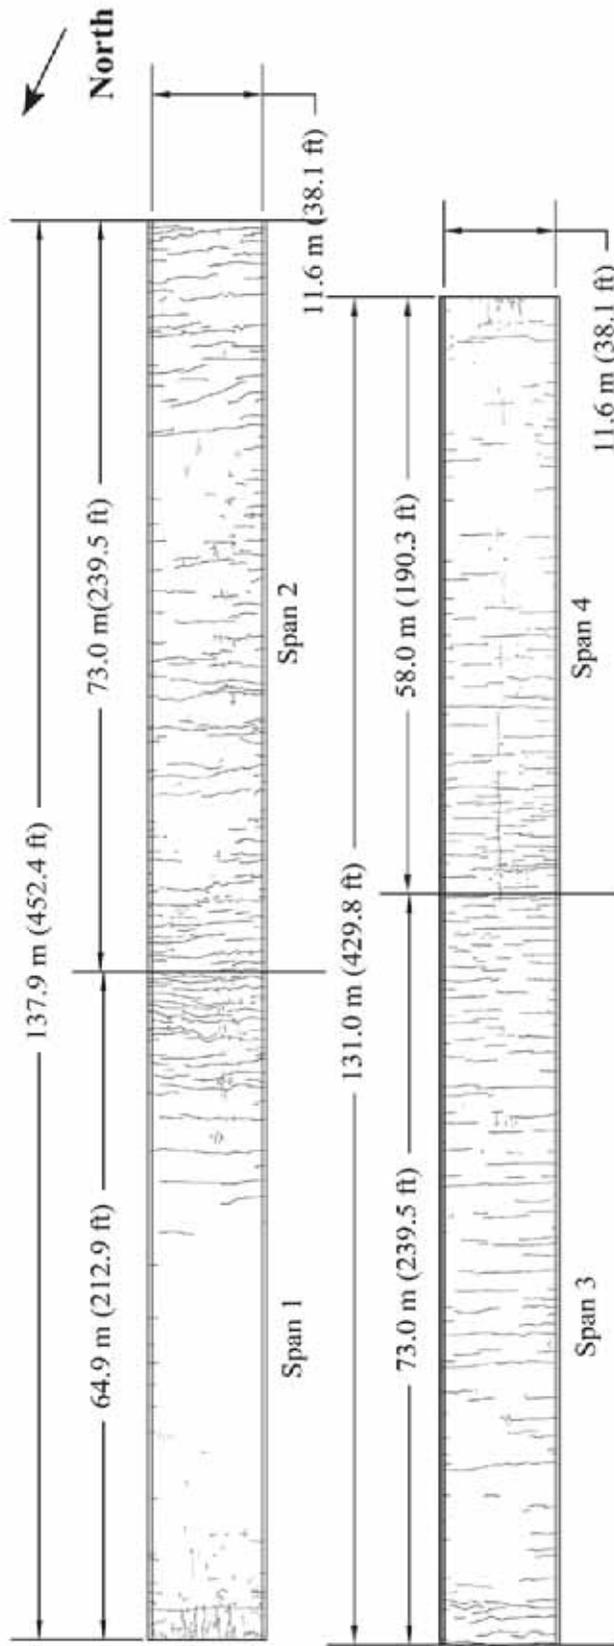
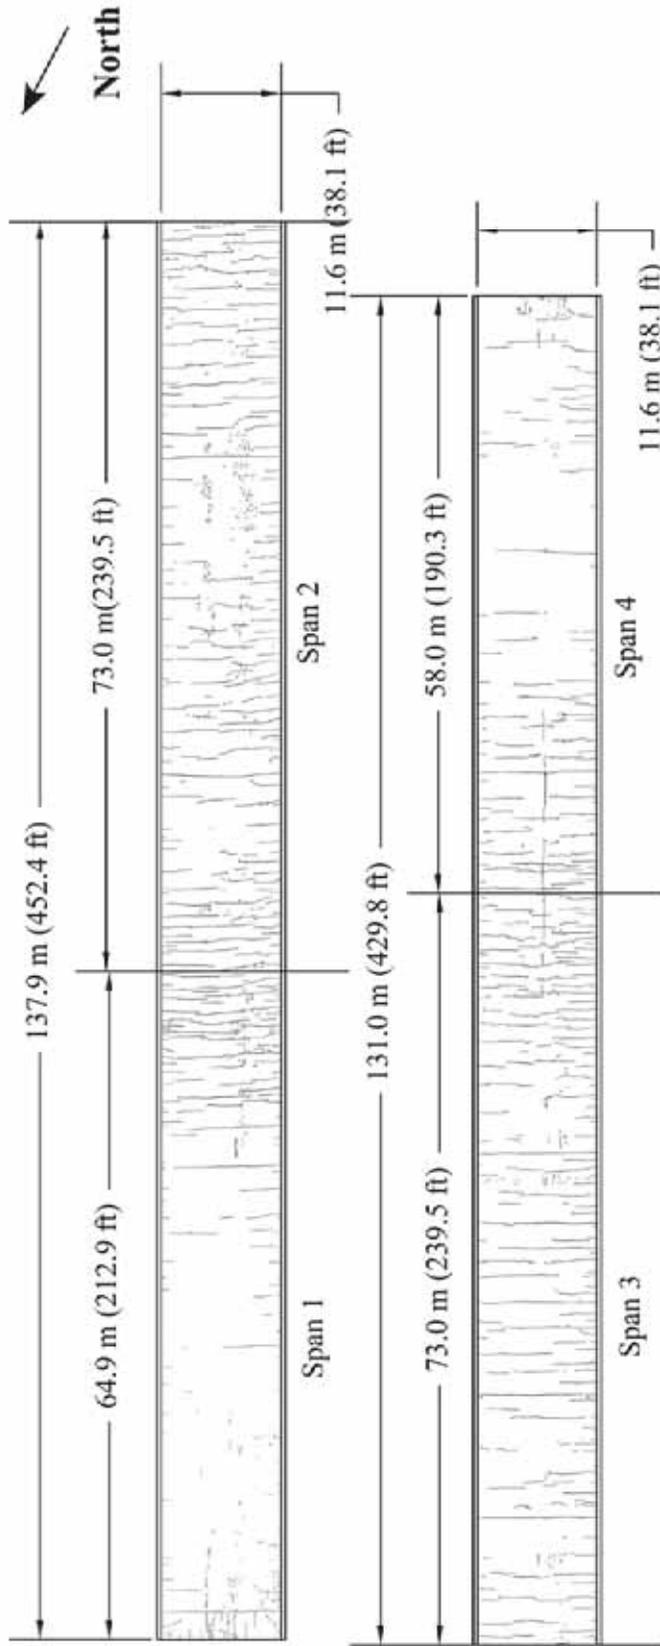
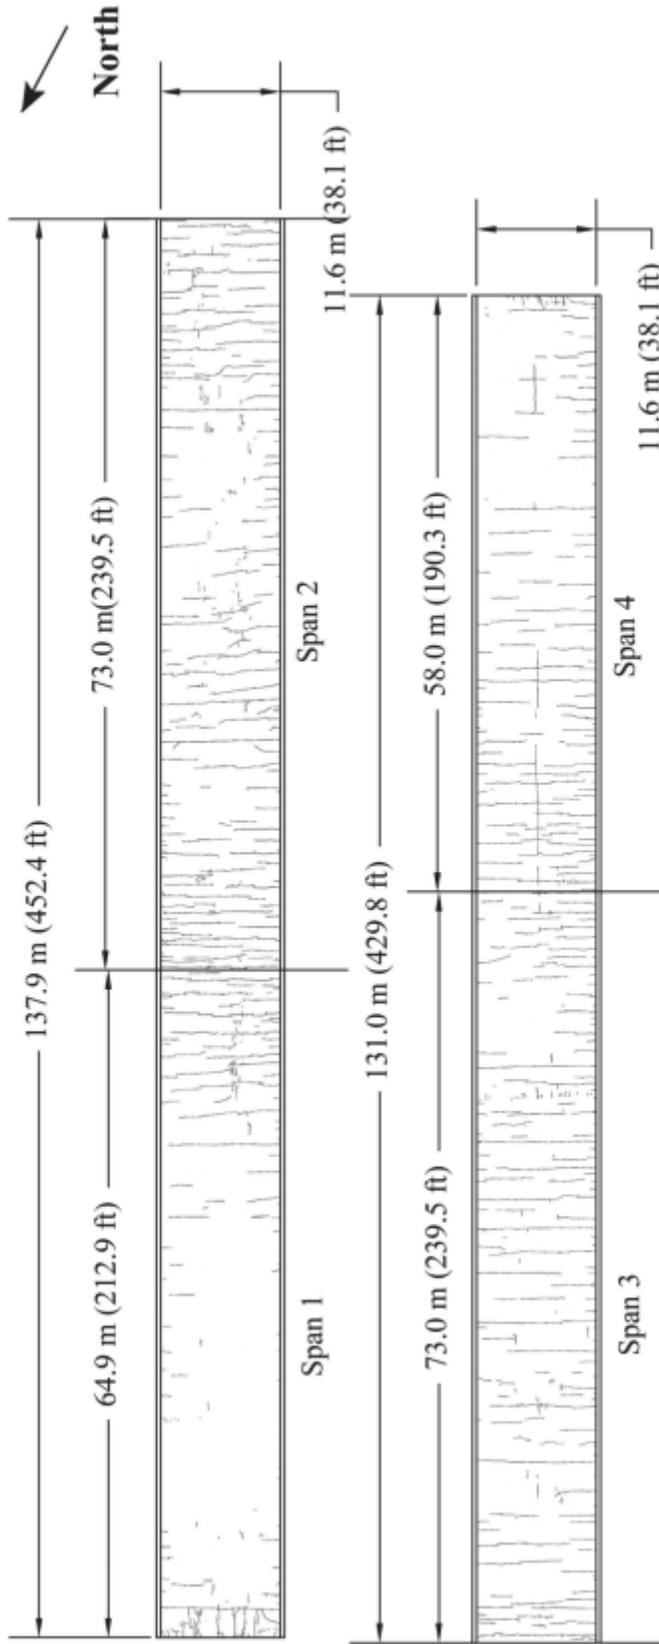
The results of Surveys 3, 4, and 5, at 31.8, 43.0, and 56.0 months, are included in this report and shown in Figures 36, 37, and 38. The crack densities in Surveys 3 and 4, 0.456 m/m²
