Underwater Inspection of Bridge Substructures Using Imaging Technology

June 14, 2018

Sponsored by
Federal Highway Administration
Office of Infrastructure
FHWA-HIF-18-049

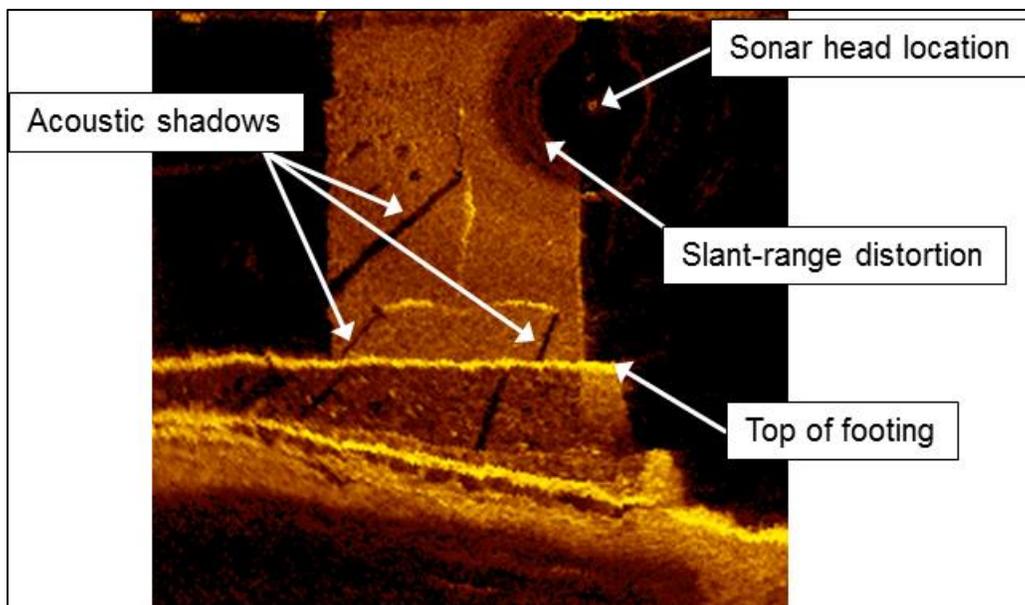
Shadows can easily be misinterpreted as defects in a bridge substructure. For example, an inverted T-shape is apparent on the face of the concrete pier in figure 18. An inspector unfamiliar with sonar may misinterpret this image as concrete deterioration or cracking. However, as shown in the bridge plans for this location in figure 19, the shape is actually a steel frame designed to mount a fixed scour monitoring device to the pier. The acoustic shadow connects to the target that formed it at the location where the steel frame is connected to the pier face.

Figure 18. Image. Sector-scanning sonar image with shadows on the face of a concrete pier.

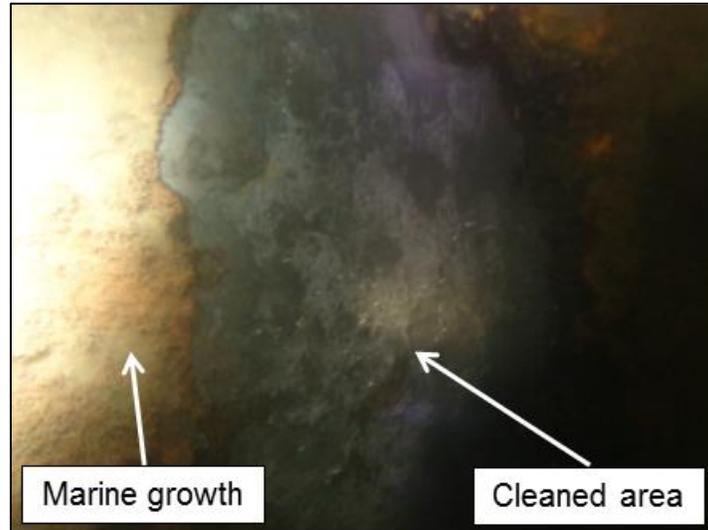
Figure 36. Photo. Steel pile showing marine growth and a level II cleaned area.

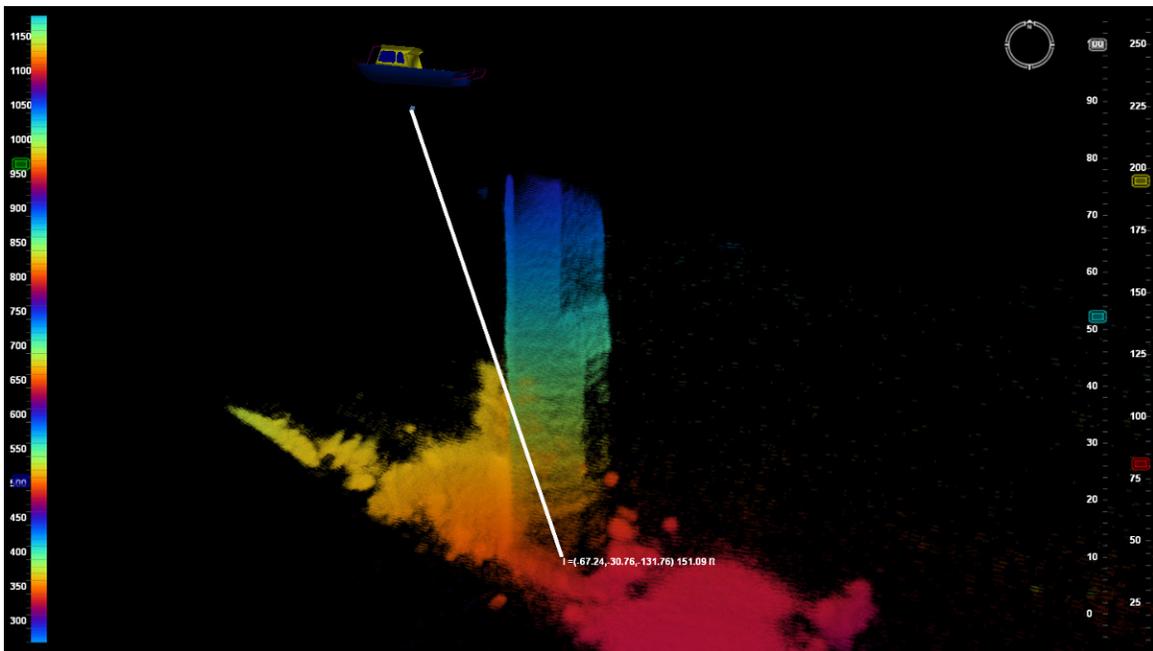
Figure 40 shows the image of bent 4 captured by the sonar. A symbol representing the data collection boat is also shown to illustrate the range required of the sonar at this site. Figure 41 is a data mosaic showing bents 4 and 5 as viewed from the west side of the bridge. The annotations on the figure demonstrate how structure dimensions can be obtained from the image. Close analysis of the images may reveal reportable observations. For example, a closer view of the base of bent 4 shown in figure 42 provides an indication of scour at the base of the bent.

Figure 40. Image. Bent 4 with boat location showing sonar range.

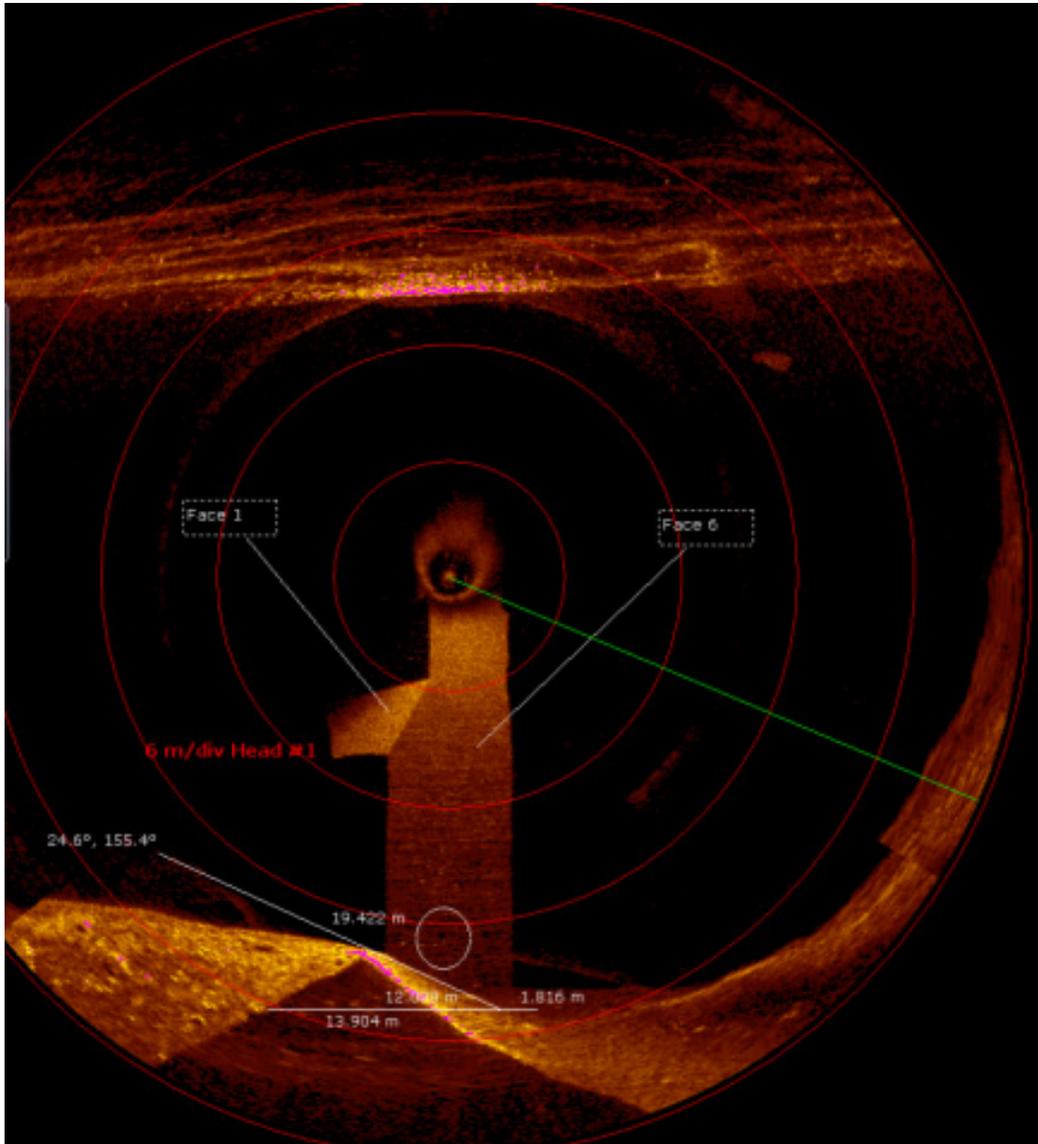
After completing the bottom scans the head was fitted into a drop frame and lowered along each face of the pier. As an example, figure 47 displays the image for face 6. It appears in good condition with the lakebed slope at the mud line at 24.6 degrees. The circled 'target' is 7.2 ft (2.2 m) above the mud line and may be a small void in the concrete face. Various anomalies were reported on other faces.

Figure 47. Image. Face 6 of the James E. Roberts Bridge.

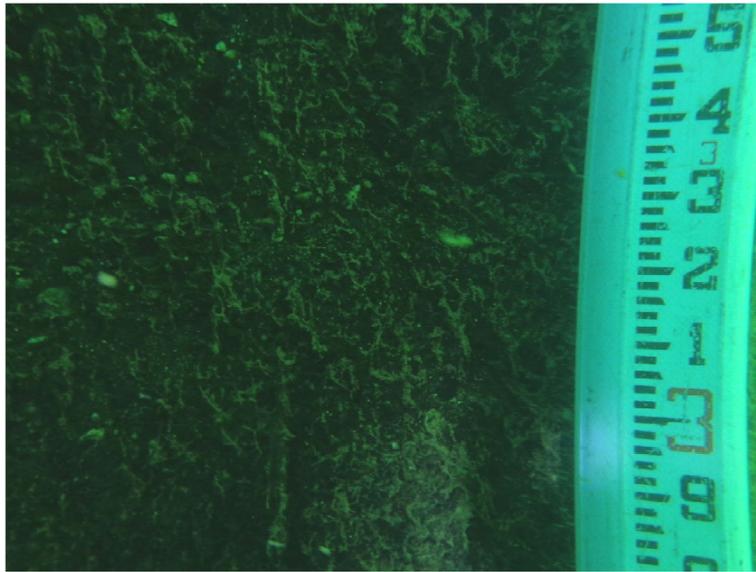
Figure 48. Photo. Marine growth on concrete 15 ft (4.6 m) below the waterline.

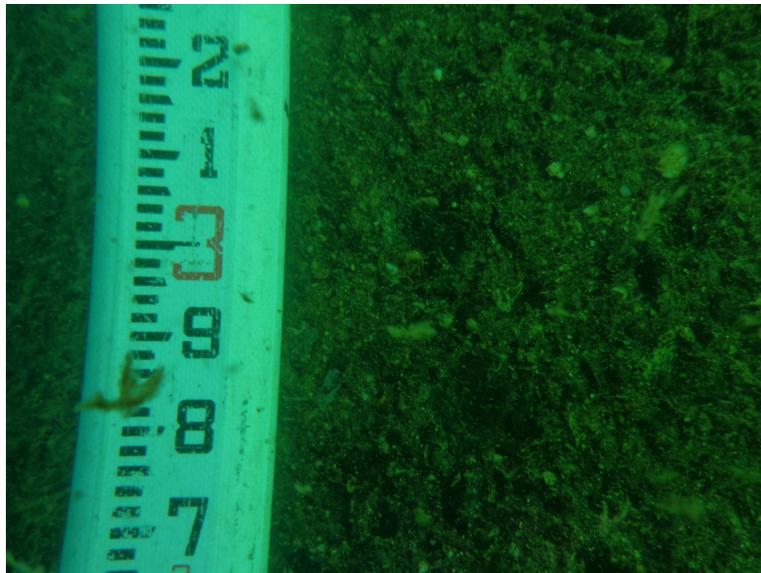
Figure 49. Photo. Typical concrete condition with level II cleaning (15 ft (4.6 m) below the waterline).

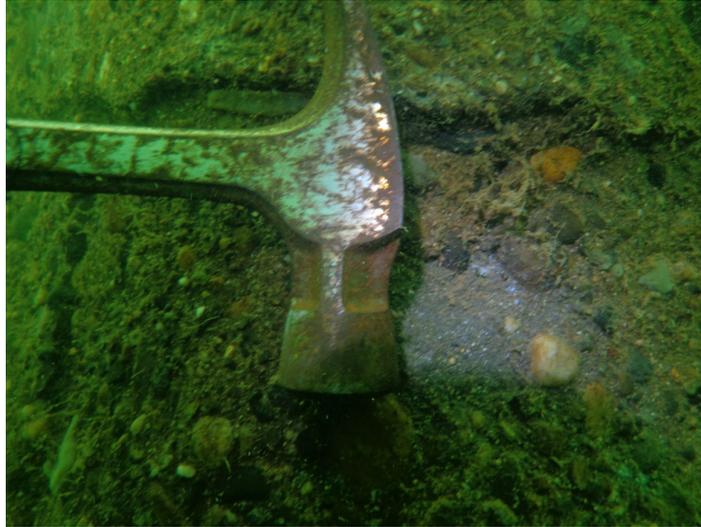
Figure 50. Photo. Typical cold joint after cleaning.

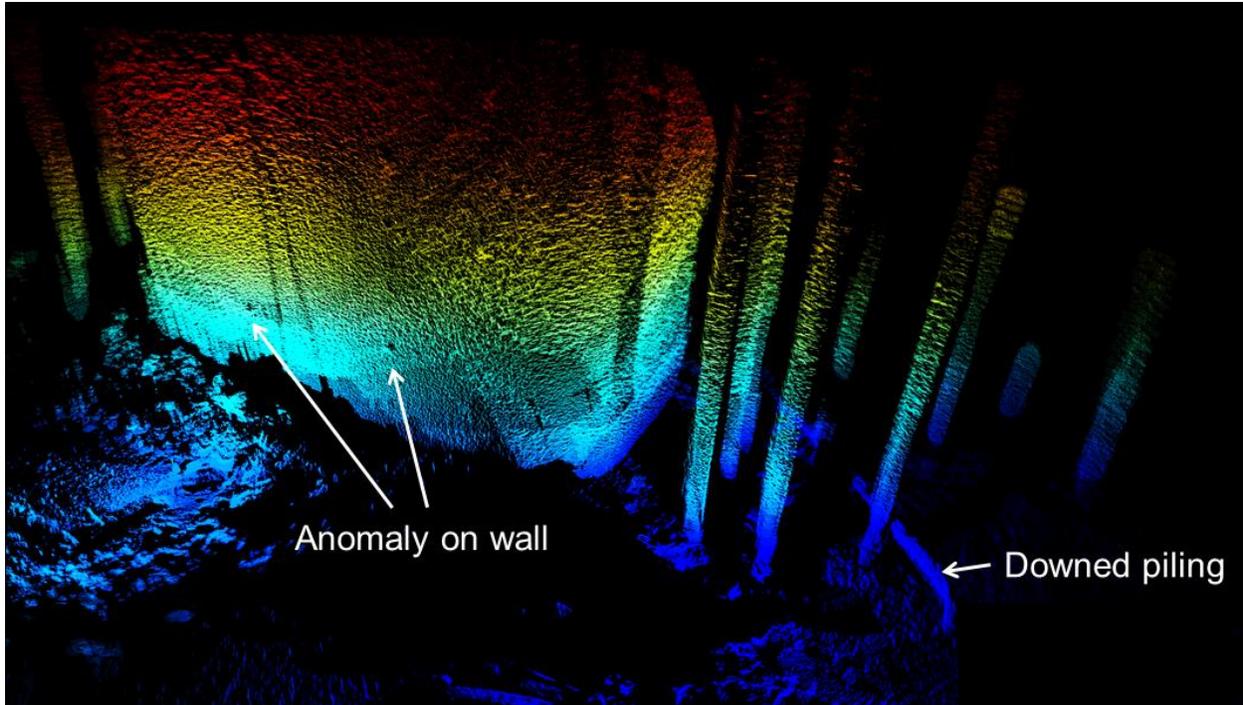
Figure 59. Image. 3D view of base of pier 3.

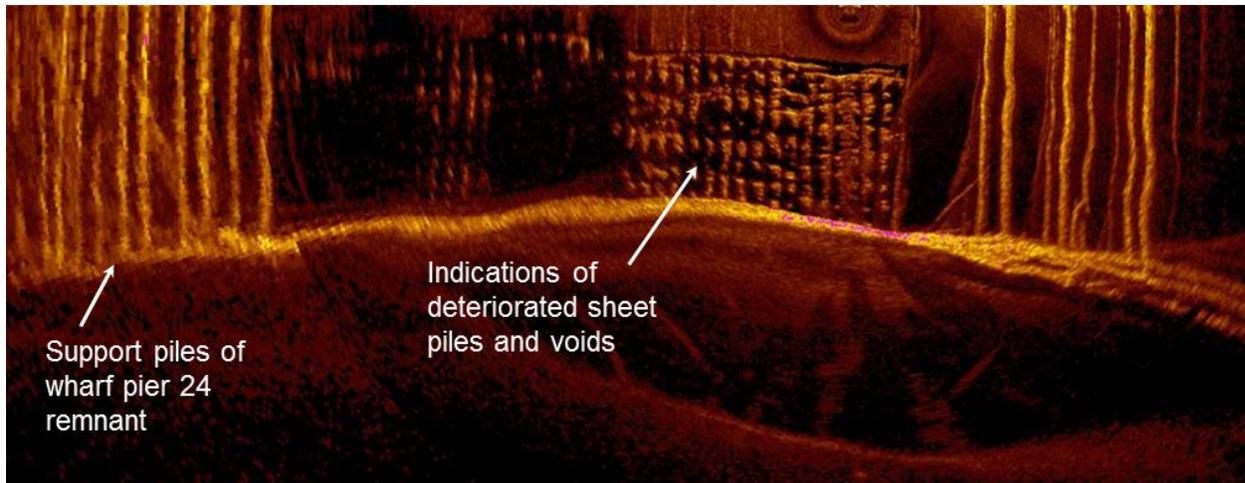
Figure 82. Image. Southeast corner of pier W2.

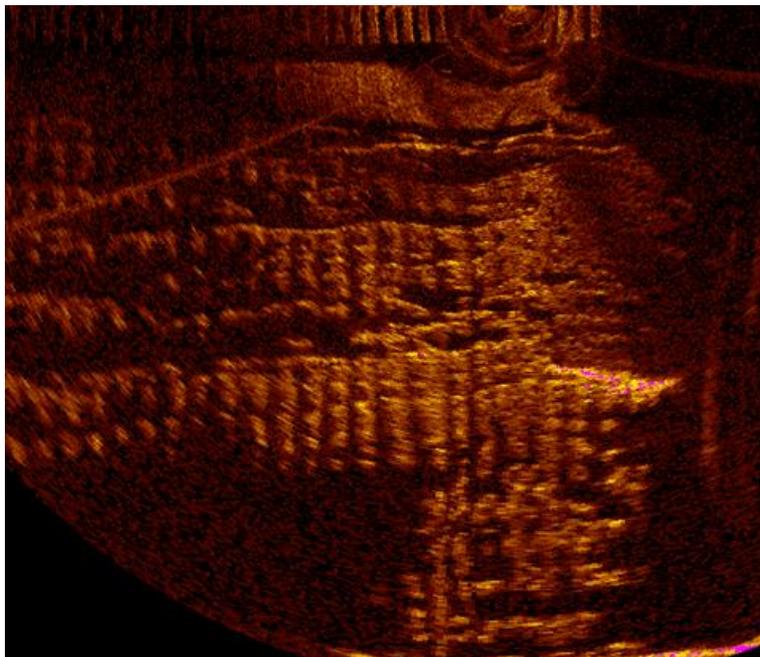
Figure 89. Image. Close-up view of the east face of pier W2.

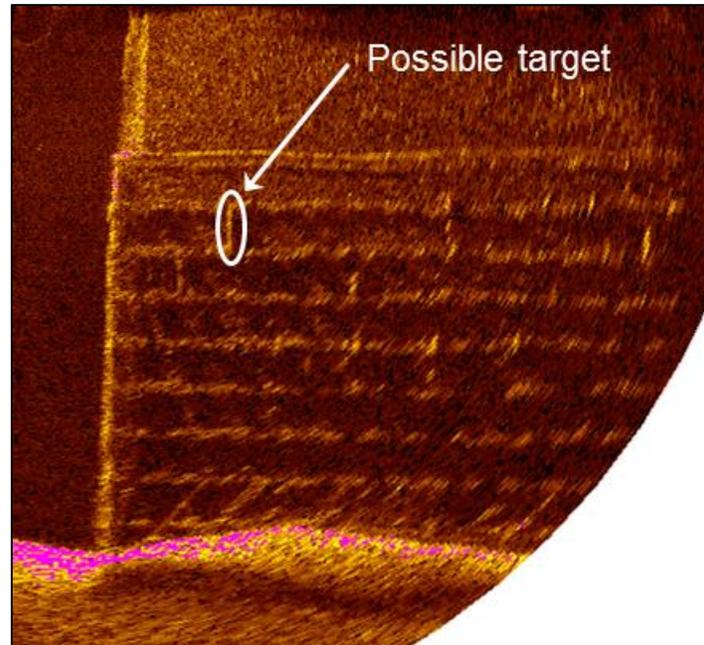
Figure 90. Image. South face of pier W6.
