Research Project Number SPR-3(017)

DEVELOPMENT OF TIE-DOWN AND TRANSITION SYSTEMS FOR TEMPORARY CONCRETE BARRIER ON ASPHALT ROAD SURFACES

MwRSF Research Report No. TRP-03-180-06

February 23, 2007

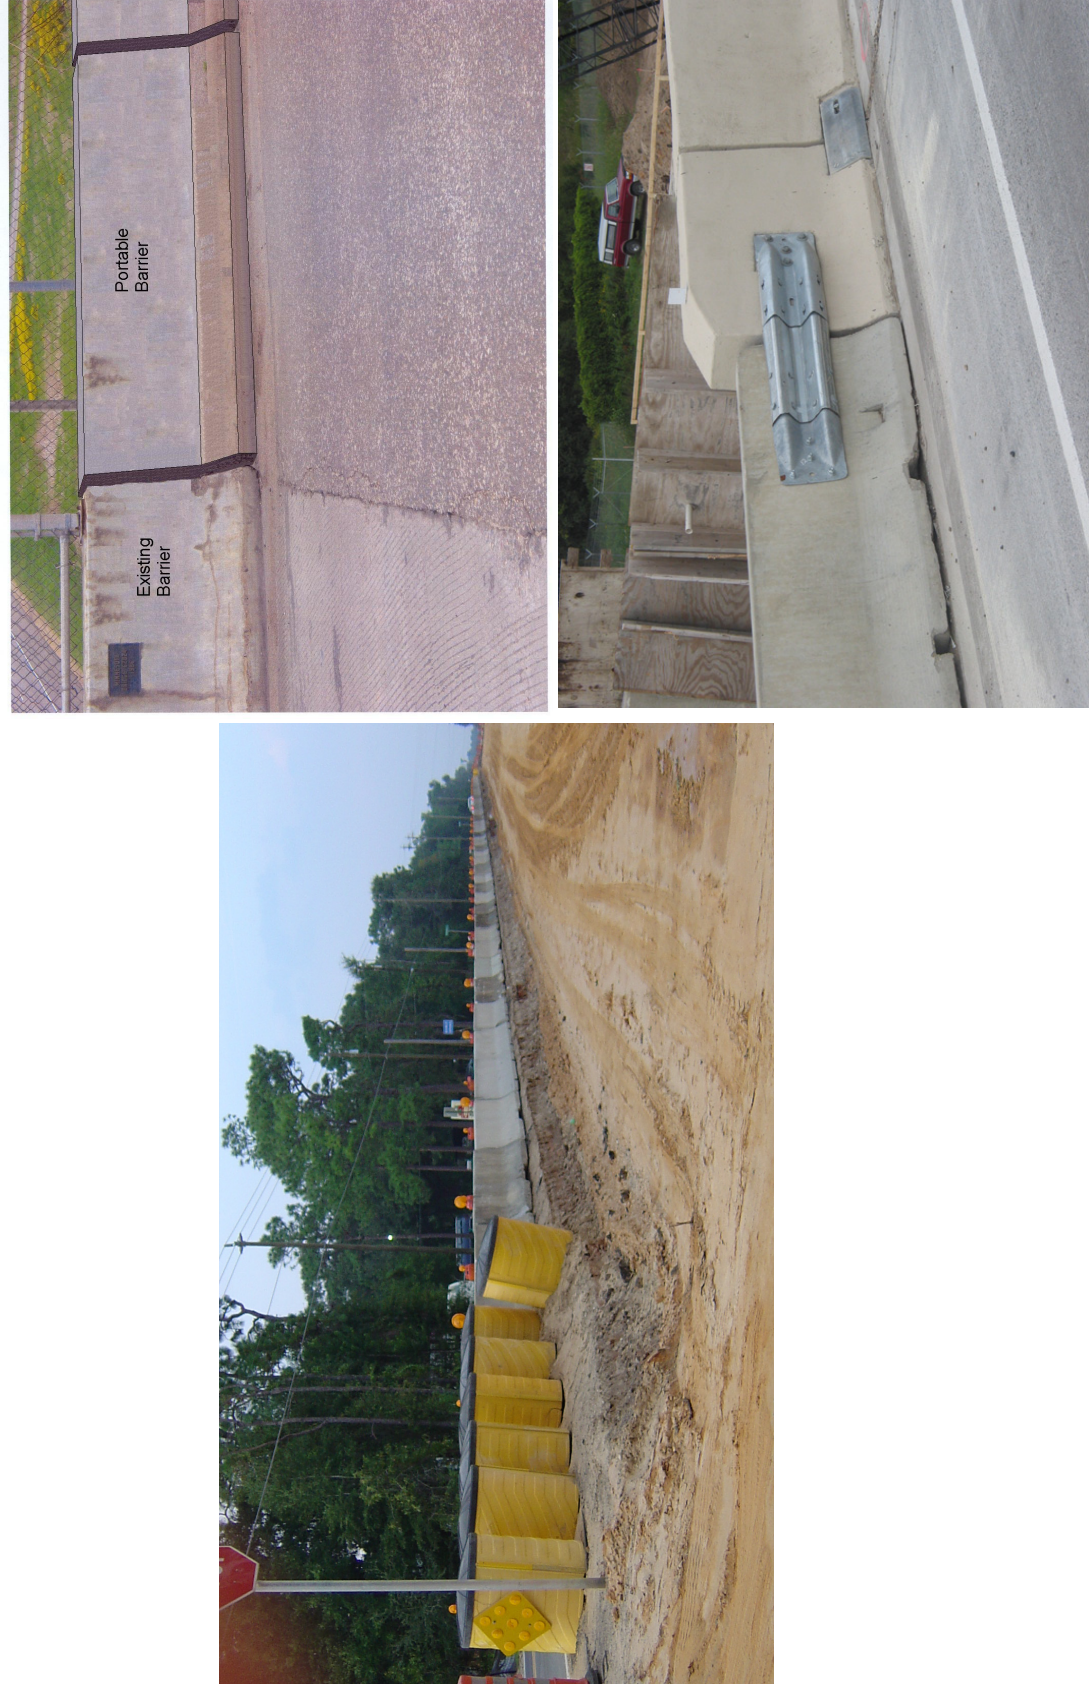
Figure 1. Temporary Concrete Barrier Installations on Asphalt: a) Near Drop-Off and b) Transition to Rigid Barrier

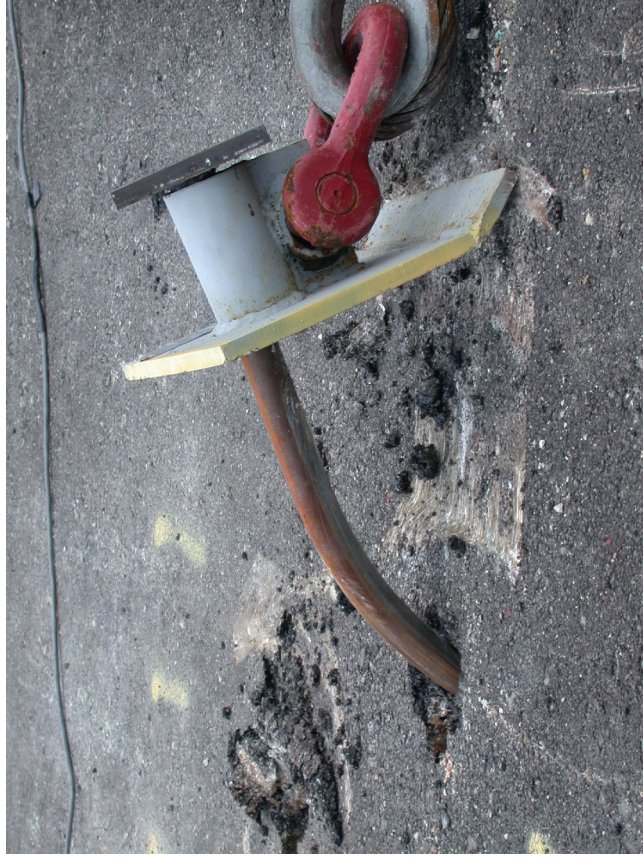
a) 28.575 mm Diameter Pin
Peak Load = 84.6 kN

Comparison of the two pin diameters demonstrated a significant difference in behavior, as shown in Figure 4. The 38.1-mm (1.5-in.) diameter pin developed a 91.4 kN (20.54 kip) peak load, which was an 8 percent increase over the 84.6 kN (19.02 kip) peak load of the 28.575-mm (1.125-in.) diameter pin. Previous experience has shown that typical impact loading for rigid, concrete barriers, when impacted with a 2,000-kg (4,409-lbs) pickup truck at 100 km/h (62.14 mph) and 25 degrees, to be in the range of 267 kN (60 kip) to 311 kN (70 kip). If the tie-down system placed three pins on the face of the temporary concrete barrier, then the lateral constraint would be in the range of 254 kN (57.1 kip) to 274 kN (61.6 kip). Thus, it was believed that either pin diameter would possess sufficient capacity to restrain barrier motion. However, it was also noted that the larger 38.1-mm (1.5-in.) diameter pin behavior was more desirable as it provided lower deflection, reduced pin deformation, and less pullout of the pin from the asphalt and soil.

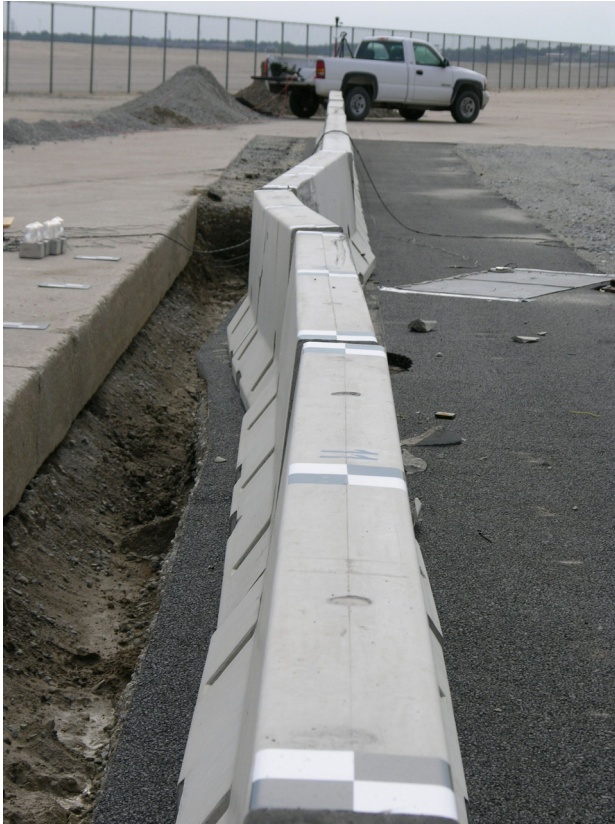
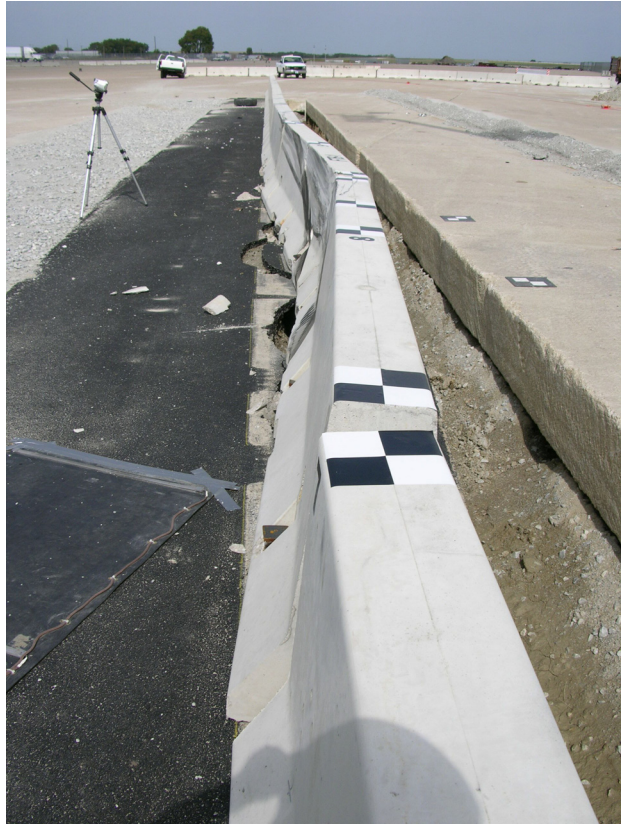
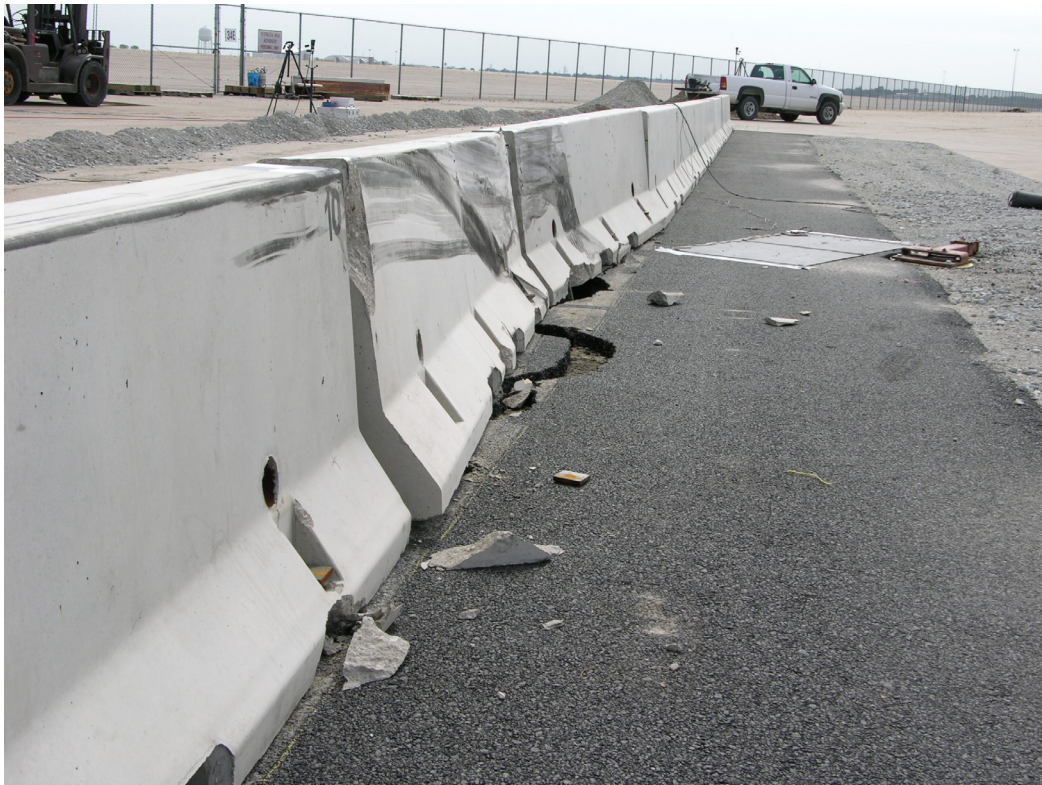
Figure 27. System Damage, Test FTB-1

Damage to the tie-down temporary barrier system was moderate, as shown in Figure 27 through Figure 29. Tire marks, scrapes, and cracking of the concrete were visible on barrier

segment nos. 8 through 10. Barrier section nos. 8 through 10 were deflected laterally. A region of soil and asphalt was observed to fracture and separate from the main road surface beneath the barrier due to loading of the tie-down pins. The separation area was approximately 7.16-m (23.5-ft) long with an average separation of 178 mm (7 in.). Deformation to several of the barrier joints and the tie-down pins was noted in the impact region. Several of the tie-down pins were pulled up between 13 to 51 mm (0.5 to 2 in.) due to barrier rotation. The steel caps on three of the pins in the impact region were disengaged from the top of the pin due to fracture of the welds. No movement of the tie-down pins was noted on the non-impacted barrier segments. Damaged concrete was observed near several of the vertical holes on the front face of the barriers in the impact region, but the reinforcing steel surrounding the holes remained intact and safely around the pins. The maximum permanent set and dynamic barrier deflections were measured to be 283 mm (11.1-in.) and 554 mm (21.8-in.), respectively.

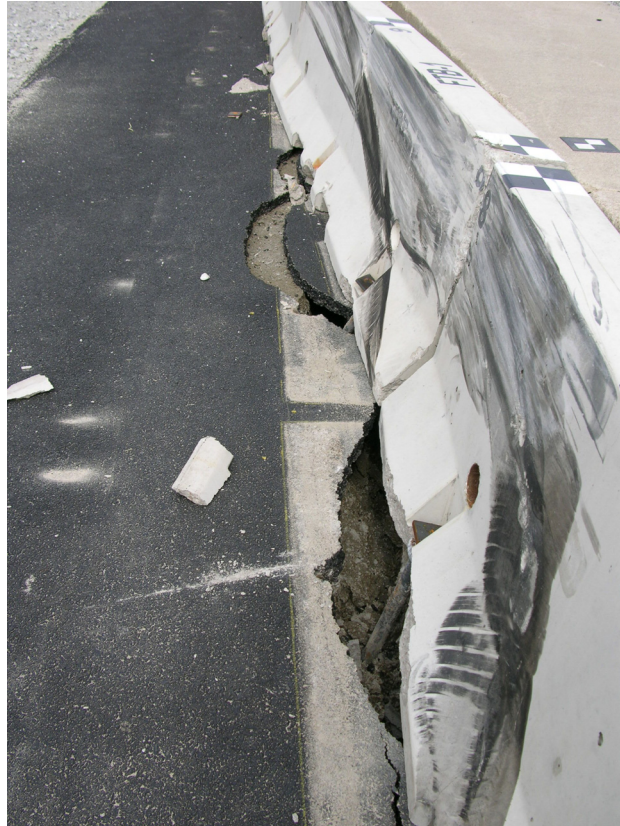
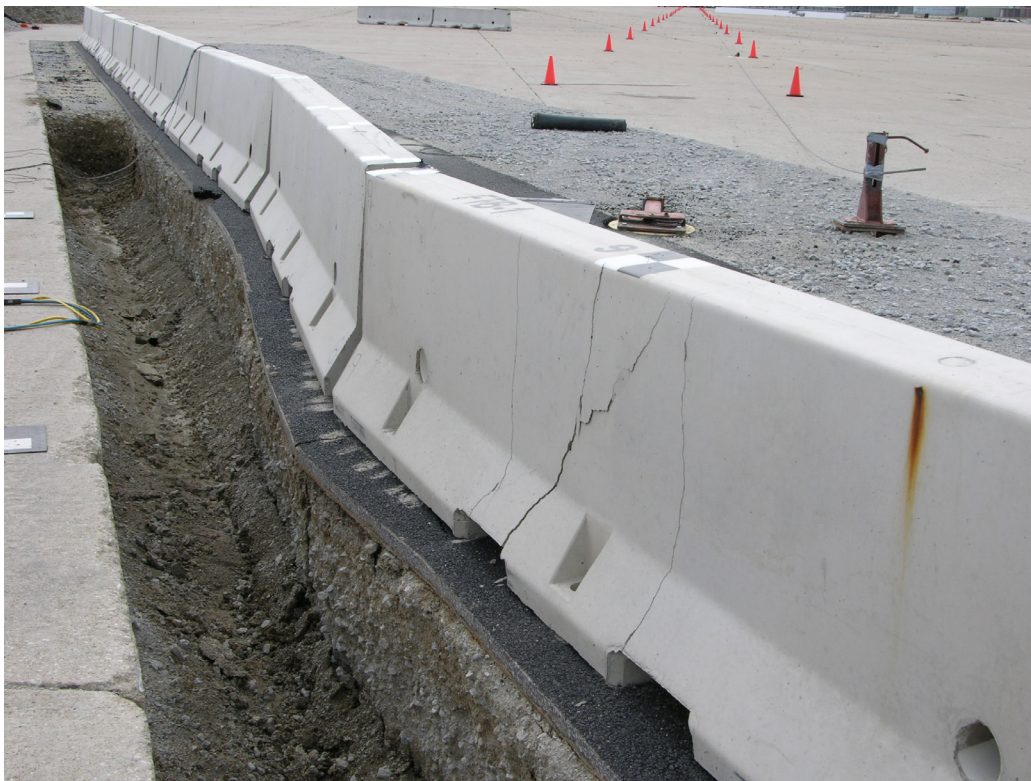
Figure 28. System Damage, Test FTB-1

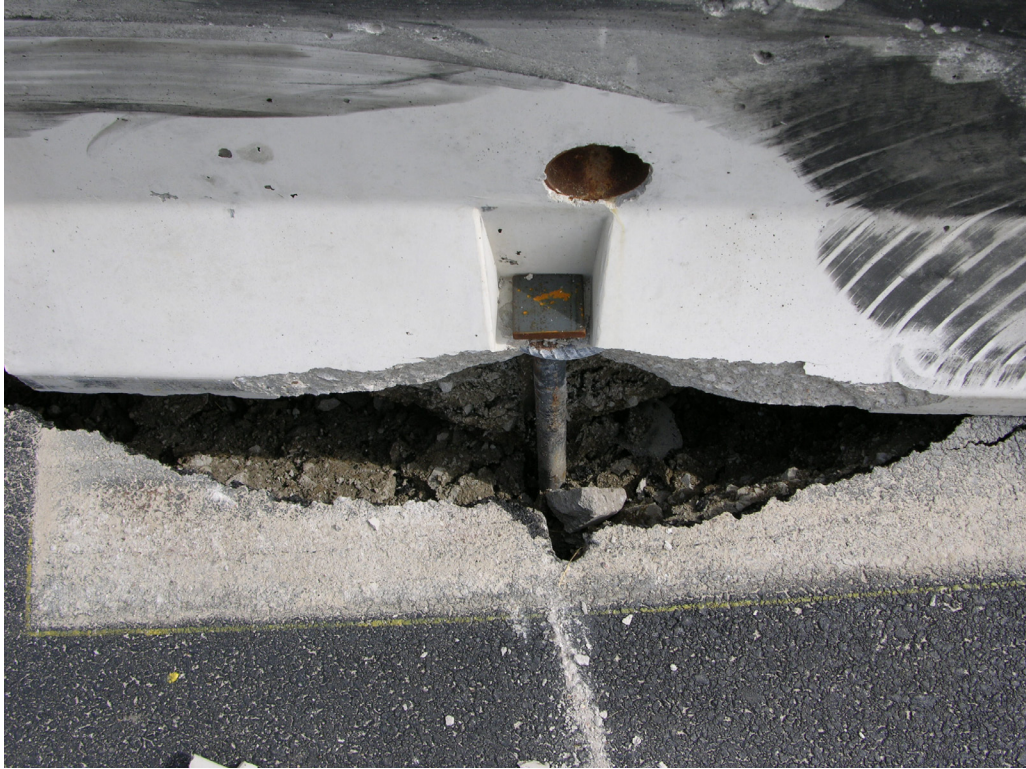
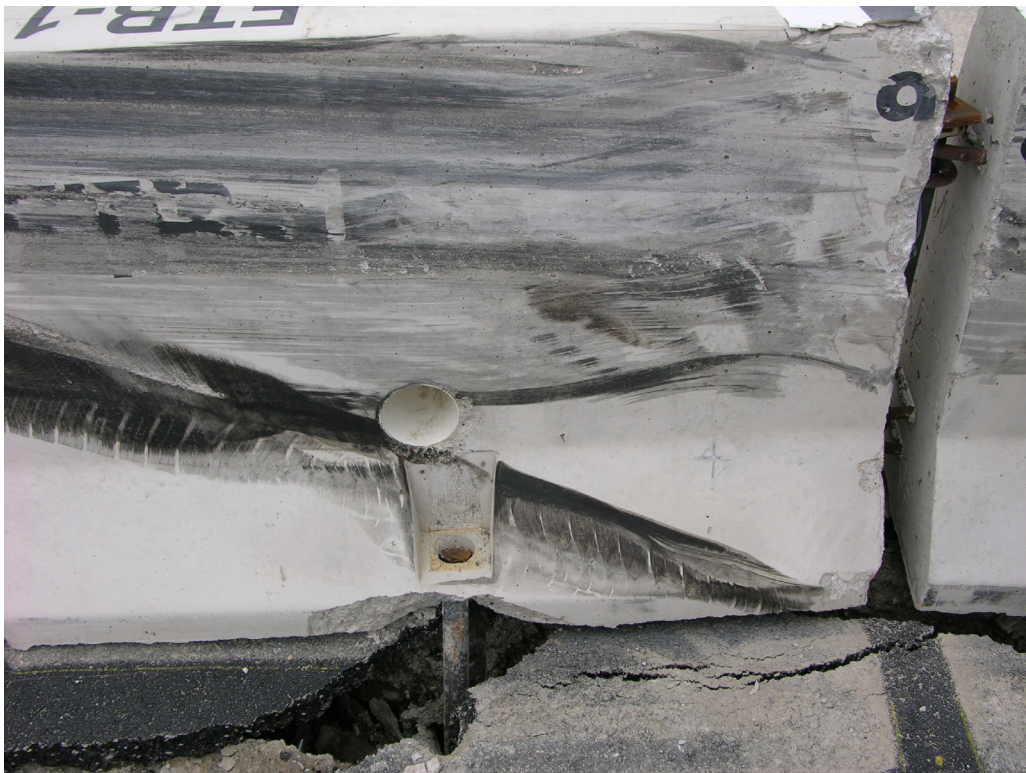
Figure 29. System Damage, Test FTB-1

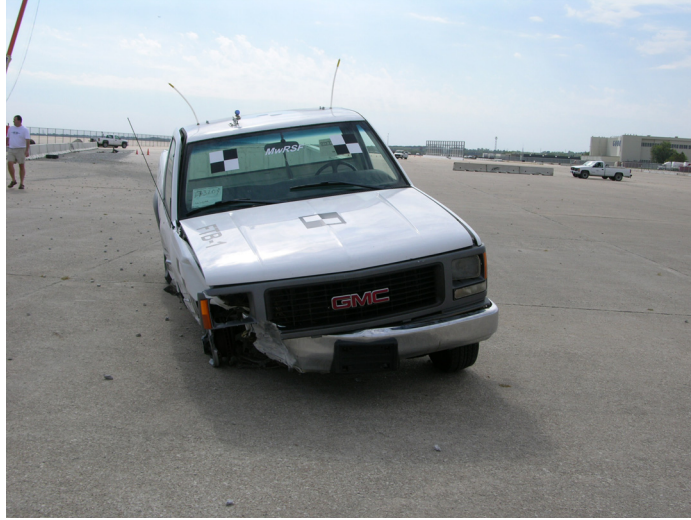
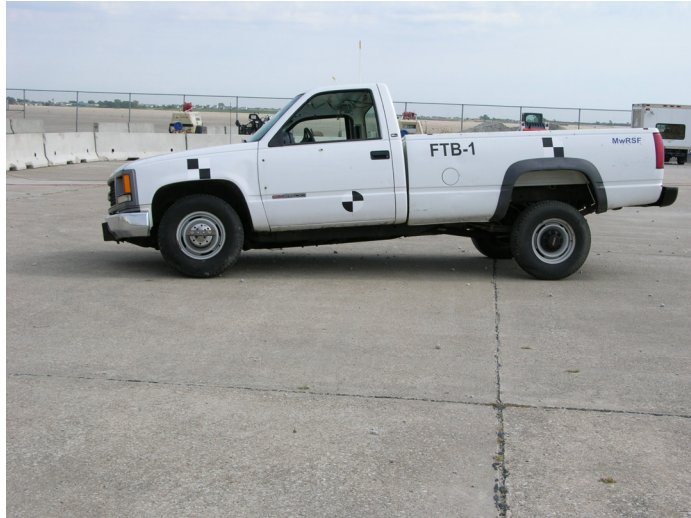
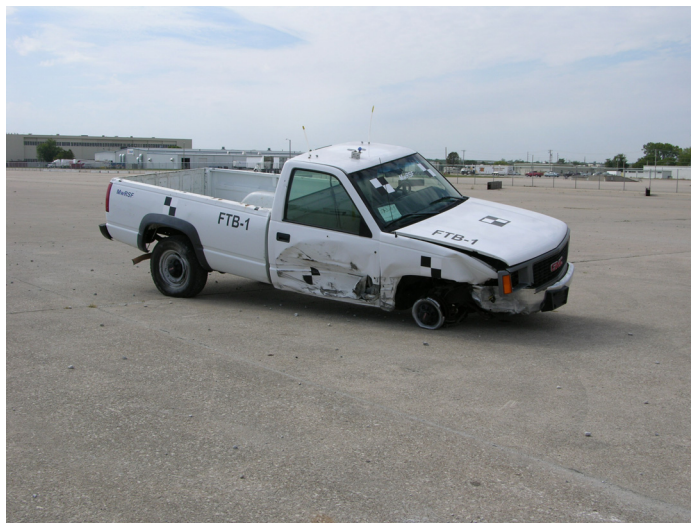
Figure 30. Vehicle Damage, Test FTB-1

Vehicle damage was moderate, as shown in Figure 30 and Figure 31. The majority of the damage to the pickup truck was focused on the right-front corner and right side where the impact occurred, including the right-front bumper, fender, and suspension components. Scrapes and dents from vehicle contact with the barriers were observed on the bottom of the truck bed and the right-side door of the vehicle. A section of the sheet metal on the front edge of the right-side door was torn away due to snagging on a barrier joint. The right-front tire and the outside of the steel rim were disengaged from the main body of the wheel assembly during impact. Minimal damage was observed in the interior occupant compartment of the vehicle, and the maximum deformation of the passenger-side floor pan was 38 mm (1.5 in.). Details from the occupant compartment deformation measurements are located in Appendix C.

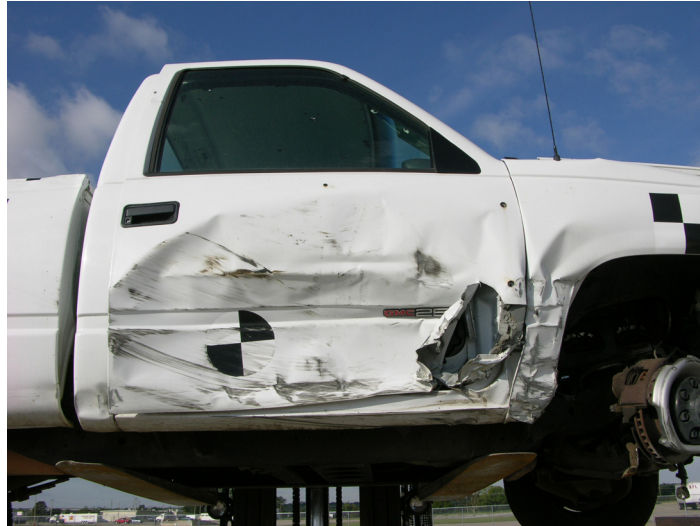
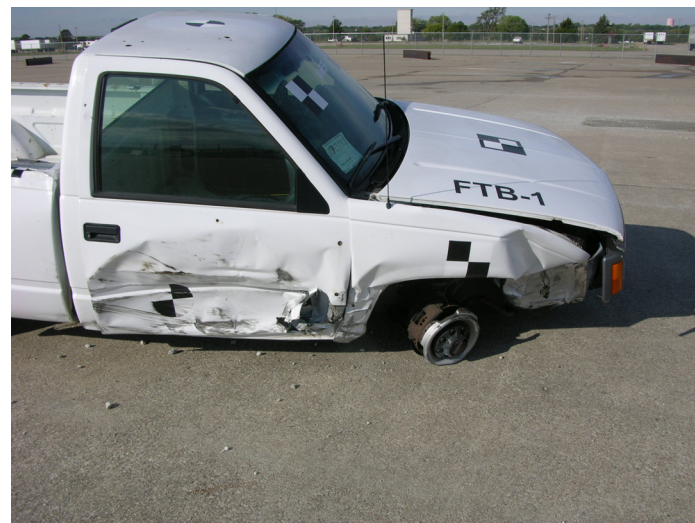
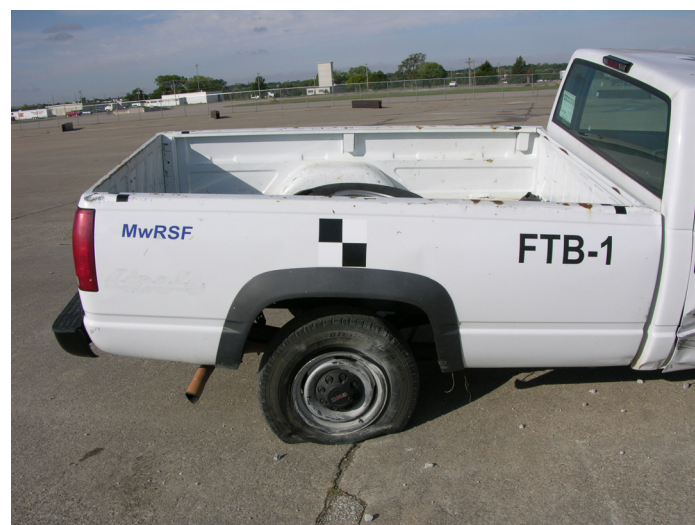
Figure 31. Vehicle Damage, Test FTB-1

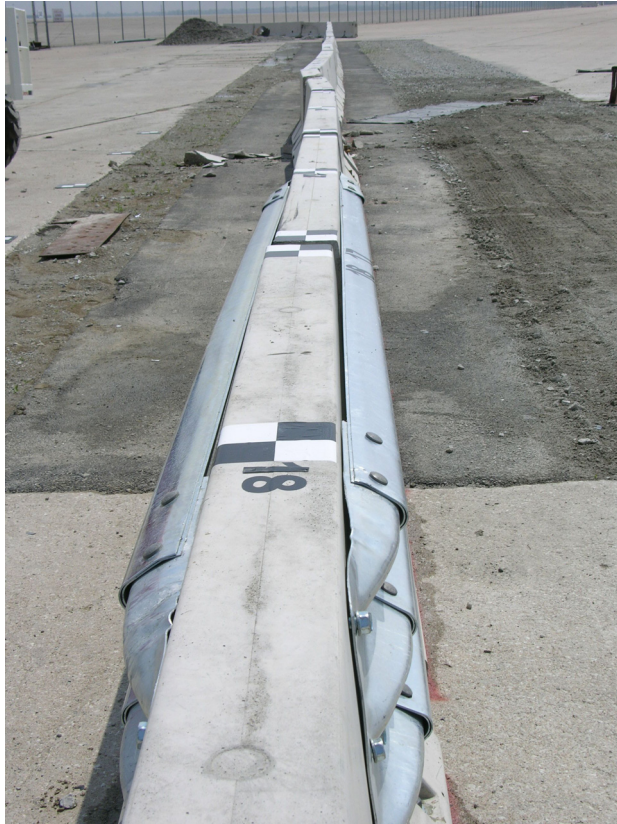
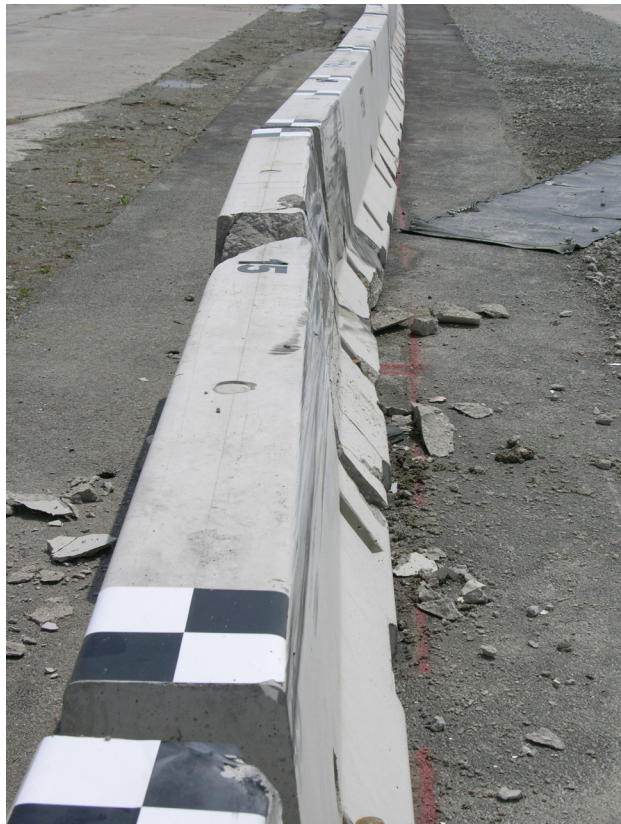
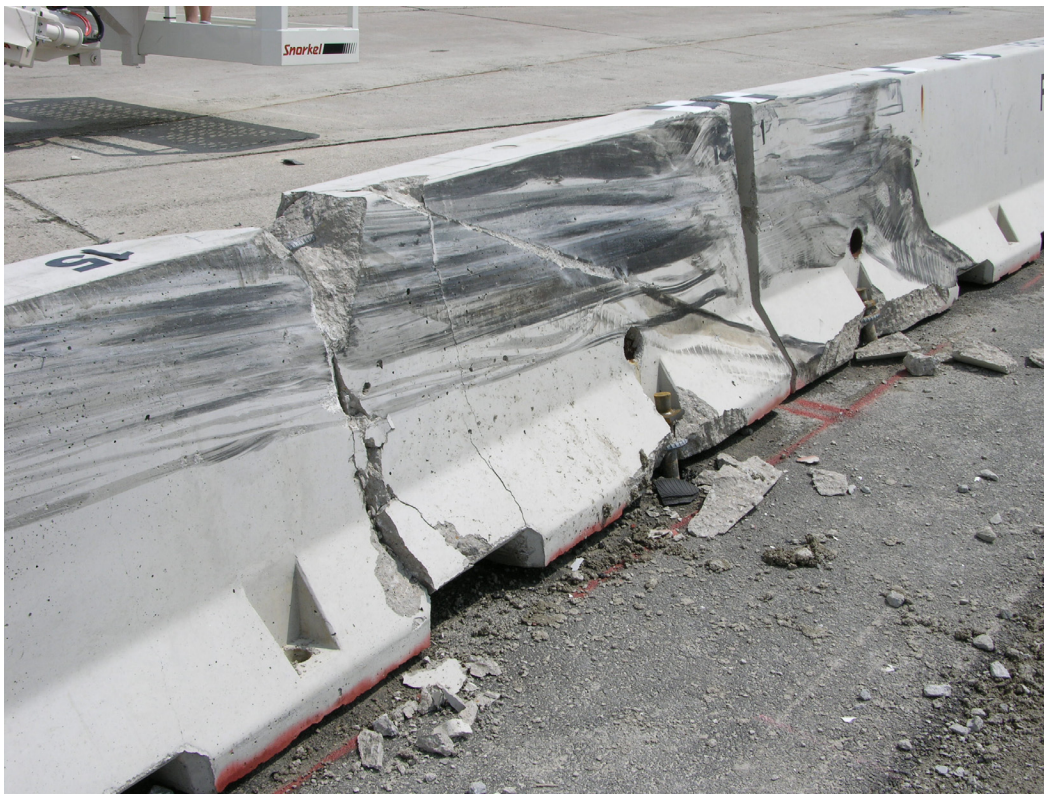
Figure 54. System Damage, Test FTB-2

Damage to the transition was moderate, as shown in Figure 54 through Figure 56. Tire marks, scrapes, and cracking of the concrete were visible on barrier segment nos. 14 through 16. Barrier segment nos. 14 through 16 were deflected laterally. Barrier no. 15 was cracked and completely fractured through the midsection of the barrier, but the reinforcing steel remained intact. Deformation to several of the barrier joints and the tie-down pins was noted in the impact region. Several of the tie-down pins were pulled up between 13 to 102 mm (0.5 to 4 in.) due to barrier rotation. No movement of the tie-down pins was noted on the non-impacted barrier segments. Damaged concrete was observed near several of the vertical holes on the front face of the barriers in the impact region, but the reinforcing steel surrounding the holes remained intact and safely around the pins. The maximum permanent set and dynamic barrier deflections were measured to be 133 mm (5.25 in.) and 467 mm (18.375 in.), respectively.

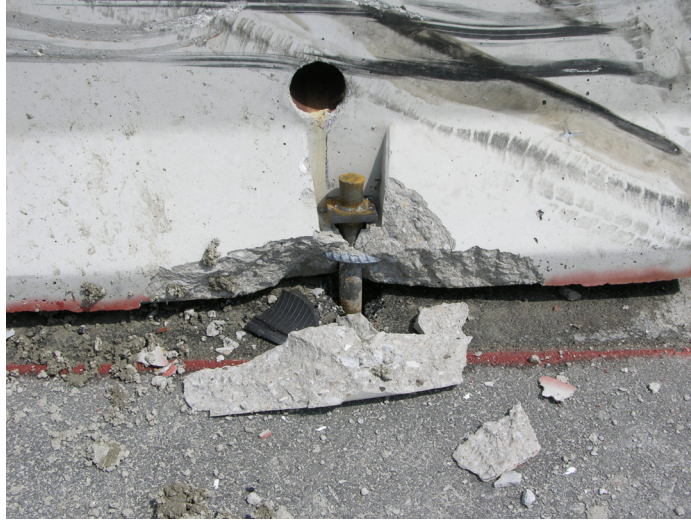
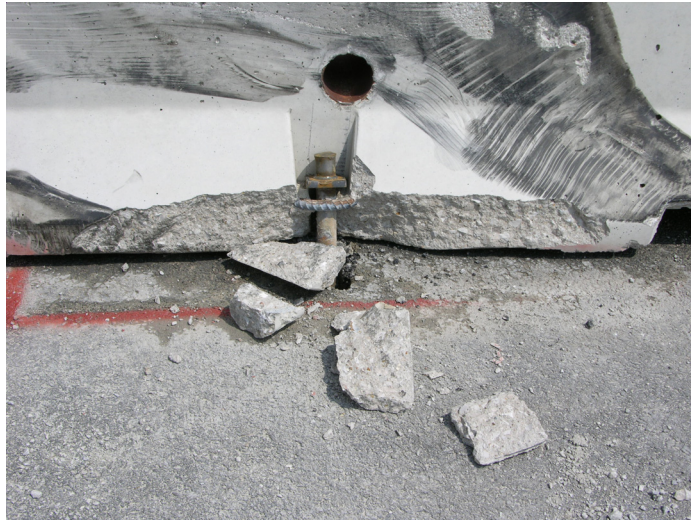
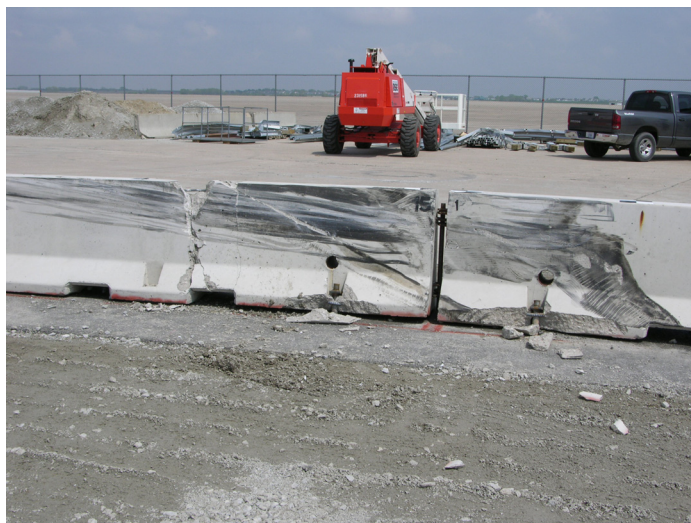
Figure 55. System Damage, Test FTB-2

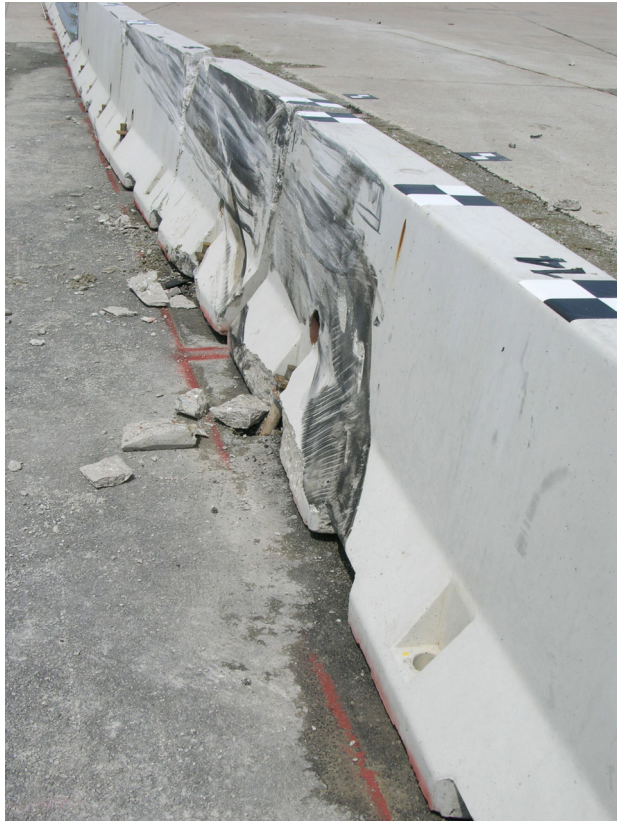
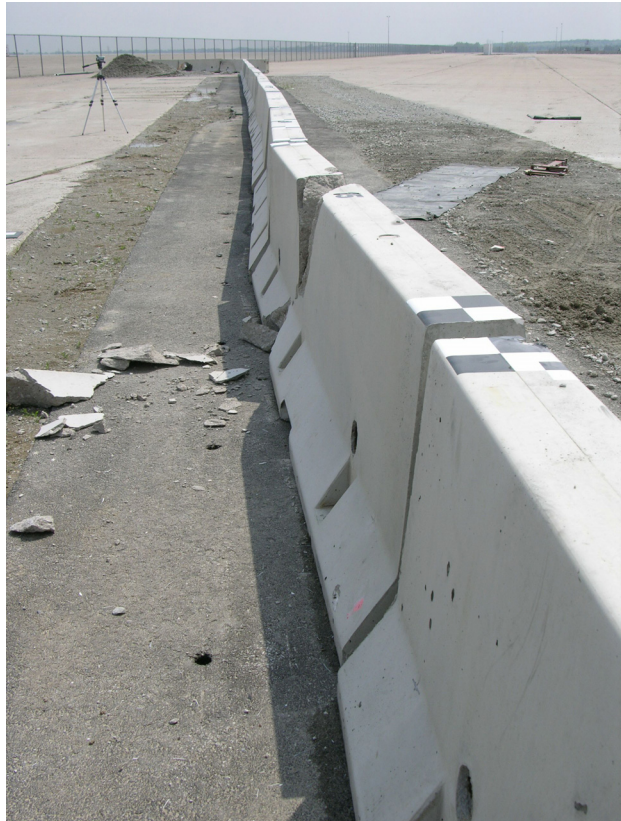
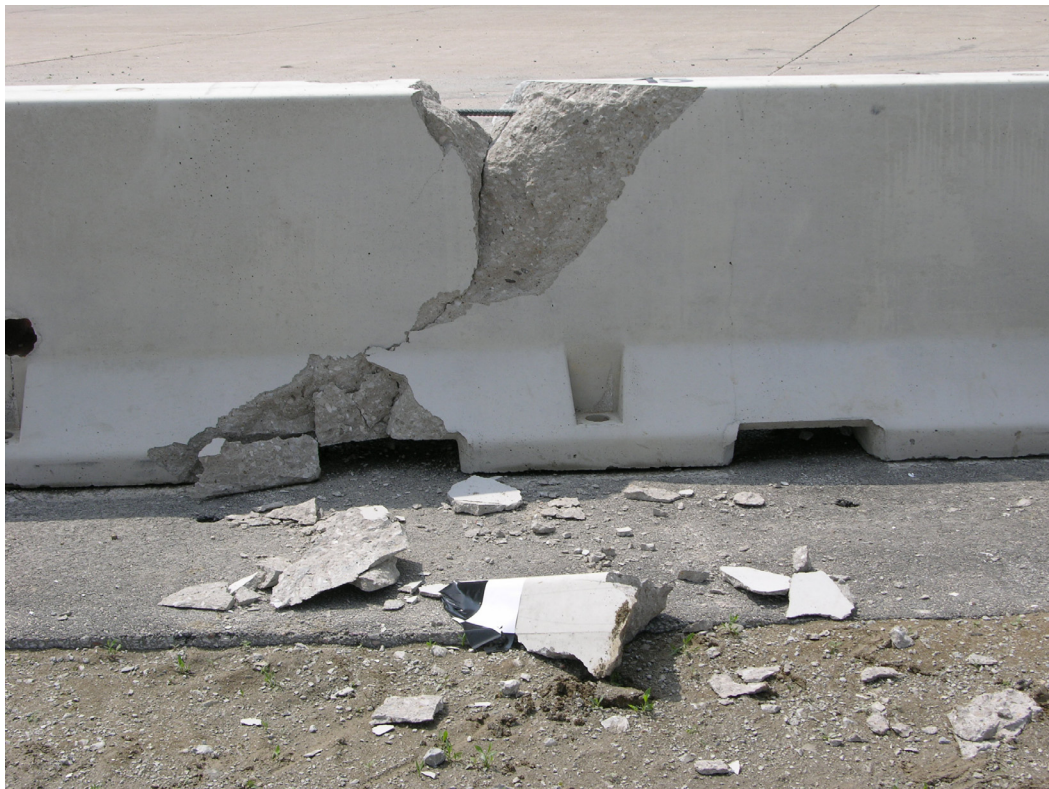
Figure 56. System Damage, Test FTB-2

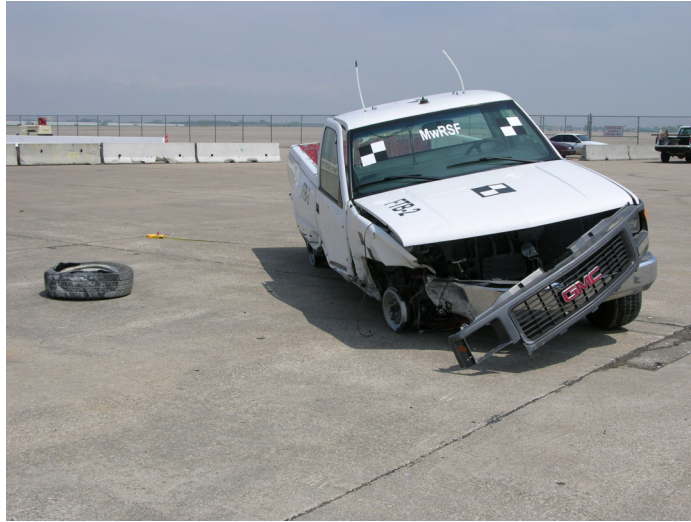
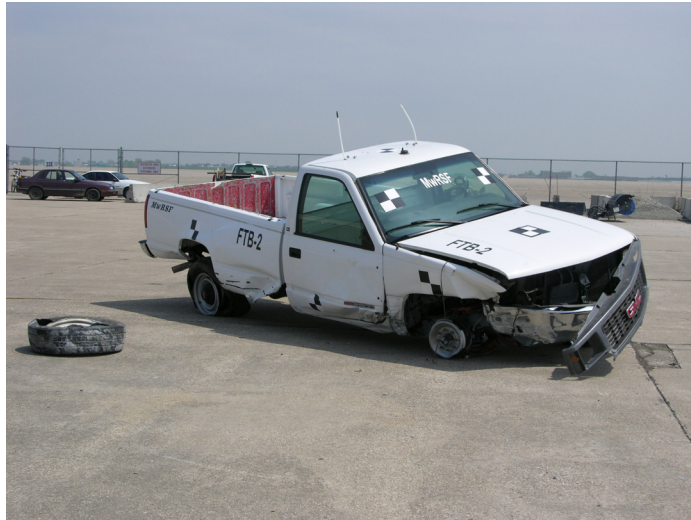
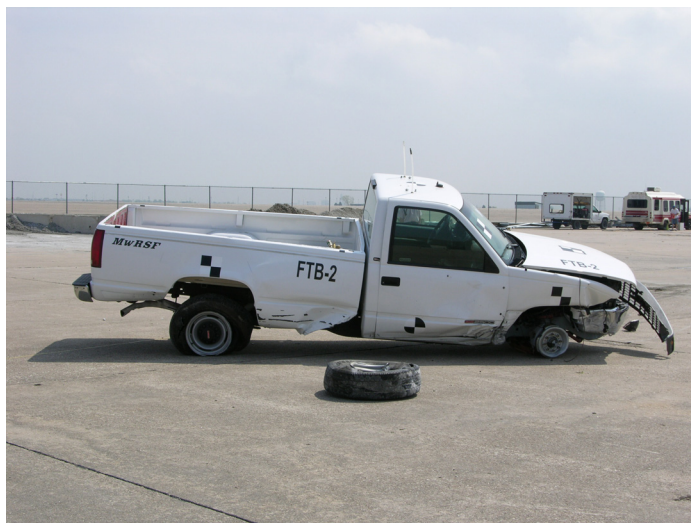
Figure 57. Vehicle Damage, Test FTB-2

Vehicle damage was moderate, as shown in Figure 57 and Figure 58. The majority of the damage to the pickup truck was focused on the right-front corner and right side where the impact occurred, including the right-front bumper, fender, and suspension components. Scrapes and dents from vehicle contact with the barriers were observed on the lower portion of the truck bed and the right-side door of the vehicle. A large indentation was also visible on the right-front edge of the truck box. The right-front tire and the outside of the steel rim were disengaged from the main body of the wheel assembly during impact. Minimal damage was observed in the interior occupant compartment of the vehicle, and the maximum deformation of the passenger-side floor pan was 102 mm (4 in.). Details from the occupant compartment deformation measurements are located in Appendix G.

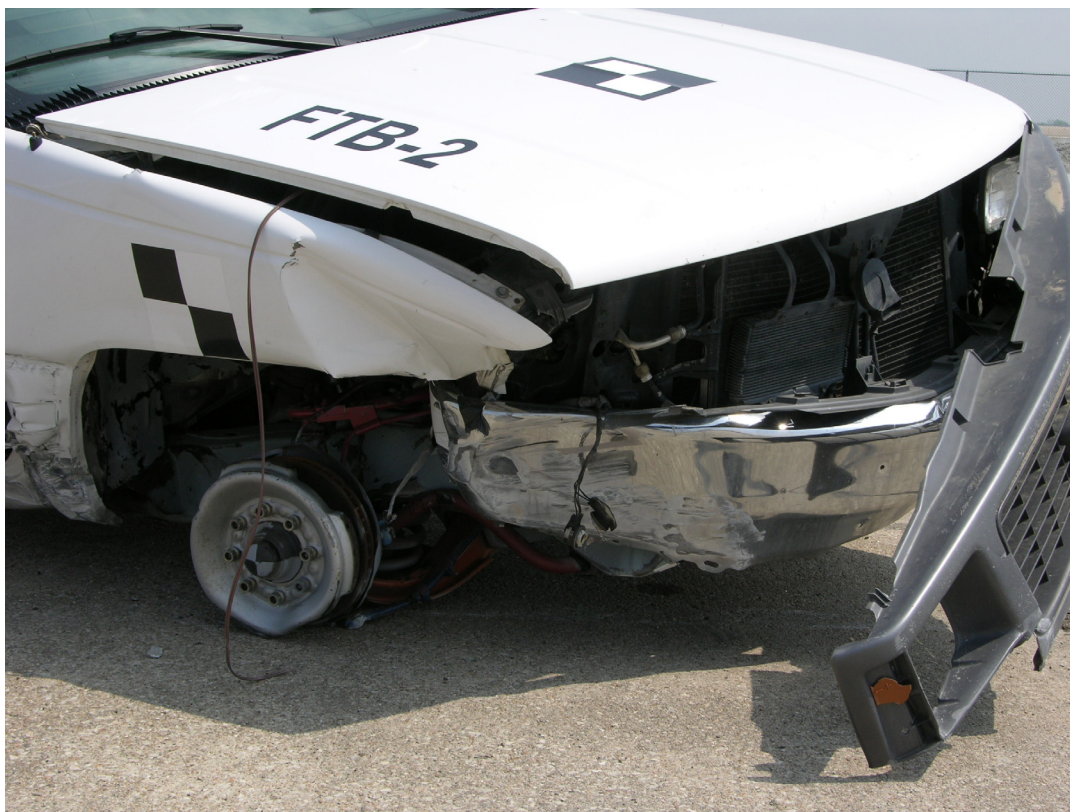
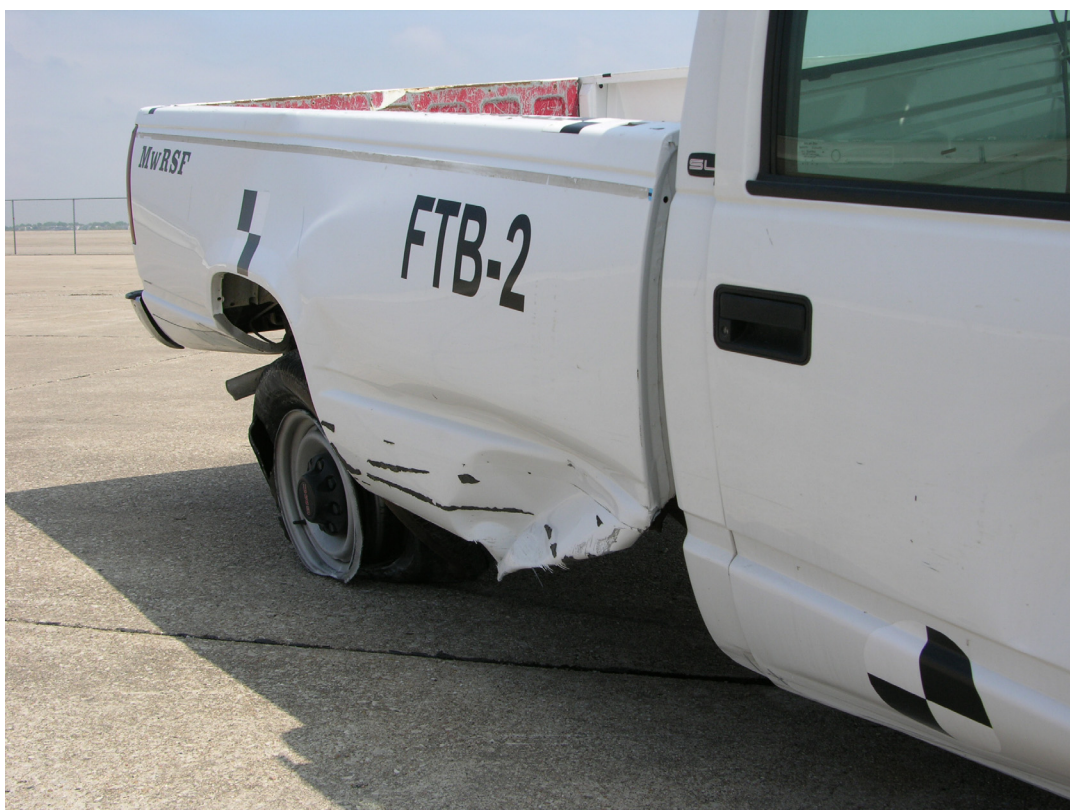
Figure 58. Vehicle Damage, Test FTB-2
