# Enhancement of Welded Steel Bridge Girders Susceptible to Distortion-Induced Fatigue

*The University of Kansas Center for Research, Inc.*

*A Transportation Pooled Fund Study - TPF-5(189)*

## **Appendix A: Development of the Angles-with-Plate Repair**

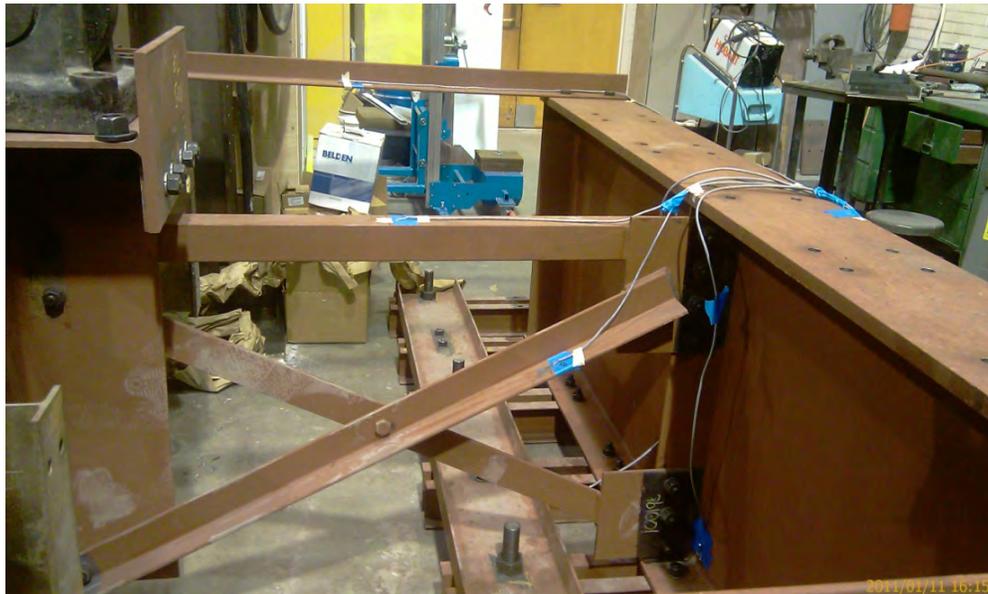
**Figure A.1: Experimental setup**

At both ends of the girder, transverse stiffeners were welded to the web and both flanges on both sides of the web. The stiffener dimensions at the girder ends were 10x876x127 mm ( $\frac{3}{8}$  x 34- $\frac{1}{2}$  x 5 in.). The girder subassembly was attached to the laboratory floor with C5x9 channels (Figures A.1 and A.2) connected to the girder through fully-tightened 19 mm ( $\frac{3}{4}$  in.) diameter A325 bolts spaced at 305 mm (1 ft) (Figure A.2). A cross frame, consisting of three L76x76x10 mm (L3x3x $\frac{3}{8}$  in.) angles with an X- configuration and a horizontal member (Figure A.3), connected the specimen to the actuator (Figure A.1 and A.3). The cross frame was connected to a WT section used to stabilize the free end of the cross frame and to prevent warping and bending of the frame while loading the specimen.

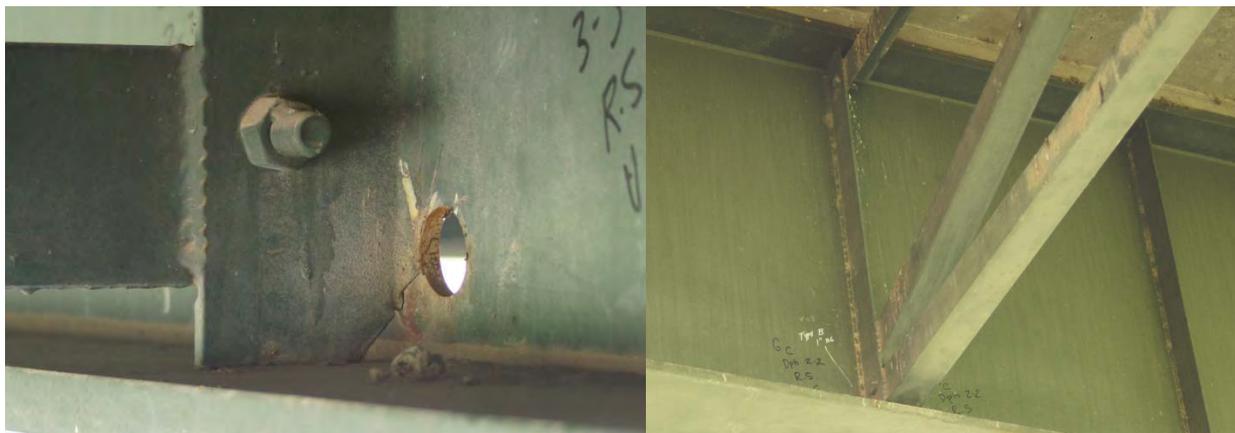
**Figure A.13: (a) Close up of web gap region of bridge in a region of positive moment and (b) Cross-frame-to-web connection**

A web gap region is created when a transverse connection plate is clipped at the top or bottom, leaving a gap between the edge of the connection plate and the unconnected adjacent girder flange (see Figure A.13). The web gap detail, widely used in the United States before the mid-1980s, was implemented in this manner to avoid welding the transverse connection plate to the flange (Castiglioni et al. 1988). This was due to concerns about creating potential for brittle fracture in the flange, a problem that was observed in European bridges early in the last century (Roddis and Zhao 2001).

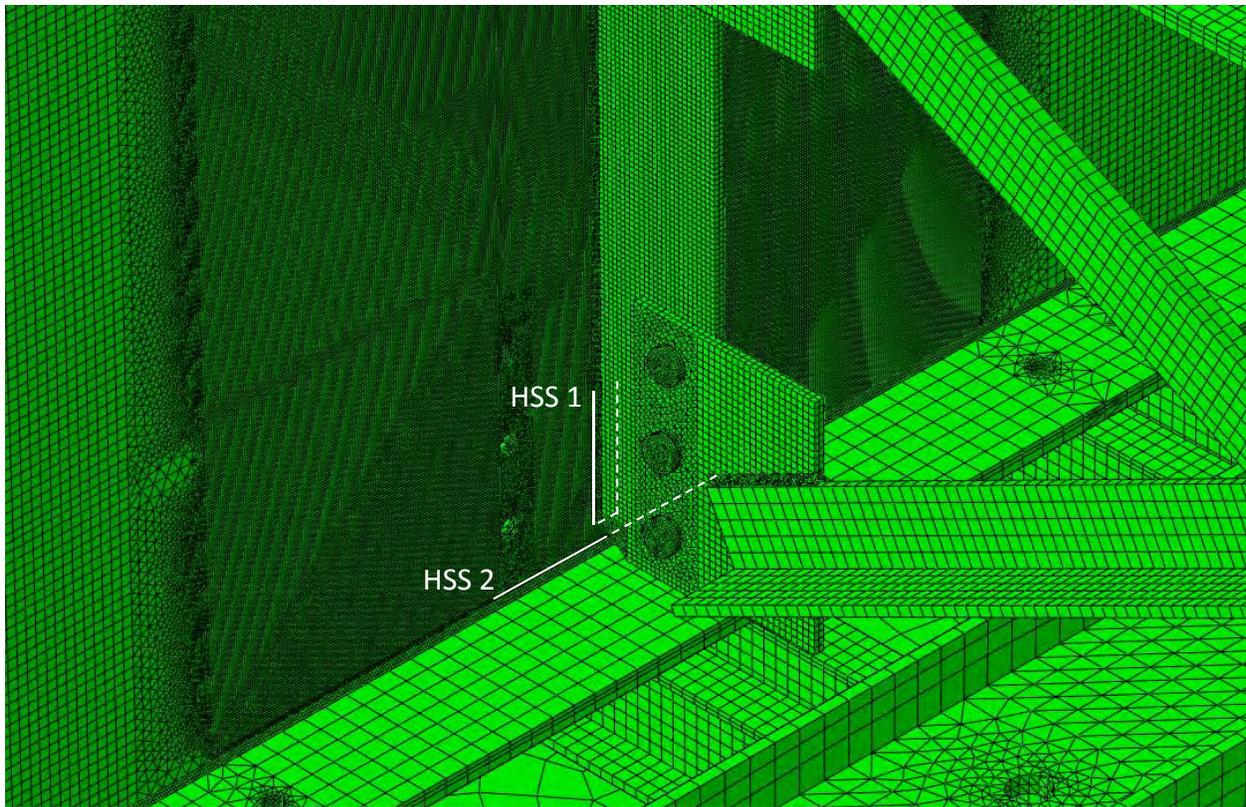
**Figure A.16: Pre-defined paths for sampling of stress demands in the various FE models**

Dimensions of the specimens and the measured material properties are presented in Appendix A.1. Linear-elastic FE models were created using eight-node brick elements (C3D8), each with 24 degrees of freedom. Mesh density was determined by performing analyses with various element sizes in the web gap region. The element size adopted in the simulations corresponded to the largest at which the rate of change of the computed HSS with respect to element size became negligible. The number of elements ranged between one and two million, depending on the retrofit measure that was modeled and the configuration of the fatigue cracks. Simulations were performed using the computer program Abaqus (SIMULIA 2008). An 813 mm (32 in.) wide strip with a reduced mesh size was defined in the girder web, centered on the transverse connection plate, spanning from the bottom to the top flange (Figure A.16). The size of the elements in this strip was set to 3 mm (0.1 in) to improve the accuracy of the calculated stress field. A 76 mm (3 in.) wide vertical strip of tetrahedral elements was used to transition from the fine mesh to a 10 mm (0.4 in.) coarser mesh used to model the web of the girder in locations away from the cross frame.

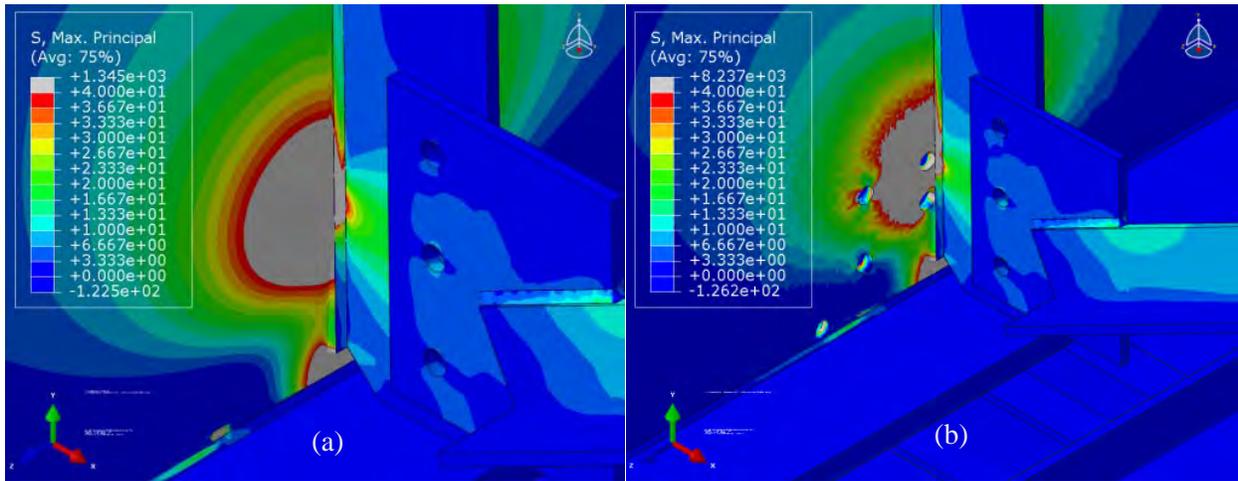
**Figure A.18: Stress field in the web gap region of a test specimen with the two fatigue cracks experimentally observed in Specimen 2 (a) Without any retrofit measure; (b) Repaired with the crack-arrest hole configuration implemented in Specimen 2.**

diameter used in the experimental study, were simulated at the tip of the cracks, at the locations shown in Figure A.18b. The location of the crack-arrest holes in the FE models corresponded to the top and bottom web gap locations drilled in Specimen 2 of the experimental study. It should be noted that holes drilled in the girder web away from the CP-to-web weld (Figure A.18b) were used to bolt the angles-with-plate retrofit measure to the girder web and were not intended to prevent crack re-initiation. Because these bolt holes were present in the specimen when it was tested, they were included in the model to account for their effect on the stress field.

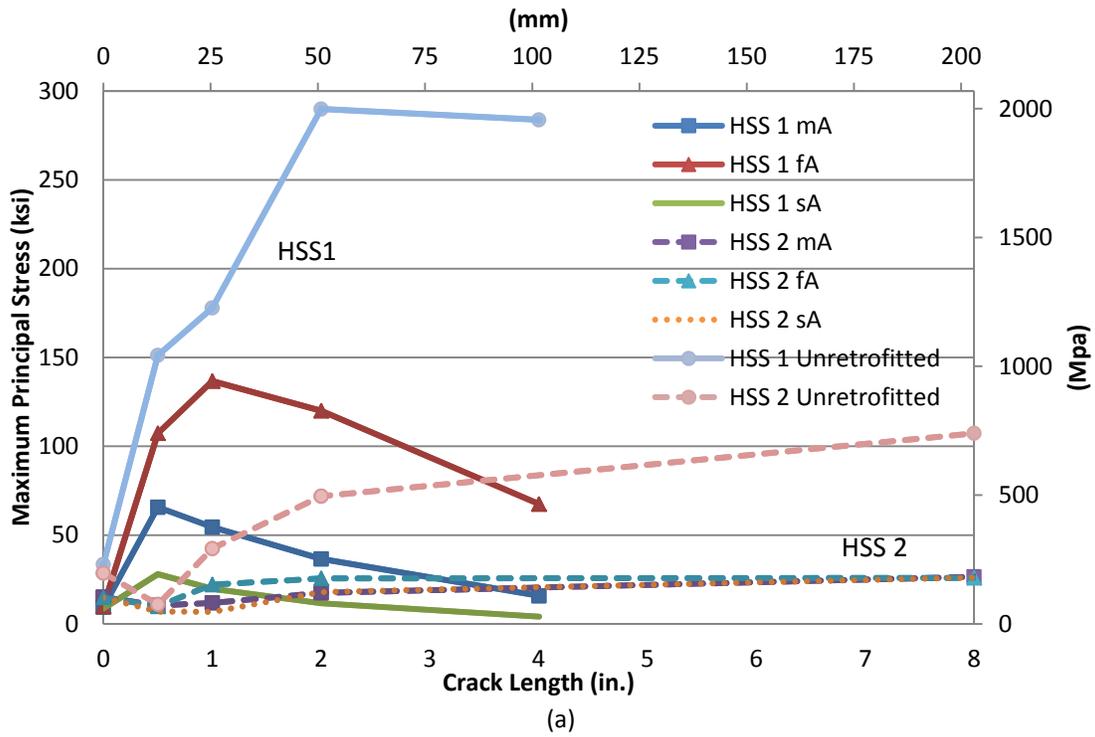
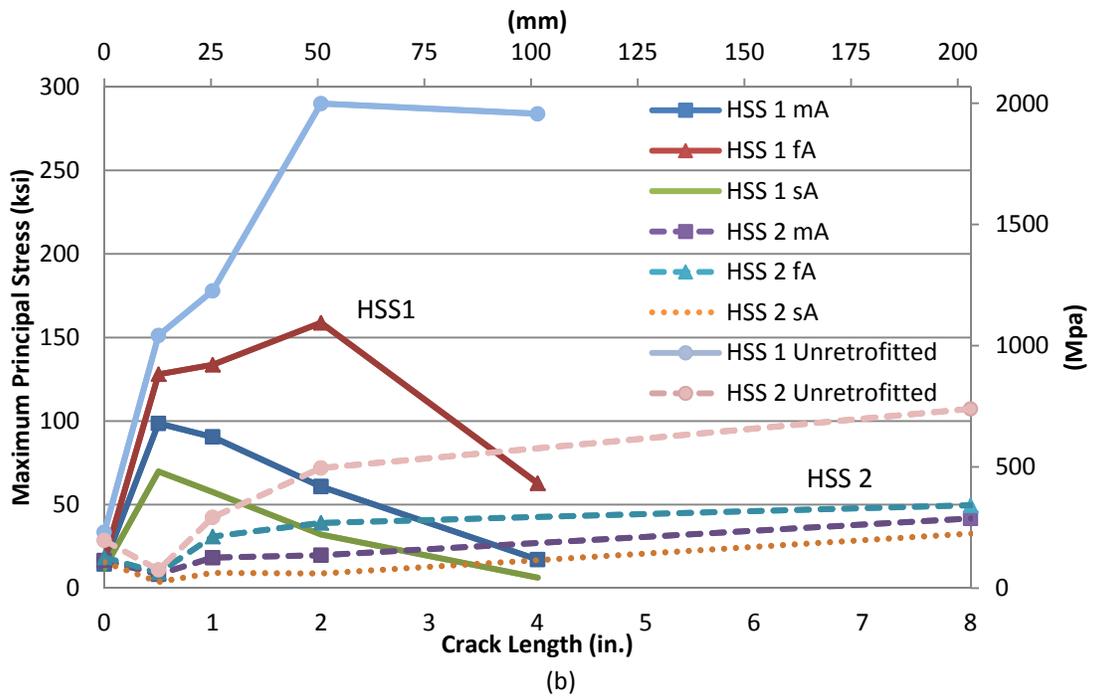
Figure A.20: Peak demand at web gap region vs. crack length for retrofitted specimens (a) HSS for stiff back plate configurations (b) HSS for flexible back plate configurations. Designations are the same used in Table A.5

demands in the retrofitted condition are quite low in magnitude. The level of stress reduction noted for HSS2 is lower than noted for HSS1, however, the stress demand in the unretrofitted condition was found to be significantly lower for HSS2 than for HSS1. These results indicate that the retrofit should be expected to provide good performance for mitigating cracking along the flange-to-web weld. An interesting phenomenon was found to occur for short crack lengths (13 mm [ $\frac{1}{2}$  in.]), in that the unretrofitted and retrofitted demands levels at HSS2 were approximately equal. This indicates that for stress levels that are sufficiently high to produce crack propagation to a length of 13 mm ( $\frac{1}{2}$  in.), the retrofit is unlikely to arrest crack propagation until it reaches a slightly greater length ( $> 25$ mm [1 in.]), at which point the retrofit becomes much more effective. As with any fatigue retrofit, a careful stress demand analysis should be performed to determine the suitability of this retrofit, especially in the presence of web-to-flange cracking.

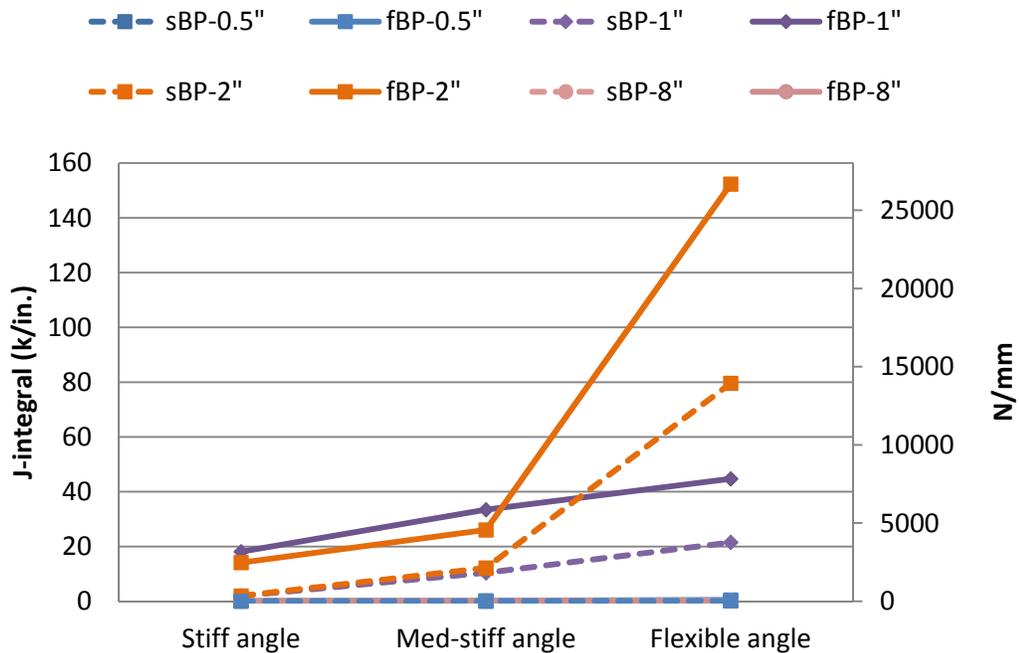
**Figure A.21: J-Integral at the tip of the horizontal crack (HSS2 in Figure A.16) vs. angle stiffness for various back plate configurations and crack lengths of retrofitted specimens (designations are the same used in Table A.5)**

*J*-Integral values (Figure A.21) computed from contours surrounding the tip of the horizontal crack at the tension face of the web showed similar trends as observed for the HSS values. The designations *sBP*, and *fBP* in Figure A.21 correspond to stiff back plate and flexible back plate, respectively. The number following the letters in the designation corresponds to the length of the horizontal crack in the model, in units of inches. Calculated *J*-Integral values indicated that retrofitted models with crack lengths of 25 mm (1 in.) and 50 mm (2 in.) had the highest propensity for growth; however, this phenomenon was absent when stiff angles were utilized. It was also found that when stiff angles are utilized, back plate stiffness did not have a large influence on crack growth propensity. When flexible angles were used, the influence of back plate stiffness was greater and the effects of crack length were more pronounced.

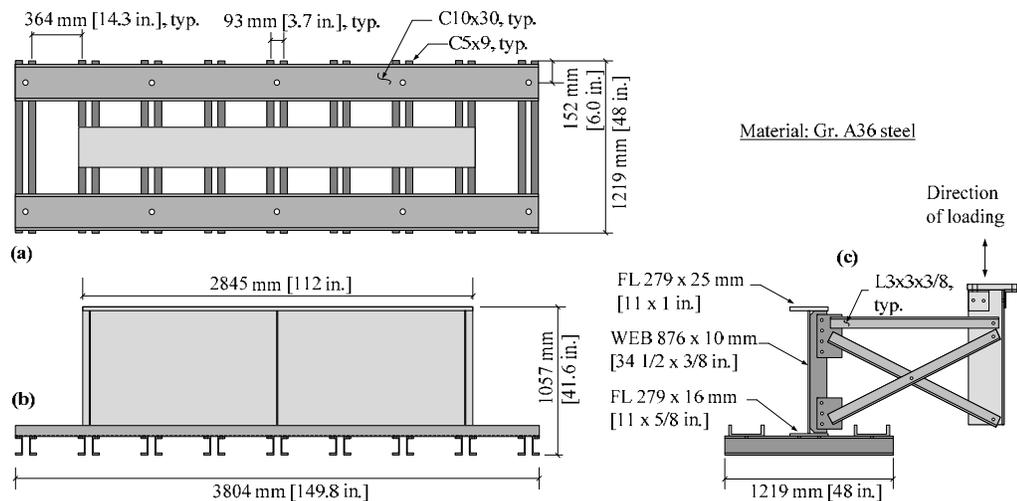
**Source: Alemdar et al. 2013(a) and (b)**  
**Figure A.23: Test set-up for 2.8 m (9.3 ft.) girder sub-assembly testing**

The test set-up used for testing the girder segments (see Appendix A.1) was such that the girder-cross frame subassembly was tested upside-down, with the girder’s top flange rotationally restrained to the laboratory strong floor. Cyclic loads were applied through a servo-controlled hydraulic actuator attached to the free end of the cross-frame elements. This test set-up eliminated in-plane bending effects on the test girders and presented a demanding out-of-plane fatigue test. The test set-up used for testing the girder segments is shown again in Figure A.23.

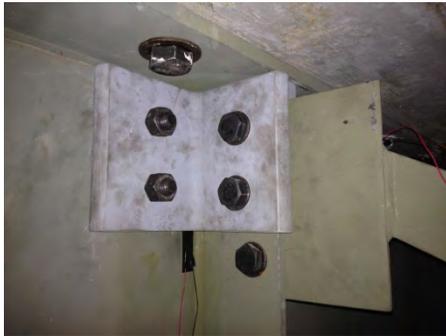
L152x152x19mm  
[L6x6x3/4"]

The retrofit investigated in Trials 2 to 6 contained two angles providing attachment between the connection plate and girder web with a backing plate on the opposing face of the web. Two L152x152x19 mm (L6x6x $\frac{3}{4}$  inch) angles were bolted to the connection plate and girder web while a 457x457x19 mm (18x8x $\frac{3}{4}$  inch) back plate was used to distribute out-of-plane forces over a large web area, as shown in Figure A.25 schematics.

Due to fit interferences with the cross frame angles, it was necessary that two retrofit angles each have one leg shortened by 25.4 mm (1 in.). Shim plates were also utilized to avoid weld interference. The bolt layout consisted of a total of six Gr. A325 19 mm ( $3/4$  in.) diameter slip-critical bolts for each retrofit application.

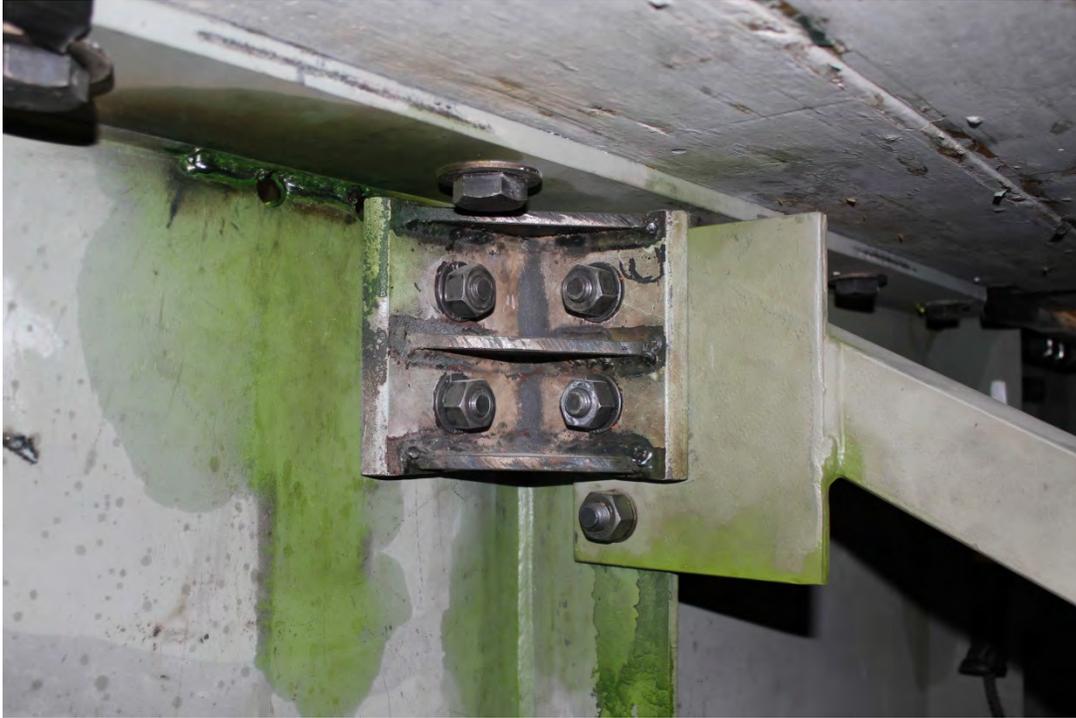
**Figure A.26: Stiffened angles-with-plate retrofit applied to exterior girders in Trial 7**

The retrofit applied in Trial 7 was identical to that used in Trials 2 to 6, except stiffening elements were added to the angle elements of the retrofit, as shown in Figure A.26.

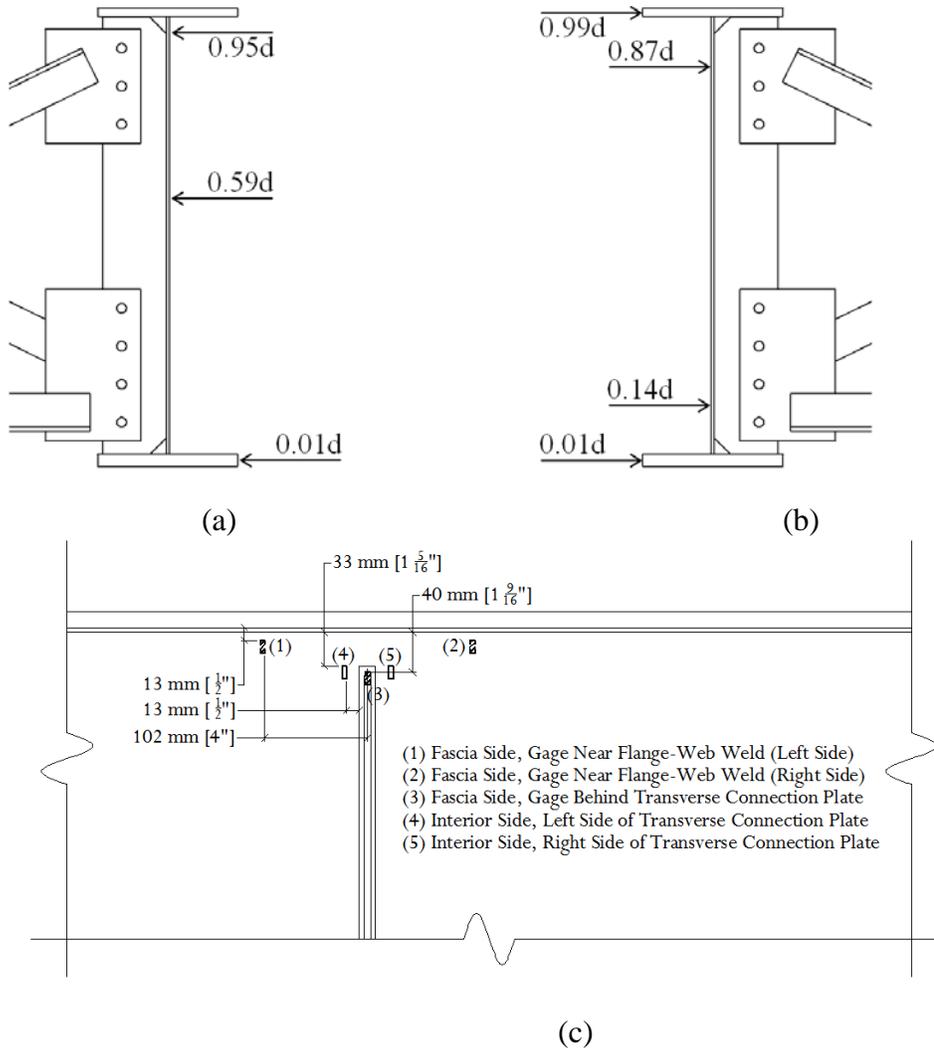
**Figure A.27: Instrumentation placements**  
**(a) LVDTs, (b) String potentiometers, and (c) Strain gages**

deflection measurements. Due to this, four string potentiometers [Figure A.27(b)] replaced the original three LVDTs monitoring lateral girder displacements.

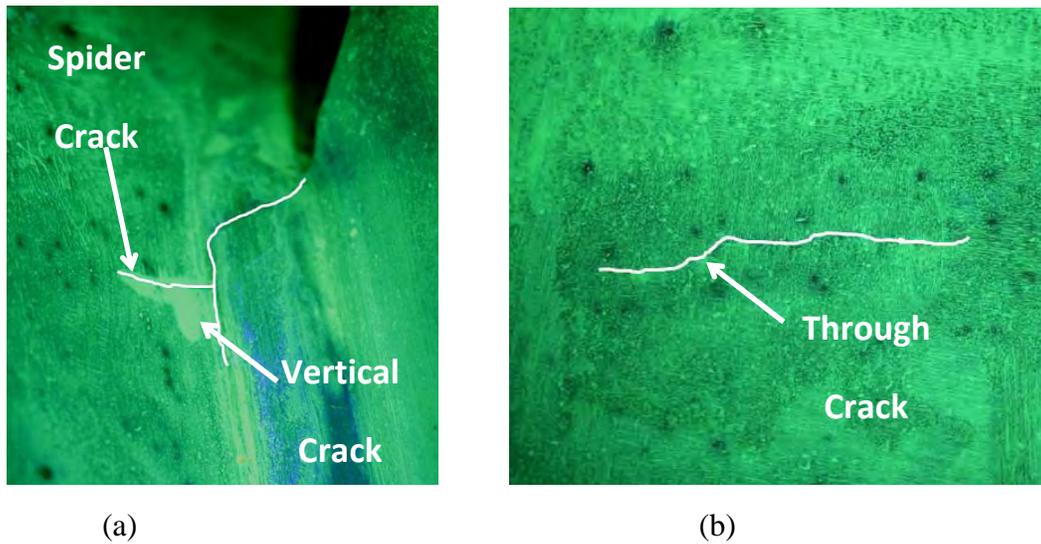
**Figure A.28: Crack definition**  
**(a) Interior side of girder web at cross frame connection plate and (b) Exterior or fascia side of girder web.**

As discussed further in the following sections of this paper, it was found that girder cracking first initiated and propagated around the connection plate-web weld in the top web gaps of the south and north girders. These cracks were closely monitored and classified by three different categories: (1) cracks growing down the weld (termed “vertical cracks”), (2) cracks growing out from the weld in the longitudinal direction of the girders (termed “spider cracks”), and (3) cracks extending through the web thickness (termed “through cracks”). Each of these three crack patterns is shown in Figure A.28. Additionally, cracking was found near the flange-web weld; these were termed “longitudinal cracks.”

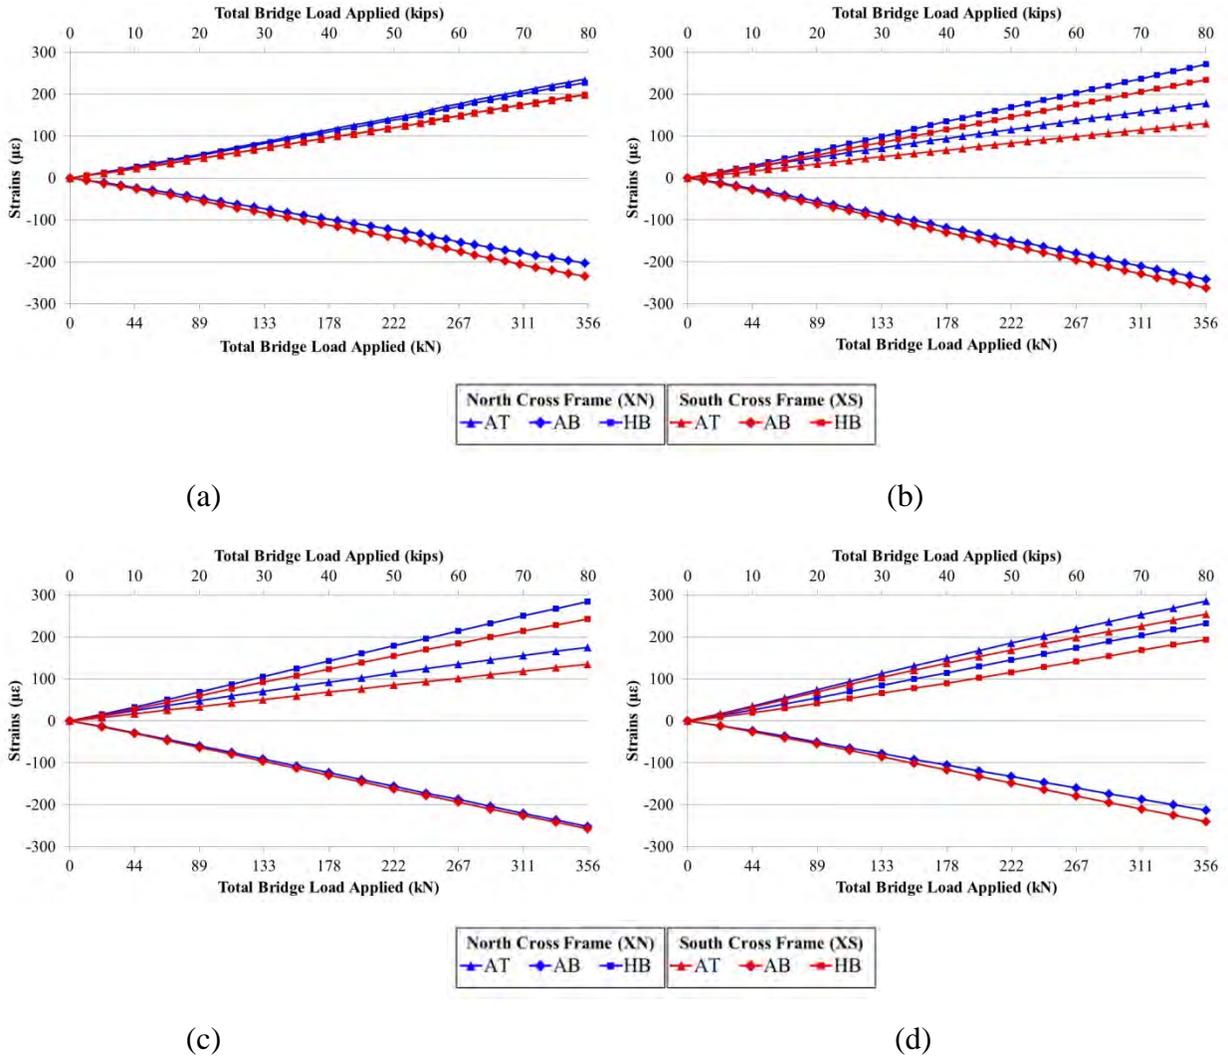
**Figure A.29: Cross frame strains**  
**(a) Uncracked, unretrofitted at 0 Cycles, (b) Cracked at 150,000 Cycles, (c) Cracked, unretrofitted at 1.35 Million Cycles, and (d) Cracked, retrofitted at 1.35 Million Cycles.**

Figure A.29 (c) and (d) show the change in strains between unretrofitted and retrofitted conditions after 1.35 million cycles. With the retrofit applied, stiffening the top web gap, inclined cross frame angles framing into the top web gap (AT) experienced an increase in tensile strain of more than 50%. Since the inclined cross frame member framing into the top web gap experienced an increase in strain, both cross frame members framing into the bottom web gap experienced decreases in strain. Inclined cross frame members framing into exterior girder bottom web gaps (AB) experienced a decrease in compressive strains while horizontal members framing into the bottom web gaps (HB) experienced a decrease in tensile strains. Strain increases in element framing into the top web gap does not directly provide any information about propensity for crack growth. It does, however, show that the retrofit allows for significantly more force transfer into the web since the cross frame strains were larger when retrofitted as compared with the unretrofitted condition.

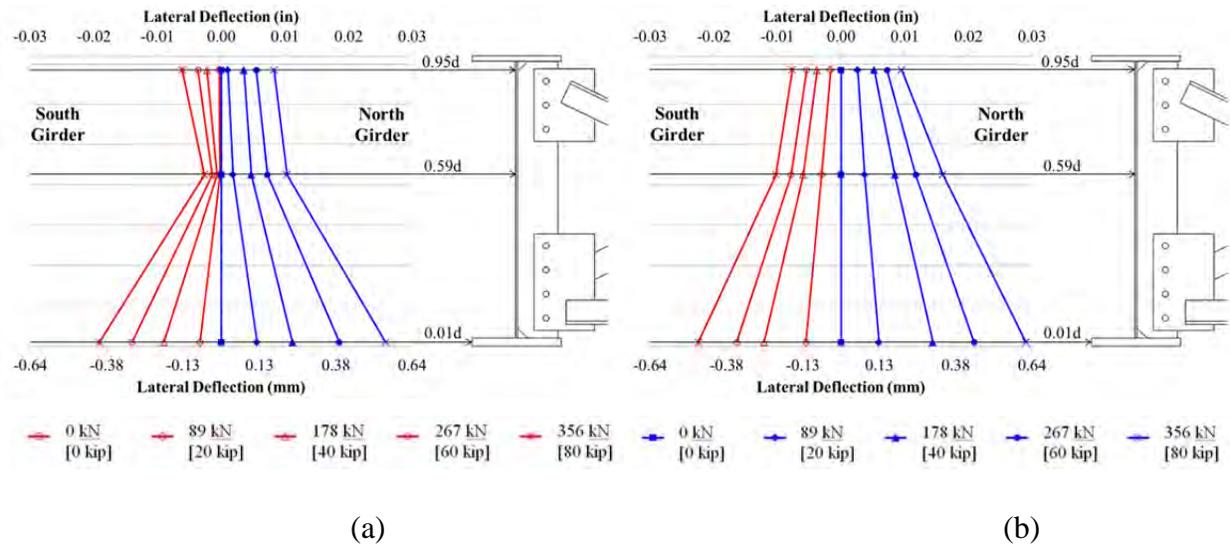
**Figure A.30: Girder lateral displacements at 150,000 cycles (End of Trials 1S and 1N) For (a) Unretrofitted and (b) Retrofitted conditions**

With the initial LVDT locations matching placements used in previous 2.8 m (9.3 ft.) girder sub-assembly testing at the University of Kansas (see Appendix A.1 and A.2), girder lateral deflections at 150,000 total cycles for both pre- and post-retrofit conditions have been presented in Figure A.30.

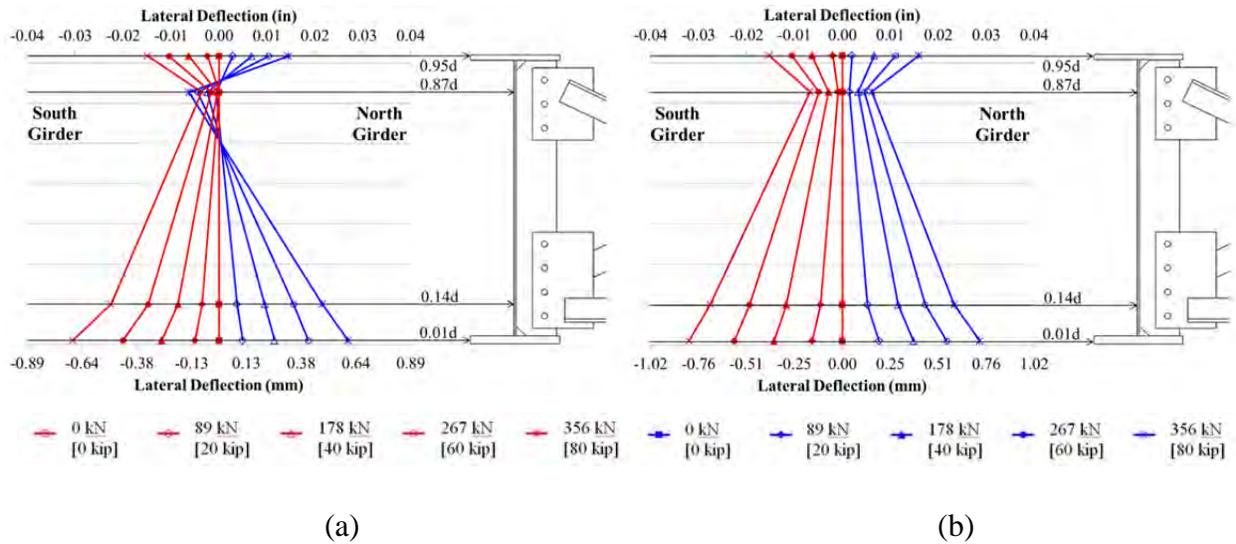
**Figure A.31: Girder lateral displacements at 1.35 Million cycles for (a) Unretrofitted and (b) Retrofitted conditions**

With the initial LVDT placements, little information could be inferred about the top web gap displacements; however, girder deflection was found to be nearly linear when the retrofit was applied [Figure A.30 (b)]. To gain greater information regarding web gap rotations, four string potentiometers replaced the existing three LVDTs. After 1.35 million cycles (end of Trials 2S and 2N), both pre- and post-retrofit girder lateral displacements can be seen in Figure A.31.

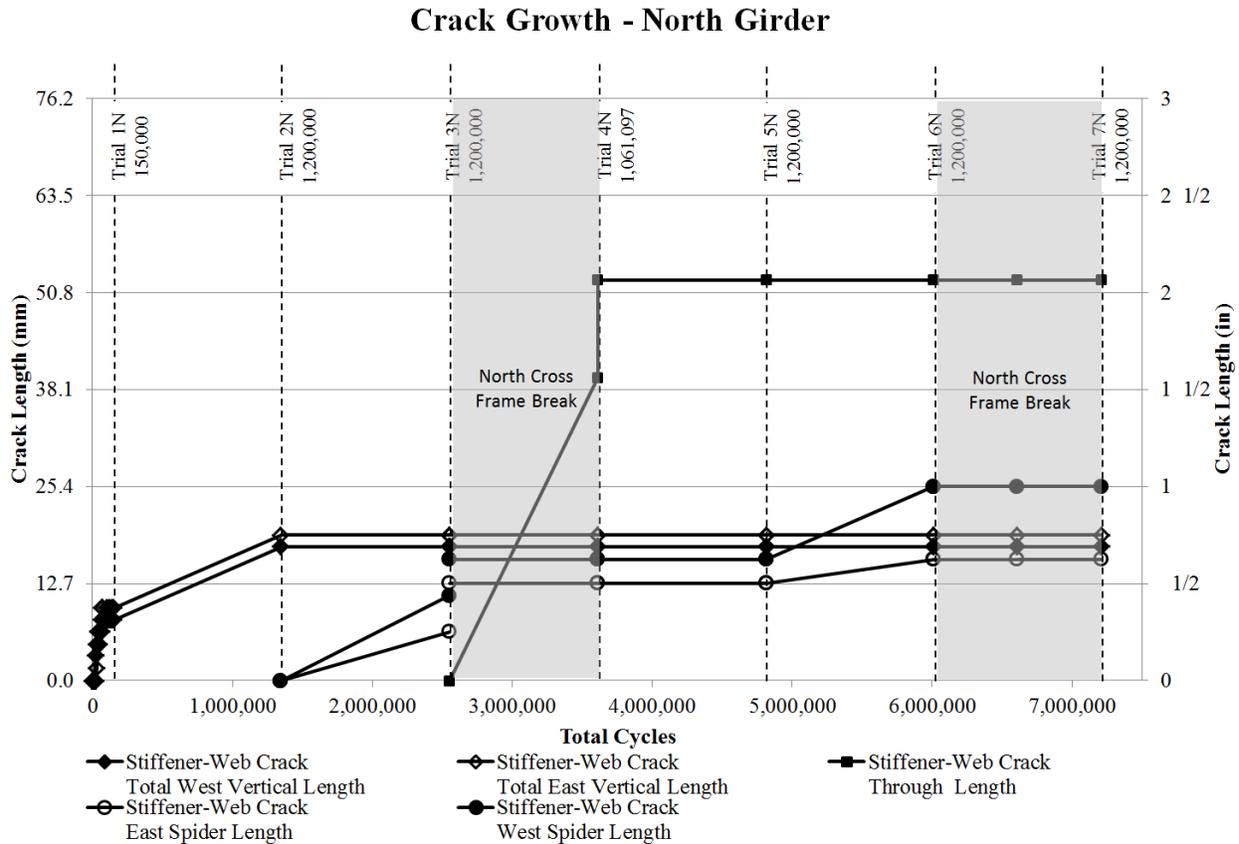
**Figure A.32: North girder crack growth around transverse connection plate**

cracks. When holes were drilled at crack tips, an instantaneous jump occurred in the graph that is not connected by a line. For locations where a crack grew into an existing crack-arrest hole, only the crack propagation was plotted. As shown in Figure A.32, an instantaneous jump at the end of that test trial is shown with a solid line to denote the difference between drilling a crack-arrest hole and propagating into a pre-existing hole.

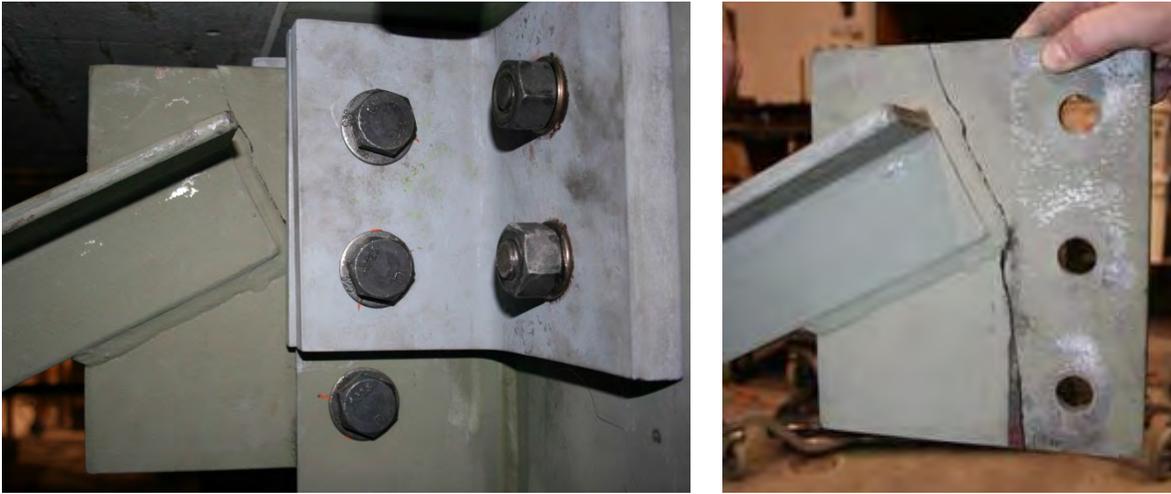
**Figure A.33: North cross frame failure during Trial 4N**

Small crack arrest holes with a 6 mm ( $\frac{1}{4}$  in.) diameter were drilled at the crack tips before the start of Trial 4N, and the angles-with-plate retrofit was reapplied and the load range was increased. Approximately 650,000 cycles into Trial 4N, a faint clicking noise was noticed originating from the connection plate in the north girder. After inspection of strain data, no significant change in bridge response was noticed. However, when the bridge was visually inspected at 1.06 million cycles into Trial 4N, the cross frame between the north and middle girders was found to be cracked completely through at the tab plate, as shown in Figure A.33.

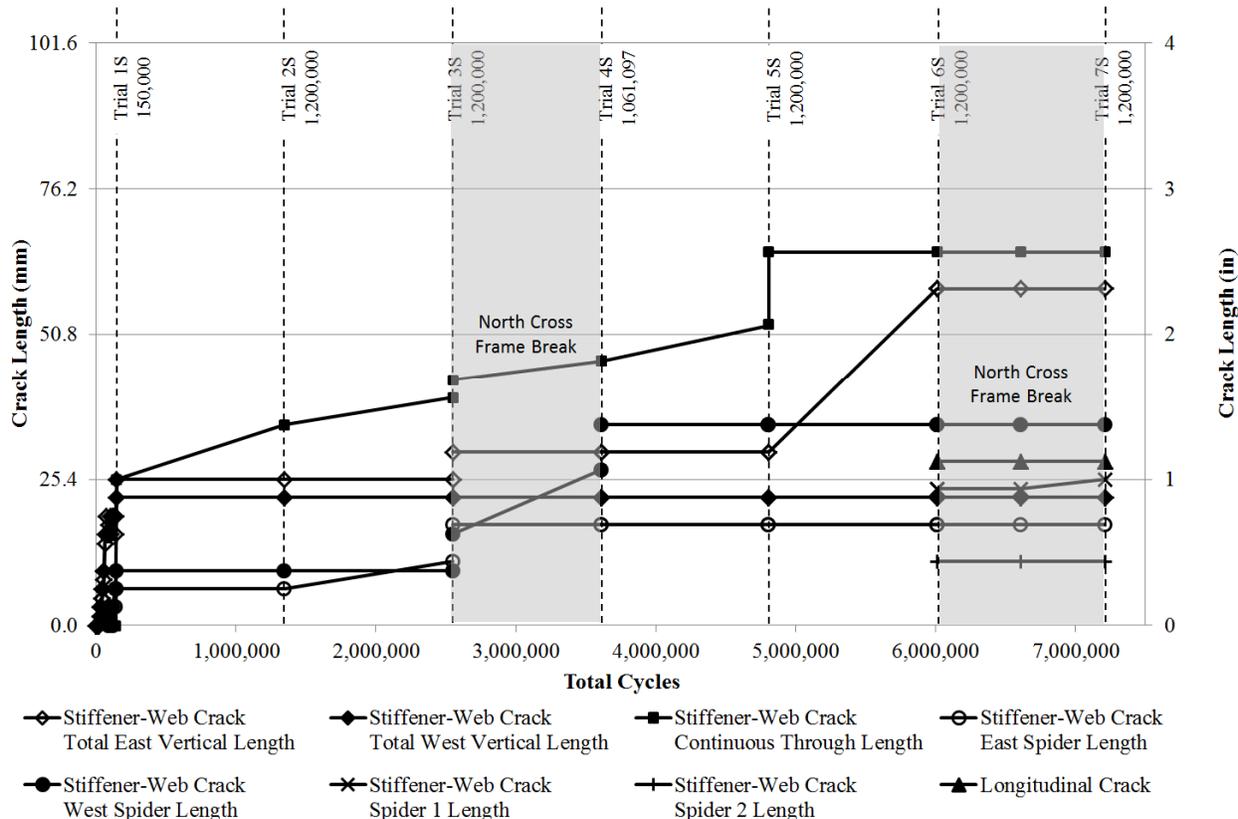
**Figure A.34: South girder crack growth around transverse connection plate**

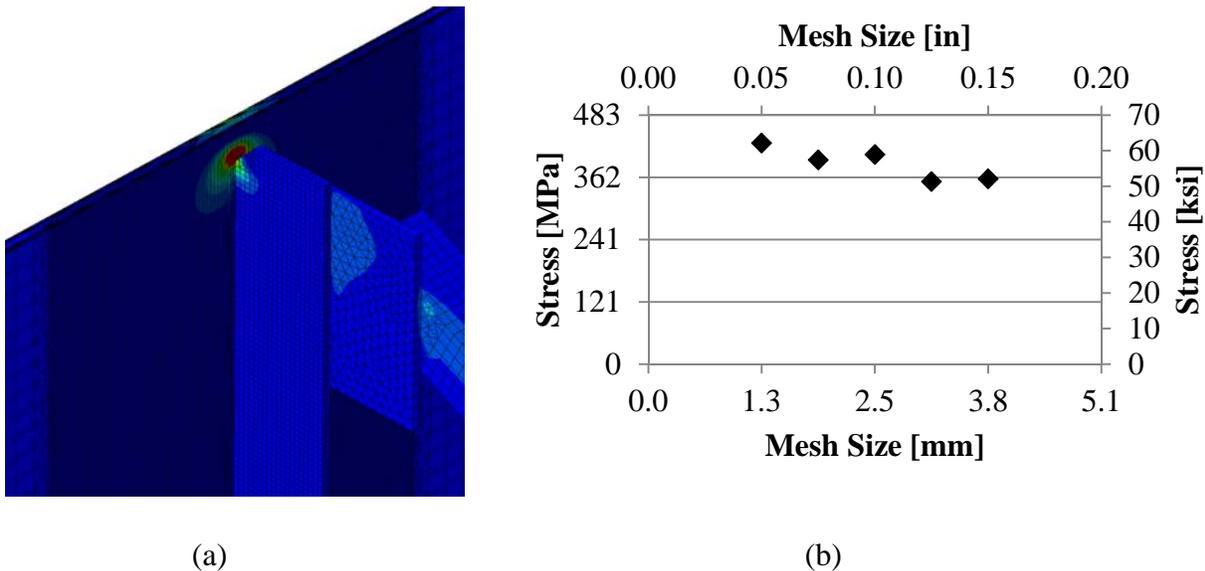
**Figure A.38: Mesh**  
**(a) Dense mesh (2.54 mm [0.1 in.]) in web gap region transitions to coarse mesh (25.4 mm [1.0 in.]) and (b) Mesh sensitivity study for changing dense region mesh**

All bridge components were constructed in Abaqus v.6.10 using three dimensional elements including mostly hexahedral elements (C3D8R) and some tetrahedral elements (C3D4) for transition regions. Each model contained approximately 3 million elements and 10 million degrees of freedom. A dense mesh was applied to the web gap region while other locations within the bridge contained a coarser mesh as shown in Figure A.38(a). Based on a convergence study performed on the dense mesh region around the connection plate-web weld, the optimal mesh size of the web gap was determined to be 2.5 mm (0.1 in.) [Figure A.38 (b)].

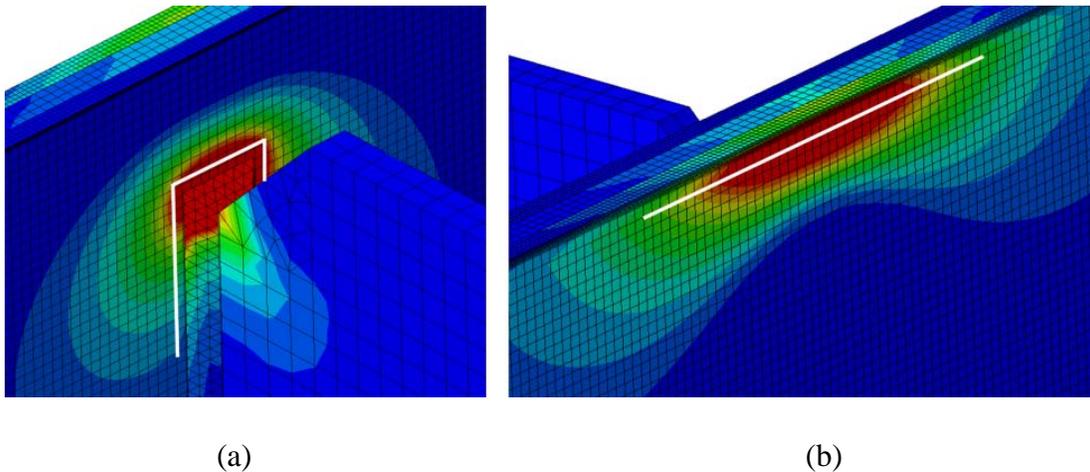
**Figure A.40: Hot Spot Stress paths for (a) Interior connection plate side or connection plate-web weld, (b) Exterior fascia side or flange-web weld**

Complicated geometry and stresses in the web gap region made performing accurate comparisons between models a difficult task. A one-point hot spot stress (HSS) procedure was used as the basis for this comparison in which stresses were extracted at a set distance (half the web thickness, 3 mm [ $1/8$  in.]) from the discontinuity, either a weld or crack. This procedure has been found to be less sensitive to mesh density than extracting maximum stress from the models (Adams 2009). Two hot spot stress paths were chosen for consideration as shown in Figure A.40.

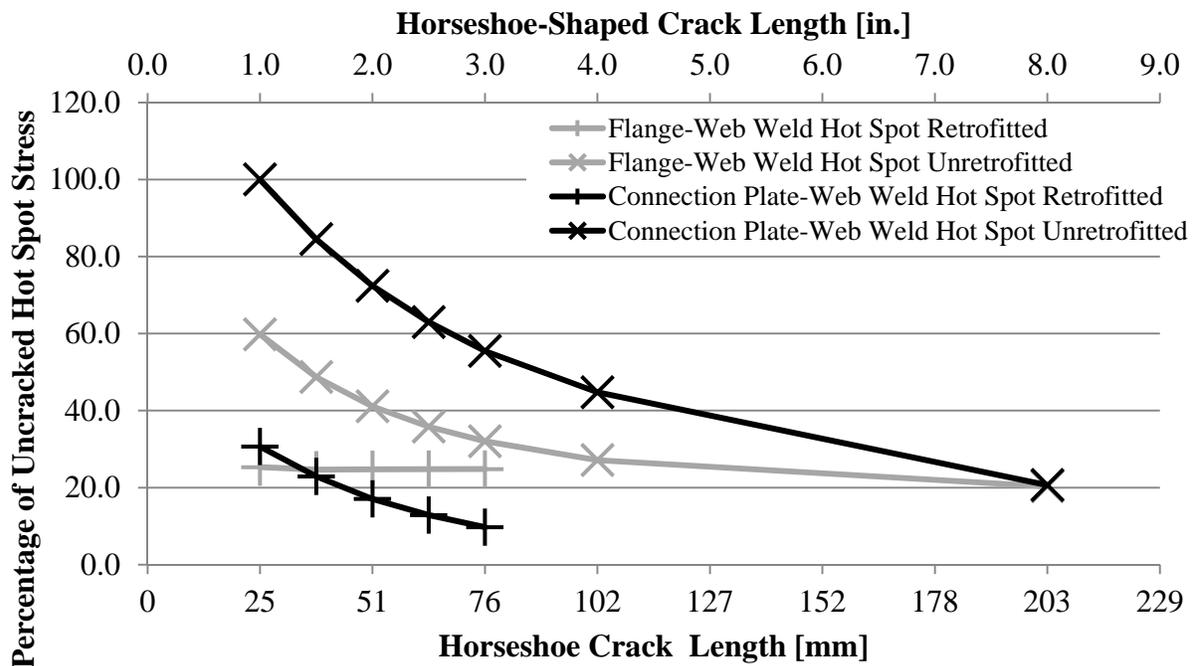
Figure A.42: Percentage of uncracked Hot Spot Stresses with change in horseshoe-shaped crack length for connection plate-web weld and flange-web weld.

For all horseshoe-shaped crack lengths studied, hot spot stress decreased or remained nearly constant as crack length increased for both retrofitted and unretrofitted conditions. The percentage of uncracked hot spot stress due to change in length of the horseshoe-shaped crack has been presented in Figure A.42.

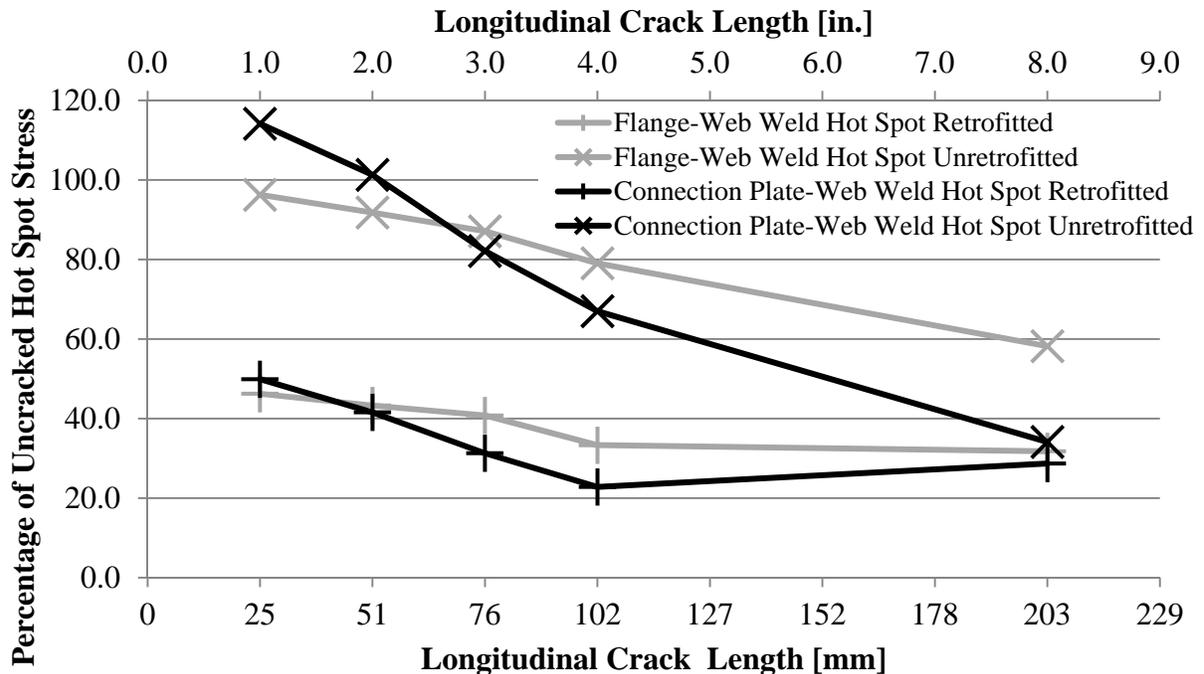
**Figure A.43: Percentage of uncracked Hot Spot Stresses with change in longitudinal crack length for connection plate-web weld and flange-web weld**

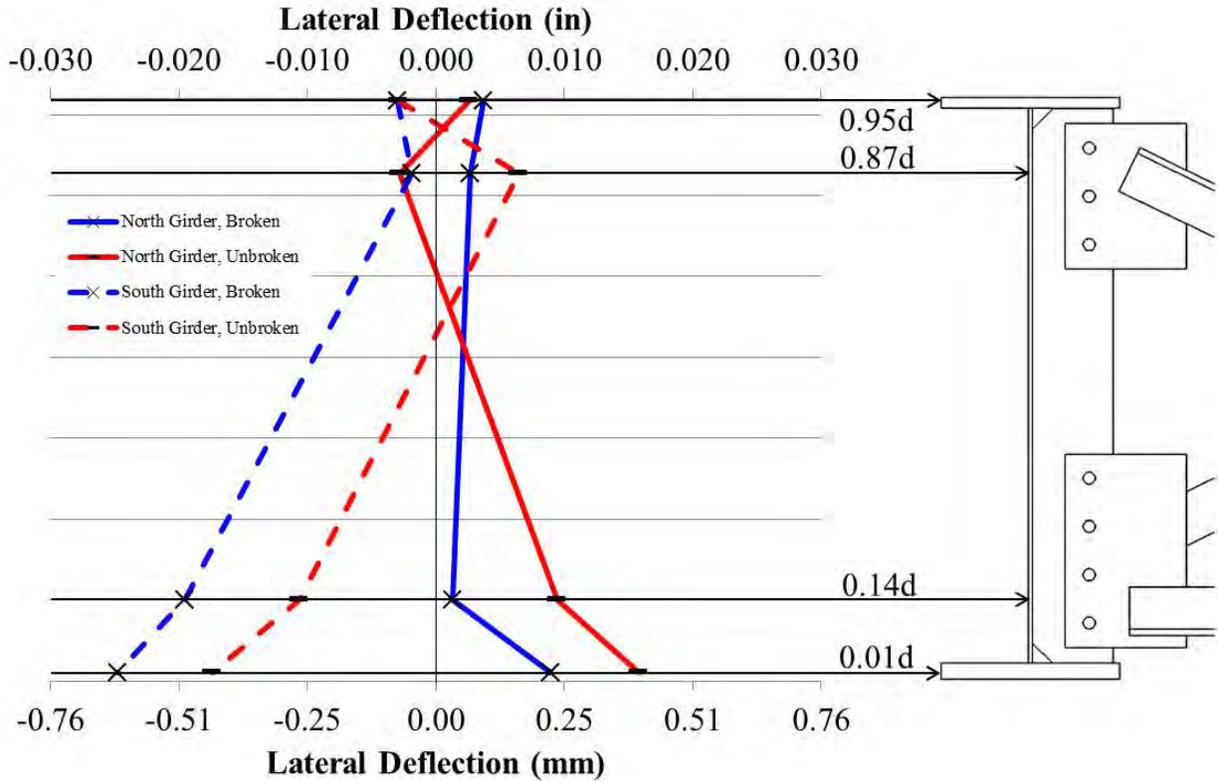
**Figure A.45: Girder lateral deflections with unbroken cross frame elements and broken cross frame element framing into the north girder top web gap**

frame was severed. In the south girder, top web gap differential deflection was still decreased, but bottom flange deflection increased significantly, resulting in larger girder rotation between top and bottom flanges.

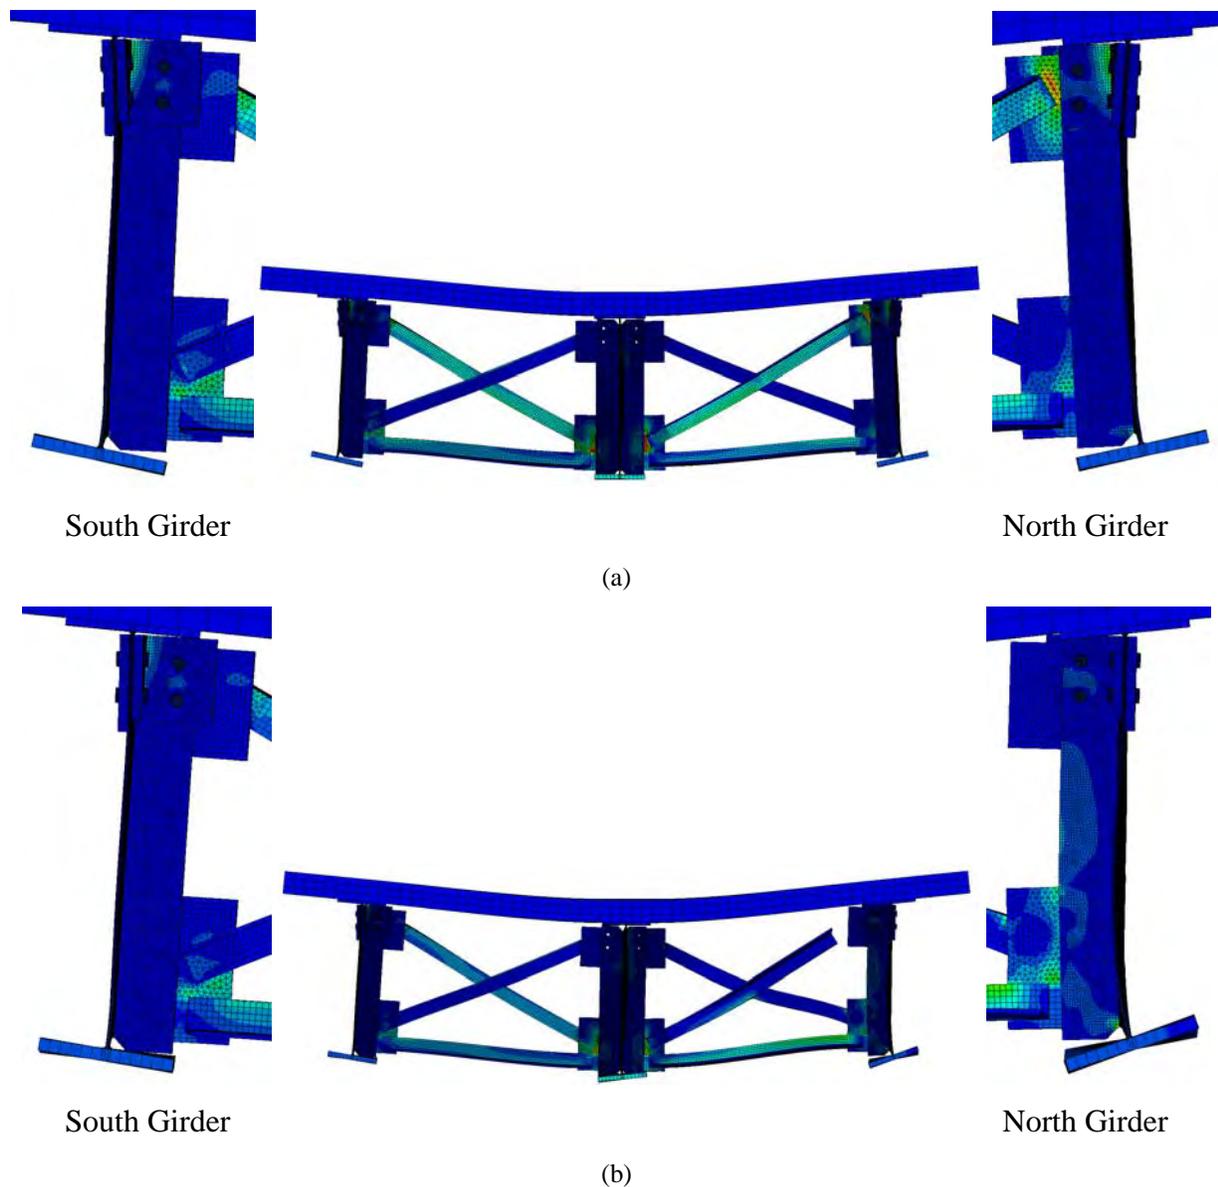
**Figure A.46: Girder deflection profiles**  
**(a) 25 mm (1 in.) cracked and retrofitted model and (b) 25 mm (1 in.) cracked and retrofitted model with broken north cross frame element**
