# Enhancement of Welded Steel Bridge Girders Susceptible to Distortion-Induced Fatigue

*The University of Kansas Center for Research, Inc.*

*A Transportation Pooled Fund Study - TPF-5(189)*

## **Appendix A: Development of the Angles-with-Plate Repair**

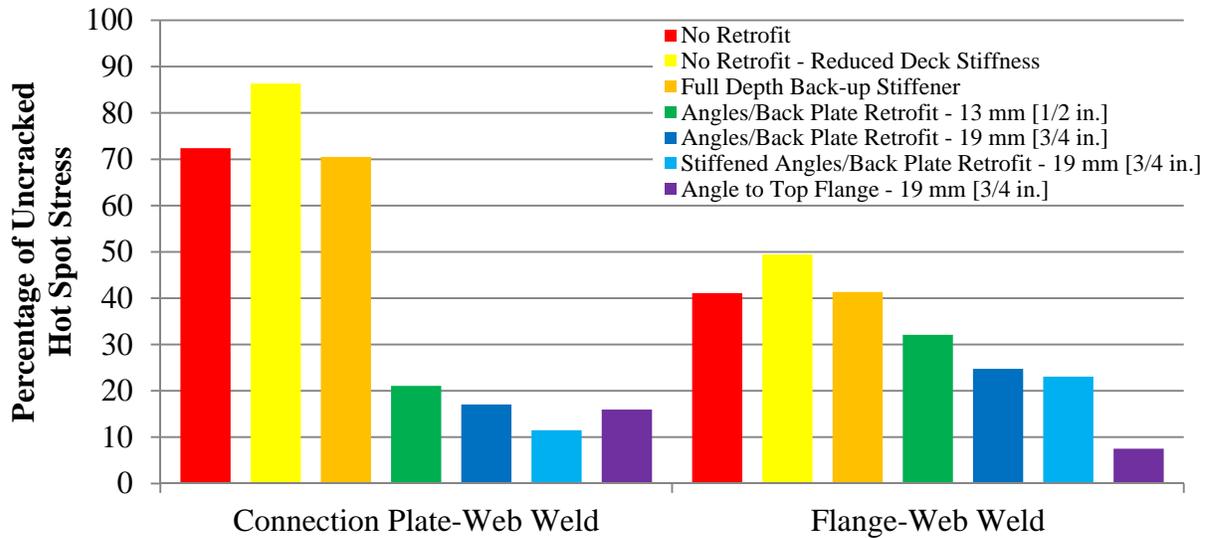
**Figure A.48: Percentage of uncracked Hot Spot Stresses for connection plate-web weld and flange-web weld with various retrofit conditions and a 51 mm (2 in.) horseshoe-shaped crack.**

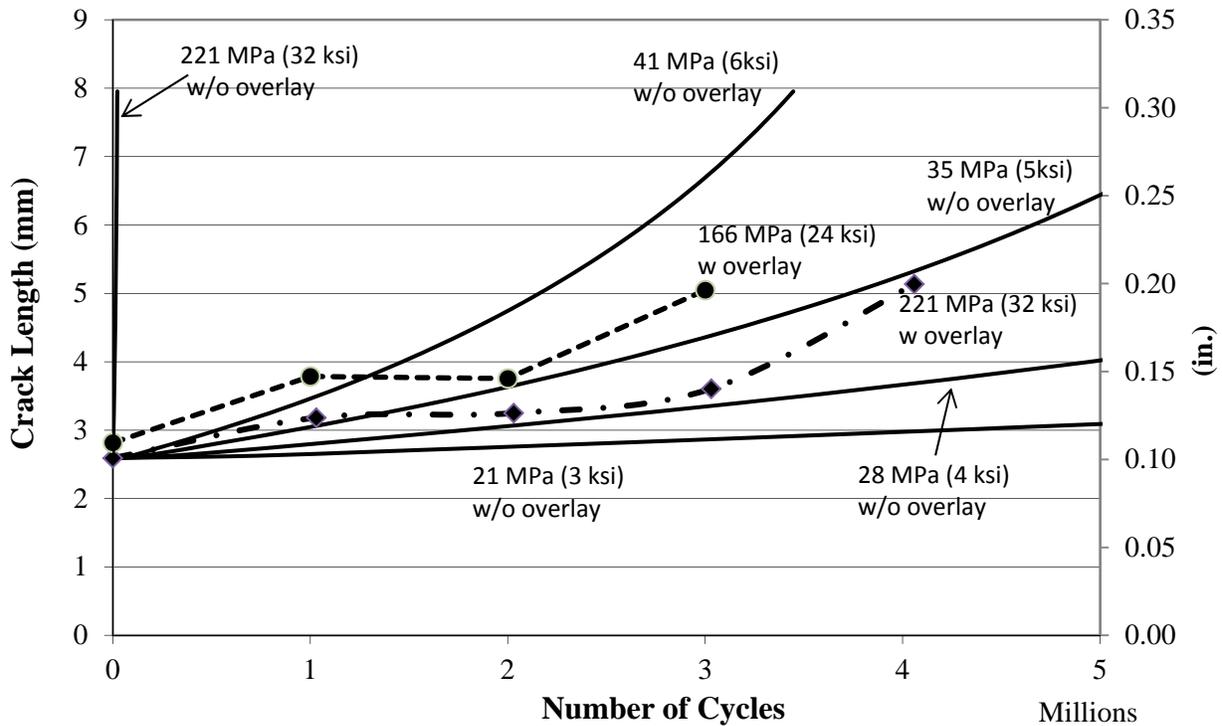
**Figure B.6: Crack progression in 3 mm ( $1/8$  in.) thick specimens**  
**Solid lines are added for comparison and correspond to theoretical crack progressions calculated using Equation B.4 with material constants of  $A=3.6 \times 10^{-10}$  and  $m=3$  for various stress ranges in a specimen configuration without overlays.**

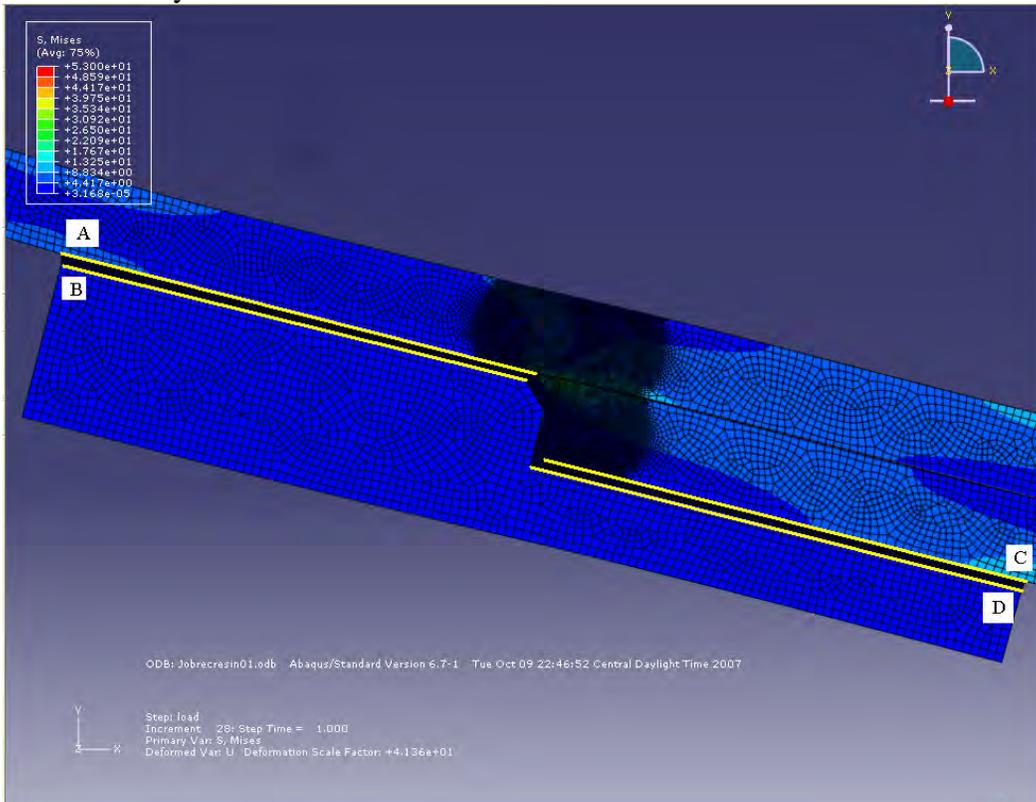
**Figure B.13: Stress comparison paths on the resin layer**

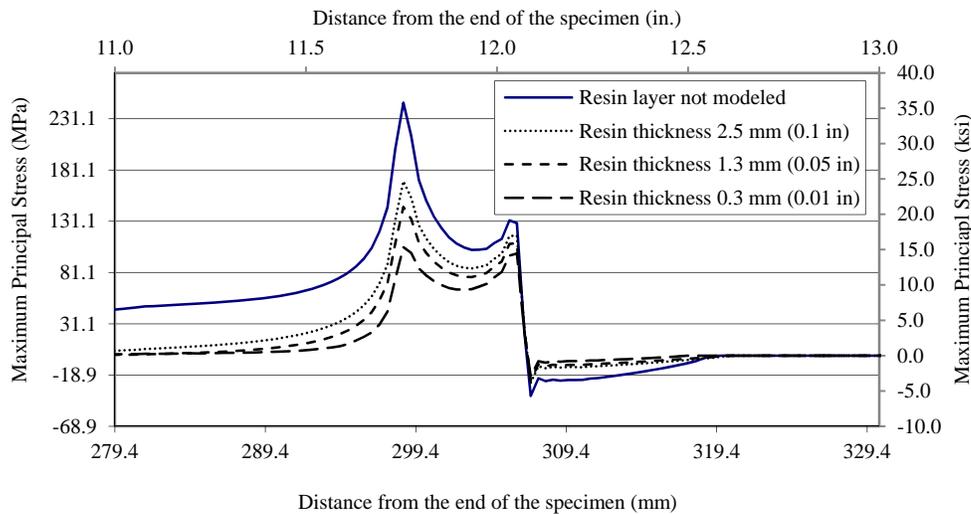
**Figure B.14: Maximum principal stress on the steel plate in the area of the weld**

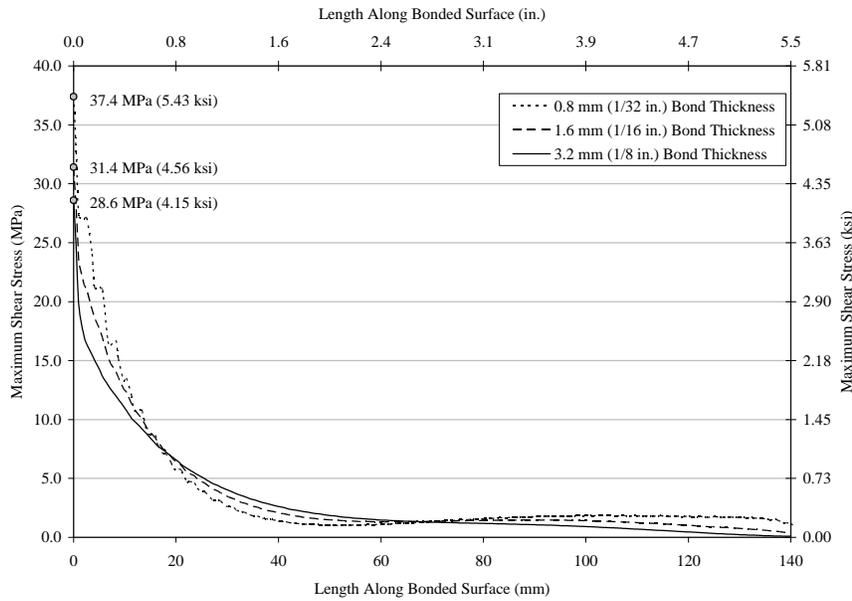
**Figure B.15: Calculated shear stress along Path A in Figure B.14 for varied bond thickness**

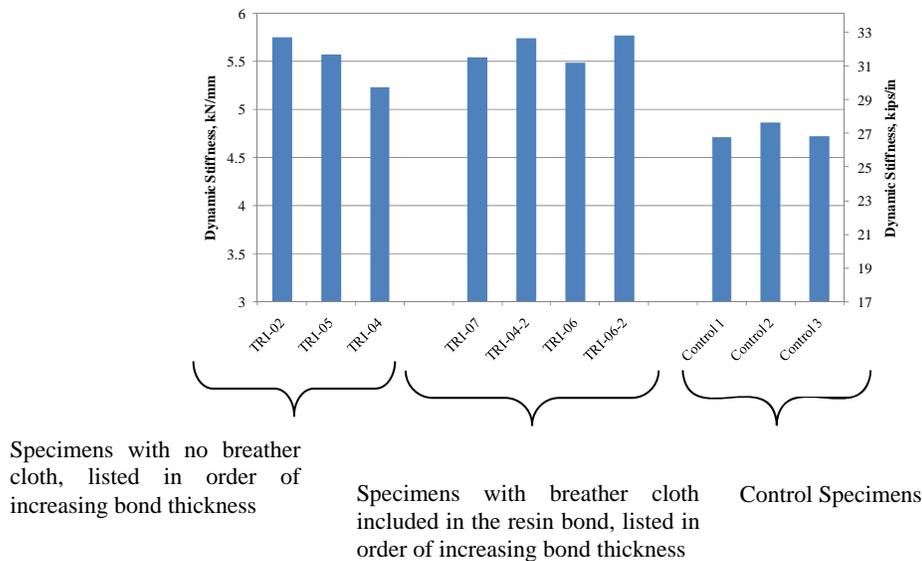
**Figure B.16: Measured dynamic stiffness of specimens**

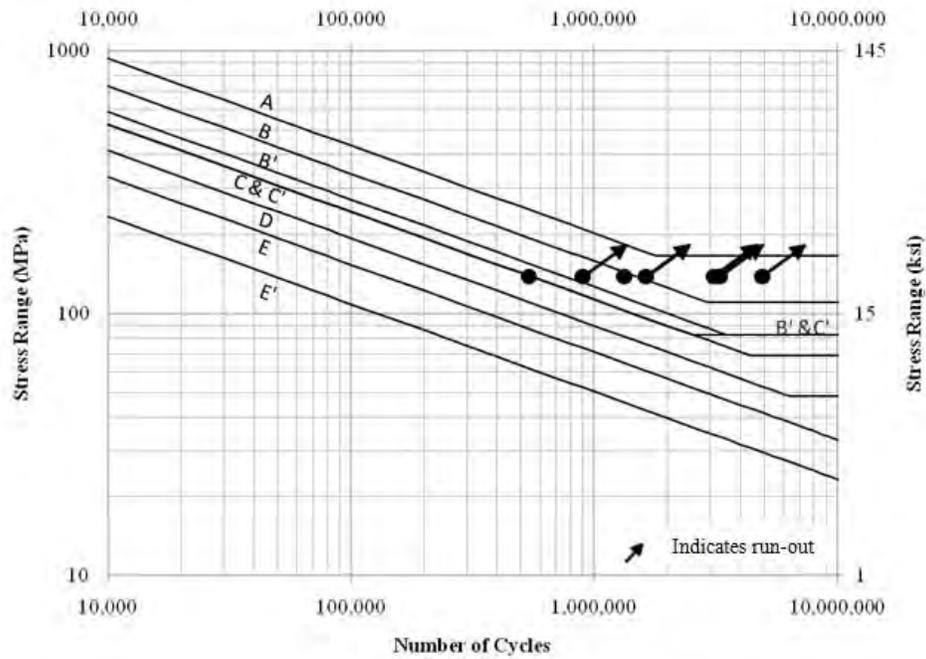
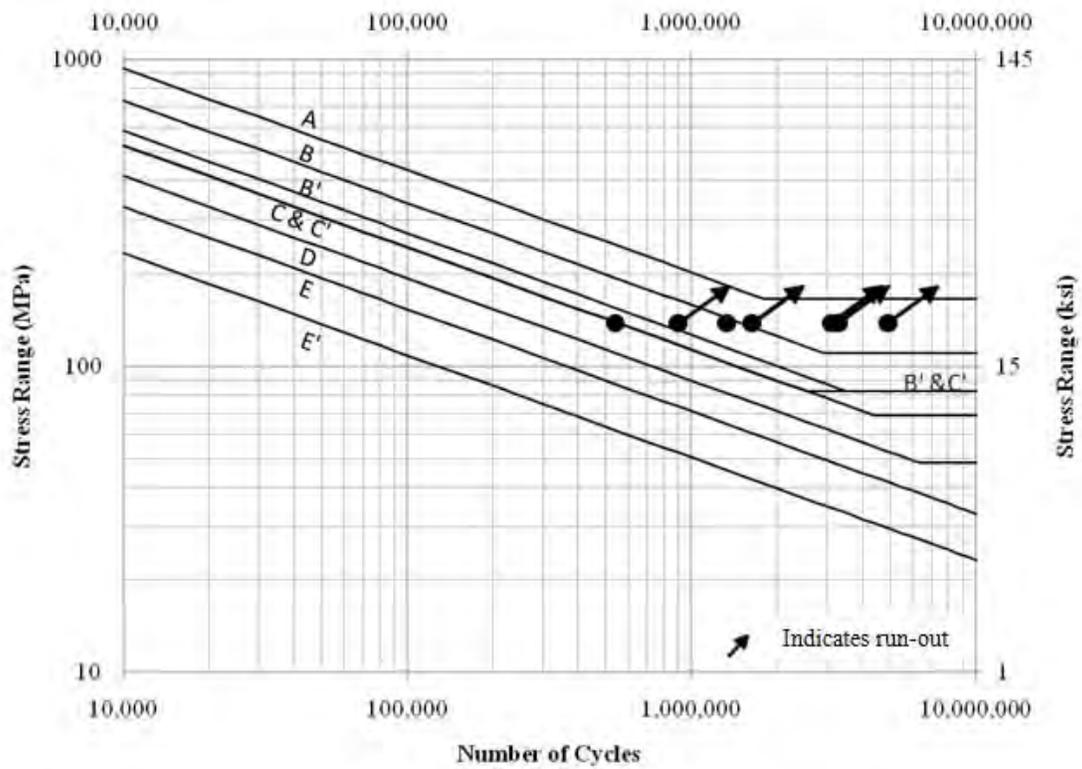
Figure B.17: S-N diagram of fatigue test results for showing the cumulative number of cycles to fatigue-crack initiation for CFRP treated specimens

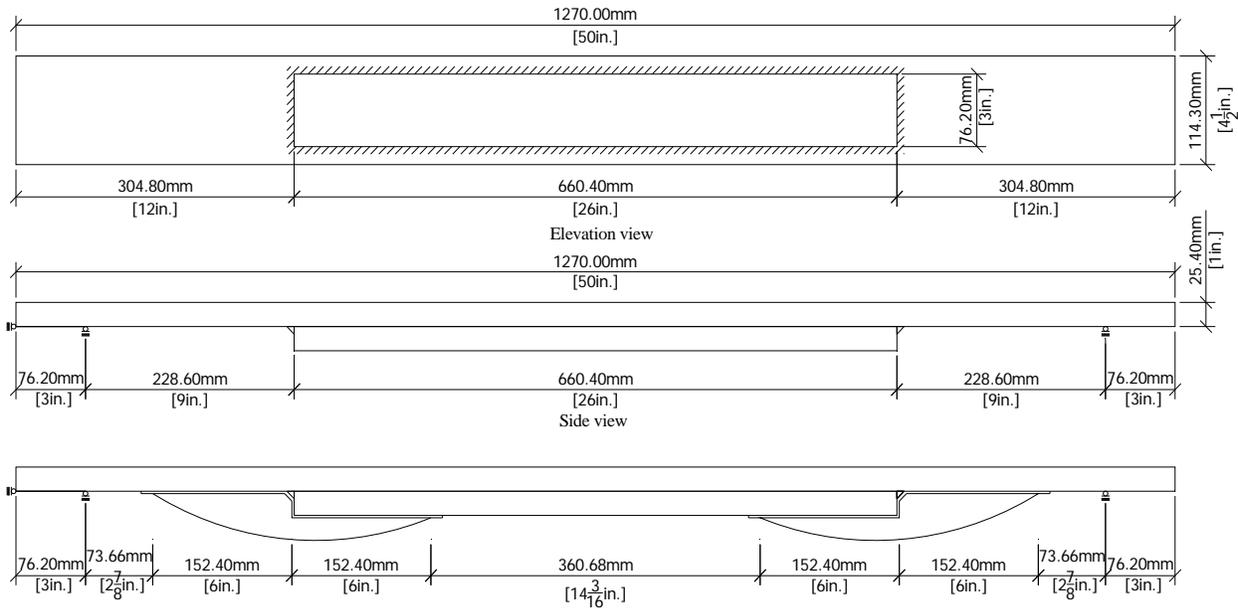
**Figure B.20: Three point bending specimens**  
**(a) Without CFRP retrofit (Vilhauer 2010); (b) With CFRP retrofit applied (Kaan 2008)**

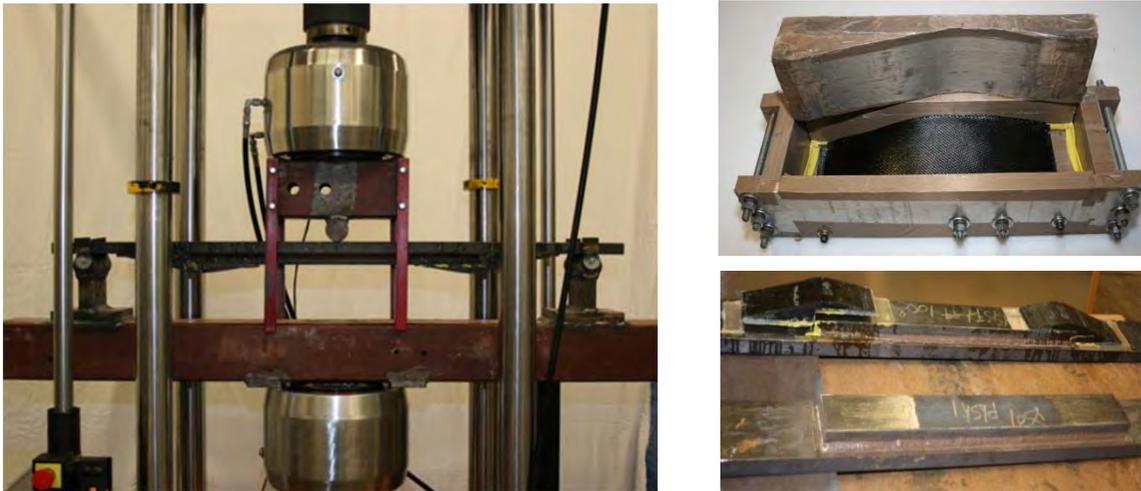
**Figure B.21: Three point bending specimens (a) Test setup; (b) CFRP overlay in fabrication mold; (c) Unreinforced and reinforced specimens side by side.**

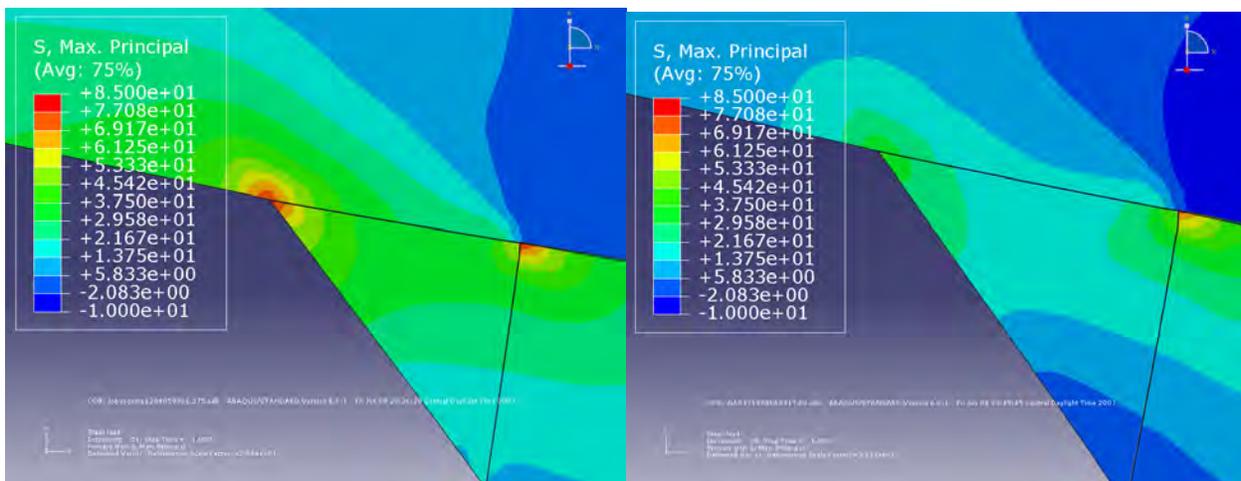
**Figure B.24: Elevation view showing maximum principal stress (a) Control specimen; (b) Specimen with smooth-shaped composite overlay (overlay not shown for clarity)**

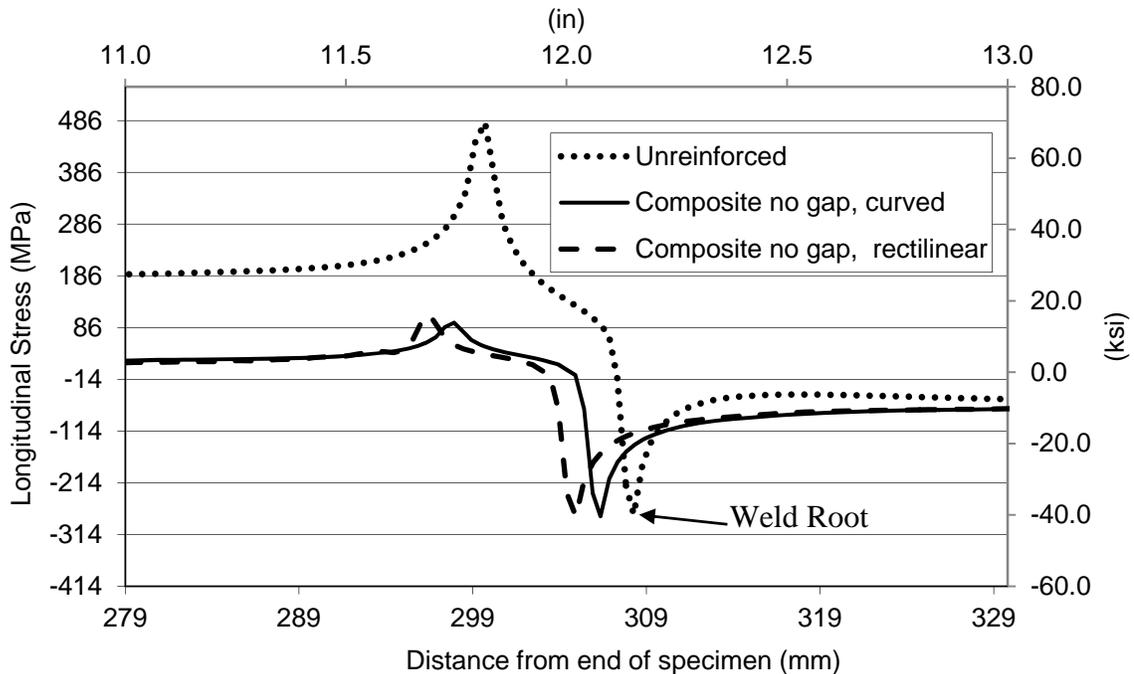
**Figure B.25: Effect of composite overlay shape on longitudinal stresses in the area of the weld**

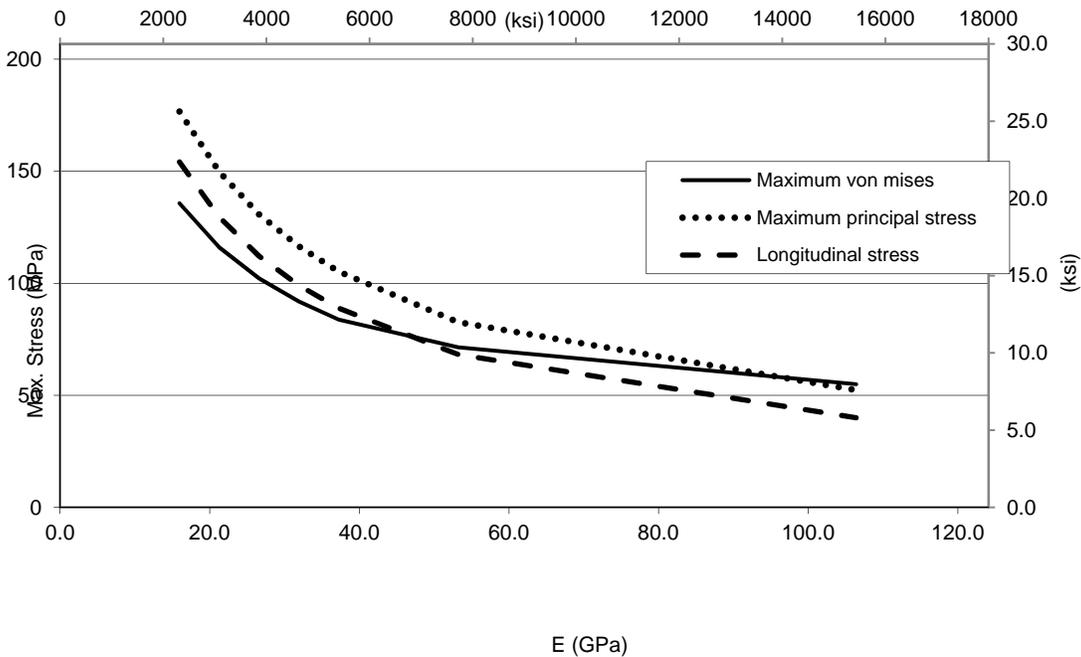
**Figure B.27: Effect of composite overlay stiffness on maximum stress demand at the weld toe**

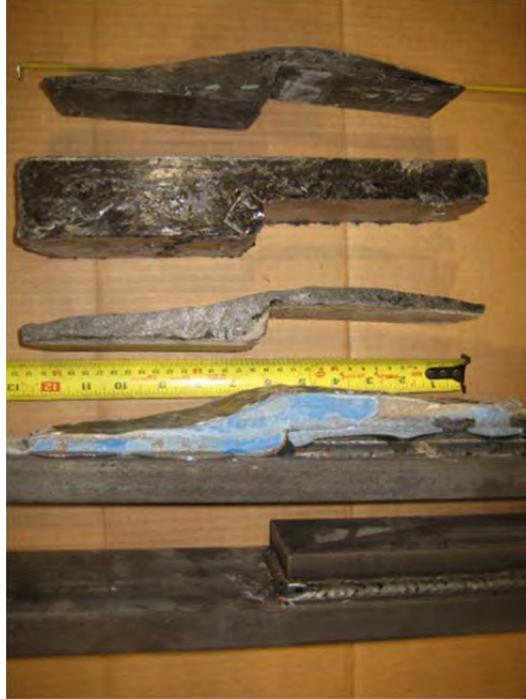
**Figure B.30: Composite overlays used in the study**

2 and CHP3 was similar to that of the prefabricated multi-layered CFRP overlay [Figure B.23(b)]. All overlays used in the testing program are shown in Figure B.30. After spraying was completed, the specimen was cured at room temperature for two days, after which the remnant resin was cleaned from the steel substrate. In the specimen designated CHP 2, a breather cloth layer was placed on the surface of the steel and saturated with resin before spraying the combined resin-chopped graphite fiber mix. In the specimen designated CHP 3, the breather cloth was soaked with Hysol® resin and cured for two hours at room temperature before a resin-chopped glass fiber mix was sprayed.

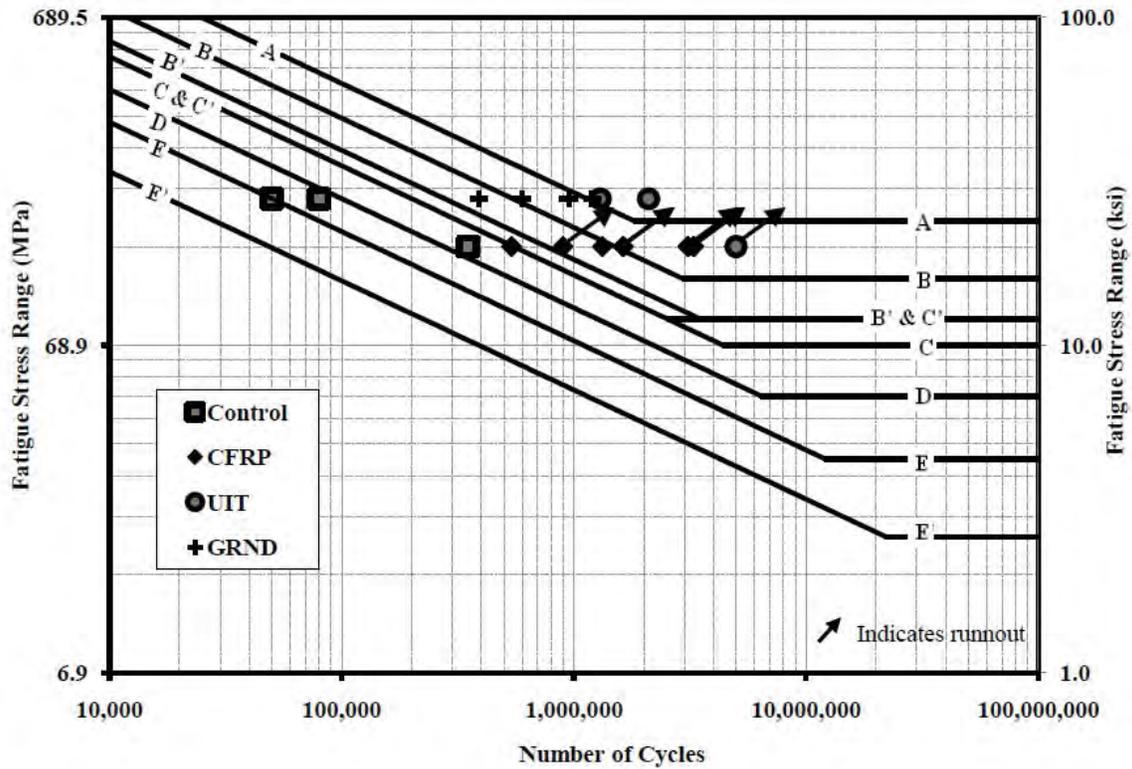
Figure B.31: Fatigue life of welded connections for various types of treatments

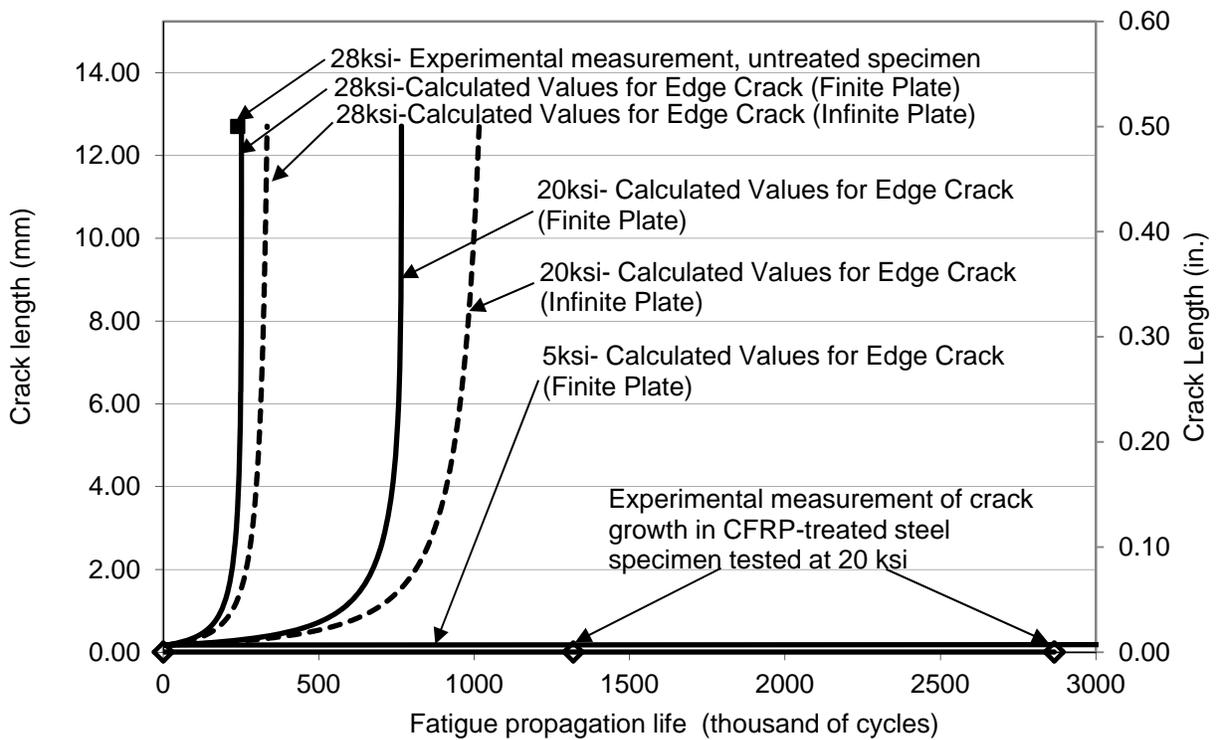
**Figure B.32: Theoretical and experimental propagation life of untreated and CFRP retrofitted three-point bending specimens**

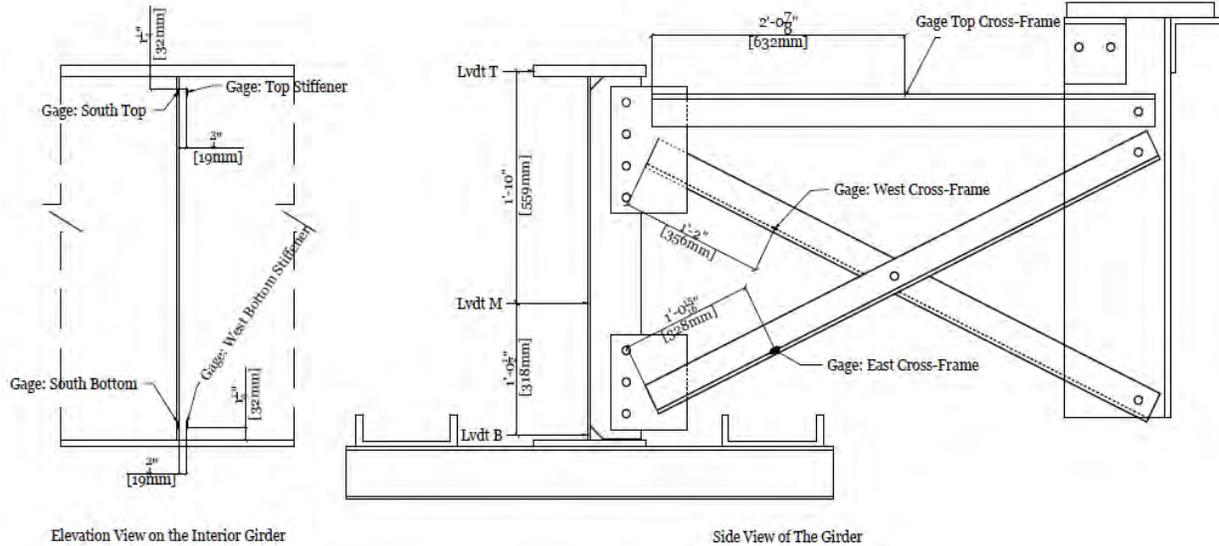
**Figure B.38: Instrumentation used on the 9.3 ft girder specimen**

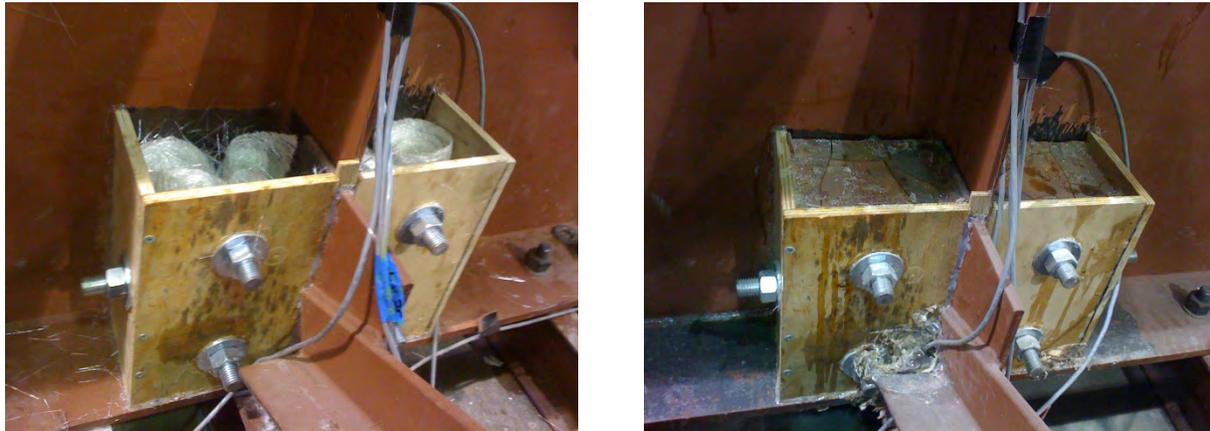
**Figure B.39: Interior view of the girder**  
**a) Prior to casting the West System™ two-part epoxy. b) View of the cured composite blocks**

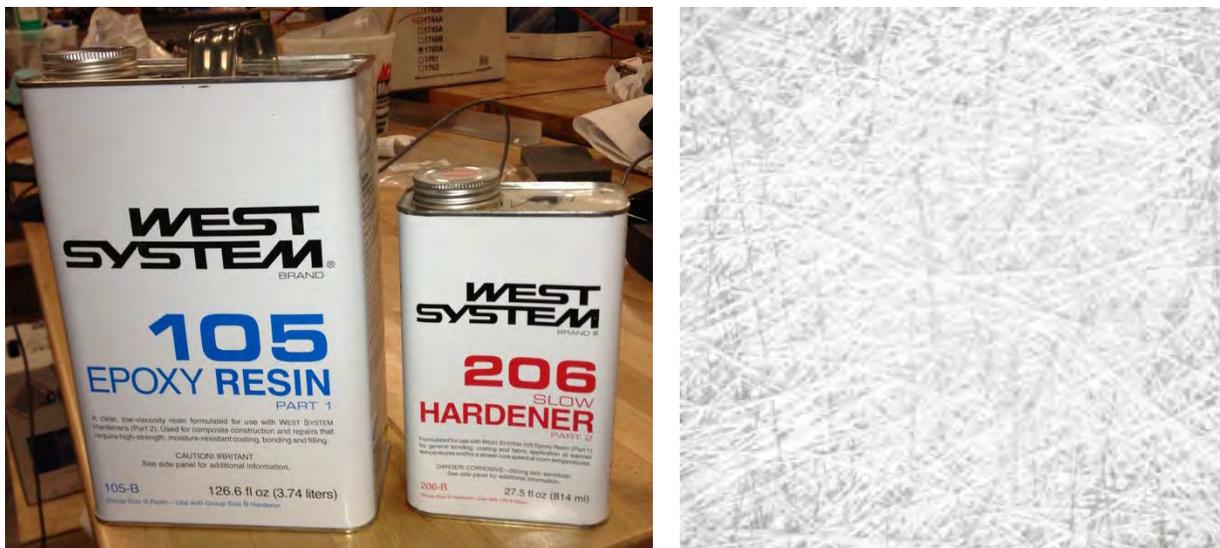
**Figure B.40: Materials used in the FRP block**  
**(a) West System™ two-part epoxy; (b) Mat fiberglass**

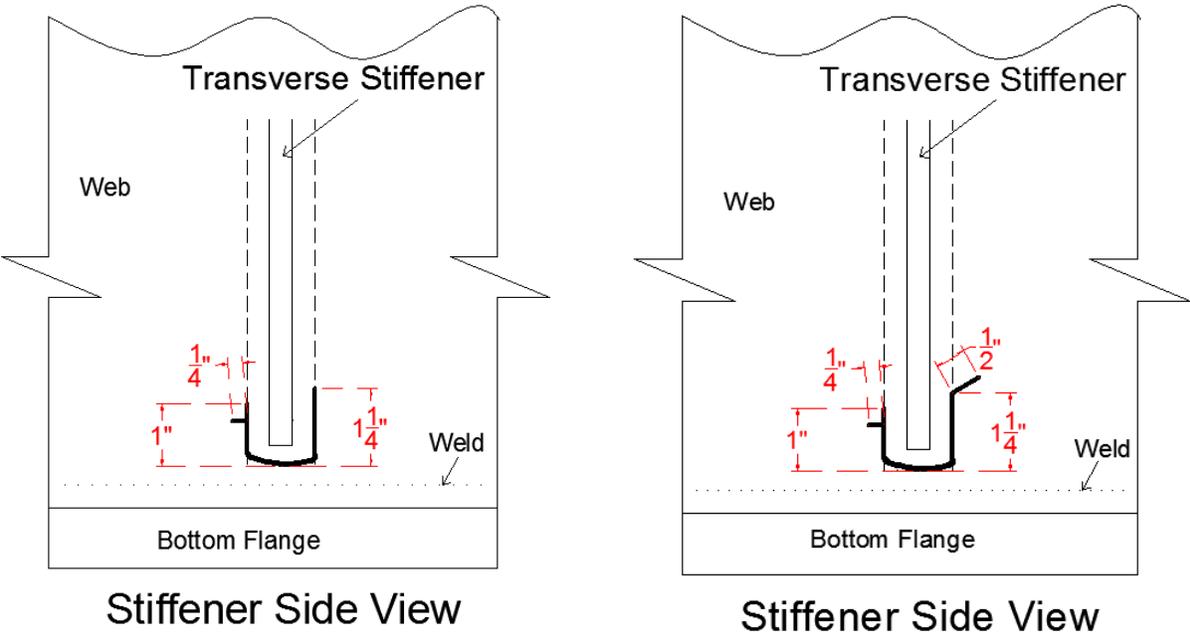
**Figure B.41: Recorded crack patterns (a) after Trial 1 (without FRP block retrofit); (b) After Trial 2 (with FRP block retrofit)**

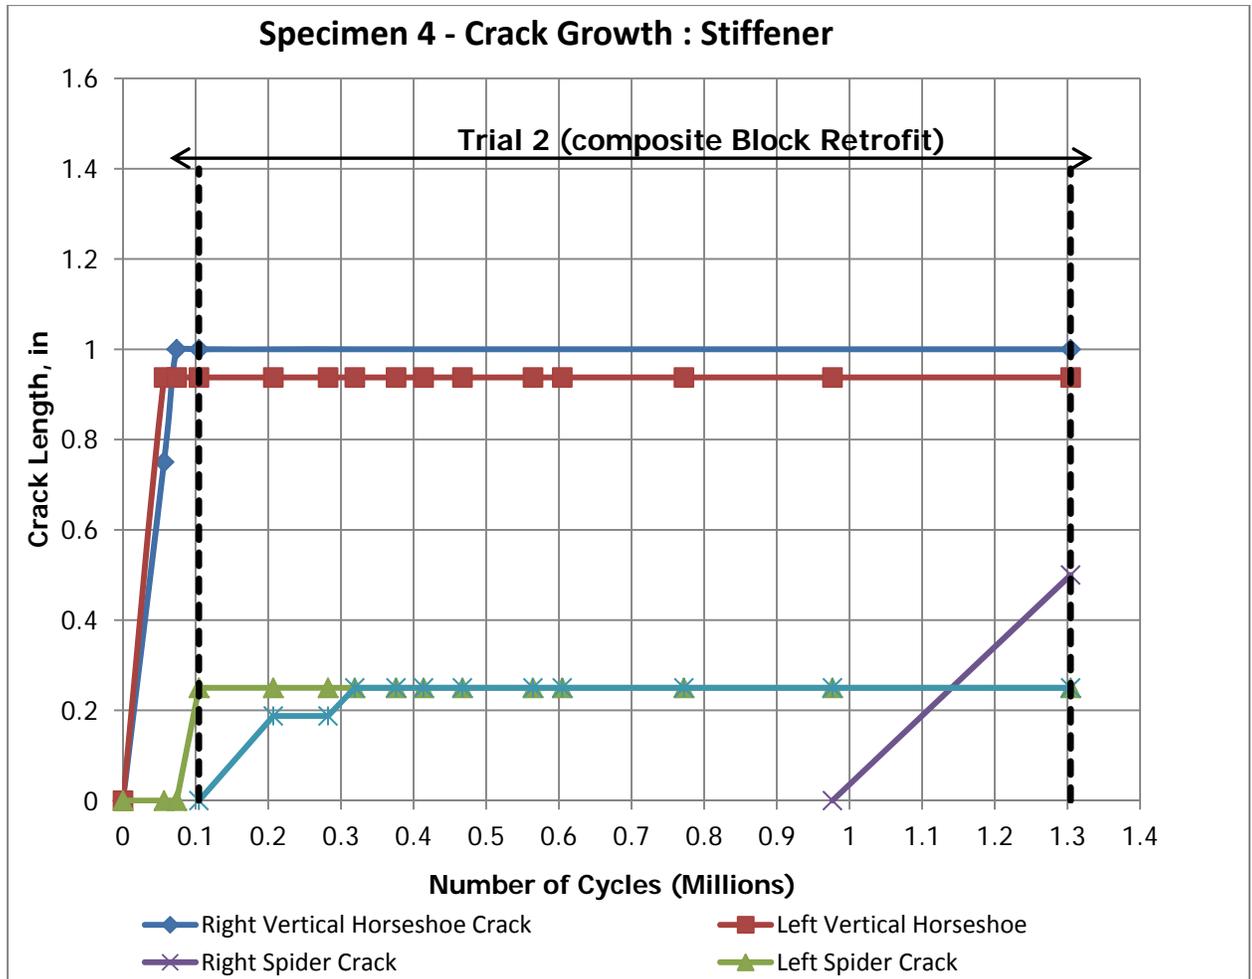
**Figure B.42: Graph of crack length vs. cycle count**

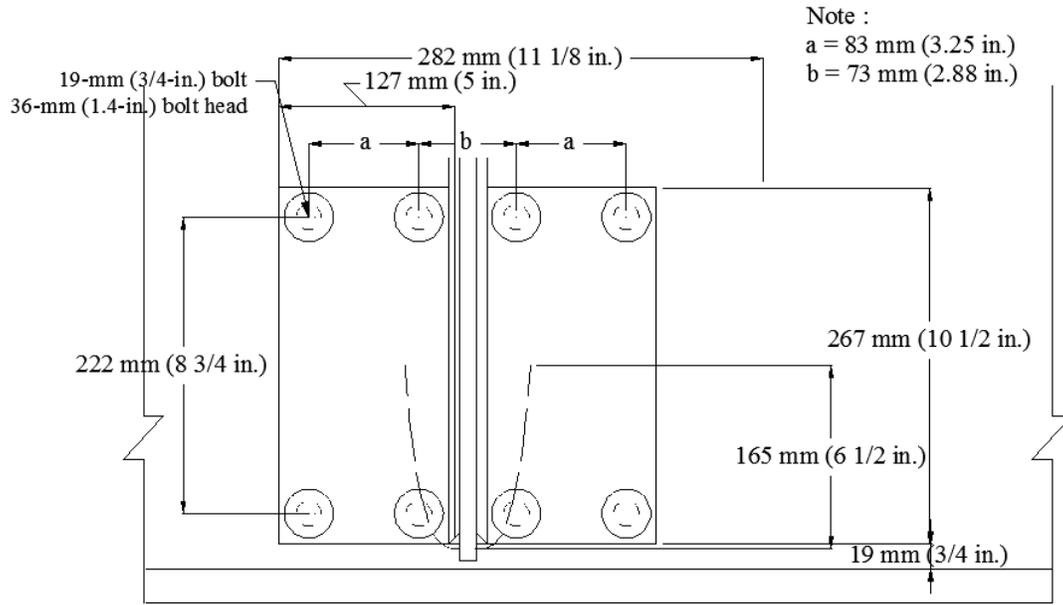
Figure B.54: Repair dimensions for crack length equal to  $\frac{1}{8}$  of the web depth

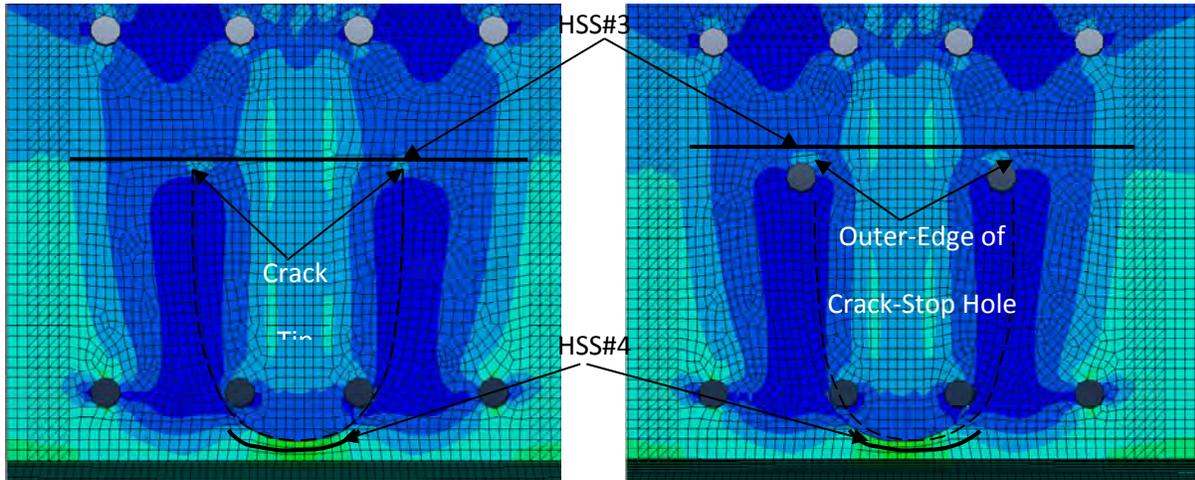
**Figure B.56: Hot spot stress paths used to evaluate fatigue damage repair methods**

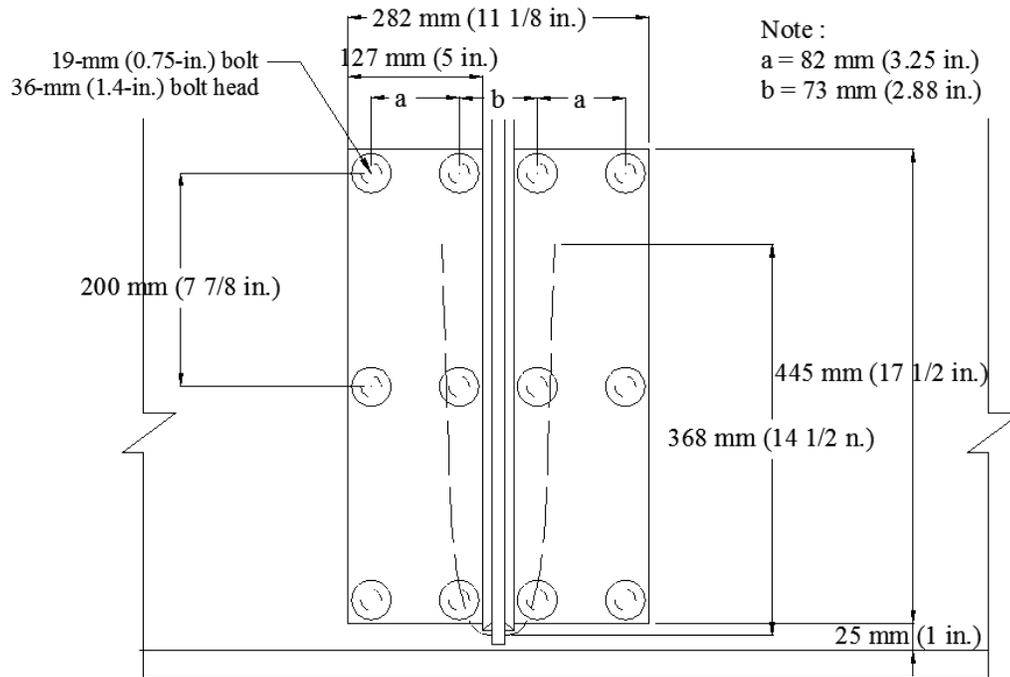
Figure B.62: CFRP repair measure with increased length of repair

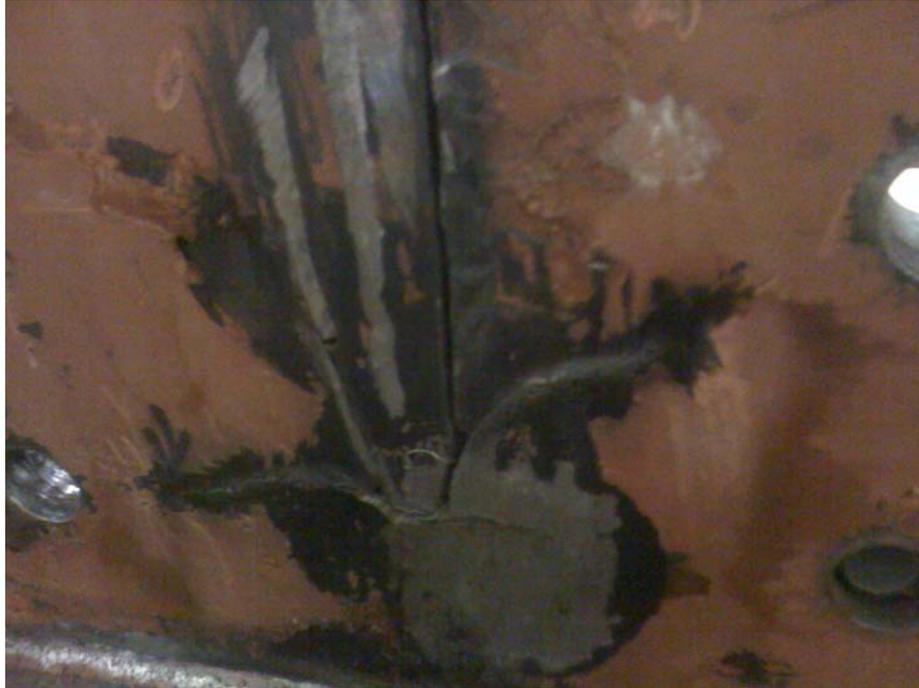
**Figure B.66: Existing cracks on exterior face of the girder's web**

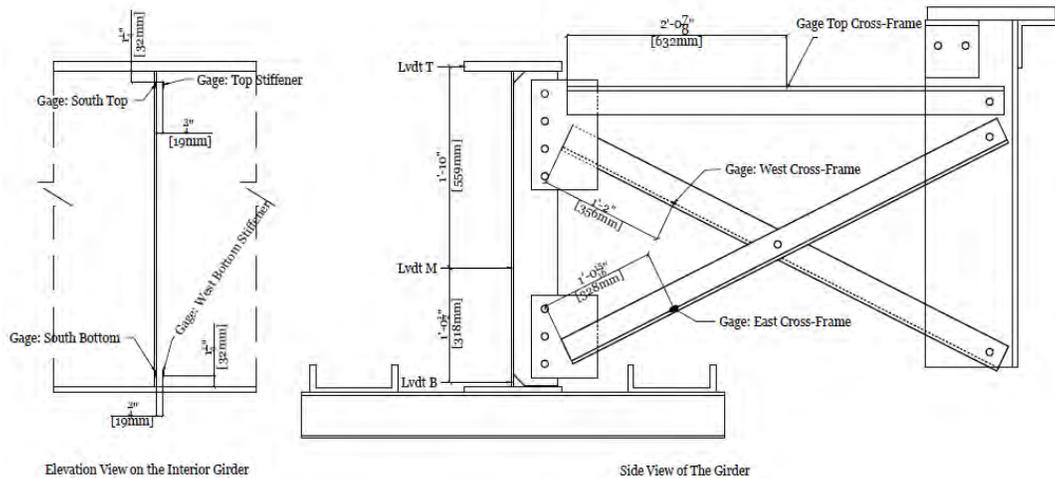
**Figure B.67: Instrumentation on the steel girder**

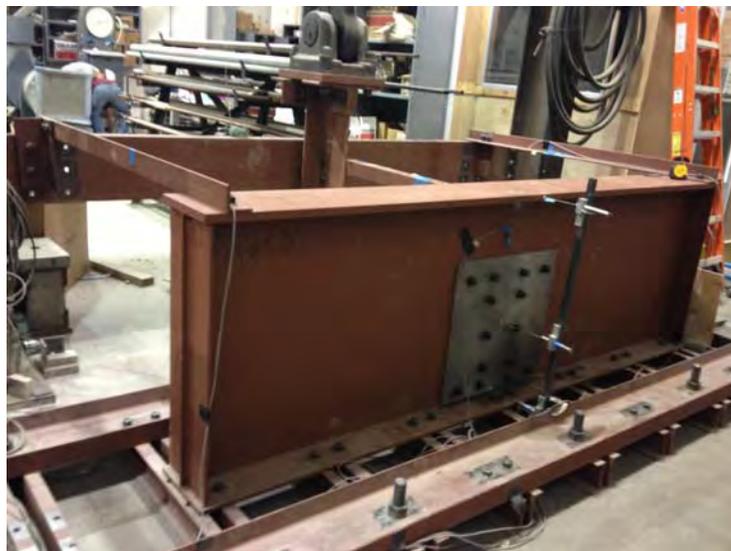
**Figure B.68: View on the exterior face of the girder's web with a steel back plate**

The specimen was tested with a cyclic tensile force that ranged from 0.5 kip to 5.7 kips applied on the top of the WT member. The test was divided into two trials: Trial 1 was performed with only the steel retrofit (only angles-with-back-plate retrofit) installed, followed by Trial 2, which included a 1.6 mm ( $1/16$  in.) thick CFRP layer attached to the web and connection plate (Figures B.68 and B.69), and sandwiched between the girder and angles-with-plate repair. In Trial 1, the steel retrofit used was two double angles and a back plate. The angles were 483 mm (19 in.) long, 2L3x3x $3/8$  standard angles, and the back plate was 13mm ( $1/2$  in.) thick with the dimension of 457 mm x 457 mm (18 x 18in.). Each angle was placed on each side of the connection plate and bolted to the girder's web using A325 structural bolts. The back plate was placed on the exterior face of the girder's web where there was no connection plate.

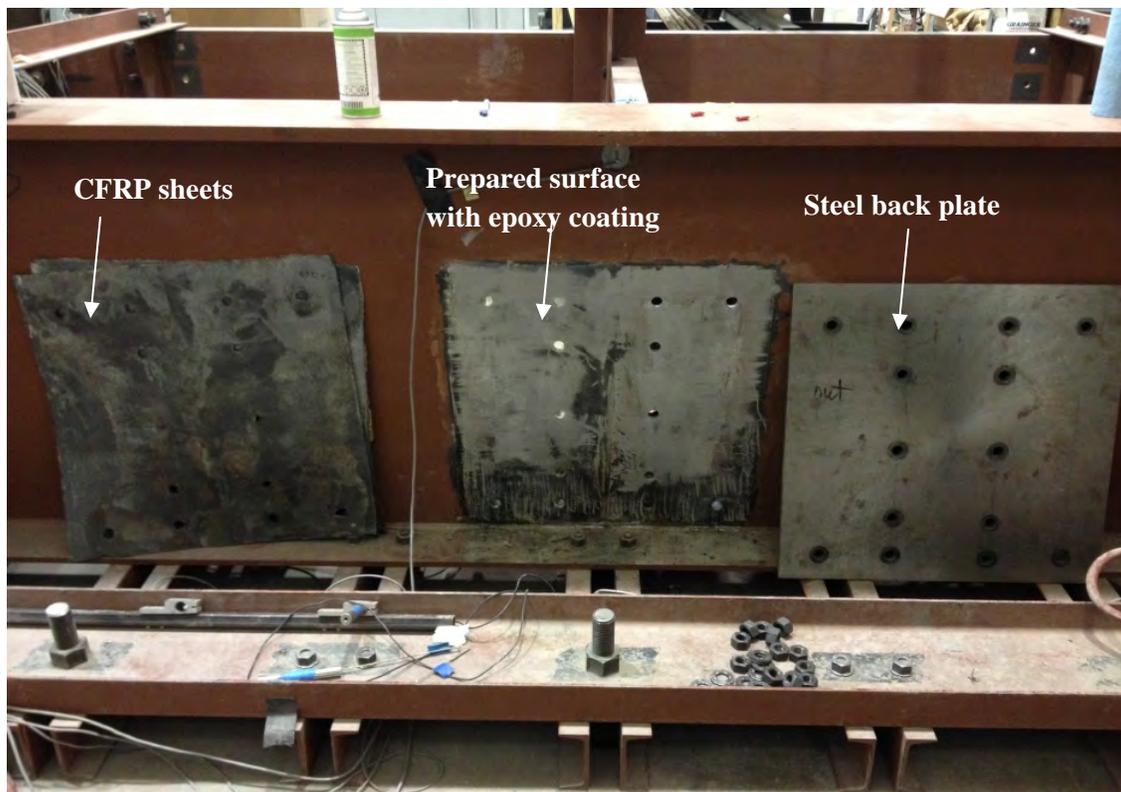
**Figure B.70: Trial 2: view of the exterior face of the girder's web**

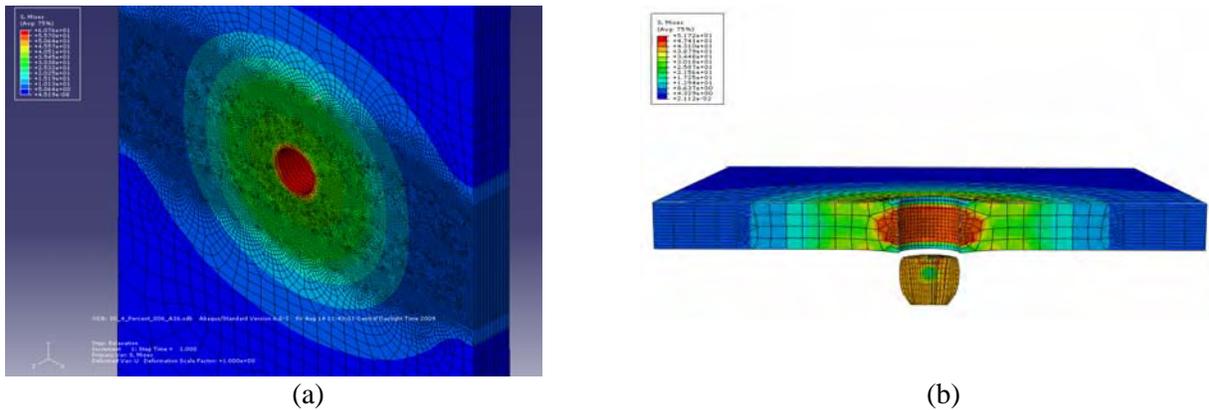
**Figure C.5: Screenshots**  
**From (a) 3D modeling of uniform expansion and resulting residual stresses in a crack-stop hole; (b) Cross-section view of plug-plate-tool interaction model showing residual stresses after the plug was loaded and removed**

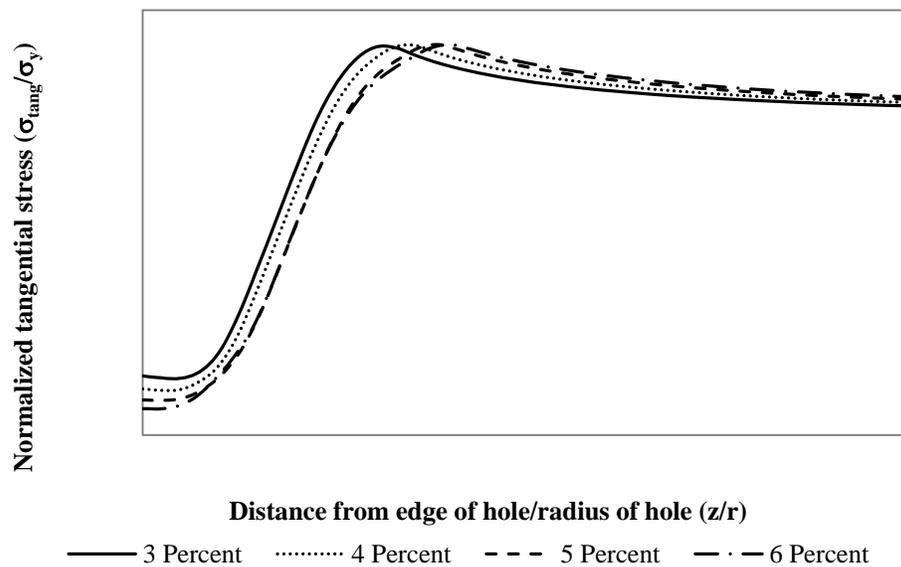
**Figure C.7: Tangential residual compressive stress fields resulting from uniform expansion mild steel 3-D models**

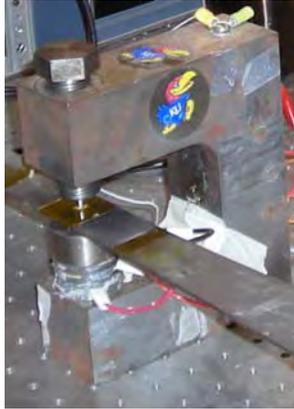
**Figure C.13: PICK tool being used to treat a steel tensile fatigue specimen**

The PICK tool was designed to compress the aluminum plug after it was inserted into a pre-drilled hole in the plate, to hold the compressive force on the plug, and to provide a stiff reaction platform to focus ultrasonic vibration into the aluminum plug and steel specimen. The PICK tool was proportioned have a large stiffness to ensure that most of the energy generated during ultrasonic vibration entered the specimen and plug, and was not absorbed by the tool itself. Ultrasonic vibration was induced by a stack of four piezoelectric transducer elements. The PICK tool was bench mounted with its major features being a C-shaped solid steel base, threaded bolt, four piezoelectric elements, and round load-transfer plate. The base and other steel components were machined from 4140 annealed steel with a yield strength of 60 ksi (412 MPa), and are shown in Figure C.13. The PICK tool was designed to accept plate material above the load transfer plate and piezoelectric element stack, and below the tip of the bolt. The hardened steel bolt tip was machined to have a truncated cone shape, with the smaller end matching the surface of the 3.2 mm ( $1/8$  in.) diameter aluminum plug. Underneath the fatigue specimen there was a round load-transfer plate, which was machined to fit on top of a nylon rod and fit tight with the top of the stack of piezoelectric elements beneath it; the nylon rod also held the piezoelectric elements in place. A hardened steel rod with a tip also machined to a dimension of 3.2 mm ( $1/8$  in.) was pressed into the top of the round load-transfer plate and completed the load path through the aluminum plug. Forces generated when the piezoelectric elements were powered with an amplified sine wave were transferred through the round load-transfer plate and into the aluminum plug. Further details regarding the design and functionality of the PICK tool are reported by Simmons (2013) and Simmons et al. (2013).

Before using the PICK tool to treat fatigue specimens, a strain gage was attached to the surface of the PICK tool and calibrated with a load cell to establish a load versus strain relationship (Simmons 2013); this calibration provided a relationship to calculate the load applied to the aluminum plug based on strain measurements on the PICK tool itself.
