# Enhancement of Welded Steel Bridge Girders Susceptible to Distortion-Induced Fatigue

*The University of Kansas Center for Research, Inc.*

*A Transportation Pooled Fund Study - TPF-5(189)*

## **Appendix A: Development of the Angles-with-Plate Repair**

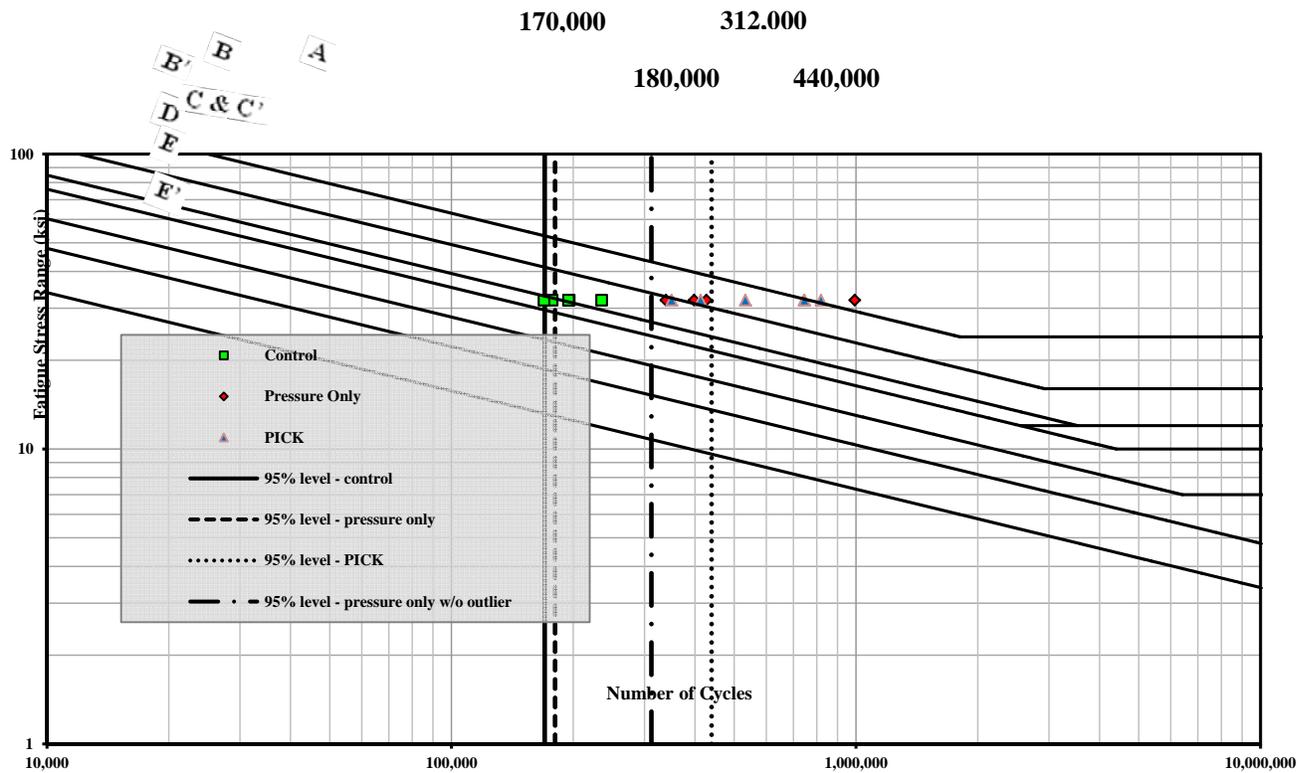
**Figure C.15: Fatigue test results plotted on S-N diagram**

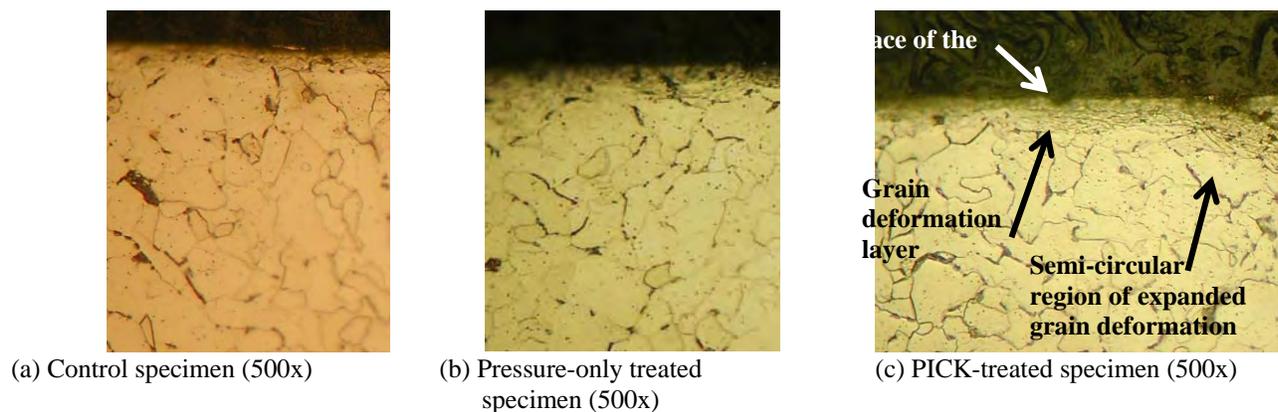
**Figure C.17: Comparison of control, pressure-only, and PICK-treated microstructures at the hole surface**

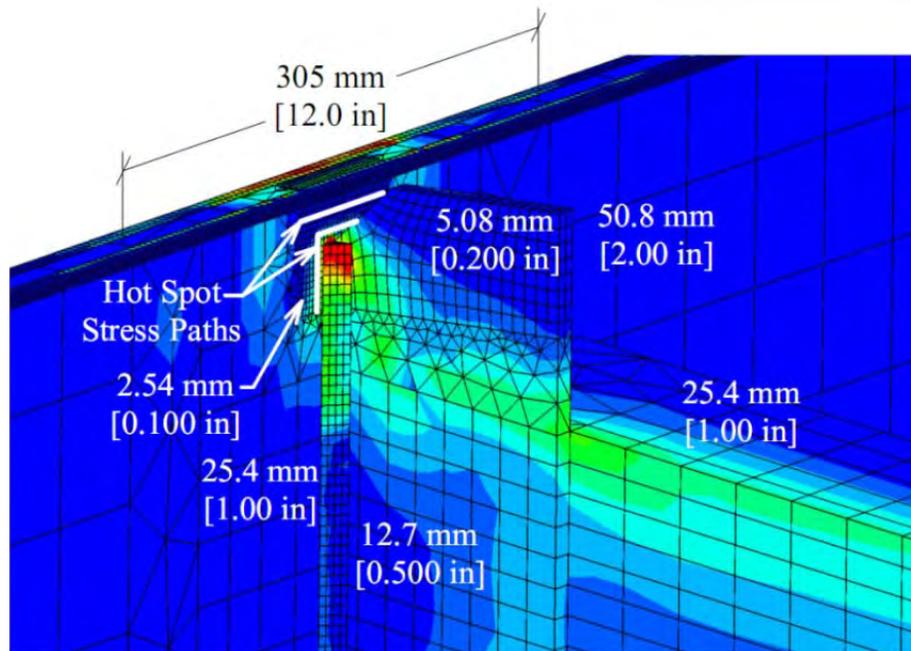
**Figure D.4: Hot Spot Stress analysis and mesh sizes**  
**Dimensions provided are element sizes**

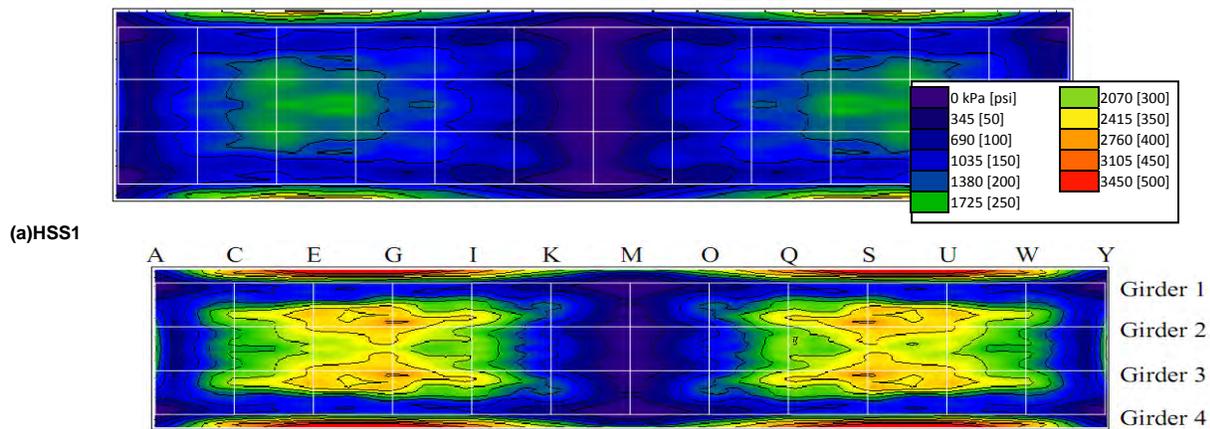
**Figure D.5: Envelope surfaces for the non-skew bridge**

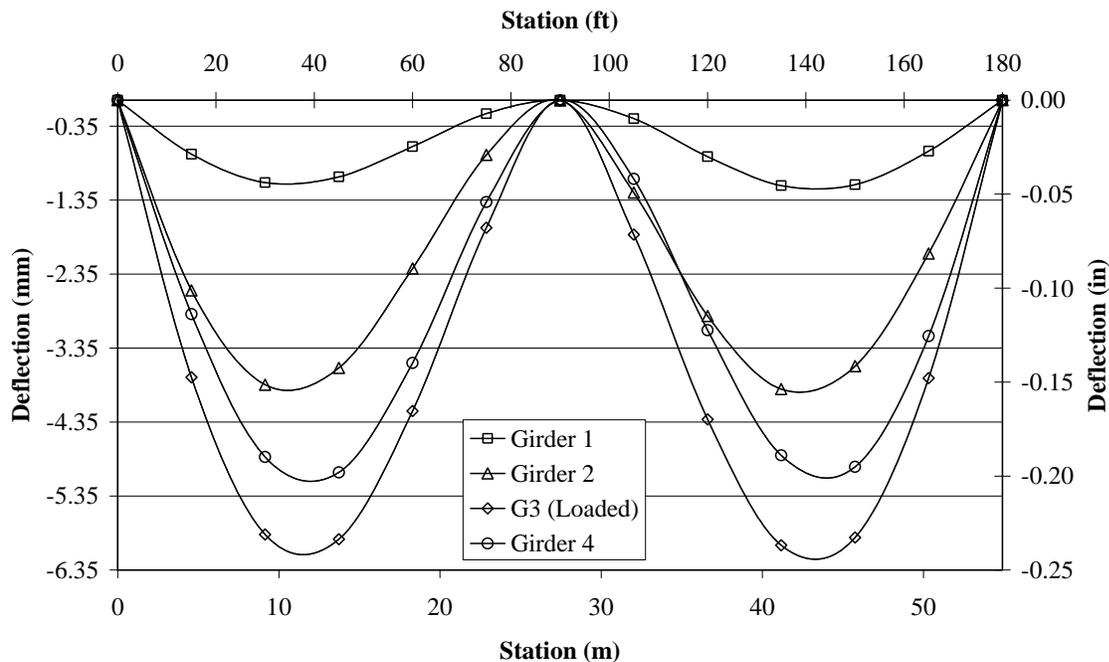
**Figure D.19: Deflected profile of girders from 40 degrees skewed model  
Cross frames positioned parallel to skew, spaced at 4.58 m (15 ft)**

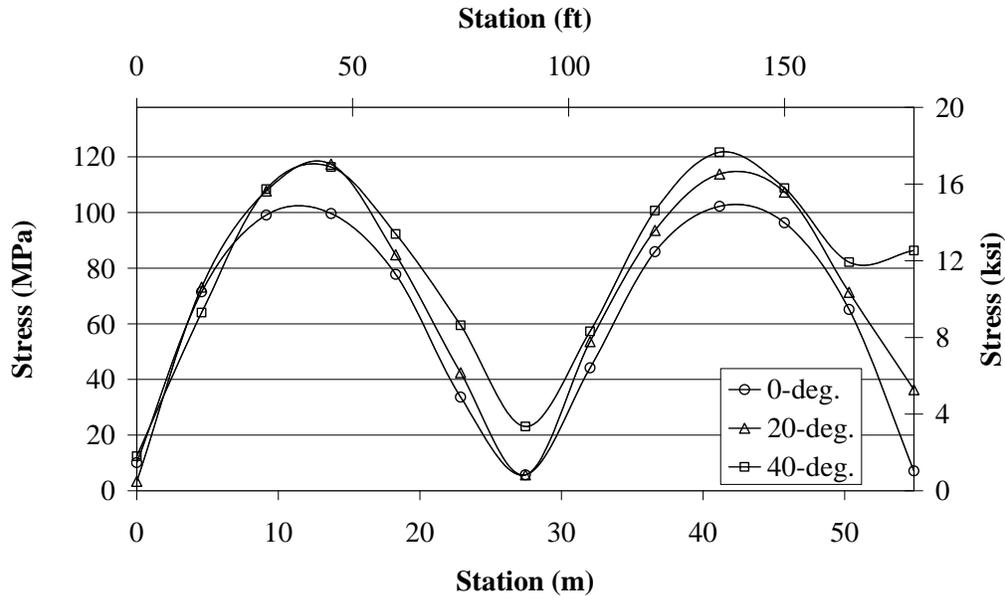
**Figure D.20: Maximum stress in top web gap region of girder 4-north at each cross frame location in parallel to skew models with 4.58 m (15 ft) spacing**

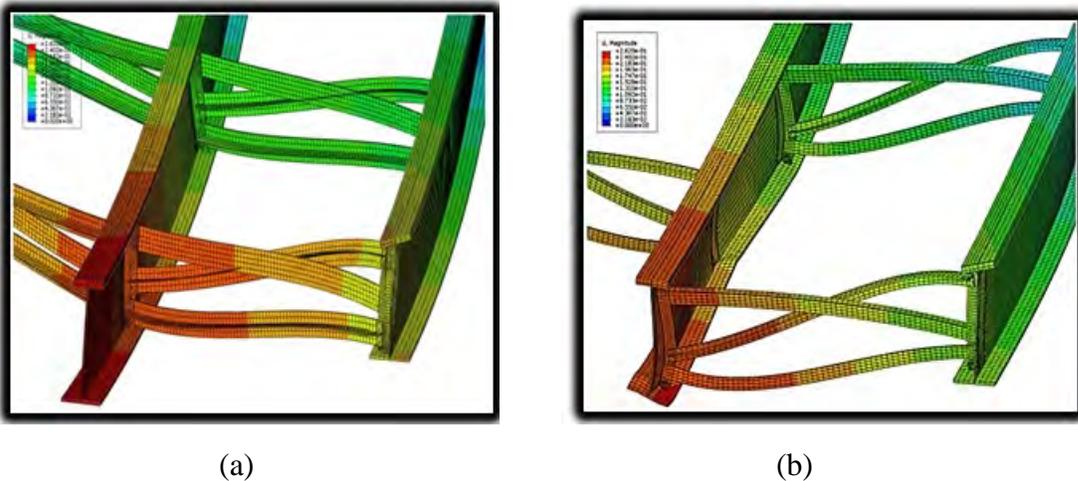
**Figure D.21: Deflected shape of 40 degree skewed bridge with 4.58 m (15.0 ft) cross frame spacing and: (a) cross frames placed parallel to skew; (b) staggered cross frames. Deck removed from view for clarity**
