TPF-5(433) Behavior of Reinforced and Unreinforced Lightweight Cellular
Concrete (LCC) For Retaining Walls

**Interim Report on Test of MSE Wall with Lightweight Cellular Concrete Backfill
and Welded-Wire Reinforcement**

November 19, 2021

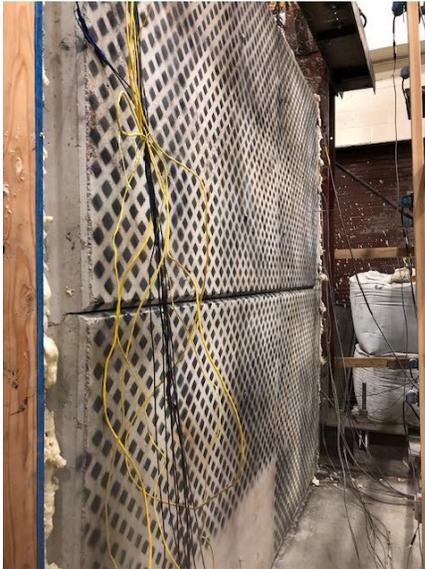
Figure 12: (a) photograph of MSE wall panel deflection at failure, and (b) measured horizontal deflection of the wall versus height above the base of the wall for selected surcharge pressures.

Based on the string potentiometer measurements on the front face of the MSE wall, horizontal wall deflection has been plotted as a function of height above the base of the wall for selected surcharge pressures in Figure 12. The string pots were located at the height of the MSE reinforcement connections. All displacement were less than about 0.30 inch for surcharge pressures up to 55 psi. At the peak surcharge pressure of 64 psi, wall deflection exceeded 0.40 inch with the maximum value at the top of the wall with deflection of about 0.15 inch at the bottom. As the strength decreased post-peak, the displacement of the MSE wall panels accelerated with the maximum value ultimately occurring at the top of the two wall panels (10 ft). Overall, displacements of the top panel were greater than those on the bottom panel.

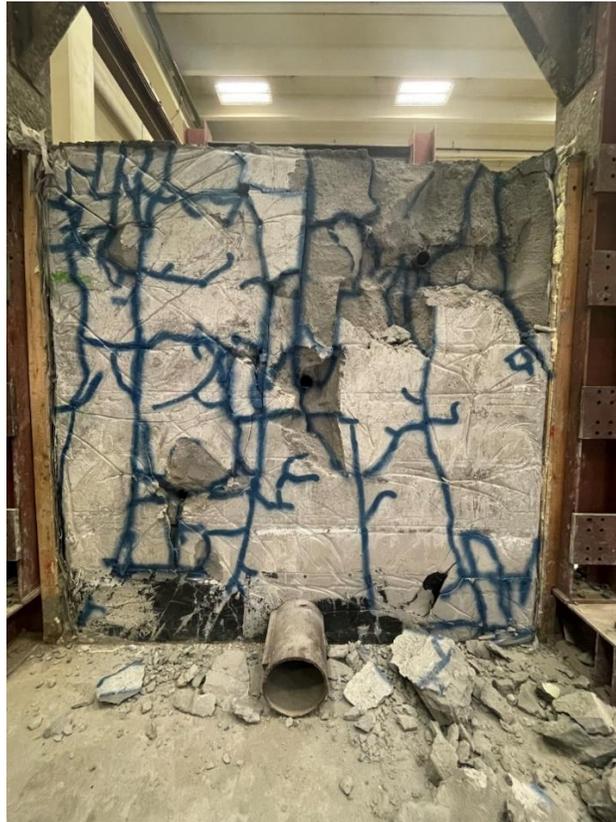
Figure 14: Photograph of the crack pattern in the LCC on the free face opposite to the MSE retaining wall side.

A photograph of the free face at the completion of the surcharge loading adjacent to the free face is shown in Figure 14. The cracks were spray-painted with blue paint to highlight their locations. The cracks consist of both vertical and horizontal or inclined cracks. Visual observations at the time that the wall was failing indicated that the top half of the wall appeared to be moving as an intact block that was sliding downward on top of the underlying shear planes. Surcharge loading was halted to prevent the sliding mass from reaching complete failure. Nevertheless, some blocks of LCC toppled to the floor once the surcharge pressure exceeded 42 psi.
