Dynamic Passive Pressure on Abutments and Pile Caps

PI's Profs. Rollins and Gerber

Quarterly Report Aug-Oct 2006

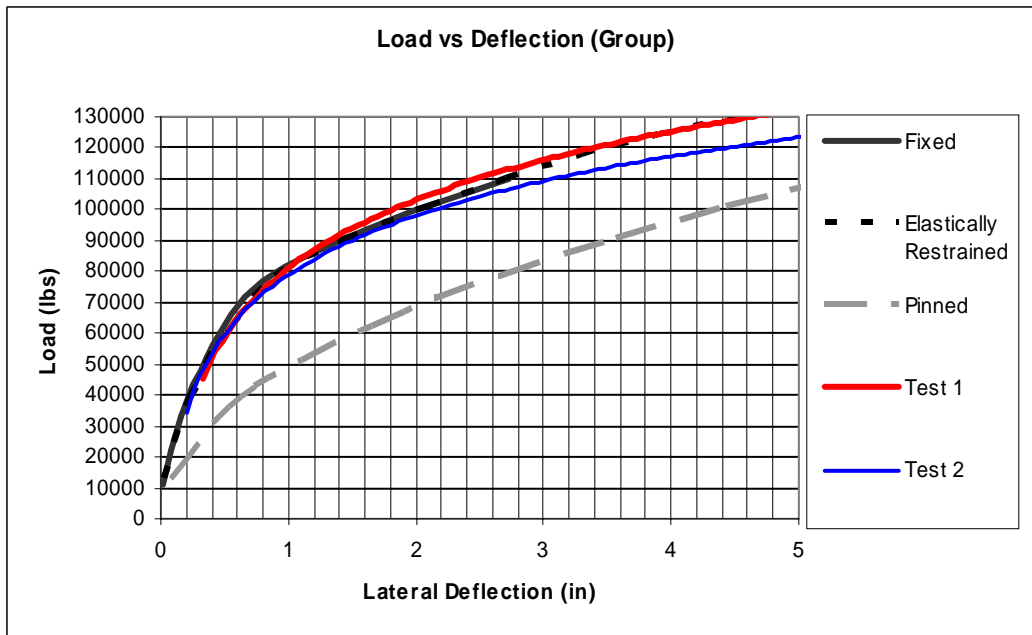
Figure 4 Measured versus predicted load-deflection curves for Test Caps 1 and 2.

Figure 4 provides plots with logarithmic trend line of the measured load-deflection curves for both Test Caps 1 and 2 as well as the load-deflection curves predicted by GROUP. As shown in Figure 4, analyses were performed with GROUP using three different boundary conditions: fixed, pinned and elastically restrained. Many

pile cap analyses assume that the pile cap provides a completely fixed head connection yet this is seldom achievable in the field. A pinned head assumption leads to much greater deflection for a given load which would represent a very conservative design approach. The elastically restrained condition utilizes a rotational stiffness coefficient $K_m\theta$ which was estimated using equations developed by Mokwa and Duncan (2003). The elastically restrained condition is believed to be the best approximation to the true field conditions; however, as shown in Figure 4, in this case the results for the elastically restrained boundary condition were almost identical to those for the fixed head condition. The agreement between the measured load-deflection curves for the Test Caps 1 and 2 are both very similar to what was predicted using group for the elastically restrained case.

While the agreement between measured and computed load-deflection curves was somewhat better for Test Cap 1 than for Test Cap 2, the opposite was true with respect to the amount of rotation. Figure 5 shows logarithmic trend lines of the observed rotation in degrees on the abscissa relative to the applied lateral load in lbs on the ordinate. Because rotation was computed using both string pots on the top and front faces of the pile cap,

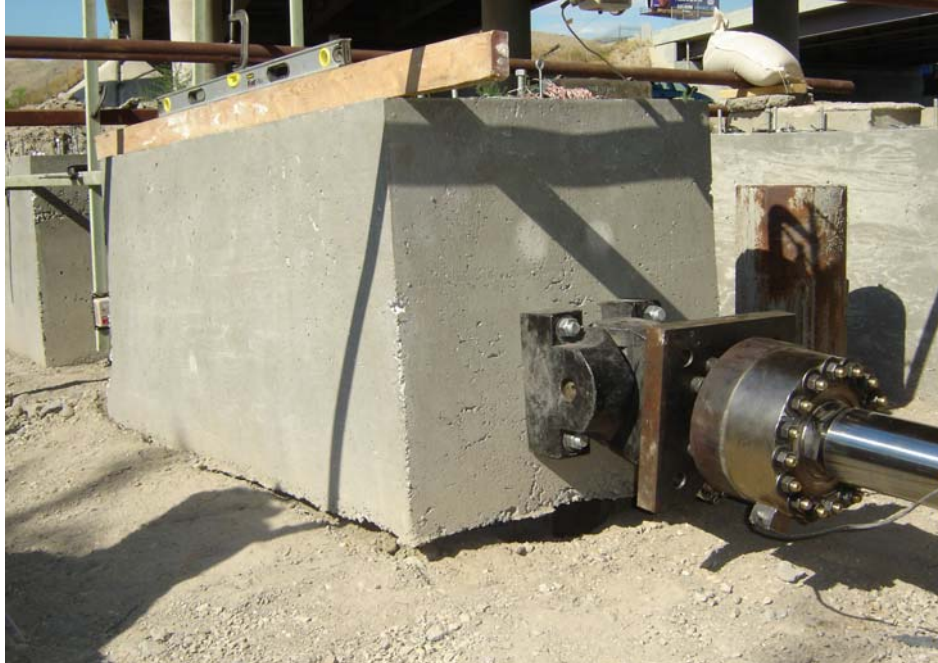
Figure 6 Uplift and rotation of Test Cap 1 at failure.

The picture in Figure 6 shows Test Cap 1 failing by an excessive amount of uplift and rotation. The connection between the pile and pile cap appeared to be adequate as no significant slippage was observed. Test Cap 2 failed in a very similar manner to that described for Test Cap 1.

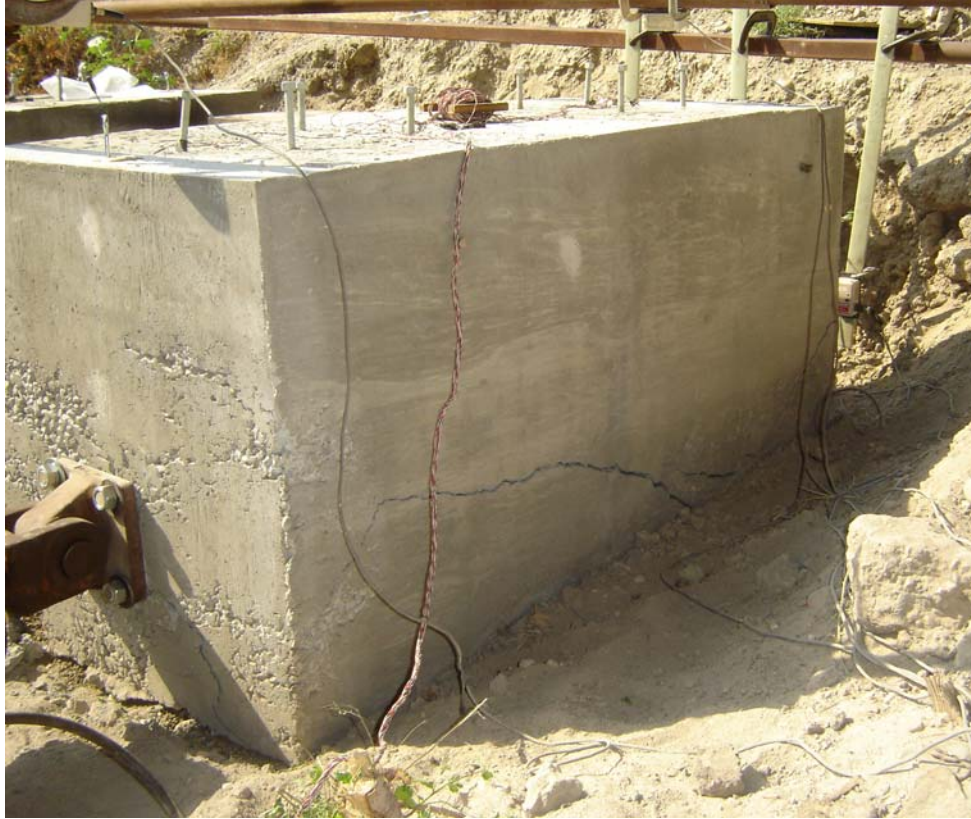
Figure 7 Initial cracking Test Cap 3.

The first two pile caps tested were typical of pile cap connections employed by Utah DOT in the field. From a cost standpoint, it would be desirable to eliminate the connection reinforcement from the design and construction of future pile caps. This approach has been used by Oregon DOT in their designs. Test 3 and Test 4 were both constructed without a reinforcing cage connecting the piles and pile cap to determine if the connection capacity could be developed along the length of the embedded pile. Test Cap 3 has a 12 inch pile embedment with a hollow steel pile, while Test Cap 4 is embedded 24 inches into the pile cap as shown in Figure 2 with a concrete filled pile. Test Cap 4 performed very similar to Test Caps 1 and 2 and failure occurred in the same way. Test 3 however failed in the connection. Initial cracking shown in Figure 7 began to develop at a lateral load of 80 kips, and as each additional loading cycle was applied, a significant amount of additional cracking developed as shown in Figure 8. With the lateral force being applied in direct line of the connection (one foot above grade), the pile cap experienced a large amount of tensile and shear forces.
