TECHBRIEF

Enhancing Conspicuity for Standard Signs and Retroreflectivity Strips on Posts

FHWA Publication No.: FHWA-HRT-22-066

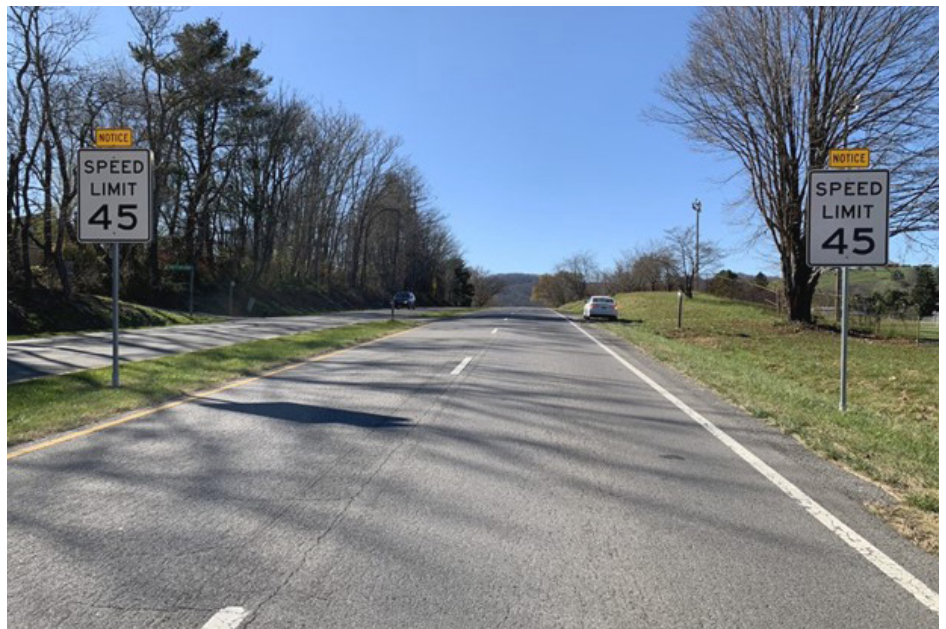
Figure 1. Graphic. Example of enhanced conspicuity for signs: W16-15P (Federal Highway Administration 2009).

A – W16-15P plaque above a regulatory or warning sign if the regulation or condition is new

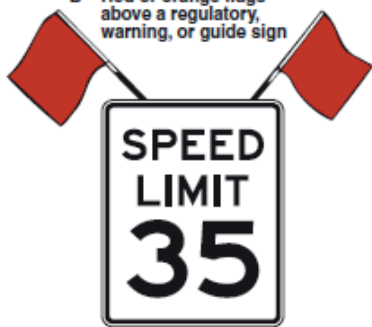
Figure 3. Graphic. Example of enhanced conspicuity for signs: W16-18P (Federal Highway Administration 2009).

C – W16-18P plaque above a regulatory sign

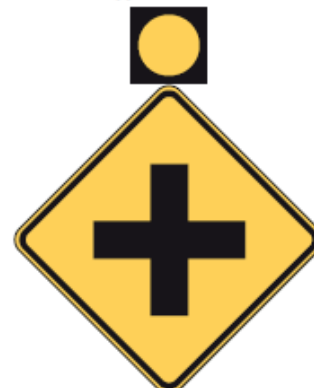
Figure 6. Graphic. Example of enhanced conspicuity for signs: supplemental beacon (Federal Highway Administration 2009).

F – Supplemental beacon

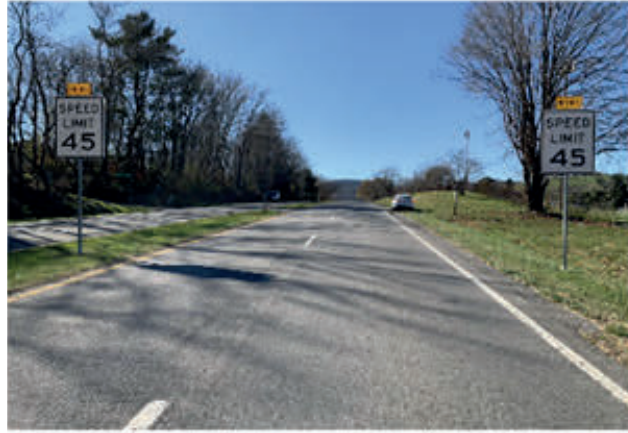
Figure 21. Photo. After treatment: fluorescent yellow NOTICE header panel.

Note: The NOTICE header panels shown in figure 21 are not compliant with the MUTCD. The MUTCD allows for only a header panel that is the full width of the sign.
